Report no. 0374

# **Tanrallt Hall, Abergele Road, Llanddulas, Abergele LL22 8HR**

## **October 2022 v1.0**

Historic Building Record Level 2

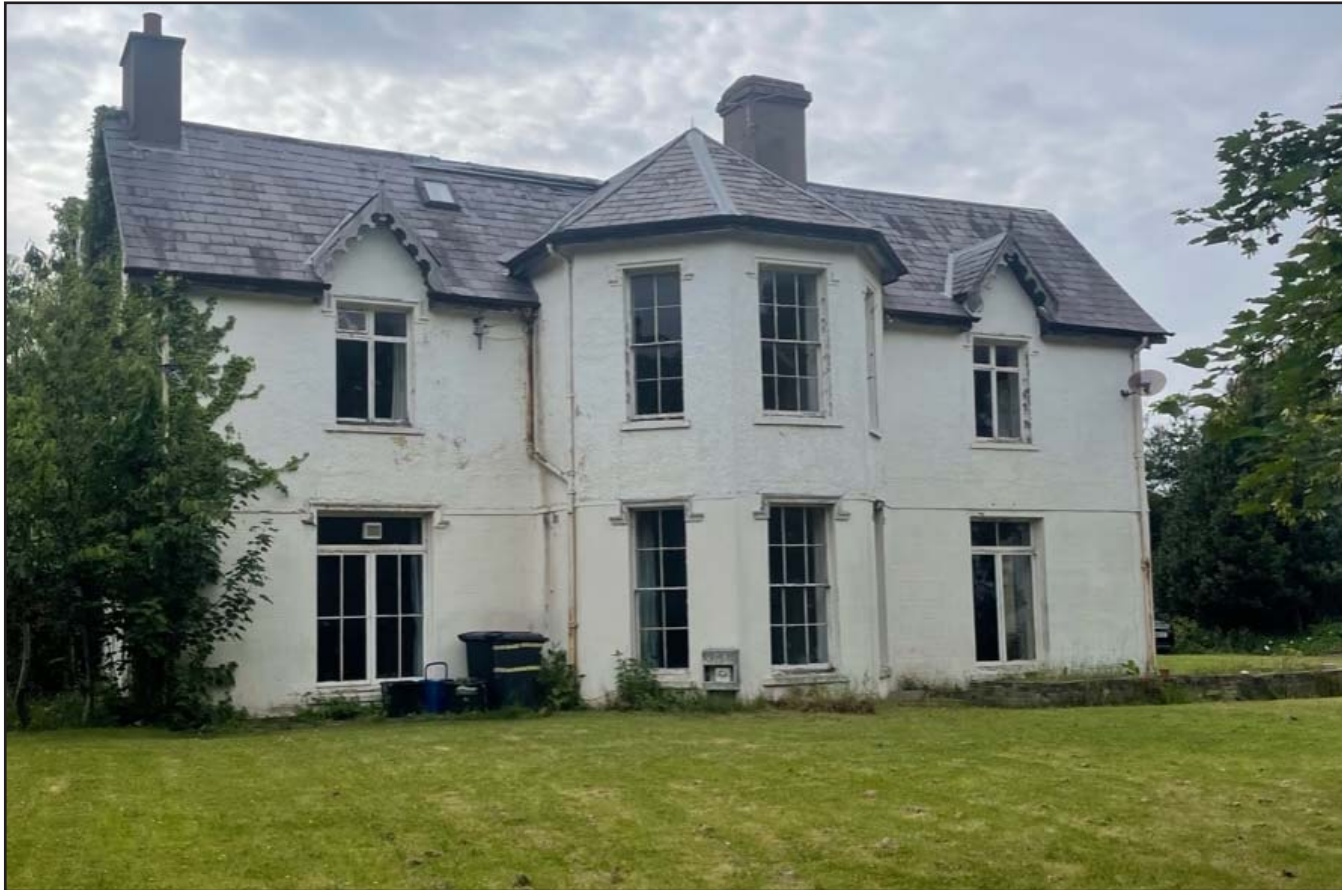
**Plate A:** View of Tan-yr-Allt Hall prior to renovation works, taken by the Client - from the southeast.

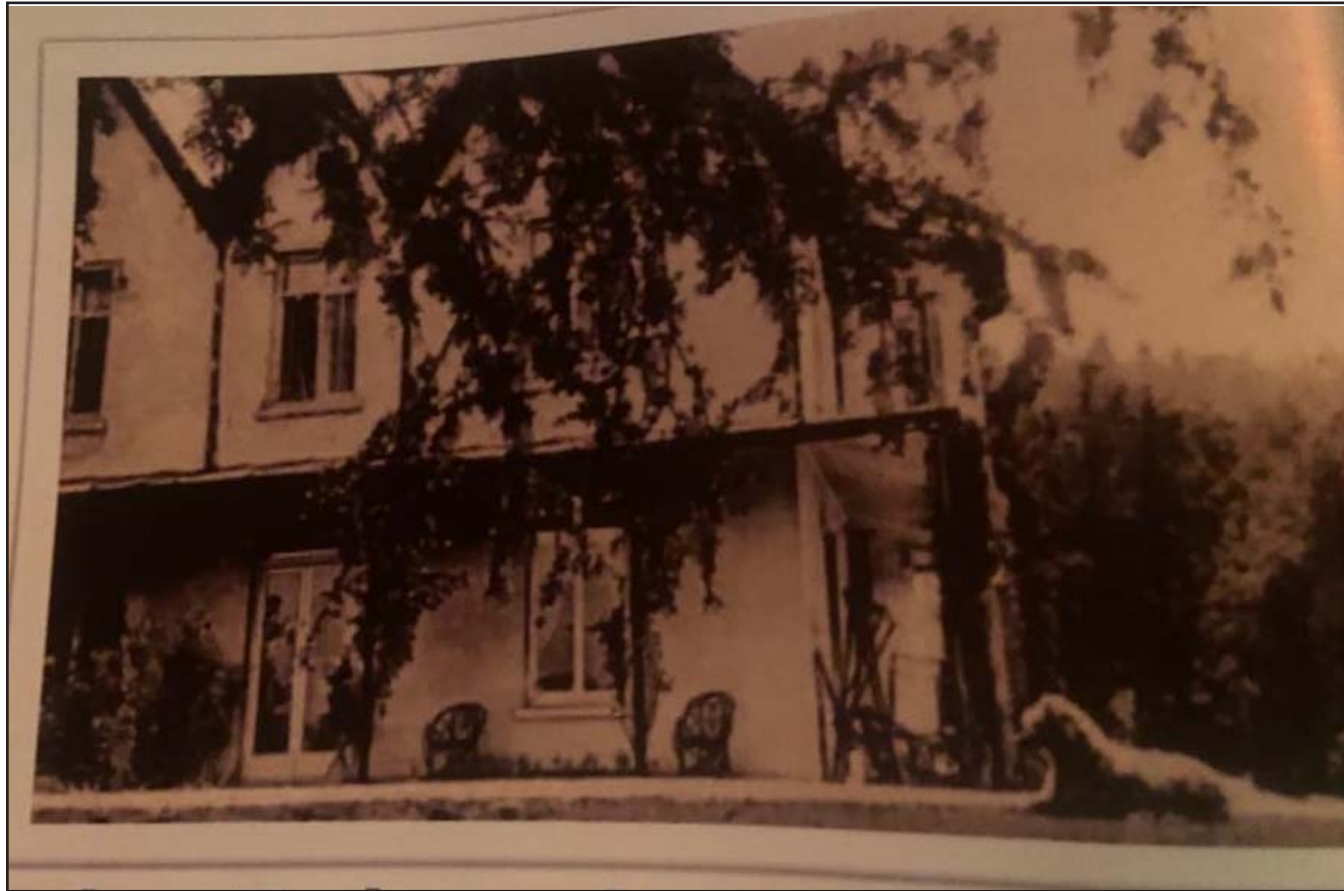
**Plate B:** Photograph of Tan-yr-Allt Hall (date unknown) provided by the Client, showing former veranda - from the east.

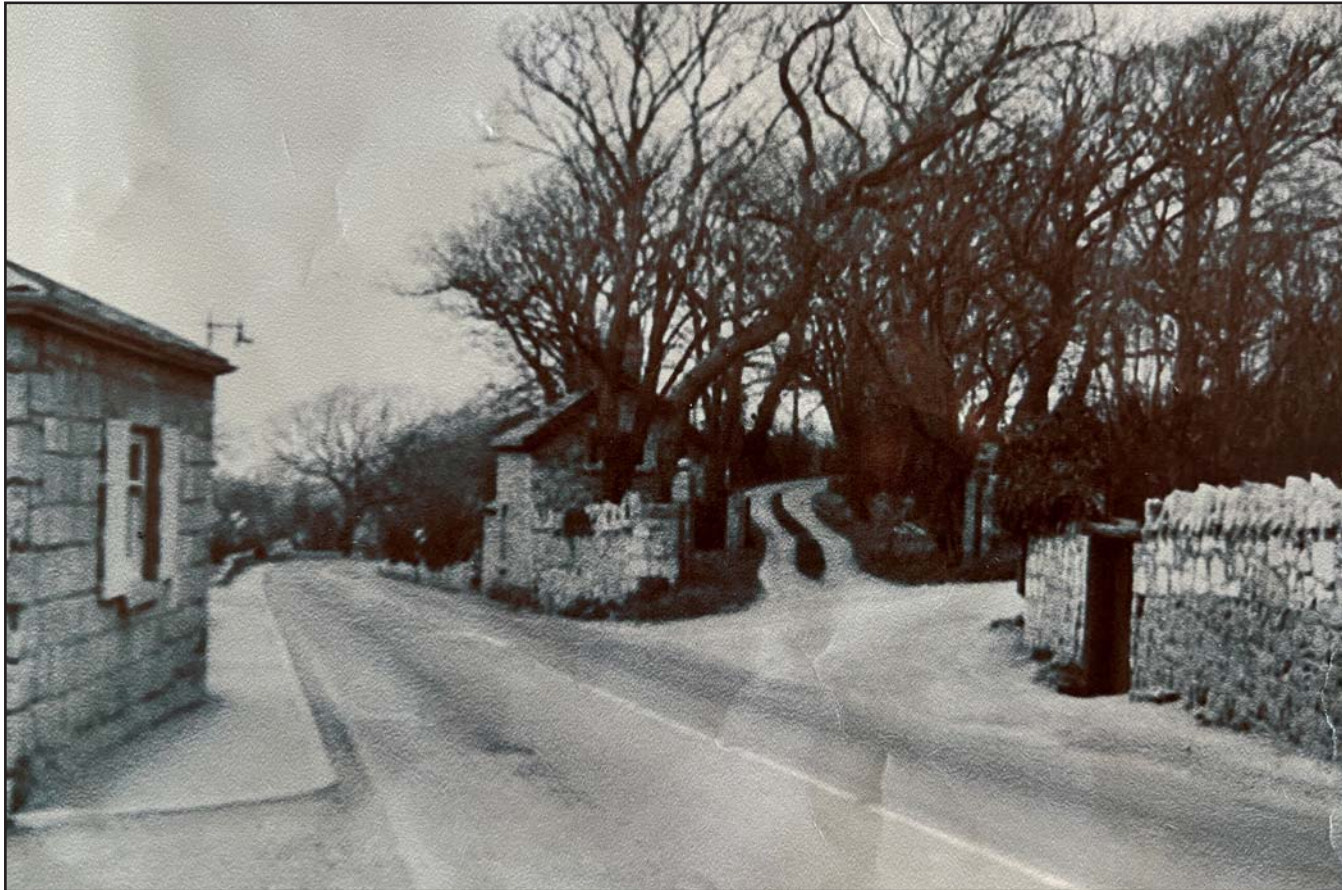
**Plate C:** Photograph of Tan-yr-Allt Hall driveway entrance (date unknown) provided by the Client, accessed from Abergele Road - from the northwest.

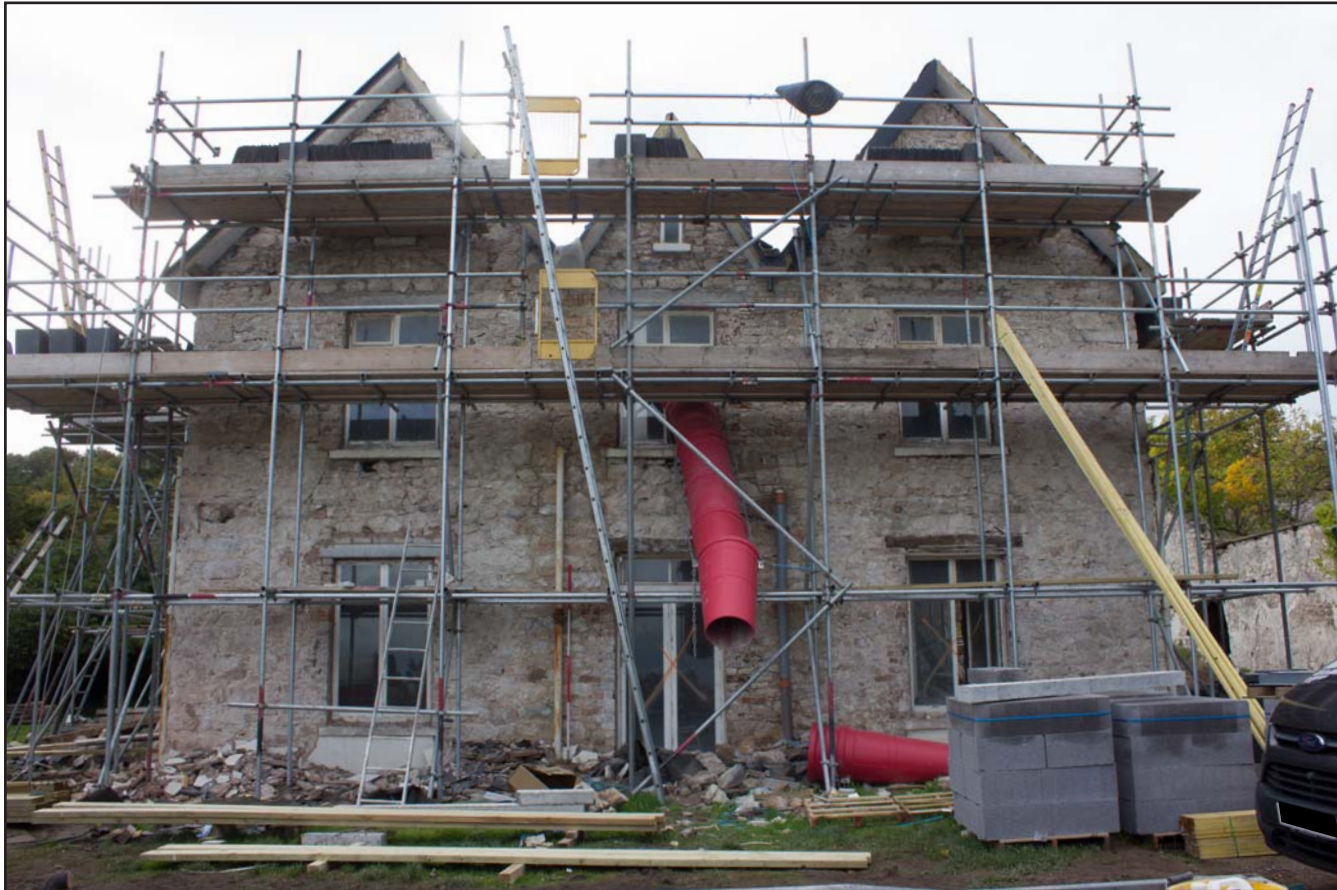
This is divided into three bays via three gables; the central one being smaller (both lower and narrower) and the flanking gables being larger and sharing identical proportions). Each of these gables have three equally spaced, single pane fixed, lancet windows in white painted wooden frames, with white painted stone sills. Beneath this arrangement at first floor level there are three equally spaced, four pane, casement windows in white painted wooden frames with white painted stone sills beneath, these windows have had their lintels replaced with concrete. These windows also have brick detail surrounds.

At ground floor level a centralised doorway opening is flanked by two, equally spaced, two pane, casement windows in white painted wooden frames. The centralised doorway has been replaced with a two-pane, fixed window, with white painted wooden frame with a single transom window above. Both windows and the doorway openings have redbrick detail surrounds. The doorway and the right-hand window have wooden lintels, whilst the left window has had its lintel replaced by concrete.

**Plate 01:** Principal, north facing elevation of Tanrallt Hall, Abergele Road, Llanddulas, Abergele - from the north - 2.00m scale

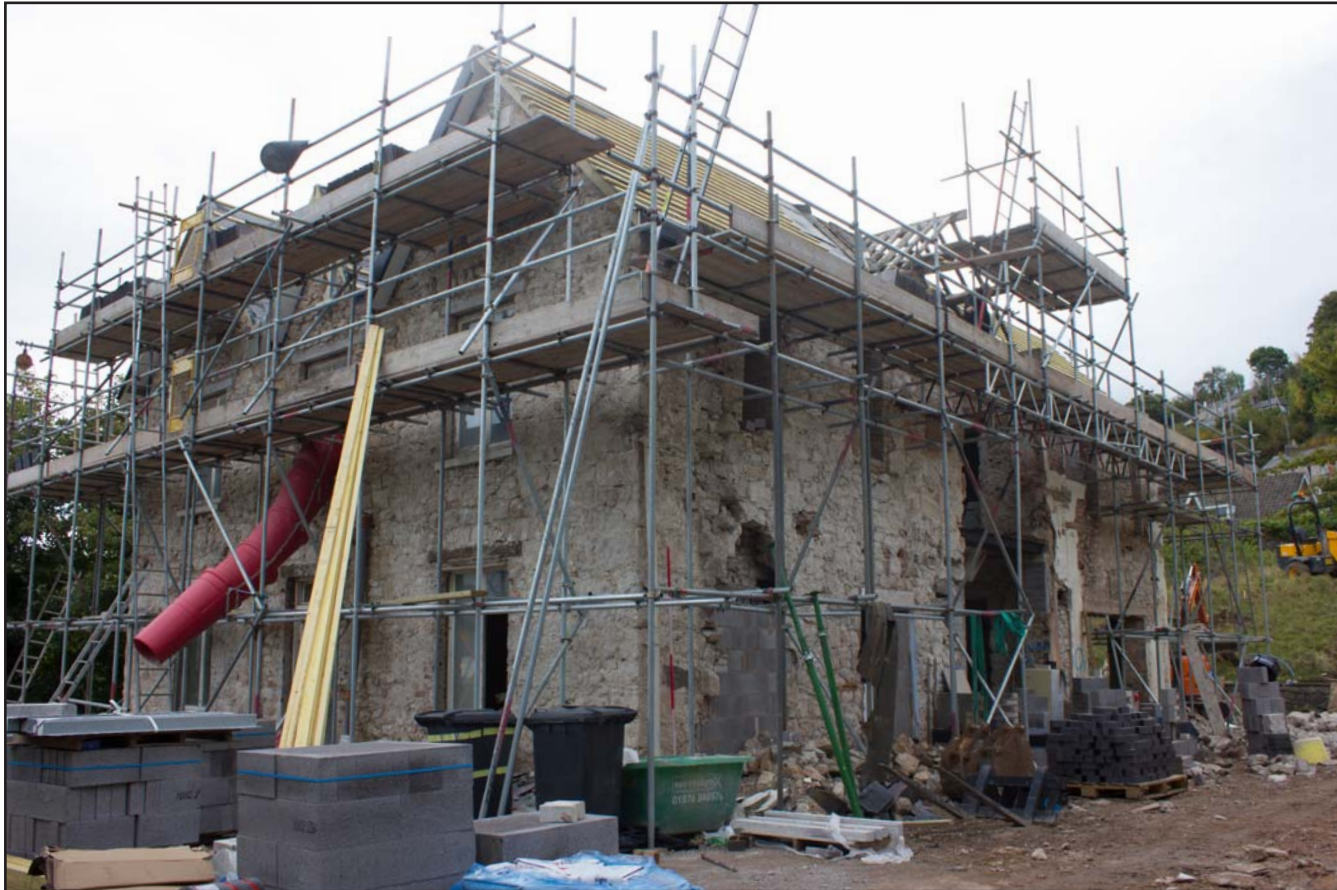
**Plate 02:** Oblique shot of northern & western elevations of Tanrallt Hall, Abergele Road, Llanddulas, Abergele - from the northwest - 2.00m scale

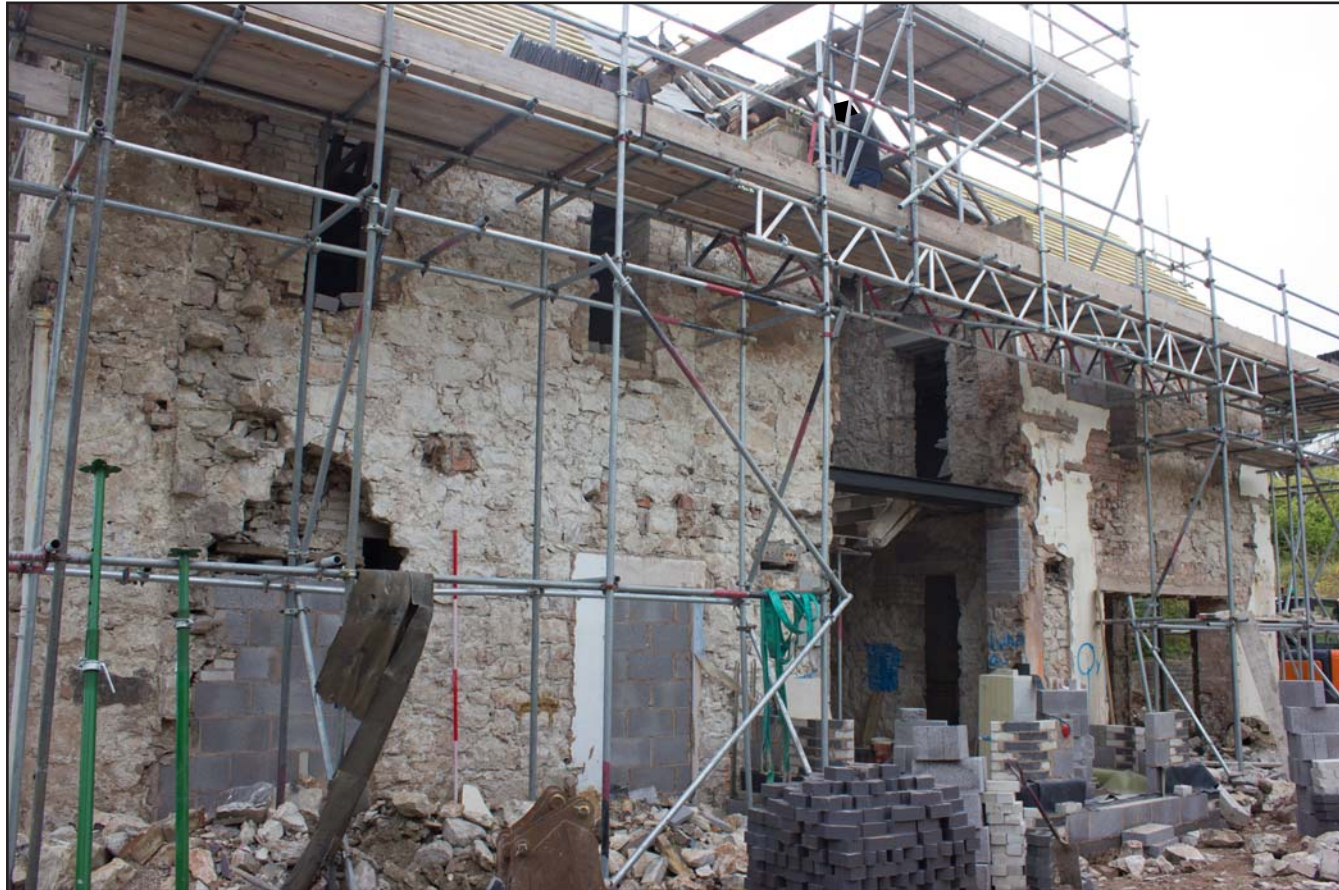
**Plate 03:** Western elevation of Tanrallt Hall, Abergele Road, Llanddulas, Abergele - from the northwest - 2.00m scale

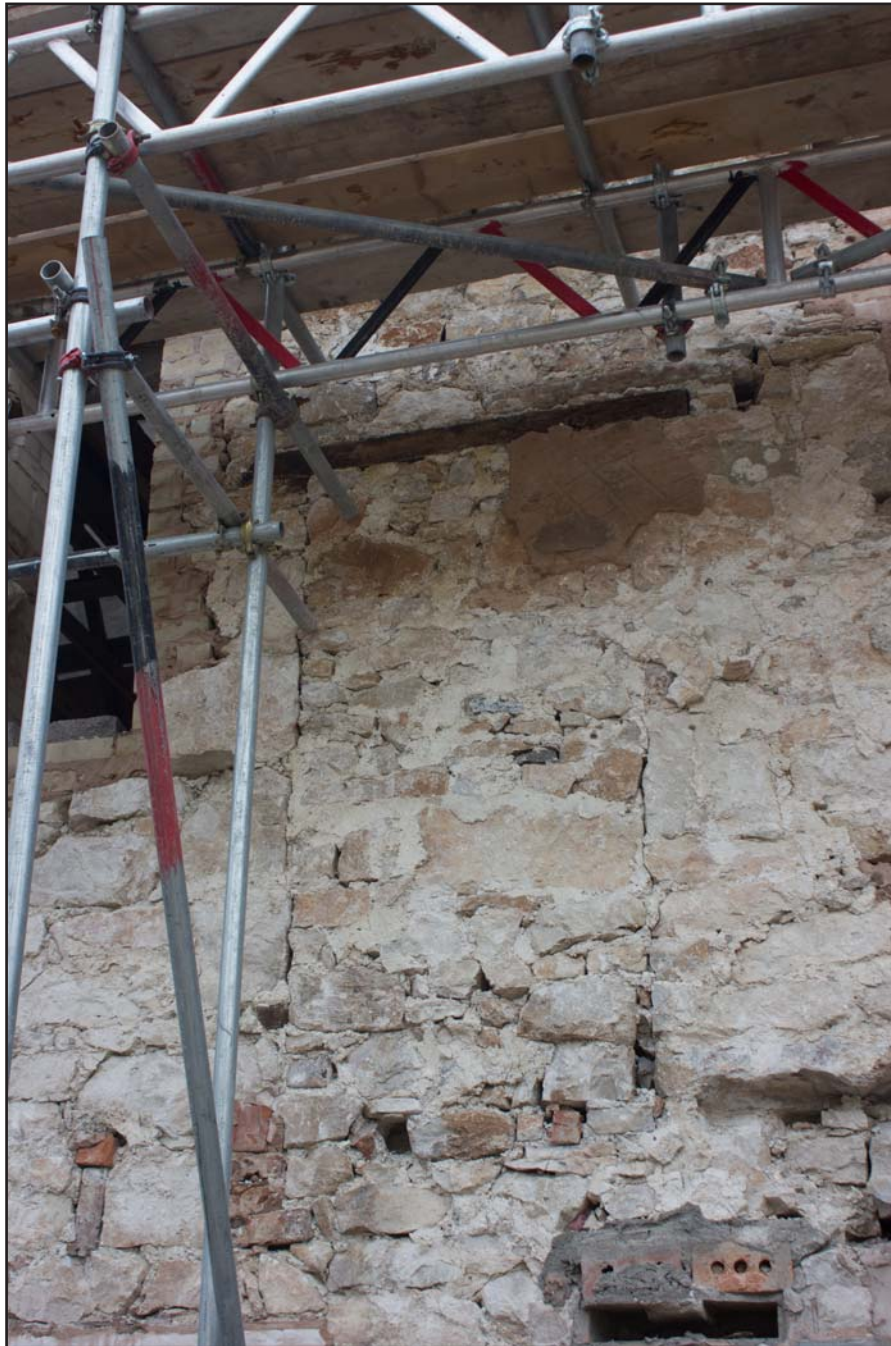
**Plate 04:** Blocked first floor doorway within western elevation of Tanrallt Hall, Abergele Road, Llanddulas, Abergele - from the west - no scale

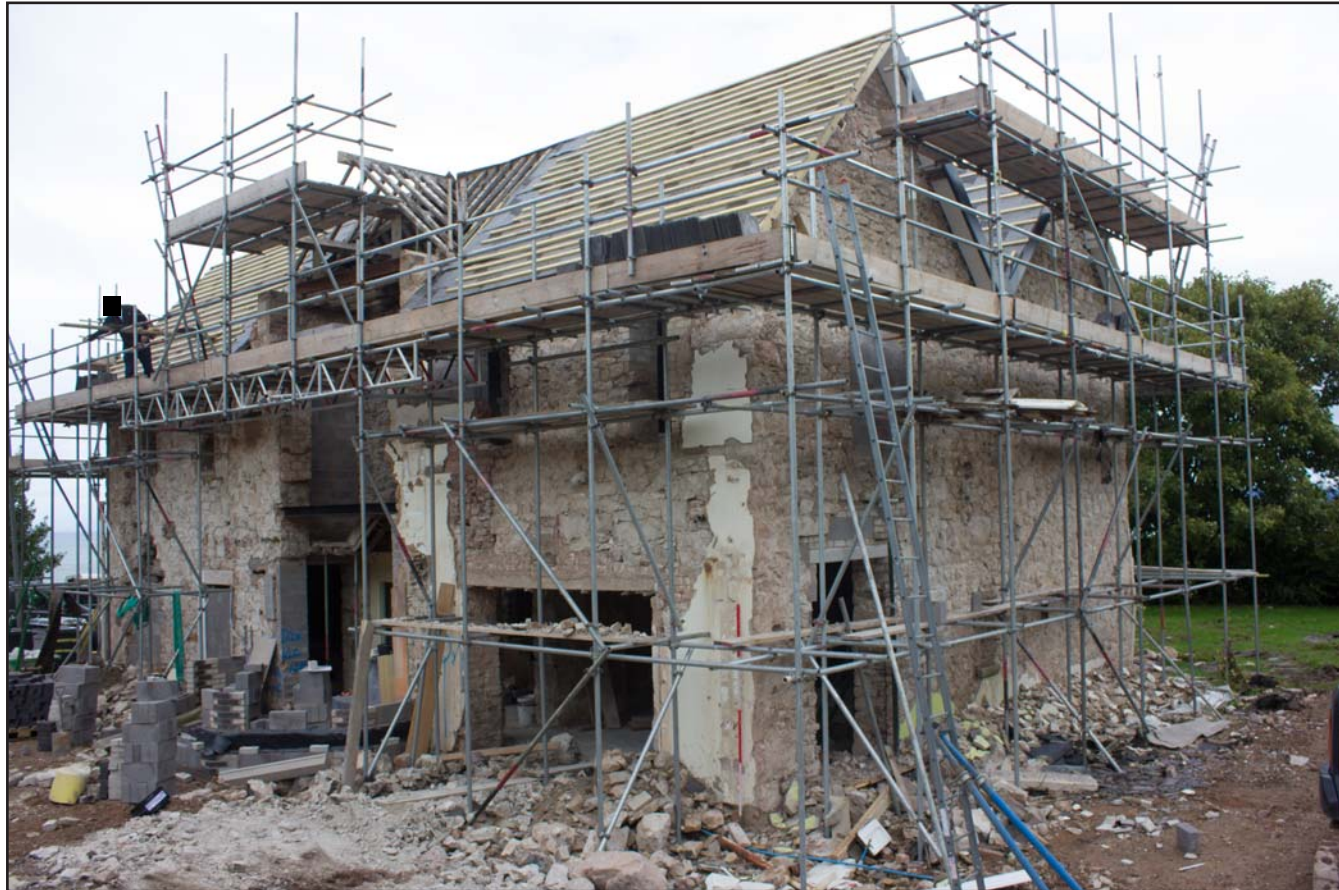
**Plate 05:** Oblique shot of western & southern elevations of Tanrallt Hall, Abergele Road, Llanddulas, Abergele - from the southwest - 2.00m scale

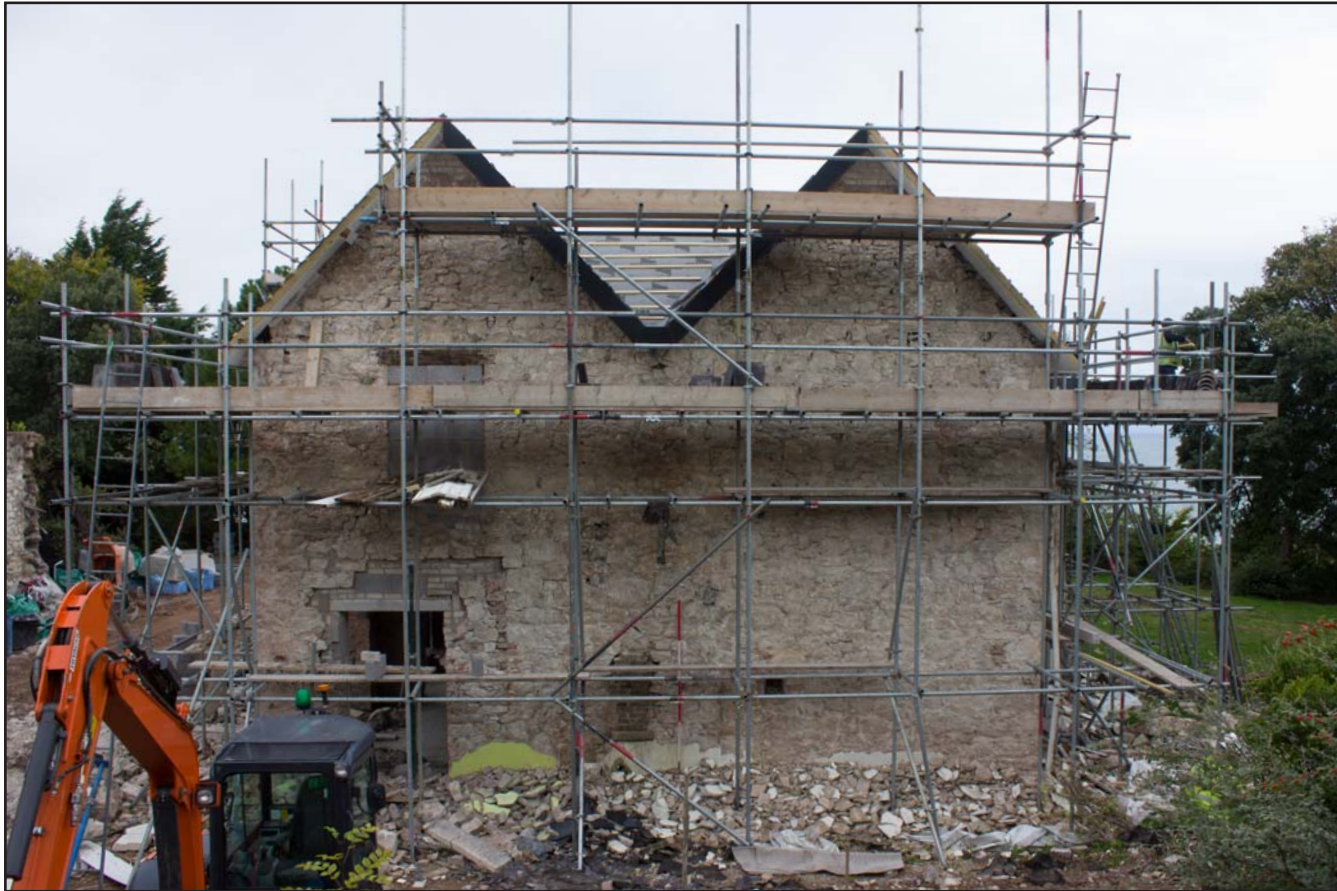
**Plate 06:** Southern elevation of Tanrallt Hall, Abergele Road, Llanddulas, Abergele - from the south - 2.00m scale

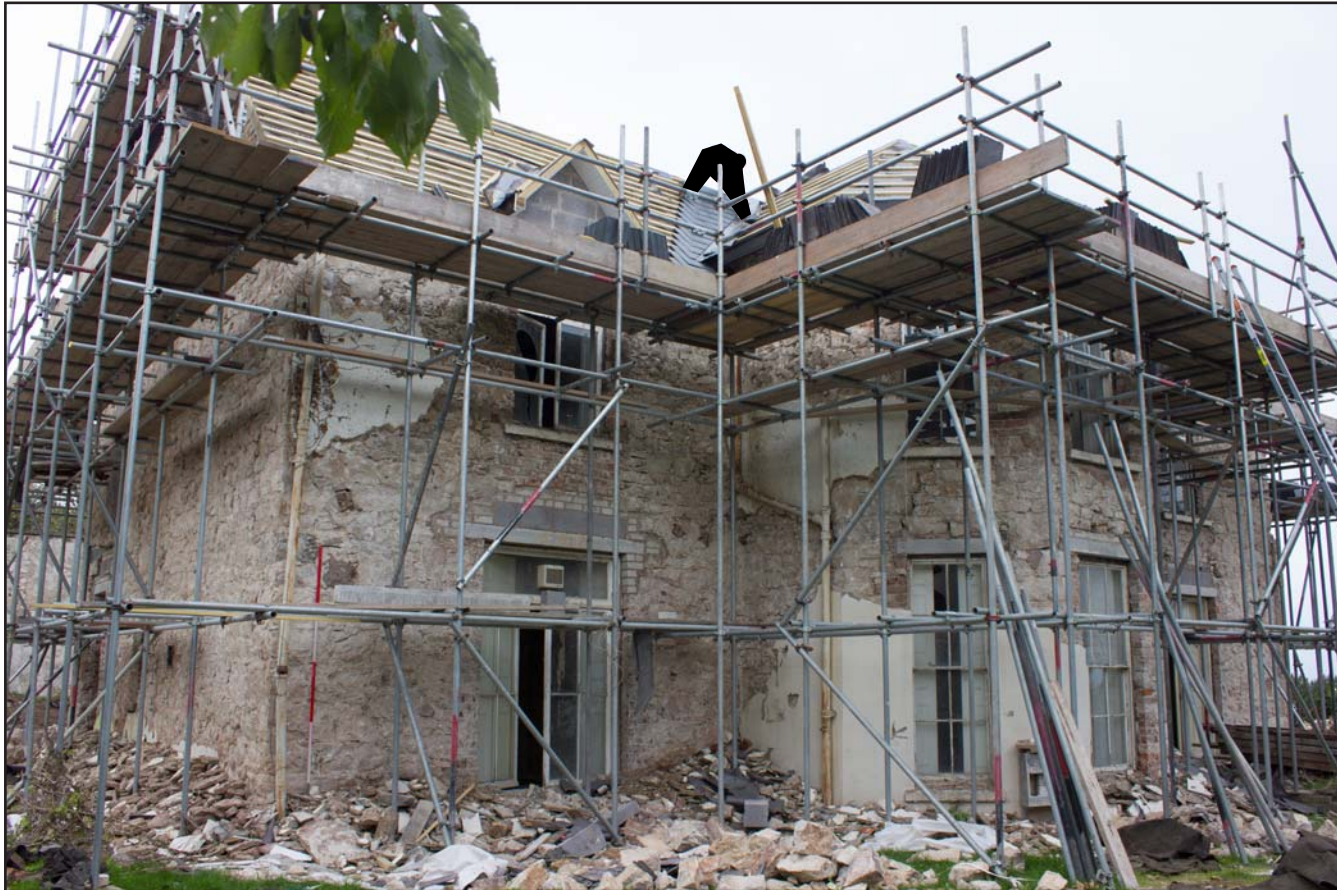
**Plate 07:** Oblique shot of southern & eastern elevations of Tanrallt Hall, Abergele Road, Llanddulas, Abergele - from the southeast - 2.00m scale

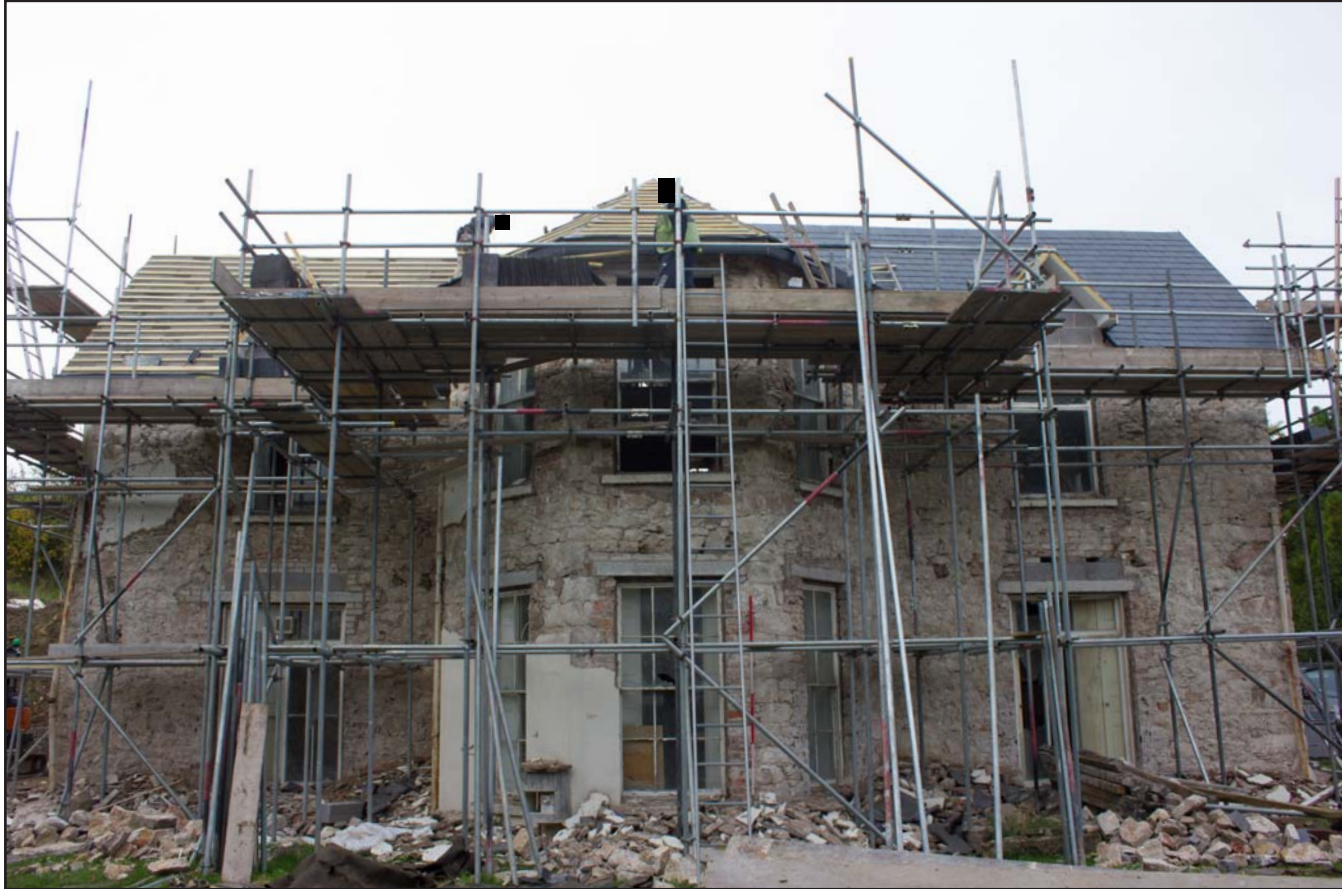
**Plate 08:** Eastern elevation of Tanrallt Hall, Abergele Road, Llanddulas, Abergele - from the east - 2.00m scale

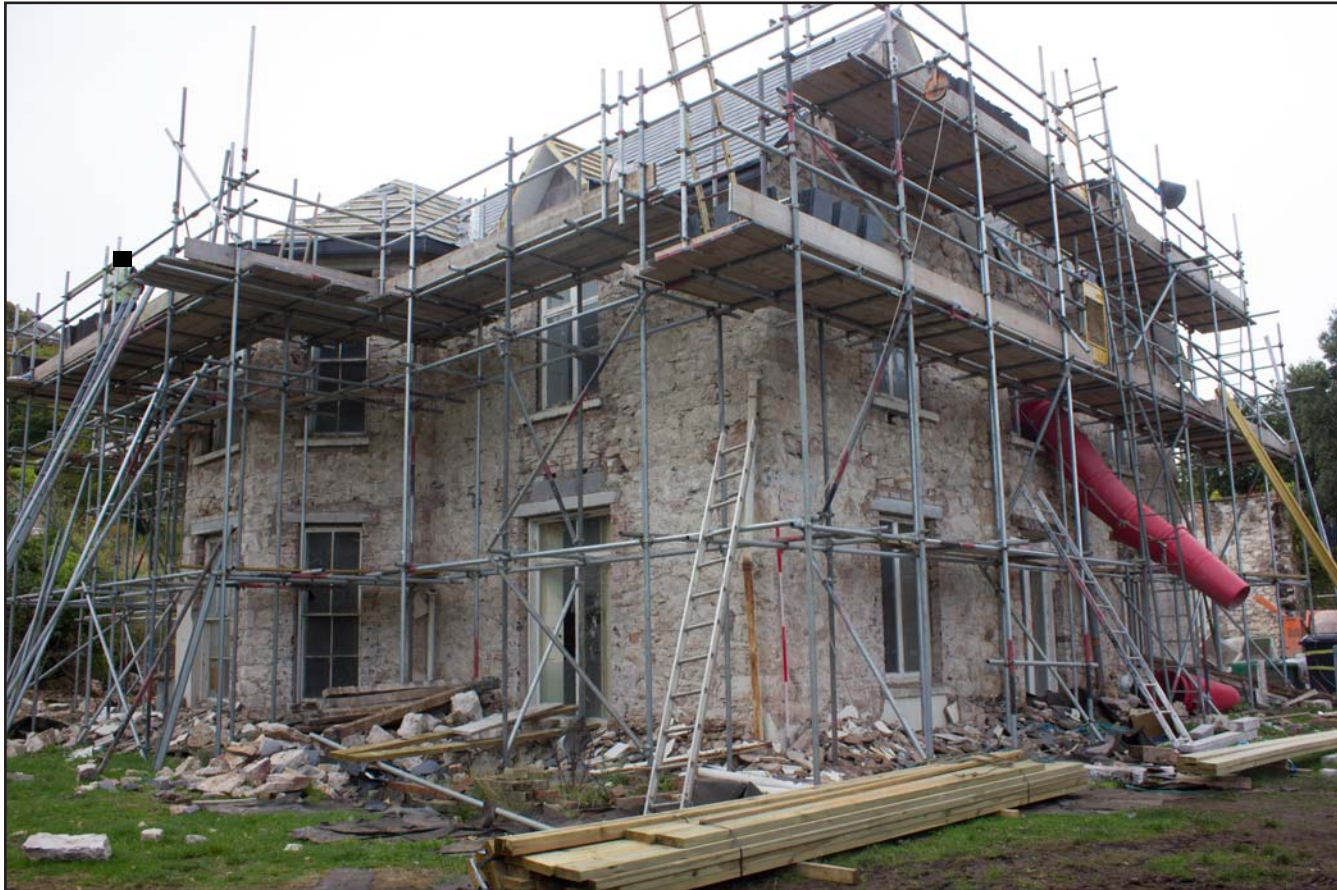
**Plate 09:** Oblique shot of eastern & northern elevations of Tanrallt Hall, Abergele Road, Llanddulas, Abergele - from the northeast - 2.00m scale

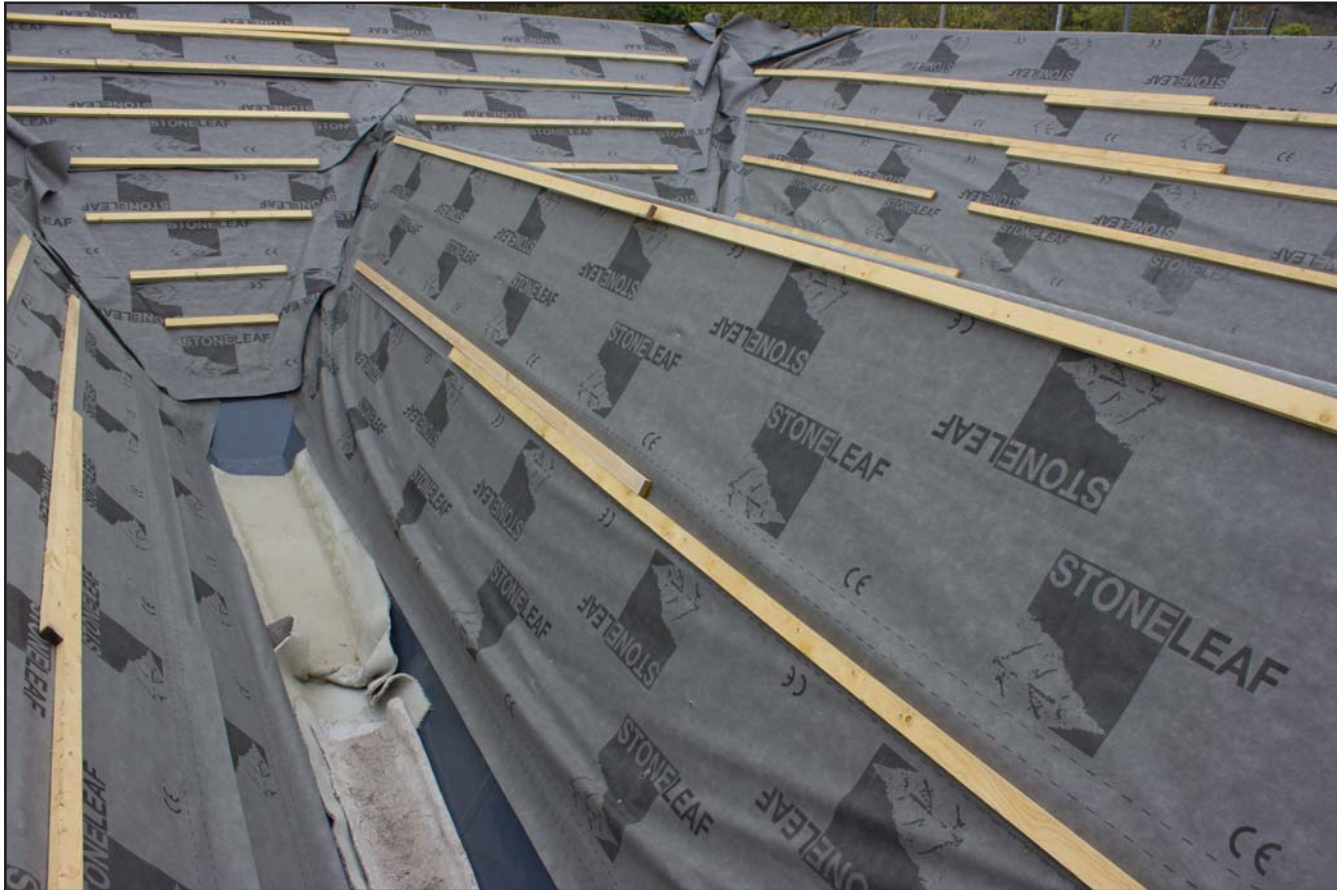
**Plate 10:** Roof configuration of Tanrallt Hall, Abergele Road, Llanddulas, Abergele - from the north - no scale

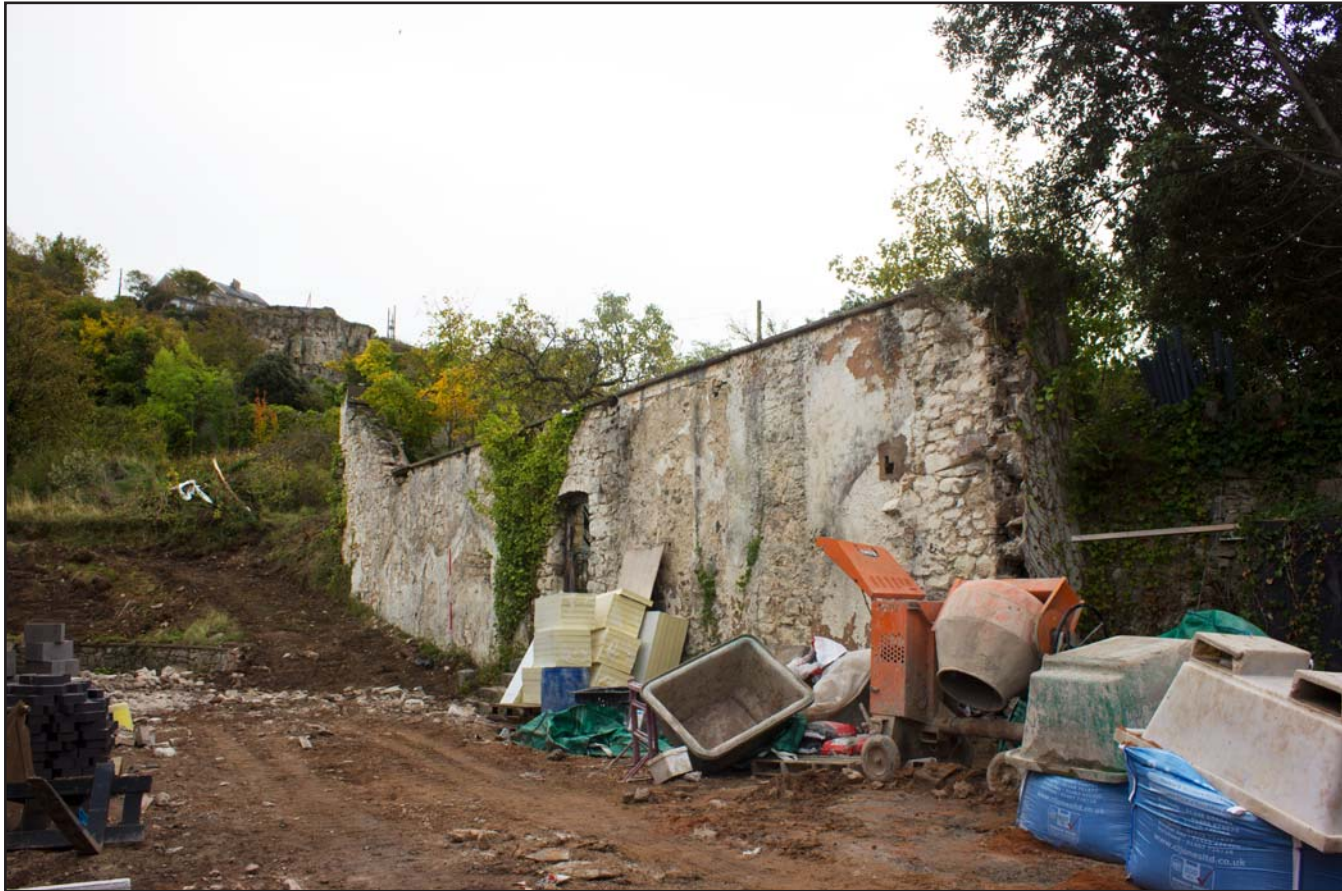
**Plate 11:** Stable yard wall of Tanrallt Hall, Abergele Road, Llanddulas, Abergele - from the northeast - 2.00m scale

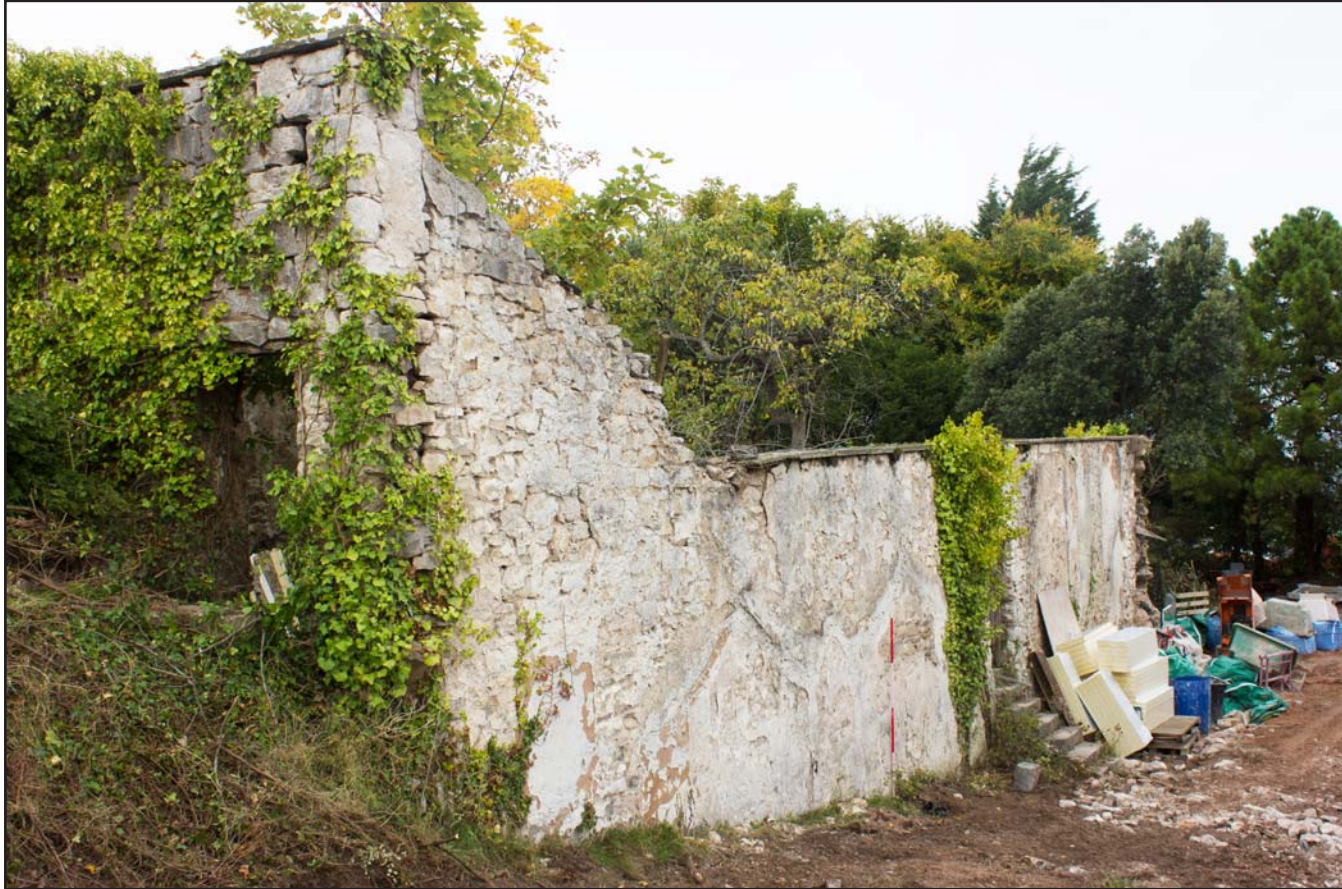
**Plate 12:** Stable yard wall of Tanrallt Hall, Abergele Road, Llanddulas, Abergele - from the southwest - 2.00m scale

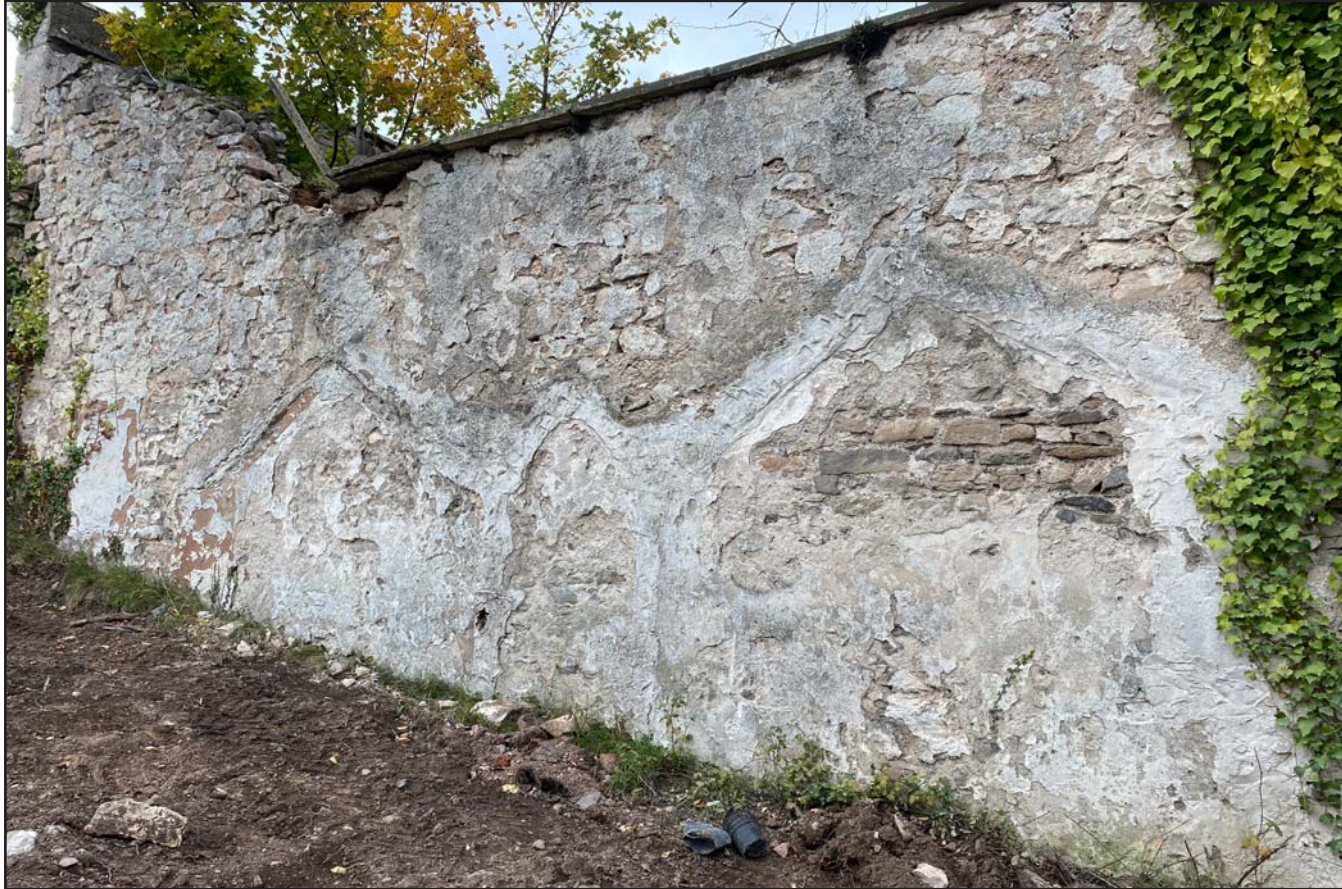
**Plate 13:** Outline of former buildings on the stable yard wall of Tanrallt Hall, Abergele Road, Llanddulas, Abergele - from the northeast - no scale

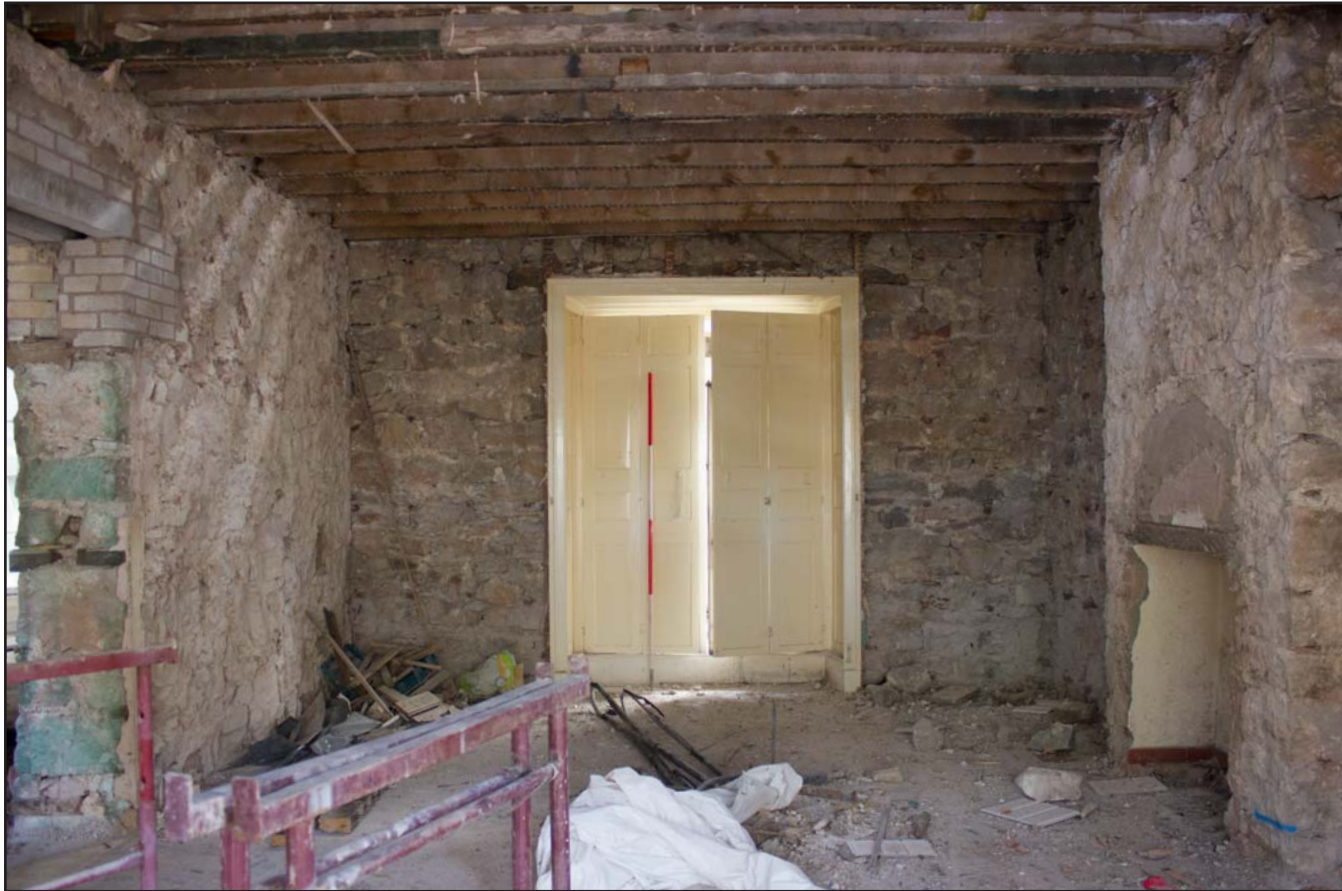
**Plate 14:** Kitchen/Dining Room, ground floor, Tanrallt Hall, Abergele Road, Llanddulas, Abergele - from the west - 2.00m scale

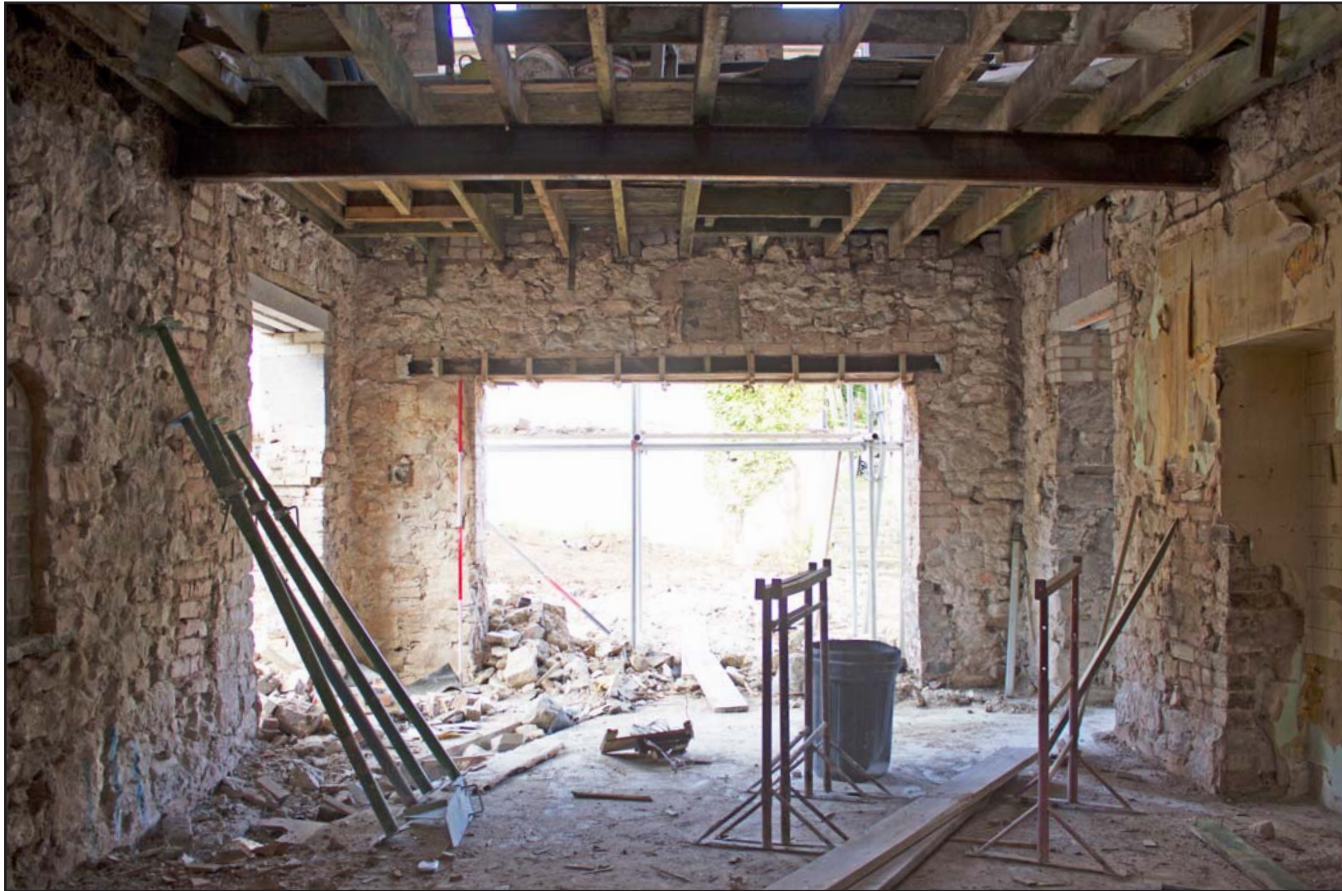
**Plate 15:** Kitchen/Dining Room, ground floor, Tanrallt Hall, Abergele Road, Llanddulas, Abergele - from the east - 2.00m scale
