Report no. 0374

# **Tanrallt Hall, Abergele Road, Llanddulas, Abergele LL22 8HR**

## **October 2022 v1.0**

Historic Building Record Level 2

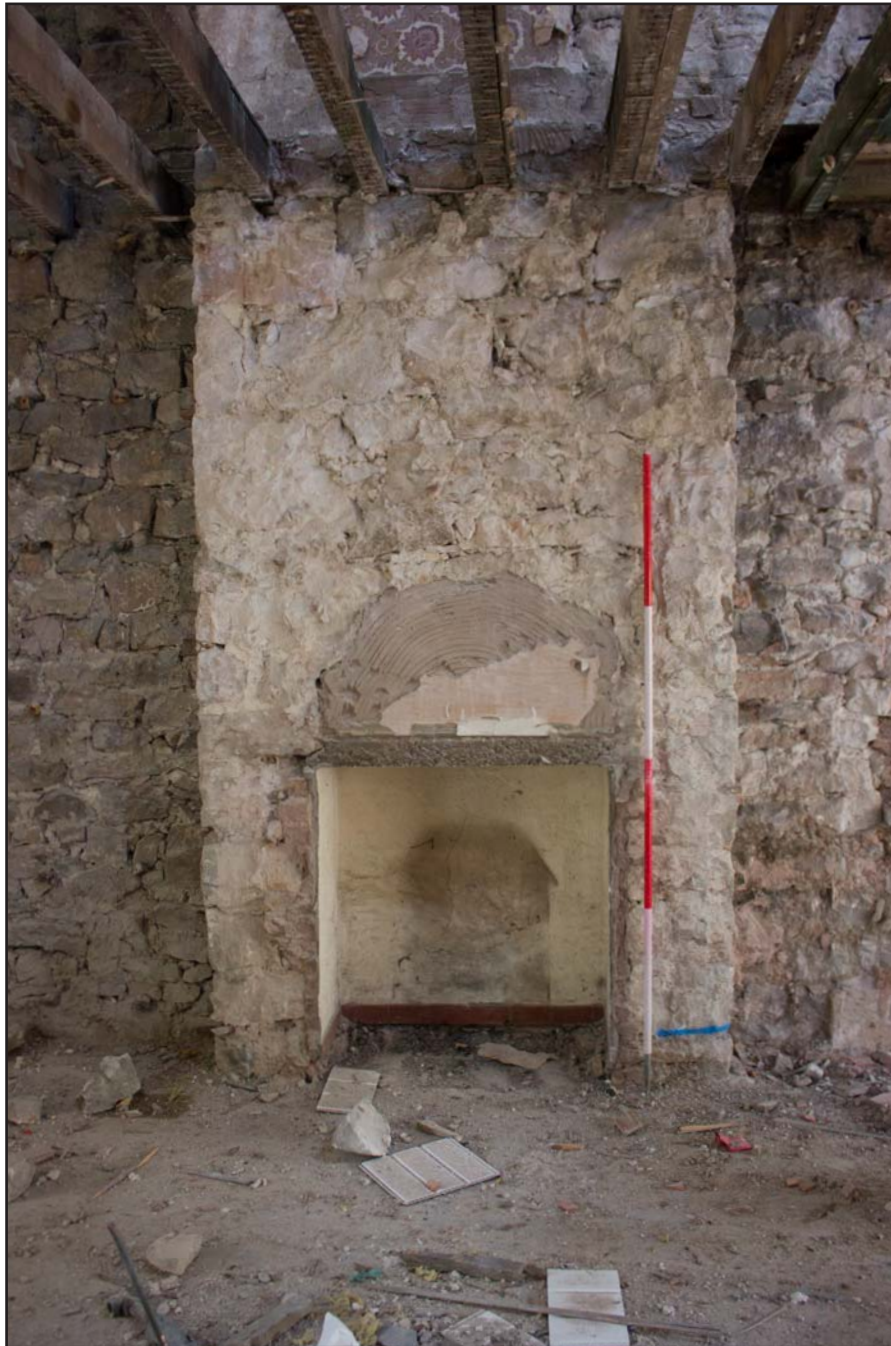
**Plate 16:** Kitchen/Dining Room, fireplace, ground floor, Tanrallt Hall, Abergele Road, Llanddulas, Abergele - from the north - 2.00m scale

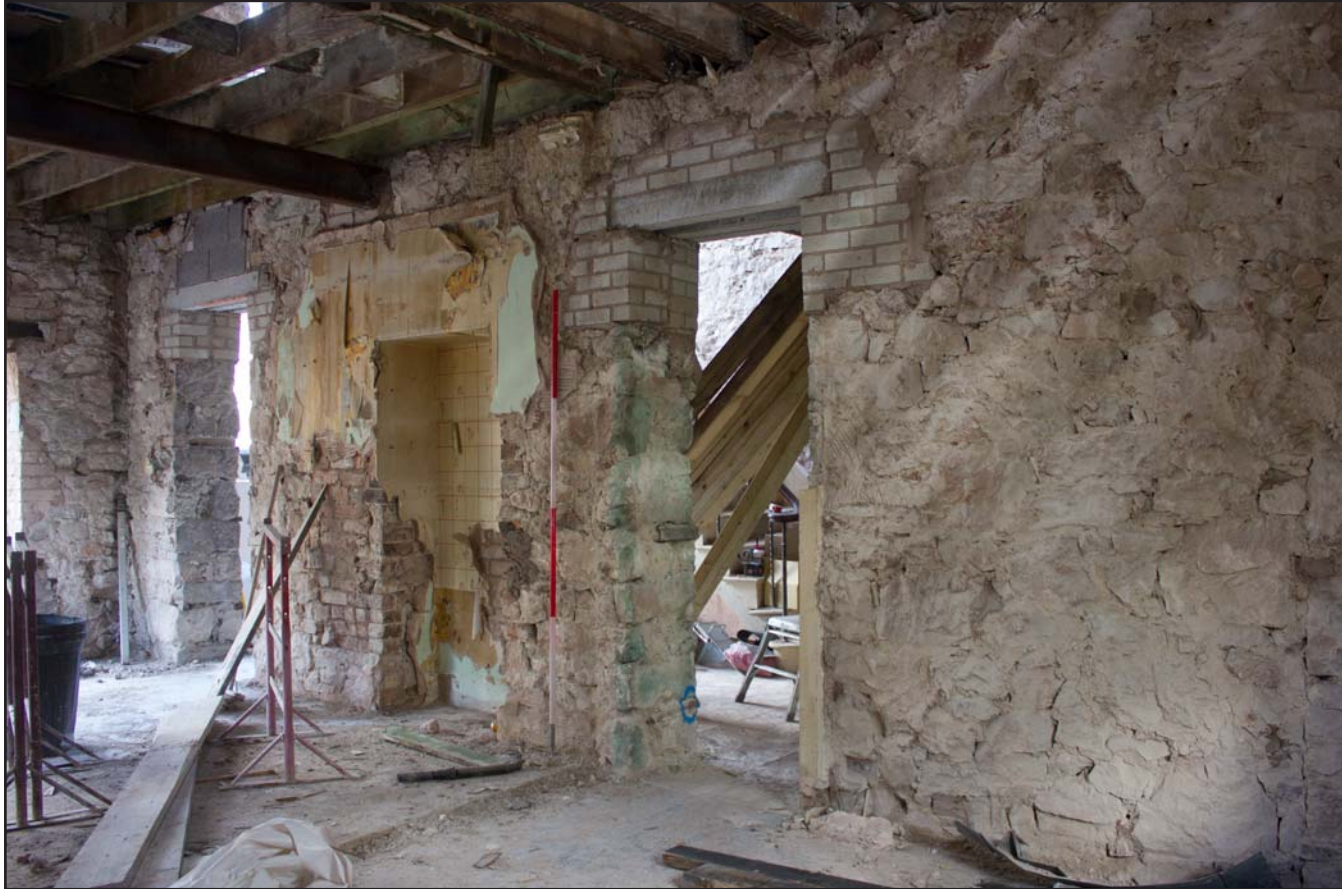
**Plate 17:** Kitchen/Dining Room, oblique shot, ground floor, Tanrallt Hall, Abergele Road, Llanddulas, Abergele - from the southeast - 2.00m scale

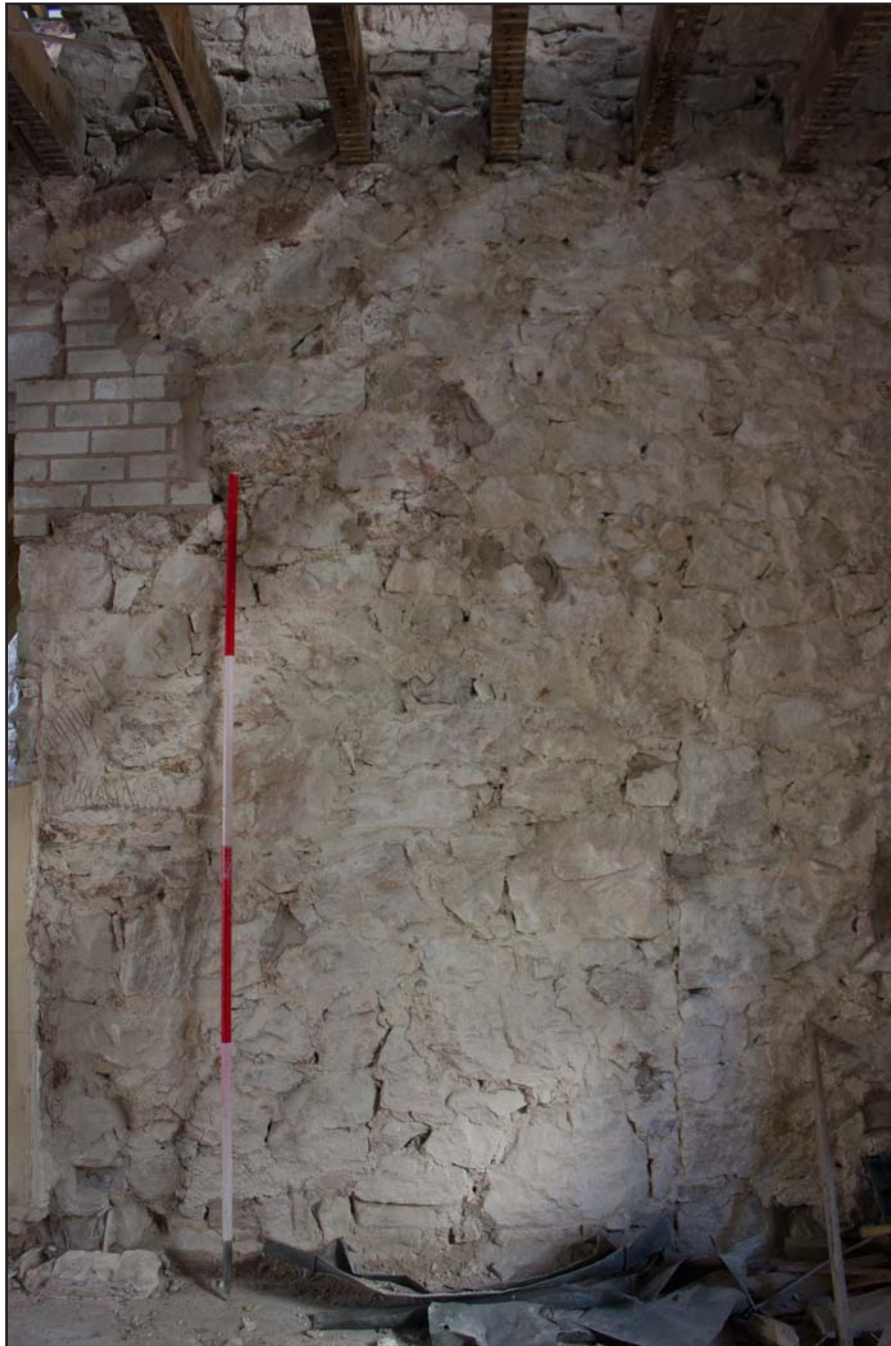
**Plate 18:** Kitchen/Dining Room, blocked door, ground floor, Tanrallt Hall, Abergele Road, Llanddulas, Abergele - from the southeast - 2.00m scale

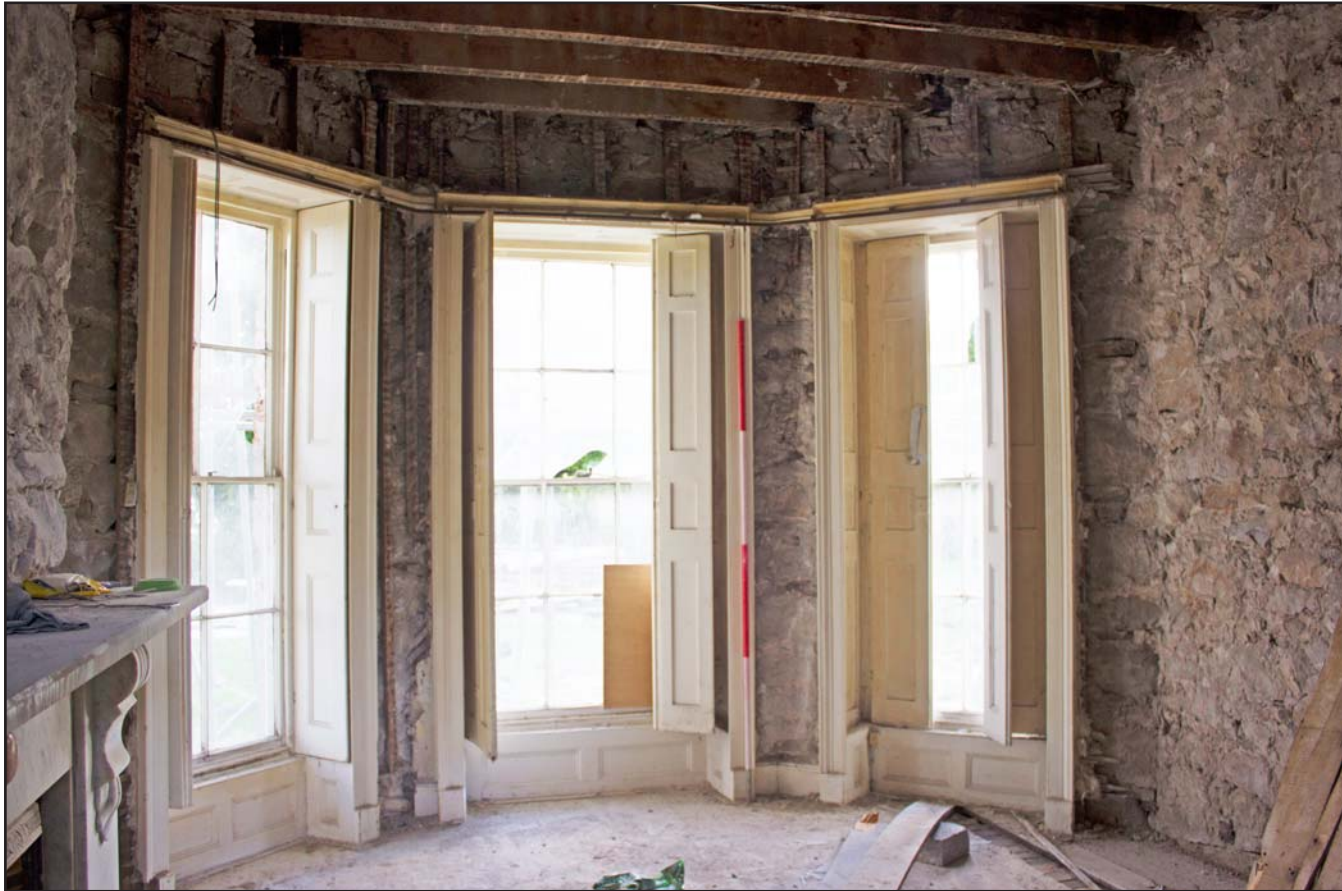
**Plate 19:** Living Room/Study, ground floor, Tanrallt Hall, Abergele Road, Llanddulas, Abergele - from the northwest - 2.00m scale

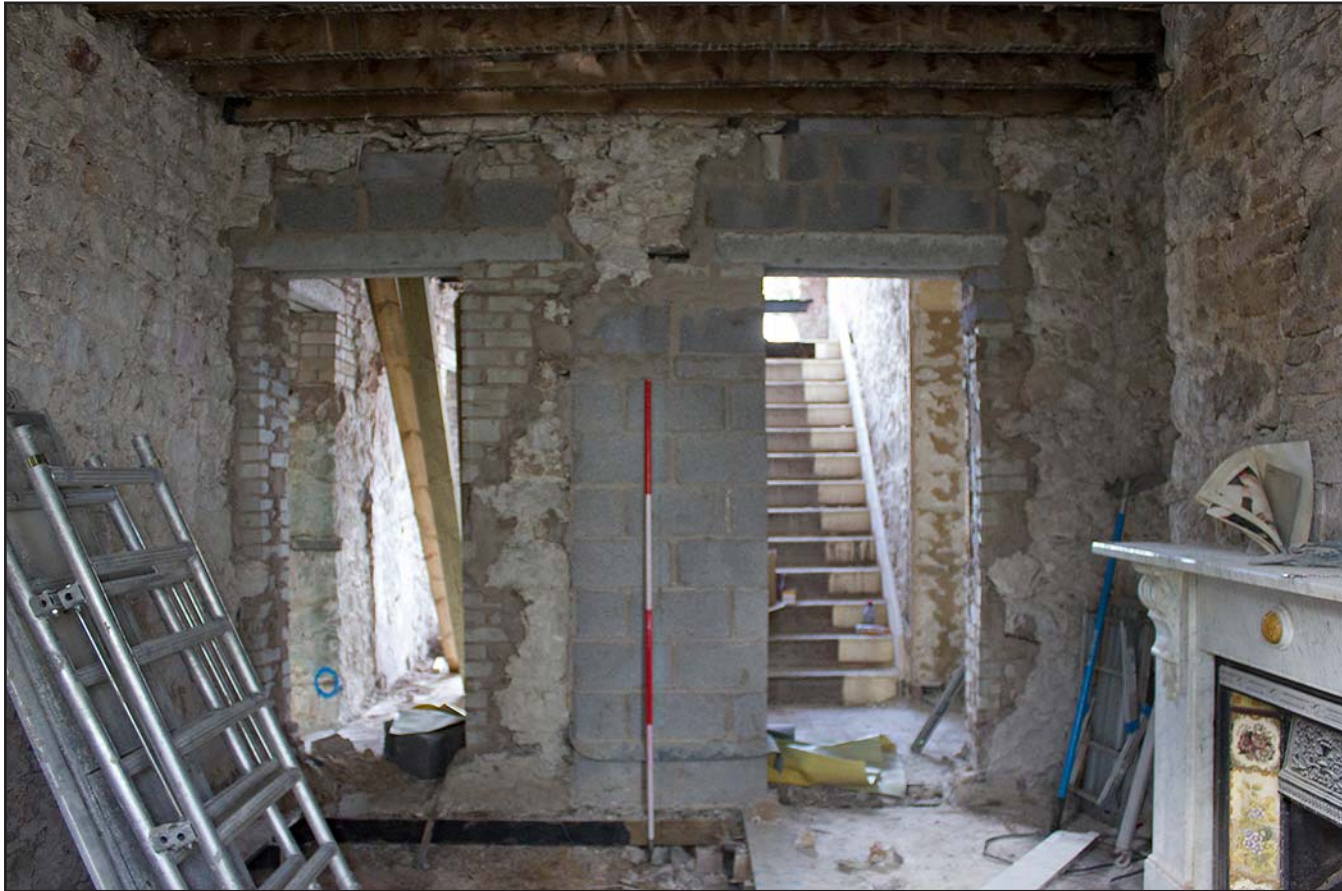
**Plate 20:** Living Room/Study, ground floor, Tanrallt Hall, Abergele Road, Llanddulas, Abergele - from the east - 2.00m scale

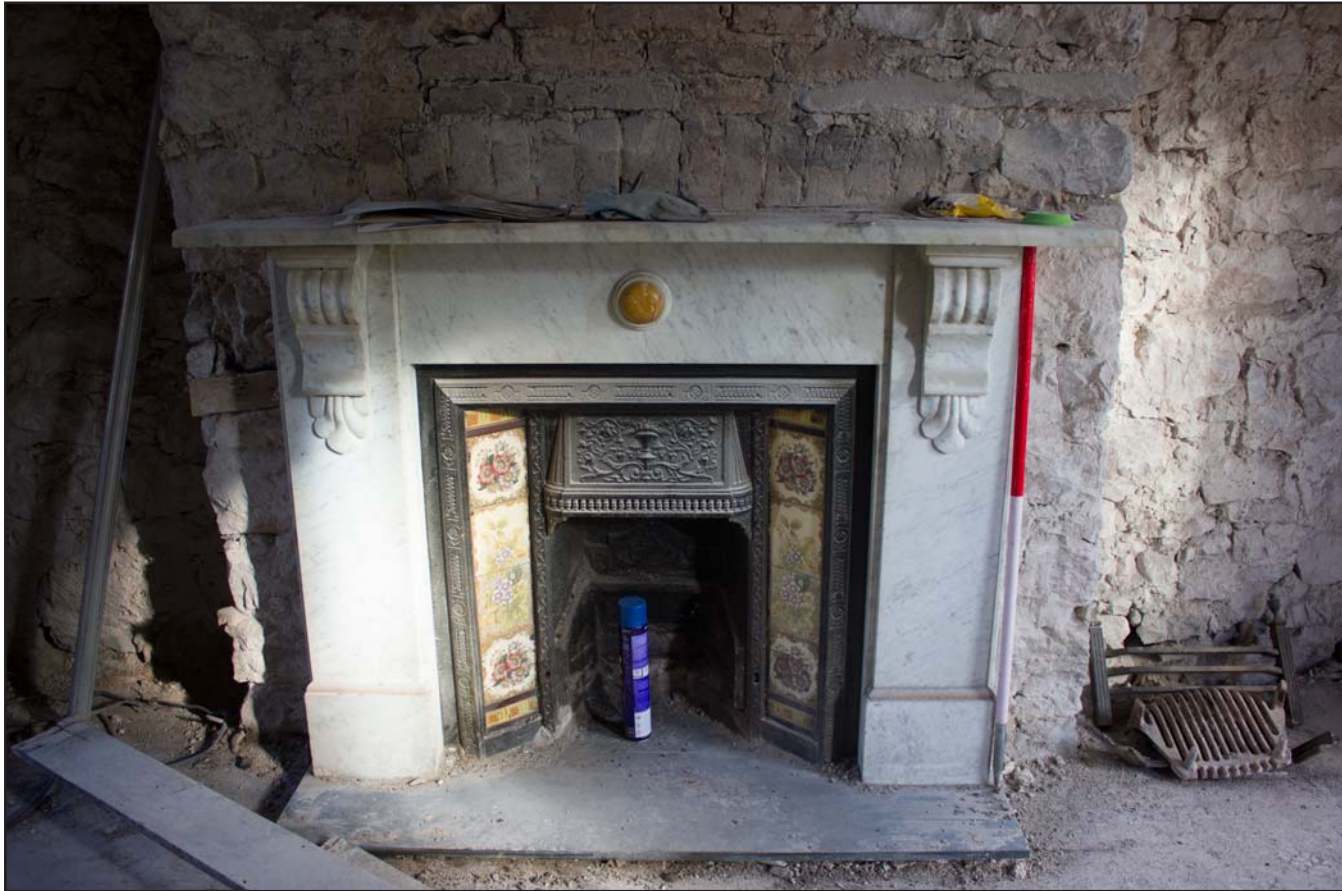
**Plate 21:** Living Room/Study, fireplace, ground floor, Tanrallt Hall, Abergele Road, Llanddulas, Abergele - from the south - 2.00m scale

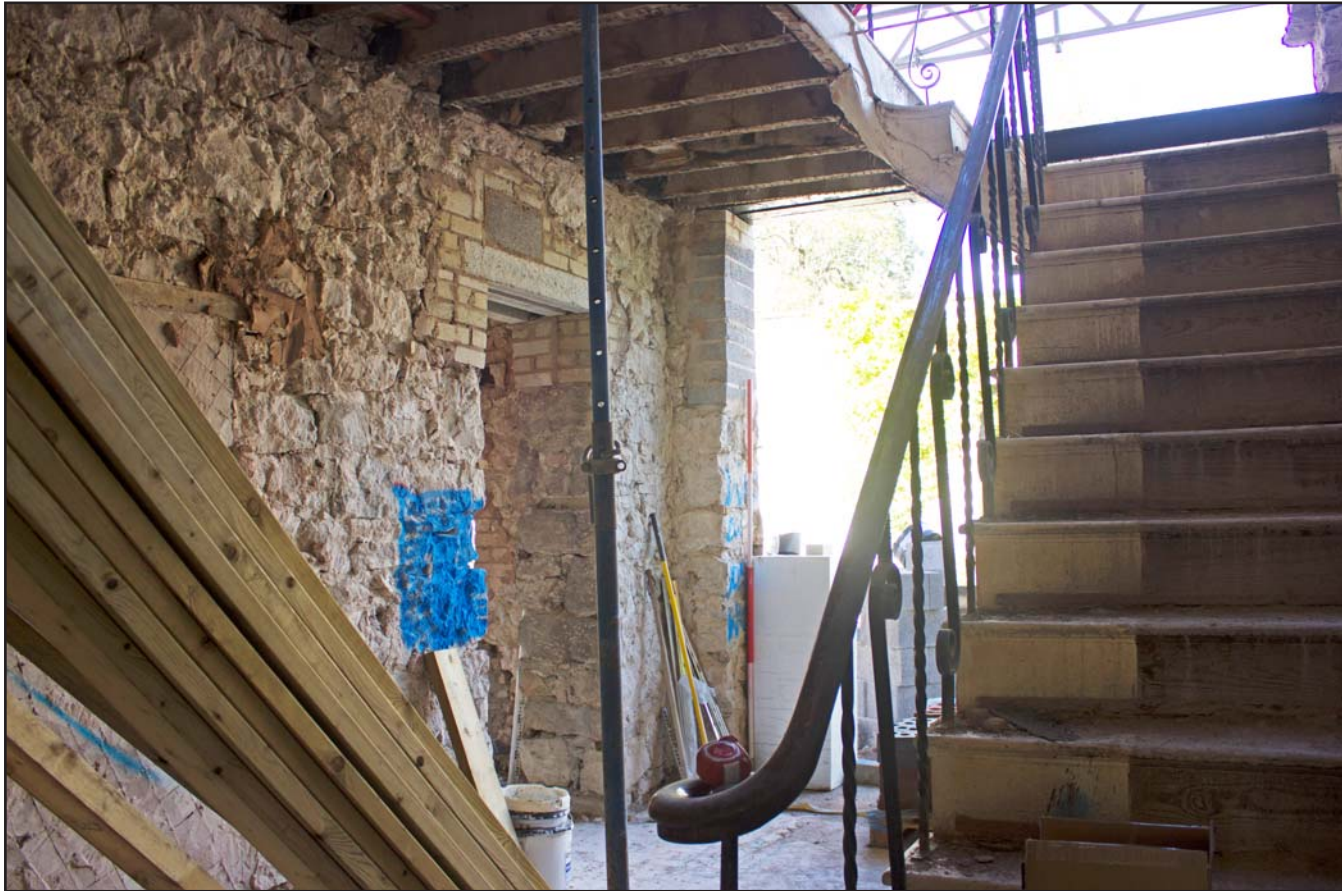
**Plate 22:** Hallway, ground floor, Tanrallt Hall, Abergele Road, Llanddulas, Abergele - from the northeast - 2.00m scale

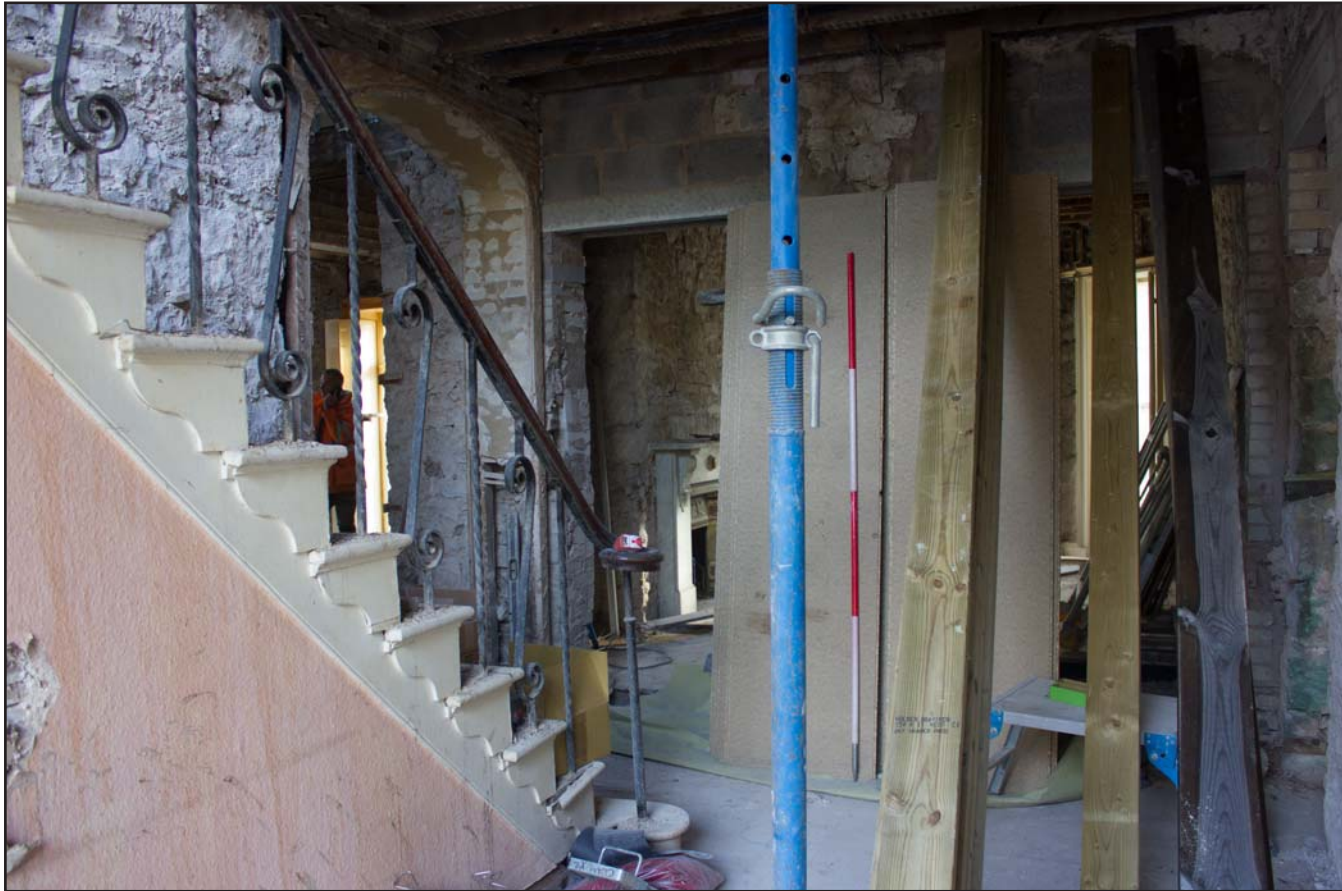
**Plate 23:** Hallway, ground floor, Tanrallt Hall, Abergele Road, Llanddulas, Abergele - from the southwest - 2.00m scale

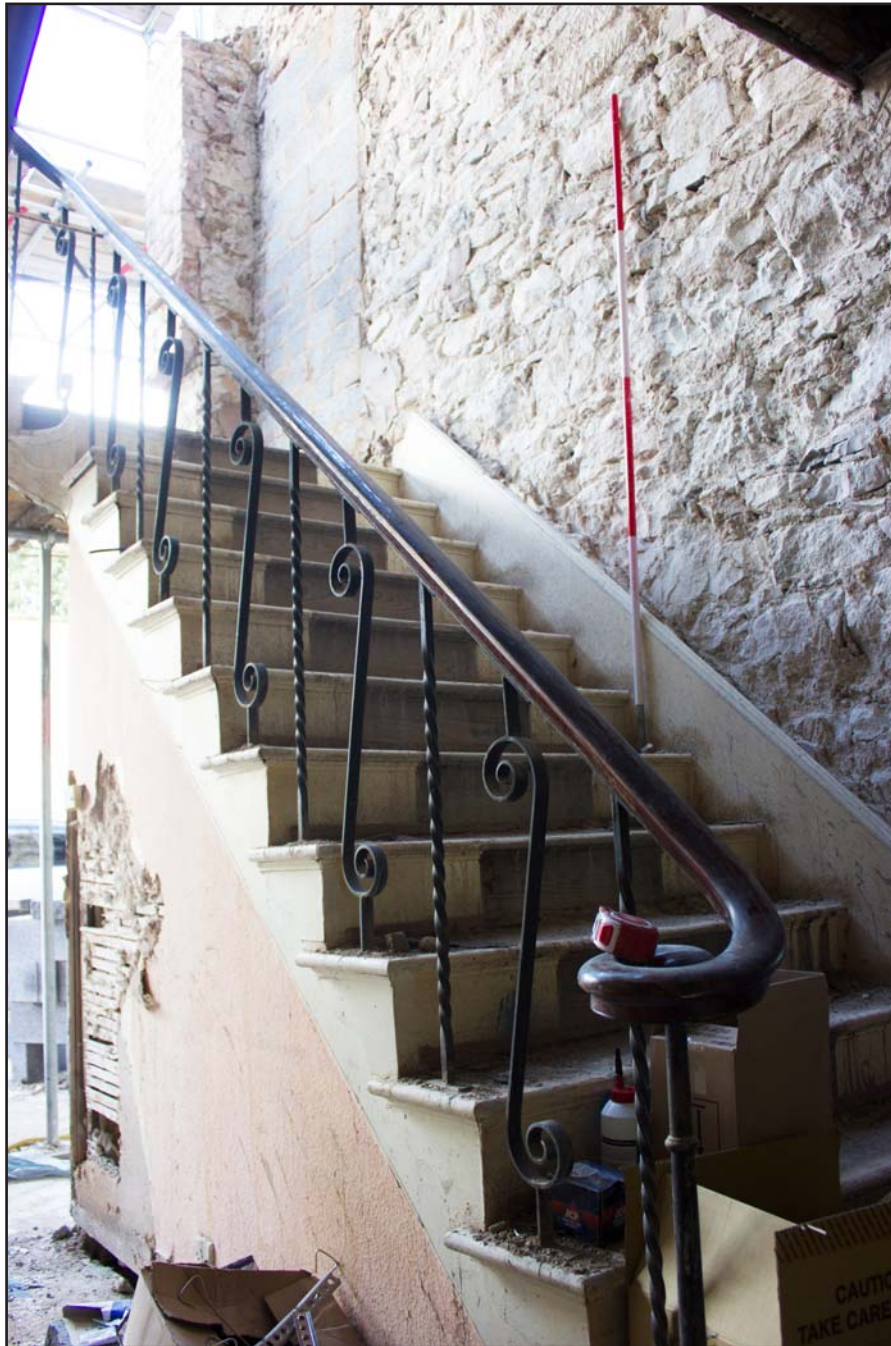
**Plate 25:** Hallway, Stairs, ground floor, Tanrallt Hall, Abergele Road, Llanddulas, Abergele - from the southeast - 2.00m scale

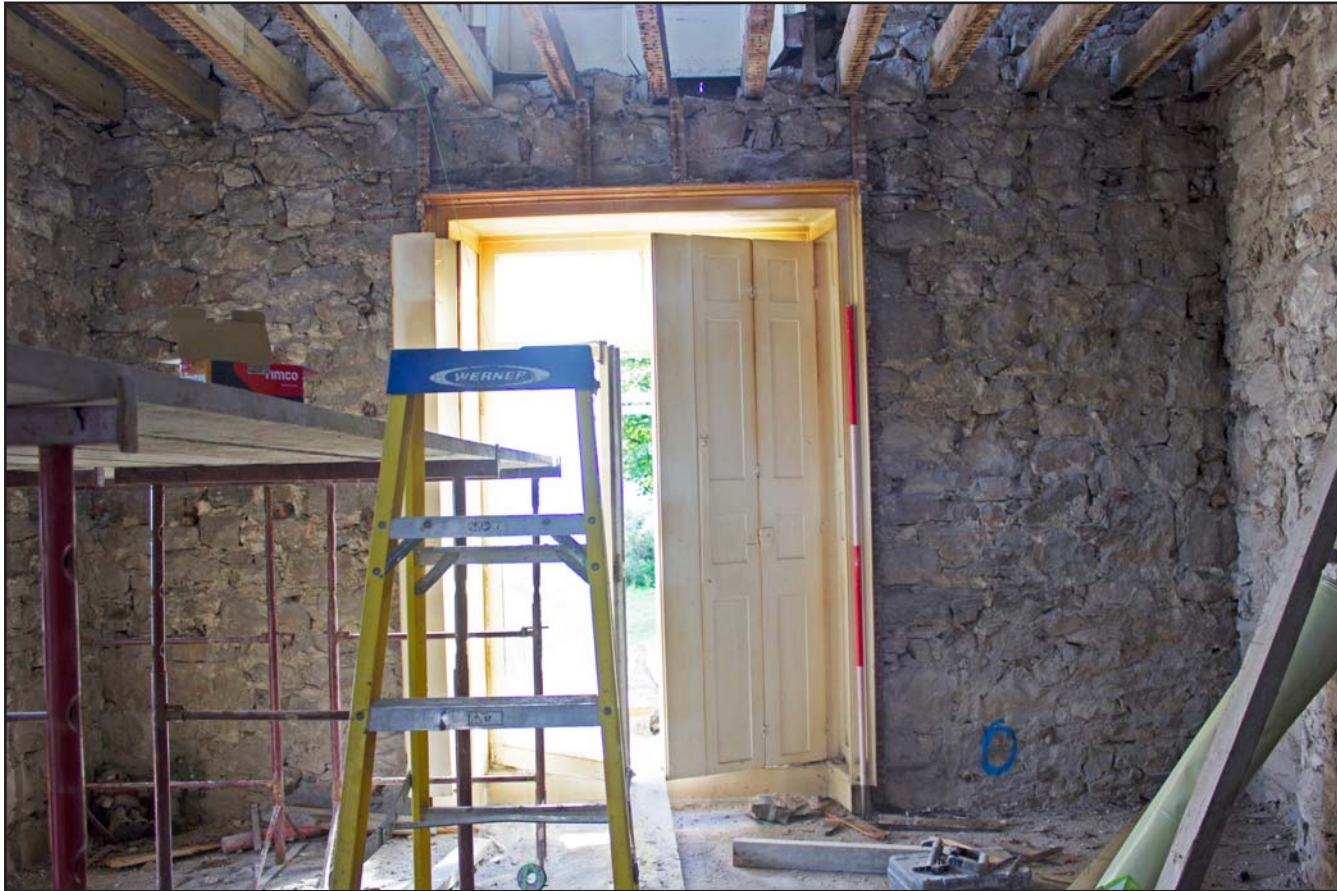
**Plate 26:** Lounge/Living Room, ground floor, Tanrallt Hall, Abergele Road, Llanddulas, Abergele - from the west - 2.00m scale

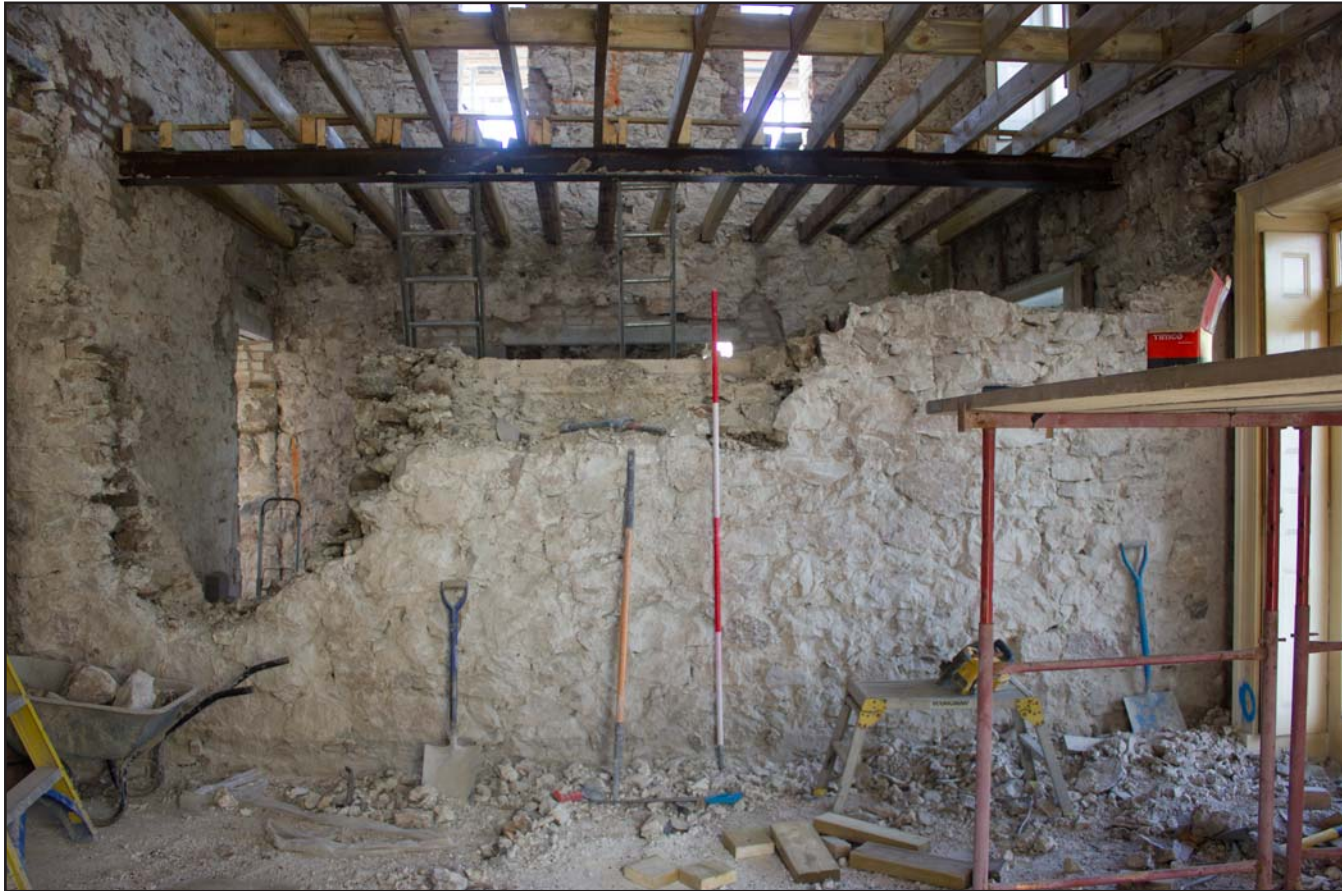
**Plate 27:** Lounge/Living Room, ground floor, Tanrallt Hall, Abergele Road, Llanddulas, Abergele - from the east - 2.00m scale

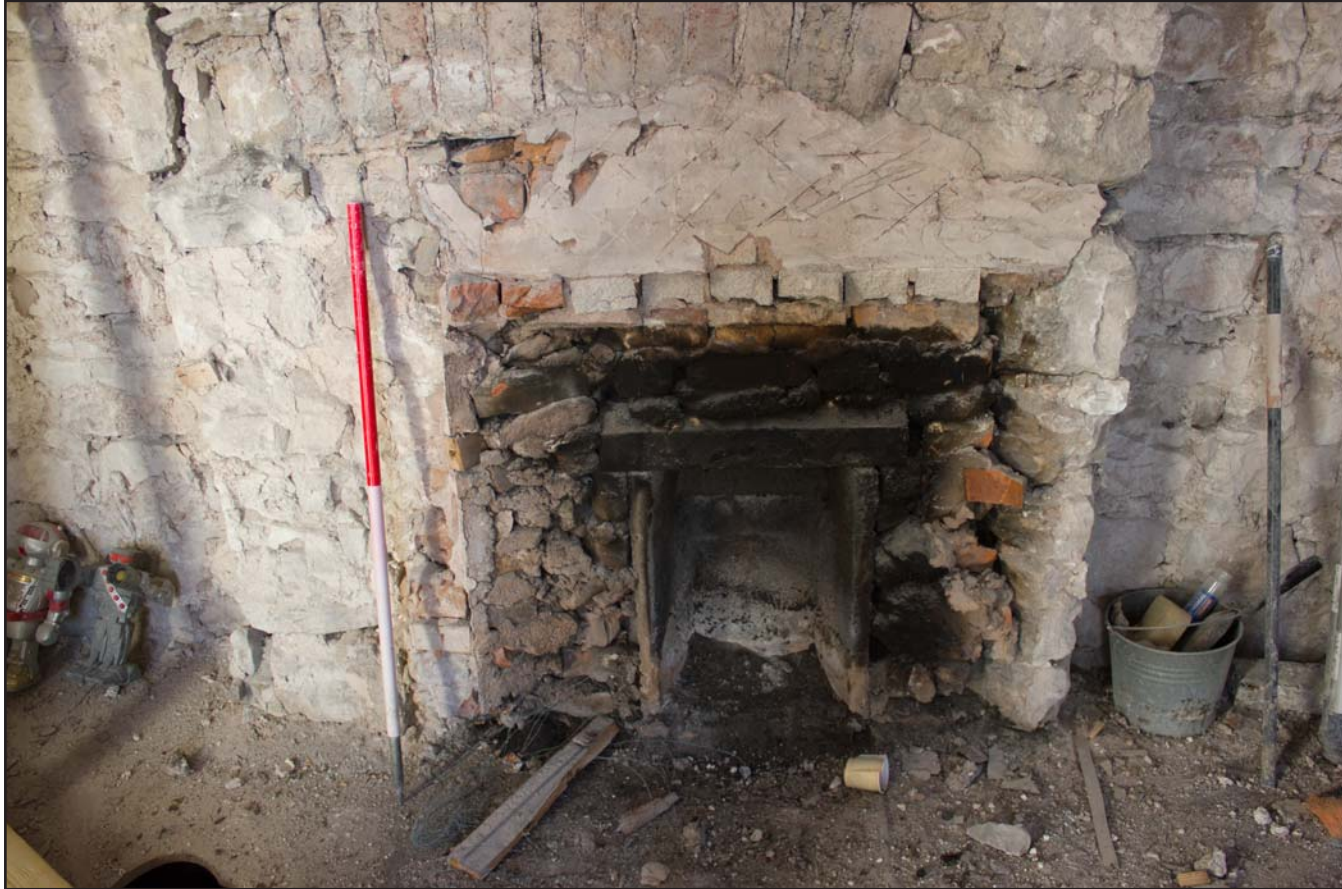
**Plate 28:** Lounge/Living Room, fireplace, ground floor, Tanrallt Hall, Abergele Road, Llanddulas, Abergele - from the east - 2.00m scale

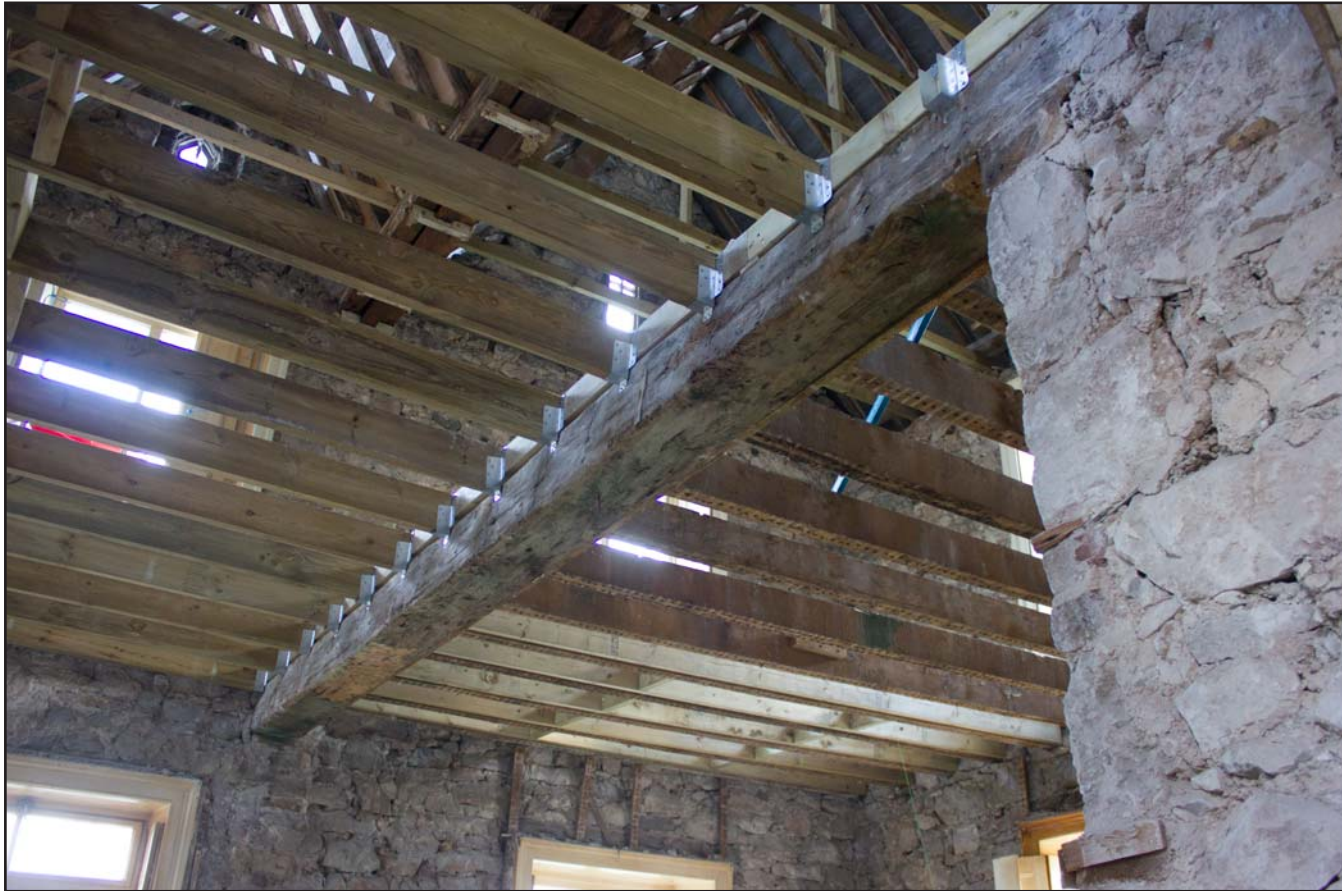
**Plate 29:** Lounge/Living Room, handhewn beam, ground floor, Tanrallt Hall, Abergele Road, Llanddulas, Abergele - from the east - no scale

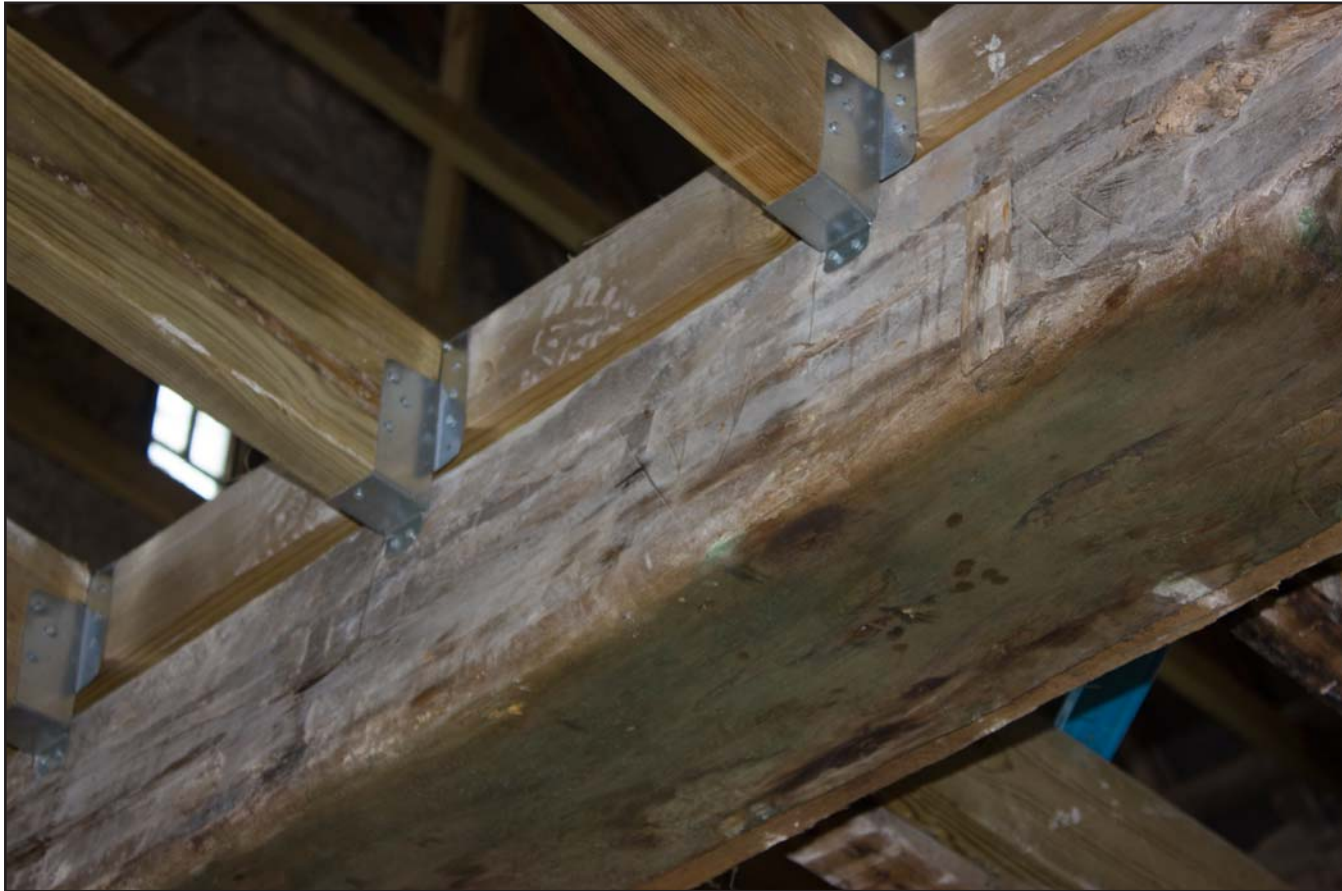
**Plate 30:** Lounge/Living Room, carpenter's marks on handhewn beam, ground floor, Tanrallt Hall, Abergele Road, Llanddulas, Abergele - from the east - no scale

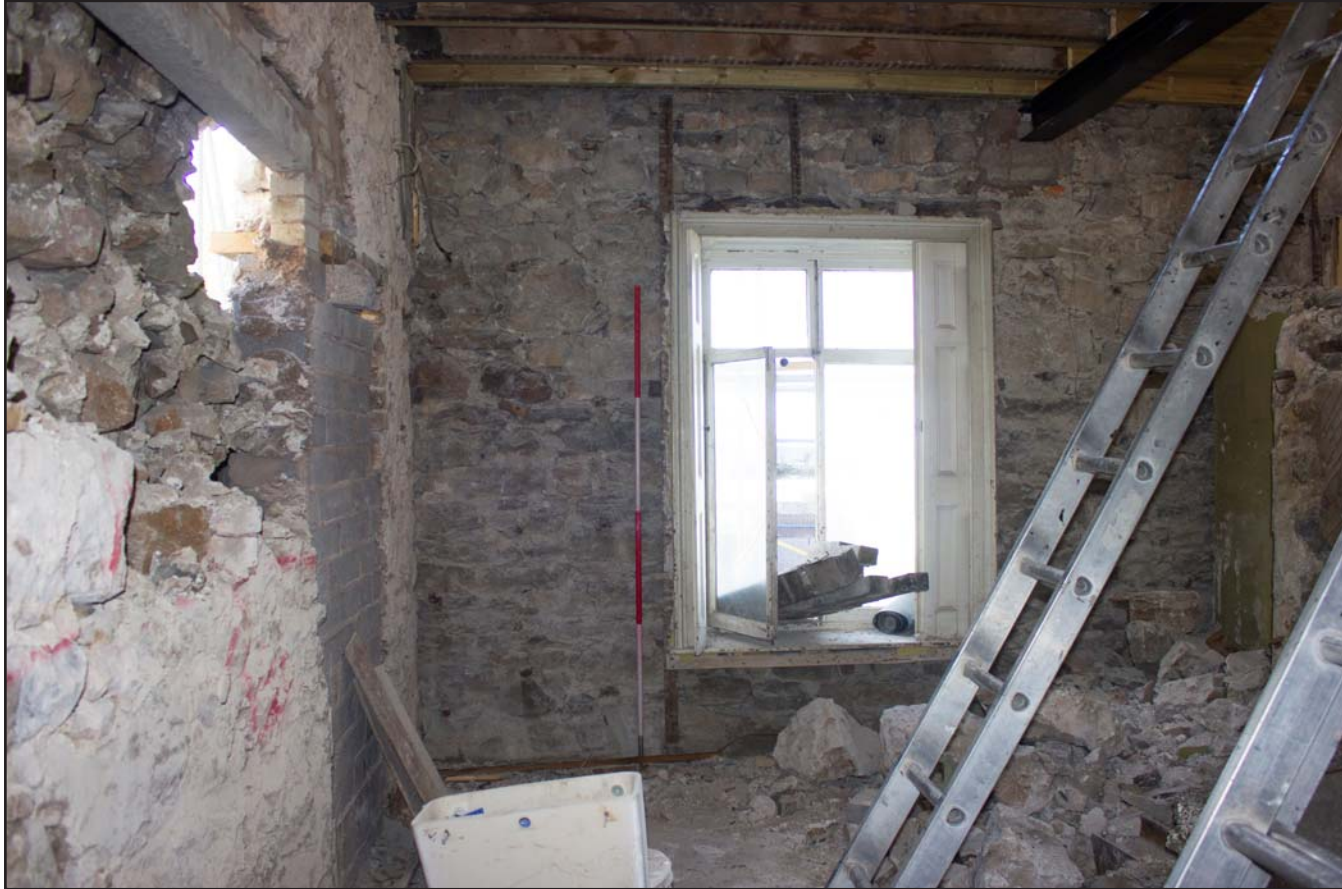
**Plate 31:** Utility/Kitchen, ground floor, Tanrallt Hall, Abergele Road, Llanddulas, Abergele - from the south - 2.00m scale

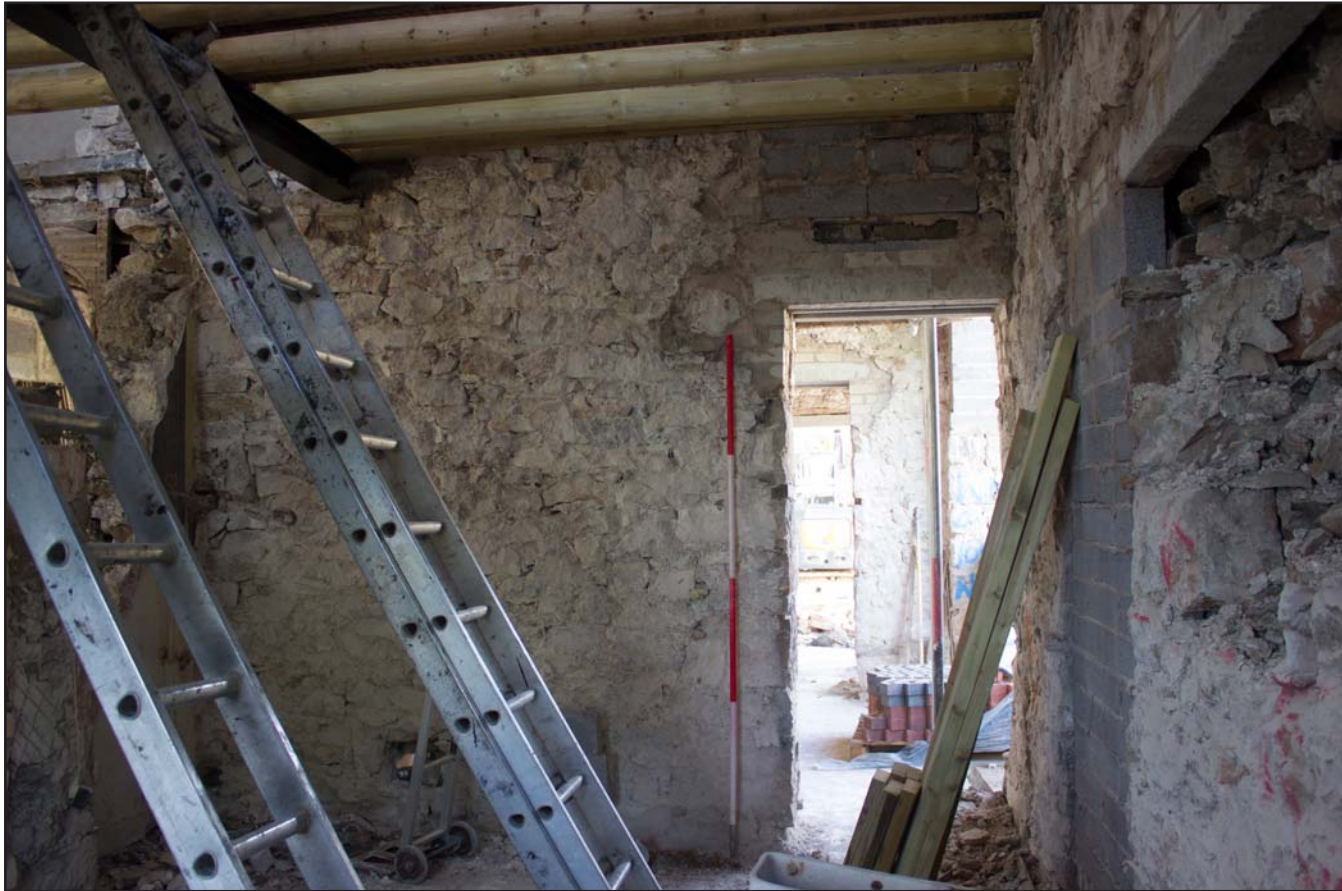
**Plate 32:** Utility/Kitchen, ground floor, Tanrallt Hall, Abergele Road, Llanddulas, Abergele - from the north - 2.00m scale

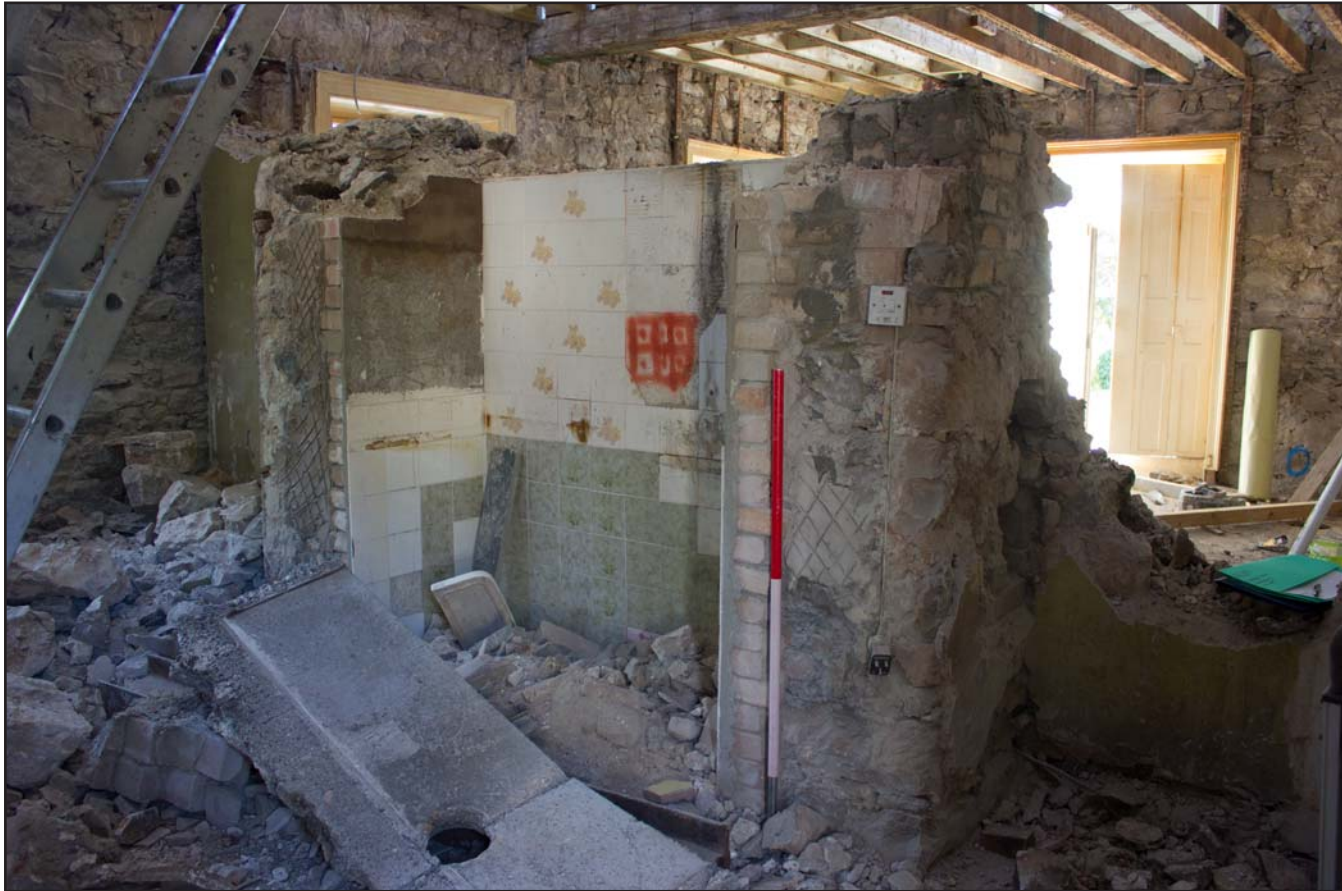
**Plate 33:** Utility/Kitchen, former kitchen hearth and chimney breast, ground floor, Tanrallt Hall, Abergele Road, Llanddulas, Abergele - from the north - 1.00m scale

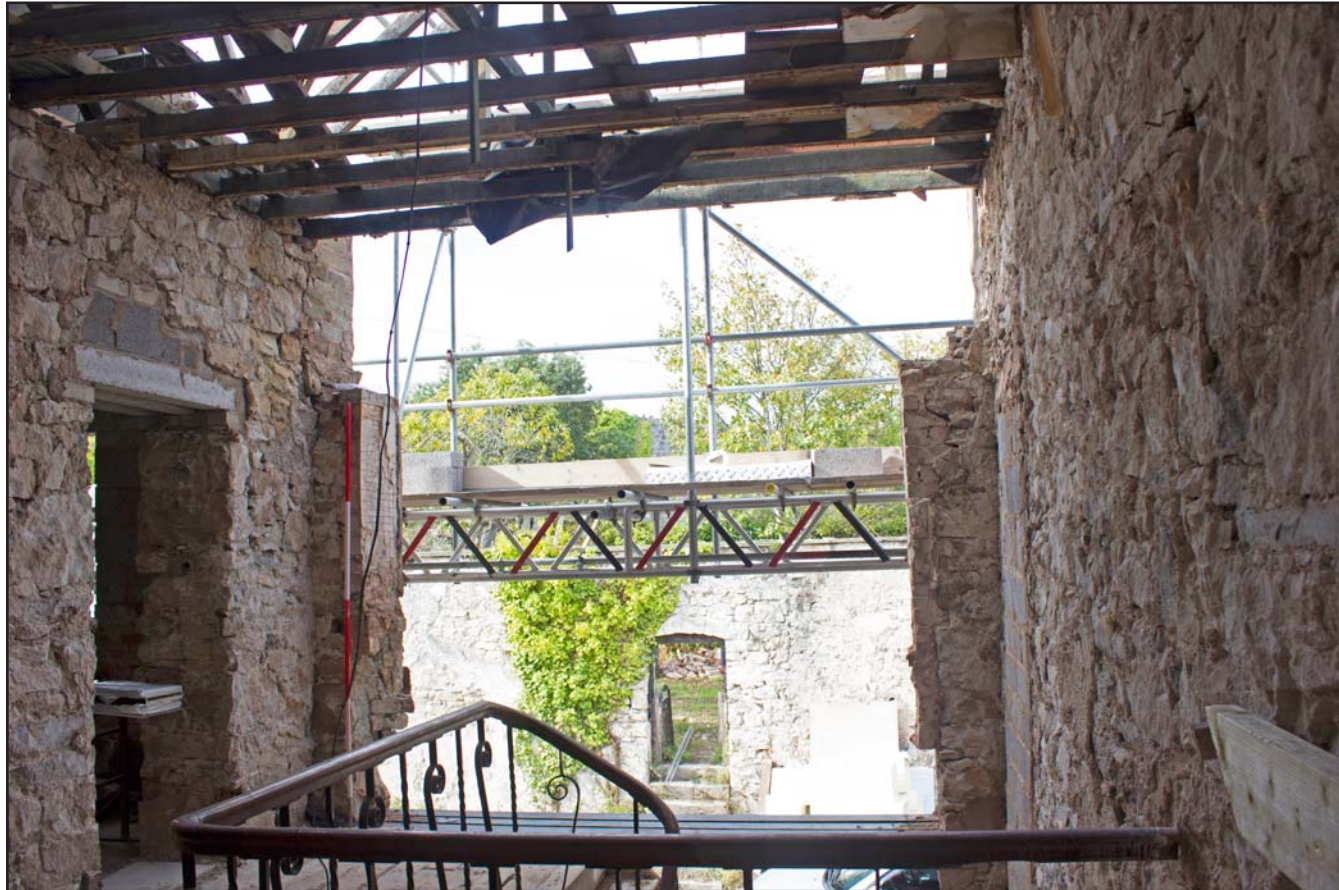
**Plate 34:** Landing, first floor, Tanrallt Hall, Abergele Road, Llanddulas, Abergele - from the northeast - 2.00m scale
