Report no. 0374

# **Tanrallt Hall, Abergele Road, Llanddulas, Abergele LL22 8HR**

## **October 2022 v1.0**

Historic Building Record Level 2

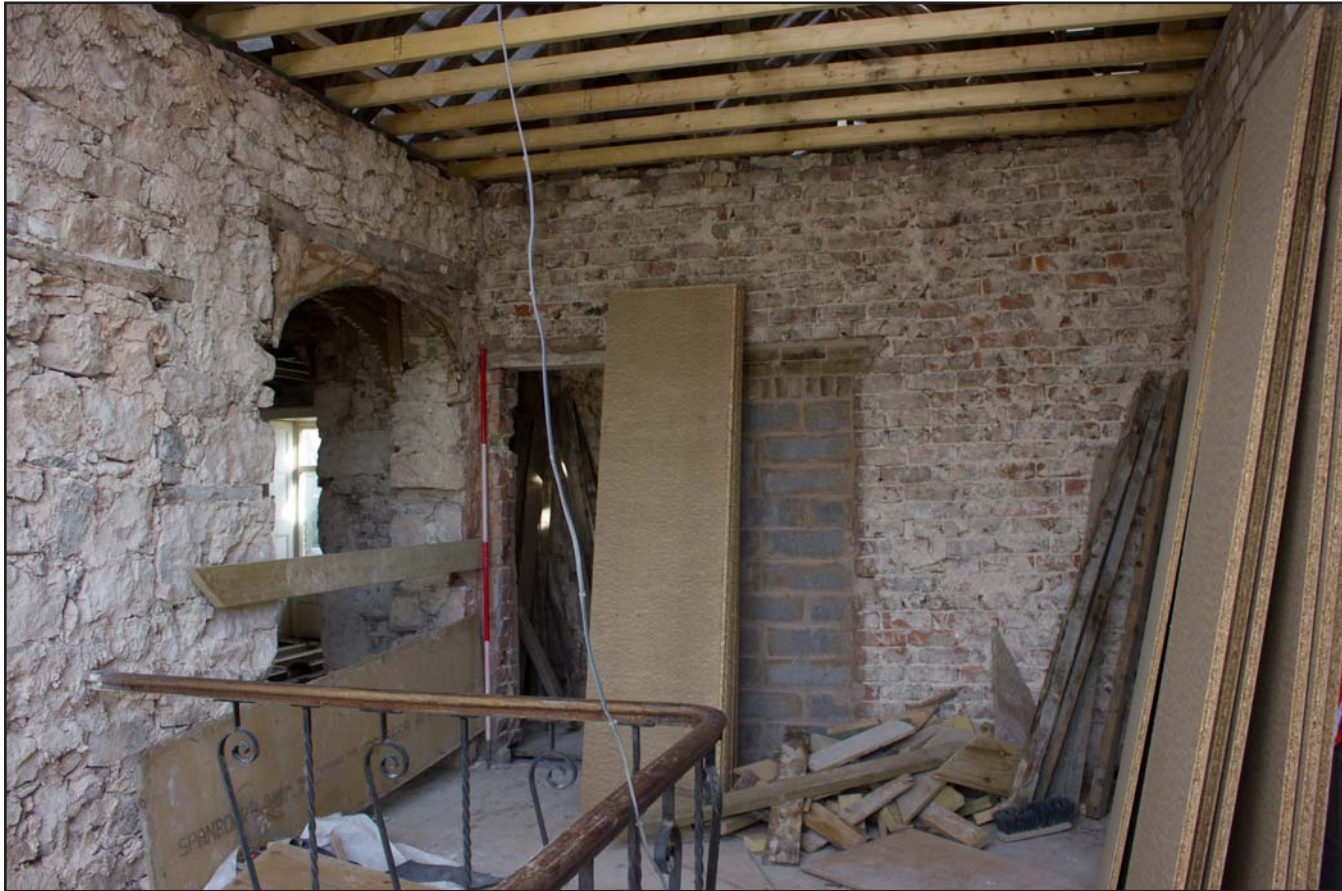
**Plate 35:** Landing, first floor, Tanrallt Hall, Abergele Road, Llanddulas, Abergele - from the southwest - 2.00m scale

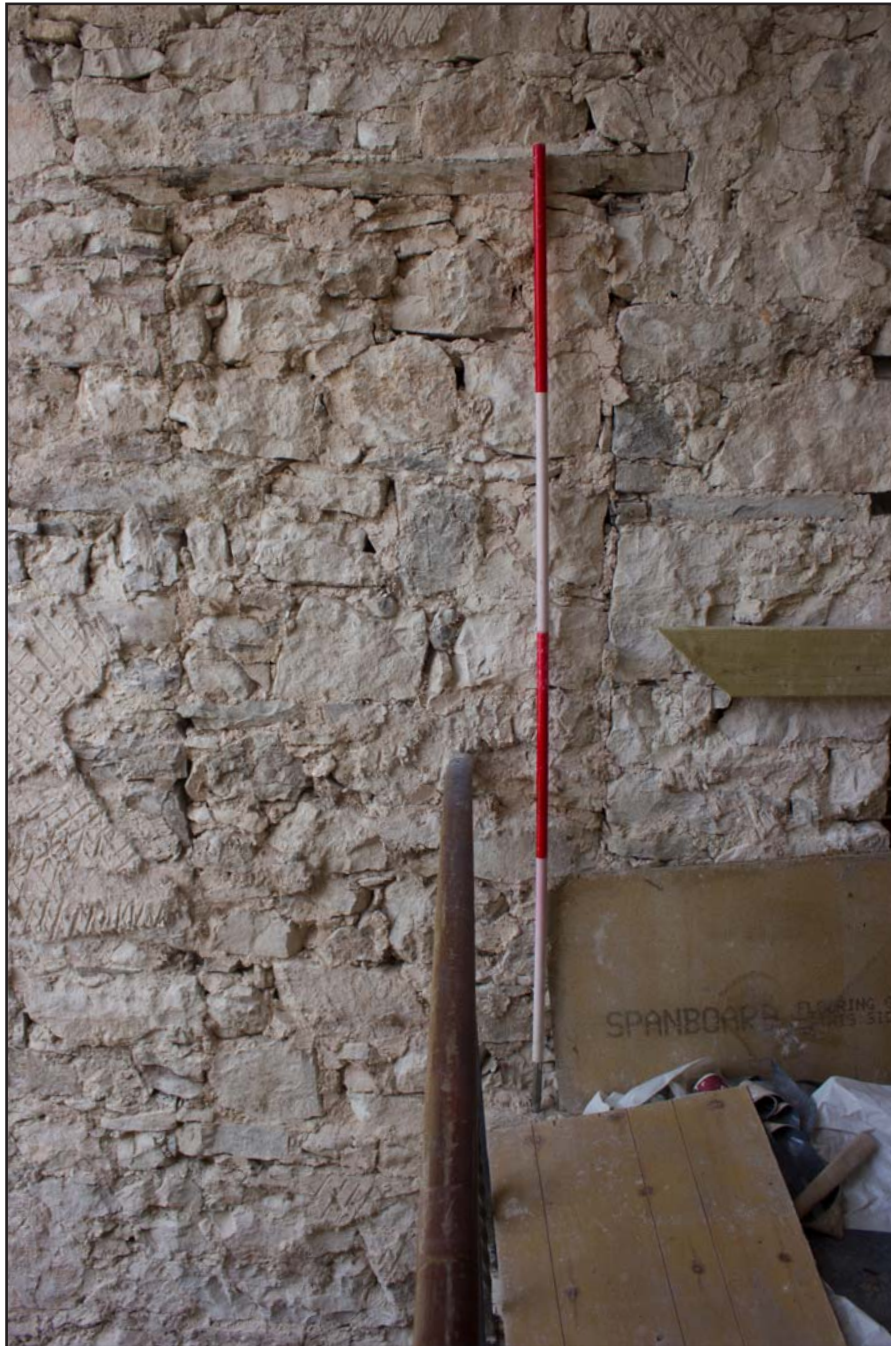
**Plate 36:** Landing, blocked door, first floor, Tanrallt Hall, Abergele Road, Llanddulas, Abergele - from the south - 2.00m scale

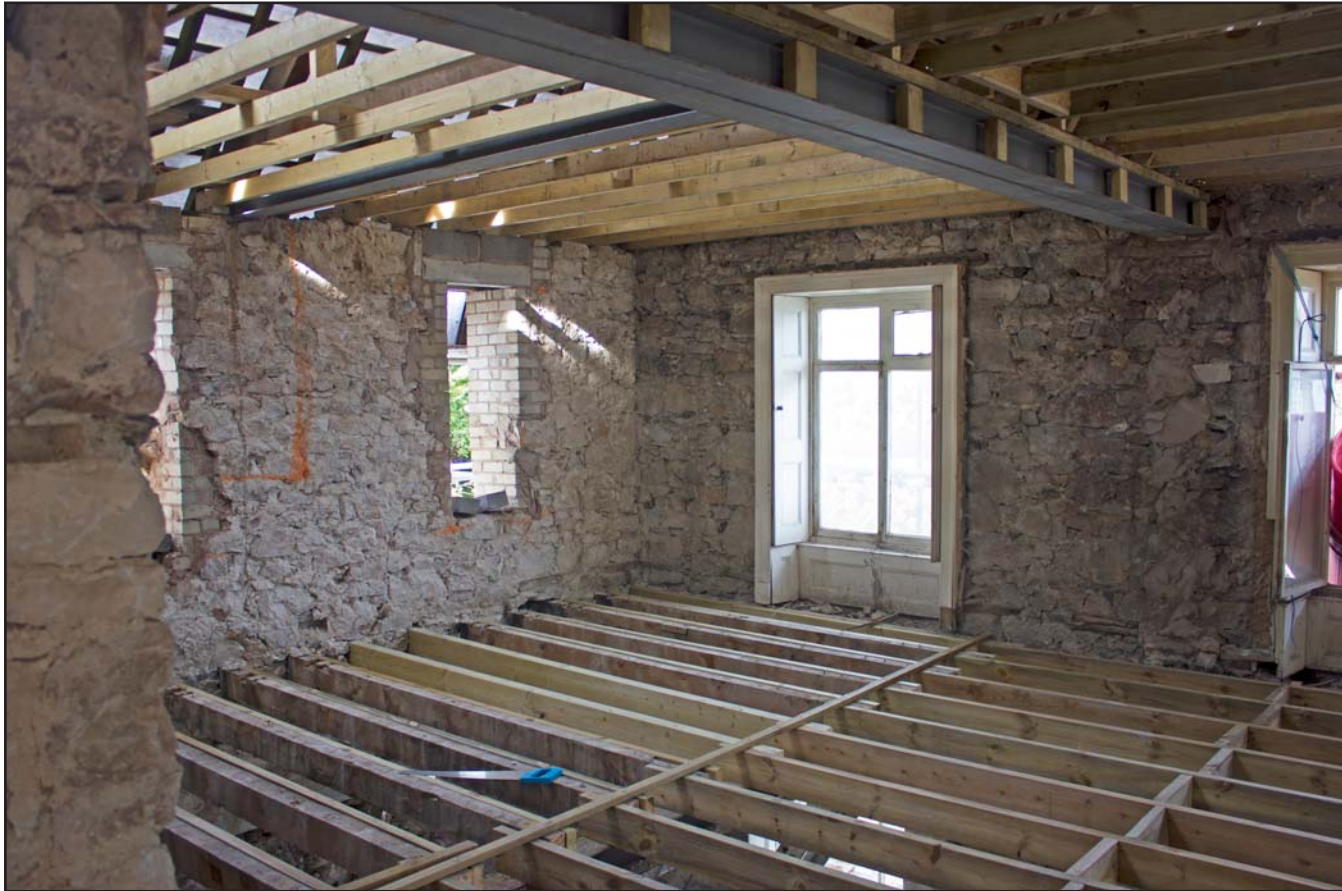
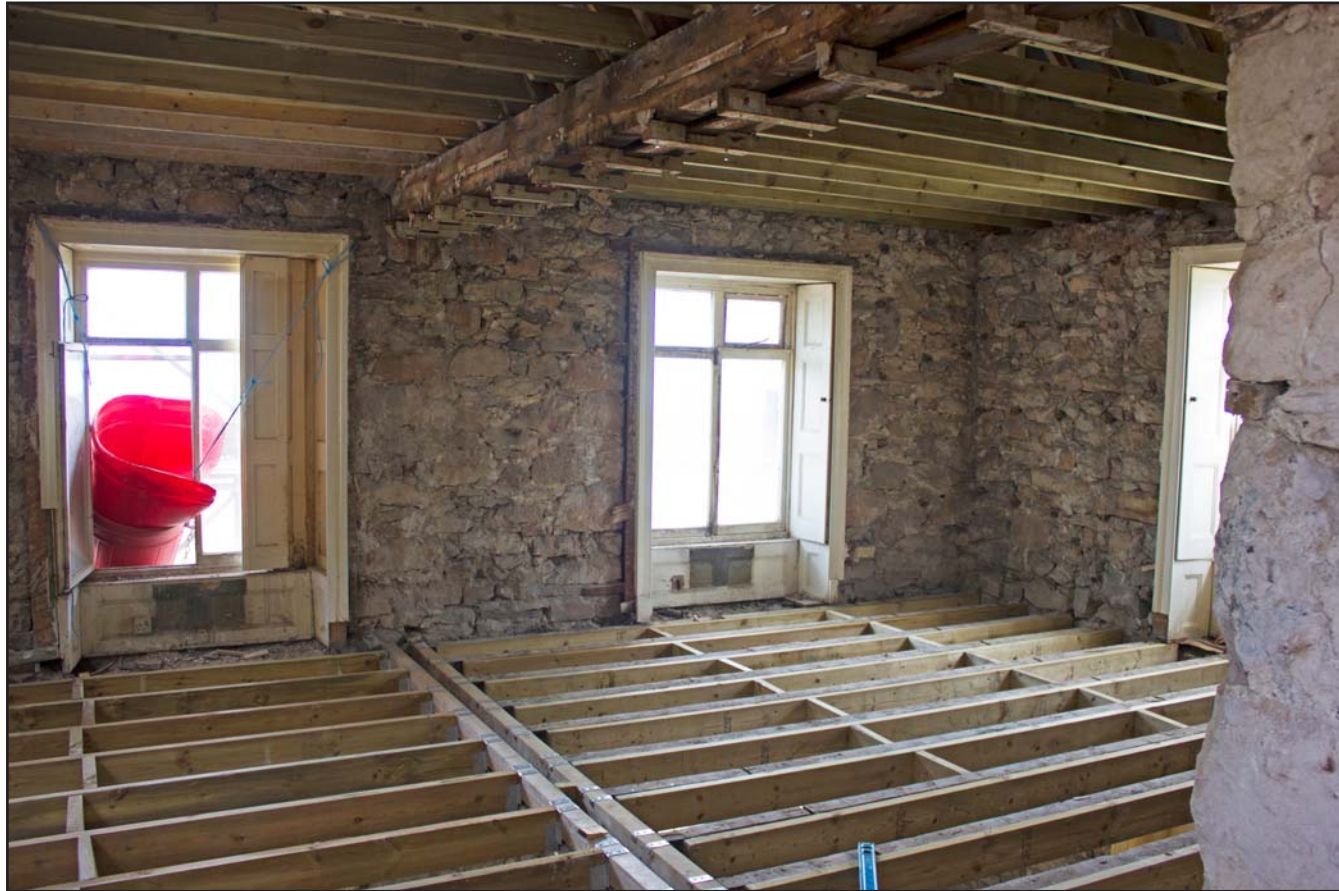
The dividing wall which must once have surely divided the rooms has been removed - forming a large rectangular room, orientated east to west and measuring 10.00m in length by 4.88m in width. This room is inaccessible due to the lack of a floor. The ceiling has been

**Plate 37:** Bedroom 1/2, first floor, Tanrallt Hall, Abergele Road, Llanddulas, Abergele - from the southeast - no scale

**Plate 38:** Bedroom 1/2, first floor, Tanrallt Hall, Abergele Road, Llanddulas, Abergele - from the southwest - no scale

removed revealing modern timber joists and the roof configuration above – which has now been replaced with a modern slate roof. To the east of centre is a hand-hewn oak beam running north to south and to the west of this a modern steel girder has been inserted on the same alignment. The walls are all of expose stone rubble bonded by lime mortar and which are coursed.

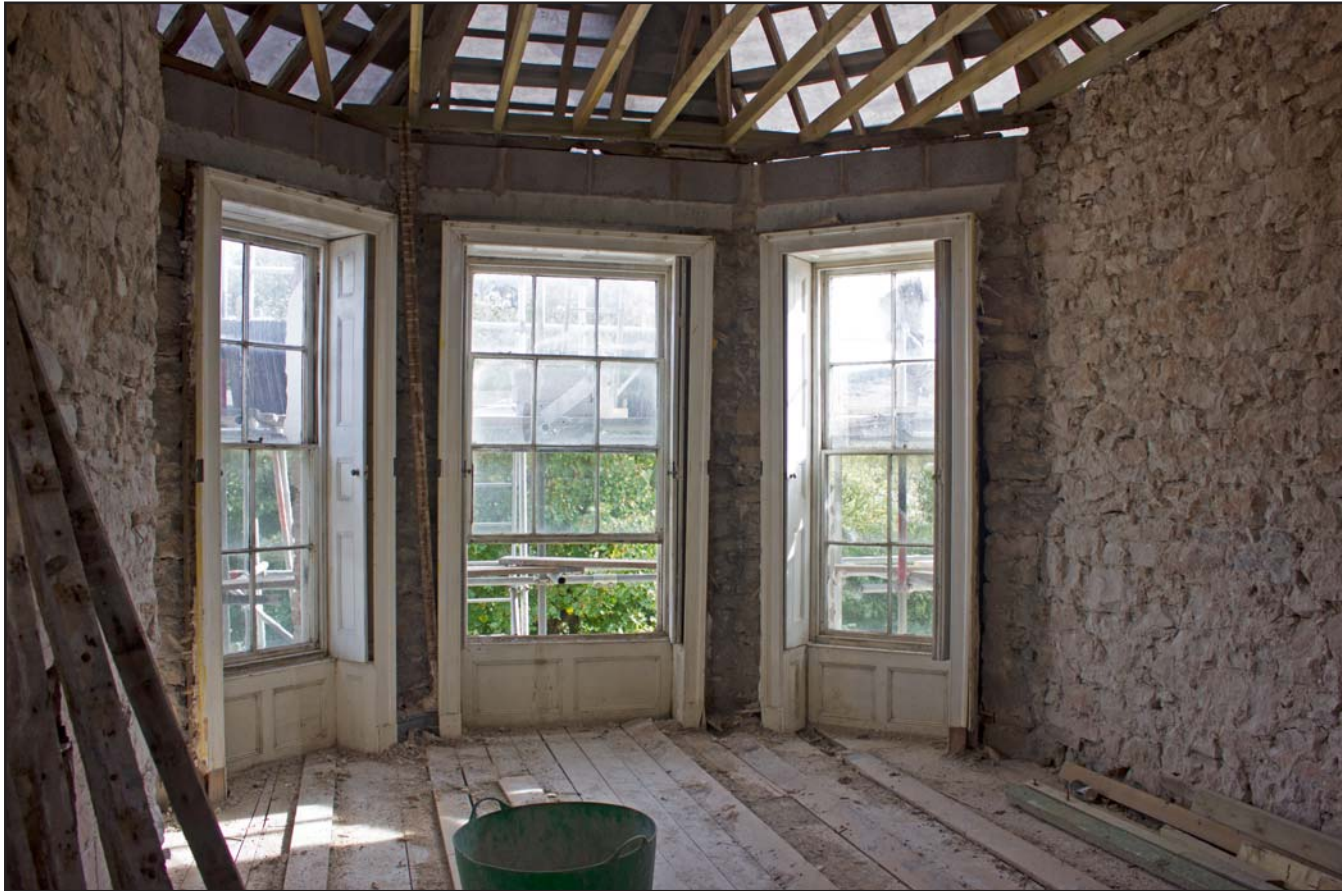
**Plate 39:** Bedroom 3, first floor, Tanrallt Hall, Abergele Road, Llanddulas, Abergele - from the east - no scale

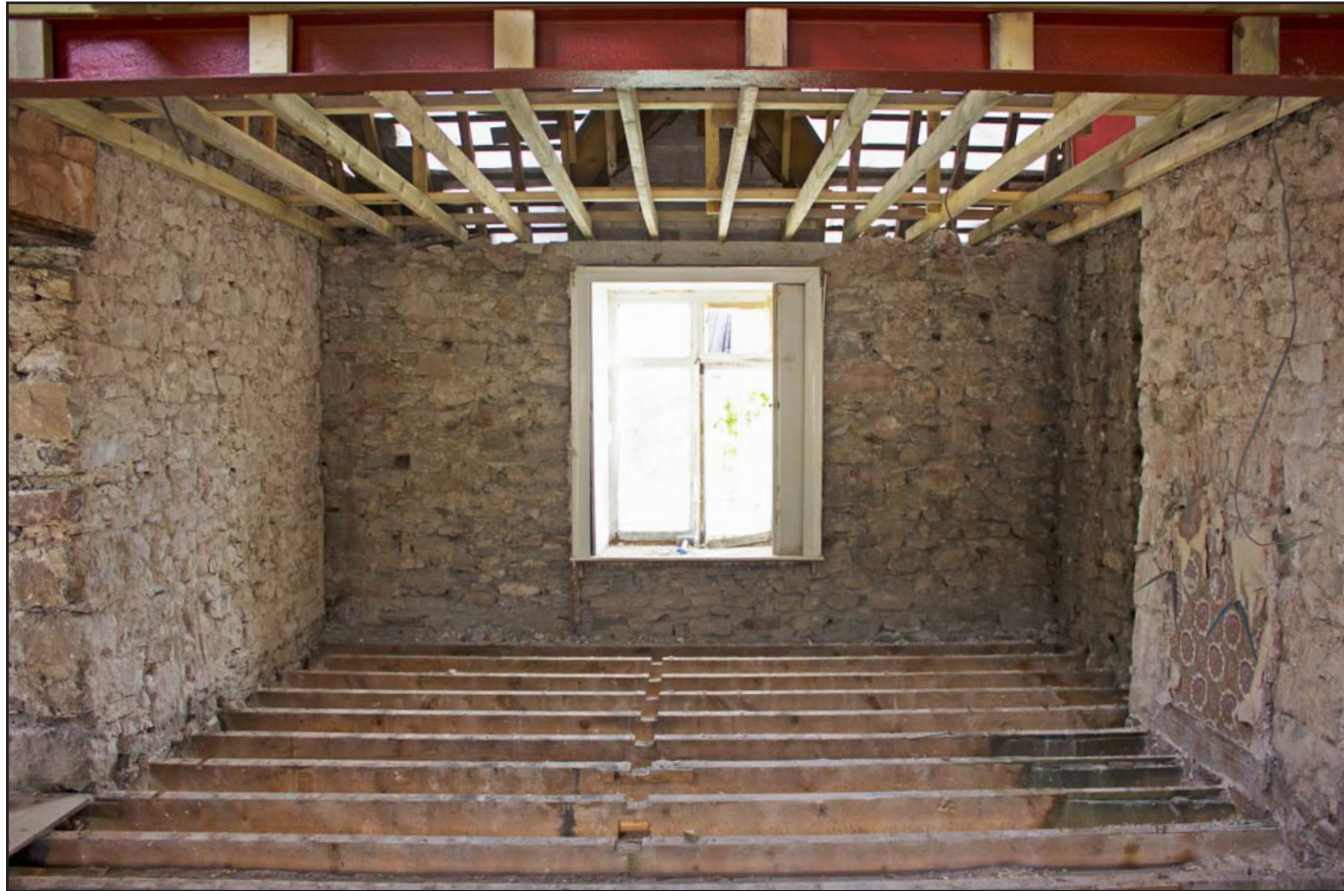
**Plate 40:** Bedroom 4, first floor, Tanrallt Hall, Abergele Road, Llanddulas, Abergele - from the west - no scale

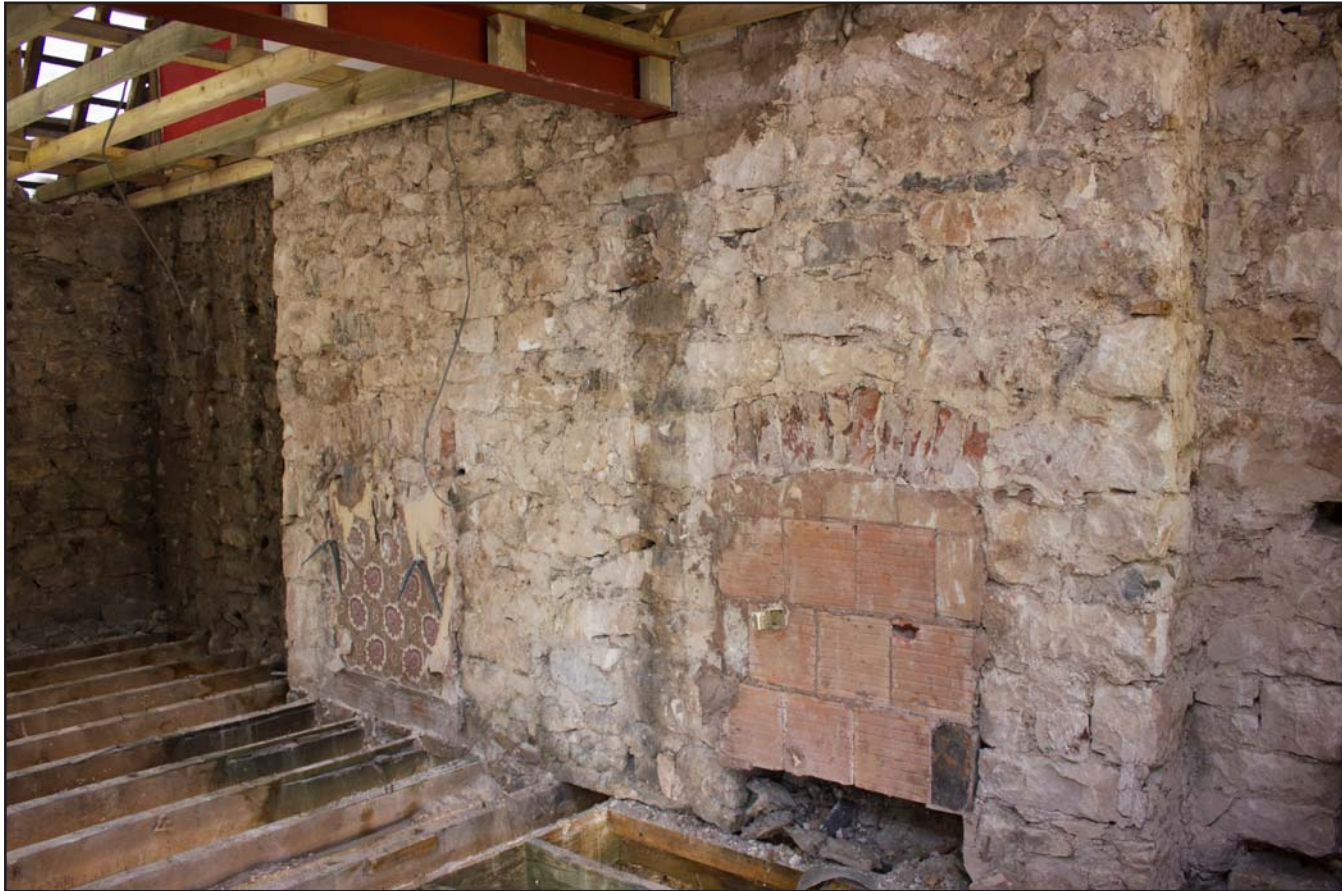
**Plate 41:** Bedroom 4, blocked fireplaces, first floor, Tanrallt Hall, Abergele Road, Llanddulas, Abergele - from the northwest - no scale

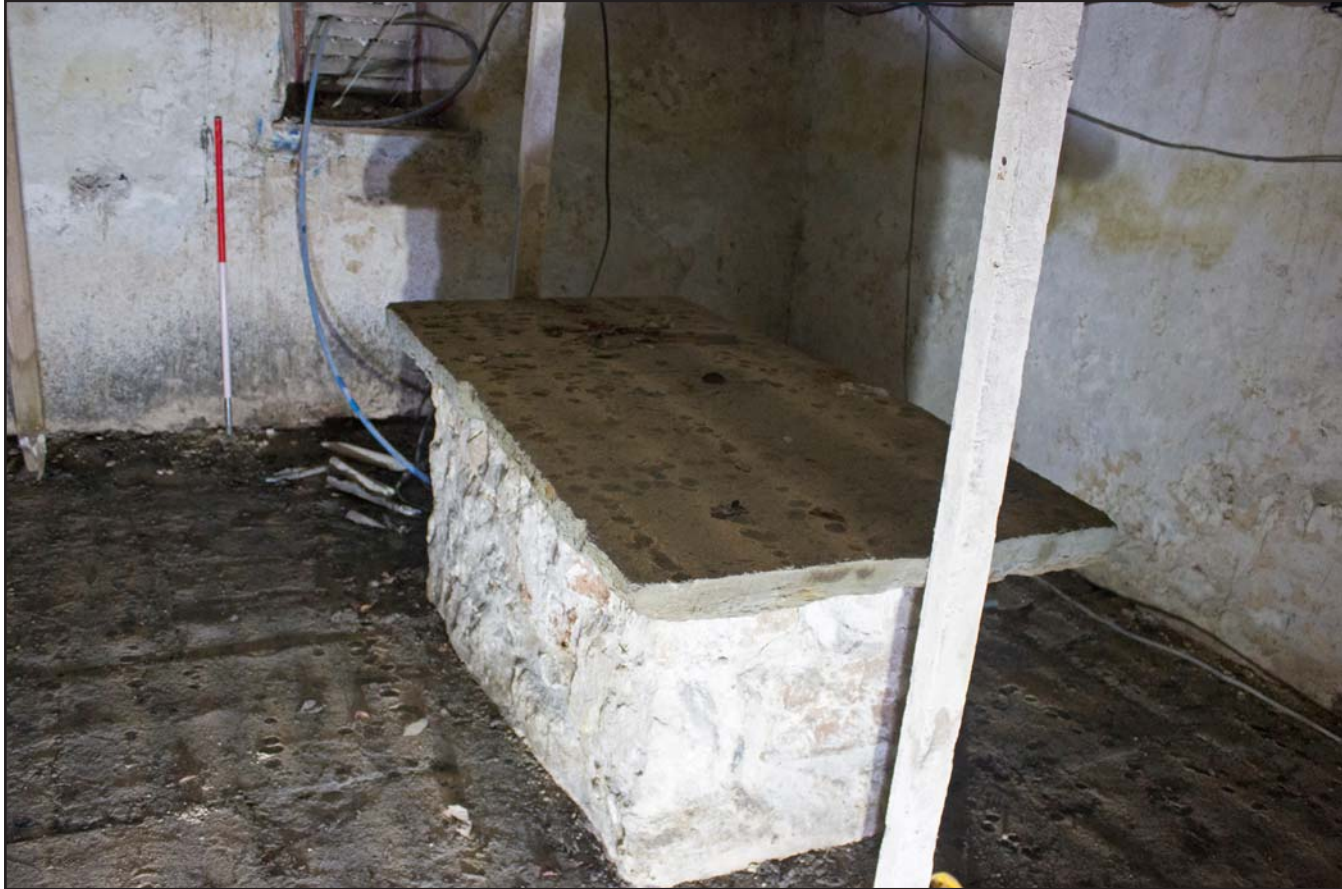
**Plate 42:** Store/preparation room, basement, Tanrallt Hall, Abergele Road, Llanddulas, Abergele - from the southwest - 1.00m scale

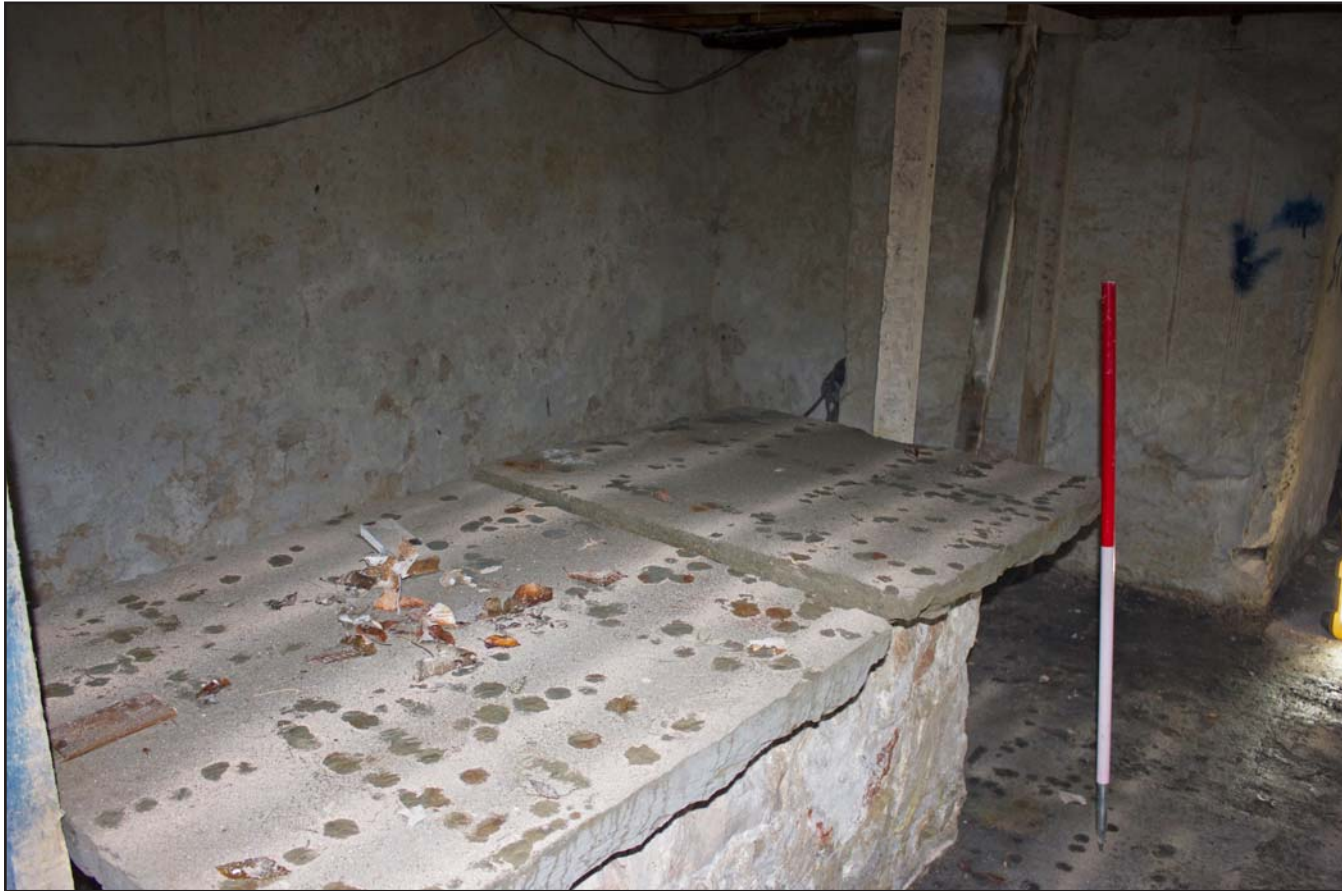
**Plate 43:** Store/preparation room, basement, Tanrallt Hall, Abergele Road, Llanddulas, Abergele - from the northwest - 1.00m scale

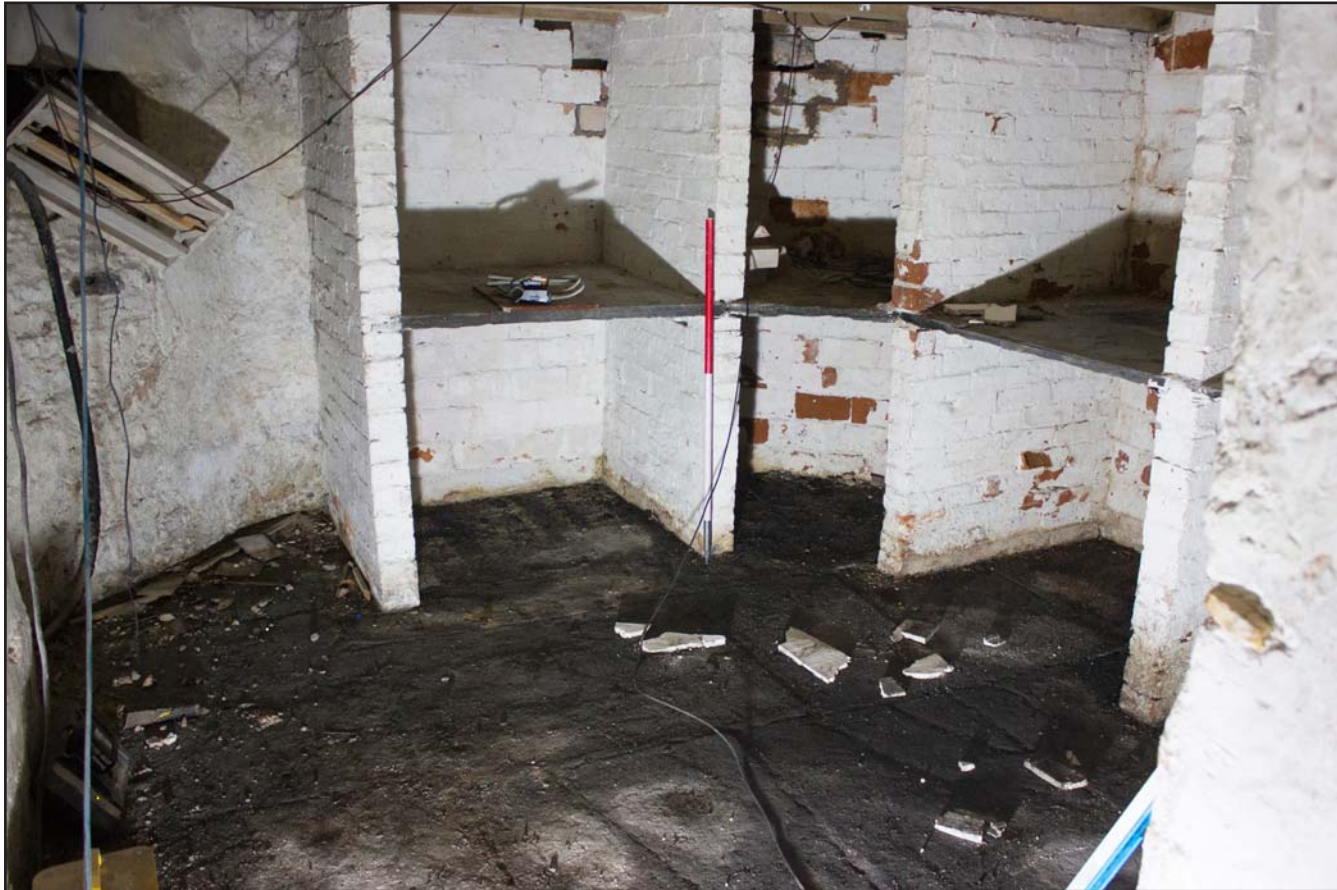
**Plate 44:** Pantry, basement, Tanrallt Hall, Abergele Road, Llanddulas, Abergele - from the northwest - 1.00m scale

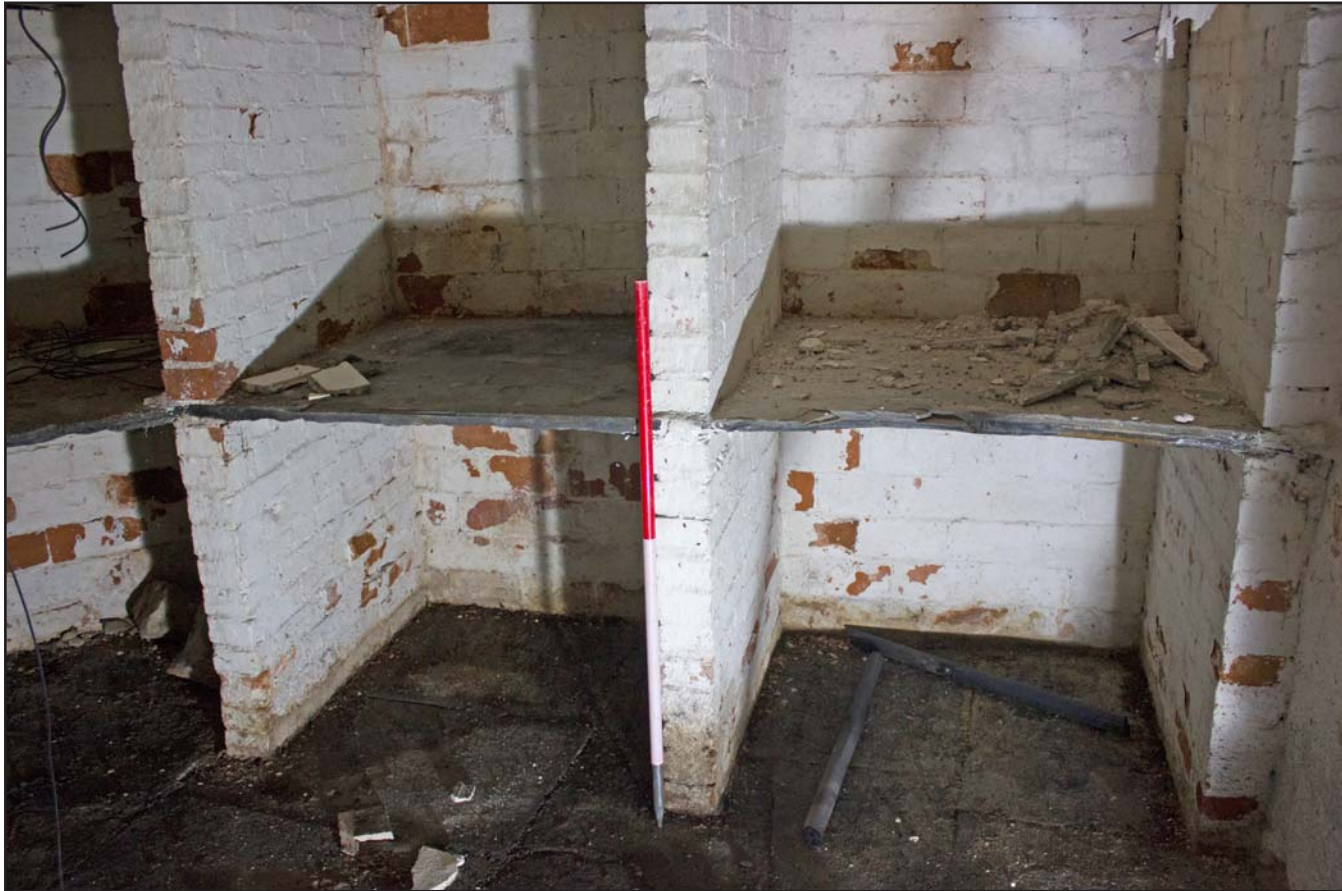
The northern elevation is featureless. The eastern elevation has brick built, projecting, cold stores/shelving which continue onto the southern elevation and amount to 8 cold store compartments - with slate shelves. The western elevation has a single doorway opening at the right-hand end permitting access to the basement corridor. The floor is of laid York stone slab.

**Plate 45:** Pantry shelves, basement, Tanrallt Hall, Abergele Road, Llanddulas, Abergele - from the north - 1.00m scale

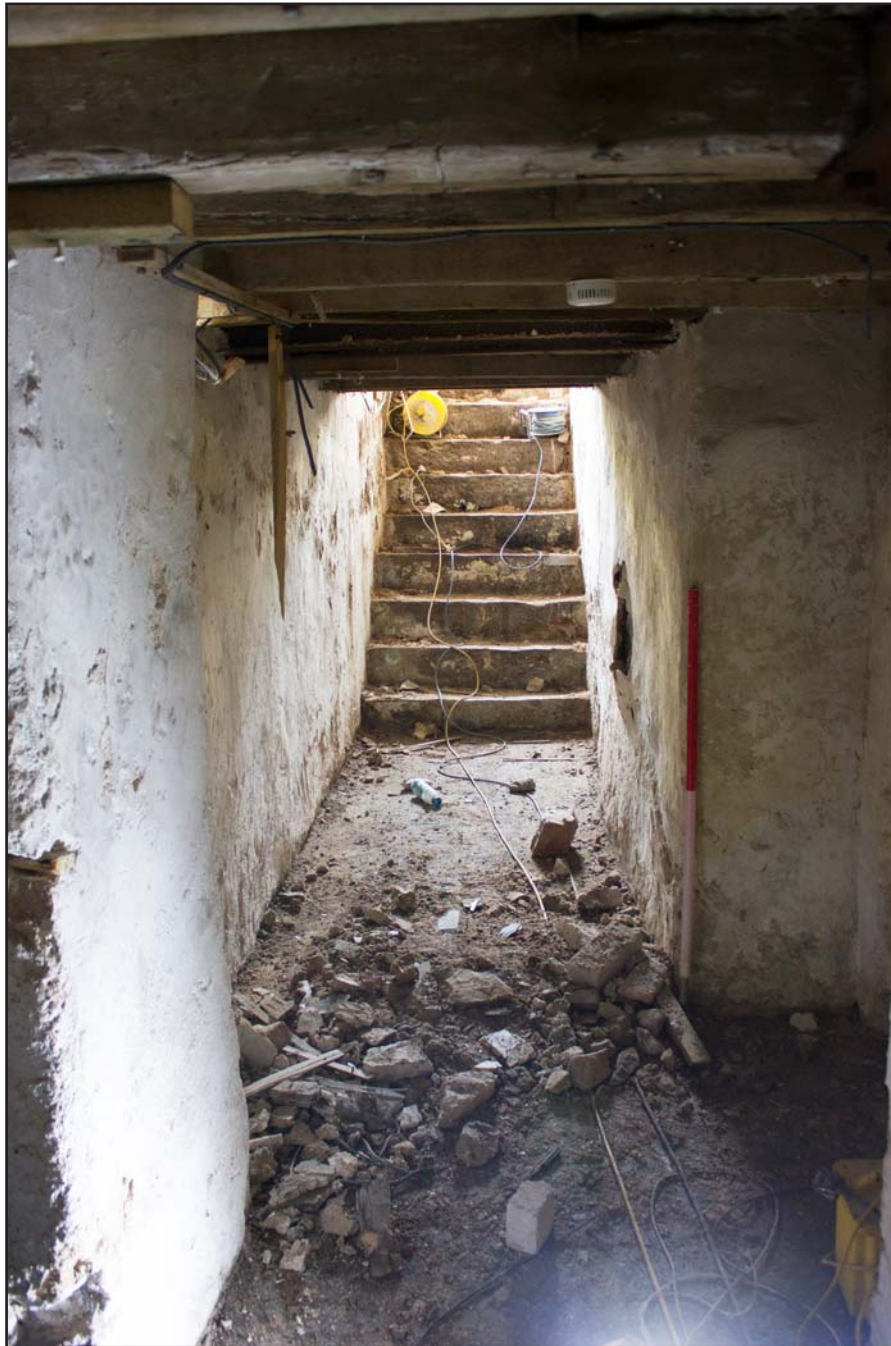
**Plate 46:** Corridor, basement, Tanrallt Hall, Abergele Road, Llanddulas, Abergele -  
from the east - 1.00m scale

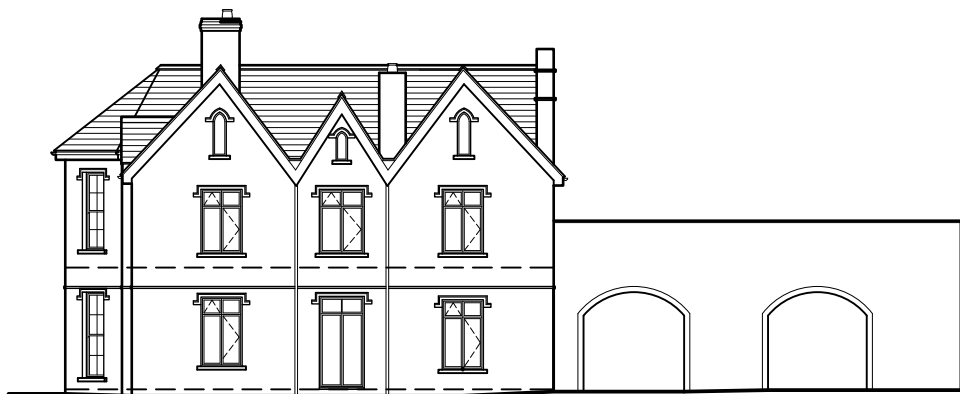
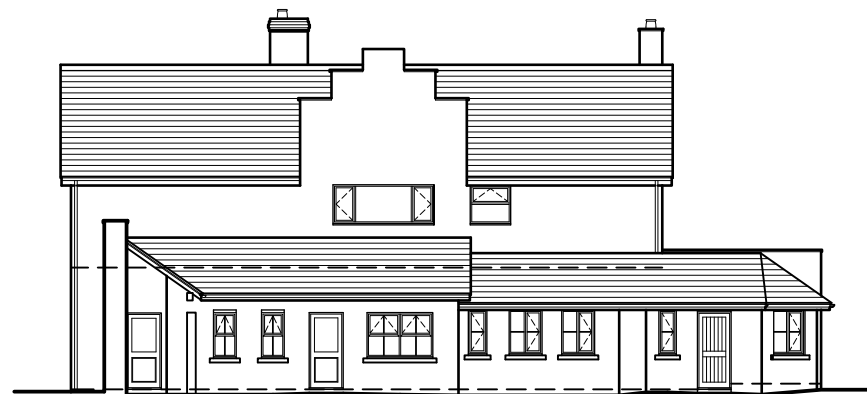
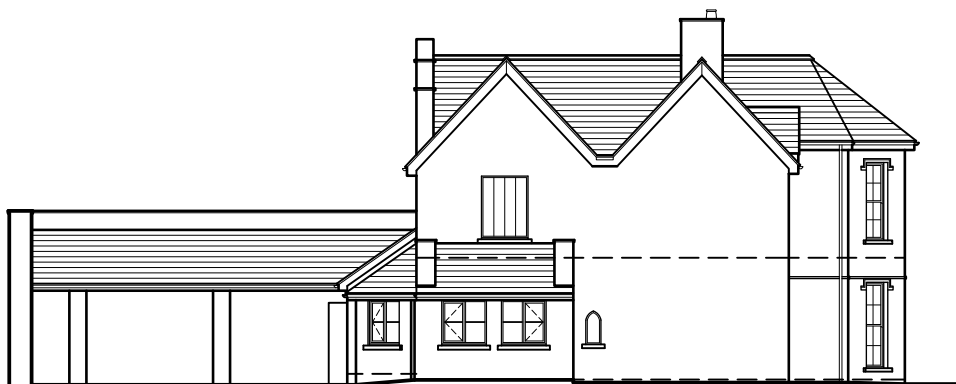
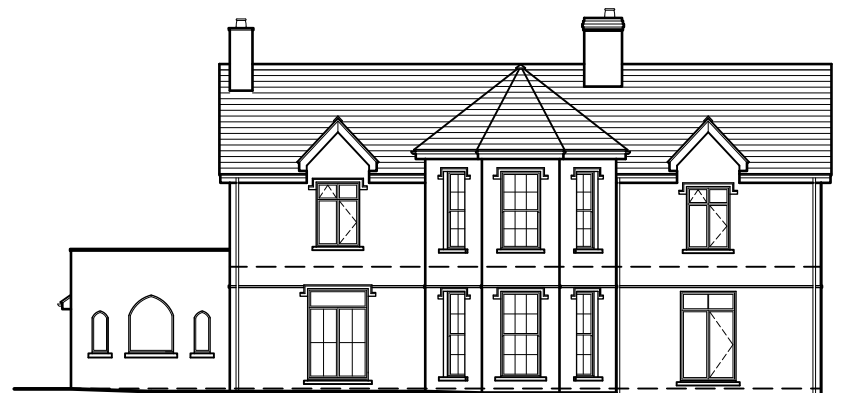
Front Elevation  
**Northern**

Side Elevation  
**Western**

Rear Elevation  
**Southern**

Side Elevation  
**Eastern**
