Heritage Impact Assessment

Brecon Lodge Ffrwdgrech Brecon Powys

January 2023

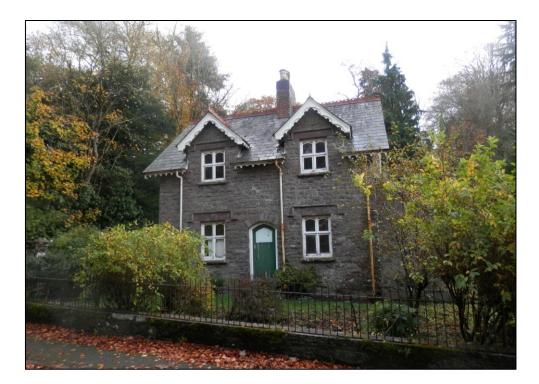
Plate 1: View looking SE towards the front of Brecon Lodge

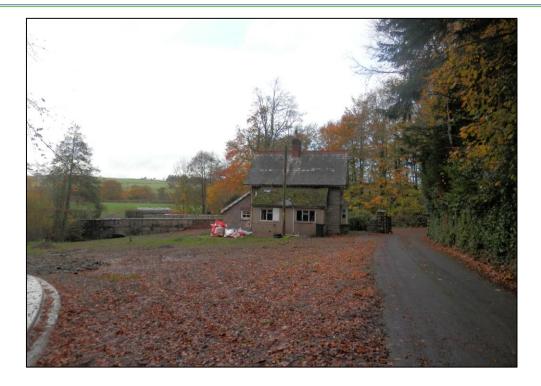
Plate 2: View looking NNW across the site of the proposed development

The proposal site (*Plates 2-5*) comprises a portion of the garden to the rear of The Grade II Listed Brecon Lodge Ffrwdgrech (*Plate 1*). The fabric and morphology of Brecon Lodge is described in greater detail in Section 6.1.1. The site, which is located to the SE of the Listed Building, is currently vacant, consisting of flat ground bordering the road leading to Ffrwdgrech House, which forms the NE boundary of the site of the proposed development. The SW boundary of the site is defined by a small unnamed stream, which joins Nant Gwdi to the immediate W of the site, which has recently been landscaped to minimise flooding across the garden of Brecon Lodge. The NW boundary of the site is defined by the rest of the garden attached to Brecon Lodge and the building itself. The site is relatively flat, with a gentle slope towards Nant Gwdi.

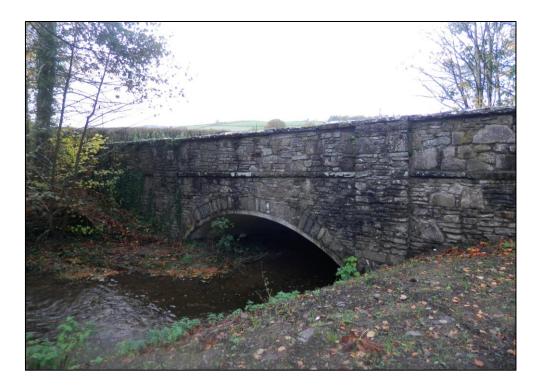
Plate 6: View looking NNW at Pont Ffrwd Grech

The 1813 map also appears to show the small stream forming the SW site boundary, which joins Nant Gwdi to the immediate W, although it is not possible to discern the course of the stream with any accuracy based on this map. The OS Surveyor's Map shows the road being carried over Nant Gwdi by a bridge, which represents Pont Ffrwd Grech (*Plate 6*; HER: HER: 70966). The bridge is first mentioned in documentary sources in 1711 and again in 1813 and is described as having three pointed and two segmented arches (Davies 1992).

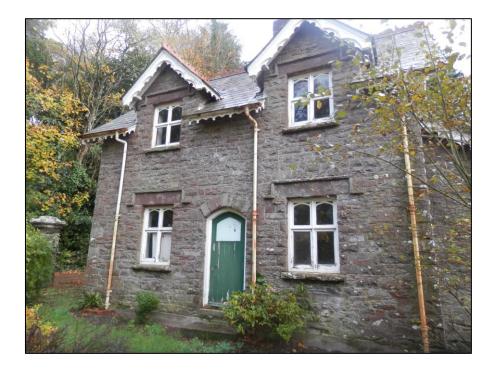
Plate 12: View looking SE at the front of Brecon Lodge

Brecon Lodge (*Plates 12-15*), which was Grade II listed in 2005 as 'The Lodge, Ffrwdgrech' (84523), is recorded as a late 19th century entrance lodge to Ffrwdgrech. The Listing records that the house was owned by the Evans family from 1881 and was previously tenanted for some years, so the Lodge may date from after 1881. The exterior of the building is described as follows in the Listing:

Brecon Lodge comprises a rectangular gabled house, one and a half storeys in height and of red sandstone rubble construction with a slate roof surmounted by a central brick chimneystack with terracotta ridge tiles and ornamental bargeboarded eaves. The principal N-facing elevation is three bays wide with a central low-arched doorway flanked by two flat-arched Tudor-style mullioned and transomed windows with hoodmoulds, while the fenestration at first floor level comprises two flat-arched mullioned and transomed windows with hoodmoulds, set beneath two ornamental bargeboarded gables (*Plate 12*).

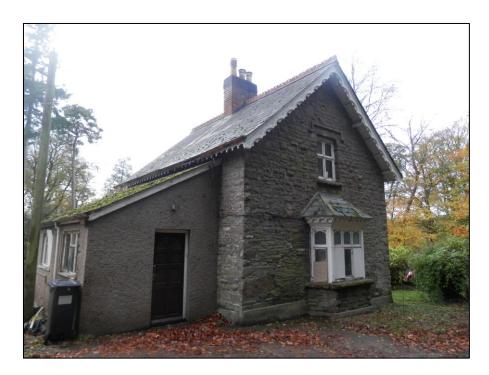
Plate 13: View looking W at E side of Brecon Lodge, showing modern le

However, it may be argued that the removal of the modern pebbledash lean-to extension will have a positive impact on the building, as it is a later 20th century addition which differs in style from the rest of Brecon Lodge and is in a poor state of repair. It is considered that the proposed refurbishment of the windows is sympathetic to the character of the existing fenestration although it is suggested that particular care should be given to preservation of the timber-framing of the canted bay window at ground level.

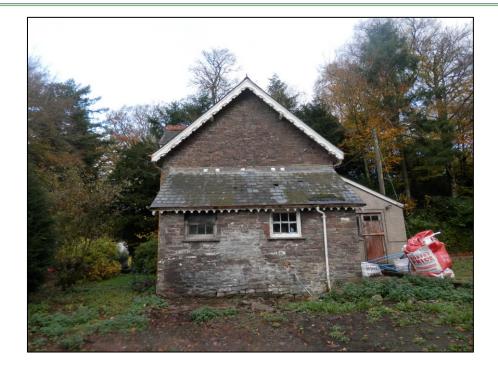
Plate 14: View looking E towards the W gable end of Brecon Lodge

The E-facing gable has a canted bay window at ground level, above which is a hoodmoulded four-light window with mullion and transom (*Plate 13*). Attached to the W gable end of the building is a single-storey stone-built lean-to extension with bargeboarded eaves which appears likely to be of late 19th/early 20th century date (*Plate 14*), while to the S is a modern single-storey lean-to structure, of brick construction with a pebbledashed exterior which appears to be of mid-late 20th century date (*Plate 15*).

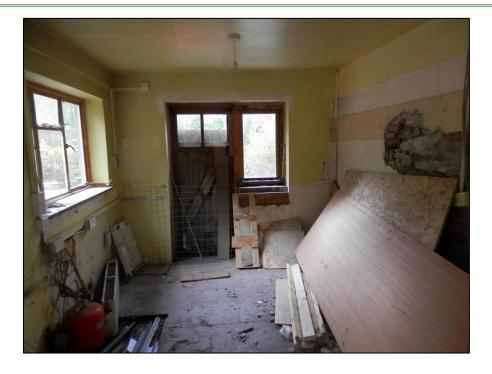
Plate 16: View looking SW across the interior of the lean-to extension to the rear of Brecon Lodge

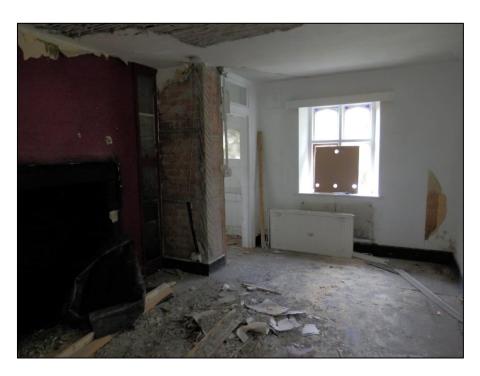
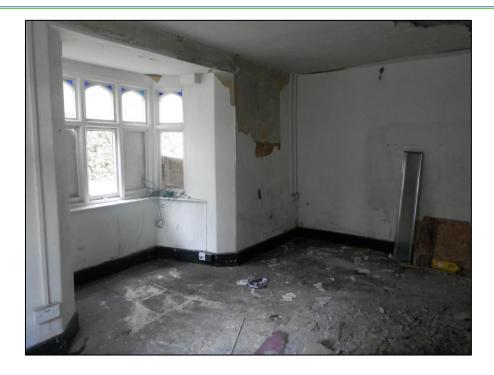
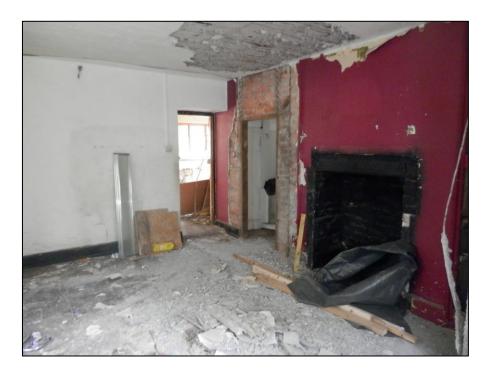
Entry to the living room is made from the later extension (*Plates 17-19*). The living room has flagstone flooring and there is a fireplace and large canted bay-window in Tudor style with coloured glass in the spandrels of the arches. However, the fireplace surround has been removed by a previous occupant to leave an empty opening. A number of windows had been broken; the glass being replaced by wooden panelling. Much damage was noted to the walls and ceiling, with wallpaper and plaster in a very poor state of repair and extensive evidence of mould/damp.

Plate 17: View looking NW across the interior of living room

Plate 18: View looking SE across the interior of the living room

Plate 19: View looking SW across the interior of the living room

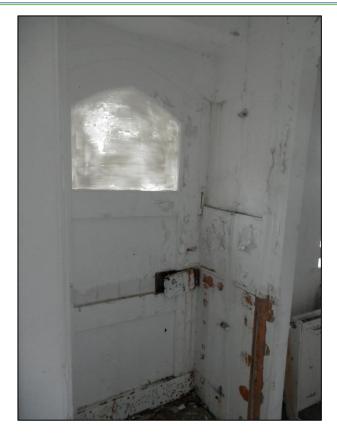
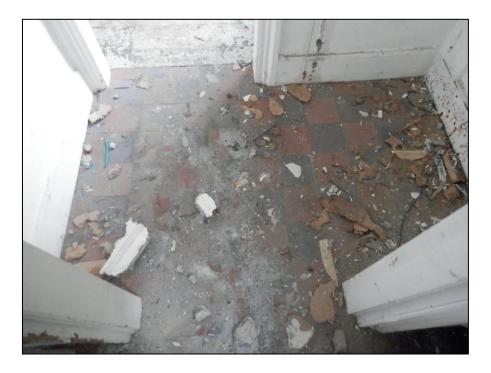
Passing through the entrance hall, which has a tiled floor (*Plates 20 & 21*), one enters a small dining room which has a small blocked fireplace, planked floorboards and plastered walls all in a poor state of repair (*Plates 22 & 23*).

Plate 20: View looking N across the entrance hall

Plate 21: View looking at the tiled floor of the entrance hall

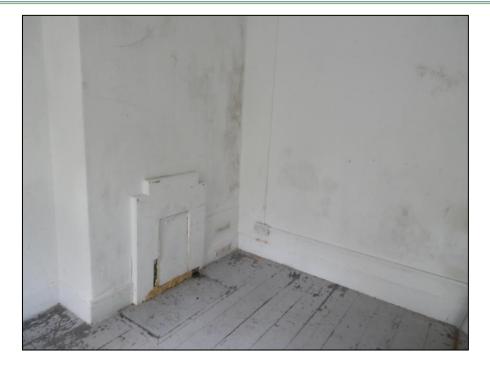
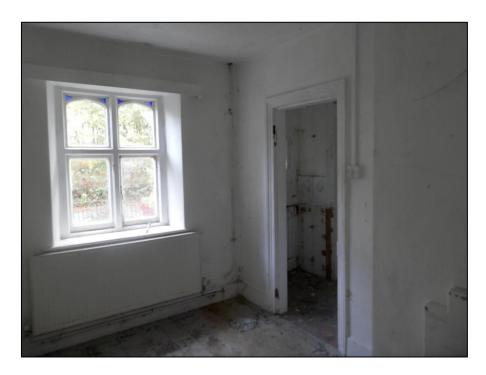
Plate 22: View looking SE across the interior of the dining room

Plate 23: View looking NE across the interior of the dining room

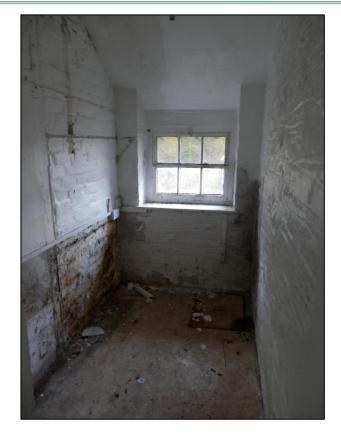
The dining room leads through to a small former kitchen located within the late 19th/early 20th century extension on the W side of the building. This had been stripped of all features and was in a poor state of repair (*Plate 24*). Returning to the living room, one reaches the downstairs landing, with stairs leading up to the first floor from which the banisters had been removed (*Plate 25*). A doorway leads from this landing to the downstairs bathroom which appears to have been created at a later date by inserting a partition wall within the W extension. The bathroom, which again is in a poor state of repair, had a toilet and bath but the plasterwork on the ceiling had been largely removed (*Plate 26*).

Plate 24: View looking SW across the interior of the kitchen

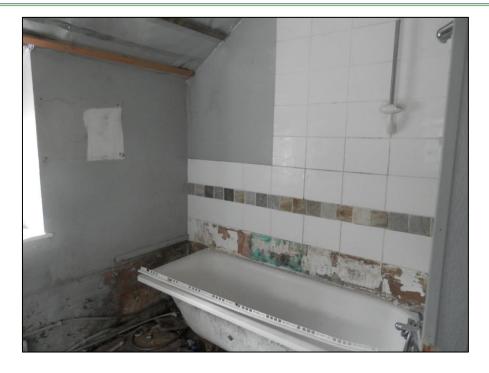
Plate 26: View looking W across the interior of the bathroom

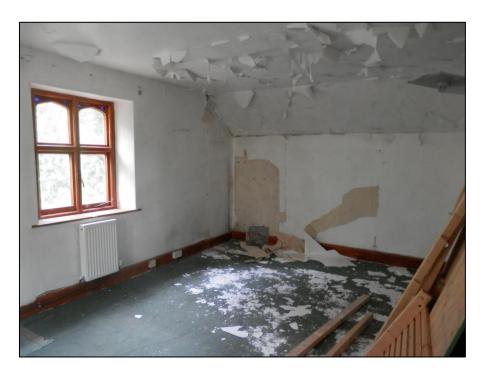
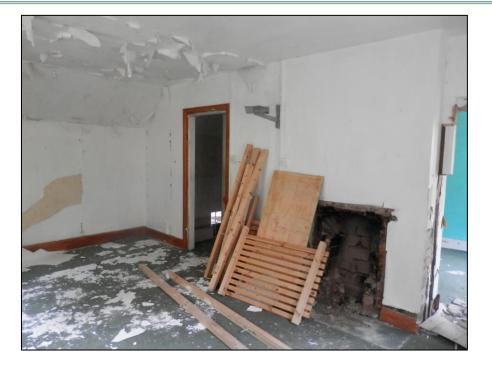
The first floor comprises two bedrooms, a larger one to the E and a smaller one to the S. The larger bedroom (*Plates 27 & 28*) is carpeted and has another removed fireplace. Again, much damage was noted to the walls and the ceiling, with wall paper and plaster being in a very poor state of repair and extensive evidence of mould/damp. The same is true of the smaller bedroom (*Plates 29 & 30*).

Plate 27: View looking SE across the larger bedroom

Plate 28: View looking SW across the larger bedroom

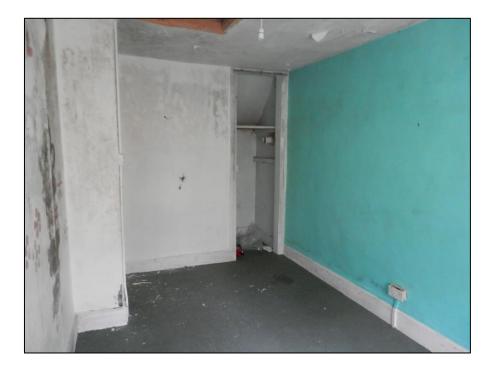
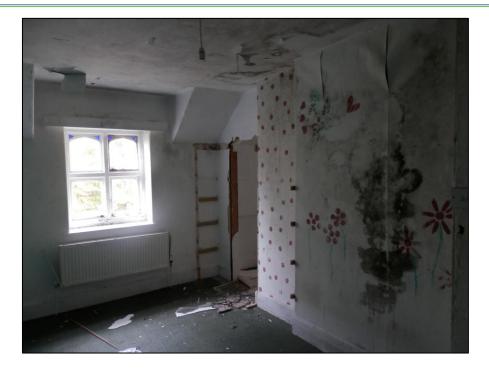
Plate 29: View looking SE across the smaller bedroom

Plate 30: View looking NW across the smaller bedroom

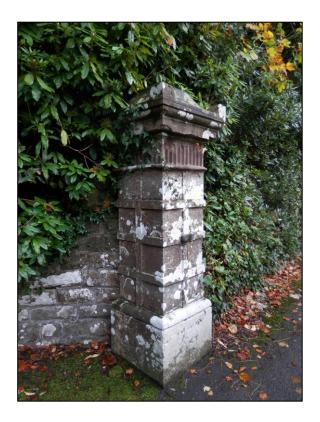
Plate 31: View looking SE at the E gatepier

The gatepiers and flanking walls and railings may be regarded as representing a heritage asset of **High** significance in architectural and historical terms. This assessment reflects their status as a Grade II listed building and well-preserved example of 19th century entrance gates to the estate associated with the historic mansion of Ffrwdgrech House. Their setting, occupying a prominent position at the entrance to the Ffrwdgrech parkland, as well their demonstrably close visual and historic association with Brecon Lodge, also contributes significantly to their significance as heritage assets.

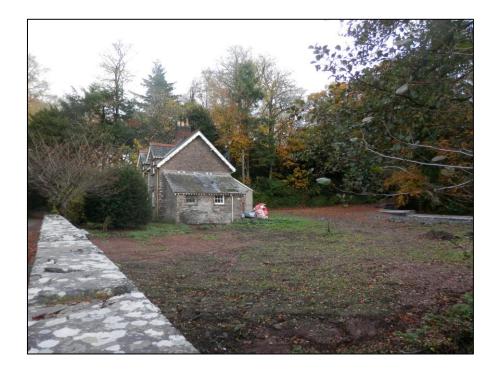
Plate 39: View looking ESE at the site of the proposed development from Pont Ffrwd Grech

Further mitigatory measures may be suggested in order to further reduce the visual impact of the development. These include potentially reorientating the building to minimise its footprint along the driveway, extending the scope of the Llangorse Quarry stone wall to further tie-in the extension with the existing fabric and the use of planting screens mirroring the planting regime of the surrounding parkland, incorporating species such as rhododendron, azalea and bamboo to lower the visual impact of the proposed development. There is also potential for further plant screening to be employed on the other side of the extension, which would have the positive impact of screening the new development from the views of Brecon Lodge from Pont Ffrwd Grech (see *Plate* 39).

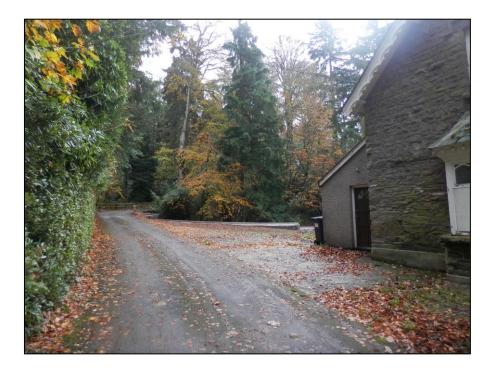
Plate 40: View looking S from the listed gatepiers towards the site of the proposed development

Visually, the impacts of the proposed development upon the listed gatepiers will be extremely similar to those upon Brecon Lodge, due to the close proximity of the two designated heritage assets. Evidently, there is a high degree of intervisibility between the site of the proposed development and the listed gatepiers (*Plate 40*).

Based on the current proposals, the magnitude of impact can be assessed as **Minor**. The proposed development will have no physical impact upon the fabric of the listed gatepiers but will have a discernible visual impact due to the proximity of the designated heritage asset to the Lodge. However, this impact will be limited by the reduced scale of the single-storey rear extension as proposed, the construction of a traditional stone boundary wall to screen the development and the implementation of appropriate landscaping measures.

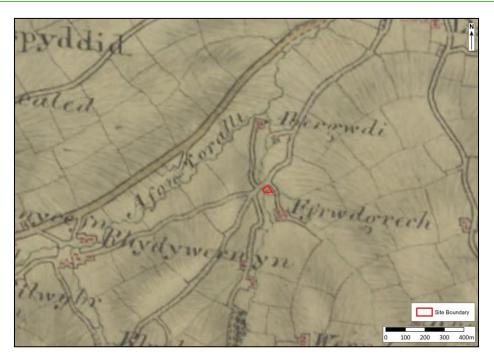
Fig. 18: Extract from the Ordnance Survey Surveyor's Drawing of Brecknock (1813) (Reproduced by courtesy of the British Library)

The 1813 Ordnance Survey (OS) Surveyors' Drawing of Brecknock (*Fig. 18*) provides the earliest available accurate cartographic source depicting the landscape containing the site of the proposed development. This appears to show a small building within the plot of land that constitutes the site, although the accuracy of OS Surveyor's Drawings with regard to individual buildings is questionable. However, if this source is showing a building within the plot, then it suggests that there may have been an earlier building, predating the existing lodge, within the site, as the HER entry (HER: 40522) and the Listed Building Data clearly state that the existing lodge dates from the late 19th century. The HER entry, for instance, gives an approximate date of 1881.

Interestingly, the same sources give a date of approximately 1828 for the construction of the house and parkland at Ffrwdgrech (HER: 32921; HER: 32922; HER: 32923; HER: 41991) and the 1813 OS map clearly shows a cluster of buildings close to the site of the house, with a drive leading up from the road along roughly the same orientation as the modern drive which passes the house. Therefore, it is likely that this represents the earlier house which predated the construction of the existing Ffrwdgrech House.
