# Tŷ Capel, Methodist Chapel, Denbigh Road, Llanfair Talhaiarn Conwy LL22 8SS (0/47796).

Historical Building Record Level 2

Report no. 0316

Historic Building Record Level 2

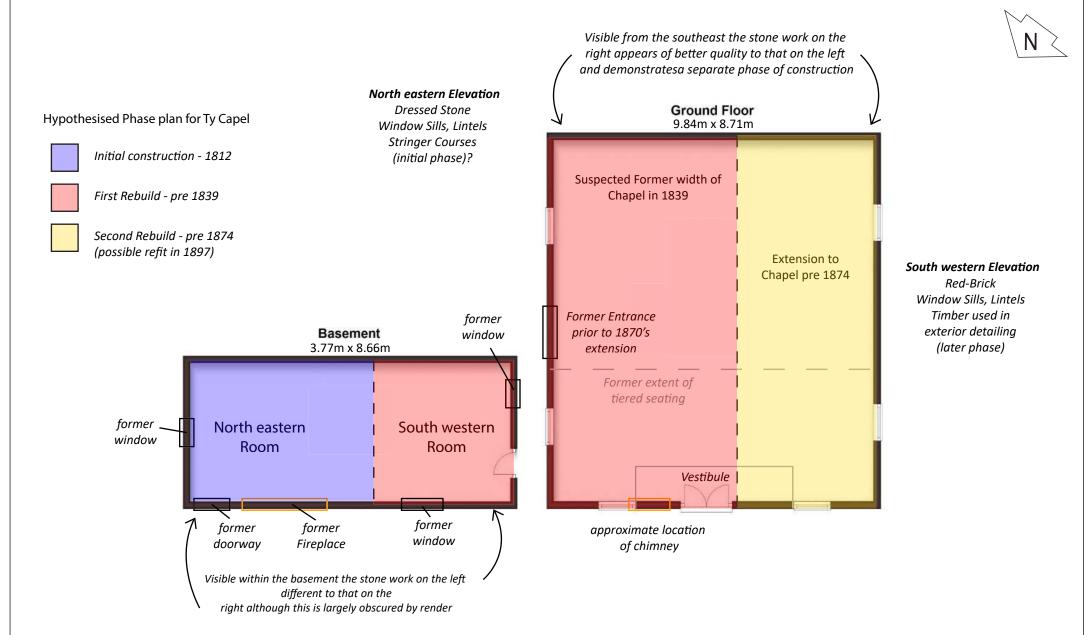
**Figure 04:** Ty Capel, Methodist Chapel, Denbigh Road, Llanfair Talhaiarn LL22 8SS existing floor plan. Scale 1:100 at A4.

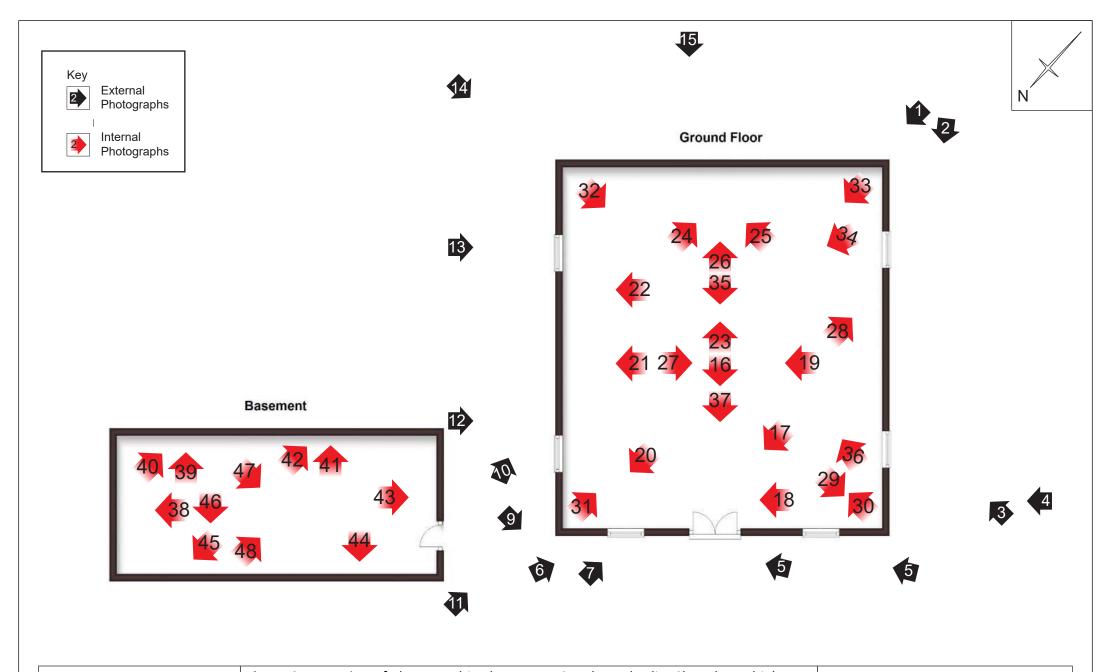
**Figure 07:** Location of photographic plates at Ty Capel, Methodist Chapel, Denbigh Road, Llanfair Talhaiarn. no Scale

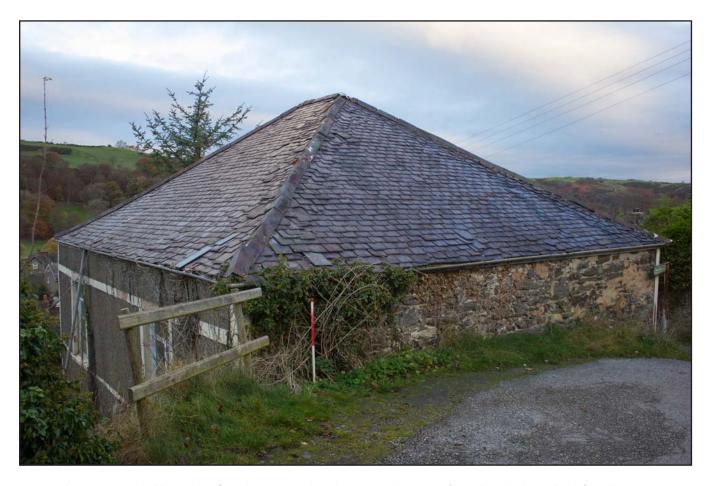
**Plate 01:** External oblique shot of south eastern and south western elevations, Tŷ Capel, Denbigh Road, Llanfairtalhaiarn, Conwy - from the south - 1.00m scale

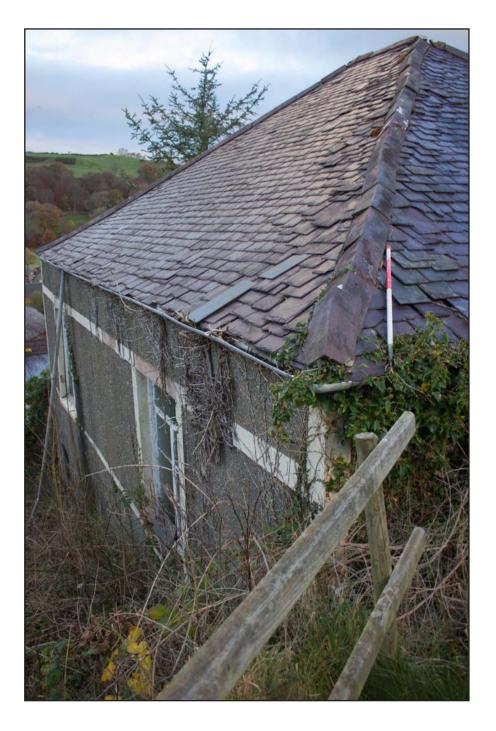
**Plate 02:** External oblique shot of south western elevation, Tŷ Capel, Denbigh Road, Llanfairtalhaiarn, Conwy - from the south - 1.00m scale

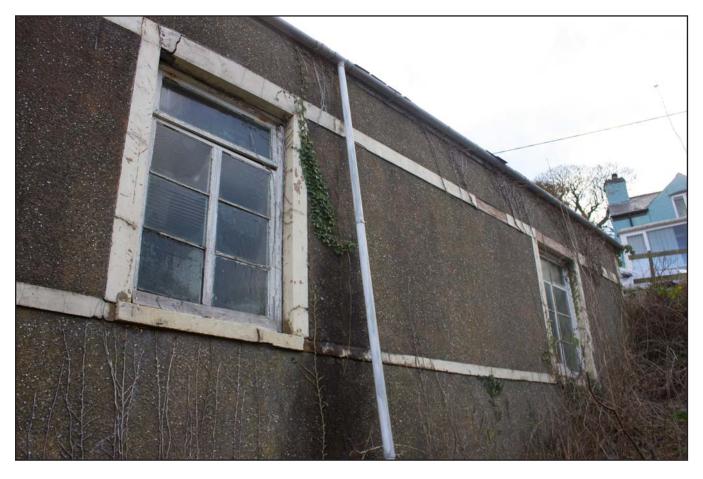
Plate 03: External oblique shot of south western elevation, Tŷ Capel, Denbigh Road, Llanfairtalhaiarn, Conwy - from the west - no scale

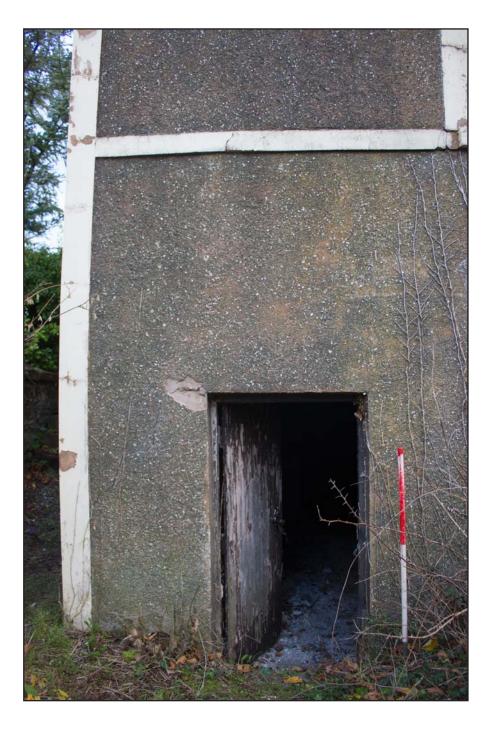
**Plate 04:** Door access to basement at left end of south western elevation, Tŷ Capel, Denbigh Road, Llanfairtalhaiarn, Conwy - from the southwest - 1.00m scale

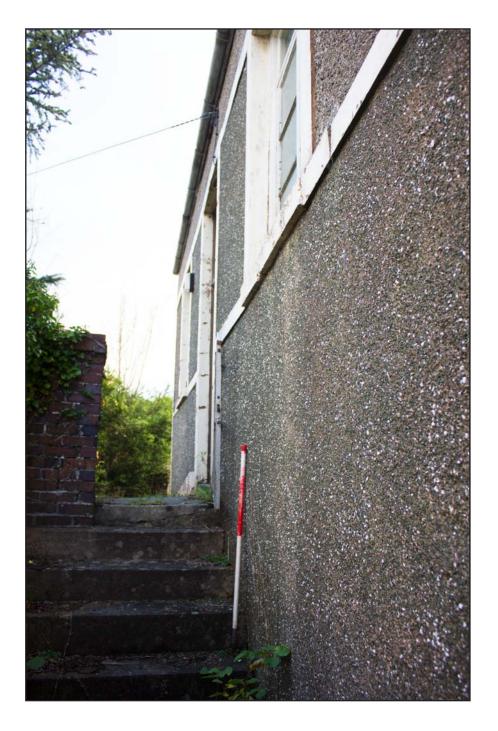
**Plate 05:** External oblique shot of north western elevation, Tŷ Capel, Denbigh Road, Llanfairtalhaiarn, Conwy - from the west - no scale

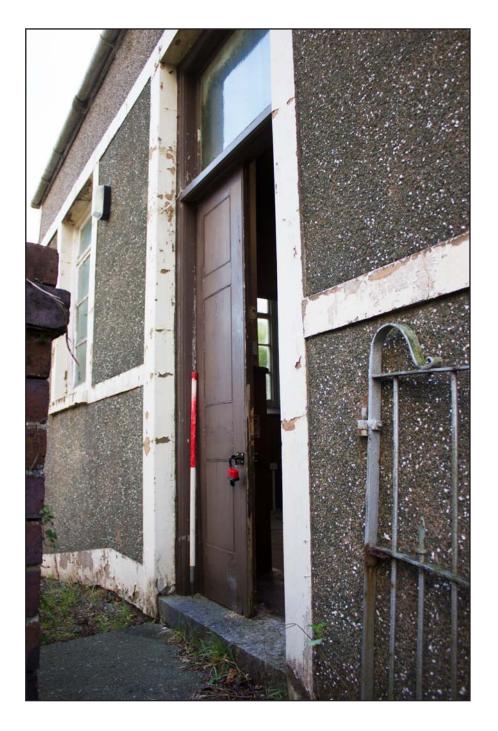
**Plate 06:** Door access to chapel at centre of north western elevation, Tŷ Capel, Denbigh Road, Llanfairtalhaiarn, Conwy - from the west - 1.00m scale

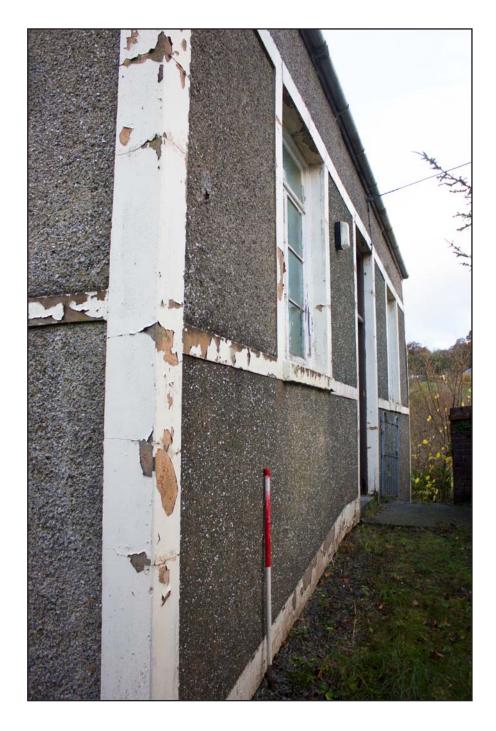
**Plate 07:** External oblique shot of north western elevation, Tŷ Capel, Denbigh Road, Llanfairtalhaiarn, Conwy - from the north - 1.00m scale

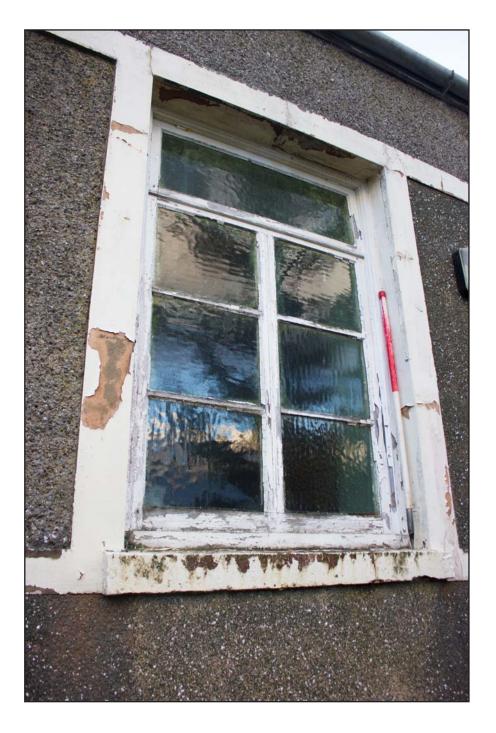
$\textbf{Plate 08:} \ \ \textbf{Window on north western elevation, T\^{y} \ \textbf{Capel, Denbigh Road, Llanfairtalhaiarn, Conwy-from the northwest-1.00m}$

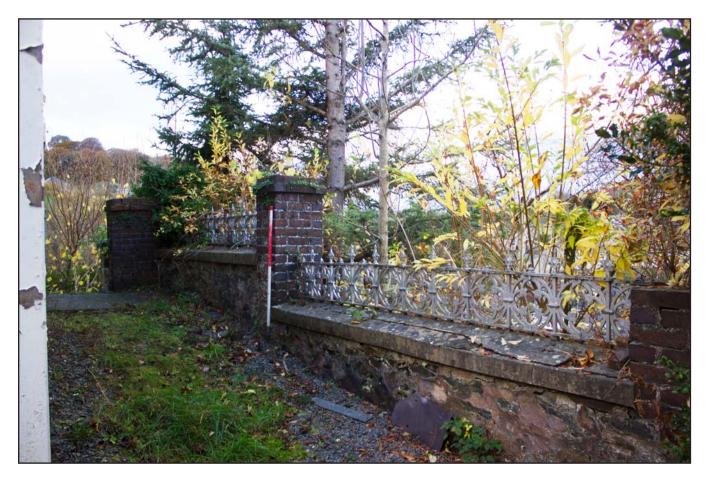
**Plate 09:** Cast iron railings to northwest of the Primary elevation, Tŷ Capel, Denbigh Road, Llanfairtalhaiarn, Conwy - from the east - 1.00m scale

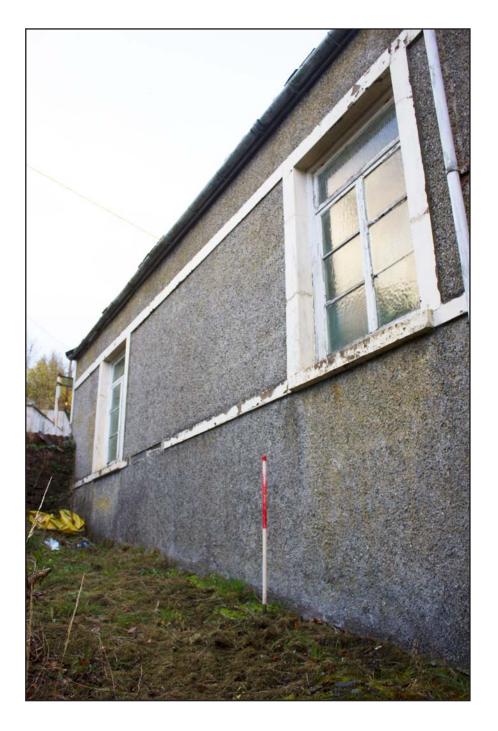
**Plate 10:** External oblique shot of north eastern elevation, Tŷ Capel, Denbigh Road, Llanfairtalhaiarn, Conwy - from the north - 1.00m scale

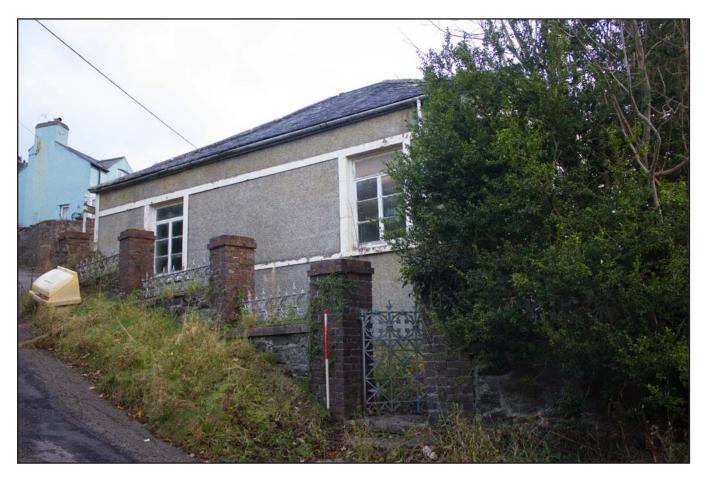
**Plate 11:** External oblique shot of north eastern elevation, Tŷ Capel, Denbigh Road, Llanfairtalhaiarn, Conwy - from the north - 1.00m scale

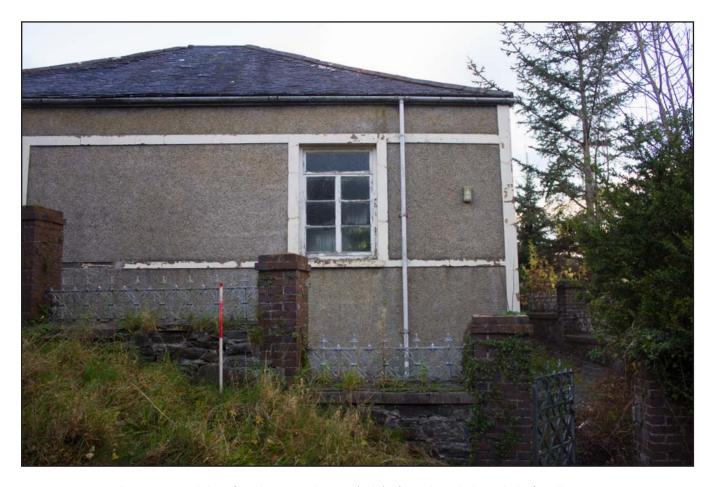
**Plate 12:** External shot of north eastern elevation (right), Tŷ Capel, Denbigh Road, Llanfairtalhaiarn, Conwy - from the northeast - 1.00m scale

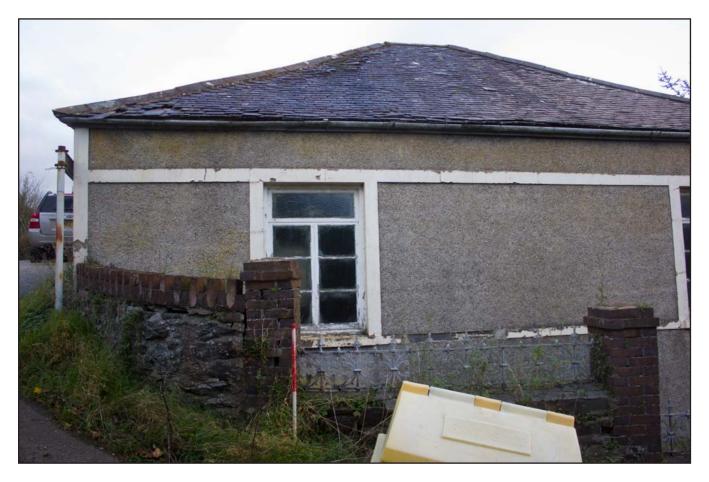
**Plate 13:** External shot of north eastern elevation (left), Tŷ Capel, Denbigh Road, Llanfairtalhaiarn, Conwy - from the northeast - 1.00m scale

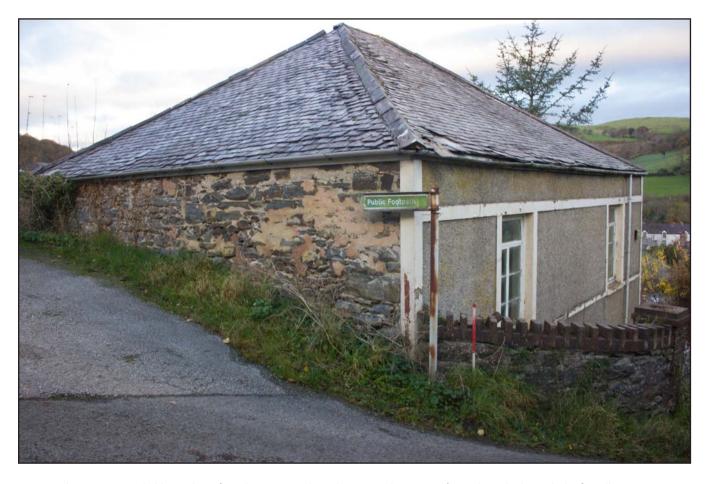
**Plate 14:** External oblique shot of north eastern and south eastern elevations, Tŷ Capel, Denbigh Road, Llanfairtalhaiarn, Conwy - from the east - 1.00m scale

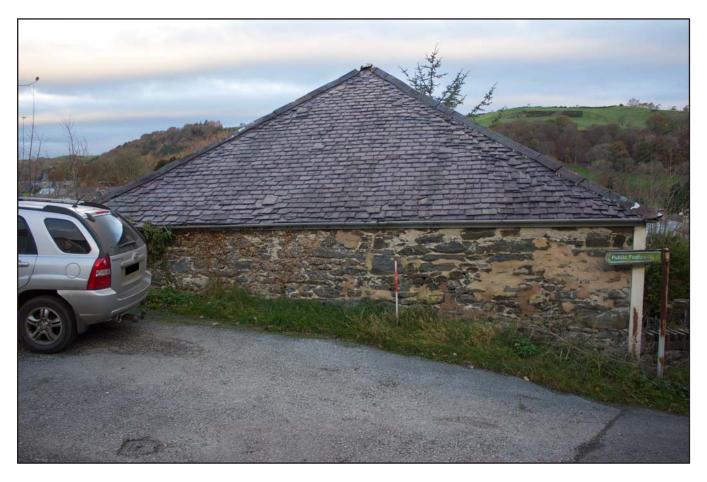
**Plate 15:** External shot of south eastern elevation, Tŷ Capel, Denbigh Road, Llanfairtalhaiarn, Conwy - from the southeast - 1.00m scale

Of note on this elevation is that the sill of the southern window is comprised of red brick and also visible beneath the coarse render more brick work was visible. This suggests that there may have been a replacement window in this corner or that an entirely new window was inserted at this location for whatever reason – for symmetry or simply to afford more light to enter the chapel in this location.

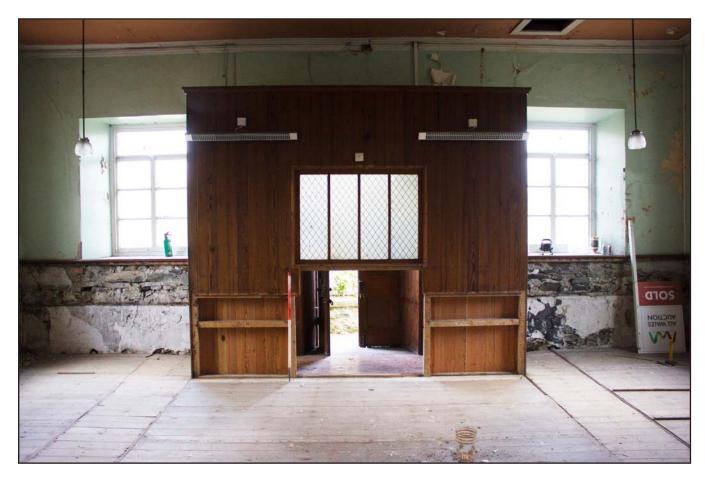
**Plate 16:** Internal shot Chapel entrance with wooden partition vestibule, Tŷ Capel, Denbigh Road, Llanfairtalhaiarn, Conwy - from the southeast - 1.00m scale

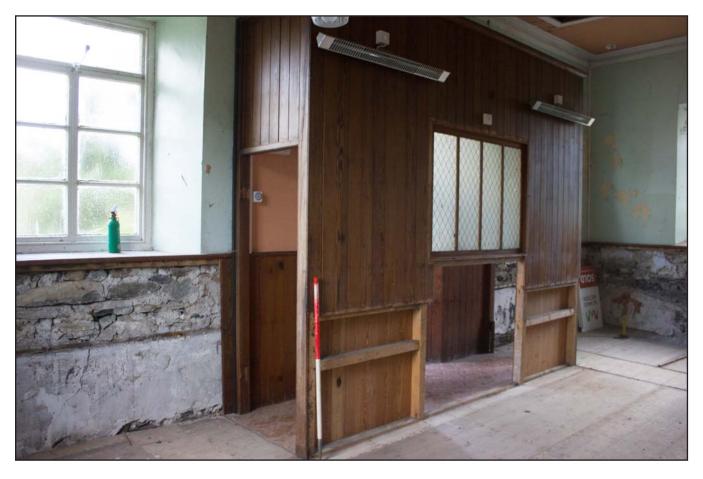
Plate 17: Internal shot Chapel entrance with wooden partition vestibule, Tŷ Capel, Denbigh Road, Llanfairtalhaiarn, Conwy - from the south - 1.00m scale

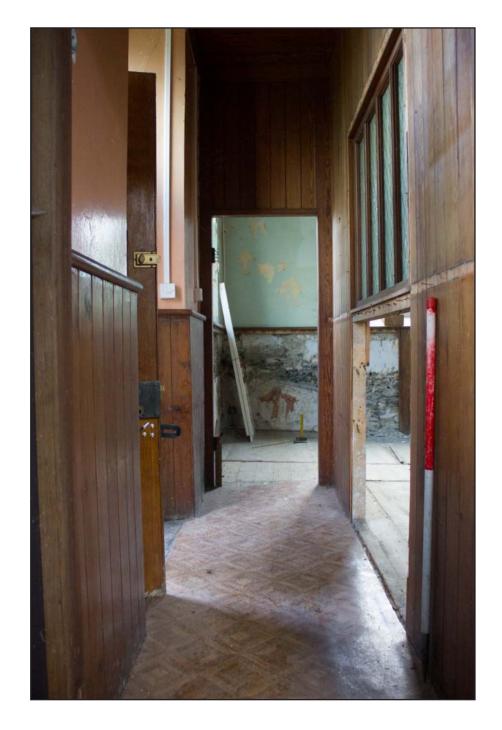
**Plate 18:** Internal shot of wooden partition vestibule, Tŷ Capel, Denbigh Road, Llanfairtalhaiarn, Conwy - from the southwest - 1.00m scale

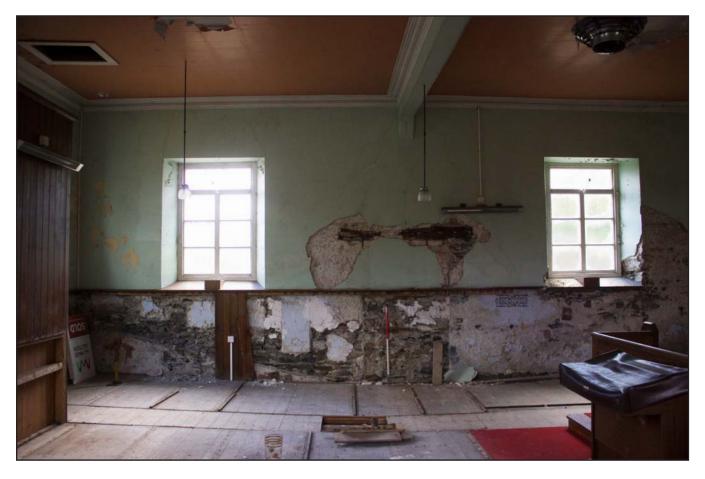
**Plate 19:** Internal shot of northeast elevation within Chapel, Tŷ Capel, Denbigh Road, Llanfairtalhaiarn, Conwy - from the southeast - 1.00m scale

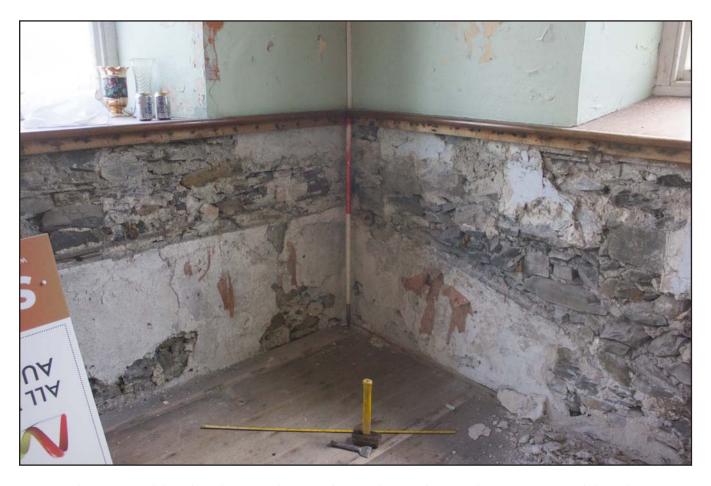
Plate 20: Internal shot, plaster line on north eastern elevation showing where tiered seating was previously located,

Tŷ Capel, Denbigh Road, Llanfairtalhaiarn, Conwy - from the south - 1.00m scale

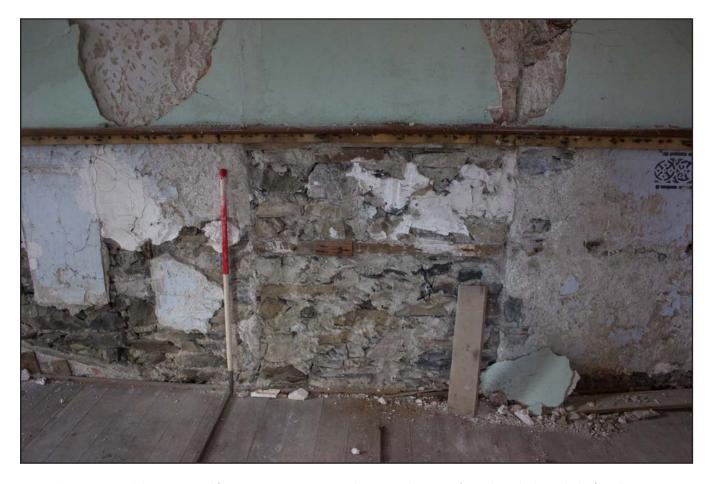
**Plate 21:** Internal shot, suspected former entranceway on north eastern elevation, Tŷ Capel, Denbigh Road, Llanfairtalhaiarn, Conwy - from the southwest - 1.00m scale

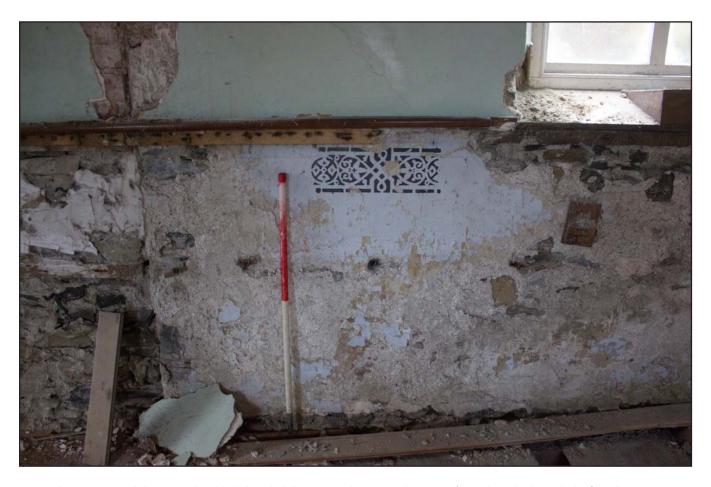
**Plate 22:** Internal shot, stencil visible below dado line on north eastern elevation, Tŷ Capel, Denbigh Road, Llanfairtalhaiarn, Conwy - from the southwest - 1.00m scale

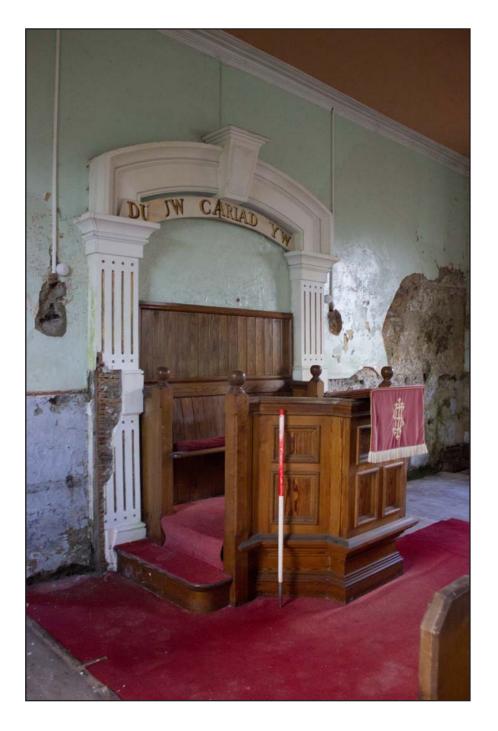
**Plate 24:** Oblique shot of pulpit on south eastern elevation, Tŷ Capel, Denbigh Road, Llanfairtalhaiarn, Conwy - from the north - 1.00m scale

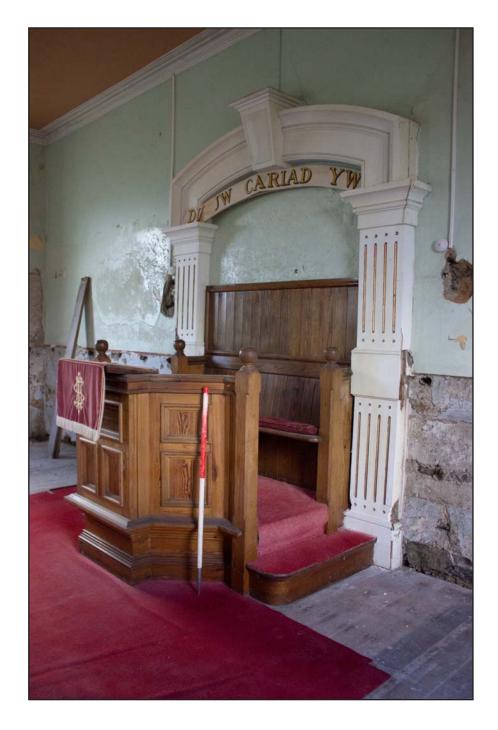
**Plate 25:** Oblique shot of pulpit on south eastern elevation, Tŷ Capel, Denbigh Road, Llanfairtalhaiarn, Conwy - from the west - 1.00m scale

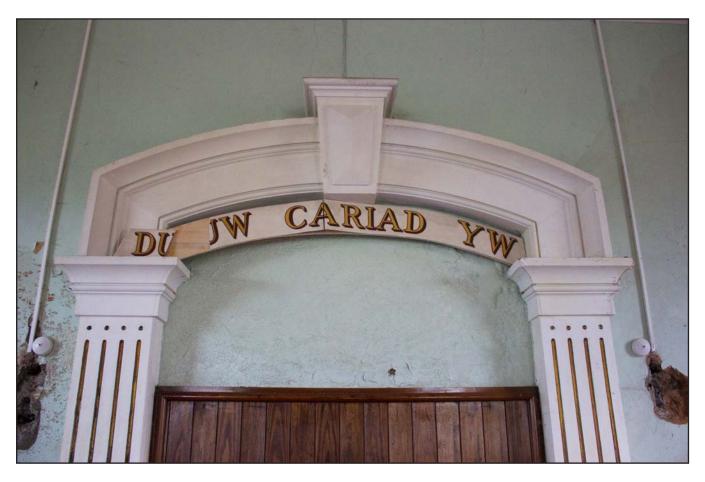
**Plate 26:** Painted banner above pulpit "DUW CARIAD YW", Tŷ Capel, Denbigh Road, Llanfairtalhaiarn, Conwy - from the northwest - no scale

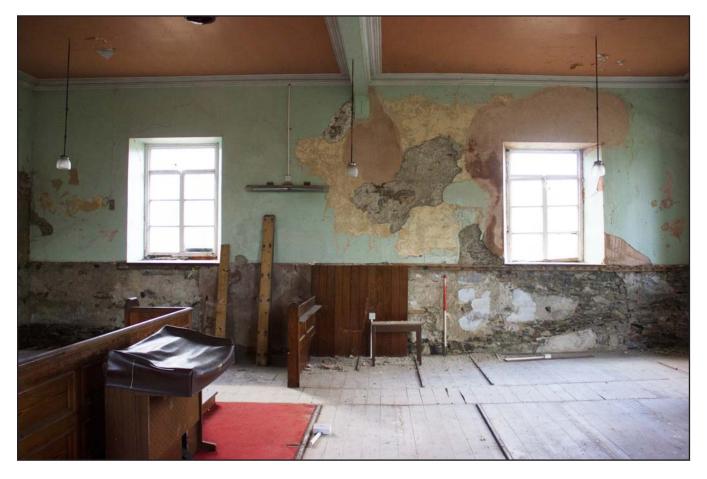
**Plate 27:** Internal shot south western elevation, Tŷ Capel, Denbigh Road, Llanfairtalhaiarn, Conwy - from the northeast - 1.00m scale

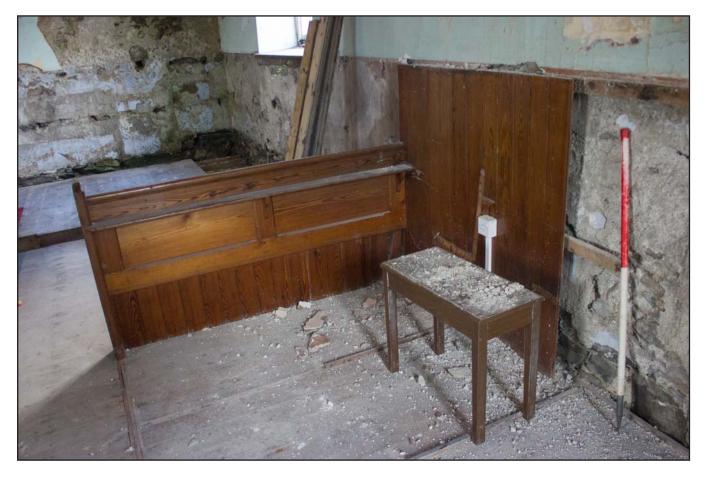
**Plate 28:** Example of pine timber panelling on south western elevation, Tŷ Capel, Denbigh Road, Llanfairtalhaiarn, Conwy - from the north - 1.00m scale

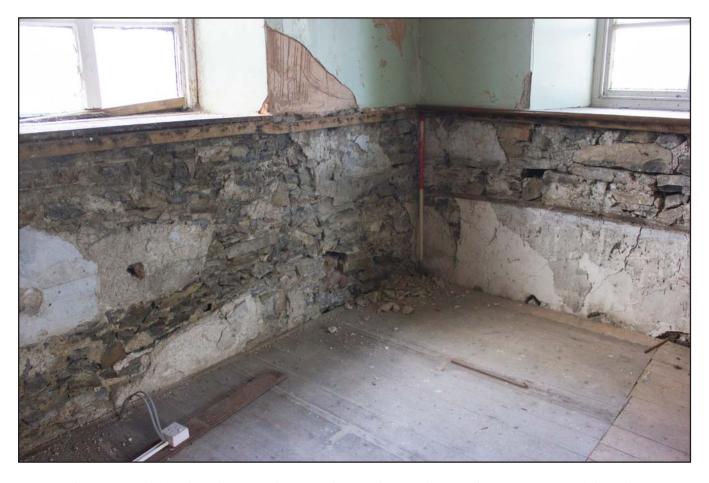
Plate 29: Internal shot, plaster line on south western elevation showing where tiered seating was previously located,

Tŷ Capel, Denbigh Road, Llanfairtalhaiarn, Conwy - from the east - 1.00m scale

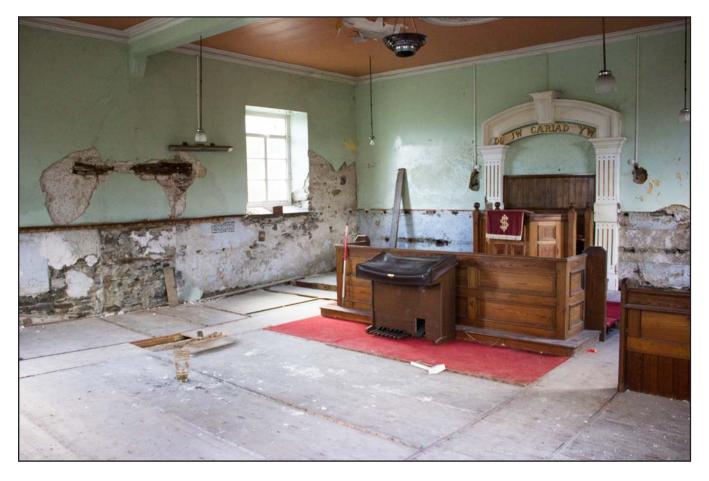
Plate 30: Oblique shot of chapel floor, Tŷ Capel, Denbigh Road, Llanfairtalhaiarn, Conwy - from the west - 1.00m scale

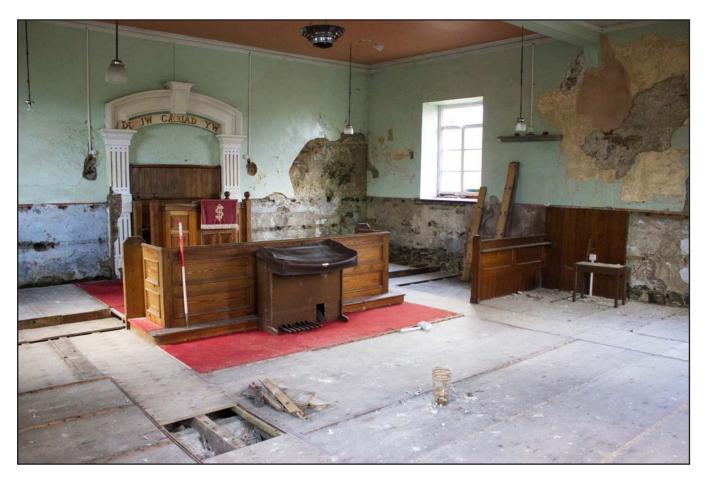
Plate 31: Oblique shot of chapel floor, Tŷ Capel, Denbigh Road, Llanfairtalhaiarn, Conwy - from the north - 1.00m scale

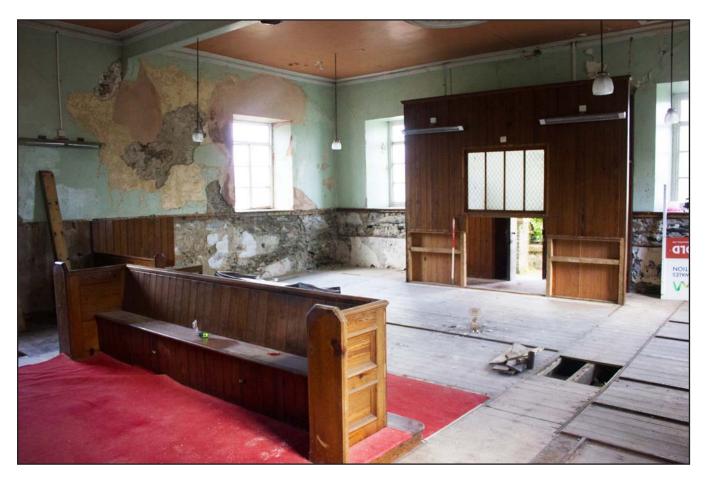
Plate 32: Oblique shot of chapel floor, Tŷ Capel, Denbigh Road, Llanfairtalhaiarn, Conwy - from the east - 1.00m scale

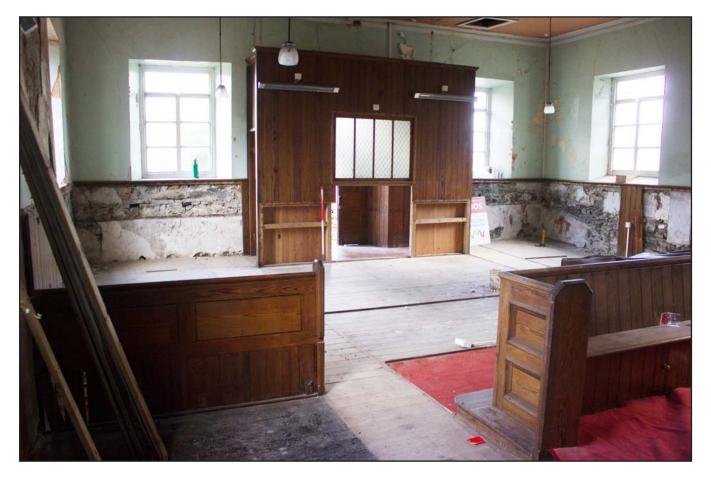
Plate 33: Oblique shot of chapel floor, Tŷ Capel, Denbigh Road, Llanfairtalhaiarn, Conwy - from the south - 1.00m scale

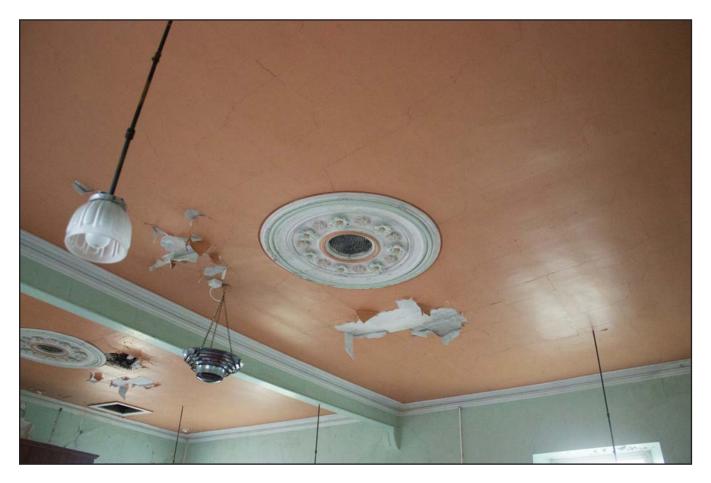
Plate 34: Internal shot of southern ceiling, Tŷ Capel, Denbigh Road, Llanfairtalhaiarn, Conwy - from the south - no scale

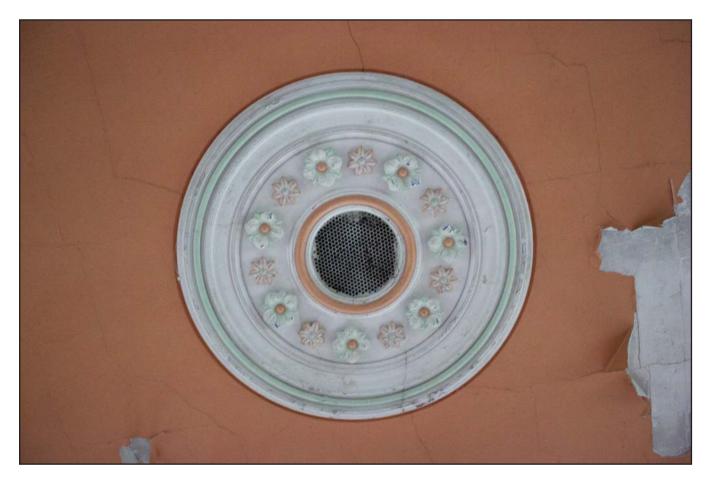
Plate 35: Internal shot of southern ceiling rose, Tŷ Capel, Denbigh Road, Llanfairtalhaiarn, Conwy - from the southeast - no scale

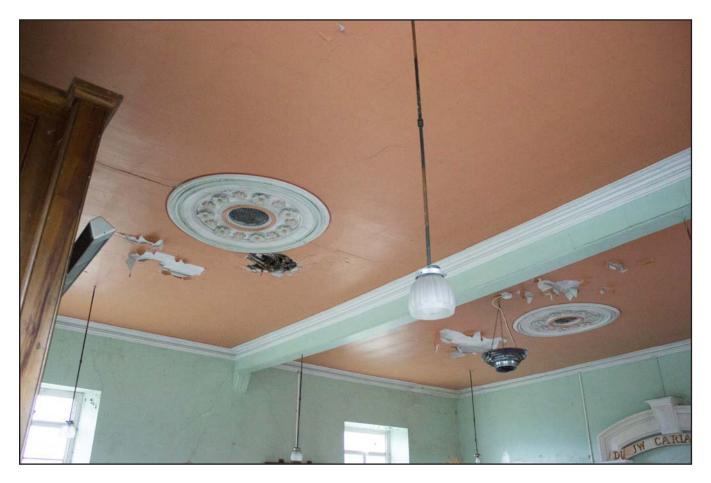
Plate 36: Internal shot of northern ceiling, Tŷ Capel, Denbigh Road, Llanfairtalhaiarn, Conwy - from the west - no scale

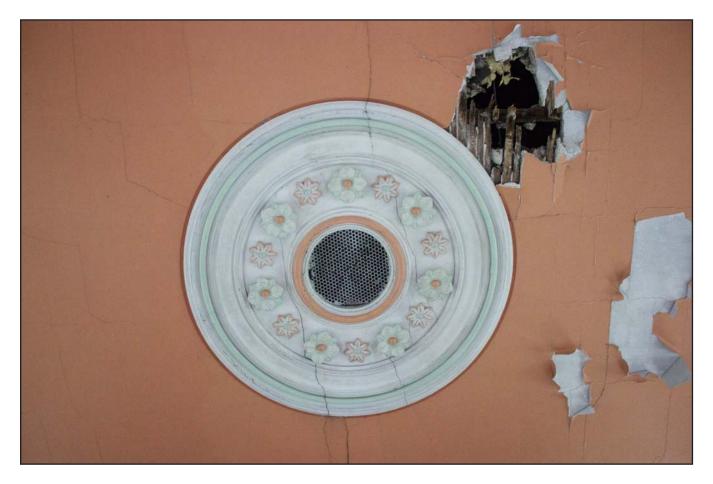
Plate 37: Internal shot of southern ceiling rose, Tŷ Capel, Denbigh Road, Llanfairtalhaiarn, Conwy - from the southeast - no scale

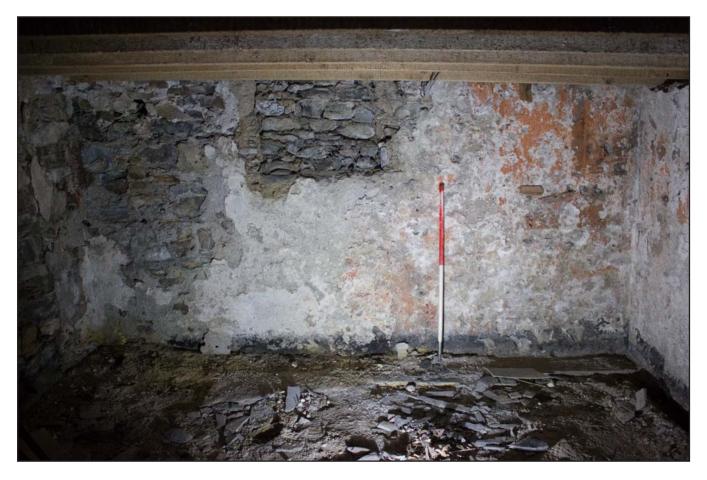
Plate 38: North eastern elevation within basement, Tŷ Capel, Denbigh Road, Llanfairtalhaiarn, Conwy - from the southwest - 1.00m scale

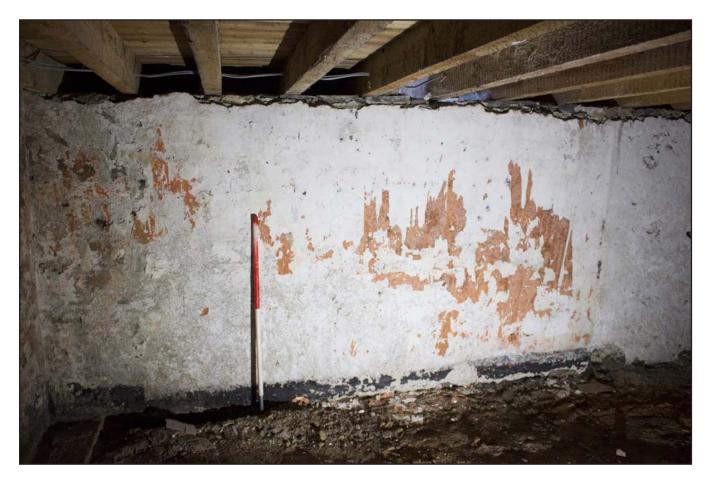
Plate 39: South eastern elevation (left) within basement , Tŷ Capel, Denbigh Road, Llanfairtalhaiarn, Conwy - from the northwest - 1.00m scale

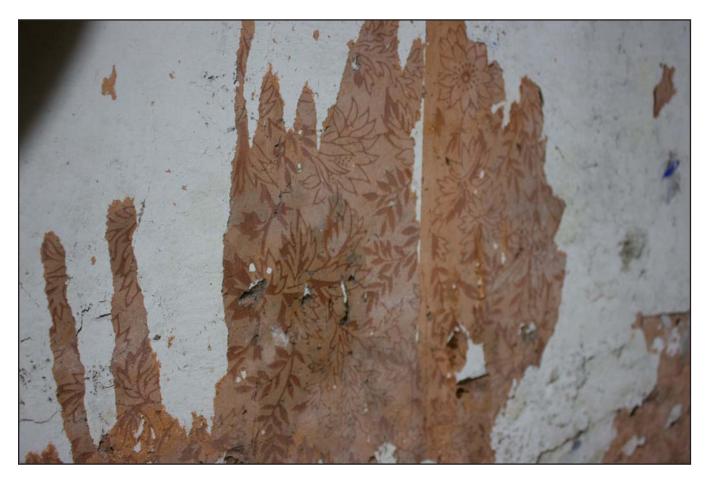
The south eastern elevation has a better state of preservation with regards to the lime render and plaster and more vivid examples of the red floral wallpaper visible in the centre and at the

Plate 40: Example of wall paper on southeast elevation, Tŷ Capel, Denbigh Road, Llanfairtalhaiarn, Conwy - from the northwest - 1.00m scale

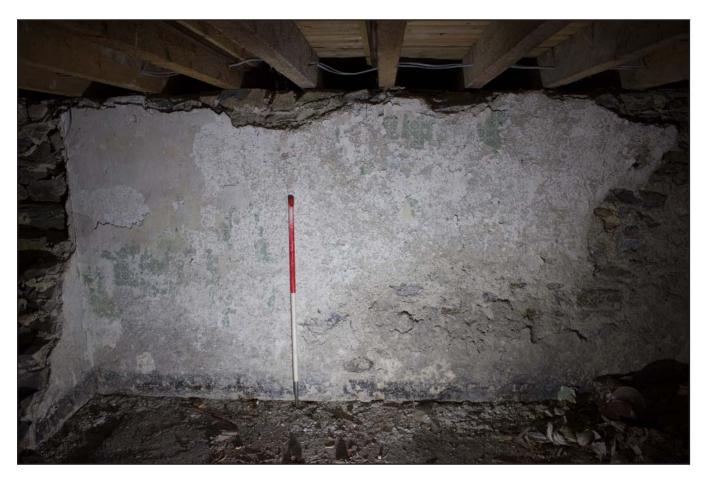
Plate 41: South eastern elevation (right) within basement , Tŷ Capel, Denbigh Road, Llanfairtalhaiarn, Conwy - from the northwest - 1.00m scale

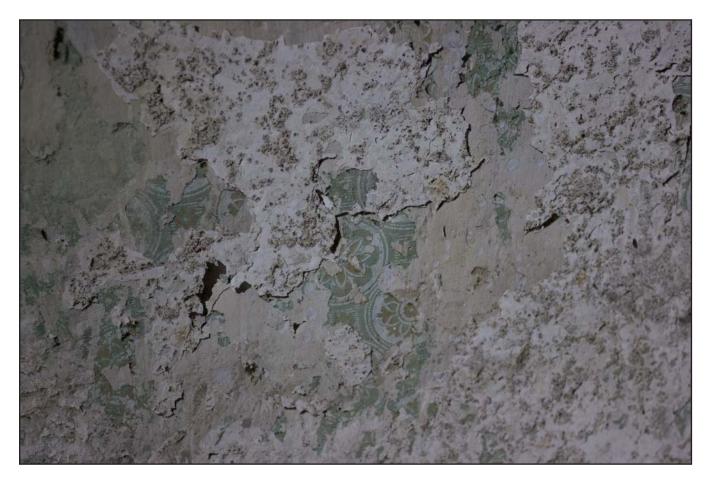
Plate 42: Example of wall paper on southeast elevation, Tŷ Capel, Denbigh Road, Llanfairtalhaiarn, Conwy - from the northwest - 1.00m scale

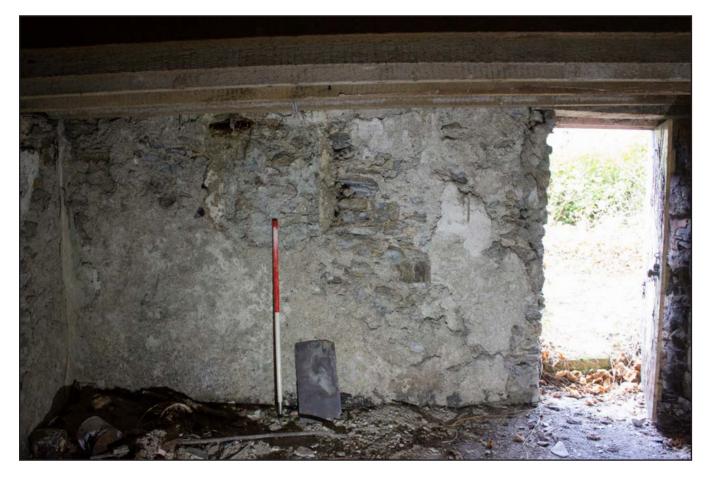
Plate 43: South western elevation within basement , Tŷ Capel, Denbigh Road, Llanfairtalhaiarn, Conwy - from the northeast - 1.00m scale

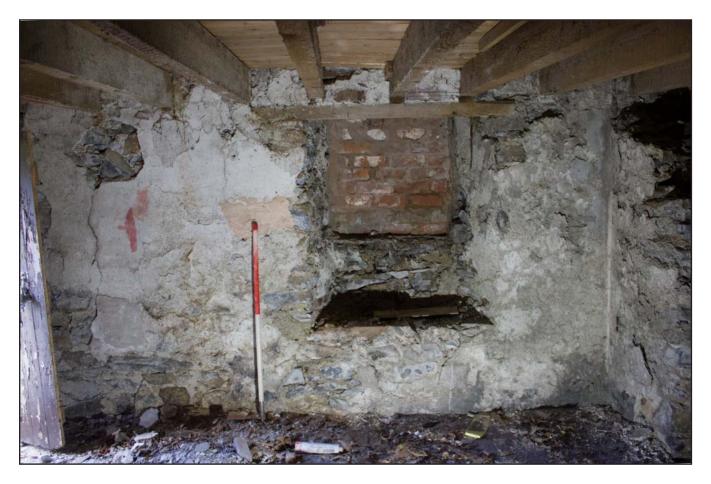
Plate 44: North western elevation (left) within basement , Tŷ Capel, Denbigh Road, Llanfairtalhaiarn, Conwy - from the southeast - 1.00m scale

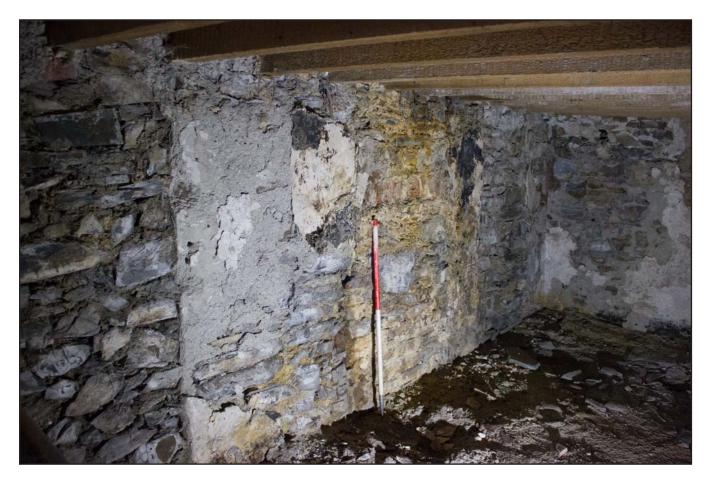
Plate 45: North western elevation (right) within basement, Tŷ Capel, Denbigh Road, Llanfairtalhaiarn, Conwy - from the south - 1.00m scale

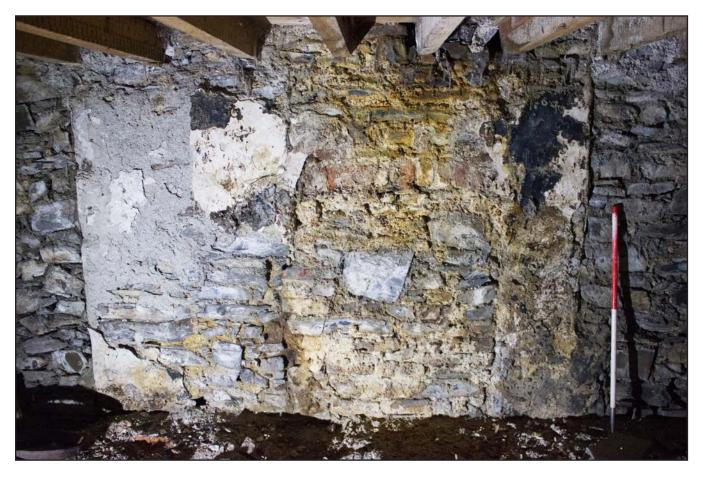
**Plate 46:** Former fireplace on the south eastern elevation within basement , Tŷ Capel, Denbigh Road, Llanfairtalhaiarn, Conwy - from the southeast - 1.00m scale

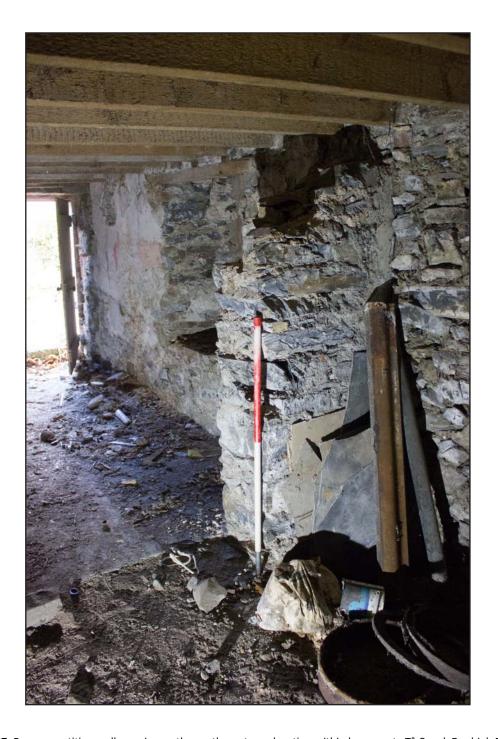
**Plate 47:** Former partition wall remains on the north western elevation within basement , Tŷ Capel, Denbigh Road, Llanfairtalhaiarn, Conwy - from the east - 1.00m scale

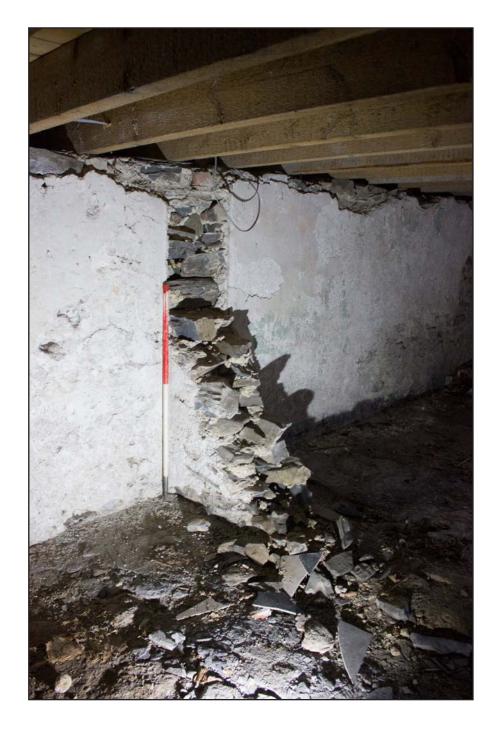
**Plate 48:** Former partition wall remains on the south eastern elevation within basement , Tŷ Capel, Denbigh Road, Llanfairtalhaiarn, Conwy - from the north - 1.00m scale
