CPAT Report No. 1912

Llyswen – Hay on Wye Water Main Test Pits

Archaeological Watching Brief

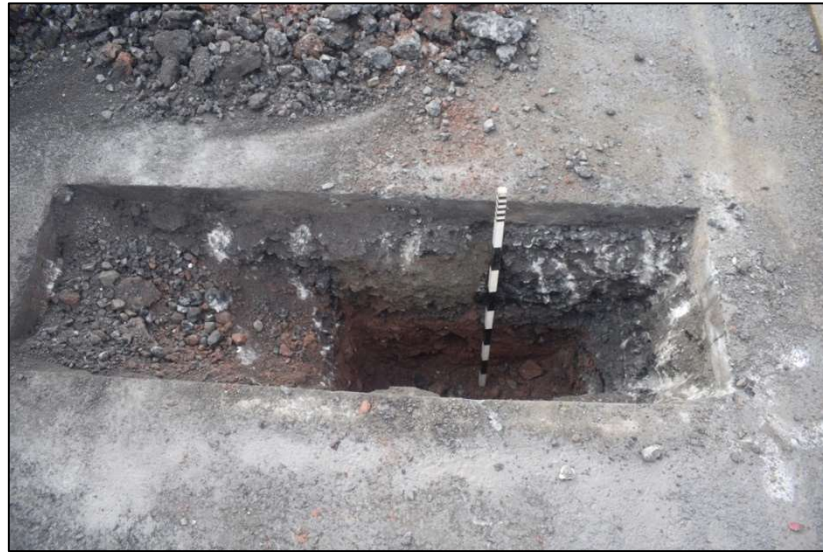
Fig. 3 Trial hole 30 viewed from the south Photo CPAT 5029_010

Trial Hole	Location	Context Description	Interpretation
TH30 (Fig. 3)	Belmont Road, Hay on Wye SO 22841 42365	(3001) Tarmac 0.12m thick (3002) Concrete 0.3m thick (3003) Tarmac 0.1m thick (3004) Firmly compacted dark red clay, very frequent small angular stones >0.42m thick	Modern road surface Sub base deposit Earlier road surface Subsoil
TH31 (Fig. 4)	Belmont Road, Hay on Wye SO 22889 42434	(3101) Tarmac 0.12m thick (3102) Concrete 0.23m thick	Modern road surface Sub base deposit

- 3.1. Excavations in Hay on Wye along Belmont Road and Broad Street revealed nothing of archaeological significance, with all the upper deposition relating to the modern road

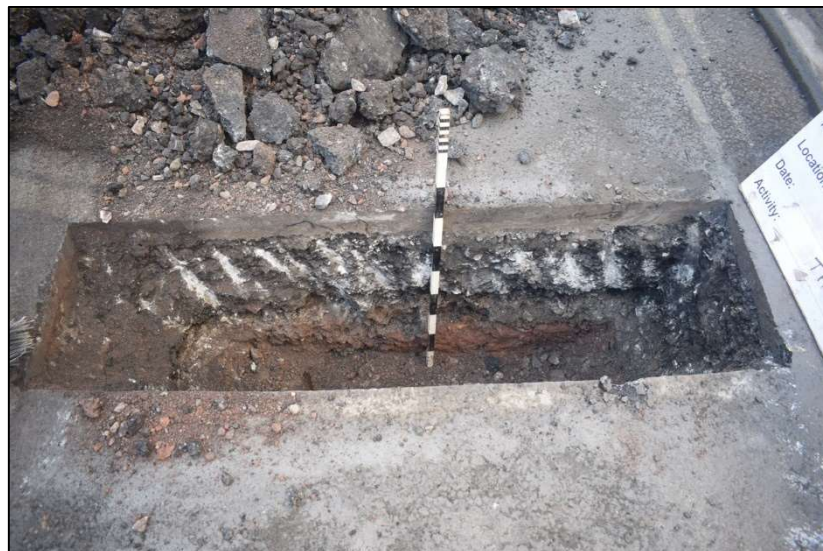
Fig. 4 Trial hole 31 viewed from the north Photo CPAT 5029_003

(3103) Tarmac 0.1m thick (3104) Compact orange clay occasional small rounded stones >0.3m thick	Earlier road surface Subsoil
TH32 (Fig. 5)	Broad Street, Hay on Wye SO 22939 42529	(3201) Tarmac 0.1m thick (3202) Compacted grey chipping 0.3m thick (3203) Sand 0.35m thick >0.35m thick	Modern road surface Sub base deposit Backfill for service pipes

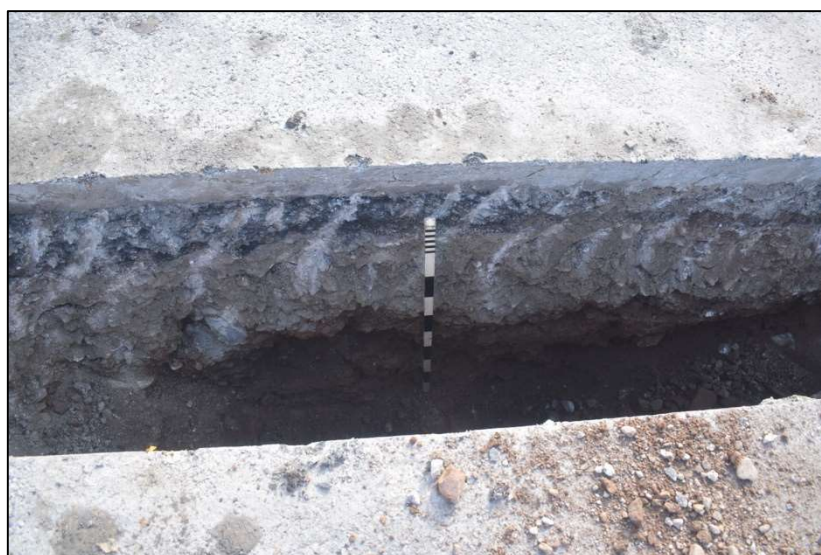
Fig. 7 Trial Hole 4 viewed from the east Photo CPAT 5029_017

Trial Hole	Location	Context Description	Interpretation
TH4 (Fig. 7)	A479 Llyswen SO 13230 38015	(0401) Tarmac 0.12m thick (0402) Gritty stone 0.25m thick (0403) Concrete 0.3m thick (0404) Compacted friable reddish silt, frequent large pebbles >0.38m thick	Modern road surface Sub base deposit Road formation layer Subsoil
TH10 (Fig. 8)	A438 near junction with A4078 SO 16639 36878	(1001) Tarmac 0.12m thick (1002) Tarmac 0.12m thick	Modern road surface Former road surface

construction, which was laid directly onto the natural subsoil. The trial hole at Llyswen also revealed nothing of archaeological significance with all the upper deposition relating to the construction of the modern A470, constructed onto natural glacial or alluvial deposition. A trial hole excavated at the junction of the A438 south of the junction with the A4078, 0.6km southwest of Three Cocks also revealed modern road construction deposition overlying the subsoil.

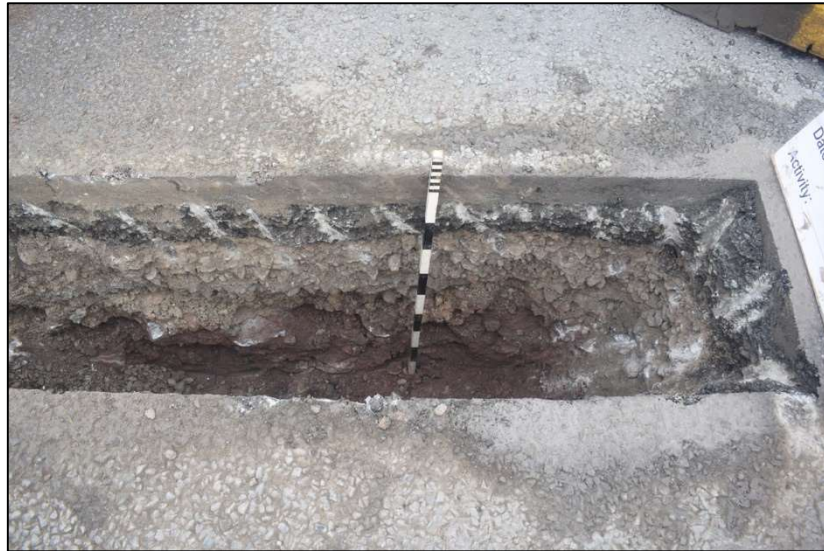
Fig. 8 Trial Hole 10 viewed from the south Photo CPAT 5029_019

(1003) Scalpings 0.4m thick (1004) Compact dark red clay, frequent large rounded or sub angular stones >0.3m thick	Sub base deposit Subsoil
TH11 (Fig. 9)	A438 Three Cocks SO 16958 37263	(1101) Tarmac 0.1m thick (1102) Asphalt 0.2m thick (1103) Concrete and stone 0.2m thick (1104) Compacted reddish brown clay silt 0.05m thick (1105) Moderately compacted red silt clay 0.35m thick (1106) Compacted clay silt and angular stone formation, slopes steeply away to south, >0.35m thick >0.2m extent (1107) Firm dark red clay Not excavated into	Modern road surface Sub base deposit Sub base deposit Surface sealing underlying deposition Possible colluvium Possible buried roadway or agger Subsoil
