CPAT Report No. 1921

Lower Gwestydd, Aberbechan, Powys

Historic Building Recording

Client name: Mr G. Randall
 CPAT Project No: 2659
 Project Name: Lower Gwestydd, Aberbechan
 Grid Reference: SO 12603 93379
 County/LPA: Powys
 Planning Application: 21/1661/FUL & 21/1662/LBC
 CPAT Report No: 1921
 Event PRN: 214643
 Report status: Final

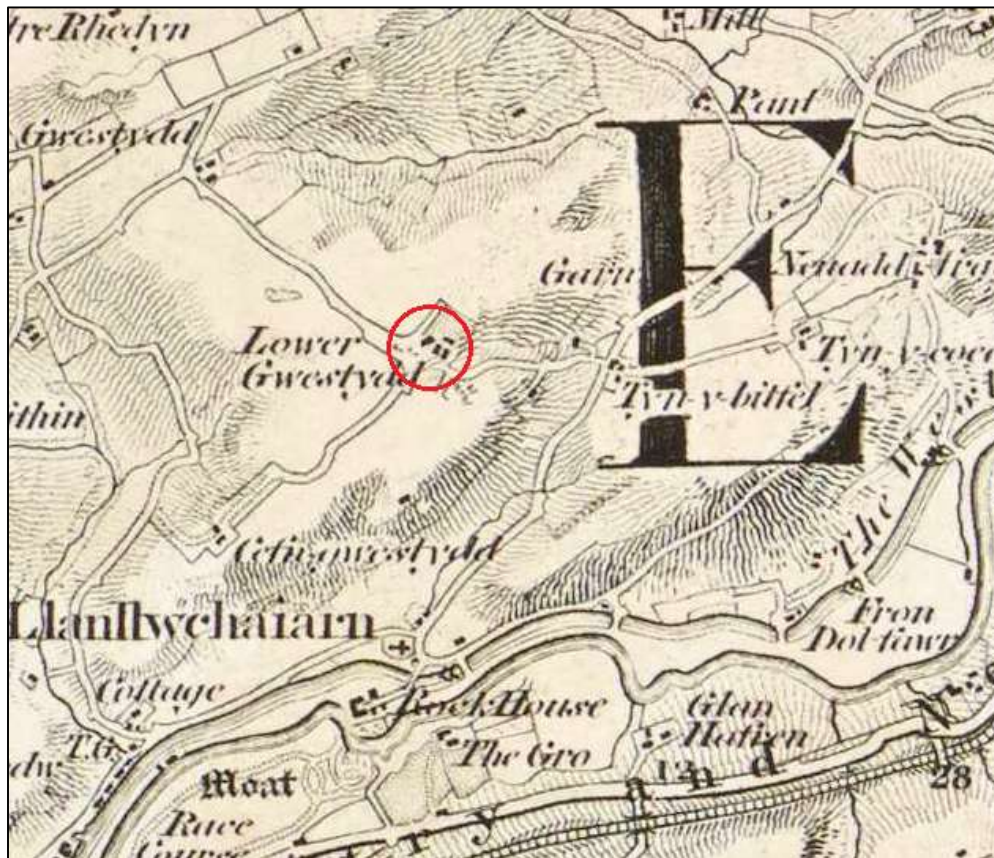
Fig. 2 Extract from the 1836 Ordnance Survey 1" map showing Lower Gwestydd (circled in red)

- 2.2. The Ordnance Survey 1" Map of 1836 (Fig. 2) records Lower Gwestydd, but the layout and orientation of the house and the farm buildings does not appear to be accurately depicted.

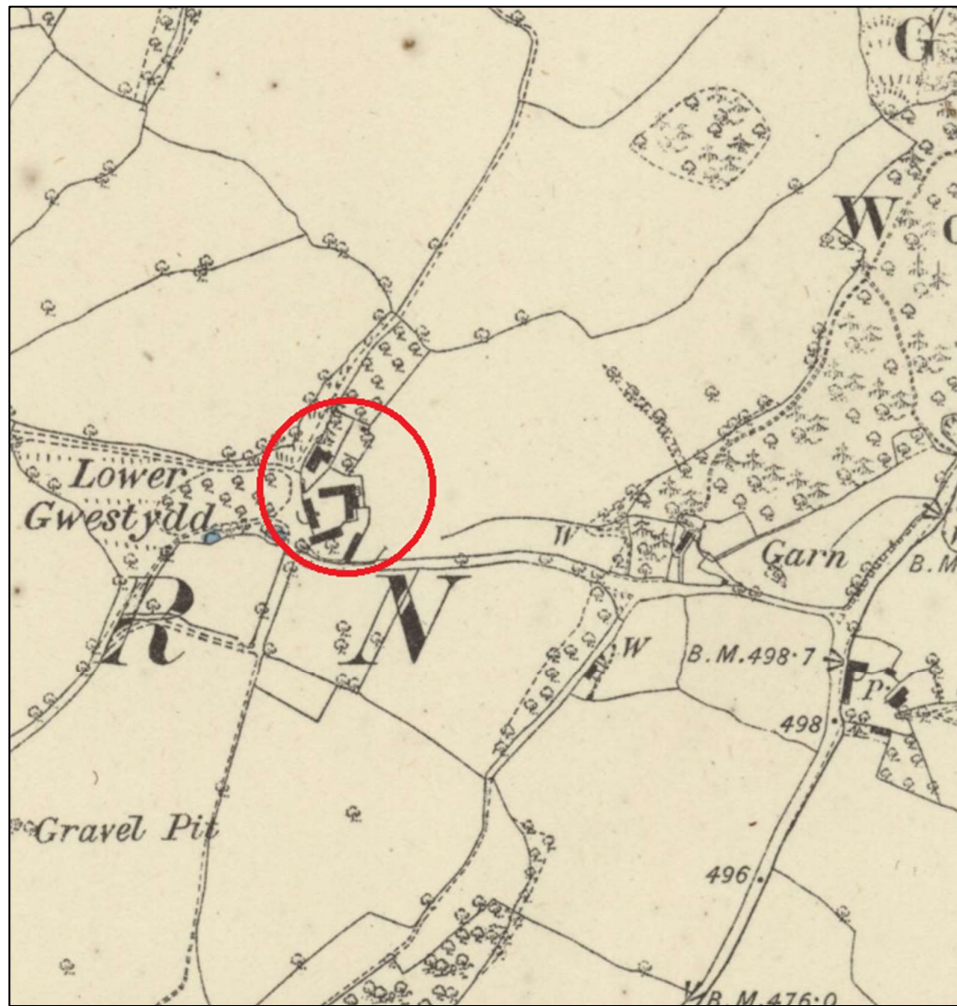
Fig. 4 Extract from the 1884 6" Ordnance Survey Map

- 2.4. The Ordnance Survey Map of 1884 records the farm in considerably more detail than the 1842 map (Fig. 4). All of the buildings recorded on the 1842 map are still present, but the farmyard has been enclosed with the construction of a north range attached to the existing east barn. An additional outbuilding and enclosure are located to the south of the farmyard.

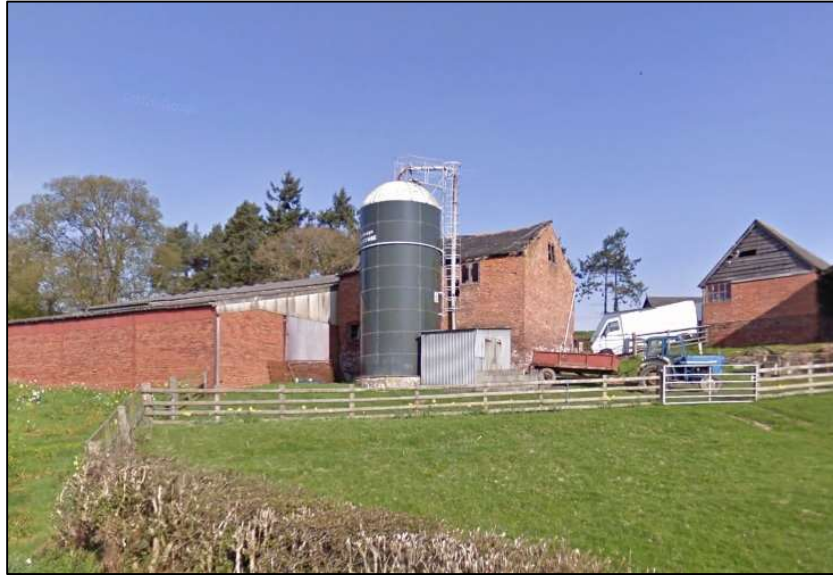
Fig. 5 The south range viewed from the south-east in April 2010 (Reproduced courtesy of Google Maps)

- 3.2. Digital online mapping recorded a two storey brick building in this location in 2010 (Google maps accessed December 2022) (Fig. 5). This building had evidently been completely taken

down between 2010 and 2022 and replaced with a modern building (Fig. 6). It was therefore not deemed necessary to carry out any further survey work in respect of this.

- 4.1. The historical building on the south range had gone at the time of survey, but historical digital mapping does record that it was a rectangular two storey building, with windows on each

storey and on the east gable end. The building was in a state of dereliction in 2010, with the roof frame partially collapsed and much of the cladding missing. Latterly it appeared to have been converted into a grain store, as indicated by the large silo on the southern elevation (Fig. 5). It is likely that the historical building was late 18th or early 19th century in date and contemporary with the west range and the historical east range.

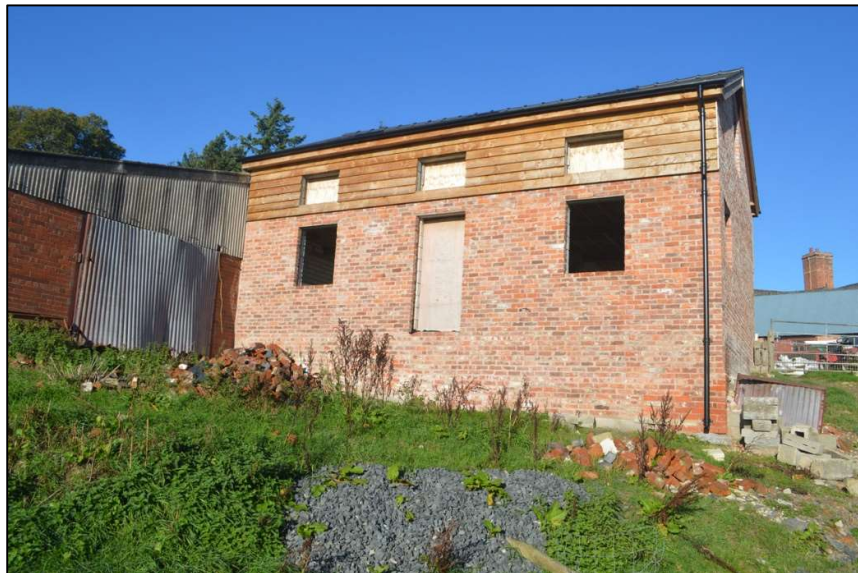
Fig. 6 The new building viewed from the south-east in November 2022 Photo CPAT 5031_005

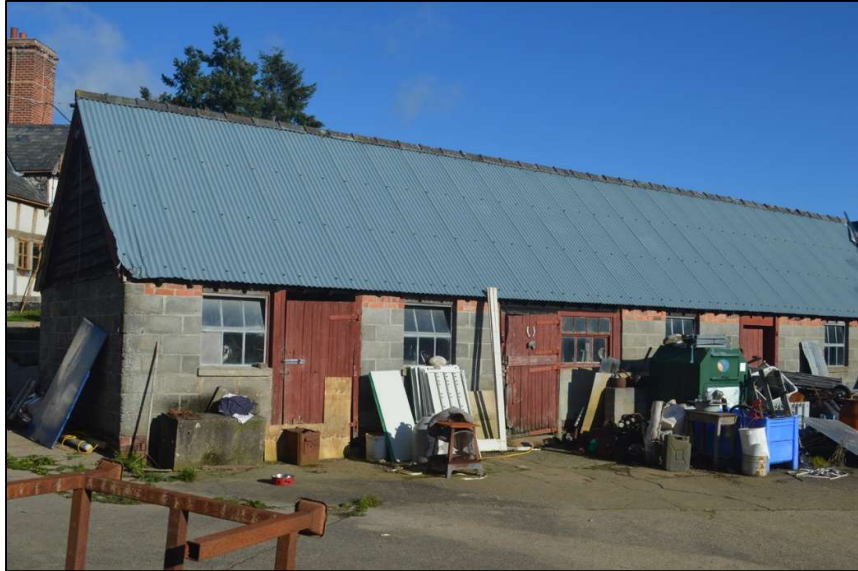
Fig. 7 View from the south of the north range Photo CPAT 5031_036

- 3.3. The east and north range comprised an L shaped continuous barn.
- 3.4. The north range was largely modern in date (Fig. 7), although there was some evidence of an earlier brick-built plinth underlying the north elevation (Fig. 8). It comprised a low single storey range with blockwork walls. There were three doorways facing out on to the yard, and three large steel framed windows with opening upper frames. The roof was clad in tin sheeting with

synthetic ridge tiles. Internally the range was open and comprised an aisled shed with cattle stalls along the northern wall and a passageway along the southern elevation. The walls were rendered internally and the floor and drain gully were concrete. The cattle stalls were equipped with water dishes and there was overhead pipework for milking equipment. The roof frame was open and comprised a king post truss design constructed using machine cut timber.

- 4.2. The north range was formerly a milking parlour and may have originally been mid-late 19th century in date. It was completely rebuilt with modern walls and flooring during the mid-late 20th century, probably in order to comply with stricter regulation regarding cattle sheds and dairies introduced during this period (Historic England, 2013, p14). It is likely that the roof frame, which was shared with the adjacent east range was retained when the range was rebuilt.

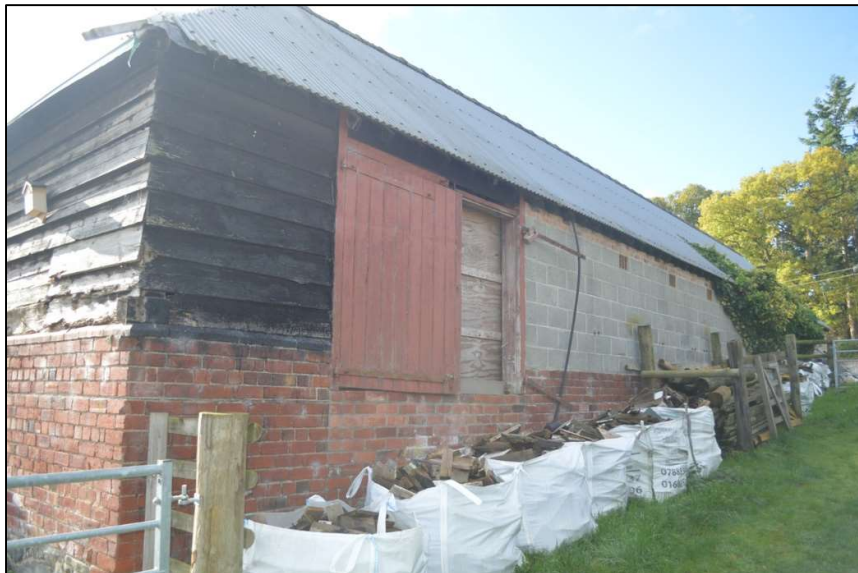
Fig. 8 View from the east looking along the north elevation of the north range Photo CPAT 5031_088

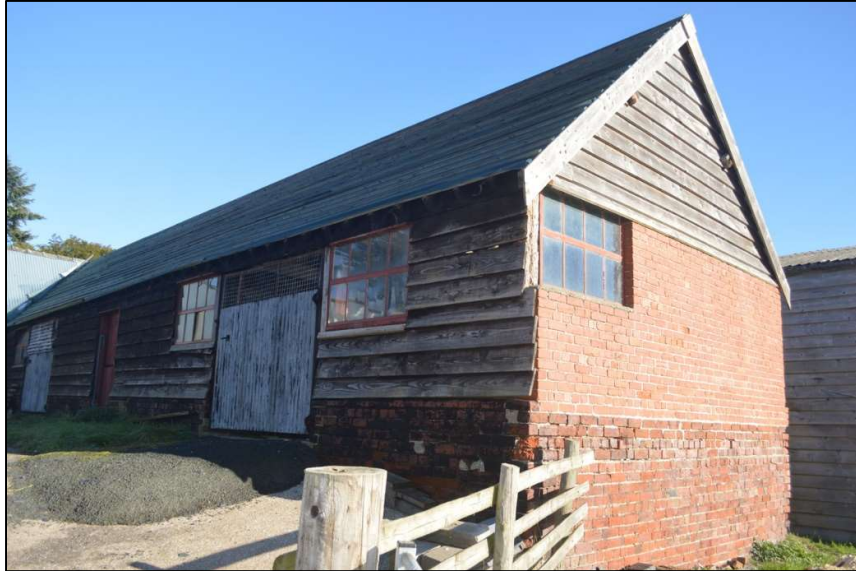
Fig. 9 The east range viewed from the south Photo CPAT 5031_009

- 3.5. The east range comprised a single storey timber-framed shed built on a brick foundation plinth. There was a separate lean to shed against the east elevation. The upper structure of the shed was sheathed with pine boarding (Fig. 9). There were two large double doorways on the west elevation facing into the farmyard, a narrower doorway and three steel framed windows, two of which were fixed and one hinged at the top. A double doorway at the

northern end of the building was originally rather lower, but had been partially infilled. The roof frame was the same design as that on the later north range, indicating that the roof had been rebuilt when this range was constructed. The south end of the barn was partially infilled with modern machine made brick. Internally the shed was open (Fig. 10), with only a single subdivision at the north end. There were a number of mid-20th century agricultural presentation certificates mounted to the roof frames.

- 4.3. The east range was originally an open plan stock shed of late 18th or early 19th century date. It is suggested that this barn was rebuilt on the same footprint during the late 19th century, as the timber wall frame and roof frame are constructed from machine-cut timbers. The roof frame is also contiguous with the attached north range so cannot have predated the original construction date for this.

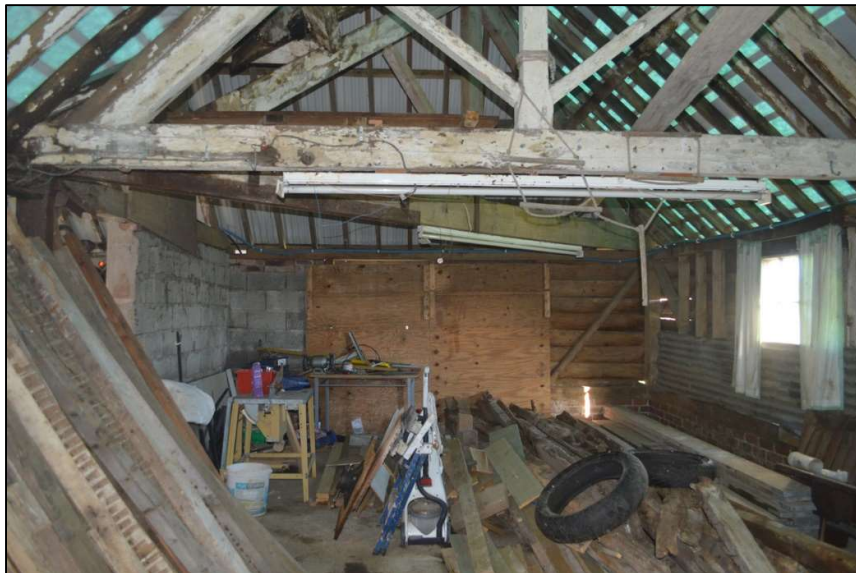
Fig. 10 Interior of the east range view from the south Photo CPAT 5031_040

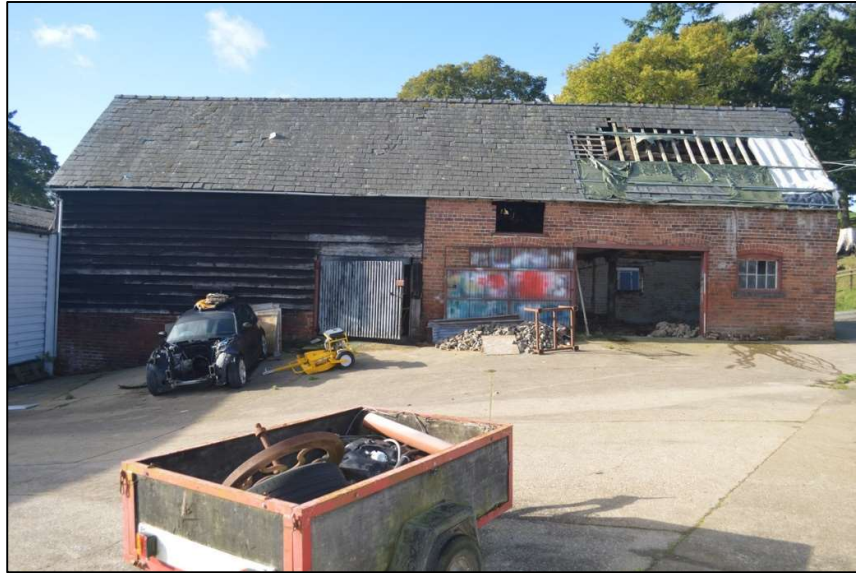
Fig.11 The west range viewed from the east Photo CPAT 5031_074

- 3.6. This comprised a single rectangular building originally subdivided into three separate areas. The north end of the barn was constructed entirely in handmade, unfroged brick, which was similar to that used in the foundation plinth of the east range, with the southern part

constructed from a timber frame sheathed in lapped board on a brick wall plinth. As with the east range the bond used was of the English Garden Wall type with a header course typically every three stretcher courses. The mortar material was a buff sandy lime with little evidence of repairs or repointing. The roof was slate with ridge tiles. There was some damage to the roof on the north-eastern side (Fig. 11).

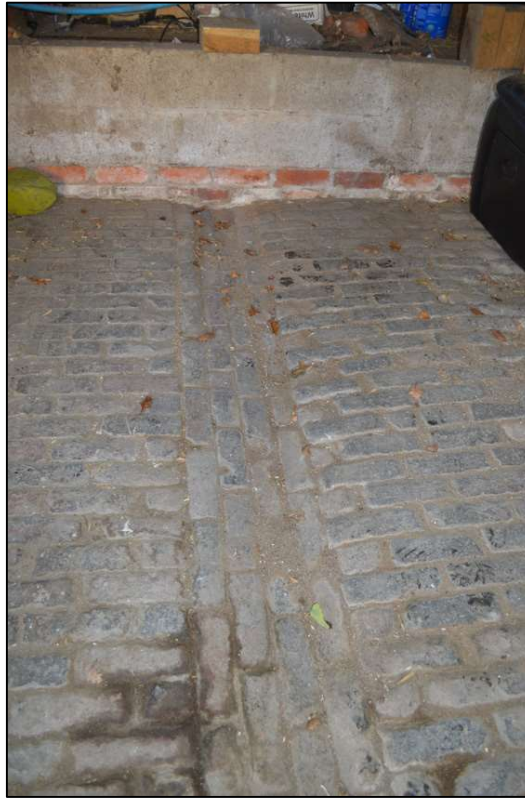
Fig. 12 Flooring in the northern end of the west range Photo CPAT 5031_020

- 3.8. The northern barn was subdivided into two large stables accessed via large 2m tall voussoir doorways in the west elevation. The position of these doorways had subsequently been obscured by a wider modern doorway insertion supported with a steel beam although the voussoirs were still extant. The stables were lit by large steel framed windows with voussoirs looking out into the farmyard and a small window on the western side of the building. Internally the stalls had been removed but the cobbled flooring and drain gulley were still partially in situ (Fig. 12). A large feed trough had been inserted in the gap between the former stables and the threshing barn indicating that it had subsequently been used as a cattle shed. The interior of the former stables had been limewashed for hygiene purposes.

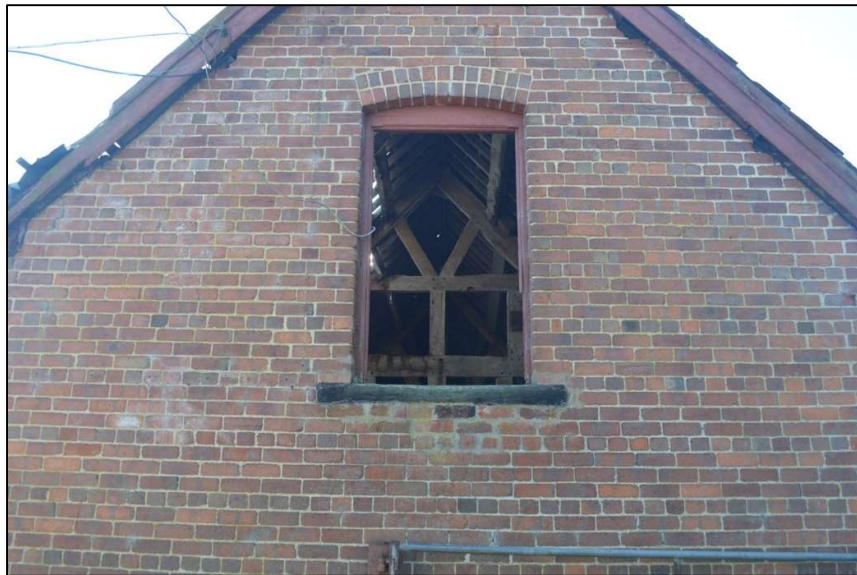
Fig. 13 High level doorway to the loft on the northern gable end of the west range Photo CPAT 5031_031

- 3.9. Above the stables was an upper level, which was separated by one of the roof trusses. The southern loft was accessed via a window or doorway on the west elevation, whereas the loft at the north end was accessed by a large high level door in the northern gable end (Fig.13).

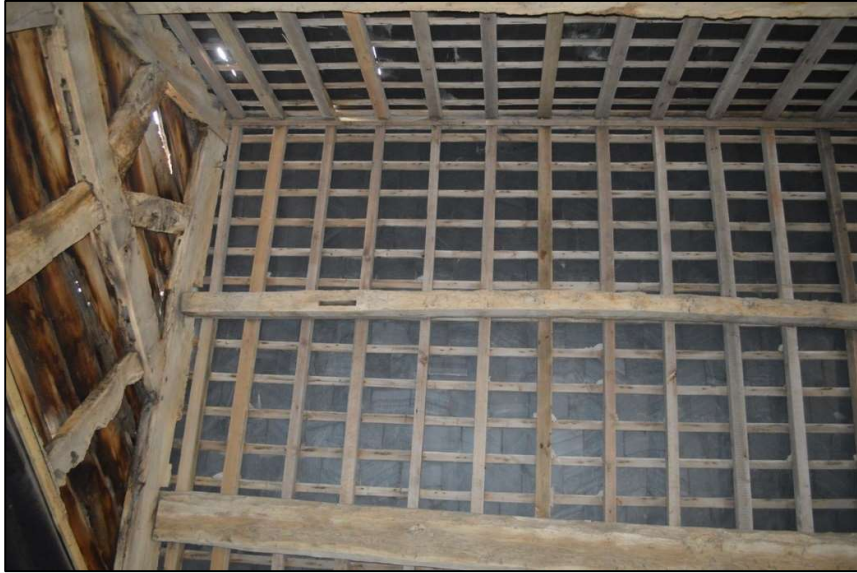
Fig. 14 Roof structure in the threshing barn (note reused wall timber in centre of shot) Photo CPAT 5031_097

The roof frames were supported by the masonry at the north end of the building and by three intermediate trusses and an end truss at the southern end. These trusses were of the queen strut type with further diagonal bracing at the top of the frame. There were three purlins on either side of the frame, with short purlins arranged side by side between each truss. There

was a cutout in the top of the truss for a ridge beam but this had been removed, possibly when the rafters had been replaced. With the exception of the rafters most of the roof and wall timbers were hand cut and worked. Some of the purlins appeared to have been reused wall timbers (Fig.14). The spaces between the frames of the internal trusses had been drilled for staves for wattle panelling (Fig. 15). The dividing truss between the threshing barn and the stables was lined with boarding.

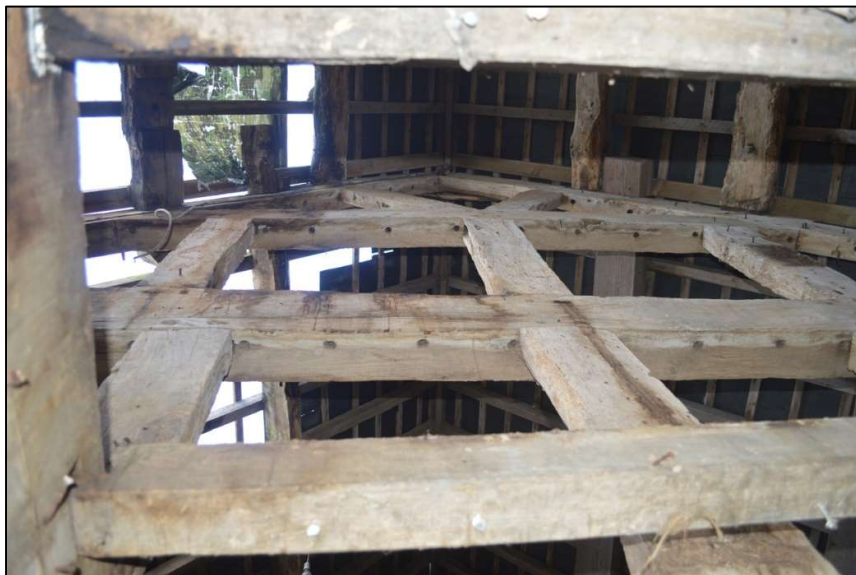
Fig. 15 Stave holes in one of the internal roof trusses Photo CPAT 5031_106

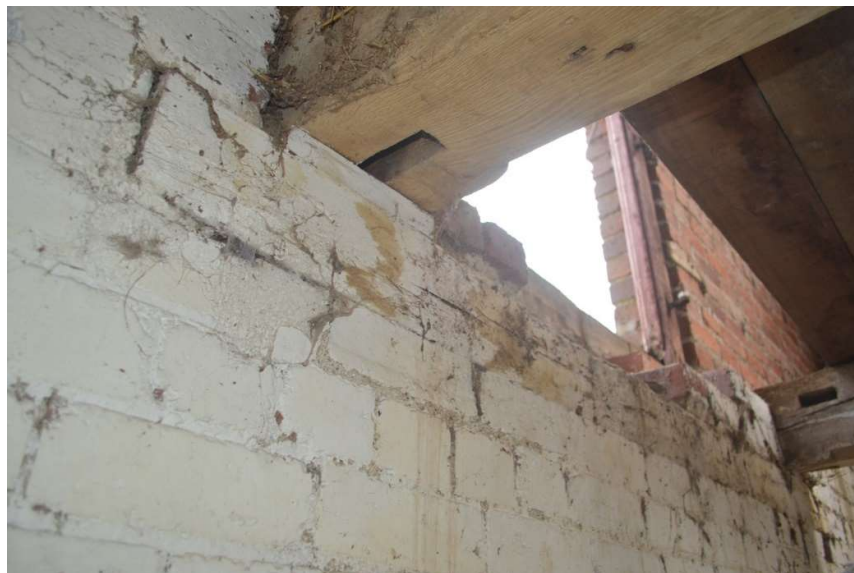
*Fig. 16 Slots in the horizontal beams in the northern end of the western range possibly for wall timbers
Photo CPAT 5031_101*

- 4.4. The west range comprised a threshing barn at the southern end, with two stables for draft horses at the northern end. There was a hay loft above one of the stables, but the space above the other may have been a granary or seed store accessed via a high level doorway on the northern gable end. It seems likely that the barn had been partially rebuilt in brick at the northern end suggesting that it was formerly an entirely timber-framed building. Some of the timber framing at the northern end of the range had beam slots for vertical wall timbers that had been partially obscured by the masonry (Fig. 16). It is entirely possible that the west range was contemporary with the construction of the house and was therefore originally 17th century in date.
