CPAT Report No. 1883

Crescent Street, Newtown, Powys

Historic Building Survey

Client name: JJP Services Ltd
CPAT Project No: 2618
Project Name: Crescent Street, Newtown
Grid Reference: SO 10658 91979
County/LPA: Powys
Planning Application: (21/1604/CAC).
CPAT Report No: 1883
PRN: 214620
Report status: Final

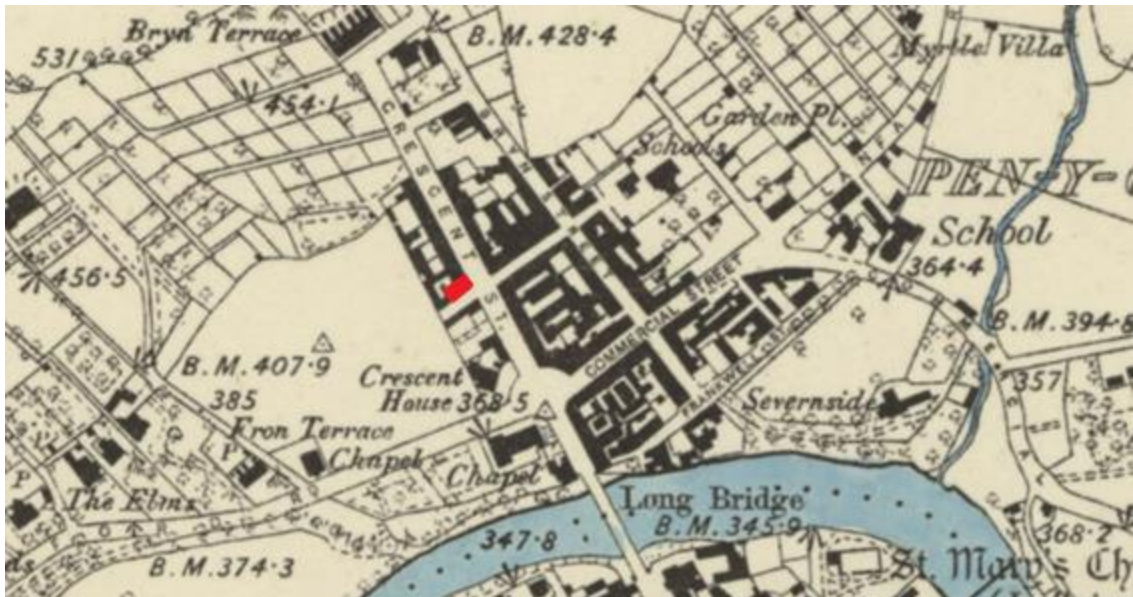
- 2.5. The site is shown as a single large structure on the 1848 tithe map and continues to be present in the first and second edition Ordnance survey maps (Figure 2 and Drawing 3).

Fig. 2 Extract from the Ordnance Survey 6" map of 1884 showing Penygloddfa with site highlighted red

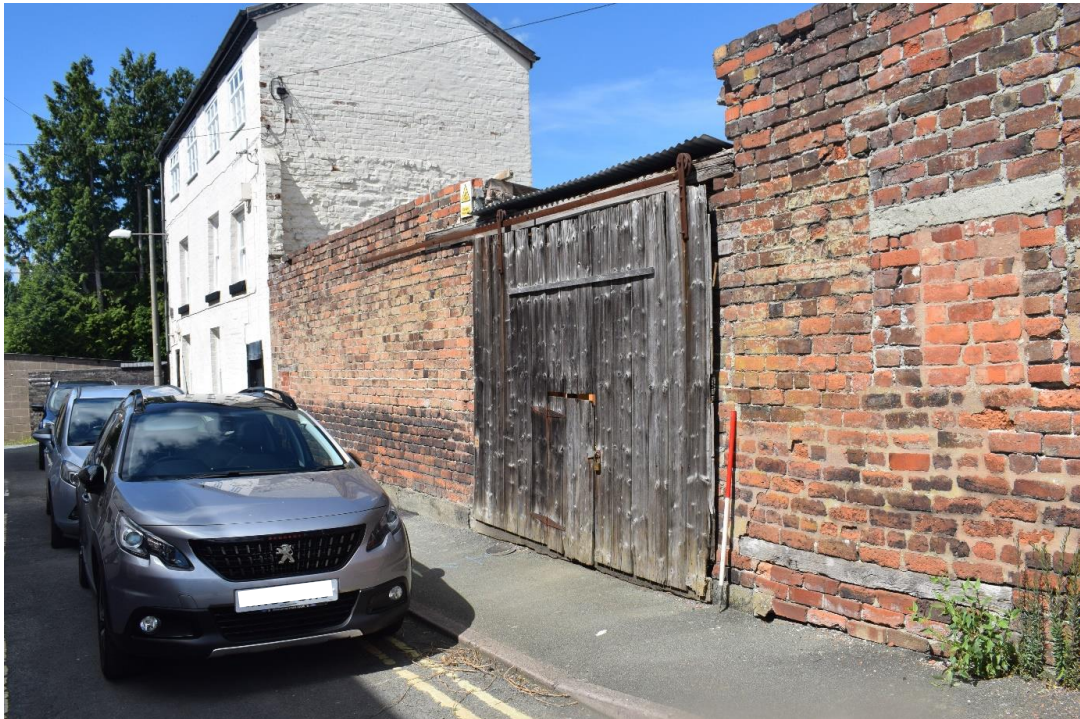
Fig. 3 Central sliding door of Union Street frontage CPAT Photograph 4998_03

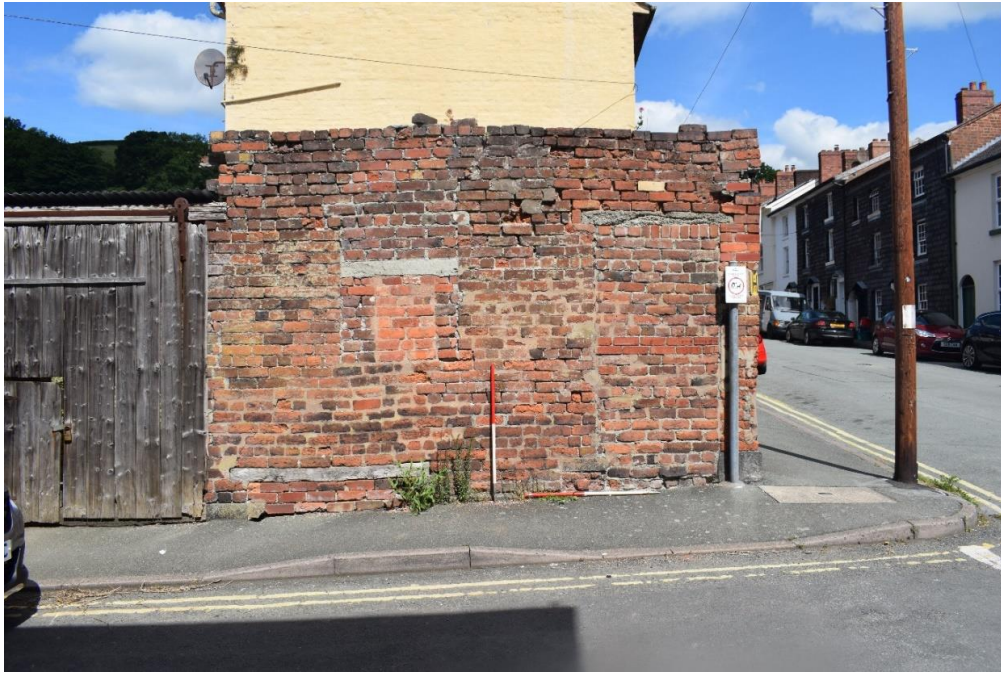
- 3.4. The eastern elevation contains evidence of a blocked-up door with a highly degraded concrete lintel (Figure 4). At either side of the door's base are stone blocks, one forming a corner stone to the building at the junction of Union Street and Crescent Street. Next to the door is a blocked-up window, within which is a degraded concrete lintel for a smaller window which has been blocked up using higher fired 20th century red brick. At the road level, there is a break in the visible stone foundation course, containing a blocked-up basement window with a simple timber lintel (Figure 4).

Fig. 4 Eastern elevation of Union Street frontage CPAT Photograph 4998_01

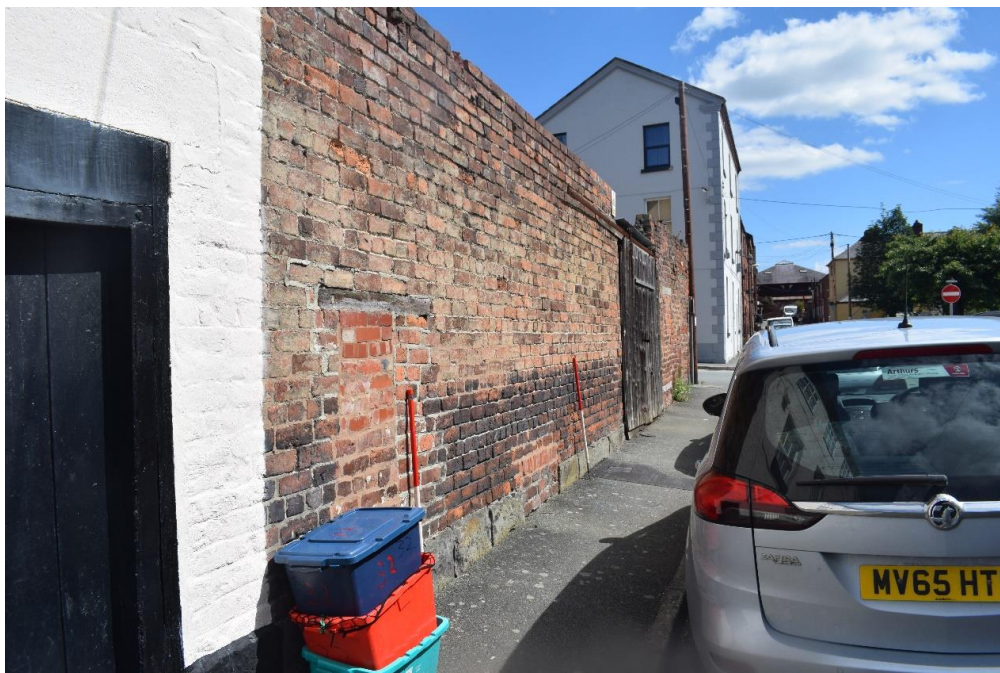
- 3.5. The stone foundation of the Union Street frontage continues up to a passageway door in No. 31 Union Street, after which the foundation layer of number 31 and 32 is comprised of brick. The western extent of the permitted development's Union Street frontage forms what is now the gable end of Number 31 Union Street, with the brickwork of Number 31 abutting the gable wall (Figure 5). This indicates that Numbers 31 and 32 Union Street were built after the structure that is present within the development area. Within the western elevation is a small blocked up narrow doorway with a timber lintel (Figure 5), located at the gable end where the elevation joins number 32 Union Street. In the centre is another break in the visible stone foundation course containing a blocked-up basement window with a red-brick header lintel.

Fig. 5 Western elevation of Union Street frontage CPAT Photograph 4998_05

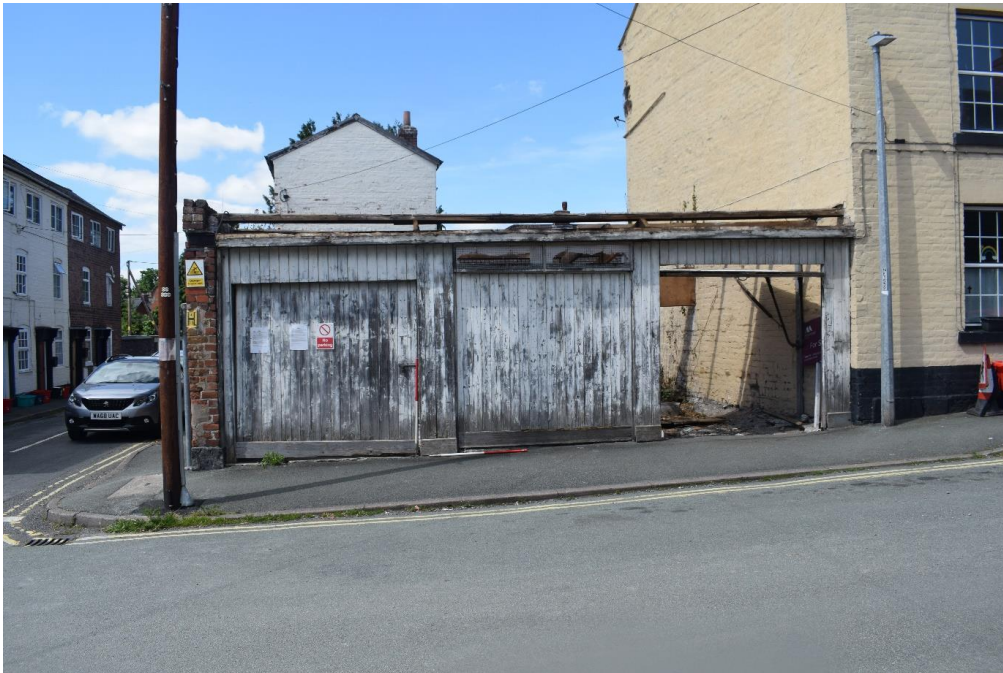
Fig. 6 Crescent Street frontage CPAT Photograph 4998_06

- 3.6. The Crescent Street frontage is comprised of a timber structure with three garage doors (Figure 6). There are no visible remains of any foundation level wall extending from the Union Street frontage, with the end of the brick elevation not appearing to have been extensively modified or a wall having been removed. The corner stone of the Union Street frontage also appears to respect this opening. Within the end of the Union Street Brick frontage is a slot for an iron beam, that is likely to be an original lintel for the Crescent Street frontage. These features suggest that there was likely to have been a timber structure or opening that was contemporary with the extant Union Street wall.

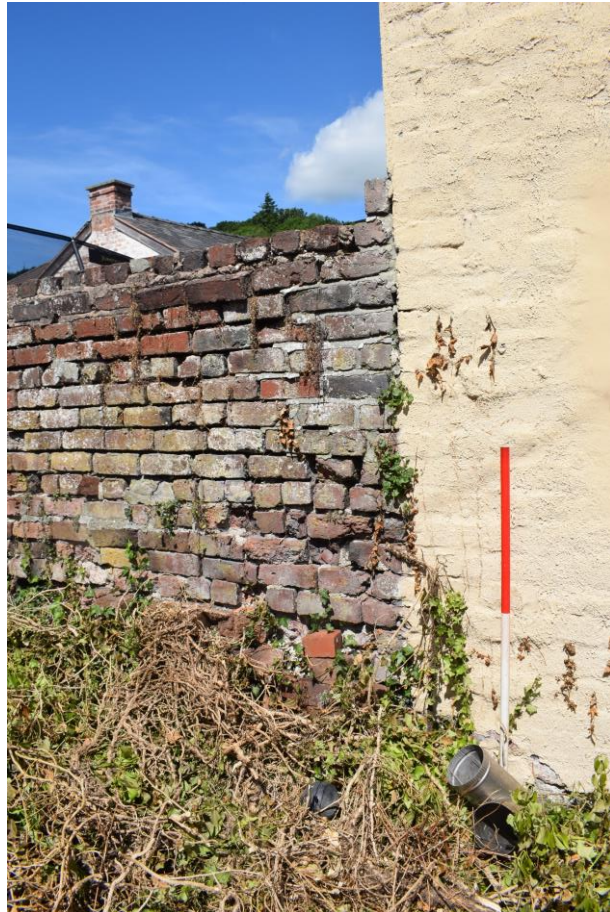
- 3.7. The internal south-facing elevation is comprised of the gable wall of Number 10 Crescent Street, and a part dilapidated red brick wall forming an outer courtyard (Figure 7). The Gable wall is comprised of rendered brick, laid in a common bond with header laces every fourth course, constructed on a rough slate foundation. Within this wall was a blocked-up doorway with what appeared to be a later higher fired brick in-fill. The south-facing elevation within the later yard comprised a modified redbrick wall, the lower courses of which are keyed into the gable wall of Number 10. The upper courses appear to have been re-established using original brick as well as 20th century high fired redbrick. Most of the mortar of this wall had degraded, however the lower courses had traces of lime mortar, with patches of cement mortar on the upper courses.

Fig. 7 Join between the Gable wall of Number 10 and the south-facing yard wall. CPAT Photograph 4998_20

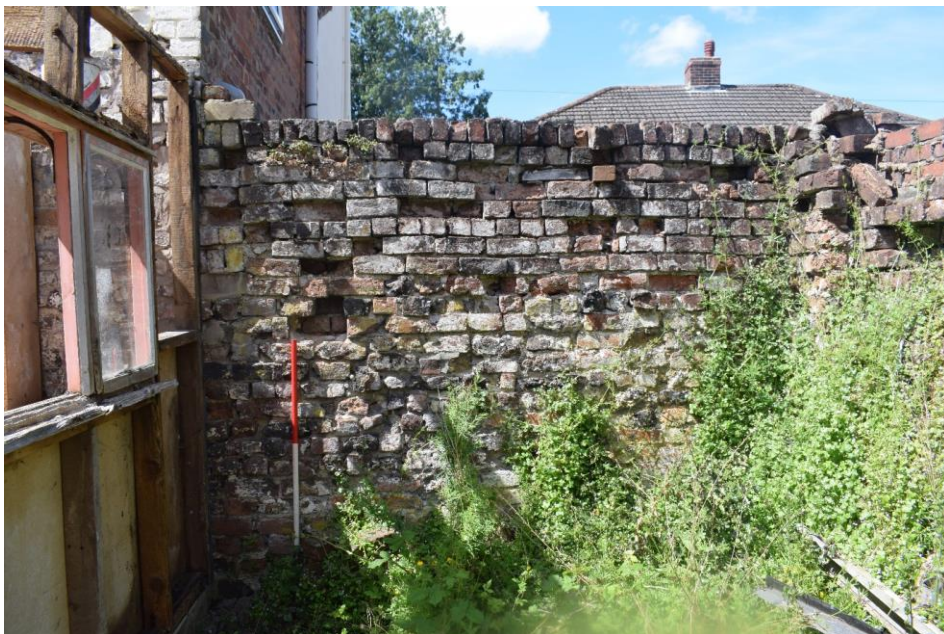
Fig. 8 East-facing yard wall. CPAT Photograph 4998_19

- 3.8. The internal east-facing elevation is comprised of the gable wall of Number 32, Union Street and a red brick wall forming part of the outer yard (Figure 8). The rendered gable wall of Number 32 is keyed into both the Union Street frontage, as well as the east-facing courtyard wall. Both are constructed of unfrogged red brick, laid in a common bond with header laces every fourth course. There were no visible openings in this wall, however, it was difficult to see the entire wall because it was partly obscured by furniture within the former workshops.
