CPAT Report No. 1863

Hafod, Carno Road, Caersws

Heritage Impact Assessment

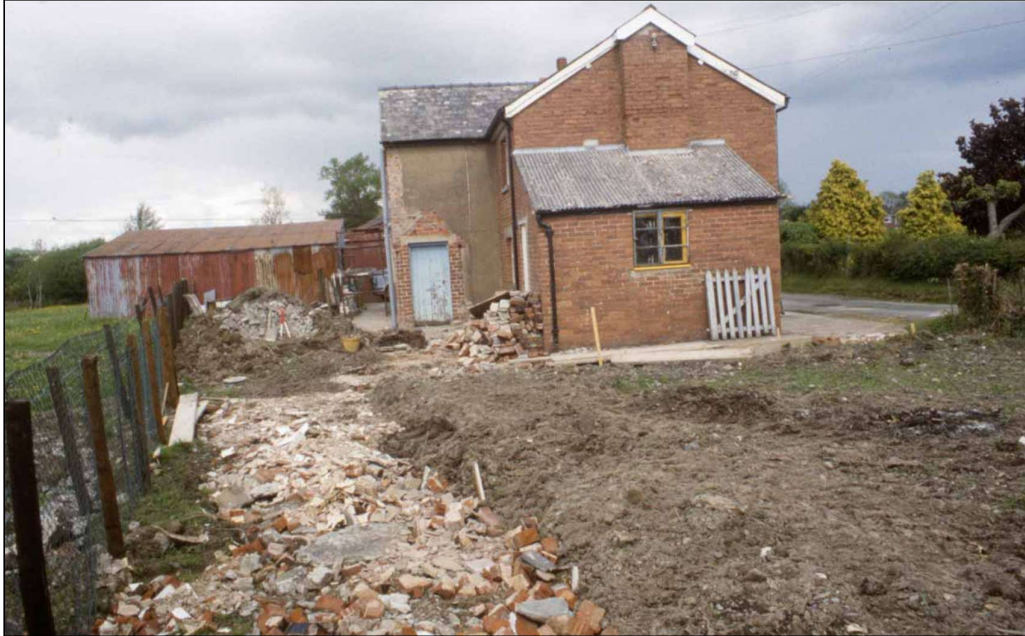
Fig. 3: Hafod viewed from the south-west in 1995, when the excavations were carried out. CPAT CS95-042-0031

- 2.4. At the north-eastern corner of the fort in Fig. 2, the number 50 identifies the approximate location of an excavation undertaken in 1995 (see Figs 3 and 4), which was carried out as a condition of the granting of scheduled monument consent for a previous extension to Hafod (Owen, 1995). The results of this work involved the excavation of a series of small trenches in an attempt to determine whether significant Roman layers were present. The location of these are depicted on Fig. 12 at the end of this report; their extents were largely restricted by the presence of services relating to Hafod and Meini-cochion.

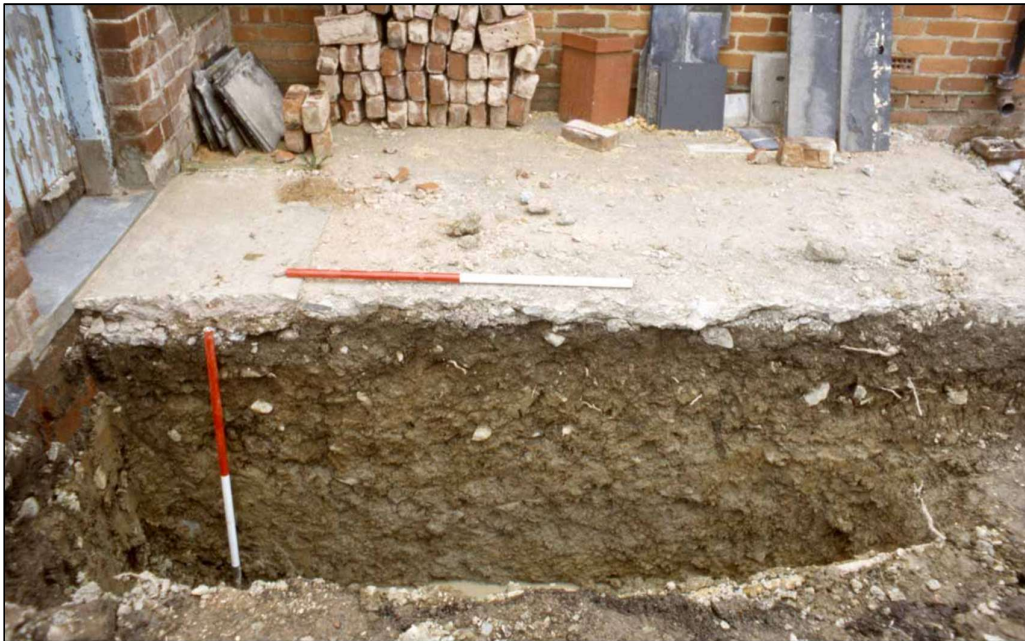
Fig. 4: Trench B from 1995, viewed from the north-west. CPAT CS95-042-0032

- 2.5. In Trench A, the surface soil comprised 0.4m of friable grey soil which contained some Roman and later material. This overlay a stiff yellowish-grey clay which was over 0.6m in thickness,

continuing to the maximum depth of the excavation at 1.0m from the surface. While the clay was thought to be of natural origin, the possibility that it represented backfilling of one of the Roman ditches was not discounted. Similar soils were apparently observed in Trench B, which was again 1.0m deep. Trenches C and D were excavated to a depth of 1.0m, but no significant features were observed.

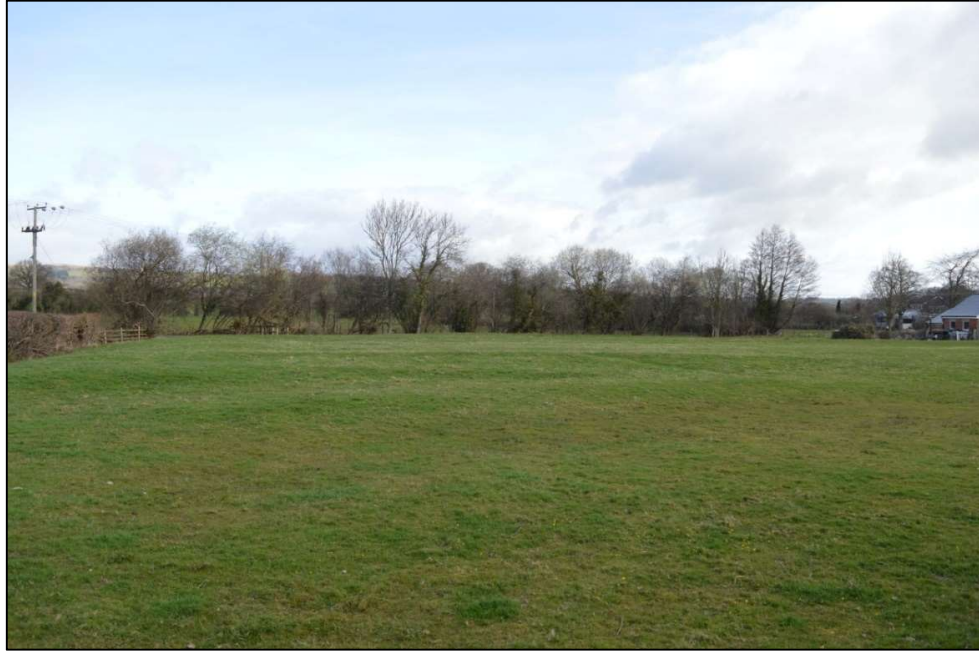
Fig. 6: Earthworks relating to the fort ditches, seen in the field to the north-west of Hafod, taken from the south-west (CPAT 4983-0019)

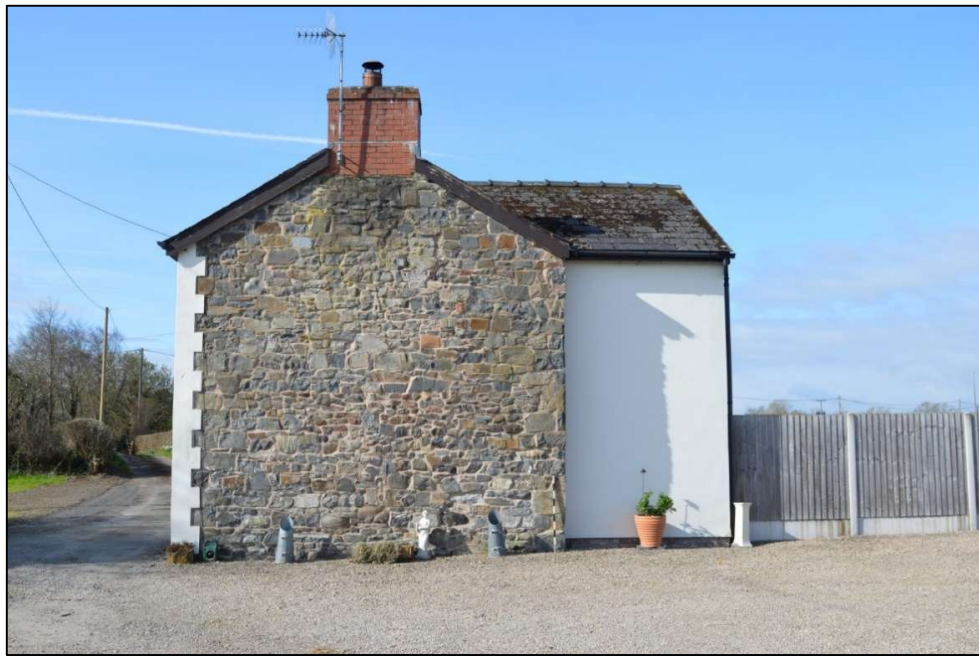
Fig. 7: The north-east end of Hafod, showing the stone end wall, the later brick extension seen on the 1902 map is to the right. CPAT 4983-0001

- 2.9. The original house at Hafod was probably stone-built, with later modifications constructed using brick. Hafod appears on the earliest available cartographic source, the 1817 Ordnance Surveyors drawing (No 198, Fig. 8), though this is at a small scale and no details can be identified. The same is true of the 1836 Ordnance Survey map (not reproduced), that was based on the surveyors drawing.

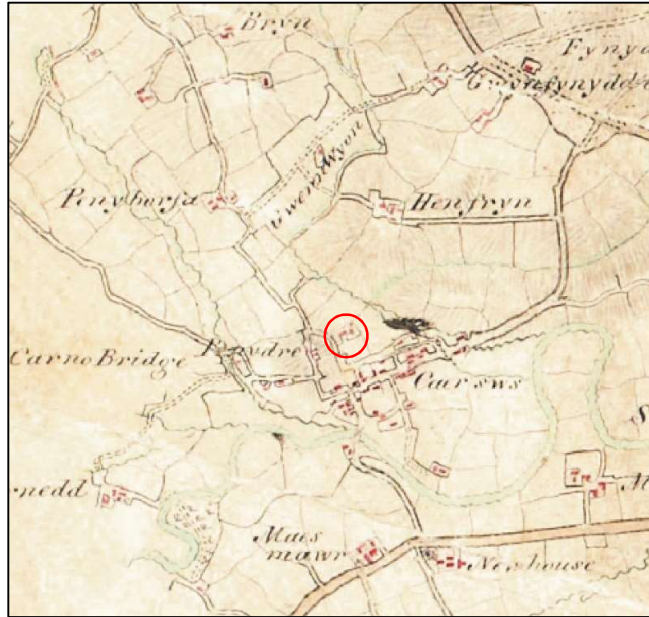
Fig. 8: Buildings at Hafod, outlined in red, as depicted on the 1817 Ordnance Surveyors drawing

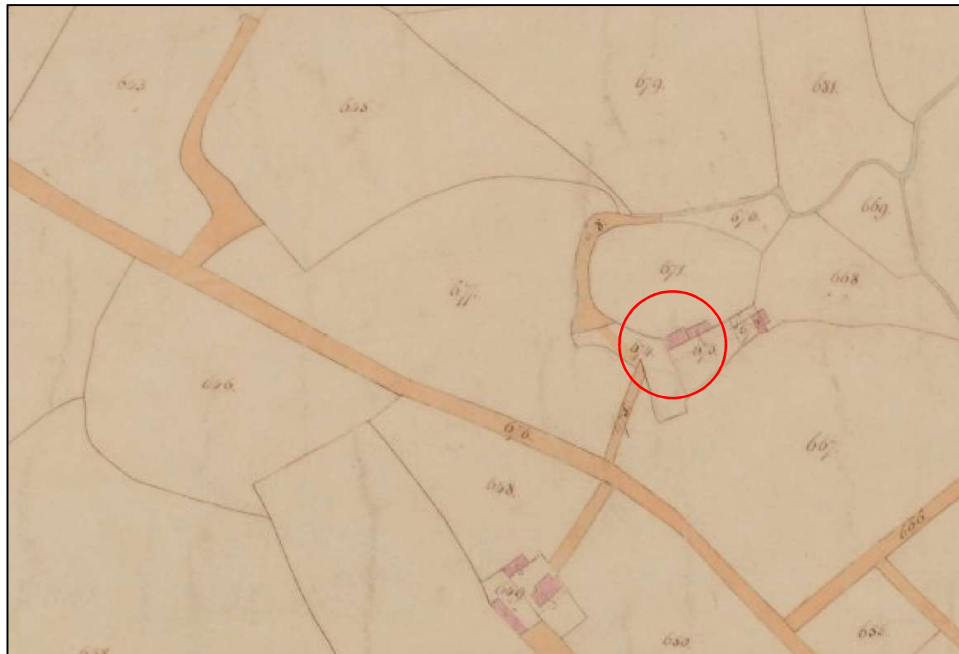
Fig. 9: Hafod, outlined in red, as depicted on the 1846 Tithe map

2.10. When the Tithe map was drawn in 1846 (Fig. 9), the house appeared to comprise two main parts placed end-to-end and aligned approximately north-east/south-west. The stone north-east end wall of Hafod (Fig. 7), is probably the only survivor from the north-east part of this 1846 building and the rest (see Fig. 3) represents what seems to have been a later, brick-built, south-western part. No other evidence for what is likely to have been an original stone house can be seen, but it seems likely that it would have extended to the north-east, beyond the current dwelling (see Fig. 12). A further structure is evident on the map to the south-west of the house, in the approximate location of the existing garage.

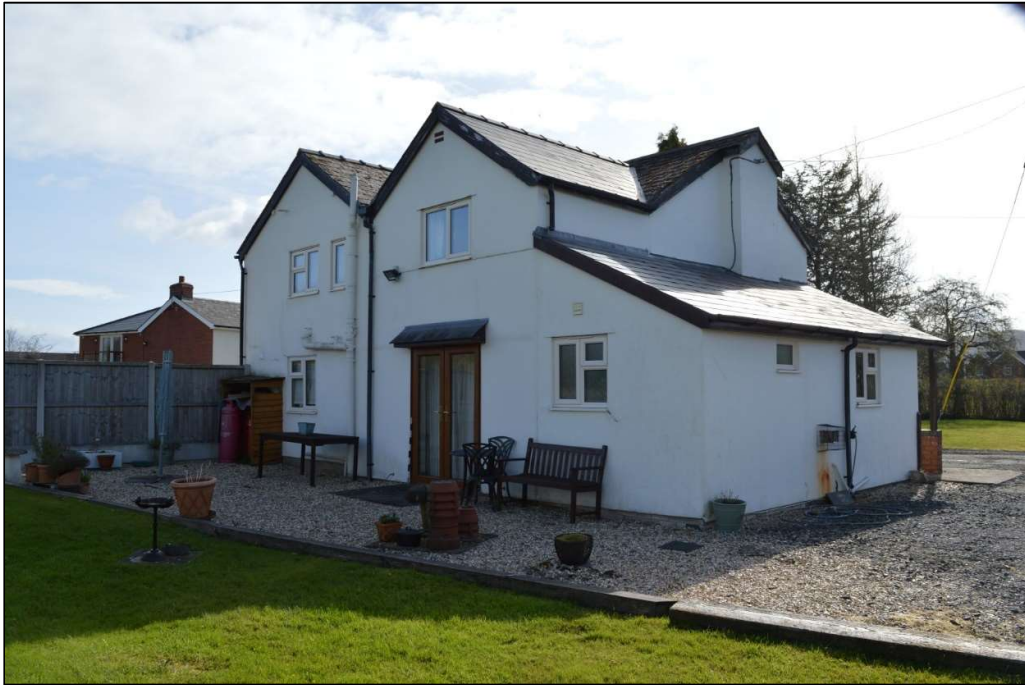
Fig. 10: Hafod viewed from the west, showing the site of the proposed extension. CPAT 4983-0006

- 3.1. The current proposals are for an extension on the north-west and south-west sides of Hafod, extending the house about 2.4m in either direction (see Fig 10). Two of the 1995 trenches (C and D) were excavated within this area, and although no evidence for Roman features was observed it has become apparent that both trenches were placed on the line of the outer ditch of the fort defences. Just over half of the width of the proposed extension on both sides lies within the scheduled area of the Caersws Roman Site (MG001), which seems to have been redrawn around Hafod after the 1995 excavation. The detached garage lies wholly within the scheduled area.

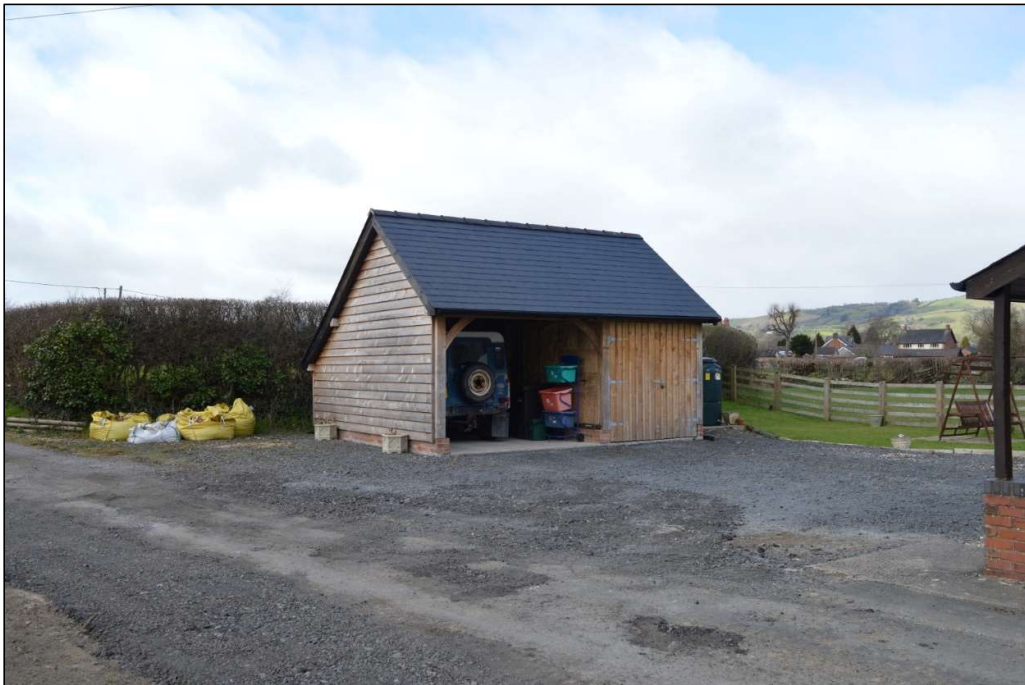
Fig. 11: The garage to the south-west of Hafod. CPAT 4983-0025

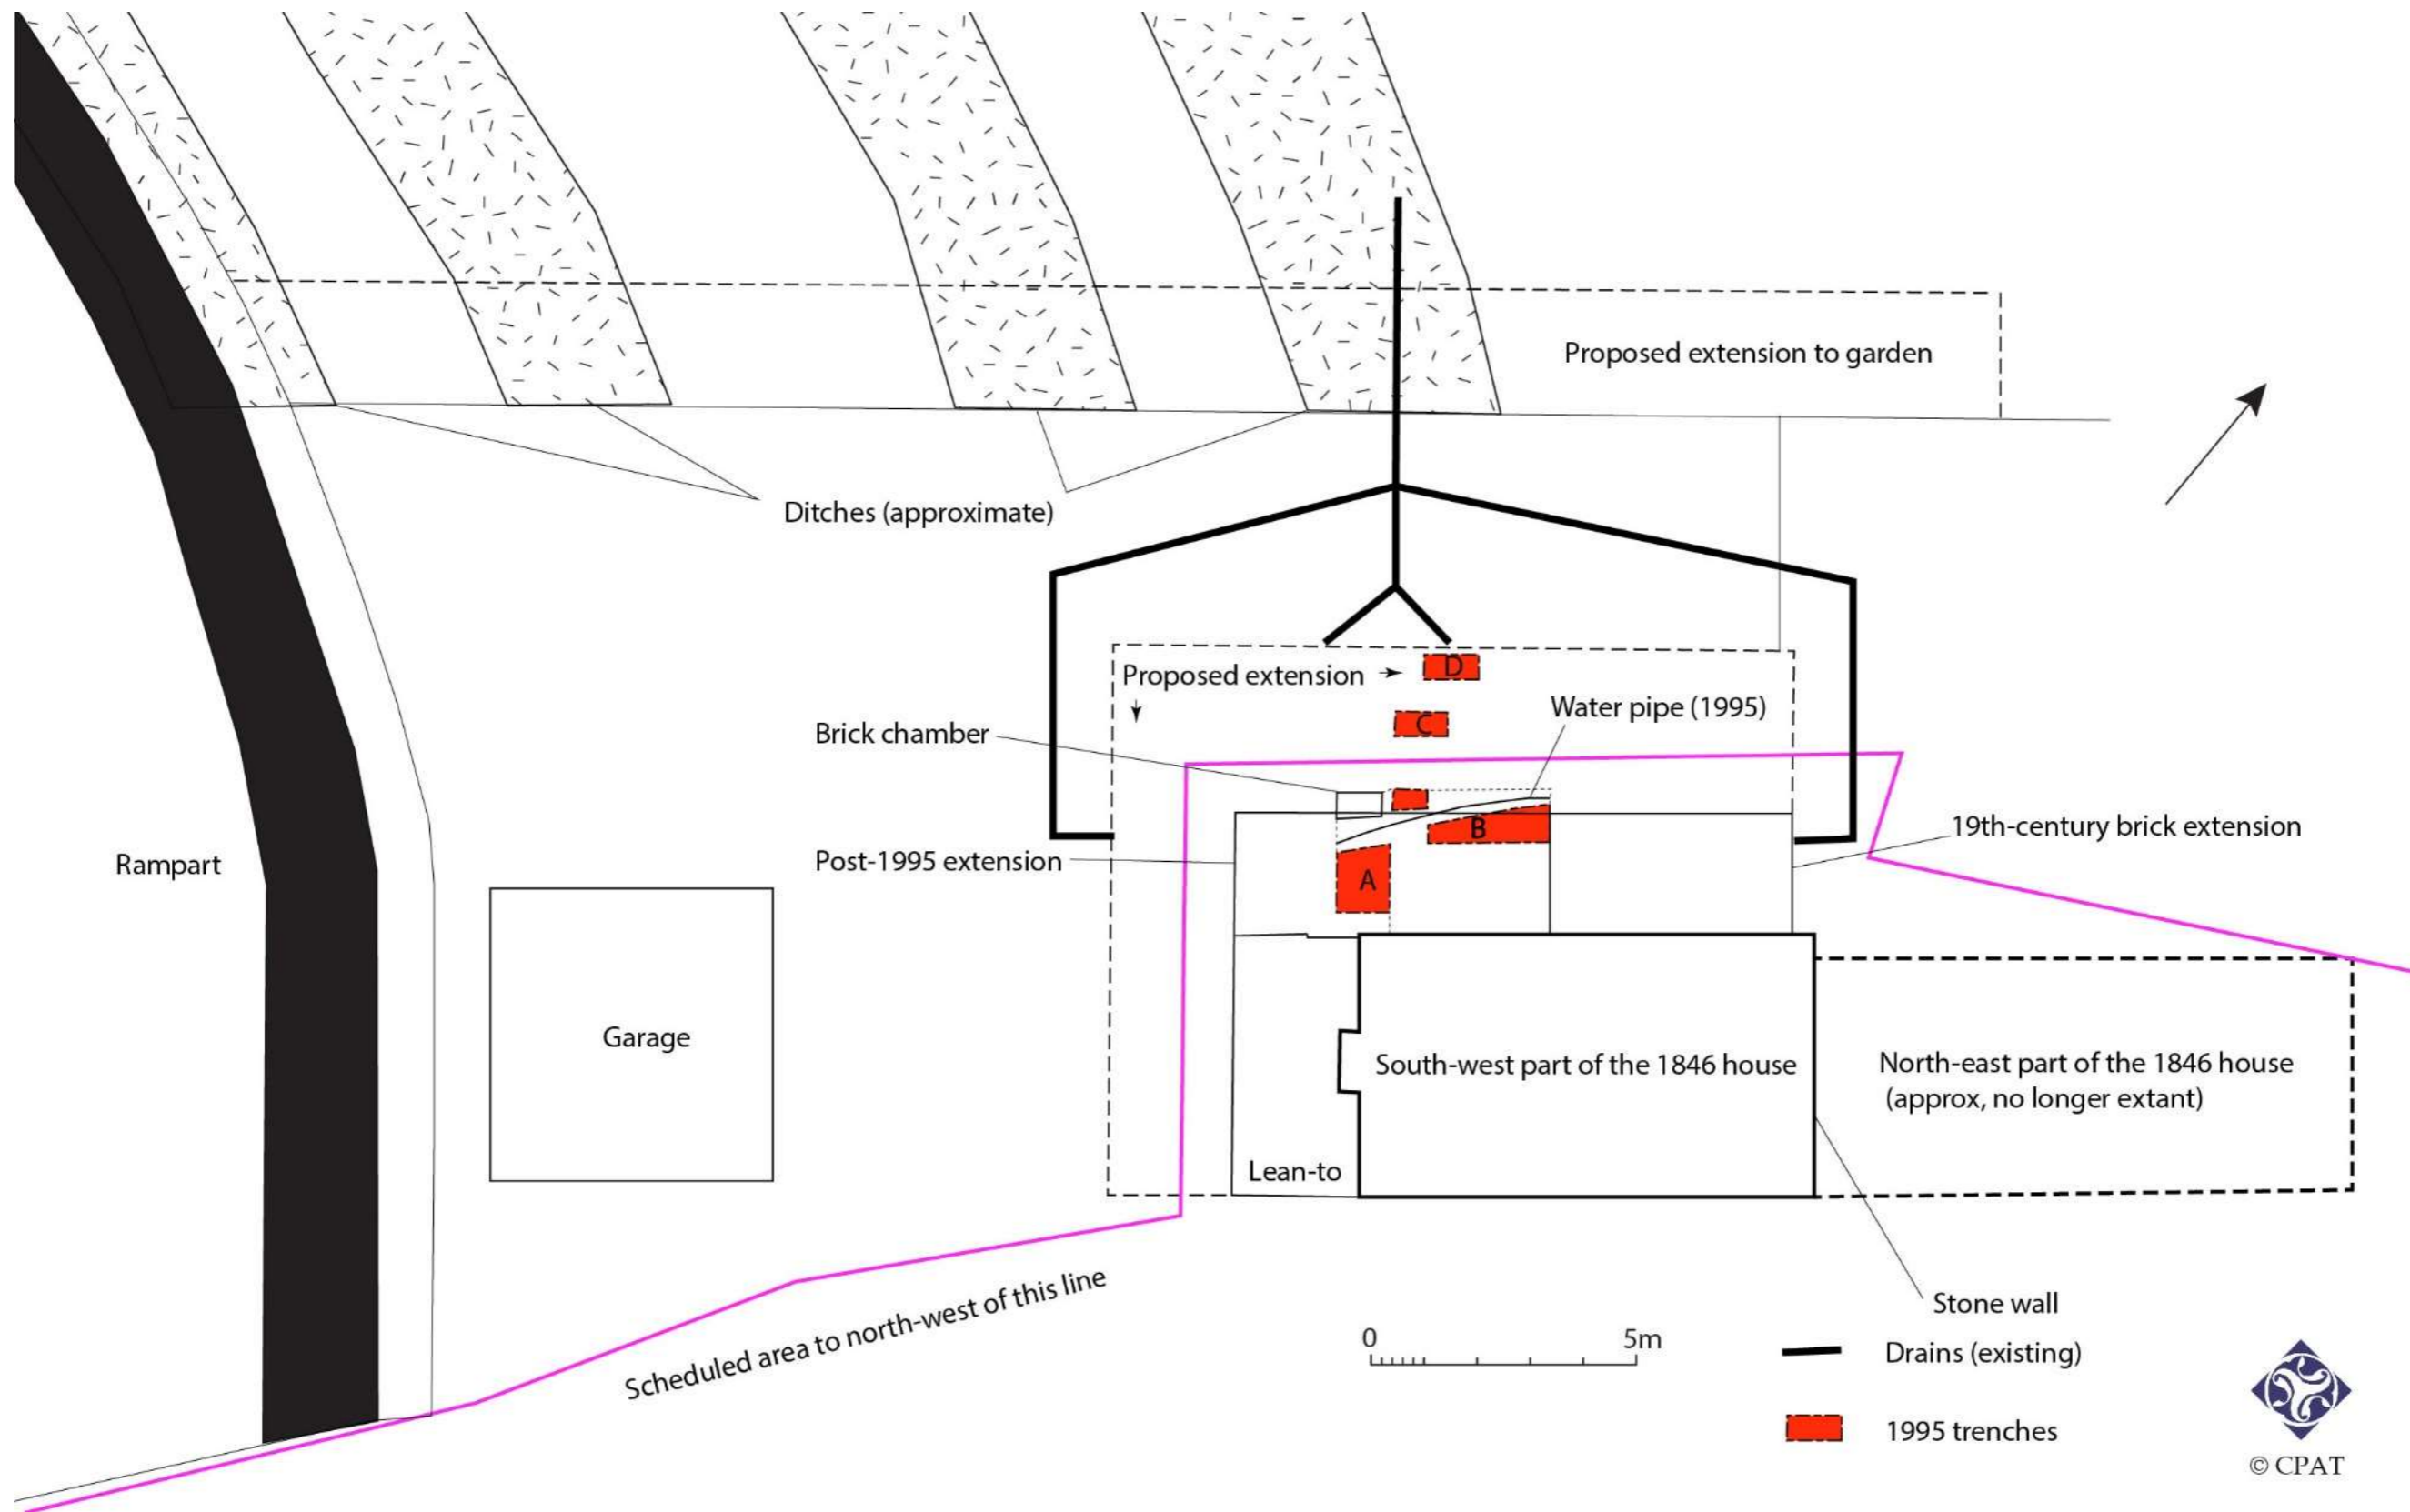
Fig. 12: Overall layout of Hafod, showing the approximate locations of the Roman defences, scheduled area, 1995 trenches and details of the house

- 2.6. Reviewing the 1995 findings in the light of more recent aerial photography (Fig. 5) it is clear that the trenches fell within the area of the fort defences but that this was not recognised, most likely in large part owing to the very small scale of the excavations (see Fig. 12).

what deposits were encountered during its construction and when that took place is not known. It could potentially be related to a brick-built tank that was seen in the 1995 excavations (Fig 12).
