CPAT Report No. 1965

# 3-8 Bay View Road, Colwyn Bay

Building Survey

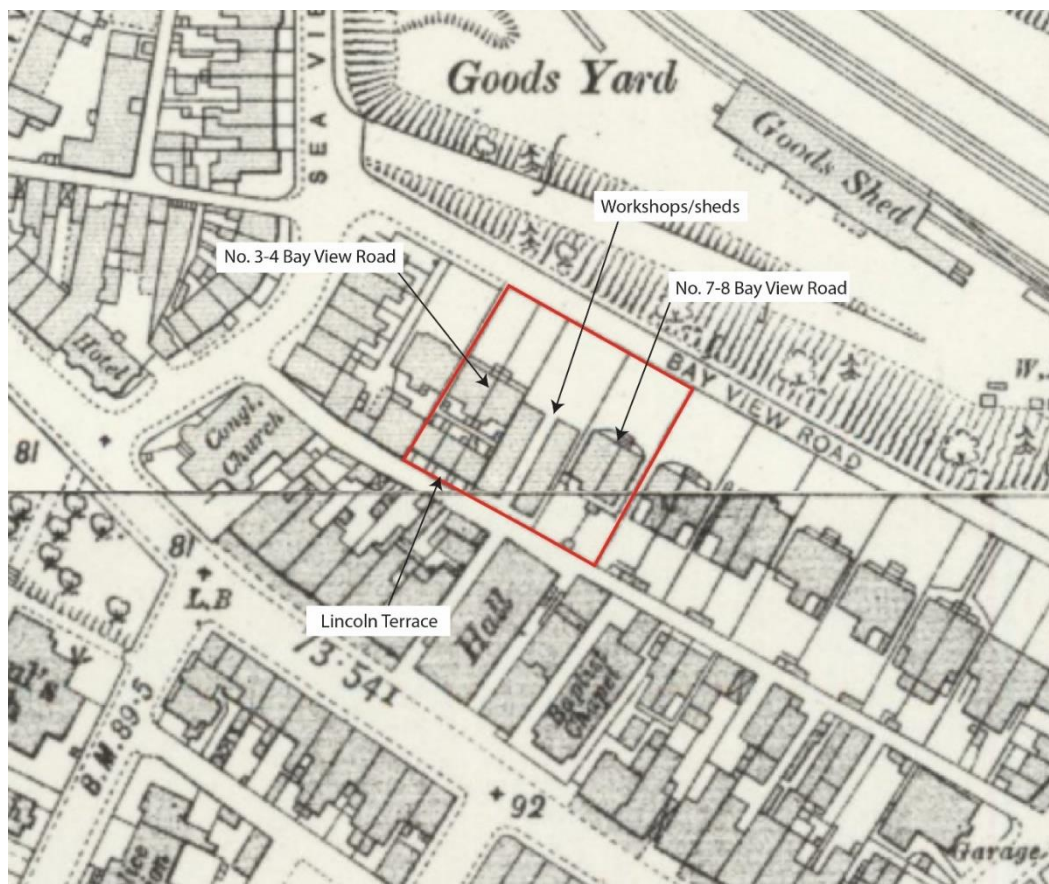
Fig. 2 Extract from the 25" 1913 Ordnance Survey map

- 2.3. The houses along Bay View Road are not shown on the 1888 Ordnance Survey map at 1:2500 scale so must have been constructed between about 1888 and 1900, as part of a wider development of this area (Fig. 2). The plot immediately to the north was formerly a sand extraction site served by a spur from the main railway line. The study area was comprised of three plots, each measuring 0.1 hectares. The westernmost plot contained two semi-detached villas on Bay View Road but set well back from the frontage. To the rear was Lincoln Terrace comprising three small houses. The central plot contained two workshops or sheds with a yard to the north of them. The easternmost plot contained two semi-detached villas, also set back from the frontage, but with gardens to the rear.

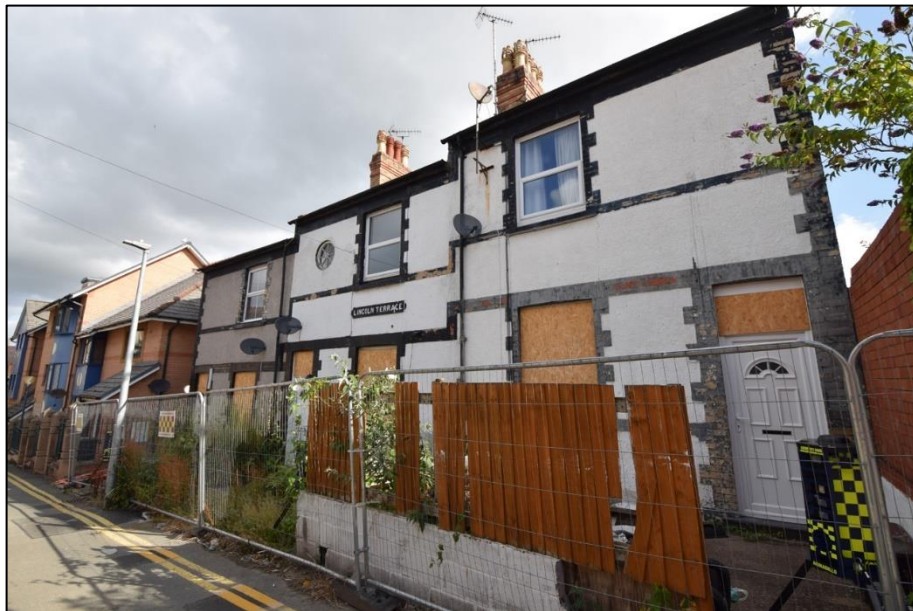
- 3.3. The terrace was constructed in rendered brick with decorative brick string coursing, detailing around the windows and doors and along the tops of the gable ends. The terrace was constructed on a steep slope from west to east, so each building was constructed slightly higher than the one to the west of it (Fig. 3). The roof was slate with central chimney stacks, Nos. 2 and 3 having a common stack. An interesting detail on the frontage of No. 2 was an ox eye window with a wheel shaped frame (Fig. 4). The other windows and doors had been replaced with UPVC.

Fig. 3 Lincoln Terrace viewed from the south Photo CPAT 5077\_003

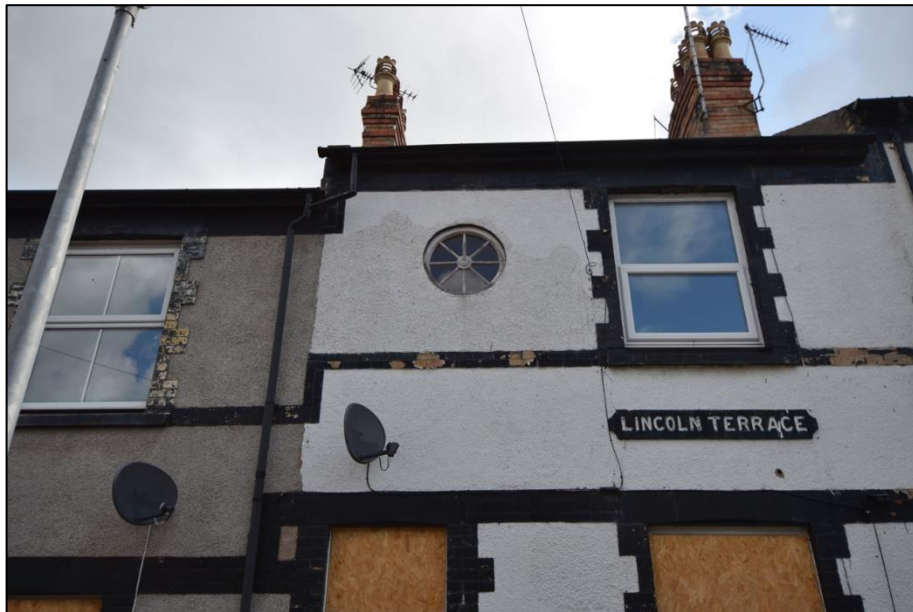
*Fig. 4 Ox eye window and sign on the frontage of No. 2 Photo CPAT 5077\_004*

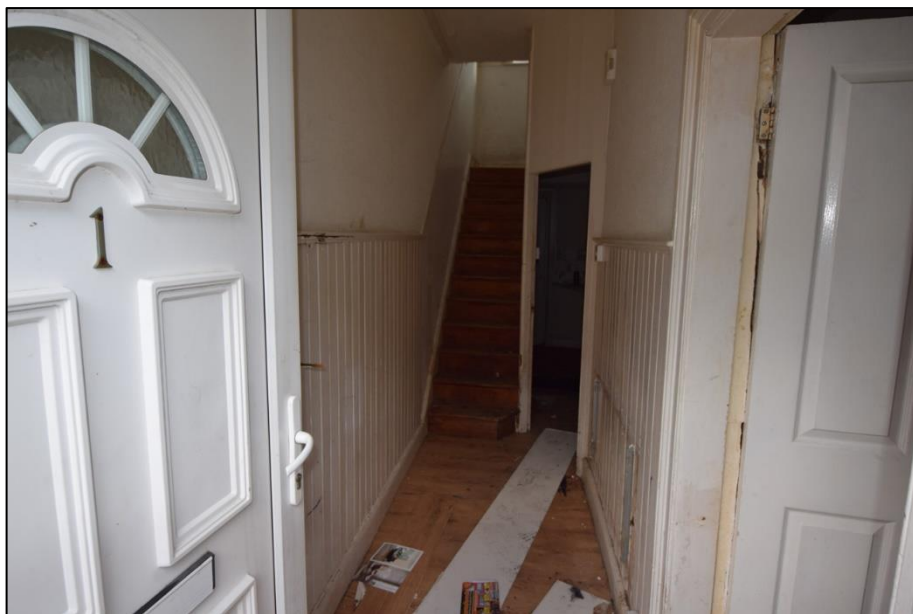
- 3.4. Internally the original layout of each of the houses was still discernible (Dwg. 6), but many of the original features had been removed or obscured, although Fig. 5 shows original panelling.

*Fig. 5 Wood panelling in the hallway of No. 1 Photo CPAT 5077\_006*

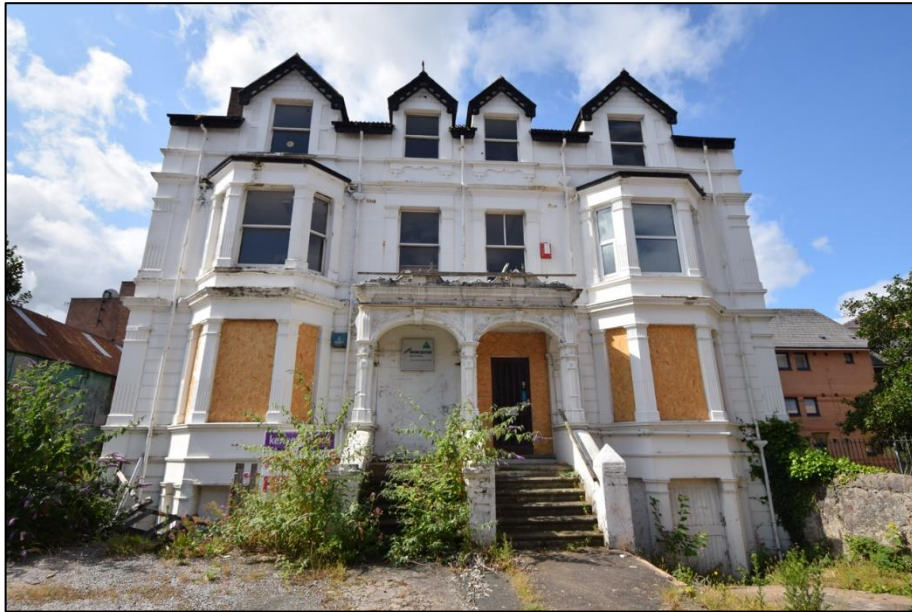
- 3.5. No. 3-4 Bay View Road (Dwg. 7) comprised two large semi-detached villas, set well back from the southern side of Bay View Road. The layout of each property was fairly similar but not identical, and the floor plan broadly mirrored each other. The building was built in red brick, which had been rendered. The frontage was painted white and was quite ornate, particularly on the bay windows and the corniced porch (Fig. 6). The bays rise through the basement, ground and first floor levels. There were large chimney stacks on either gable end and a smaller chimney on the two storey outshut to the rear of the building.

*Fig. 6 North facing (principal) elevation of No 3-4 Photo CPAT 5077\_031*

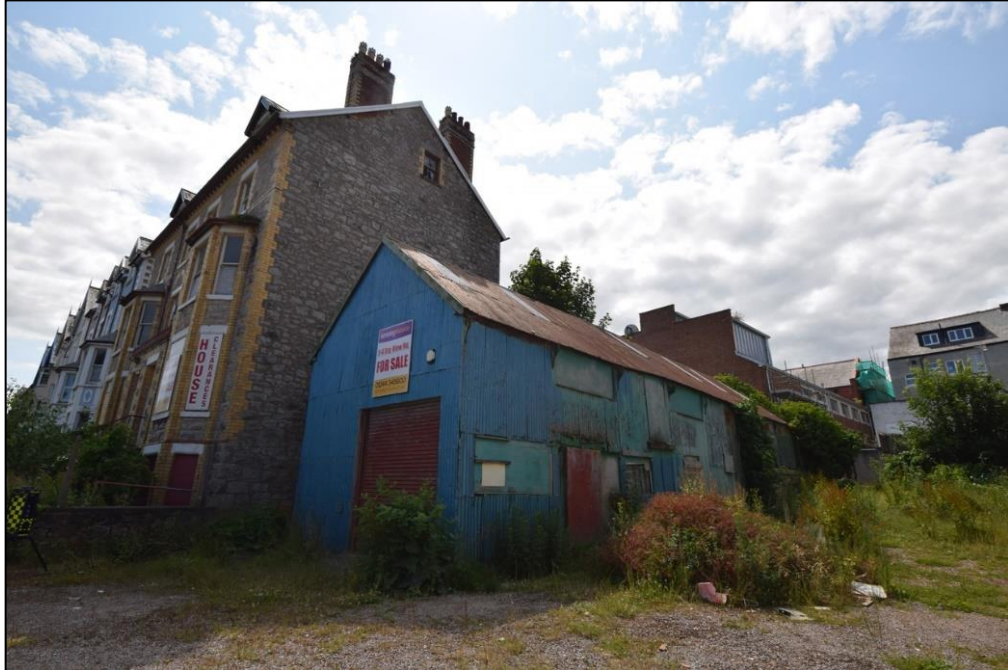
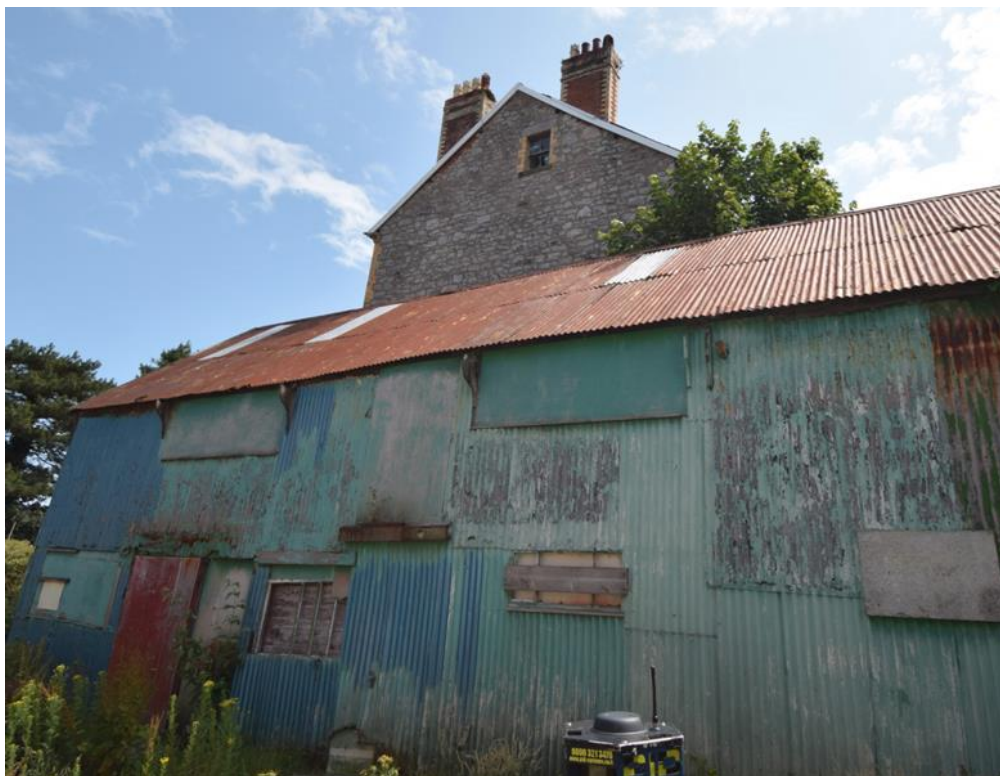
- 3.10. The central plot, presumably Nos. 5-6 Bay View Road, was occupied by a long 2 storey timber framed corrugated iron clad shed or workshop (Fig. 8). There were large window apertures on the upper floor, a large doorway in the northern gable end and other doorways on the west elevation. Historical mapping suggests that it was constructed by 1900 and that a later workshop with similar dimensions was constructed during the 1910s on the adjacent side of the plot to the west.

*Fig 8 Workshop adjacent to 7 Bay View Road, looking south and east 5077\_086 & 087*

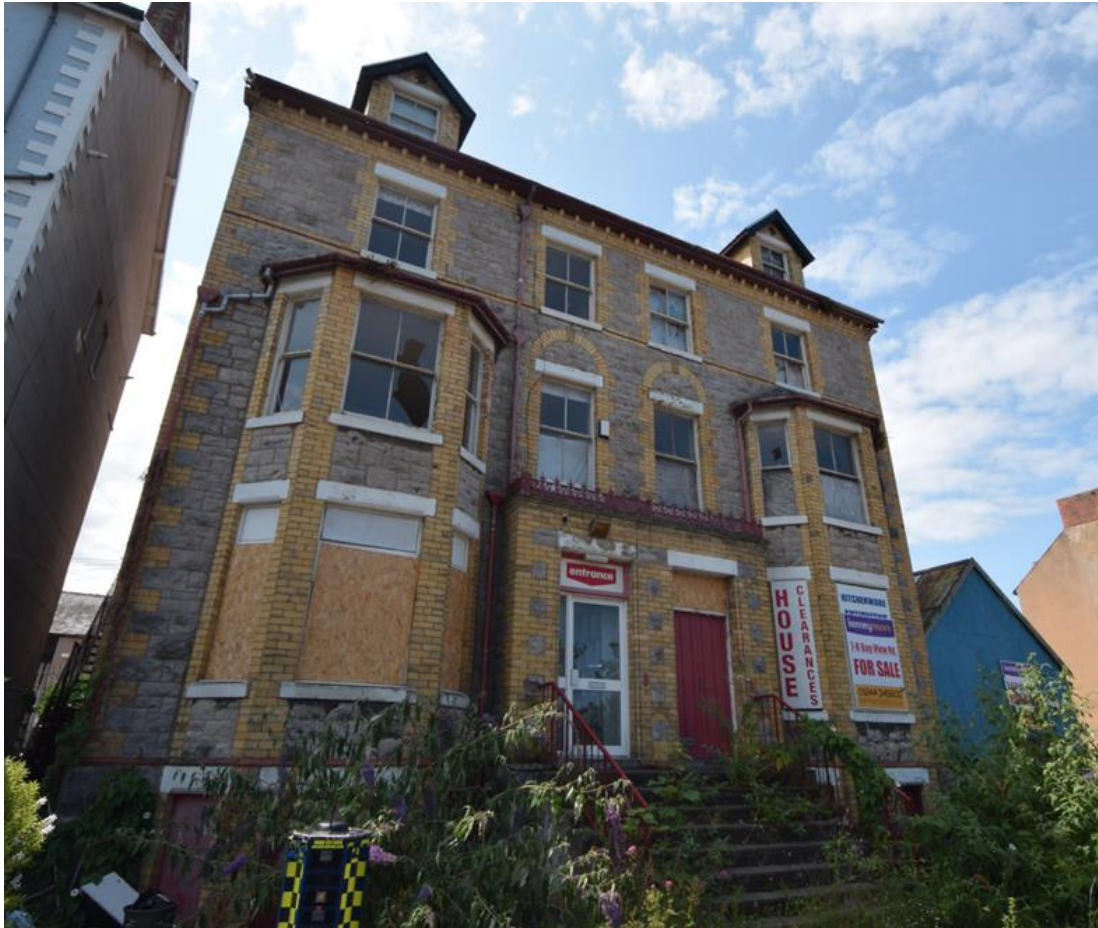
- 3.11. No. 7-8 Bay View Road comprised a pair of semi-detached houses of five storeys (Fig. 9; Dwgs. 8 & 9). The construction was in local rock-faced stone with yellow brick dressings, and the façade was largely without the architectural embellishments and aesthetic feel of 3-4 Bay View Road. Bay windows extend from the basement through the ground and first floor levels. A flat-roofed concrete extension had been added to the rear in the mid 20<sup>th</sup> century.

*Fig 9 North facing (principal) elevation of Nos 7-8 Bay View Road CPAT 5077\_088*

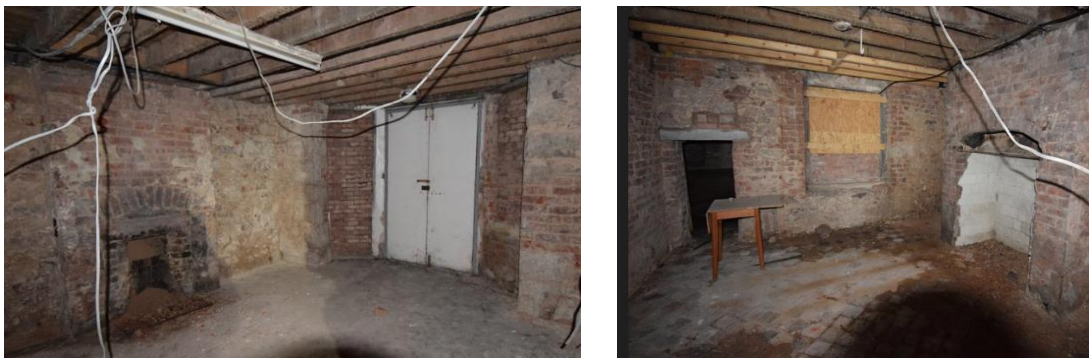
- 3.12. The basement was accessed by a simple staircase beneath the main stairs. The walls were brick and the floor red and black tiles. Fireplaces were located in gable walls. The original bay windows had been replaced by doors (Fig. 10).

*Fig 10 Basement showing replacement door, fireplaces and tiled floor CPAT 5077\_121 & 122*

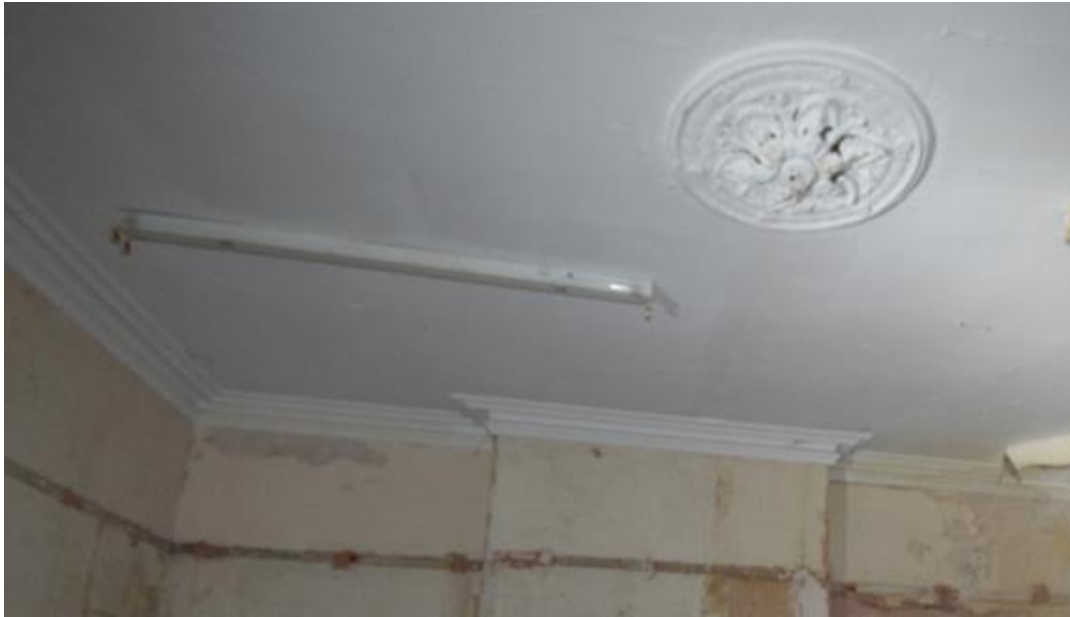
- 3.13. The ground floor was accessed by a series of steps with cast iron decorative railing above (Fig. 9). Although the windows in No 8 have been replaced by uVPC, those in No 7 have retained the timber sash typical of these kinds of property. Some coving and decorative central light fittings survived (Fig. 11). The concrete extension at the rear has no architectural merit.

*Fig. 11 Ground floor surviving decorative features CPAT 5077\_114*

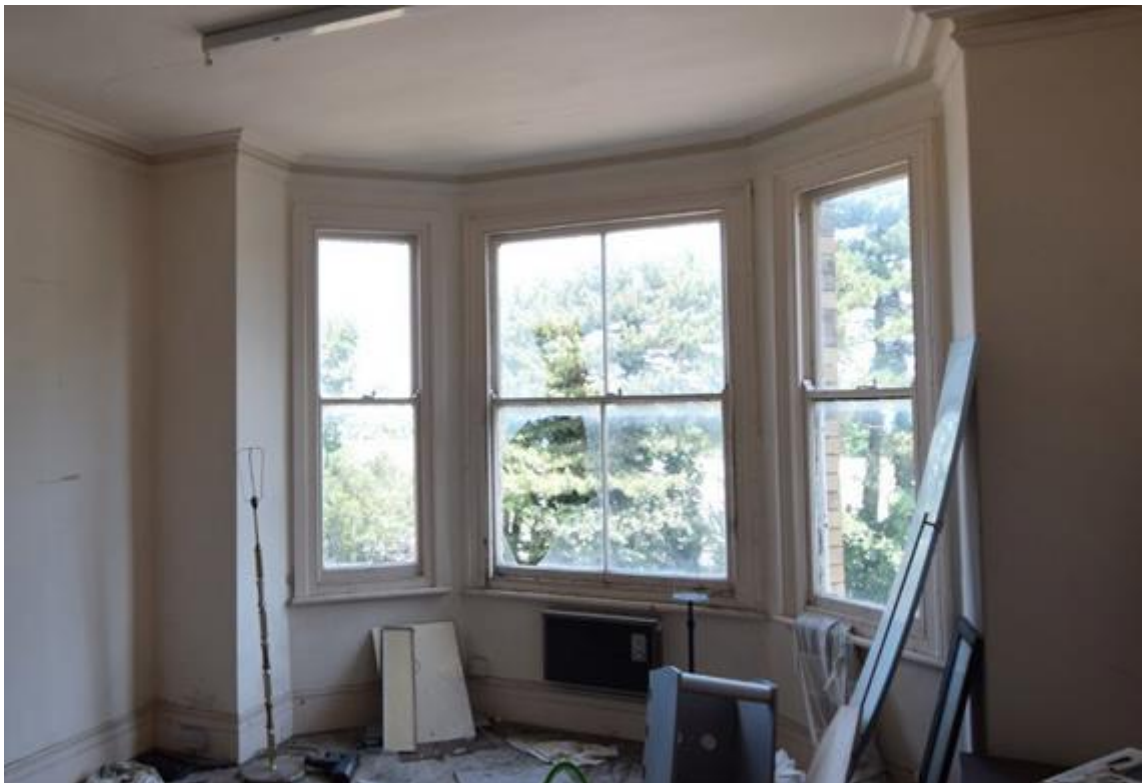
- 3.14. The first floor rooms retained some simple coving and skirting boards, and their original sash windows and floorboards (Fig. 12), but fireplaces had been blocked up. A decorative block pattern had been used for the main staircase (Fig. 13) which led up to the first floor.

*Fig. 12 1<sup>st</sup> floor original sash windows and surviving coving and skirting board Photo CPAT 5077\_101*

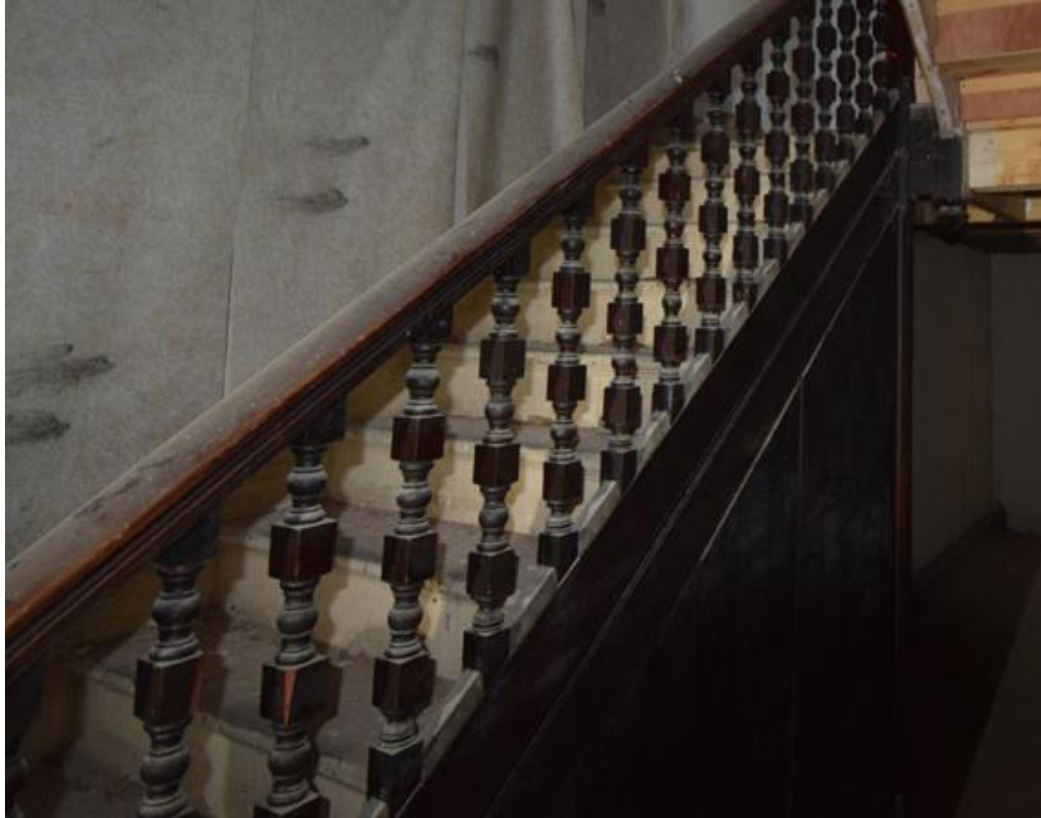
*Fig. 13 Main staircase to first floor level CPAT 5077\_120*

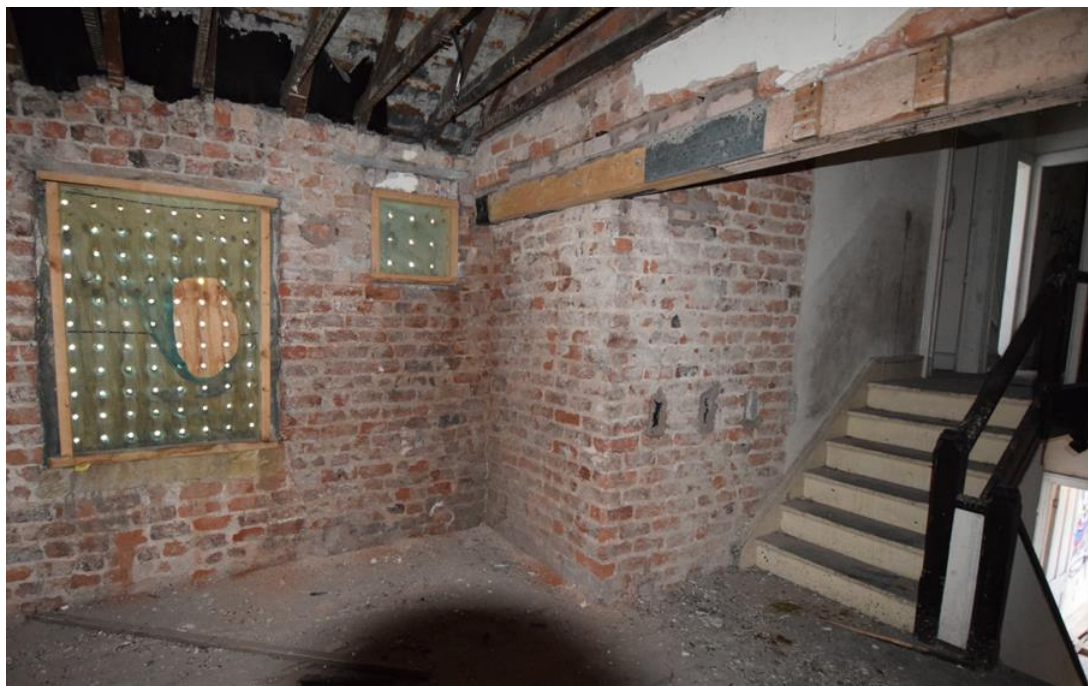
- 3.15. Much of the rear section of the second floor had been stripped out for maintenance to remove dry rot (Fig. 14). The front rooms on this level had some original sash windows, but otherwise there was very little of architectural interest and the fireplaces had been infilled. The third floor comprised very plain rooms with dormer windows, located within the roof space.

*Fig 14 2<sup>nd</sup> floor showing rafters and brick walls, with stairs to other floors CPAT 5077-155*

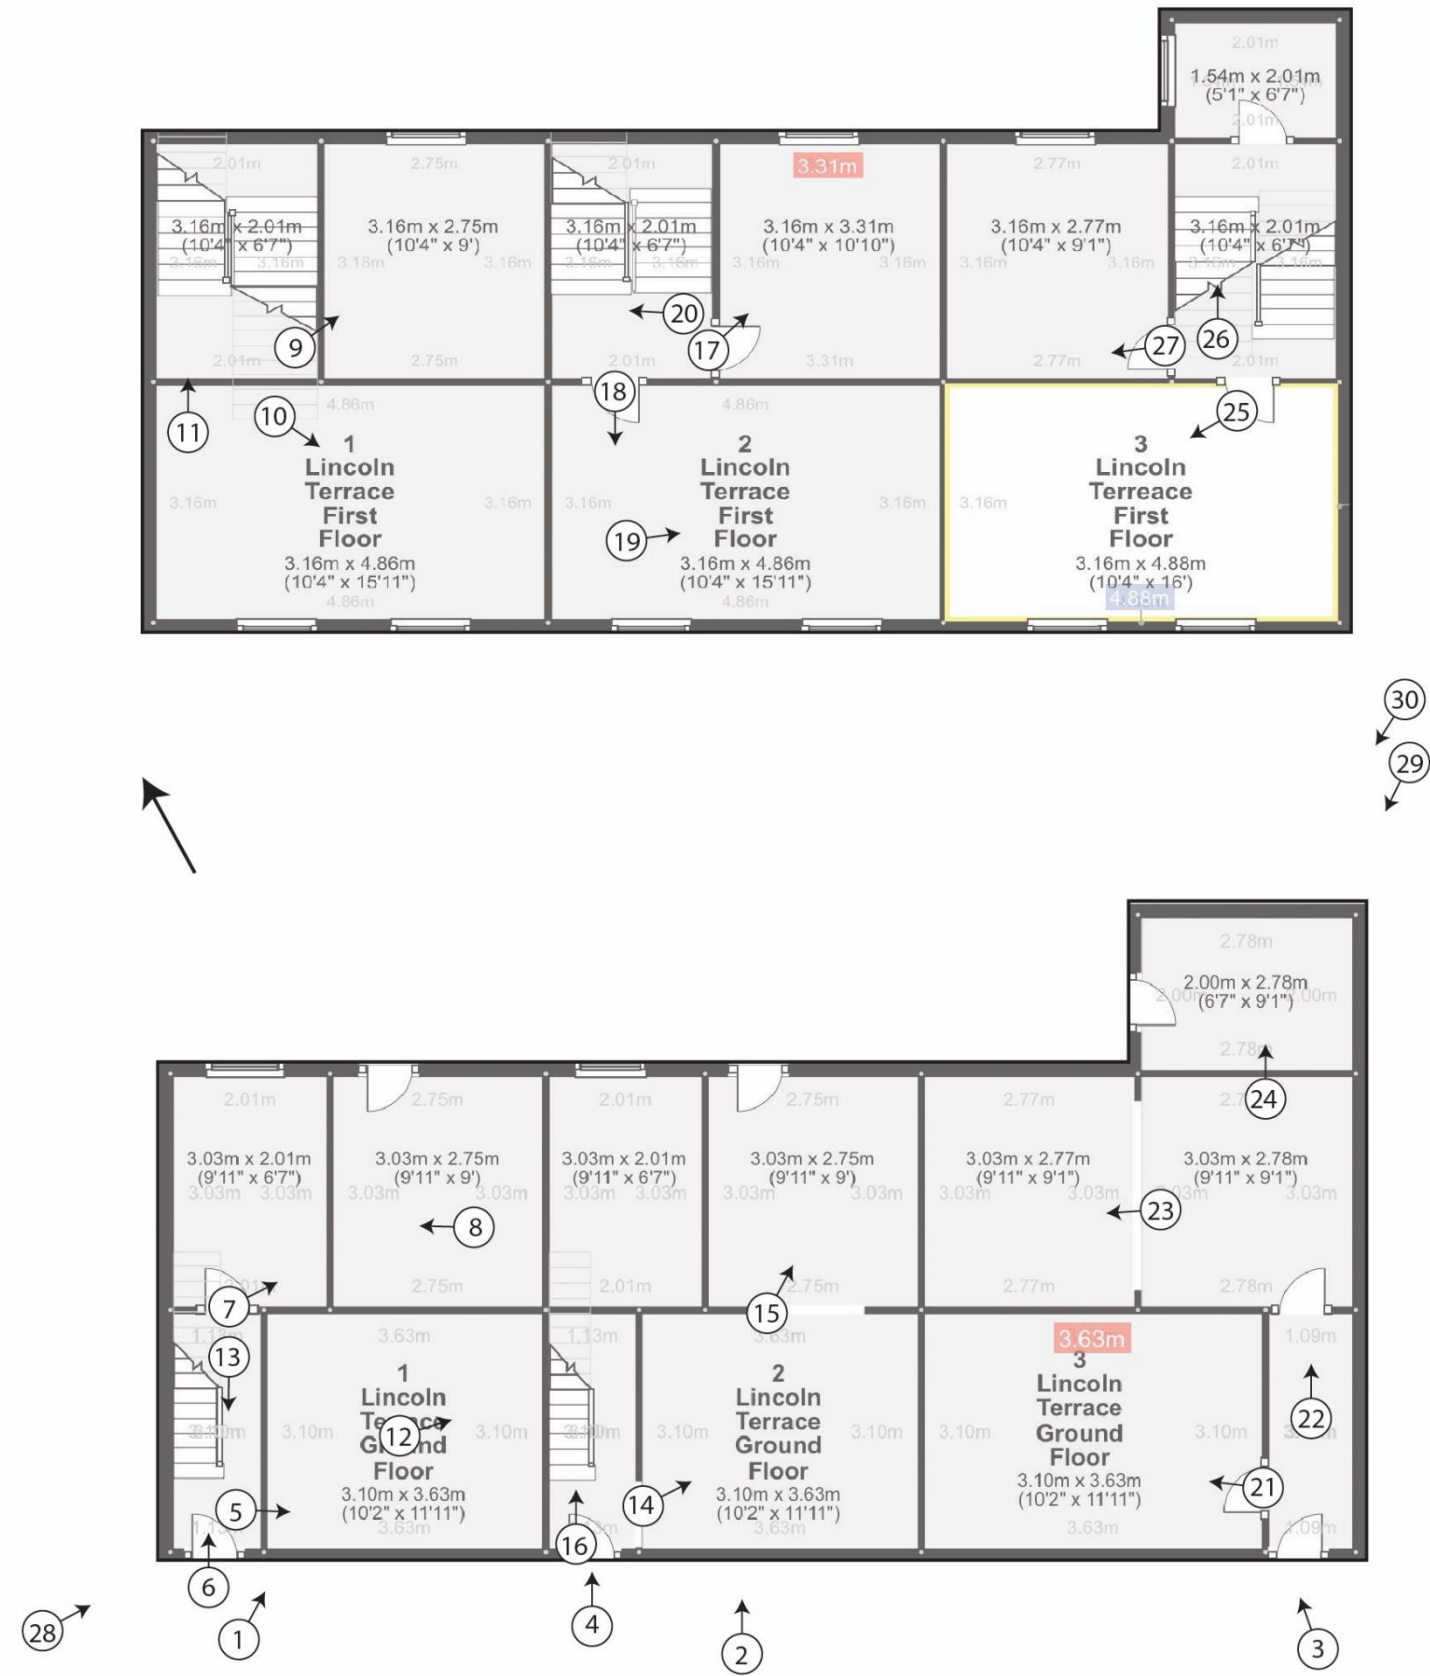
Dwg 6: Photographic location plan of Nos1-3 Lincoln Terrace

- 3.2. Lincoln Terrace (Dwg. 6) comprised three houses located to the rear of Nos. 3-4 Bay View Road on Back Bay View Road; a narrow road running parallel to Bay View Road to the south. All were two storey, with a parlour, a kitchen and a utility room or larder accessed via a hallway on the ground floor and two bedrooms accessed via a landing on the upper floor. Nos. 1 and 2 were identical in layout, No. 3 was similar in plan but also had a modern extension to the rear.
