Name: Nant-gau-uchaf

Parish: Mynyddislwyn **Location:** Croespenmaen

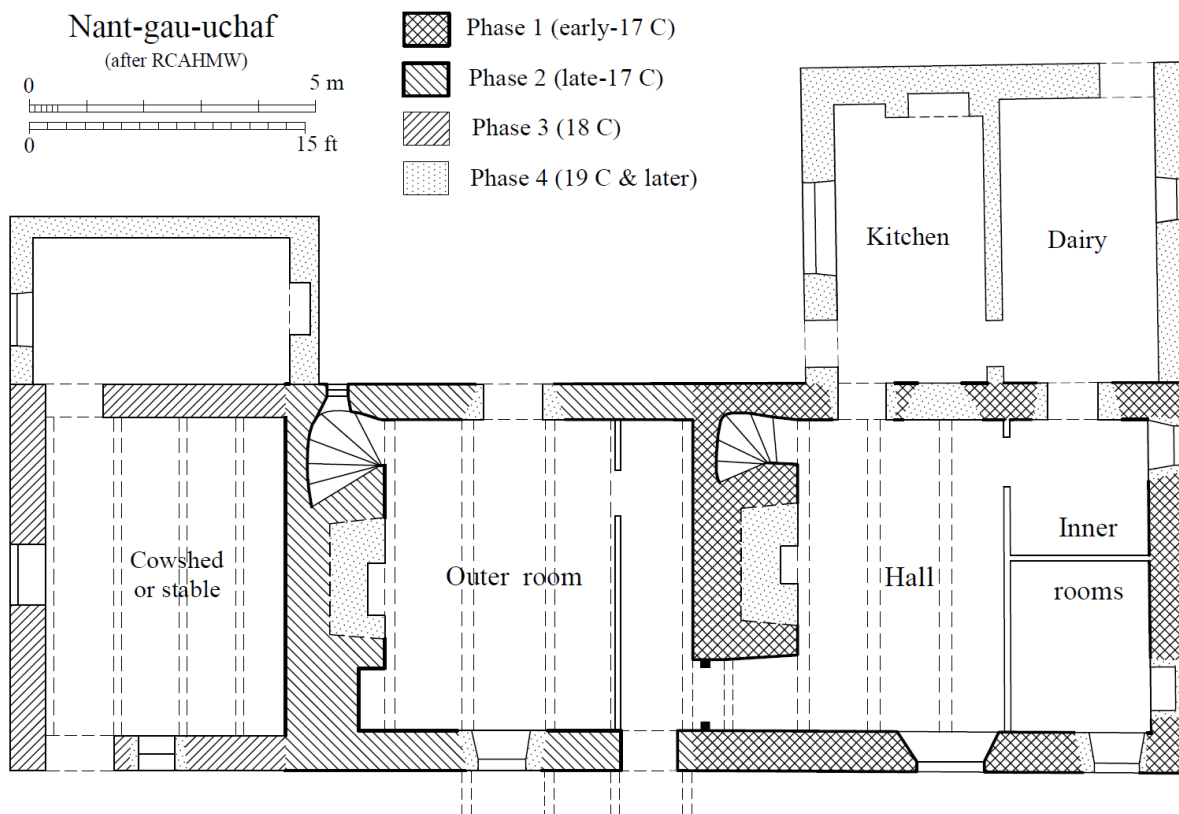
Maps:

Description: This large farmstead on the ridge between the Sirhowy and Ebbw valleys was demolished in 1977 and its site is now occupied by an industrial estate. Fortunately, the RCAHMW carried out a survey at the time, and this account is based on those notes. The above plan is also based on the survey, with hatching representing the likely structural phases.

The house consisted of a long, downhill-sited range, aligned roughly north-south, with two extensions at the rear. It had limewashed rubble walls, stone tiles, brick chimneys and inserted dormers on the first floor. A short section of a pentice survived along part of the east frontage at the time of survey (see drawing below, based on a sketch by Peter Smith). Most of the door and window openings had also been altered over the years.

Development: Nant-gau-uchaf was clearly an interesting building of several phases, the various additions resulting in a very elongated linear plan. Its loss is to be regretted. Judging from changes in the stonework and the varying timber details, it is clear that the upper end was the original house, probably early-seventeenth century in date, and that the outer room was added towards the end of the century. The small cowshed / stable at the lower end may have been added in the eighteenth century, and the two rear wings in the nineteenth.
