CPAT Report No. 1718

**St Peter's and St Illtyd's Church,
Llanhamlach**

Archaeological Watching Brief

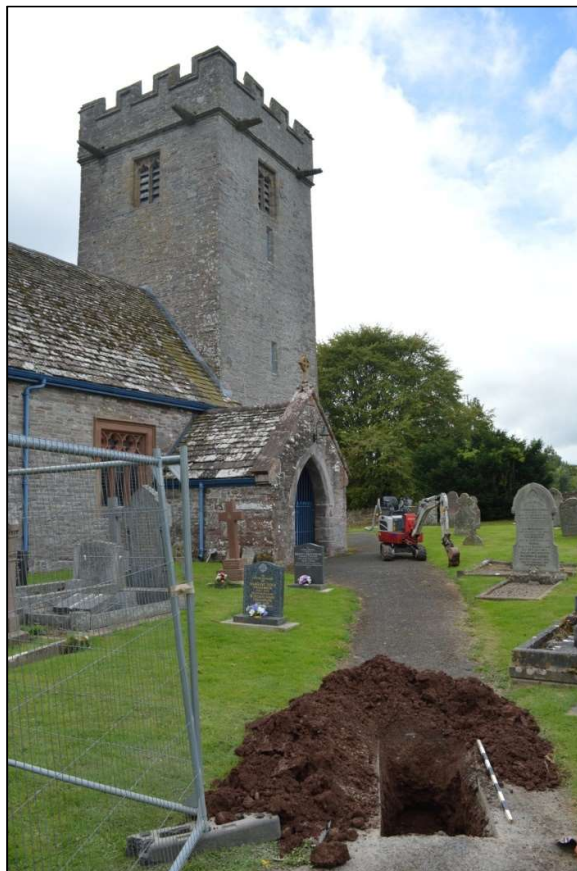
Fig. 2: One of the trenches in the churchyard path. CPAT 4725-0010

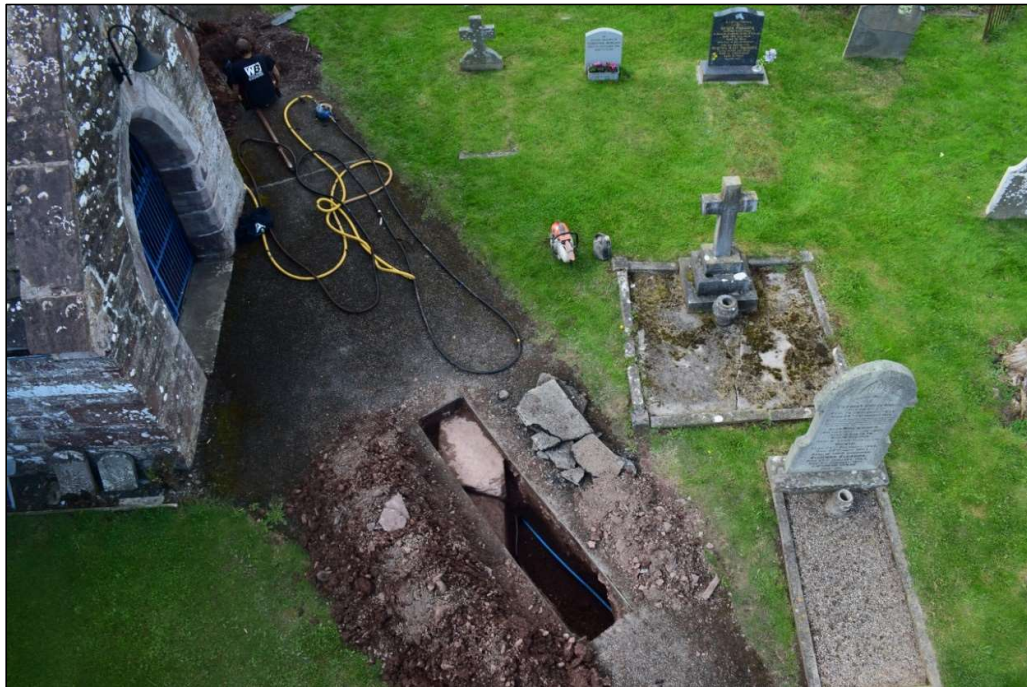
- 3.5. Structural evidence was found in Pit 4 (Figs. 3 and 4), where the basal course or foundation of a stone wall (405) was revealed, comprising two large, abutting, sandstone blocks with lime mortar bonding. This was aligned east/west and lay approximately 2m to the north of the porch. The former existence of a north aisle to the church has already been highlighted by David Morgan in the church information booklet (Morgan 2017), which provides information regarding a watercolour produced by Sir Richard Colt Hoare in 1802. This apparently depicts the church immediately before it went through a phase of rebuilding and shows a north aisle, somewhat shorter than the main body of the church but with a lean-to structure at its east end. Both were soon to be demolished when they were painted. The foundations of the lean-to were found in a watching brief carried out during drainage work at the north-east corner of the church in 2003 and it seems clear that the foundation seen in Pit 4 was for the north wall of the north aisle shown on the watercolour.

Fig. 3: The foundation stones of the north wall (405) of the north aisle in Pit 4 with the porch to the left, from the east. CPAT 4725-0001

- 4.1. The watching brief has added to our knowledge of the history of the church at Llanhamlach, clarifying certain points and raising others, hitherto unsuspected. First amongst these was the discovery of the foundation of the wall of the north aisle, the presence of which had been suggested by David Morgan from his scrutiny of a watercolour of the church dating to 1802. The aisle was demolished soon afterwards but it is now possible to determine the approximate extent of the foundations, it would have been approximately 6m in width.

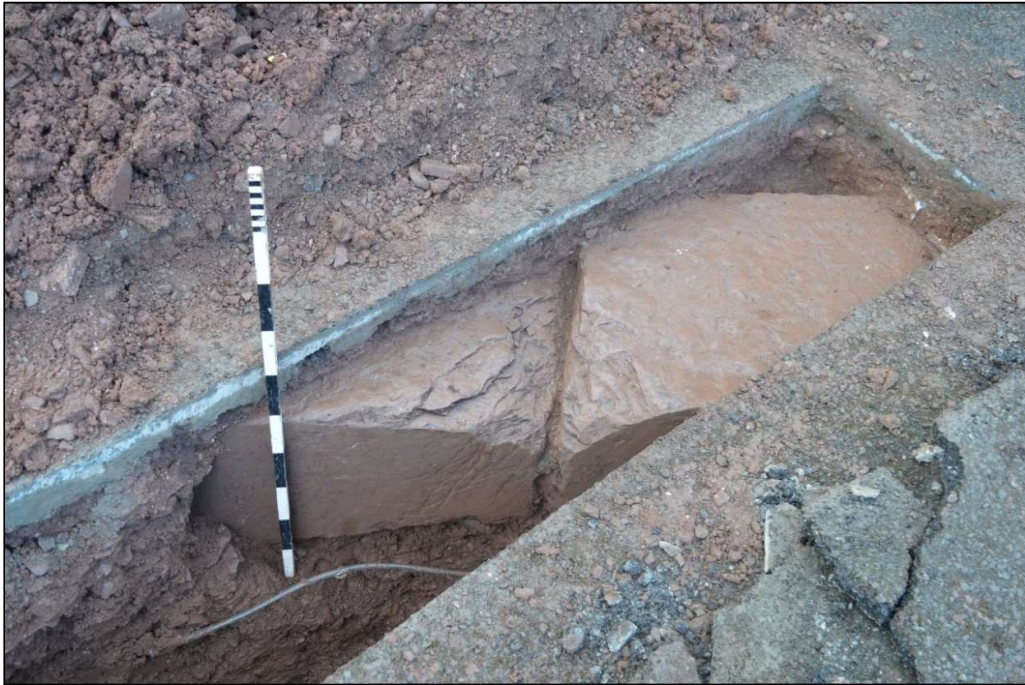
Fig. 4: The foundation stones of the north wall (405) of the former north aisle, from the north. CPAT 4725-0022

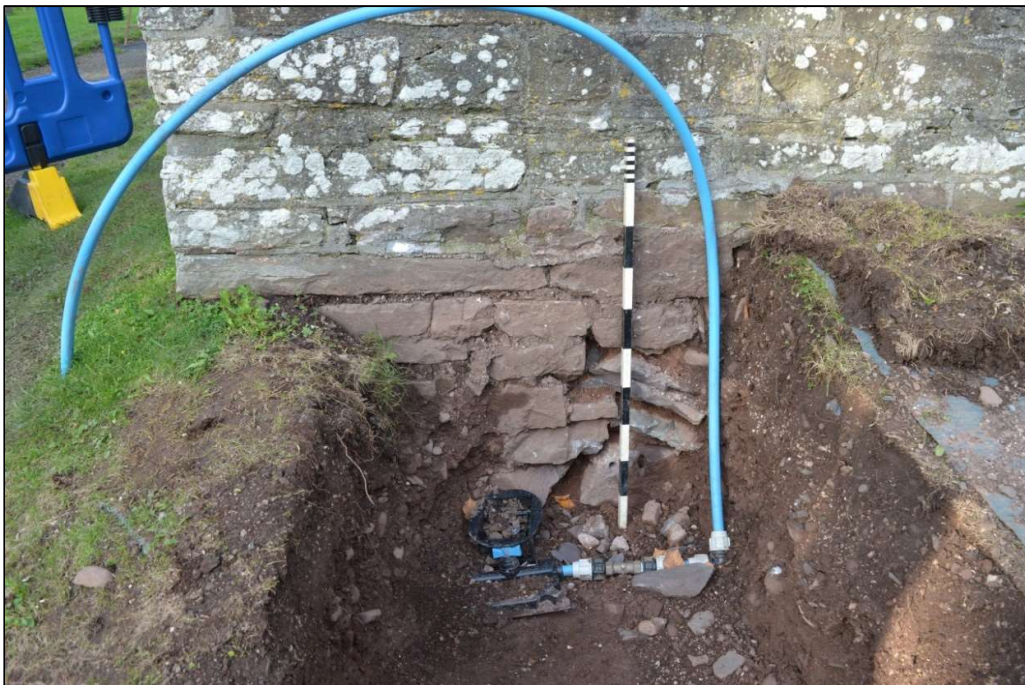
Fig. 5: Pit 9 on the south side of the tower. CPAT 4725-0035

- 3.7. No features or finds were found in Pit 9, which was excavated through 0.2m of grey-brown silt (901) and 0.65m of reddish-grey rounded gravel and cobbles (902) but it was interesting to understand something of the construction of the tower. In contrast to the above ground appearance of the tower, which has a more regular, coursed appearance from the use of flat sandstone slabs, the below ground section has a more random appearance (Fig. 5) and is formed from angular pieces of sandstone (903). Whether this indicates a difference in age it is not possible to say without further study but Morgan (2017) has noted that the tower shows signs of rebuilding, so this is at least a possibility.

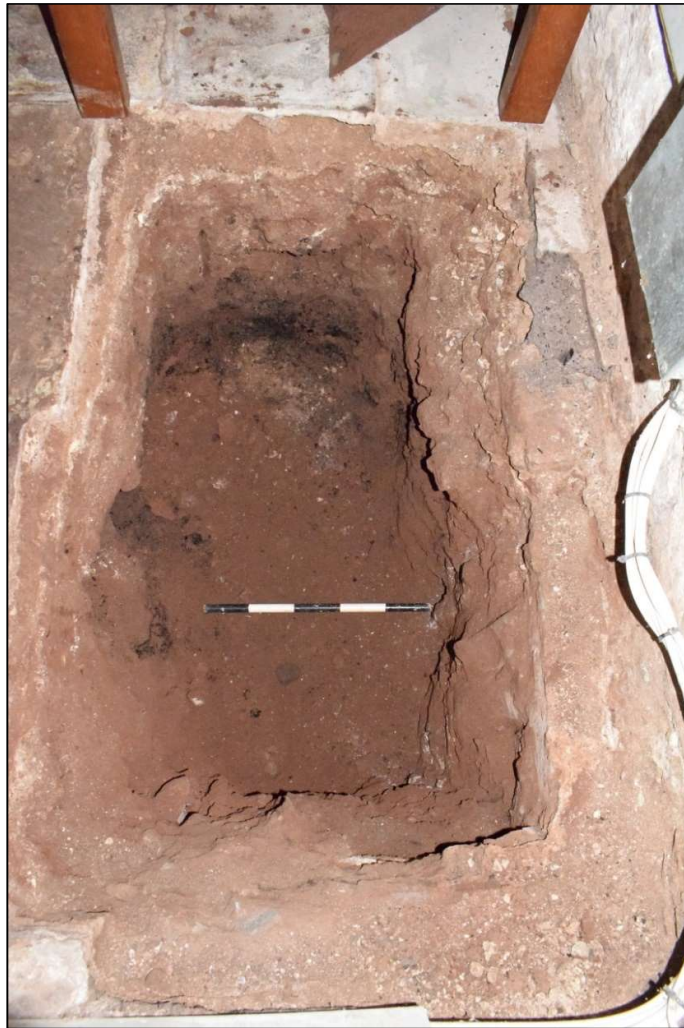
Fig. 6: Pit 10 within the tower, showing the charcoal deposit. CPAT 4725-0048

- 3.8. Pit 10 (Fig. 6), was excavated within the interior of the tower and involved the temporary removal of a number of sandstone slabs (1001) that form the floor. Amongst the underlying reddish soil, mortar and stone (1002) some disarticulated bone was identified and recovered for storage and reburial. An area of charcoal was revealed within 1002 at a depth of between 0.4m and 0.75m on the east side of the pit, which appeared to have been oak and so potentially related to timber that was once structural. Unfortunately, the charcoal deposit was powdery and could have come from a number of sources, so would be unreliable in dating. This may be further corroboration for phasing of the tower structure by providing evidence of a fire which could have led to an episode of rebuilding. Morgan's work on the history of the

church suggests that the two phases recognisable in the structure of the tower are fairly close in date, the earliest belonging to the 14th– or 15th-century and the latest to the second half of the 15th century or early years of the 16th.

- 4.2. The tower at the west end of the church was already thought to have been subjected to rebuilding at some point in the past, and the results of the watching brief have added support to that theory. Two factors were identified, firstly that there was a difference between the construction of the base and the tower itself and secondly that oak charcoal in the interior suggests there had been a fire involving structural timbers; this may have led to the need for a rebuild of the tower.

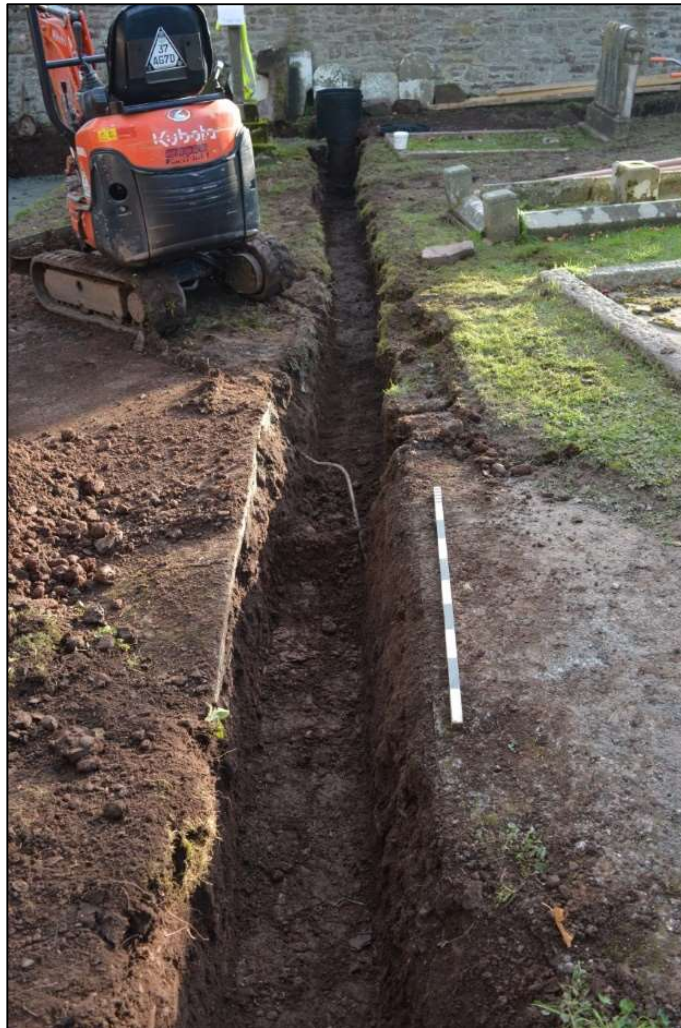
- 3.10. Within the churchyard, a small bank (1206), 0.7m wide and 0.3m high, now lying just over 0.2m below the surface was observed in the trench running south from the tower (Fig. 7). The bank was composed of a reddish clay silt (Fig. 8) and was covered by a reddish-brown clay silt (1204) which was evidently a later deposit. This may have been part of the dump of material identified during the evaluation phase of work, which has been thought to potentially represent a phase of construction or rebuilding at the church. If so, this suggests the bank predates the 19th century, but its function remains unknown.

Fig. 7: The trench running south from the tower, from the north. CPAT 4725-0036

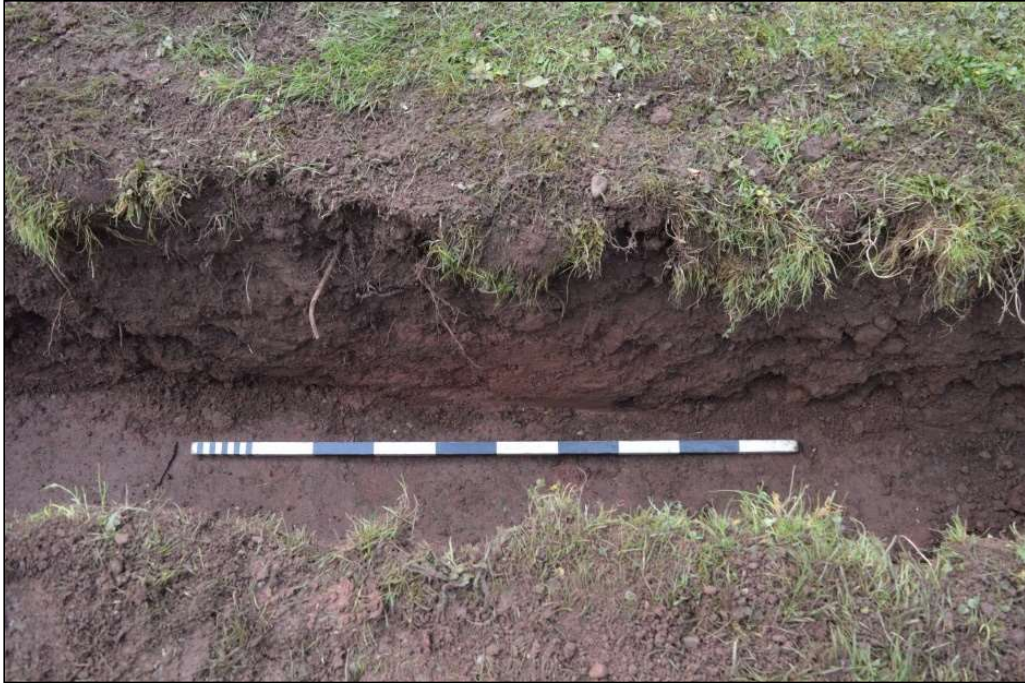
Fig. 8: The small bank (1106) in the trench running south from the tower, visible in section from the west. 4725-0032

- 4.3. On the south side of the church, a small bank with an east/west alignment was seen in one of the trenches, which had been covered up by material thought to relate to levelling of the churchyard during a phase of rebuilding at the church. The date of this feature and its purpose could not be estimated owing to the very limited exposure that was seen, but it seems likely that it predates the 19th century.

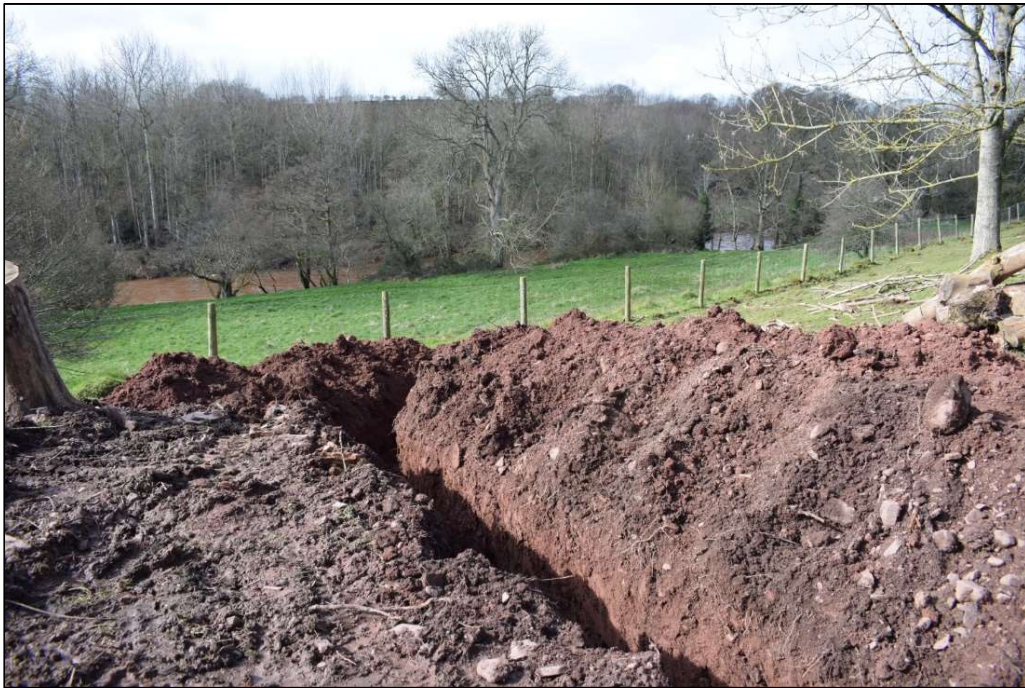
Fig. 9: The trench excavation for the soakaway, from the north-east. CPAT 4725-0053

- 3.11. No features of archaeological interest were seen in the locations of the septic tank and the soakaway, which both lay in the field outside the churchyard boundary to the south-west.
