CPAT Report No. 1869

# Proposed Development at Rydal Penrhos, Colwyn Bay, Conwy

Desk Based Assessment and Landscape Survey

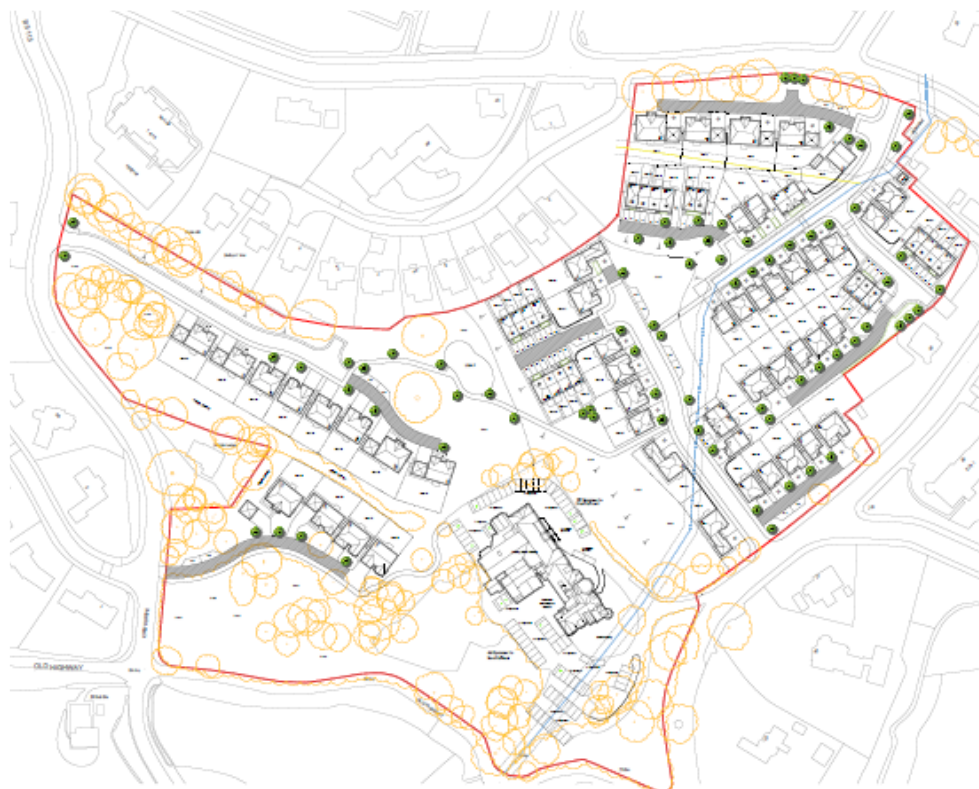
*Fig. 2 Proposed housing development*

- 1.2. The parkland around Rydal Penrhos is currently being considered for residential redevelopment with new housing laid out to create space around the main building so as to retain its landscape setting. The listed building of the former Pwllcrochan House will be

repurposed into 32 apartments, with demolition of some of the architecturally and historically unimportant additions which currently detract from the special interest of the building.

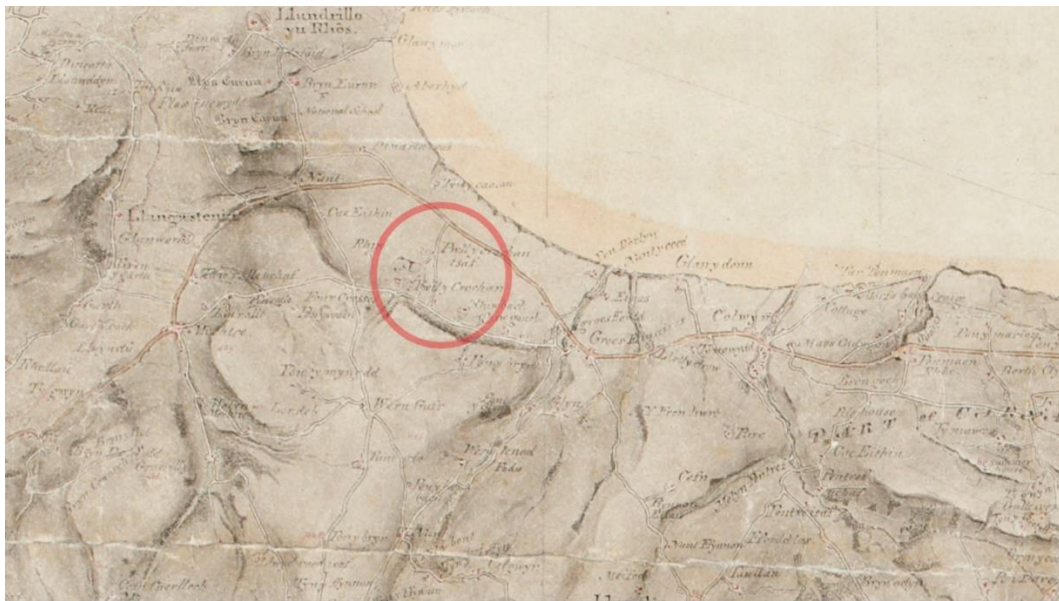
*Fig. 3 Extract from 1819 Ordnance Survey Drawings: Bryn Asaph (OSD 309) (site circled in red)*

- 5.25. The earliest cartographic reference to Pwllcrochen is on an 1819 survey map of Bryn Asaph (Figure 3). The map depicts Pwllcrochen hall with Pwllcrochen Isaf farm to the north. The map is low in detail, with no architectural or landscape features depicted. The map does show the roadway leading from Pwllcrochen Isaf running directly to the hall.

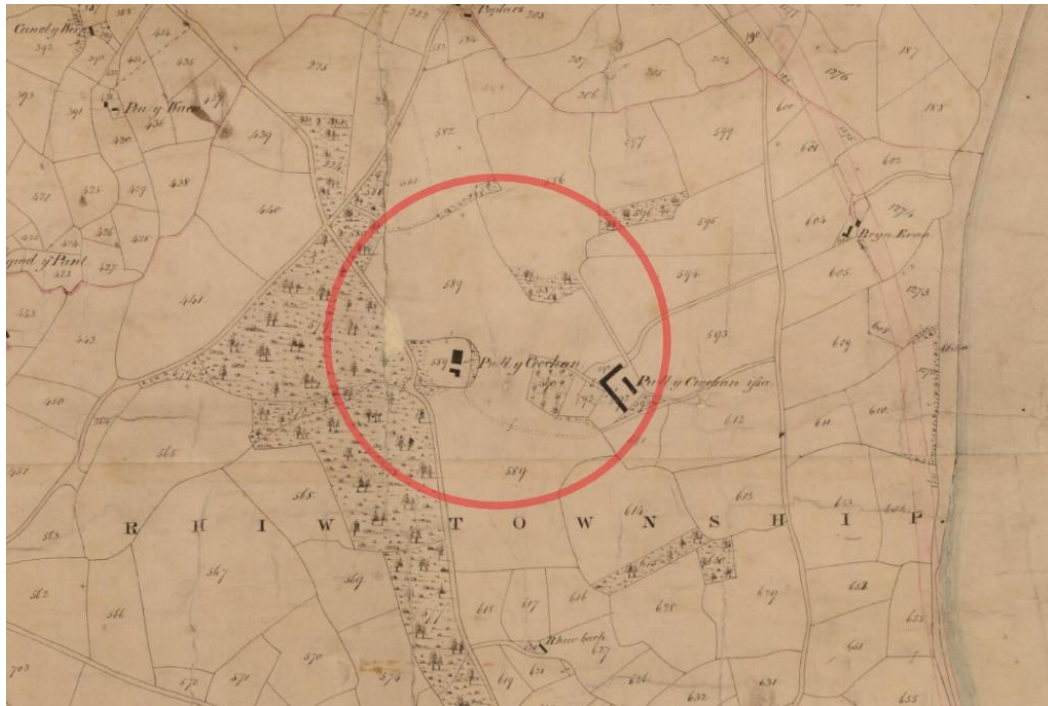
Fig. 4 Extract from 1847 tithe map (site circled in red)

- 5.26. The tithe map of 1847 (Figure 4) depicts the estate with the main house comprised of two detached structures with a curving footpath leading towards Pwllcrochen Isaf. Between the main house and the farm is an enclosed ornamental garden listed in the apportionment as an orchard. At this time, the apportionment records that the estate is owned and occupied by Lady Erskin and encompasses the house, plantations, and woodlands as well as a substantial area of arable and pastoral farmland. The estate farm, Pwllcrochen Isaf and surrounding fields are recorded as being occupied by Mr Moses Roberts.

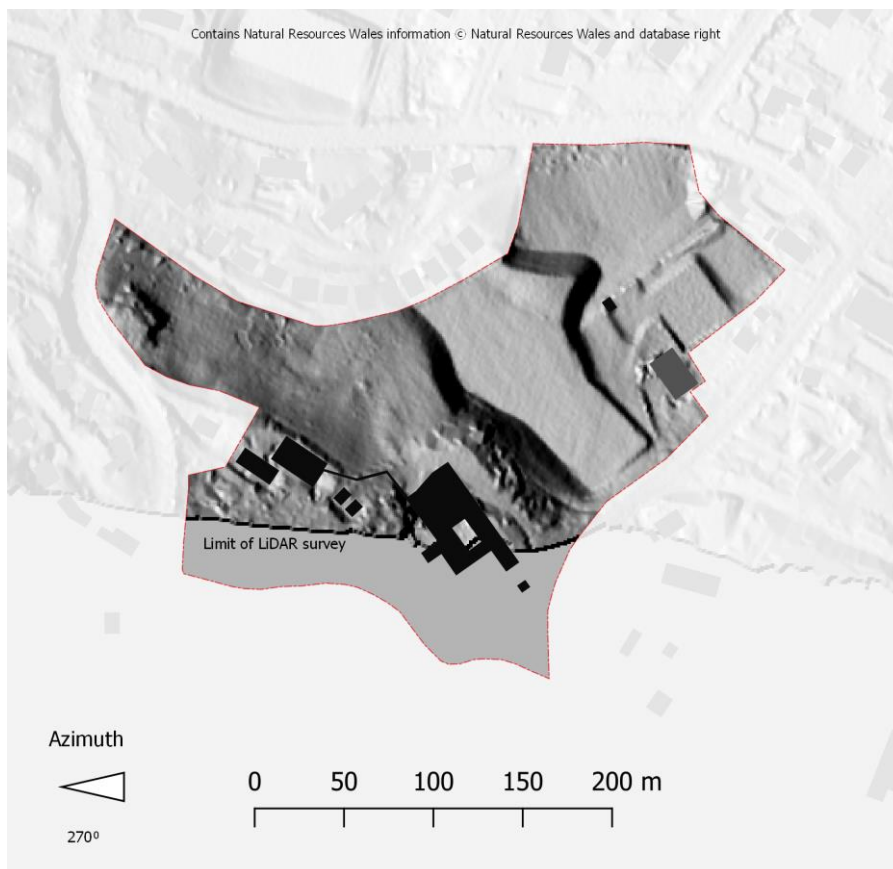
*Fig. 7 LiDAR model of development area.*

- 5.30. Analysis of a digital terrain model produced from LiDAR data identified possible cultivation features on the northern grassed area as well as faint linear features likely associated with footpaths and/or drains within the sloping fields to the west of the main house. At the western edge of the development area, the LiDAR shows a two-tiered mound which was subsequently investigated during the landscape survey in Section 9. The extent of landscaping associated with the playing fields to the north of the main building were clearly highlighted in the data, consequently an area of 1.16 hectares has been heavily disturbed (Figure. 7).

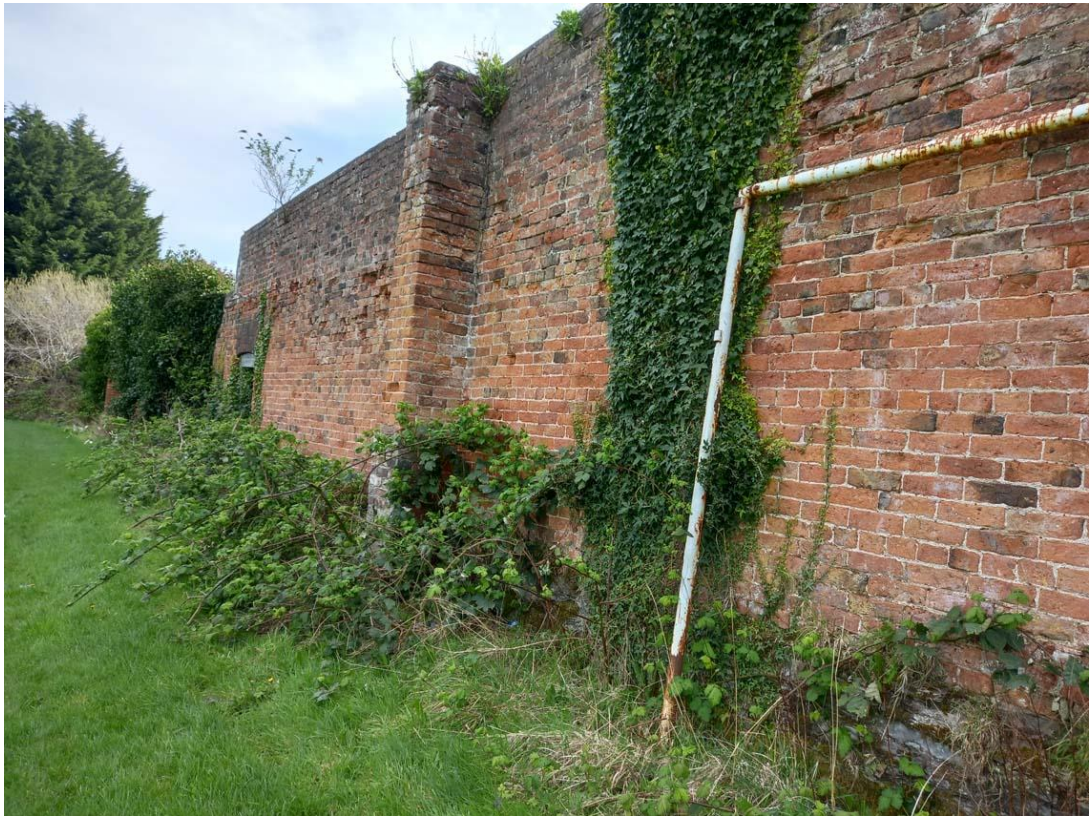
*Fig. 9 Northwest facing elevation of walled garden. CPAT Photo 4985-005*

- 7.2. Surviving structures of the walled garden include the entire length of its northern and eastern walls, and a part of the south wall. A building at the north-western corner referred to as a pump house in the Heritage Statement, is shown on the 1879 OS map, with a possible reference also shown on the Tithe map.

- 7.3. Including the pump house, the north wall measures c.84m x c.3m high at the east end, and almost 4m high at the west end (photo 4985-004). Foundations comprise 4 -5 courses of shale-like stone visible above ground level, constructed from individual slabs up to 0.55 x 0.1m in dimensions. Above this the construction appears to be a single phase with poorly fired, unfrogged bricks 91/4" x 23/4" x 41/4" (23 x 7 x 11cm) of probable Georgian date (photos 4985-005, 007 and 009). Six brick-built buttresses on stone foundations are distributed 10m apart along the exterior face of the wall, 0.45m wide and 0.56m deep; these appear contemporary with the main structure. A doorway has been inserted along the wall between the 2nd and 3rd buttresses from the western end (the brickwork of the arched lintel is different from the wall). The opening is 1.9m high and 1.2m wide filled with a timber door and frame (jambs are 0.15m each side with a door 0.9m wide). The frame and lintel are joined as a pegged construction (photo 4985-006). The wall is 10 courses higher over the doorway from this point until it meets the pump house at the western end. Further east of the doorway a zone along the wall shows where buildings were positioned against its north-facing exterior (the wall had been white-washed and some metal fastenings remained fixed into the wall photo 4985-008). This range of buildings is not shown on the 1879 OS map but is depicted on maps from 1888 – 1954 (Figure 8). Photo 4985-031 (Figure 9) shows a long extent of the wall from the pump house to the location of the range of demolished buildings, with the doorway and higher section of wall above it.

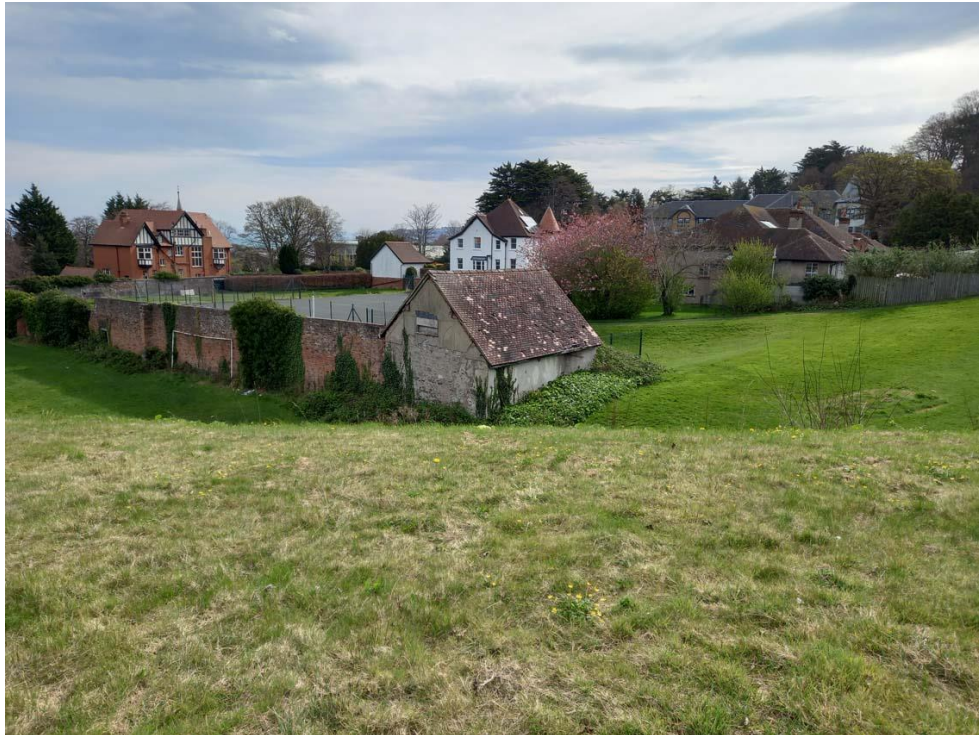
- 7.7. At the north-western corner of the walled garden a stone-built structure faces into the interior (Figure 10). It measures c.6m x 4m and has a red-tiled pitched roof as well as mock half-timber-frame painted on to the upper storey (photo 4585-002). The south face has a small doorway with a window either side and a window above. The east face has a larger opening perhaps for access of garden machinery. This is described as the Pump House for a swimming pool that has since been infilled although the depression in the ground where the pool was located is still visible as an earthwork (photo 4585-029 and 014) (Ainsley Gommon Dec 2021 supplementary appraisal page 18). As this structure is of coursed stone it is in keeping with some of the built environment associated with the hotel and it could date to the end of the 19th century, as a building in this location is shown on the 1888 OS map.

*Fig. 10 Pumphouse adjoining walled garden. CPAT Photo 4985-012*

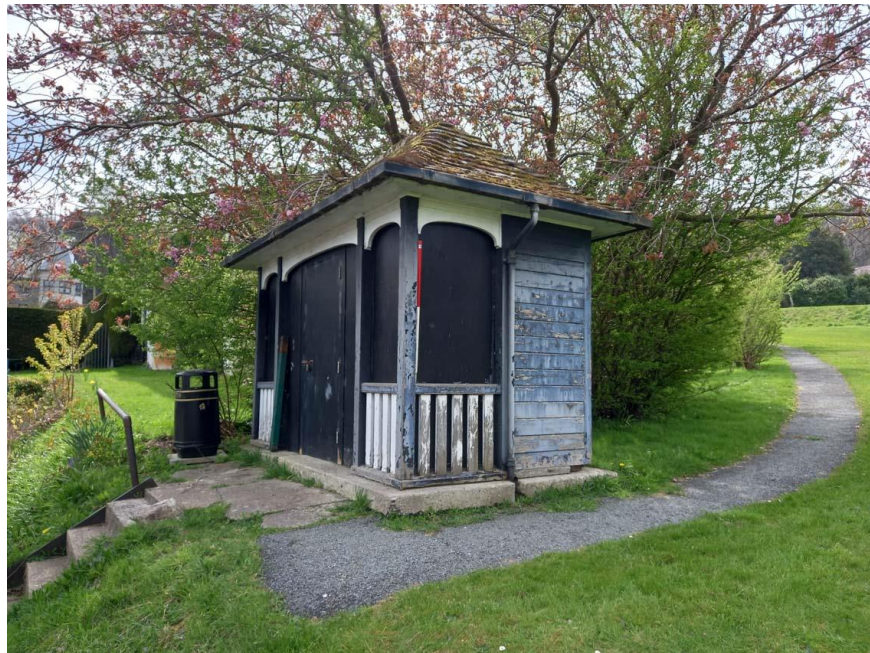
- 7.8. A small clapper-board rectangular building facing the tennis courts, 3.75 x 1.9m, and 2.2m high to the eaves from its concrete plinth, was a sports pavilion (photo 4985-030 Figure 11). It has a red-tiled hipped roof and some ornamental embellishments. It is not depicted on the 1954 OS map, so it may date to a slightly later period.

*Fig. 11 Pavilion within walled garden. CPAT Photo 4985-030*

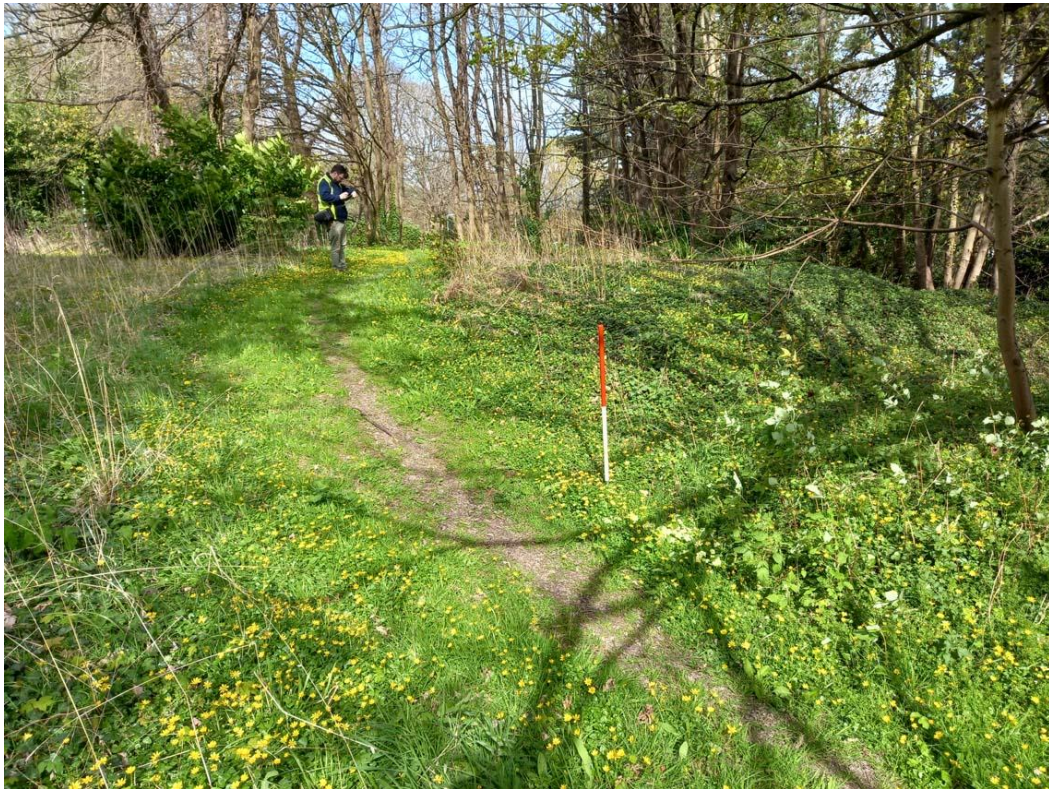
*Fig. 12 Garden mound located at the western end of the site. CPAT Photo 4985-014*

- 7.9. In the north-western corner of the proposed development site a large earth and stone mound has been constructed (Figure 12) (photos 4985-014 – 016). This is not shown on OS maps and is now overgrown with trees, but it seems likely that it is the result of dumping deliberately to make a prospect mound as part of a perambulation of the hotel pleasure grounds. It has long-distance panoramas over the former gardens and town to Colwyn Bay beyond and set within a path on one side is a concrete block that might have formed part of a stepped route.

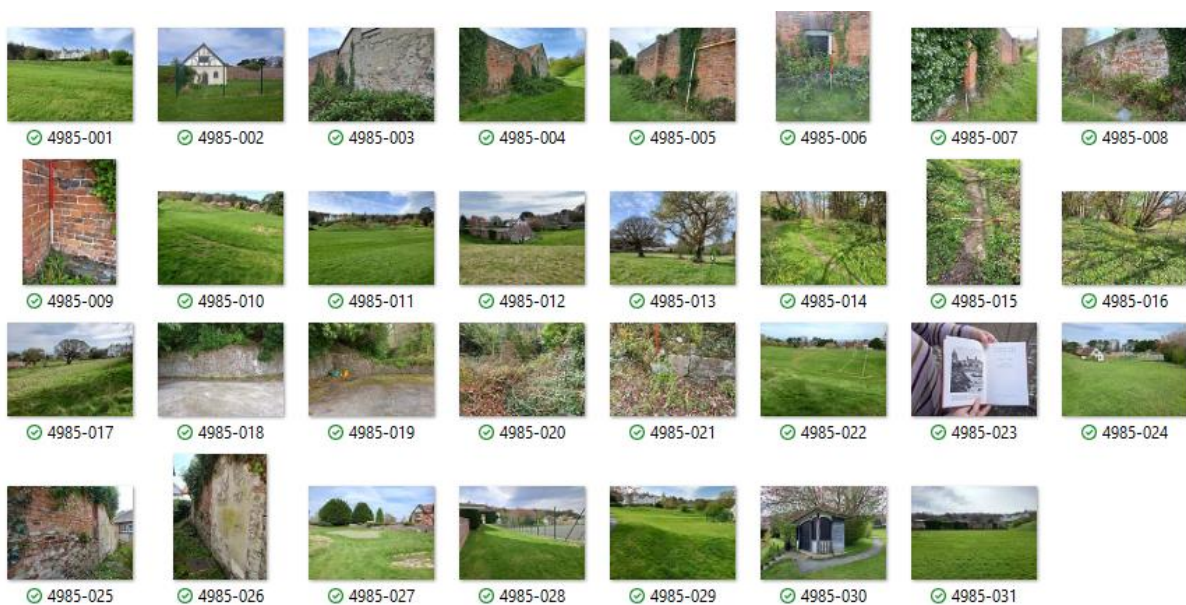
*Fig. 13 Landscape survey photo sheet.*

- 7.1. A site walkover, photographic and GPS survey was conducted over the proposed development site on 11/4/22. The weather was fine and visibility good. A total of 31 photographs were taken (Figure 13) and GPS used for mapping out earthworks (Drawing 3). Most of these were probably relatively modern features but could include some of more historic value. The built heritage was also recorded, although the main school building and previous hotel complex was not included as this was undertaken by Ainsley Gommon Architects (Heritage Statement and Appraisal February and December 2021).
