Gurnos Quarry Leat and Tramroad, Cyfarthfa, Merthyr Tydfil

Standing Building Recording, Total Station Survey and
Archaeological Watching Brief

Report No. 1328

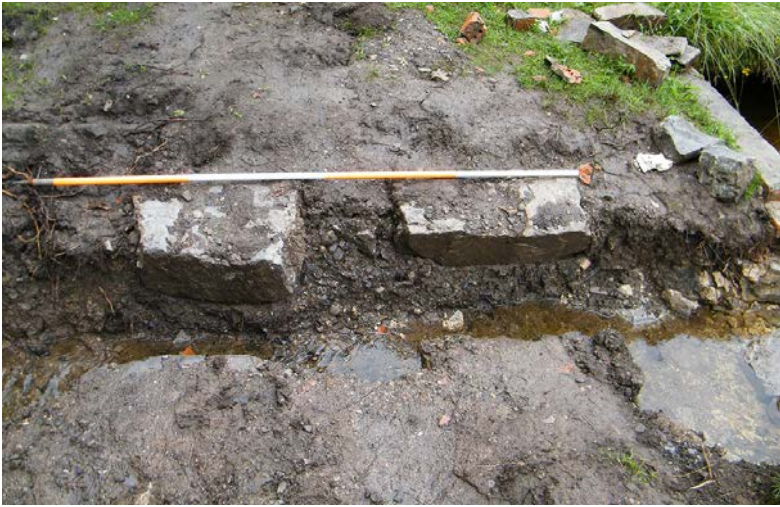
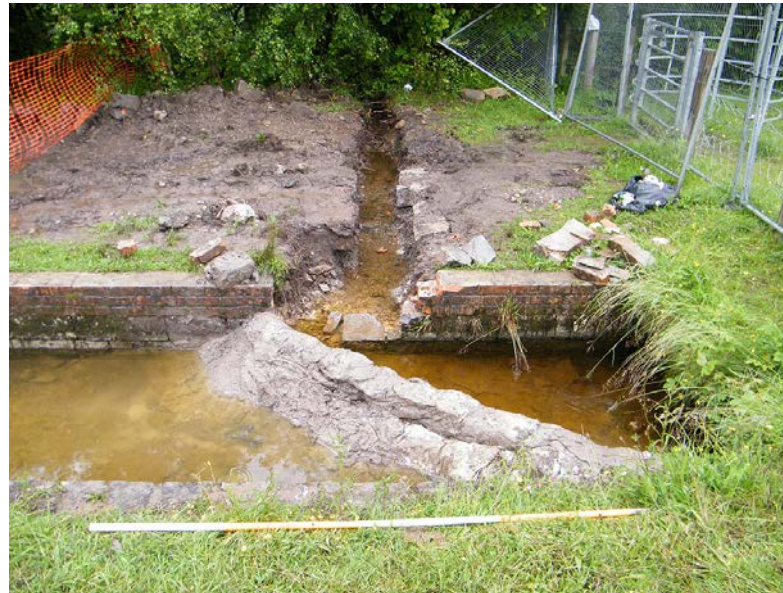
Fig. 9
Drainage channel
cut through the
tramroad at Chain 2

c. Measured section through drainage channel

Evidence for previous remedial drainage works were noted at Chain 70 where missing sleeper stones were noted and a stone-lined open channel ran across the tramroad. Another drainage feature of a recent date was noted at Chain 676 (fig. 10) where a blue plastic flexi pipe was visible on the western side of the tramroad. Another blue flexi pipe was noted running across the tramroad at Chain 225.

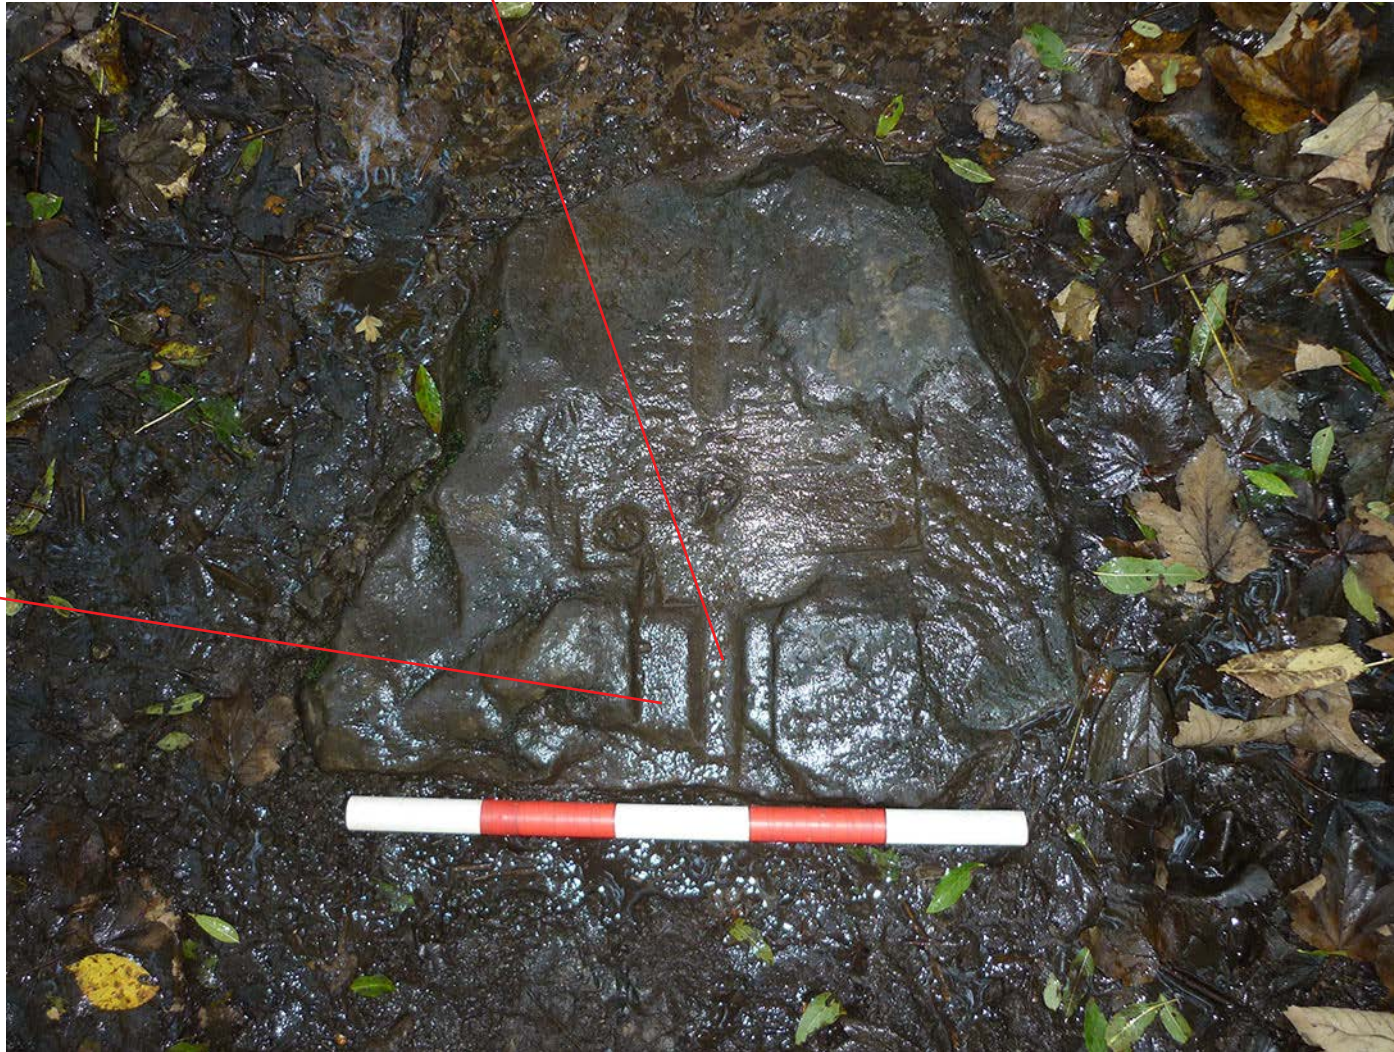
Fig. 15
Sleeper stone with
wear marks from
rail and tram wheel

Wear from tramwheel

Wear from rail

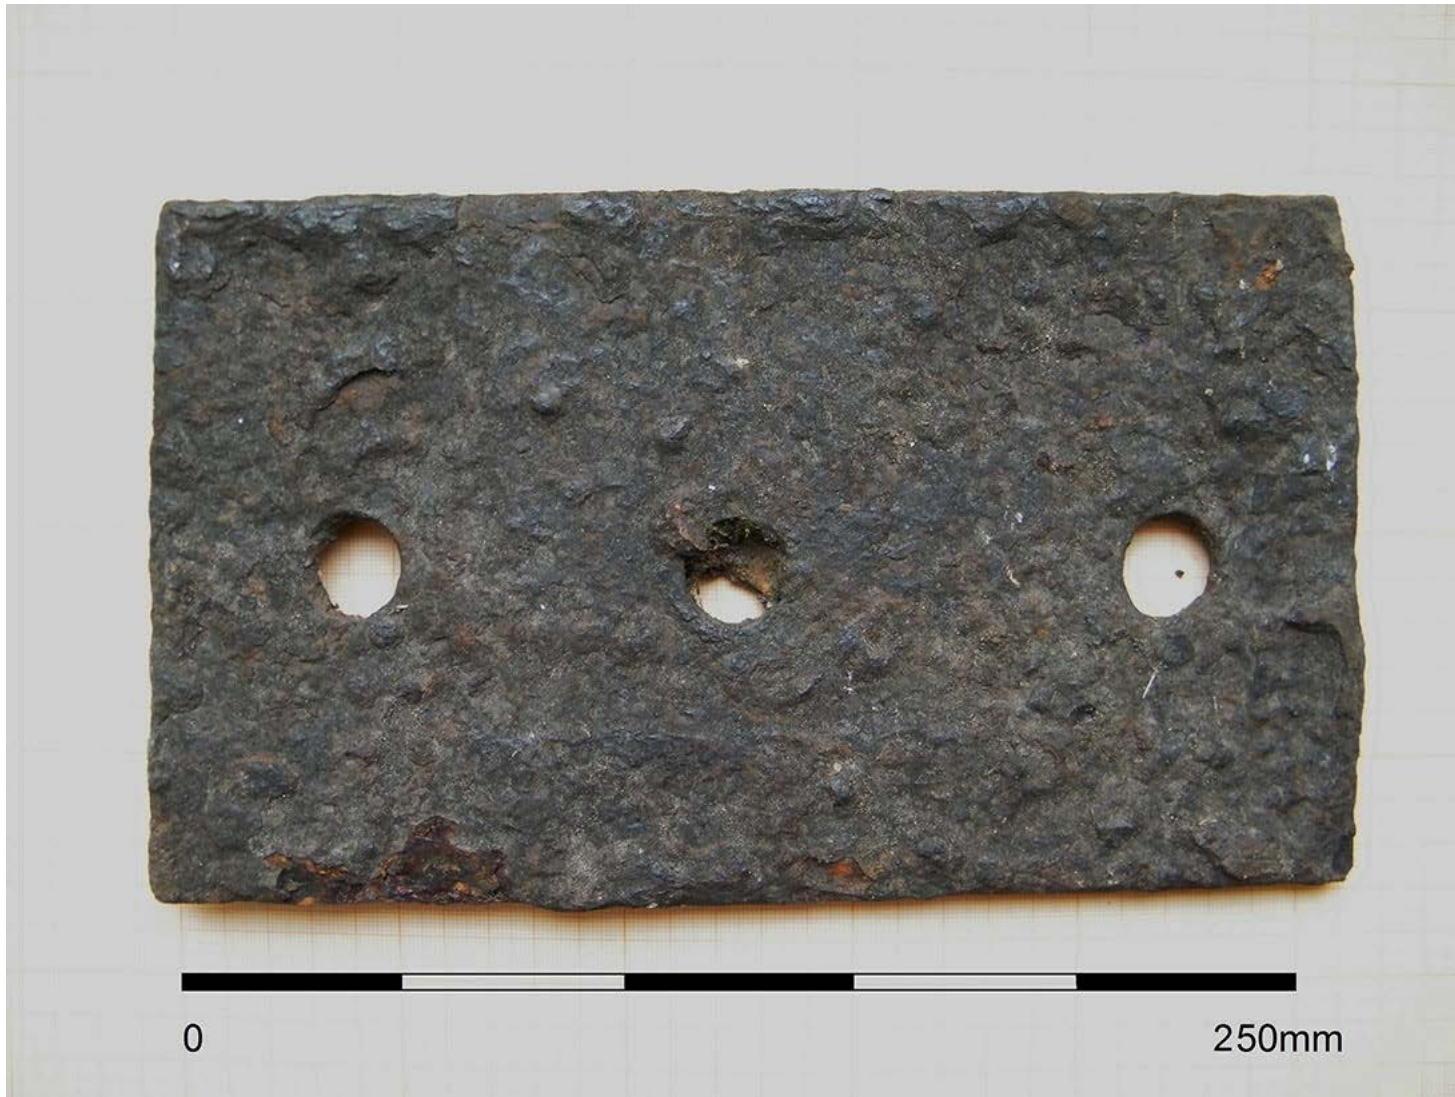
Fig. 16
Iron plate found
in situ on the
tramroad

A single in situ iron fixture was found during the survey, although the fixing spikes were not present and it was removed from site. It comprised a flat iron plate 0.26m in length, 0.15m wide and 0.06m thick. It had three equidistant holes positioned slightly off-centre along the long axis of the plate (fig. 16). The holes were of 0.022m diameter and slightly oval, probably due to wear. The function of this plate is not fully understood, although it may have been positioned between the sleeper stone and the chair.

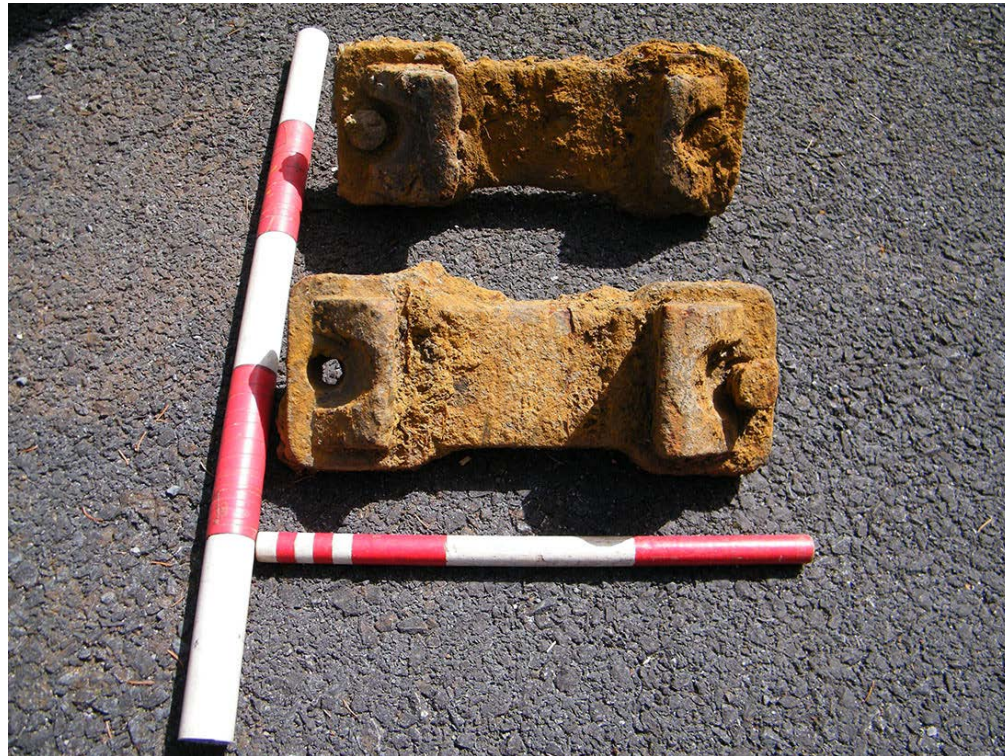
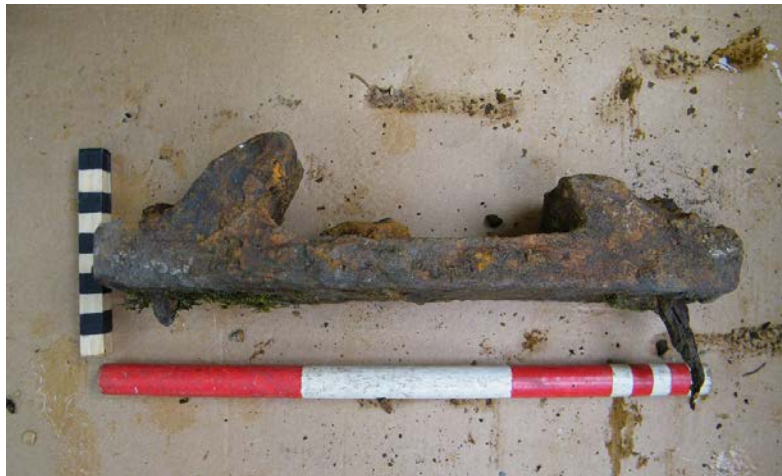
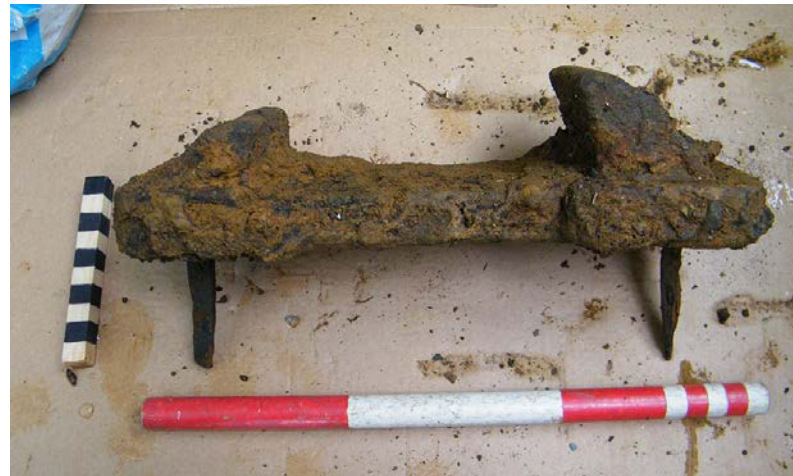
Fig. 17
Chairs found
during the watching
brief

- Type A – narrow rectangular chair with angled cheeks. The single example found measured 0.3m in length, 80mm wide and had a thickness of 20mm. The cheeks were of different heights, one being 20mm and the other 35mm in height. There were two holes in the base plate, at each end outside the cheeks, which were 20mm in diameter. The single example of a type A chair was found with both its mounting spike bolts still in situ.

a. Two type B chairs

b. A type A chair

c. A type B chair

The wear marks on the sleeper stones indicate that the type A chairs were earlier than the type B chairs. Where clear sets of multiple chair indentations survived, the wear marks from type A were overlain and/or partially removed by the wear marks from type B. Type A is represented by a single find [SF#5] and type B by two examples [SF#3 & SF#4], all recovered from the silt within the leat. Also recovered from the Leat was a cast iron rail sill [SF#6] (fig. 19). The sill

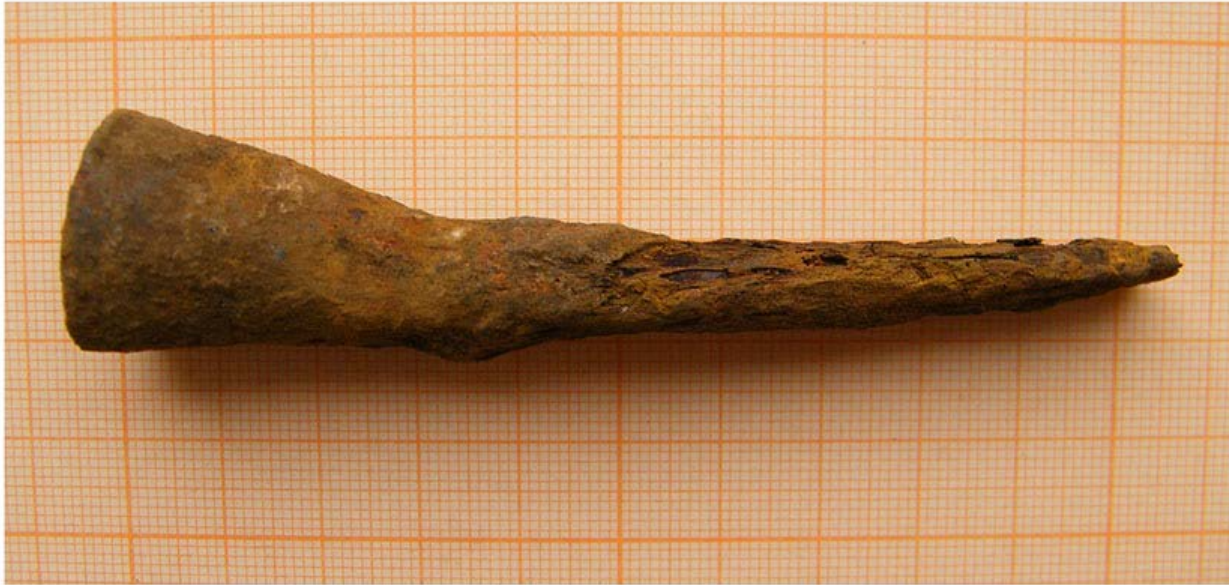
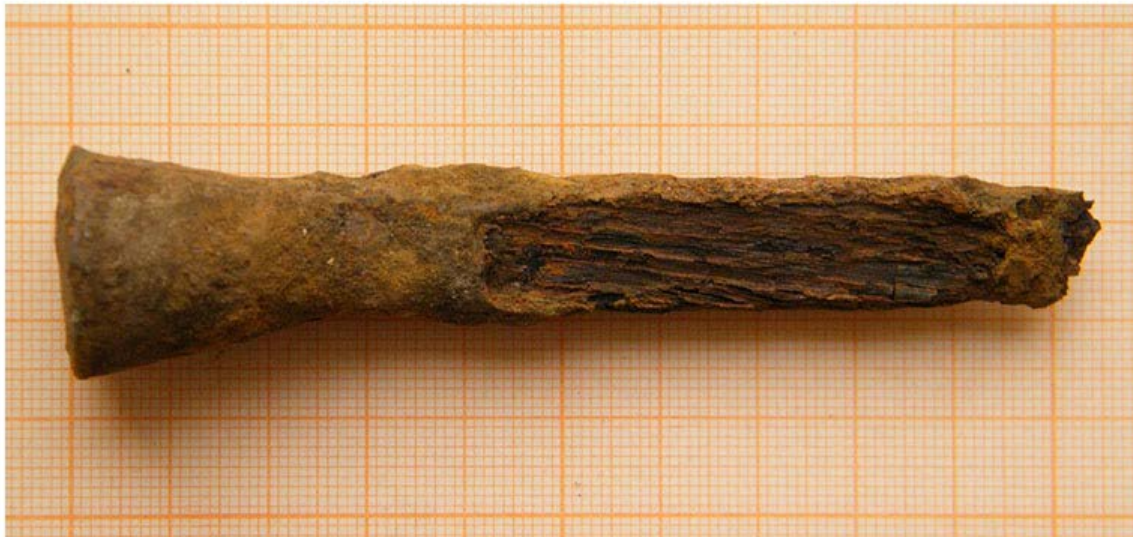
Fig. 18
A rail spike found
in situ on the
tramroad

A fixing single rail spike (SF#2) was found in situ in one of the sleeper stones. The spikes were manufactured from iron and were sub circular at the top, tapering to a flat chisel form at the tip (fig. 18). The one measured example was 0.1m in length and 25mm in diameter at the top whilst at the tip it was 12mm wide.

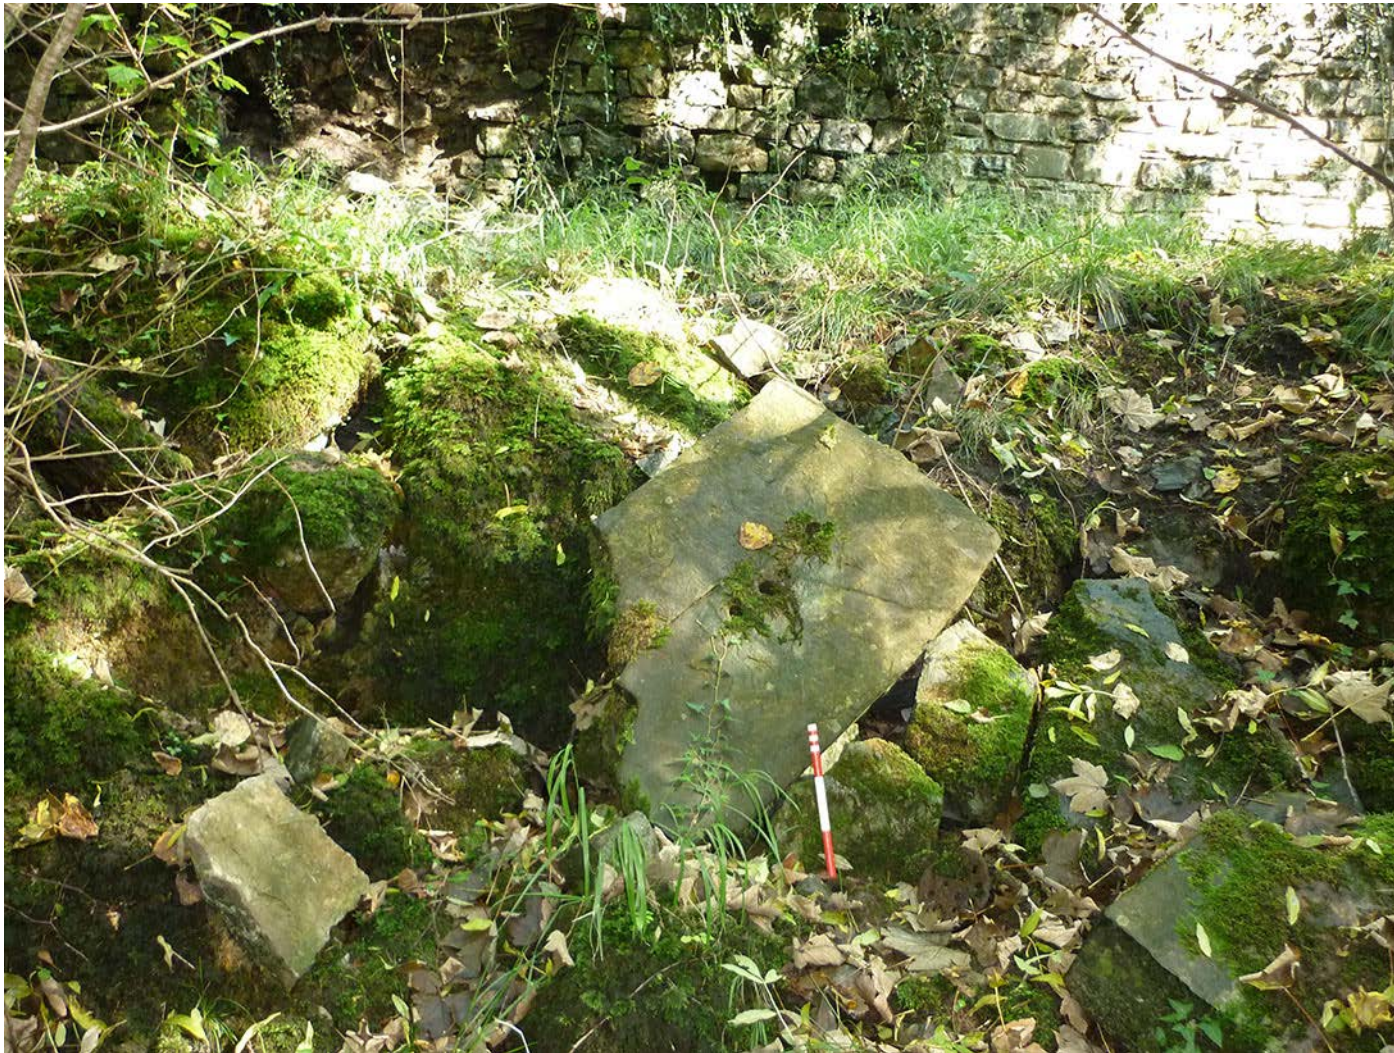
Fig. 19
Displaced sleeper
stone found slumped
into the river at
Chain 297

A number of displaced sleeper stones were noted within the river at the northern end of the site. A 4m length of concrete kerb stones was set into the surface of the Tramroad at Chain 305 and displaced sleeper stones were also noted in this location, both on the surface of the Tramroad and on the river bank a few metres to the north at chain 297 (fig. 19). Damaged sleeper stones were noted in a number of locations (Chain 140, Chain 290, Chain 525, Chain 535, Chain 730), although many were masked by overlying deposits and it is likely that more damaged sleeper stones would be found if the overlying deposits were removed.

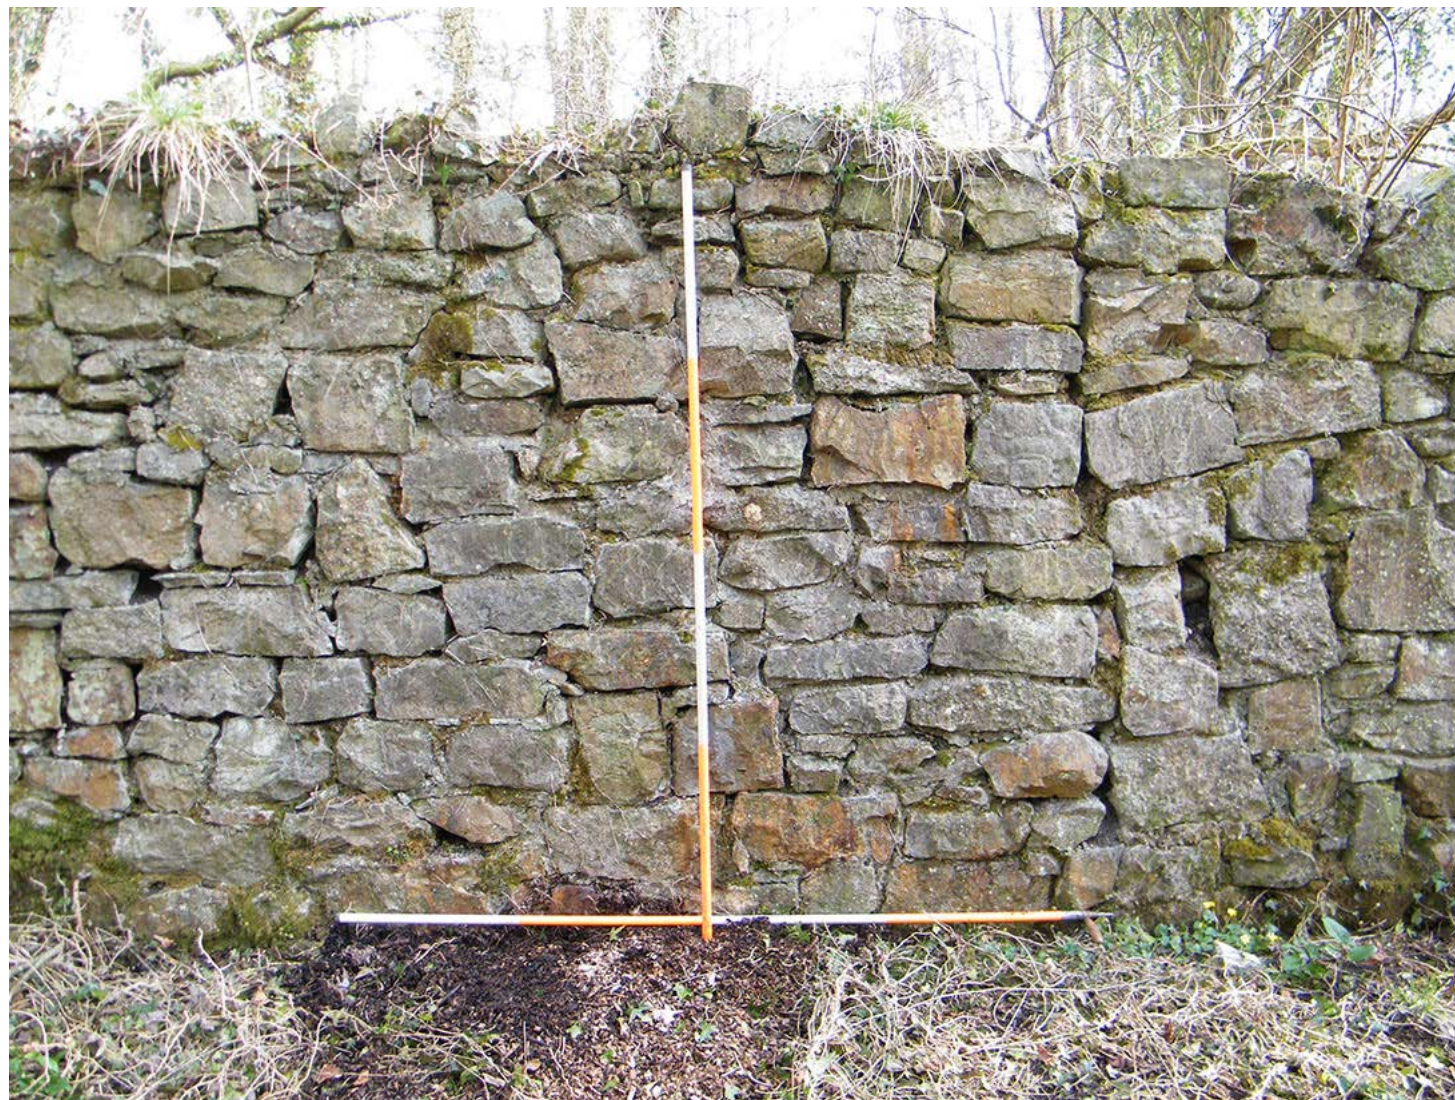
Fig. 20
The TRW at Chain
630

Projecting walls at Chain 660

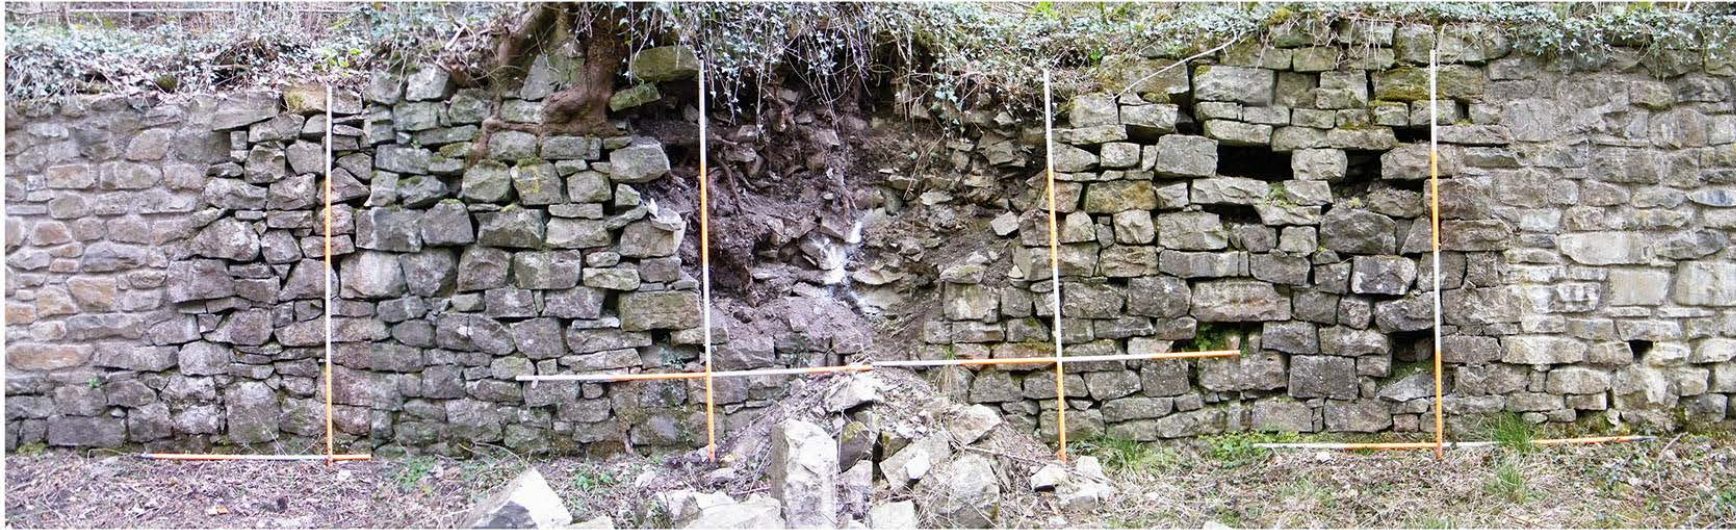
Fig. 24
A section of TRW
at Chain 500
during consolidation

The TRW was lowered for a 10m section at Chain 540, to allow machine access to the tramroad. The machines were to be used in the restoration works and this location was also adjacent to the location for the new link walkway. In the area directly below the pipe bridge a 40m long section of the TRW was taken down and rebuilt. The TRW to the north of the pipe bridge had seen considerable collapse due to water erosion caused by the leaking leat (fig. 24).

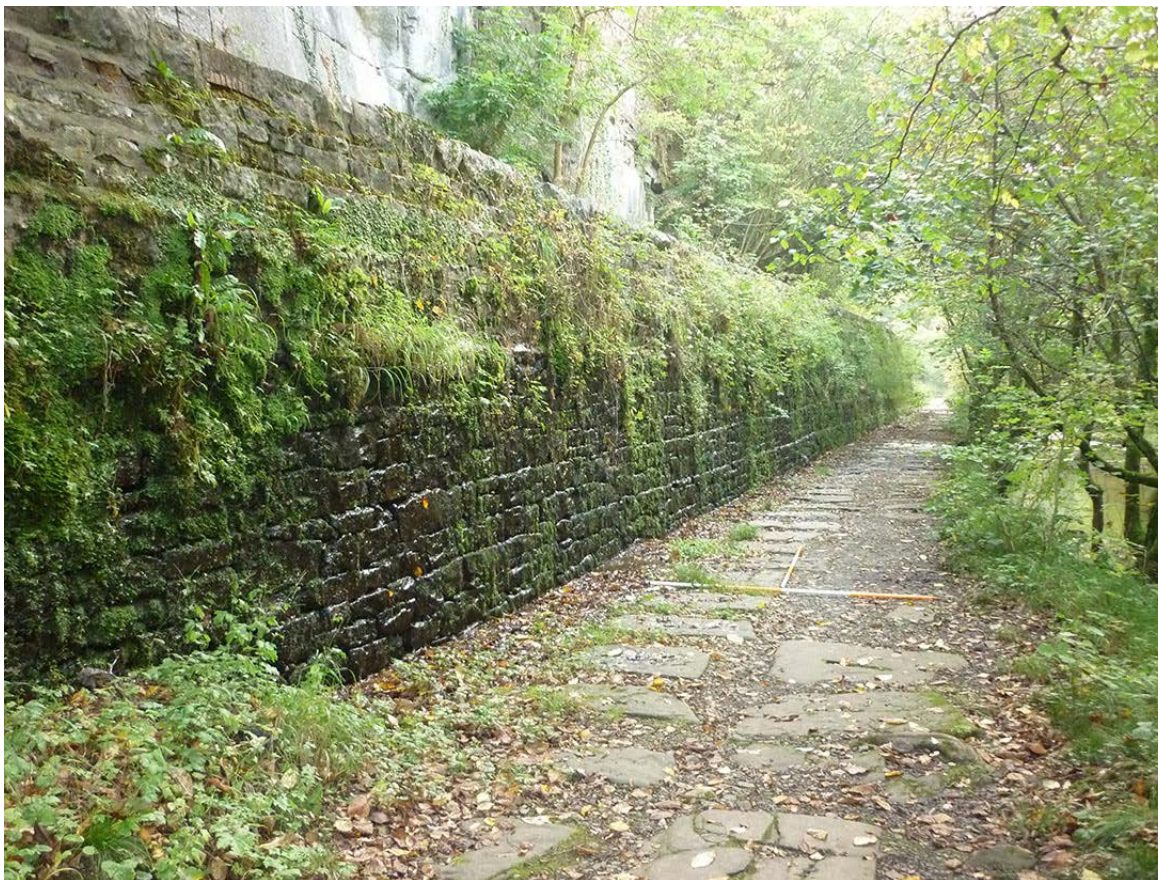
Fig. 26
View S along the
Embankment
Retaining Wall

The Embankment Retaining Wall is nearly vertical for around 2m to 4m in height and stepped above, with 4 steps joining it to the leat wall. The wall is built from random coursed rubble with an average block size of 0.3m by 0.4m, and was largely covered by mosses and lichens that were not removed during the works. Lengths of the upper, stepped, section were able to be examined from above and it was noted that there were a number of places where two courses of bricks had replaced the original stonework of the upper step. These brick courses are thought to be repairs to the original leat structure.

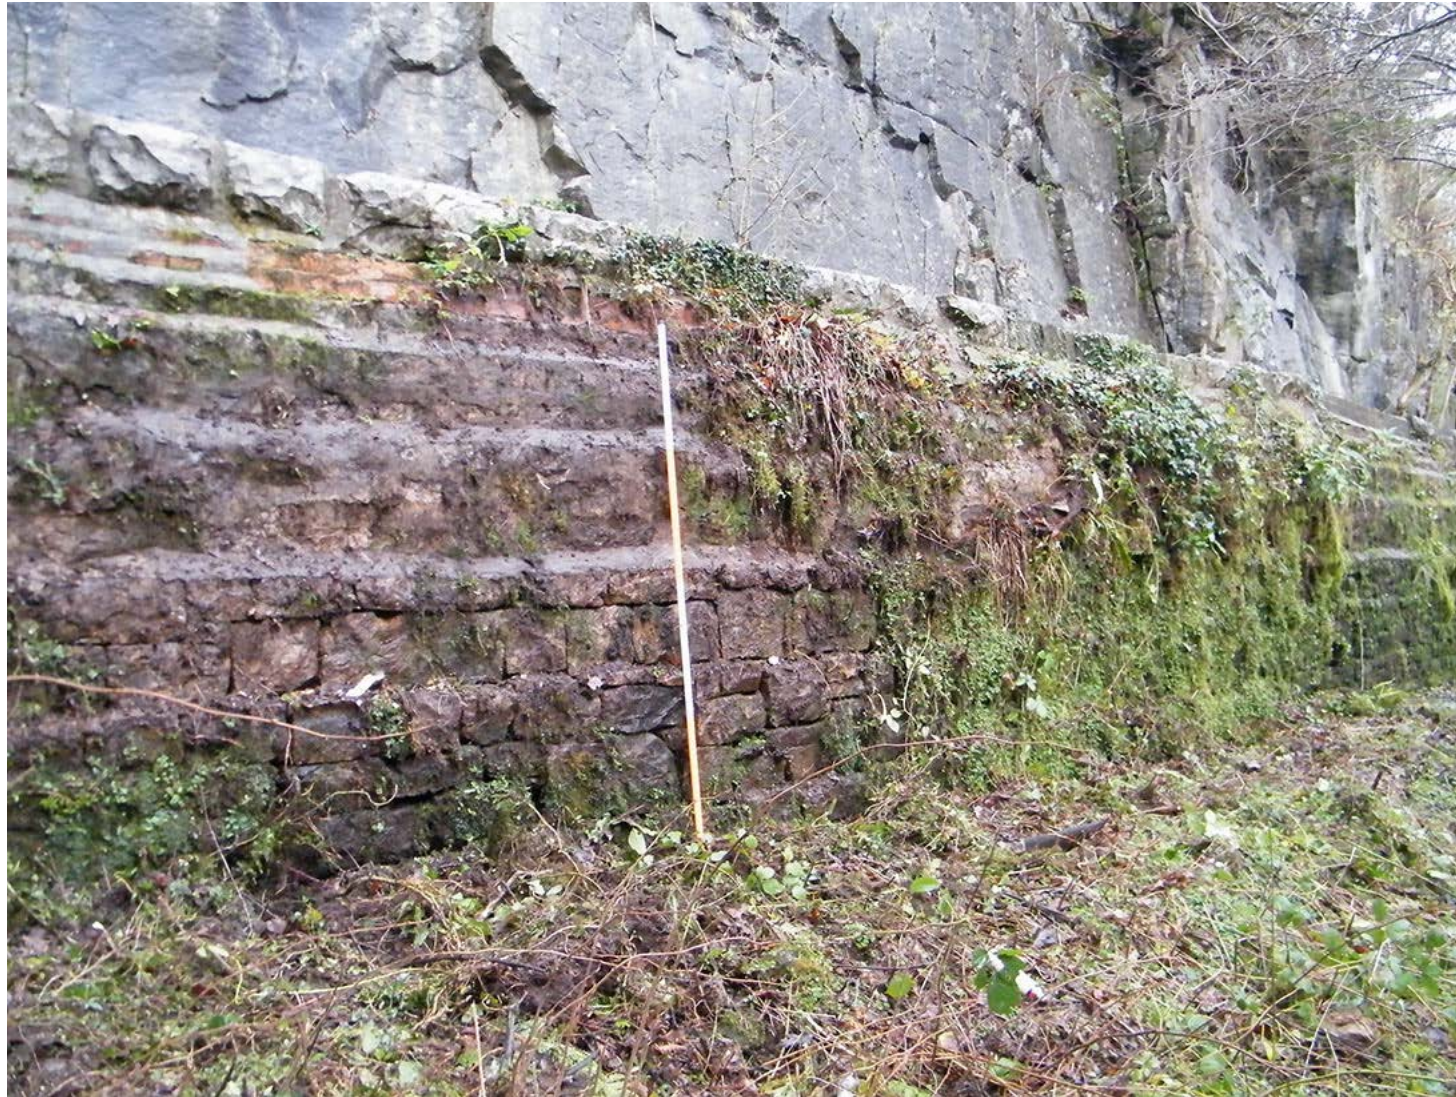
Fig. 27
Stepped wall where
the ERW meets the
leat wall

From Chain 130 northwards the vertical section of the wall disappears, as the levels of the leat and tramroad start to converge, with only the stepped masonry separating the tramroad and the leat wall (fig. 27). The steps are largely brick built, with a masonry capping, which suggests a large scale rebuild of the northern end of the leat at some point. Other sections of brickwork within the embankment wall suggest that multiple phases of rebuilding/repair were necessary over the working life of the structure.

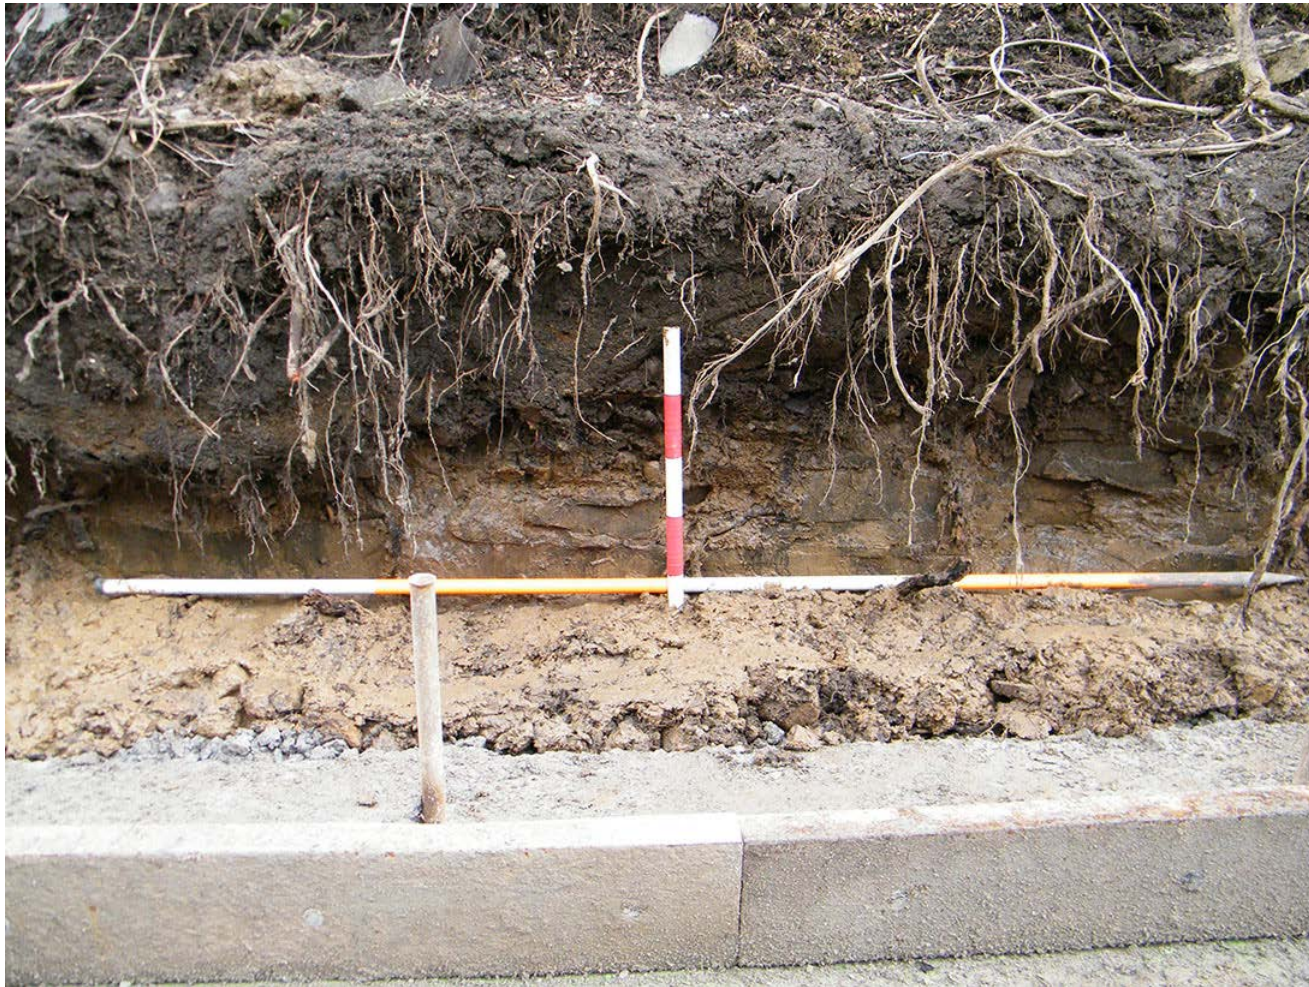
Fig. 29
Section of the
eastern leat wall at
Chain 785

In the area now occupied by the twin pipes the western side of the leat comprised a brick built wall of relatively modern date, while the original eastern wall of the leat was not visible. At Chain 785 a 2m long section of masonry was identified on the eastern side of the leat during works to repair a leaking water main (fig. 29). The masonry survived as a single course of roughly coursed rubble with blocks of 0.2 to 0.25m in height and 0.3 to 0.5m in length. It was not possible to determine whether the blocks were bonded, although this is likely. The masonry section was located 2.3m to the east of the western leat wall making the channel here wider than the rest of the leat. The 1875 map (fig. 2) shows that the leat channel does widen at the southern end, in the area where the line of the leat curves eastwards away from the route of the tramroad (between Chain 550 and Chain 770). It is unclear what function this would have served, but does account for the missing eastern wall which is likely to be buried below the eastern bank.

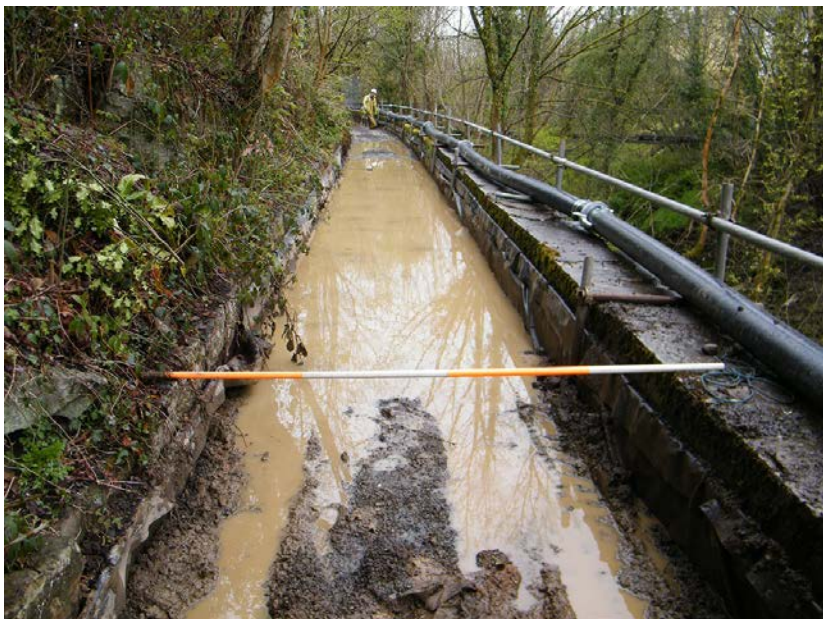
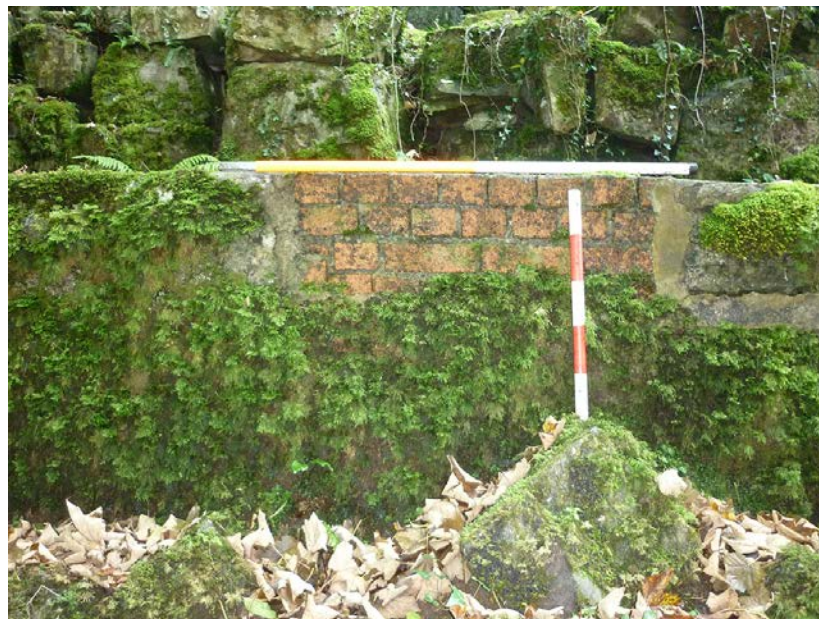
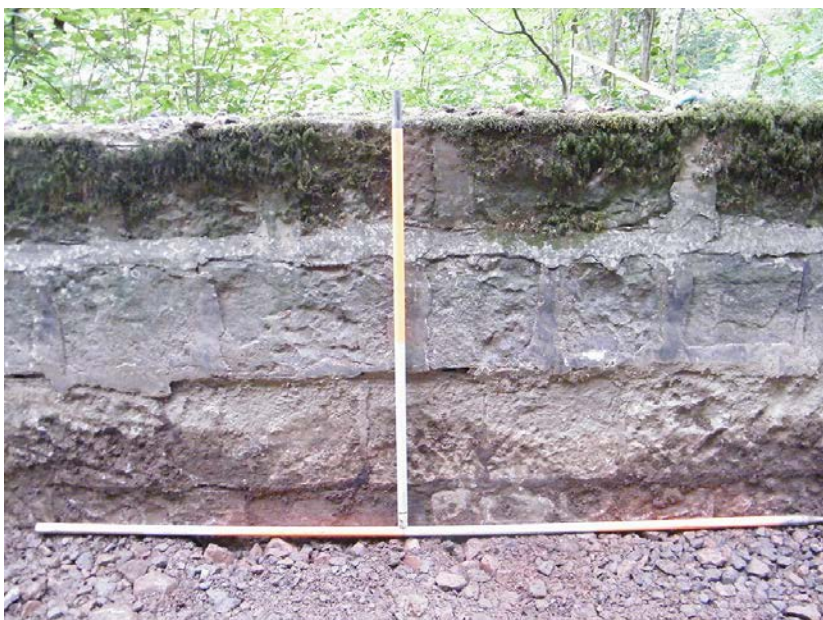
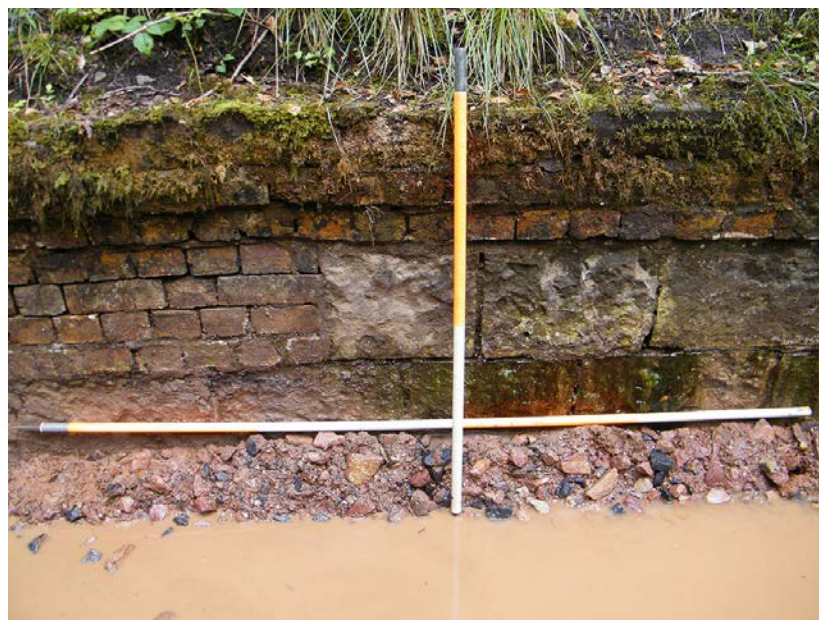
Fig. 30
Evidence of repairs
to the leat

A series of recent repairs had been undertaken to the leat (fig. 30) and these, along with earlier repairs/modifications, were visible in the masonry. The recent repairs included the laying of a waterproof liner in some areas of the leat, undertaken in 2008 by Merthyr Tydfil County Borough Council. The butyl liner was attached to the inside face of the leat walls by wooden batons, and were clearly visible from Chain 490 to Chain 330. Other repairs were undertaken by the Council in the summer of 2001 when at chain 400 a 24m long section was rebuilt following a collapse in March 2000. A number of other sections of repair were noted on the western leat wall, sections where brickwork had been added to the upper course of the leat walls and also sections where brick appeared to have been used to replace the masonry:

- A 16m long section of brickwork was noted 11m to the north of Overflow 1,
- A 3m long section of brickwork on top of the masonry was noted at Chain 160,
- A 14m long section of brickwork made up the western leat wall at Chain 150,
- A small brickwork patch was noted at chain 228,
- A 3.3m long stretch of brickwork was noted at Chain 130,
- A small brickwork patch was noted at Chain 110,
- An 8m long stretch of brickwork was noted at Chain 8,
- A short section of aero bricks were noted at Chain 394. These were cemented to the inner face of the western leat wall next to a section of the Butyl liner,
- Bricks were set into the top of the leat to replace a missing masonry block at Chain 340,

- A 1.5m long stretch of bricks was noted at Chain 294,
- A 1.2m long stretch of bricks was noted at Chain 276,
- A small patch of bricks was noted at Chain 91,

All of the damaged sections on both eastern and western leat walls were repaired during the restoration works.

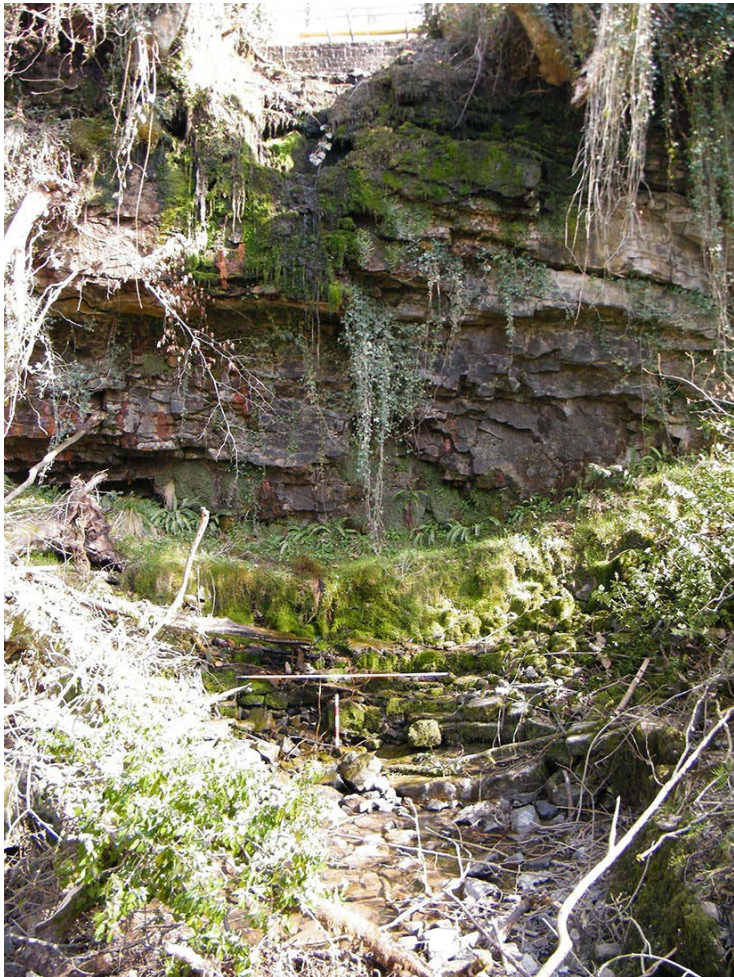
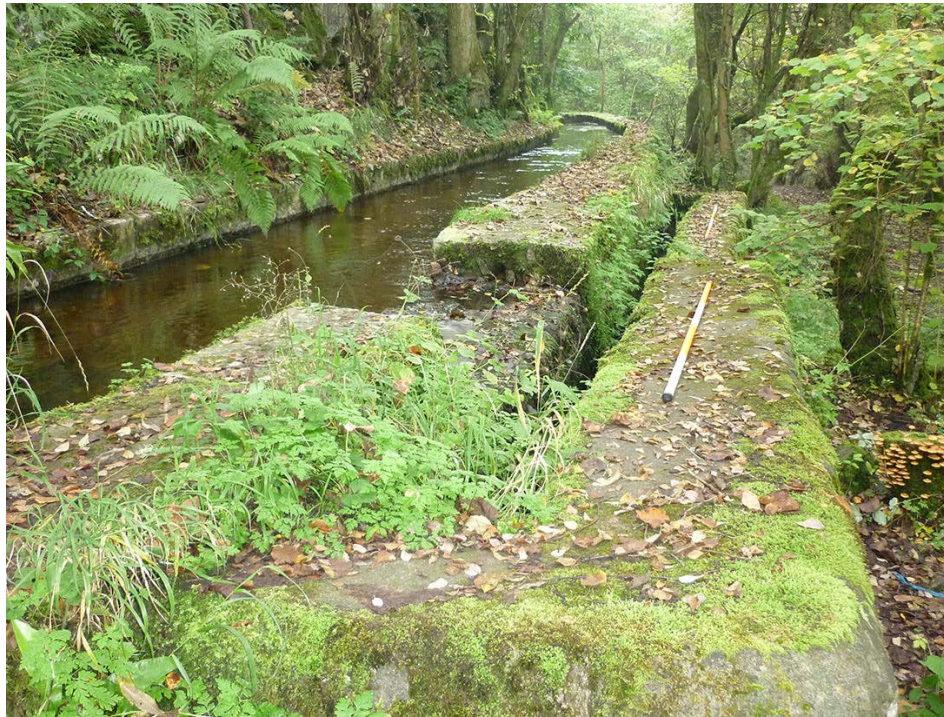
Fig. 31
The overflows on
the leat

b. Overflow No. 2

a. Overflow No. 1

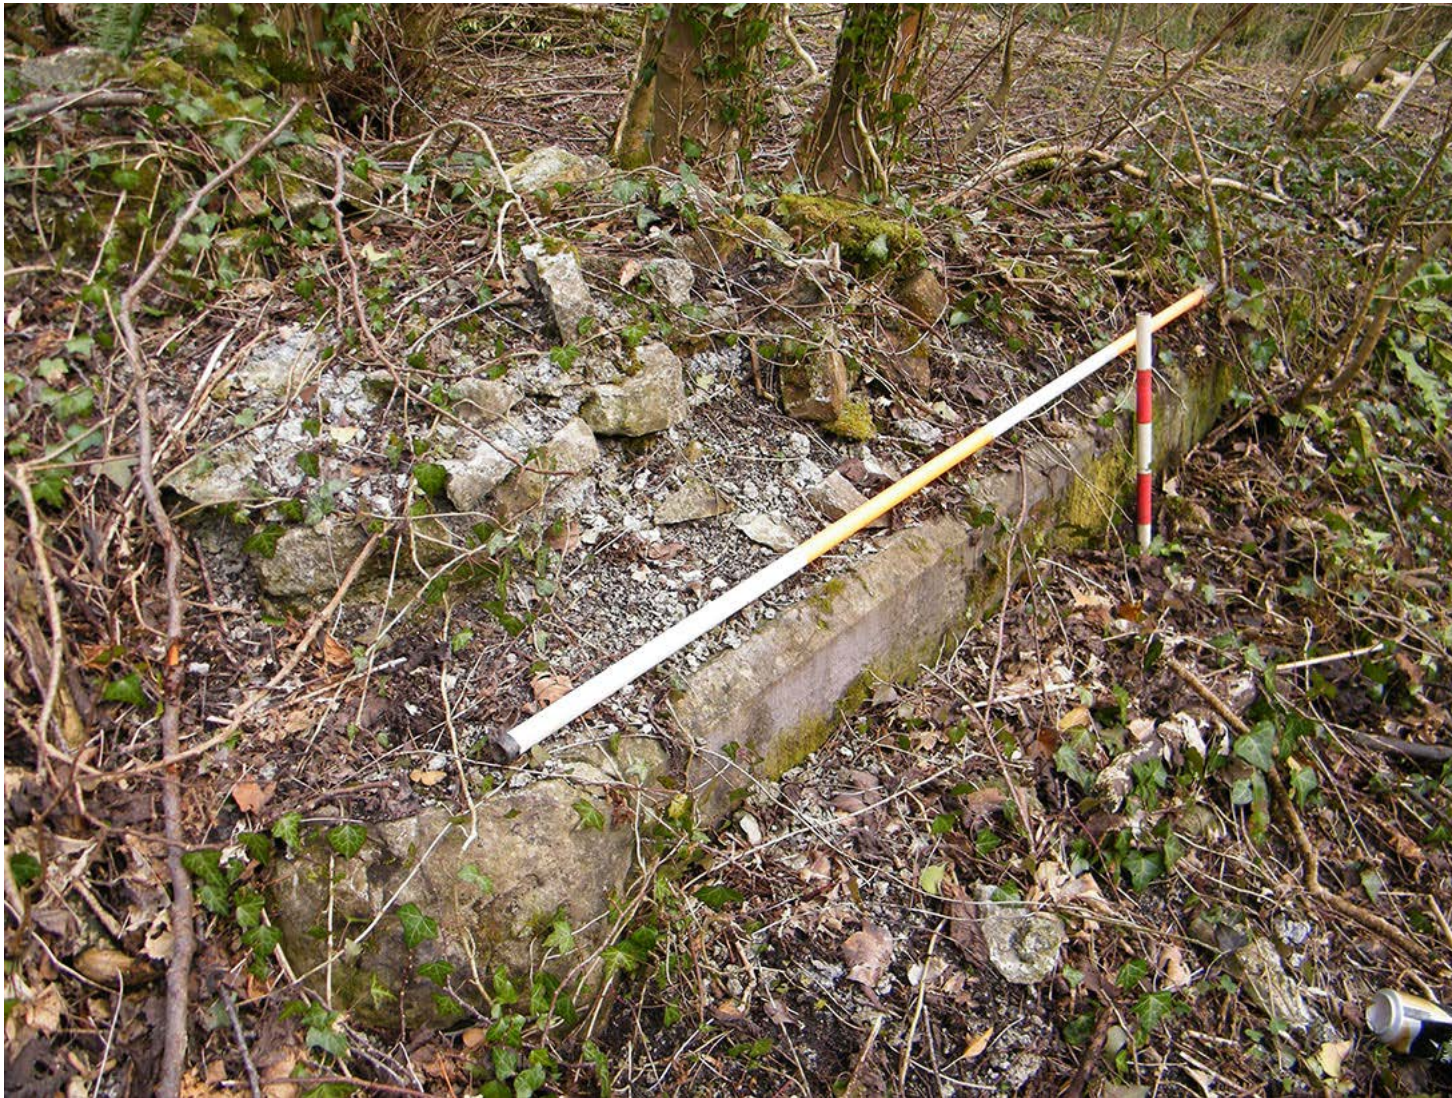
Fig. 32
The structure
identified in the
area of the new
link walkway

The excavations for the construction of the ramp for the new link walkway involved the removal of the topsoil deposits in a section that ran diagonally north-westwards from the western side of the leat at Chain 600 to join the Tramroad adjacent to the pipe bridge at Chain 500. This area contained large quantities of dumped material, including bricks thought to have been brought to site during one of the phases of repair to the leat walls, and household rubbish. On the slope to the west of the ramp a section was excavated to allow for the placement of a number of Gabion baskets. This involved minor terracing of the bank and exposed a deposit of stone aggregate probably associated with the construction of the pipe bridge in 1970.
