St David's Church, Rhymney

Archaeological Watching Brief

Report No. 1043

Date: **January 2012**

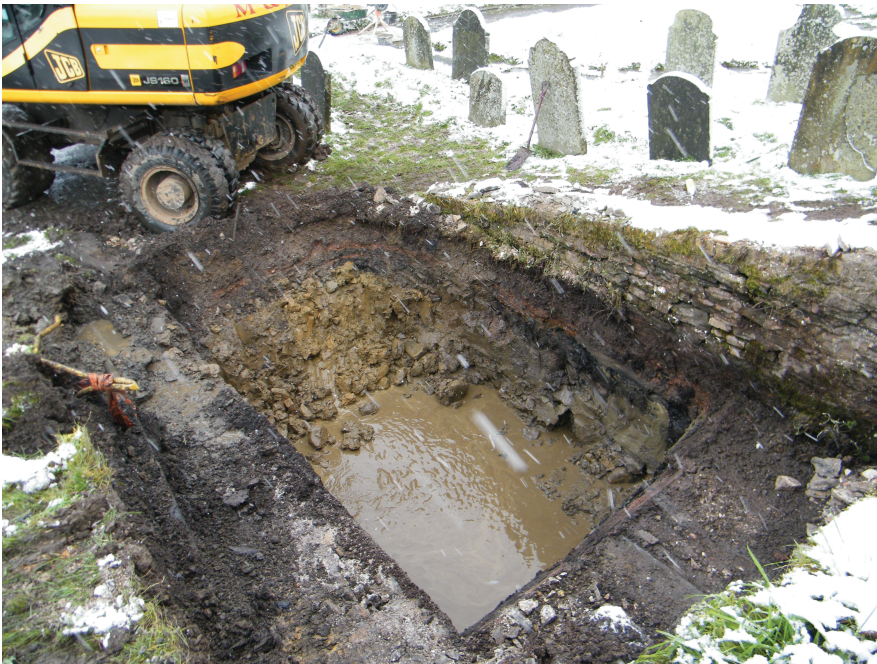
Fig. 4
Views across the
trench

Underlying the topsoil across the entire trench was a thin layer of redeposited red and black clay. This was up to 0.25m thick and appears to have been laid down as a levelling deposit, possibly during the construction of the basement access (fig. 3 and 4).

View across cess pit trench - looking west

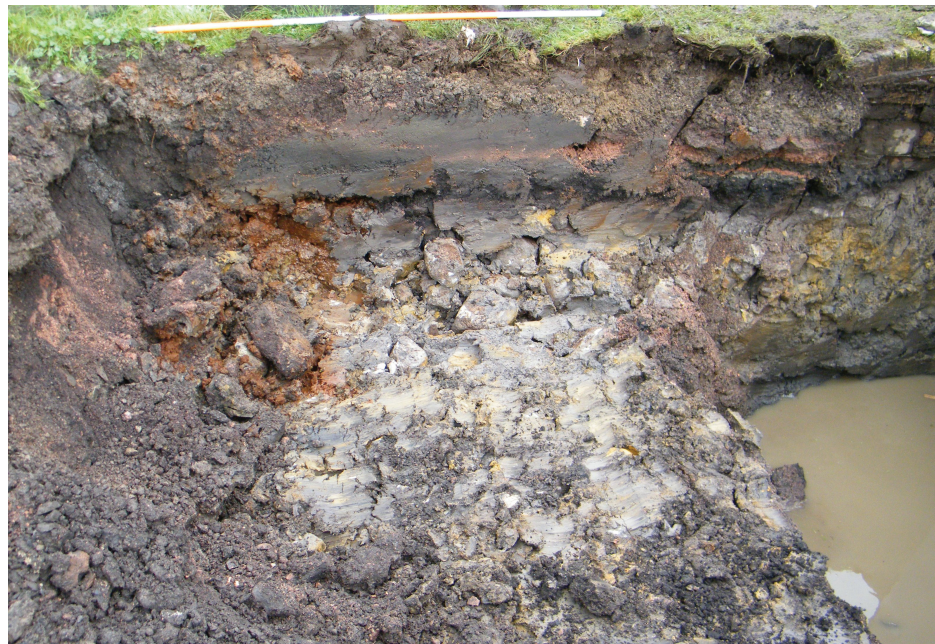
Below the red and black clay layer was the yellow clay and shattered sandstone natural (fig. 3 and 4). A large drain or sewerage pipe was identified in the base of the trench, lying within the natural clay (fig. 3).

South-facing section at the western end of the trench
