Castle Cinema Merthyr Tydfil

Archaeological Watching Brief

By
Adrian Hadley
&
Chris E Smith
Report No. 1134

Date: **June 2013**

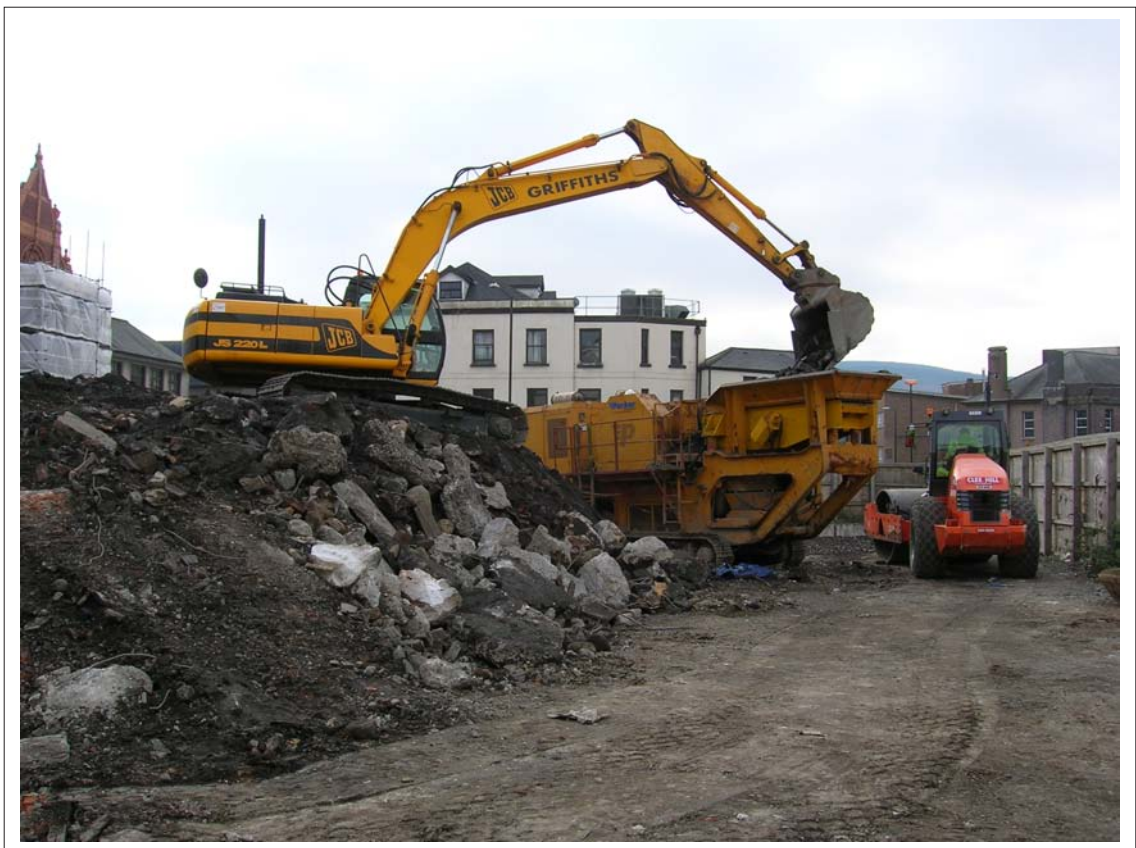
Plate 2: Working shot of the remediation works (Looking south south west)

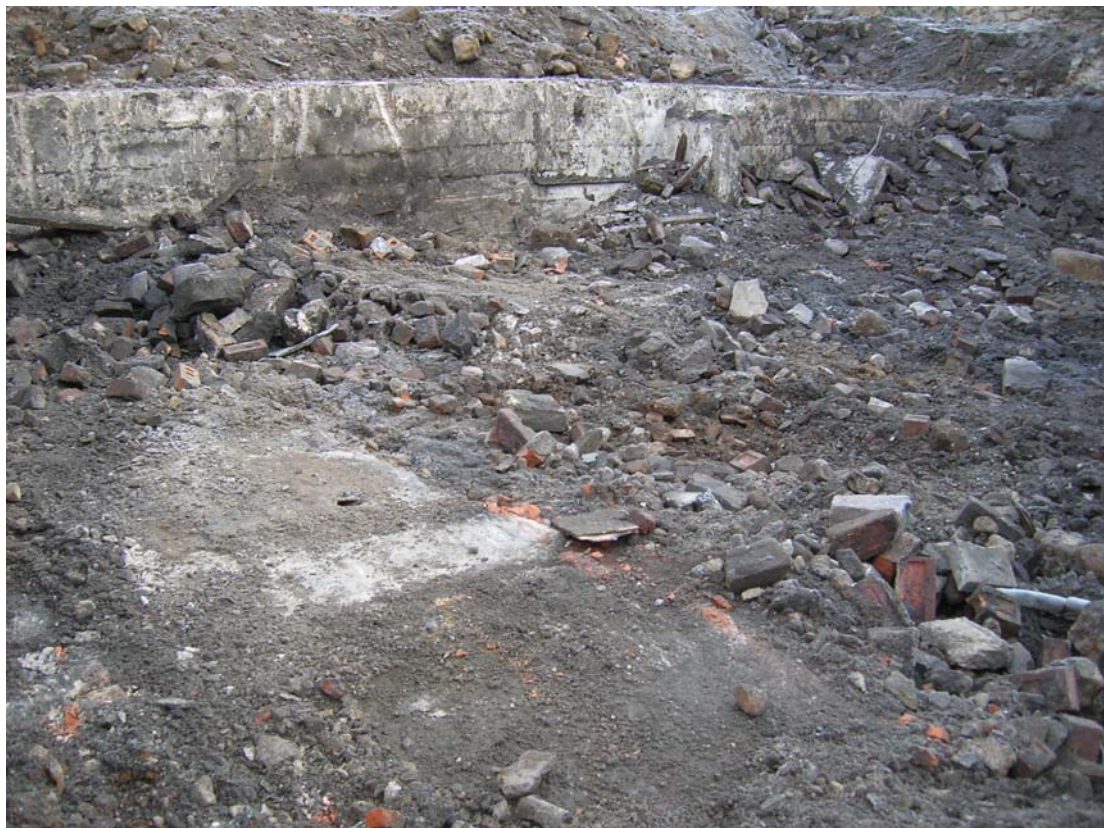
- 4.2.2 Basement 1 (Fig 5, Plates 3-4) At the southern end of the site, over two metres depth of demolition rubble was excavated to expose a large basement associated with the Castle Cinema. This area was triangular in shape, defined by boundary walls fronting Castle Street and Castle Yard, and to the north by a substantial concrete wall (that ran across the site). The latter structure was 0.7m wide and 14.9m long, aligned east-south-east to west-north-west. The basement, demarcated by these three retaining walls, extended approximately 14.4m north-south by 16.7m east-west. The floor comprised a concrete slab, at least 150mm (6 inches) thick. Overall the cellar was about 2.5m deep; the floor level was recorded as 175.20m OD.

Plate 3: General view of basement 1 at the southern end of the site, with part of the floor slab in the foreground and the concrete retaining wall in the background (Looking north east)

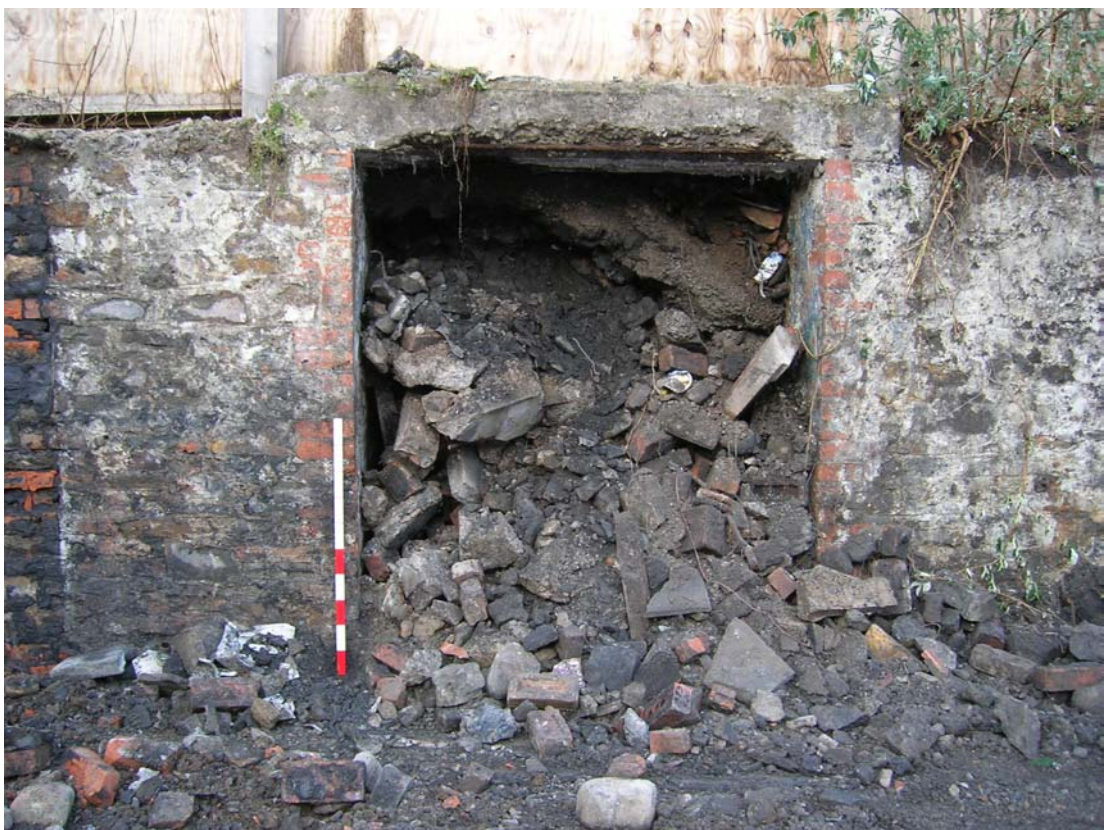
- 4.2.4 The most significant feature within this basement was a partially blocked-up pavement light, or basement access, located on the western elevation. The internal opening was 1.83m (6 foot) wide and 2.11m (6 foot 11 inches) high. This feature was defined within the pavement along Castle Yard as a rectangle of tarmac within brick paving, to give an estimated depth of 1.78m for the recess. Within the cellar, the corners of the opening were of Ebbw Vale brick. The wall above had formerly been supported by the extant 0.25m thick concrete lintel (which had been cast *in situ* over steel bars). This opening was seemingly constructed as a basement access for the cinema, but the original opening could be contemporary with the Castle Inn.

Plate 4: View of the pavement light within basement 1, along the boundary with Castle Yard (Looking north west). Scale 1x1m

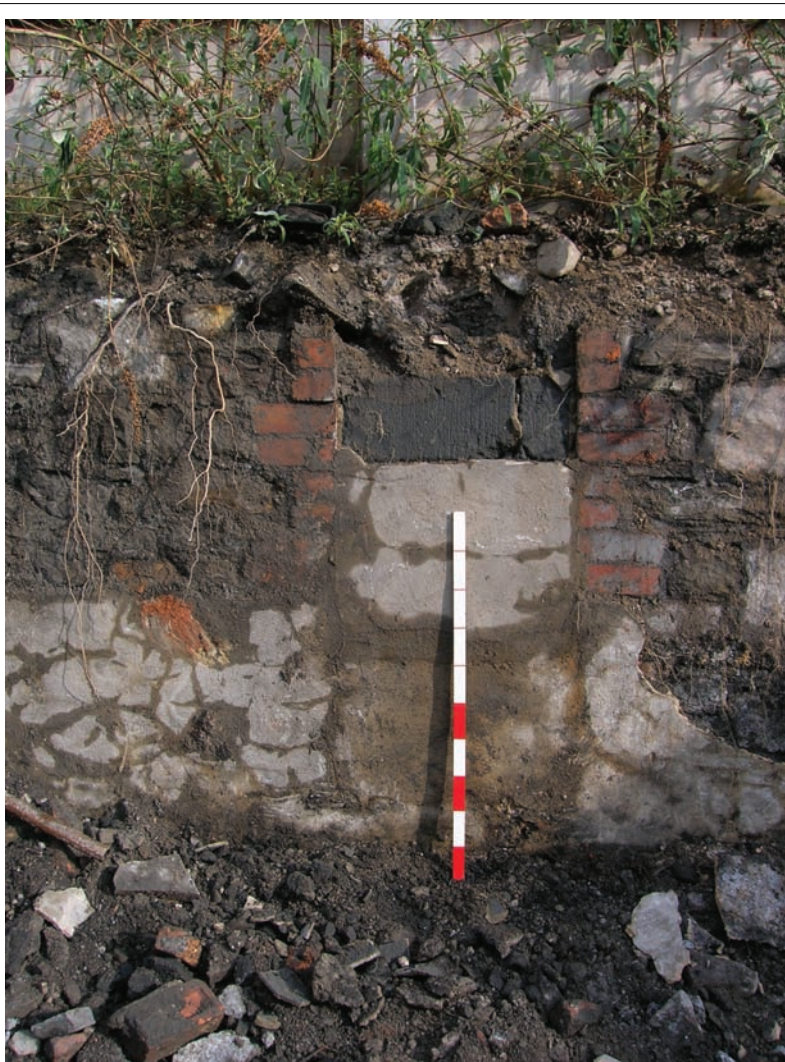
- 4.2.8 A blocked pavement light or coal chute was identified on the eastern elevation. This would have extended onto the pavement along the High Street, but no evidence for the opening was found beyond the site boundary. This feature was 0.61m (2 foot) wide. Lime mortar render was recorded on the same wall, which provides a further indication that this modern basement may have originated as a cellar.

Plate 5: View of blocked coal chute within basement 2 (Looking east). Scale 1x1m

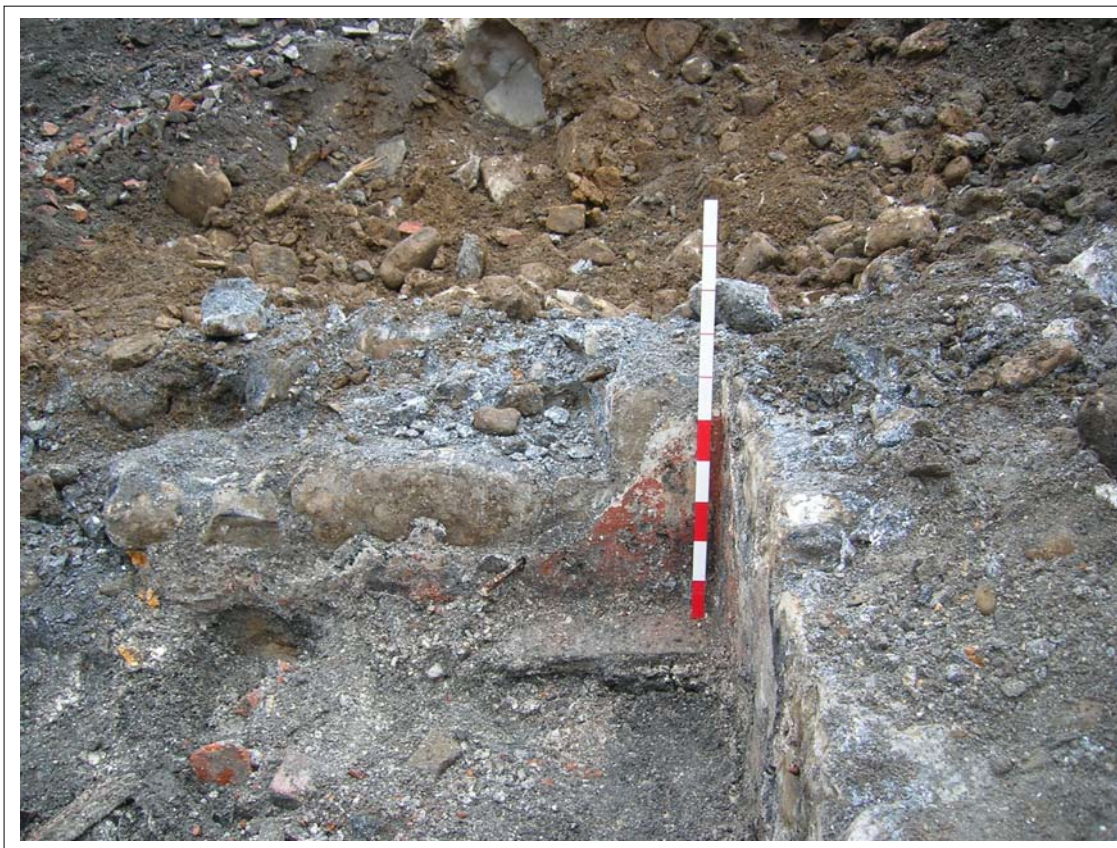
- 4.2.10 Cellar 1 (Fig 6, Plates 6-9) This cellar was identified to the north of the concrete base recorded along the eastern boundary wall. The back wall of the cellar was largely intact. The south-west corner of the cellar comprised a stone wall with lime mortar, about 0.47m or 0.7m wide. This extended internally 3.7m along the side wall (east-west) and 2.5m (north-south) along the back of the cellar, to an opening (1.02m) that

Plate 6: View of the south west corner of cellar 1 (Looking south)
Scale 1x1m

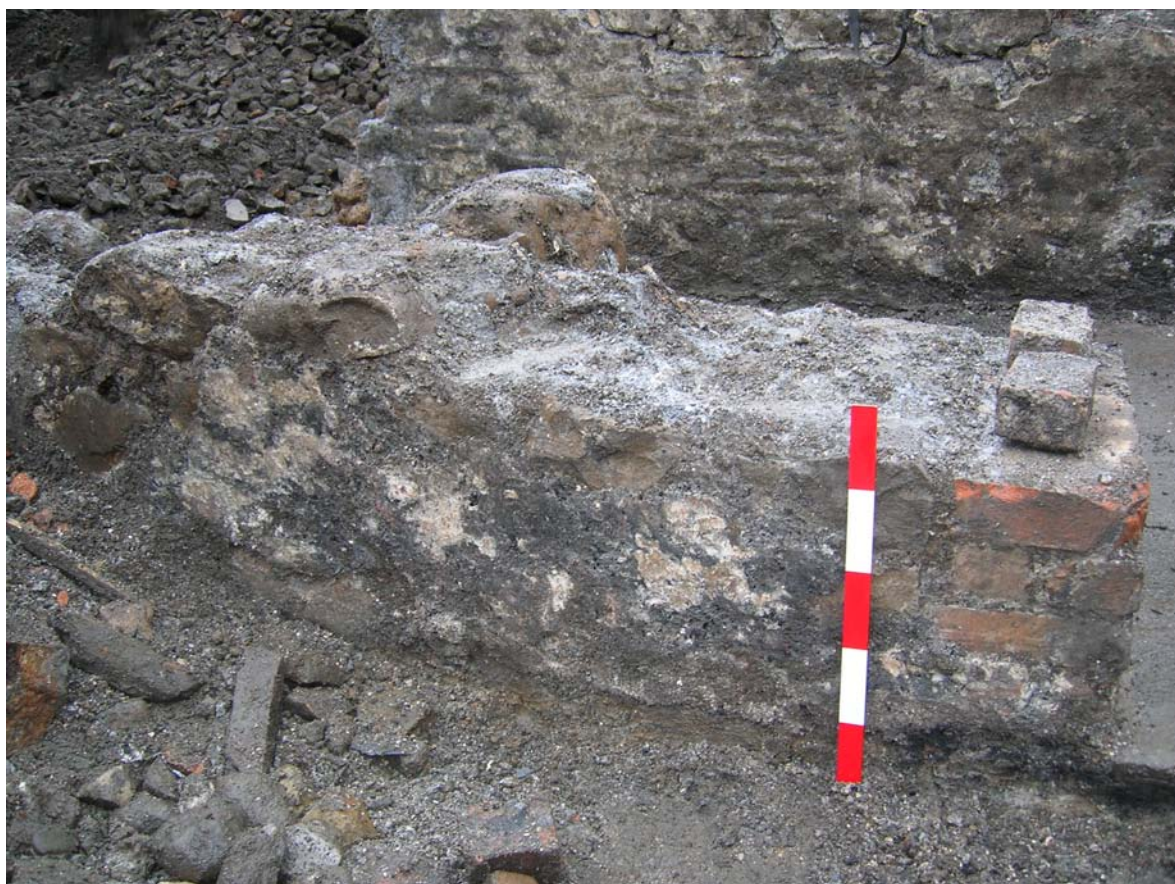
lead to another cellar further west (Cellar 4). Brickwork flanked the entranceway to this cellar, and a single brick skin was evident along a 2.44m long section of the back wall, between the opening and the north-west corner. Overall the back wall was 0.74m-0.8m thick. The north wall had only partly survived, but was recorded as approximately 0.6m thick. It was noted that the northern wall was not perpendicular to the back wall.

Plate 7: View of back wall of cellar 1 (western elevation) in foreground, with the entrance to cellar 4 on the right (looking west). Cellar 4 is shown in the background
Scale 1x0.5m

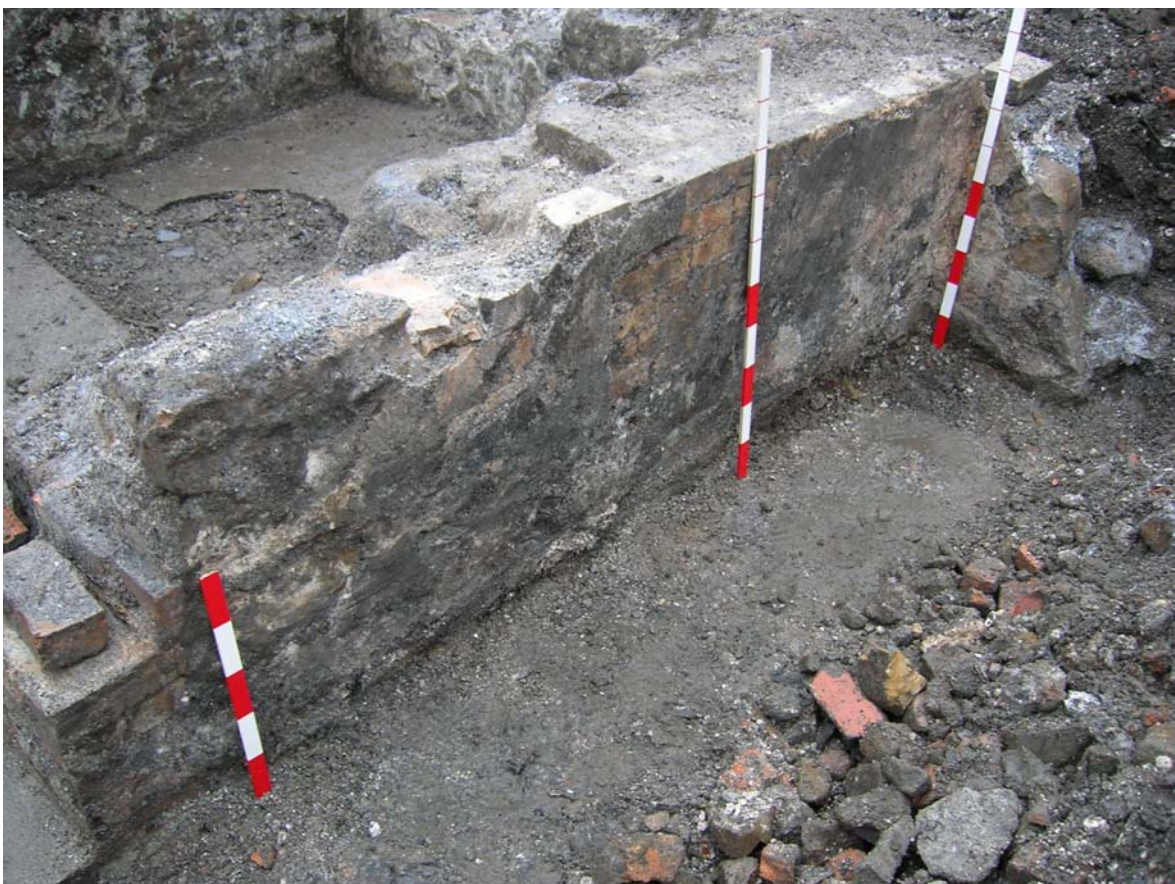
Plate 8: Oblique shot of the north west corner of cellar 1 (looking north west).
Cellar 4 is shown in the background

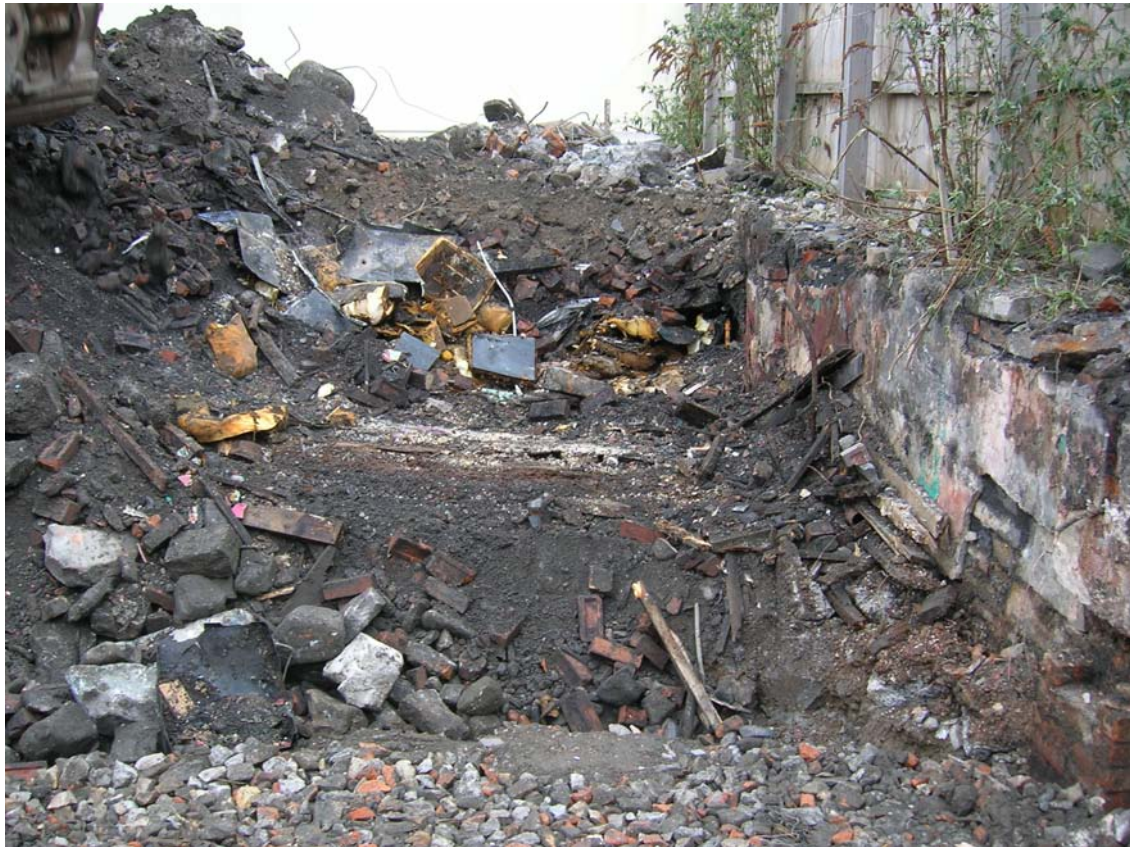
Plate 9: Working shot of the excavation (over Cellars 1&2), showing demolition material along the boundary with the High Street (looking north).

- 4.2.13 Cellar 2 (Fig 6, Plates 9-10) Another corner wall was identified towards the northern end of the site. The back wall of this cellar was set back some 4.5m from the eastern boundary with the High Street. The walls here were predominantly built in stone, but with some brickwork evident. The cellar floor consisted of pennant flagstones. The average height of the floor was 175.87m OD, which is similar to the level recorded within Cellar 1.

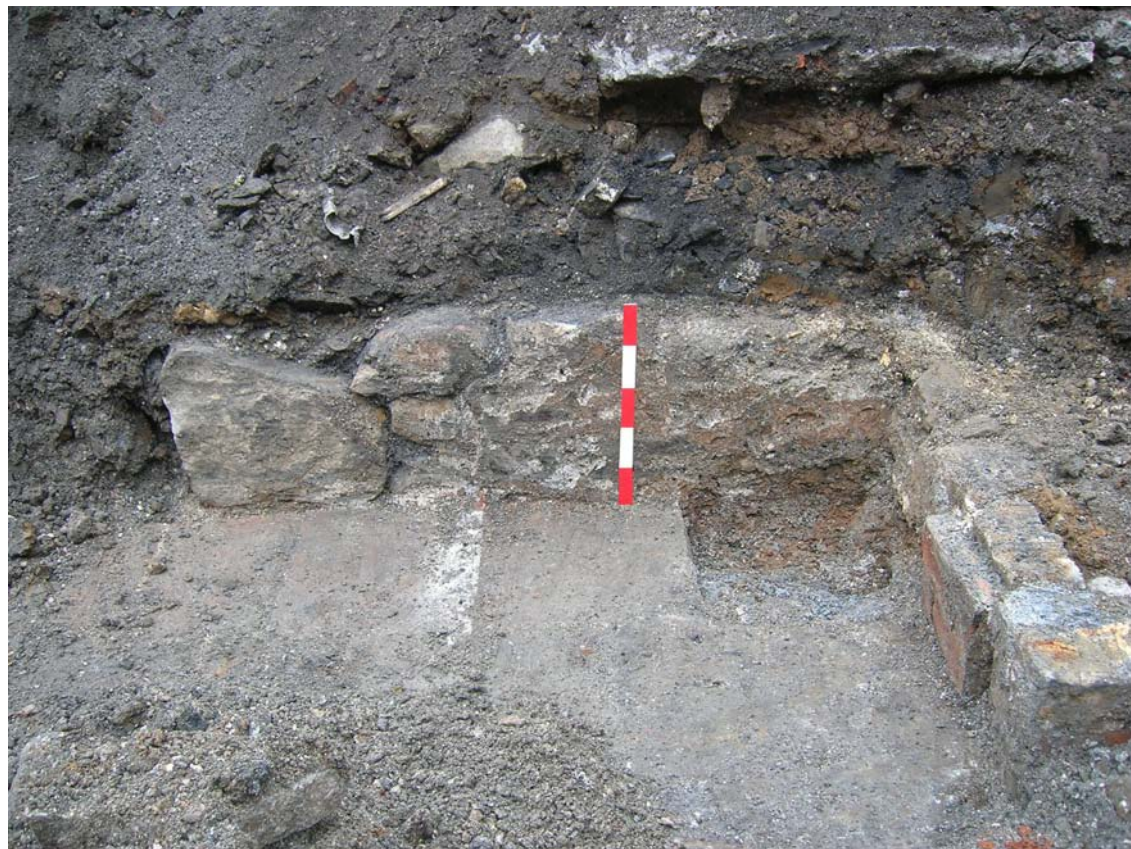
Plate 10: View of the north-west corner of Cellar 2 (looking west-north-west). In the background infill material is shown over the rear cellar wall (western elevation). The northern elevation is shown to the right, with the entrance to Cellar 3 at the bottom right. Scale 1x0.5m

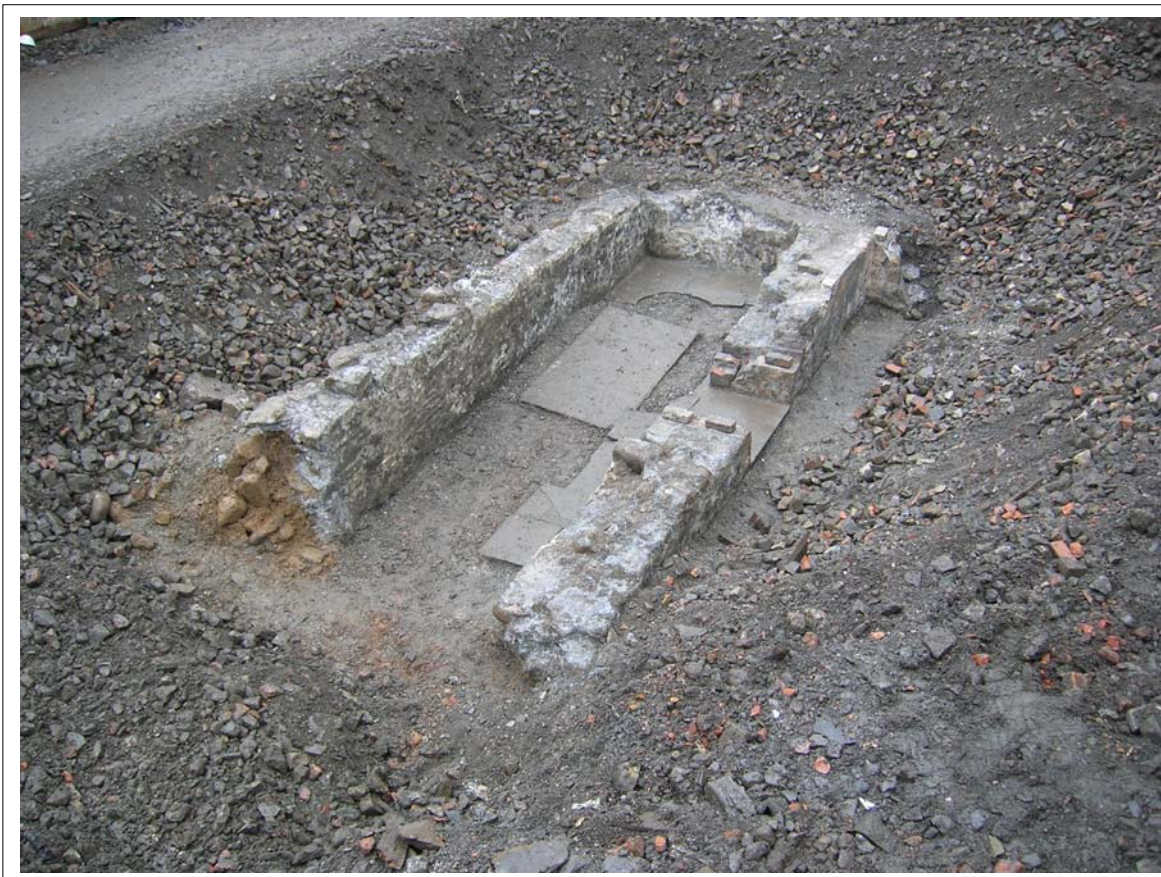
- 4.2.20 Cellar 4 (Fig 6, Plates 11-12) This was the best preserved cellar found during the watching brief. The walls of this structure were largely intact, recorded as up to 1.2 tall. The southern wall had been damaged by previous groundworks, but the line of this structure was evident on the ground. Many of the pennant flagstones were also missing and replaced by a large steel plate (some 40mm thick) over the central part of the cellar floor.

- 4.2.22 This cellar was rectangular in plan. Overall, the cellar measured 1.6m-1.7m east-west and 6.3m north-south (to the line of the southern wall). The floor comprised pennant flagstones, although many of these were missing. The average height of the floor was 175.78m OD, which is similar to the level recorded within Cellar 1.

Plate 11: Overview of Cellar 4 (looking north-north-west).

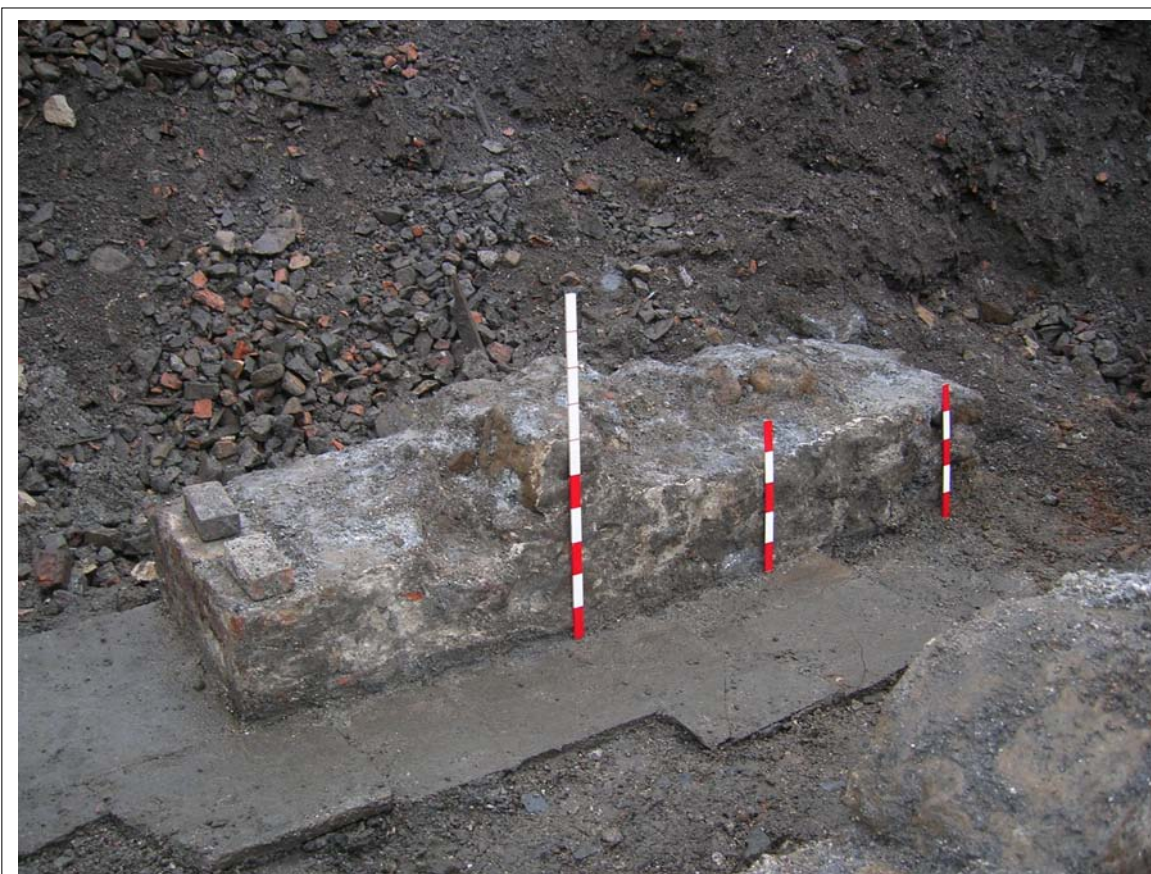
- 4.2.23 The three extant walls were predominantly built of stone in lime mortar with some brick noted flanking the entrance on the eastern wall. The walls had also been plastered in lime mortar. The wall dividing cellars 1 and 4 was 0.74m to 0.8m thick. The remaining walls to the north, south and west were some 0.6m wide. The back (west) wall bowed outwards at the top (by about 10cm); this may not be an original feature of this wall, but more likely the result of previous groundworks (for the Castle Cinema).

Plate 12: Oblique shot of the south-east corner of Cellar 4 (looking east-south-east). The entrance from Cellar 1 is shown on the left. Scales 1x1m & 2x0.5m

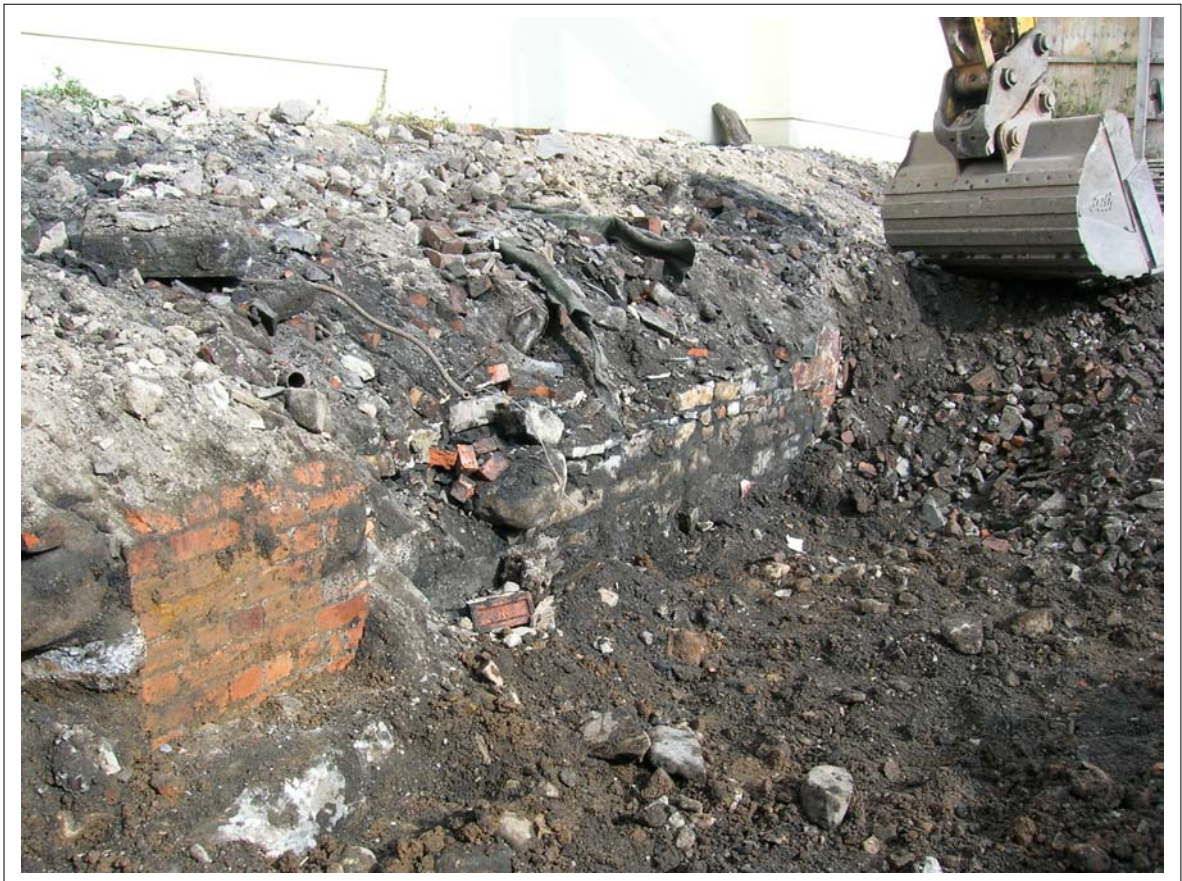
- 4.2.27 Northern Boundary Wall. The 3m wide strip at the northern end of the site was not excavated in order to avoid disturbance to the adjoining property (No.97 High Street). However, two small trial pits were excavated along this wall at the start of the remediation work. The foundation depth at both locations was more than a metre deep. At surface, this wall was over 0.5m wide, extending below the neighbouring building. It is evident that this is a substantial foundation, possibly contemporary with the Castle Inn.

Plate 13: Working shot of the excavation along the wall near the northern site boundary (looking north-north-east). This wall was built as part of the Castle Cinema.

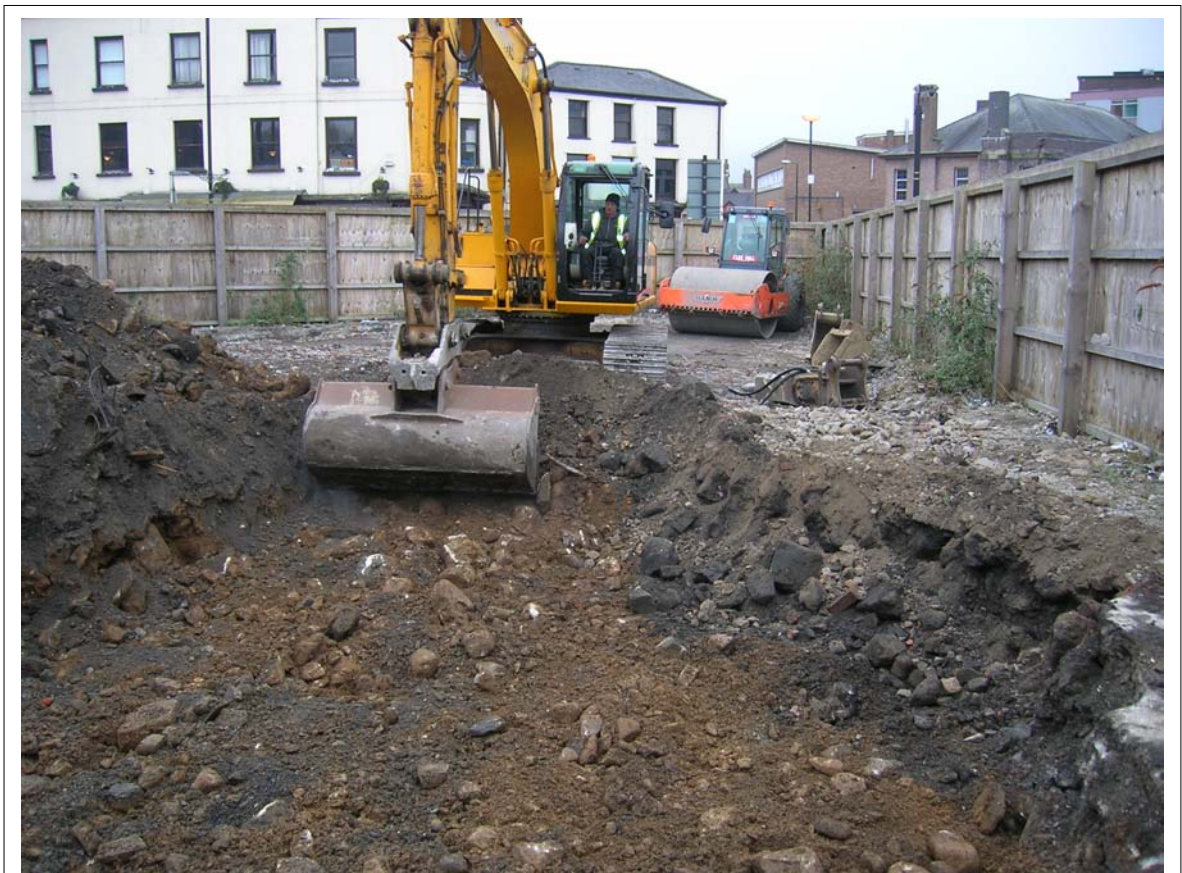
- 4.2.28 Undisturbed Ground adjacent to Western Site Boundary. The foundation depth of the stone wall along the western side of the site was recorded at approximately 0.8m - 1.5m below ground level. This is considerably less deep than the perimeter wall within Basement 1 (further along the western elevation) and the site boundary opposite (along the High Street).

- 4.2.29 Between 1.2m and 2m of rubble was excavated along the western boundary. The natural subsoil was also encountered at shallower depth within this area, noted to be approximately 0.8m below surface at 176.80m OD. There is consequently no evidence for cellars in this part of the site. Moreover, the comparative absence of disturbed ground suggests that formerly this area was used as yards to the back of the Castle Inn.

Plate 14: Working shot of the excavation, along the western side of the site, across the probable location of yards to the rear of the Castle Inn (looking south-south-west).
