Llwynbarried Hall Cowhouse Nantmel, Powys

Archaeological Building Recording

By
Chris E Smith BA (Hons) MA MCIfA
Report No. 1309

Date: February 2015

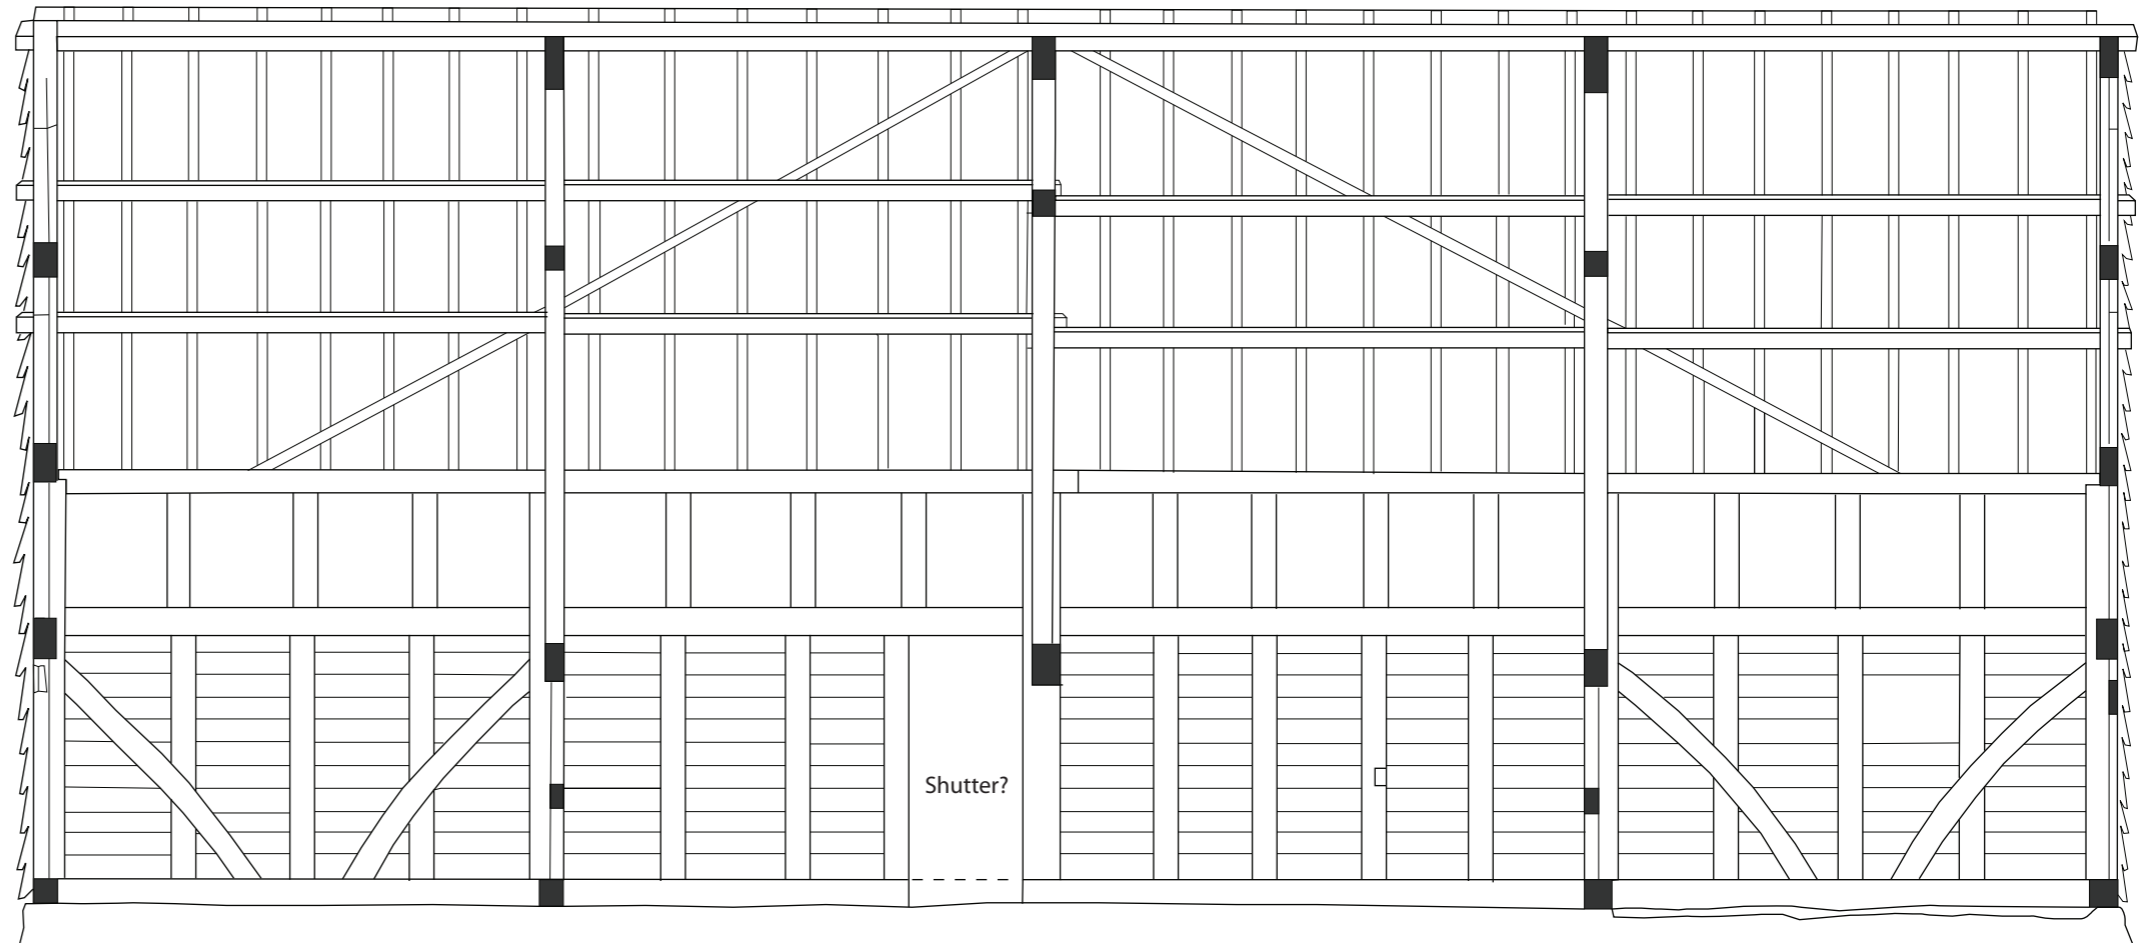
Gable end section A - A, East side
Box Framing
(After RCAHMW 1973)

“A timber framed weather boarded cowhouse dated 177, on a platformed site across the slope. The main frame is of boxed-frame construction but the internal trusses use an upper cruck construction. Any loft floor there may have been is now mainly removed but the open upper section of the side wall suggests the loft was used for the storage of hay. A doorway in each bay of the south wall indicated accommodation for animals, but only two outer bays were partitioned off. The roof construction includes the long racking wind brace, which halves through each rafter” (RCAHMW, 1973).

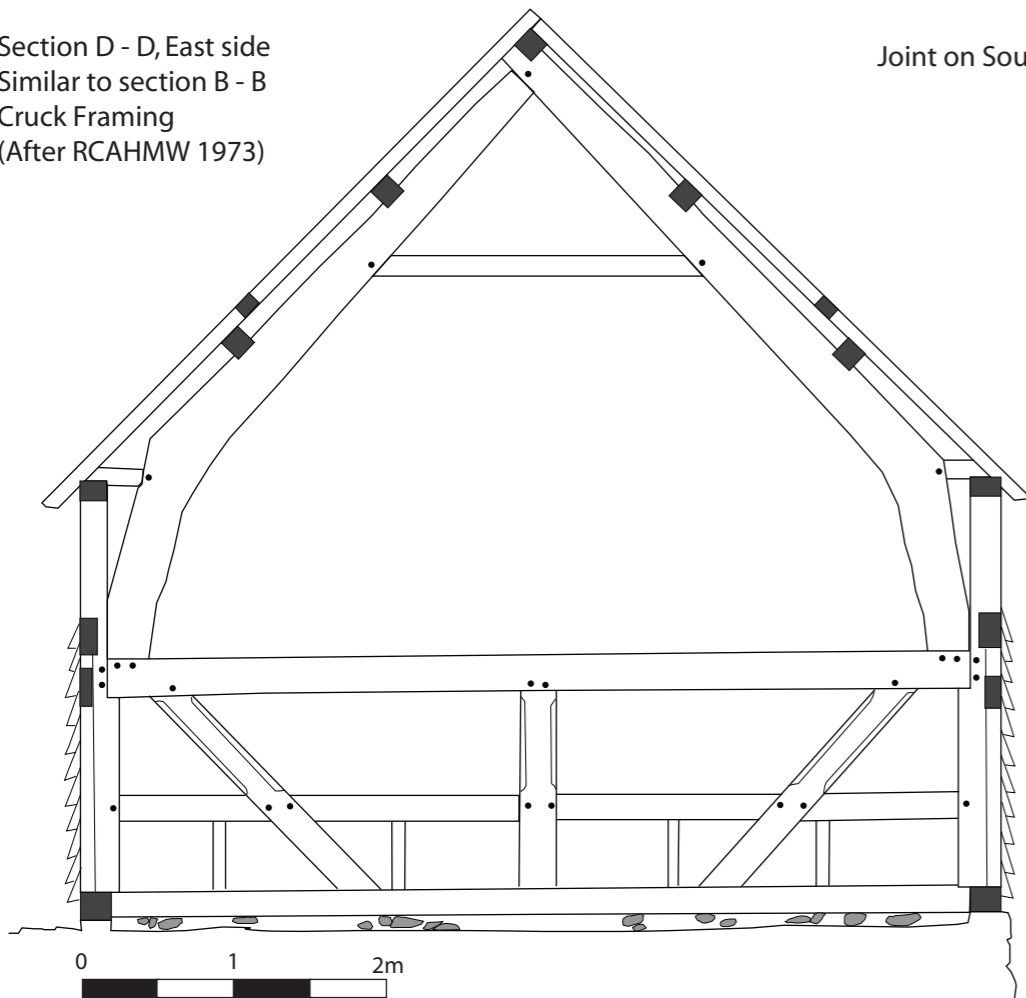
Joint on South-west side

Section D - D, East side
 Similar to section B - B
 Cruck Framing
 (After RCAHMW 1973)

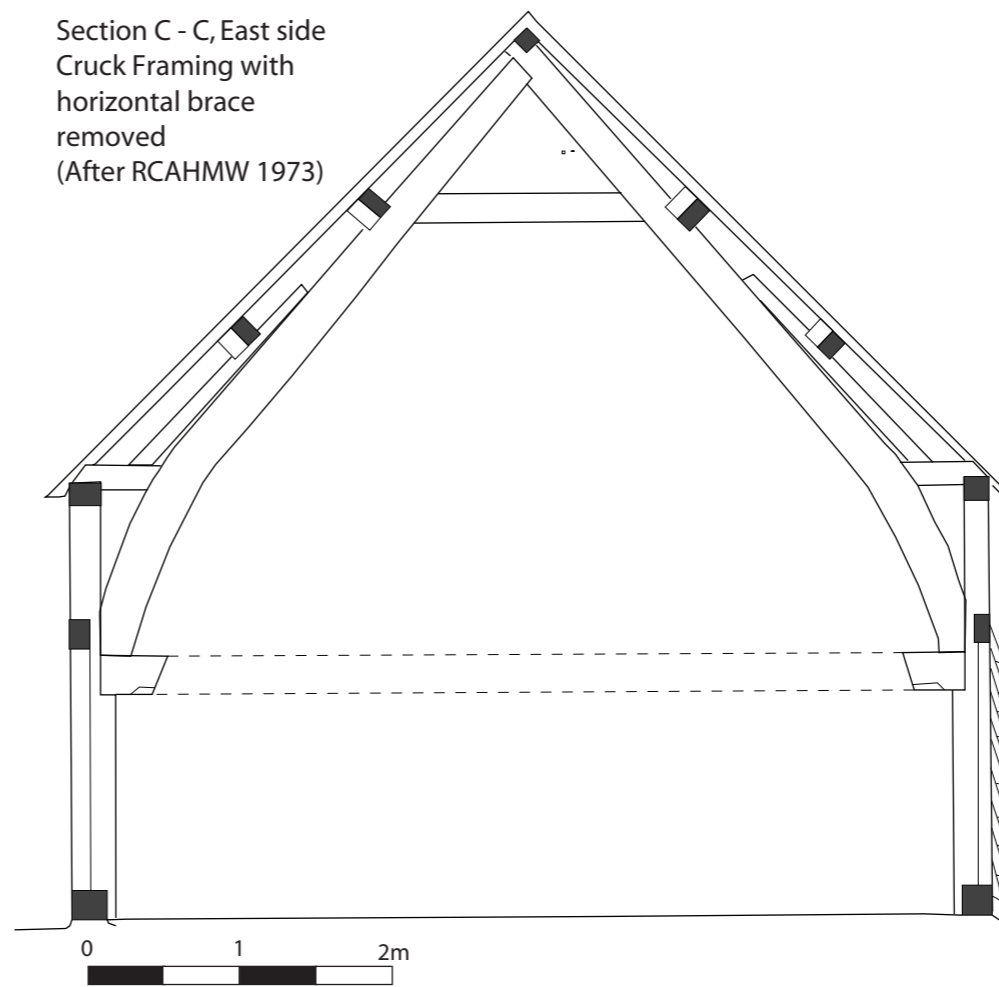
Detail truss B.
 Joint on South
 side

- 4.7.2 The two crucks to the east of the western gable end have notably had their central horizontal braces removed (Plate 77). These have clearly been sawn through at both ends, seemingly to remove the partitions between the bays and thus create an open space within the centre of the barn. This would also have removed any loft space. The removal of the horizontal braces is unlikely to have taken place prior to the late 19th century extension of the barn which likely offered further structural integrity.

Section C - C, East side
 Cruck Framing with
 horizontal brace
 removed
 (After RCAHMW 1973)

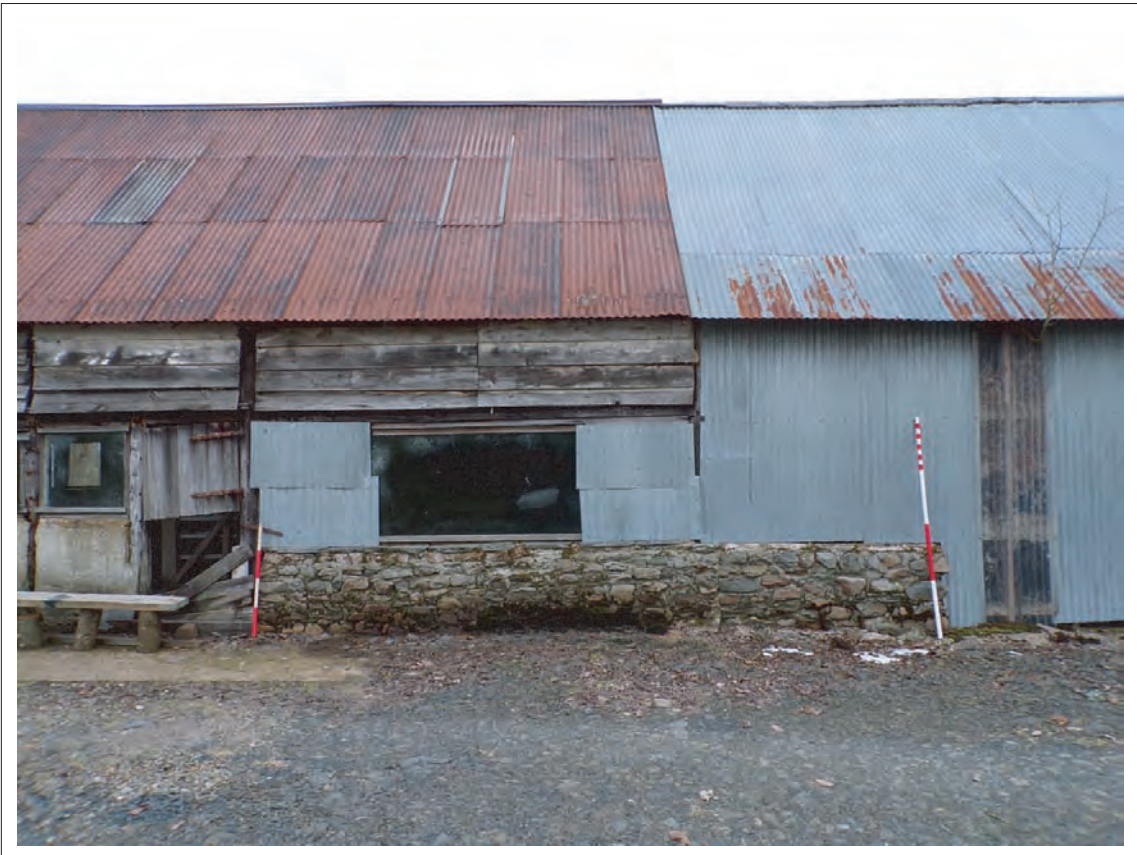
Plate 5: View of southern elevation where 1870s extension butts 1772 cowhouse
Looking north, Scales 1x1m & 1x2m

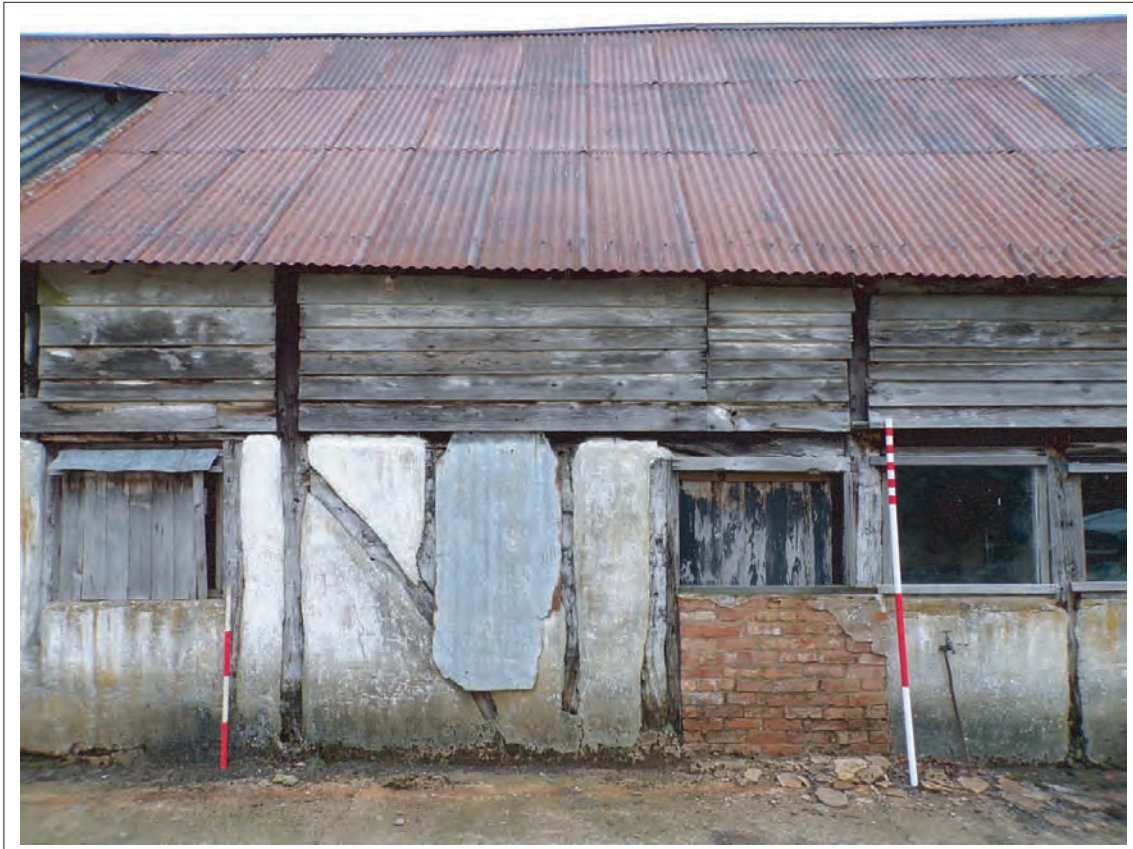
4.3.2 The four doorways into the original 18th century structure are visible although the two middle ones have been blocked, one by being bricked up the other by, presumably earlier, plaster infill.

Plate 8: View of blocked doorways within southern elevation to left of each ranging rod
Looking north, Scale 1x1m & 1x2m

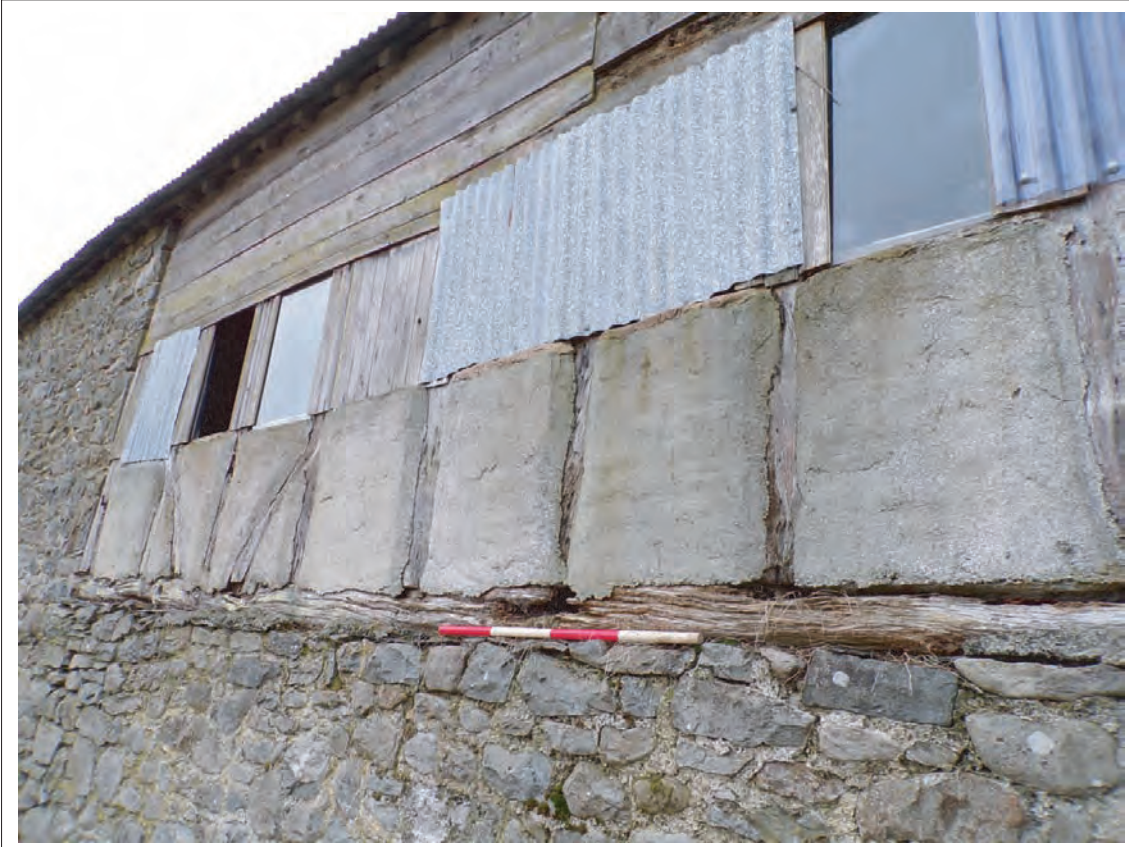
- 4.4.5 The 1772 timber framing is seen within the north facing elevation and is noted to be in a bad state of repair owing to its exposure to the elements. The original, presumably lath and plaster, infill between the framing has been replaced/repared with what appears to be cement.

Plate 20: Detail view of timber frame deterioration within north elevation
Note cement infill/repair. Looking south east, Scale 1x1m

5.3.2 The conversion of the structure into a domestic dwelling will ensure its continued survival and protect the badly damaged external timbers.

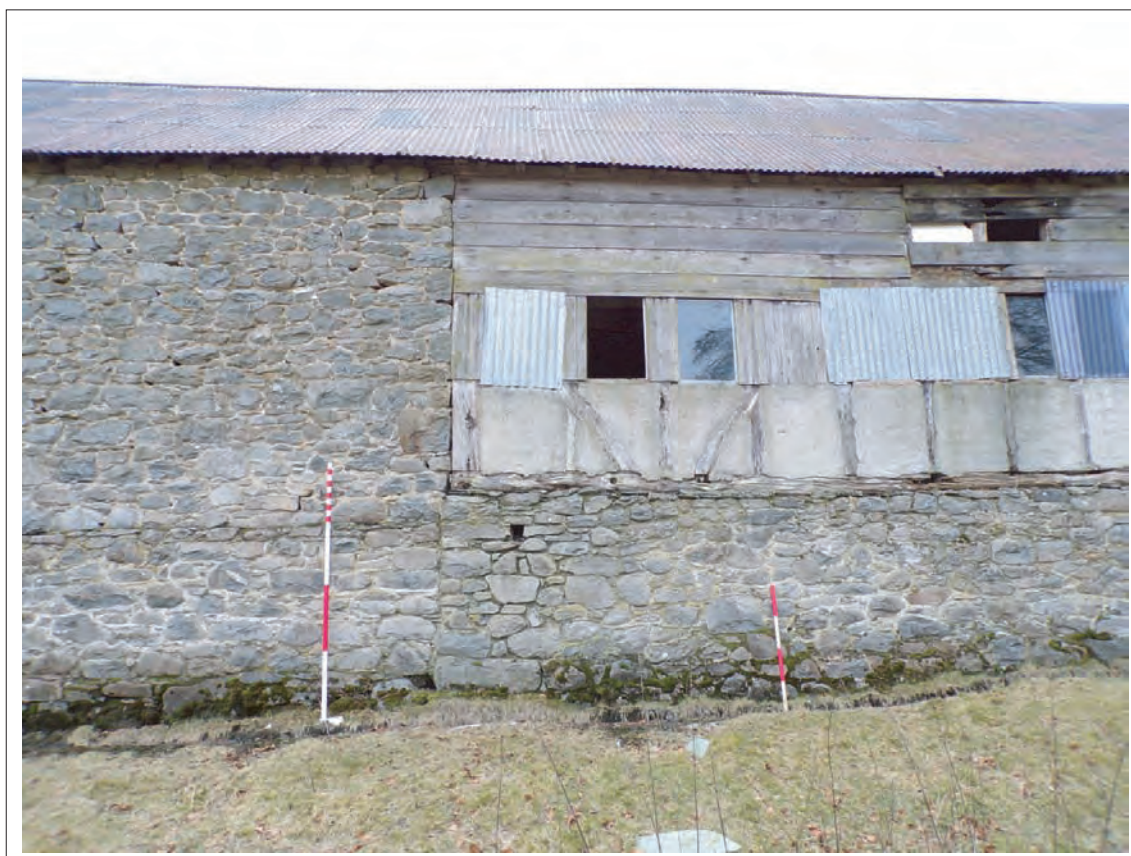
4.4.4 The differentiation in 18th and 19th century builds is even easier identified at the eastern end of the north elevation. A readily apparent butt joint (Plate 22) shows where the 1870s build was added to the 1772 original.

Plate 22: View of butt joint between 1772 structure (right) and 1870s extension (left)
Looking south, Scales 1x1m & 1x2m

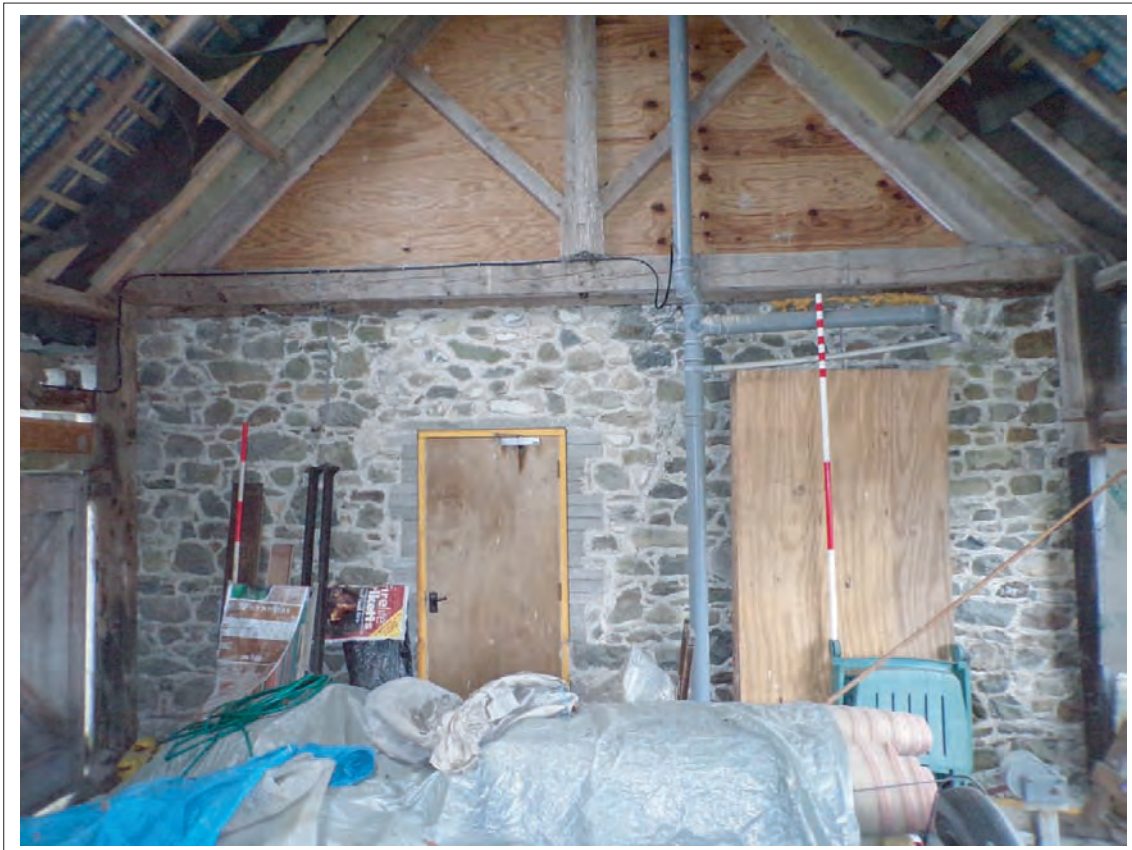
- 4.6.1 The timber frame at the western end of the structure butts the north-south range. Lower stone infill with a modern doorway (Plate 31) suggests that originally this area would have been open between the cowhouse and the north-south range. The floor in the western end of the cowhouse is of poured concrete, thus masking any original features. The roof truss at this western end is of the king post variety (Harris, 1978).

Plate 31: View west of timber king post frame butting north-south range
Scales 1x1m & 1x2m

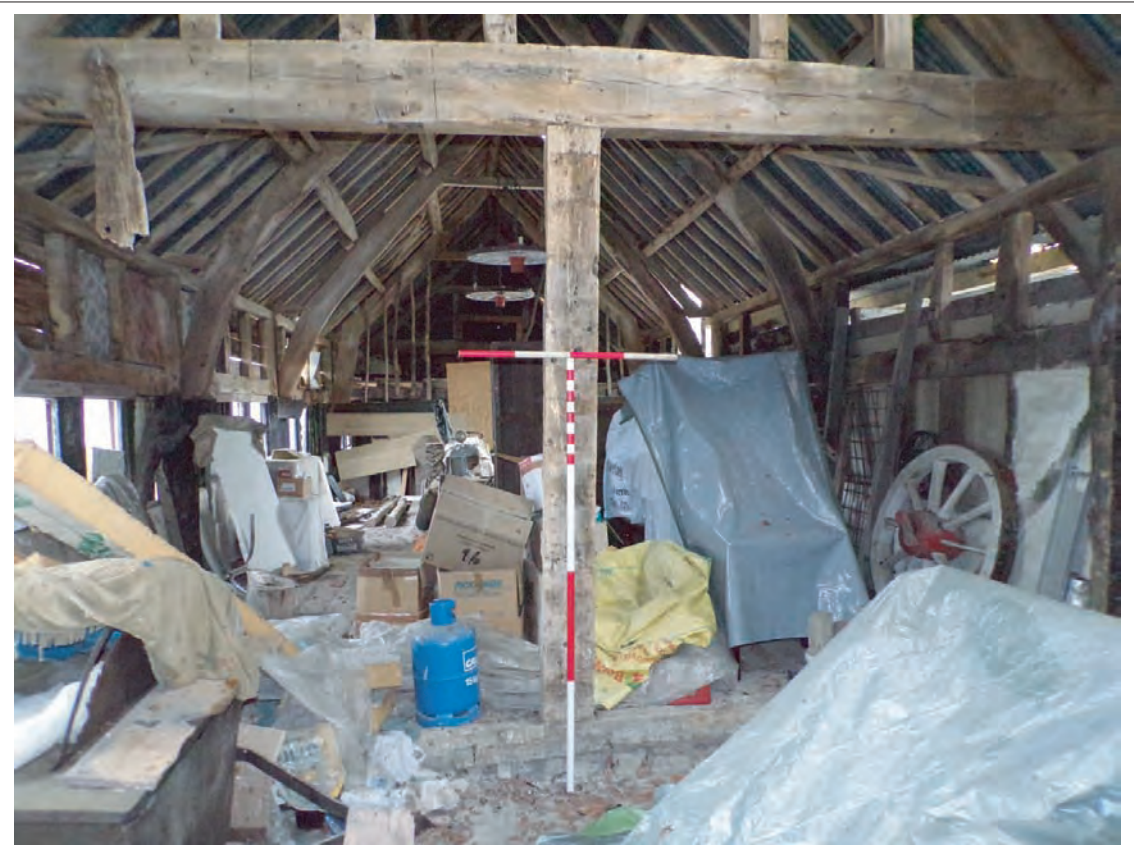
- 4.7.1 As previously mentioned, the 1772 cowhouse consisted of three upper crucks sandwiched between two box framed gable ends, resulting in a four bay structure (Figs 5-7, Plates 31-58). An exposed sill beam at the base of the western gable end (Plate 34) has a higher floor level to its east, inside the original 1772 structure. A roughly square area of floor planking, approximately 3x3m, is located immediately to the east of the western gable end. Its function is unknown and it was partially obscured at the time of the survey by agricultural equipment. The remainder of the floor within the original 1772 structure is now composed of poured concrete with no original features apparent.

Plate 34: View east along original 1772 cowhouse with box frame gable end in foreground. Note exposed sill beam and change in ground level beyond. Scales 1x1m & 1x2m

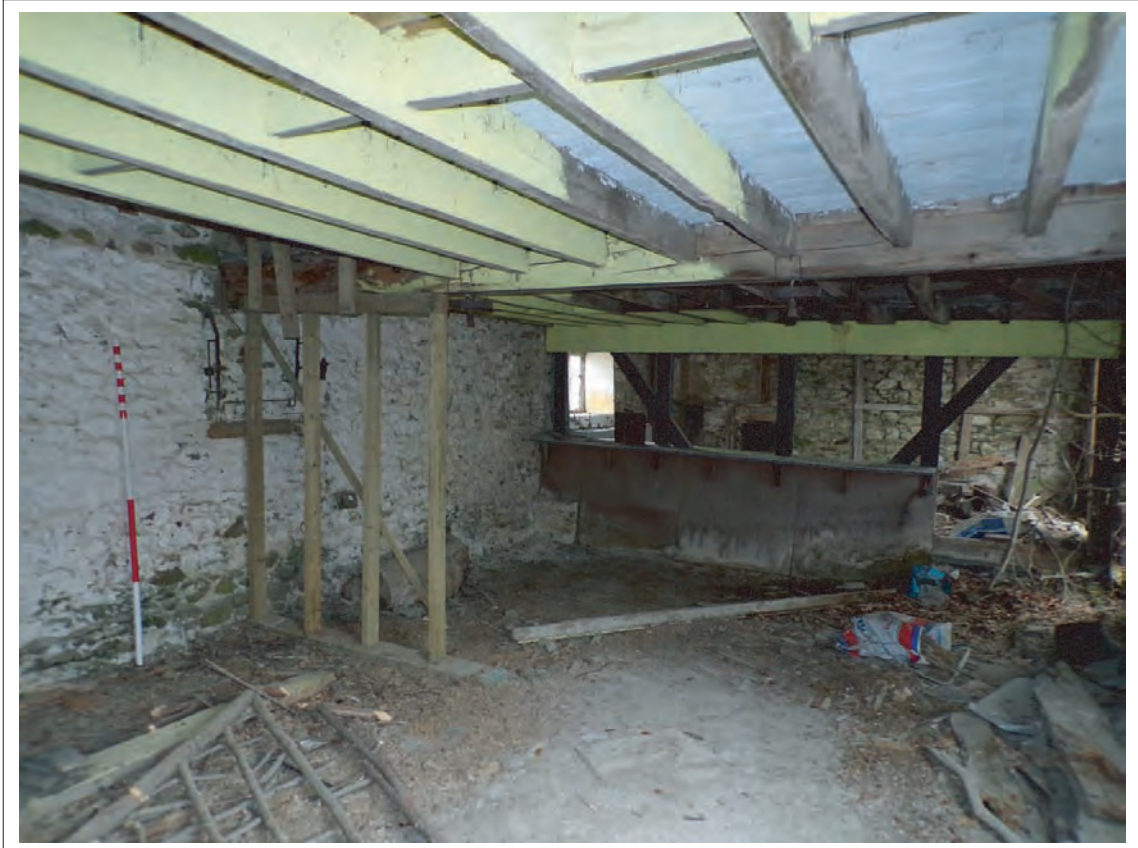
Plate 63: View north east of removed partition within 1870s extension now propped with modern supports. Scale 1x2m

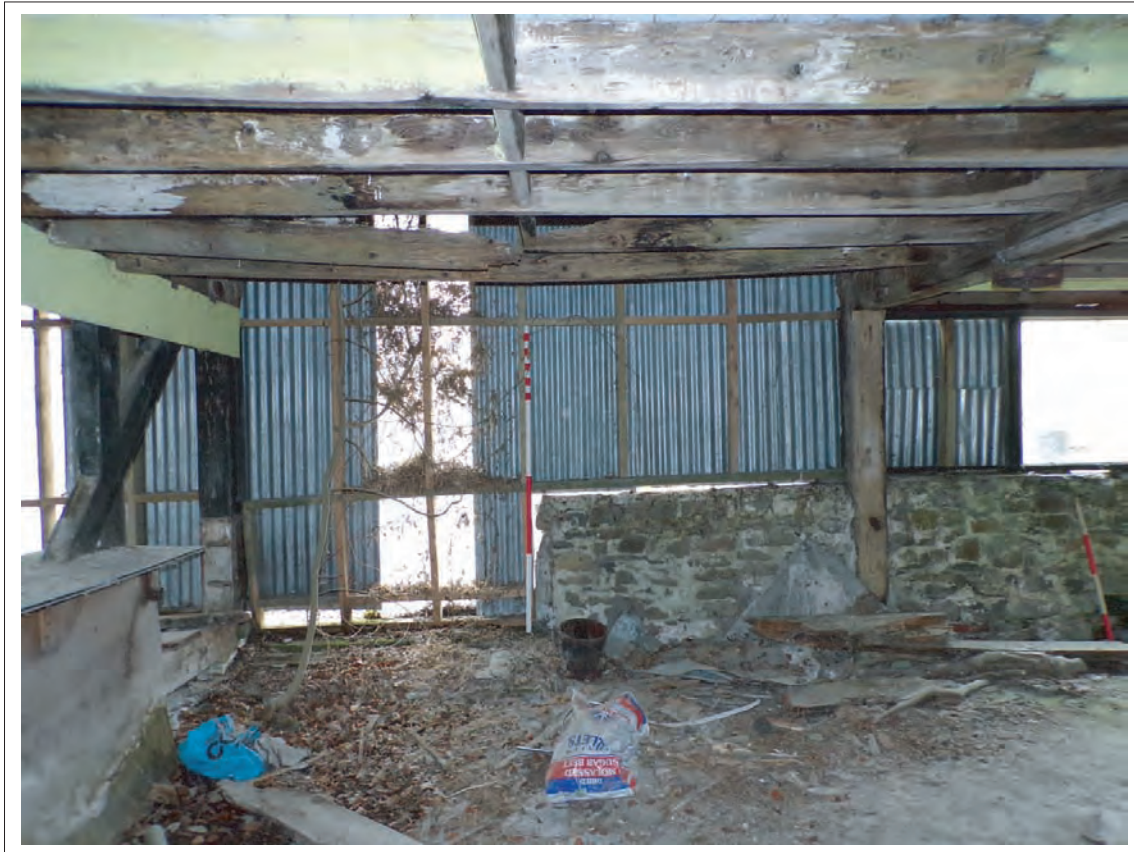
- 4.9.2 Access to the upper level of the 1870s extension was not possible owing to broken floor joists and rotten planking (Plate 65, 67, 70).
- 4.9.3 A partition within the centre of the 1870s extension appears to have been removed in order to create a larger open space. The space occupied by this partition now contains modern supports as the main joist has been weakened.

Plate 65: View of modern corrugated sheeting covering former open area within southern elevation of 1870s extension. Looking south, Scales 1x1m & 1x2m

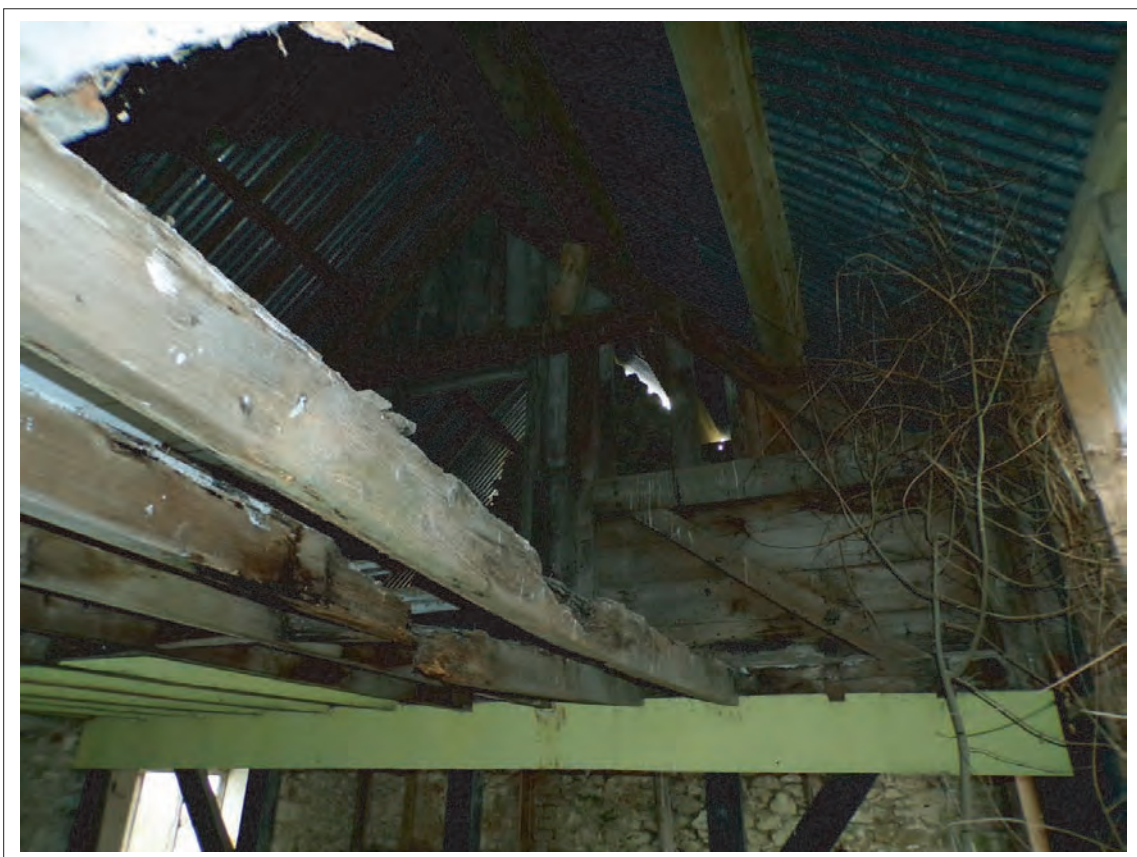
5.2.6 The 19th century stonework and timbers are also in a good state of repair with the exception of broken floor joists and boards at the western eastern end.

Plate 76: View of damaged loft flooring within eastern end of 1870s extension

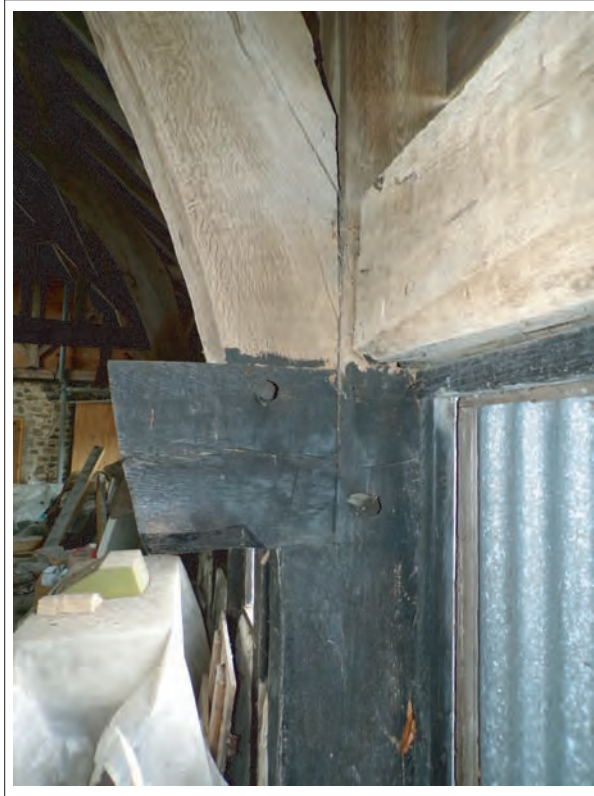
Plate 77: View of upper cruck sat on stub of removed horizontal brace.
