## **Prospect Place, Ebbw Vale**

Archaeological Watching Brief

Report No. 1131

**May 2013**

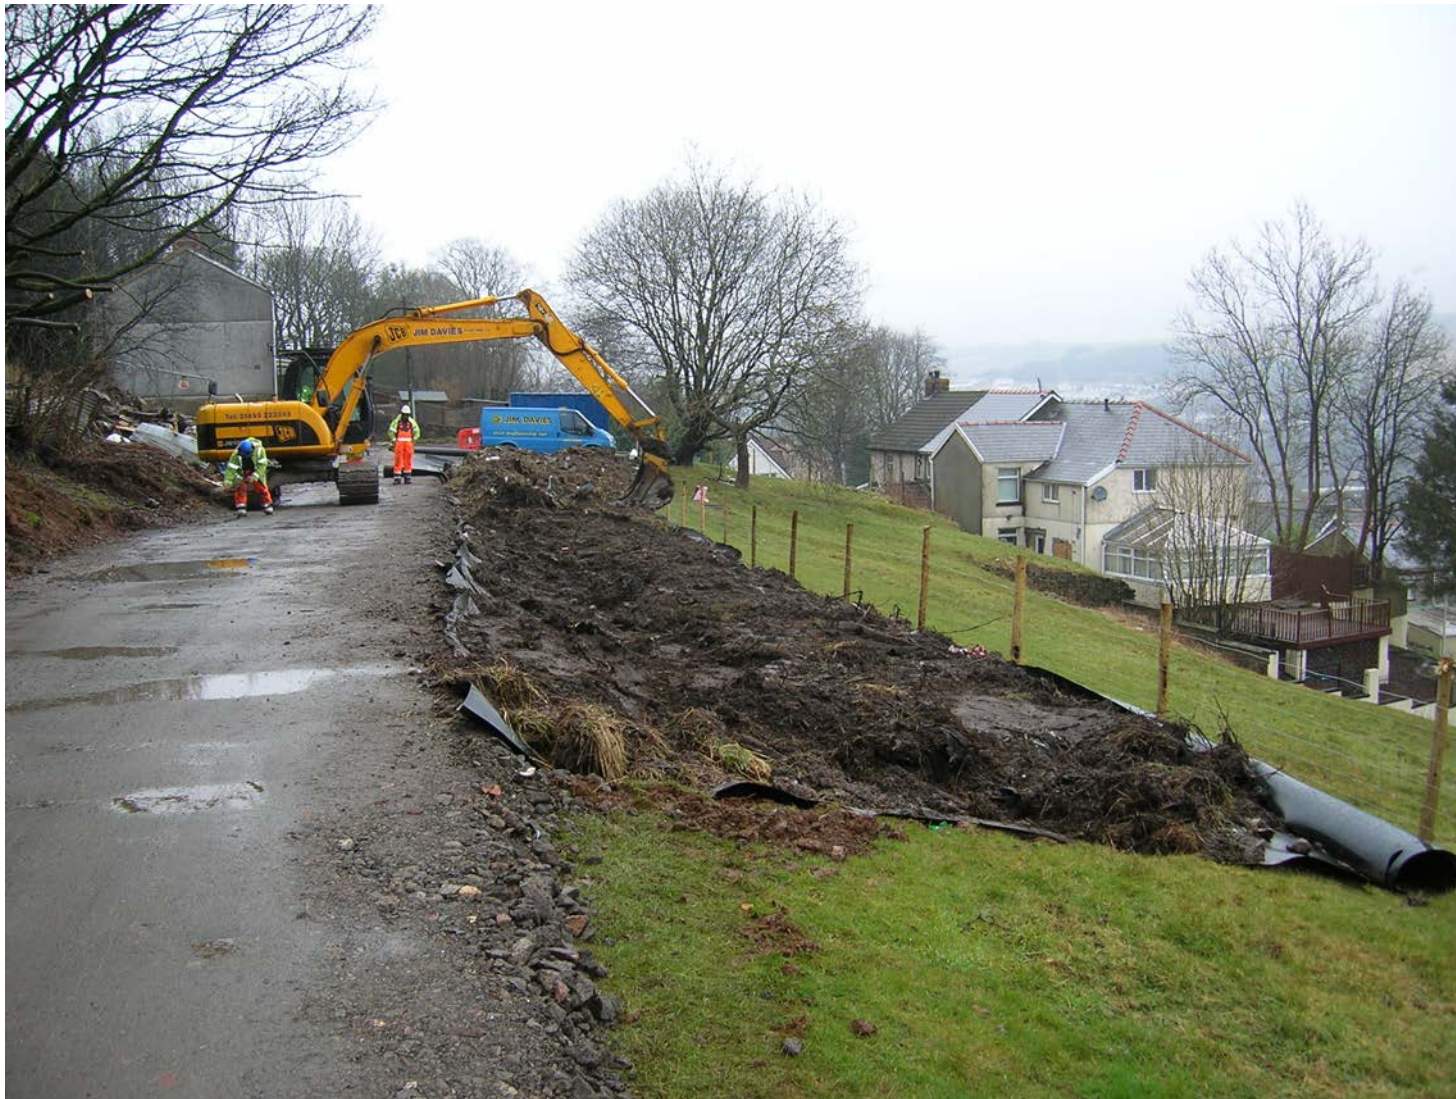
Fig. 3  
View of the  
temporary access  
road and soil bund  
between Rodderick  
Place and Mount  
Street.

Looking North

The soil strip for the access road between Roderick Place and Mount Street was limited to a width of five metres (fig. 3). Although some rubble was noted during monitoring, there was no evidence for *in situ* remains of terraced housing (Hammond Row). The soil strip was subsequently extended in order to build soil bunds (over membrane) on either side of the access route. No structures were found during these excavations. This suggests that the demolition material from these terrace properties had previously been taken off-site. It is also possible that the foundations of the terrace were disturbed (or dug out) when this area was landscaped.

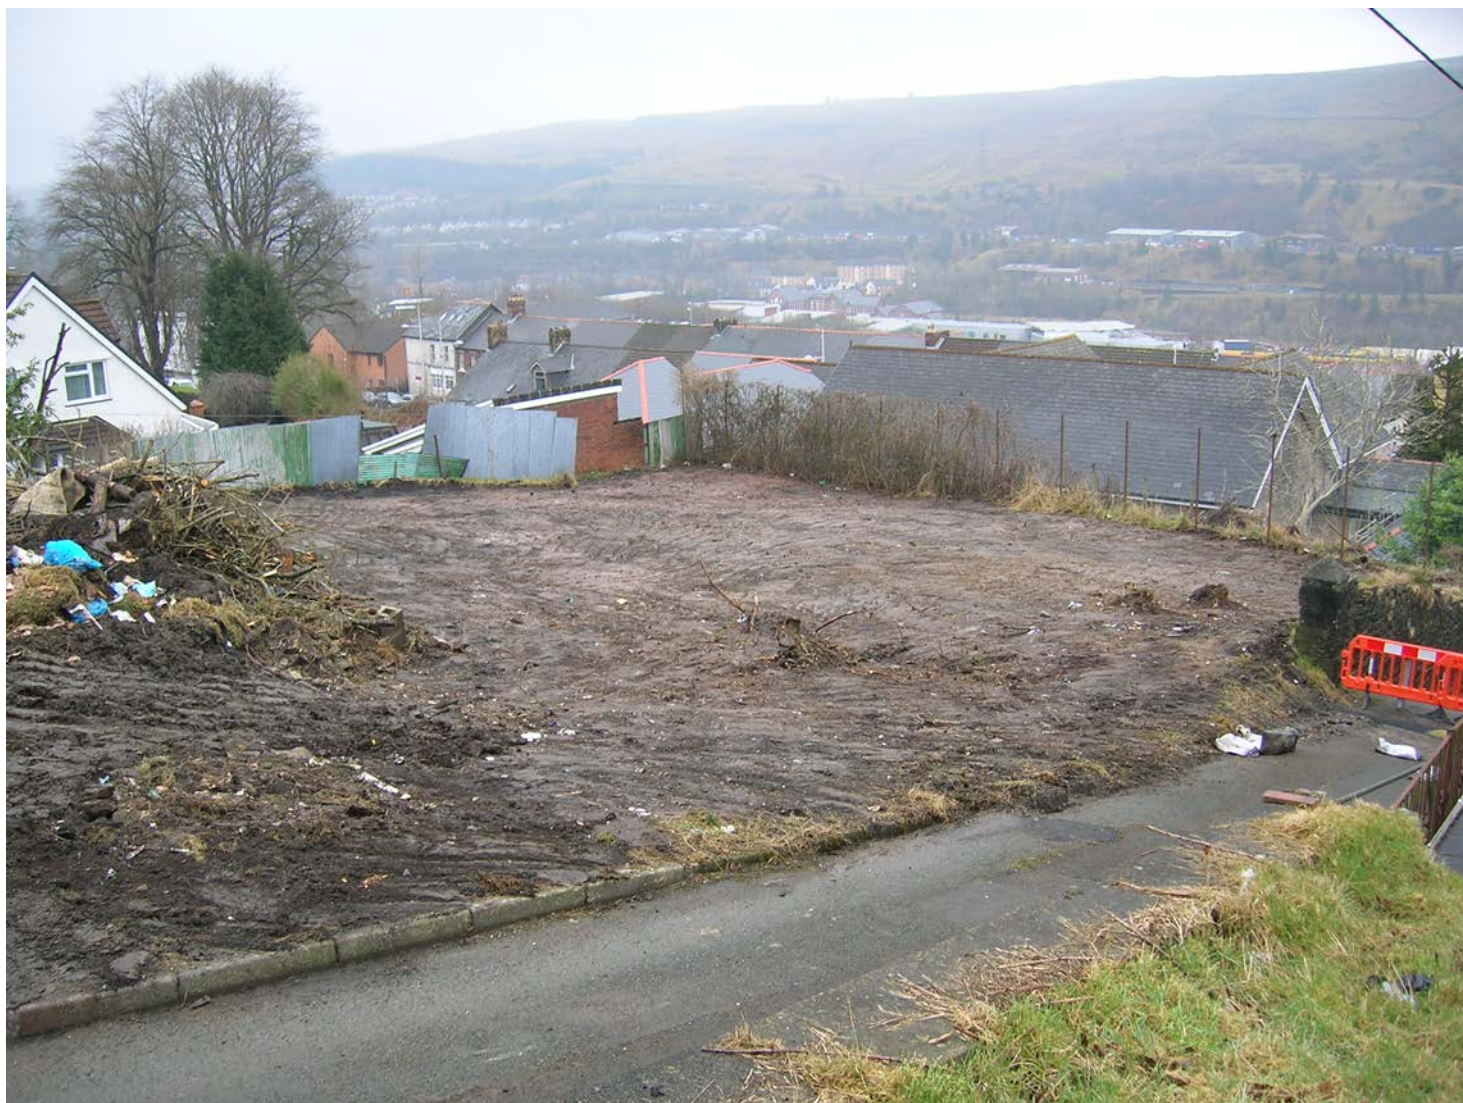
Fig. 4  
General view of  
development site.

Looking NE

To the north of Mount Street, between 2m and 4m of soil were excavated across the main development area (fig. 4). Extant stone walls and flagstone floors were encountered on this site. These demarcated a complete terrace row (Prospect Place) with adjoining pavement and roadway to the east (down-slope; fig 5 & fig 5a). The extant structures were cleared of demolition rubble to expose the floors and surviving external and internal walls of five dwellings (fig. 6). A cellar was also excavated below part of the house at the southern end of the terrace (fig. 7). The extant walls of the houses were predominantly constructed from sandstone in lime mortar. The internal walls were of brick construction.

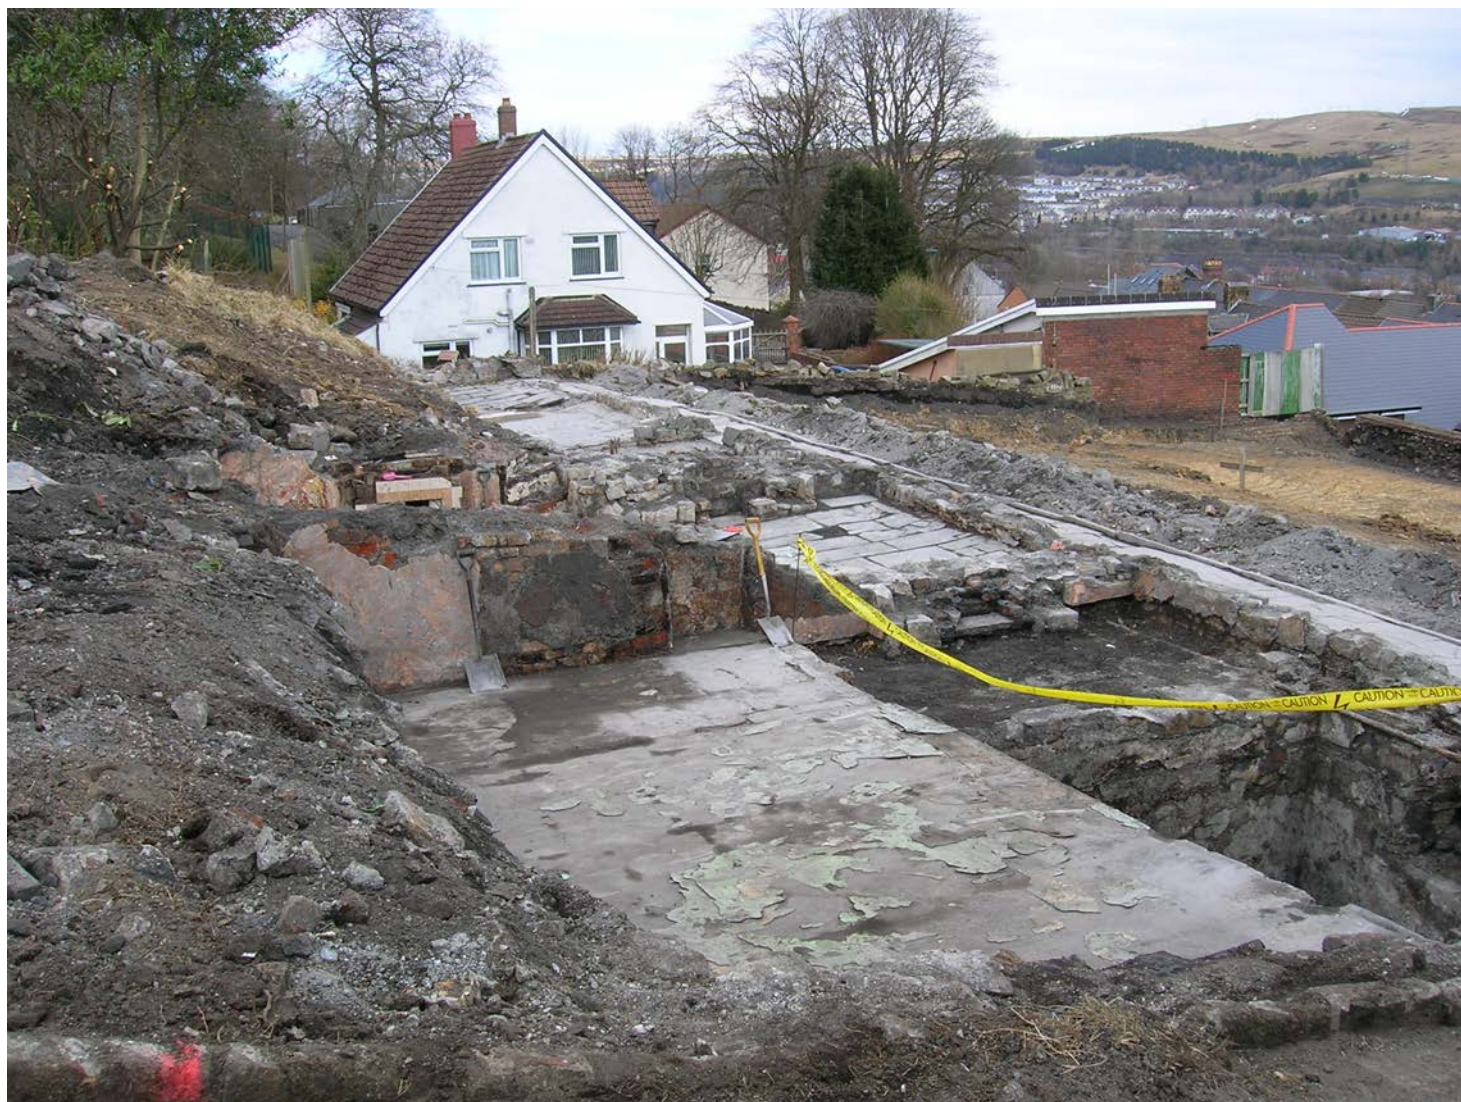
Fig. 6  
The remains of the  
houses of Prospect  
Place.

Looking NE

Overall the back of No.1 measured 5.75m to 5.8m across (north-south) by 3.3m front to back (east-west) from the presumed line of the internal wall (fig. 6). The flooring comprised flagstones, although these had been covered by a one inch (25mm) cement screed across a large part of this area.

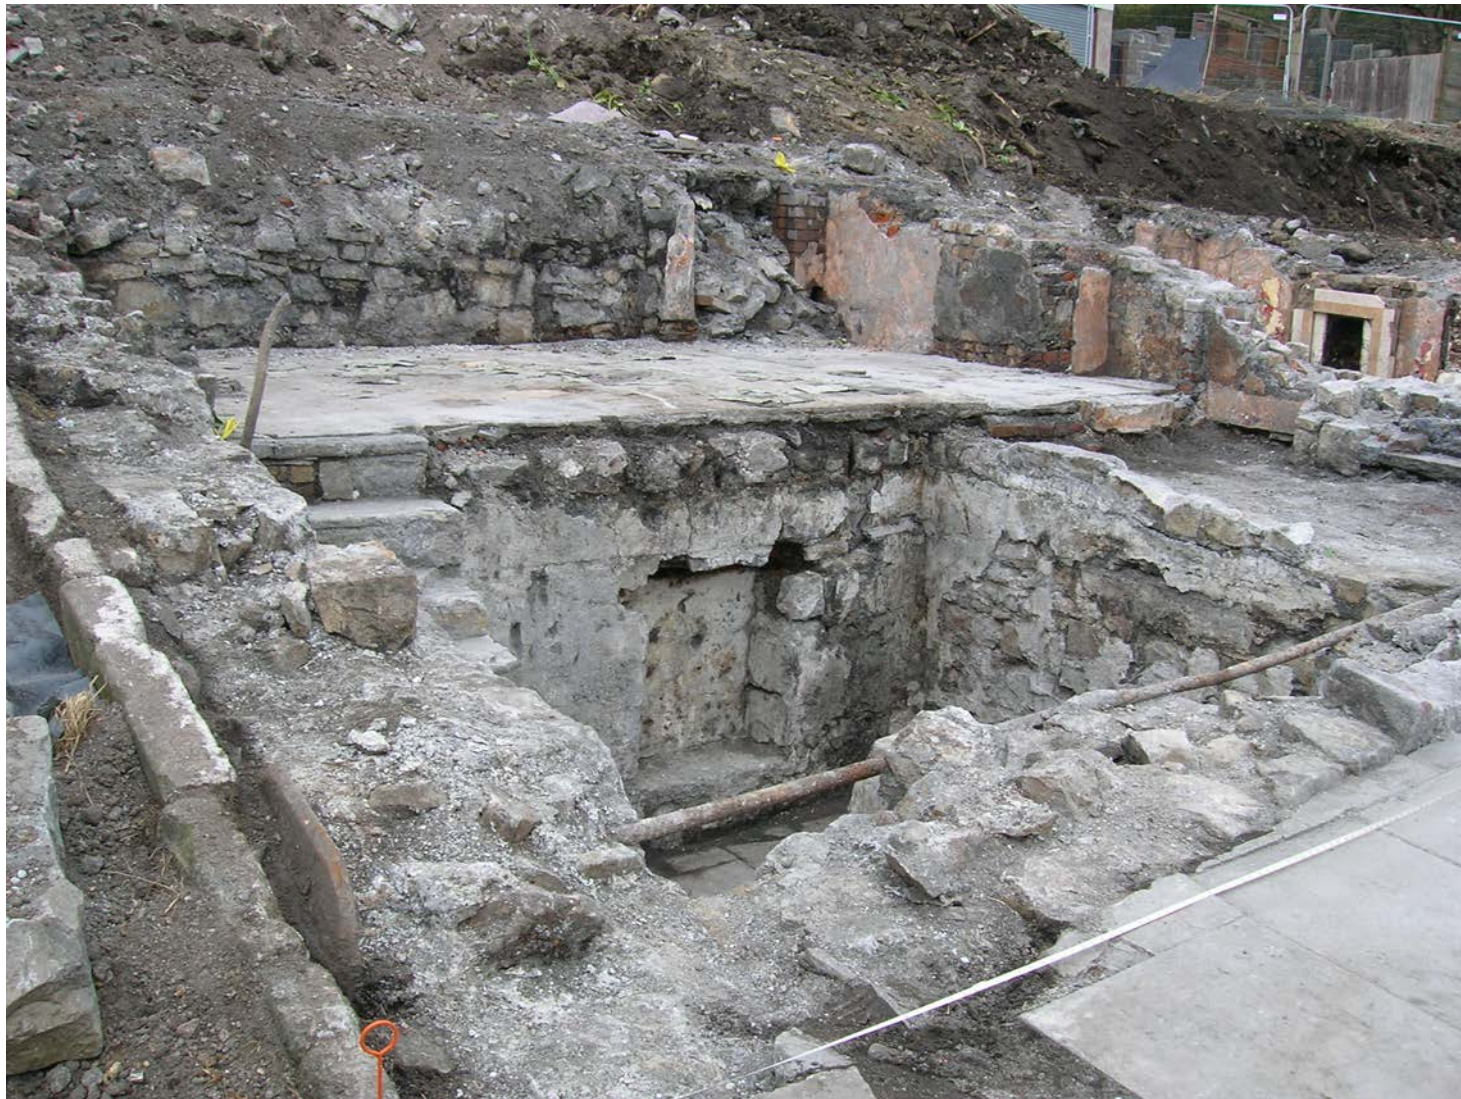
Fig. 7  
General view of  
No. 1 Prospect  
Place.

Looking NW

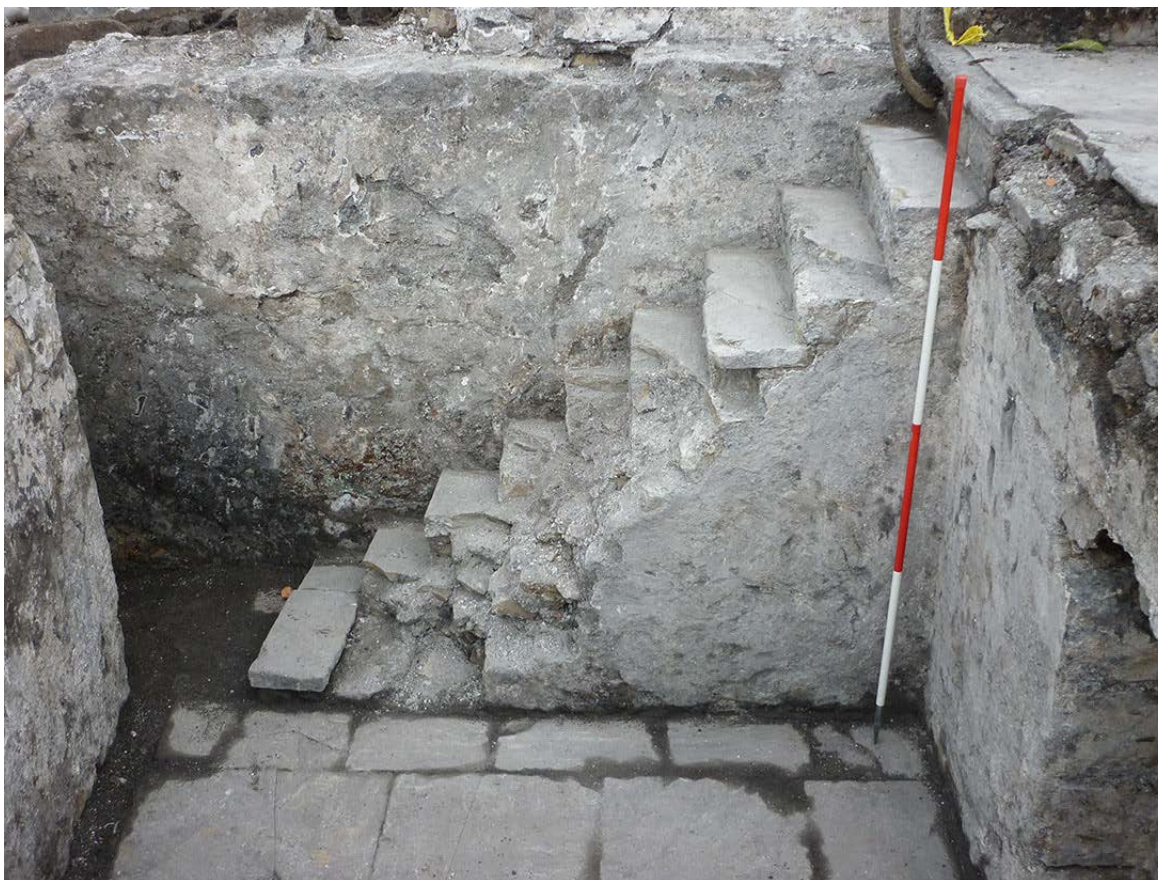
Fig. 8  
The stone staircase  
within the cellar of  
No. 1 Prospect  
Place.

Looking SSE

Access to the cellar was via a stone staircase leading from the back room (fig. 8). This staircase was 0.9m wide and 2.35m long. The central section appears to have been damaged during the demolition of this property.

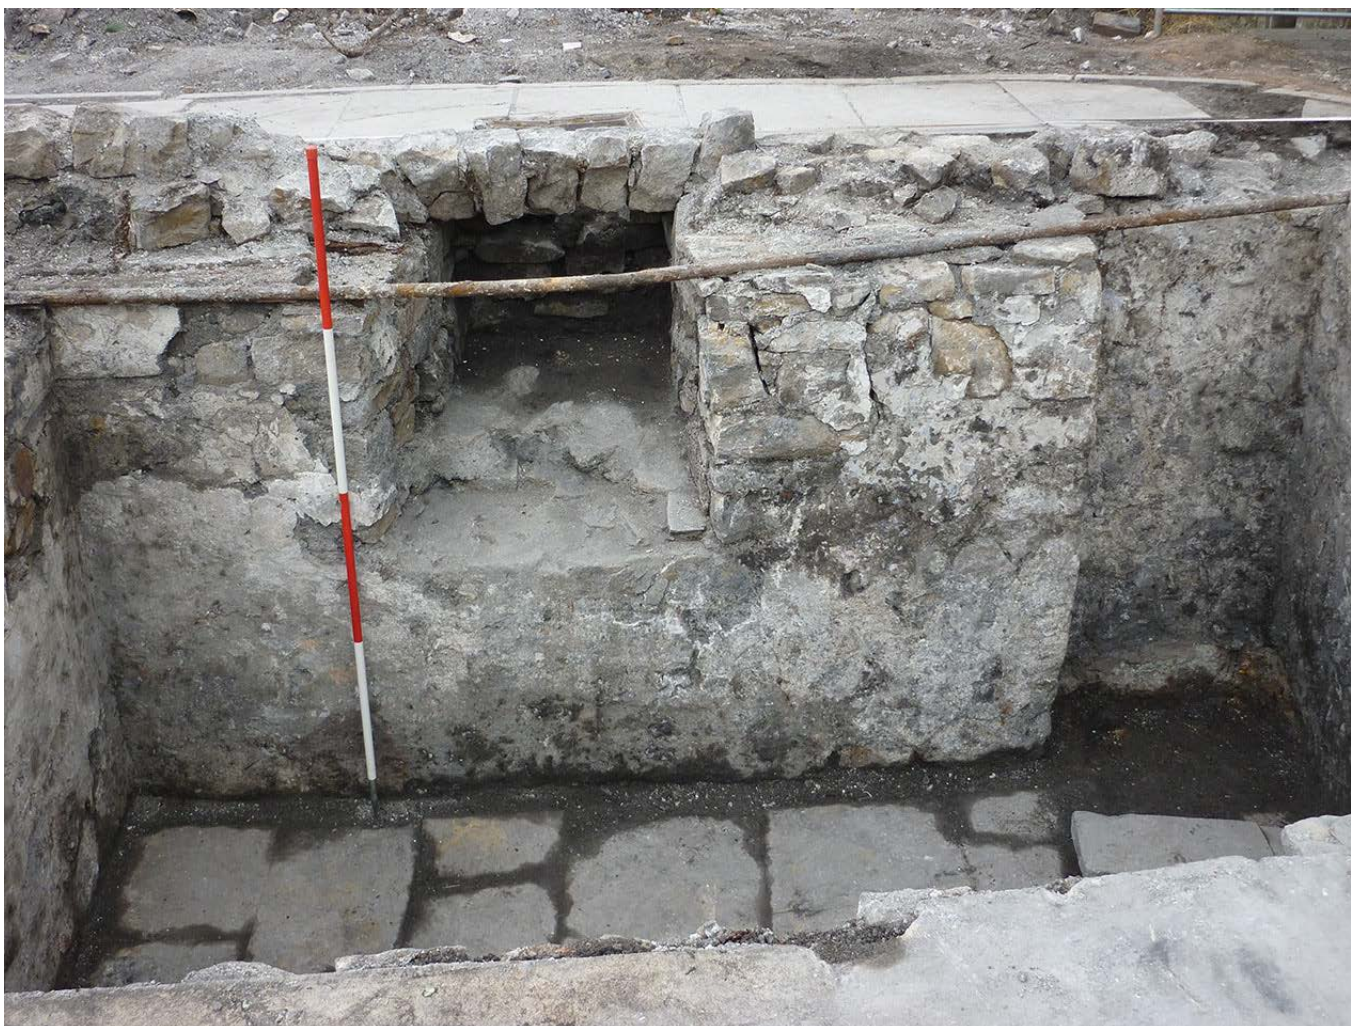
Fig. 9  
The coal chute  
within the cellar of  
No. 1 Prospect  
Place.

Looking ENE

The front (east) wall of the cellar was between 0.65m and 0.98m thick. A stone ledge, about 0.15m wide, was noted at the top of the cellar wall; this was presumably intended to support floor joists/boards. A coal chute was positioned centrally on this wall (fig. 9). The chute extended under the front wall into the pavement at the front of the house (fig. 10).

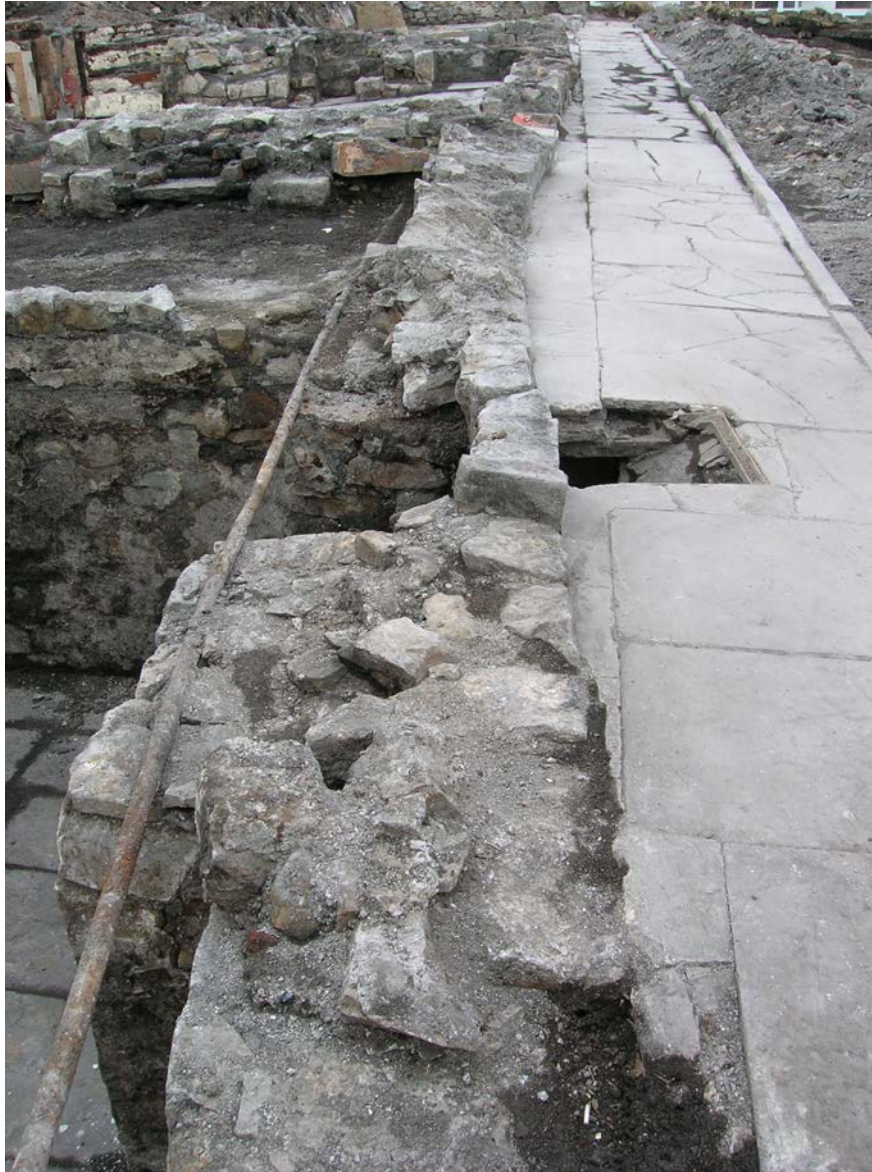
Fig. 10  
The front wall of  
No's 1 and 2  
Prospect Place  
showing the distinct  
bow and the top of  
the coal chute.

The front section of the house measured internally 6.15m - 6.20m across (north-south) by 3.05m front to back (east-west). This wall was 0.44m - 0.50m thick, built over the cellar wall noted above. The southern corner of this building appeared to be *in situ*, but the remaining front wall had a pronounced bow of up to 35cm (fig. 10).

The front doorway appeared to be marked by a wall return located towards the southern end of the building. A cast iron cover for a coal chute was located within the pavement, adjacent to the probable entrance (fig. 10). The cover appears to have been repositioned at some point (and paving slabs re-laid) to take account of the horizontal movement in the front wall.

The southern (side) wall of the cellar was 0.65m thick (to include a 0.15m wide ledge at the top). The staircase extended along this wall. The opposite (northern) wall was much less substantial; measuring only 0.28m thick. A recess was noted on the back wall (western elevation); recorded as 0.98m wide by 0.91m tall and 0.22m deep. It was evident from the brick inserts within the flooring that the bow visible in the north-west corner of the cellar probably formed during the life of the building. This wall has probably buckled due to compression resulting from the horizontal (westward) movement of the front wall.

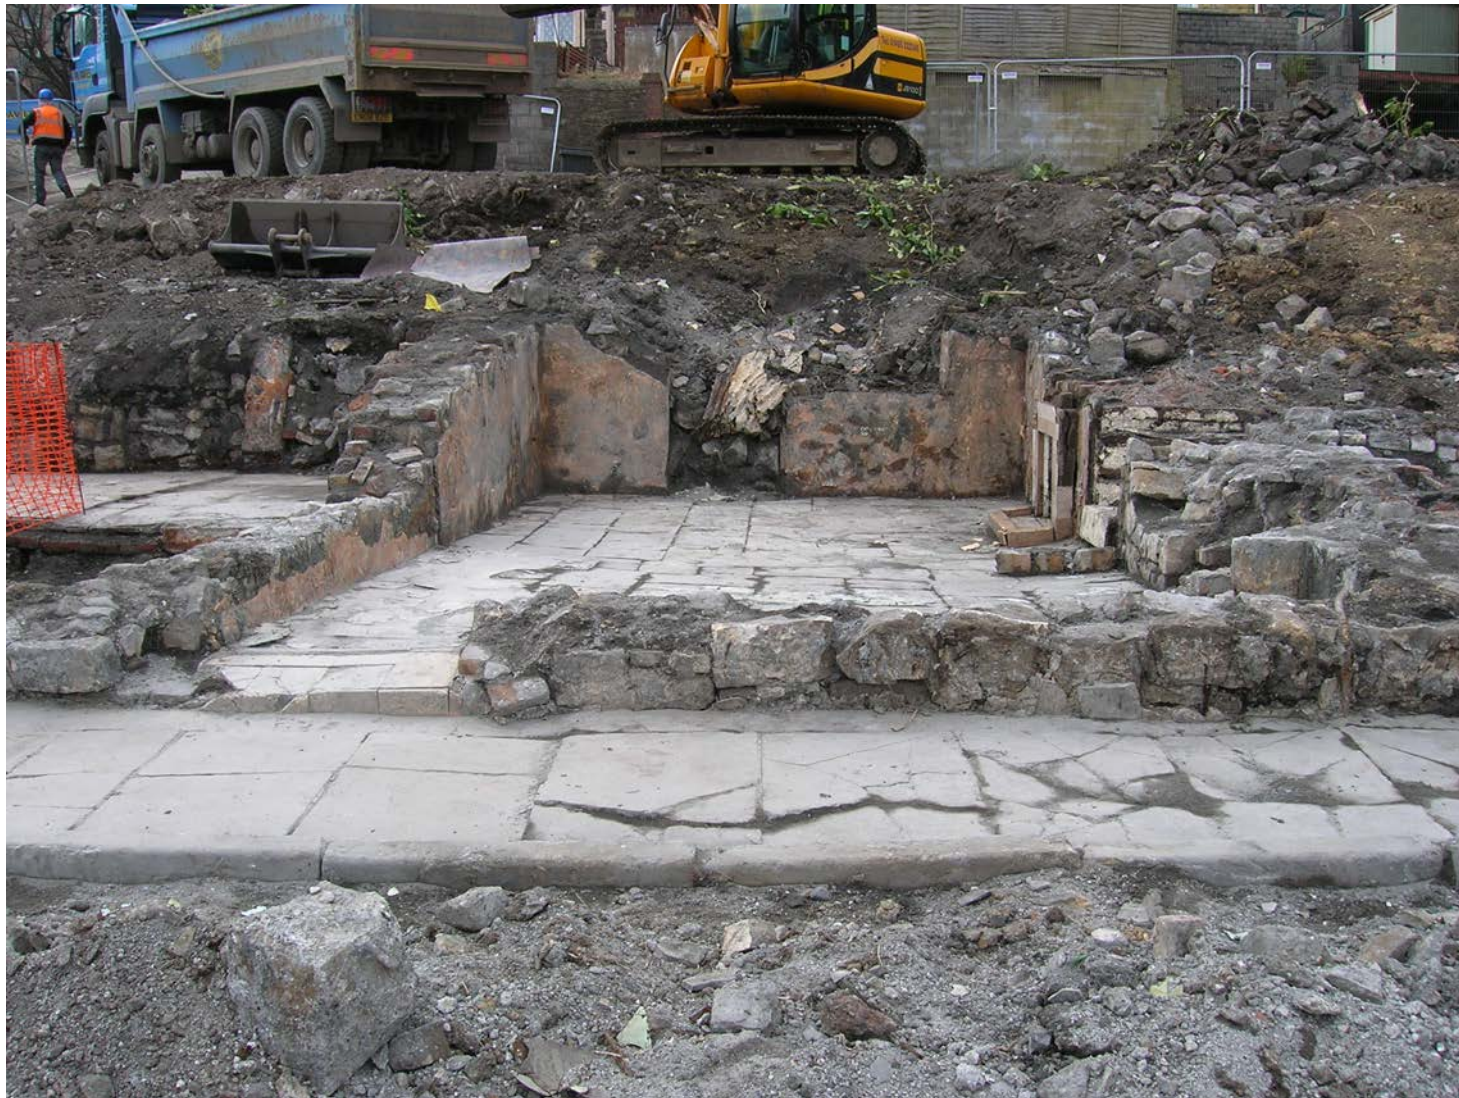
Fig. 11  
General view of  
No. 2 Prospect  
Place.

Looking WSW

The front room measured 3.85m across (north-south) and 3.10m - 3.2m front to back (east-west). The flooring consisted of sandstone flags (fig. 11).

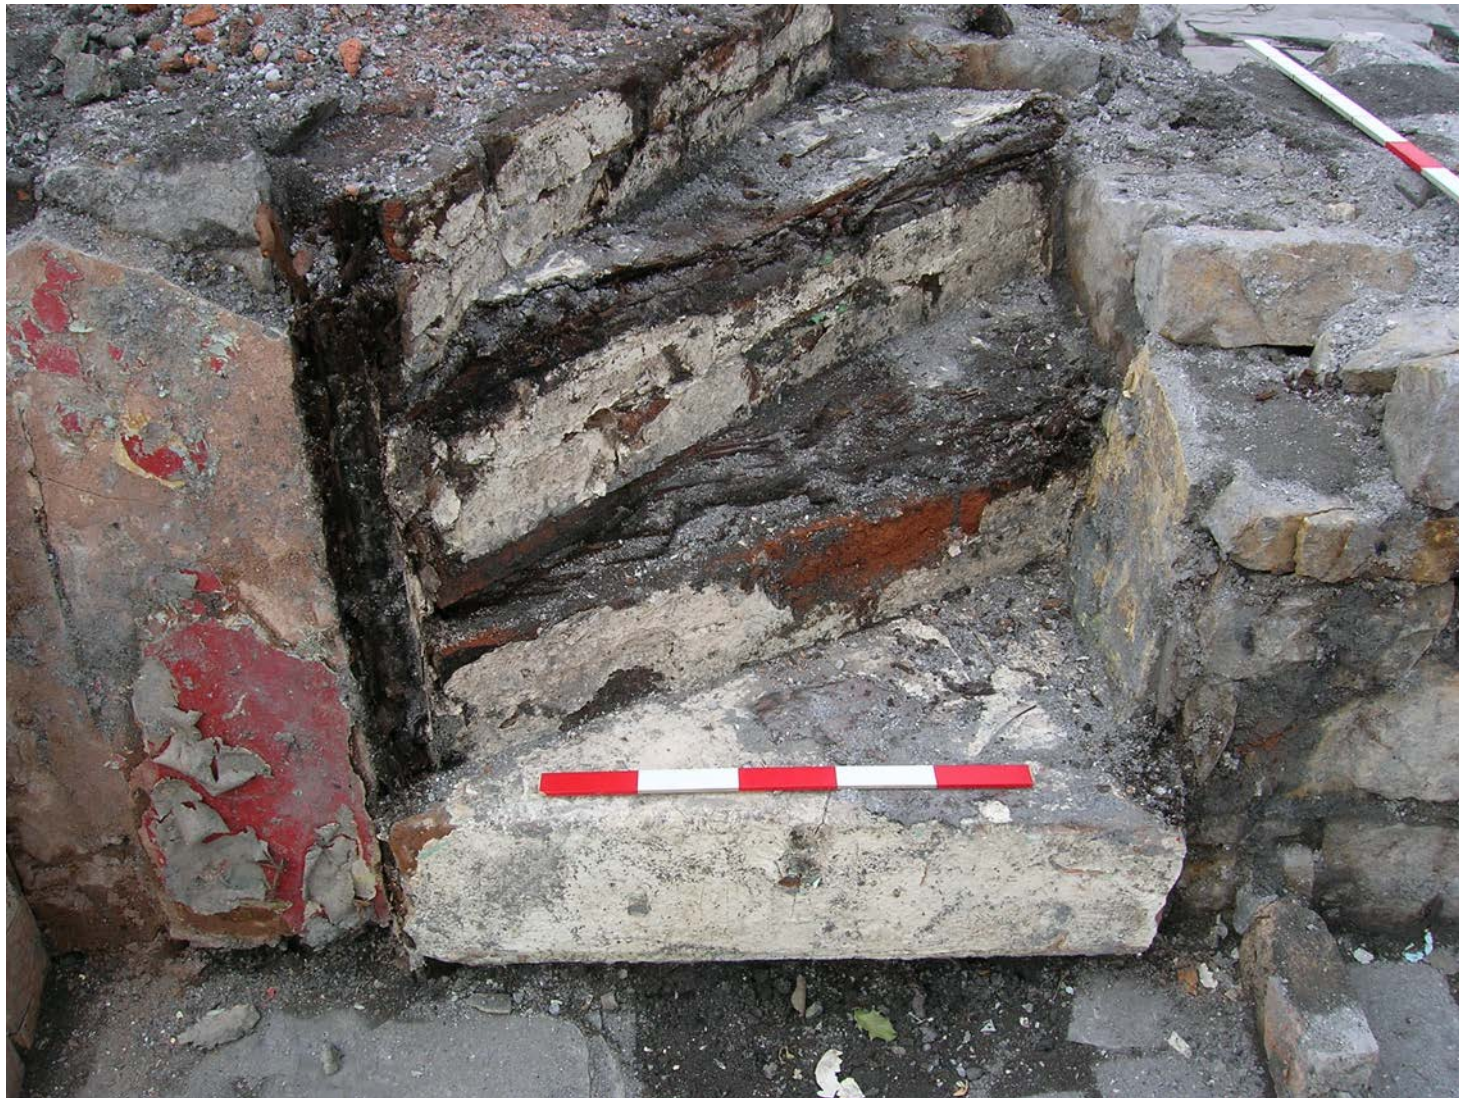
Fig. 12  
The staircase within  
No. 2 Prospect  
Place.

Looking NNW

A mid twentieth century fireplace was positioned centrally on the northern wall. A staircase was located to the left (east) of the fireplace; this was built in brick, with wooden treads extending over the risers (fig. 12). Only the lower section of the staircase survived. The bottom three steps turned within a 0.8m square stairwell.

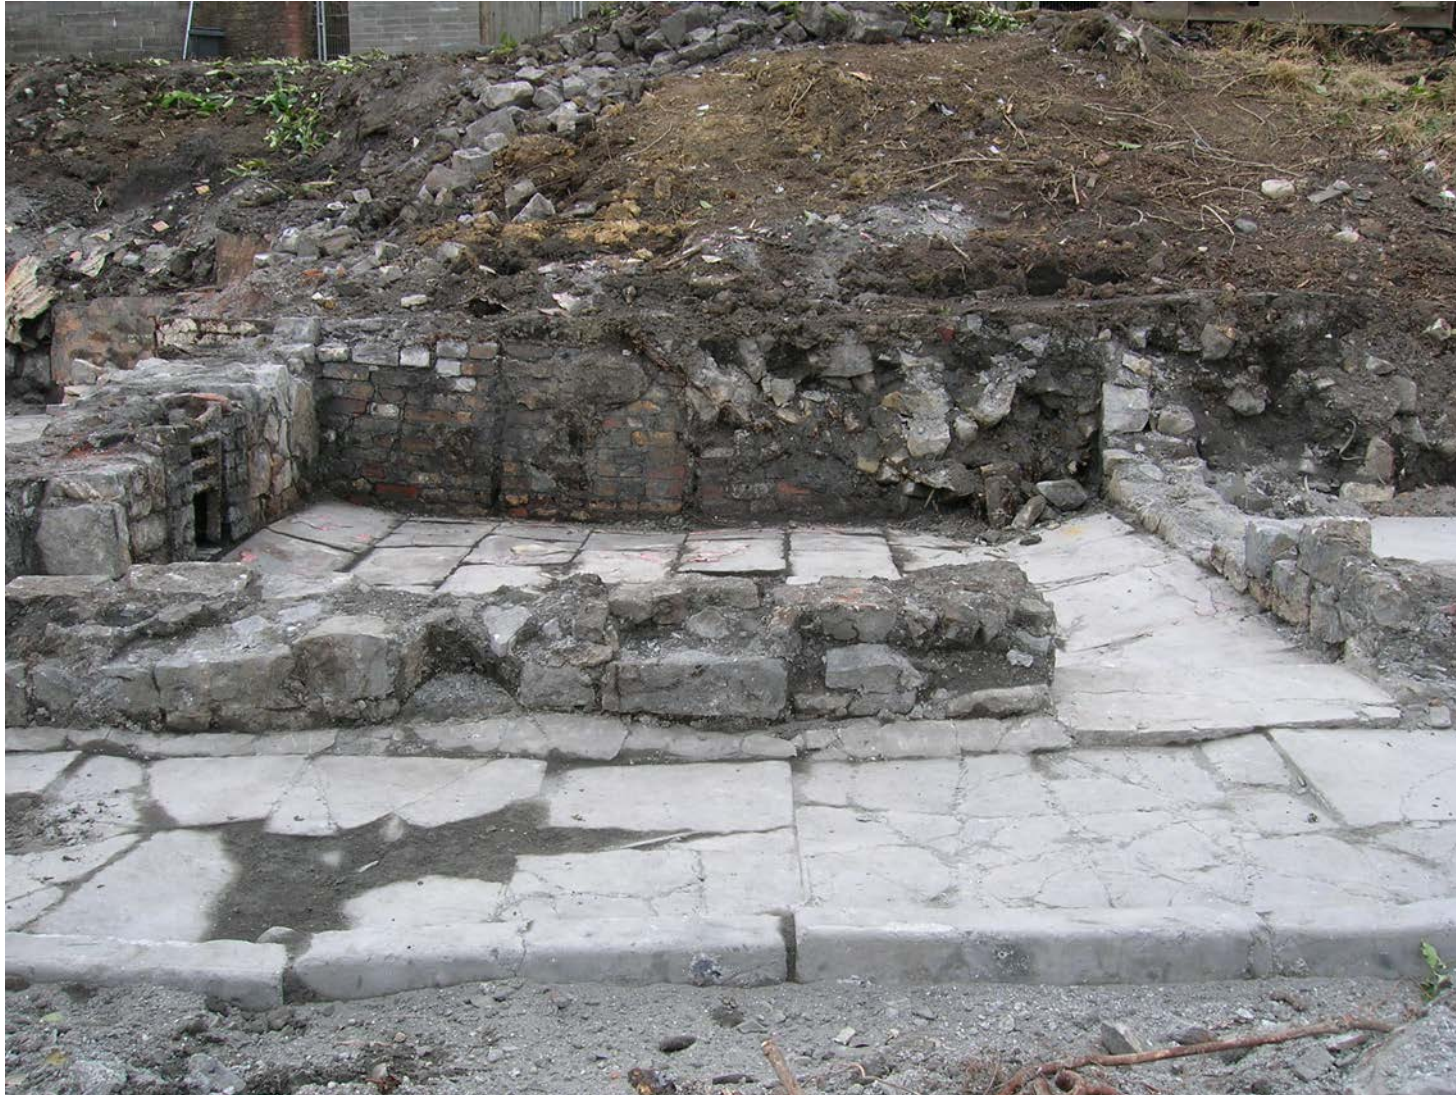
Fig. 13  
General view of  
No.3 Prospect Place

Looking WSW

The front room measured 3.85m across (north-south) and 3.2m front to back (east-west). The flooring consisted of sandstone flags (fig. 13).

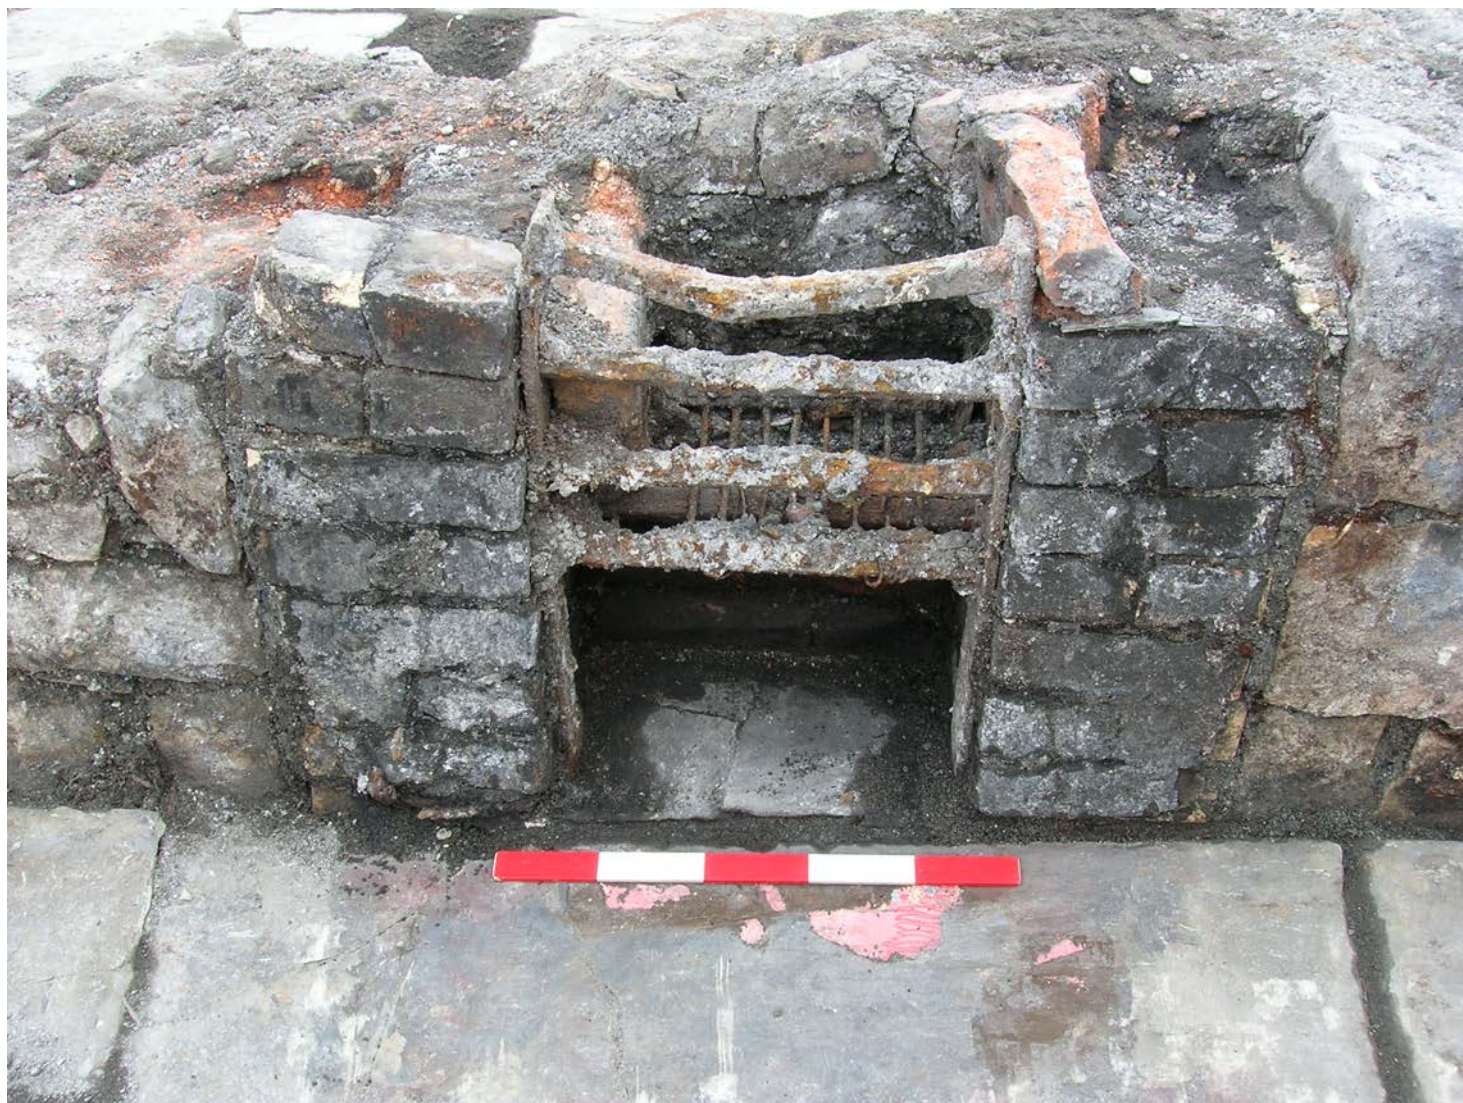
Fig. 14  
The fireplace  
within No.3  
Prospect Place

Looking SSE

A fireplace was positioned centrally on the southern elevation. This comprised a cast iron grate set in brickworks surrounds (fig. 14). This flue was positioned back to back with that of No.2, set within the 1.22m thick party wall. The opposite wall (northern elevation) was of less substantial construction, being 0.43m to 0.5m thick.

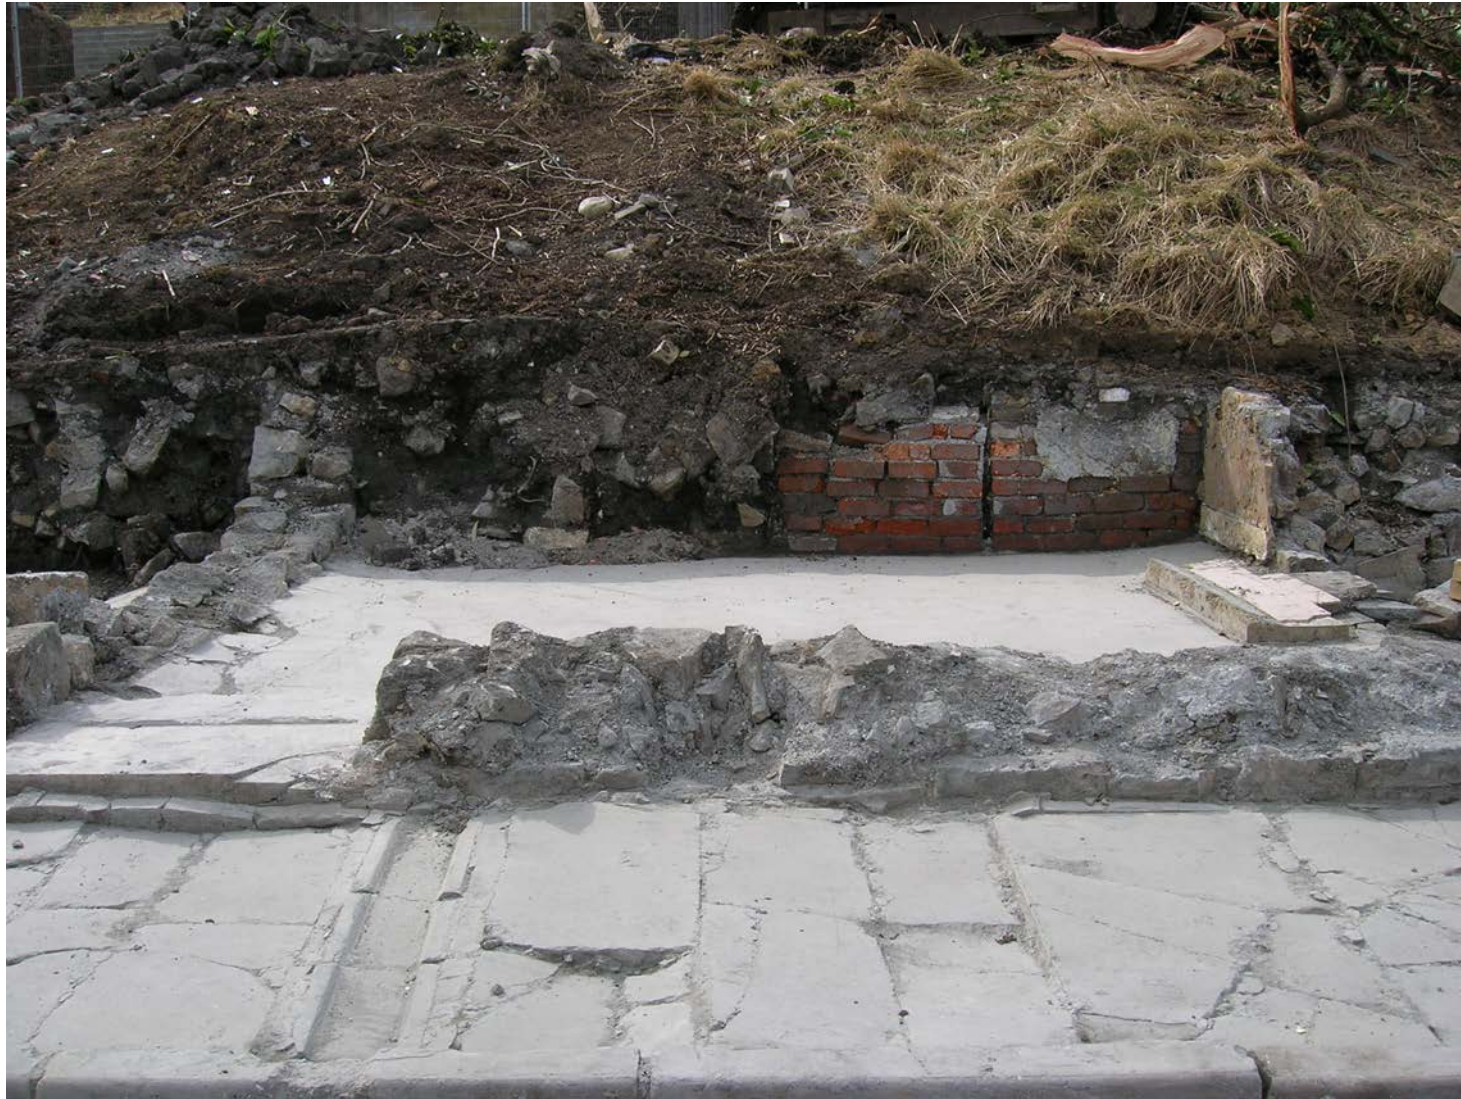
Fig. 15  
General view of  
No.4 Prospect Place

Looking WSW

This property appeared to have the same two-room layout as Nos. 2 and 3 Prospect Place, although it was not fully revealed during the groundworks. The front room measured 4m across (north-south) and 3.2m front to back (east-west). The floor consisted of a thin concrete slab laid over the original flagstones (fig. 15).

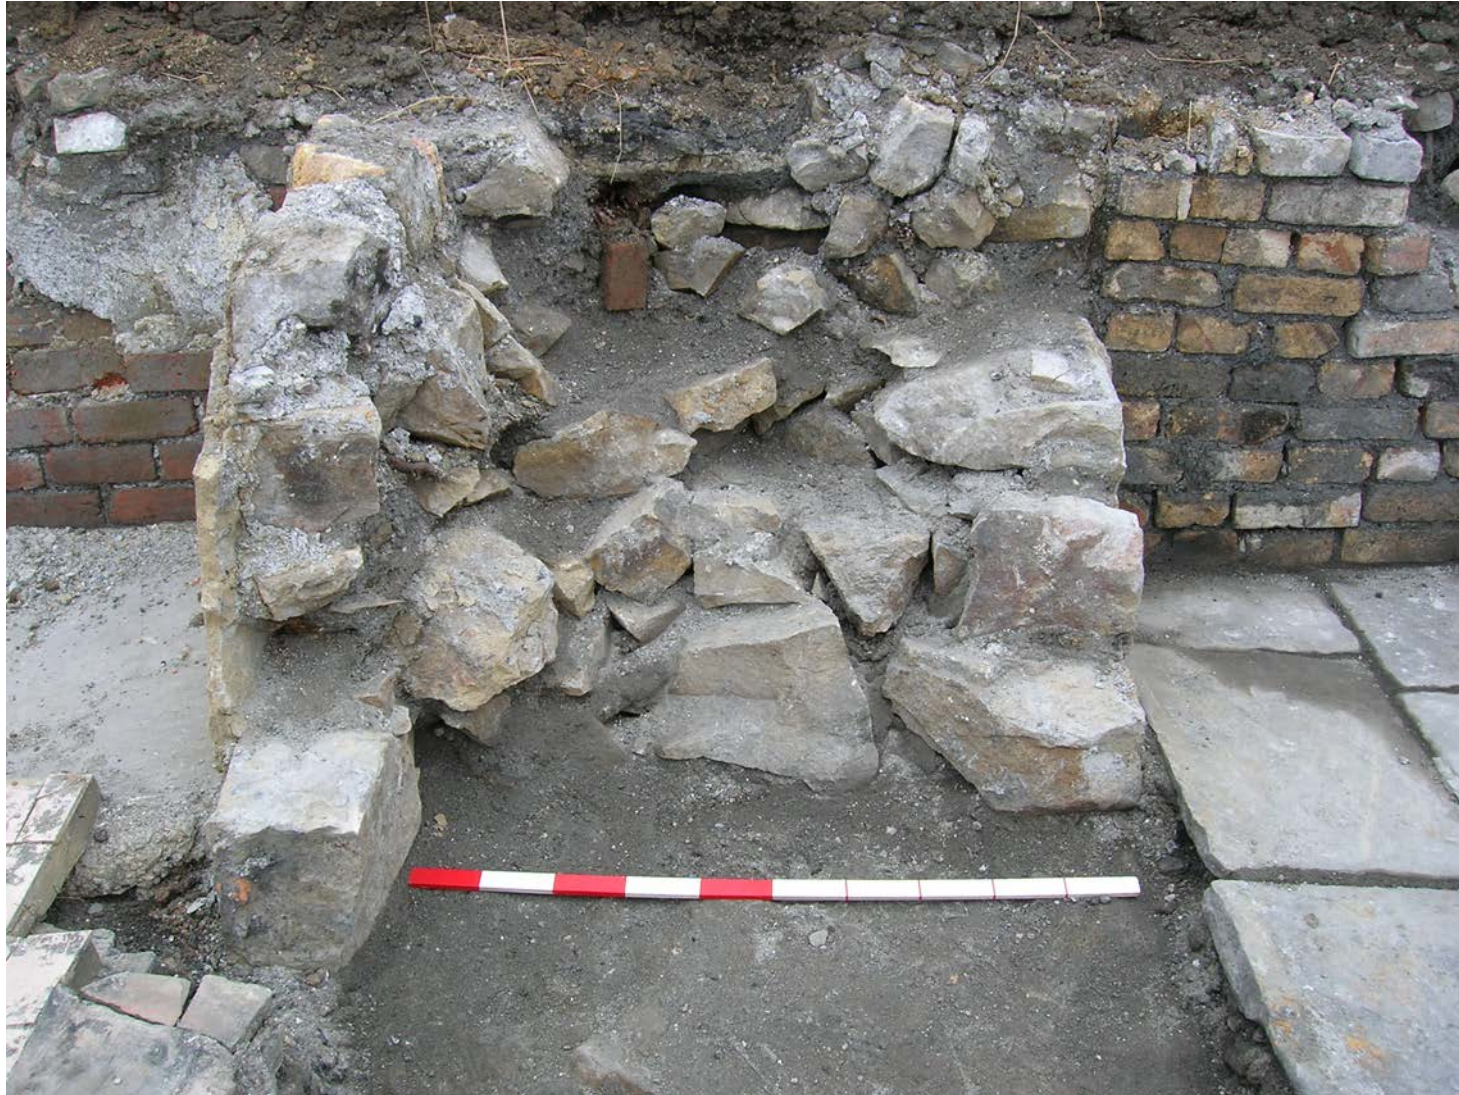
Fig. 16  
Section through the  
party wall between  
Nos 4 and 5  
Prospect Place

Looking WSW

The side wall to the north of this room was noted to be 1.22m wide, the same width as the substantial party wall shared by Nos. 2 and 3. A section of this wall had survived to the rear of this room; showing the general construction of facing stones in lime mortar with a rubble core at least 0.6m across (fig. 16). The position of the original chimney was marked by a twentieth century hearth, positioned approximately central to this wall

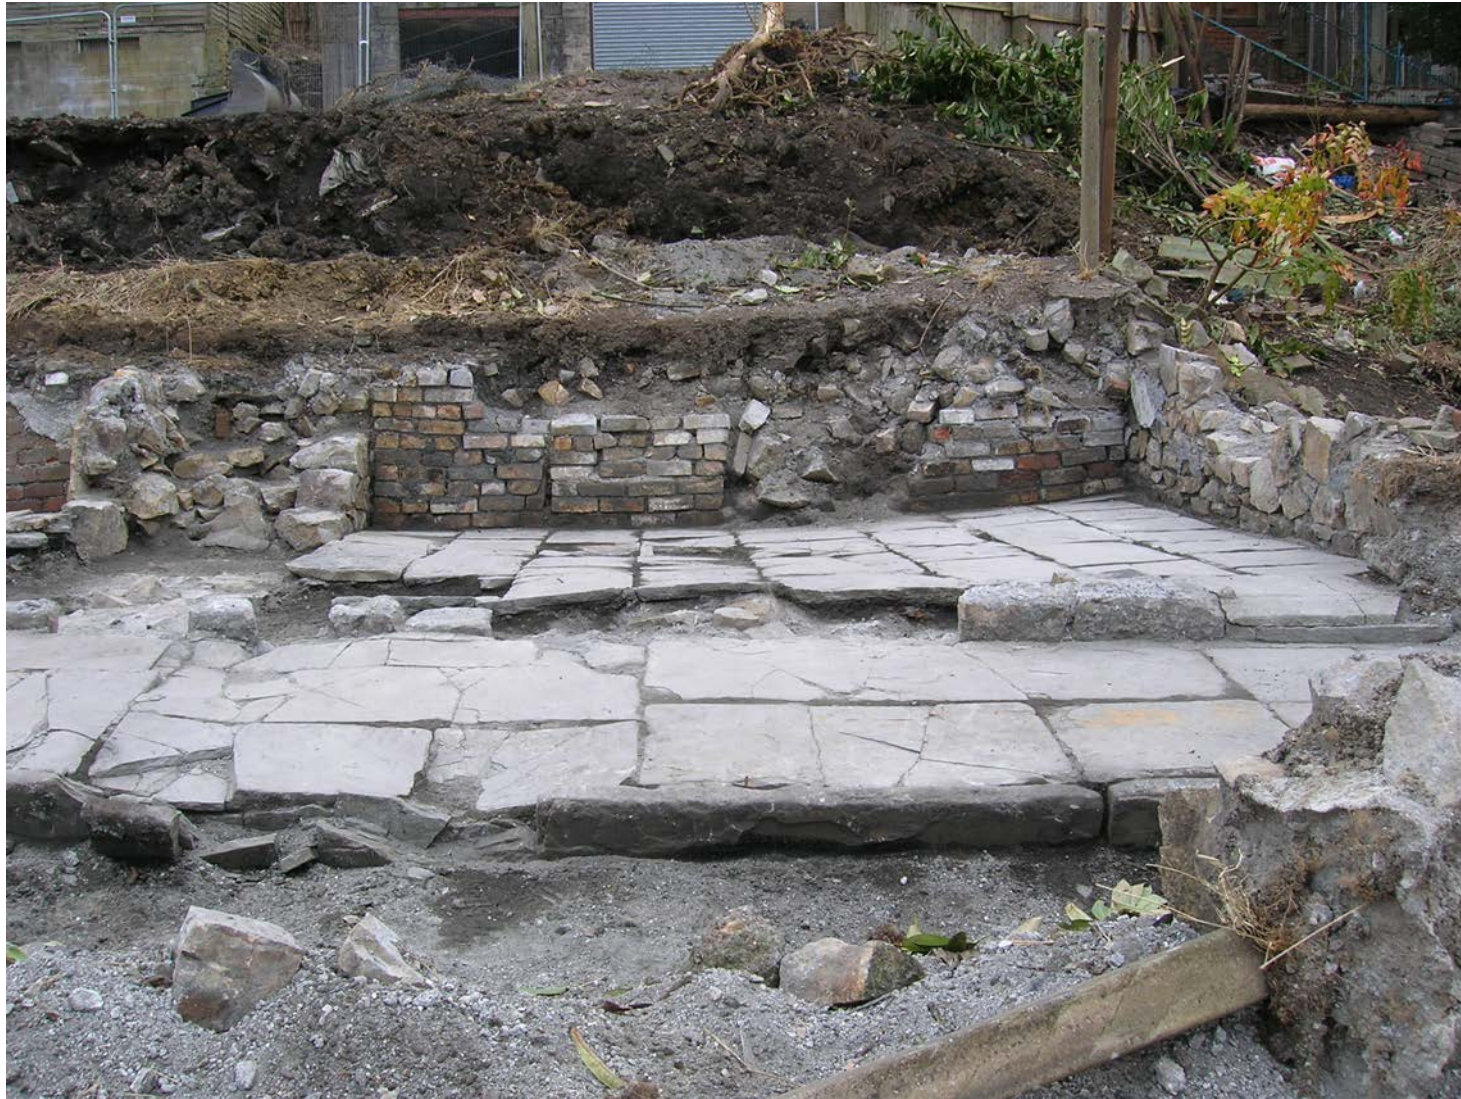
Fig. 17  
General view of  
No.5 Prospect Place

Looking WSW

No. 5 had a two-room layout similar to Nos. 2 to 4 Prospect Place. The front room measured 3.9m across (north-south) and 3.20m front to back (east-west). Very few architectural features had survived in this property, although unlike in No. 4, the flagstones had survived more or less intact (fig. 17).
