## **Prospect Place, Ebbw Vale**

Archaeological Watching Brief

Report No. 1131

**May 2013**

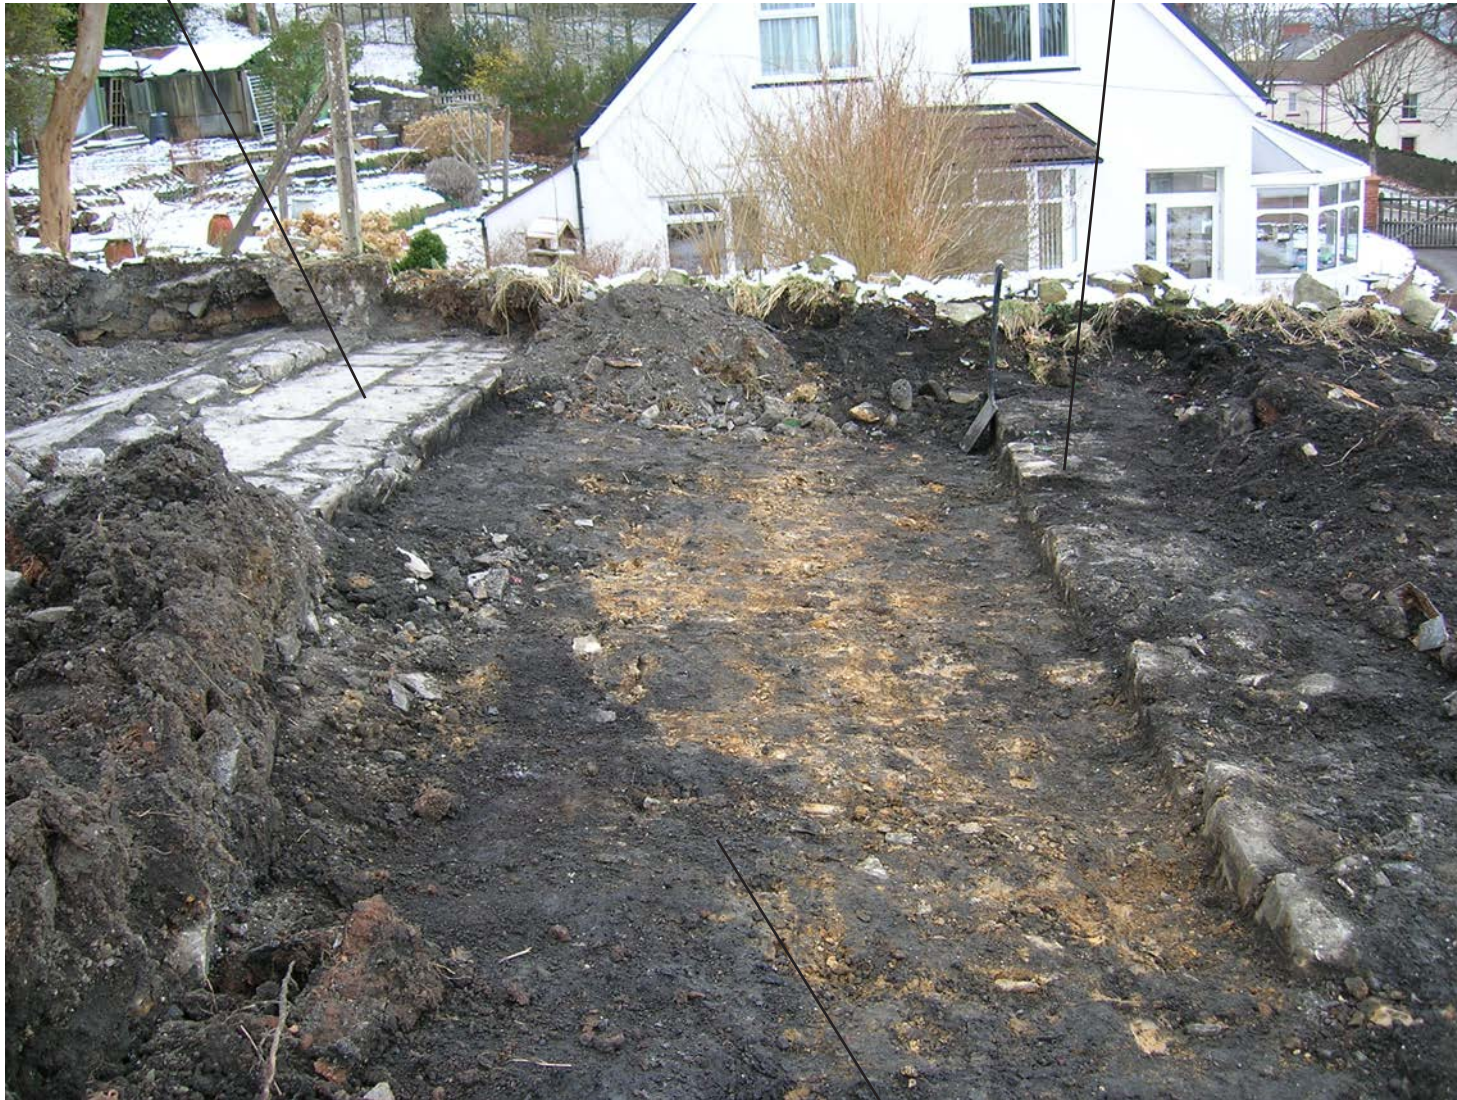
Fig. 18  
The pavement,  
road and boundary  
wall to the east of  
the houses on  
Prospect Place

Original slab pavement

Boundary wall

Road

Looking N

During the groundworks, the access road for Prospect Place was identified to the east of the terrace housing. The former road was defined by a pavement to the west and a stone wall to the east. Some patches of old tarmac were found along the line of the road; this surface appears to have been laid directly on top of the natural subsoil (fig. 18).

The pavement in front of the houses was about a metre wide, extending along the entire length of the terrace row. The original stone paving slabs and kerb stones had survived at the northern end of the site; the remaining slabs and kerbs were of concrete.

The short stretch of wall discovered to the east of the terrace, in front of Nos. 4 and 5, was built of stone blocks in lime mortar. It was approximately 0.5m wide and extended some 8.4m (to align with the extant stone pillar on Mount Street). The average height of the wall was 0.5m lower than the pavement, which suggests that

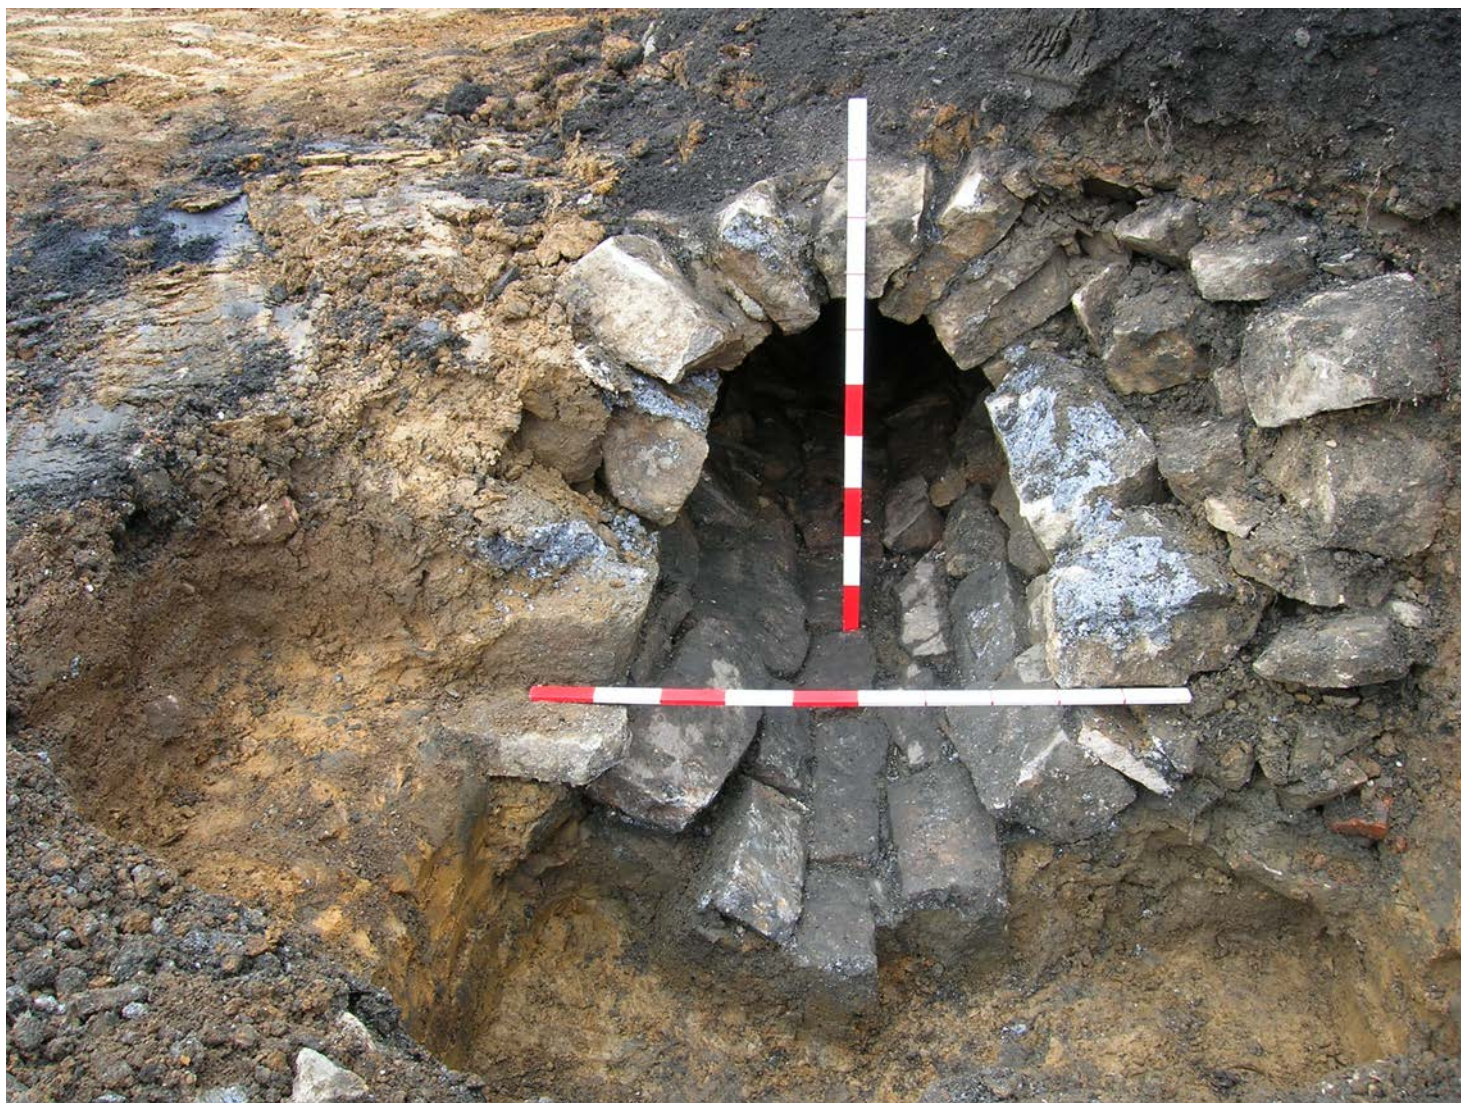
Fig. 19  
Culvert identified  
to the north of  
the houses on  
Prospect Place

Looking W

A large culvert (fig. 5 and fig. 5a) was identified along the northern side boundary. This feature had an internal diameter of 0.55-0.65m and was at least 15m long, running downhill on a predominantly east-west alignment. For the most part it was built of large stone blocks, with the upper stones forming an arch set in lime mortar (fig. 19). Towards the bottom of the site, the culvert was built in brick; it is here that the culvert appeared to turn approximately 45 degrees, to run (north-south) parallel to the boundary with the Institute.

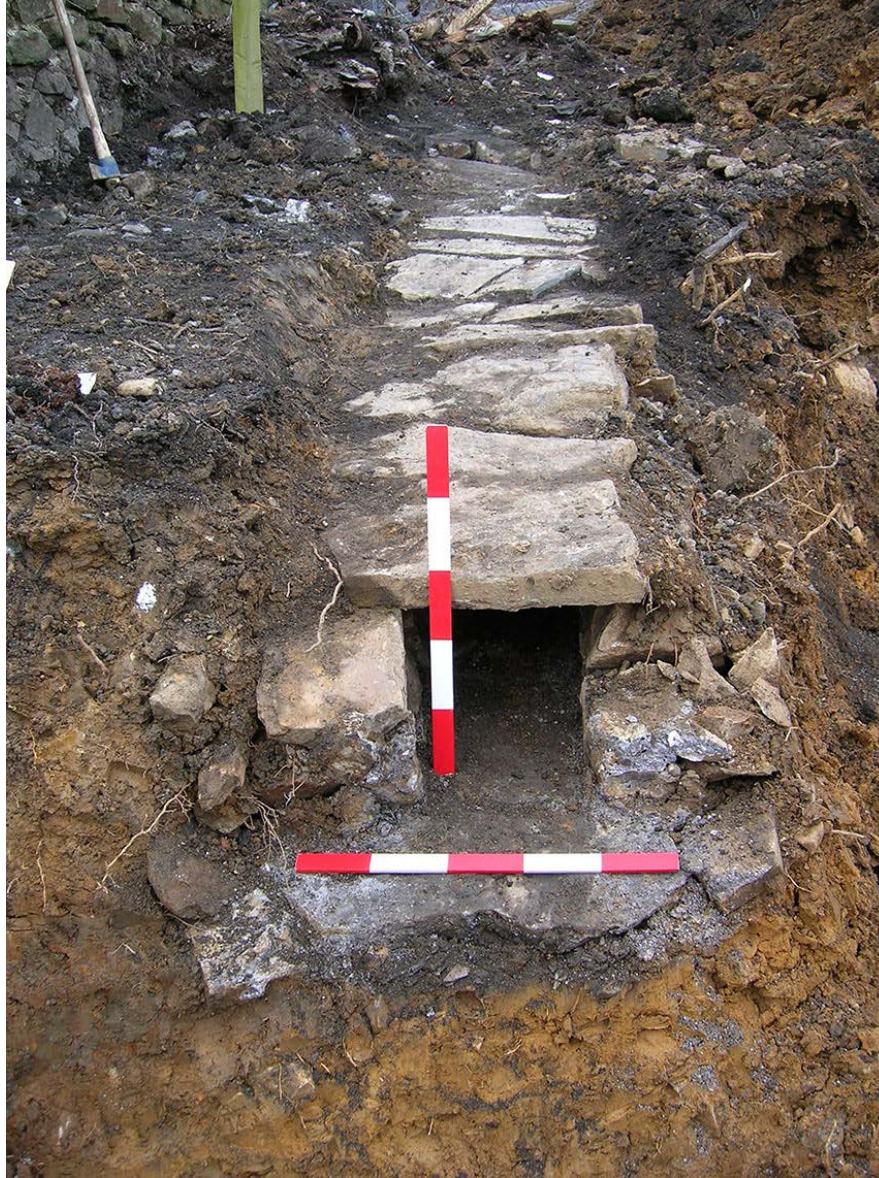
Fig. 20  
Slab covered culvert  
identified to the  
south of the houses  
on Prospect Place

Looking NE

Another drain or culvert was discovered on the southern side of the site, although this was much smaller, at approximately 0.25m square (fig. 20). The culvert ran downhill from the eastern end of Prospect Place (at the junction with Mount Street). This feature extended some 6.5m in an east-north-east direction, but appears to have been disturbed at the lower end of the development site. This culvert was constructed of blocks set in lime mortar over sandstone slabs. The top was also covered with slabs. This culvert was covered by around 0.3m of topsoil.
