Ardwyn, Former Children's Home Dinas Powys

Standing Building Recording

Report 1317

Ardwyn, Former Children's Home, Dinas Powys

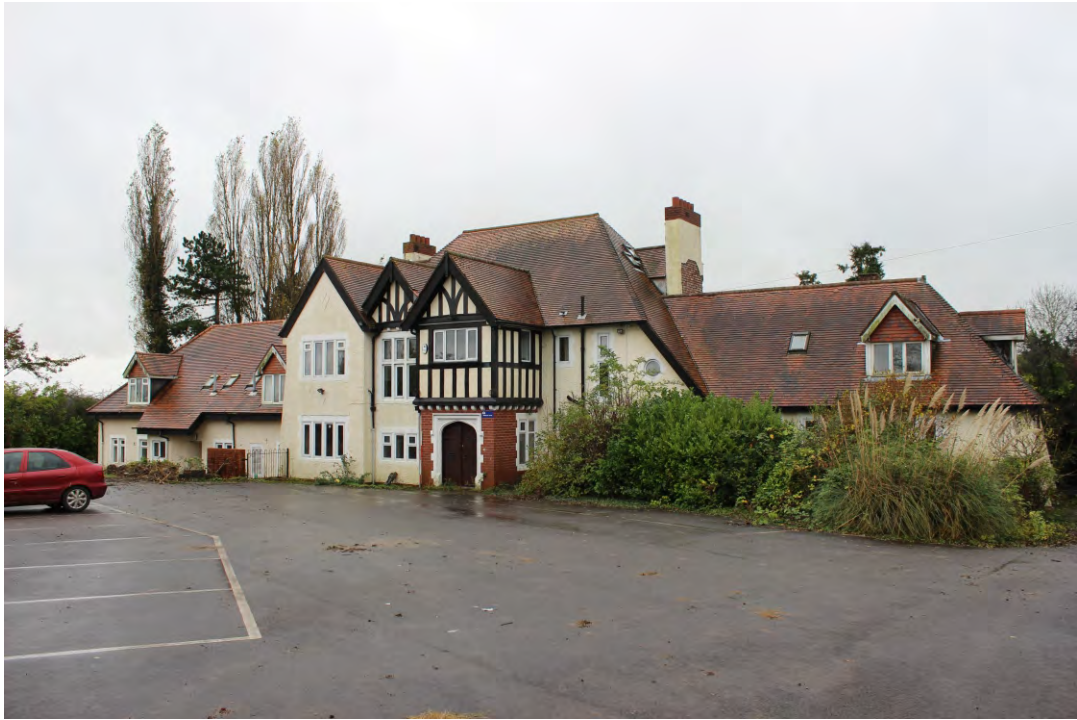
Plate 1: View south, showing Ardwyn north-east elevation(front)

- The insertion of modern double glazing and fire doors throughout.
- The insertion of a gabled dormer and skylight in the north wing, north-east elevation. Plate 1
- The blocking of a doorway in the north-west elevation. Plate 6
- The insertion of a gabled dormer in the north wing, south-west elevation. Plate 7
- The extension south-east. Plate 10-12
- The insertion of stairs in the entrance hallway. Plate 15
- The insertion of a modern kitchen. Plate 35
- The insertion of a modern tiled storage room. Plate 37
- The blocking of ground floor fireplace. Plate 40
- Replacement of the stairs. Plate 51
- The blocking of the first floor bedroom fireplace. Plate 55
- The blocking of a doorway in the first floor games room. Plate 57

The building can be viewed as three sections (Plate 1); the central main section is three storey (Plate 2), the north-west wing is two storey (Plate 6 and 7) and the south-east wing is two storey (Plate 10-13). The building is orientated north-west to south-east, with the two wings at either end of the central section slightly smaller in width than the centre. They are all constructed of brick in a stretcher bond with the lower half of the wall left exposed and the upper sections with a pebble stucco effect painted cream. The main entrance on the north-east elevation is a half-timbered construction of Tudor style with the adjacent gable also similarly constructed (Plate 2).

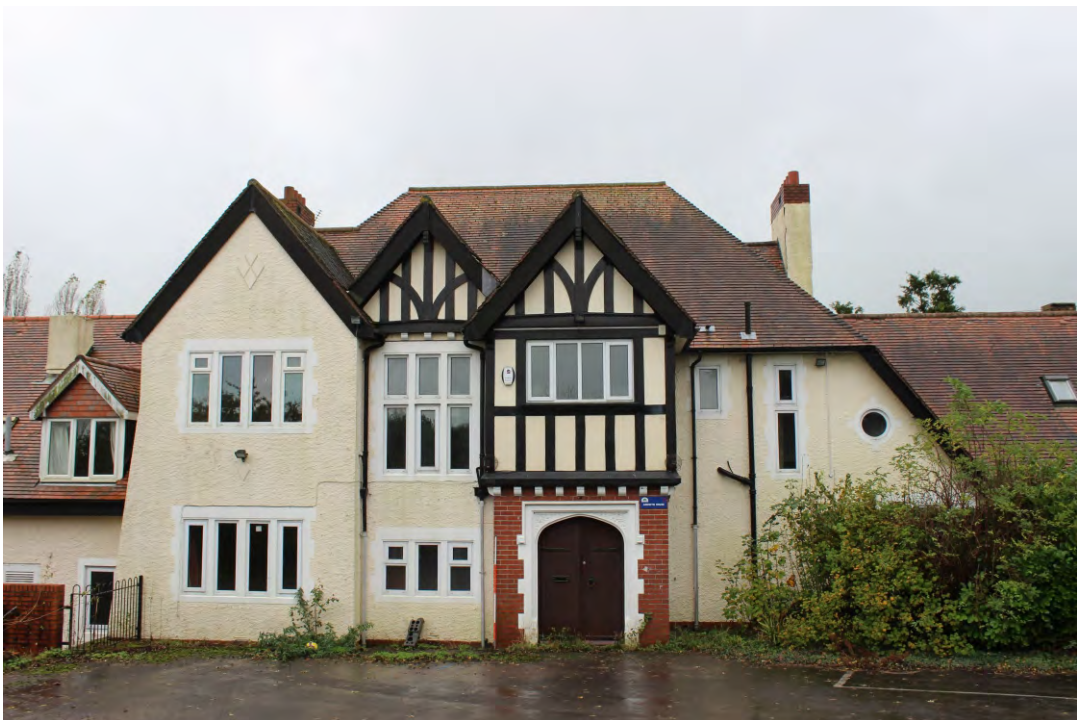
Plate 2: View south-west, showing north-east elevation main frontage

The central section is a hipped roof construction, with a triple gable frontage and an outshot - a section of roof extending further down - at the north end (Plate 2). The rear elevation is twin gabled with a wide valley (Plate 8 and 9). The north-west and south-east wings are of a hipped roof construction which join the main central section, off centre toward the east side. The eaves are all overhanging timber boards painted black. The wings are interspersed with gabled dormers (Plate 10 and 12) and the roof trusses, where visible inside the building, appear as a common roof truss (Plate 65). There are two main chimney stacks located at either end of the main central section of the building, with a third smaller one visible on the south-east elevation of the south-east wing (Plate 10). The building is roofed with ceramic plain flat tiles with a half-round ridge plate (Plate 13).

The **south-east elevation** of the building has a two storey triple gable front which protrudes from the building, with the central gable slightly recessed from the flanking (Plate 2). The southern gable has a flared buttress on its southern end with four light mullioned windows in ground and first floor, with polished ashlar effect stucco, painted white around the window surround. A decorative diamond is located between the first and second floor with a group of four between the eaves of the roof. The central gable has a shorter three light mullioned window in its ground floor, with a taller six light mullioned and transom window in the floor above, both have the same polished ashlar effect stucco painted white around the window. The gable roof above the window is constructed with timber framing painted black, supported on a projecting ovolo moulded corbel table, with dentil carvings along the bottom chord and close studding and arched braces (Plate 2 and 3).

North of the projecting gables, the main building has pebble stucco that has been painted a cream colour. A short single light window with polished stucco effect surround painted white is located in the first floor, a second tall slim window with a one over one light is adjacent. The roof just past the tall slim window has an outshot which proceeds down to the level of the ground floor ceiling, under the eaves of the outshot, still located in the first floor is a single light circular window with white stucco effect surround (Plate 2).

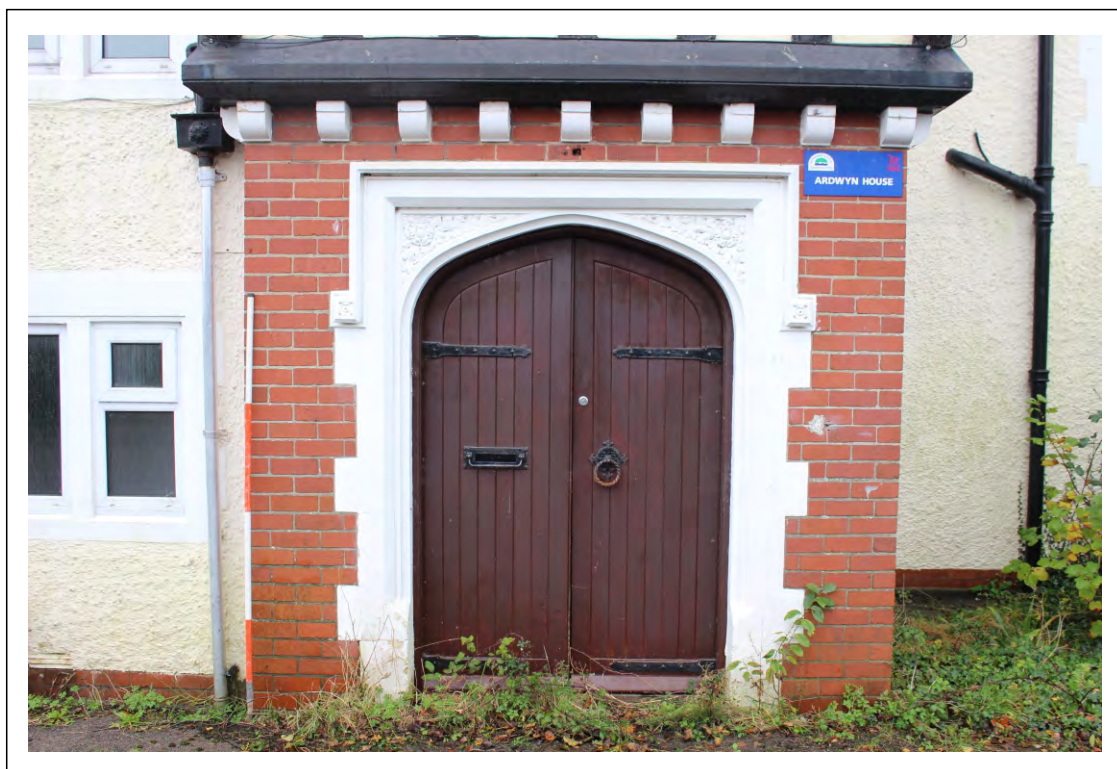
Plate 4: View south-west, showing main doorway

The **northern gable** has the main doorway for the building and is a half-timbered construction with the ground floor that of brick and the first floor and eaves of the gable constructed of timber framing (Plate 3). The doorway has a four-centred arch, with moulded spandrels featuring Tudor rosettes and a hood mould above. The door surround has polished stucco ashlar effect, painted white around the doorway (Plate 4). Above the doorway is an ovolo moulded corbel table supporting a projecting chamfered edge beam, with close studding above and a four light modern window centrally located in the first floor, with an ovolo carved sill. The gable is in the same style as previously noted, with close studding, arched braces and dentil work along the bottom chord. The eaves are overhanging, constructed of timber painted black supported on ovolo corbels. The side of the projecting gable has a two light mullioned window in the ground floor and abutting the main building, with polished stucco effect surround, painted white.

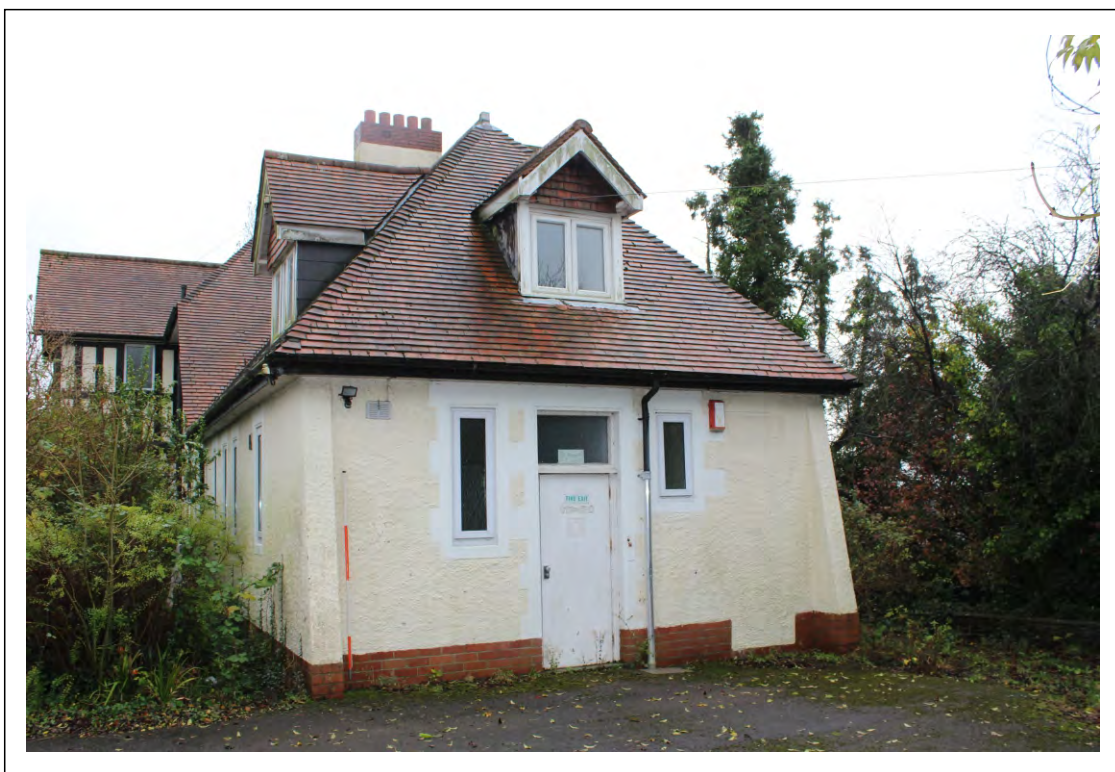
Plate 6: View south-east, showing north-west elevation

The ground floor of the **north-east elevation** below the outshot is a three light mullioned window, with white stucco effect polished surround, four more tall thin single light windows are present. Three are evenly spaced centrally along the north-west wing, whilst the fourth is slightly further north. The roof of the northern end of the wing is a gabled dormer with a modern three light window. The wing is supported by flared buttresses which extend north-west at either end of the north-west elevation (Plate 6).

The north-west elevation of the wing has a single door located centrally with flanking single light thin windows, the eastern window slightly taller than the west, with a second blocked doorway to the west of these. The windows and doorways, including one that is blocked, have polished stucco around the surrounds, painted white for the existing fenestrations, and cream for the blocked example. A small, two light, gabled dormer window is located centrally in the roof above (Plate 6).

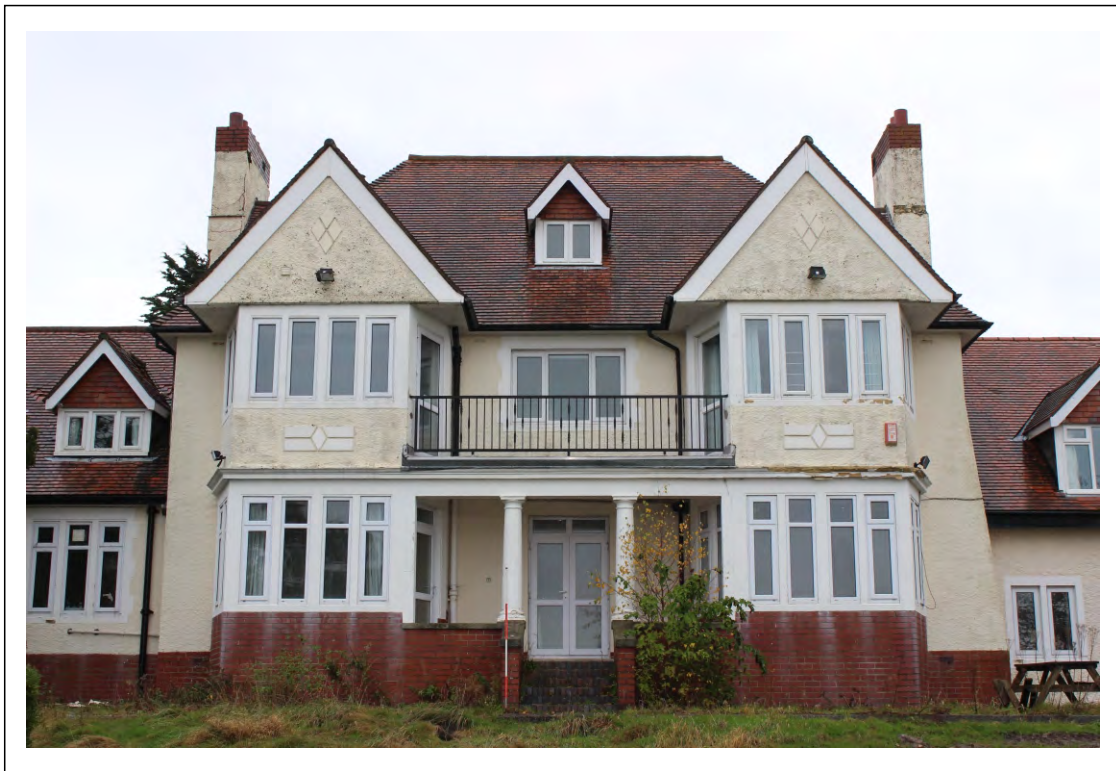
Plate 9: View north-west, showing main building south-western elevation

The main central three storey section of the building protrudes out from the north wing along the south-east elevation and extends outward again where the twin gables are located at either end (Plate 8). Octagonal window bays are located below the gables on the ground and first floor. The central bay on each floor has tall four light mullioned windows, with two lights on the outer panels. Doorways are located on the internal panels of the bays, with the exception of the southern ground floor internal panel, which has a tall two light mullioned window. A balcony joins the twin gables on the first floor, supported by a pair of columns on a brick wall which extends towards the centre from the window bays. A moulded cornice runs horizontally around the window bays and the bottom of the balcony. A flight of steps is located centrally between the twin gables which leads up from the garden to a modern double doorway. Centrally in the first floor between the twin gables is a modern three light window. In the roof above is a small thin gabled dormer with modern two light windows. The eaves of the twin gables are timber painted white with diamond decorations located centrally, a second polished stucco effect decoration is located below the central bay on the first floor. The southern end of the main central section of the building has a flared buttress and marks the limits of the original building (Plate 9).

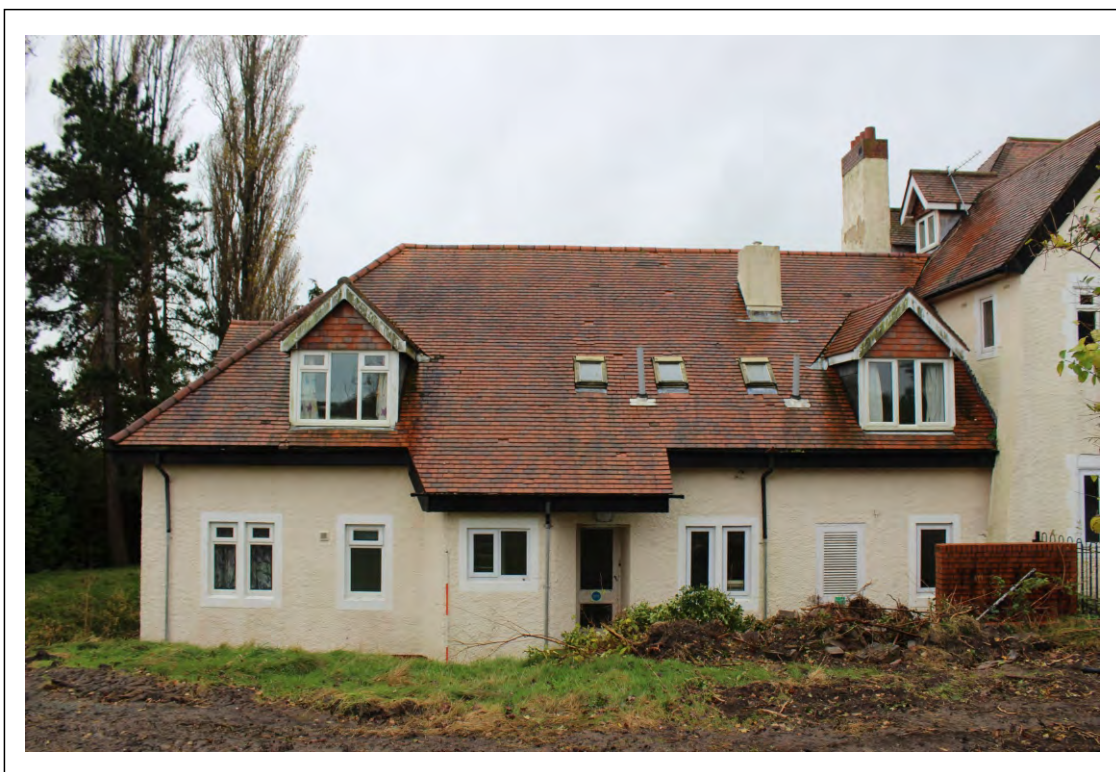
Plate 10: View south-west, showing later southern extension north-east elevation

The **north-east elevation** of the southern wing has a recessed fire escape located centrally along its length, with an outshot forming part of a covered area in front of the doorway and a protruding octagonal bay with a two light modern window to the south. South of this is a single light modern window with a two light mullioned modern window south again. North of the doorway is a two light modern mullioned window and toward the north end of the elevation a single modern light window with a maintenance vent between the two. The windows have the same white painted plain square stucco effect surrounds as the rear elevation. Two gabled dormer with modern three light windows are located at either end of the roof, with three small skylights located approximately central in the roof, with a small square chimney stack toward the north end (Plate 10).

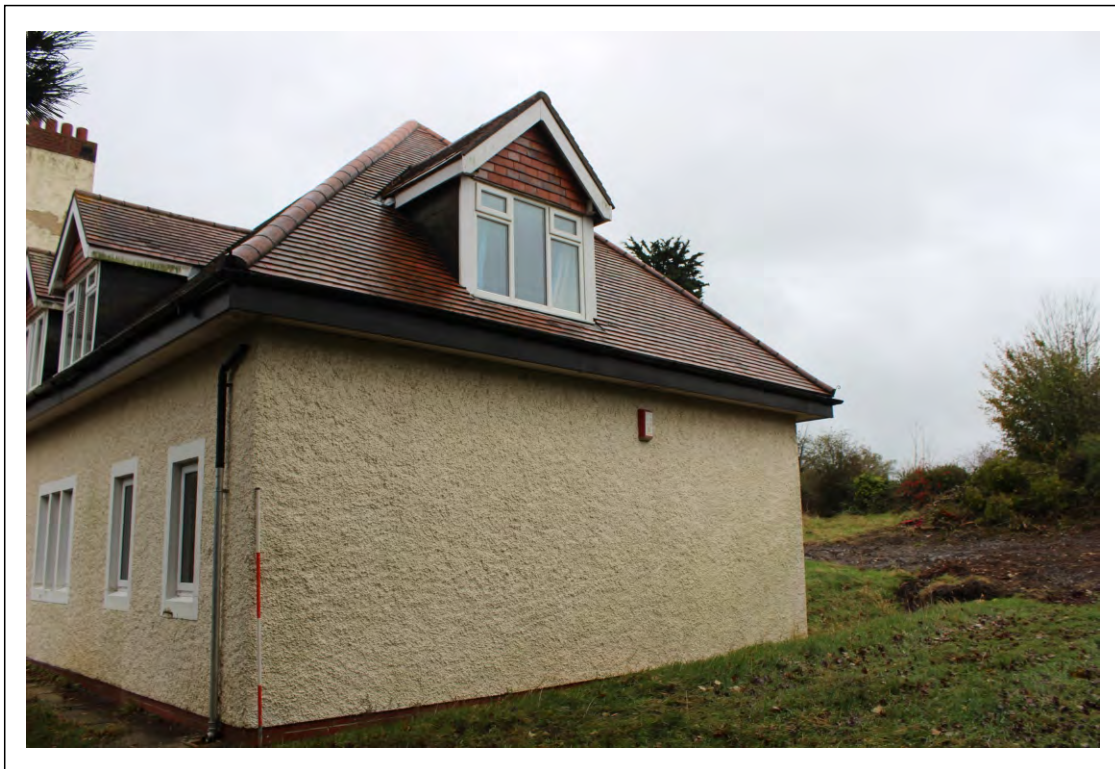
Plate 11: View north, showing later southern extension south-east elevation

The southern wing has five windows along the south-west elevation, from north to south; two light mullioned, three light mullioned, three light mullioned, single light and single light. The surrounds of these windows are of painted white plain square stucco effect without any ashlar effect indentation or scoring. Three gabled dormers approximately evenly spaced are located in the roof above with modern three light windows. The south-east elevation of the south wing has a single gabled dormer in the roof offset toward the west (Plate 11 and 12).

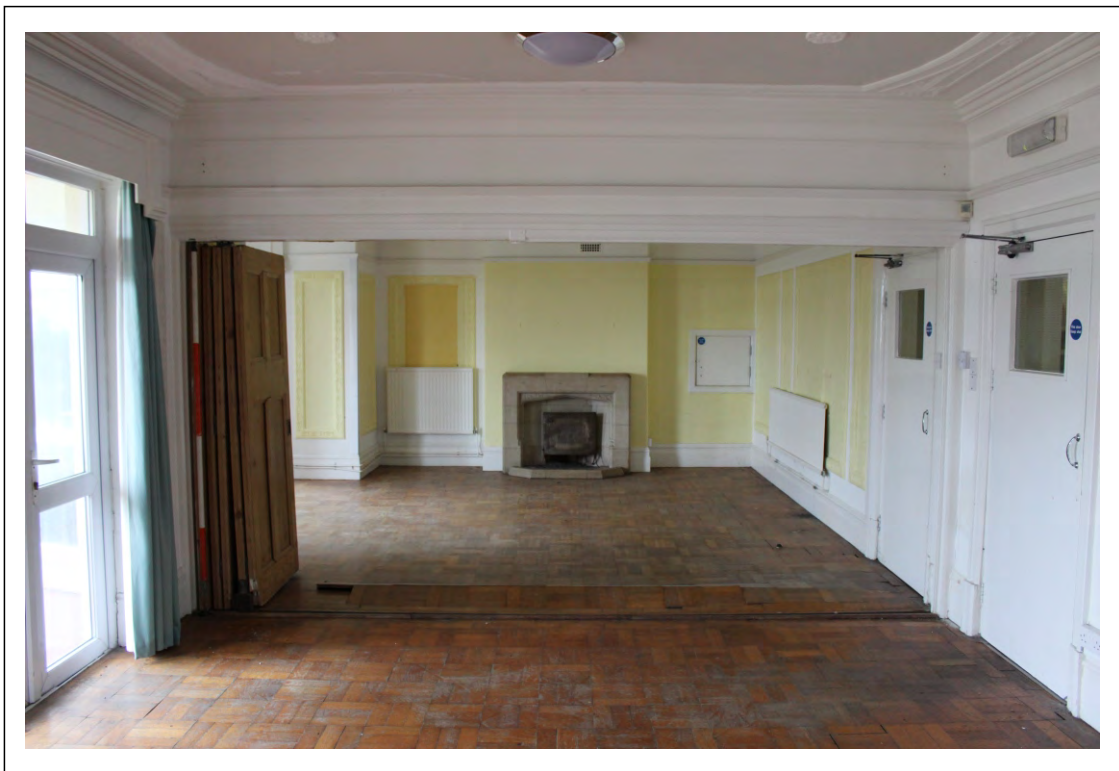
Plate 18: View north-west, showing northern dining room

The main dining room located off the hallway is a long rectangular room split by a folding screen wall (Plate 18). At either end of the room are the original art deco fireplaces (Plate 20-22). Octagonal window bays with chamfered edged mullioned windows are located at either end of the western wall with ornate carved pelmet boxes featuring Tudor rosettes (Plate 25). Plaster work panels festoon almost all the walls with foliate decorated borders (Plate 28 and 29). The ceilings are similarly decorated with the roof beams heavily moulded with cornice work bordering long roof panels, which feature further leaf decorations and Tudor rosettes (Plate 26, 27, 30 - 34). The

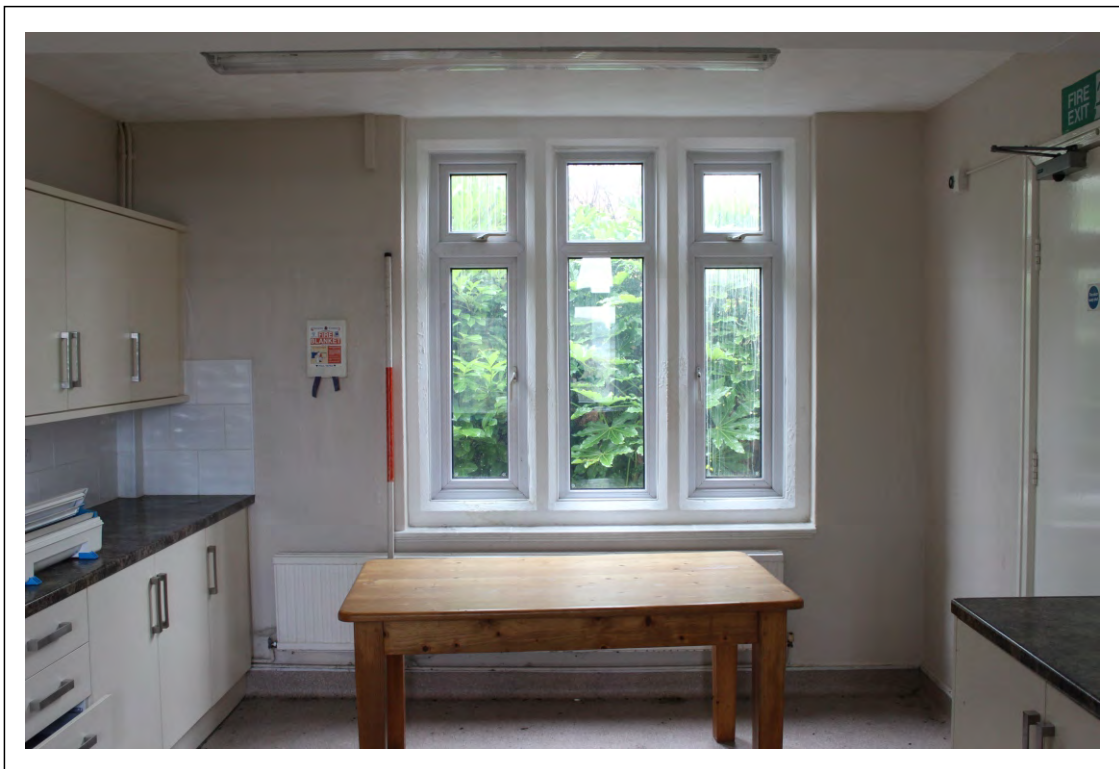
Plate 36: View north-east, showing ground floor north wing modern kitchen

Proceeding from the dining hall north along the corridor is the main kitchen, which has chamfered edged three light mullion windows in the east and west walls (Plate 36). The kitchen and internal features appear to be all modern (Plate 35). Leading north from the kitchen is a tiled storage room which has a chamfered edged two light mullioned window in its western wall. A doorway straight ahead leads further along the corridor with a door to the right which leads to a second storage room which has two single light chamfered edged mullioned windows in the east wall. These room appear modern in fabric and have been stripped of any original features. The tiled room has one arched recess in the north wall abutting the west (Plate 37). This possibly related to the blocked wall in the north-west elevation of the building.

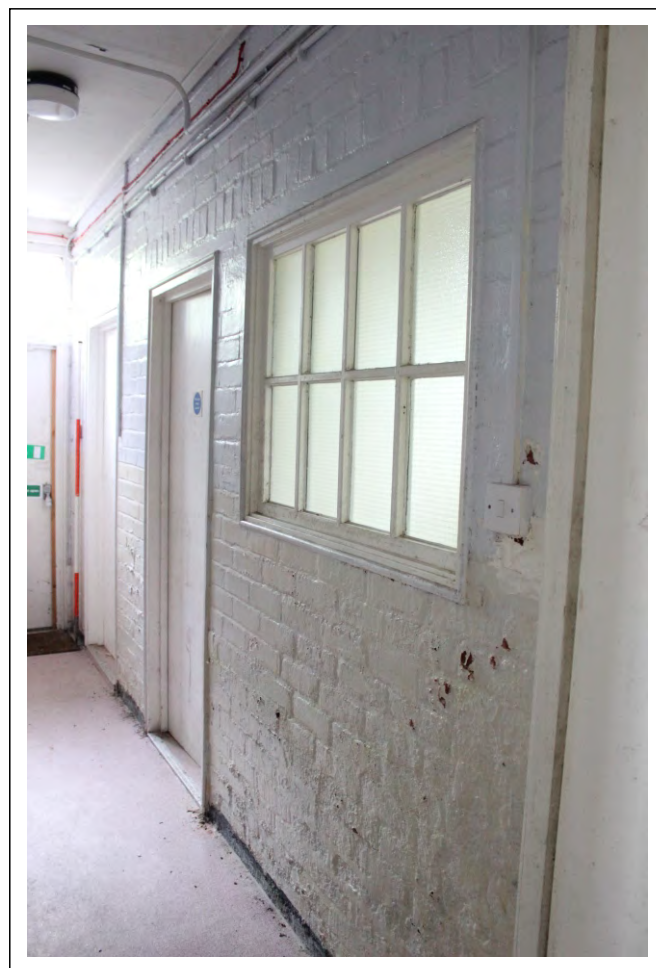
Plate 38: View north-west, north wing corridor

Entering the corridor to the north, there is a glass internal window four over four light in the east wall which is constructed of brick and painted white (Plate 38). Adjacent to the glass panel is a door which leads onto a room with two single light windows at either end of the east wall. The room has been stripped and is modern in fabric. Adjacent to this room is a small storage room with exposed brick and no notable features.

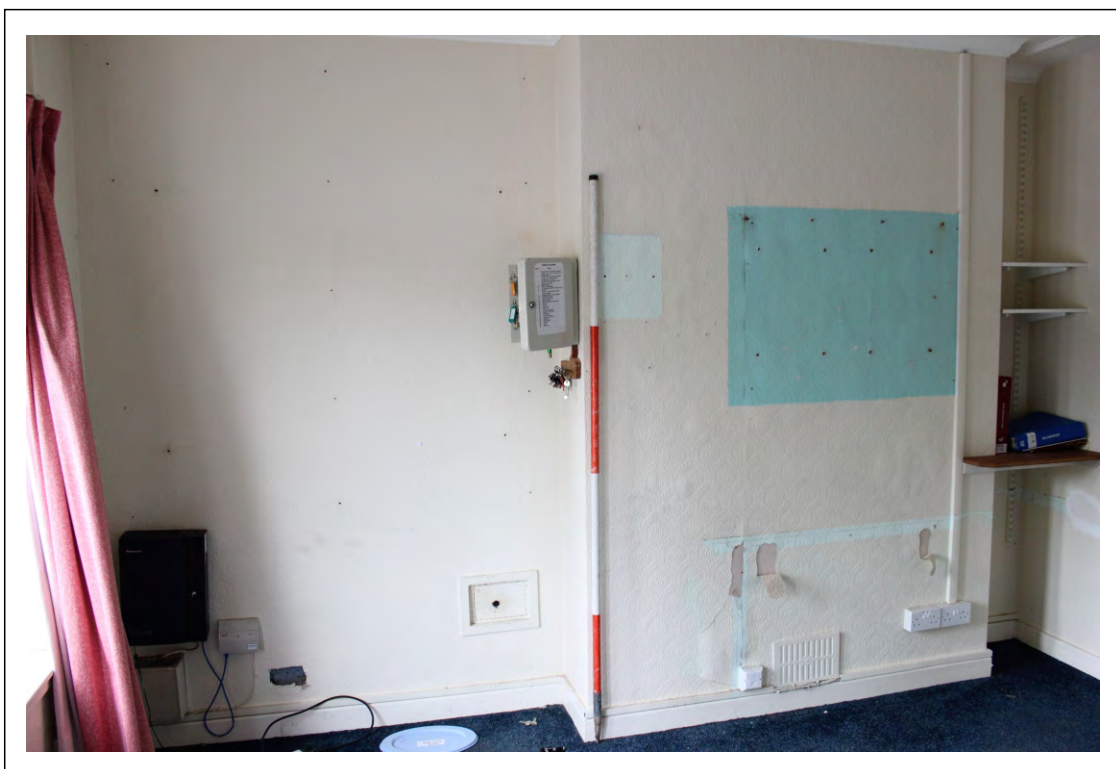
Plate 40: View south-east, showing blocked fireplace

The corridor which leads right from the main hallway has a door at the end which enters the north wing, adjacent to this is a second doorway which enters under the stair well. The room under the stairwell has original red quarry tiles which may have been utilised throughout the ground floor entrance hallway originally and appear to underlie the stud wall separating the room from the corridor (Plate 17). Turning left from the hallway, the corridor contains the main stairs that lead up to the first floor and a doorway adjacent that leads onto a large room with a blocked fireplace against the southern wall and chamfered mullioned windows in the east wall; this room held a key box and appeared to be a carer's room (Plate 40).

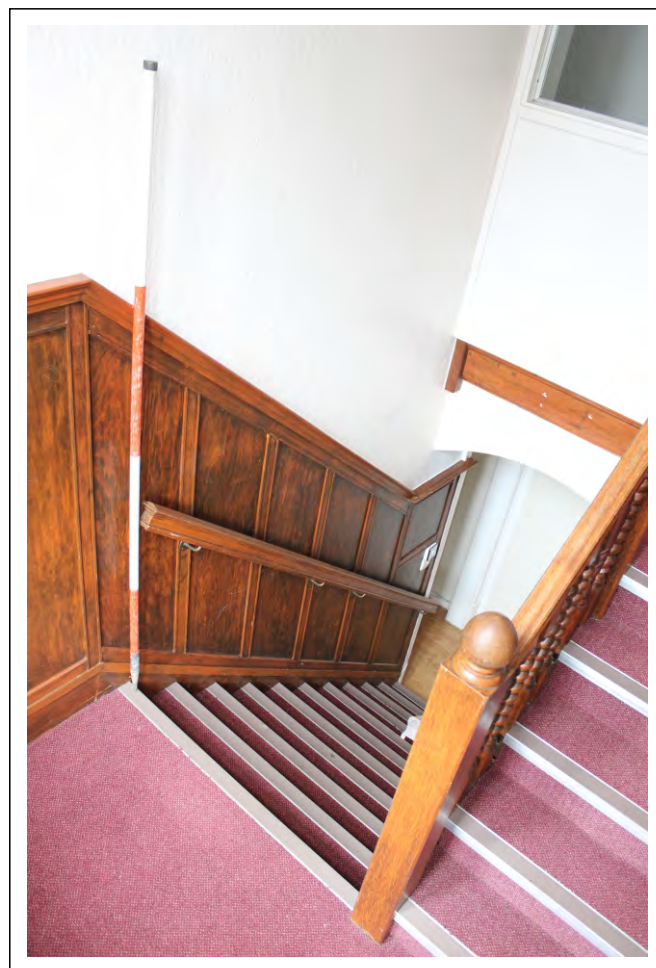
Plate 50: View south-west, showing main timber clad stairwell

The main flight of steps which leads up to the first floor from the hallway by the main entrance doors is constructed of timber panelling, which appears to be original (Plate 50). The stairs have a half landing with tall chamfered edged three over three light mullioned and transom windows (Plate 52). The lower ballustrade which are present from the half landing up to the first floor are the turned type and appear original except one, the upper landing ballustrade appear to be later additions and are a plain vase type (Plate 51). The stairwell is separated by a stud wall from the landing, which has a glass window and doorway which access the main first floor corridor.

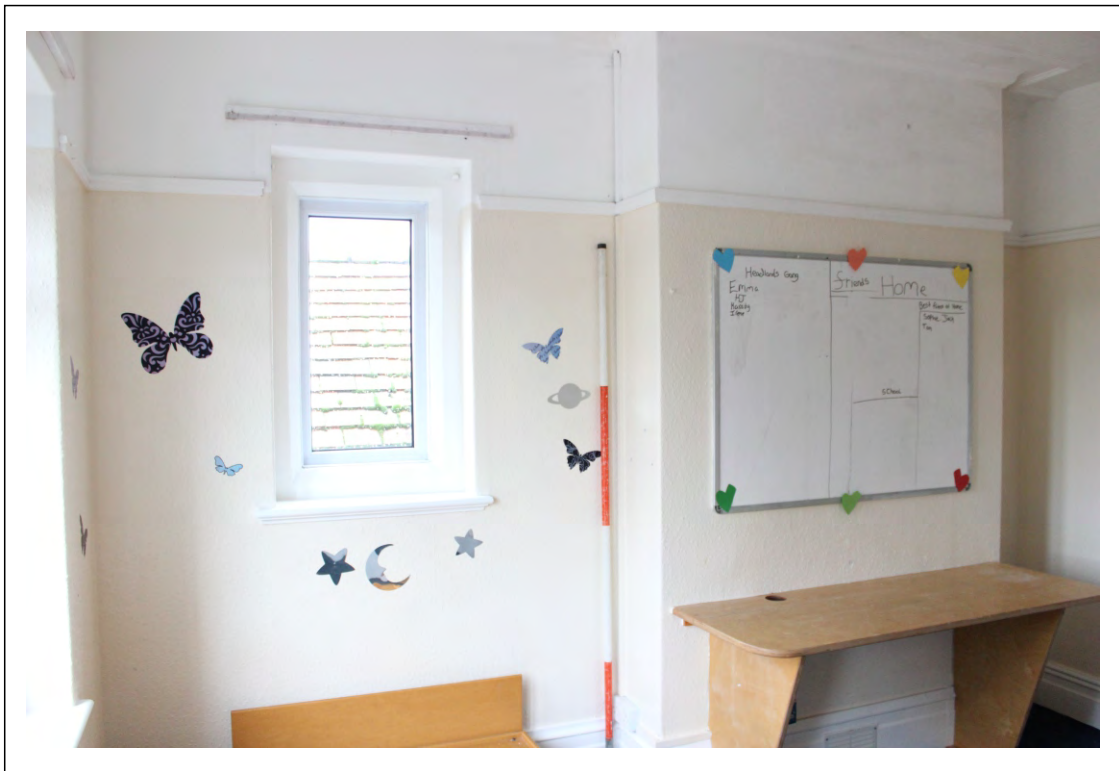
Plate 55: View south-east, showing main first floor bedroom blocked fireplace

Entering the first floor corridor from the main stairs the corridor leads left with a doorway leading to a bedroom on the left (Plate 53), with what appeared to be a blocked fireplace in the south wall, with a small single light window adjacent and a four

light chamfered edge mullioned window in the east wall (Plate 55). The doorway opposite was marked as 'games room'. The room had an octagonal bay window in the west wall, with the original plain pelmet box, a blocked door was located in the north wall, with a blocked window and fireplace in the east (Plate 56-58). A small single light window was adjacent to the chimney breast. Adjacent to the games room door was a modern shower and toilet unit with a modern three light window at the far end. Adjacent and right of this door along the corridor was a second octagonal bay window room, with a blocked fireplace in the north wall with an adjacent single light window to the left (Plate 59). There was no pelmet box or other features in this room and it may have served as an office as there was a key box for the building on the wall. Opposite this room the doorway was marked as the 'art room' and had a built in cupboard in the corner and a works surface with a sink unit. A single light window was located in the north wall and a modern four light window in the east.

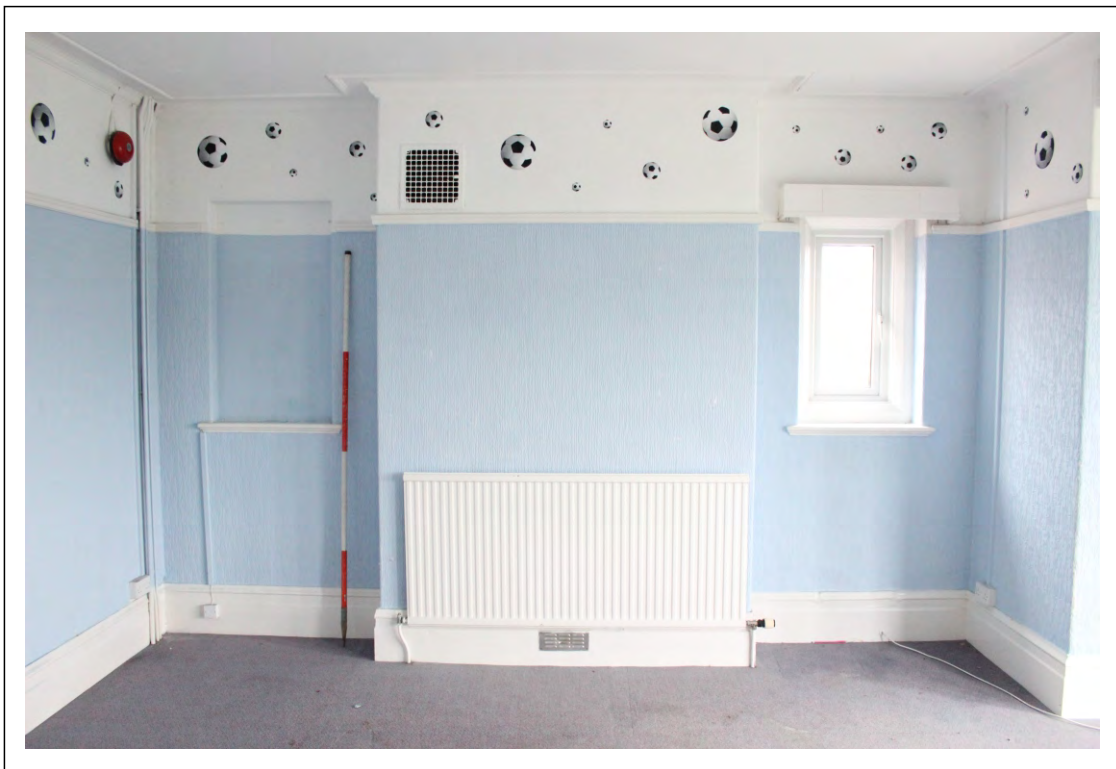
Plate 58: View south-east, showing first floor games room blocked fireplace and window

- The blocking of a window in the first floor games room. Plate 58
- The blocking of a fireplace in the first floor bay window room. Plate 59
- The insertion of a modern bathroom in first floor north wing. Plate 64
- The insertion of a skylight in second floor northern room. Plate 72

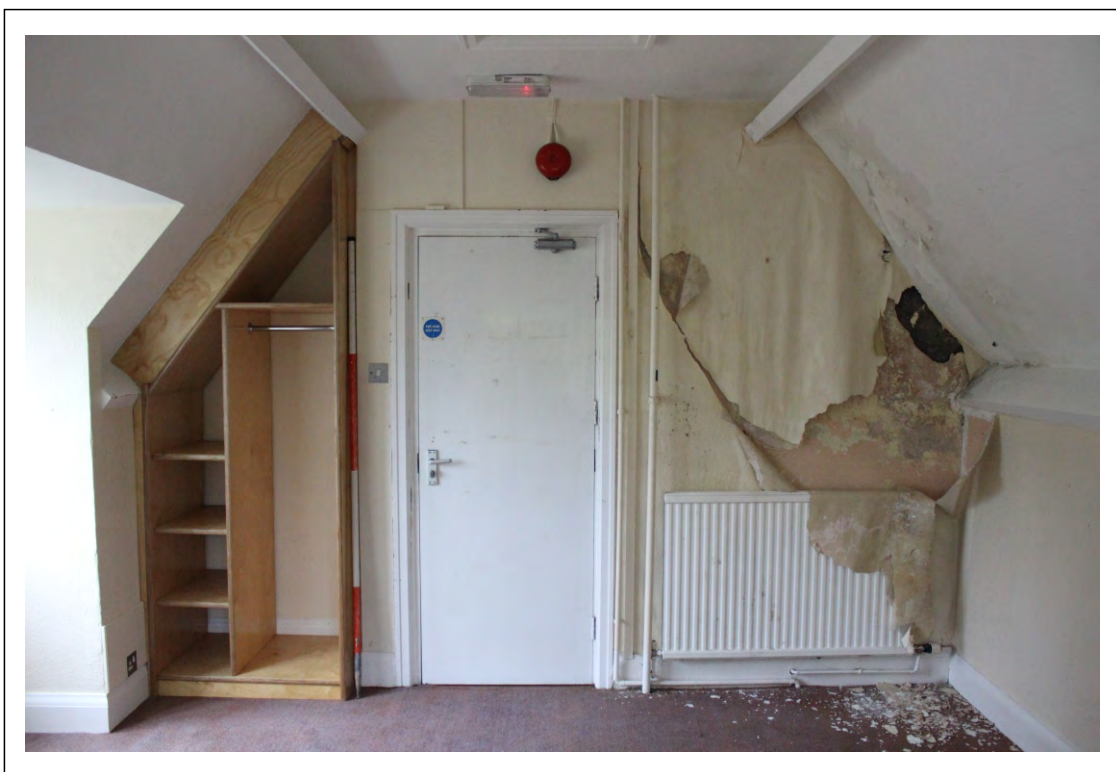
Plate 66: View south-east, showing first floor north wing end bedroom

The north wing corridor has a two doorways on the left side, with a third at the far end, the right side of the corridor has modern skylights and a recess in the roof eaves for cupboard space (Plate 61 and 62). The first doorway leads to a bedroom with a gabled dormer in the west wall and a built in wardrobe in the south wall (Plate 63). The second doorway is a modern bathroom unit with a gabled dormer window in the west wall (Plate 64). The door at the end of the corridor leads to another bedroom with a gabled dormer window in the north and east walls (Plate 65). The only notable features apparent in this room was the exposed roof supports (Plate 66 and 67).

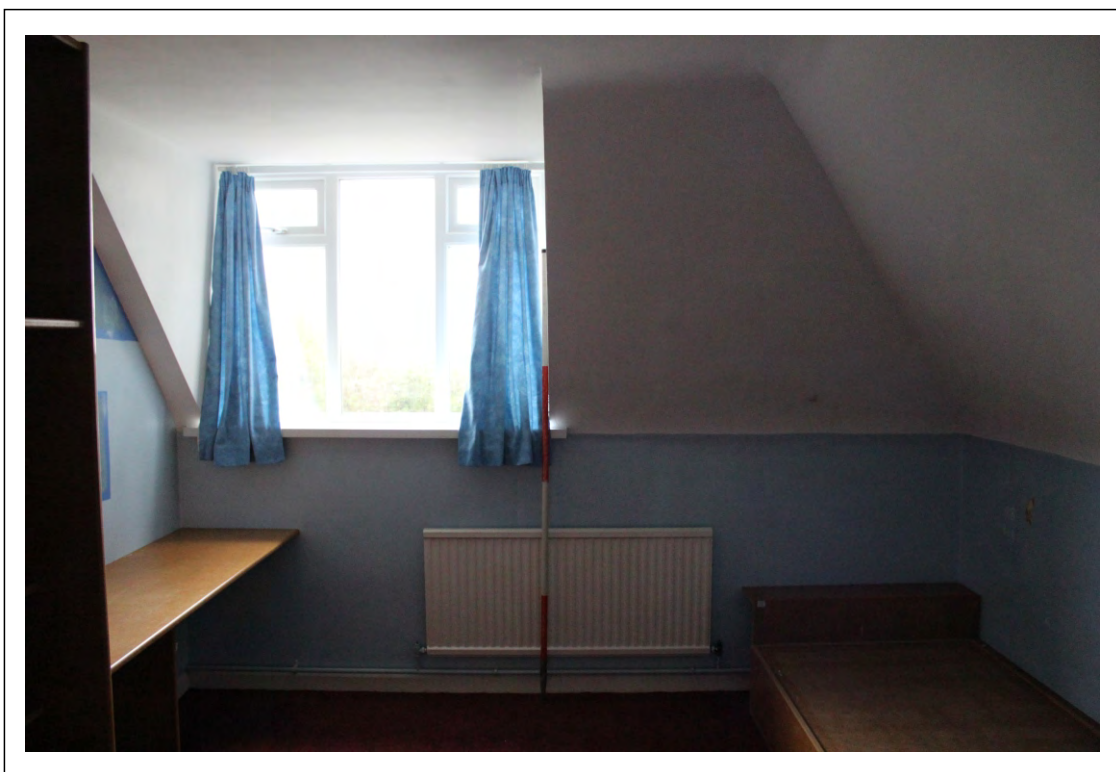
Plate 68: View south-east, showing first floor south wing end bedroom with gabled dormer window

The corridor at the opposite end of the building which leads down a flight of steps to the south wing first floor has the carer's bedroom in the first door on the left, fitted with notification alarm of doors opening. The bedroom has a gabled dormer window in the west wall and a doorway leading to an en-suite toilet and shower in the north wall. Further along the corridor along the left side, is a modern bathroom and toilet, with a second toilet adjacent. The third door leads down a flight of steps to a half landing and then down to the fire escape on the ground floor. Along the right side of the corridor are three bedrooms, all similarly fitted with storage for clothes, a small desk and un-sprung bed, with a gabled dormer window in each, at the far end of the corridor are two further bedrooms in each corner (Plate 68).

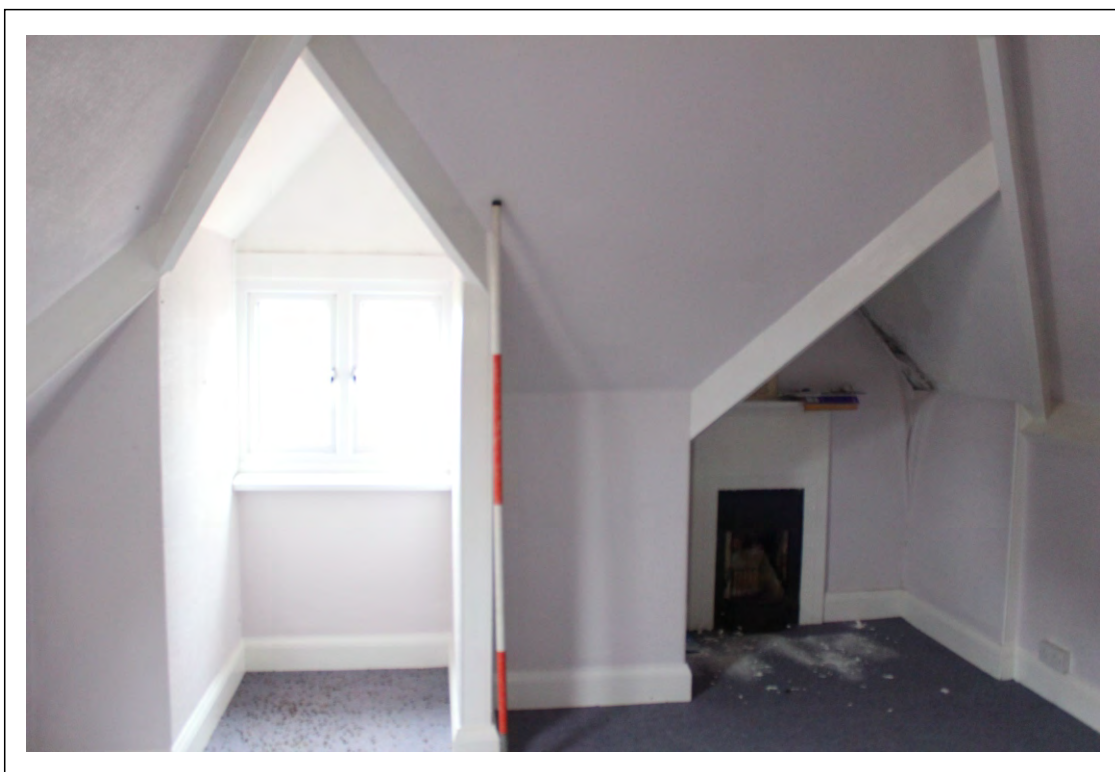
Plate 74: View south-east, showing second floor southern room

Proceeding up the stairs to the second floor there appears to be a further two bedrooms, each with a small fireplace and cupboard fitted with a sink. The corridor on the second floor leads from the stairs south, with a doorway on the right leading to the first bedroom with the cupboard/sink in the south wall, a gabled dormer window in the west and the fireplace in the north wall (Plate 69-73). The room also has a modern skylight adjacent to the fireplace. At the far end of the corridor is the doorway to the second room, with a cupboard/sink in the north wall, and a fireplace and gabled dormer window in the south. Exposed roof timbers were visible, but these rooms had also undergone modernisation during the renovation work in 1990s and few features were apparent (Plate 74).
