Pwll Ddu Tunnel, Blaenavon

Archaeological Watching Brief

Report No: 1227

Prepared For: Torfaen County Borough Council

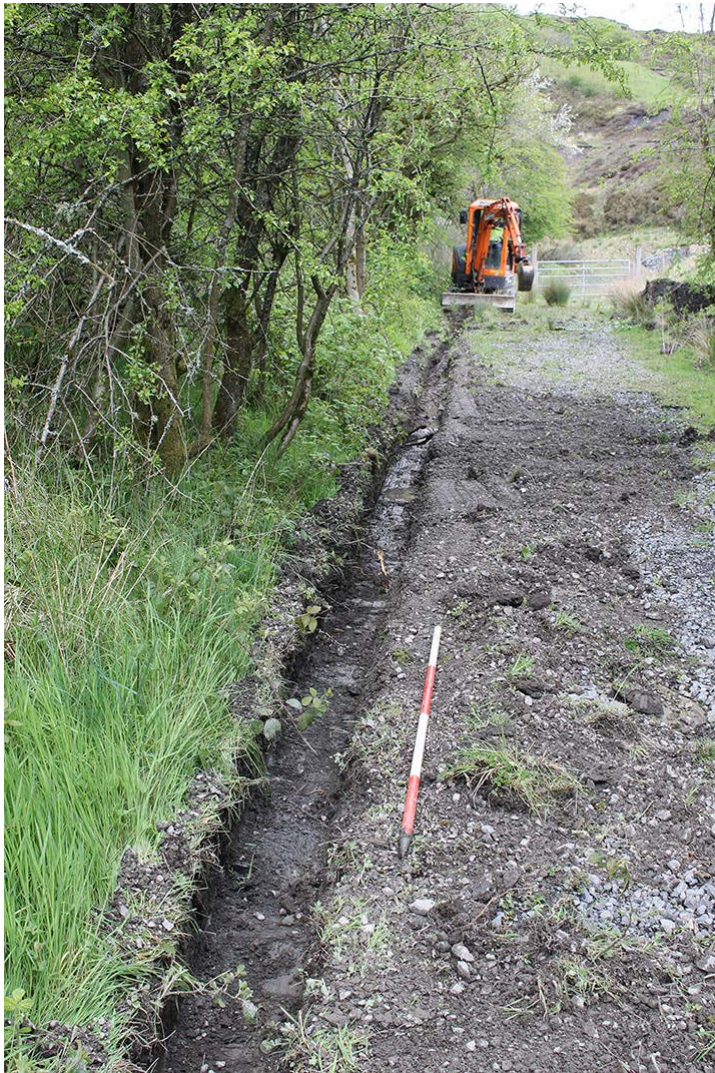
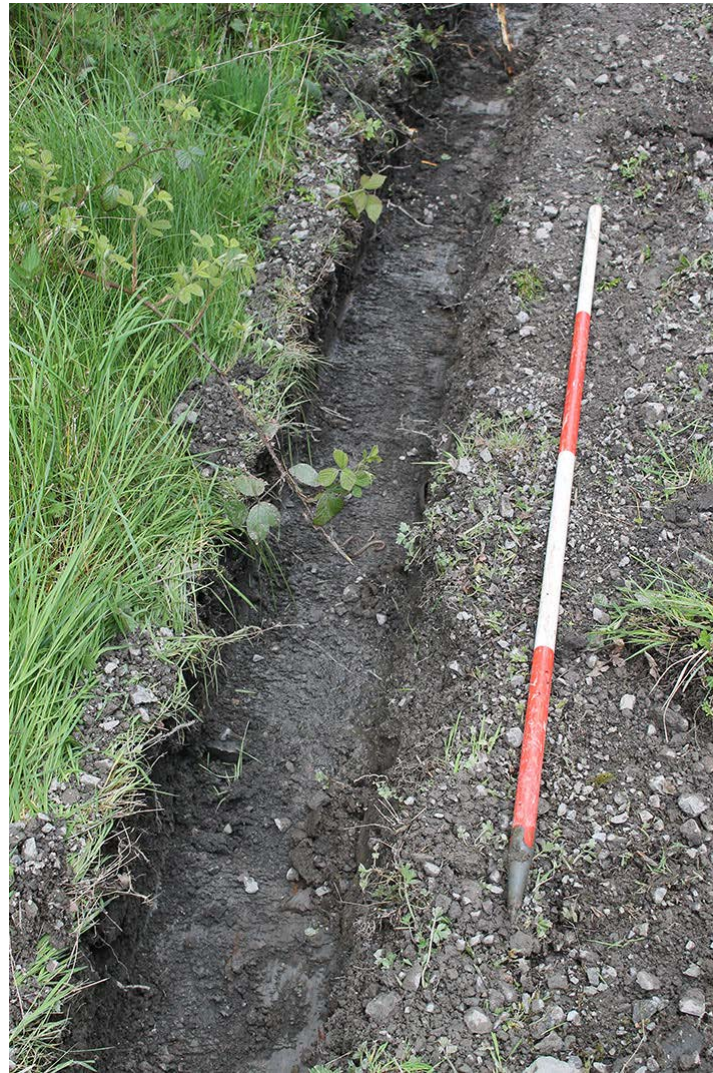
Fig. 2
Trench excavated
along the western
edge of the
tramway.

The trench was excavated by a 3t mechanical excavator fitted with a 0.4m wide toothless bucket (fig. 2). The trench was excavated in spits to a depth of 0.6m.

The trench was excavated through a homogenous deposit of dark brown/grey silt containing modern plastic, metal and glass (fig. 2). Patches of coal dust were identified along the line of the trench, but investigation revealed these to be dumps of material within the silt and not related to any archaeology.

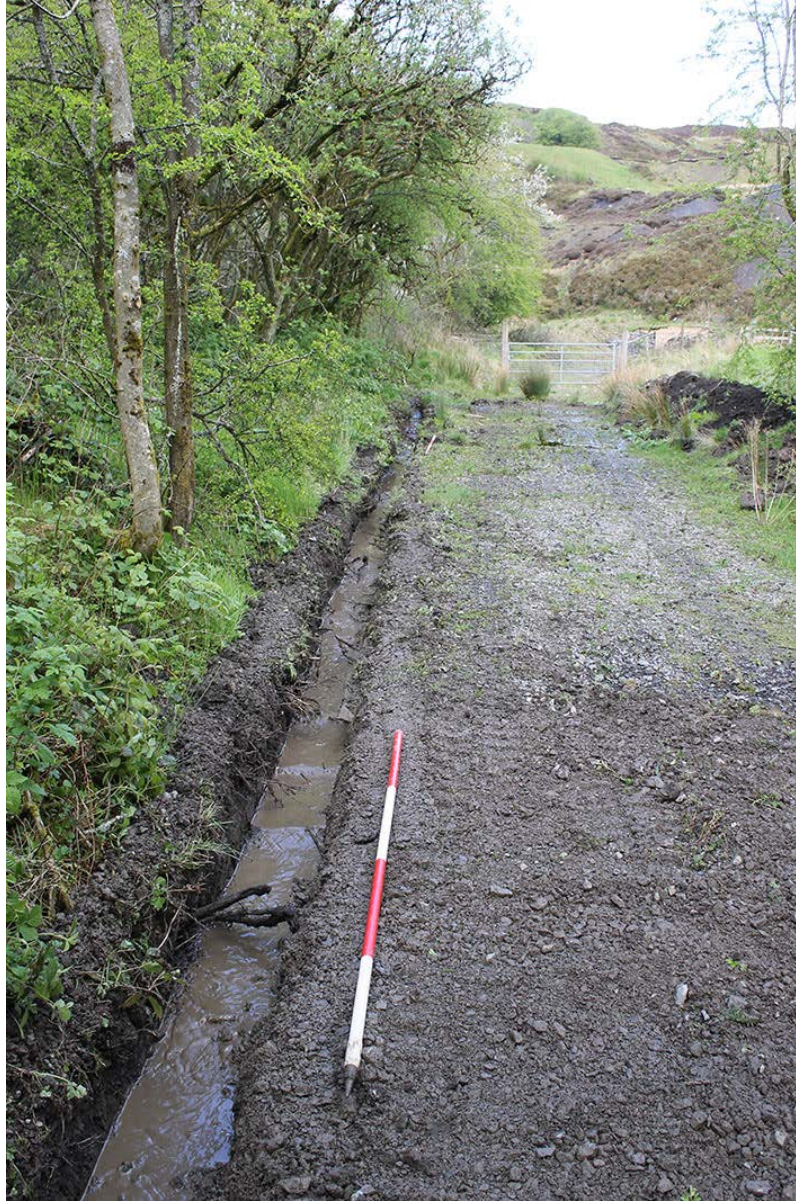
Fig. 3
Water flowing along
the newly
excavated trench.

No finds or features of archaeological interest were revealed during the excavation of the new drainage trench. The trench flowed with water as soon as a breach was made between it and the existing water outlet at the northern end of the new drain (fig. 3).

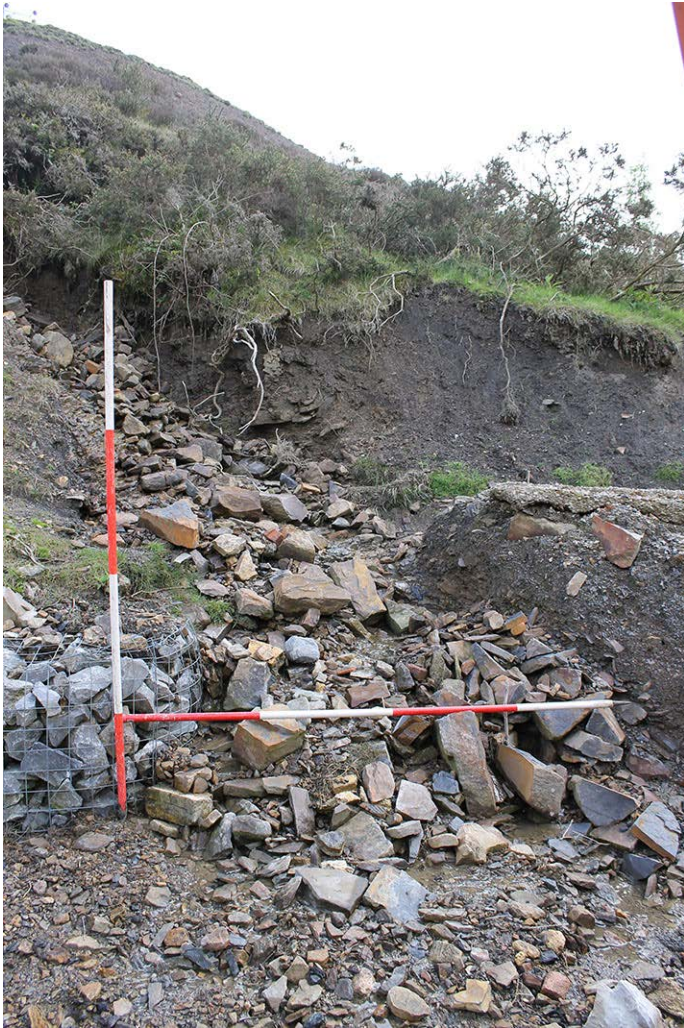
Fig. 4
The gabion baskets
area

A trench measuring 2.5m long and 1m wide was excavated into the bank immediately south-east of the Pwll Ddu tunnel portal. The trench was dug through the bank of the tramway, which comprised made ground, and a deposit of waterborne rocks that had washed down the steep slope of the spoil tip (fig. 4).

a. Before excavation - showing the deposit of water bourned rocks on the tramway edge

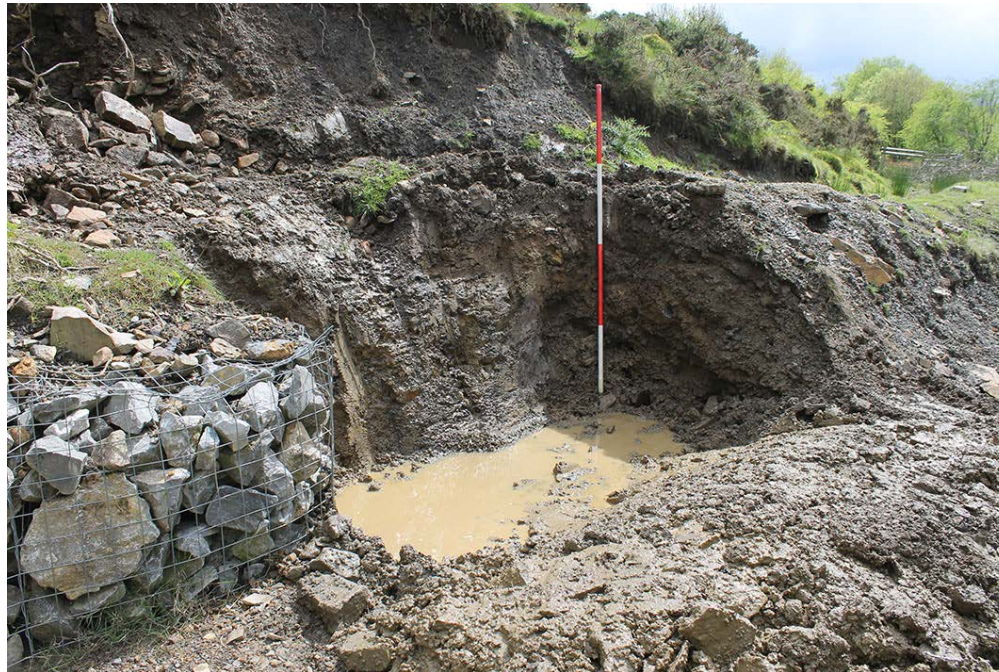
The bank material comprised fragments of shale, sandstone and limestone together with modern scalplings, and appears to have been built relatively recently, probably during the 2011 restoration works. No features of archaeological interest were revealed.

b. Gabion basket trench, post-excitation

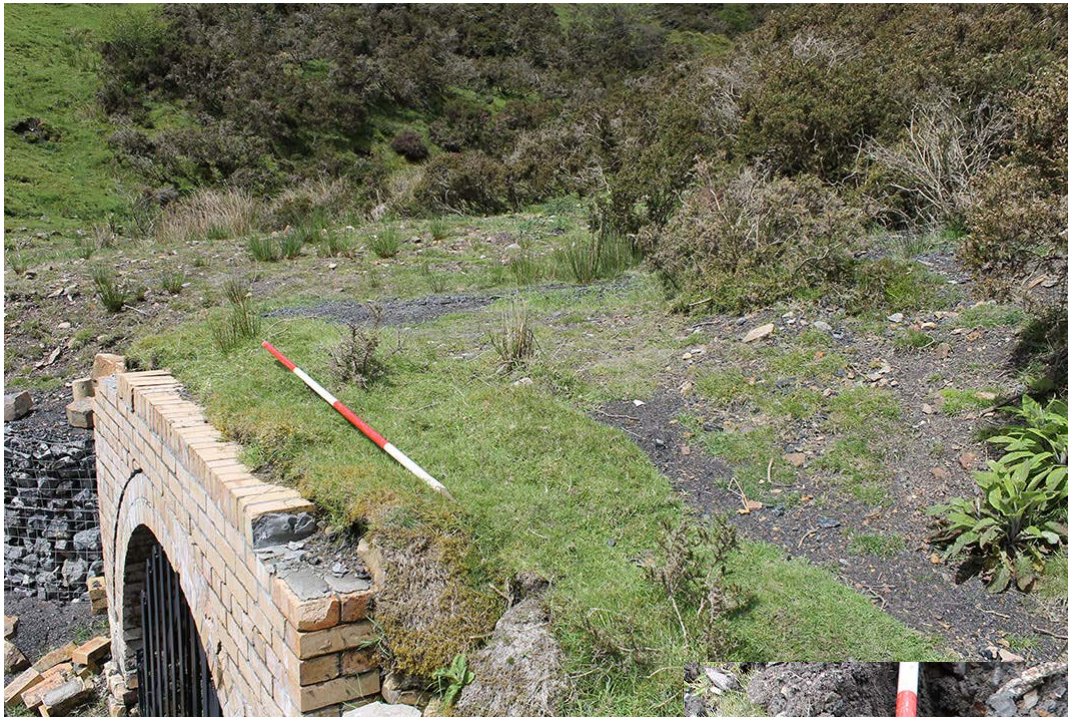
Fig. 5
The tunnel top
investigation trench

A small trench, measuring 1.5m long by 1m wide and up to 0.5m deep, was excavated through the ground overlying the top of the tunnel to reveal the original brick arch of the tunnel (fig.

5). The aim was to establish how far below the ground the original structure is, what state of repair it is in, what works were undertaken during the 2011 restoration and what impact these had had on the original brickwork.

a. Location of the investigation trench

The trench was backfilled to prevent disturbance to the original tunnel structure.

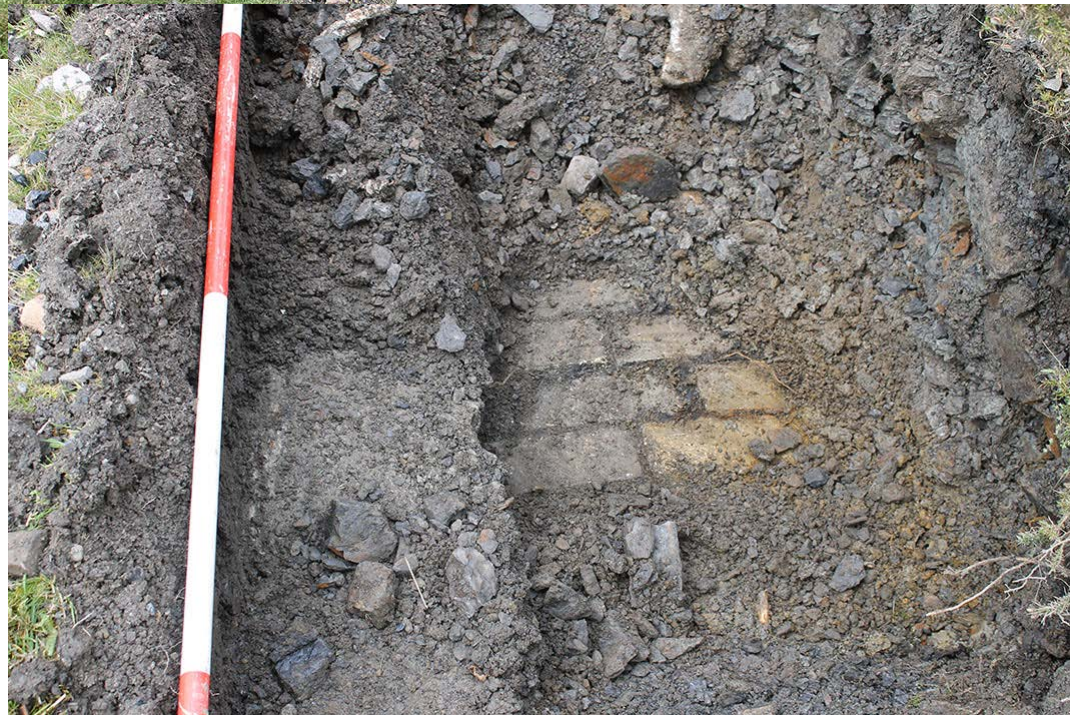
The trench revealed a layer of modern concrete, 0.25m thick on the southern side of the trench. This was related to the 2011 restoration works and partly overlay the original brickwork of the tunnel. The original tunnel masonry was revealed as the large, buff, furnace bricks extant at the base of the portal arch – seven of the bricks were revealed in the trench and these were found to be sturdy and sound, with no signs of cracks or failure in the joints.

b. Original brickwork (right) and modern concrete (left)
