## **Skokholm Island, Pembrokeshire**

Archaeological Watching Brief

Report No. 1162

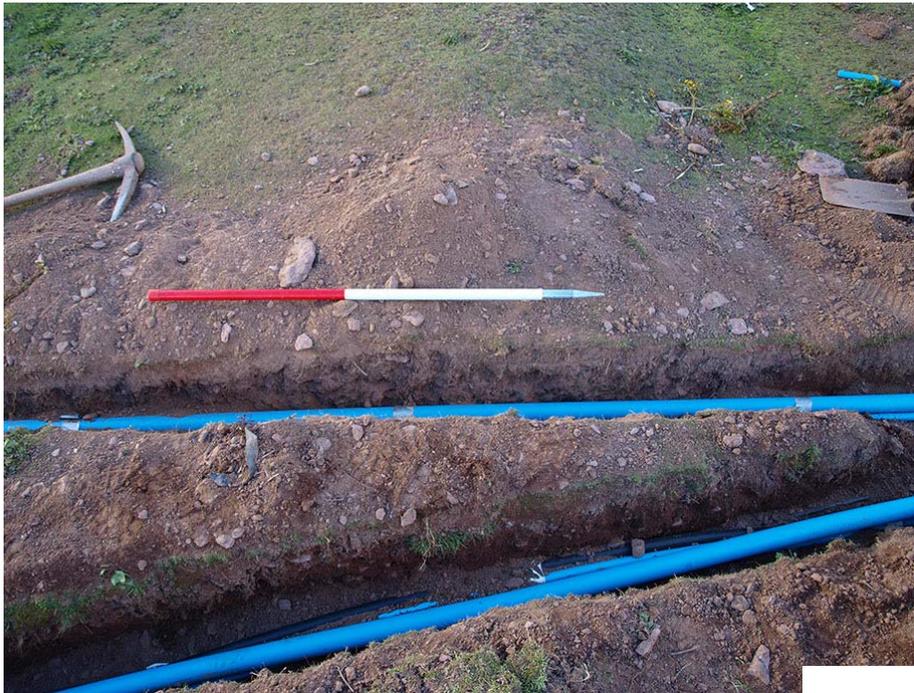
The groundworks for the installation of the water pipes consisted of a series of hand dug trenches around and to the east of the main buildings (fig. 3). The trenches were U-shaped in profile, around 200m in total length, and on average 0.3 to 0.4m wide at the top with an average depth of 0.2 to 0.25m. Two stretches of trench dug to the east of the building complex were shallower and narrower, averaging 0.2m wide at the top and 0.1 to 0.15m deep.

The first comprised a linear earthwork running north-south roughly parallel to the extant wall to the west of the building complex (fig. 3 No. 1). The linear consisted of an earthen mound that consisted of redeposited subsoil with no stone inclusions (fig. 4). There was no visible buried turf line and no artefacts were recovered. A similar linear was visible to the east of the building complex.

A second area of archaeological interest was identified within the gateway into the building complex (fig. 3 No. 2). Here, a thin layer (0.1m thick) of rough cobbling was encountered, which was slightly convex in section (fig. 5). This produced 19<sup>th</sup> and 20<sup>th</sup> century pottery and a redeposited flint flake. The trenches within the interior area of the building complex also produced similar pottery together with brick roof slate and modern iron remains.

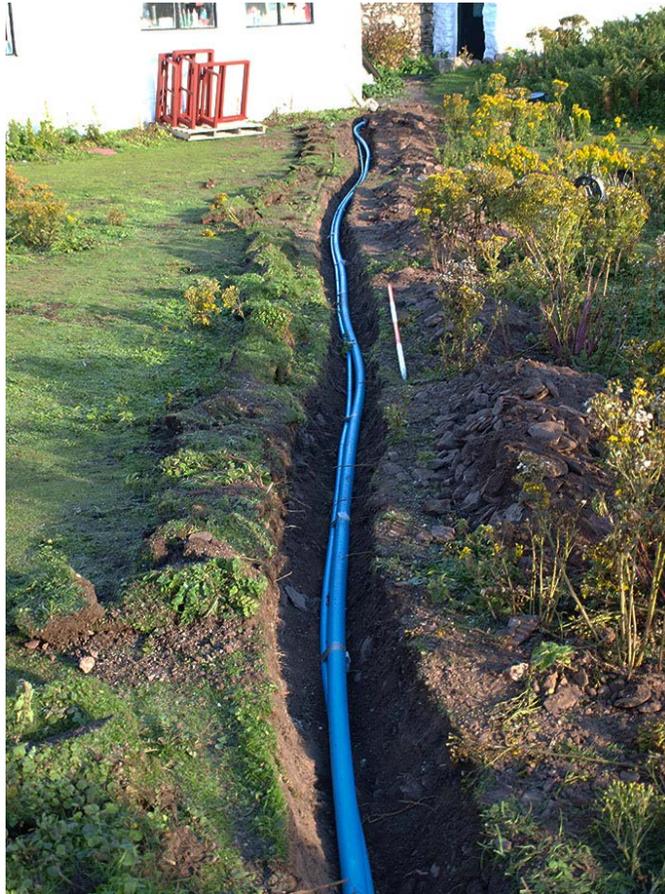
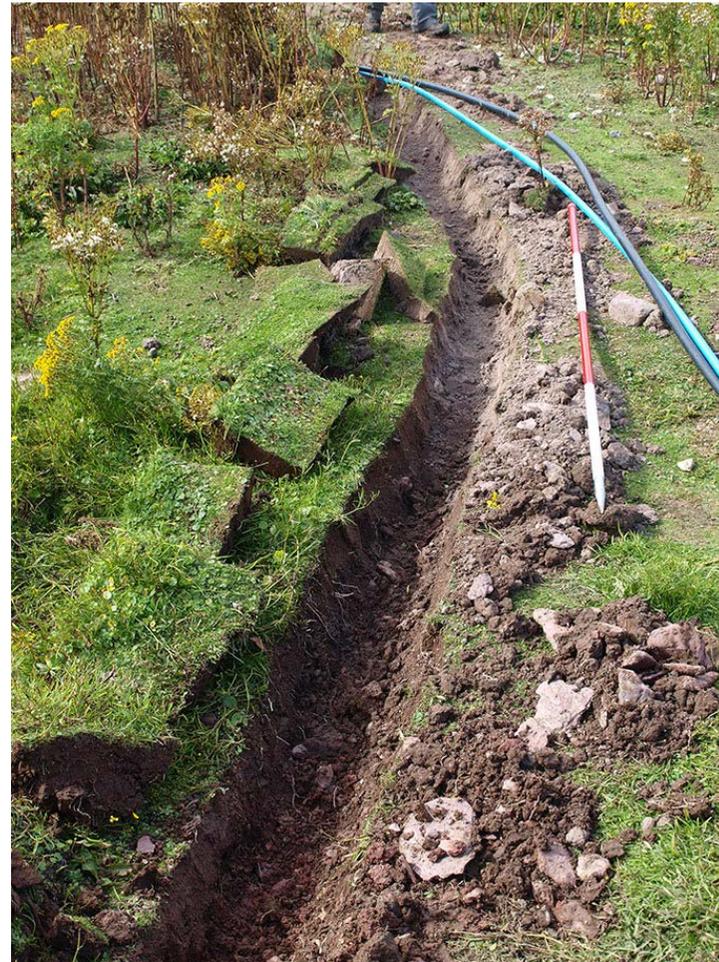
Fig. 6  
View of excavated  
trench around the  
building complex

The pipe trenches ran close to a number of drystone field walls and a possible sheepfold. No finds were identified away from the building complex, with the shallow nature of the trenching the likely reason for this (see figs. 6 and 7 for further pipe trench views).

Pipe trench excavated to the west of the building complex

Pipe trench excavated to the east of the building complex
