Ystrad English Congregational Church Ton Pentre

Level 2 Historic Building Record

August 2023

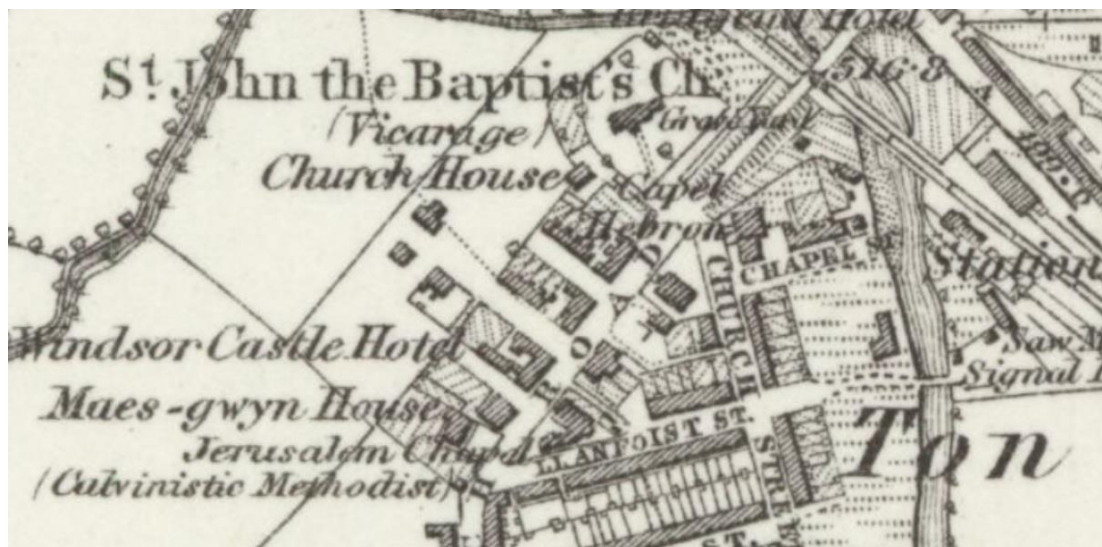
Figure 2. Ordnance Survey map, 1884.

The original Ystrad English Congregational Church was built in 1870 and is shown on the Ordnance Survey map published in 1884, the survey for which was conducted in 1874-5 (fig 2). A tablet on the front of the building was salvaged and placed on a new chapel which was

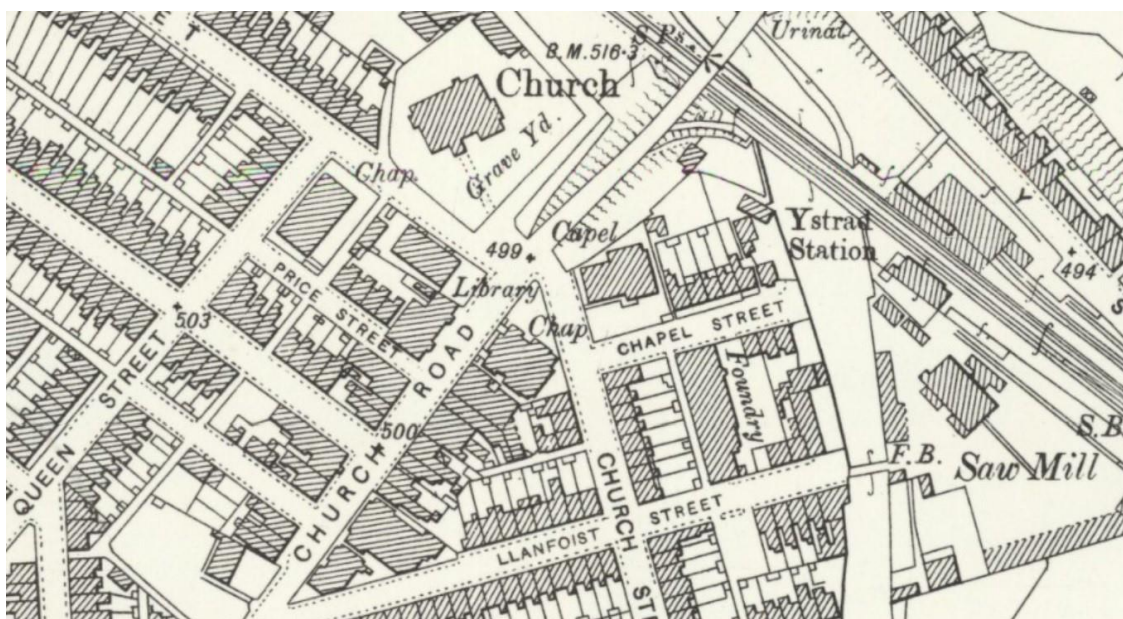
Figure 4. Ordnance Survey, 1900. The map shows Hebron and Bethesda Chapels, St John's Church and the Workmen's Institute at the junction of main roads in the village.

built in 1884. The date is inscribed on the building in four places (fig 3). The new building is shown on the subsequent Ordnance Survey maps from 1900 onwards (fig 4).

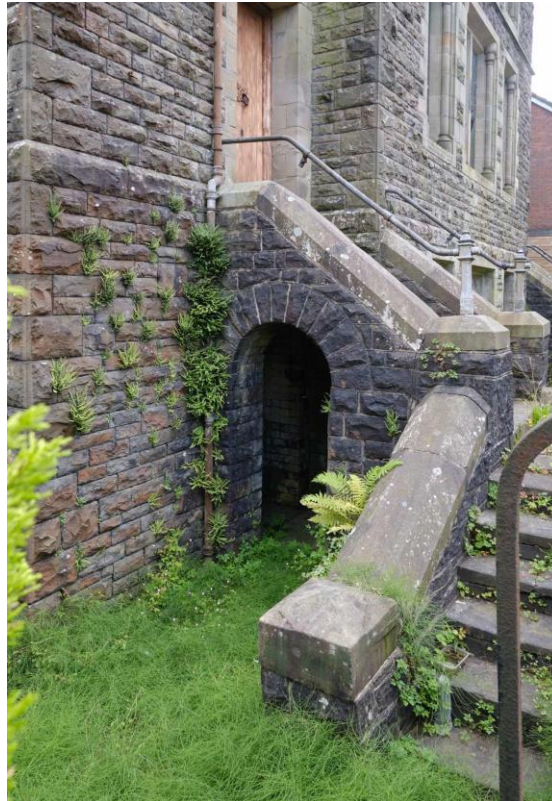
Steps, with flanking walls and simple railings, lead up to the two entrances on Church Road, where there are also steps at right angles to basement level, which is below street level on Church Road (fig 6). Beneath these entrance steps are round-headed doorways to the stair towers at basement level. The doorway on the right-hand (W) side is blocked.

Figure 6. Steps to main entrance and basement doors, Church Road front.

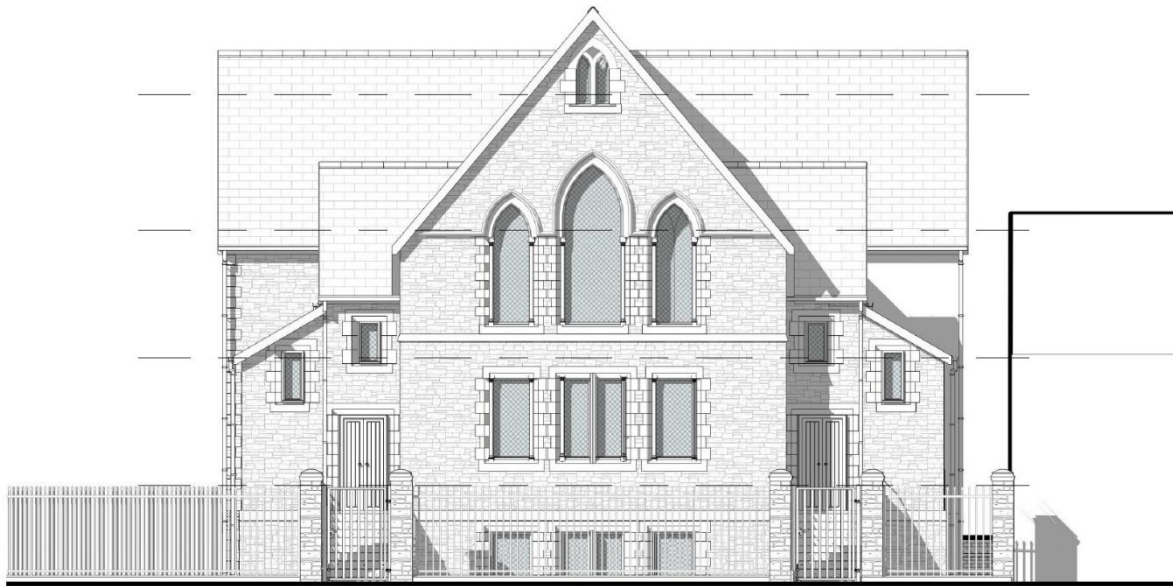
The chapel has a gable-end entry, typical of the late-nineteenth century, facing Church Road and is built of local Pennant sandstone, with Gothic detail, under a slate roof with clay ridge tiles. The chapel has a basement storey, which housed the Sunday School, stair towers set slightly back on either side of the entrance front, and a plan that incorporates shallow transepts. Treatment of the stonework varies. To the Church Road front it is laid as snecked, rock-faced stone with freestone dressings. At ground, gallery and basement levels is a two-light window flanked by single-light windows (fig 7). At ground-floor level there are nook shafts but the windows are square-headed. At gallery level is a sill band and the windows also have nook shafts and are pointed. The central window has Y-tracery. These windows all have diamond-pattern leaded lights, with some coloured glass. Beneath the apex is a two-light vent, pointed with Y-tracery. In the basement there is a similar arrangement of

two-light flanked by single-light windows, but the windows are square-headed, unadorned and have diamond-pattern cast-iron glazing bars.

Figure 7. Church Road front.

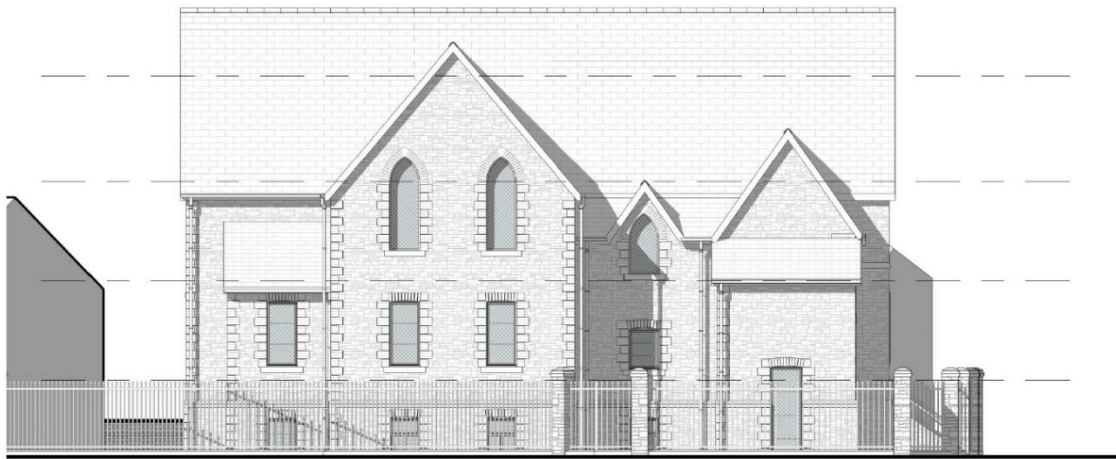
The Church Street front is of secondary importance. It is built of rock-faced stone but openings have yellow-brick dressings incorporating thin keystones and there is a blue-brick sill band at ground-floor level. The openings are original but many of the windows have been replaced (fig 8). To the right is a tall stair window. To its left are single windows under cambered heads in basement and at ground-floor level, but the gallery window is pointed and is beneath a gable that breaks the eaves line. Beneath the gallery window is a tablet salvaged from the original building and set up on the new building, with the date of the new

Figure 8. Church Street front.

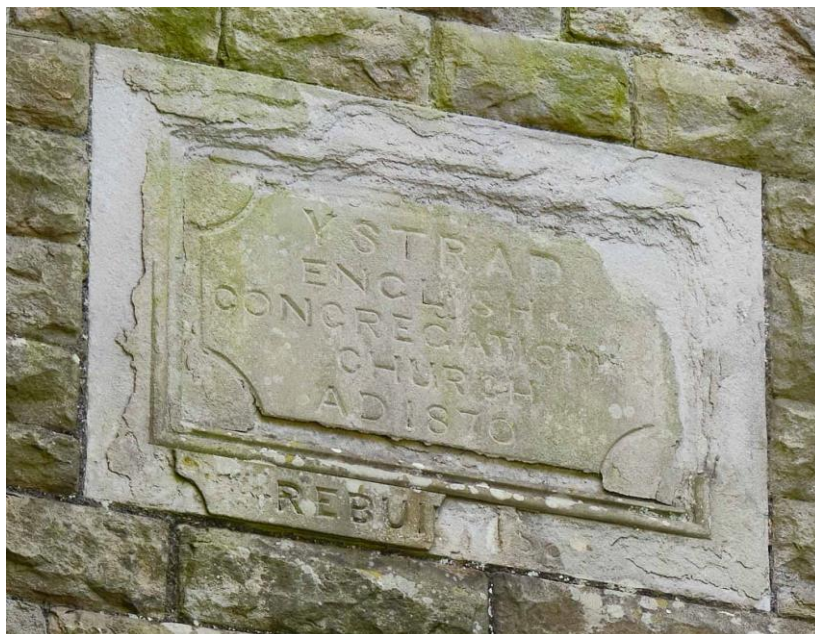
building added (the stonework is partly eroded and the new date is no longer legible) (fig 9).
It reads:

Ystrad
English
Congregational
Church
AD 1870
Rebuilt ...

Figure 9. Tablet salvaged from 1870 chapel, in Church Street front.

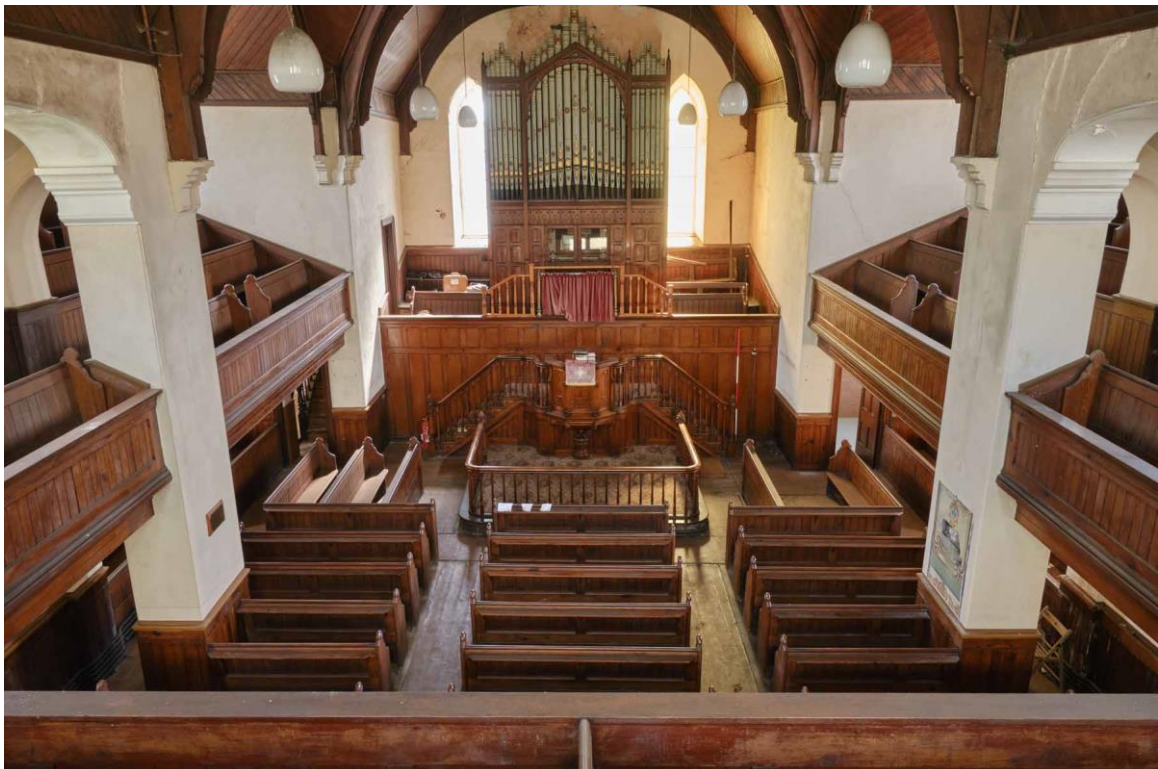
Figure 12. Interior, viewed from the back of the gallery.

There is a raked gallery on three sides (figs 12, 13). The side sections are supported on a thick plain pier which also defines the aisles that provide access to the seating. It has a boarded front on a moulded cornice. The clock opposite the pulpit is a modern addition.

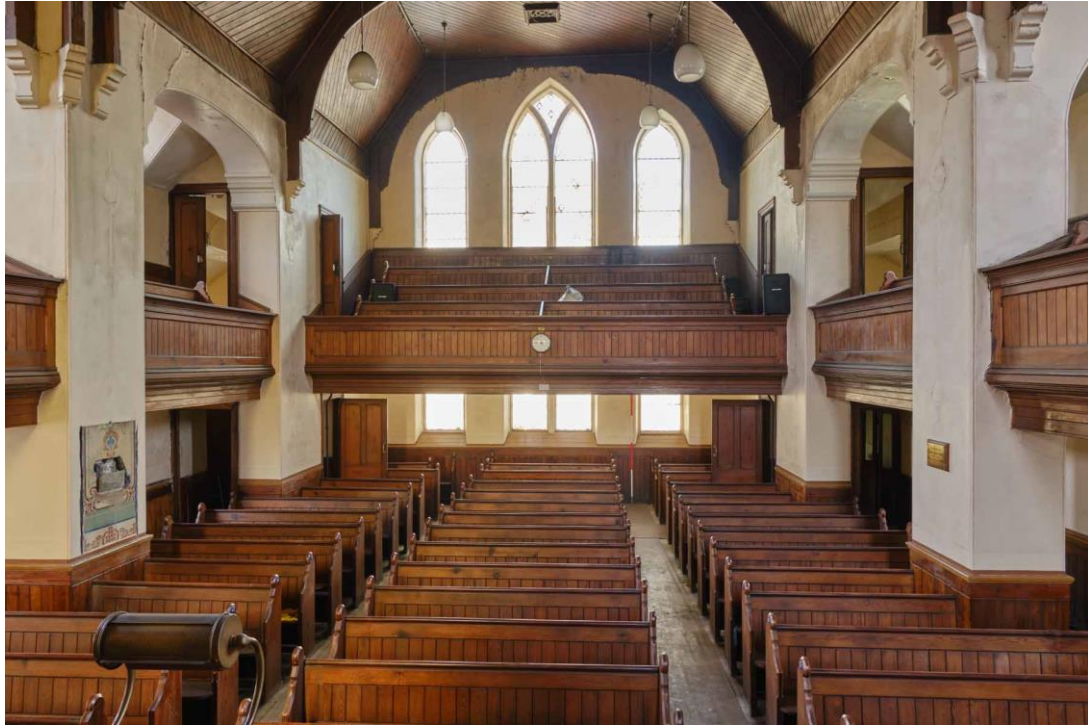
Figure 13. Interior, viewed from the pulpit.

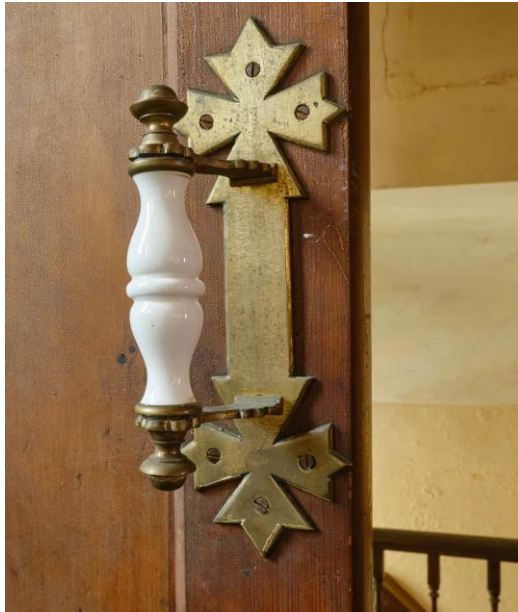
Between the top of the stairs and the transepts each side has a moulded elliptical arch, on moulded responds, an a pointed arch through which access was gained to the gallery pews in the transepts (fig 14). Original panelled doors have been retained, which have decorative brass and ivory handles (fig 15).

Figure 15. Gallery door handle.

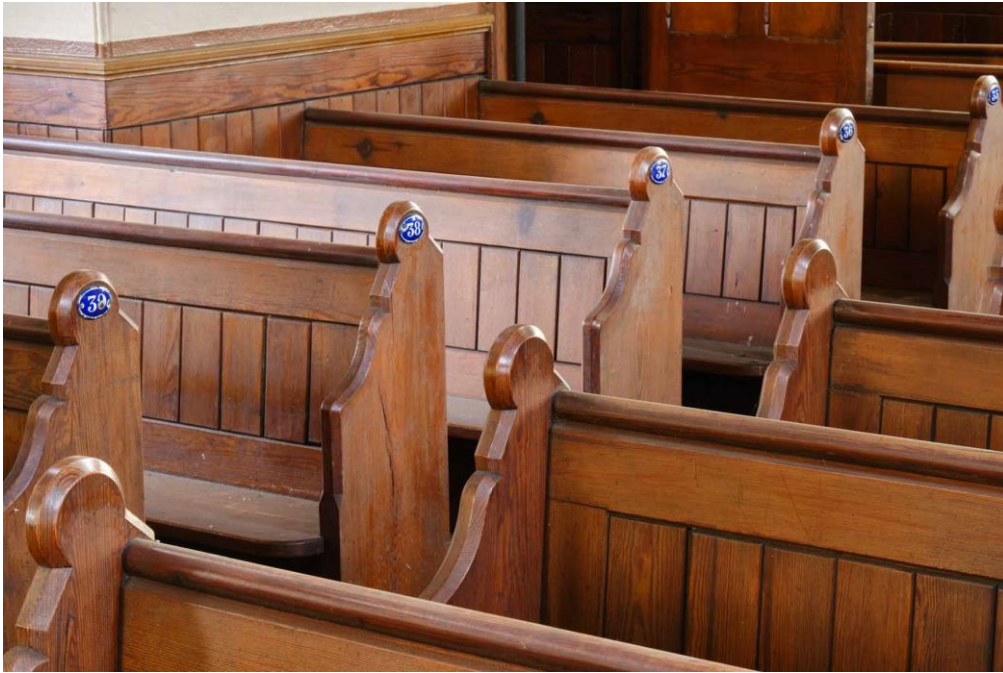
Figure 17. Pews, with shaped and numbered ends.

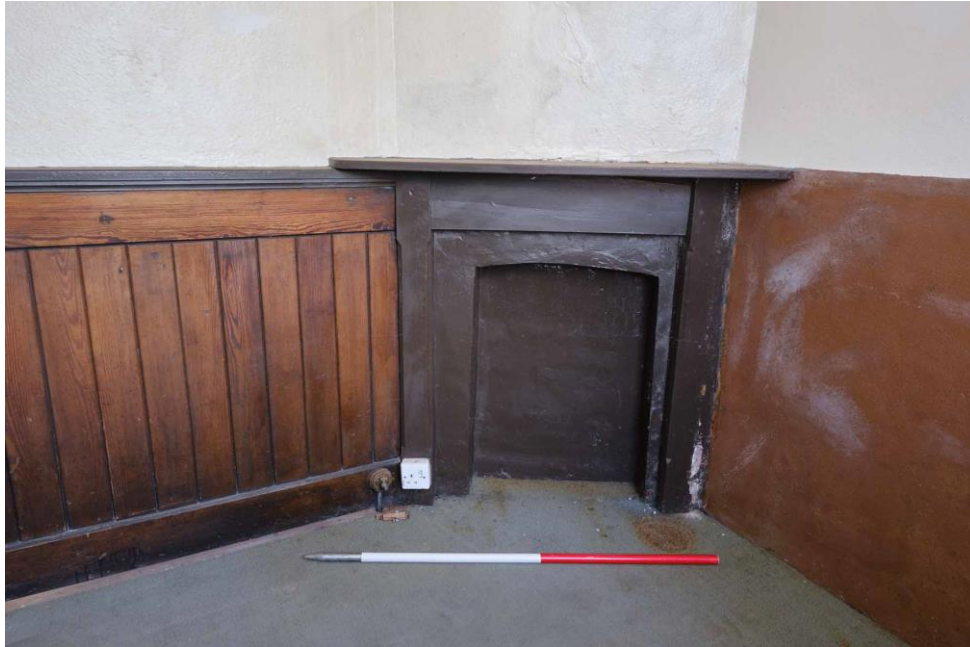
Figure 19. The vestry fireplace.

There is a small vestry at the rear on the right-hand side of the pulpit. This has a blocked fireplace and, like the remainder the chapel, a boarded wainscot (fig 19). On the left-hand side, at the rear, is the rear stairs, an open-well stair similar to the main stairs. It provides access to the organ and pews behind the pulpit, as well as down to the basement, where there is an in-built cupboard below the stairs (fig 20).

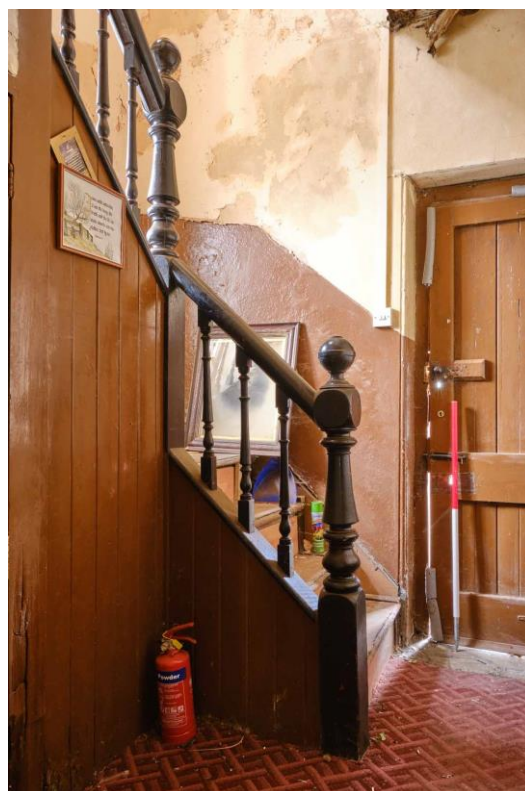
Figure 20. Rear stairs to basement.

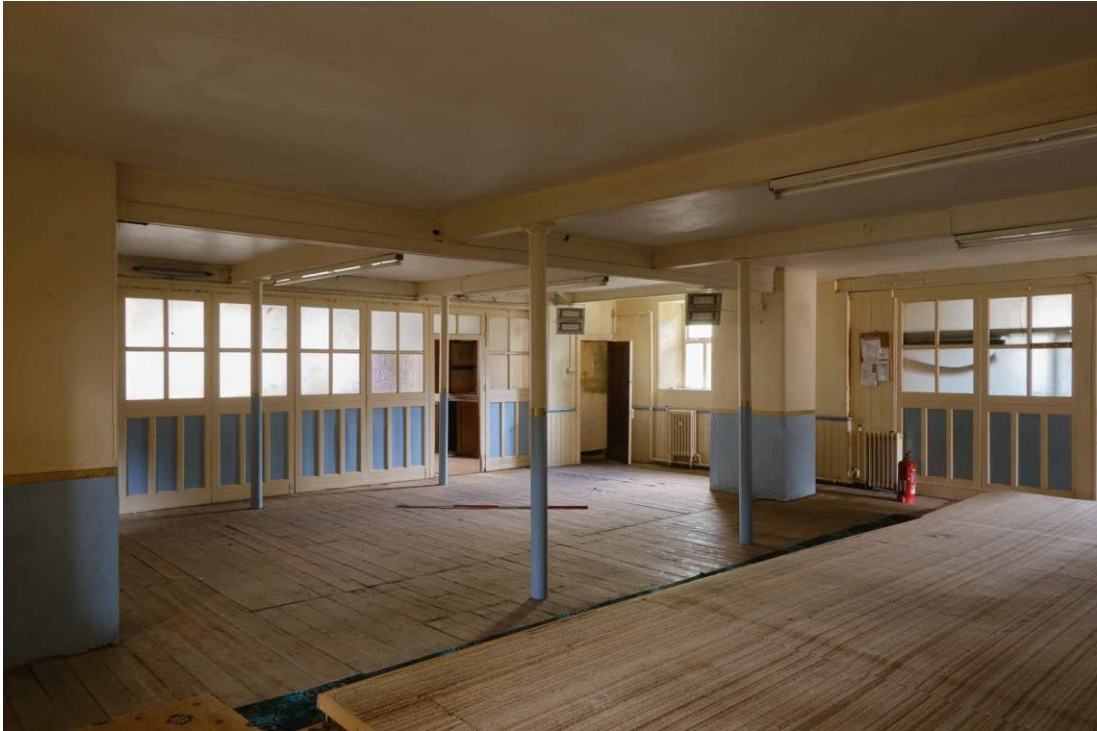
Figure 21. Basement with cast-iron posts supporting the ground floor.

In the basement, the entrance lobbies from the front and rear entrances have flagstone floors. The remainder is mainly floorboards. There is a large basement room in which pairs of cast iron posts support two spine beams that carry the ground floor (fig 21). Around this room are half-glazed panelled partitions, incorporating doors, that open to inner rooms on the north-west and north-east sides (fig 22). On the west side there is a modern kitchen, including a kitchen extension below the vestry, and a toilet in the position of the north-west stairwell. The basement doorway in the rear (south-east) wall opens to a storage area, which has a concrete floor. There is a rubble-stone wall between the storage area and the main basement room which has a shallow-projecting plinth and may be the back wall of the original 1870 chapel.

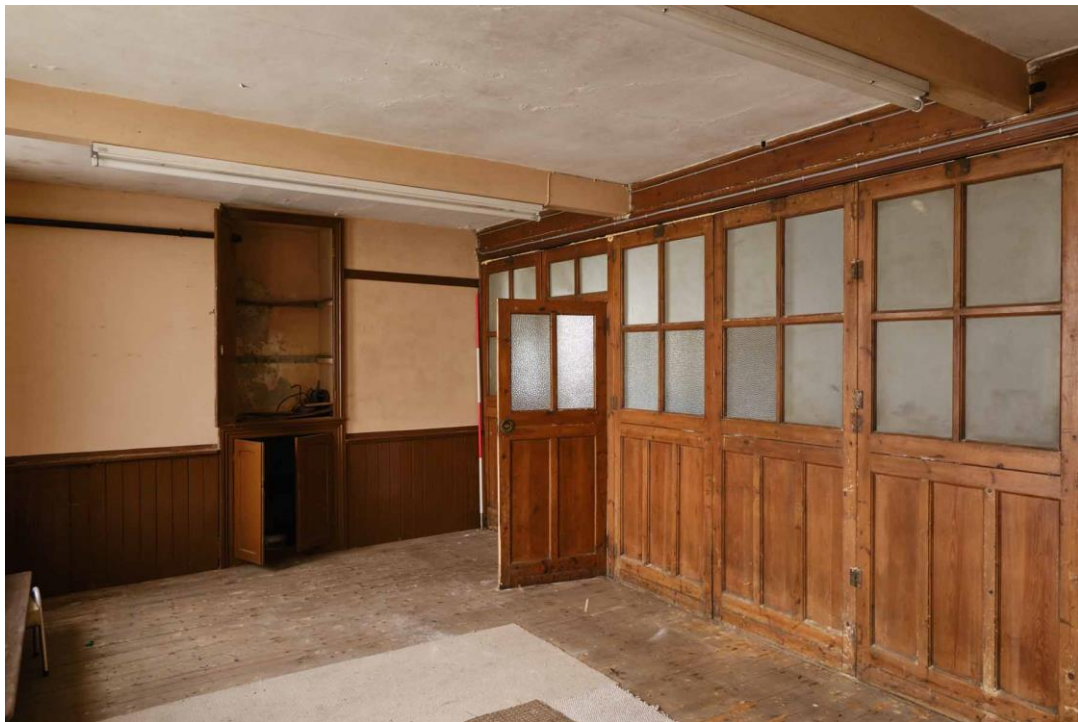
Figure 22. Basement, with partition to inner room.
