Historic Building Recording

Wrexham University

Report Number: 24-1021

Client:	Wrexham University
Author(s):	Blair Poole & Rachael Matthews
Listed Building No:	1851
Planning Application:	P/2023/0901
Document Ref:	24-1021-HBR-v1.0
Date:	22 March 2024
NGR:	332612,351236

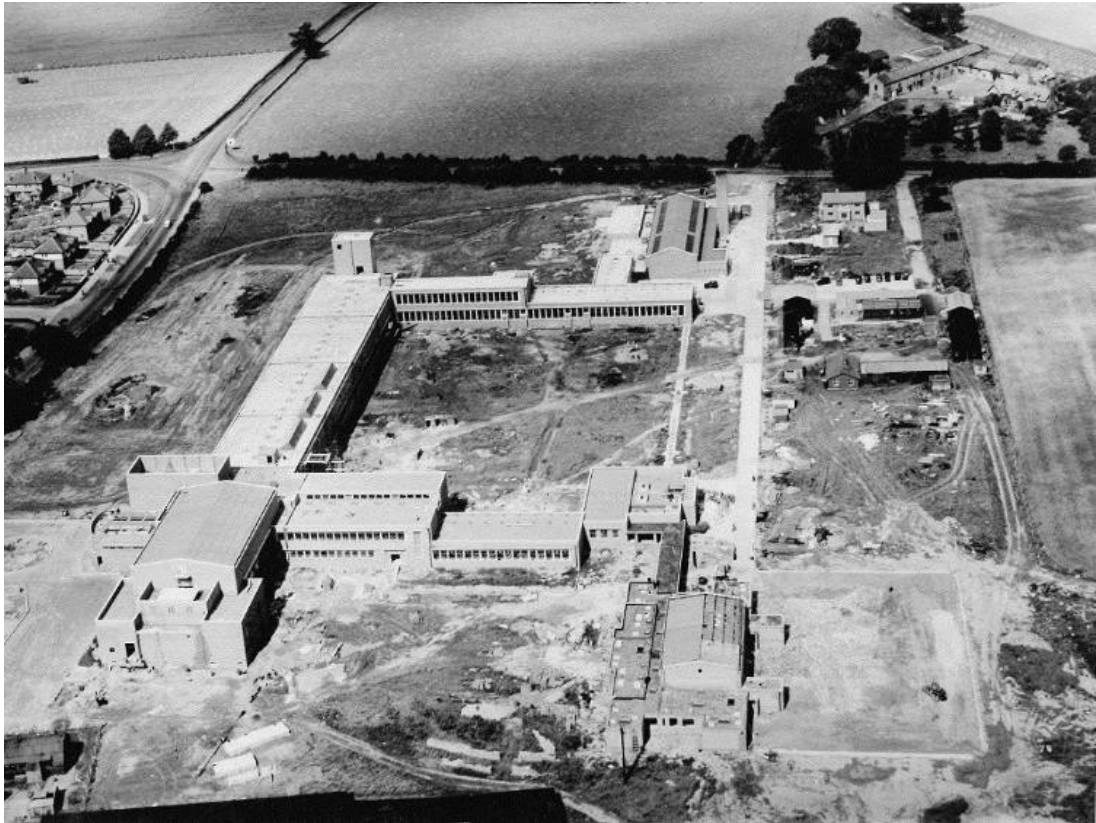
Plate 1: Construction of the campus in 1950 (Peoples Collection Wales)

- 3.8 The Plas Coch campus commenced construction in 1950 (Plate 1) as a coherent modernist design around a large rear quadrangle, with three primary blocks, all overlooking the quadrangle to allow good light ingress, with Corridor C being constructed for teaching physics, chemistry, and biological sciences. The original design by Sir Patrick Abercromby, saw laboratories sited on the ground floor and classrooms above. Internal decorative elements were commissioned and the original tiles in the main foyer, designed by Peggy Angus as a representation of the flow of learning, are still on display.

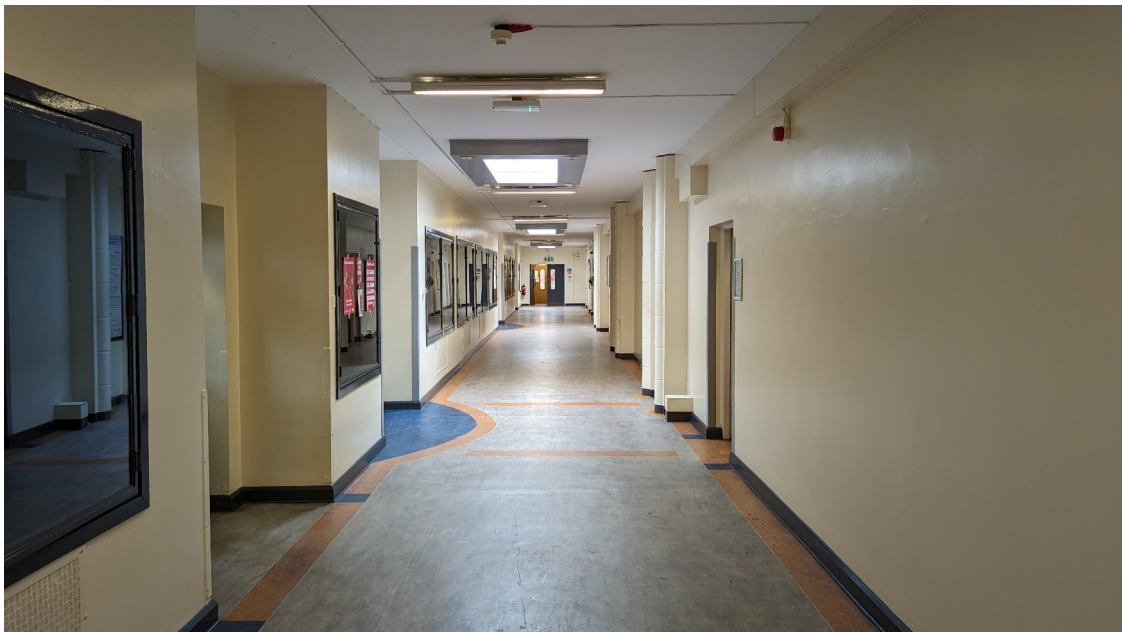
Plate 3: The corridor, looking southeast

6.2.1 The corridor runs along a northwest-southeast alignment offering access to the classrooms on both sides, and accessed via the courtyard to the southeast and an exit towards Plas Coch at the northwest (Plate 3).

6.2.2 The decorative style of the corridor has a very late 20th century feel of geometric patterns and false columns. This may form part of the 1992 refit of the college.

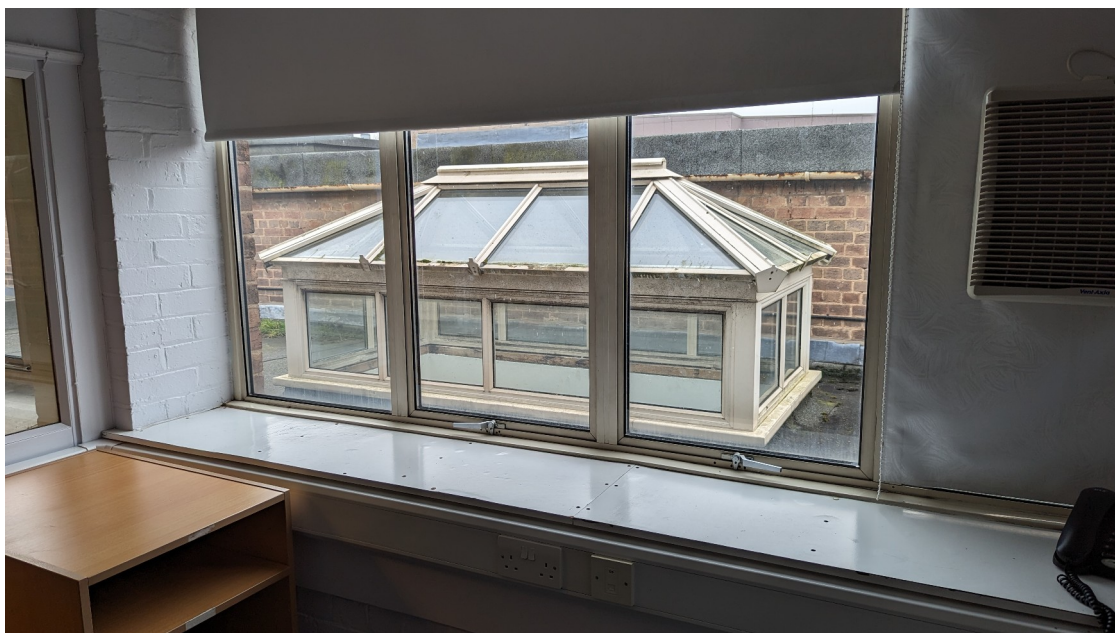
Plate 4: Lantern light over corridor

6.2.3 The corridor is well lit via a combination of strip lighting and lantern lights allowing natural light in. These lantern lights are all later 20th century replacements of metal frames and uPVC coating (Plate 4).

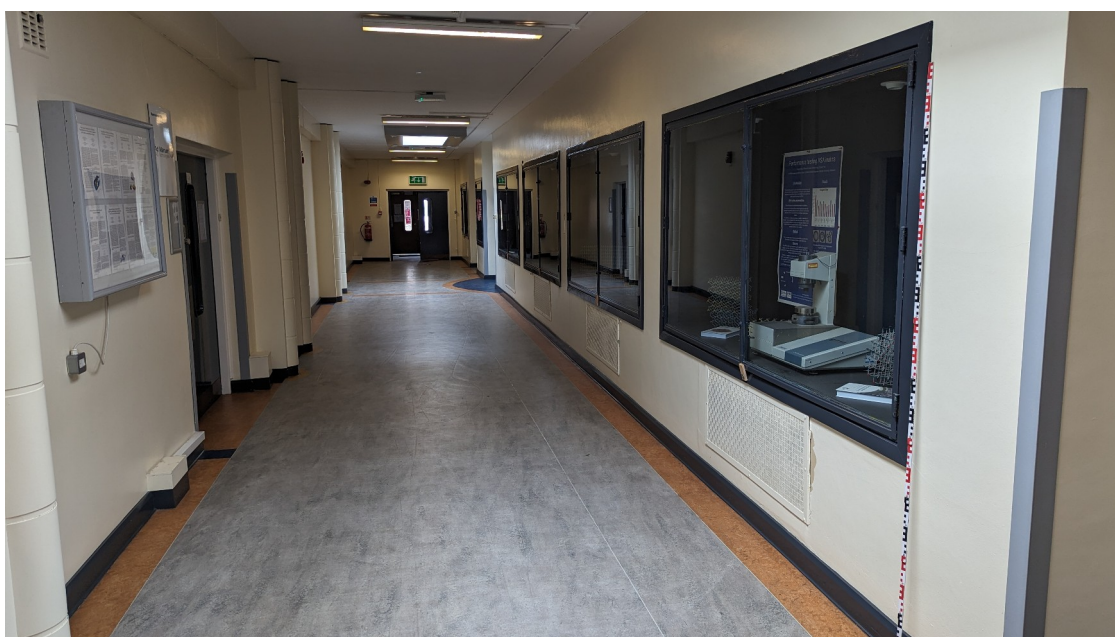
Plate 5: Display cases along corridor

6.2.4 The northeast side of the corridor is lined by display cases, with wooden frames and metal vents situated below (Plate 5).

6.2.5 The display cases appear to be original features that have been painted to match the livery of the late 20th century refit. At the southeastern entrance to the corridor is a small sink area that represents a 21st century modification, located in a partitioned entrance vestibule (Plate 6).

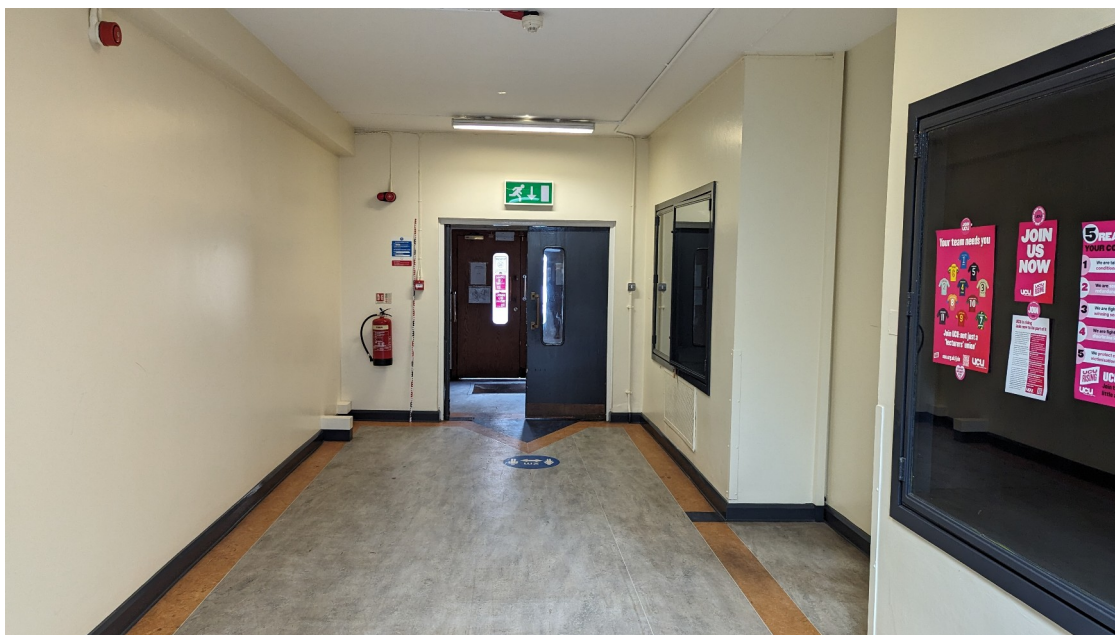
Plate 7: Northwest emergency exit

6.2.6 The northwestern end of the corridor is marked by an emergency exit (Plate 7), mirroring the entrance vestibule to the southeast.

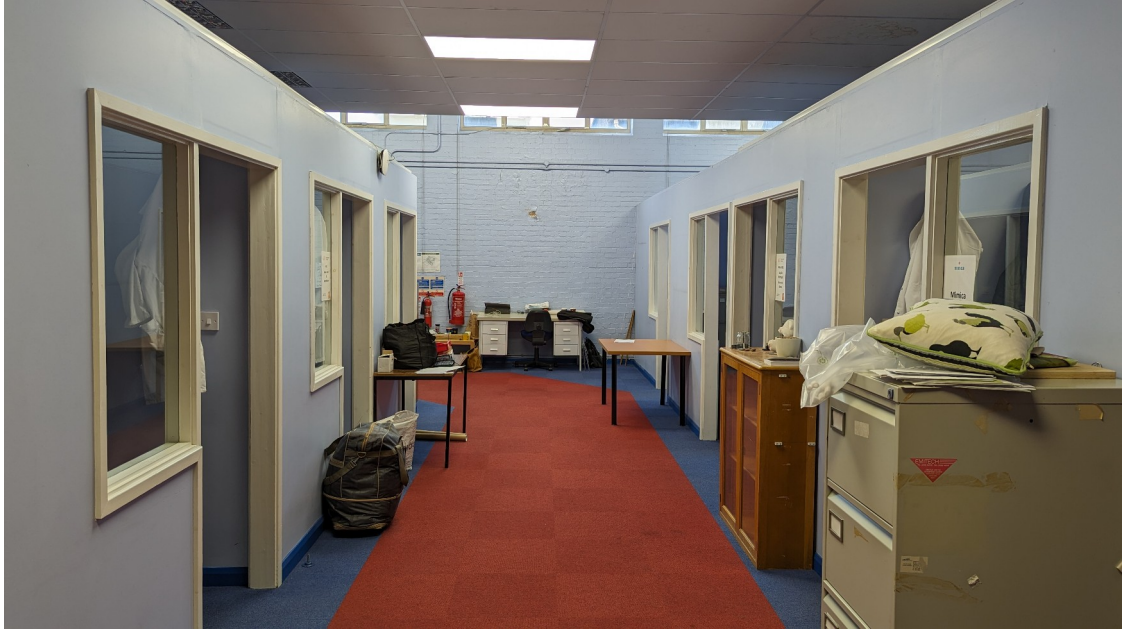
Plate 8: Room C34 looking southwest

6.3.1 Room C34 was located to the northeast of the corridor at the southeastern end. The room was a classroom that had been subdivided into smaller office pods (Plate 8). These pods were of wooden frames and are clearly late 20th to early 21st century inserted elements, leaving the entrance area open (Plate 8 & Plate 9).

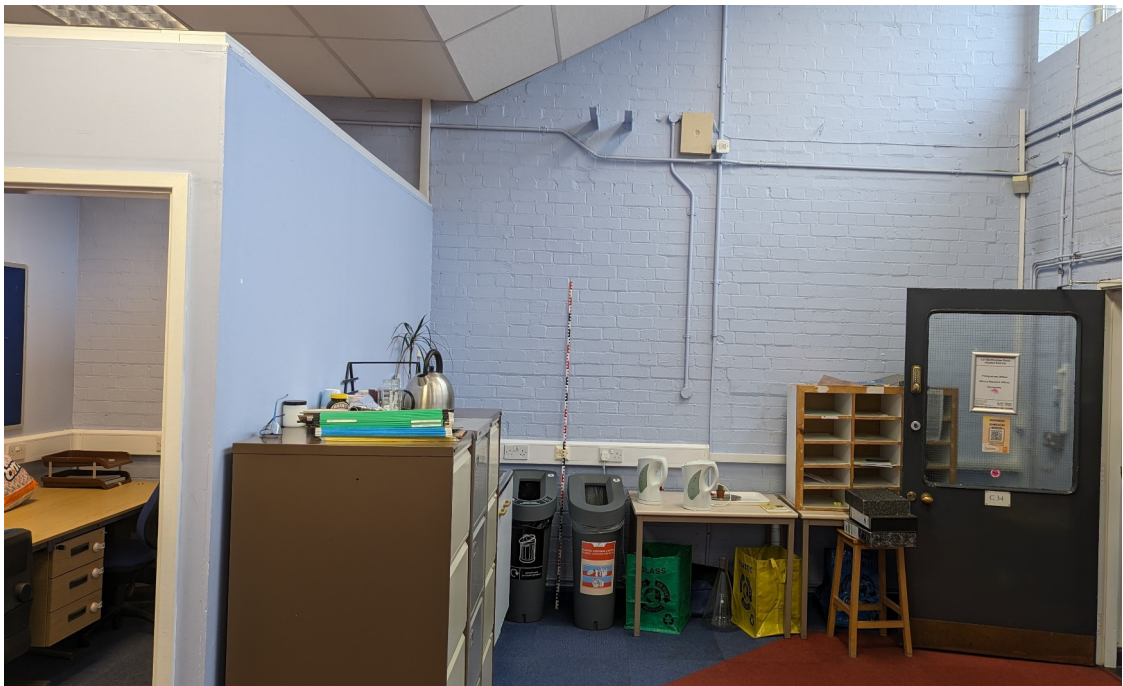
Plate 9: Room C34 looking southeast

6.3.2 The rooms were of painted brickwork, in English Bond of alternating header/stretcher courses (Plate 9).

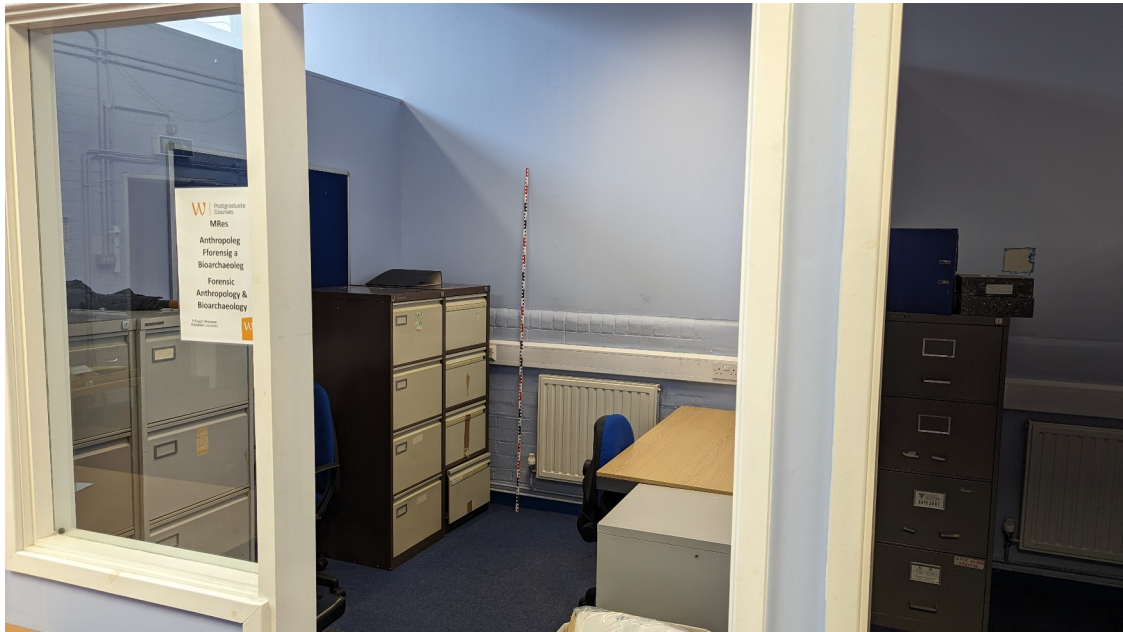
Plate 10: Room C34 pod form, with bullnose brick course

6.3.3 This bond was present to full height on the northeast, southeast and southwest walls, however, the northwest wall only showed brickwork up to a height of 1.2m, where a course of bullnose bricks forms a radial edge, suggesting the wall was inset from this point. Above the bullnose course, panelling has been installed to ceiling height (Plate 10). This feature has been seen in other institutional buildings, such as trade schools in Lancashire, where window walls are present to allow greater light and visibility between areas.

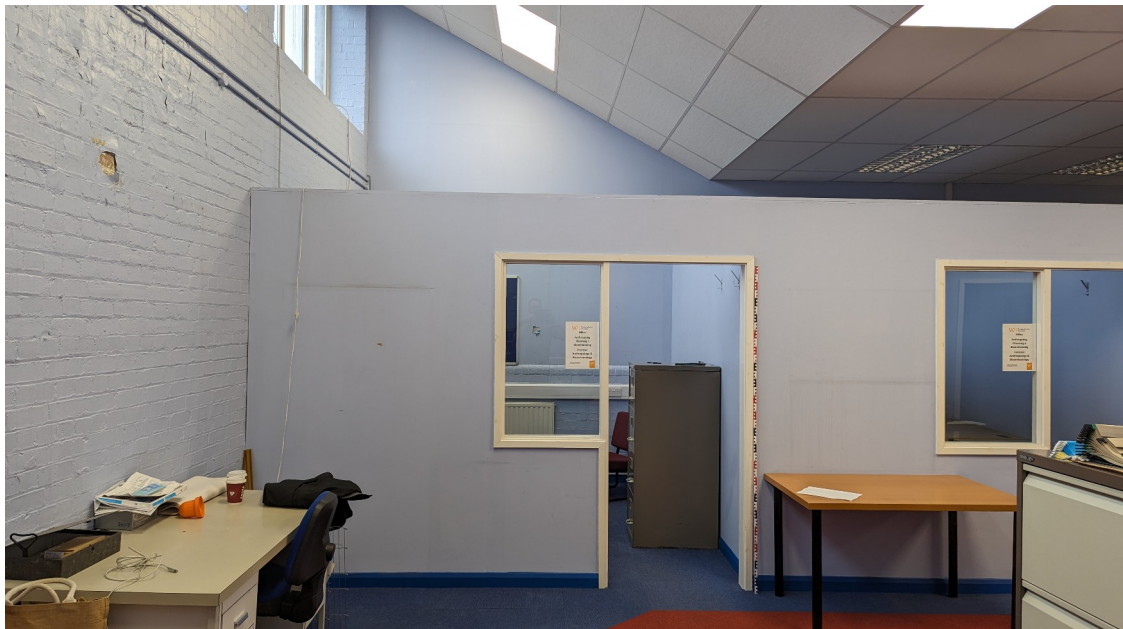
Plate 11: Room C34, looking northwest

6.3.4 The southwestern wall, bounding the corridor, is the only full height wall visible, as a floating ceiling has been installed, thought to be concealing the earlier

fixings and ephemera from the technical college such as pulleys and hoists. Aerial imagery from the time of construction shows the roof as a gables construction with roof lights allowing natural light into the structure (Plate 1). Where the ceiling slopes up, it revealed the first floor level, with large windows allowing natural light into the room from above the corridor (Plate 11).

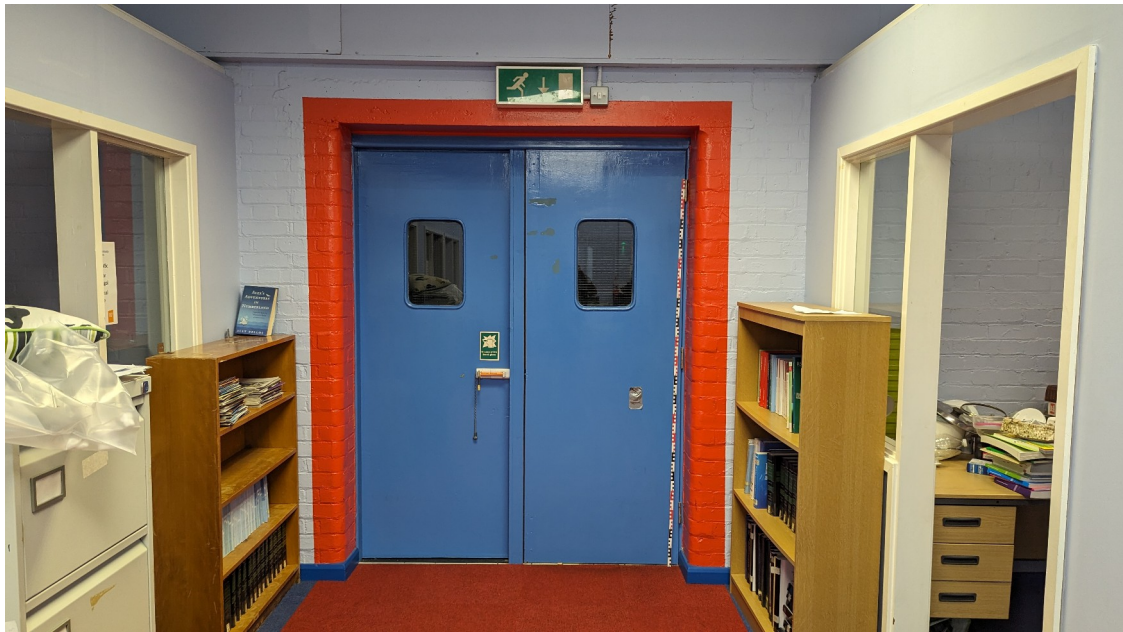
Plate 12: Room C34 northeastern exit

- 6.3.5 The bullnose brick design can also be seen in the edging of the emergency exit on the northeast wall, which have been painted red, as has the concrete lintel (Plate 12). Modern safety doors have been installed to replace the original fixtures.

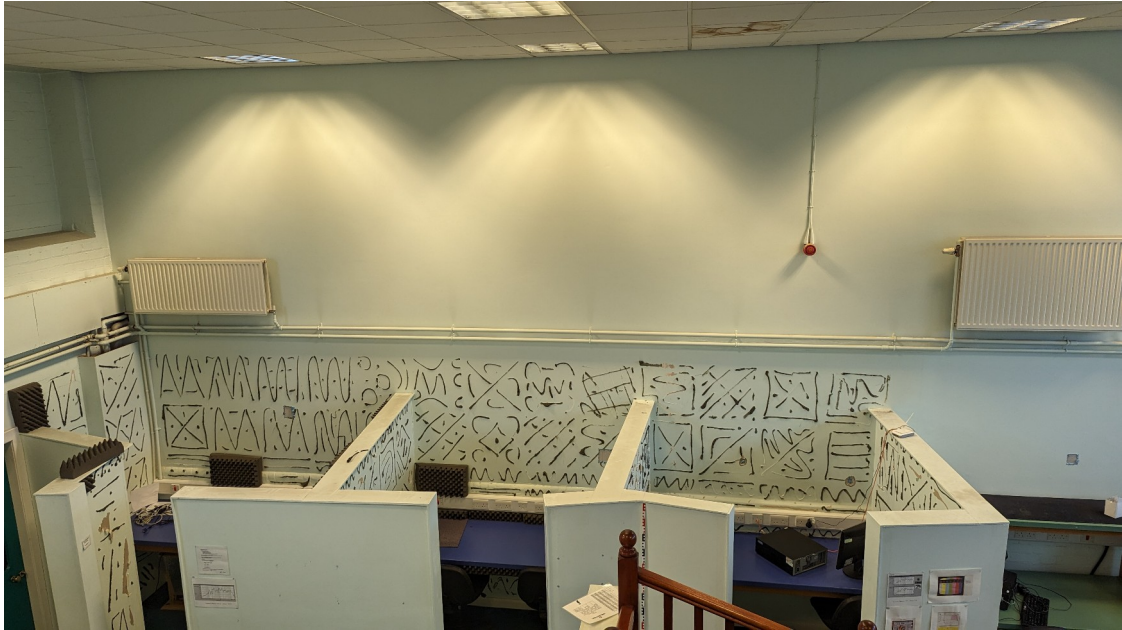
Plate 13: Room C36a, looking southeast

- 6.4.1 To the northwest of C34 was Room C36a, accessed via Room C36 discussed below. As with C34 the room had been sub-divided by low partitions, however, in this case they were angled partitions for audio functions (Plate 13). These were all modern insertions and not part of the original layout of the room. The open plan of the room and presence of an inserted late 20th century staircase, allowed for good views at the time of survey to help understand the original layout of the classrooms.

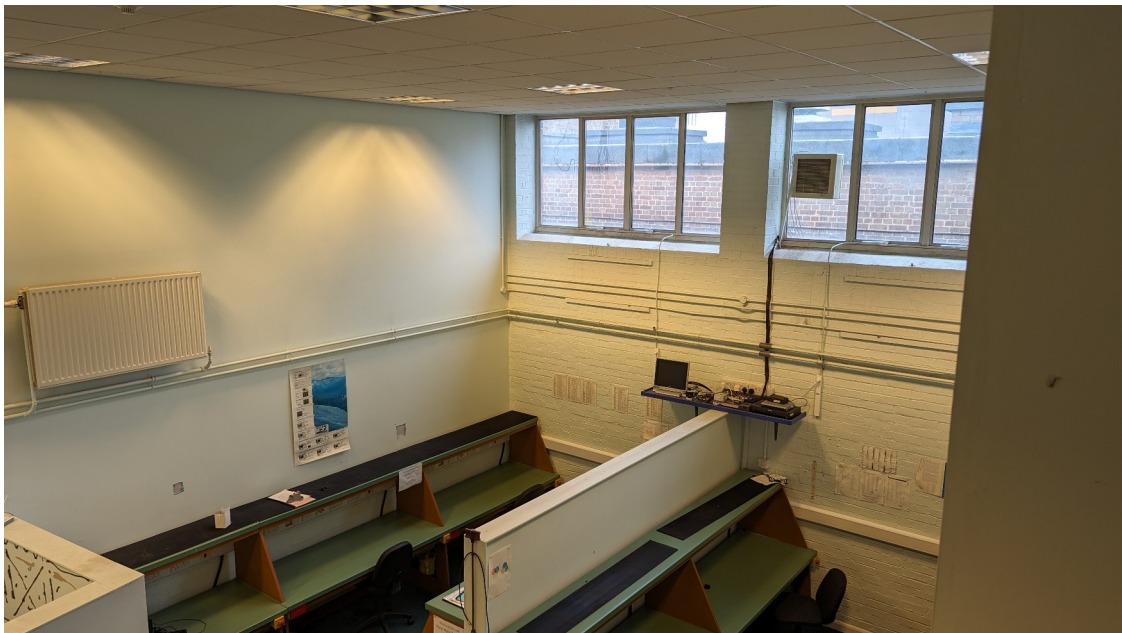
Plate 14: Room C36a, looking southwest

6.4.2 The walls were of painted blue and were of English bond brickwork, showing the same design features as room C34, with bullnosed bricks running along the wall between C34 and 36a, and panelling above.

6.4.3 The full ceiling was a suspended tiled ceiling obscuring the original features, meeting the northeast and southwest walls at the window lintel height (Plate 14). The windows, as with C34, were situated at first floor height, above the roof of the corridor, allowing natural light into the room. This is mirrored on the northeast wall (Plate 15), where the eastern window has been blocked to account for the erection of an extension outside this room.

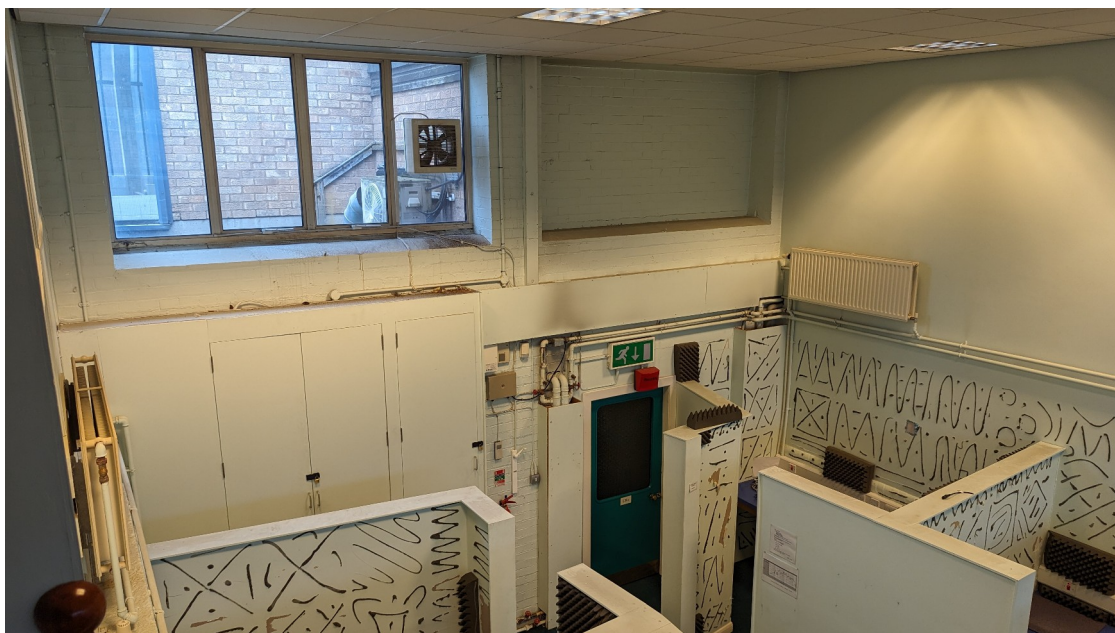
Plate 15: Room C36a, looking northeast

6.4.4 The northeast wall had a series of cabinets attached to the wall and an inserted doorway at the eastern end. This doorway is not an original feature and has a simple wooden frame inserted into the original brickwork.

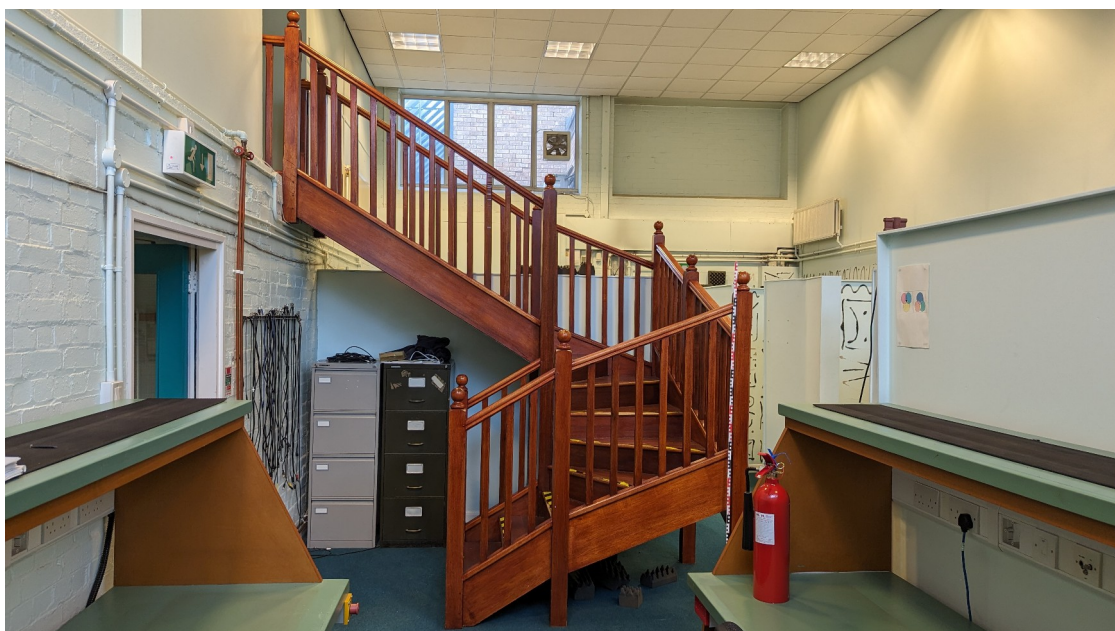
Plate 16: Room C36a, staircase

6.4.5 Located central to the room, leading to the first floor level of the northwest wall, is a wooden staircase (Plate 16). This does not appear to be an original feature and likely dates to the later 20th century, when the area above C36 was converted to a classroom. The staircase is not tied into the construction of the wall, but instead has been attached to it.

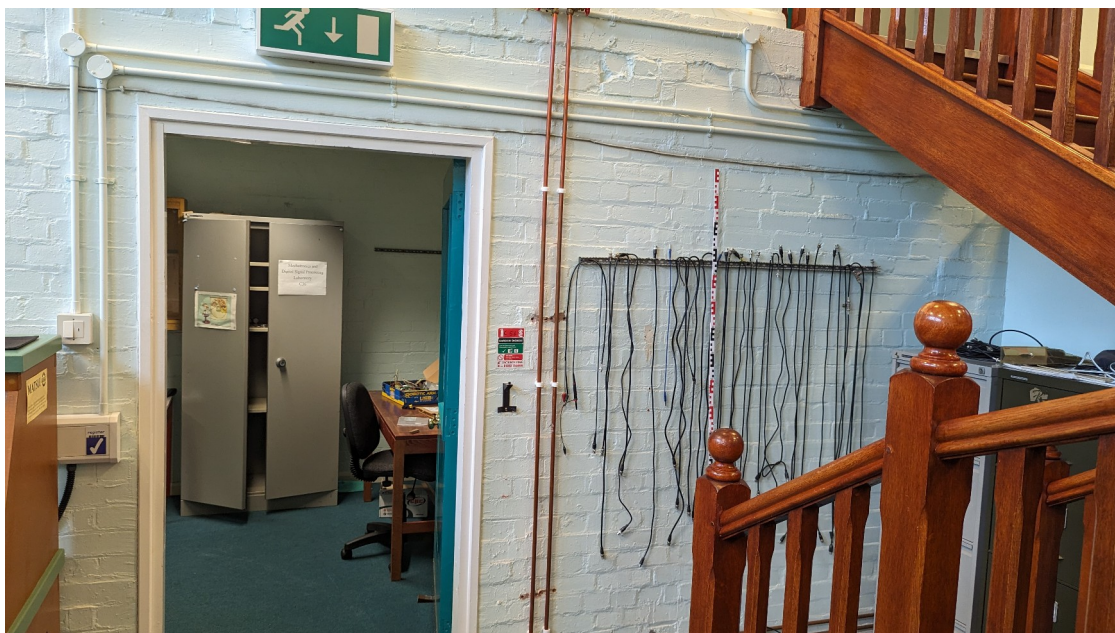
Plate 17: Room C36a, doorway to C36

6.4.6 Below the staircase is the access to room C36, which has a simple wooden frame, with a concrete lintel above (Plate 17).

6.4.7 To the east of the doorway to C36 is a blocked doorway, marked by an *in-situ* concrete lintel and differing brickwork infill. This second, blocked, doorway leads to the eastern half of C36, currently only accessible via C38 (Figure 10).

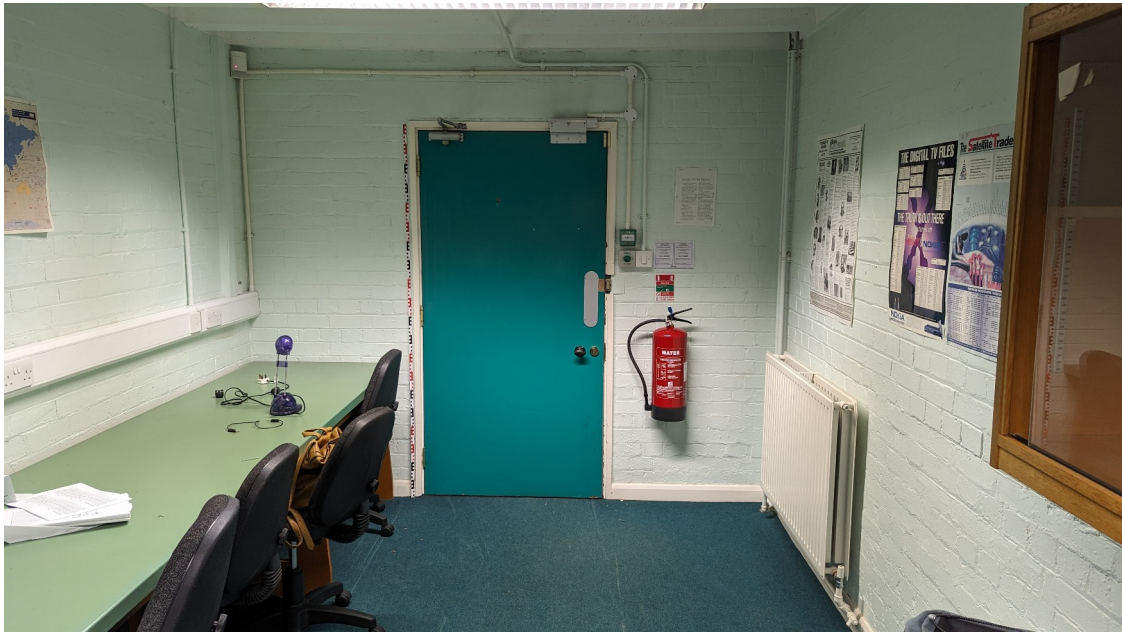
Plate 18: Room C36, doorway to corridor

6.5.1 Room C36 allows access to C36a from the corridor via a simple wooden frame doorway with concrete lintel, and is a single storey barrow room of painted brick in English Bond (Plate 18).

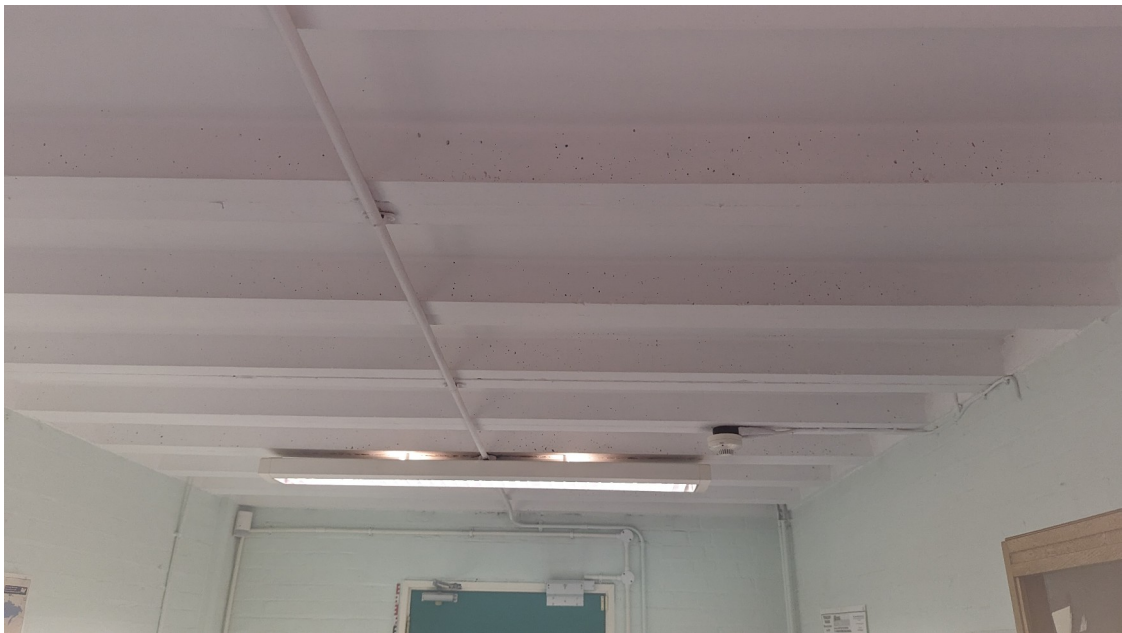
Plate 19: Room C36, ceiling

6.5.2 The ceiling for C36 is a ridged concrete construction (Plate 19), which currently has a classroom above, however may have originally been a mezzanine based on the early images of the construction of the campus.

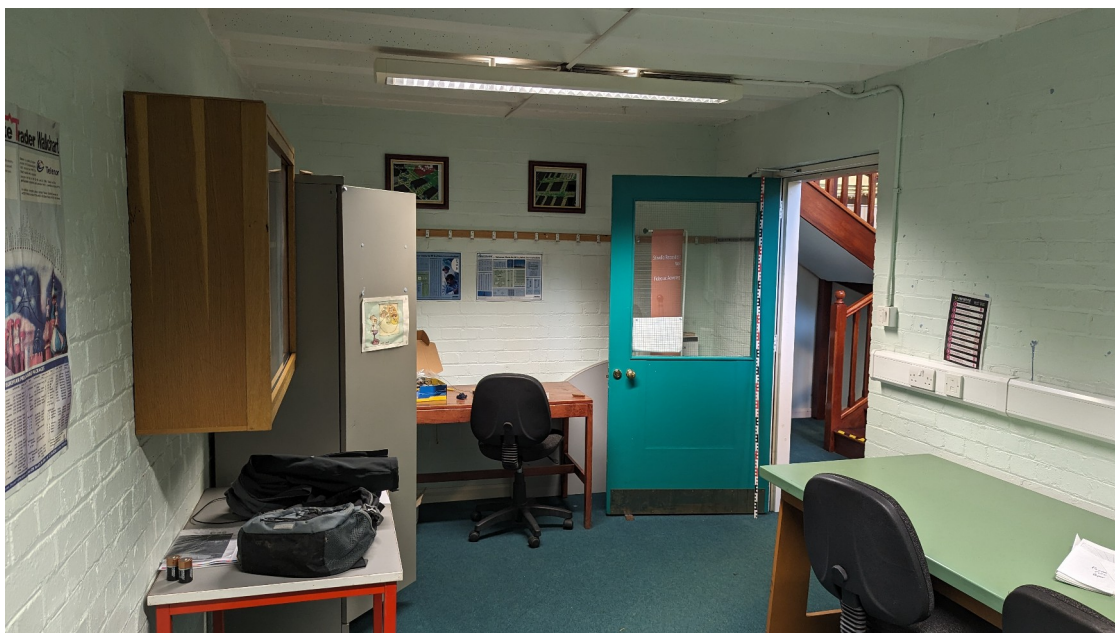
Plate 20: Room C36, looking northeast

6.5.3 The simple form of the room (Plate 20) suggests a possible cloakroom giving access to the workshops, where coveralls or work wear could be put on prior to practical work commencing.

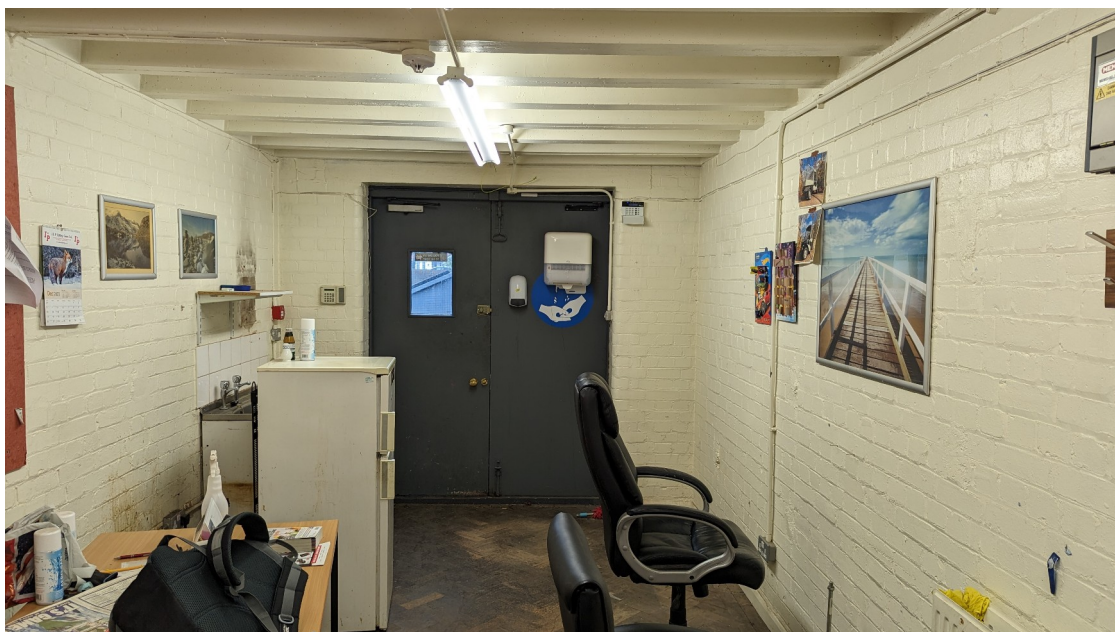
Plate 21: Room C36 east, looking northeast

6.6.1 The counterpart of C36 west is C36 east, accessed via C38, and retains much of the original fabric, suggesting C36 west may have looked similar at point of construction.

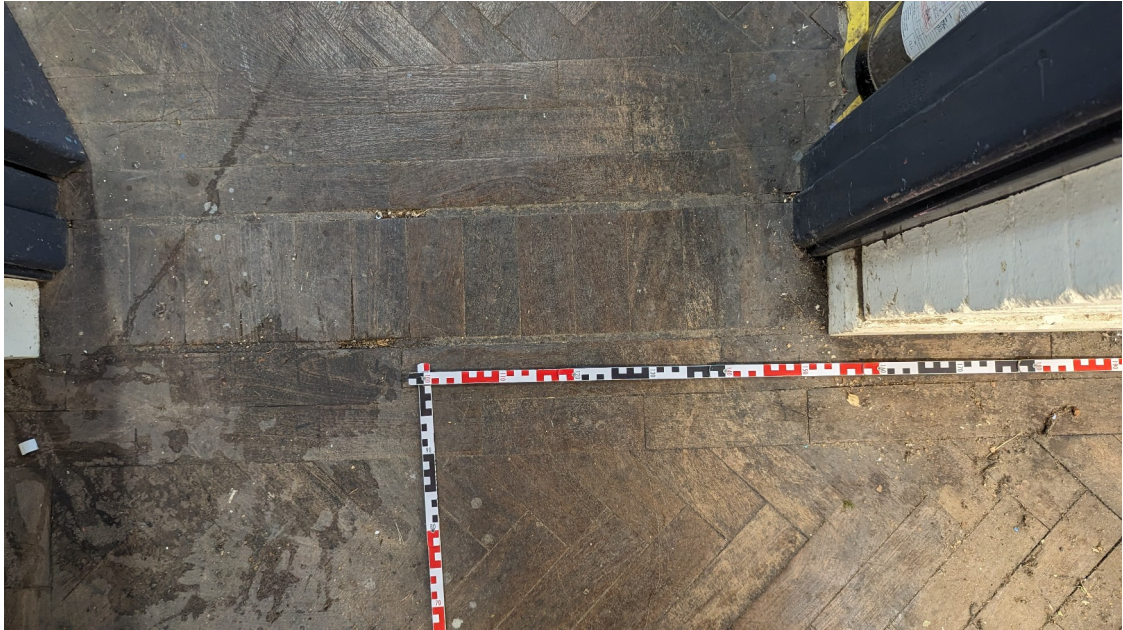
Plate 22: Room C36 east, parquet flooring

6.6.2 The brickwork, in English Bond, has been painted with. The wooden parquet flooring is intact laid in a herringbone pattern, with linear edging (Plate 22).

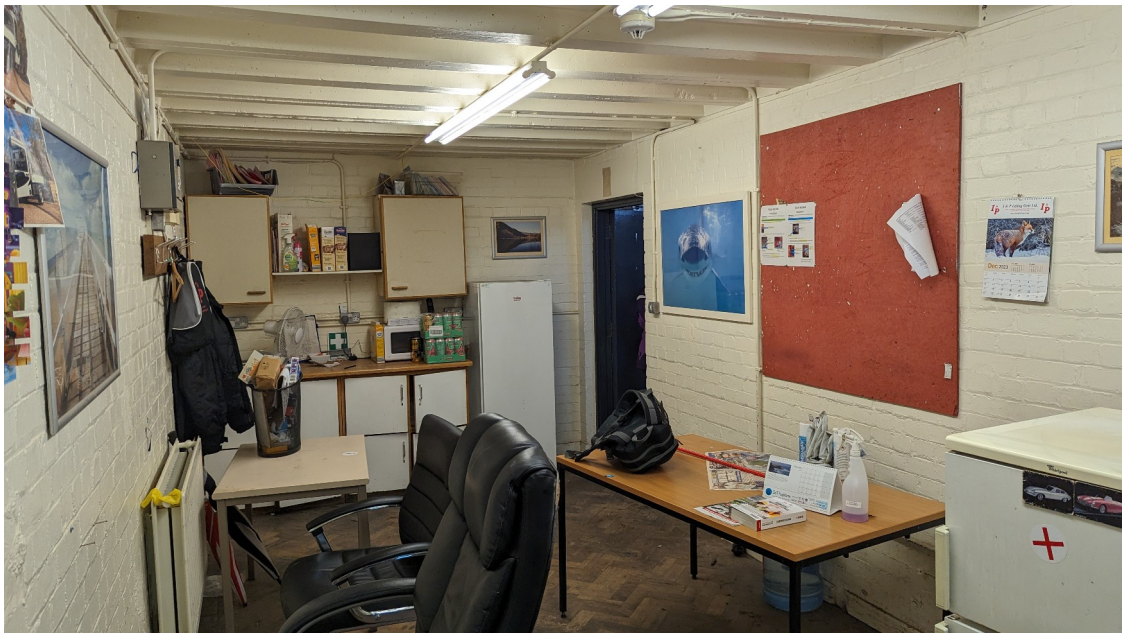
Plate 23: Room C36 east, looking southwest

6.6.3 At the western end of the room the blocked doorway is evident via differing brick fabric and the lintel above where the doorway would have been (Plate 23).

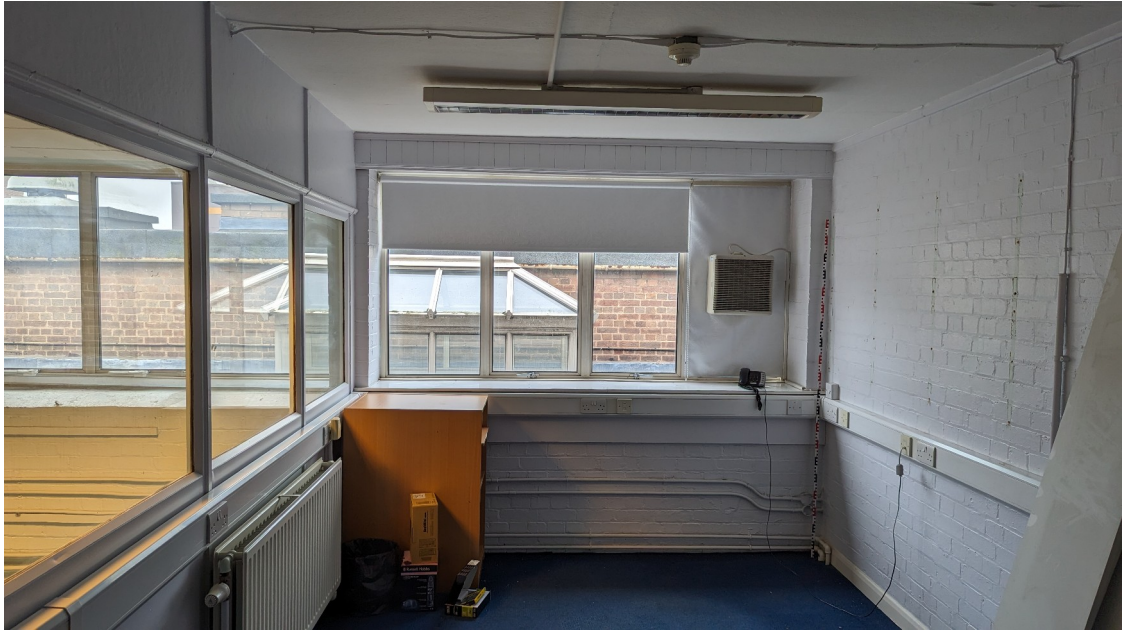
Plate 24: Room C36 first floor, looking southwest

6.7.1 Above C36 the area has been enclosed to form a modern classroom (Plate 24). The northwestern wall is of brick in English Bond, suggesting a hard division between C36a and C38. The southeastern wall was a partition and window wall and was not load bearing, being constructed of a stud framework.

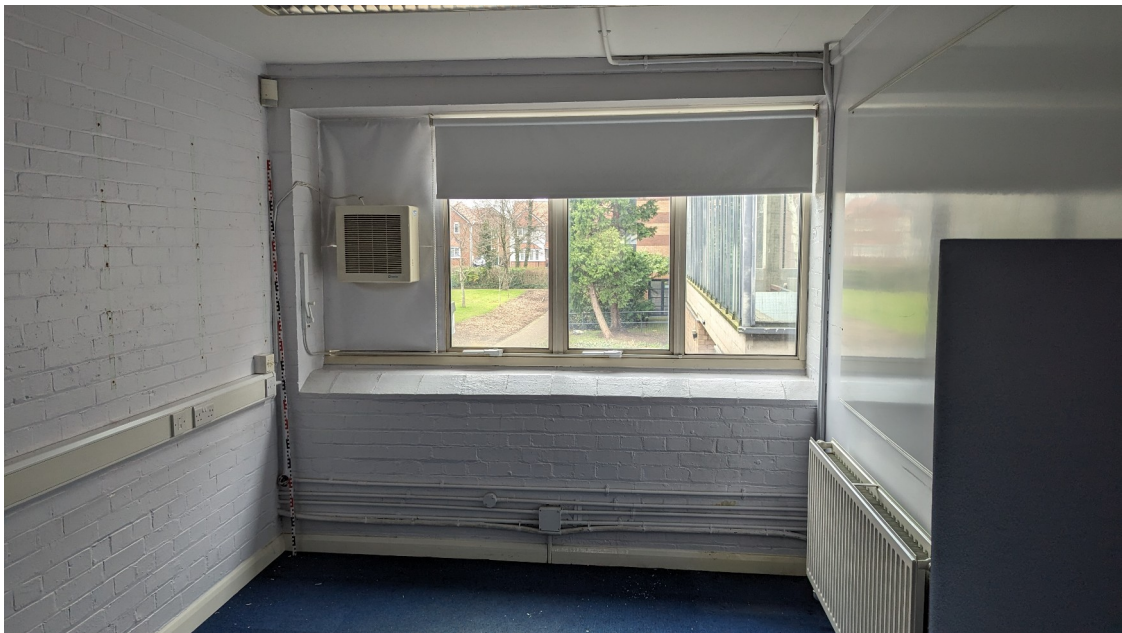
Plate 25: Room C36 first floor, looking northeast

6.7.2 The window on the northeastern wall matches the first floor windows on the northeast wall of C36a, with sloped tiled cills and concrete lintel (Plate 25).

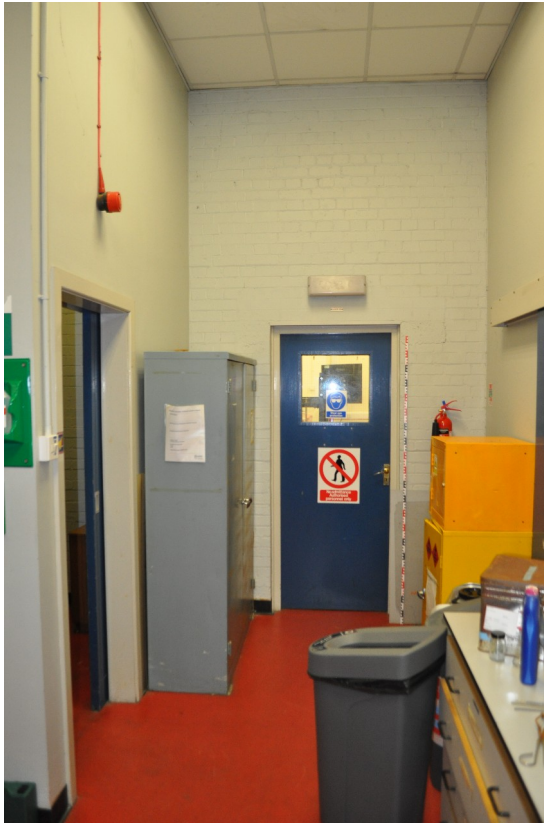
Plate 26: Entrance to C43

wall (Plate 26). This partitioning is a late 20th to early 21st century modification to the room.

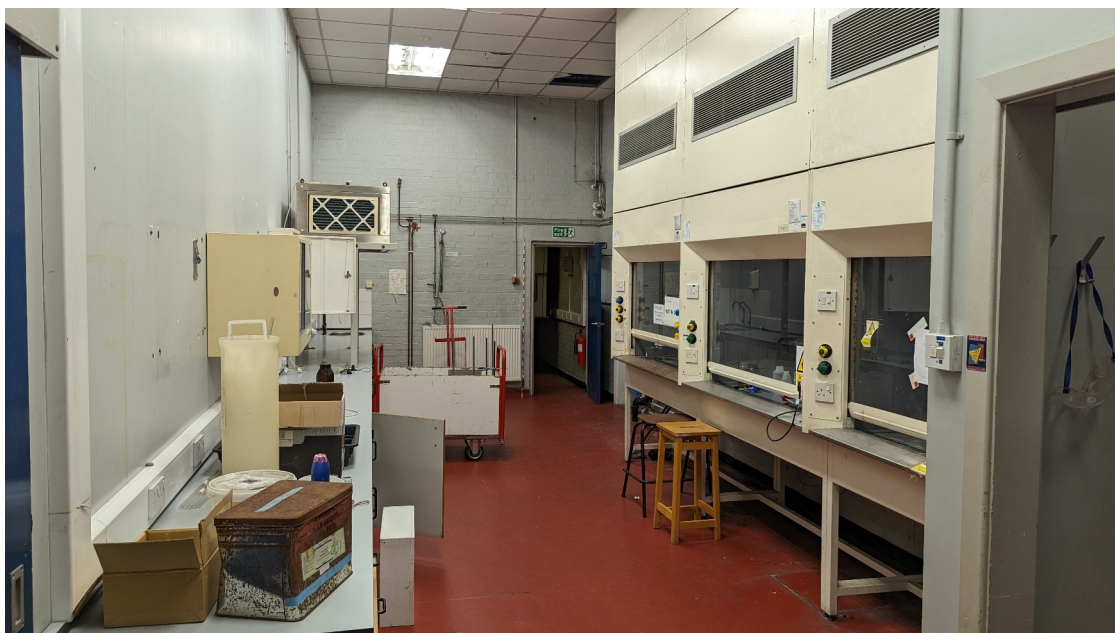
Plate 27: Room C43 first floor, looking northwest

6.8.3 A suspended tile ceiling and modern floor covering obscure any historic fabric in those areas. The southwestern wall was a late 20th to 21st century stud partition wall dividing off what would have been the other half of this classroom (Plate 27).

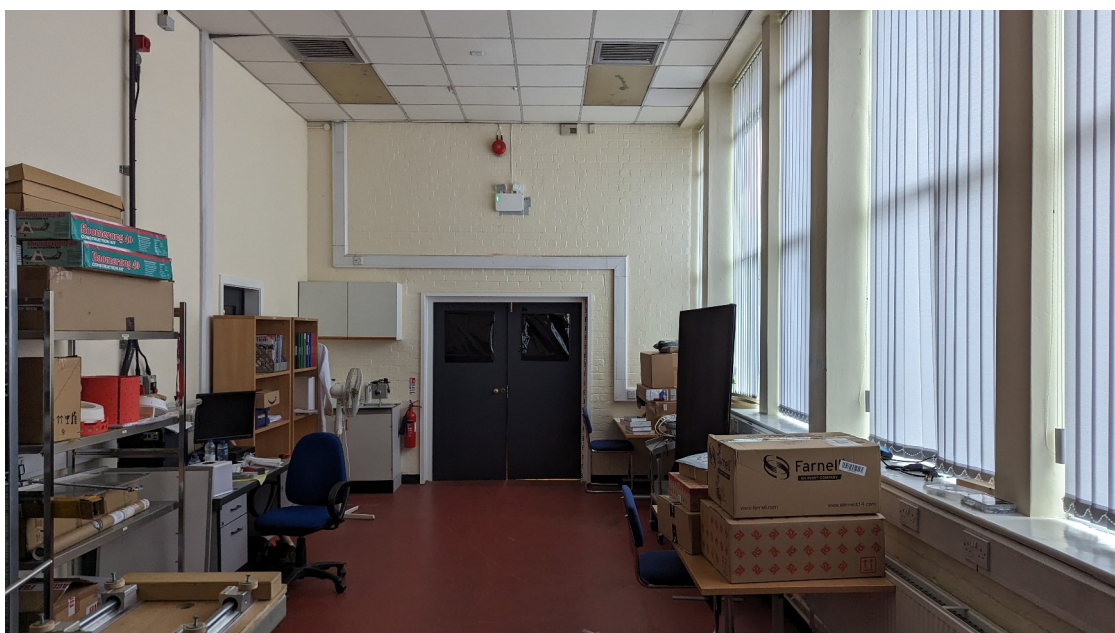
Plate 28: Room C43 first floor, looking southeast

6.8.4 The southwestern partition of C43 continues the suspended ceiling and coated flooring, however the southwestern wall contains the full height windows that are integral to the design of the college from the 1950s and offer a great deal of natural light into the space (Plate 28). The doorway leading into this area, via C41b, appears to be a later inserted frame, with none of the original design features, such as concrete lintel or bullnosed edging, present.

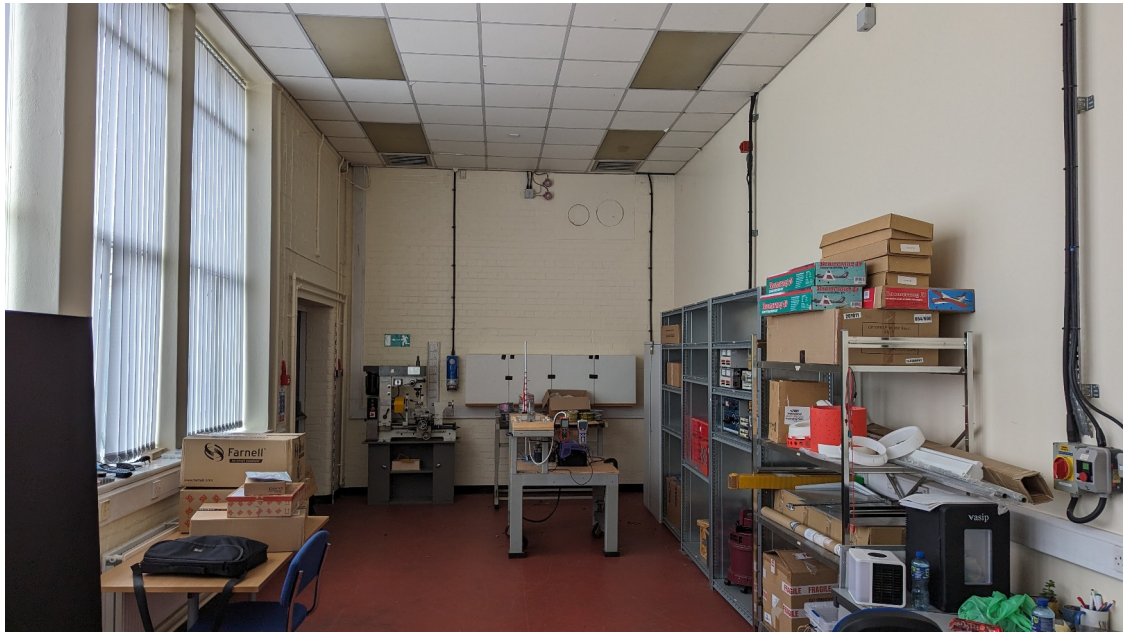
Plate 29: Room C43 first floor, looking northwest

6.8.5 To the northwest corner of the room the original exit doors can be found matching those seen in C34, with concrete lintel and bullnose brick edging to the sides (Plate 29).
