**LEVEL 1 BUILDING RECORDING OF
FORMER AGRICULTURAL BUILDING
AT BROOKHOUSE FARM, CWMGILLA
LANE, KNIGHTON, POWYS LD7 1PG
Planning Application
P/2017/1018 (Powys)**

Report by: Trysor

Trysor Project No. 2022/836
CPAT HER EVENT PRN : 167117

DYDDIAD 10^{fed} Mehefin 2022 **DATE** 10th June 2022

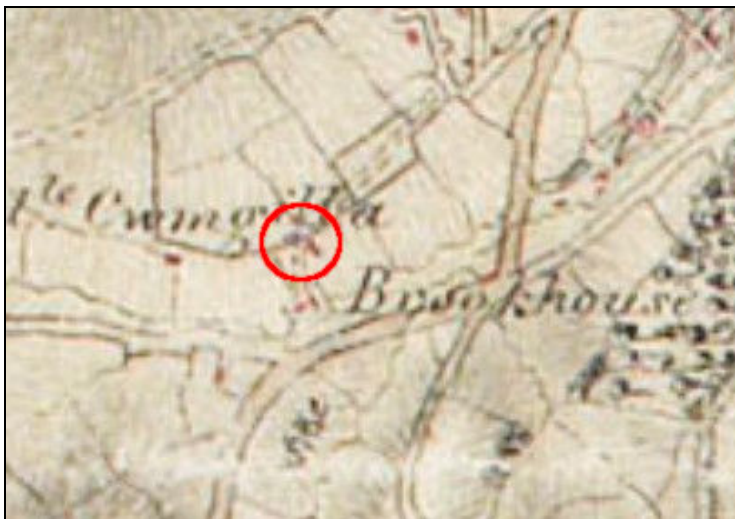
Figure 3: The 1815 Ordnance Survey Original Surveyors Drawing shows a building at the site of the barn complex (ringed in red), with another to its northwest. It seems to show a single barn, but this may not be an accurate representation of the layout of the barns at the time and merely be indicative of the presence of buildings at the location.

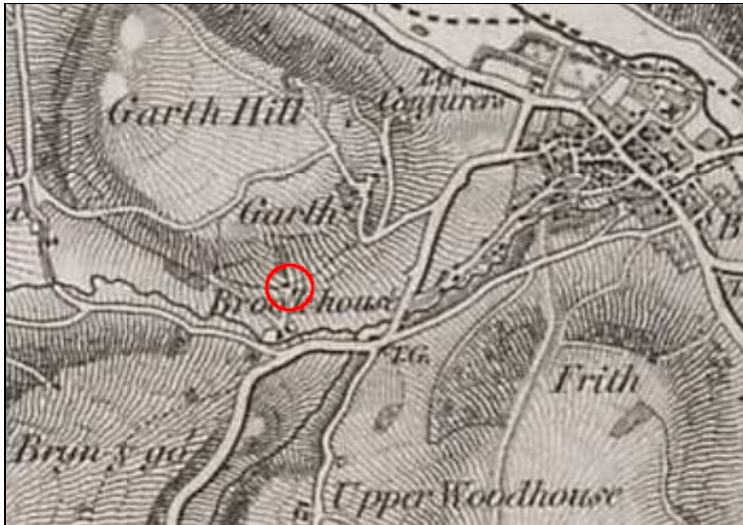
Figure 4: The 1833 Ordnance Survey First Series map also shows a building at the site of the barn complex (ringed in red), with another to its northwest. This map shows the proximity of Brookhouse Farm to Knighton.

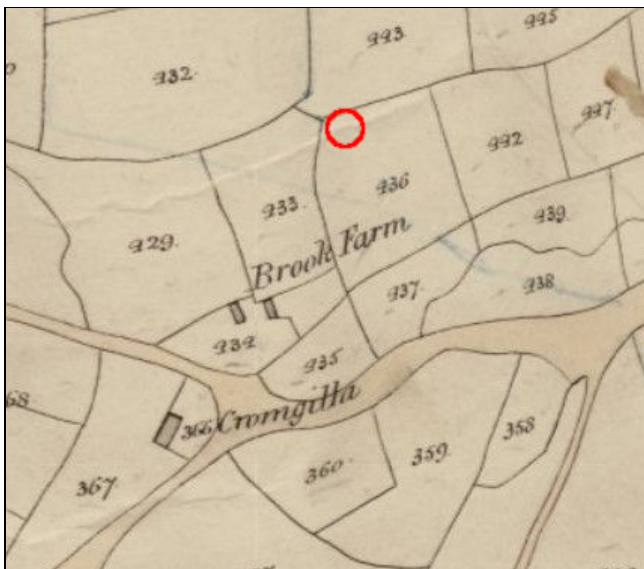
Figure 5: The 1840 Knighton parish tithe map does not show the barn complex (which would be in field 436) or the building to its northwest (which would be in the southwest corner of parcel 443). Neither field is named, therefore the map sheds no light on the history of the barn complex. The buildings shown at "Brook Farm" appear to only include two farm buildings, the house itself does not seem to be depicted (it would be in parcel 434).

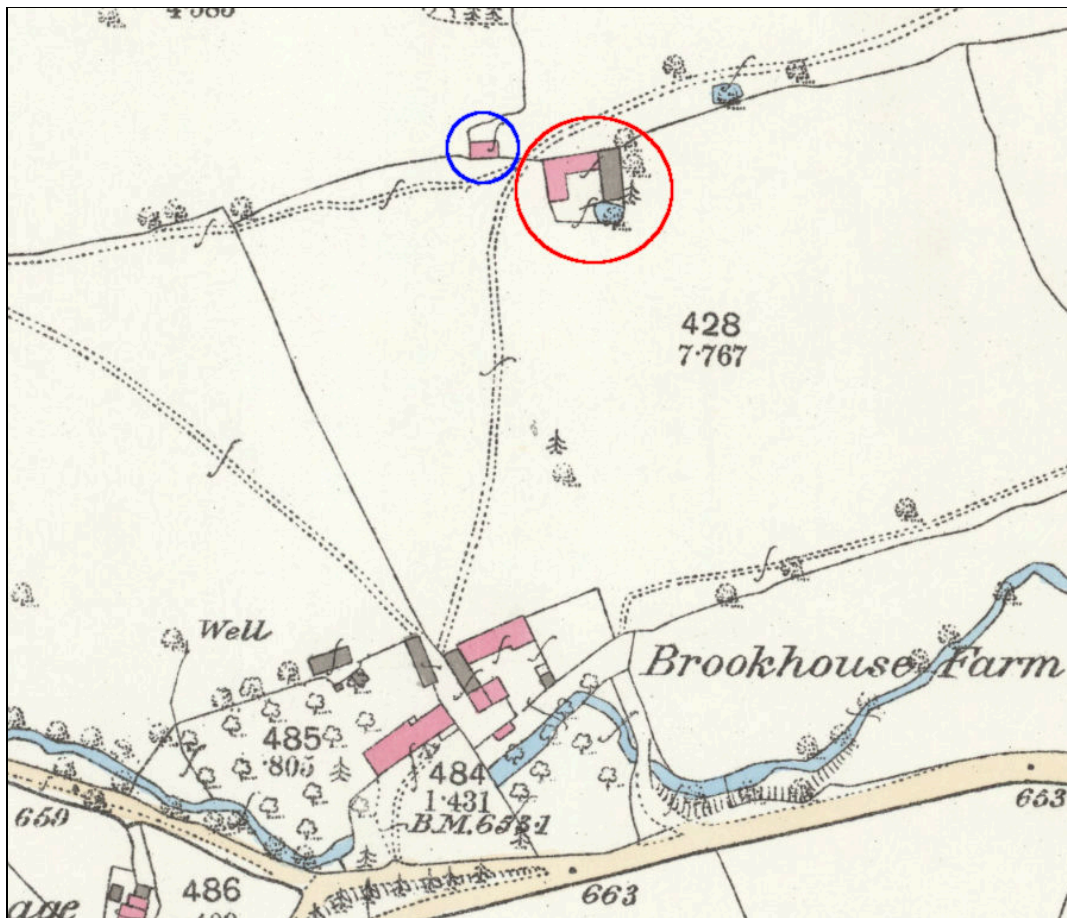
Figure 6: The 1889 1:2500 scale Ordnance Survey map is the first clear depiction of the buildings at Brookhouse Farm, including the barn complex (ringed in red) and the now lost building to its northwest side (ringed in blue). The stone foundations of this lost structure remain under cover of trees. The buildings shaded in pink are slate roofed, those in grey probably roofed with corrugated iron sheeting. Note that there was a pond to the south of the East Barn at this time.

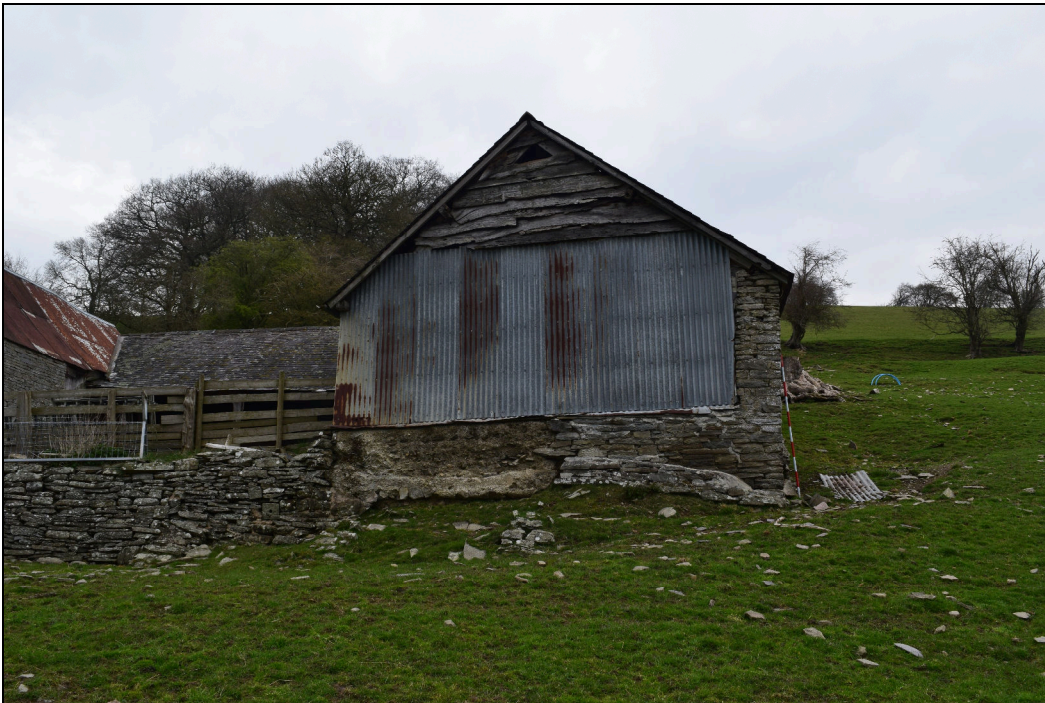
Plate 4: GBB2022_004 – A view of the southern gable of the East Barn, showing the plinth on which the south end of the building stands. Some facing stones have fallen away and been replaced by modern concrete mixed with stone. Looking north.

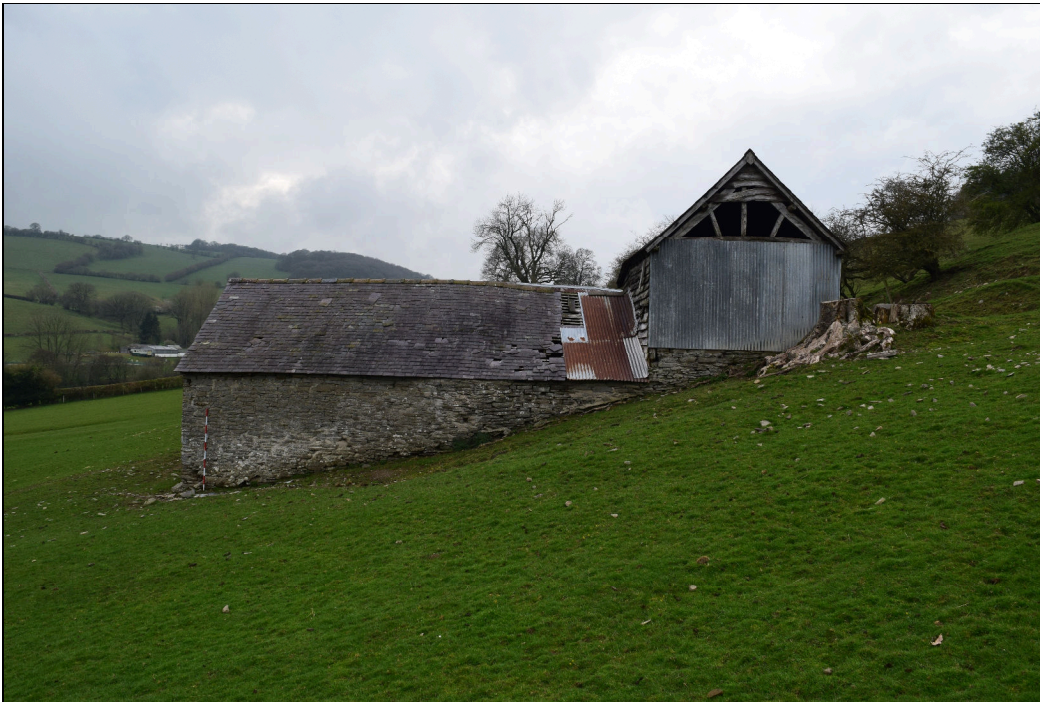
Plate 5: GBB2022_005 – A view of the East Barn with its raised Hay Loft to the right. They share a continuous eastern wall and appear to be contemporary. Looking west.

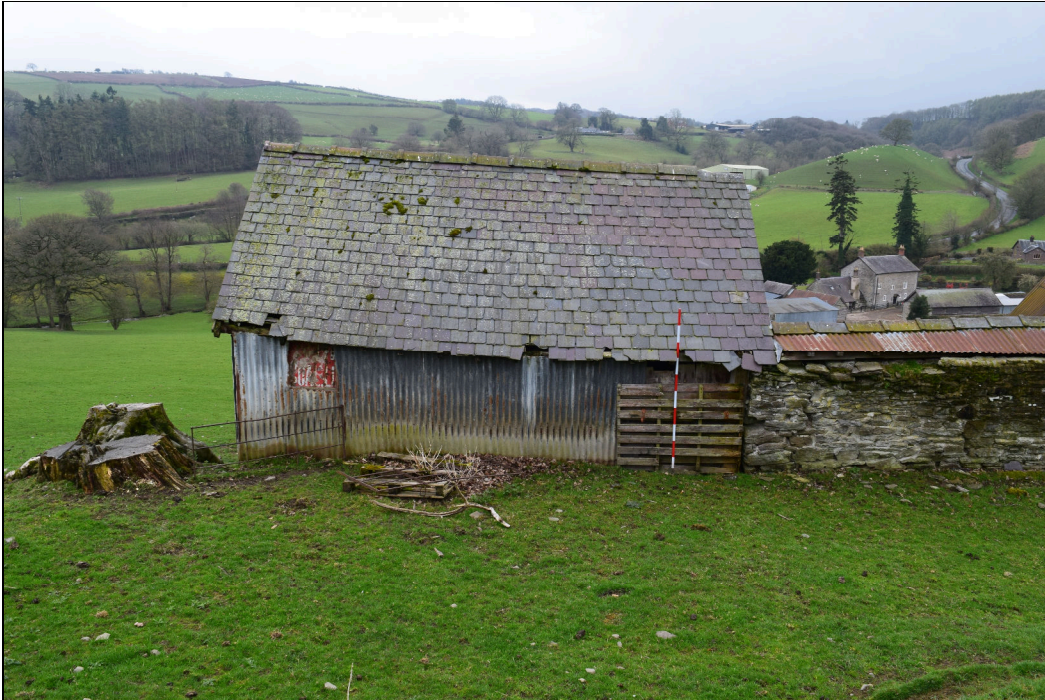
Plate 7: GBB2022_007 – A view of north side of the Hay Loft, showing the slate roof. The timber-framed north wall has been clad with corrugated sheeting. Looking south.

7.1.5 The East Barn also shares the revetment wall at its northern end (Plate 29), with its eastern lateral wall also stone-built (Plate 30). It is divided from the Cowhouse by a short, separate stone wall (Plate 28) through which is a door leading into the Cowhouse. The southern gable wall is timber-framed, now clad in corrugated steel sheeting, but set on a stone-faced plinth (Plate 4 & 24). The western side of the East Barn is mostly open to the yard, with the roof supported by a combination of modern wooden posts (two of which are railway sleepers) and a steel post (Plate 23). The northern end of the East Barn has a second storey, which is the hayloft (Plate 5 & 22). The hayloft is timber-framed, set on the stone walls of the ground floor level. It is now weatherboarded on its south and west sides (Plate 22), with the east and north sides clad in corrugated steel (Plates 6 & 7). The East Barn, including the hayloft, has a slate roof (Plate 7).

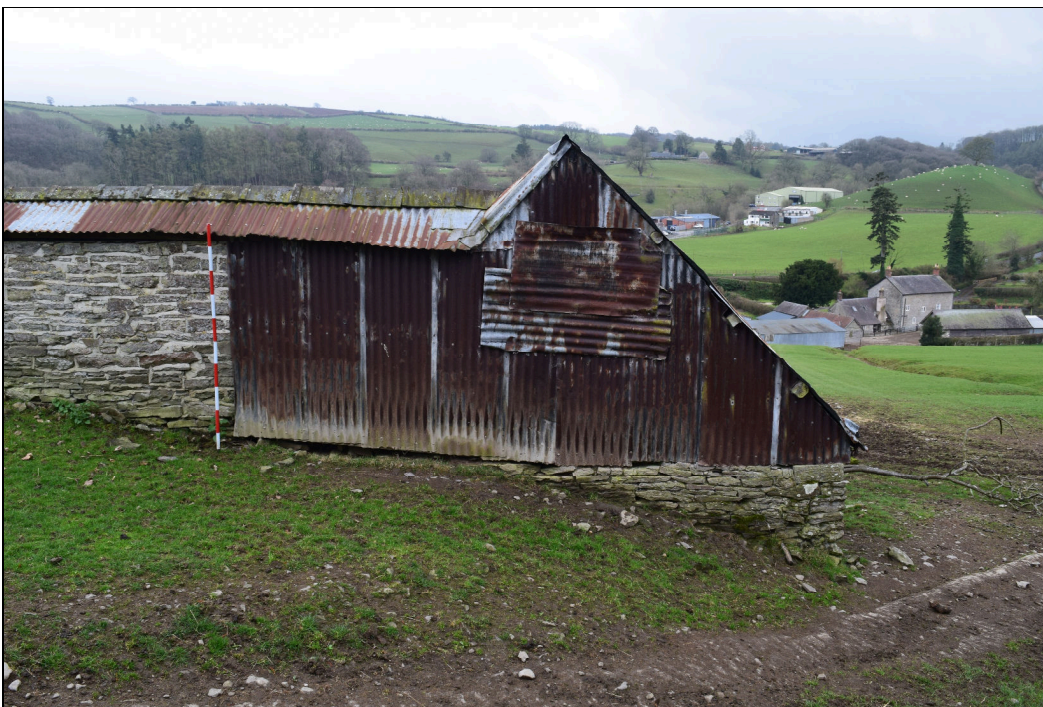
Plate 10: GBB2022_010 – A view of the north side of the West Barn. The timber-framed wall is clad in corrugated sheeting. Looking south.

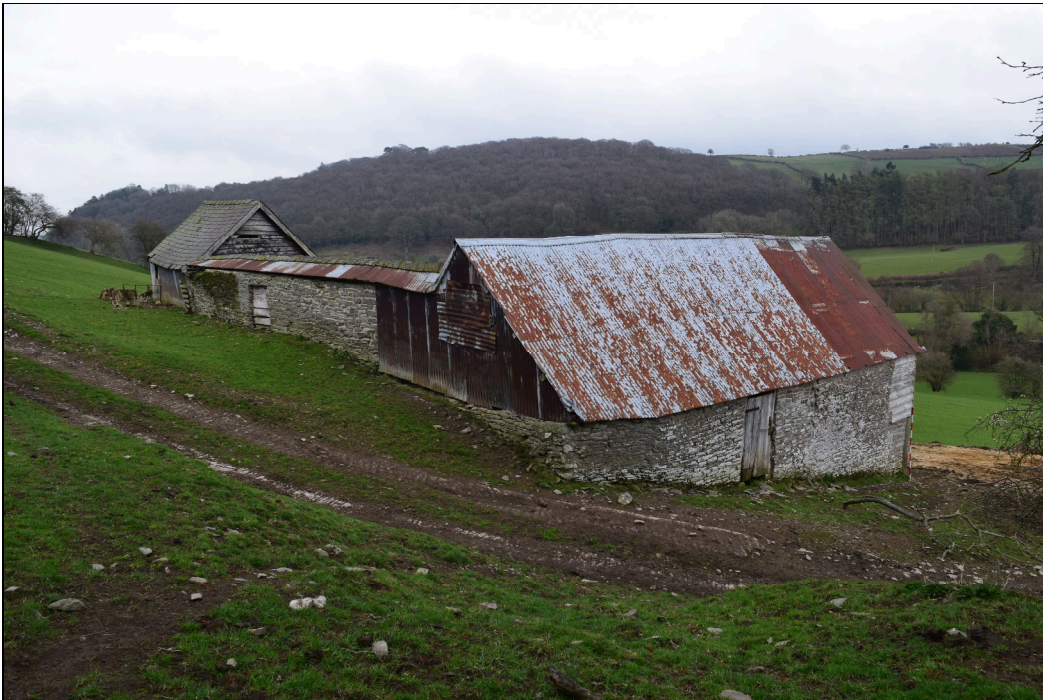
Plate 11: GBB2022_011 – A view of the barn complex, showing the stone western wall of the West Barn, which has a corrugated steel roof over timber. Looking southeast.

boarded but has evidently been replaced at some time. The West Barn now has a corrugated steel roof (Plates 9 & 11).

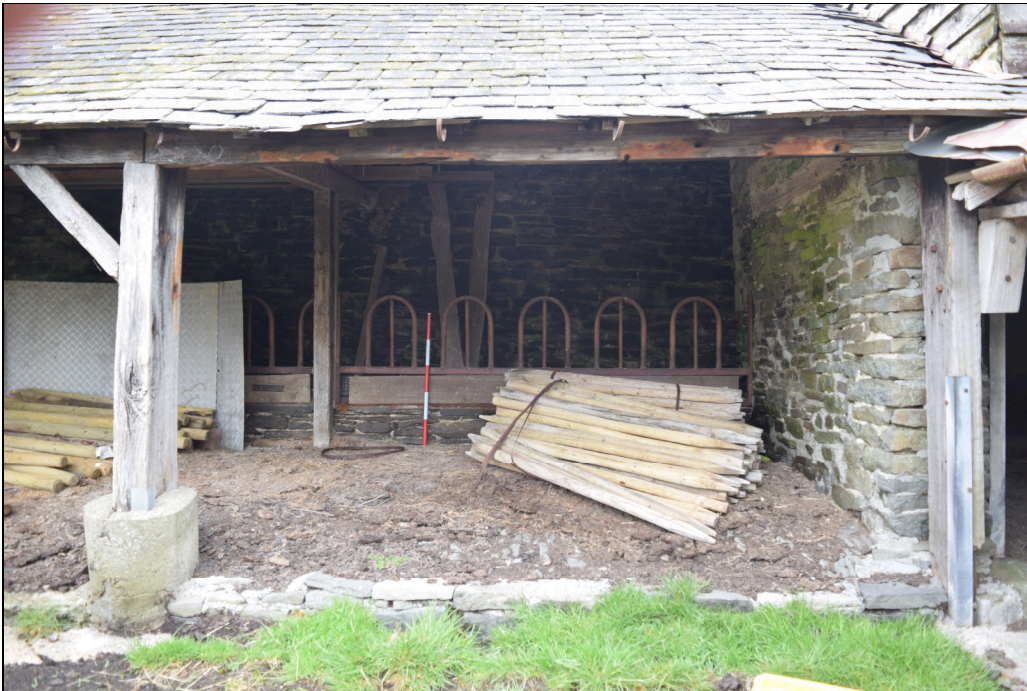
Plate 14: GBB2022_014 – A view of the east side of the Cowhouse. The original roof posts here have been replaced with wooden railway sleepers. Looking north.

7.1.4 The Cowhouse shares the revetment wall, which forms the northern side of the complex (Plate 14). Viewed from the north, upslope, this wall is heightened 1.4 metres above ground level and has a pitching door at its centre through which hay could be pitched into the building (Plate 9). Its western side is defined by the timber-framed, wood-clad wall of the eastern side of the West Barn and there is a doorway through this wall into the West Barn (Plates 13 & 15). The southern side of the Cowhouse is open to the yard, with a series of four posts across this side supporting the roof (Plate 12). The east side of the Cowhouse is formed by a free-standing stone wall (Plates 14 & 16), which is separated from the revetment wall to the north by a doorway into the East Barn (Plate 28). This wall extends out to the south as far as the line of posts supporting the Cowhouse Roof. The Cowhouse has a corrugated steel roof with terracotta ridge tiles (Plate 9).

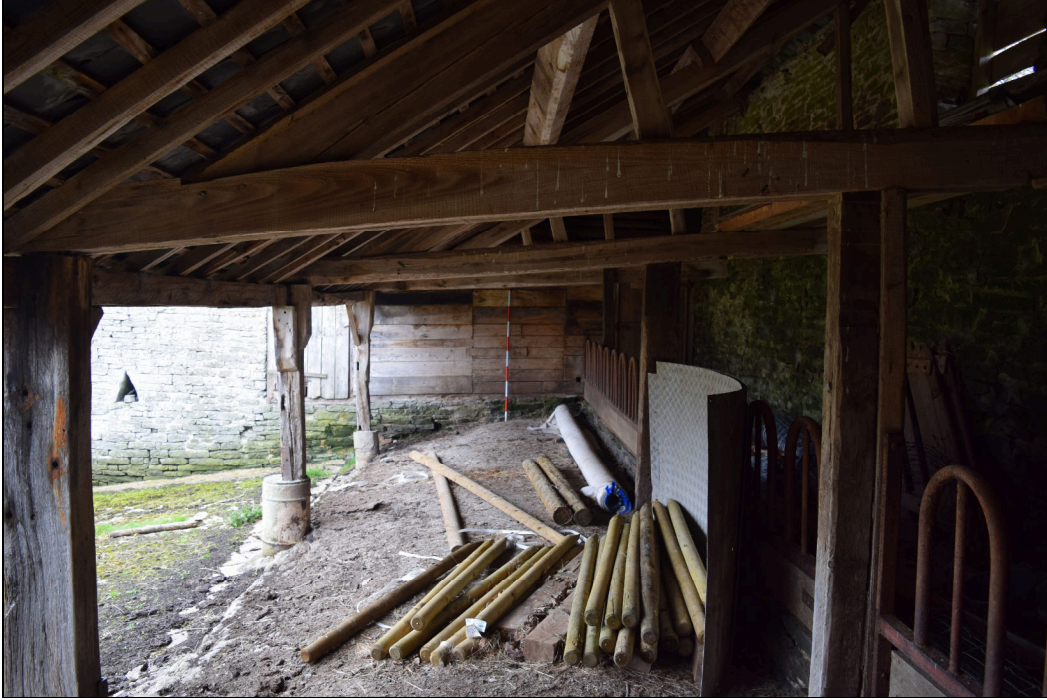
Plate 15: GBB2022_015 – A view inside the Cowhouse, showing the stalls and the raised feeding trough. Note the stone wall to the right, the bottom half of which is a revetment into the hillside. Looking west.

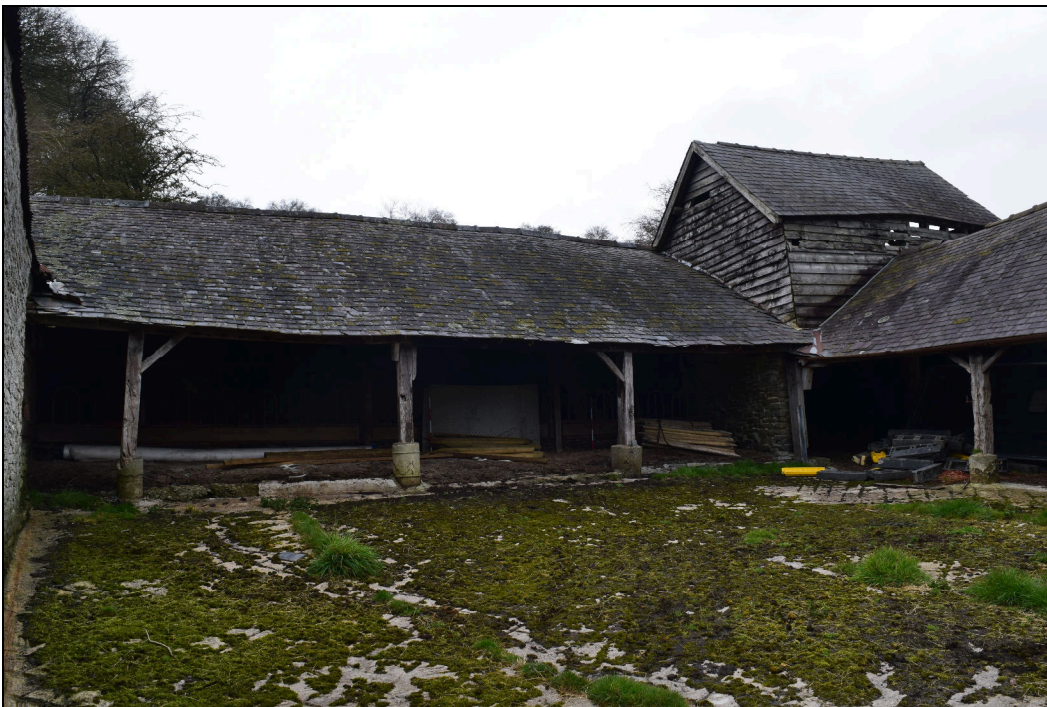
Plate 18: GBB2022_018 – An external view of the Cowhouse, showing its relationship with the hayloft at the north end of the East Barn. The hayloft is weatherboarded at first-storey level and has a stone wall at its west side at ground floor level. Looking northeast.

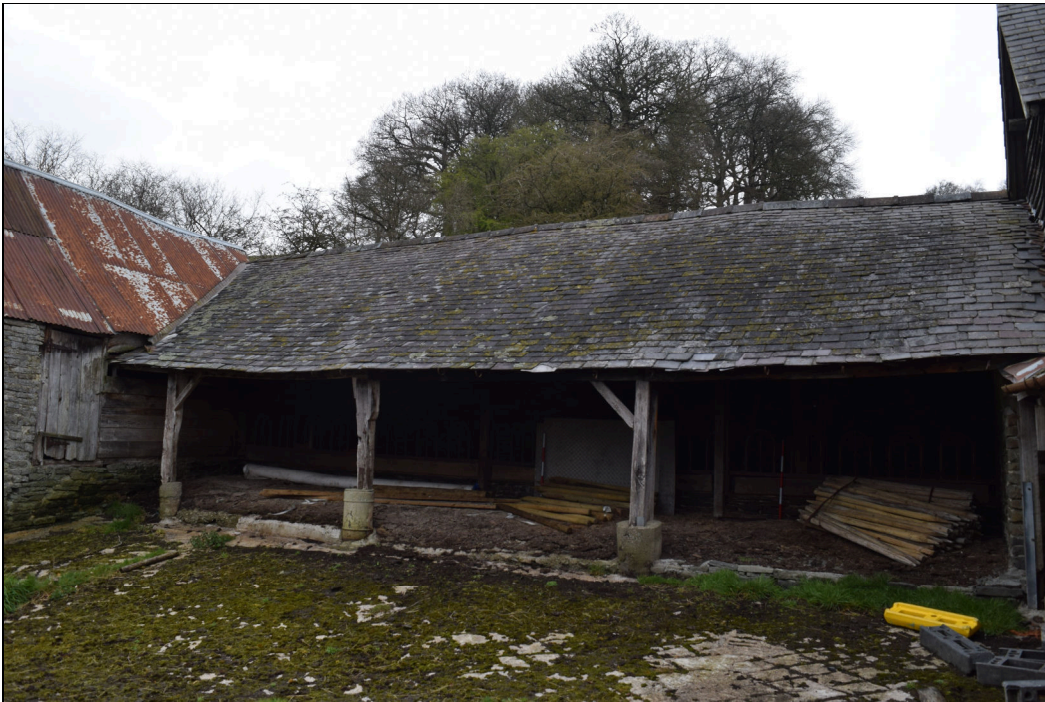
Plate 19: GBB2022_019 – An external view of the Cowhouse, showing its relationship with the north end of the West Barn. It appears that the Cowhouse is a later insertion into the complex. Looking north-northwest.

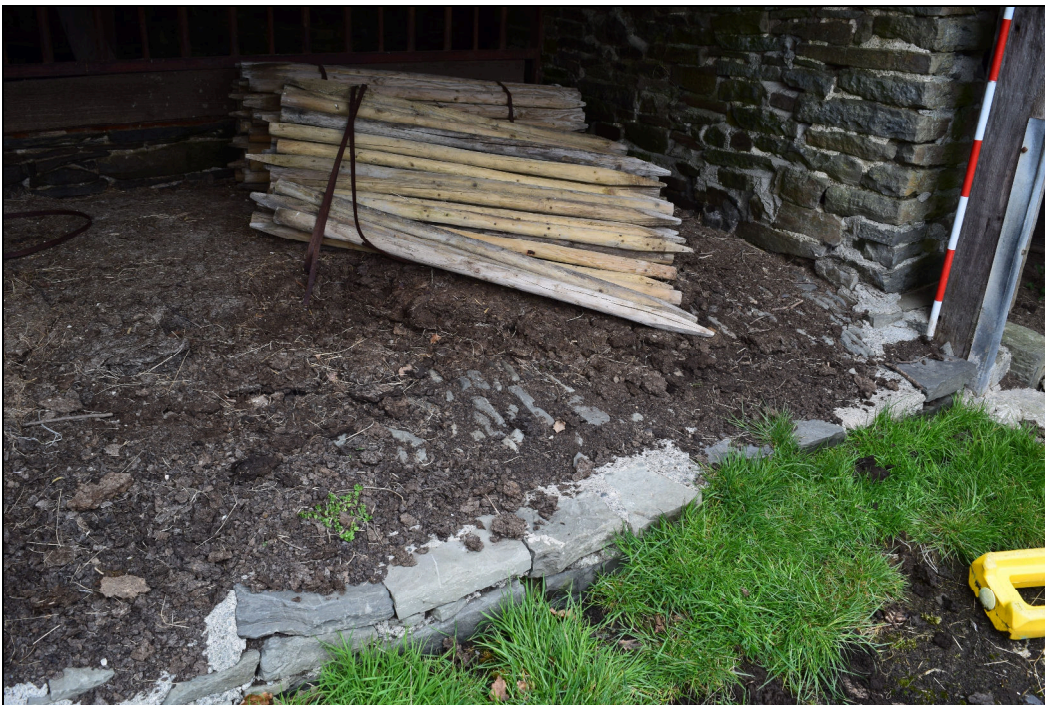
Plate 20: GBB2022_020 – A view of the Cowhouse floor, showing cobbling visible through the layer of dung which hides much of the surface. Looking northeast.

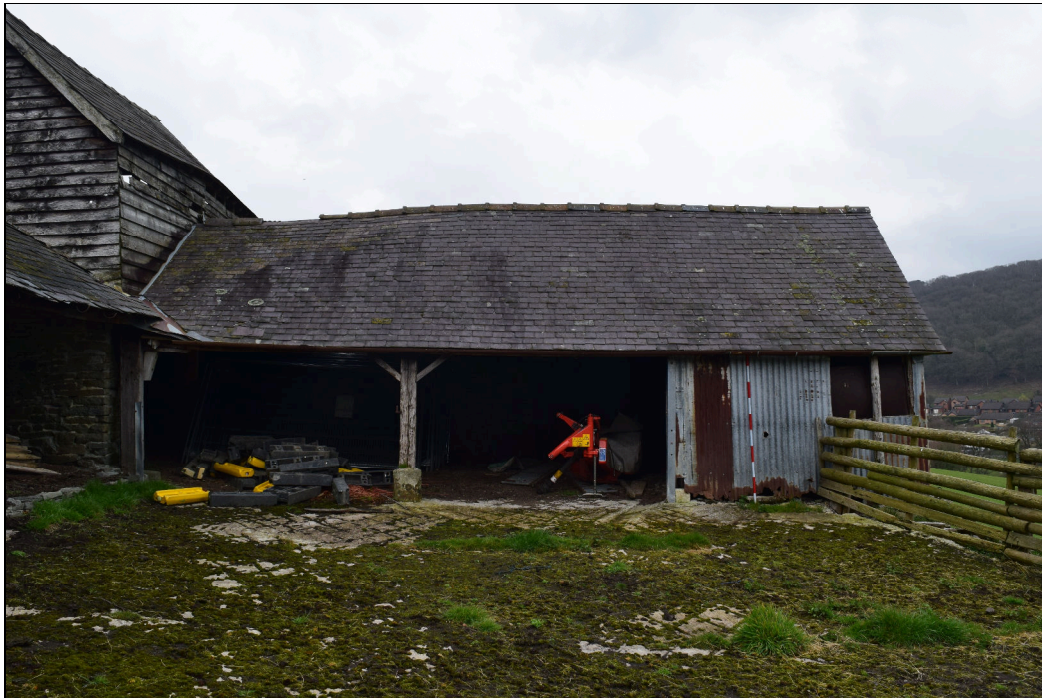
Plate 23: GBB2022_023 – A view of the East Barn. This side of the barn is left open. It is not clear whether it was originally open-sided, but there is no evidence of a lateral wall on this side, apart from a section below the hayloft, which may have been added when the central Cowhouse was inserted. Looking east.

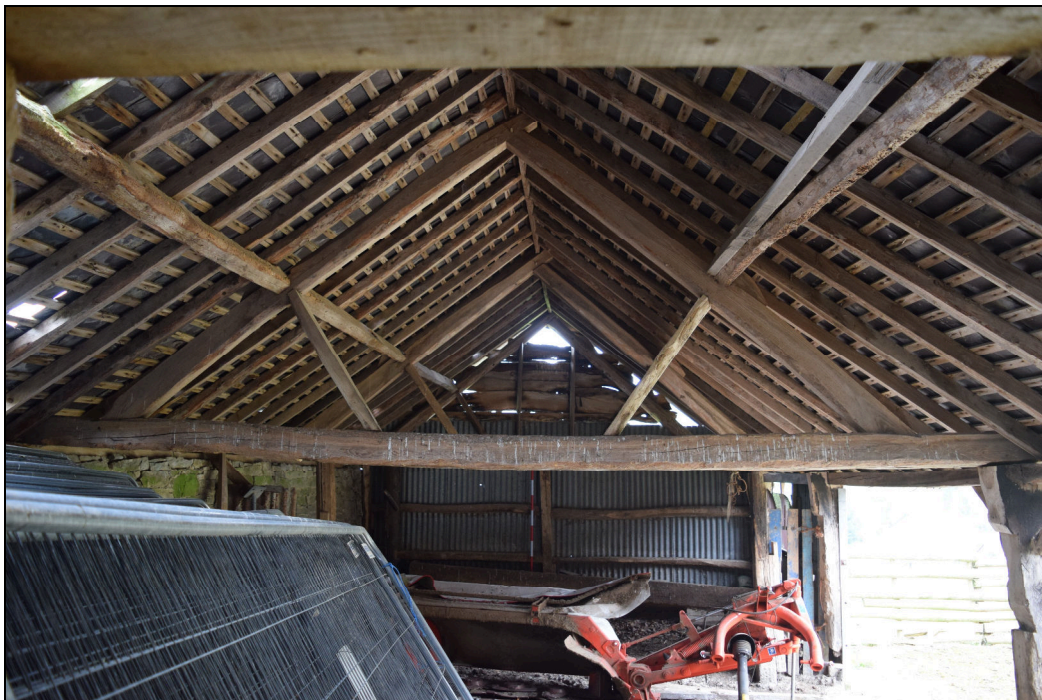
Plate 24: GBB2022_024 – A view inside the East Barn towards the south gable end, the wall of which is crudely built and clad in corrugated sheeting. Looking south.

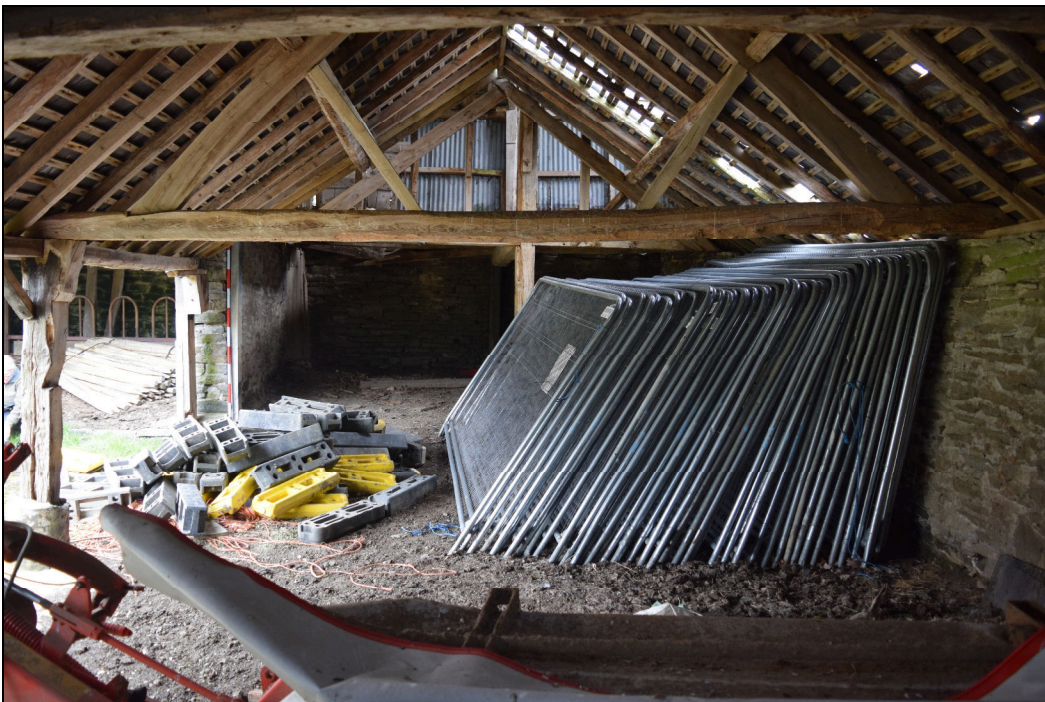
Plate 26: GBB2022_026 – A view inside the East Barn towards the north end, where there are stone walls beneath the hayloft. The corrugated sheeting visible at first-floor level is the inside of the north wall of the hayloft. Looking north.

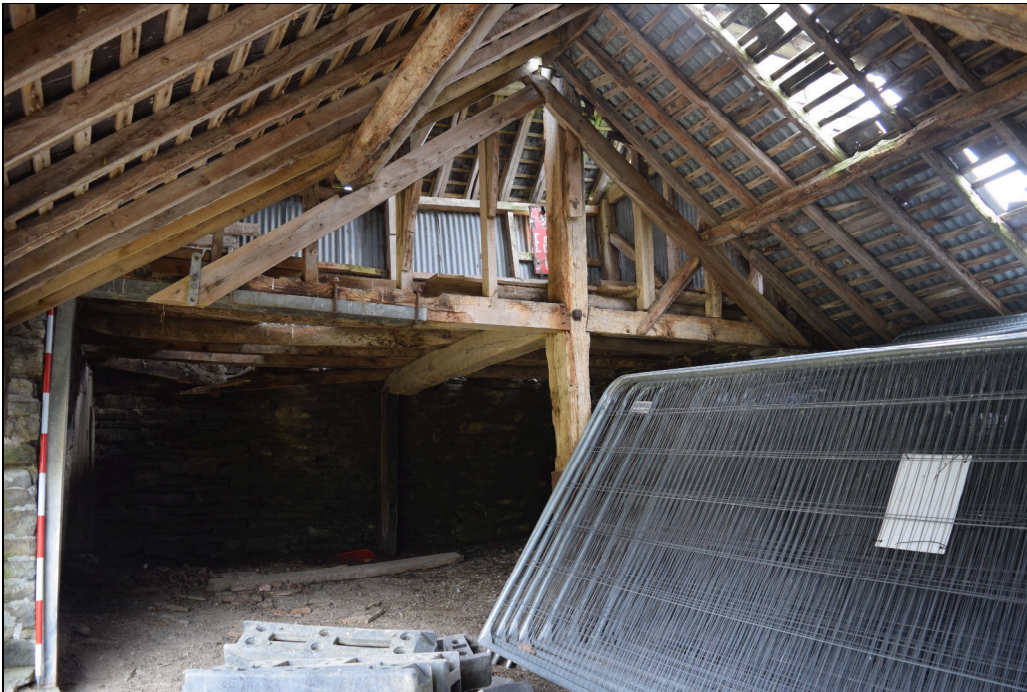
Plate 27: GBB2022_027 – A view inside the East Barn towards the hayloft. The corrugated sheeting visible at first-floor level is the inside of the north wall of the hayloft. Substantial beams support the floor of the hayloft. Looking north-northeast.

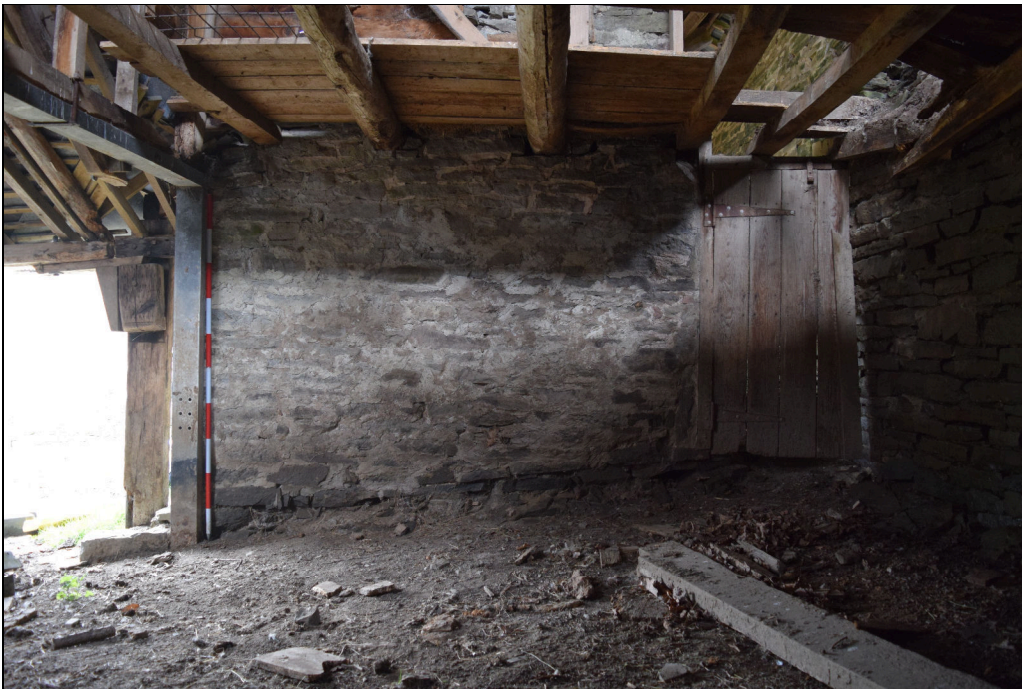
Plate 28: GBB2022_028 – A view inside the area beneath the hayloft at the north end of the East Barn, showing the stone wall dividing it from the Cowhouse, which is accessed through the door to the right. Looking west.

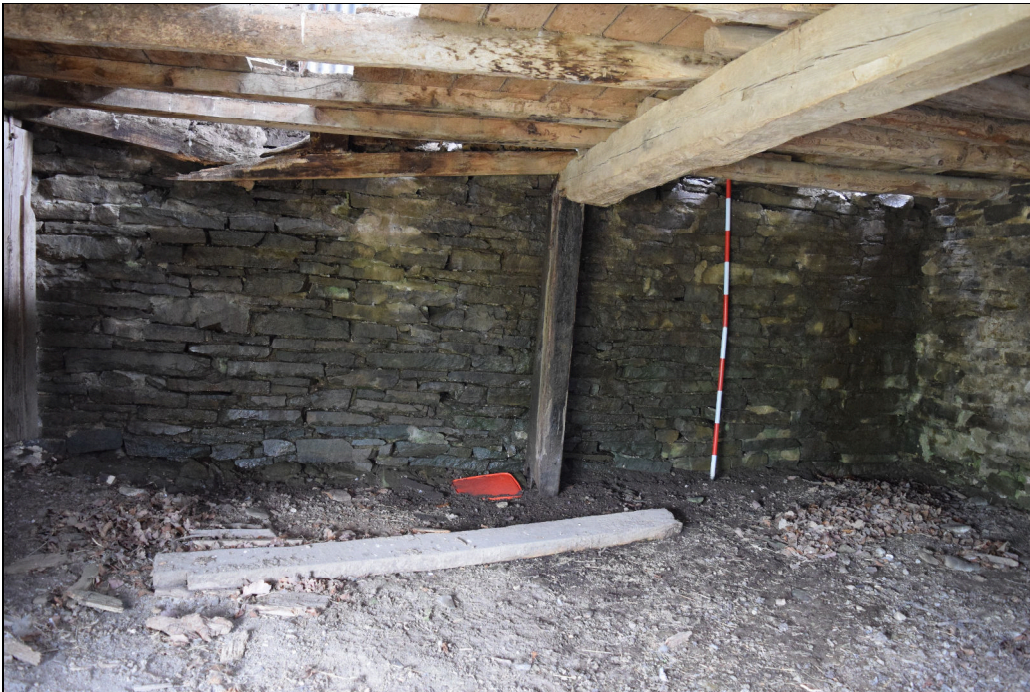
Plate 29: GBB2022_029 – A view inside the area beneath the hayloft at the north end of the East Barn, showing the stone revetment wall forming its northern side. Looking north.

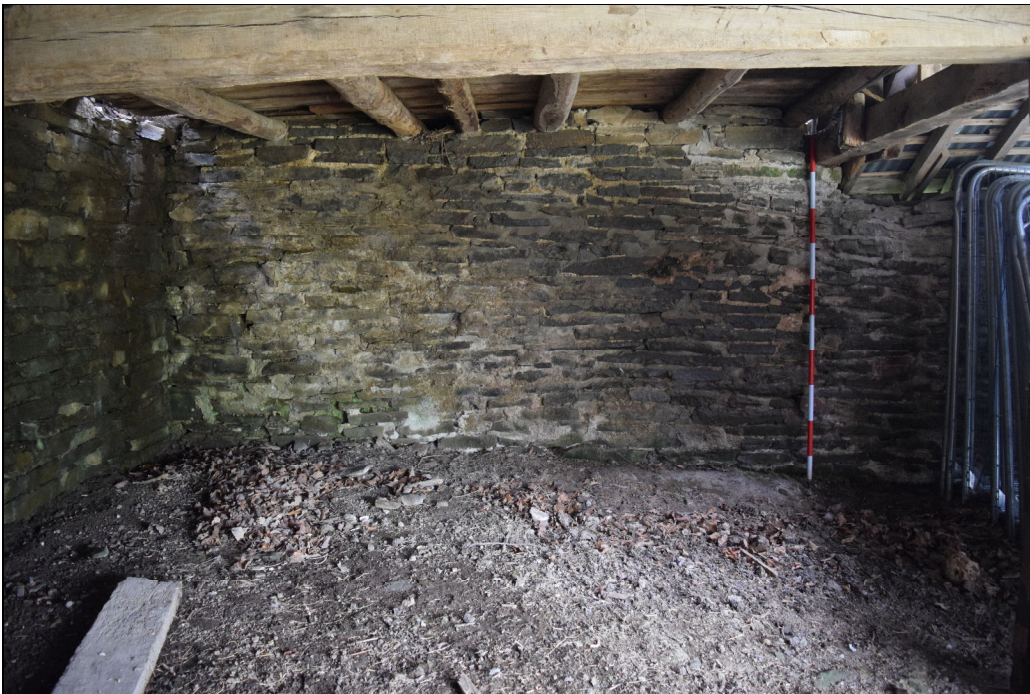
Plate 30: GBB2022_030 – A view inside the area beneath the hayloft at the east side of the East Barn, showing the stone revetment wall forming its eastern side. Looking east.

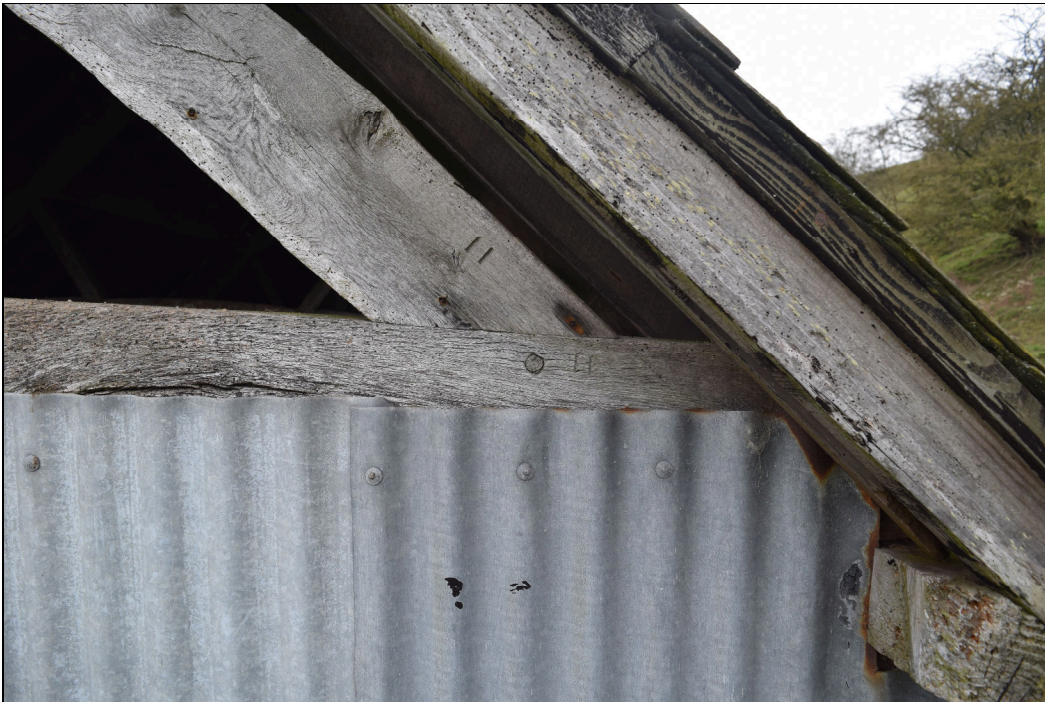
Plate 37: GBB2022_037 – A view of carpenters' marks in the roof truss in the east side of the hayloft. Looking west.

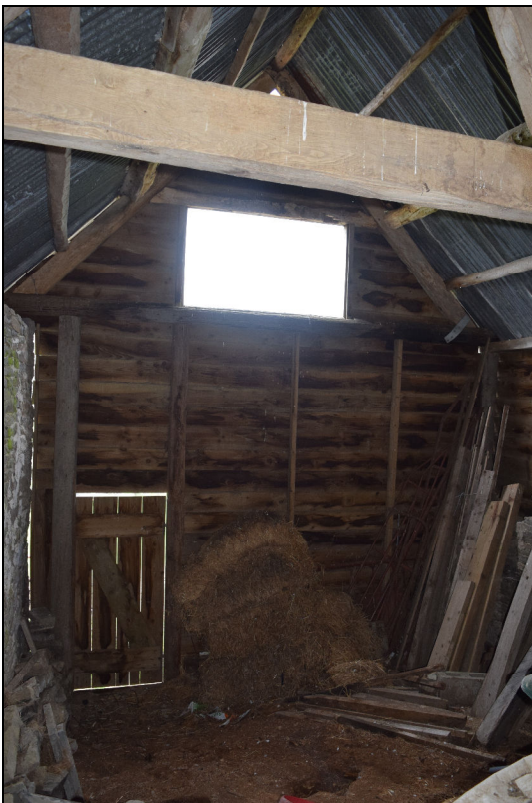
*Plate 42: GBB2022_042 – A
view inside the West Barn. The
south gable wall consists of
modern boarding. Looking
south.*

7.1.3 The West Barn has the stone revetment wall forming the base of its north side, with a timber-framed gable rising above it (Plate 47). The timbers are a mixture of relatively modern round softwood lengths and re-used hardwood beams, indicating that the wall has been rebuilt or repaired at some point (Plate 48). The timbers are clad in corrugated steel sheeting. There is no evidence that this gable wall was ever wholly stone built, and it may have been weatherboarded originally. The west lateral wall is stone-built, with a doorway through it just north of centre (Plates 11 & 40). The southern end of this wall has been rebuilt, partially in stone and partially with timber-framing covered by weatherboards (Plate 1). The southern half of the eastern lateral wall is also stone built, as far as a doorway just north of centre (Plates 38 & 43). North of this doorway the wall is of timber boarding over a wooden frame (Plate 45). The roof truss supported on a section of reused hardwood beam which suggests that the structure has been heavily modified in the past (Plate 46). The floor level of the southern third of the West Barn is at least 1 metre lower than the rest of the building and could have been used as a cart shed originally. The southern gable wall is of modern construction, with weatherboarding over a timber frame (Plates 3, 42 & 56). The original gable wall was probably also timber-framed and weather-

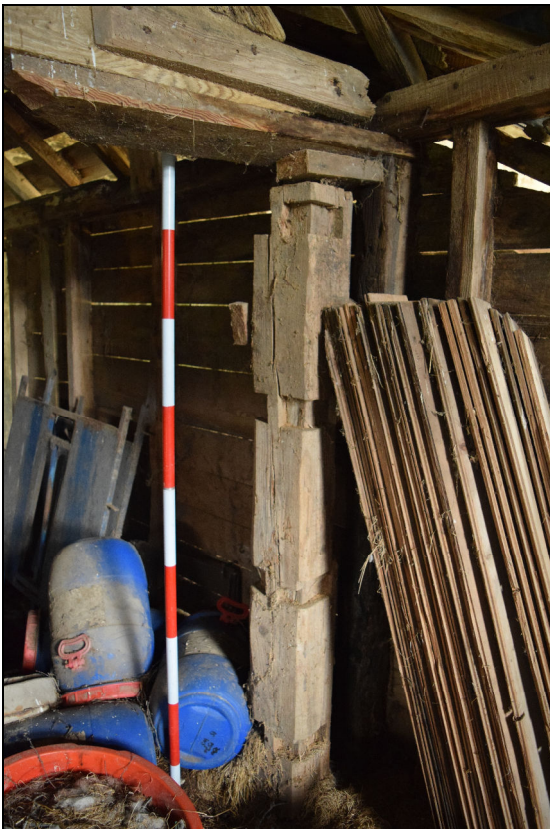
Plate 46: GBB2022_046 – A view inside the West Barn, showing a reused timber supporting a roof truss. Looking northeast.

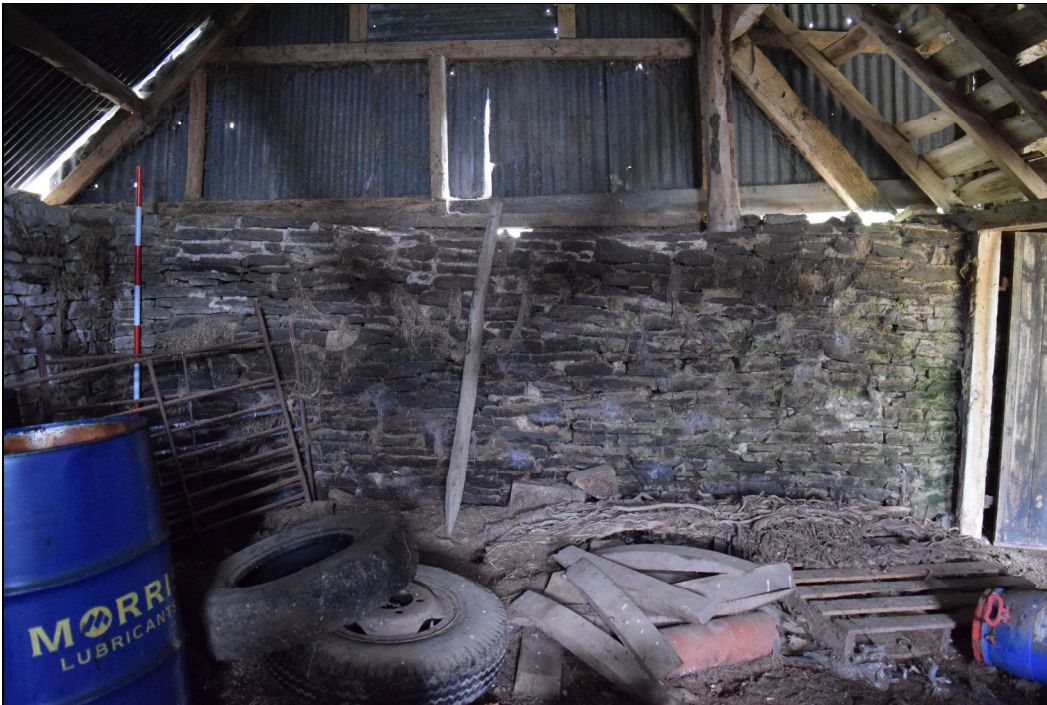
Plate 47: GBB2022_047 – A view inside the West Barn, showing the revetment wall at the north end of the barn. Looking north.

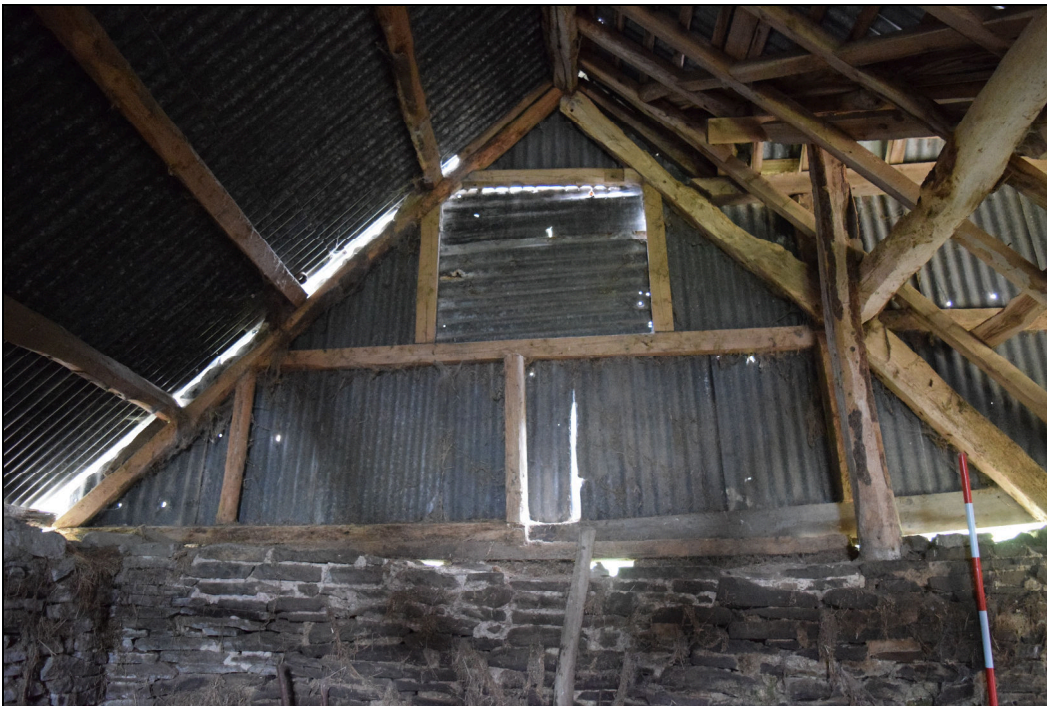
Plate 48: GBB2022_048 – A view inside the West Barn, showing the timber-framed gable wall above the revetment wall at the north end of the barn. Looking north.

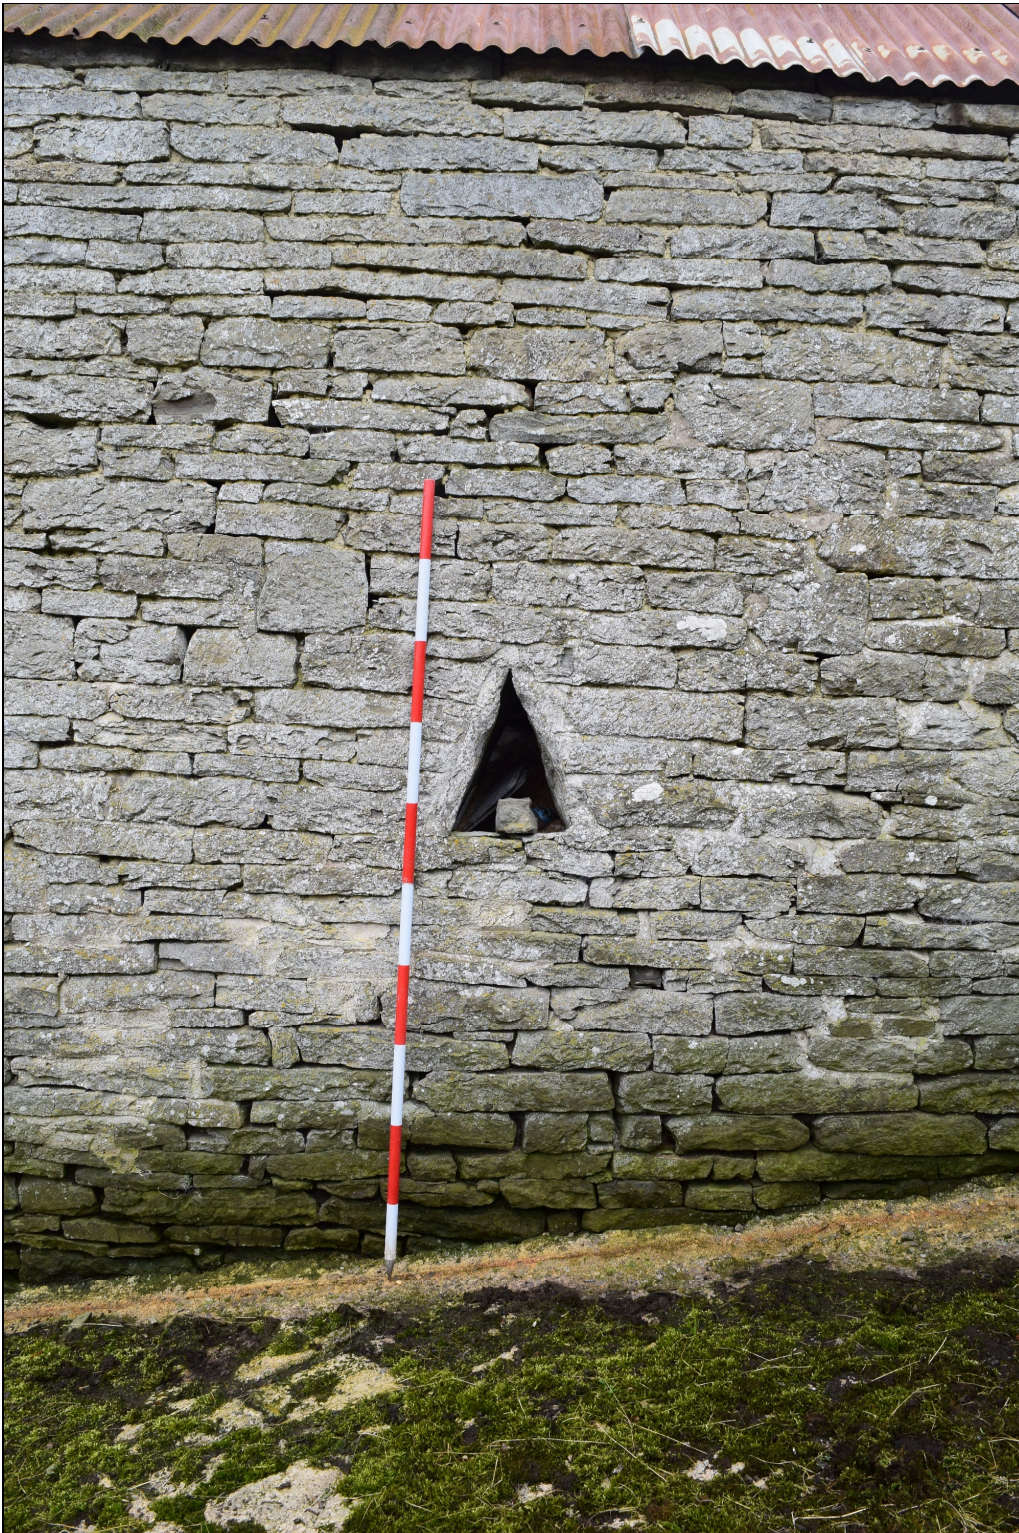
Plate 50: GBB2022_050 – A view of a triangular ventilation hole in the east wall of the West Barn, viewed from outside. Looking west.
