**LEVEL 1 BUILDING RECORDING OF
FORMER AGRICULTURAL BUILDING
AT BROOKHOUSE FARM, CWMGILLA
LANE, KNIGHTON, POWYS LD7 1PG
Planning Application
P/2017/1018 (Powys)**

Report by: Trysor

Trysor Project No. 2022/836
CPAT HER EVENT PRN : 167117

DYDDIAD 10^{fed} Mehefin 2022 **DATE** 10th June 2022

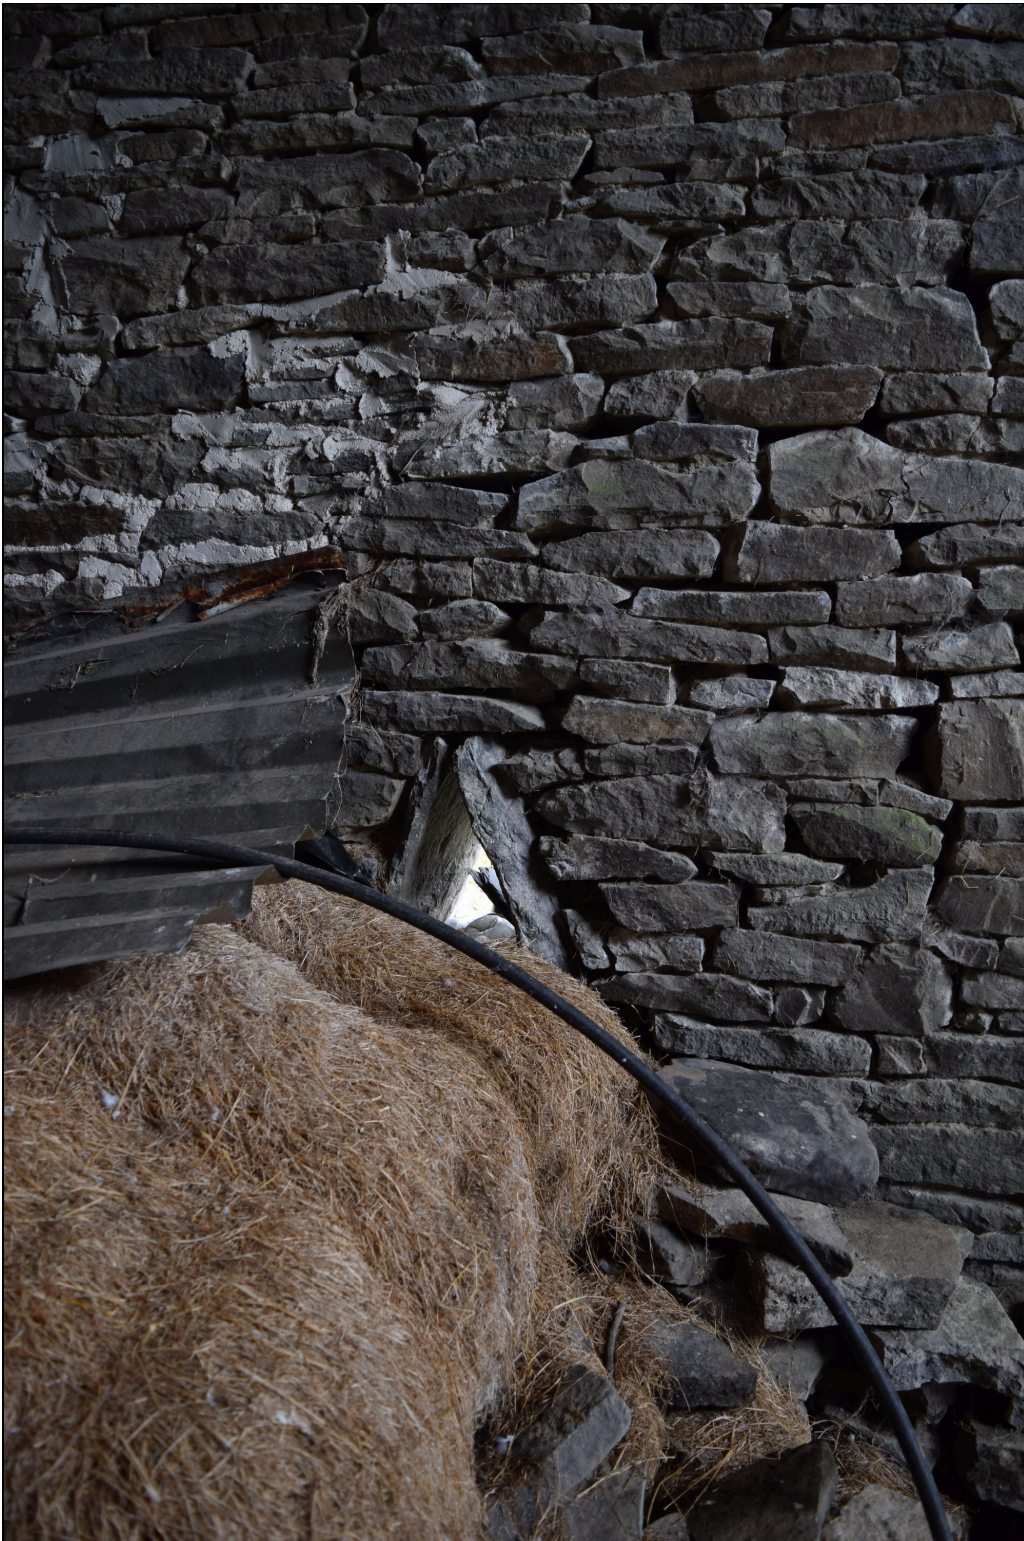
Plate 51: GBB2022_051 – A view of a triangular ventilation hole in the east wall of the West Barn, viewed from inside the barn. Looking east.

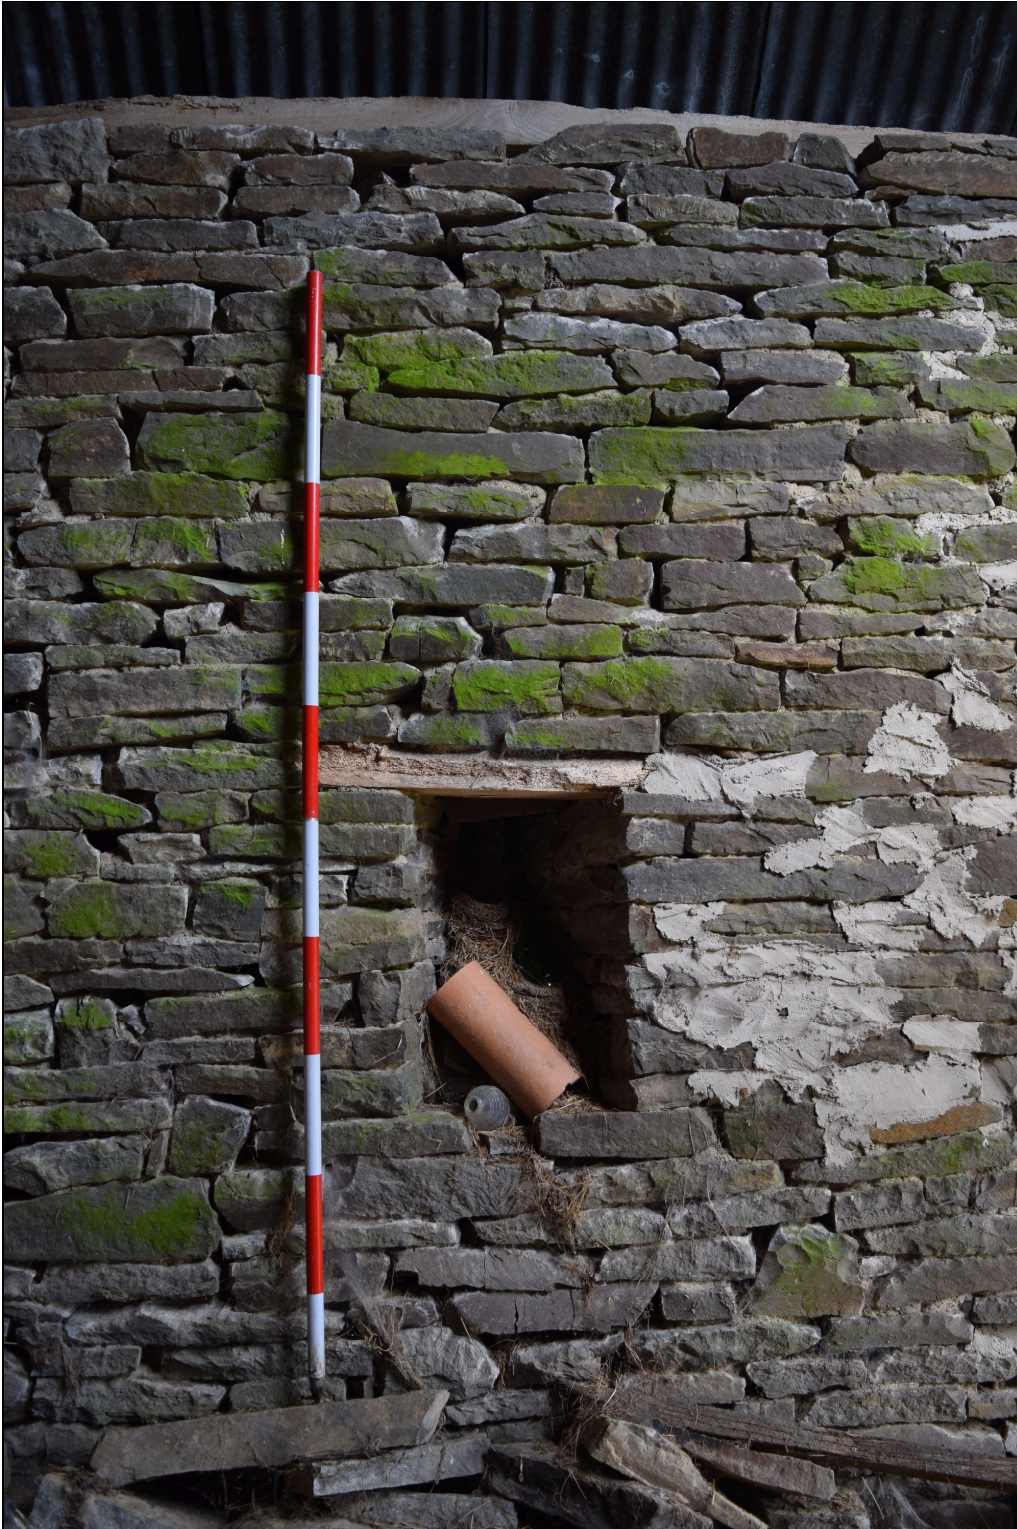
Plate 52: GBB2022_052 – A view of a rectangular niche in the east wall of the West Barn, viewed from inside the barn. Looking east.

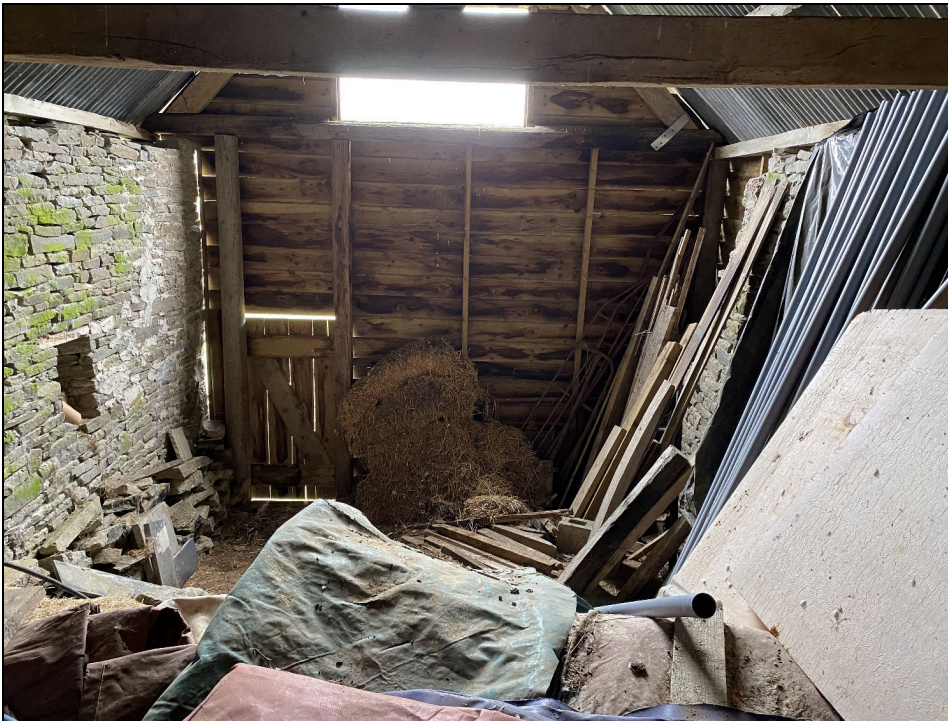
Plate 56: GBB2022_056 – A view of the lower end of the West Barn, which may have originally served as a cart shed. Looking south.

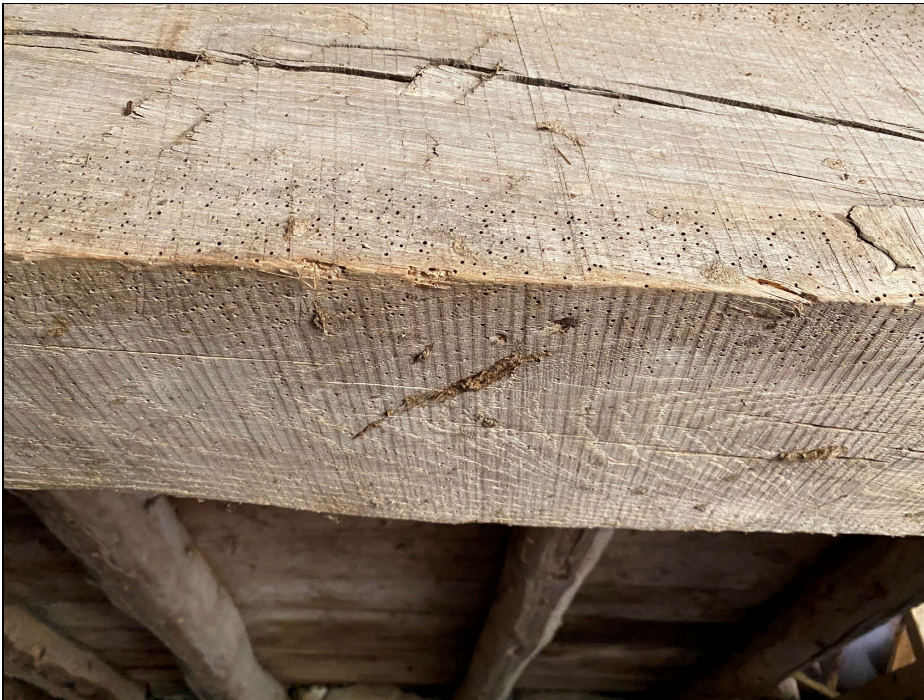
Plate 57: GBB2022_057 – A view of bandsaw kerf marks on a beam under the hayloft in the East West Barn. These would usually be dated to the mid-19th century. Looking east.

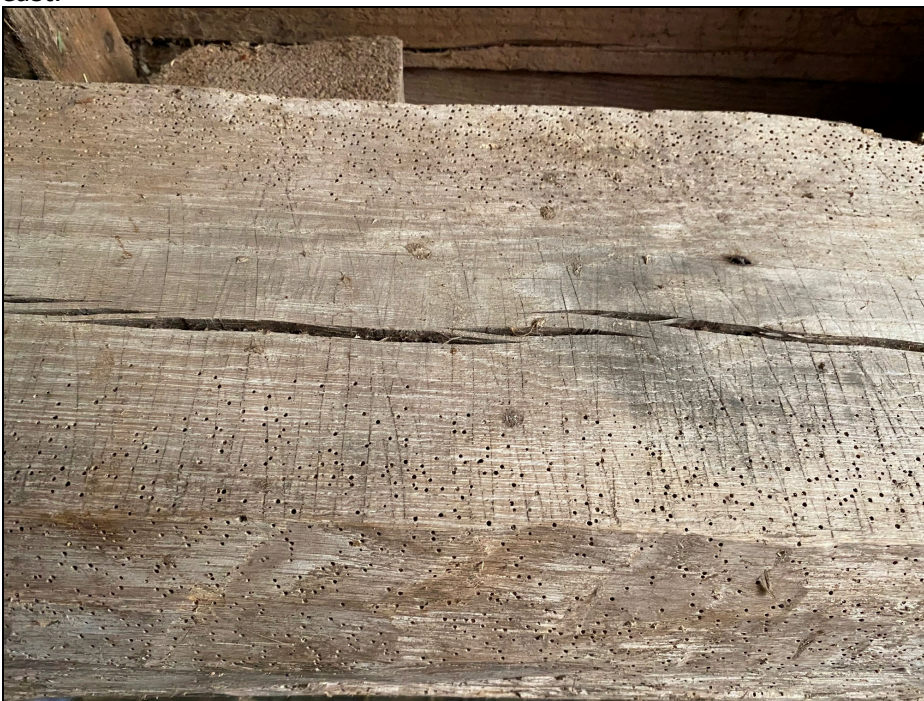
Plate 58: GBB2022_058 – A view of pit-saw kerf marks on the same beam as seen in photograph GBB2022_057 under the hayloft in the East West Barn. These usually might be assigned a pre-19th century but are on the same beam as band saw kerf marks. Looking east.

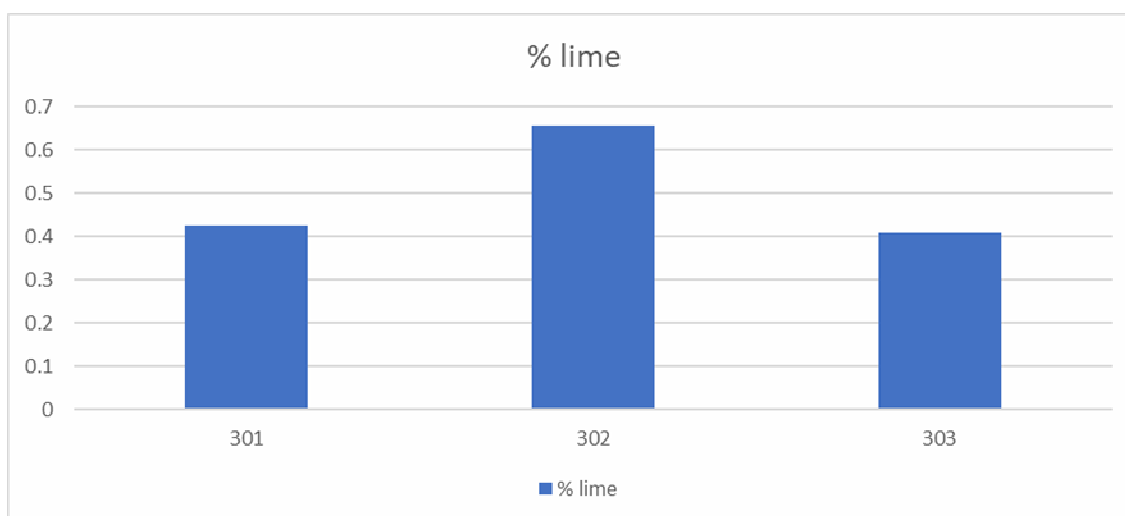
Figure 1: lime in mortar samples

A single aliquot (subsample) from each sample was dried and crushed, then dissolved in dilute hydrochloric acid as recommended by Cadw (2004, 2); the residue was filtered and dried by gentle heating and weighed. Overall composition of the mortar was calculated from the aggregate and soluble (Calcium Chloride) components.
