Royal Hotel, Bridge Street, Llangollen Heritage Impact Statement January 2024

Trysor Project No. 2023/918
CPAT HER Event PRN - 215549

This report assesses how proposed variations to a consented planning application 03/2022/0173 and Listed Building consent 03/2022/0174 would impact on the historic fabric of the Royal Hotel.

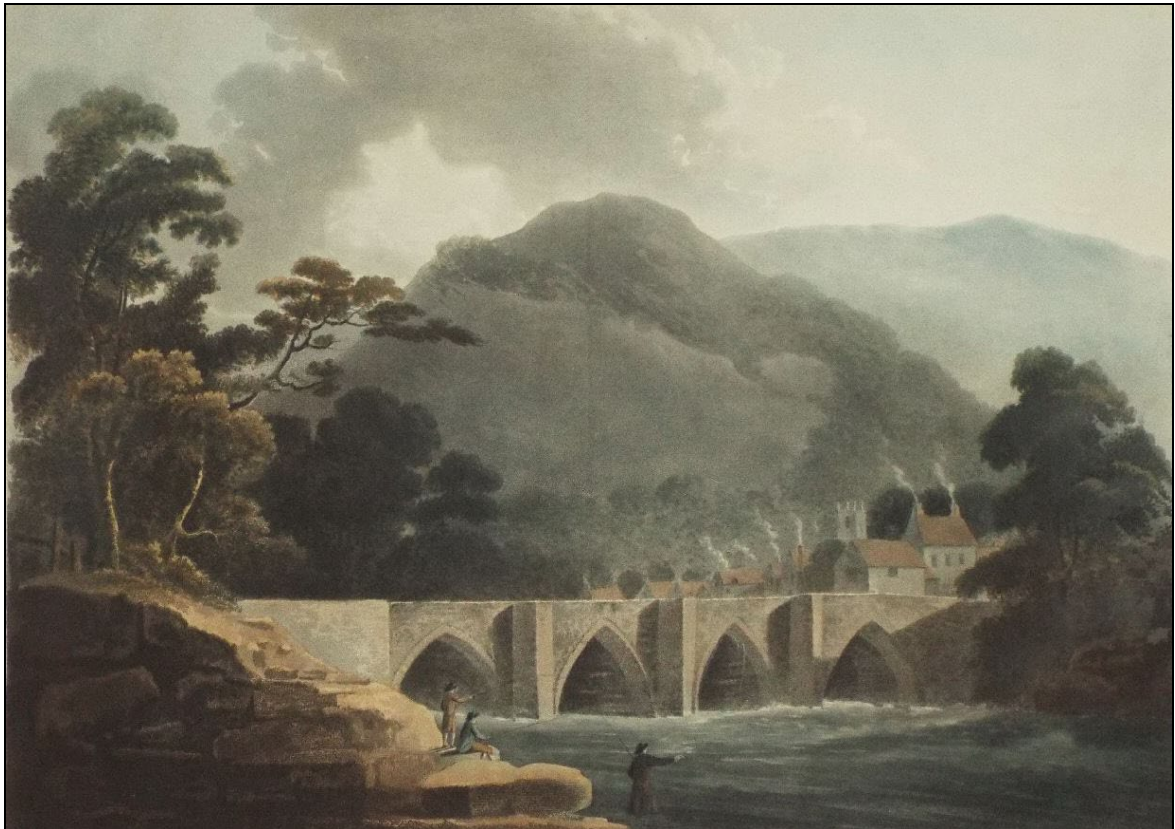
Figure 2: Llangollen Bridge, a lithograph by Francis Jukes and Thomas Walmsley, 1794. This depiction appears to be accurate as it corresponds with a 1791 Survey of Llangollen reproduced by Cadw in "Llangollen - Understanding Urban Character" (Cadw, 2016, p.75). This shows that the Kings Head seen on later maps had not been built as late as the early 1790s. The single building at the end of the bridge is on the site of the present hotel and may represent a forerunner of the Kings Head.

4.1.2 A lithograph of Llangollen Bridge by Jukes and Walmsley published in 1794 shows the site of the present hotel but does not show any building recognisable as the Kings Head, see Figure 2. A building shown close to the southern end of the bridge appears to be on the site of the present hotel but this was probably removed during the 19th century and no trace of it now survives. This building is probably the one shown on a 1791 estate map of Llangollen (Cadw, 2016, p.75).

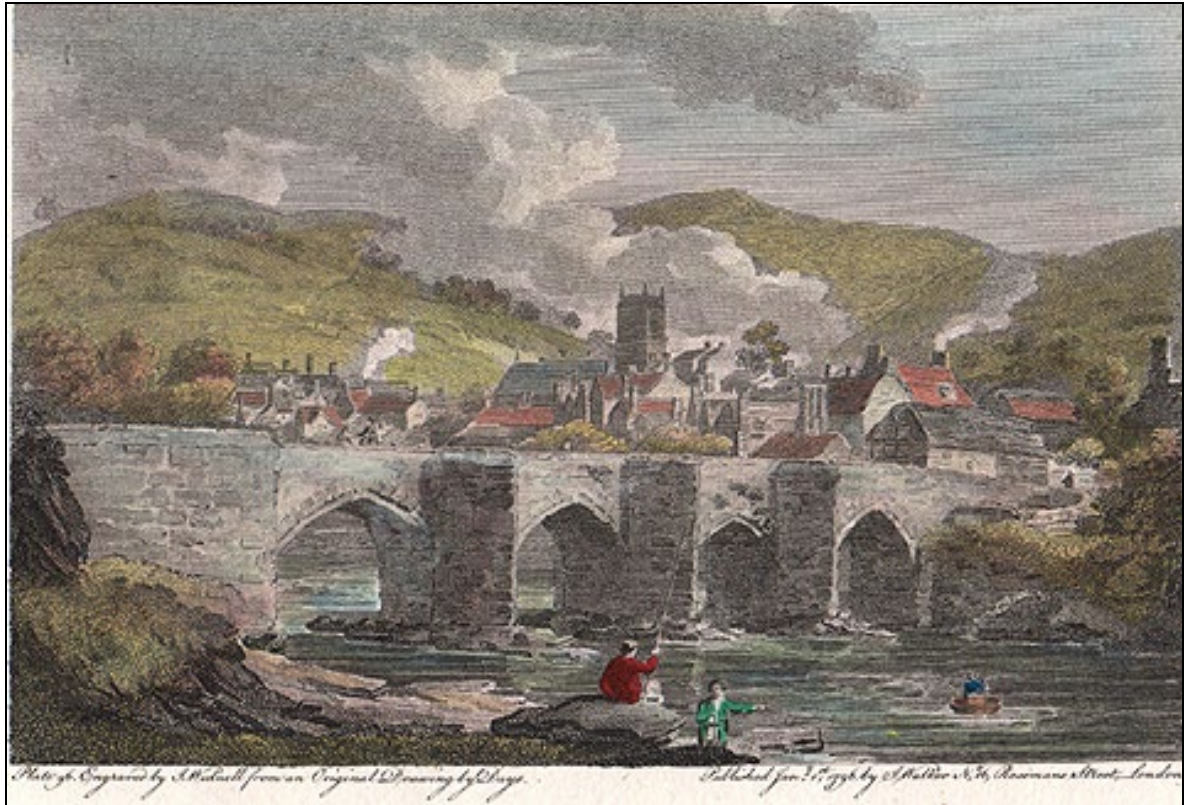
Figure 3: Llangollen Bridge, by J. Widnell and based on an original drawing by Edward Dayes, dating to 1796. This shows a similar arrangement at the site of the King's Head/Royal Hotel compared to the Jukes and Walmsley image of 1794, with a building next to the bridge at its southern end. The building to its left with the tall chimneys might stand on or close to the 19th century site of the King's Head.

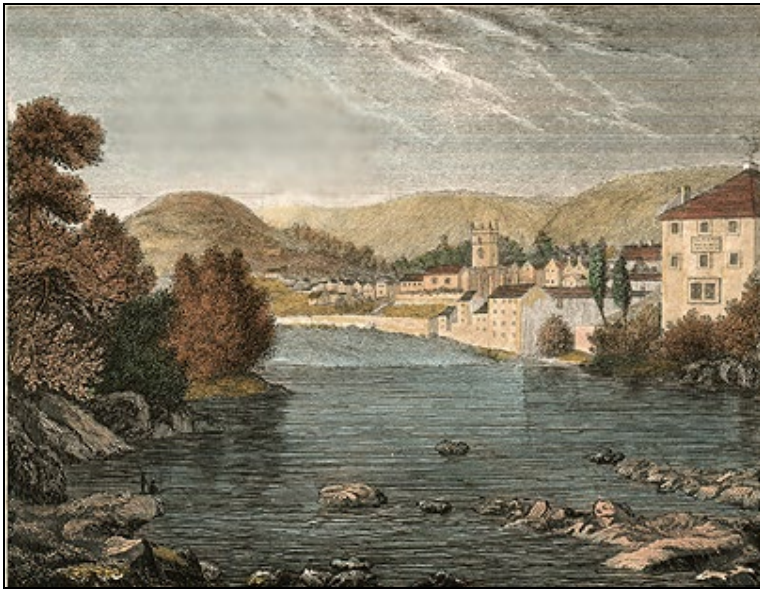
Figure 4: A view southeastwards from Llangollen Bridge in 1830, by T. Tunbridge, shows the large Georgian building "New Hotel" overlooking the River Dee to the far right of the image.

4.2.9 It is probable that the advert was placed by Joseph Davies around time of the expansion of the King's Head with the intention of reminding regular clientele of the qualities of the place. This was the time that the "New Hotel" was built alongside the old King's Head. This fine Georgian building still forms a substantial part of the modern hotel and appears as a prominent building in many prints of Llangollen and its famous bridge during the middle part of the 19th century. It consists of a square, three-storeyed building with cellars which overlooks the river Dee to the north, see Figures 4, 5 and 6.

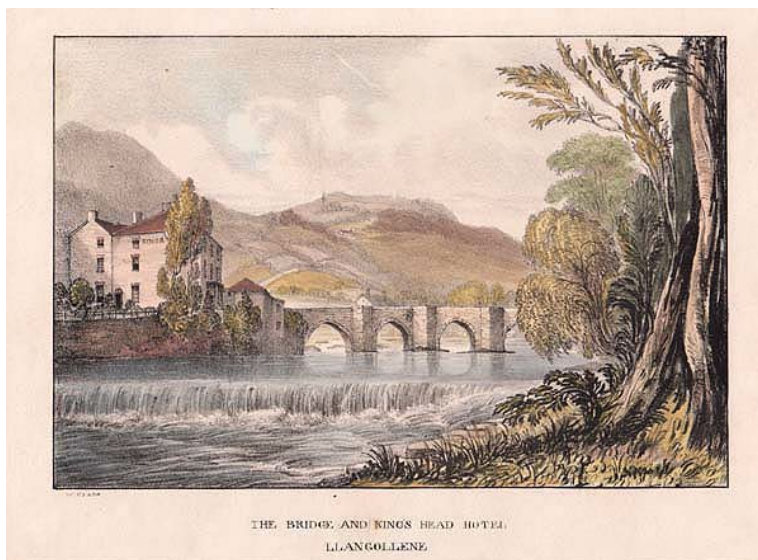
Figure 5: A depiction of the King's Head by W. Crane, dating to 1835. This shows again the large Georgian hotel built here in 1815 – the "New Hotel" mentioned by Anne Lister. The narrow building at the far-left side of the image is probably the earlier King's Head building, facing Bridge Street and still includes the main entrance into the modern hotel.

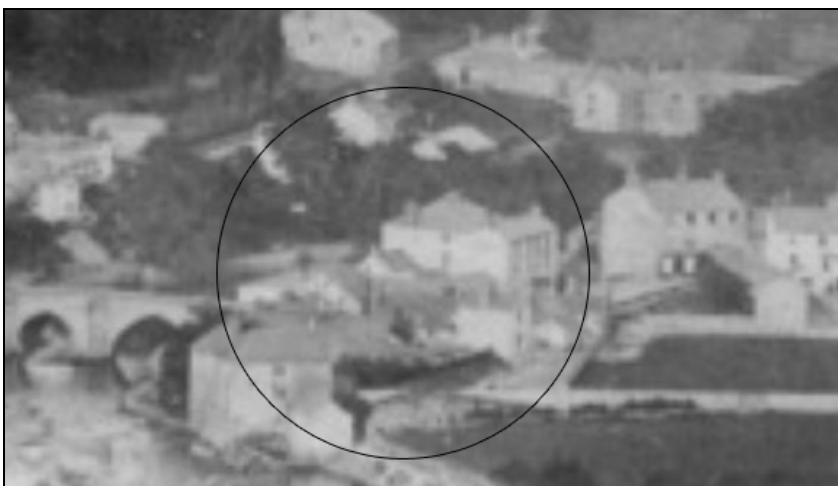
Figure 8: The King's Head and Royal Hotel complex (ringed) from a rare aerial view of Llangollen, presumably taken from a balloon, said to date to 1859. Note the tall Georgian buildings at the eastern part of the complex and the low buildings closer to the bridge. The latter buildings were removed later in the 19th century. This is probably close to the arrangement shown on the 1840 tithe map.

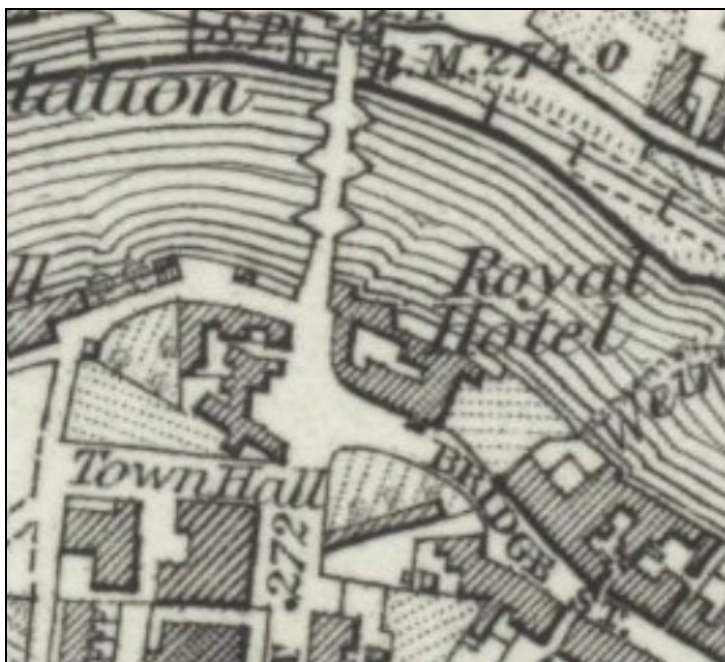
Figure 9: An excerpt from the 1874 1:10560 Ordnance Survey map. The hotel by this time is closer to its present arrangement, with the new wing added around 1870 shown along Castle Street and its junction with Bridge Street. Castle Street was a new road and the river bridge had been widened by this time.

4.3.3 The 1874 1:2500 scale Ordnance Survey map shows that the layout of the hotel had changed, see Figure 9. Castle Street had appeared and along its eastern side a new wing of the hotel had been built, running from the bridge to the junction with Bridge Street and around the corner along the northern side of Bridge Street to join up with the previously existing Georgian building at the main entrance to the hotel.

4.3.4 The addition of the Victorian wing to the western side of the complex seems to have followed the sale of the Llantysilio estate in 1867. The auction was held at the "Royal King's Head Hotel" and included the sale of the hotel itself. Within a few years, certainly by the time the 1874 Ordnance Survey map had been surveyed and drawn, the addition had been completed. It is thought that the same architect was used as designed the new Town Hall, which stands nearby on the west side of Castle Street (visible on the map in Figure 9).

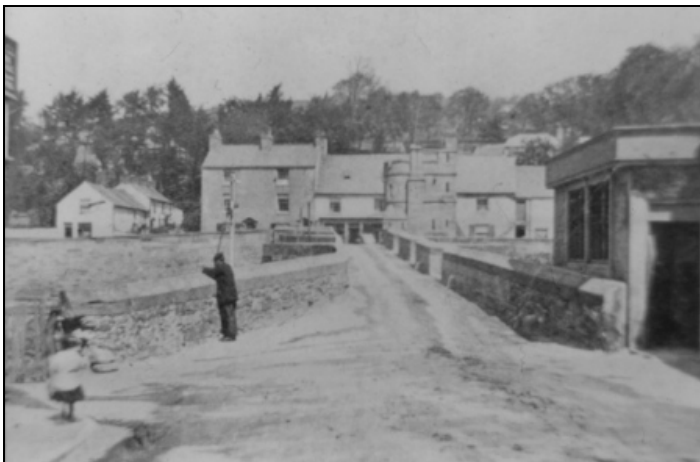
Figure 10: A photograph of the bridge around 1870 with the single-story building of the Royal Hotel to the right-hand side.

4.3.6 Two interesting photographs reflect the changes of this period. The first dated to around 1870 shows the old Llangollen Bridge before it was widened in 1873, see Figure 10. At the edge of the photograph the end of the old building attached to the King's Head and Royal Hotel is just visible. The impact of the new Victorian wing on views at that end of the widened bridge is evident when the early photograph is compared with the scene presented in the second photograph, see Figure 11, which is undated but is presumed to date to the period around 1890.

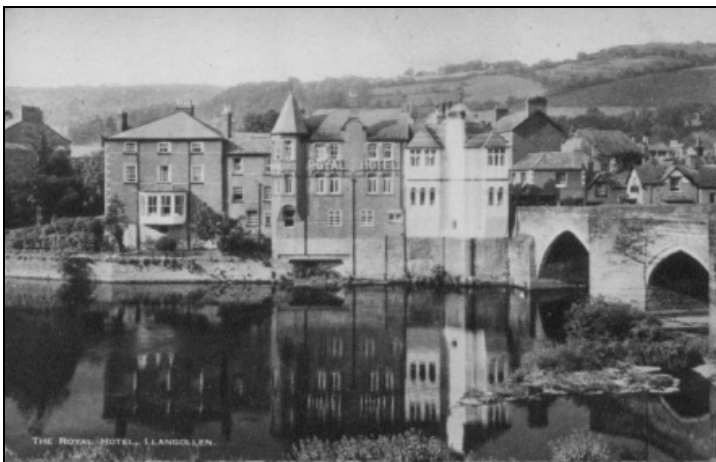
Figure 14: The Royal Hotel in 1937, with its northern façade now instantly recognisable when compared to the modern building. The most modern extension would not be added until the 1960s, when a new wing was added to the eastern side of the Georgian hotel. The riverside decking had also not yet appeared at this stage and garden panting can be seen in front of the Georgian part of the hotel. Modern doors have now replaced the windows seen centre left in the image at the lower level of the building below the Royal Hotel sign.

5.6.7 The northern elevations of the hotel complex, facing the river, have been treated very differently in the past. In recent times they have had a similar “black and white” décor to that of the southern and western facades of the hotel, but in earlier times wings of different dates along the riverside were decorated differently, being either left unpainted or painted in different colours (see figures 11, 14 and 16).

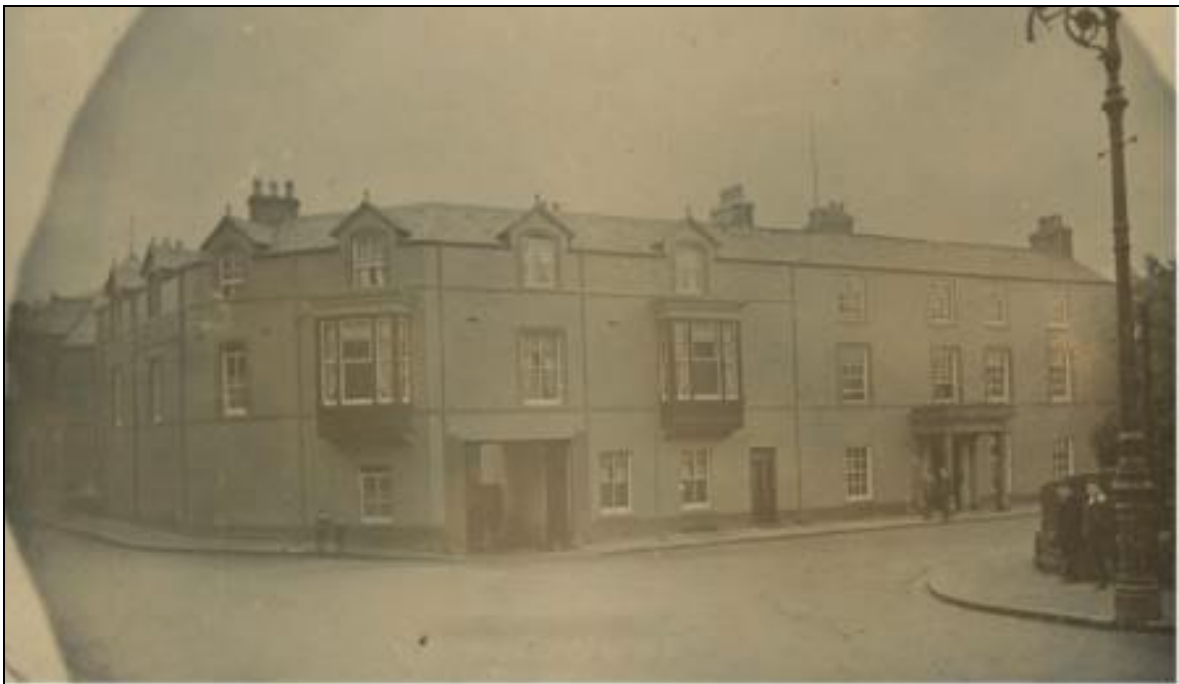
Figure 15: The southern side of the Royal Hotel c.1890-1900. This is a rare view of this side of the hotel in earlier times. It shows the southern side of the Georgian hotel, including the main entrance, to the right. The rest of the building dates to c.1870, including the large doorway giving access to the courtyard inside the complex. There have been key changes since the photograph was taken. A modern extension was added to the Georgian hotel, at the extreme right of the photograph. The windowless and doorless ground floor to the left was changed during the early decades of the 20th century (see Figure 16).

4.3.7 The northern side of the hotel, visible from the river bridge and the north bank of the river has always been the most photographed and painted part of the establishment, despite the fact that the main entrance has always been to the southern side of the building, on Bridge Street. Few images of the southern side of the hotel are known, none of which appear to survive from the pre-photographic era. One important photograph, which probably dates to the period around 1890-1900 shows the hotel when viewed from Castle Street, looking at the junction of Castle Street and Bridge Street, see Figure 15. This shows the southern and western sides of the Victorian range of c.1870 as well as the façade of the Georgian hotel, where the main entrance was and remains located.

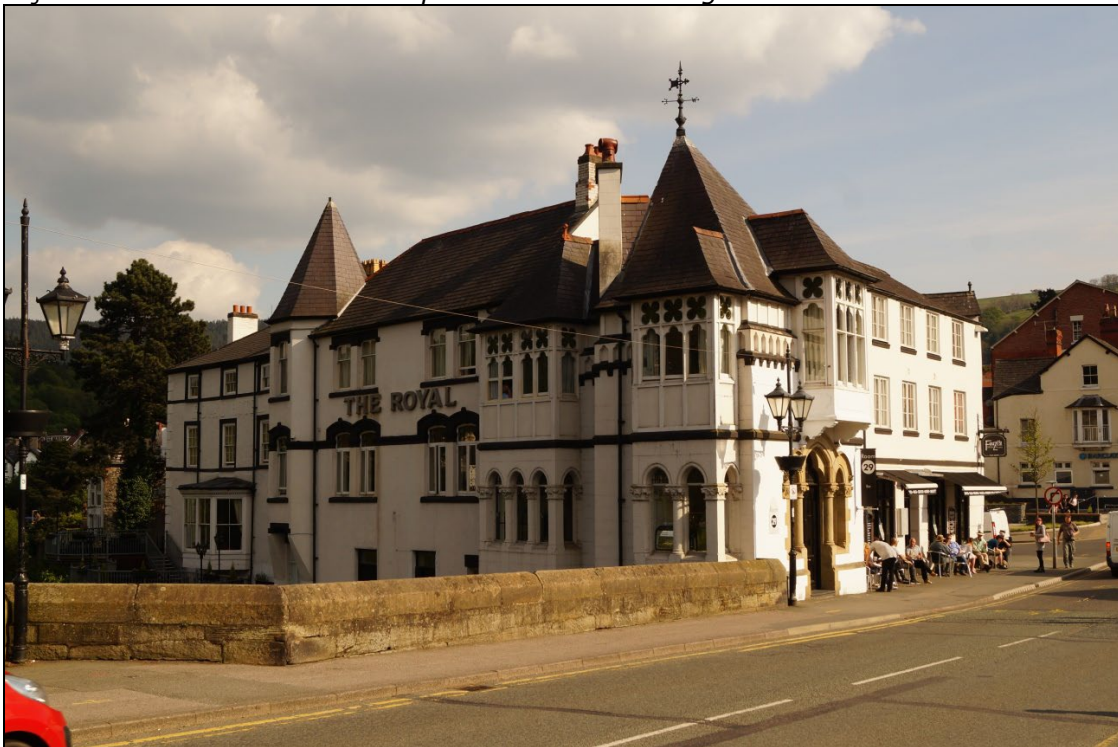
Figure 17: Viewed from the river bridge in 2019, the western side of the hotel along Castle Street is seen to have been further changed in modern times, with a streetside café operating. The ground floor windows are now large, shop-front type windows. This change appears to date to the later 20th century, certainly post-1960, based on photographic evidence. The external décor of the northern façade was now uniform.

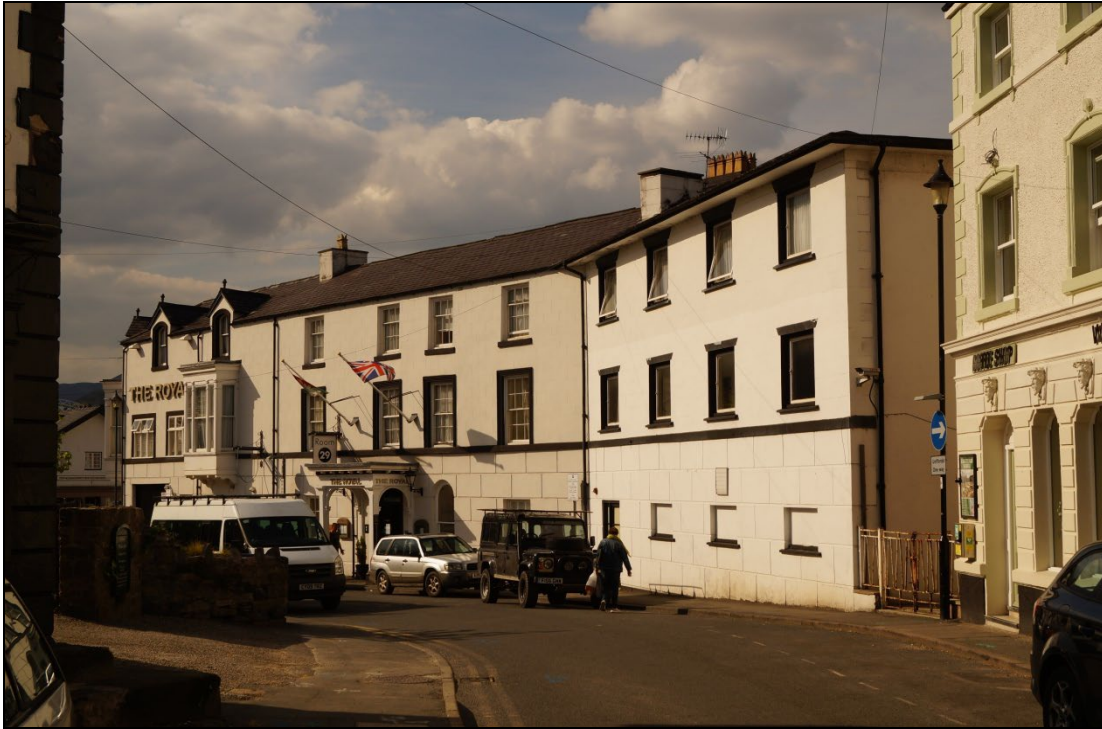
Figure 21: A view of the Royal Hotel from Castle Street. The four dormer windows of the Victorian wing are prominent but there were originally six, as two identical windows were originally present in the roof to the left of the photograph.

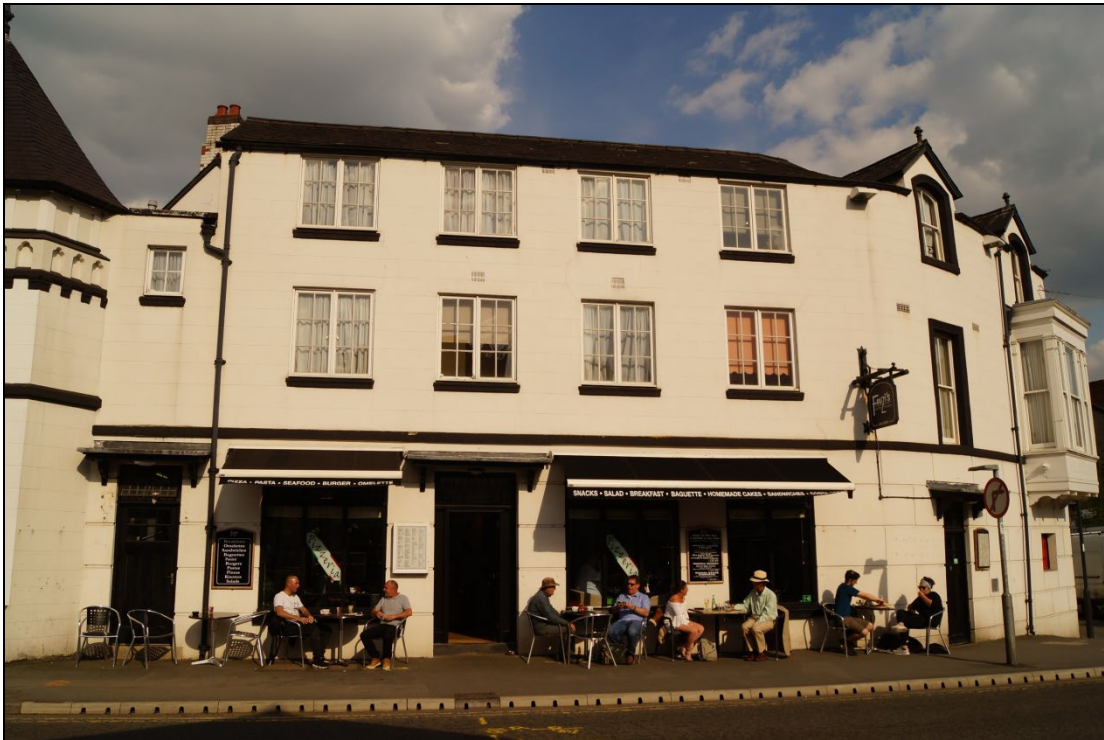
Figure 22: The streetside café in Castle Street. Because of the loss of the dormer windows and the insertion of the shop windows and upstairs windows this section of the Victorian building no longer blends into the sections to the left or right, which were built at the same time.

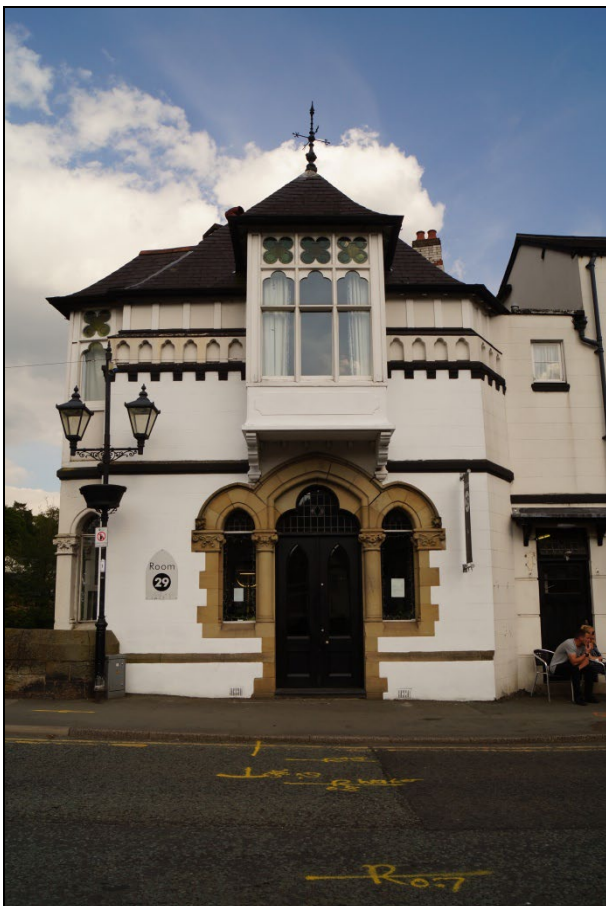
Figure 23: The mock-Gothic architecture of the section of the Victorian hotel at the end of the bridge stands out as the most elaborate and eye-catching part of the modern hotel complex. Undoubtedly this was a conscious decision by the architect as this is the part of the building closest to the bridge and most viewed by visitors.

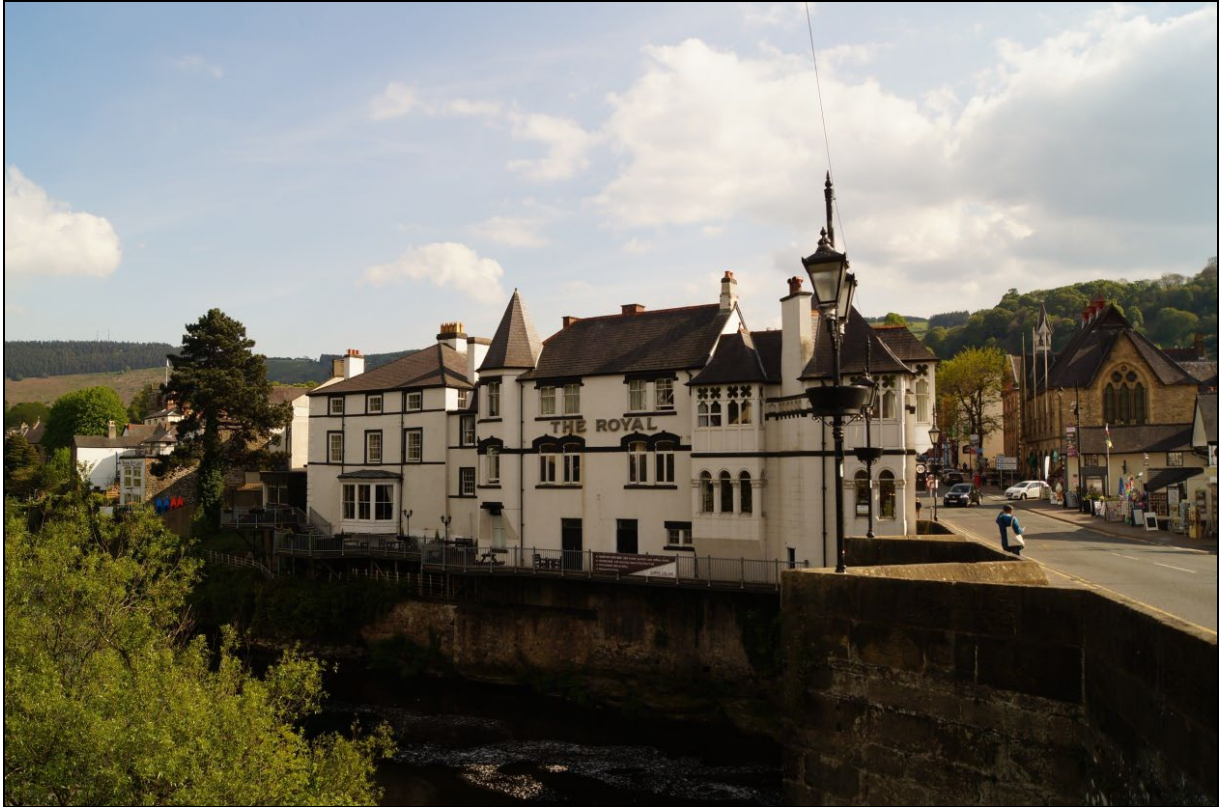
Figure 24: The popular view of the hotel, seen from the bridge. The Georgian Hotel of 1815 stands to the left. The late Victorian addition bears the name of The Royal to the centre, where a pair of modern doors have replaced earlier windows to give access to the modern riverside decking. The Gothic architecture of the 1870 wing is seen to the right, adjacent to Castle Street.

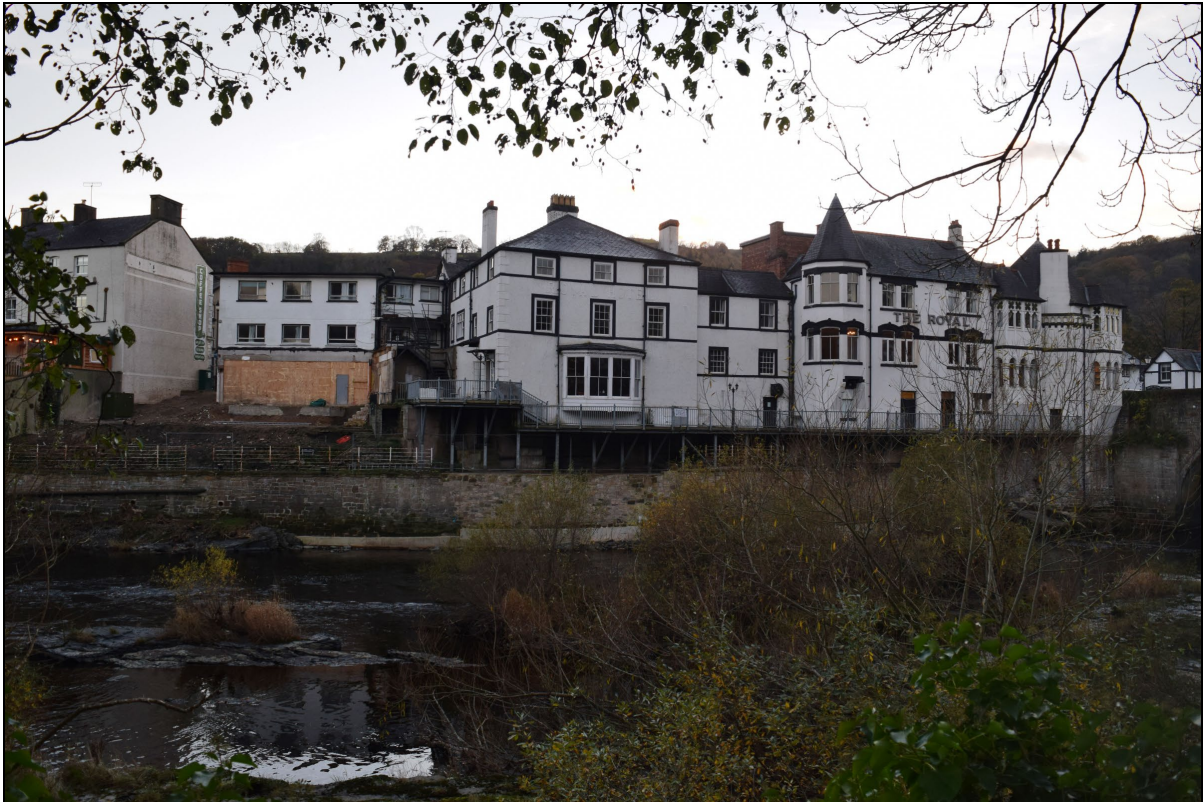
Figure 25: The Royal Hotel viewed from the opposite side of the river in November 2021. The rear section of the 20th century wing of the hotel had been removed during May 2021, leaving the space seen to the left side of the hotel here.

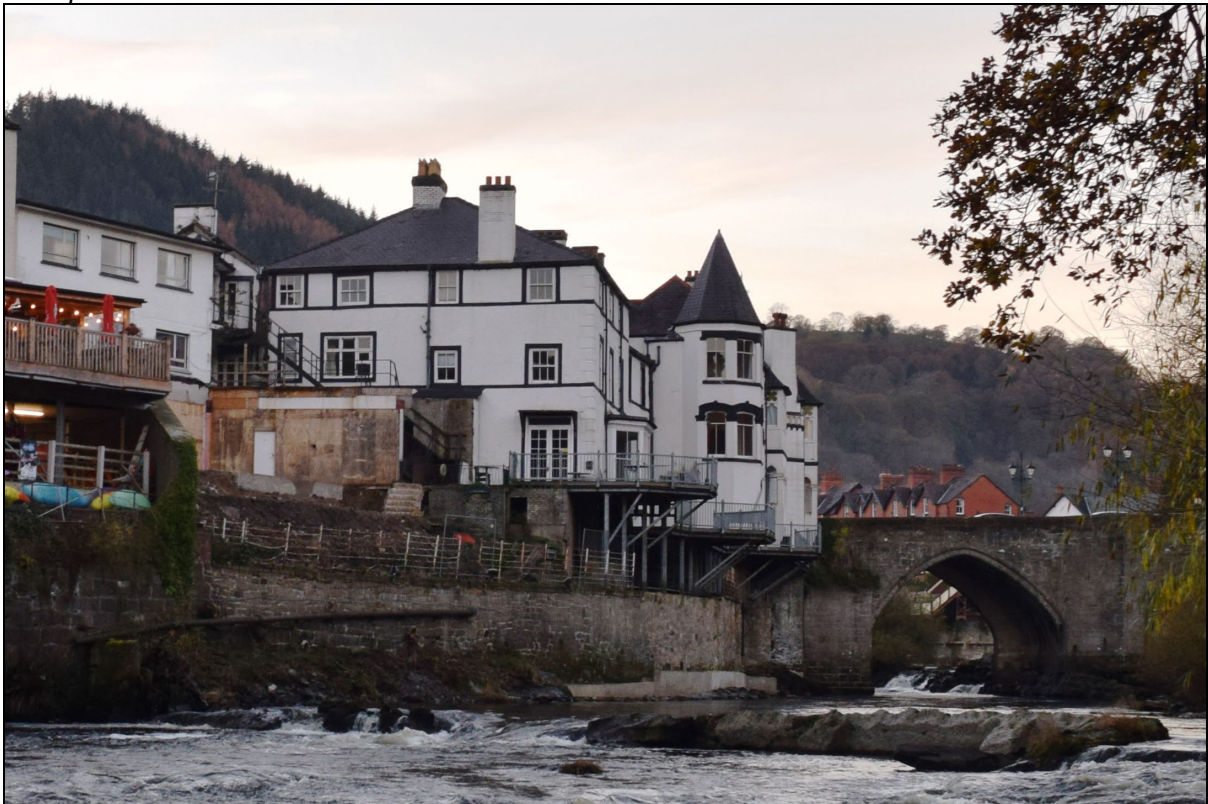
Figure 26: A view of the hotel from the opposite riverbank in November 2021. The 20th century wing has been removed, revealing the western side "New Hotel" of 1815 although many of the openings are of more recent date. This space will be filled again by the proposed spa building.

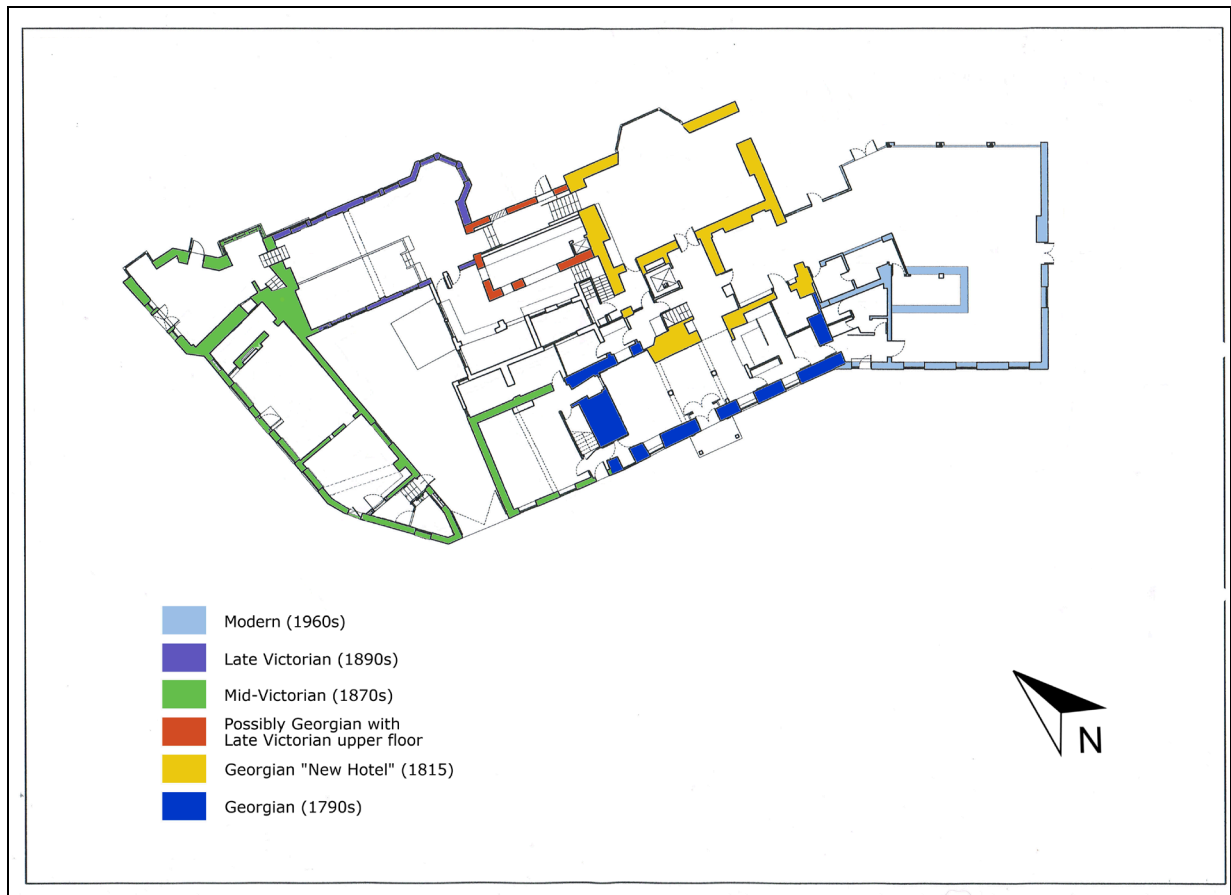
Figure 27: A ground floor plan of the hotel showing the phases of the complex as presently understood.

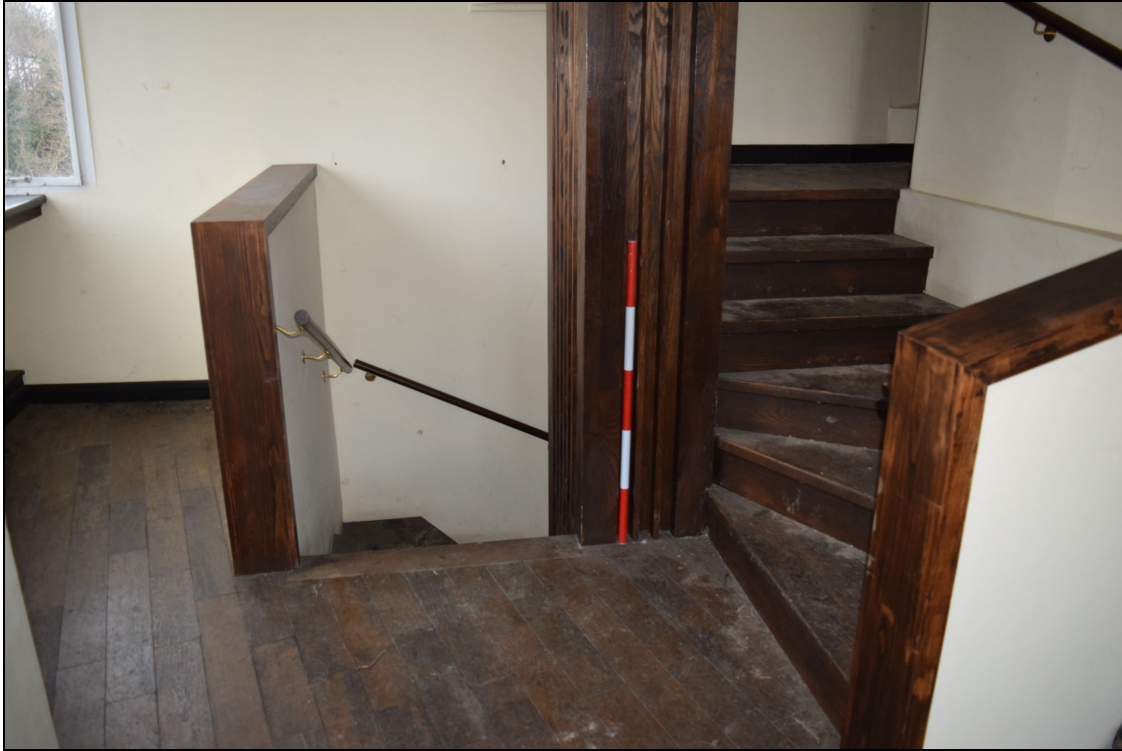
Figure 27: The top of the stairs connecting the ground floor and basement at the northwest corner of the mid-Victorian wing of the hotel, which will be replaced (B2). It is thought to be non-original, and its surroundings appear modern, but its fabric should be checked during removal to ensure the modern fabric does not obscure an earlier arrangement.

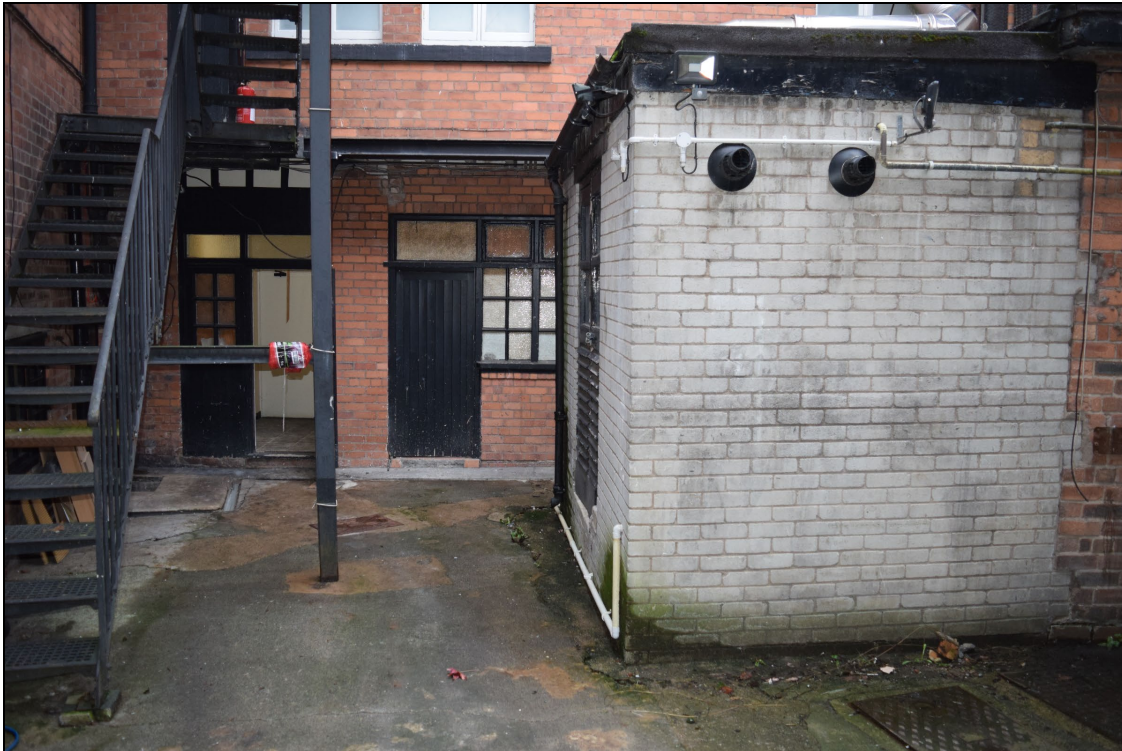
Figure 28: (right above): The central courtyard is at basement level. The brickwork is late 19th century in date and appears to have been built between the publication of the 1880 and 1900 1:10560 Ordnance Survey maps. There are also 20th century elements, such as the block seen to the right of centre, which do not appear on the 1900 Ordnance Survey map. The facing doors will be widened (B5 & B6) and their fabric should be recorded before removal.

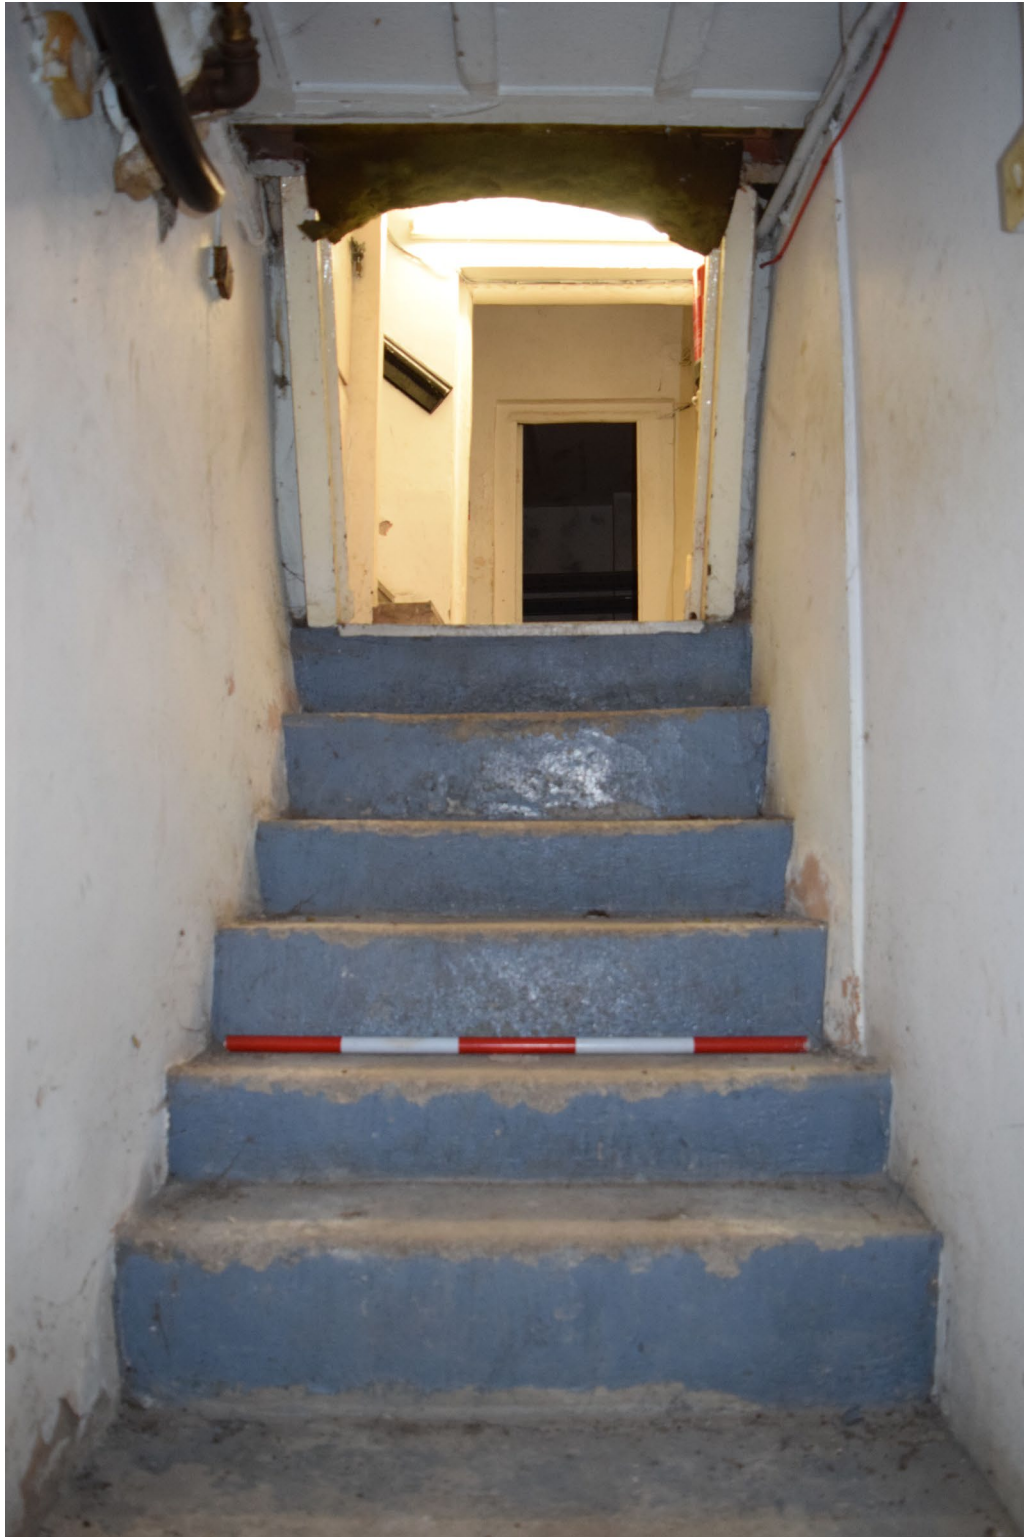
Figure 29: The steps leading from basement level down to the sub-basement level, which lies beneath the Georgian "New Hotel", B24. The date of this access point is not known but the steps appear to be relatively modern concrete. Work to modify this access point to the sub-basement to increase headroom may reveal original fabric and should be monitored.

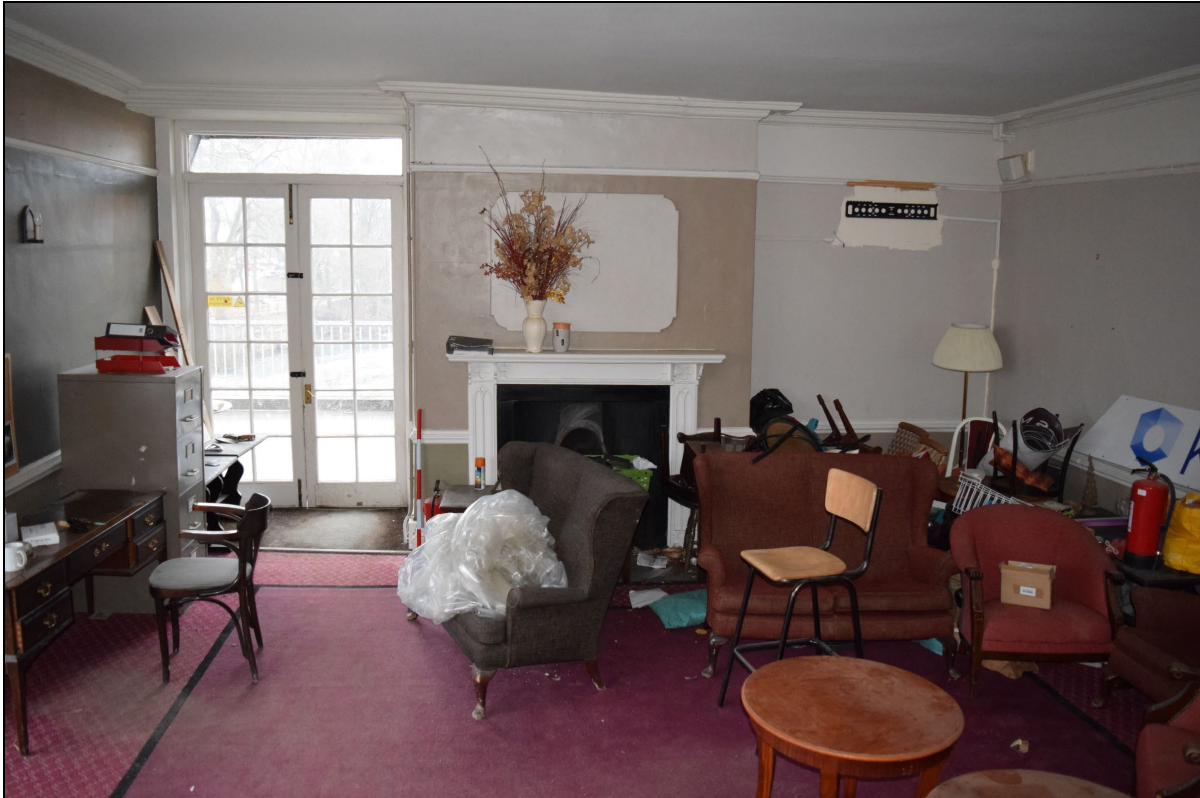
Figure 30: A view inside the main lounge of the Georgian "New Hotel". The doorway to the left is not an original feature and will be replaced (GF24). It is proposed that another doorway (GF23) is opened through the wall to the right of the chimney breast. This will involve removing original fabric which should be monitored and recorded. The fireplace will remain in place.

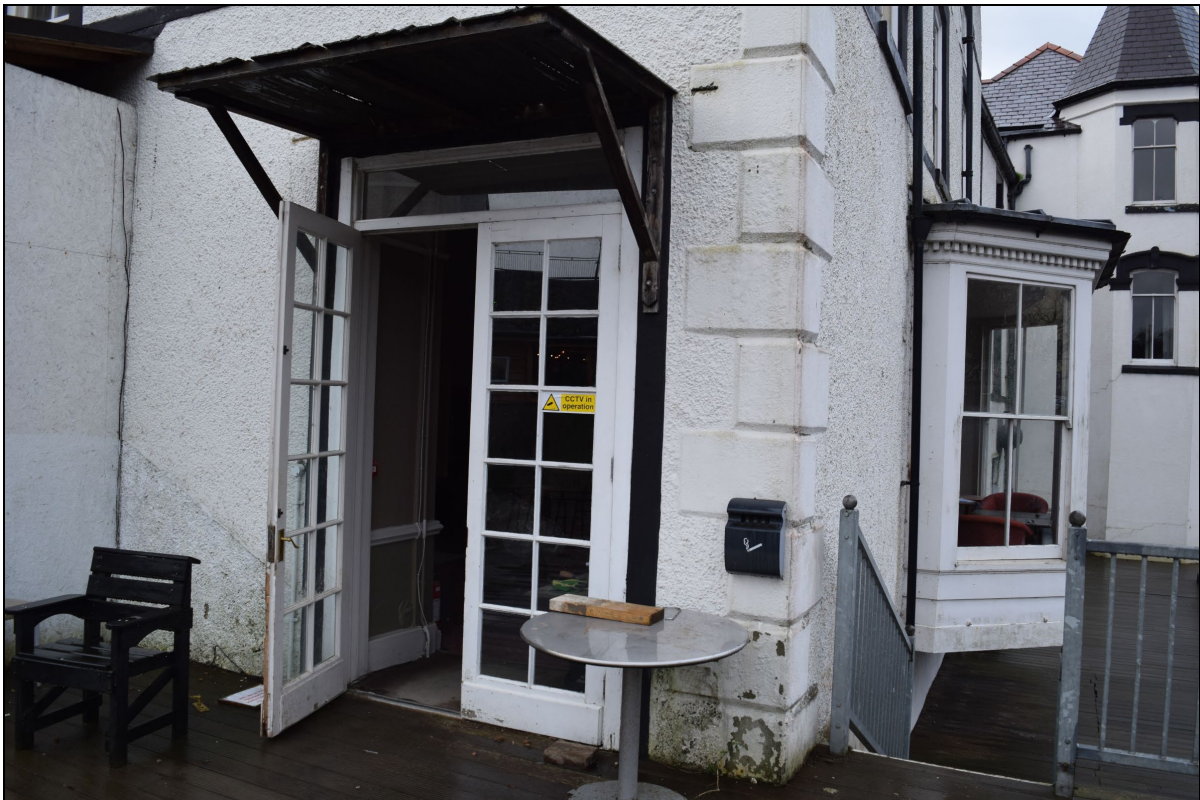
Figure 31: An external doorway of the doorway (GF24) seen in the previous plate. The render and false quoin stones are relatively modern additions.

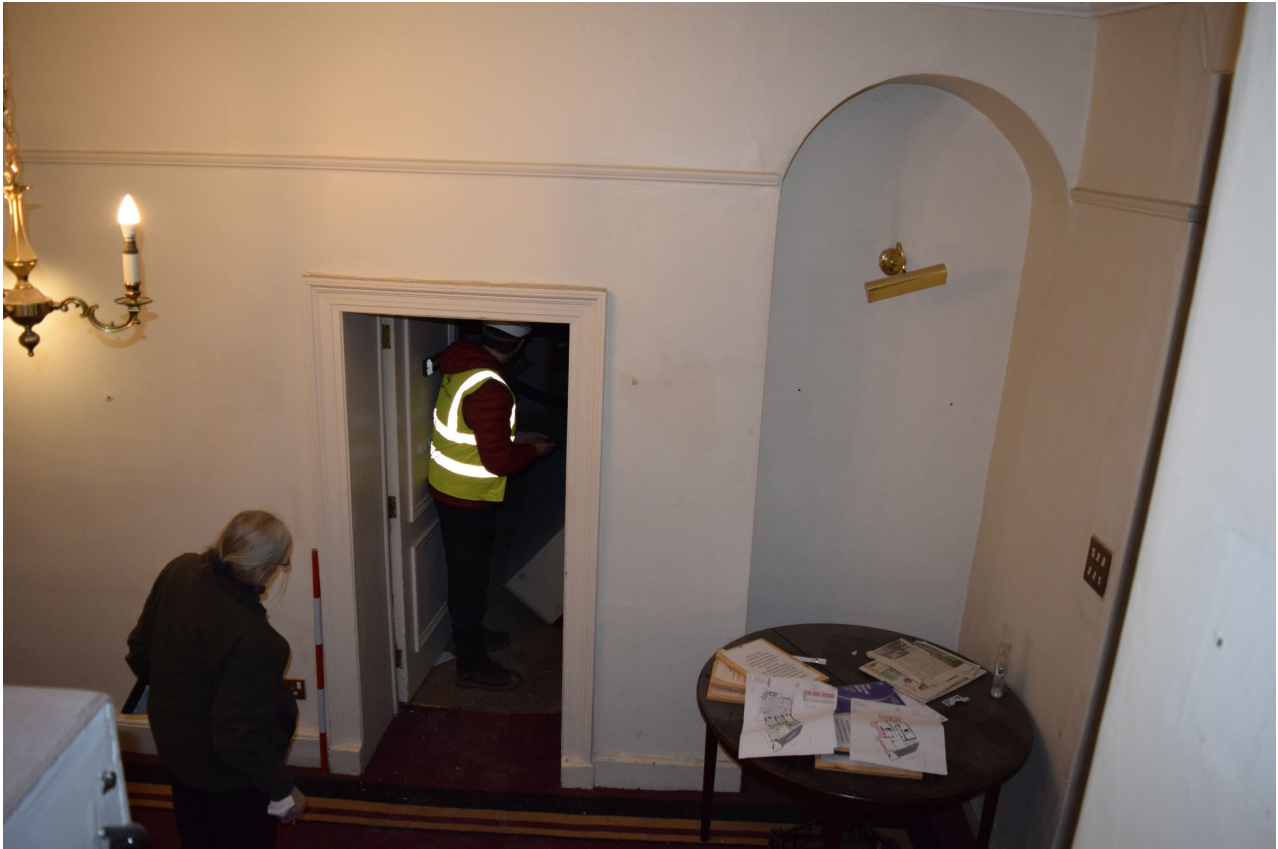
Figure 32: A view inside the hallway of the ground floor of the Georgian "New Hotel", viewed from the main staircase. It was proposed that the open door will be infilled (GF21) and a new doorway opened through the arched alcove to the right of centre (GF20). Under the requested variation the wall would be maintained as it currently is. The present doorway is probably not an original feature, whilst the alcove may be an original opening which appears to only be blocked by a thin stud wall. This arrangement shows the complexity of the building and the scale of modifications which have been made during the past 200 years. The monitoring of the removal of the existing plaster and stud walling may well reveal details which help better interpret the history of the building.
