Royal Hotel, Bridge Street, Llangollen Heritage Impact Statement January 2024

Trysor Project No. 2023/918
CPAT HER Event PRN - 215549

This report assesses how proposed variations to a consented planning application 03/2022/0173 and Listed Building consent 03/2022/0174 would impact on the historic fabric of the Royal Hotel.

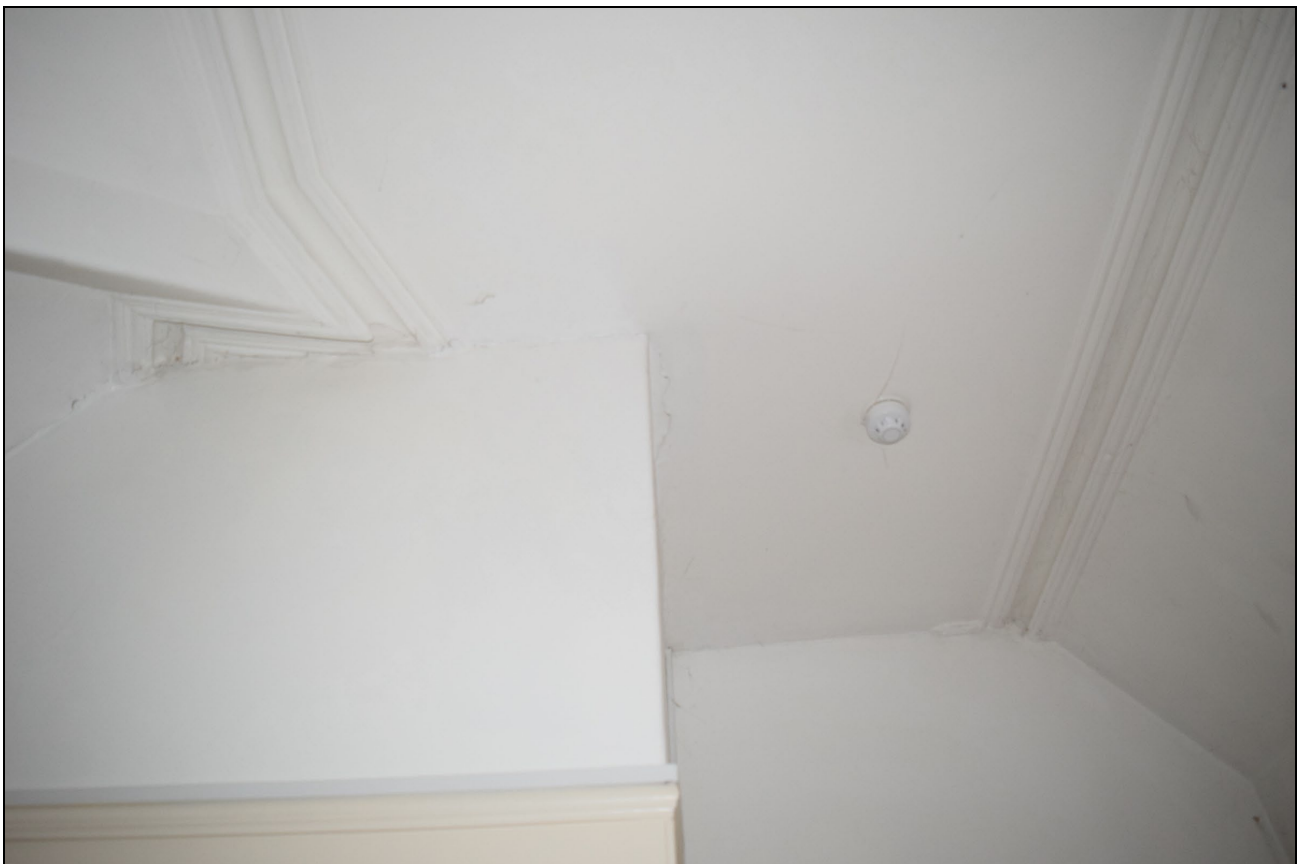
Figure 33: The ceilings of the first-floor rooms at the northwestern corner of the hotel at first floor level show that the mid-Victorian rooms have been subdivided by later stud walling, with original plaster coving cut by the later walls. Removing some of these later walls (FF1) may restore some rooms to a condition closer to their original form. The date of the stud walling is not always clear, however, and could range from late-Victorian to late 20th century, hence this work needs to be monitored and recorded where historic fabric is revealed or removed.

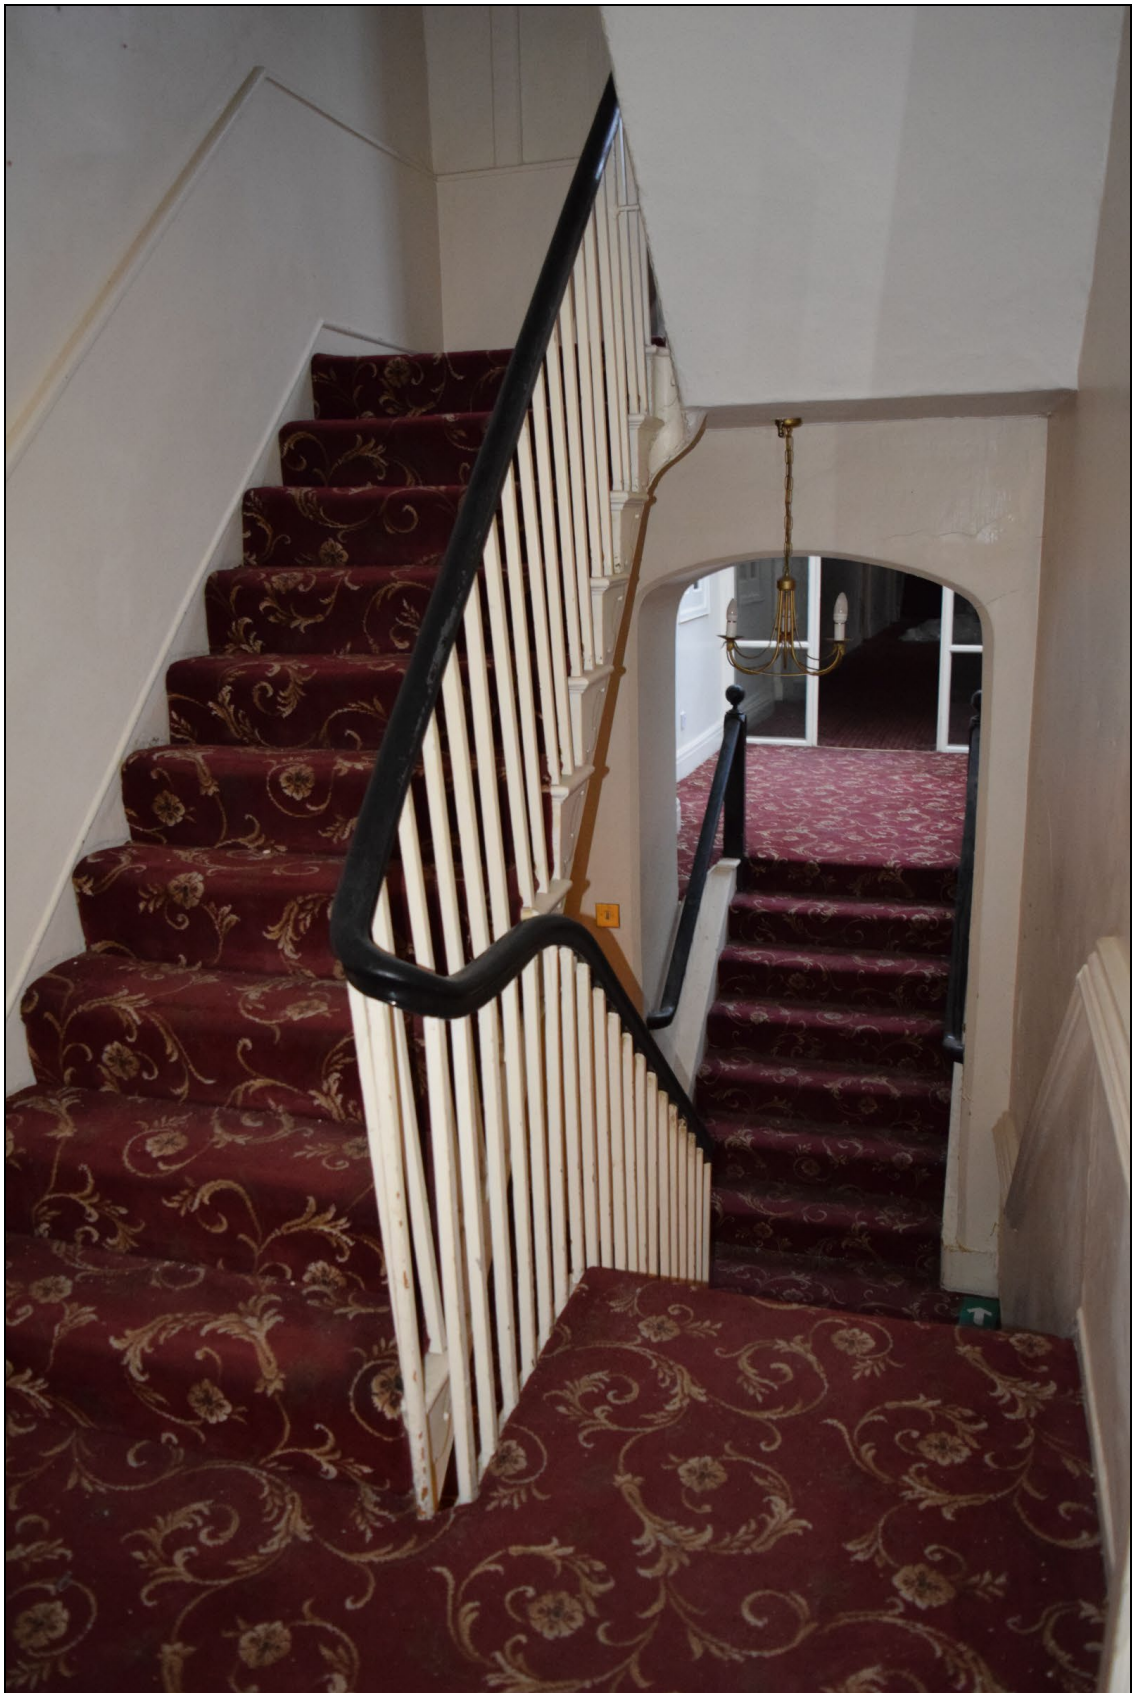
Figure 34: The original staircase, seen here on the landing between the first and second floors. The staircase lies within the "New Hotel" and probably dates to 1815 and is one of the most important historical features within the complex. There are no proposals which will impact on the staircase although the banisters may need some remedial work.

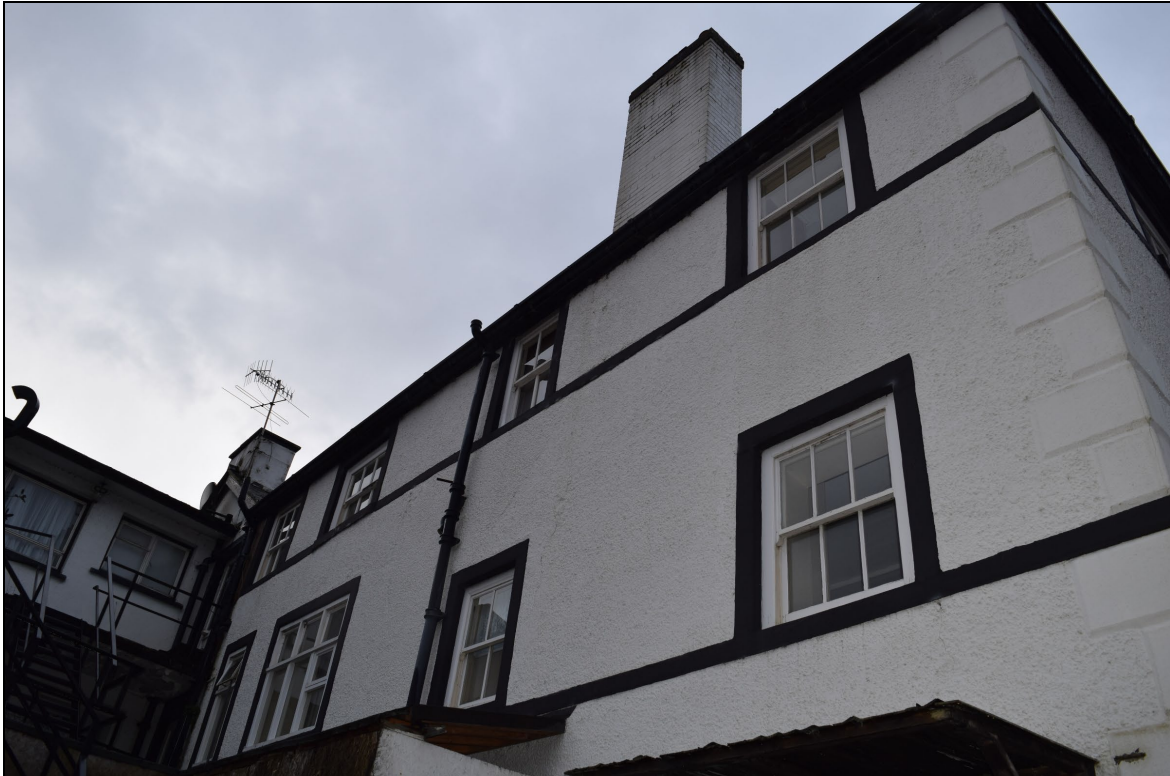
Figure 36: A view of the eastern side of the Georgian "New Hotel". 19th century prints of the building show only a single upstairs window at second floor level in this side of the building. It is not certain if the original windows survive to the left side of the elevation, window SF15 will be blocked but SF16 retained. The remaining windows appear to relate to later modifications of Victorian or early 20th century date.

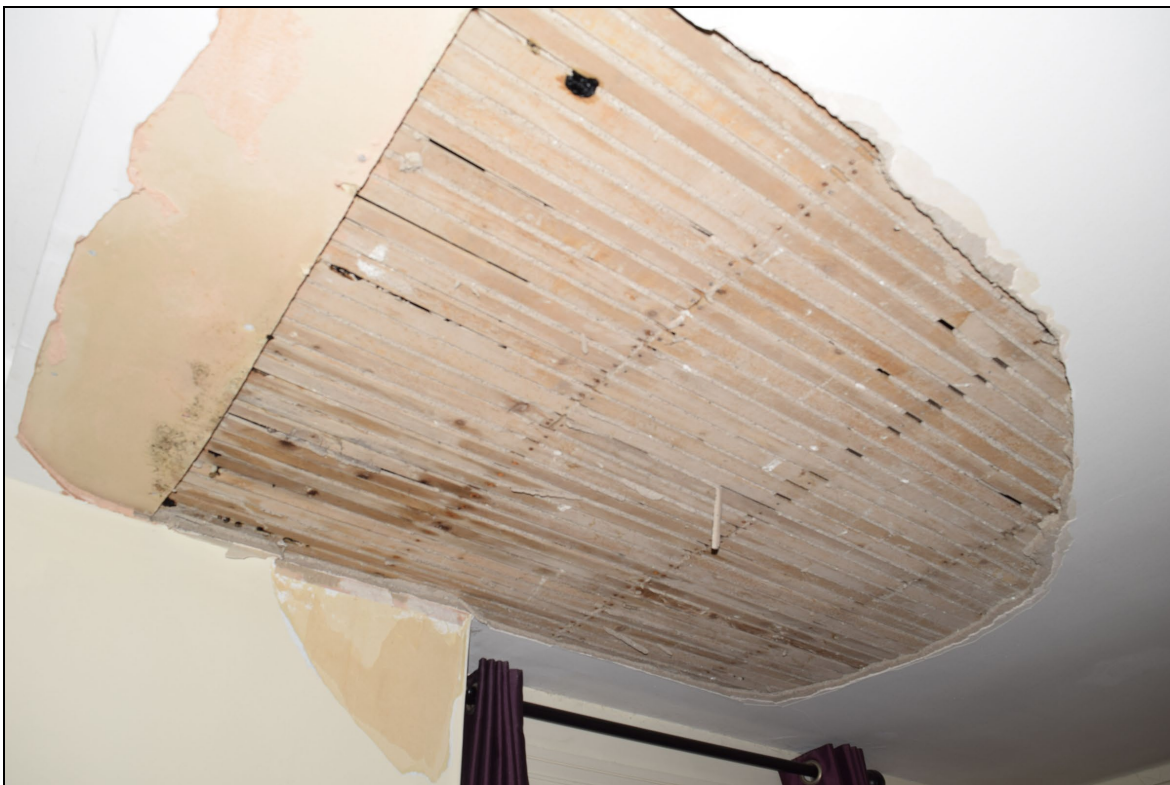
Figure 37: A damaged section of ceiling on the second floor of the Victorian wing of the hotel facing Bridge Street reveals original laths beneath the plasterwork.

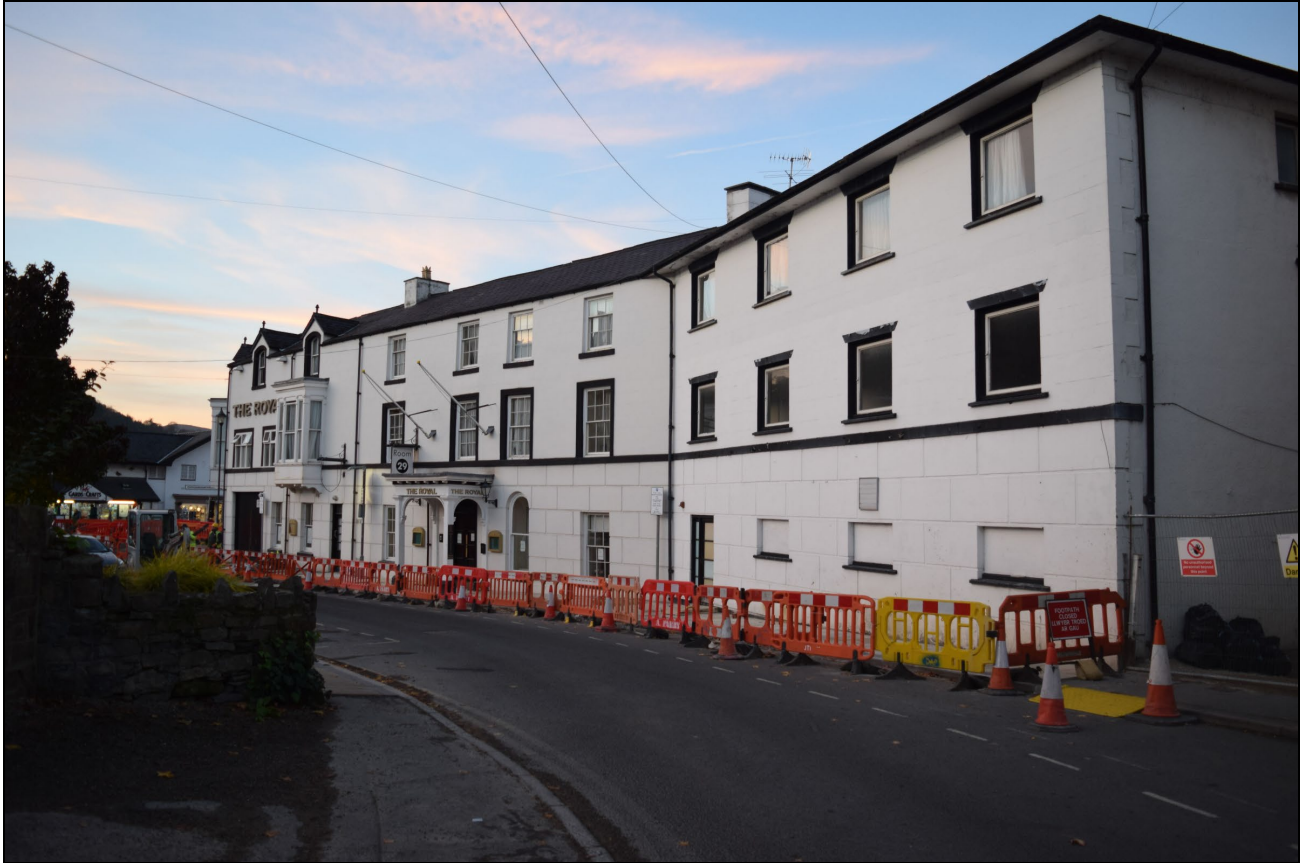
Figure 38: A view of the hotel from Bridge Street, November 2021. The 20th century wing is seen to the left of centre. The proposed changes to this wing include the addition of shopfront-style awnings over the ground floor door and windows and the addition of a pitched slate roof to replace the present flat roof. These changes will enhance the appearance of the modern wing and the complex as a whole. A cantilevered section would be added to the gable end to the right of this image, at first and second floor level.

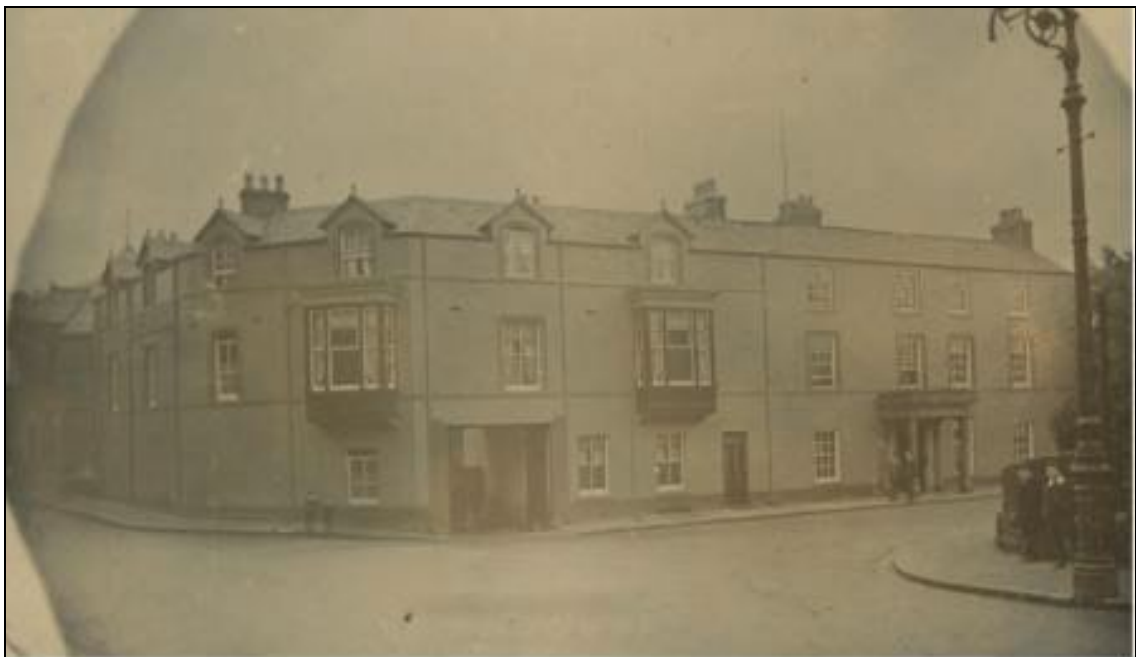
Figure 39: This photograph appears to show that the façade of the Royal Hotel was uniform in terms of its décor around 1900.

5.6.4 The earliest known photograph of the south elevation of the Royal Hotel is a black and white photograph dating to circa 1900 (Plate 38). This shows the south and west elevations painted in one tone, with a darker colour on the woodwork of the bay window and doors, with white window frames.

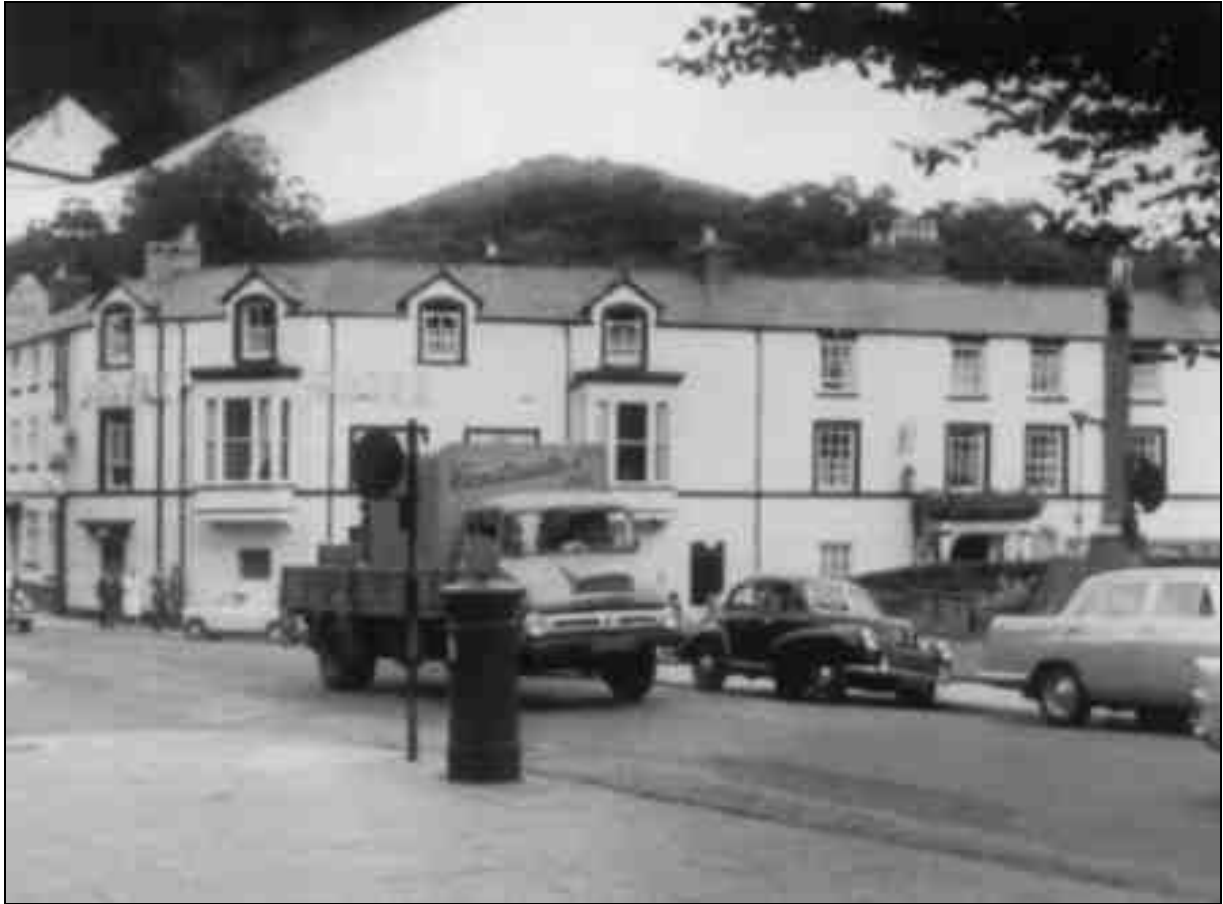
Figure 40: This photograph shows the uniformity of the external décor of the hotel façade in the mid-20th century.

5.6.5 Another black & white photograph dating to 1950 (Plate 39) again shows a single, coherent decorative style across the entire south elevation. By this time the building appears to have been painted white or a very light colour, with a darker colour (probably black) used on the raised render around some windows, gutters and downpipes and also on a single horizontal band between the ground floor and first floor which runs across the entire south elevation.

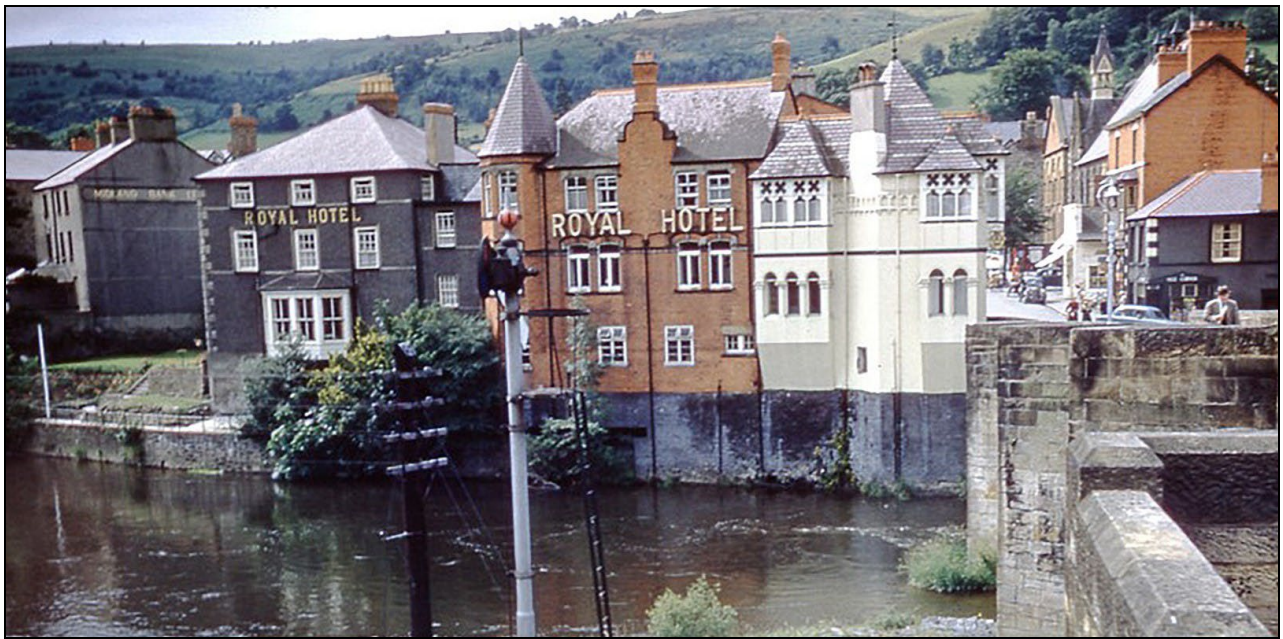
Figure 41: This photograph from 1950 shows how each wing of the hotel once had very distinctive but different external décor; the Georgian wing is to the left, the red-brick late Victorian wing is to the centre and the mid-Victorian wing to the right is painted cream.

5.6.7 The northern elevations of the hotel complex, facing the river, have been treated very differently in the past. In recent times they have had a similar “black and white” décor to that of the southern and western facades of the hotel, but in earlier times wings of different dates along the riverside were decorated differently, being either left unpainted or painted in different colours (see figures 11, 14 and 16).

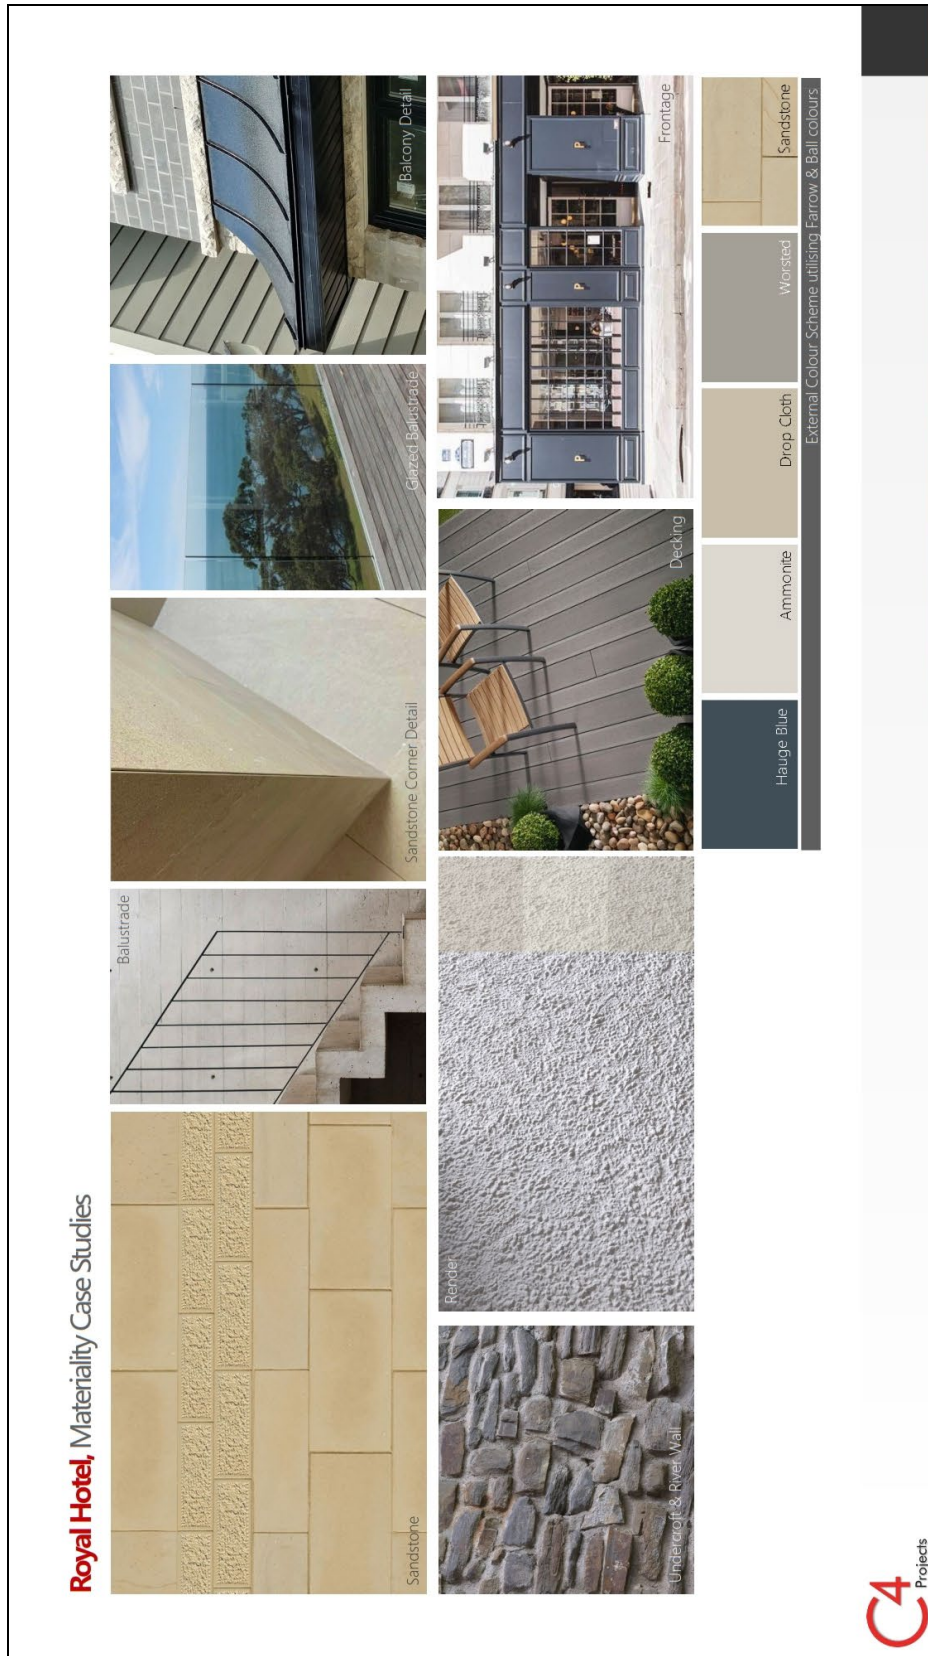
Figure XX: Client Materiality and Colour Scheme. The Ammonite will be used on the painted render on the southern and western façades, with Ammonite, Dropcloth and Worsted used on the northern façade to highlight different phases of the hotel's history with the darker colour used for the oldest, Georgian elements.
