**LEVEL 2 BUILDING RECORDING AT
YEWTREE BARN,
DEFYNNOG, POWYS
PLANNING APPLICATION
21/19619/FUL (BBNPA)**

September 2022

Trysor Project No. 2022/841
CPAT HER EVENT PRN : 167122

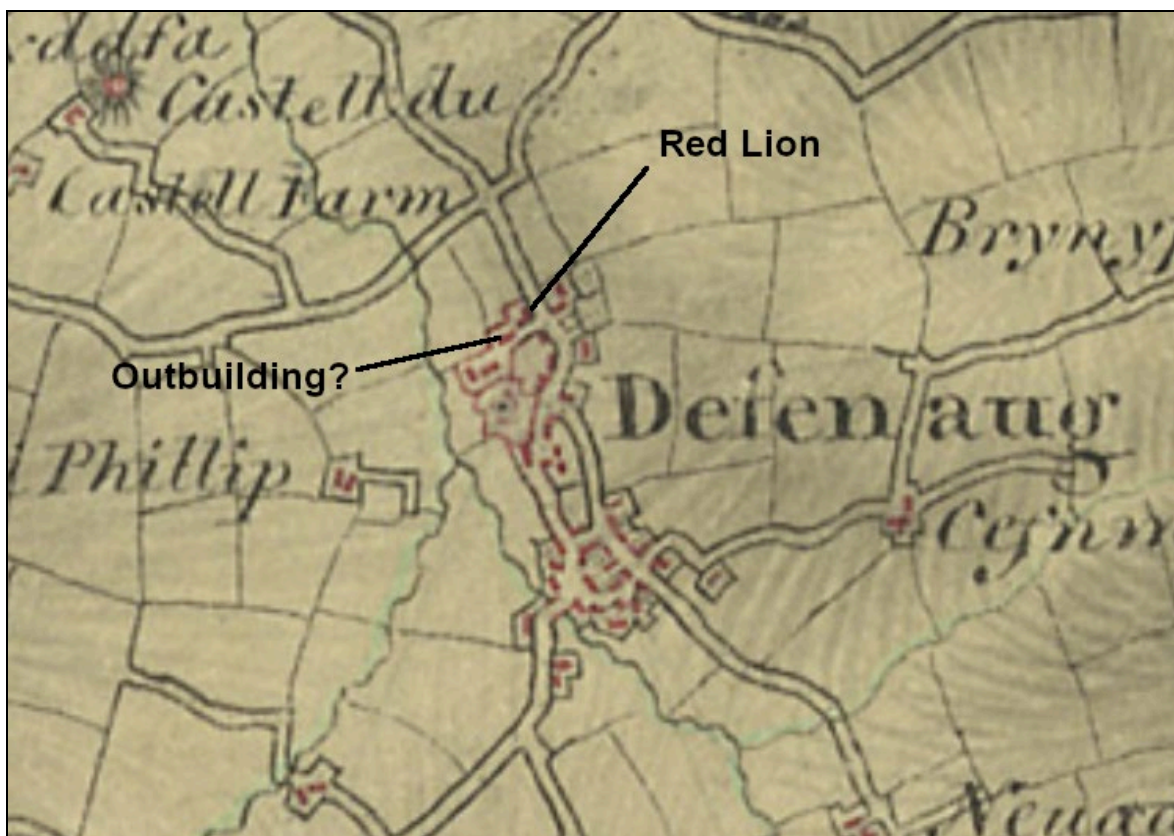
Figure 3: The 1813 Ordnance Survey Original Surveyors Drawing shows a building at the site of the Red Lion (later the Yew Tree) and another at right angles to the southern end of Yew Tree Barn.

5.2 The origin of the building is not clear. The earliest available map is the Ordnance Survey's Original Surveyors Drawings, produced for this area in 1813. This map does not show a building corresponding to the form and location of the present building, though a rectangular building is shown at right angles to the present building, which may overlap with its southern end. This may have been a dwelling or possibly an outbuilding to another building which is shown just to the east on the site of the later Red Lion Inn (see Figure 3).

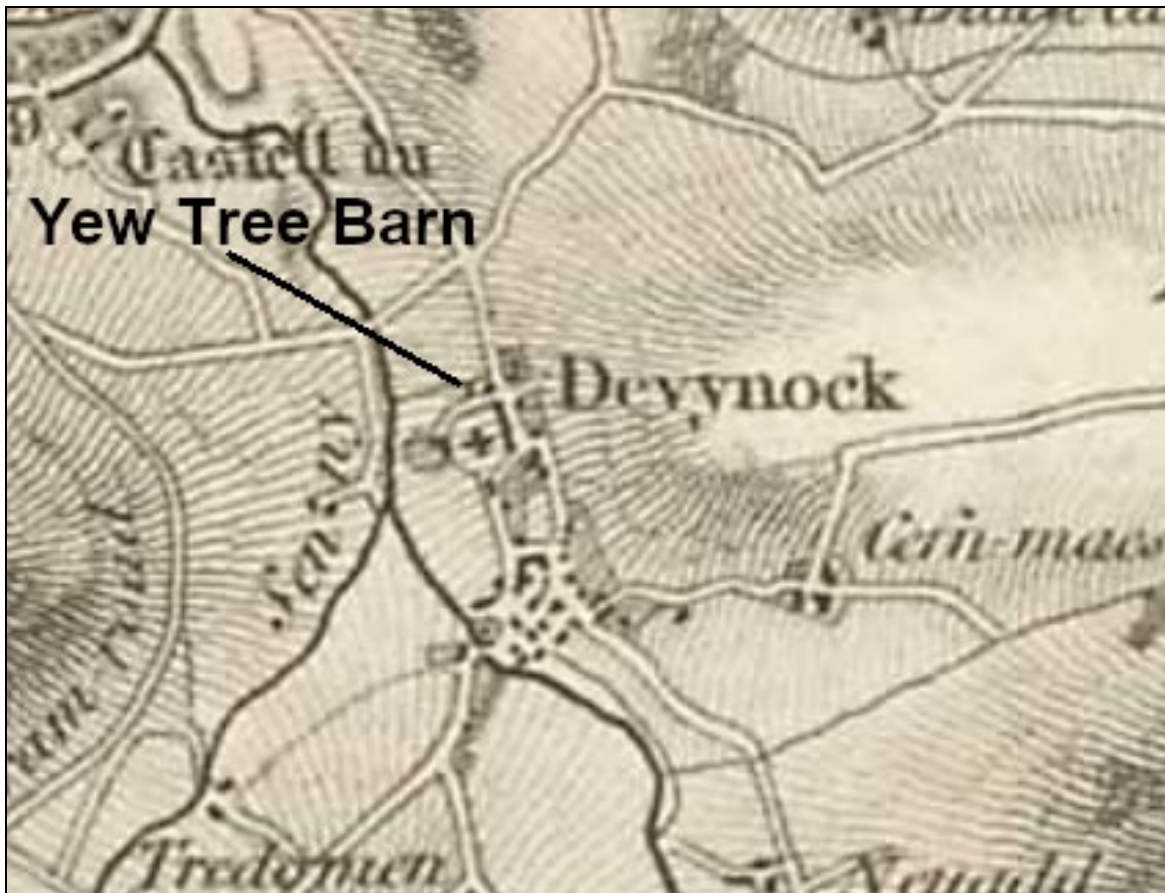
Figure 4: The 1832 Ordnance Survey First Series map shows a different layout at the proposed development site. It is possible that the Yew Tree Barn is shown on this map.

5.3 The 1832 Ordnance Survey First Series map is based on the Original Surveyors Drawings. This map shows a markedly different layout of buildings at the proposed development site. A building is still shown on the site of the inn, but to its western side is rectangular building aligned north-northeast to south-southwest, approximately matching the shape and size to the present Yew Tree Barn (see Figure 4). This may imply that between the time of the 1813 survey and the production of the 1832 map a significant change had occurred and a completely new building had appeared at the site.

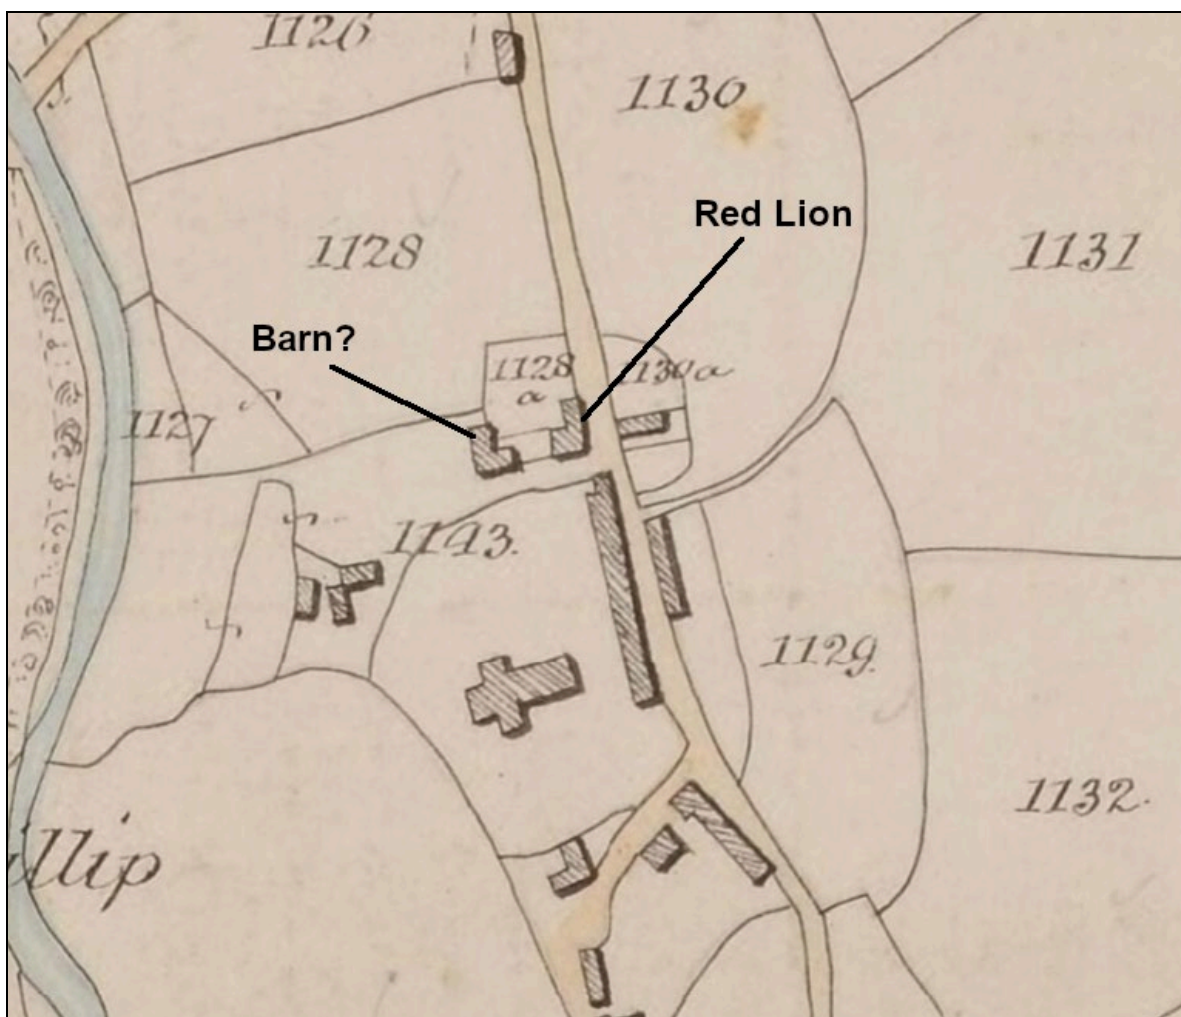
Figure 5: The 1840 parish tithe map shows that two L-shaped buildings occupied the site of the later Red Lion public house and the present building.

5.4 The Defynnog parish tithe map of 1840 shows the layout of buildings around the present building more clearly. Within parcel 1128a an L-shaped building is shown on the site of the later Red Lion Inn, and a second L-shaped building occupies the site of the present building (see Figure 5).

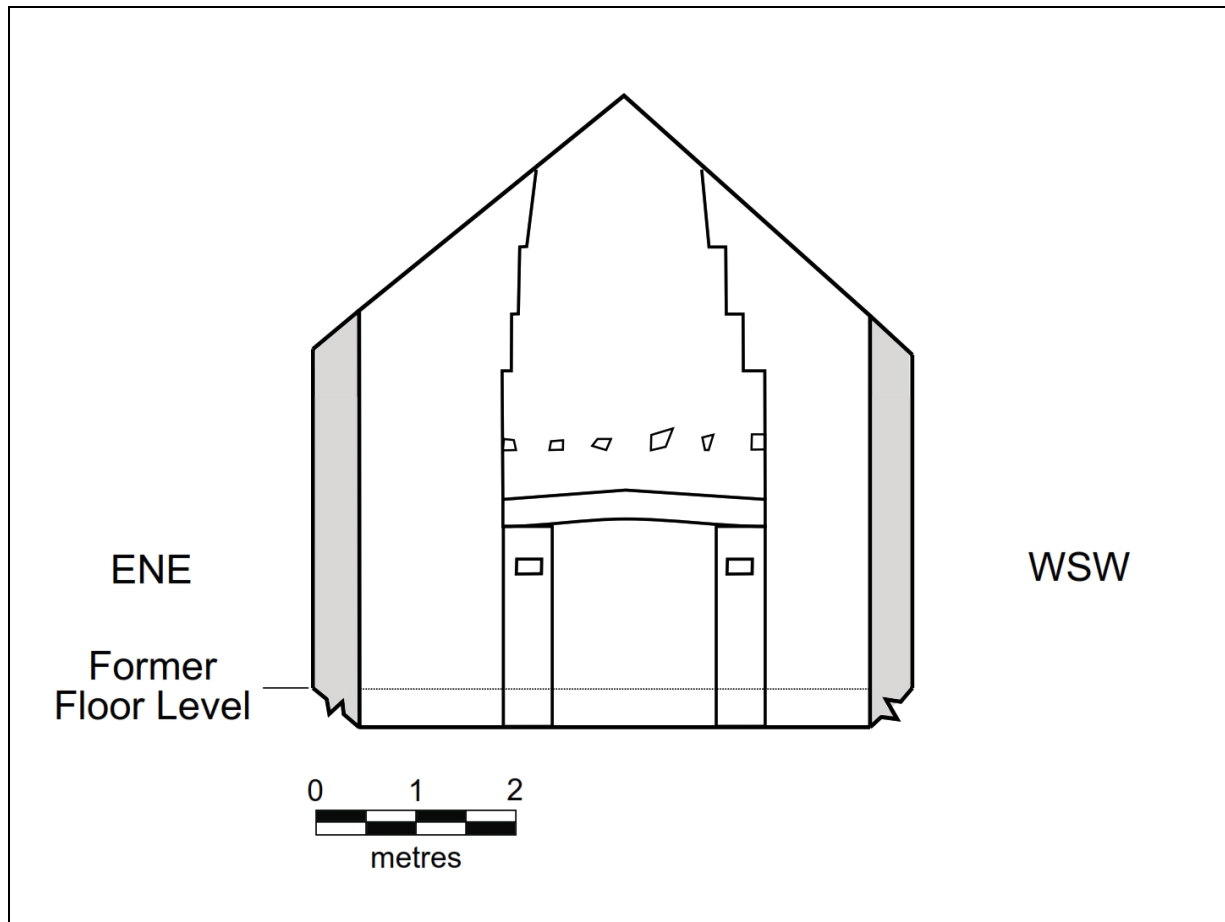
Figure 8: Elevation of inside of south gable wall, Yew Tree Barn, showing the chimney and fireplace.

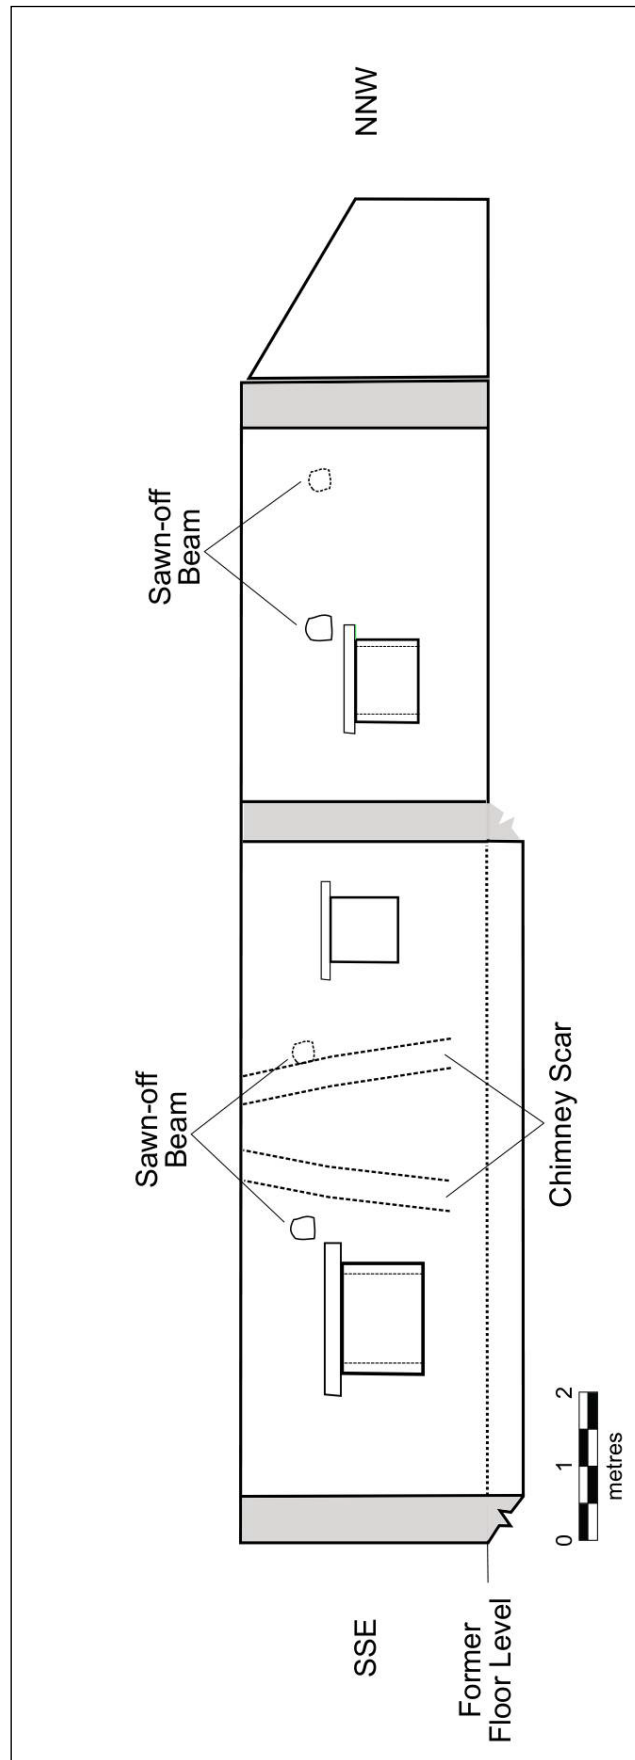
Figure 9: Elevation of inside of west lateral wall of
Yew Tree Barn, Defynnog.

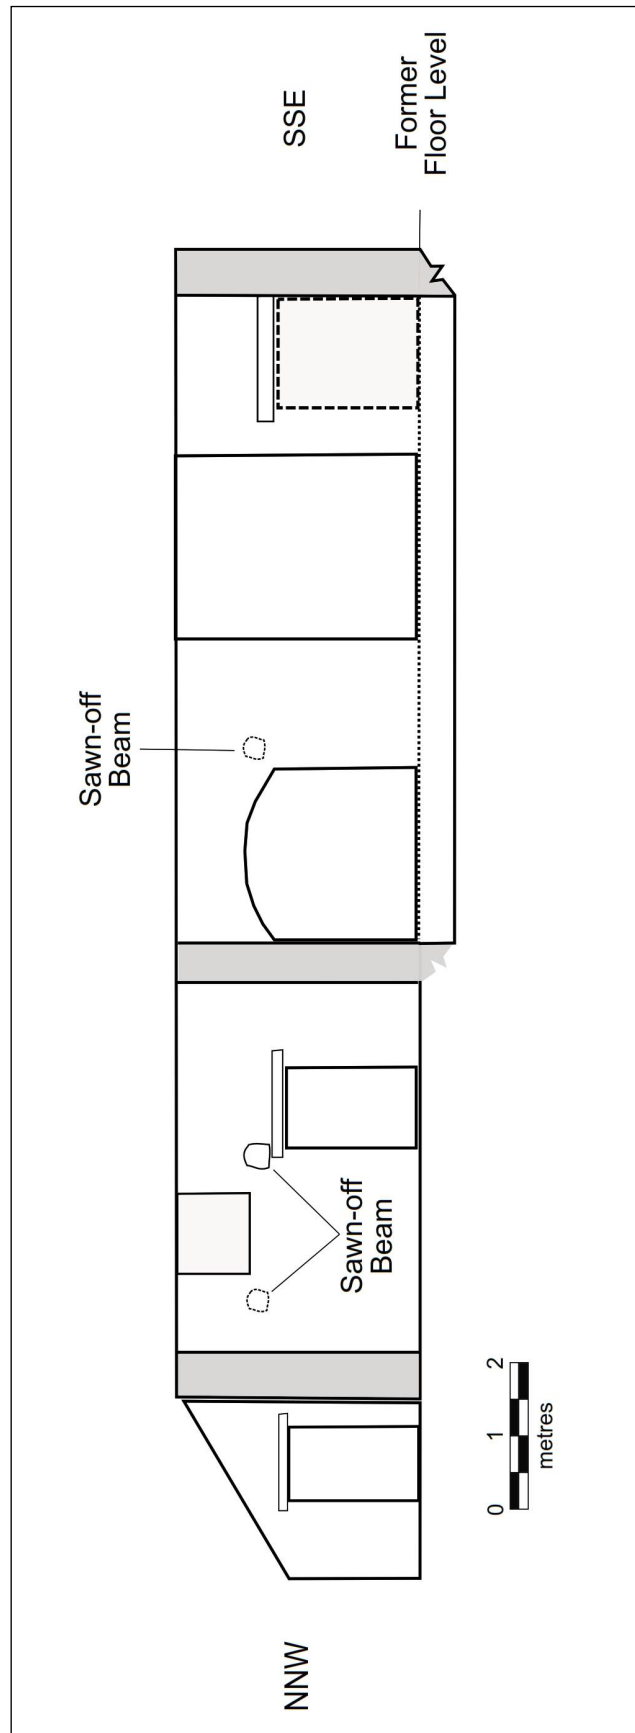
Figure 11: Elevation of inside of east lateral wall of Yew Tree Barn, Defynnog.

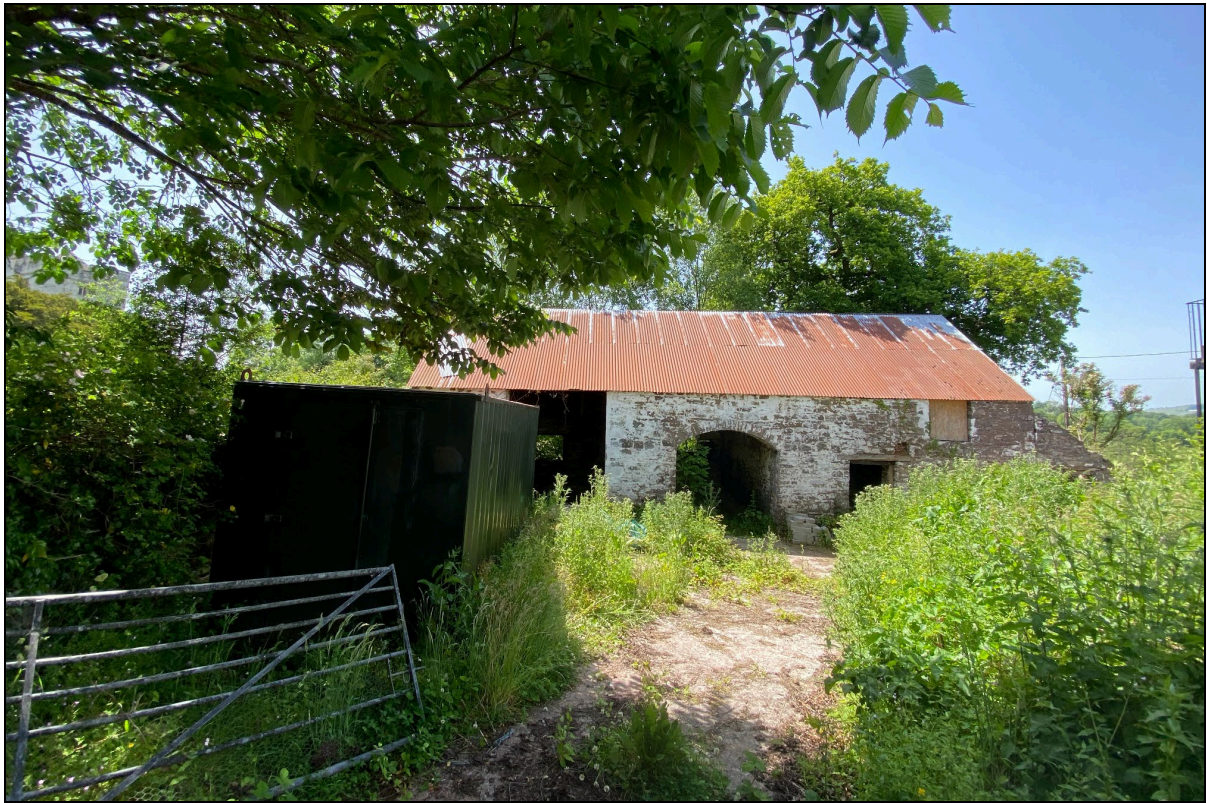
Plate 1: YTB2022_001. A view of the Yew Tree Barn. Looking west.

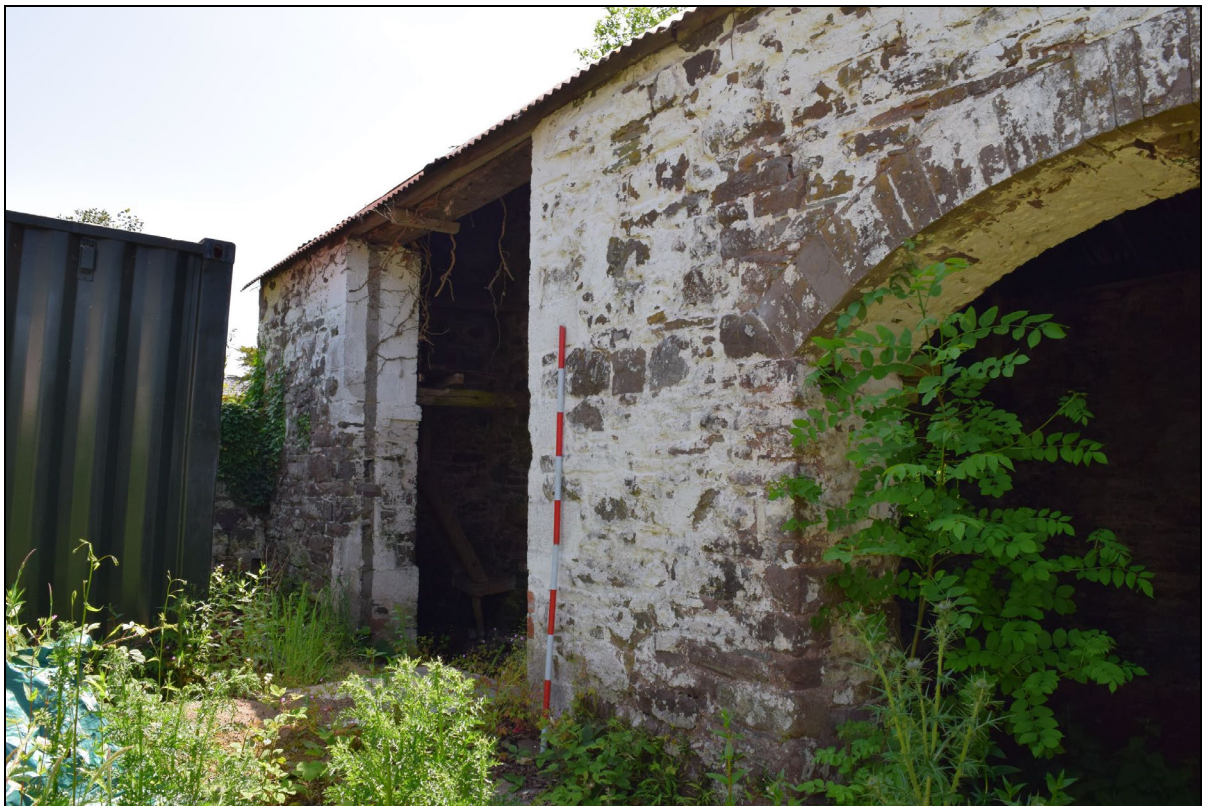
Plate 2: YTB2022_002. A view of the southern end of the eastern-facing façade of the building. The large opening seen left of centre shows evidence of having been enlarged in modern times as concrete blockwork is seen either side of the opening. Looking south.

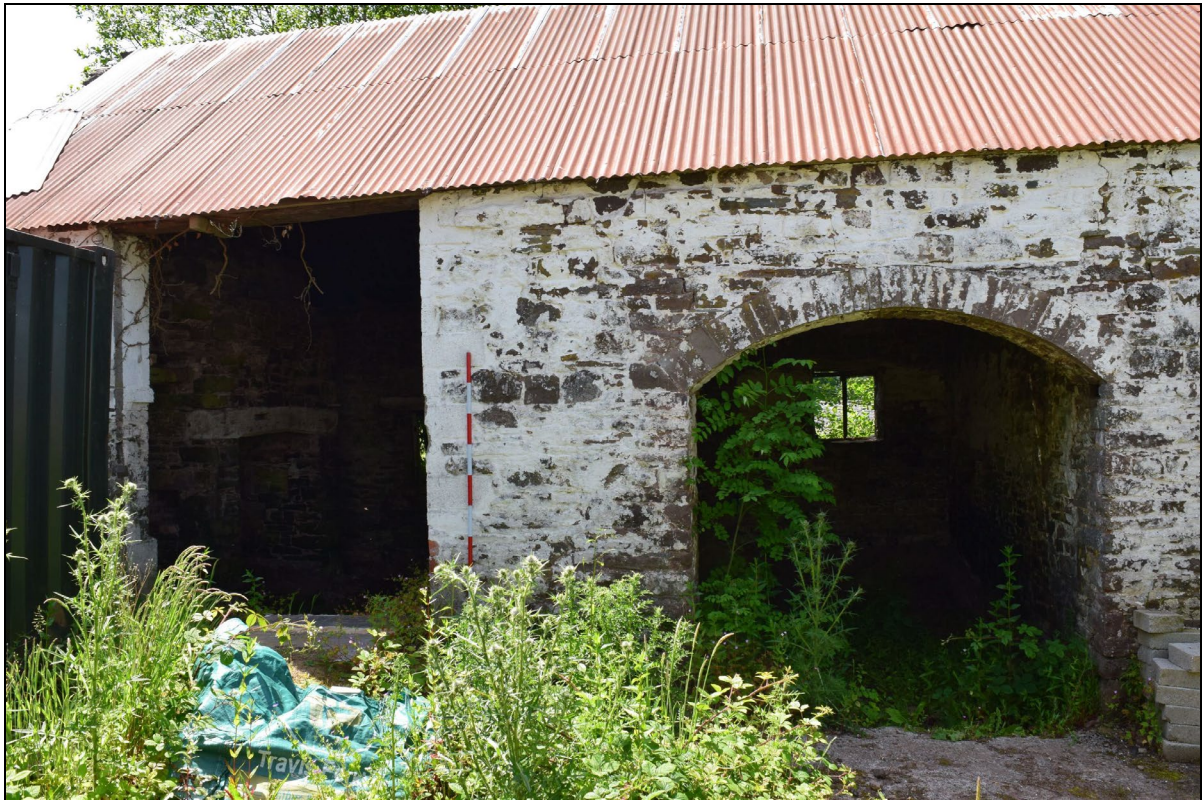
Plate 3: YTB2022_003. A view of the southern end of the east-facing façade of the building showing the two entrances. The arch to the right is original the larger opening to the left appears to have been enlarged in modern times. Looking west-southwest.

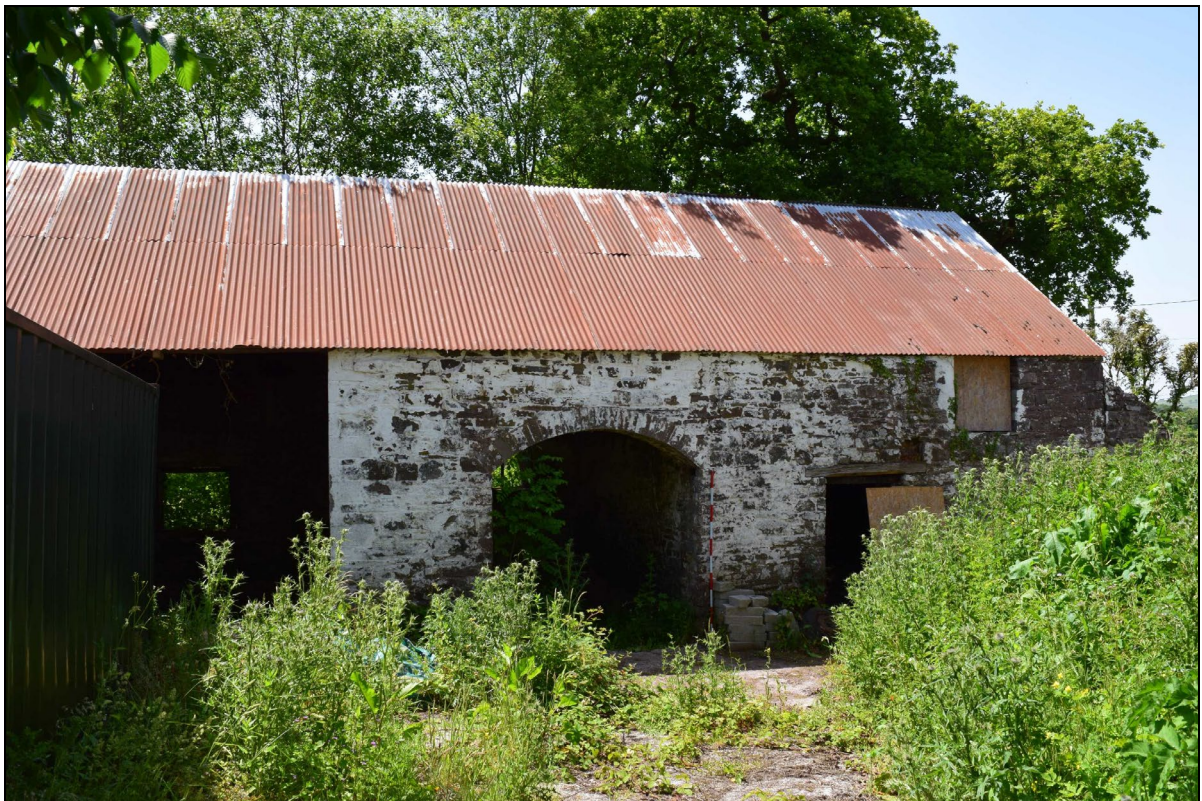
Plate 4: YTB2022_004. A view of the façade of Yew Tree Barn. The door to the right enters the northern room inside the building. Looking west.

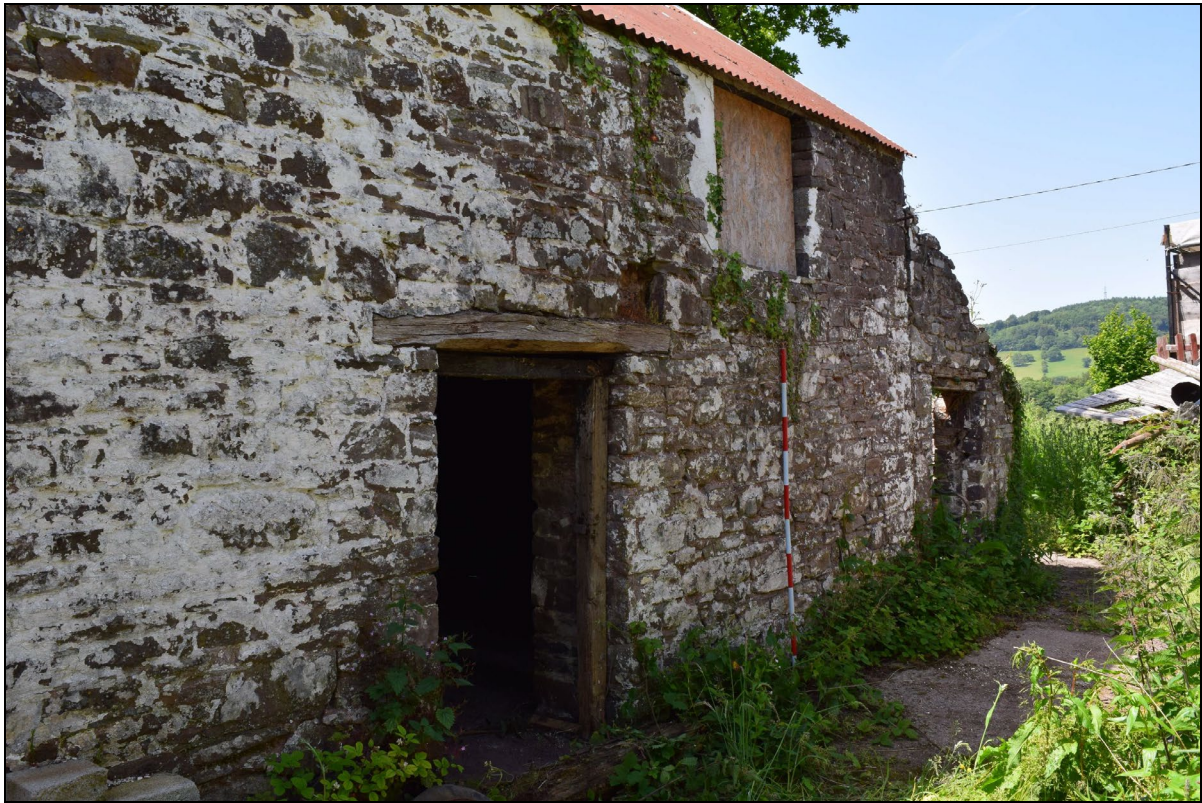
Plate 5: YTB2022_005. A view of the northern end of the building, showing the eastern side of a lean-to built against the gable wall of the building at the northern end. Looking northwest.

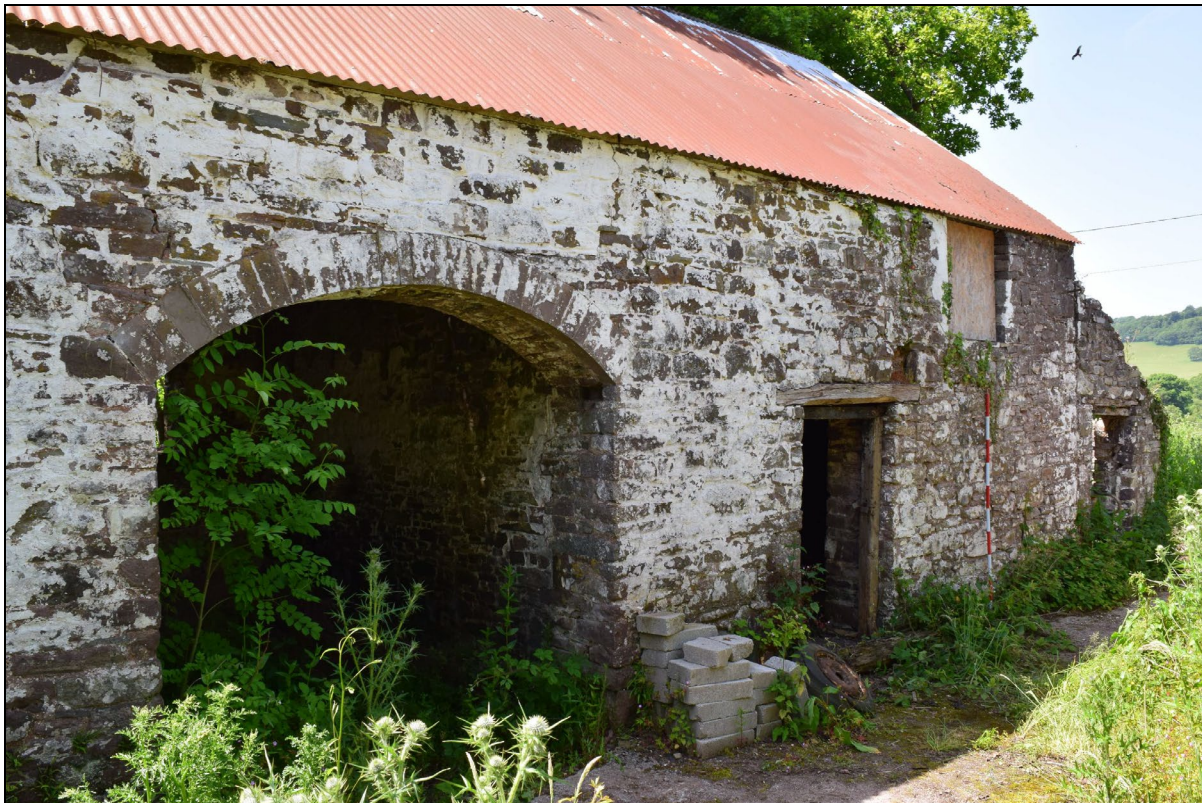
Plate 6: YTB2022_006. A view of the central and northern part of the building, showing the arched entrance into the southern room of the building and the door into the northern room. Looking northwest.

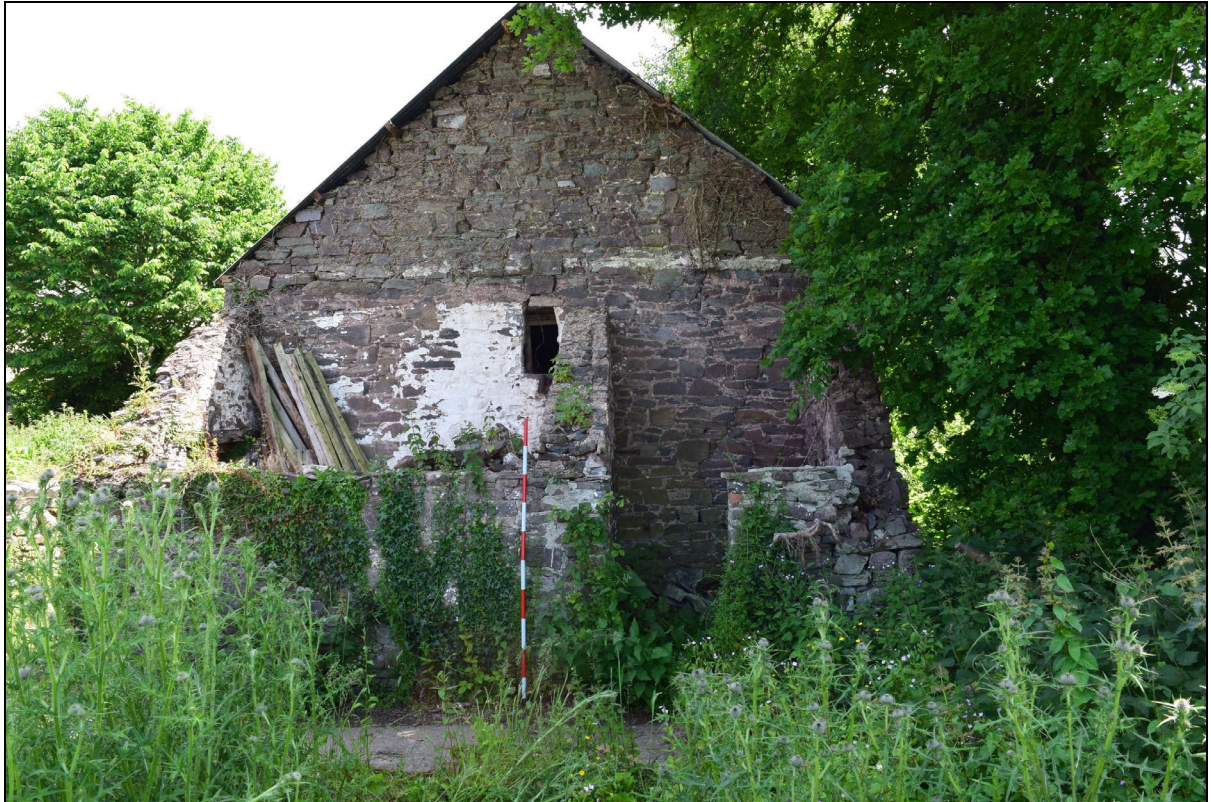
Plate 7: YTB2022_007. A view of the north-facing gable wall of the building and the adjoining lean-to. Looking south-southeast.

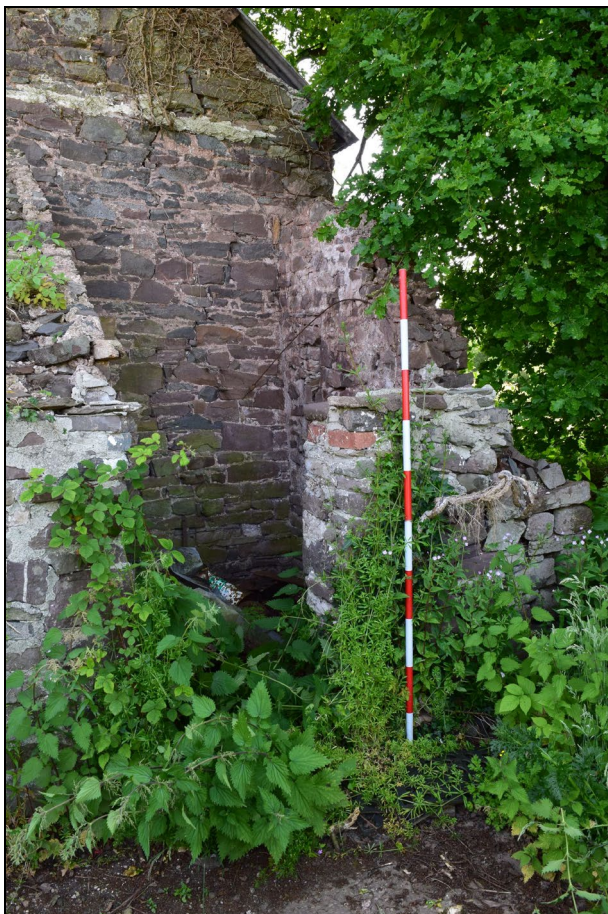
Plate 8: YTB2022_008. A view of the western room within the now roofless lean-to against the north-facing gable wall of the building. Looking south-southwest.

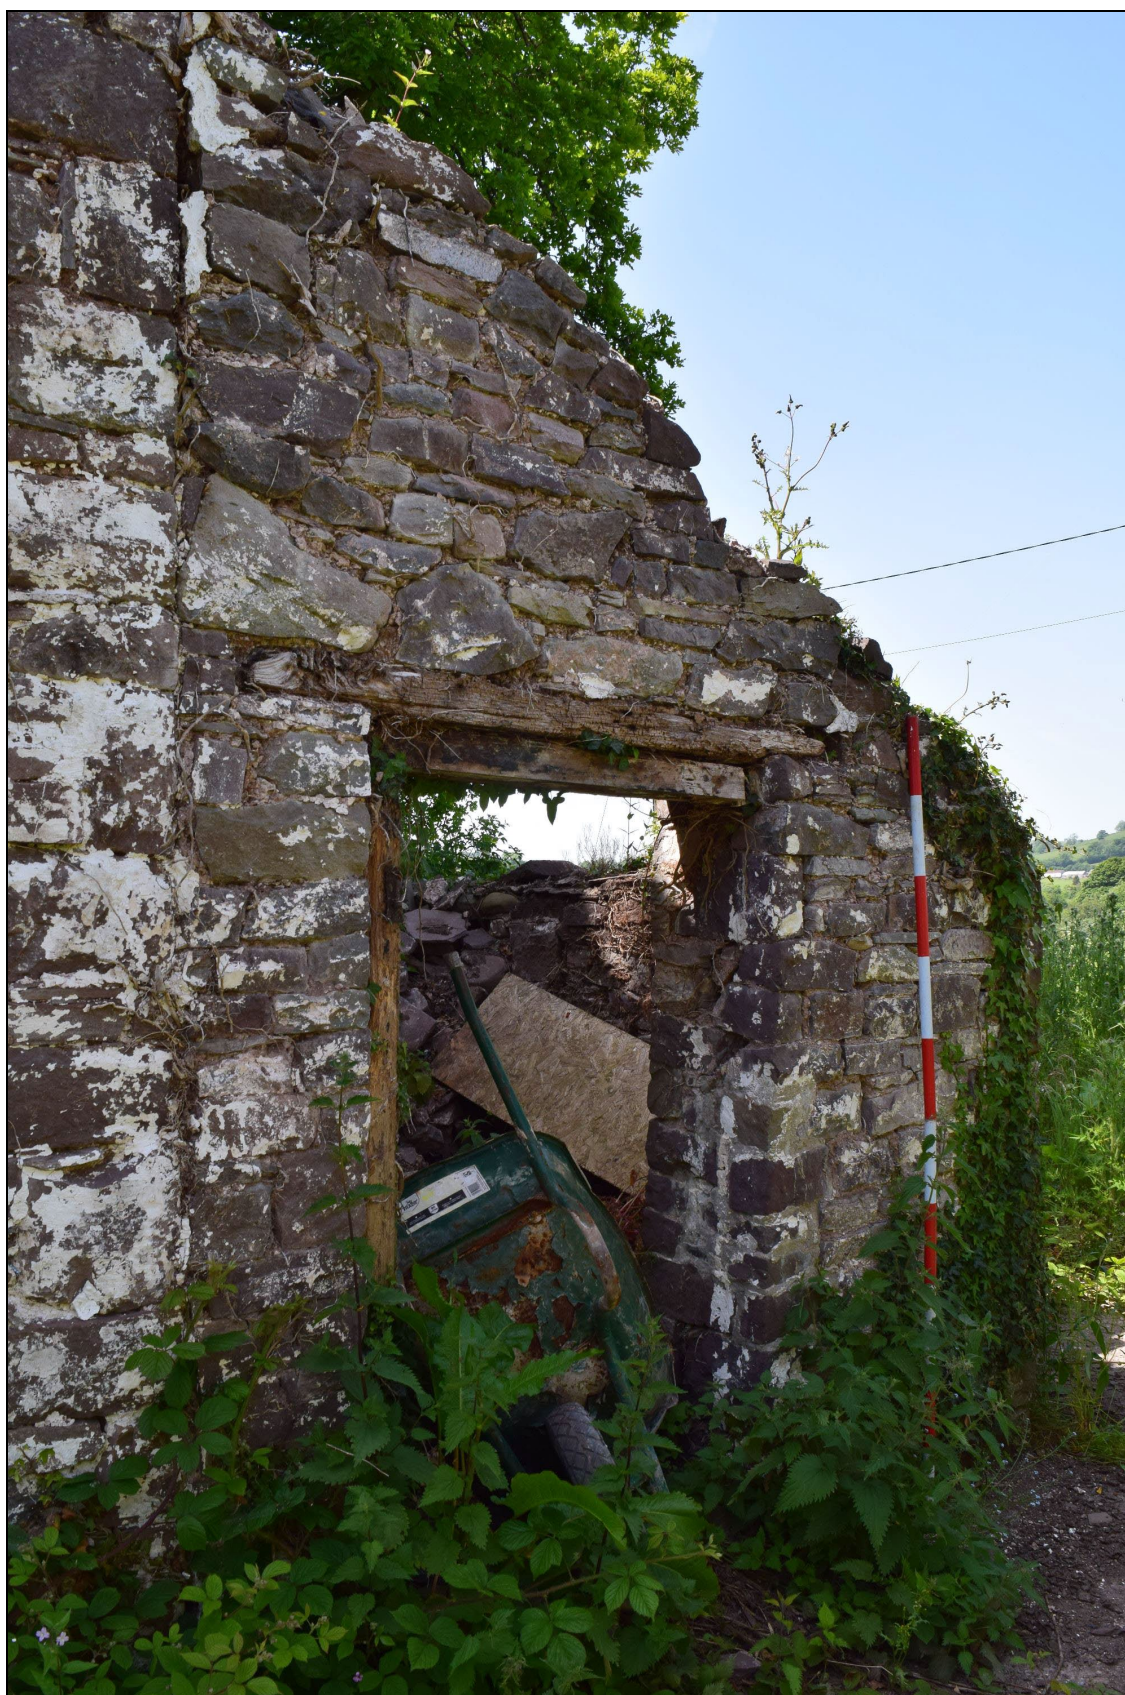
Plate 9: YTB2022_009. A view through the door into the eastern room inside the now roofless lean-to against the north-facing gable end of the building. Looking west-northwest.

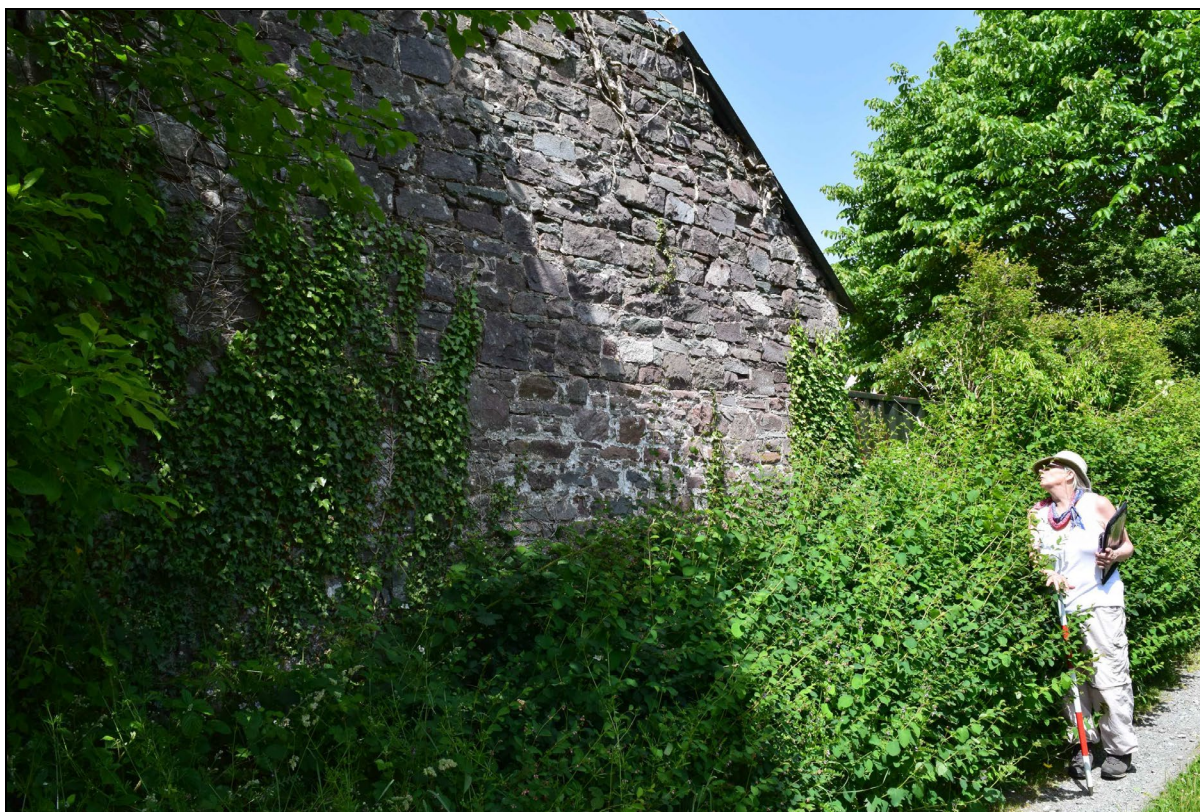
Plate 10: YTB2022_010. A view of the south-facing gable wall of the building. Looking northeast.

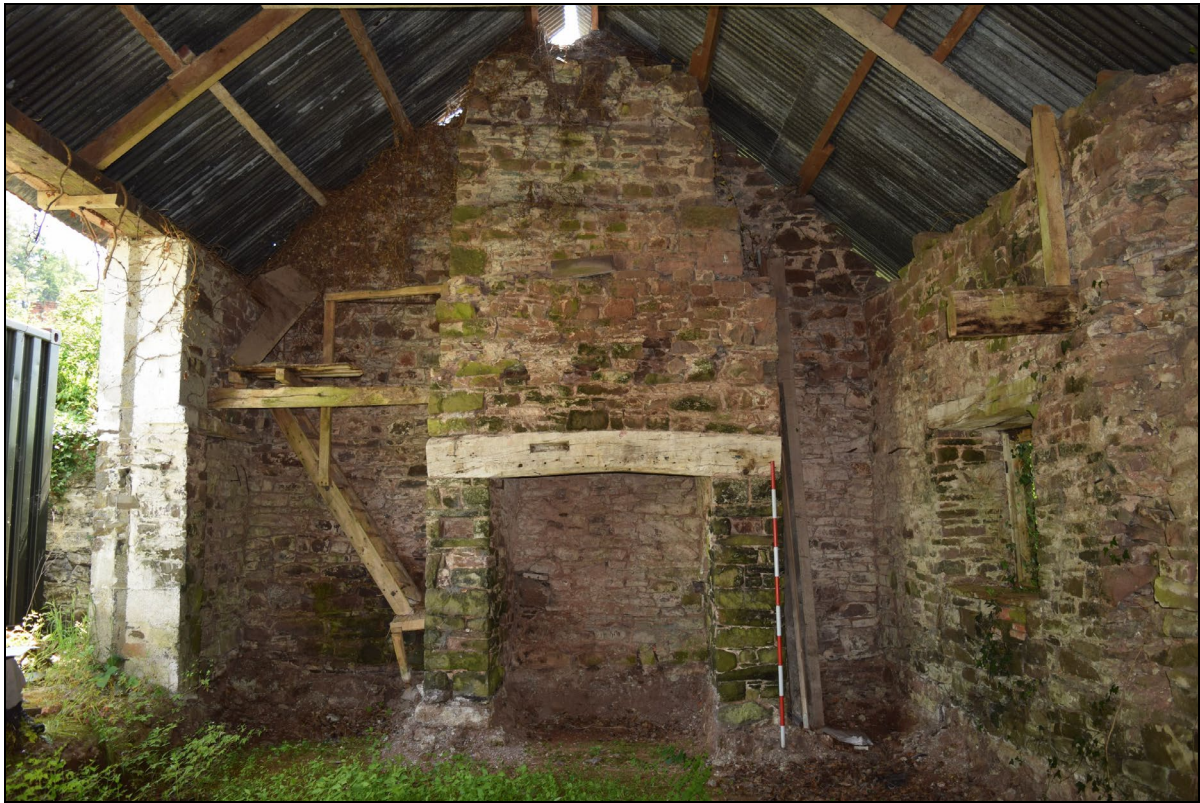
Plate 12: YTB2022_012. A view of the fireplace against the southern gable wall of the building. Looking south-southeast.

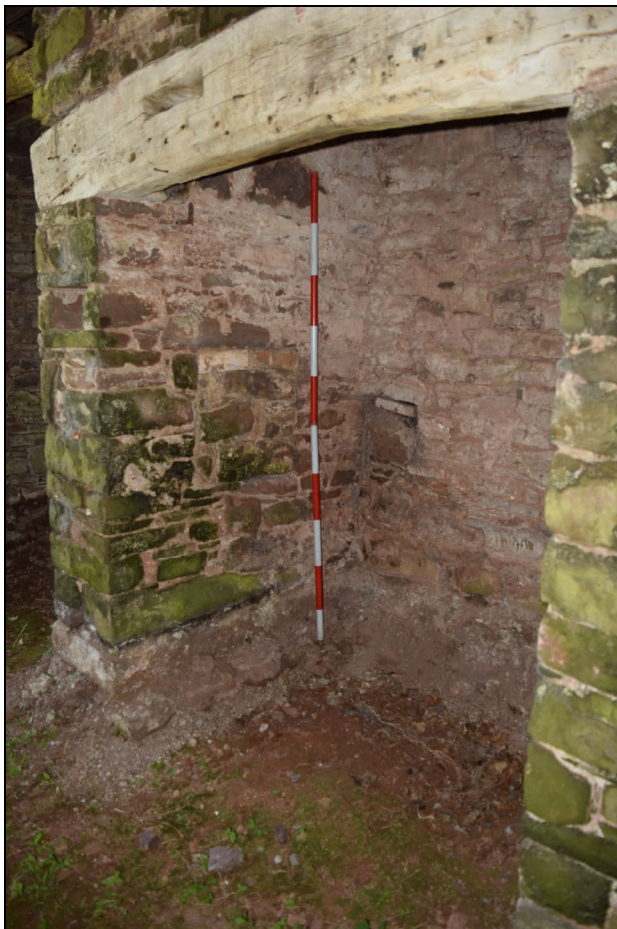
Plate 13: YTB2022_013. A view inside the southern fireplace showing a now blocked-up niche inside the fireplace, left of centre. Looking east.

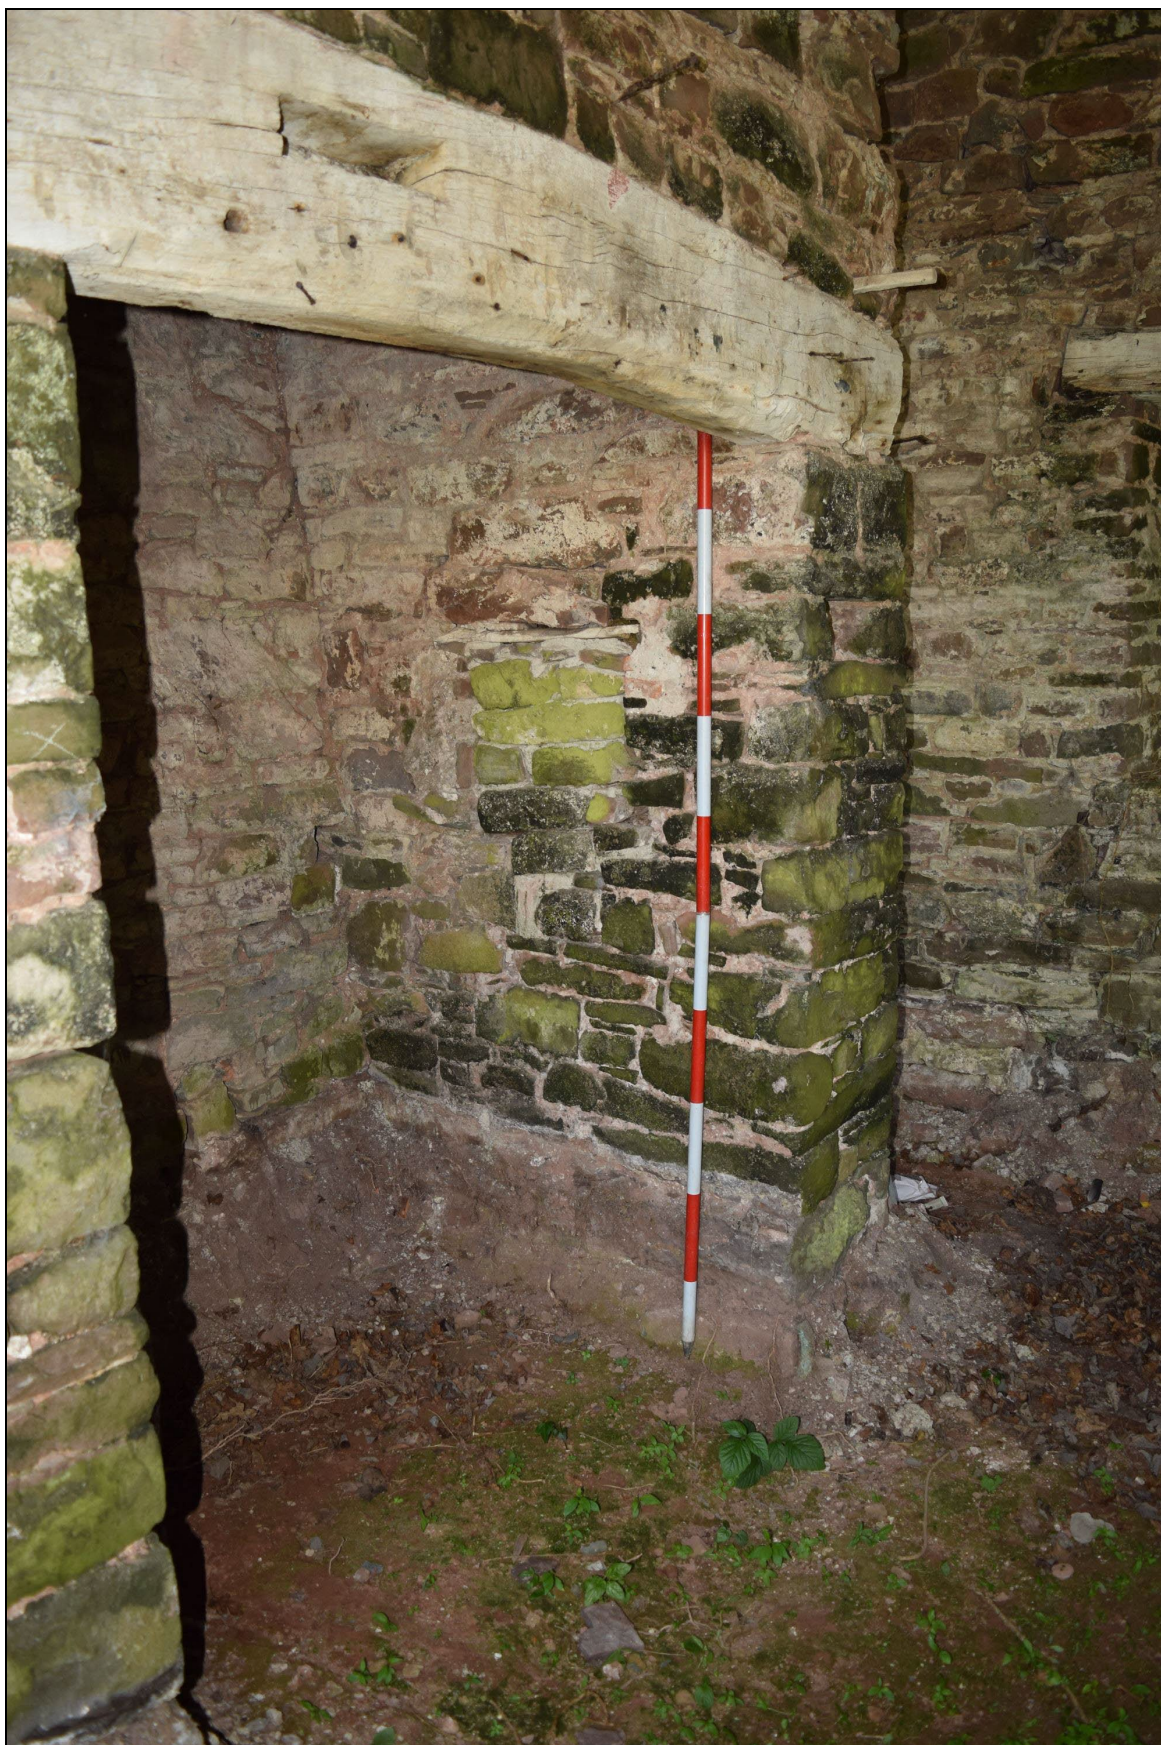
Plate 14: YTB2022_014. A view inside the southern fireplace showing a now blocked-up niche inside the fireplace, left of centre. Note the recycled timber used for the beam above the hearth. Looking southwest.

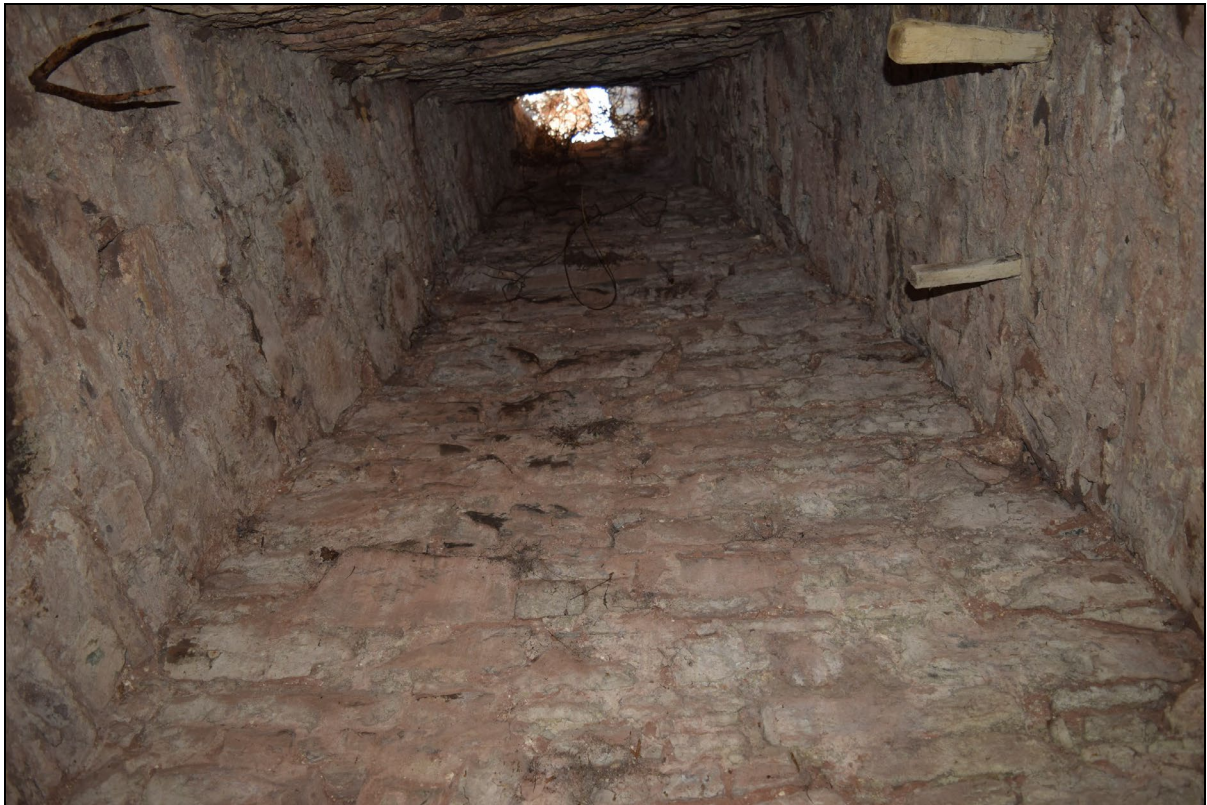
Plate 15: YTB2022_015. A view up the chimney from within the southern fireplace. Looking south-southeast.

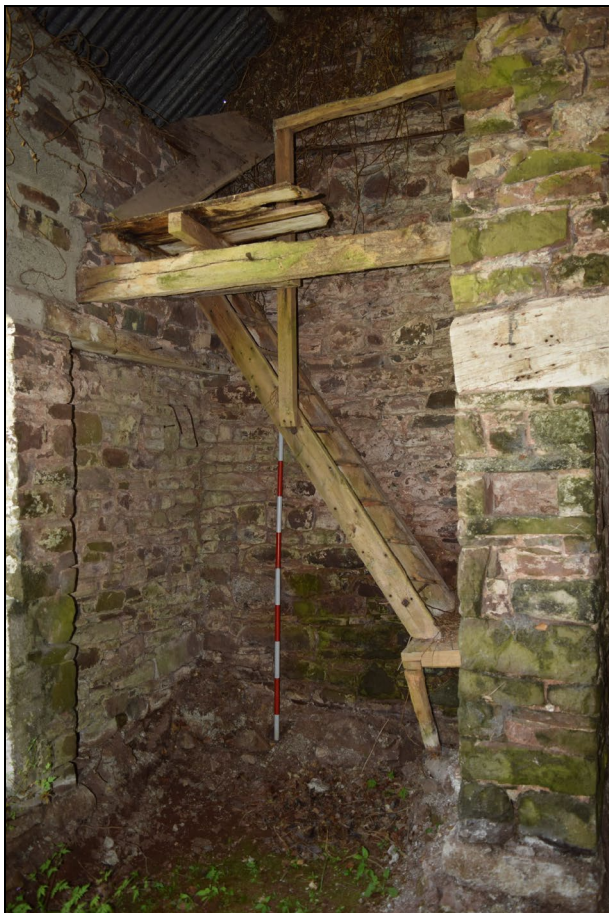
Plate 16: YTB2022_016. A view of a simple ladder which formerly led to the now removed loft inside the southeastern corner of the building. Looking southeast.
