**LEVEL 2 BUILDING RECORDING AT
YEWTREE BARN,
DEFYNNOG, POWYS
PLANNING APPLICATION
21/19619/FUL (BBNPA)**

September 2022

Trysor Project No. 2022/841
CPAT HER EVENT PRN : 167122

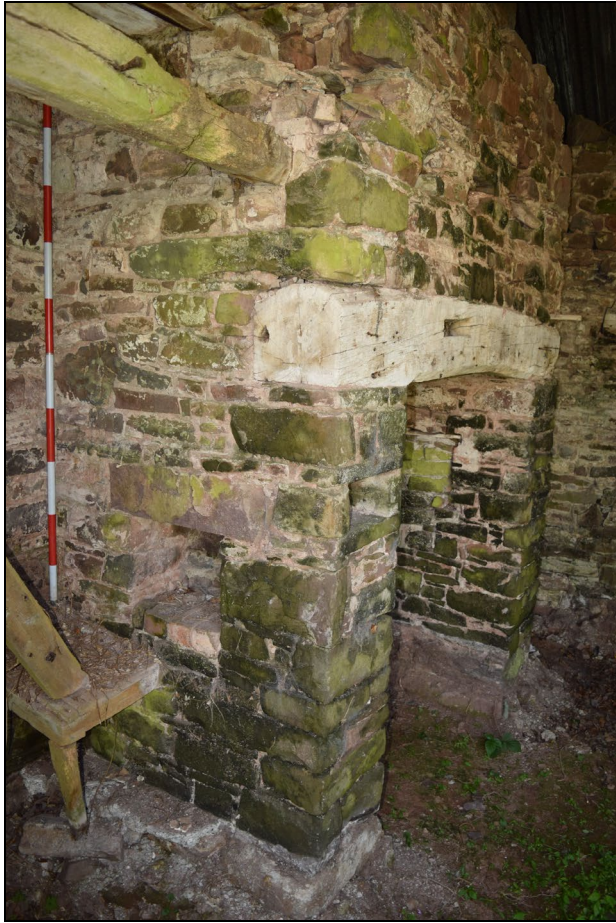
Plate 17: YTB2022_017. A view of the fireplace inside the building, showing an open niche, left of centre, on the outside of the chimney breast. Looking southwest.

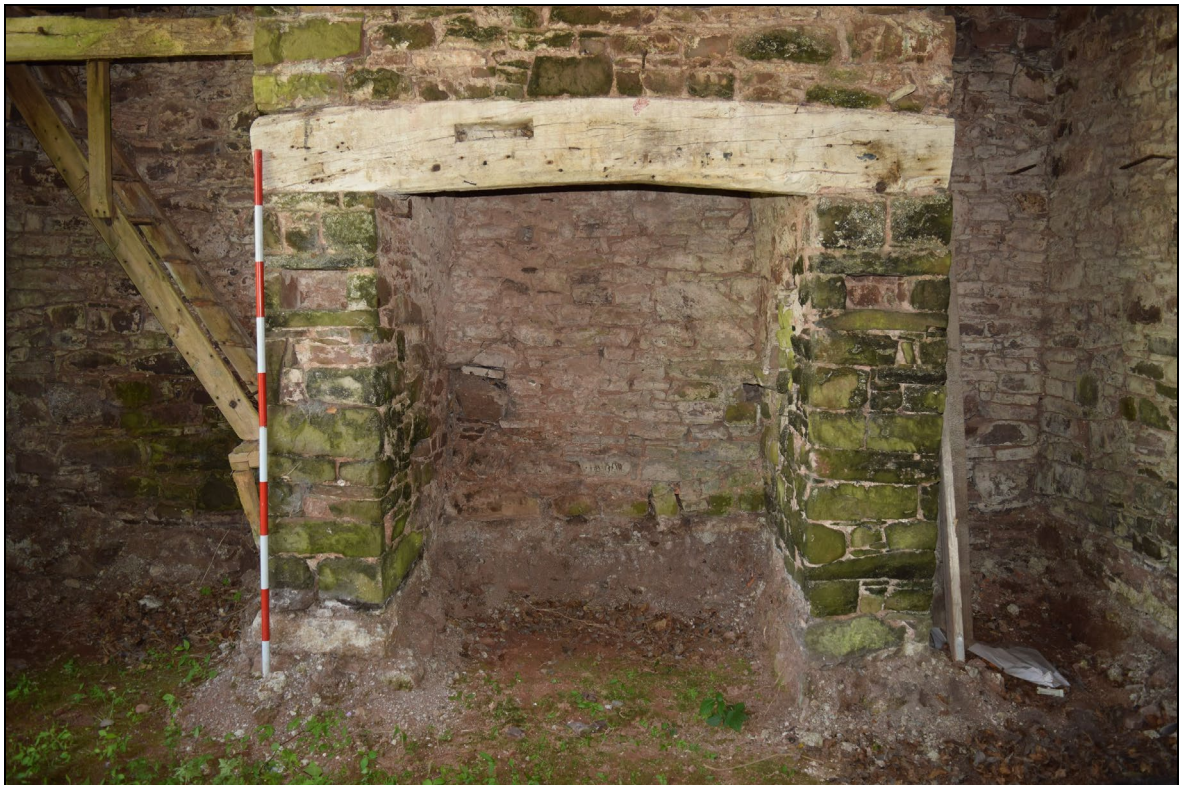
Plate 18: YTB2022_0018. A closer view of the fireplace. Looking south-southeast.

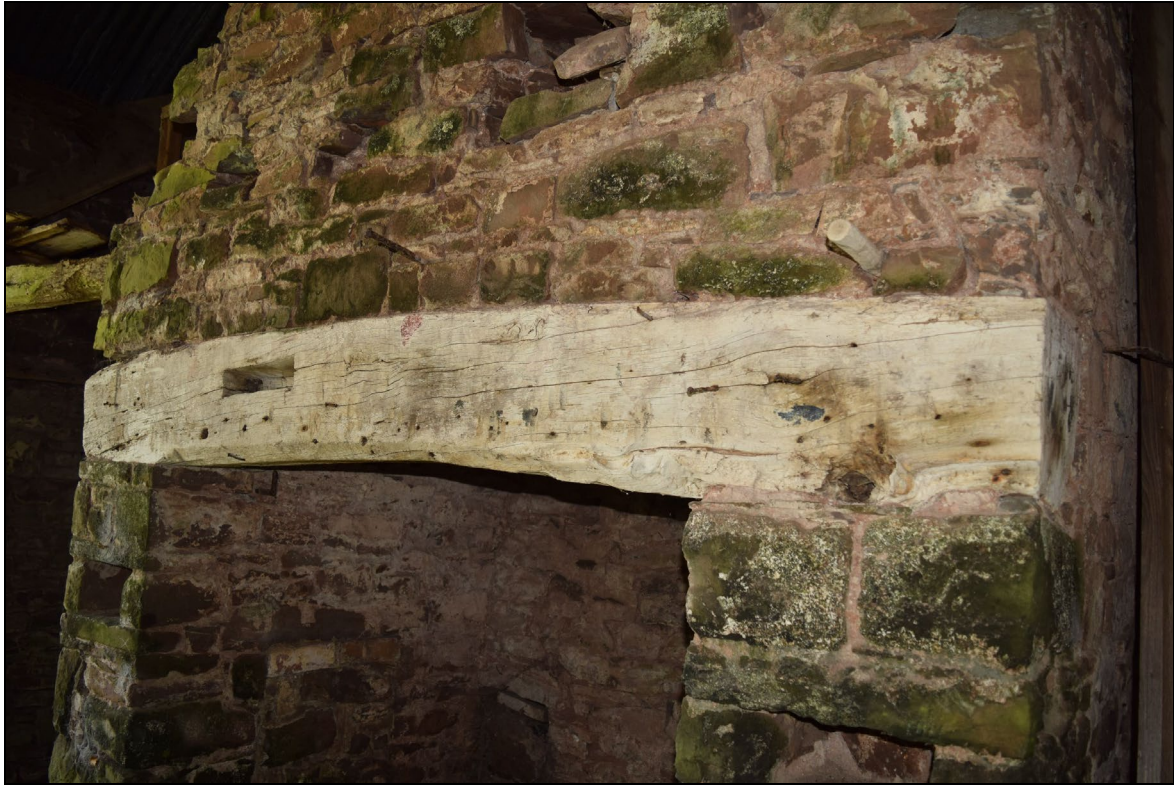
Plate 19: YTB2022_019. A view of the oak beam above the fireplace. The timber has clearly been reused from another building or an earlier iteration of the building. Looking southeast.

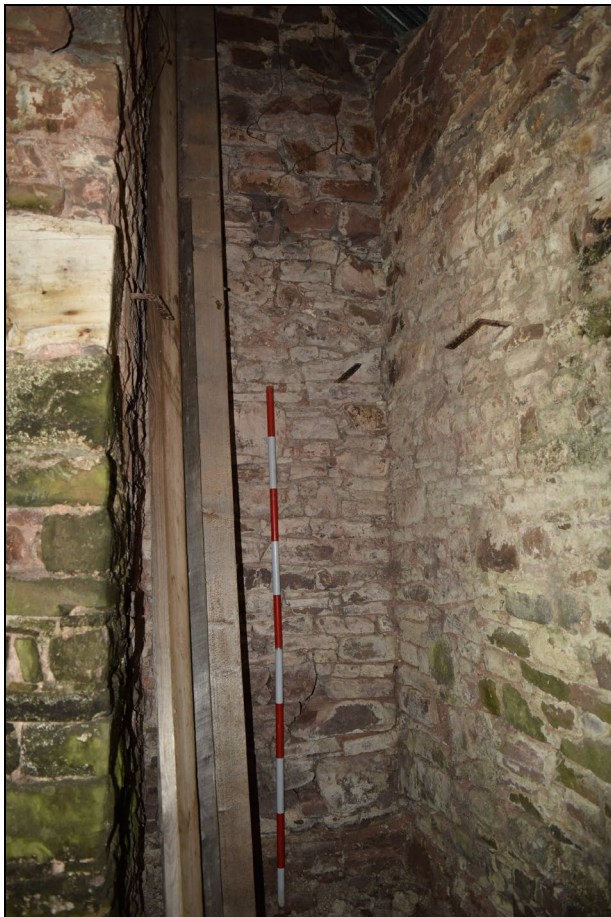
Plate 20: YTB2022_020. A view into the alcove at the southwest corner of the barn. Looking south-southeast.

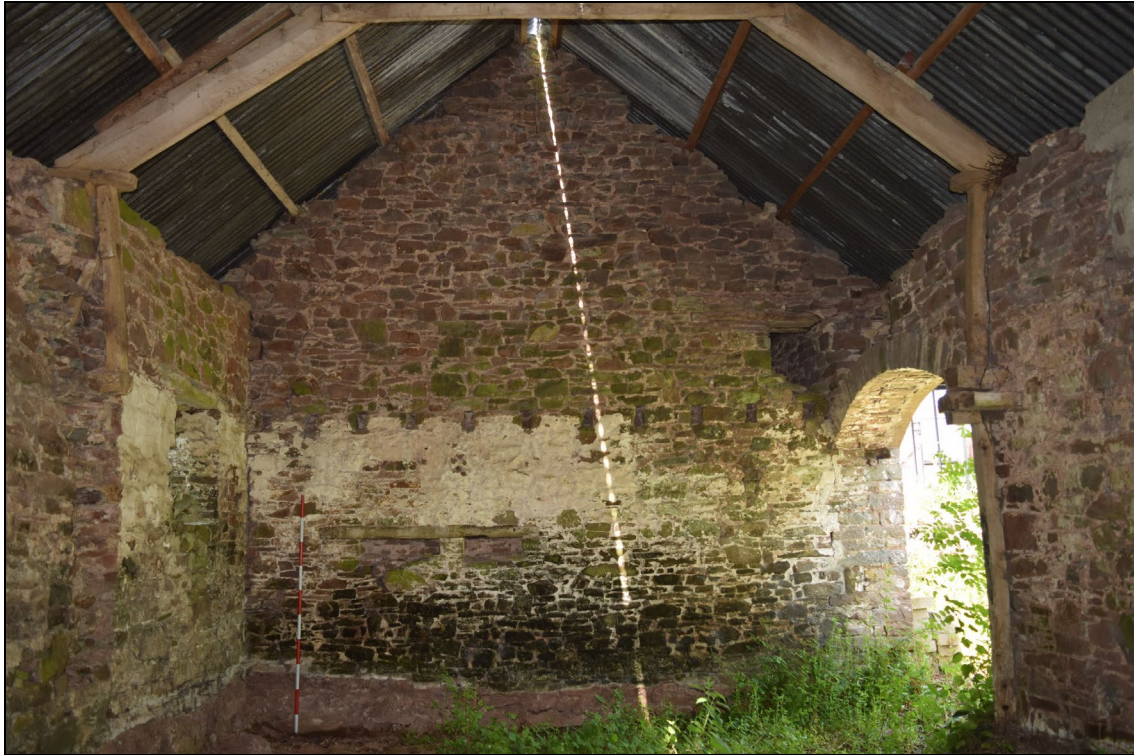
Plate 21: YTB2022_021. A view of the internal wall which divides the two parts of the building. Note the line of joist holes across the wall which is evidence there was formerly a loft inside the building. Sawn-off beams can be seen either side of the building. Looking north-northwest.

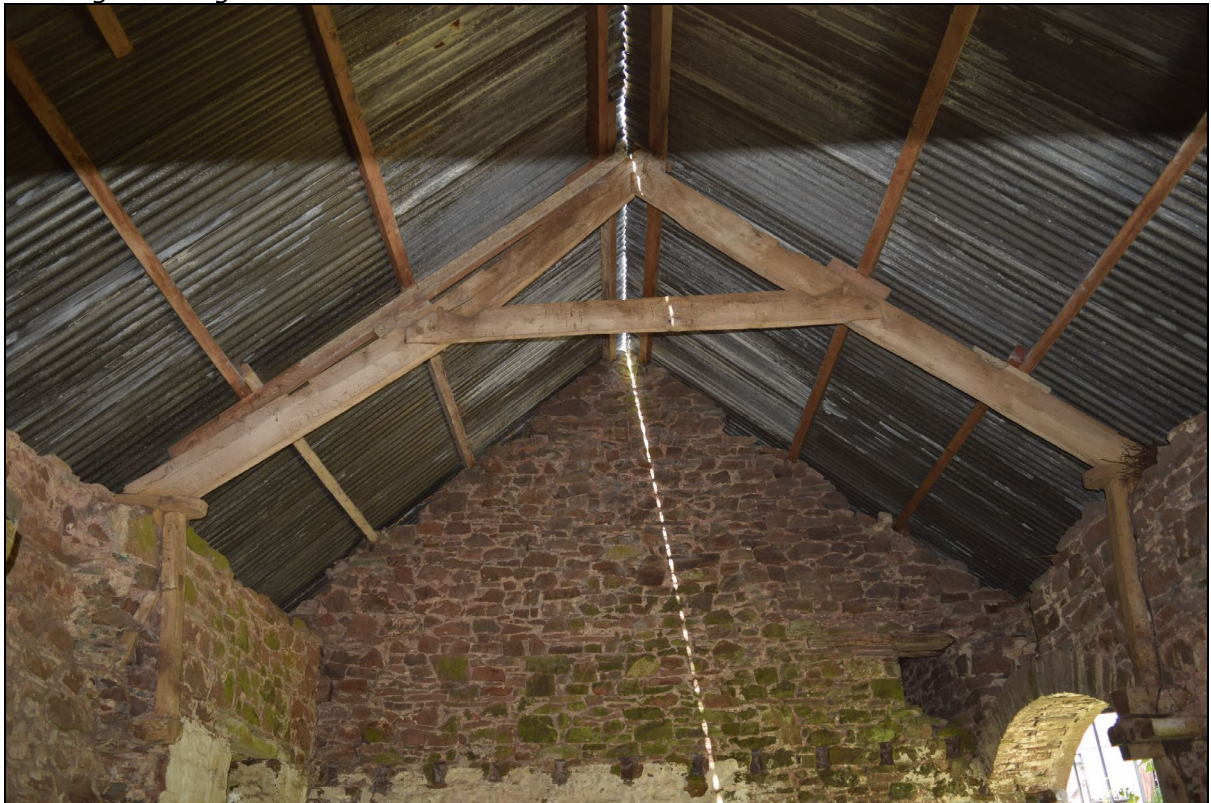
Plate 22: YTB2022_022. A view of the internal wall which divides the parts of the inside the building, showing a simple A-frame oak roof truss which is wooden pegged and rests on wooden pads at wallplate level at either side. Looking north-northwest.

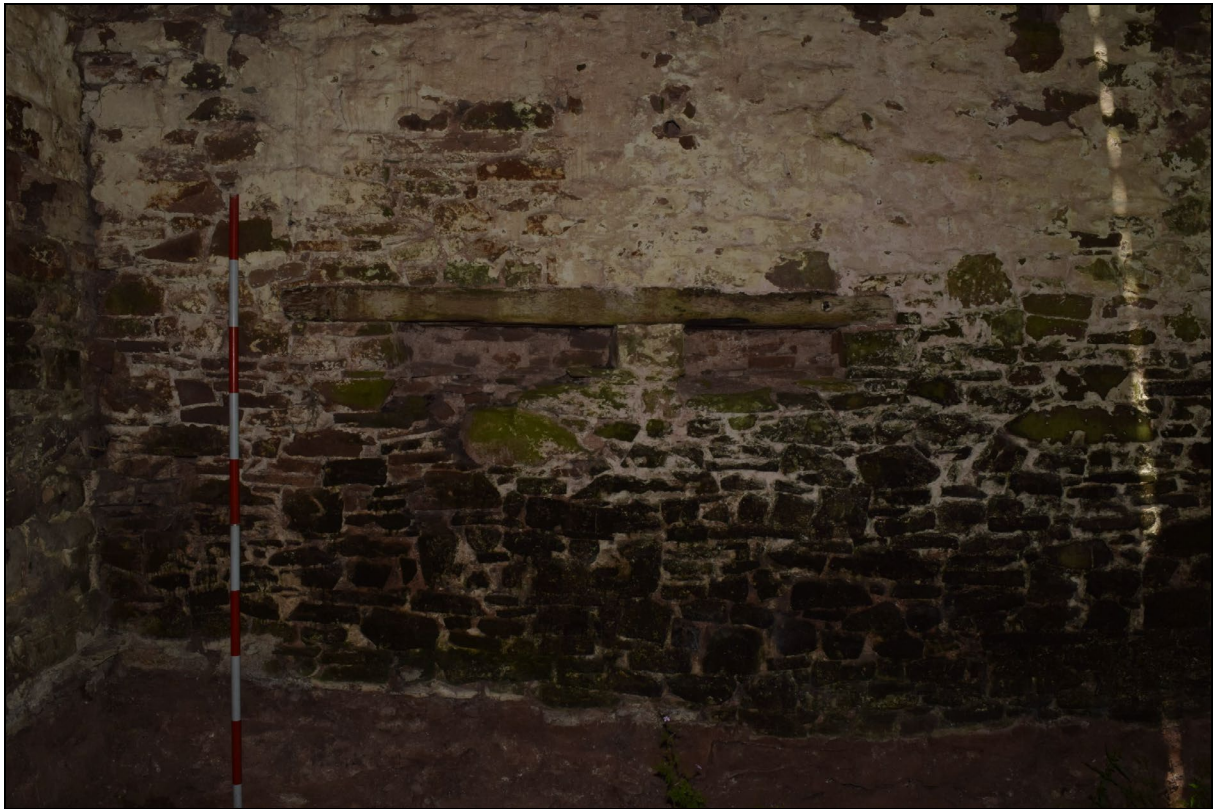
Plate 23: YTB2022_023. A view of niches built into the internal wall inside the southern part of the building, beneath a wooden lintel. Looking north-northwest.

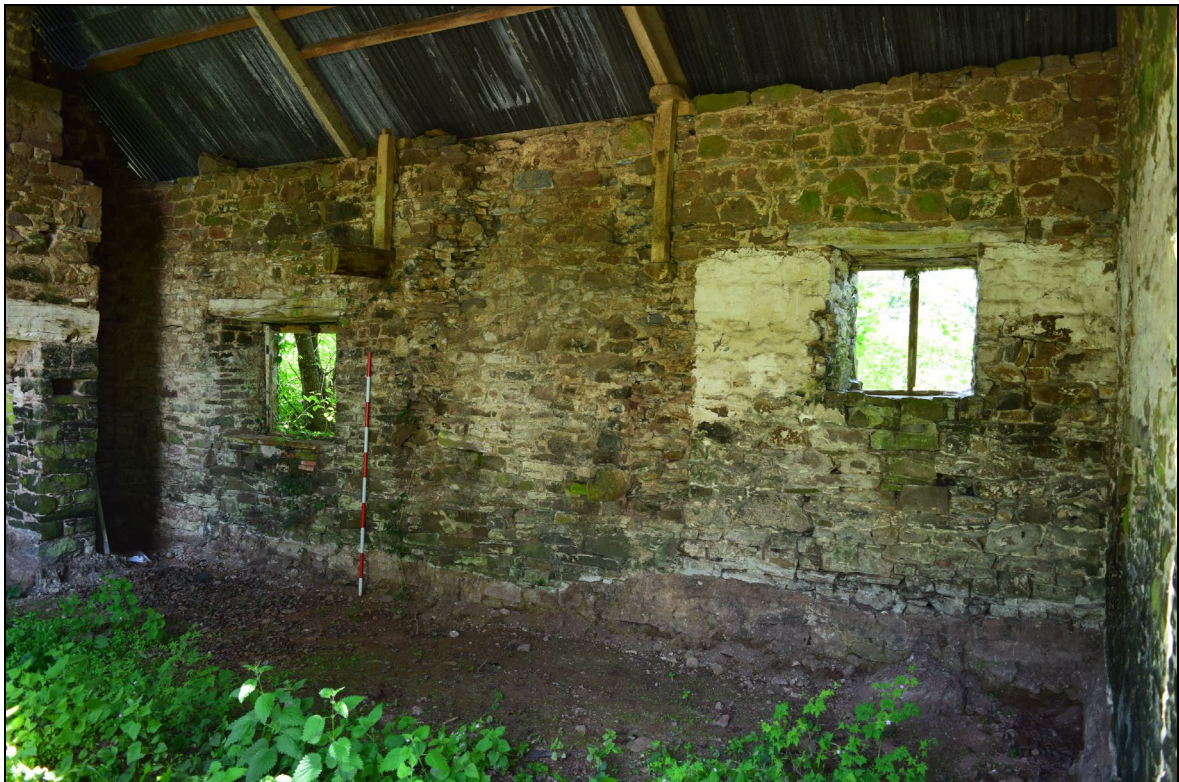
Plate 24: YTB2022_024. A view of the western lateral wall inside the southern end of the building, showing two splayed windows. At the centre is the scar of a former chimney which originally located against this wall. Note the floor has been removed in the past. Looking southwest.

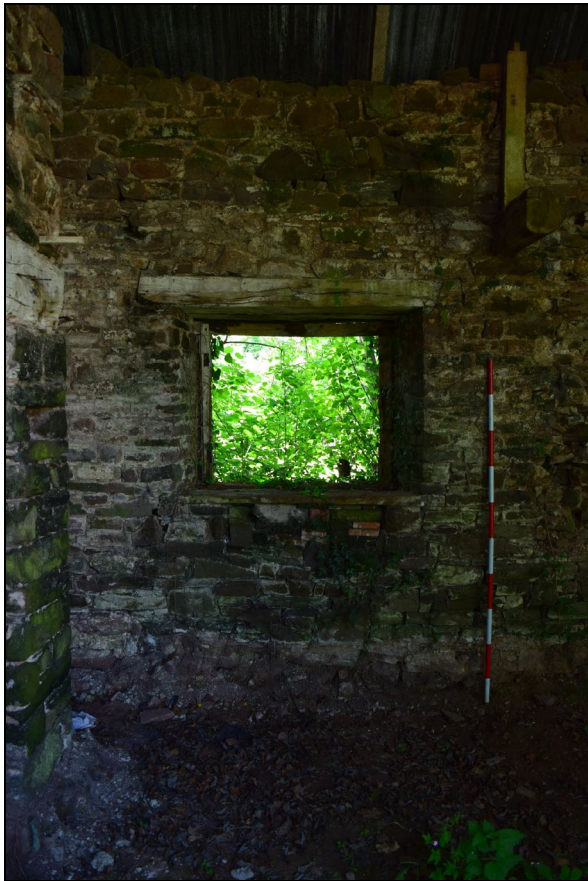
Plate 25: YTB2022_025. A view of the southern window through the western lateral wall. Note the wooden lintel and the sawn-off beam to the right. Looking west-southwest.

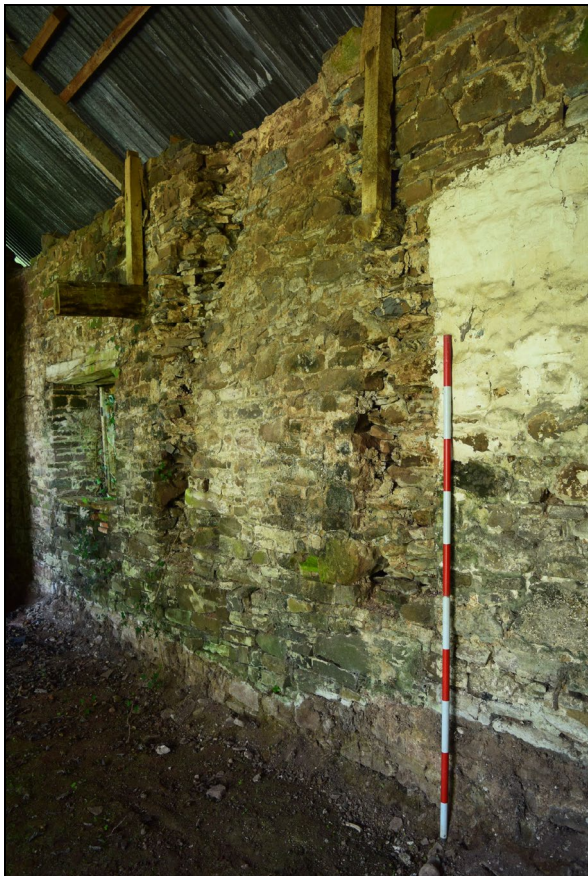
Plate 26: YTB2022_026. A view of the chimney scar against the western lateral wall. Looking south. Note that the scar starts c. 1.10 metre above the current surface. Looking south.

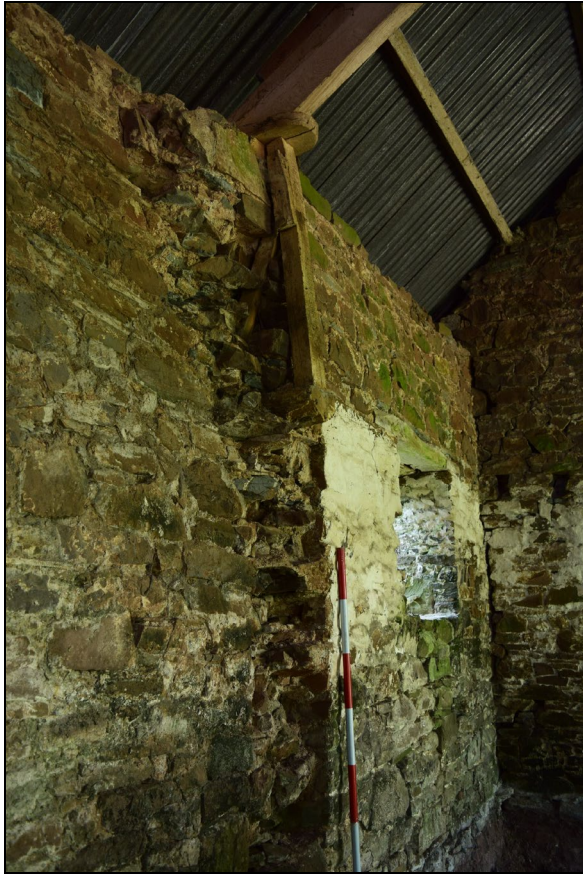
Plate 27: YTB2022_027. A view of the northern part of the chimney scar against the western lateral wall. Looking northwest. Note the supporting timber for the wall pad on which the truss rests

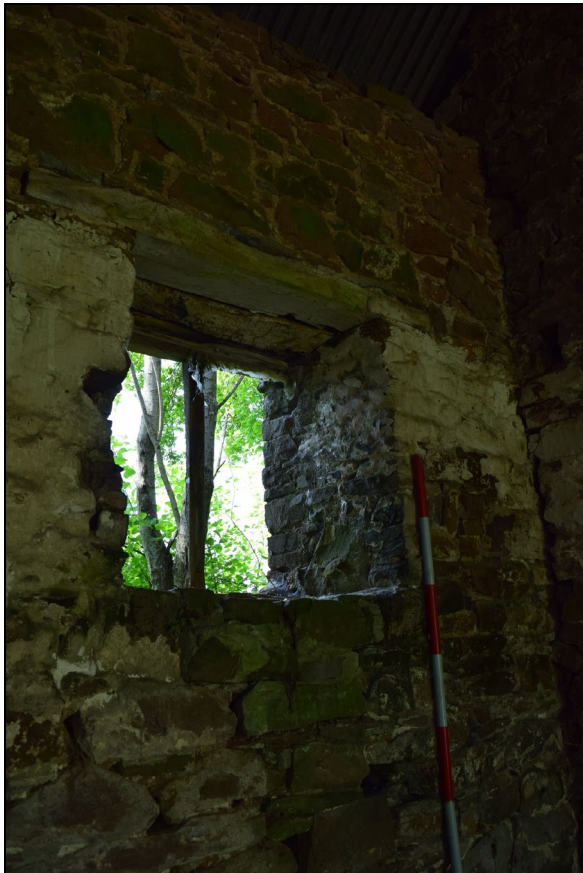
Plate 28: YTB2022_028. A view of the northern window through the western lateral wall. Looking west.

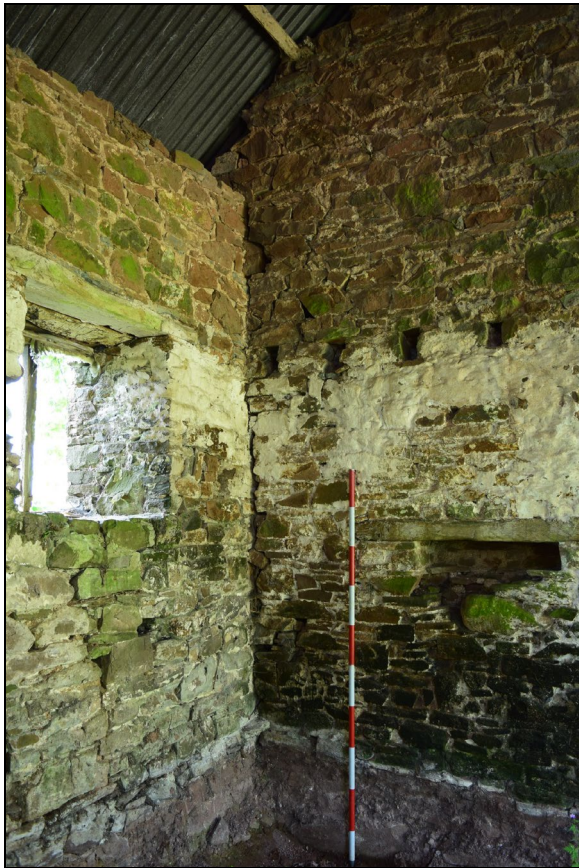
Plate 29: YTB2022_029. A view of the northwestern corner inside the southern section of the building, showing that the internal wall has been built against and over the lateral wall to the left. Looking northwest.

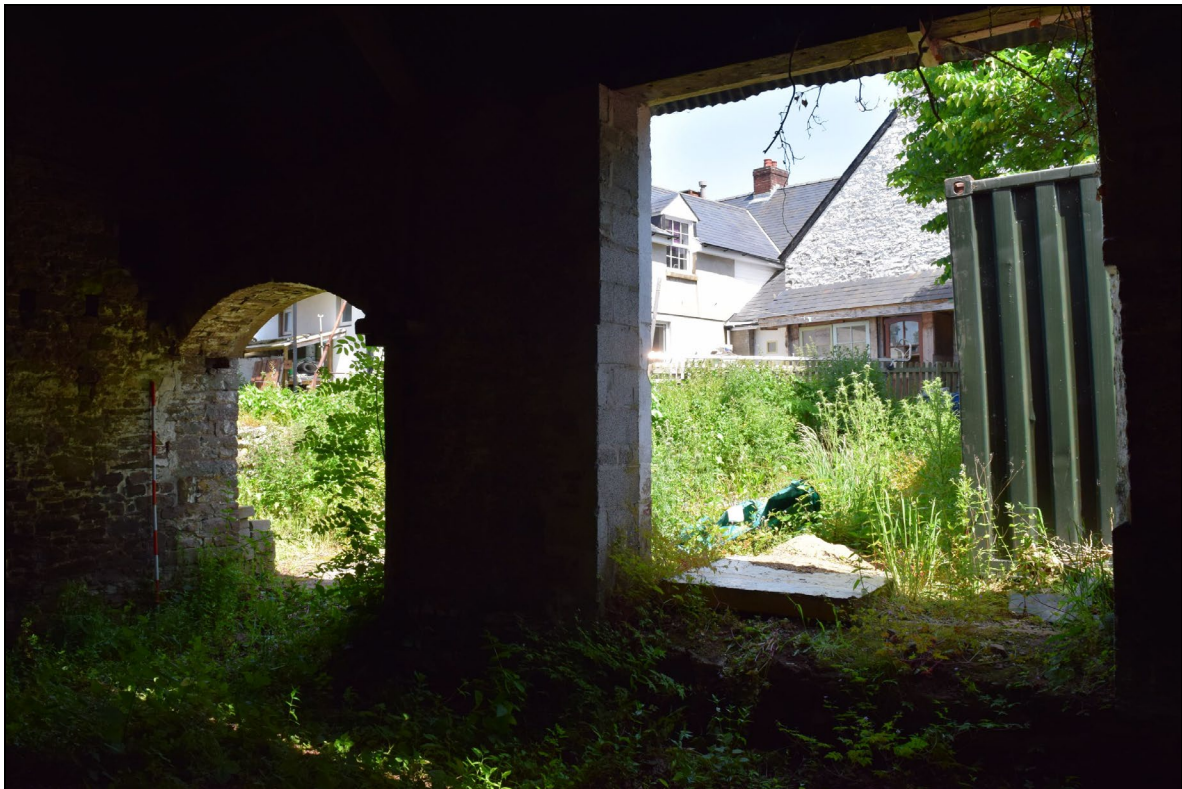
Plate 30: YTB2022_030. A view looking outwards through the large entrance doorways in the east-facing façade at the southern end of the building. Note the modern blockwork along the edge of the opening to the right. Looking northeast.

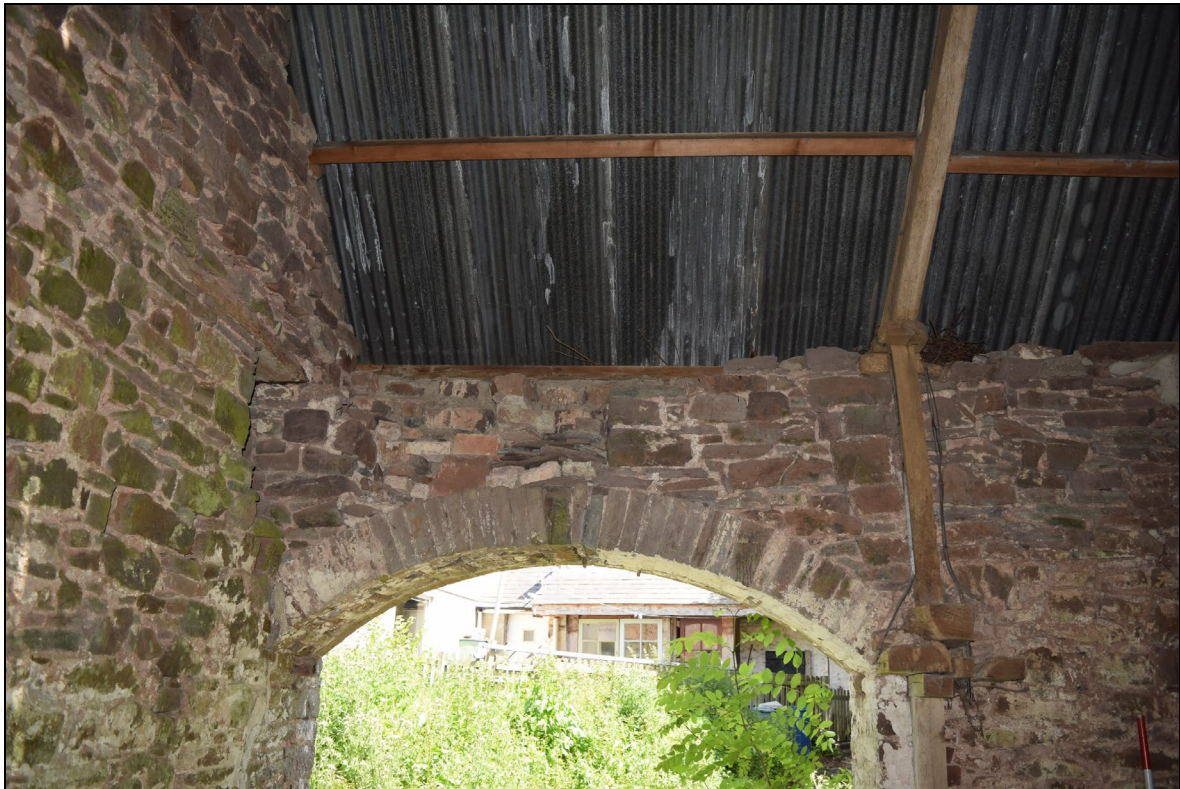
Plate 31: YTB2022_031. A view looking outwards through the arched entrance doorway in the east-facing façade at the southern end of the building. Looking east-northeast.

6.3.5 The eastern lateral wall of the southern section of the building includes an original arched cart door towards its northern end, which is 2.4 metres wide (Plates 30 & 31). A second doorway has been created through the southern end of the wall in modern times, extending from

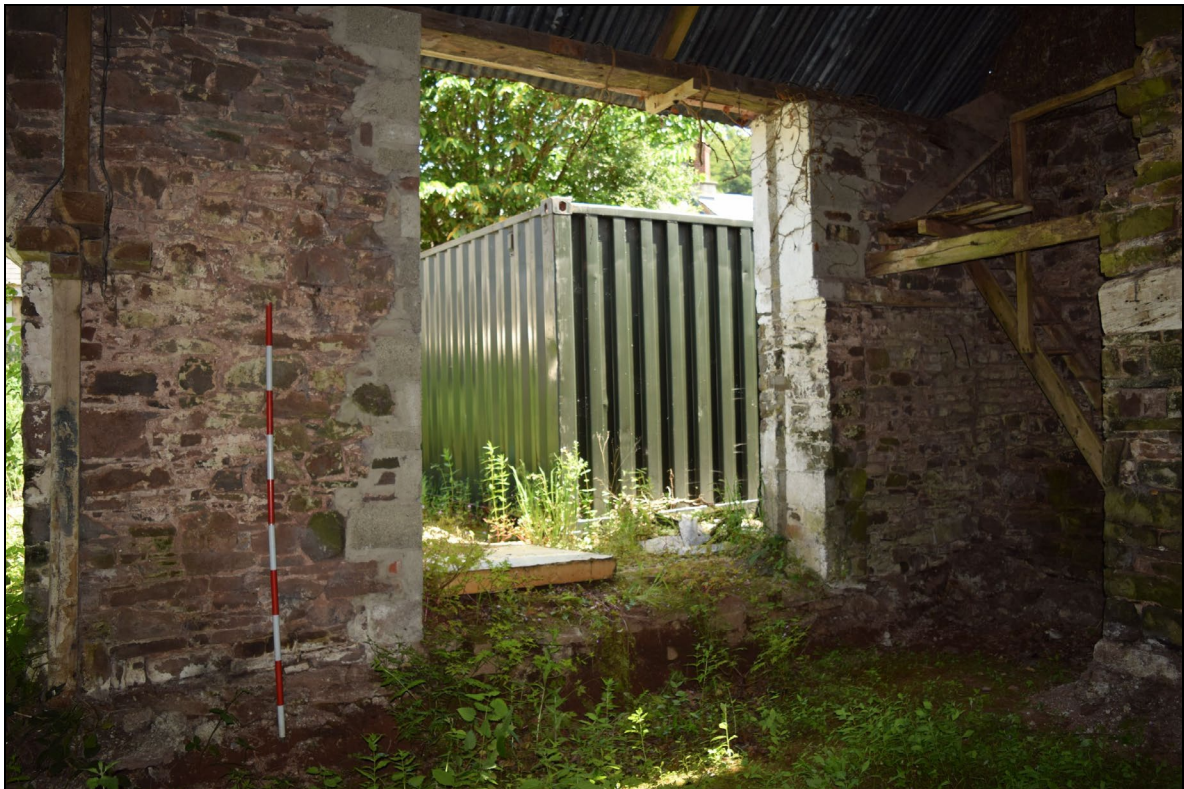
Plate 32: YTB2022_032. A view looking outwards through the large entrance doorway in the east-facing façade at the southern end of the building. Modern blockwork either side of the opening suggests there was an earlier entrance here, which has possibly been widened and heightened. Looking east.

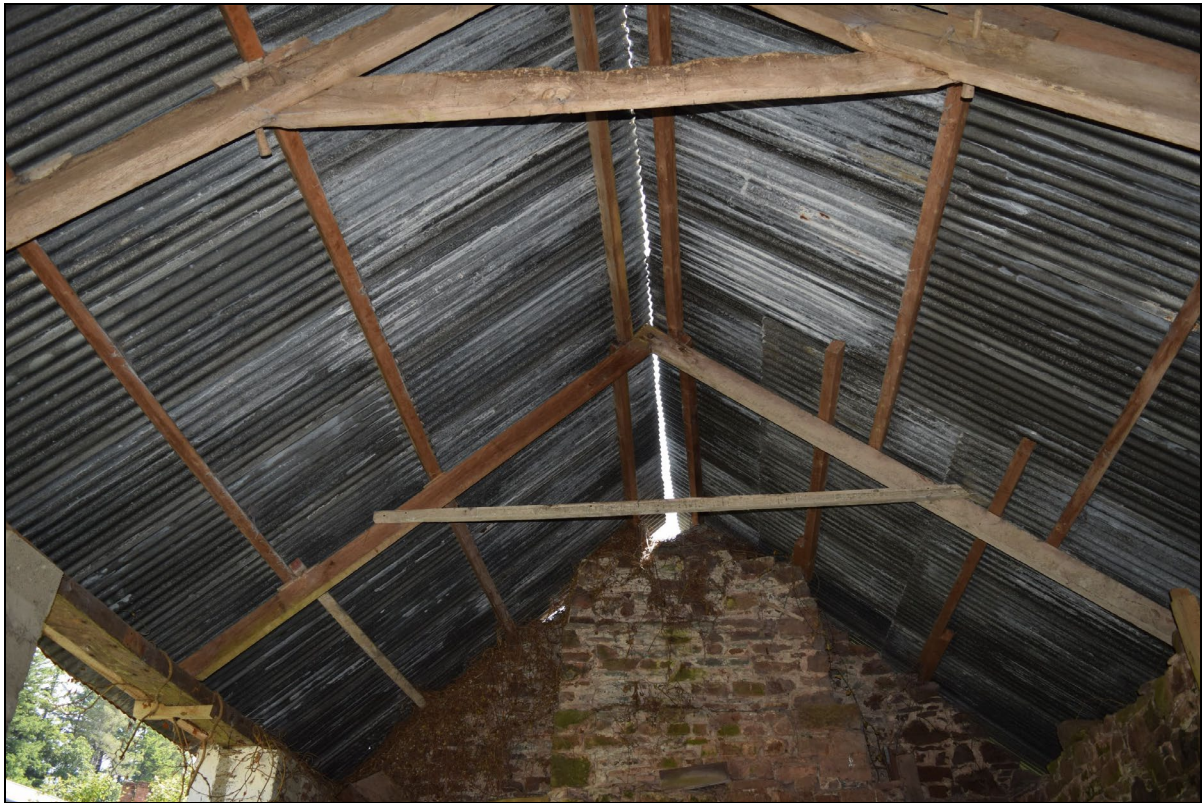
6.2.2 It is likely that the building once had a slate roof, but during the 20th century the roof was extensively repaired with new timbers added to replace the original frame and the whole roof clad with corrugated steel sheeting. It was noted that a large quantity of thick, locally derived stone roofing slates is stored in the northern section of the building and may have come from the original roof (Plate 43).

Plate 33: YTB2022_033. A view of the roof inside the southern part of the building, showing a modern A-frame truss. Looking south-southeast.

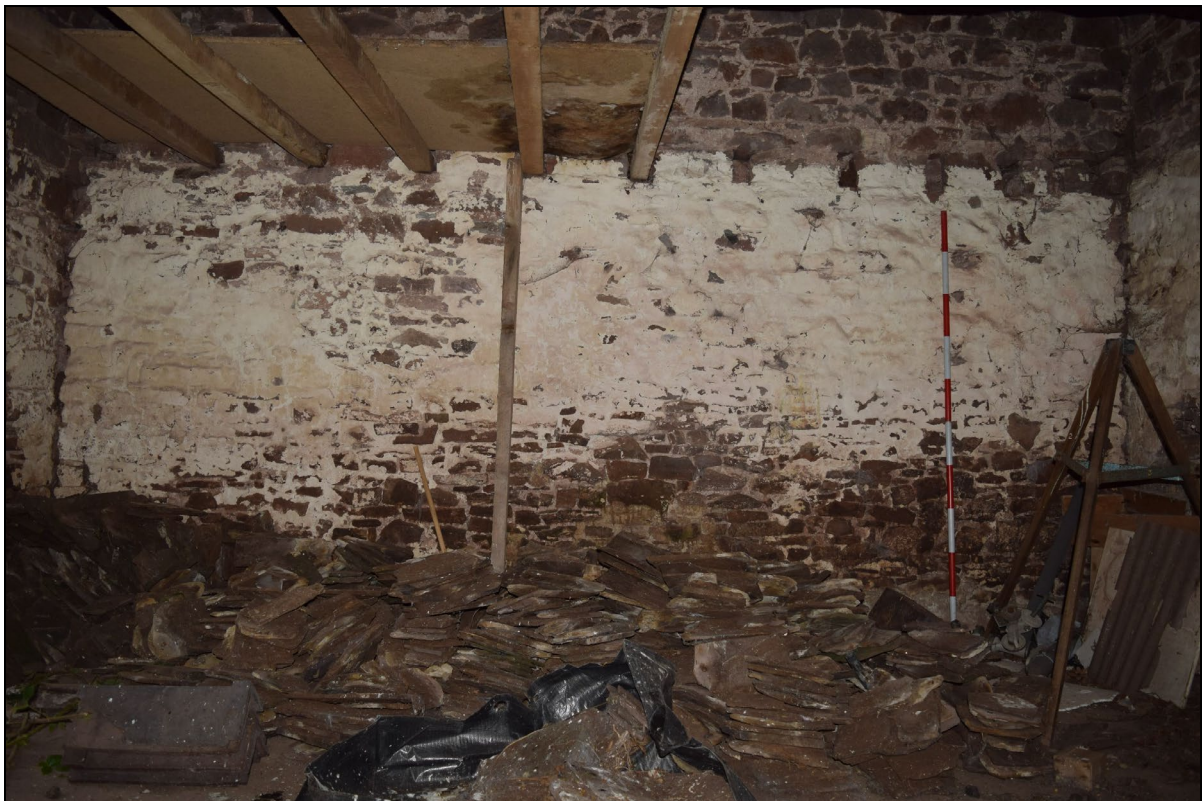
Plate 34: YTB2022_034. A view of the lower part of the internal wall dividing the two sections of the building, viewed from inside the northern section. Looking south-southeast.

6.4.1 The southern wall of the northern section is the stone partition wall which separates it from the southern section (Plates 34 & 35). It includes the joist holes for the loft and the narrow opening at loft level which gave access to the now lost loft in the southern section but has no other features.

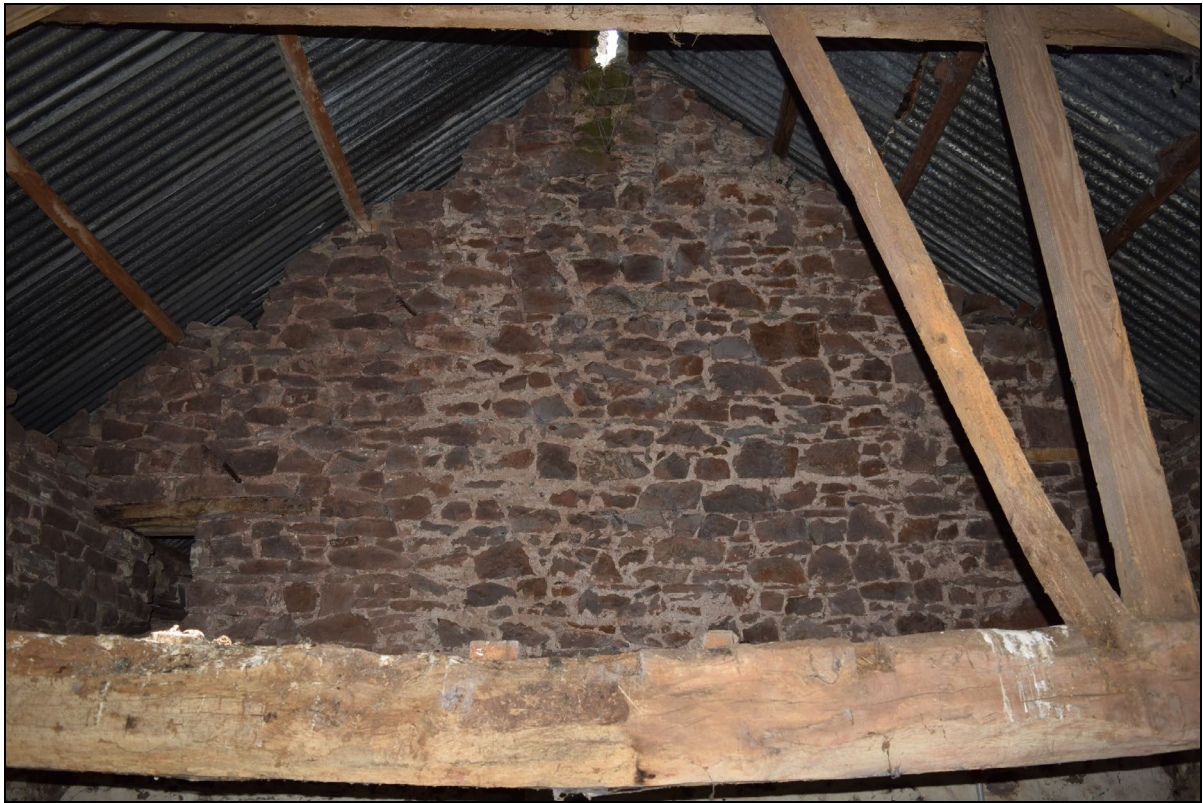
Plate 35: YTB2022_035. A view of the upper part of the internal wall dividing the two sections of the building, viewed from inside the northern section. Looking south-southeast.

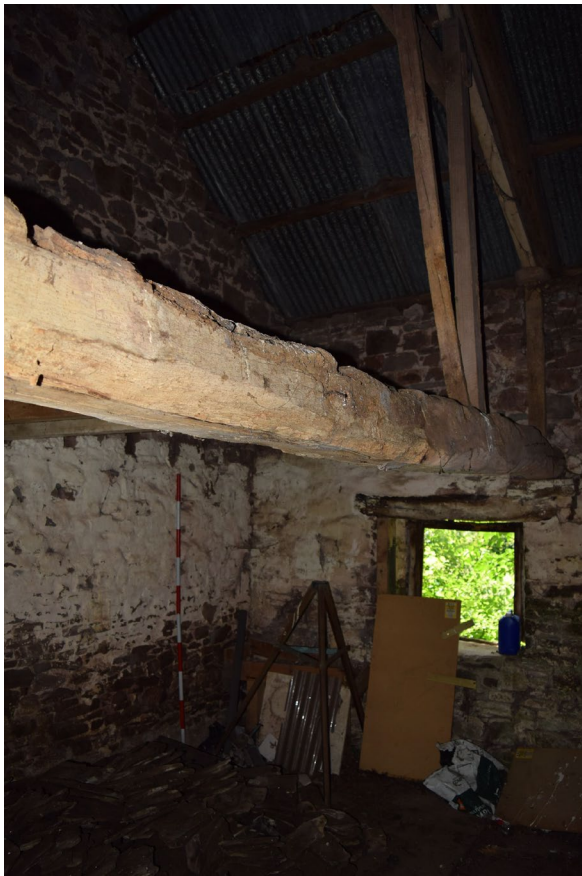
6.4 The northern section of the building is smaller. It still retains part of its loft, which extended across the southern half of the section and was supported on a heavy oak beam. Some machine sawn joists remain in place, with some chipboard flooring also surviving, indicating that modern repairs had been made to the loft (Plates 34 to 38 & 41).

Plate 36: YTB2022_036. A view inside the northern section of the building, showing a heavy oak beam which supported a loft across the southern side of the room. The window through the western lateral wall is also seen. Looking southwest.

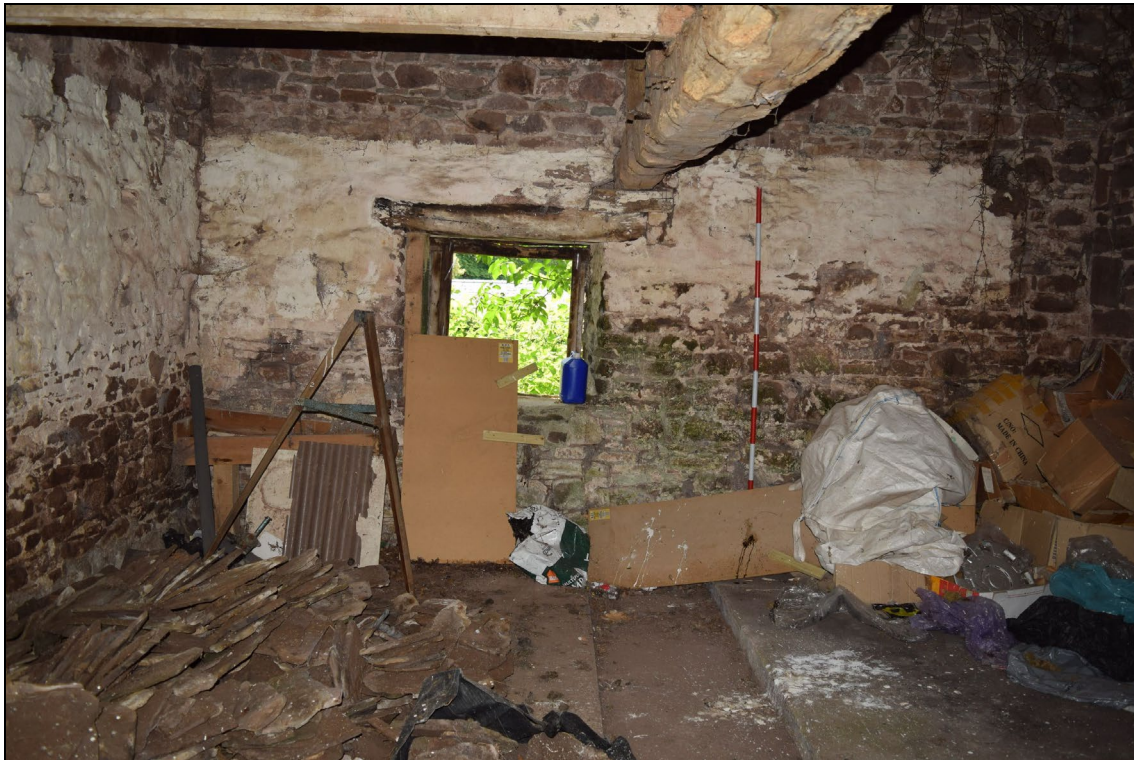
Plate 37: YTB2022_037. A view inside the northern section of the building, showing the window through the western lateral wall. The beam and a joist of the loft can be seen at the top of the image. Note the 20th century concrete floor with a sunken walkway through its centre. Looking west-southwest.

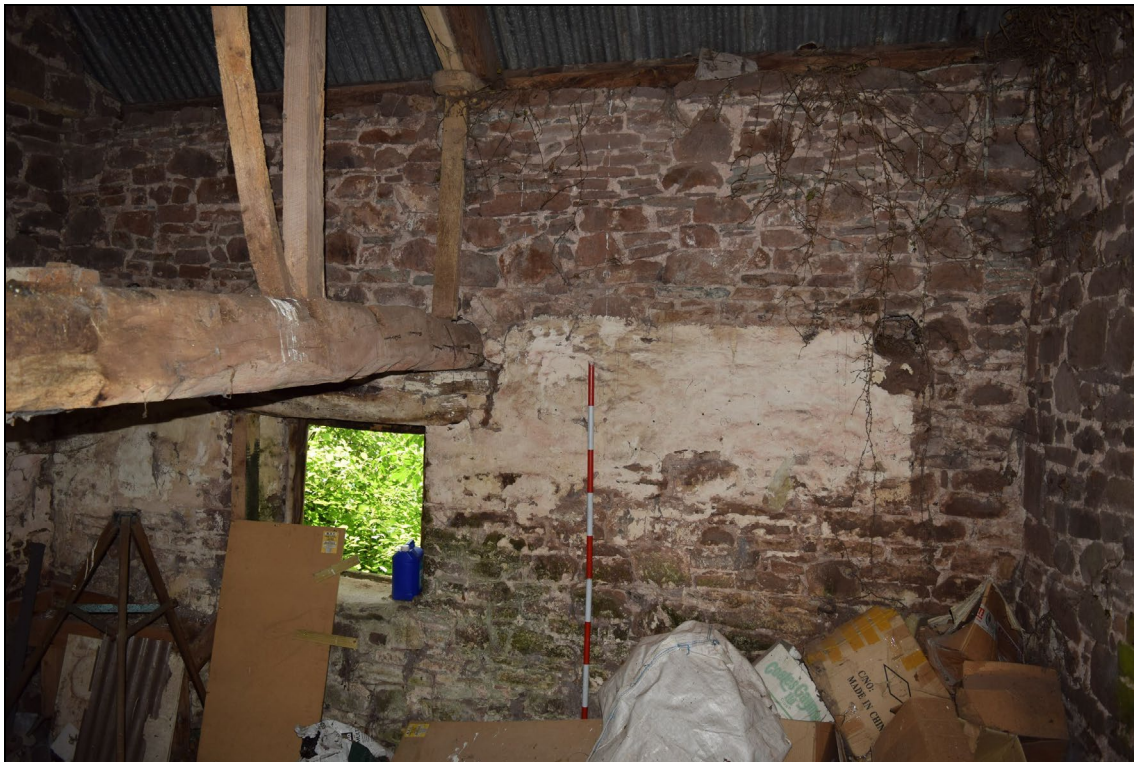
Plate 38: YTB2022_038. A view of the western lateral wall at the northern end of the building showing the heavy beam supporting the loft floor resting on the wooden lintel of the window. Note a sawn-off beam to the right, evidence of a beam which formerly supported the loft floor. Looking southwest.

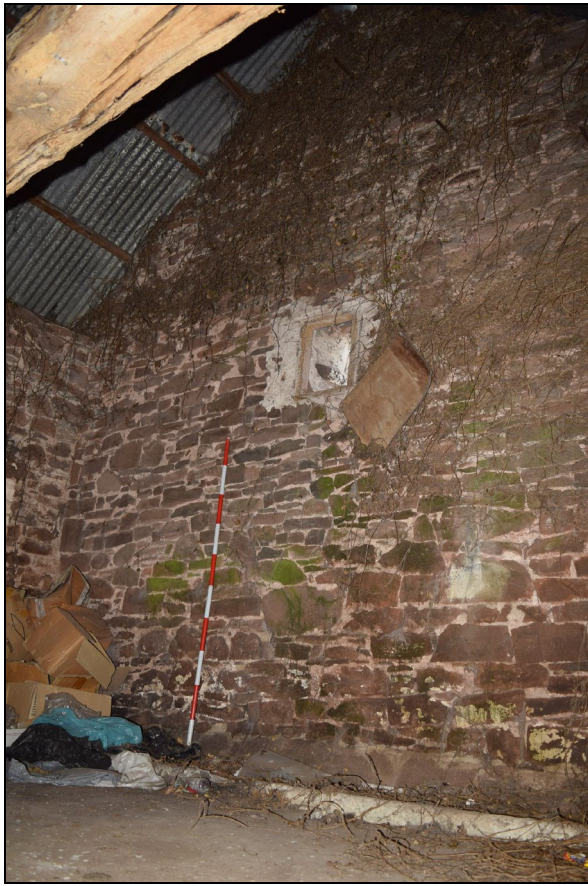
6.4.3 The northern side of this section is the north gable wall of the building. It has a small window at the centre of the wall, which appears to have been reduced or repaired at some point. A modern concrete feeding trough runs along the base of this wall.

Plate 39: YTB2022_039. A view inside the northern gable wall of the building. Note the concrete feeding trough at the base of the wall. The central window appears to have been repaired or modified, or may in fact be a more modern insert. Looking northwest.

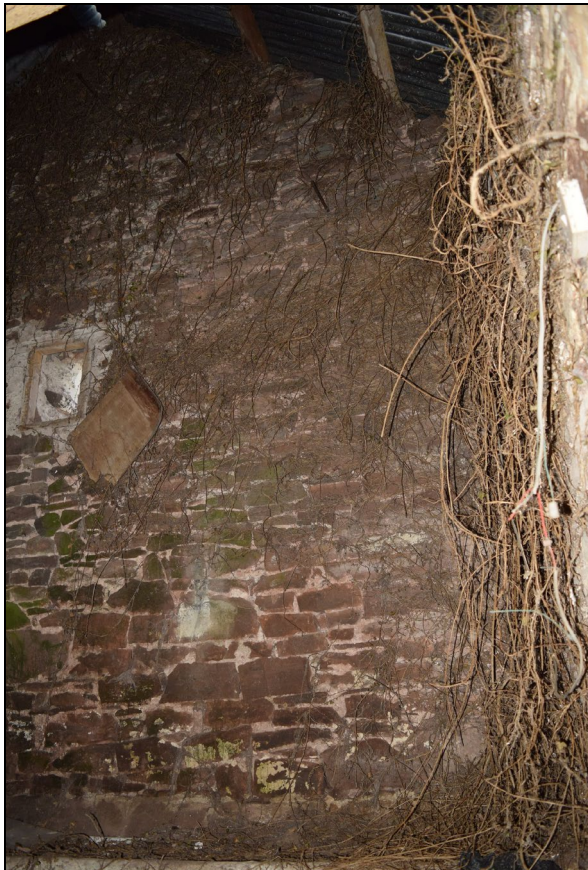
Plate 40: YTB2022_040. A view of the inside of the northern gable wall. Looking north-northwest.

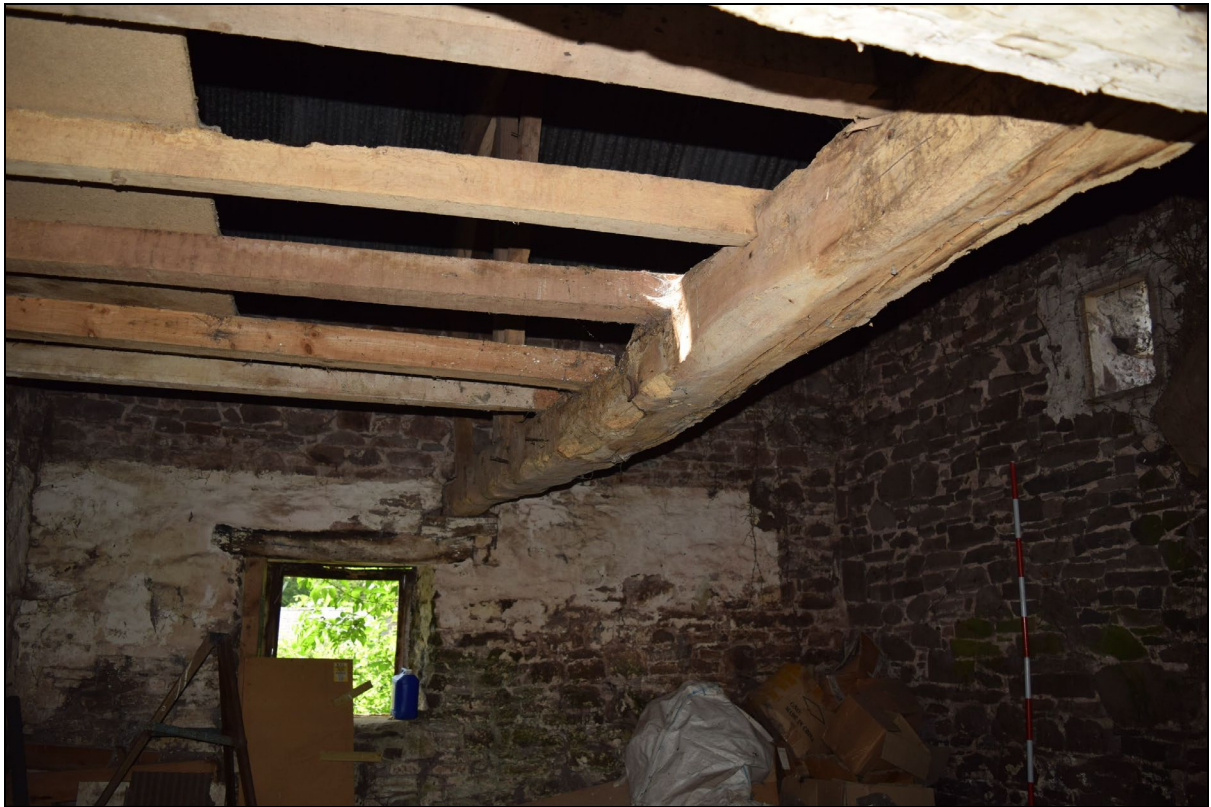
Plate 41: YTB2022_041. A view of the inside of the northern section of the building. Looking west.

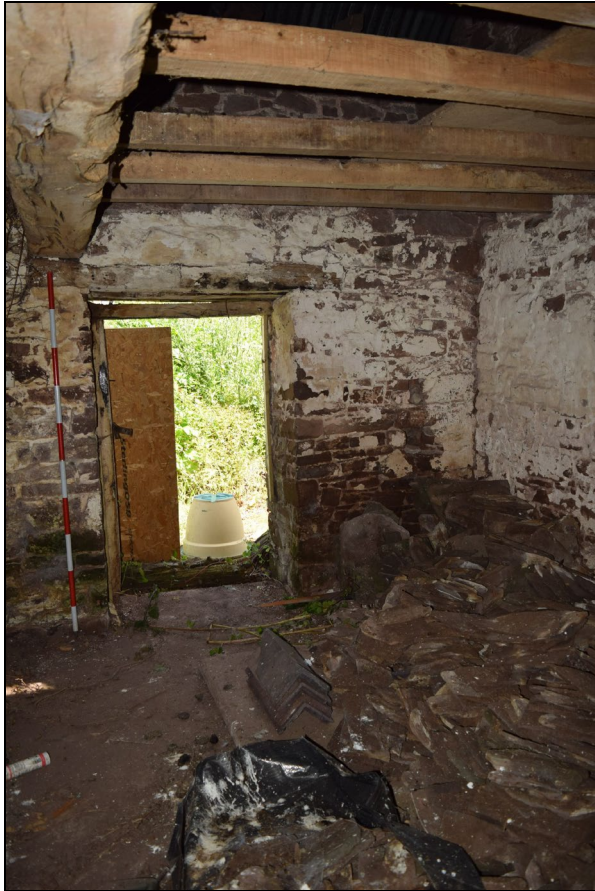
Plate 43: YTB2022_043. A view towards the eastern lateral wall at the northern end of the building, showing the doorway. Looking east-northeast.

This wall also has the doorway leading into the northern section (Plate 43).

YTB2022_043	A view towards the eastern lateral wall at the northern end of the building, showing the doorway.	East	17/06/2022
YTB2022_044	A view towards the eastern lateral wall at the northern end of the building, showing the wall above the doorway.	East-northeast.	17/06/2022

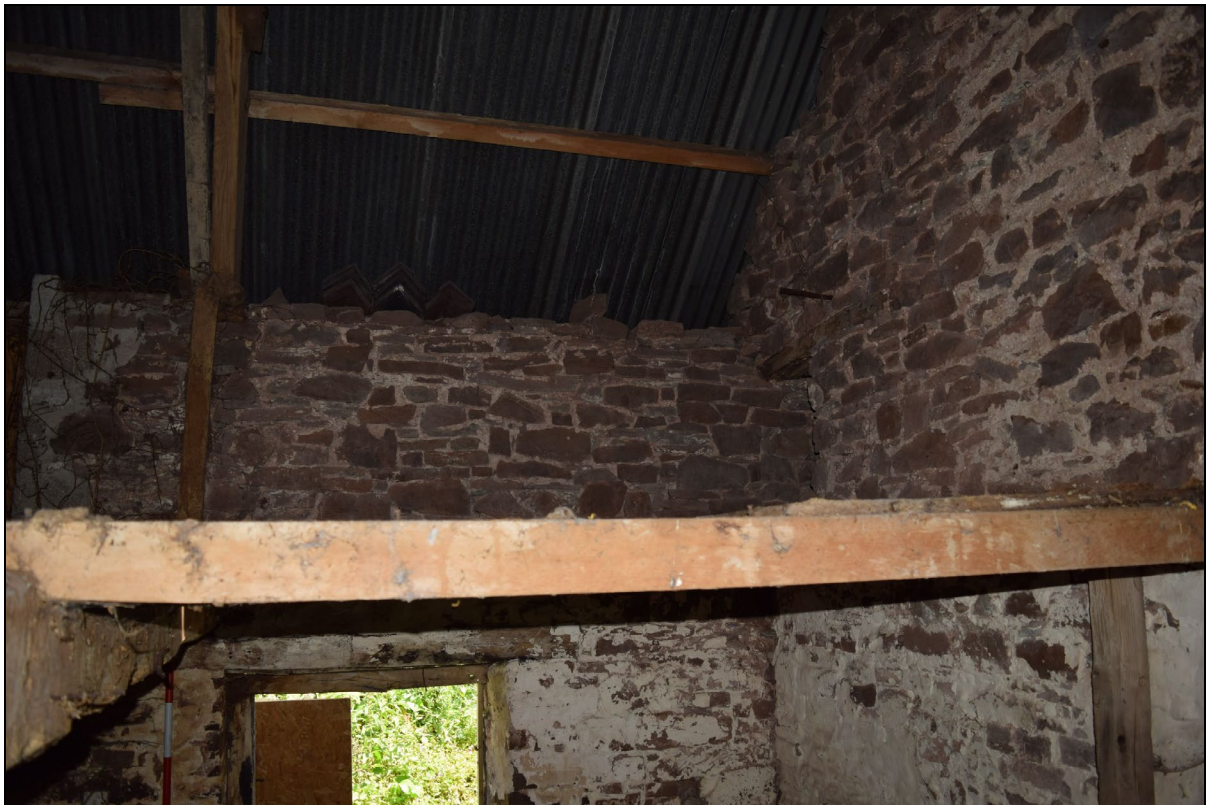
Plate 44: YTB2022_044. A view towards the eastern lateral wall at the northern end of the building, showing the wall above the doorway. Looking east-northeast.
