**LEVEL 2 BUILDING RECORDING AT
YEWTREE BARN,
DEFYNNOG, POWYS
PLANNING APPLICATION
21/19619/FUL (BBNPA)**

September 2022

Trysor Project No. 2022/841
CPAT HER EVENT PRN : 167122

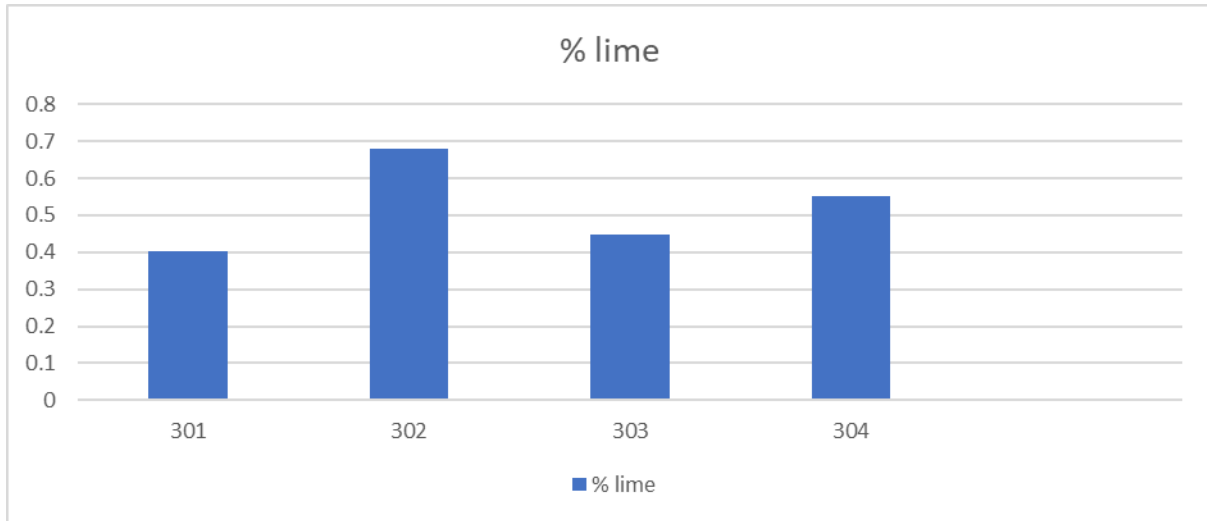
Percentage of lime

A single aliquot (subsample) from each sample was dried and crushed and analysed by the acid digestion method (dissolved in dilute hydrochloric acid) as recommended by Cadw (2004, 2); the residue was filtered and dried by gentle heating, and weighed. Overall composition of the mortar was calculated from the aggregate and soluble (Calcium Chloride) components.
