Heritage Impact Assessment, Kingscombe, Llanmihangel Road, Llanblethian, Cowbridge, CF71 7JA

Report by: Trysor

August 2021

Trysor Project No. 2021/795
HER Event Record PRN – GGAT E006710

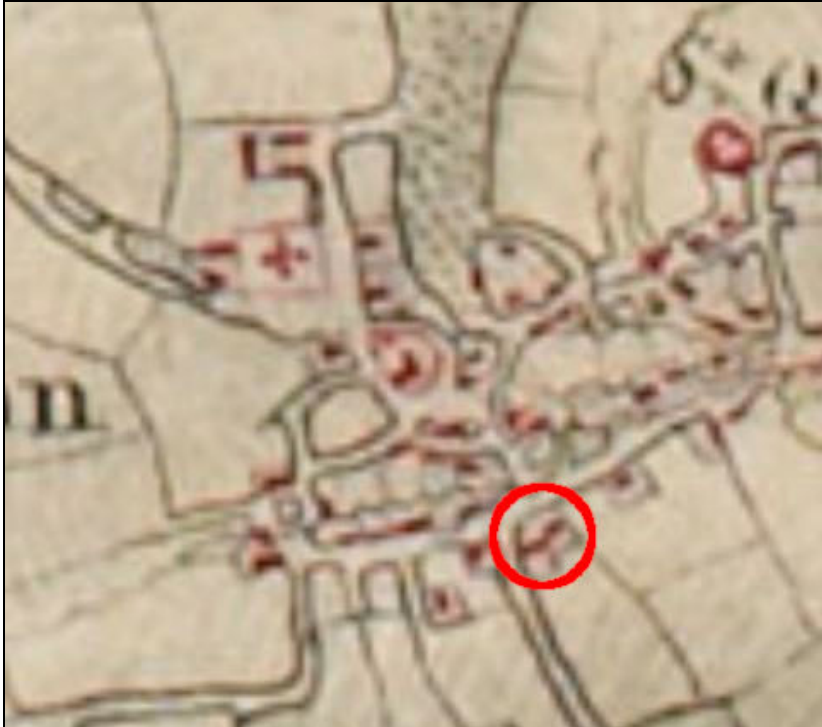
Figure 4: The 1813 Ordnance Survey Original Surveyors Drawings map (Bridgend Sheet 178) clearly shows buildings at Kingscombe.

4.1.4 The Ordnance Survey’s Original Surveyors Drawing of 1813 (Figure 4) is the first map to show a large building at the site of Kingscombe, and it seems likely that it represent the house, though the map is not detailed enough to be able to appreciate the plan or character of the house at that time. This map also shows a second building, presumably an outbuilding, to the northeast of the dwelling.

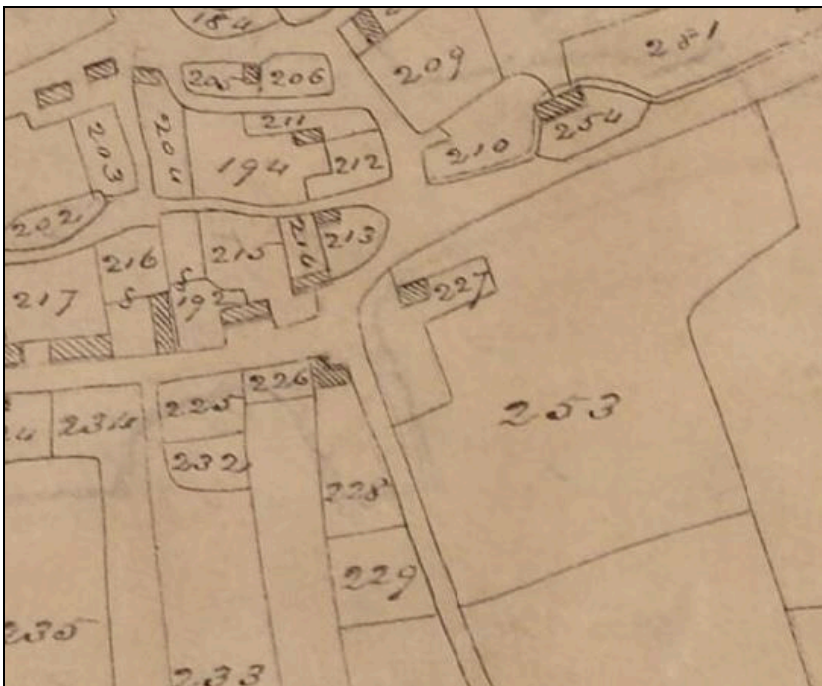
Figure 5: The 1841 Llanblethian parish tithe map shows only a single building at Kingscombe which appears smaller than the current house.

4.1.5 The 1841 Llanblethian parish tithe map (Figure 5) does not show the present house at Kingscombe. It is not known why it is absent, but the accompanying tithe apportionment records that parcel 227 included the House and Garden. The adjacent fields, parcels 252 and 253, were named as Upper Field and Lower Field and were over 7 acres in extent in total. The property was owned and occupied by one William Lewis.

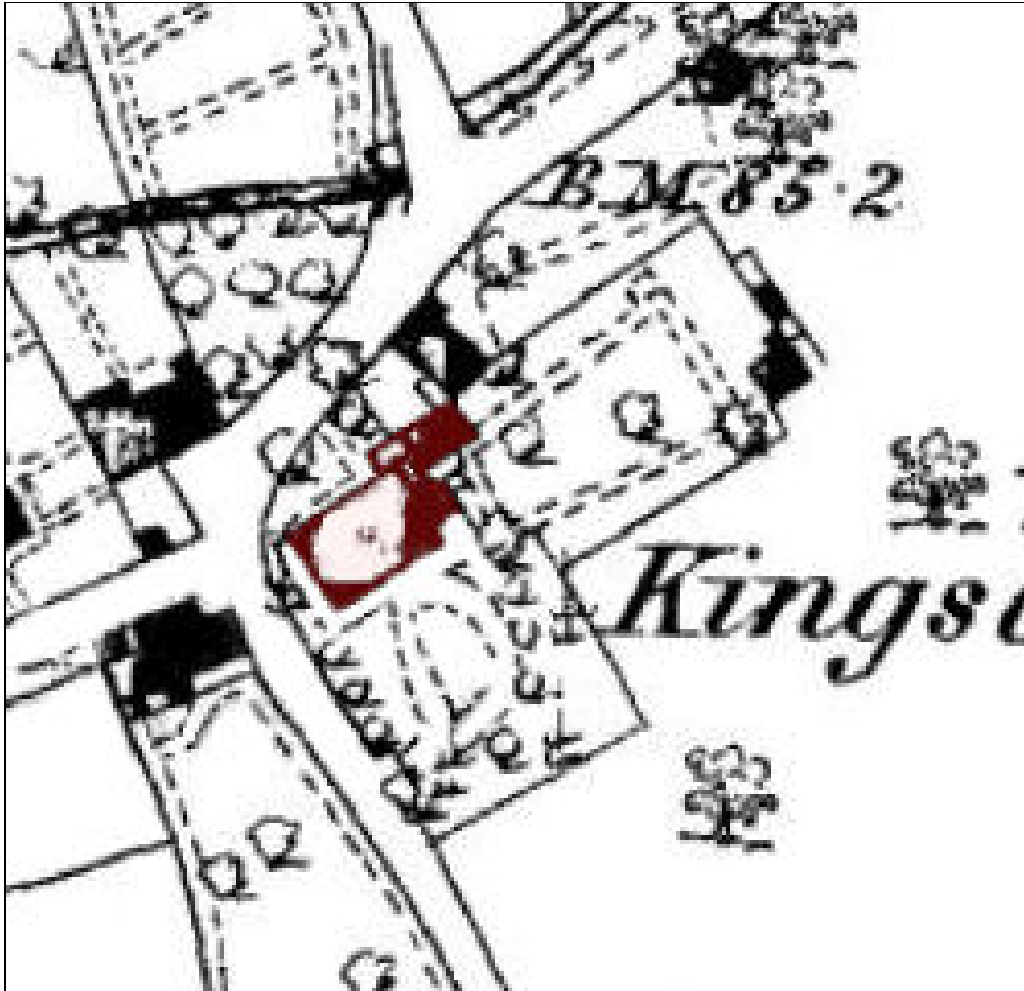
Figure 6: The 1879 Ordnance Survey map 1:2500 scale shows Kingscombe as a much larger complex. The house and attached outbuilding to the northeast are shaded red here. The outbuilding, which may have been the Granary, seems to occupy the position of the single building shown on the 1841 tithe map. This map shows that a porch or conservatory connected to the northeastern corner of the house to the adjacent outbuilding, as suggested in Figure 3 above. The outbuilding is now part of Trecregyn, as is the second outbuilding shown to its northern side on this map.

4.1.7 The first detailed map of the property is the 1877 1:2500 Scale Ordnance Survey map (Figure 6). This shows the present house in place, along with a range of outbuildings attached to its northeastern corner. The latter now form part of the adjacent property of Trecregyn. This map shows that the present entrance into the property to the south is in place, along with a carriage drive and well-organised garden area.

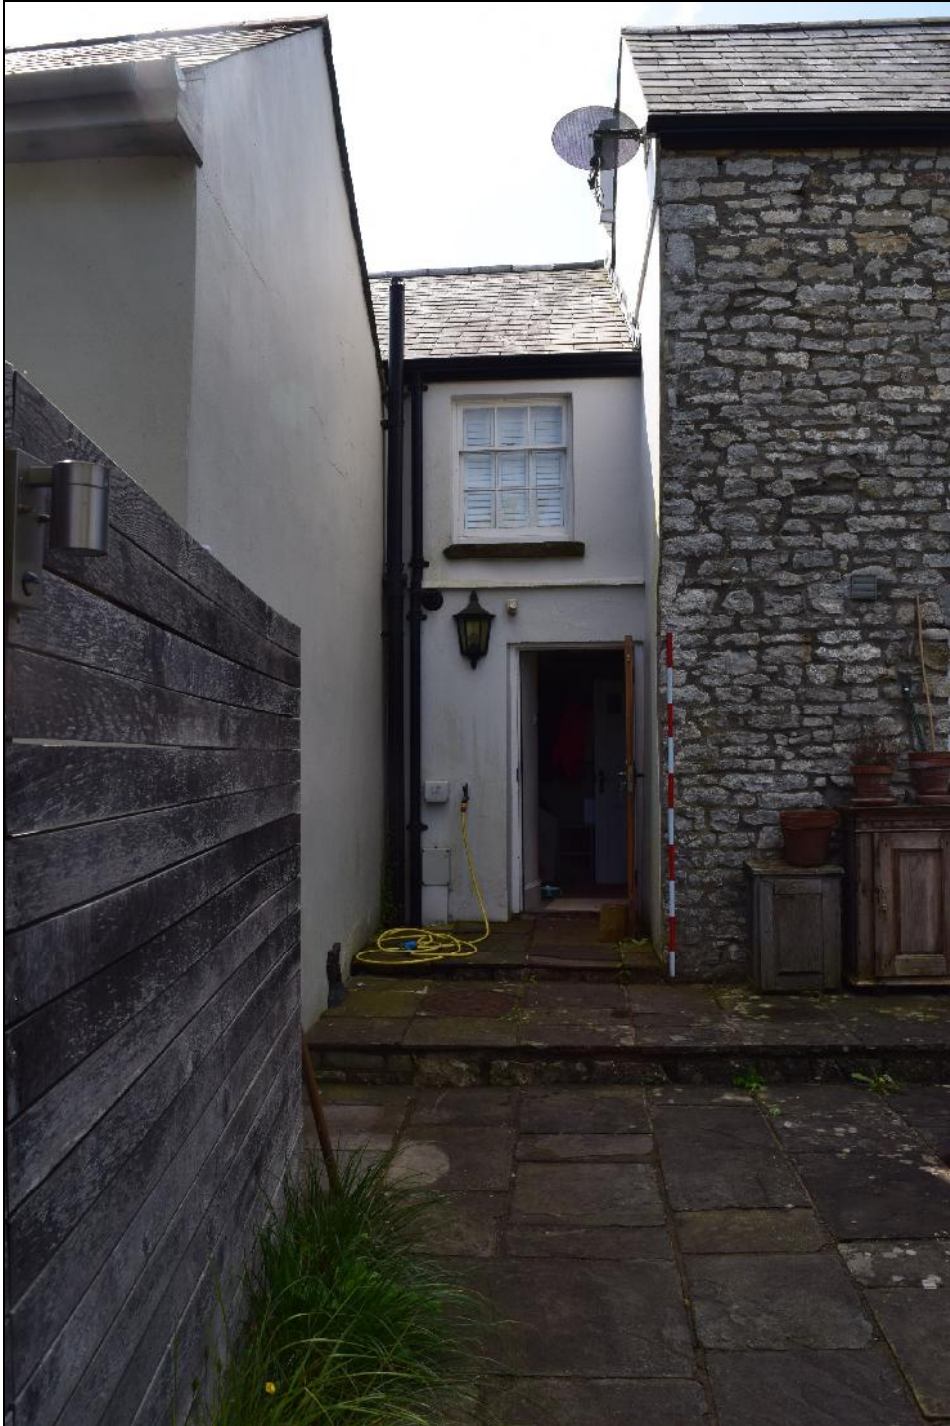
Plate 1: KCM2021_001 The rear of the property looking south-southeast where the "boot room" would be located. The corner of the main building is bare stone with no obvious quoin stones apart from towards the top of the wall where a repair has been made. The infilling structure is the modern two storey extension, although the lower wall is older and part of the range of domestic and farm buildings attached to the house. The gable of a former outbuilding is seen to the left, which has been heightened in modern times but which was originally connected to the house by a porch or conservatory which stood in the area shown here.

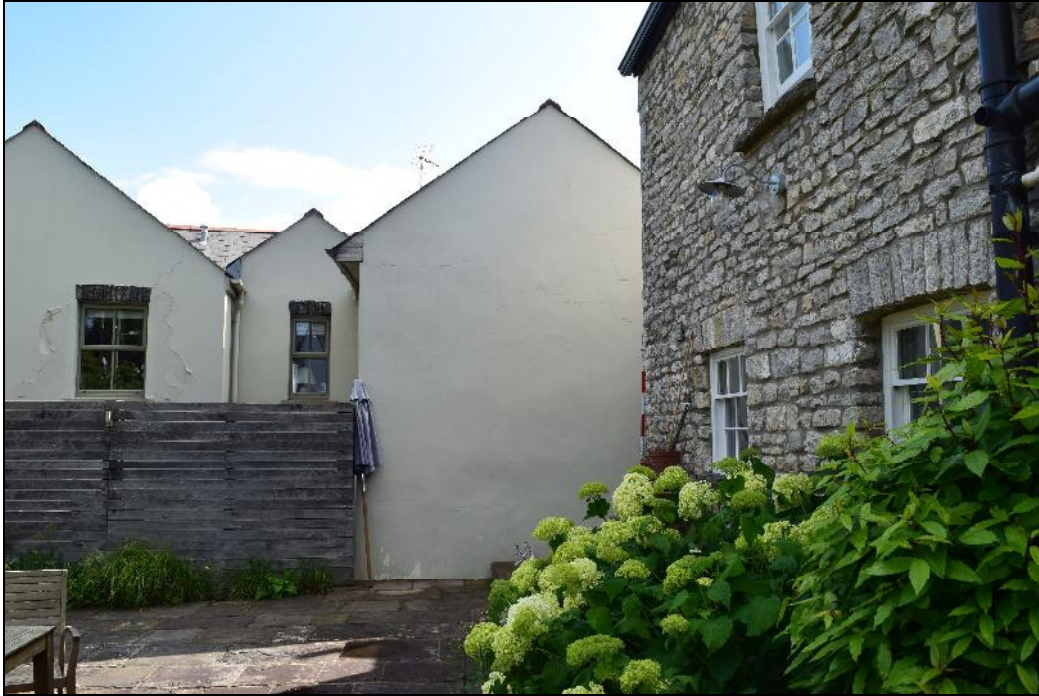
Plate 2: KCM2021_002 Looking east-northeast at the range of converted and extended former domestic/farm buildings that were attached to the northern corner of Kingscombe house. In the 19th century a conservatory or porch joined the house to the gable wall right of centre.

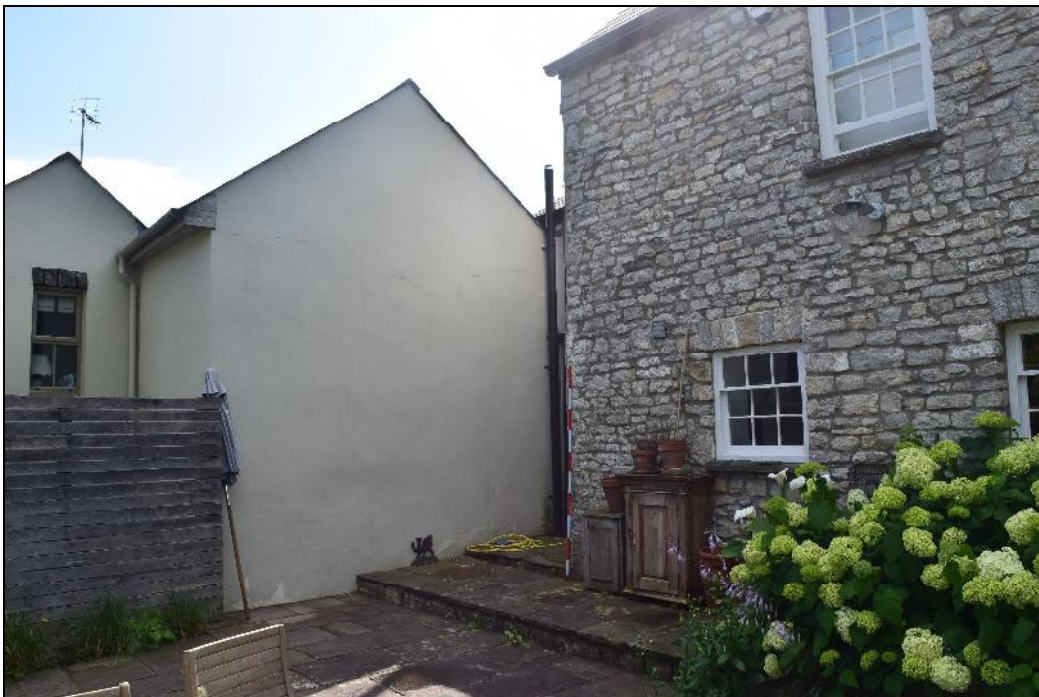
Plate 3: KCM2021_003 A view looking southeast towards where the "boot room" is to be in a location that on the 1877, 1899, 1919 and 1971 1:2500 Ordnance Survey maps was occupied by a porch or conservatory which wrapped around the end of the house. The window centre right was formerly a doorway and has been blocked in.

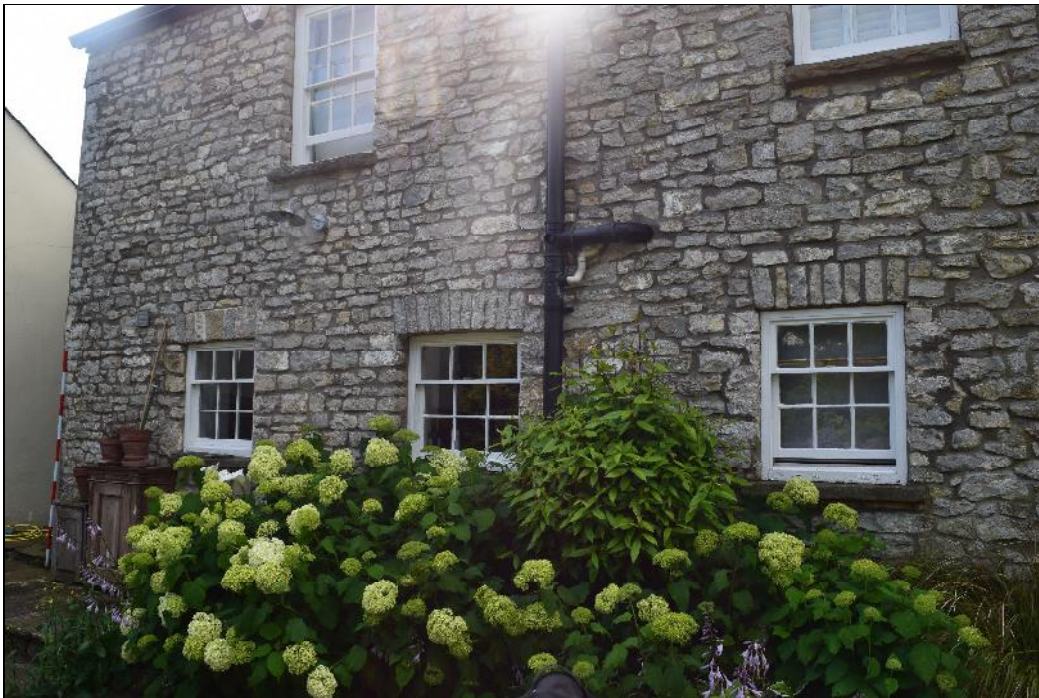
Plate 4: KCM2021_004 The rear of the house looking south-southeast the window centre right appears to have been added or altered as can be seen by the stone work and pointing around it. The window farthest to the left is the former blocked-in door.

This wall bears evidence of earlier modifications to the house. The central ground floor window appears to have been inserted at a later date for the ground floor WC. The kitchen window at the eastern end of this wall is evidently a blocked doorway, suggesting further changes made in relatively recent times.

4.1.12 The stone voussoirs of the arches above both the ground floor WC window and the blocked doorway now serving as the kitchen window are markedly different in character to those of the other windows and doorway through the northern lateral wall, demonstrating that they are later modifications.

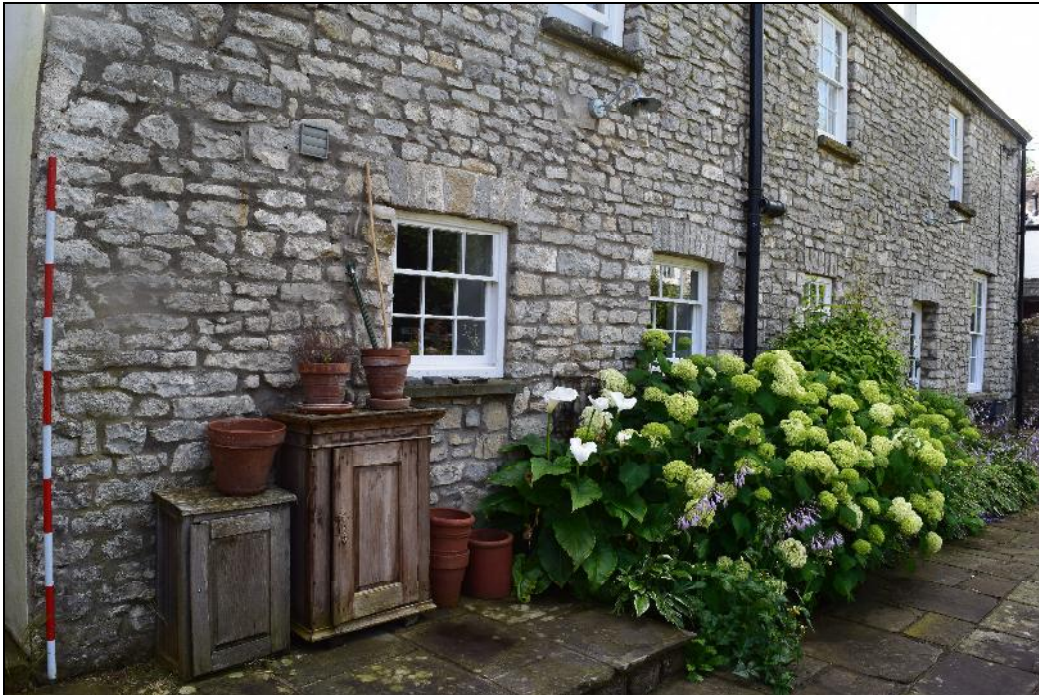
Plate 5: KCM2021_005 The rear of the house looking south-southwest. A straight joint below the window to the left of centre is evidence of its earlier use as a doorway. The 19th century porch or conservatory may have extended beyond this doorway which would have given access from the kitchen into the lost porch.

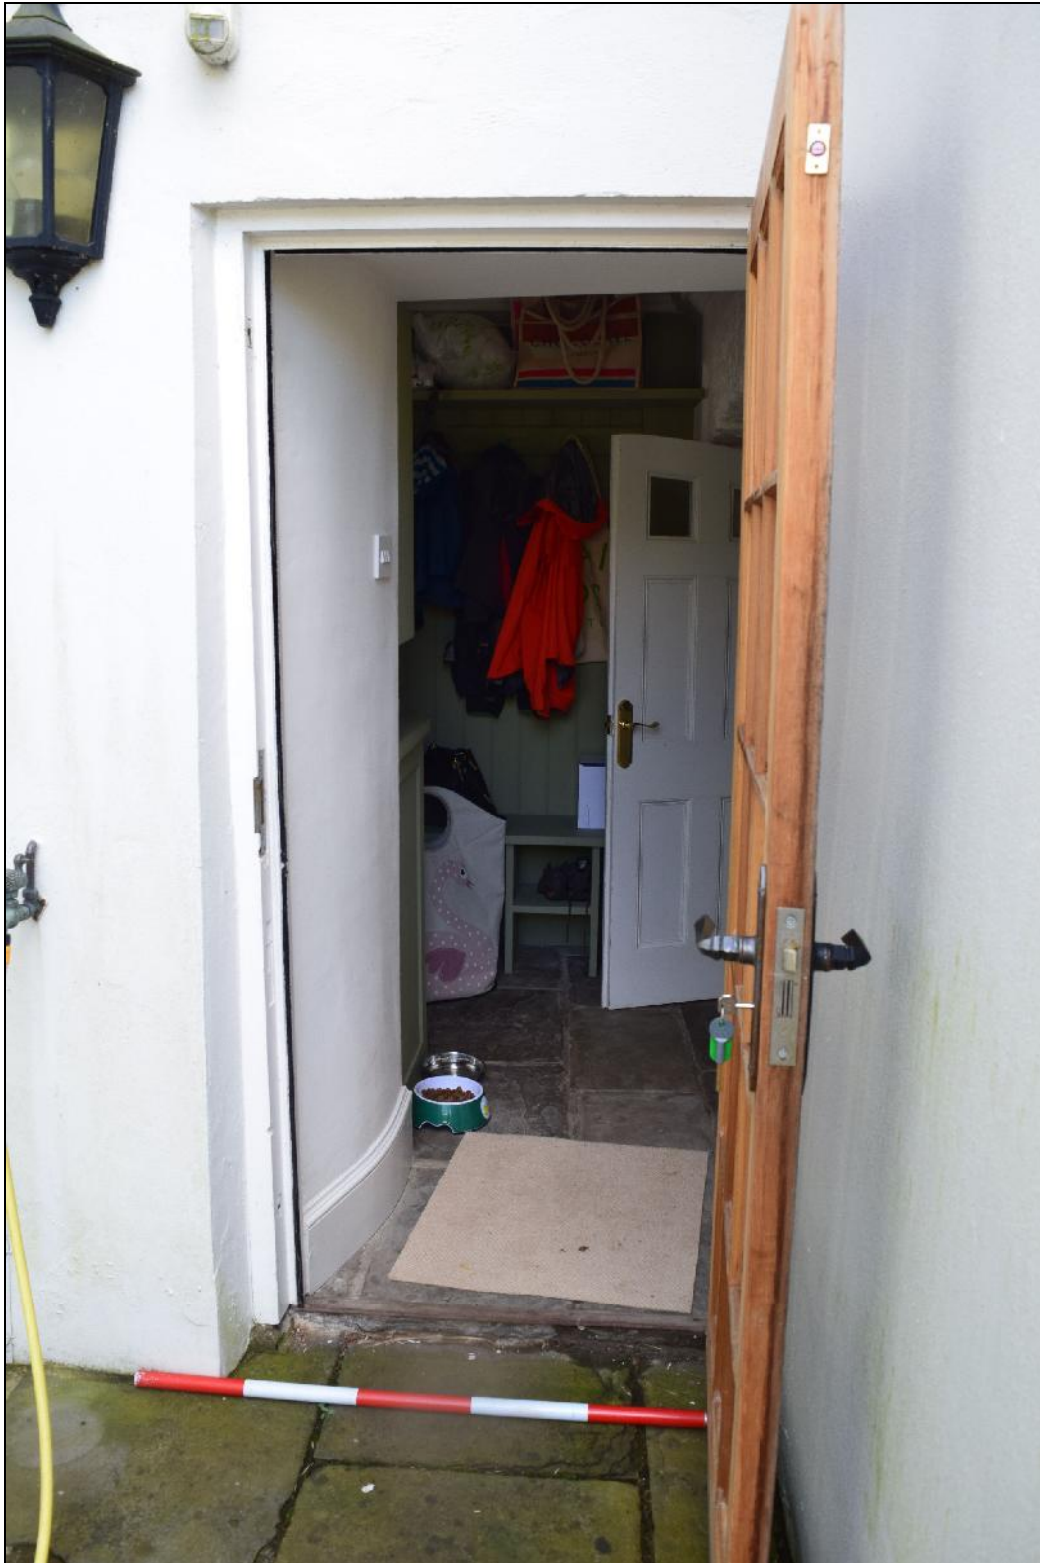
Plate 8: KCM2021_008 A view looking south-southeast through the external door into the utility room. The thickness of the wall here suggests that this was an earlier wall and not built during the modern two storey extension. The doorway is thought to be modern, as the original entrance to the kitchen has been partly blocked up and turned into a window.

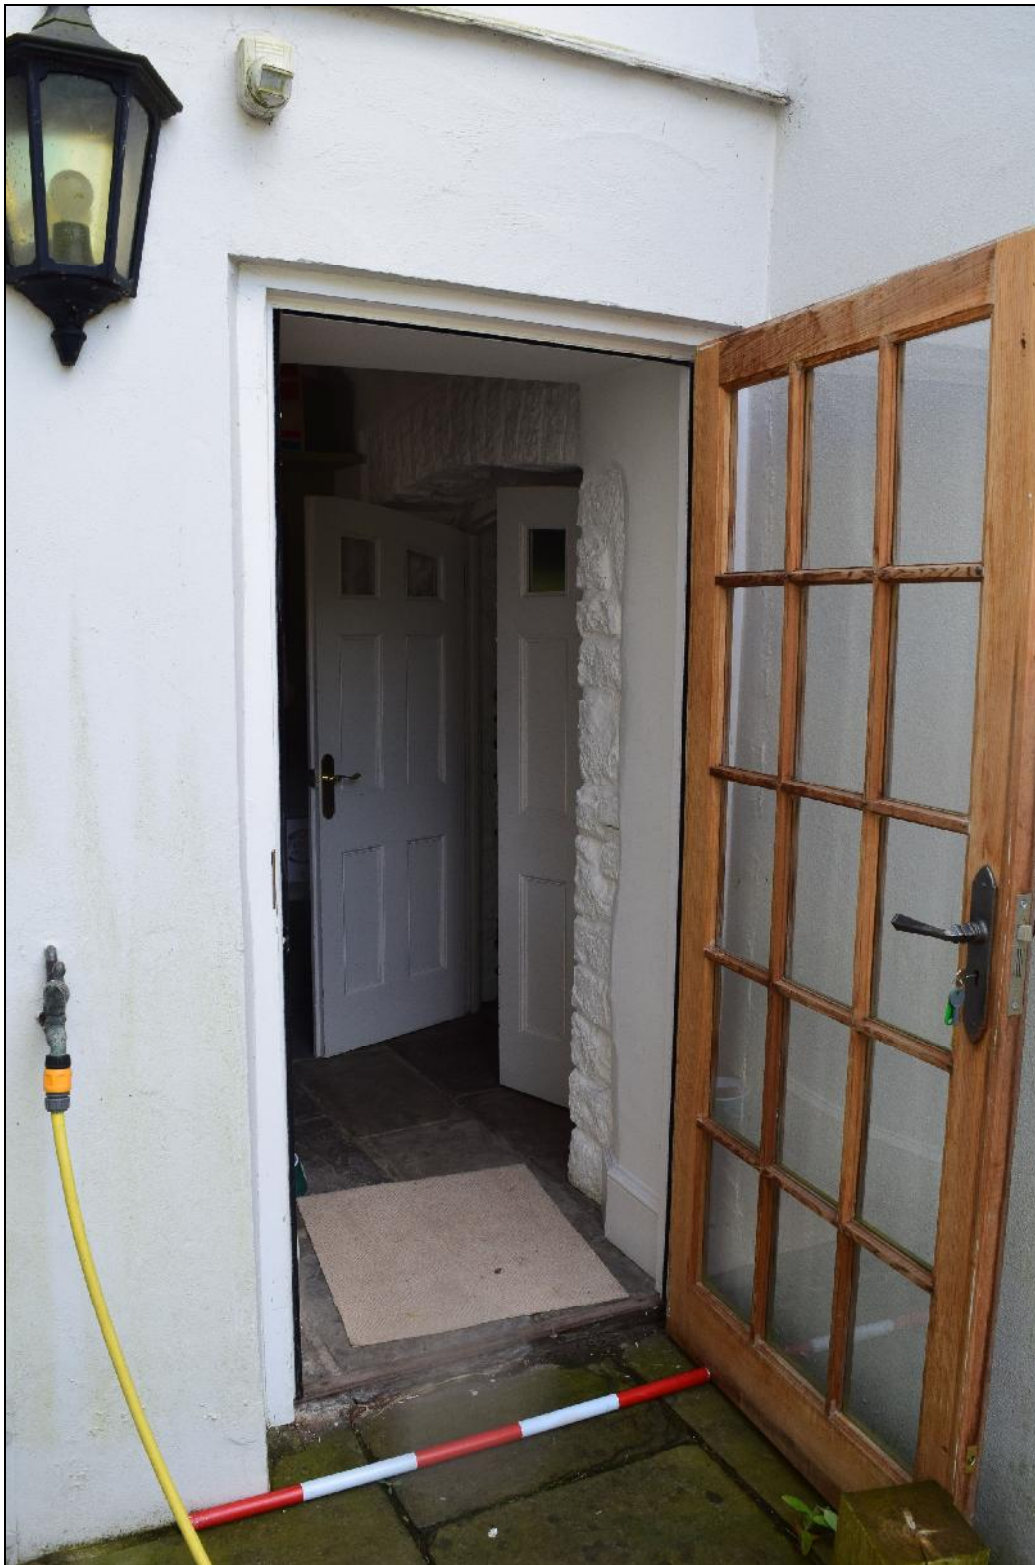
Plate 9: KCM2021_009 A view looking south-southwest through the external door into the utility room and through to the current double doors into the kitchen

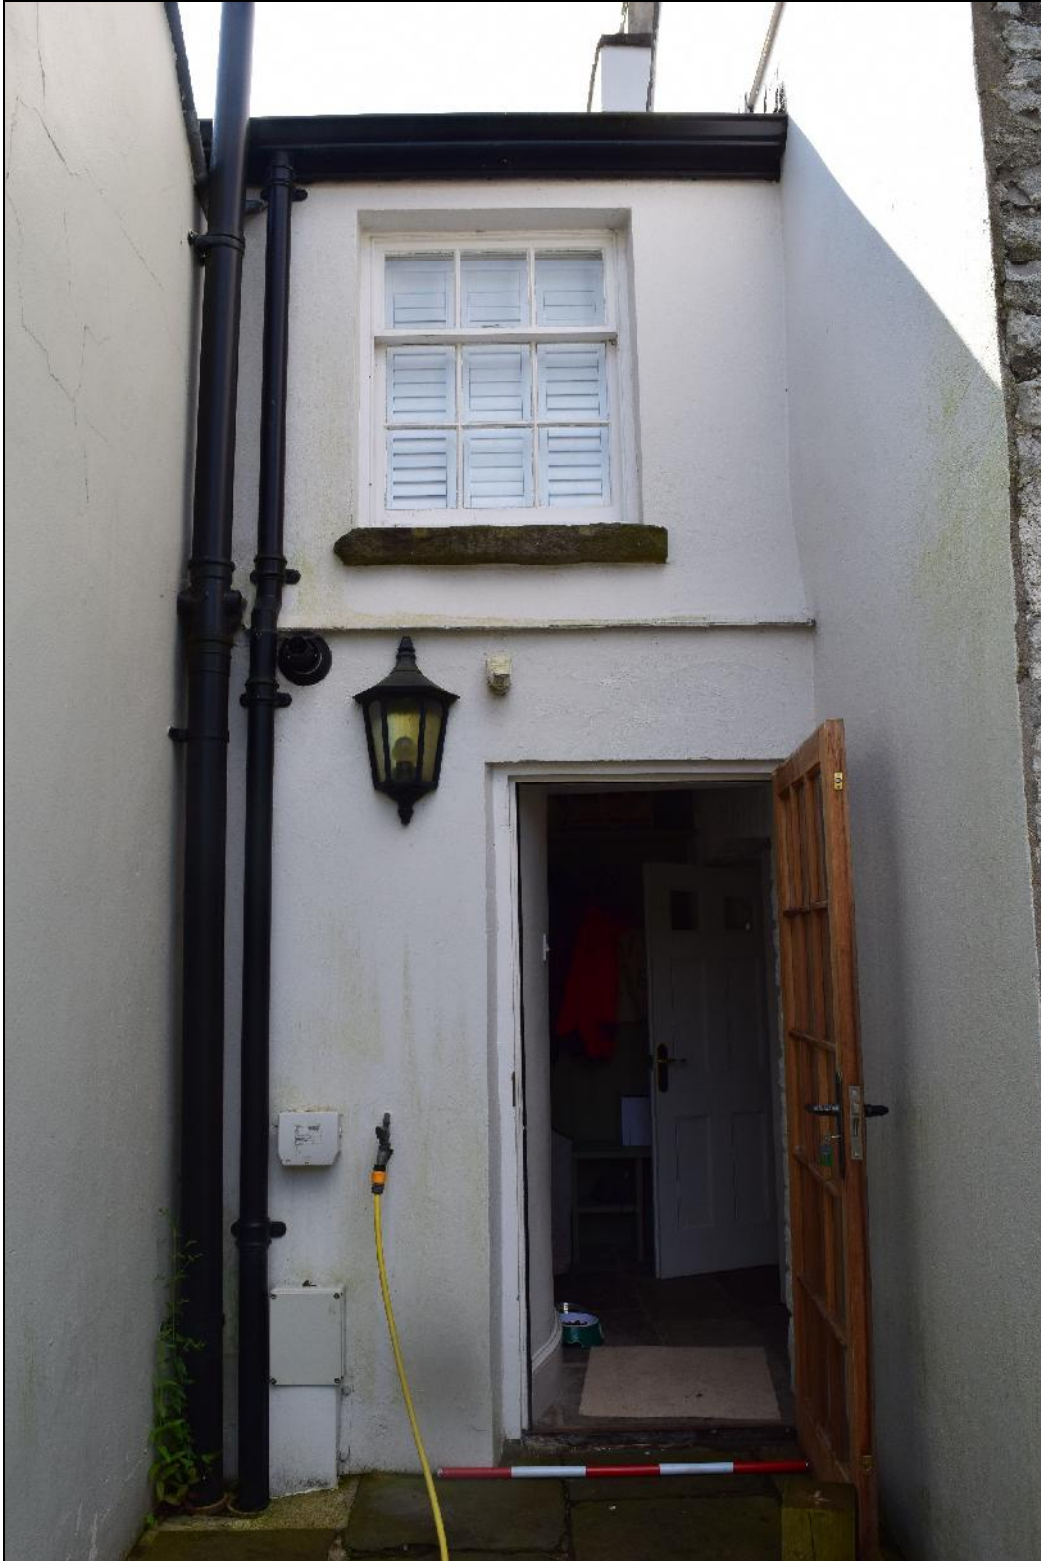
Plate 10: KCM2021_010 A view looking south-southeast into the utility room from where the boot-room would be located. The upper storey and window seen here have been added in modern times.

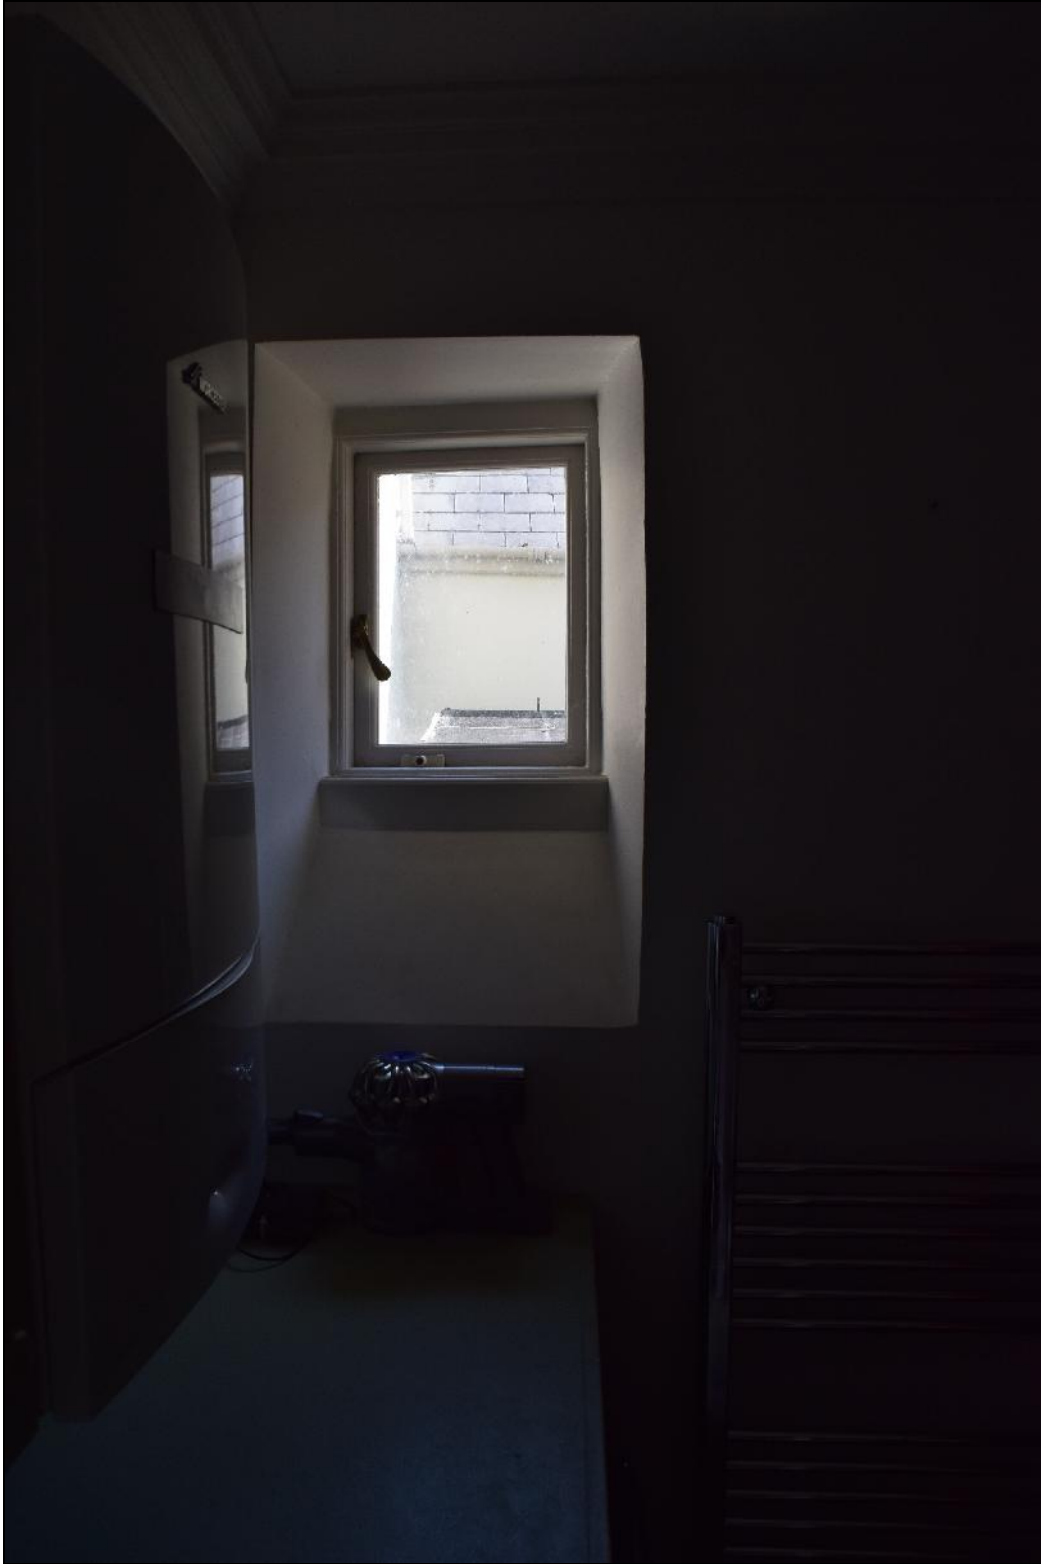
Plate 11: KCM2021_011 A view looking east-northeast to a small window in the utility room.

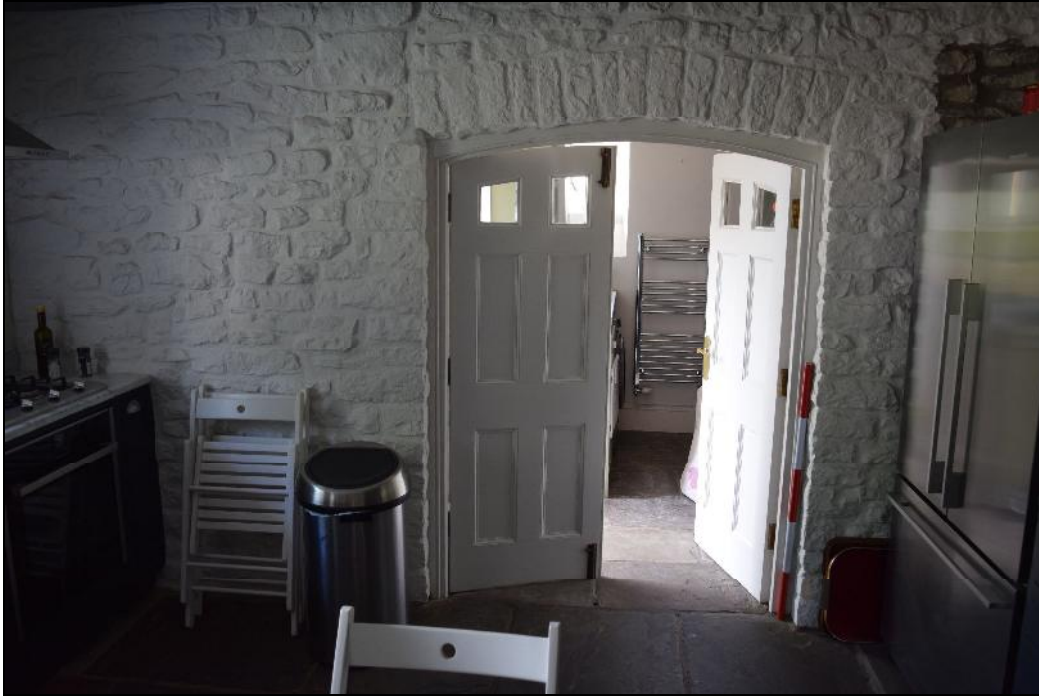
Plate 12: KCM2021_012 A view east-northeast from the kitchen towards the current double doors into the utility room. The stonework around the door suggests some alteration has happened here in the past, whether the insertion of a new door, or alteration to an existing door.

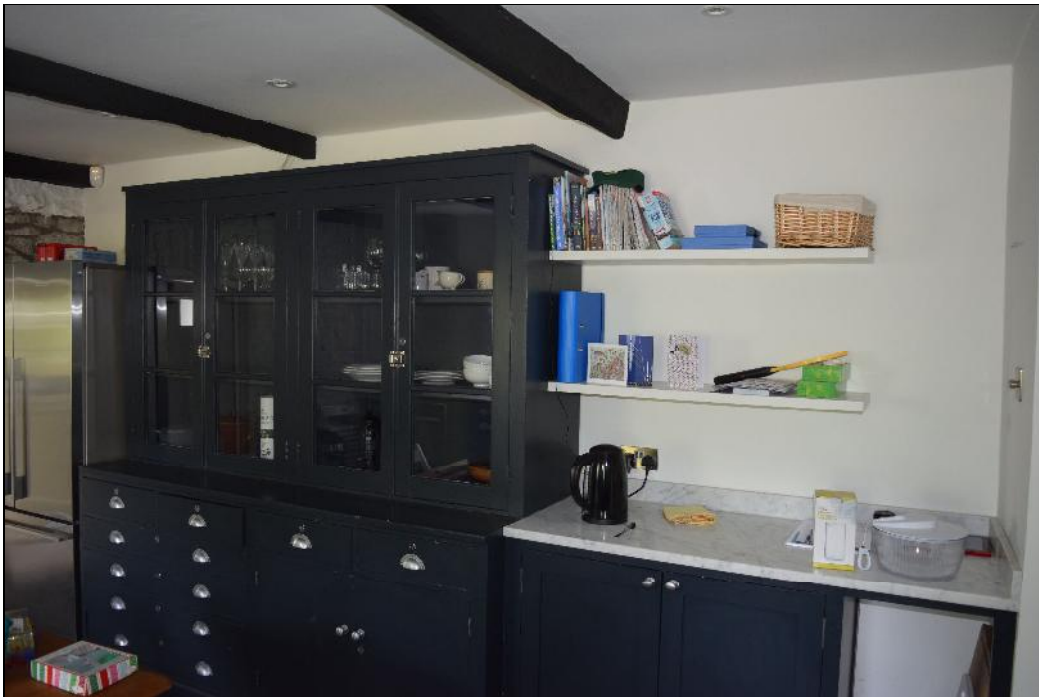
Plate 13: KCM2021_013 A view looking southeast to the wall between the kitchen and the reception room to the south. The kitchen units are modern

5.2 Internal changes planned for the kitchen include the replacement of the present, modern kitchen, with new units and fittings. This change would not impact on the historic fabric of the house as the units and fittings are modern.

5.2.2 In terms of scale this is a modest modification which would not change the external appearance of the house but will require the removal of a section of what appears to be an original internal wall of the house.

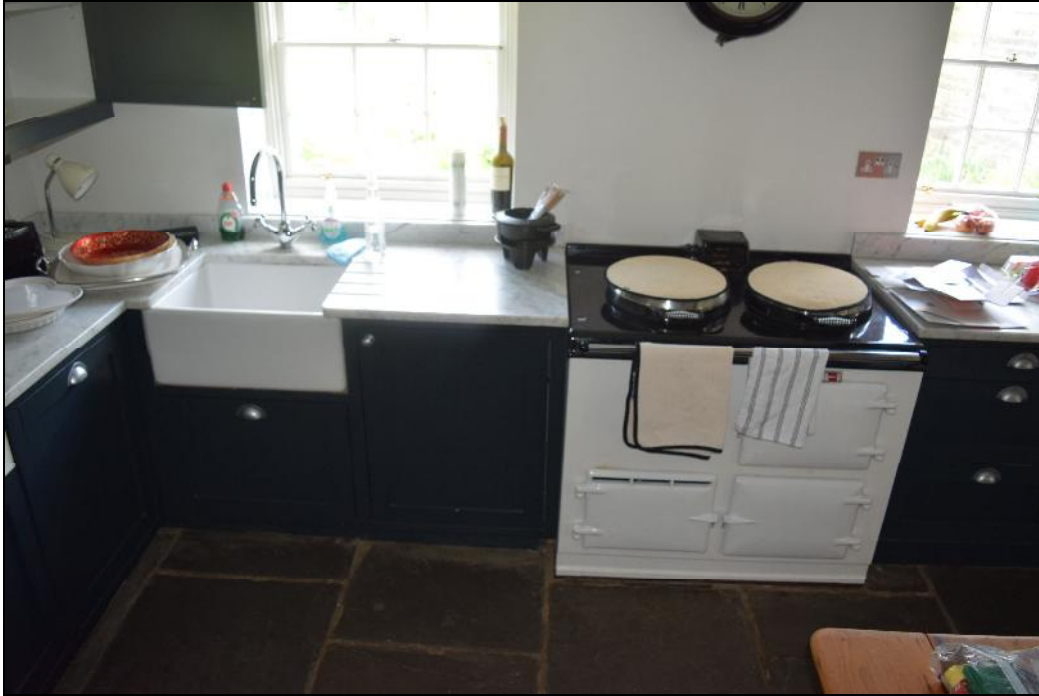
Plate 14: KCM2021_014 A view looking northwest in the kitchen, all the units are modern.

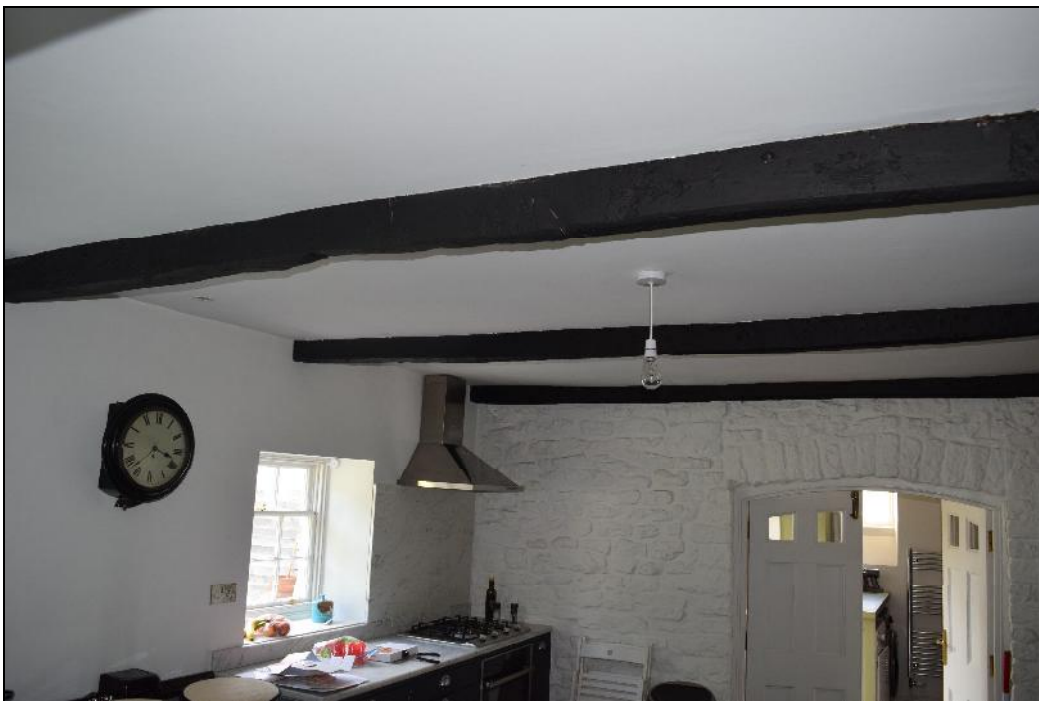
Plate 15: KCM2021_015 A view looking north-northeast in the kitchen. The window to the left of centre was previously a doorway.

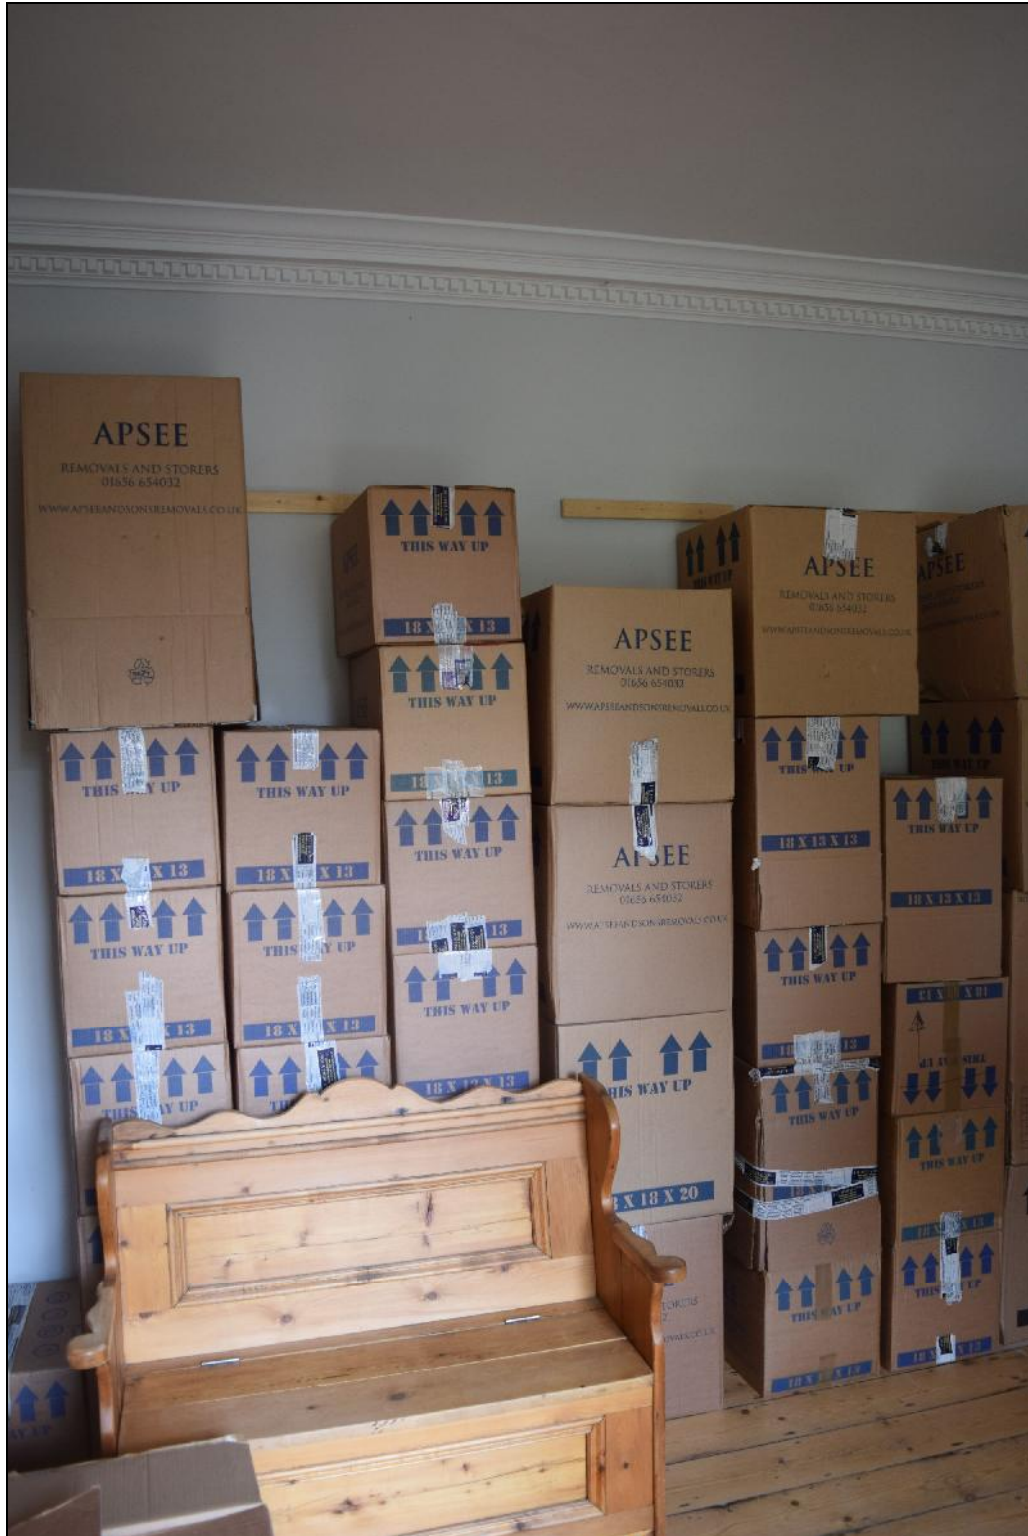
Plate 16: KCM2021_016 A view looking north-northwest in the southern reception room towards the wall shared with the kitchen, through which it is proposed to create an opening.

5.2.3 The opening of the new doorway would also require the creation of a step to link the two rooms as their floors are at different levels, with

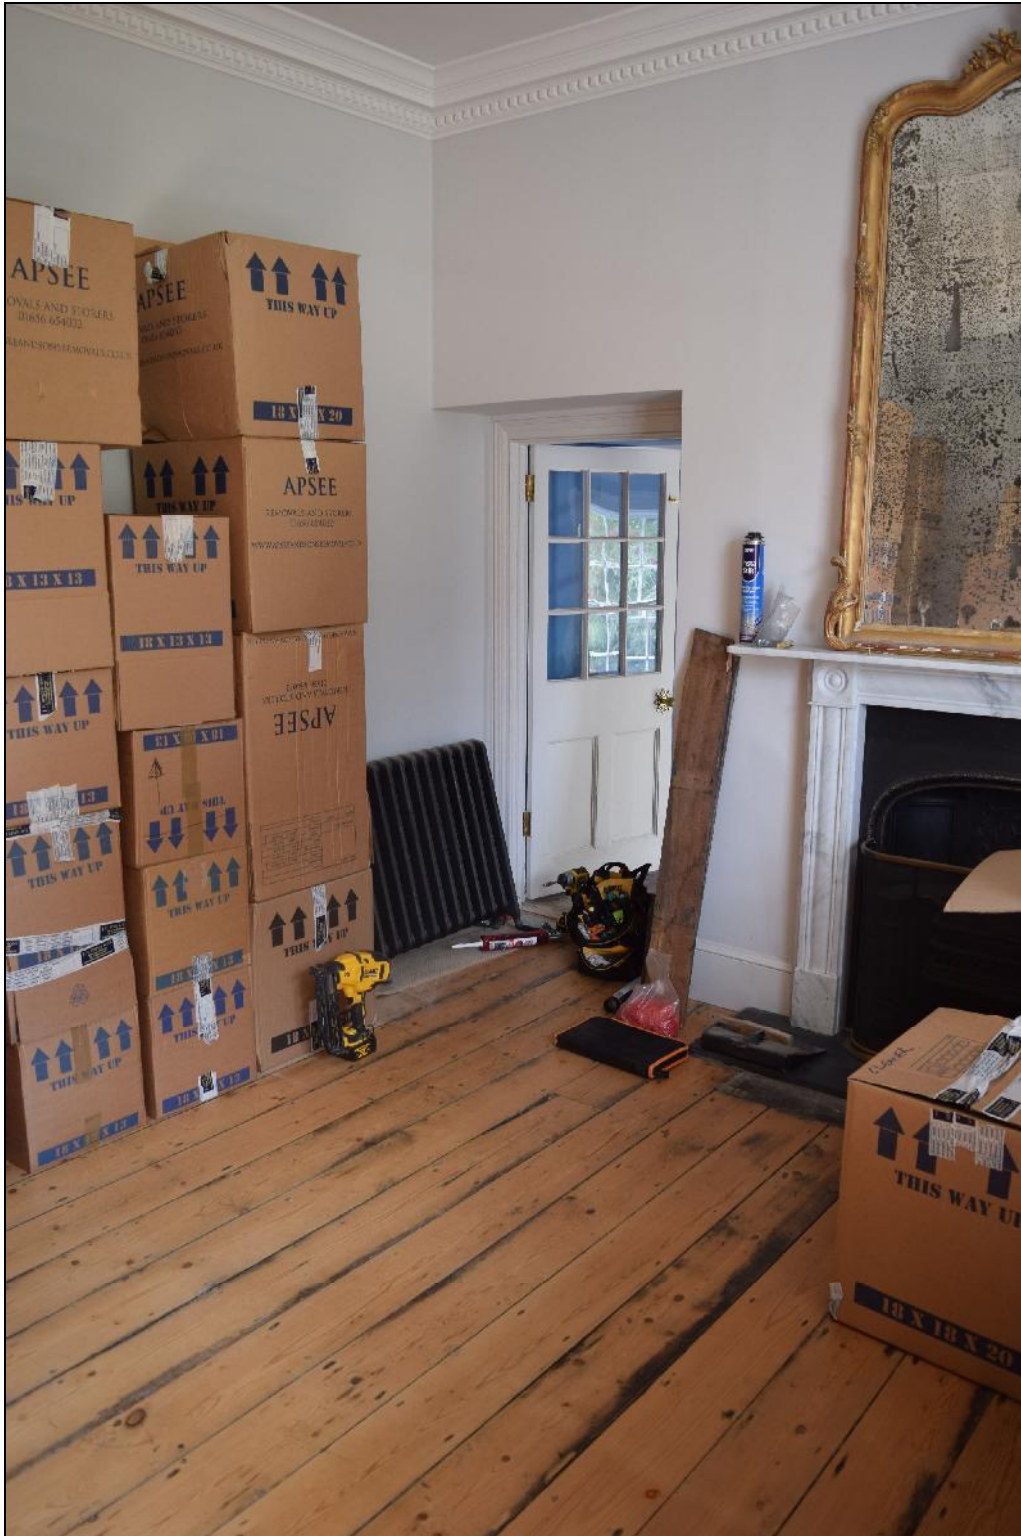
Plate 17: KCM2021_ 017 A view looking north-northeast towards a door into the extension from the south reception room.

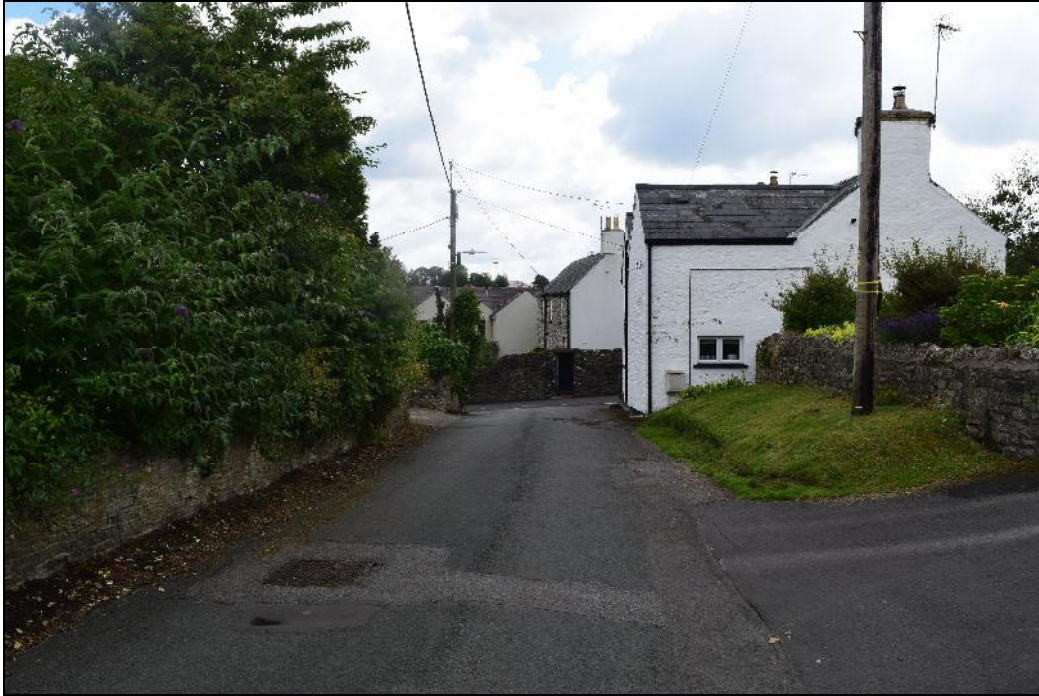
Plate 18: KCM2021_018 A view From Factory Road looking east-northeast towards Kingscombe. The proposed "boot-room" extension would be seen from here, but it is important to remember that in the past a porch or conservatory occupied essentially the same position.

5.1.3 When viewed from the direction of Factory Road, the proposed addition would be seen against the gable end wall of the rear, southwestern wing of Trecregyn, which probably represents the former granary building of Kingscombe and has been heightened by the addition of an upper floor in modern times. It would therefore not impact on a view of historical significance.

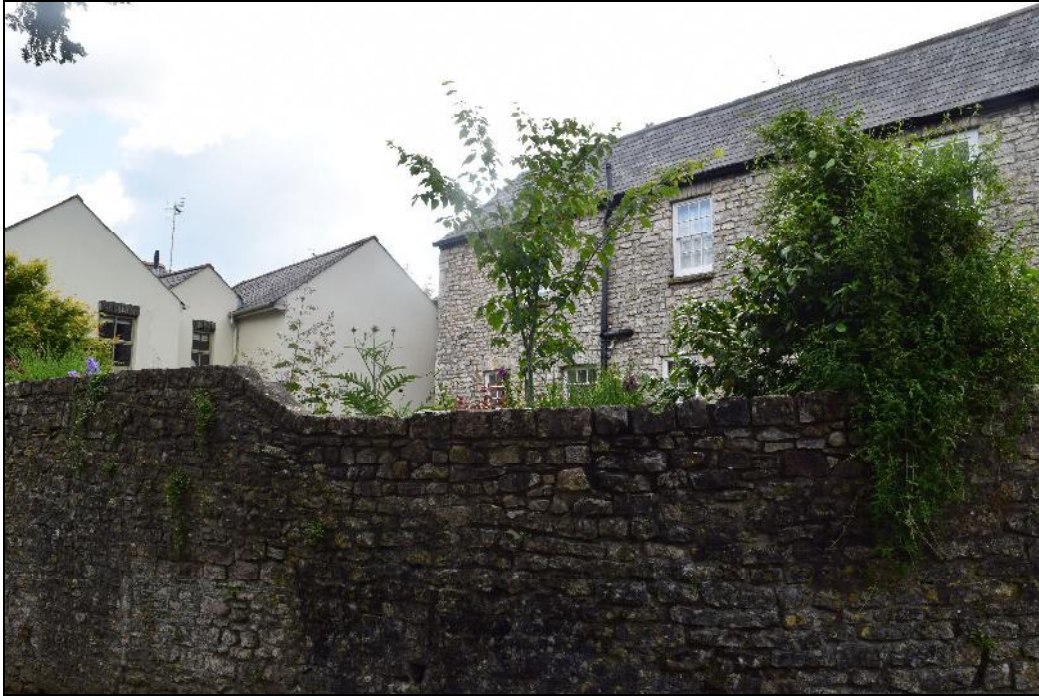
Plate 22: KCM2021_022 A view from the road looking southeast towards Kingscombe. The high wall can be appreciated here as the road is sunk down below garden level within Kingscombe itself.
