Heritage Impact Assessment, Kingscombe, Llanmihangel Road, Llanblethian, Cowbridge, CF71 7JA

Report by: Trysor

August 2021

Trysor Project No. 2021/795
HER Event Record PRN – GGAT E006710

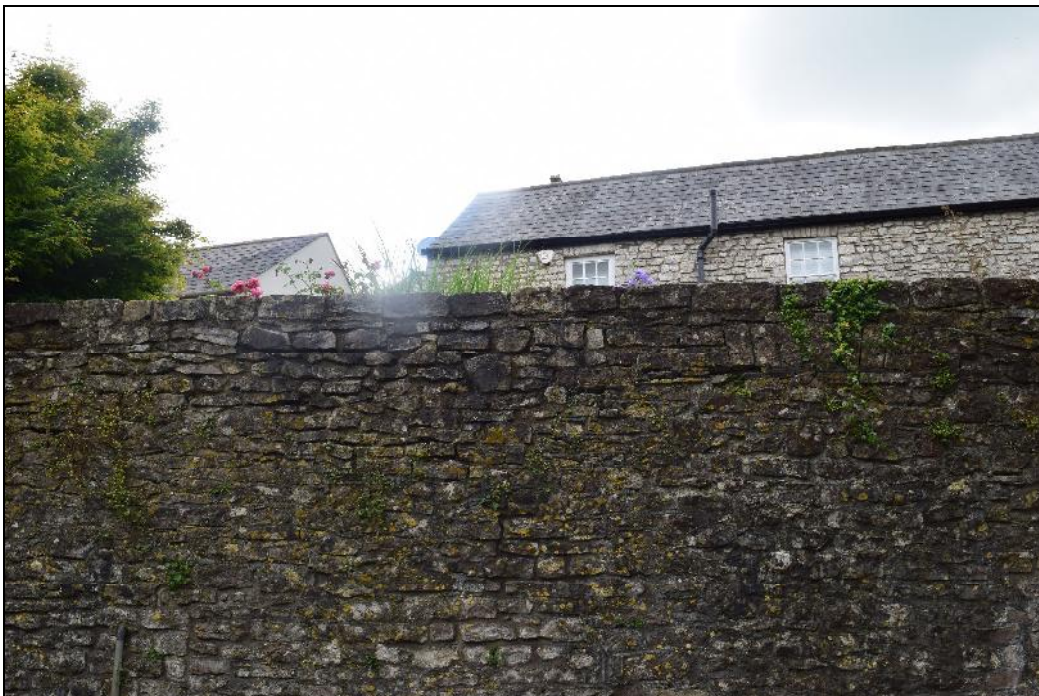
Plate 23: KCM2021_023 A view of Kingscombe from the road looking south-southeast. The high garden wall would block views of the proposed conservatory from this angle.
