**CPAT Report No. 1934**

# **Trevor Basin Corrugated Shed**

Historic Building Recording

Organisation	Clwyd-Powys Archaeological Trust
Client Name	Canal and River Trust
CPAT Project No	2678
Project Name	Trevor Basin Corrugated Shed
Project Type	Historic Building Recording
Project Manager	Tim Malim
Project Supervisor	Will Logan
Grid Reference	SJ 27153 42254
County/LPA	Wrexham County Borough
Planning Reference	N/A
CPAT Report No	1934

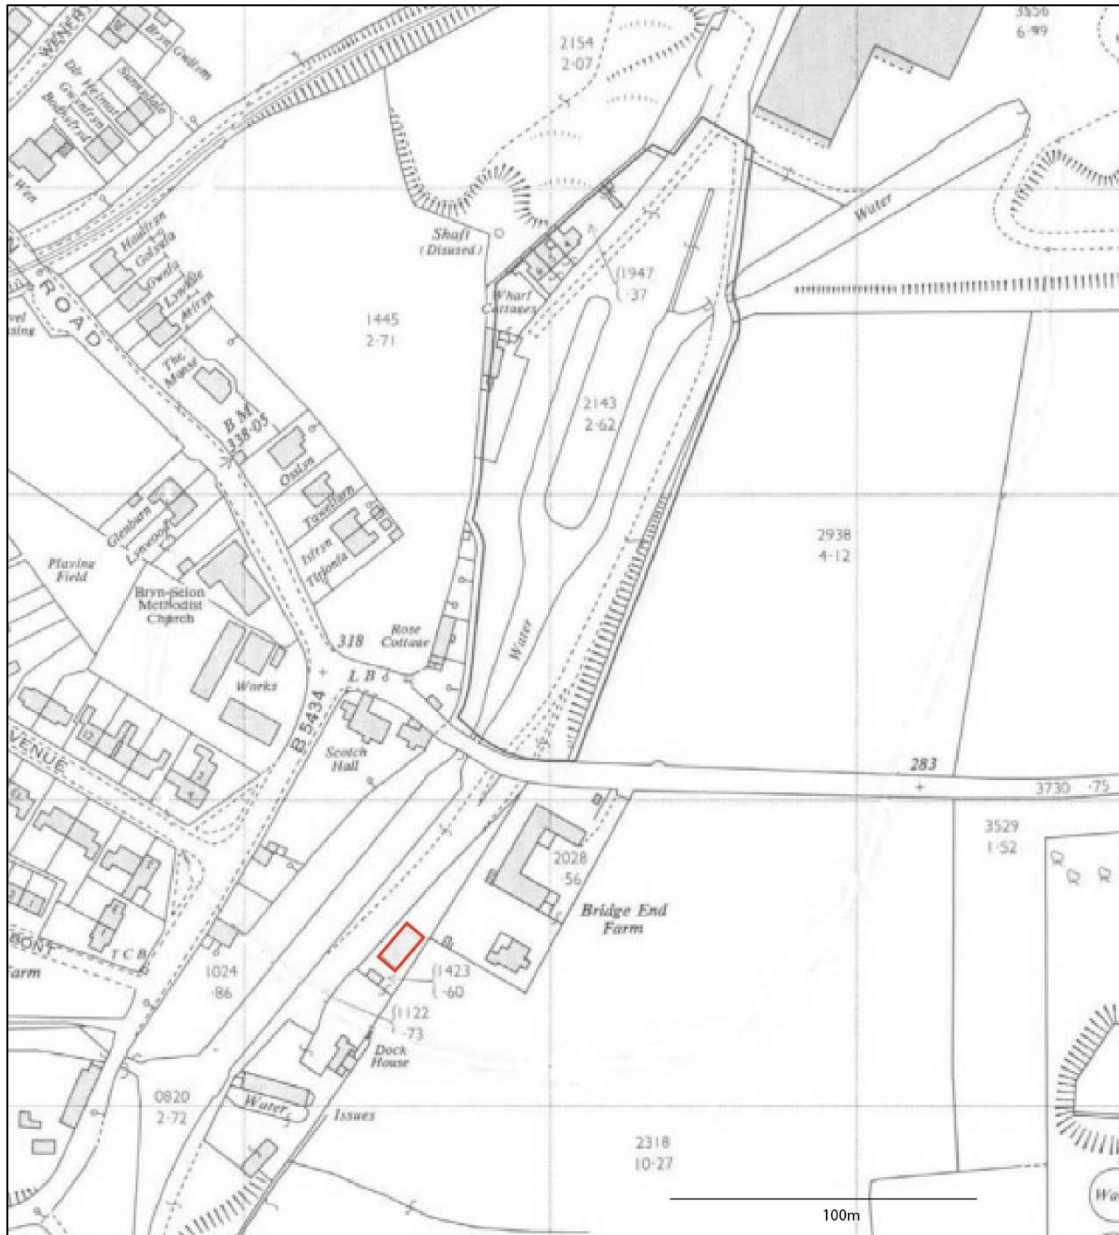
Fig. 3 1961 National Grid Plan

- 2.8. Subsequent mapping records the development of Trevor and the decline of the transfer docks. The 1961 Ordnance Survey Plan is the earliest record of the corrugated shed (Fig. 3). The building is located on a triangular plot adjacent to the Basin with a small building to the south of it. It appears to have been constructed as part of the dry dock complex of buildings.

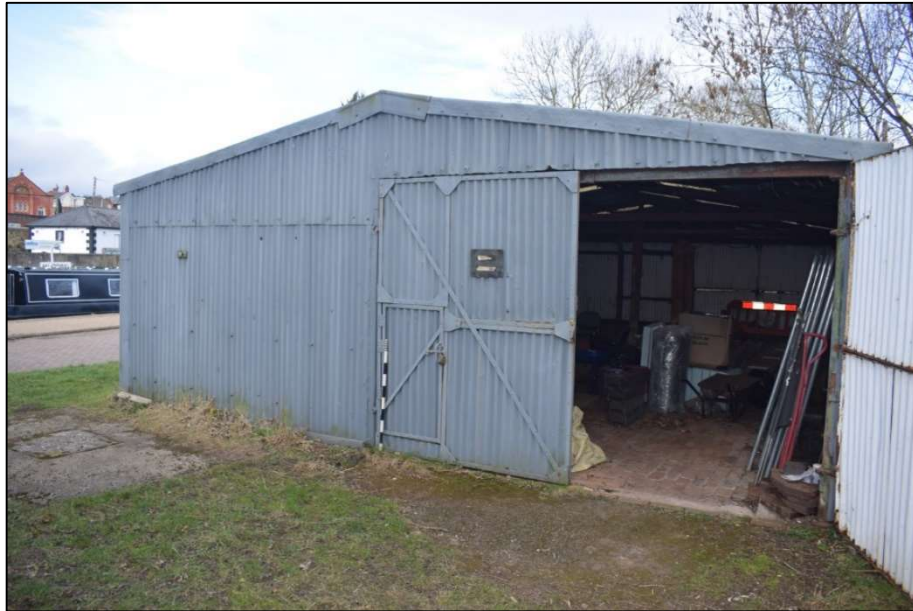
*Fig. 4 South end of the building Photo CPAT 5041\_011*

- 3.3. There were large double doorways in each gable end measuring 3.6m in width (Fig. 4). The west elevation contained a doorway (Fig. 5) and two steel-framed casement windows, each 2m in width (Fig. 7). A ventilator was inserted in the east elevation and a small kiosk or outbuilding was located against the northern end.

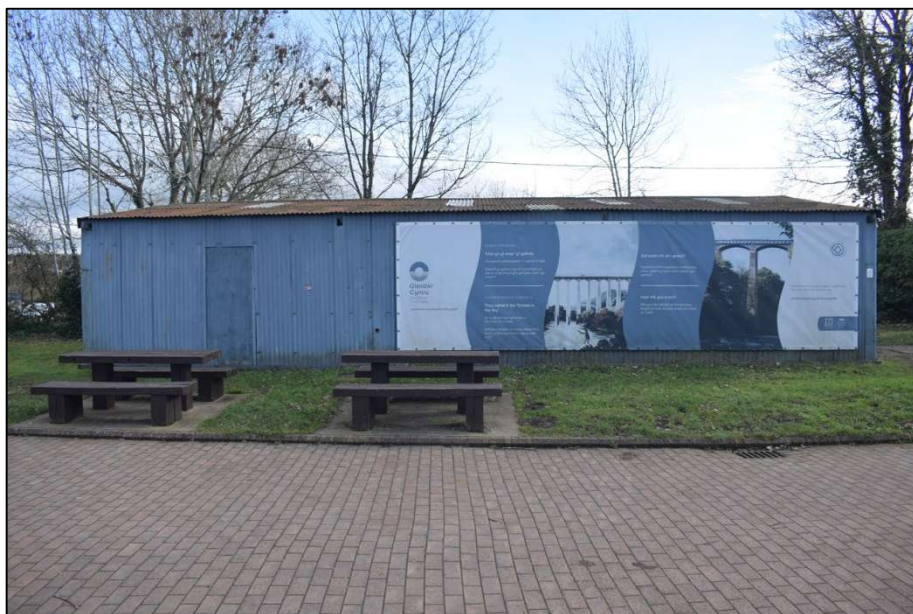
*Fig. 5 West elevation of the building Photo CPAT 5041\_003*

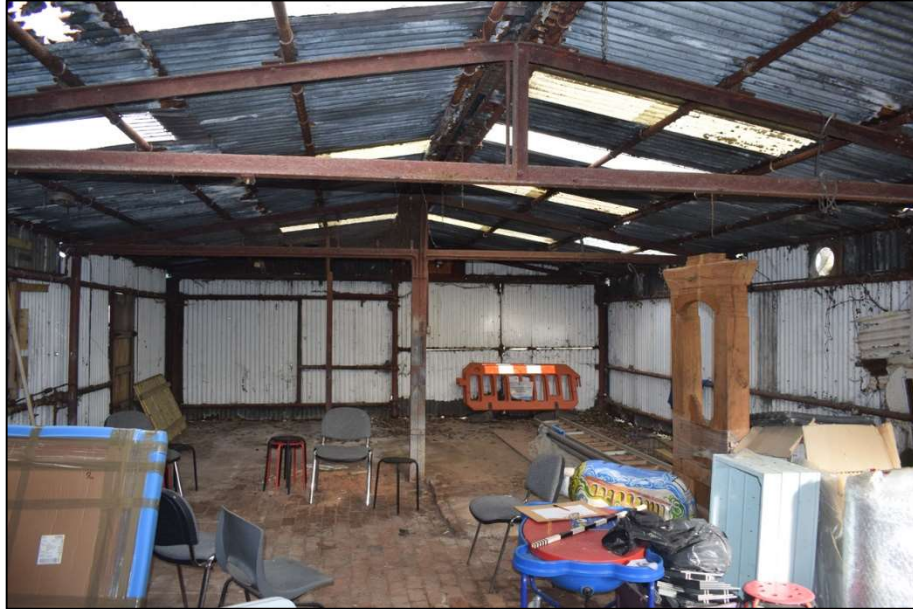
*Fig. 6 Interior of the shed viewed from the south Photo CPAT 5041\_012*

- 3.5. The roof frame was supported by tubular members (Figs. 6, 8 and 9) which were made of cast iron, with a round base which was bolted into the floor. The top mount was rectangular and bolted to the roof beams. The wall cladding was attached via horizontal tubes, bolted to the vertical members and attached to the cladding by U-bolts.

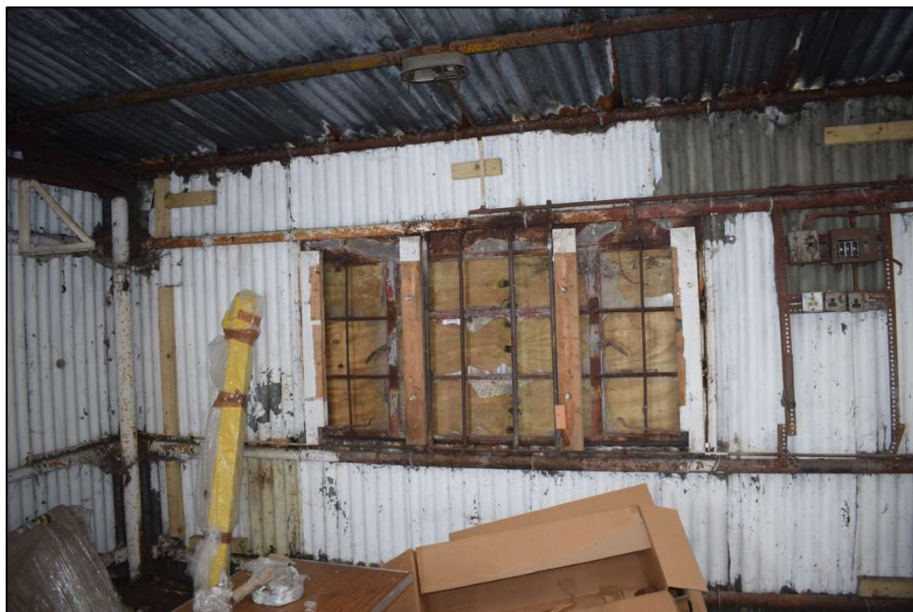
*Fig. 7 Window frame viewed internally Photo CPAT 5041\_024*

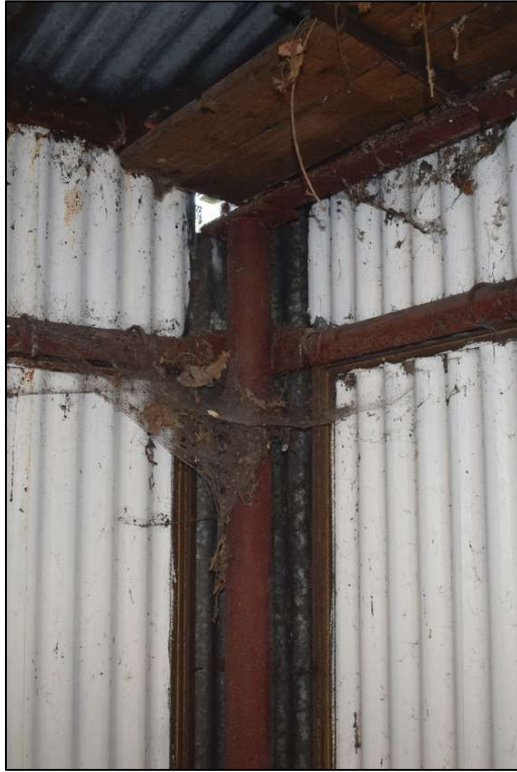
*CPAT Photo 5041\_018*

*Fig. 8 Upper cast tubular support*

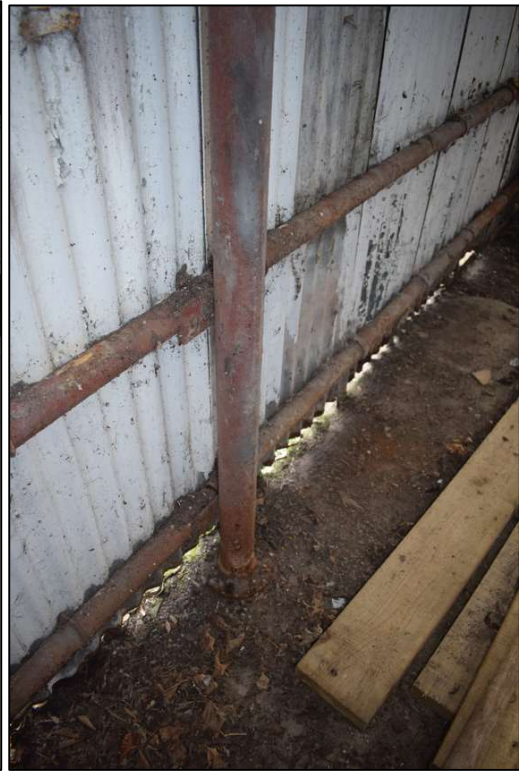
*CPAT Photo 5041\_031*

*Fig. 9 Lower cast tubular support*

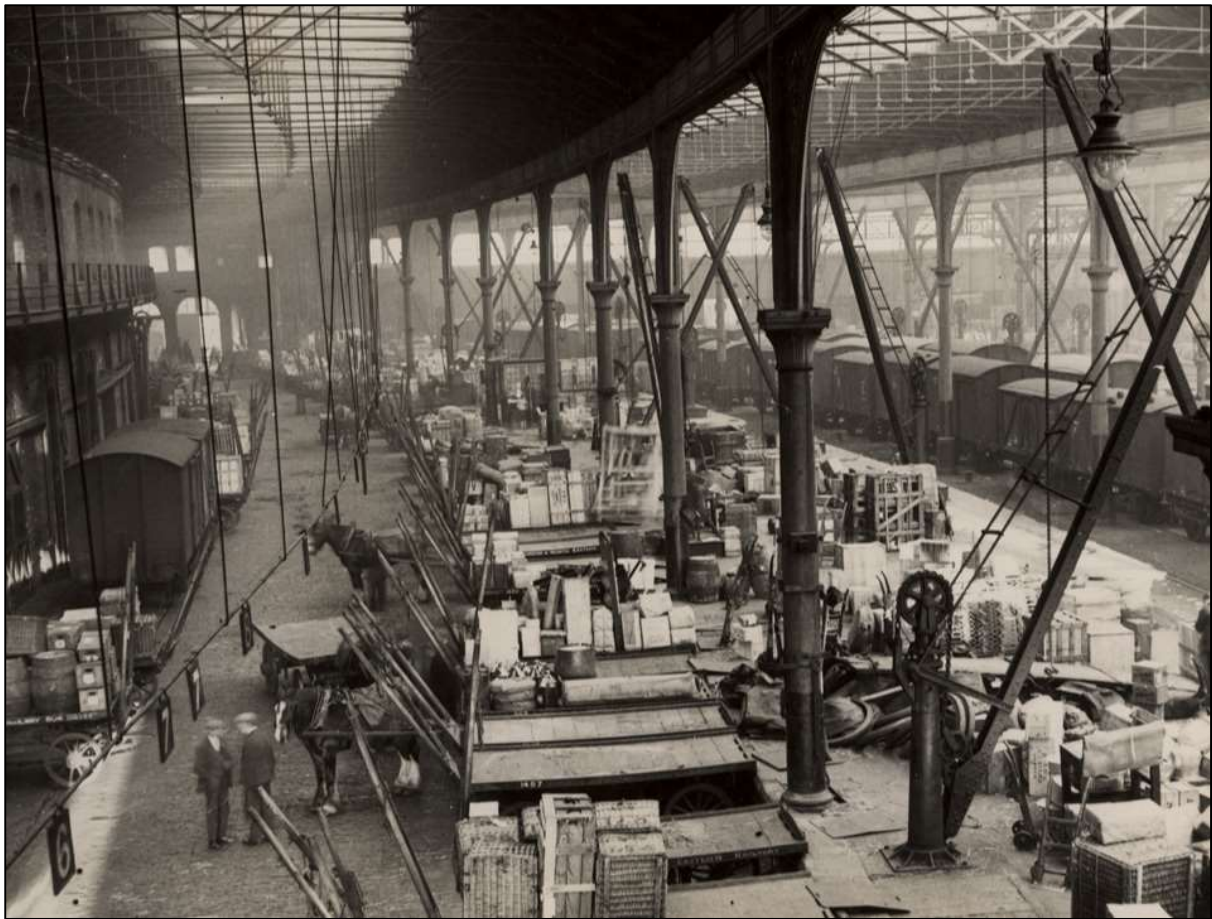
*Fig. 10 Interior shot of the Forth Goods station in Newcastle-on-Tyne. Note the design of the lower roof frame supports which is similar to those used in the building on the Trevor Basin*

- 4.1. The corrugated shed was probably constructed during the mid-20<sup>th</sup> century. It was originally considered that it may have been a pre-fabricated building of the type used during the First and Second World Wars, but it seems more likely it was constructed piecemeal utilising materials that were locally available. The cast tubular wall members were of particular interest. They are similar in appearance and design to those used in railway architecture and it is possible that they were reused components from the goods transfer shed or another railway building in the nearby vicinity. The goods shed itself was extant on 1930s mapping but had gone by 1961. A similar roof support design is shown in Fig. 10.
