## **Ty'r Person Farm, Upper Church Village, Pontypridd**

Archaeological Level 2 Building  
Recording

Report No. 1928

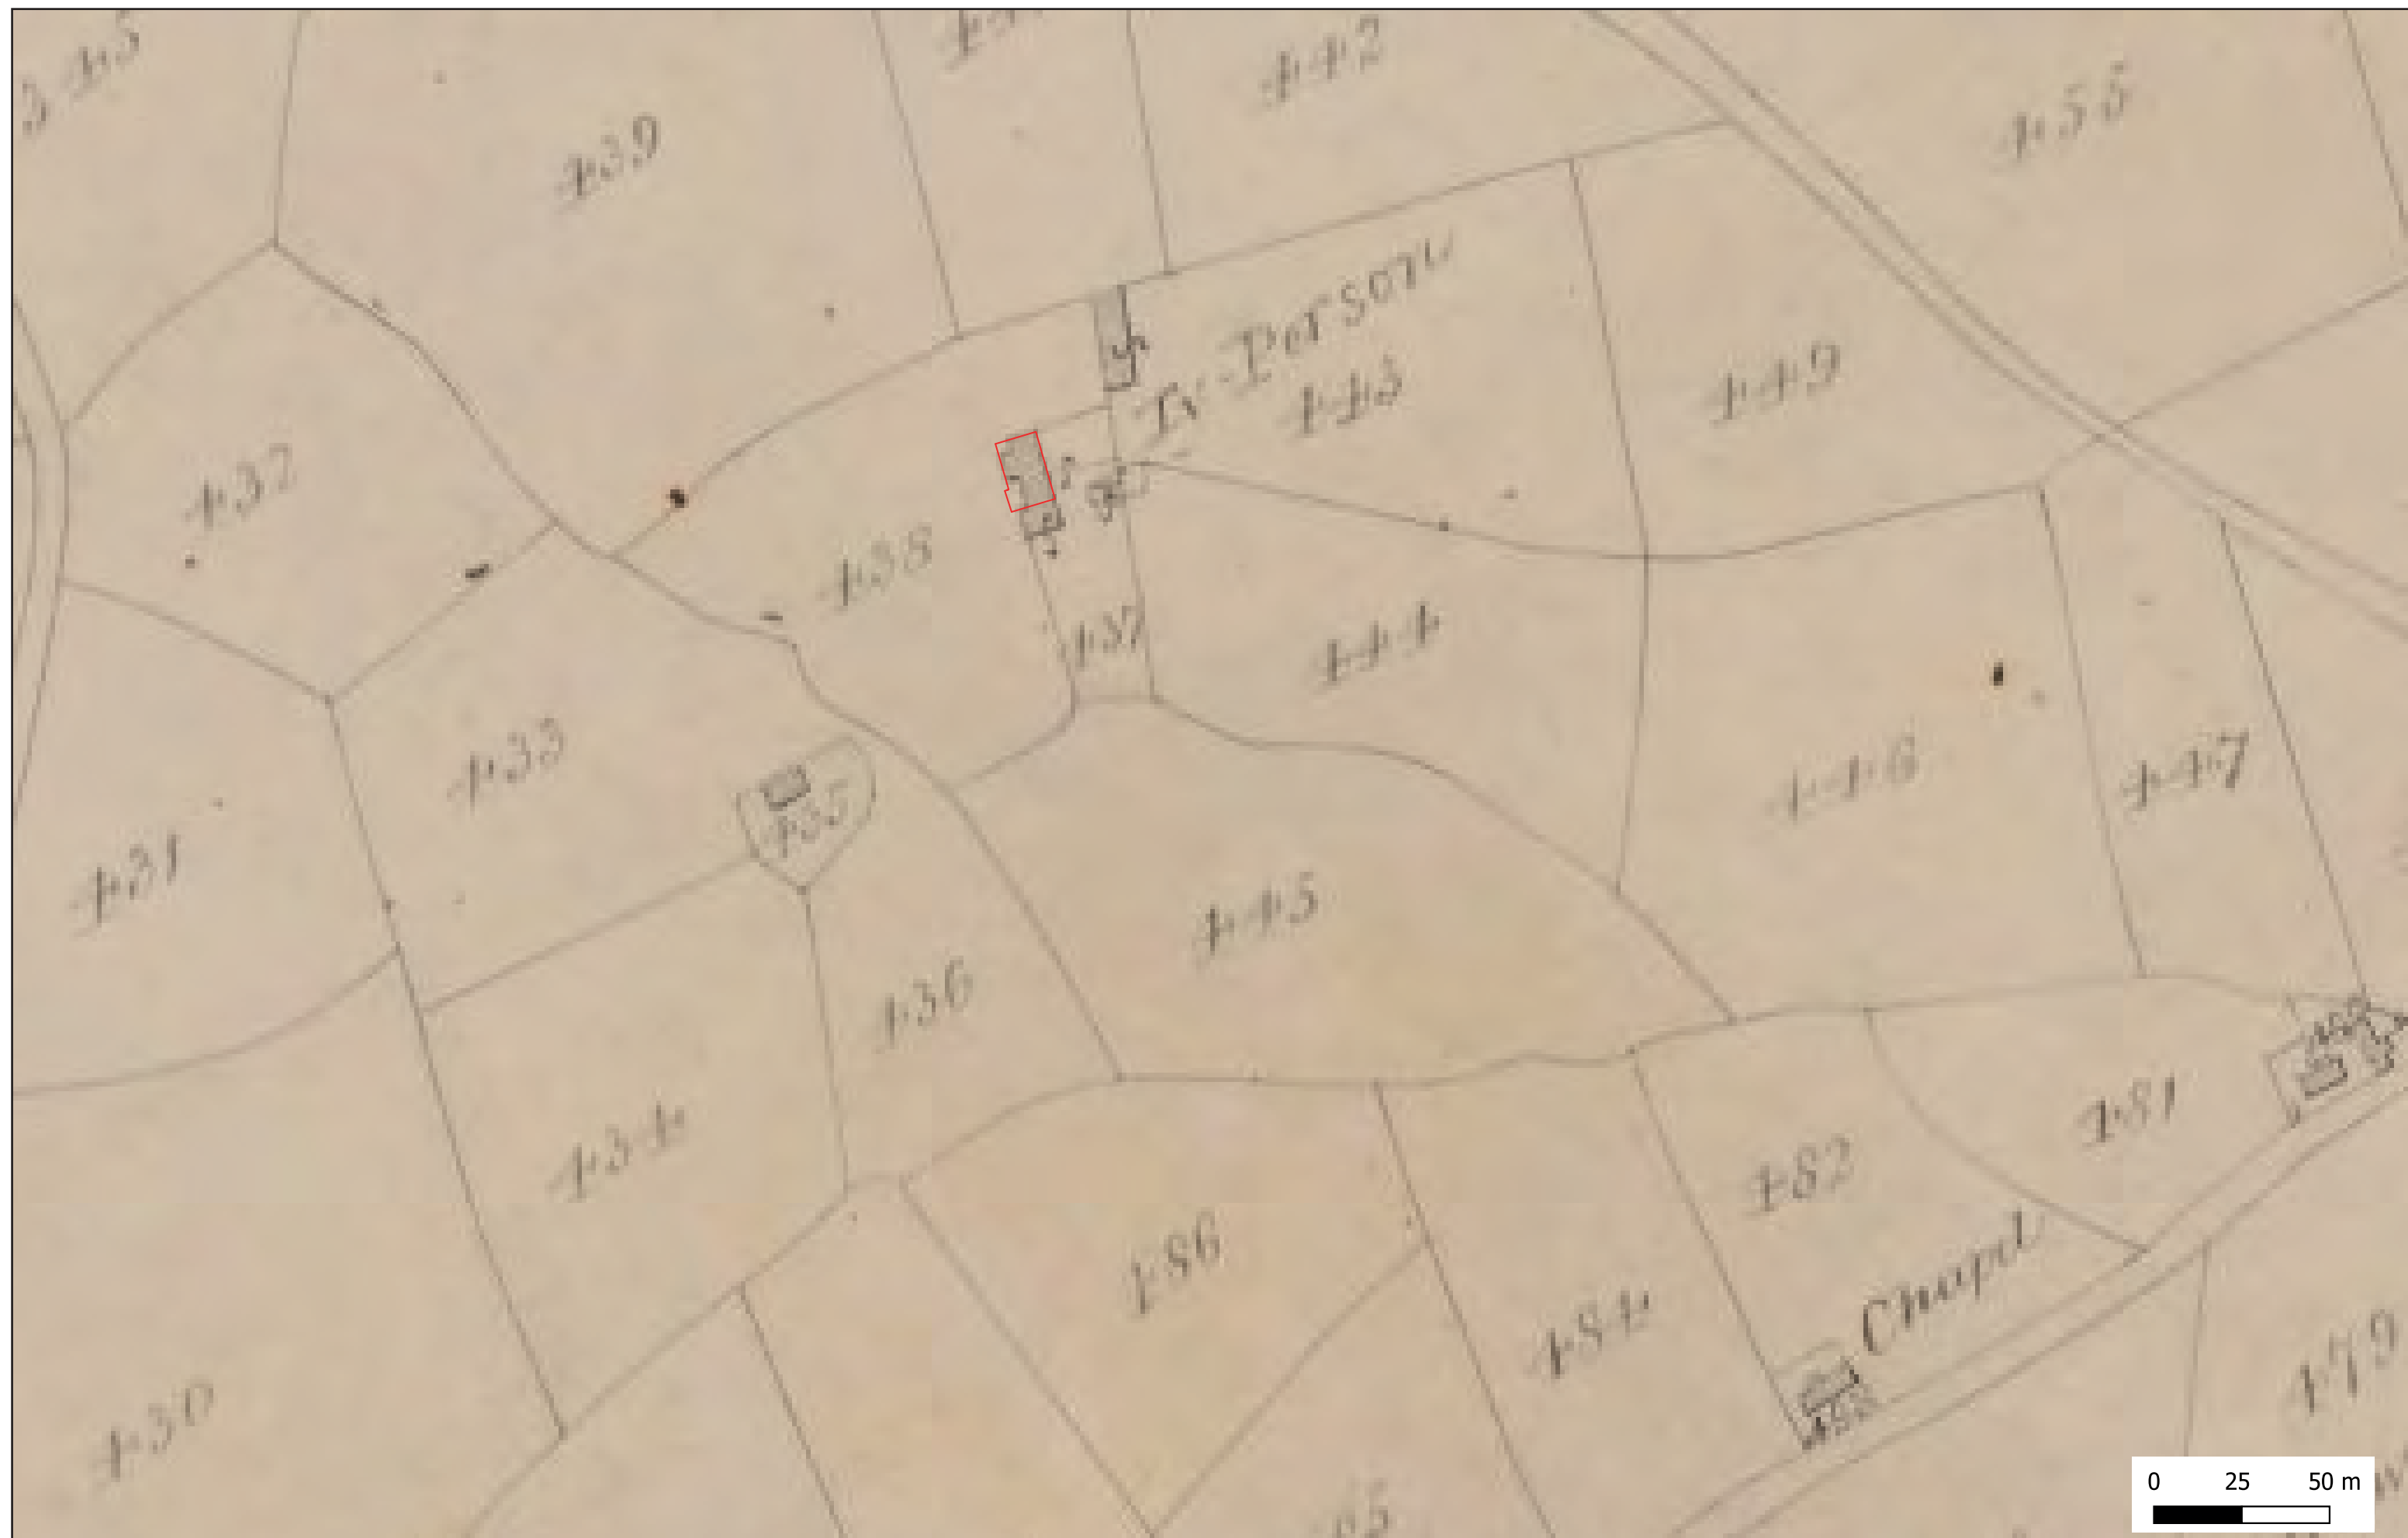
Figure 4. Extract from the Tithe Map of Llantwit Vardre, Glamorgan, 1844.

- 3.2.2 The 1844 Tithe map shows that Ty'r Person Farm was already in existence at that time. Although the survey of the building is not entirely accurate, it would appear that it consisted of four attached square or rectangular cells arranged north – south, each of varying size. These four cells have survived in the fabric of the building until today. It is the northernmost two cells that comprise the domestic quarters of the farm, with the southern two cells comprising barns.

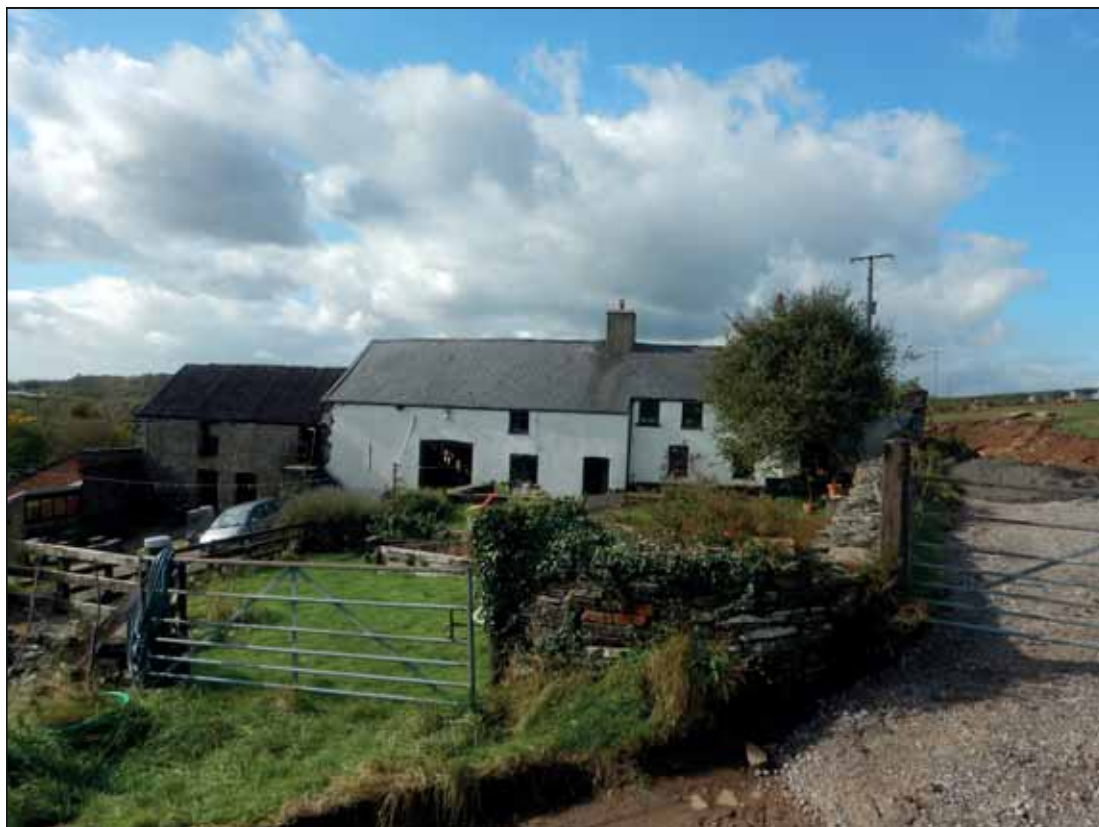
Plate 1. Ty'r Person Farm, looking west.

4.1.1 Ty'r Person farmhouse and barn is a north – south orientated gable ended two-storey building (Plate 1). The northern section of the house is slightly narrower, stepping in of the eastern wall, with a catslide roof to the west. The building is cut into the hillside to the north and west, and the floor level drops down from the northern section of the house to the southern section and then again to the barn, following the hillslope. The building is constructed from rubble stone with lime mortar and has a slate roof. The whole building exterior has been concrete rendered. A small wood lean-to woodshed is located immediately to the north-east of the house, attached only by the south-west corner.

4.2.1 The east-facing elevation is a long two-storey façade with the southern element projecting slightly (Plate 1).

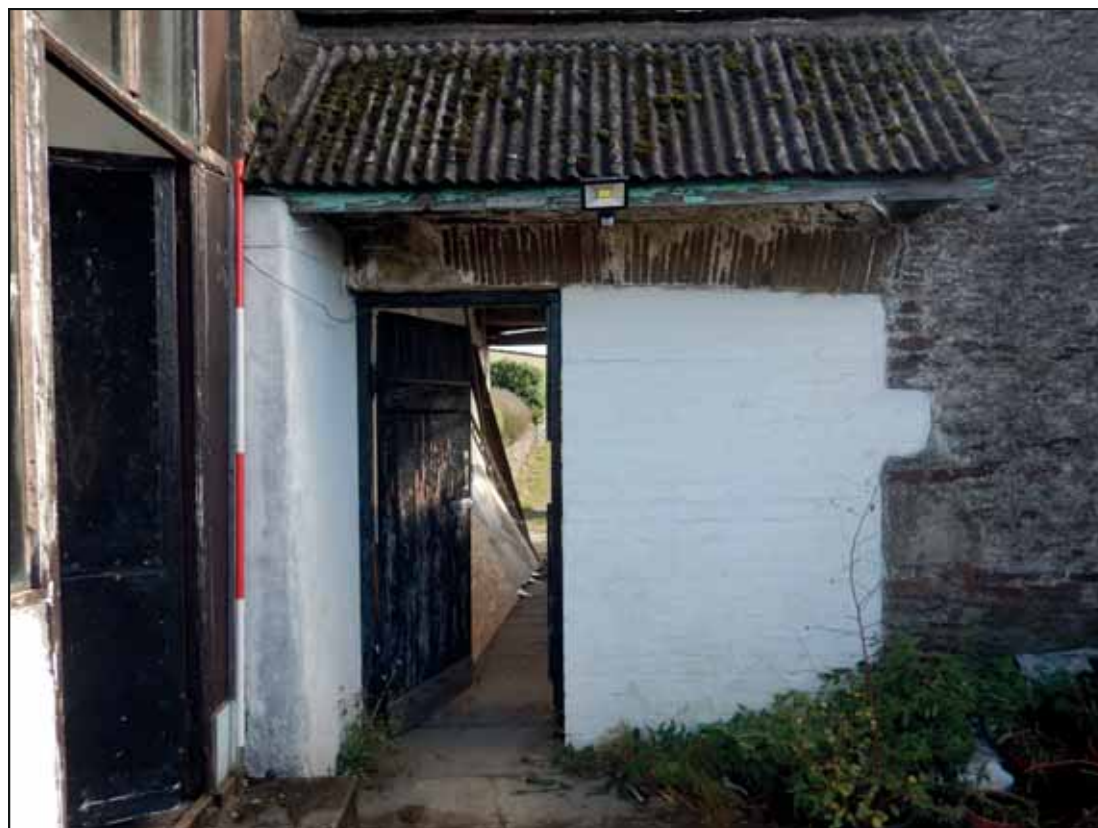
Plate 14. Partially bricked up coach doorway to west-facing elevation of barn, looking east. 2m scale.

- 4.3.26 There are large coach doorways to the north of both the east and west walls. The one in the east wall has a timber frame in poor condition and no doors. The one to the west wall has been partially bricked up with a timber door added to the north side (Plate 45). A timber lintel extends across the original opening. Both walls also have arrow-slit windows with timber lintels to the south (Plates 46 and 47). There is a brick repair patch under that to the west wall. The only fixture on the walls is a horseshoe mortared into the east wall to the south of the coach doorway with rope attached (Plate 48).

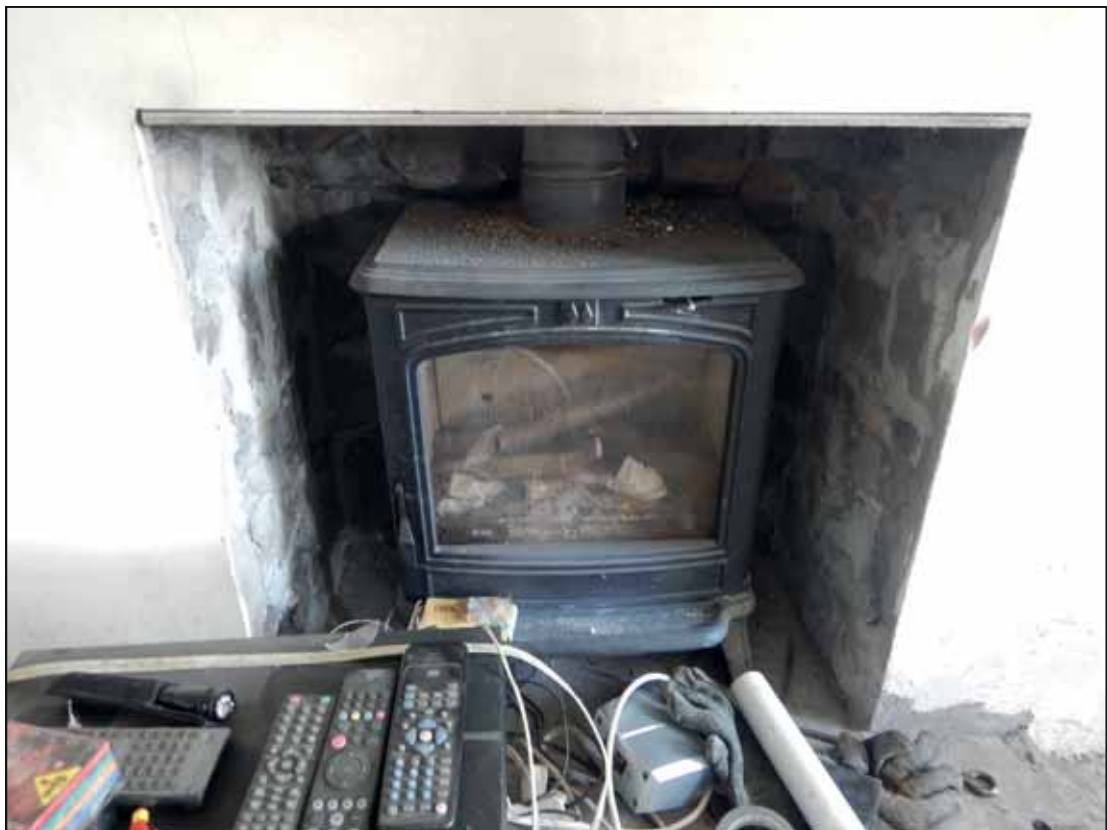
Plate 23. Wood burner in fireplace to north wall of Lounge, looking north.

- 4.3.4 There is a modern wood burner to the centre of the north wall (Plate 23). It is in a recess of exposed stone and concrete mortar, which is probably a modern infill of a larger earlier fireplace, with no surround and a cement hearth.

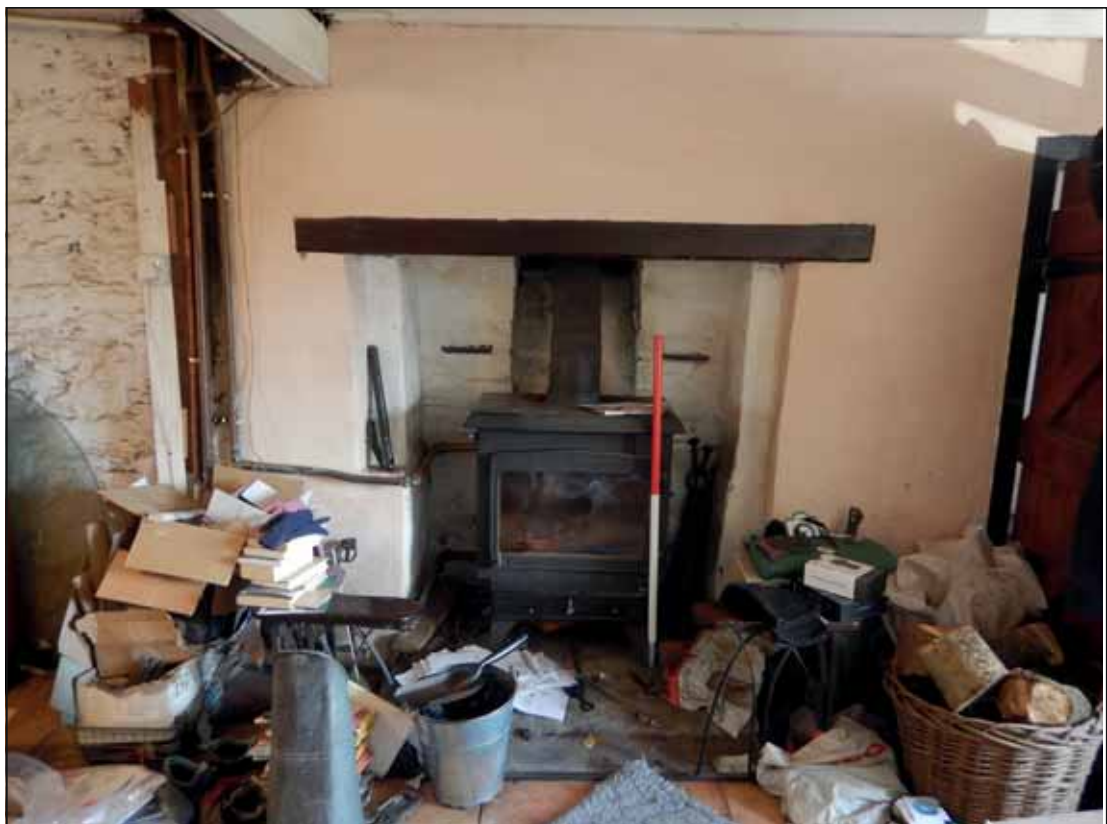
Plate 29. Fireplace with burner to the north wall of the Dining Room. 1m scale.

- 4.3.8 To the east of centre on the north wall is a fireplace with a modern wood burner (Plate 29). It is of painted stone and brickwork with a stone hearth and a wooden lintel flush to
