Cross Keys Hotel, Old Road, Skewen, Neath Port Talbot

Level 2 Building Survey

Report No: 1908

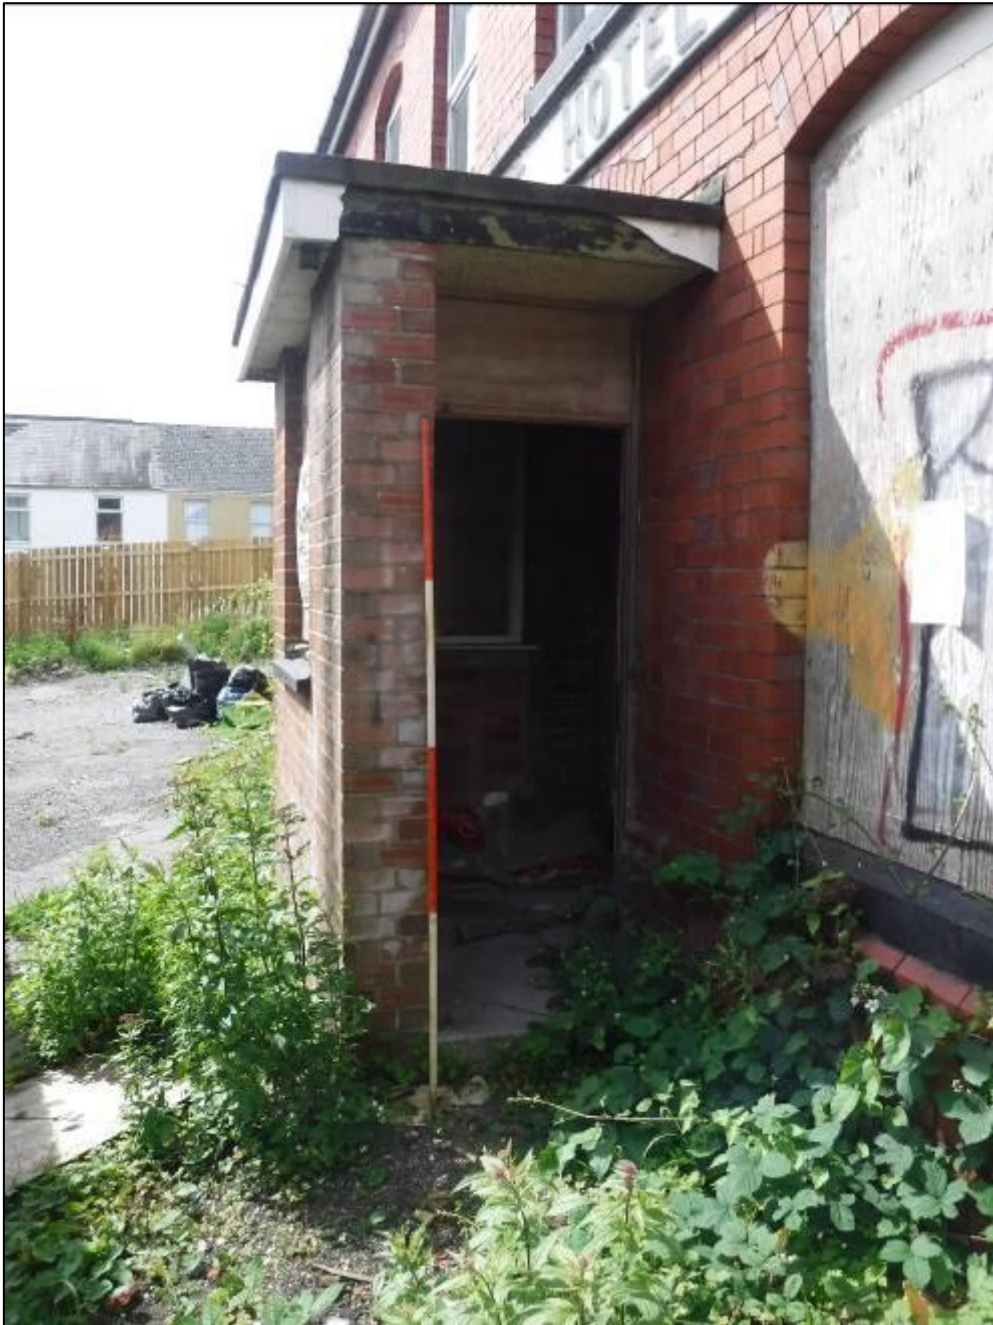
Plate 2. Front porch protruding front elevation constructed in 1960s/70s, south-west facing, 2m scale

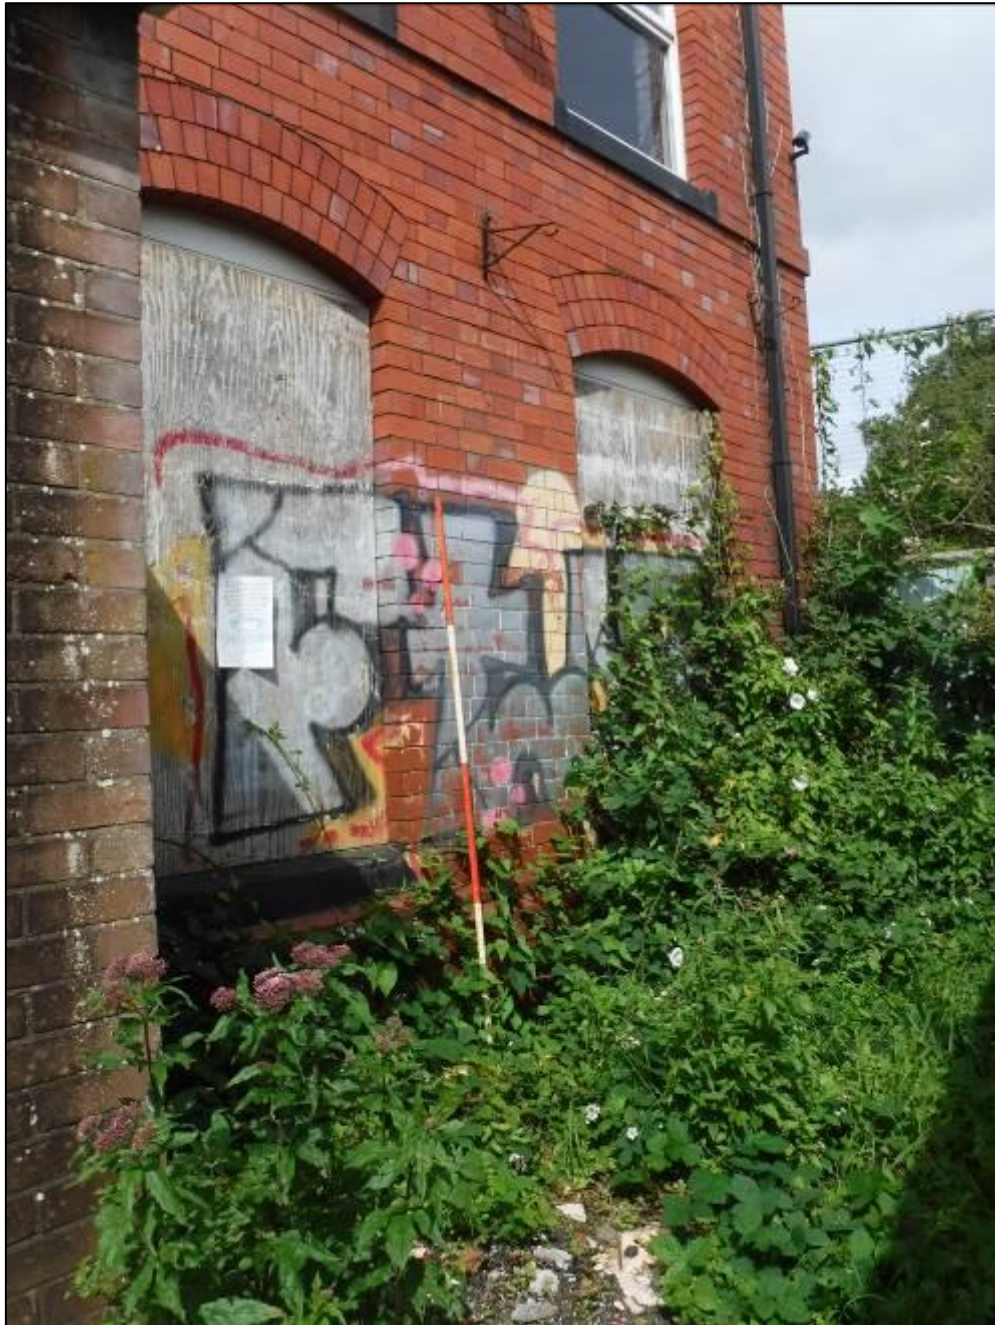
Plate 3. Two windows on ground floor of front elevation, with segmental arches and stone lintels, north-west facing, 2m scale.

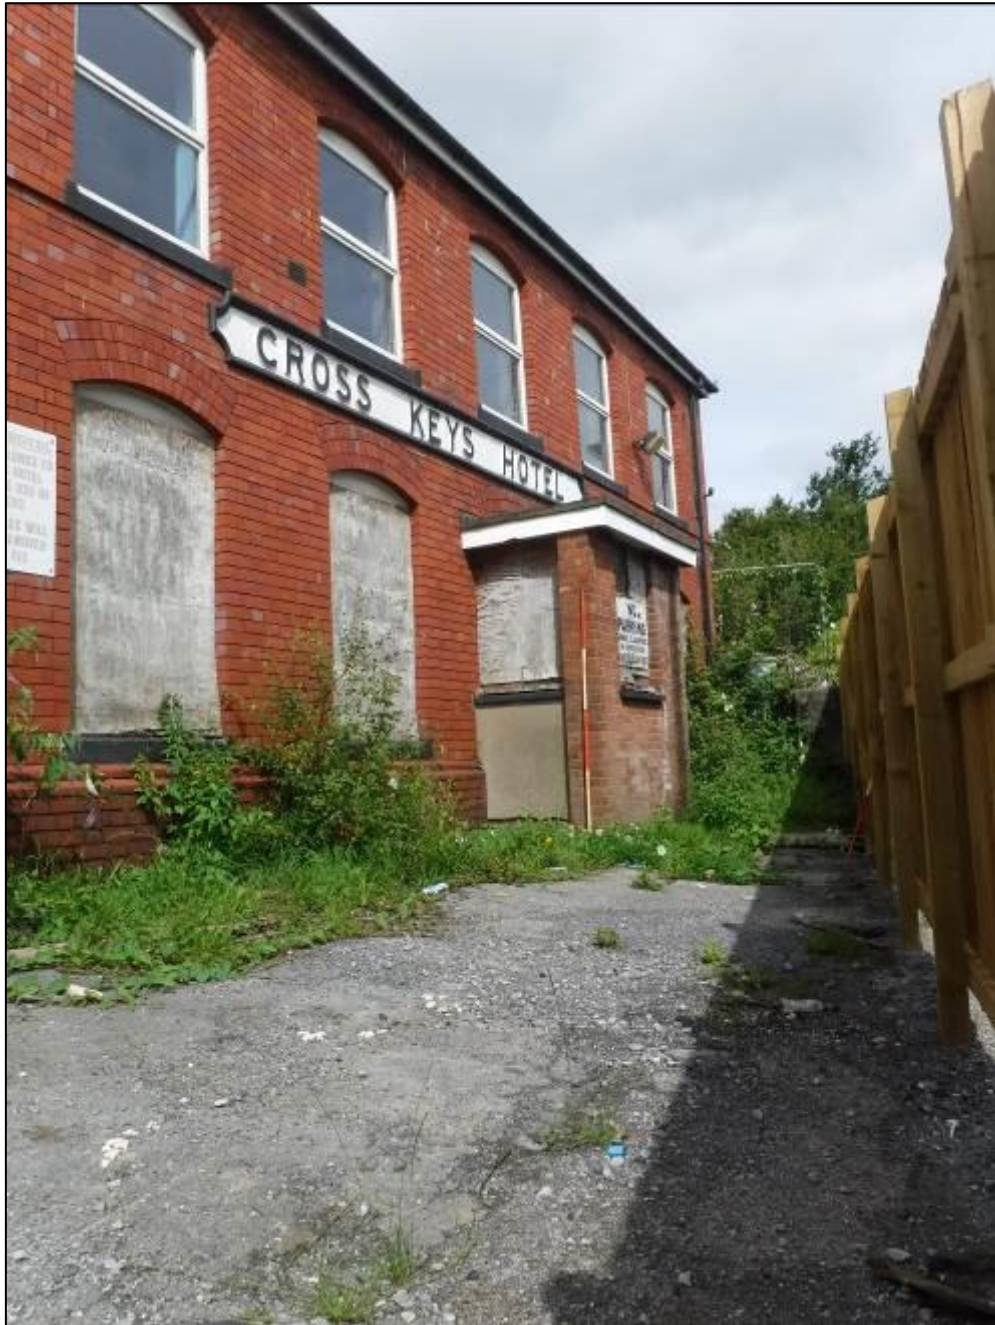
- 5.3.1 The front elevation has two-storeys with six windows on the upper storey and five windows on the ground floor (Plate 5 & 12). All of the windows on the ground floor have been blocked and boarded for security reasons. The windows on the upper storey were not boarded, but they appear to be relatively modern replacements. On the ground floor there is also a small, single-storey, flat roofed porch which protrudes from the front elevation (Plate 2 & 5). This porch has the entrance door to the building on its north elevation, and a blocked window on its east and south elevation. This porch appears to be a later edition to the building.

Plate 5. Front elevation, north-west facing, 2m scale

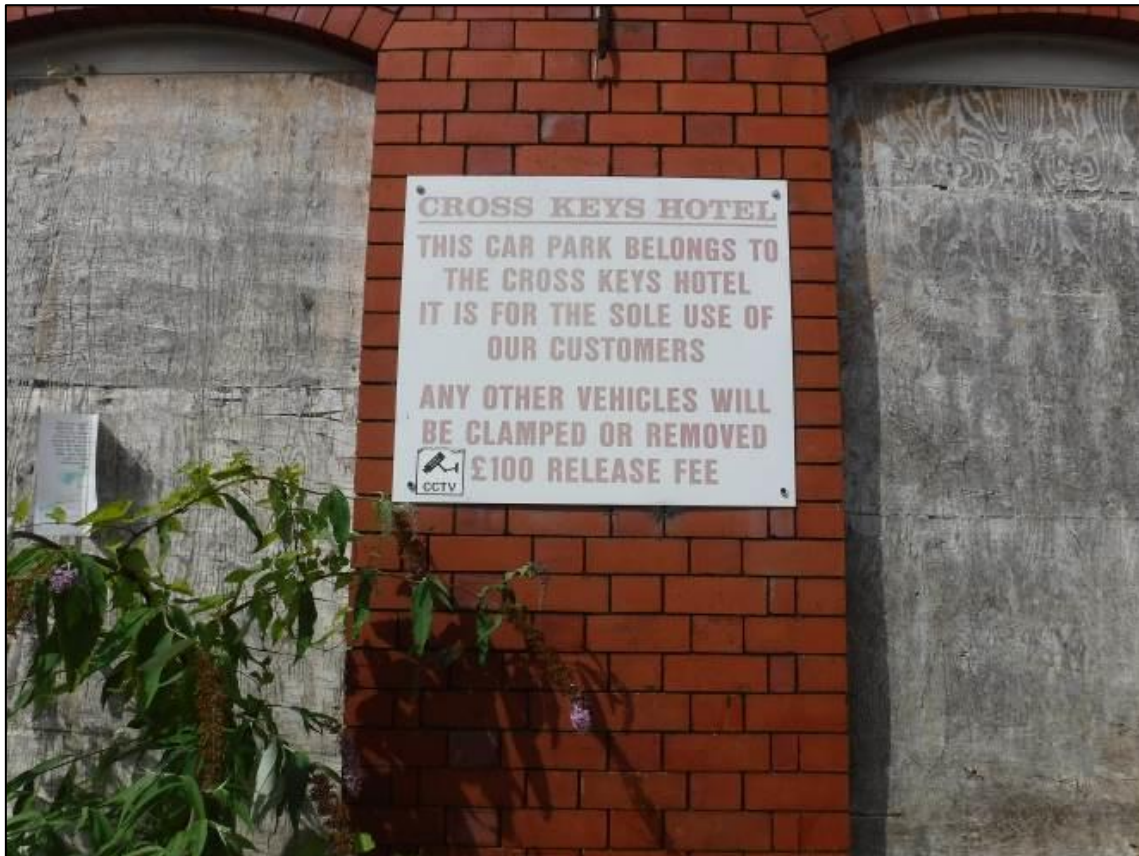
Unfortunately, the age of this sign is not clear. There is also a sign affixed to the front elevation of the ground floor (Plate 6), in between two of the most southern windows, it reads:

This sign appears to be relatively modern, and probably dates to the last few decades of the buildings use as a public house.

Plate 6. Sign/parking notice on front elevation, west facing

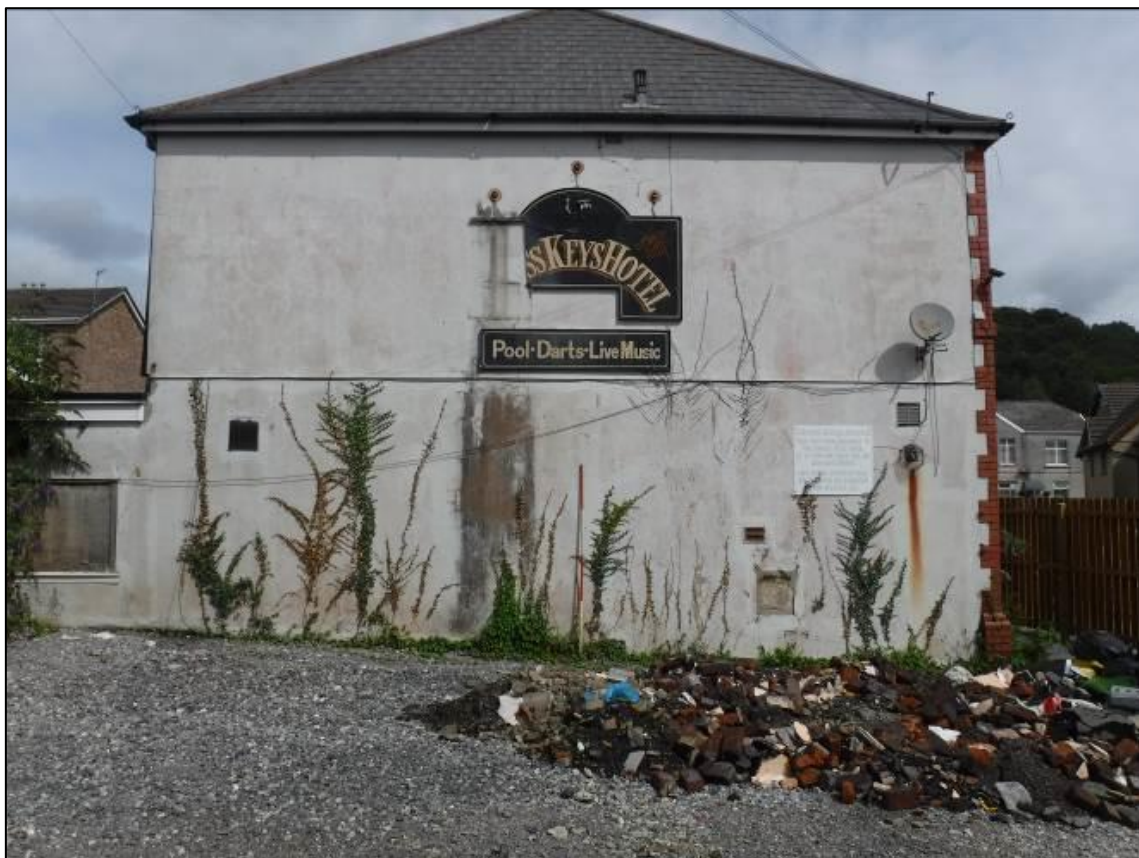
- 5.4.1 Unlike the front elevation, the southern elevation, does not have a brick constructed finish, and instead has a rendered finish. The current colour of this render is a light discoloured grey colour (Plate 7). The later single-storey, flat roofed, extension at the rear of the building can be seen clearly from this elevation, and the extension has a small blocked and boarded window facing southwards (Plate 11).
- 5.4.2 On the upper storey of this elevation there is a damaged sign for the public house, it reads:

Plate 7. Southern elevation, north facing, 2m scale

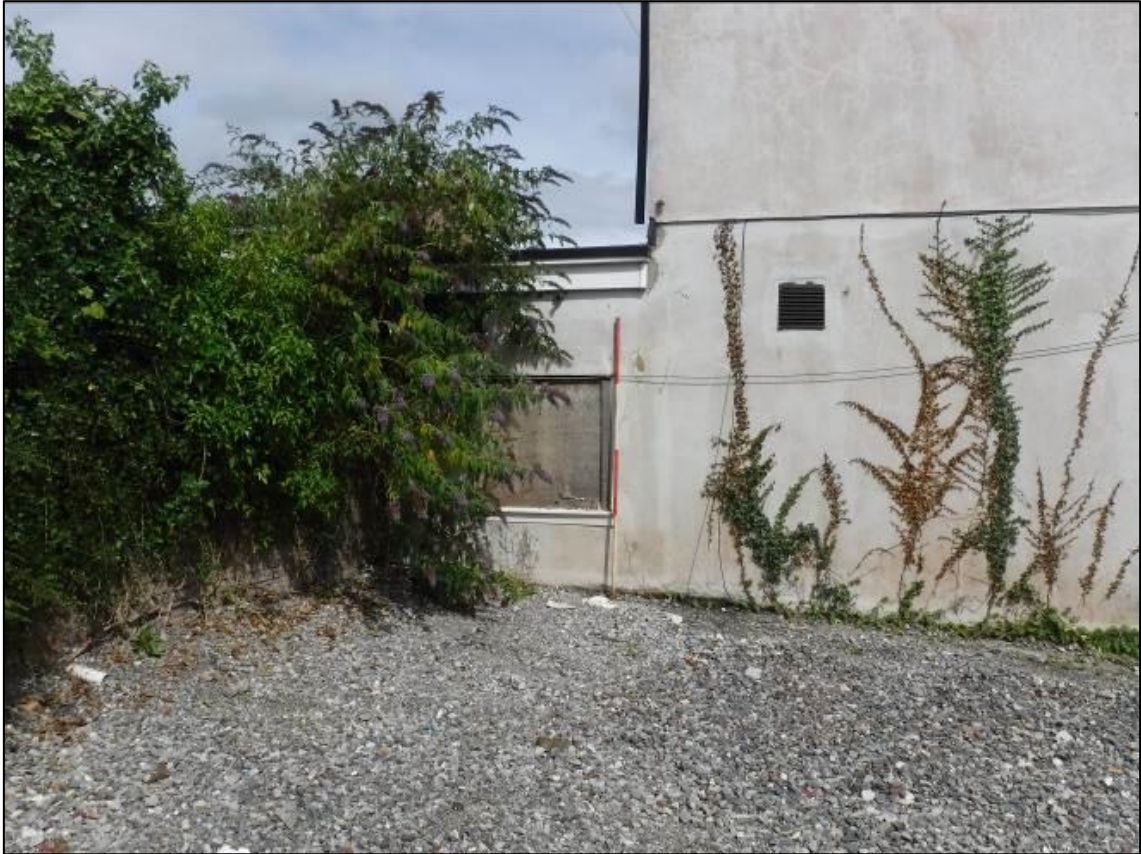
Plate 10. Southern elevation, 1960s/1970s single-storey extension, north facing, 2m scale

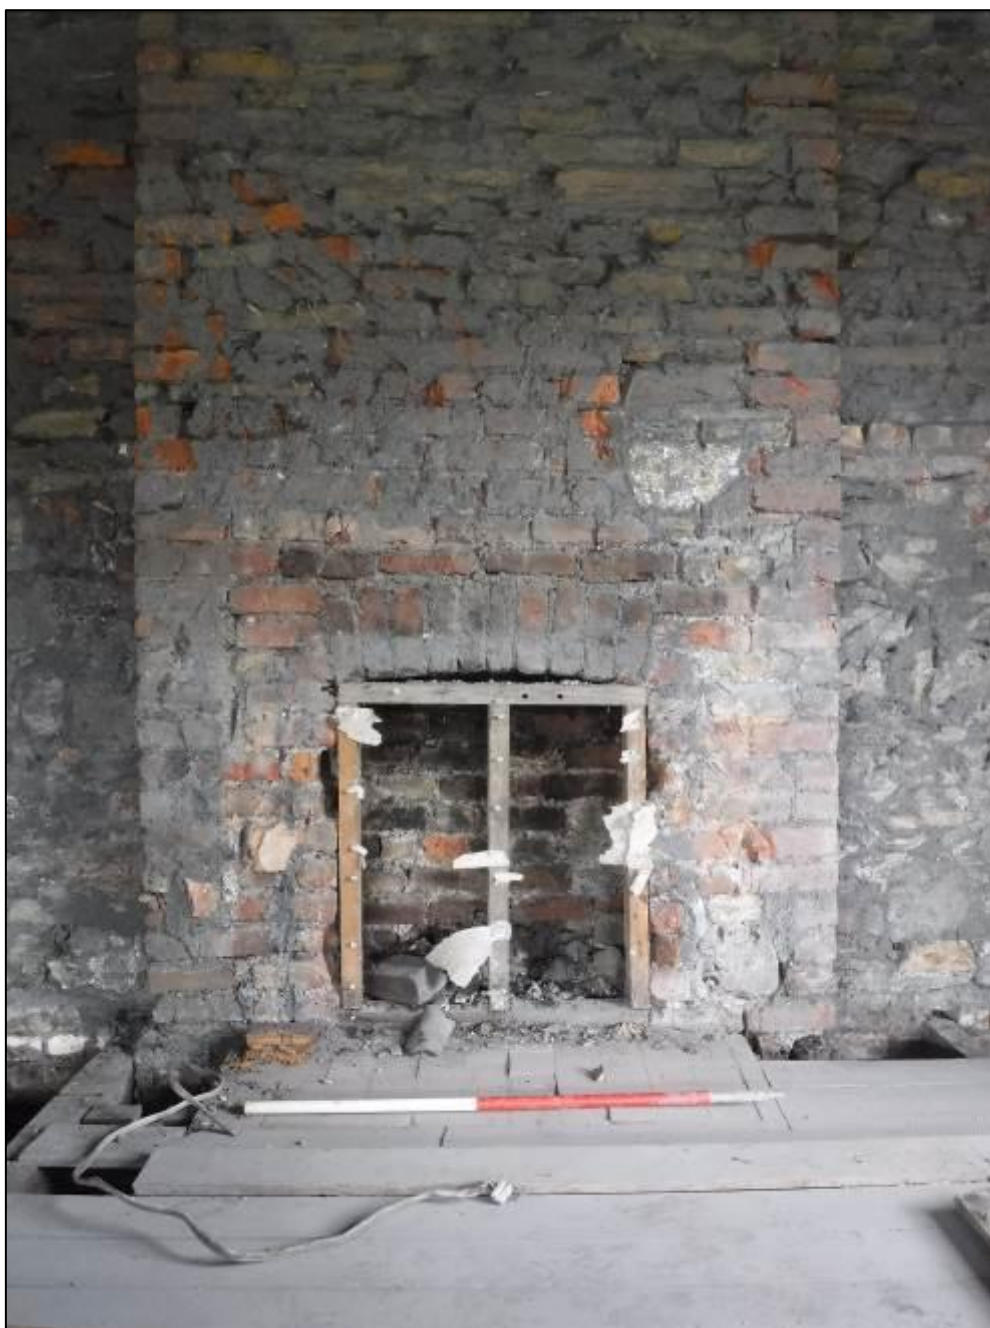
Plate 21. First floor: western wall, chimney breast previously had been blocked by a wooden framed partition, facing west, 1m scale

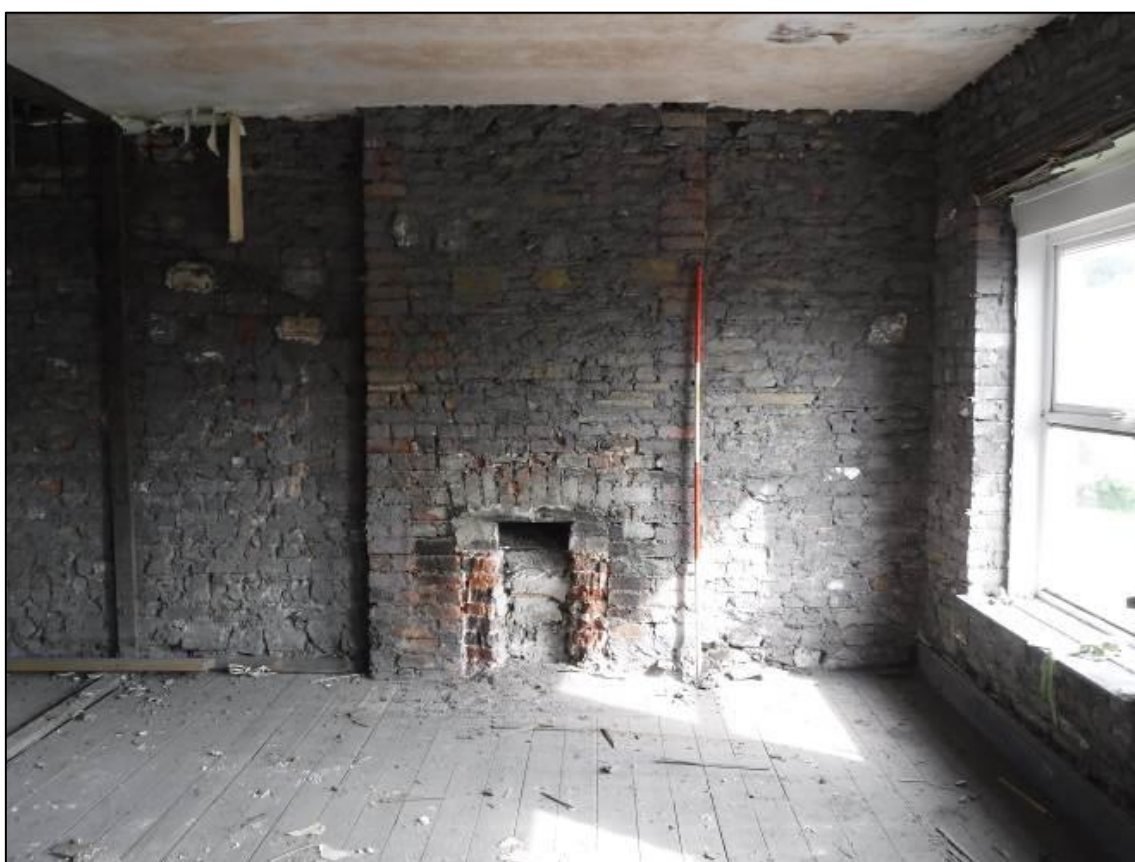
Plate 23. First Floor, northern wall, chimney breast with blocked fireplace, facing north, 2m scale

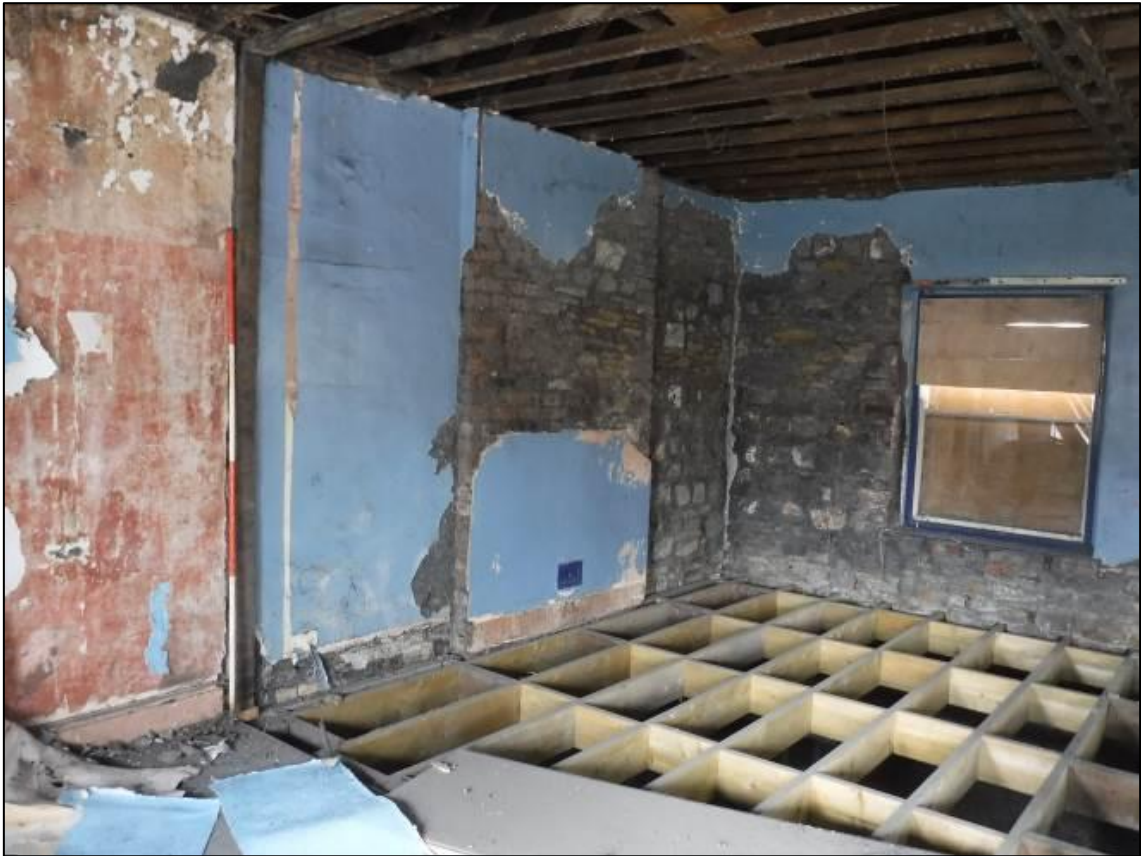
Plate 33. First floor: southern wall, with chimney breast partially exposed along with exposed floor joists, south-west facing, 2m scale

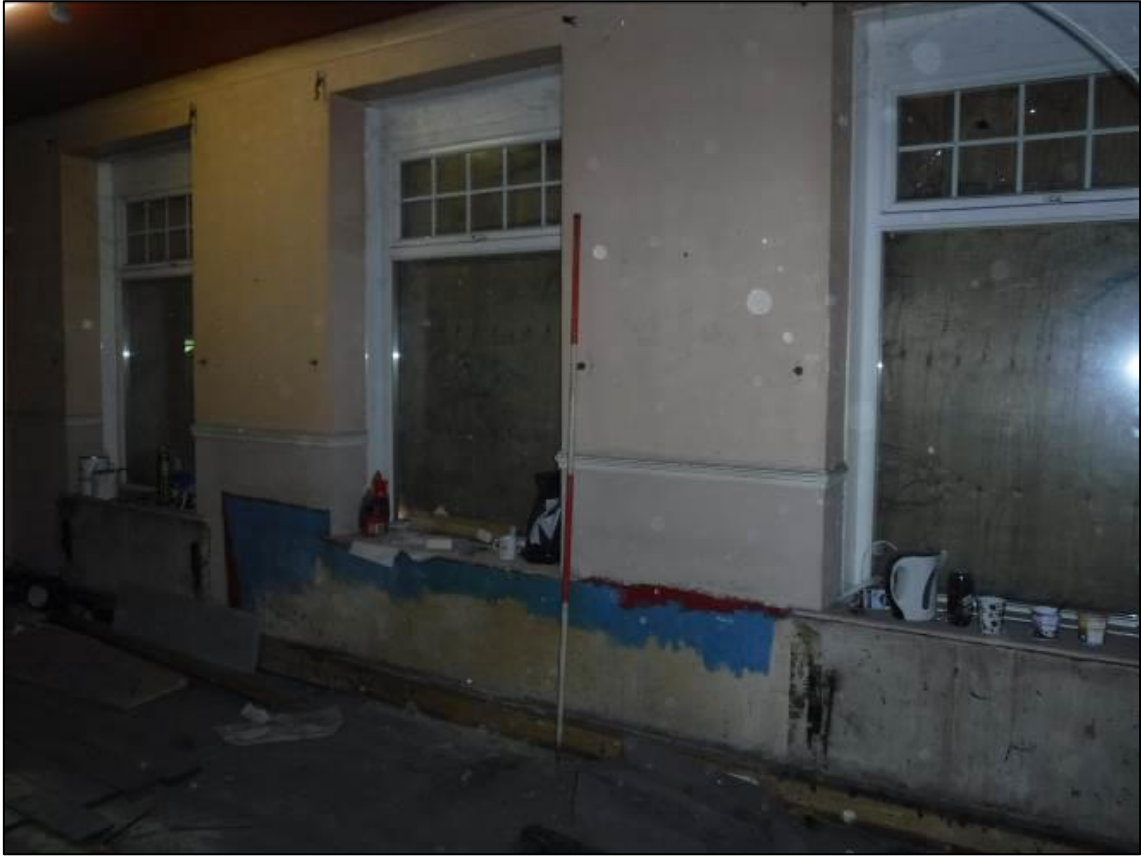
Plate 59. Ground floor, Room 4: eastern wall with blocked windows, north-east facing, 2m scale

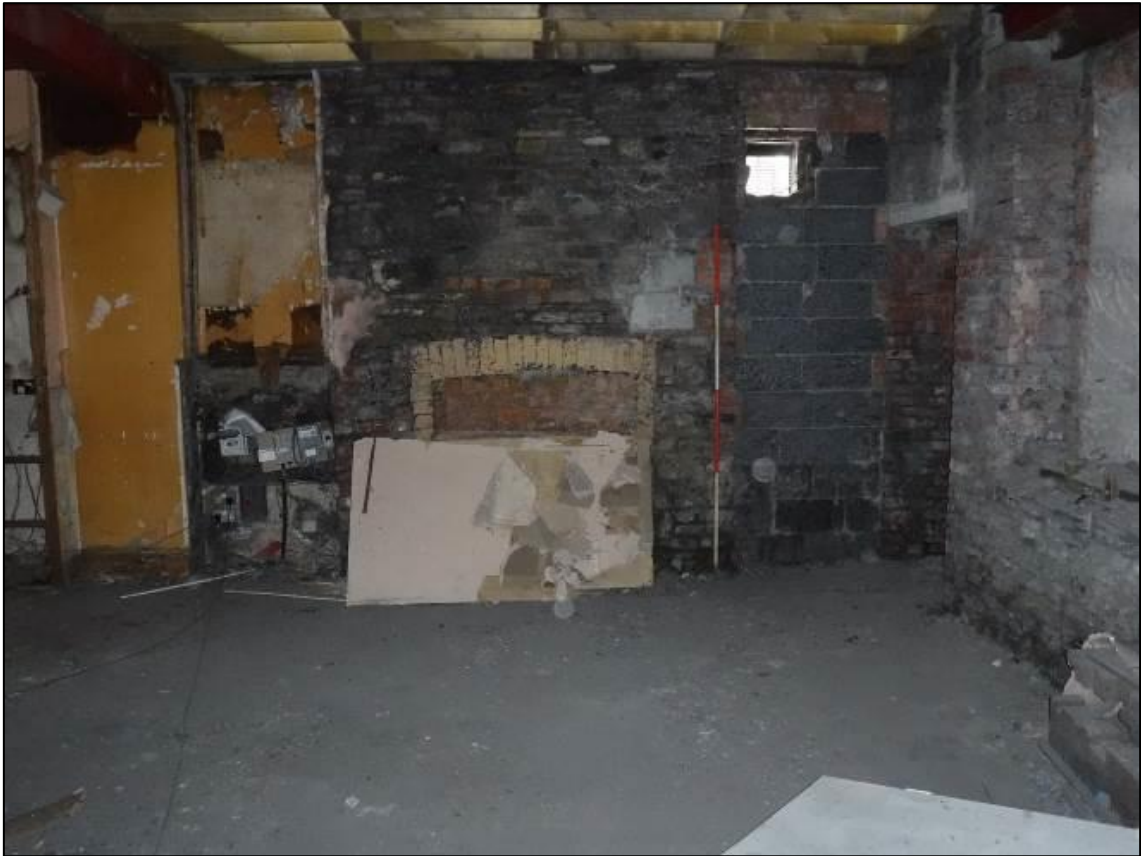
Plate 61. Ground floor, Room 4: southern wall with chimney breast and bricked-up fireplace, south facing, 2m scale

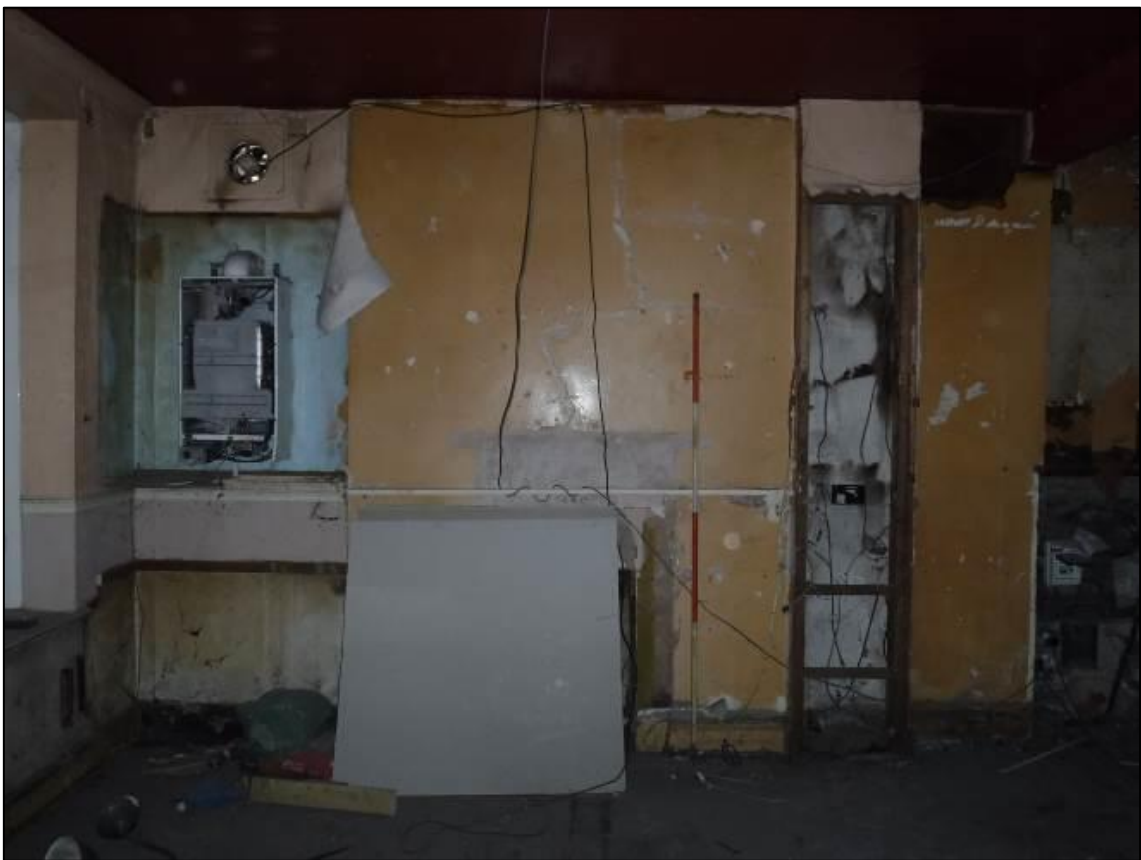
Plate 62. Ground floor, Room 4: southern wall with chimney breast with fireplace covered up by plaster and paint, south facing, 2m scale

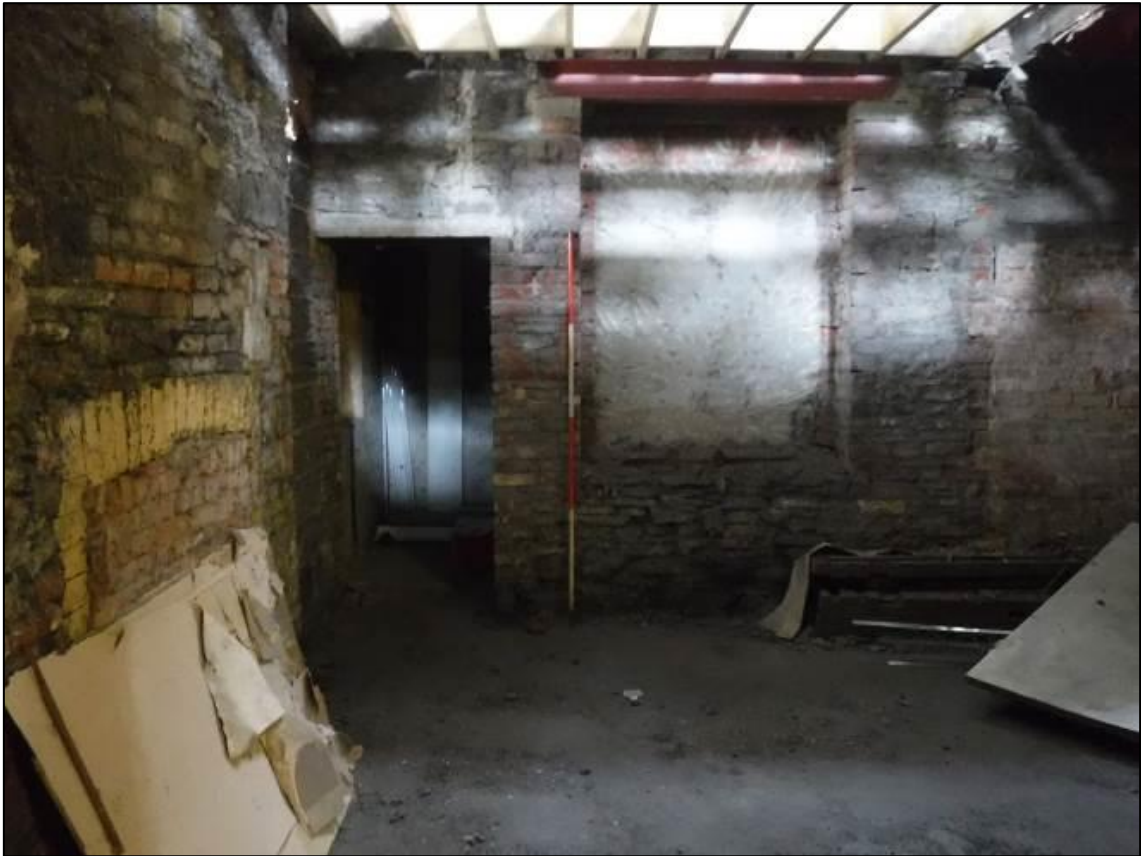
Plate 63. Ground floor, Room 4: view towards western wall, original window can clearly be seen blocked up with concrete blocks, with doorway to Room 5 adjacent to window, west facing, 2m scale

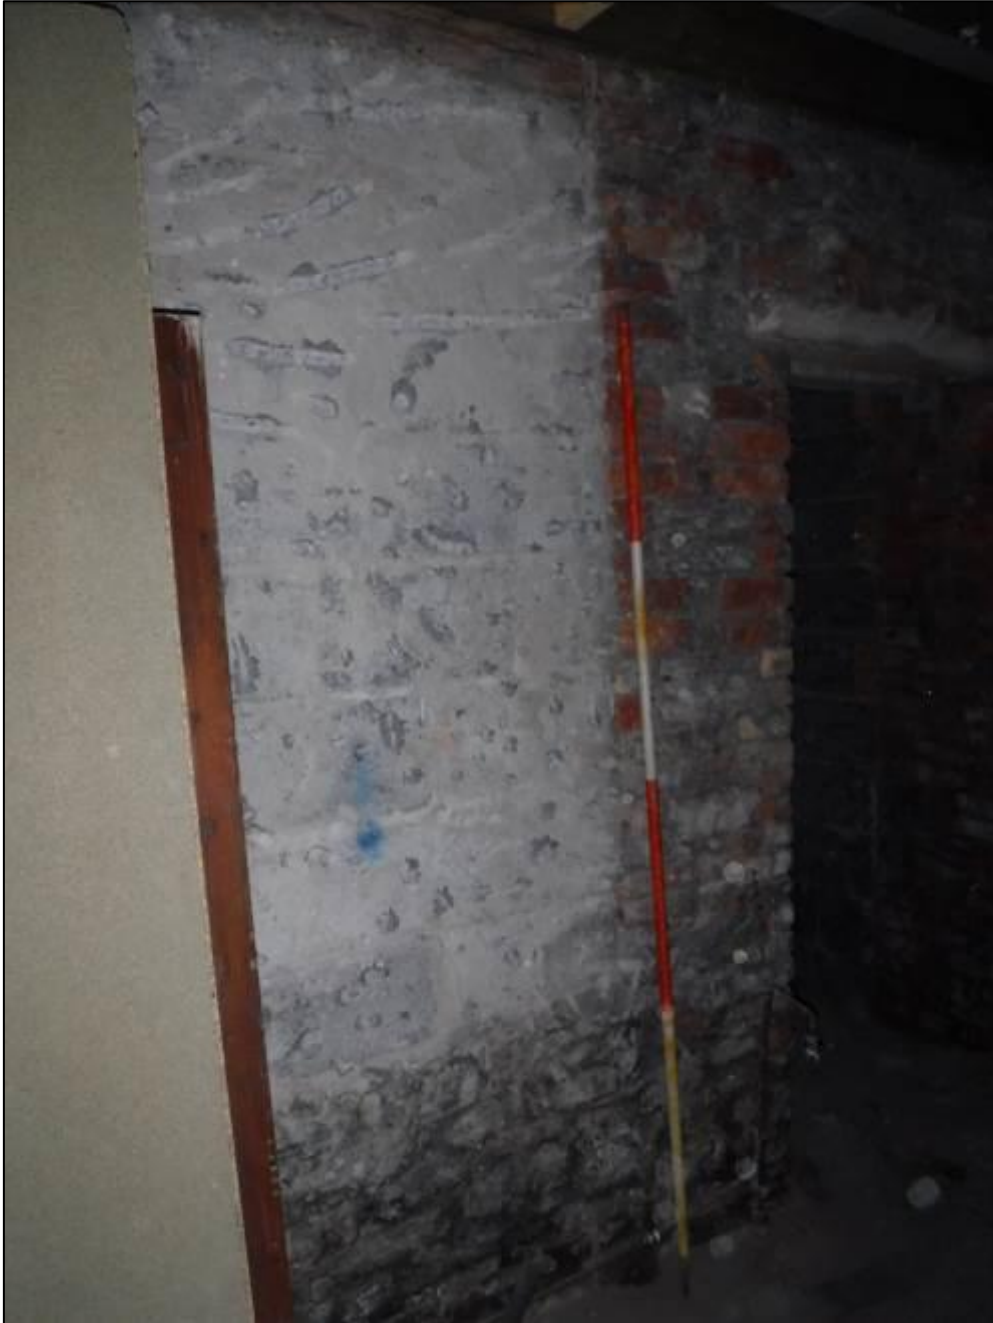
Plate 65. Ground floor, Room 5: eastern wall and original exterior wall of building, with blocked window clearly visible, alongside doorway to Room 4, south-east facing, 2m scale

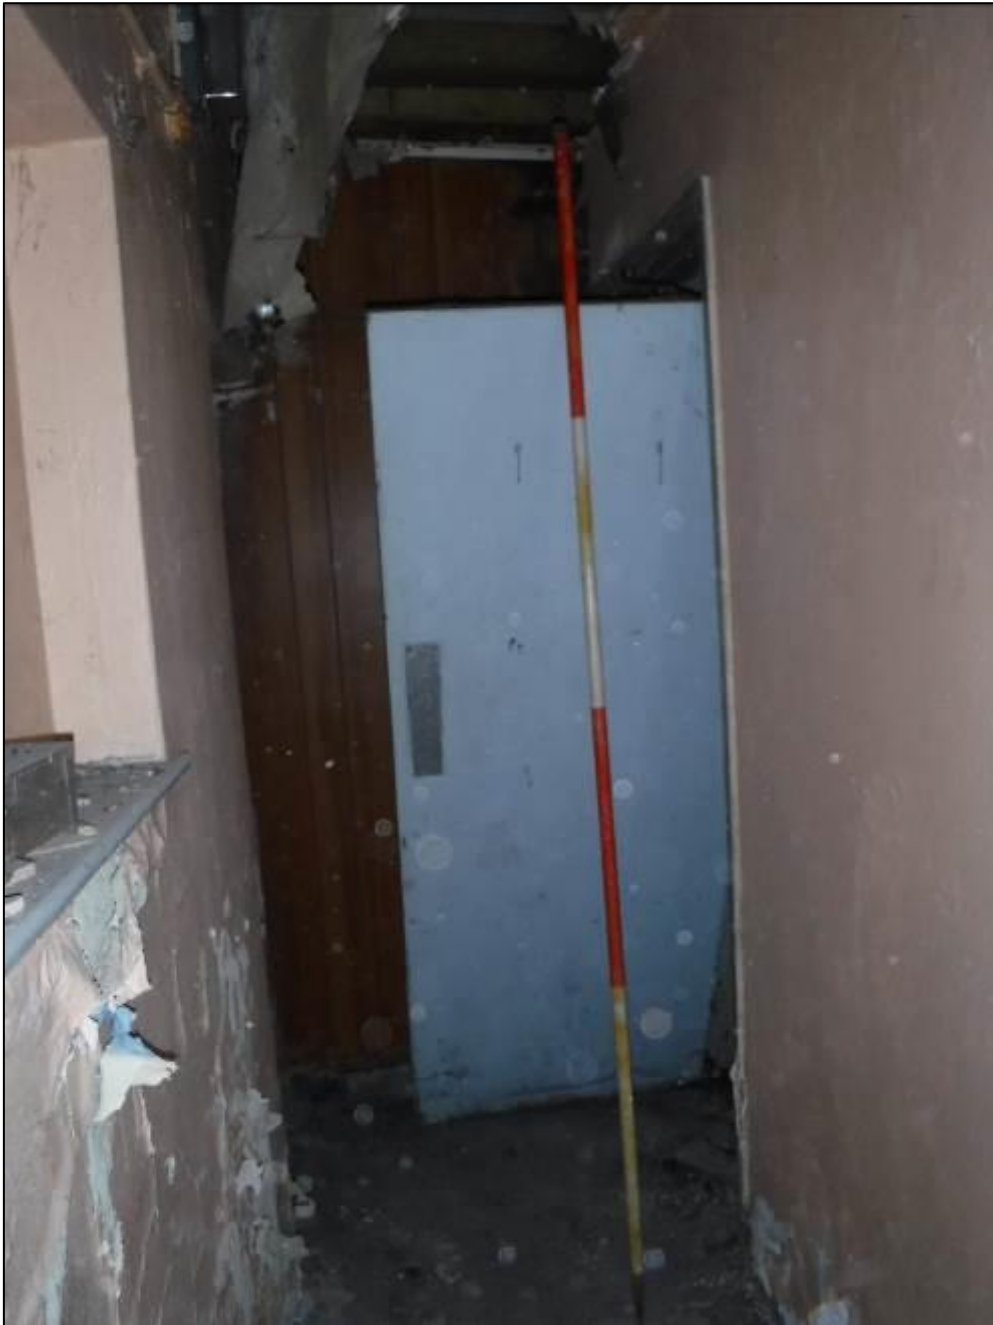
Plate 68. Ground floor, Room 7, blocked entrance to room, west facing, 2m scale
