HOREB WELSH BAPTIST CHAPEL, CASTLE HILL, GELLIGAER, CAERPHILLY

Archaeological Building Recording

Report No. 2040

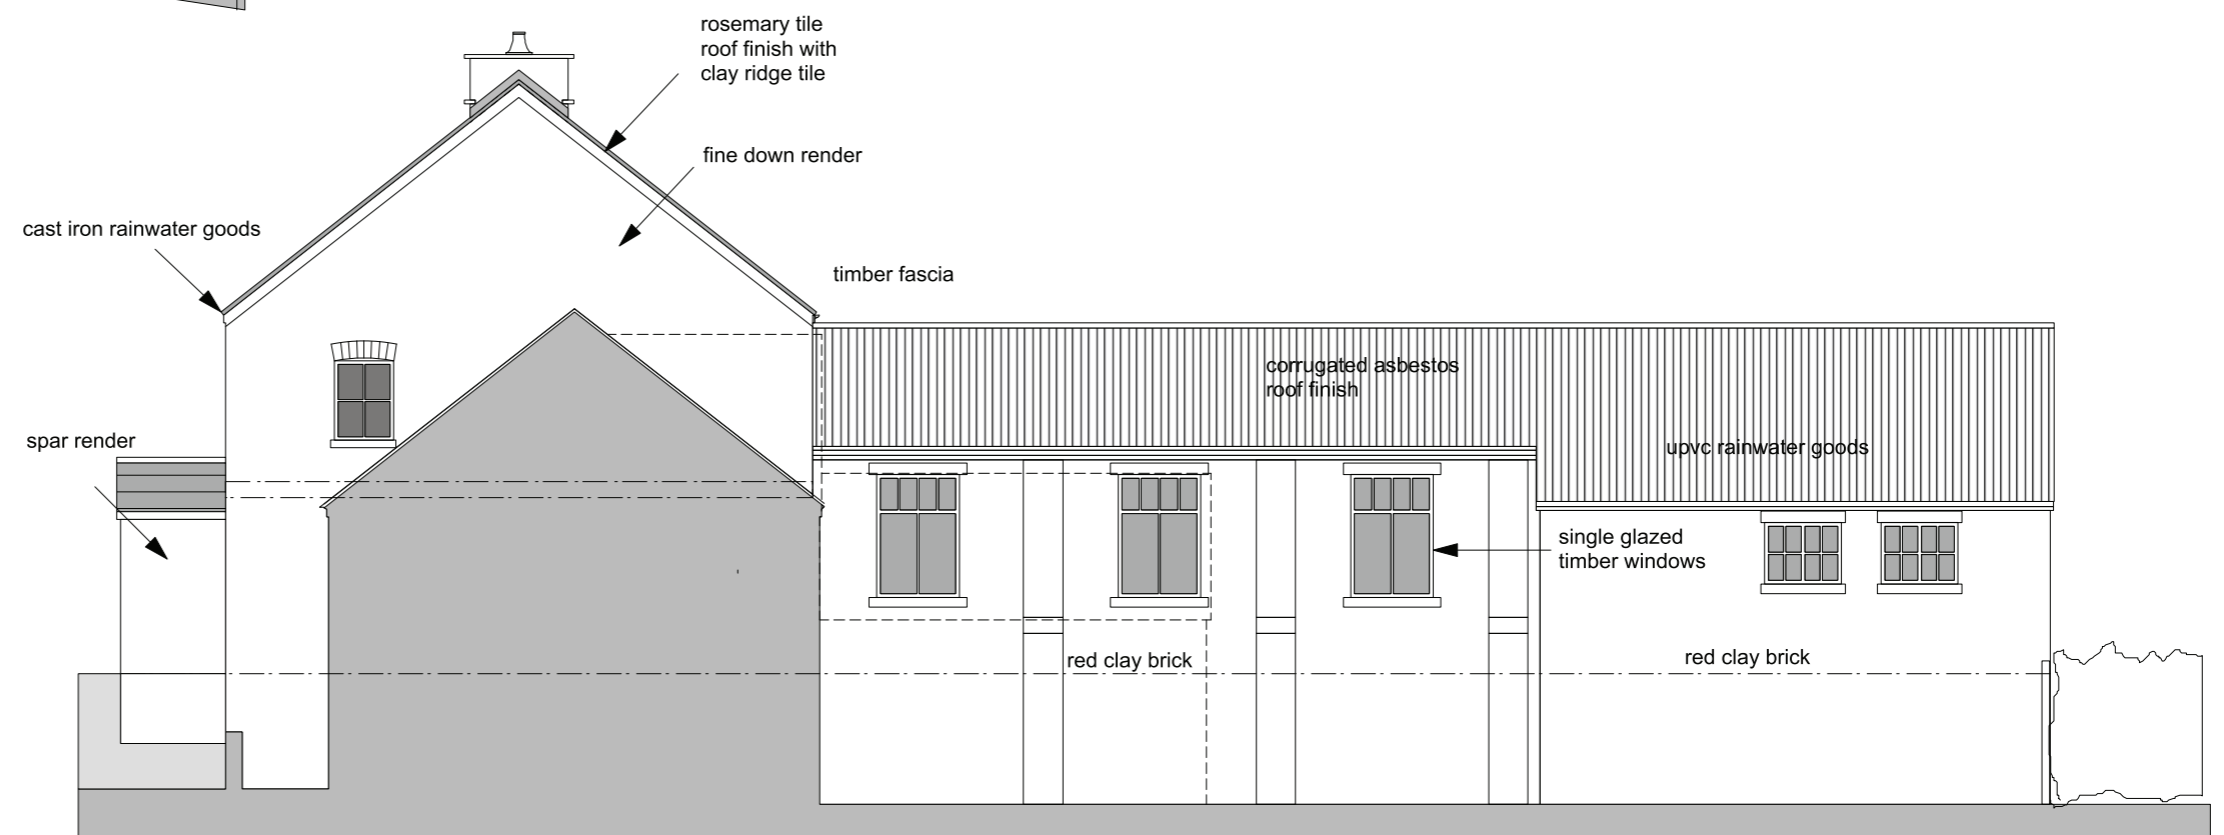
Figure 5. Front and east-facing elevations of Horeb Welsh Baptist Chapel

- 3.2.5 The east-facing elevation consists of the gable end of the original building, the side of the porch, and the side of the rear extension (Figure 5).

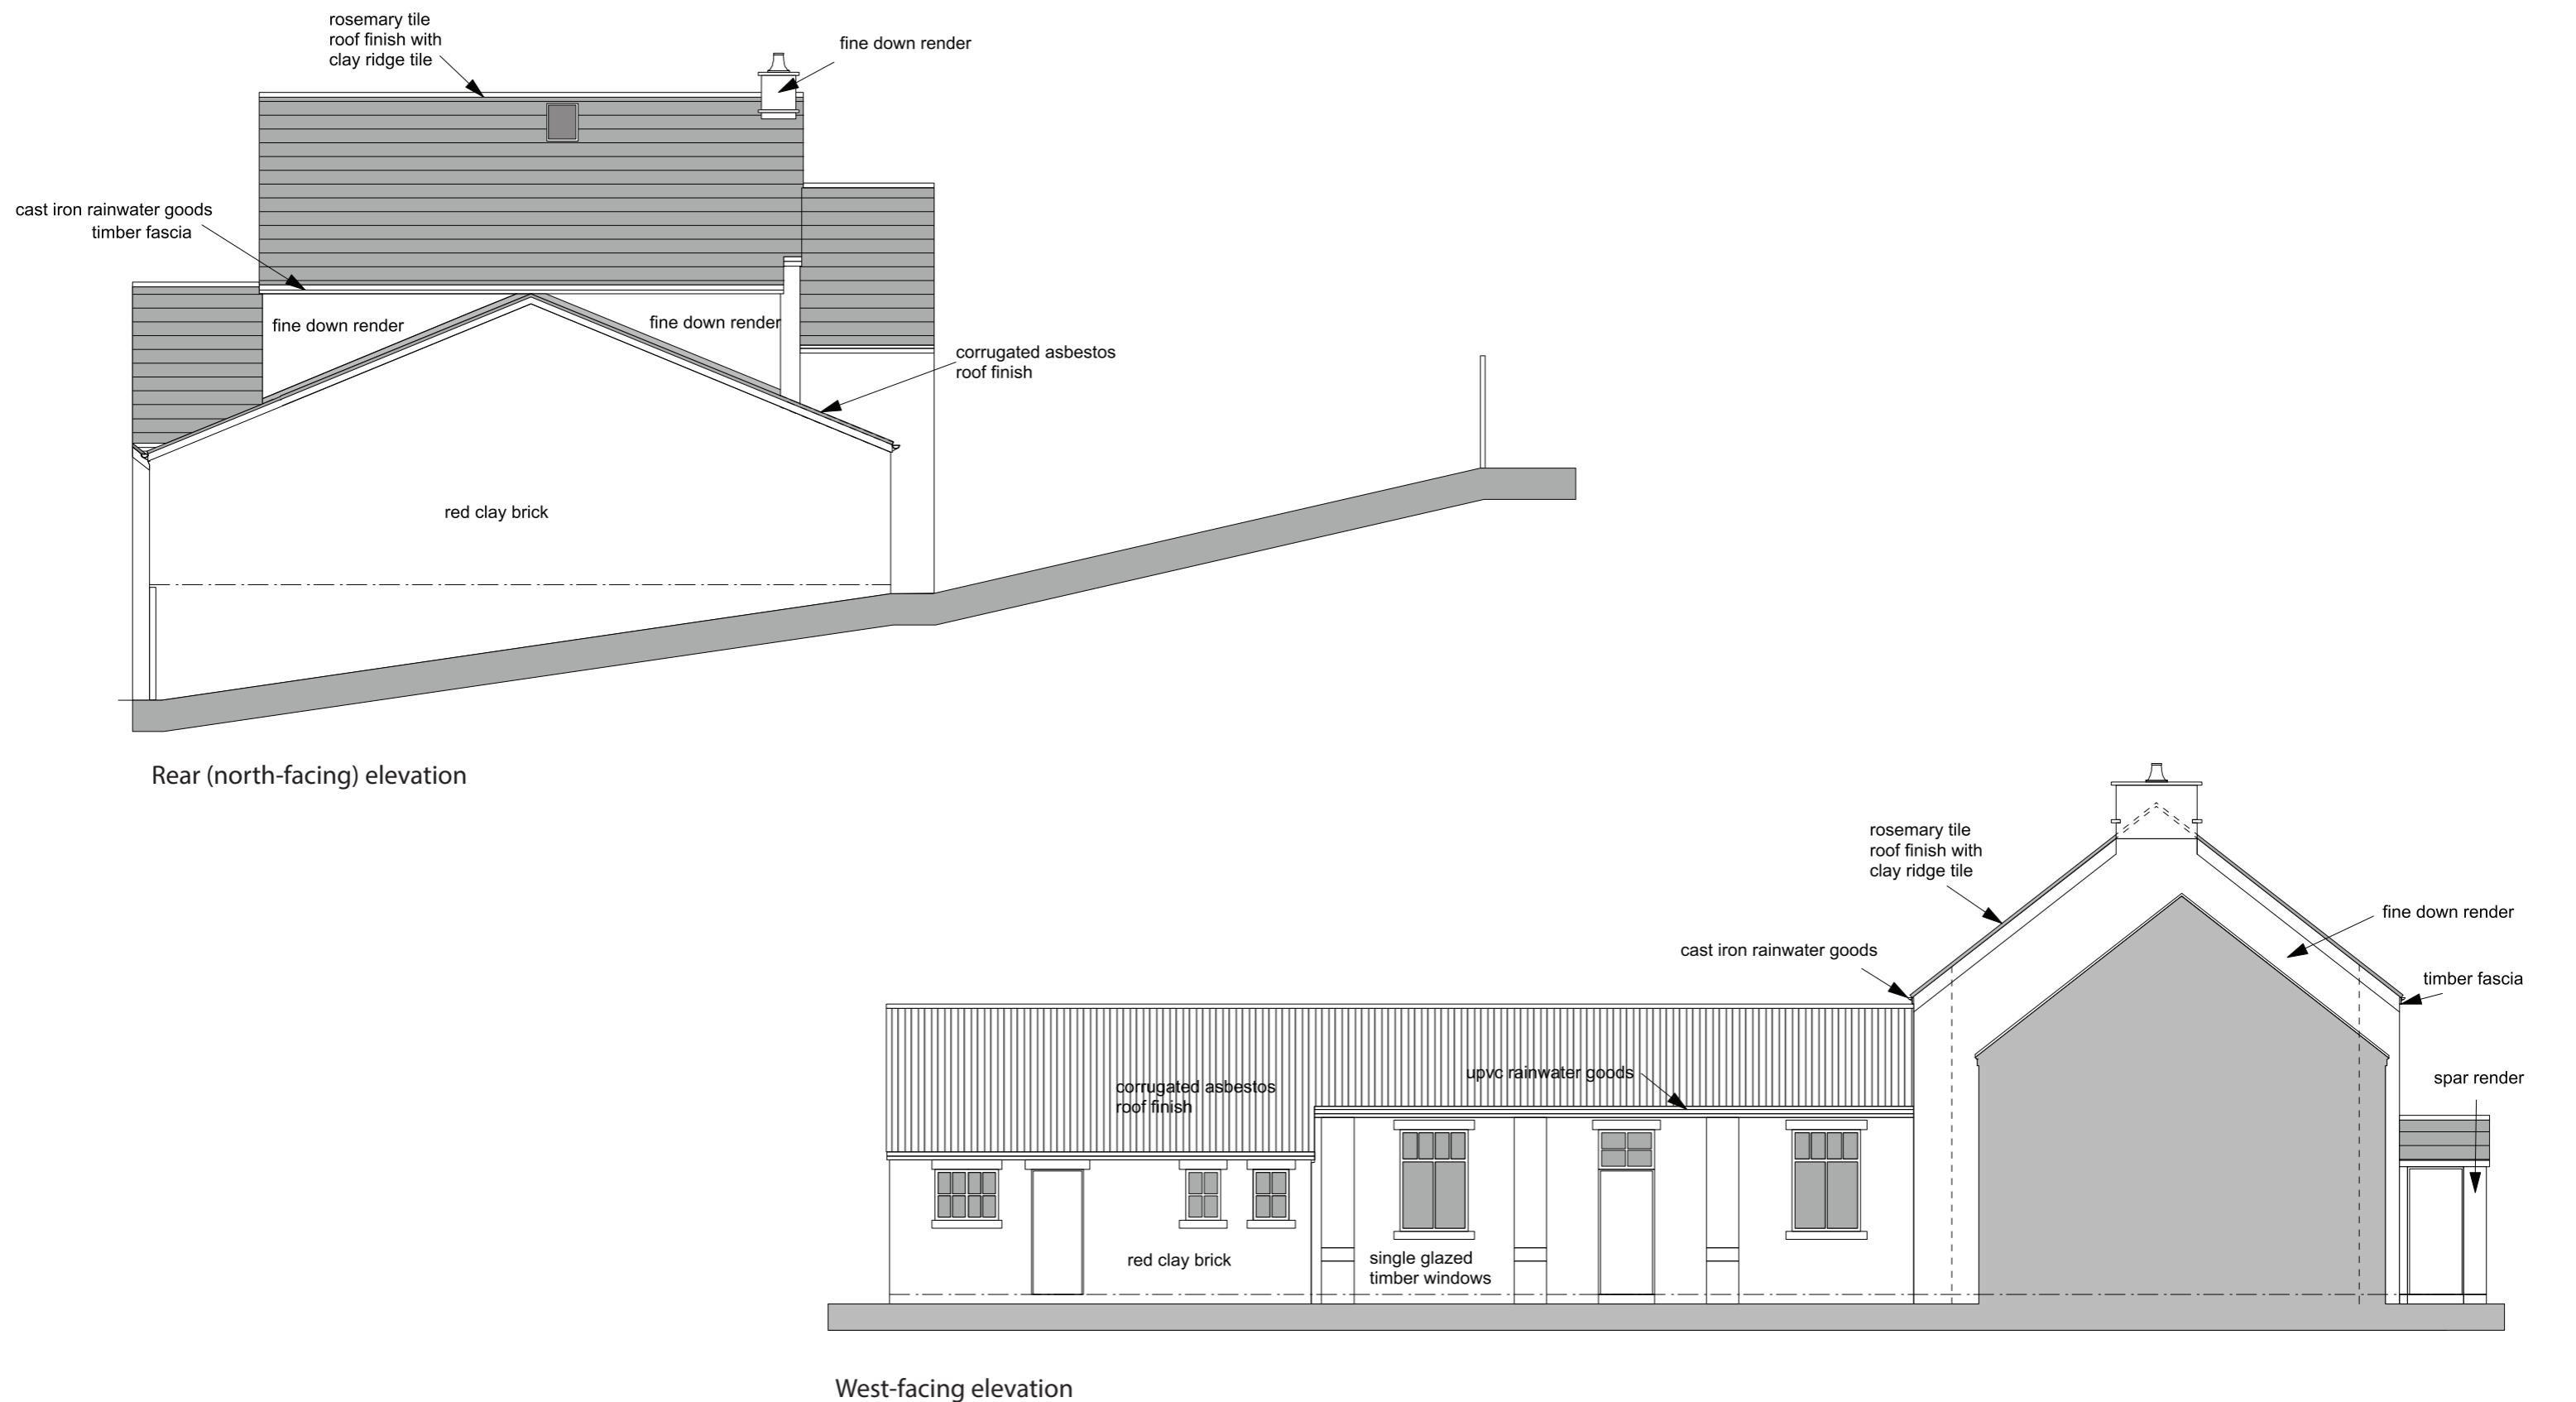
Figure 6. North-facing and west-facing elevations of Horeb Welsh Baptist Chapel

- 3.2.9 The north-facing elevation consists of the long wall of the original building and the gable end of the rear extension (Figure 6).
- 3.2.10 The original building has cement render to the rear elevation (Plate 13). There is a skylight to the centre of the top of the roof.
- 3.2.11 The rear extension is of red brick in a stretcher bond (Plate 14). It has black-painted wooden fascias to the roof.

- 3.2.12 The west-facing elevation consists of the long wall of the rear extension, the gable end of the original building and the side of the gabled front porch (Figure 6).
- 3.2.13 The rear extension is a single storey with five bays (Plate 15). The northern two bays are projecting. It is of red brick in a stretcher bond. The southern three bays are divided by narrow brick pilasters. The five windows have all been boarded up. They have smooth finished cement sills and lintels (Plate 16). There is a door to the northernmost bay which has also been boarded up. The building is currently accessed by a door to the second bay from the south (Plate 17). There are two foundation stones to the pilasters to the right-hand side of the doorway. The first is inscribed:

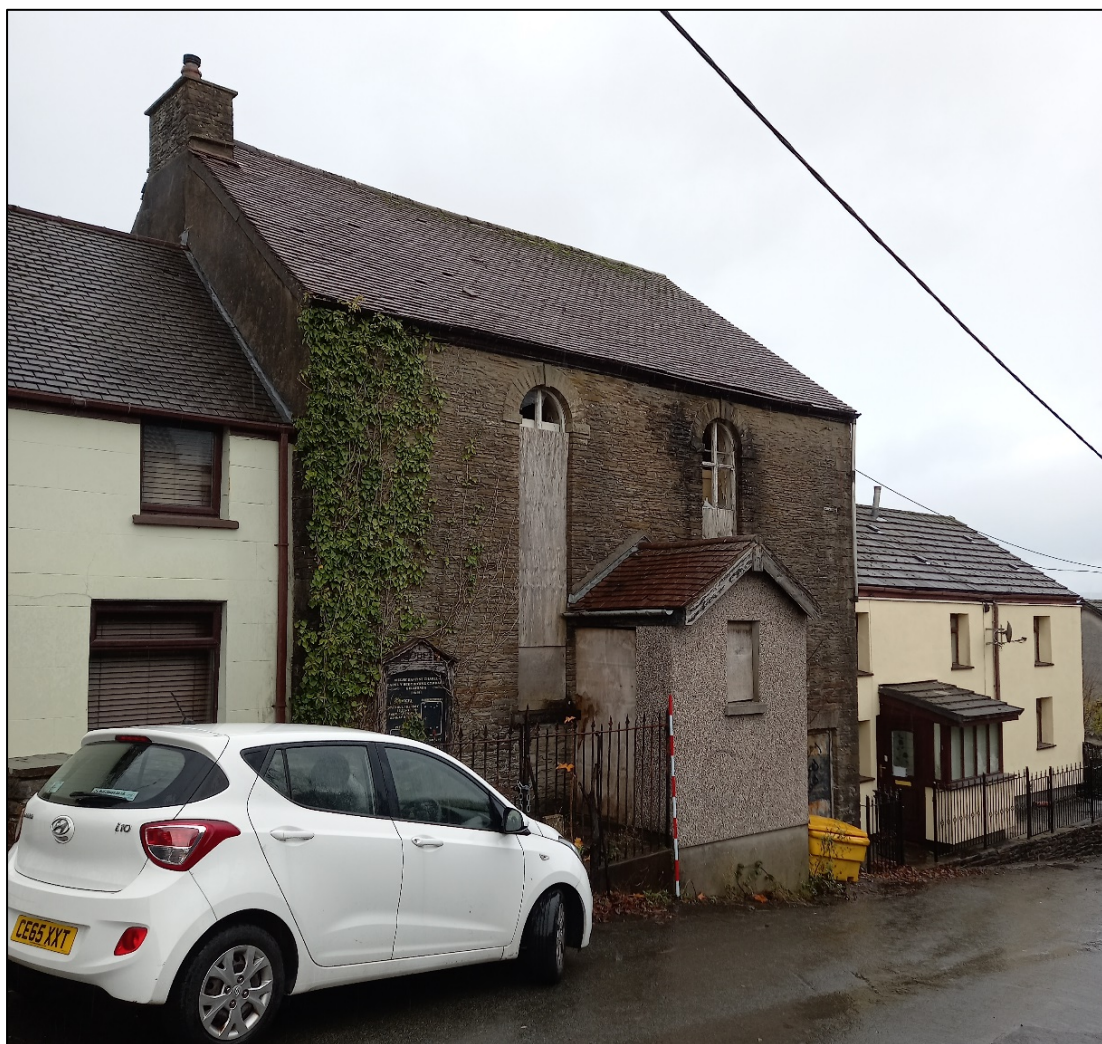
Plate 2: South-facing elevation of Horeb Welsh Baptist Chapel, looking north-east. 2m scale.

- 3.2.1 The front elevation of the Chapel is the long wall of the building with a central single storey gabled entrance porch (Figure 5; Plate 2). The main building wall is of thin, coursed local squared rubble stone with larger quoins, while the porch is rendered with spar dash (Plate 3).

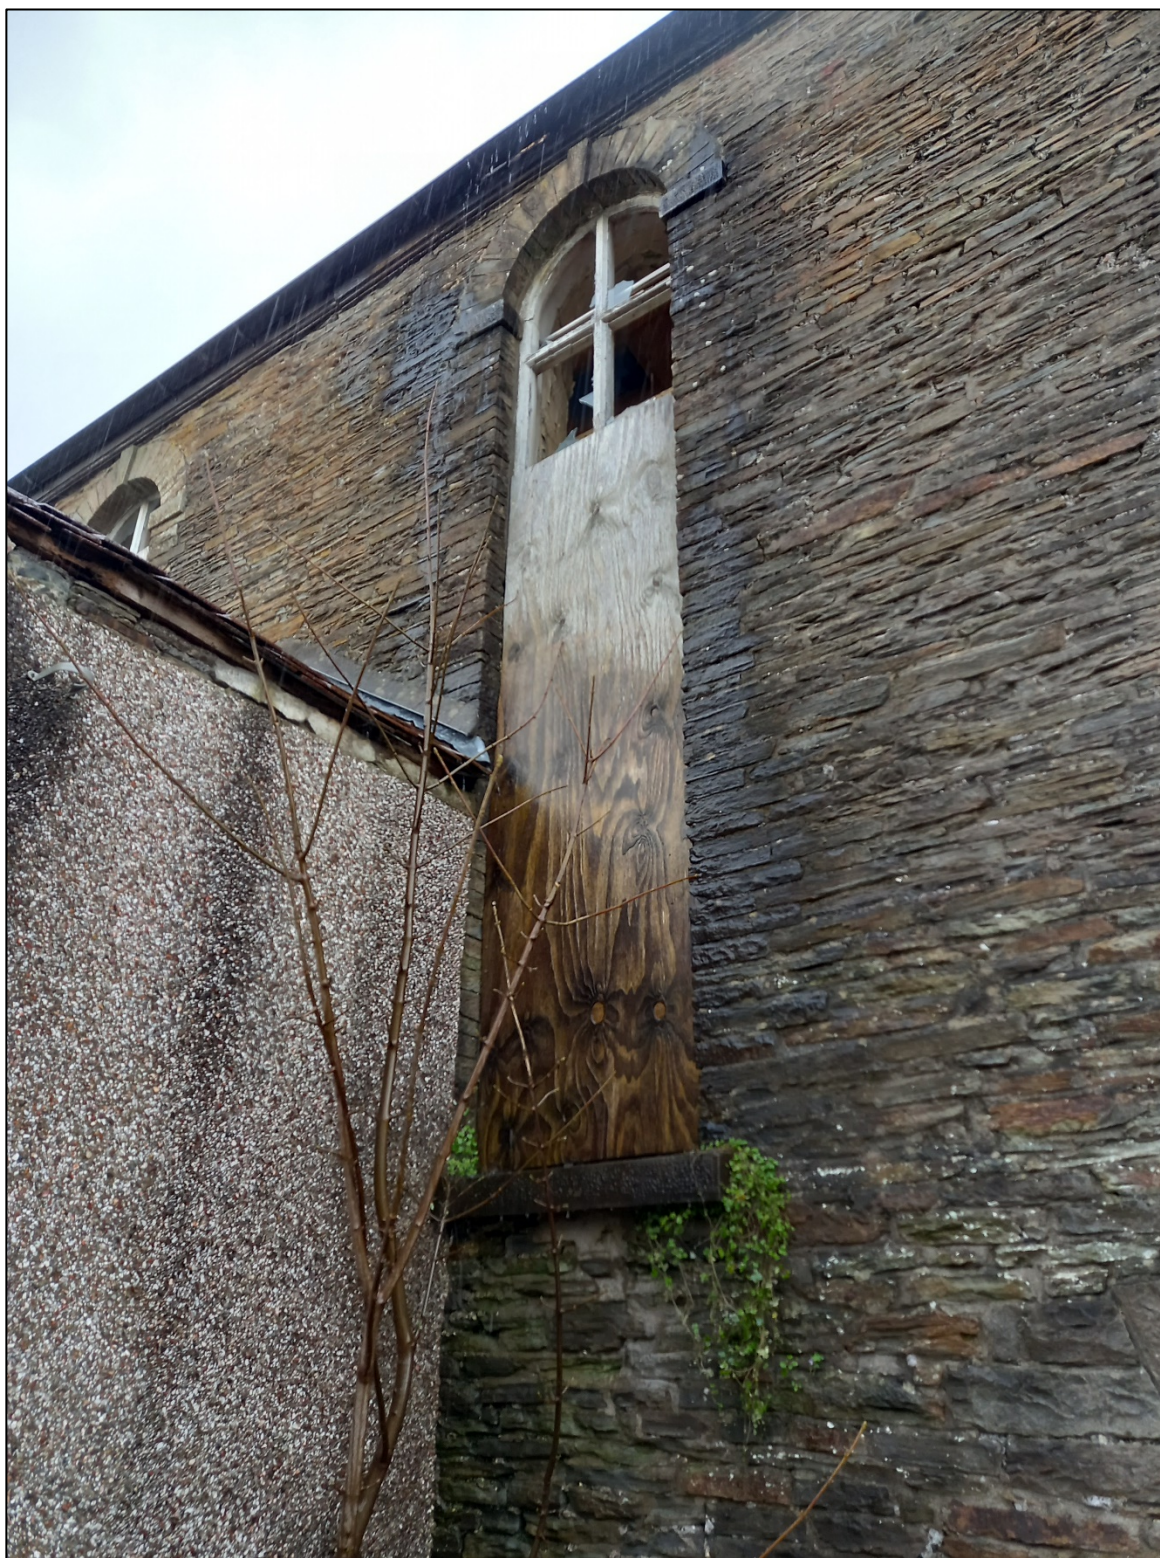
Plate 4: Right-hand window to front elevation of Horeb Chapel, looking north-west.

- 3.2.2 Two round arch windows extend to the roof eaves (Plate 4). They have tooled stone sills and the smooth finished voussoir arches with projecting keystones sit on tooled stone stops. The windows have been almost completely boarded up, but their white-painted wooden frames are visible to the top.

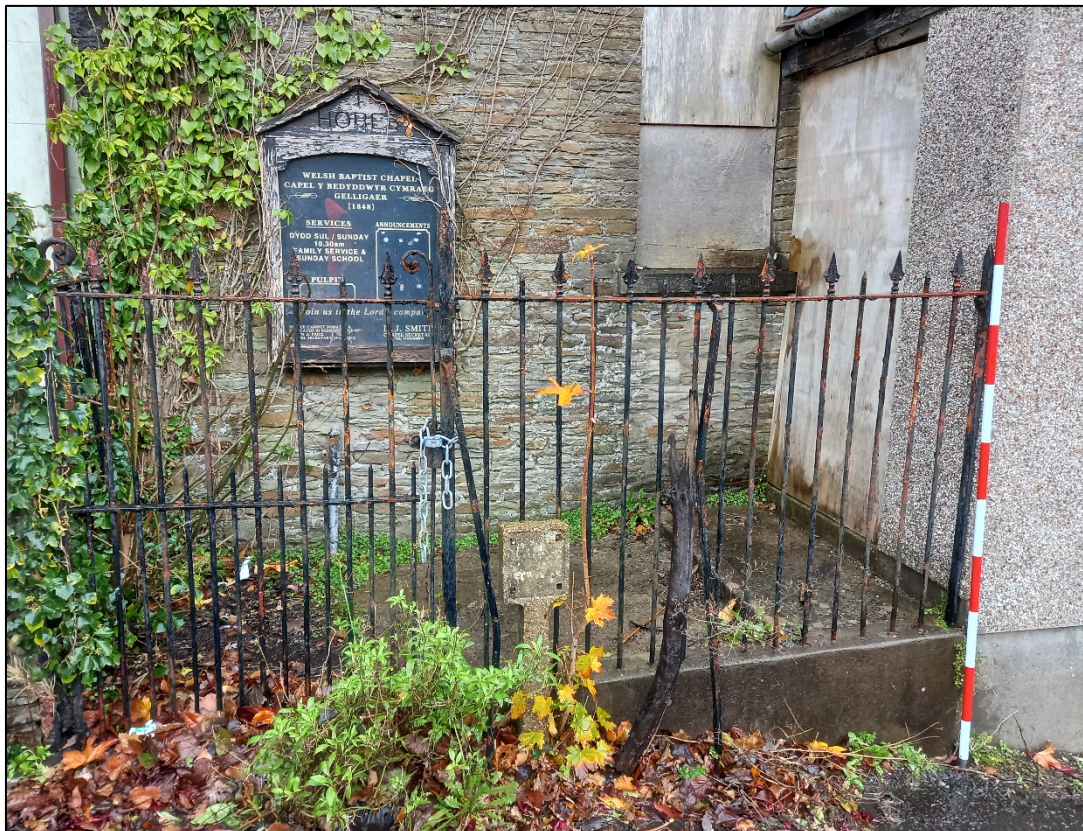
Plate 6: Small entrance courtyard area enclosed by railings to the west of the porch, looking north. 2m scale.

- 3.2.4 The entrance is on the west-facing side of the porch. There is a small front courtyard area enclosed by wrought iron railing and a gate (Plate 6). The doorway has been boarded up. On the wall of the main building is a wooden sign (Plate 7).

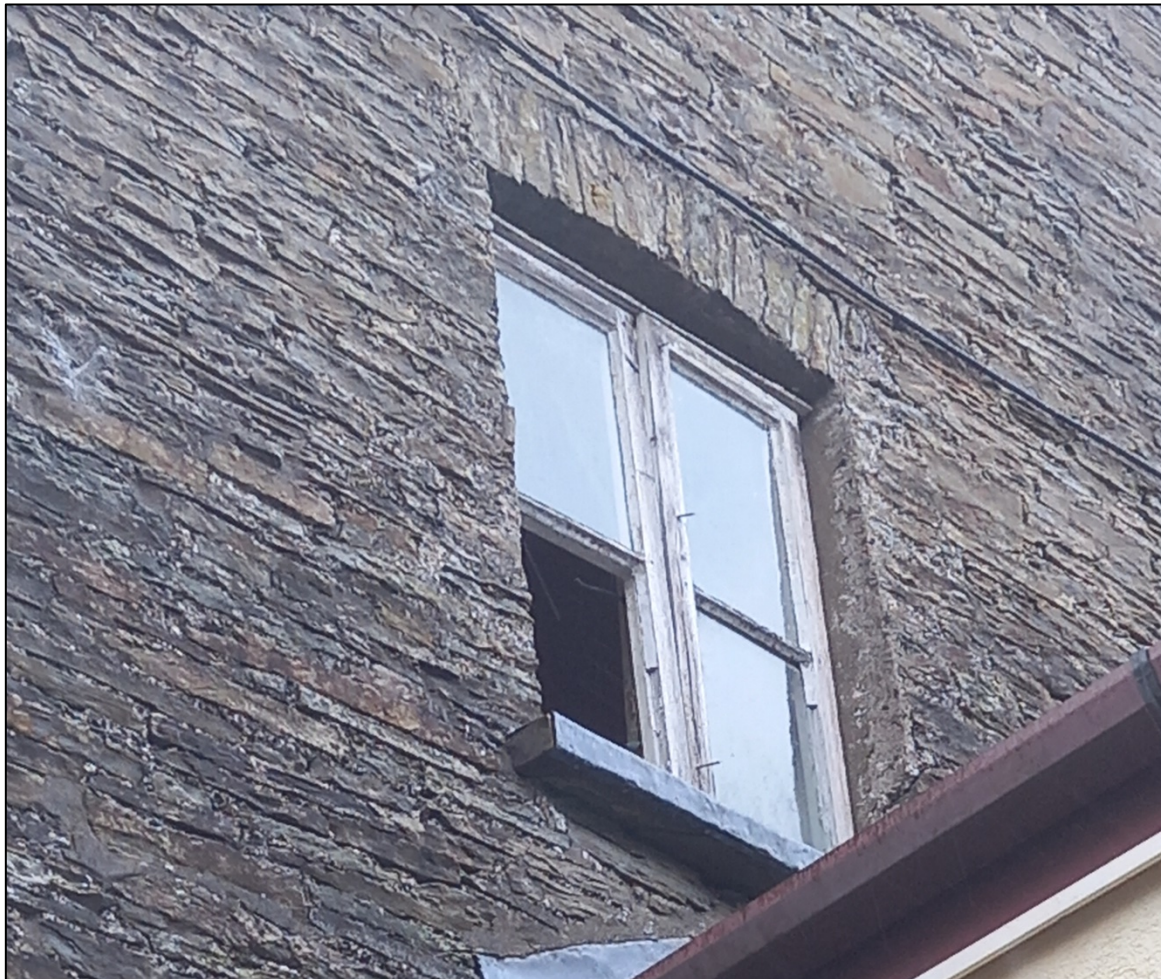
Plate 10: Window to second storey of east-facing elevation, looking north-west.

- 3.2.6 The projecting porch is spar dashed, with smooth render to the lower part where the ground level drops (Plate 8).
- 3.2.7 The gable end of the original building is adjoined by the neighbouring cottage (Plate 9). The wall is of thin coursed local squared rubble stone with larger quoins to the corners. There is a small window to the second storey. It has a stone sill and voussoirs and the window is a wooden framed, four-light casement window (Plate 10).

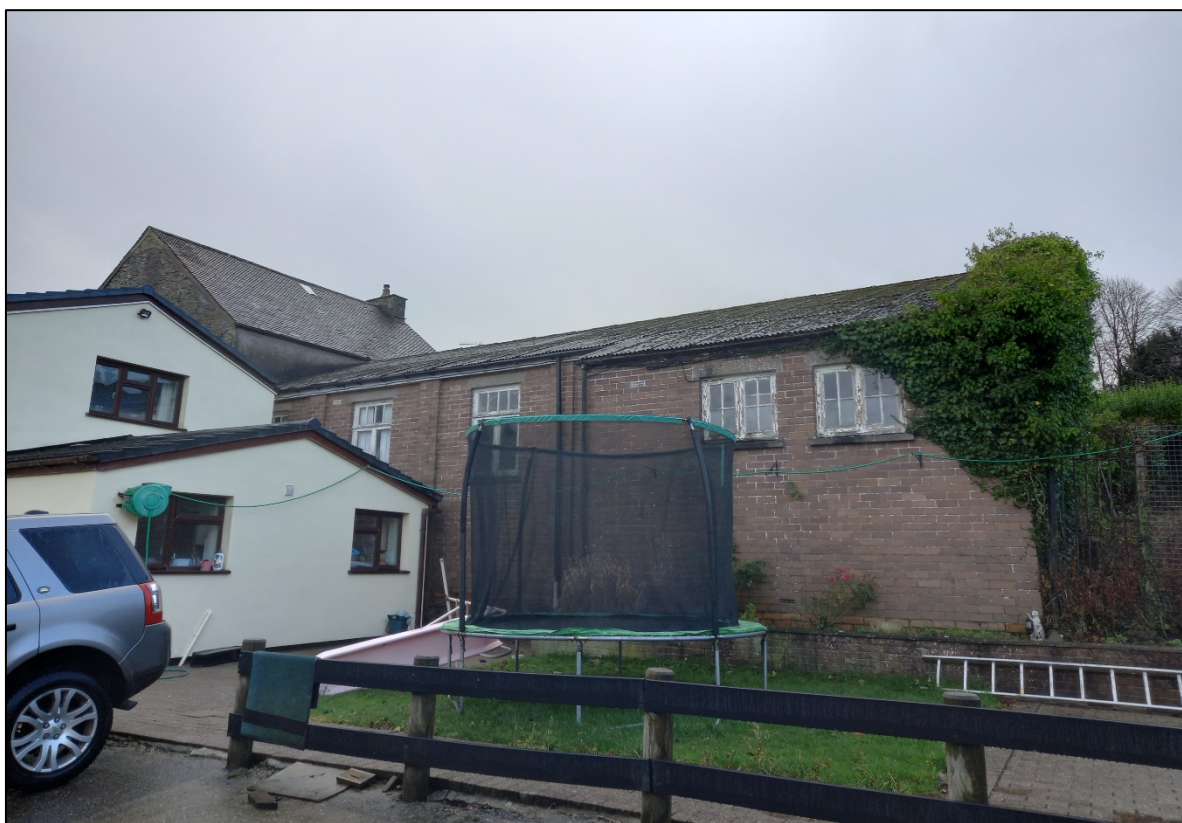
Plate 11: East-facing elevation of rear extension, looking south-west.

- 3.2.8 The rear extension is of red brick in a stretcher bond (Plate 11). It is single storey with five bays. The northern two bays are projecting. The southern three bays are divided by narrow brick pilasters (Plate 12). The windows all have smooth finished cement sills and lintels and are wooden framed. The southern three windows are two-light mullion

casement windows with four-light transom above. The northern two windows are eight-light mullion and transom casement windows.

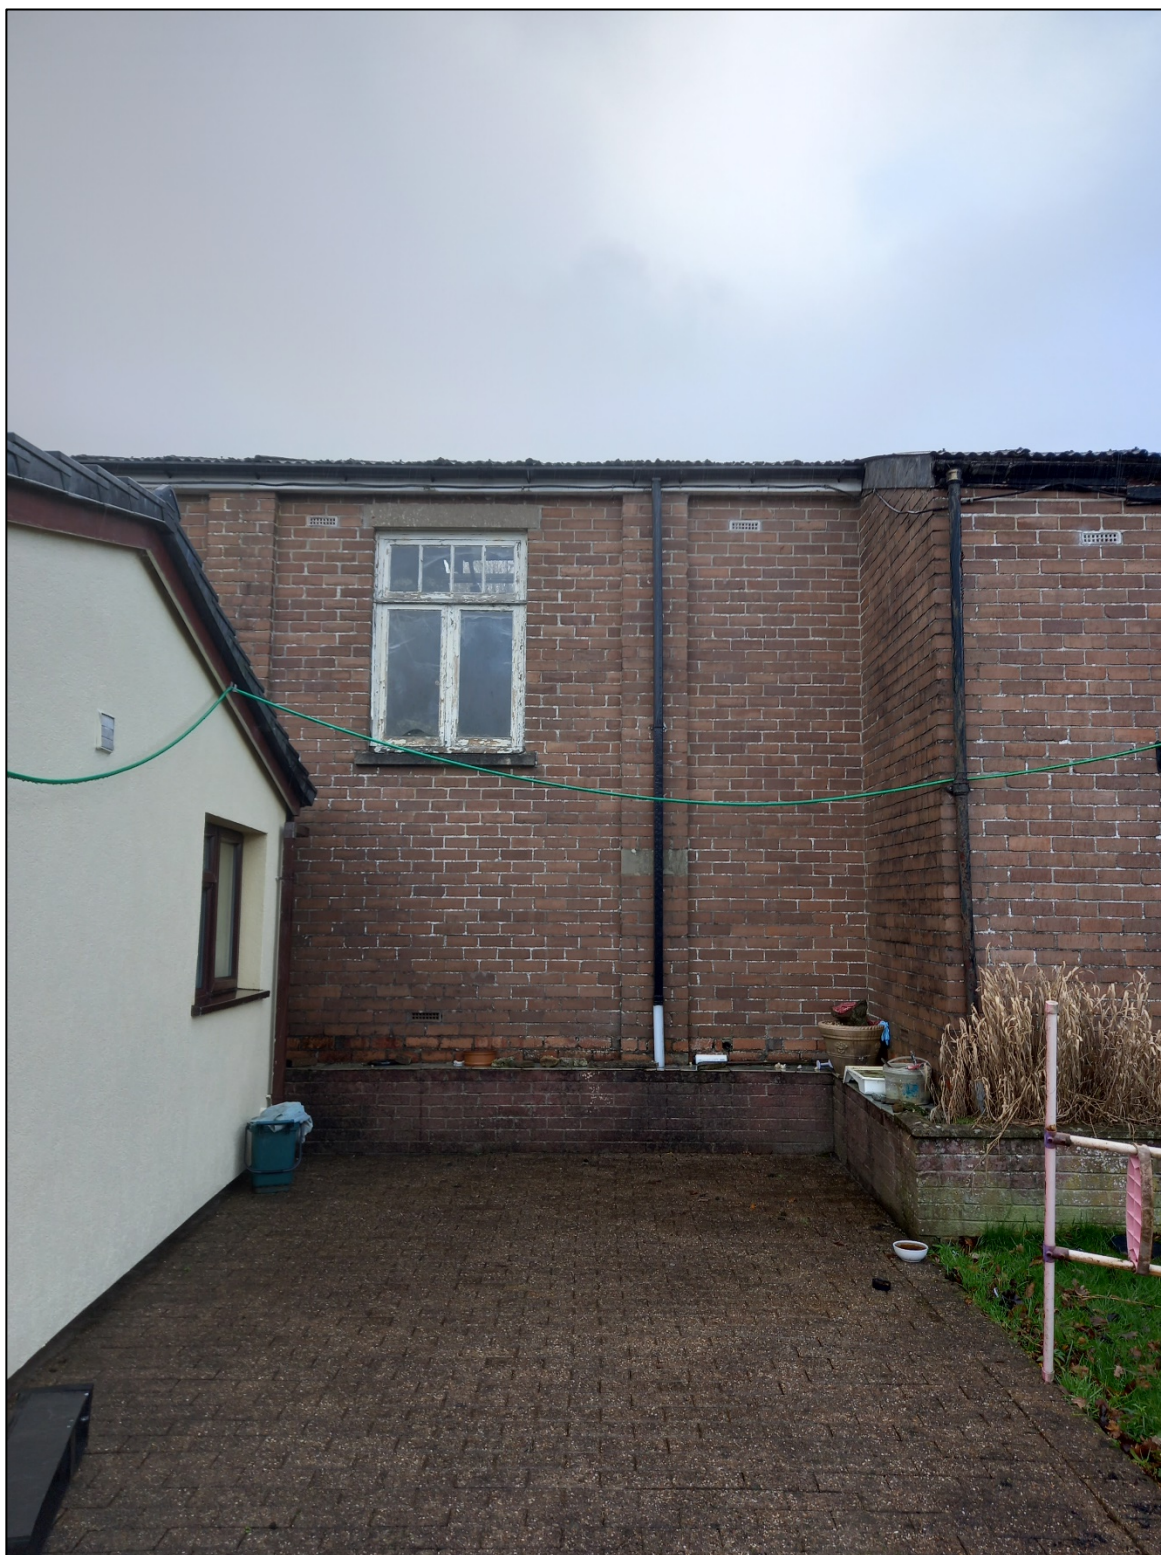
Plate 12: Third bay from the south on the east-facing elevation of the rear extension, showing narrow brick pilasters dividing bays. Looking west.

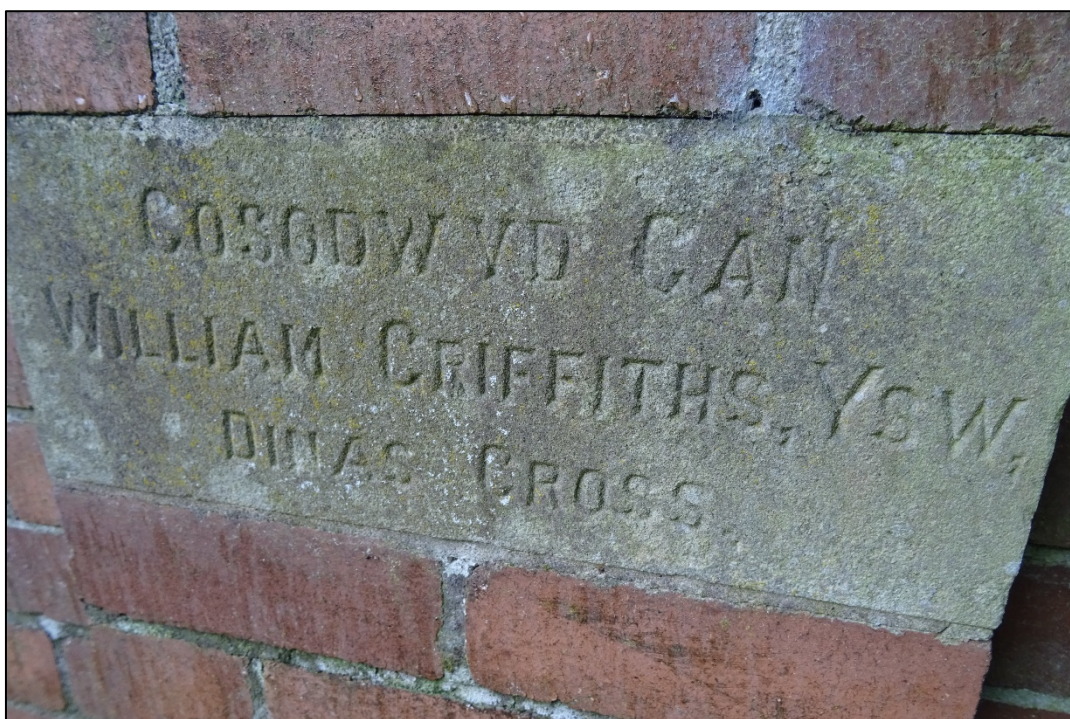
“Gosbodwyd Gan William Griffiths, Ysw, Dinas Cross”

[Set by William Griffiths, Esq., Dinas Cross]

Plate 18: Foundation stone to brick pilaster to right of doorway, looking east.

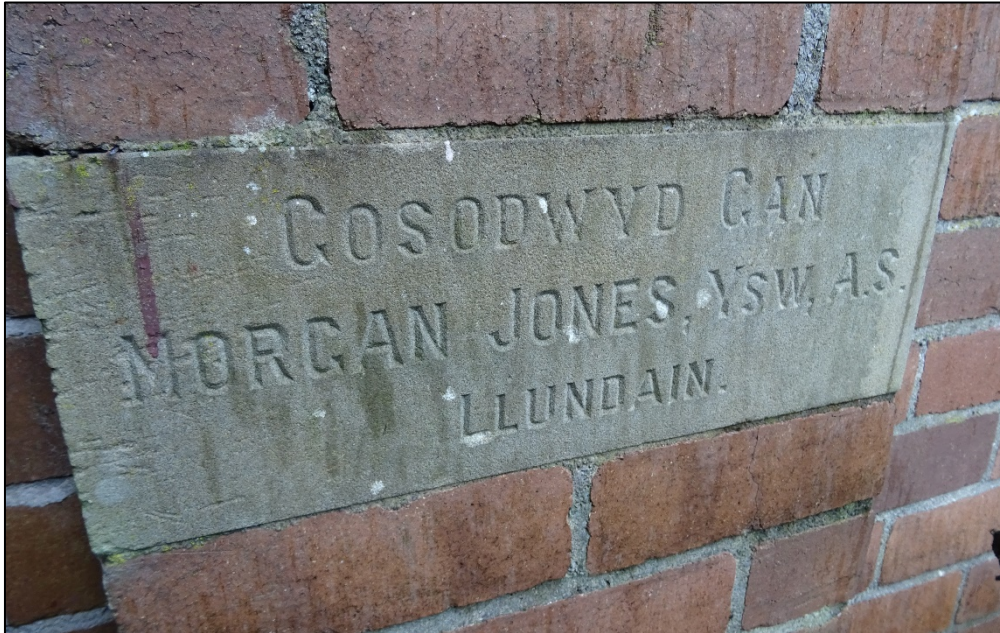
- 3.2.14 The second is inscribed:

“Gosbodwyd Gan Morgan Jones, Ysw, A.S. Llundain”

[Set by Morgan Jones, Esq., M.P. London]

Plate 19: Foundation stone to brick pilaster to right of doorway, looking south-east.

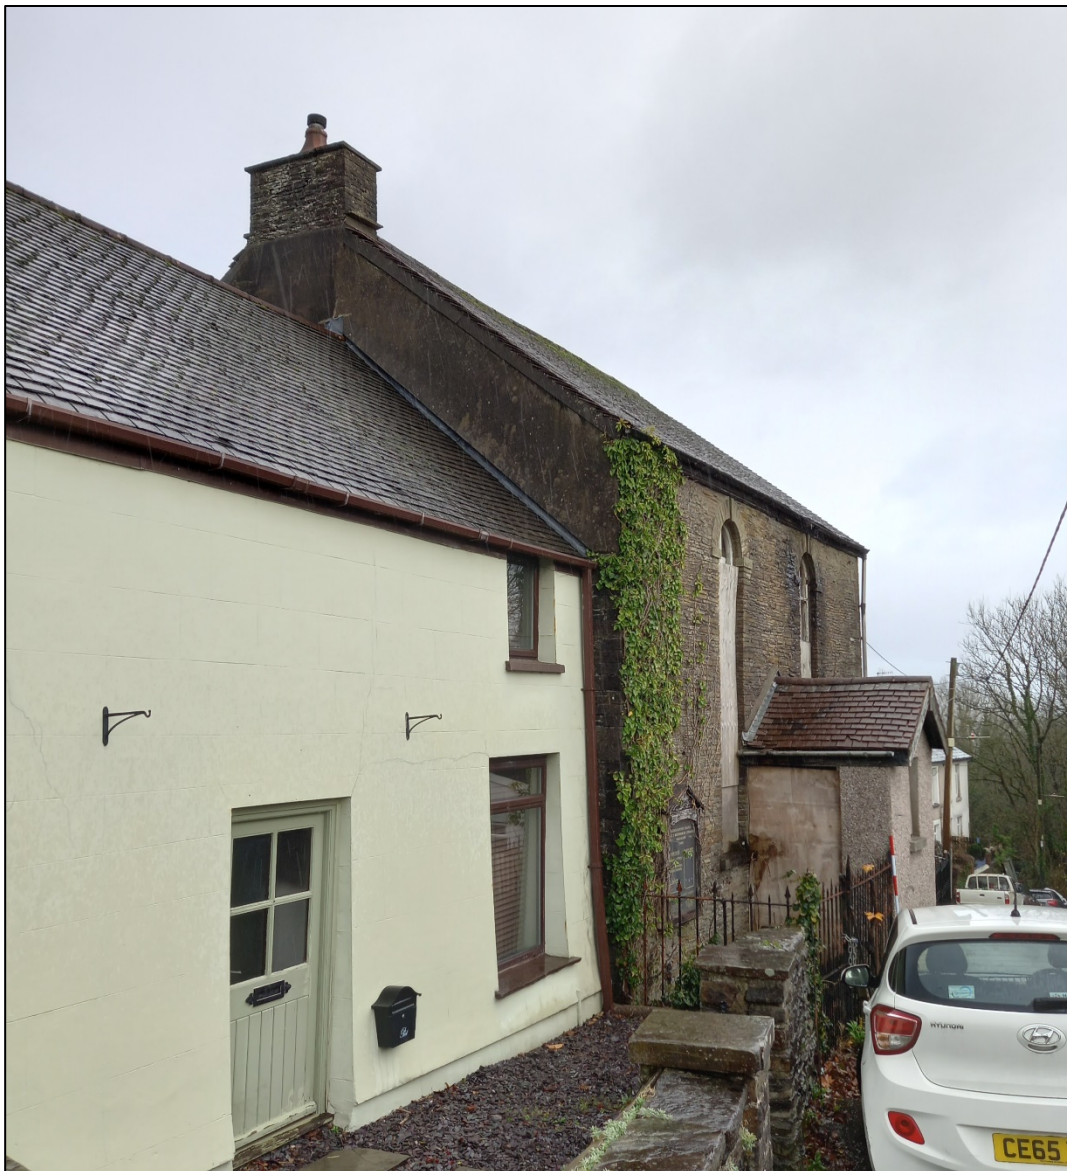
Plate 20: West-facing elevation of original building, looking east.

- 3.2.15 The gable end of the original building is adjoined by the neighbouring cottage (Plate 20). The section of the building that remains exposed has cement render. There is a rubble stone chimney stack to the roof apex with a ceramic chimney pot.

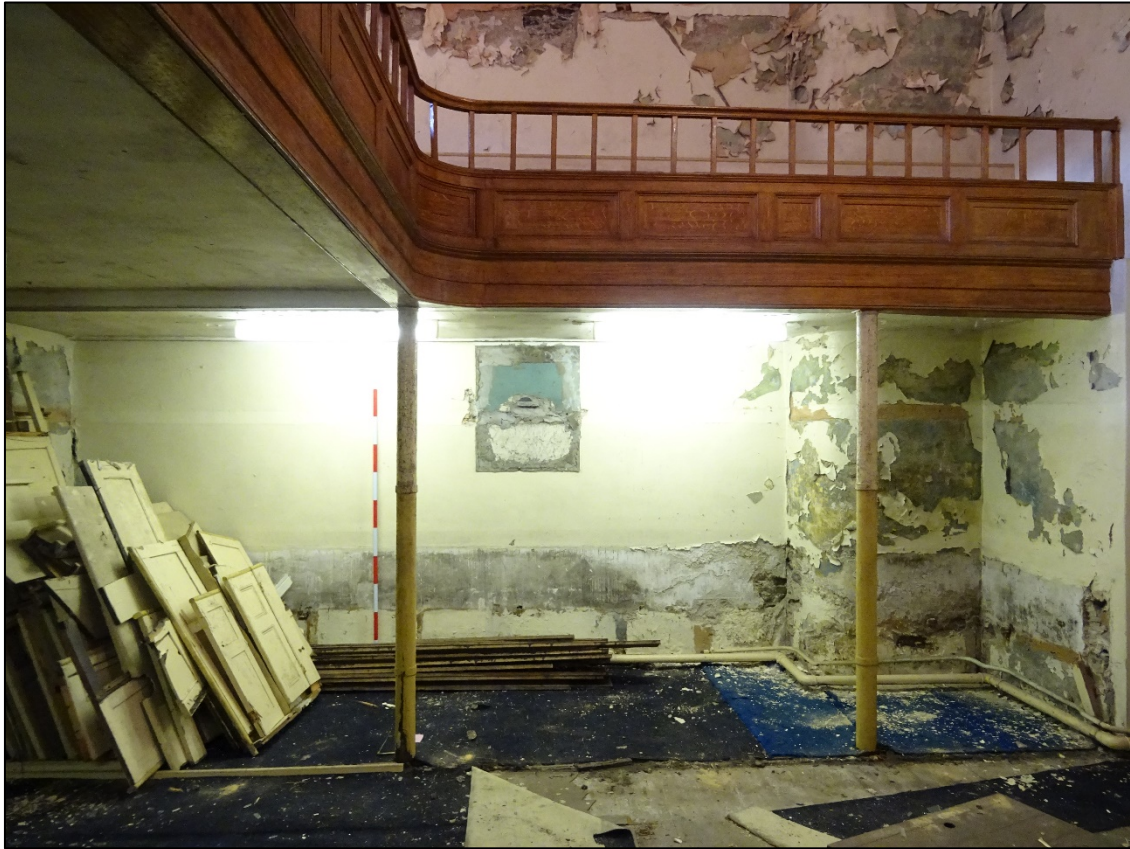
Plate 23: Chapel interior, looking west. 2m scale.

- 3.3.3 The walls are painted plaster, in poor condition (Plate 23). The paint is peeling in many places, revealing an earlier bluish-green paint below. In the north-east corner the wall steps in slightly and it has a rounded corner (Plate 24). A war memorial plaque (recently removed and taken to a local school) had been attached to the west wall. Where this has been removed it is possible to see earlier red painted stencilled foliage decoration (Plate 25). Stencilled decoration is also visible on the gallery east wall under peeling paint (Plate 26).

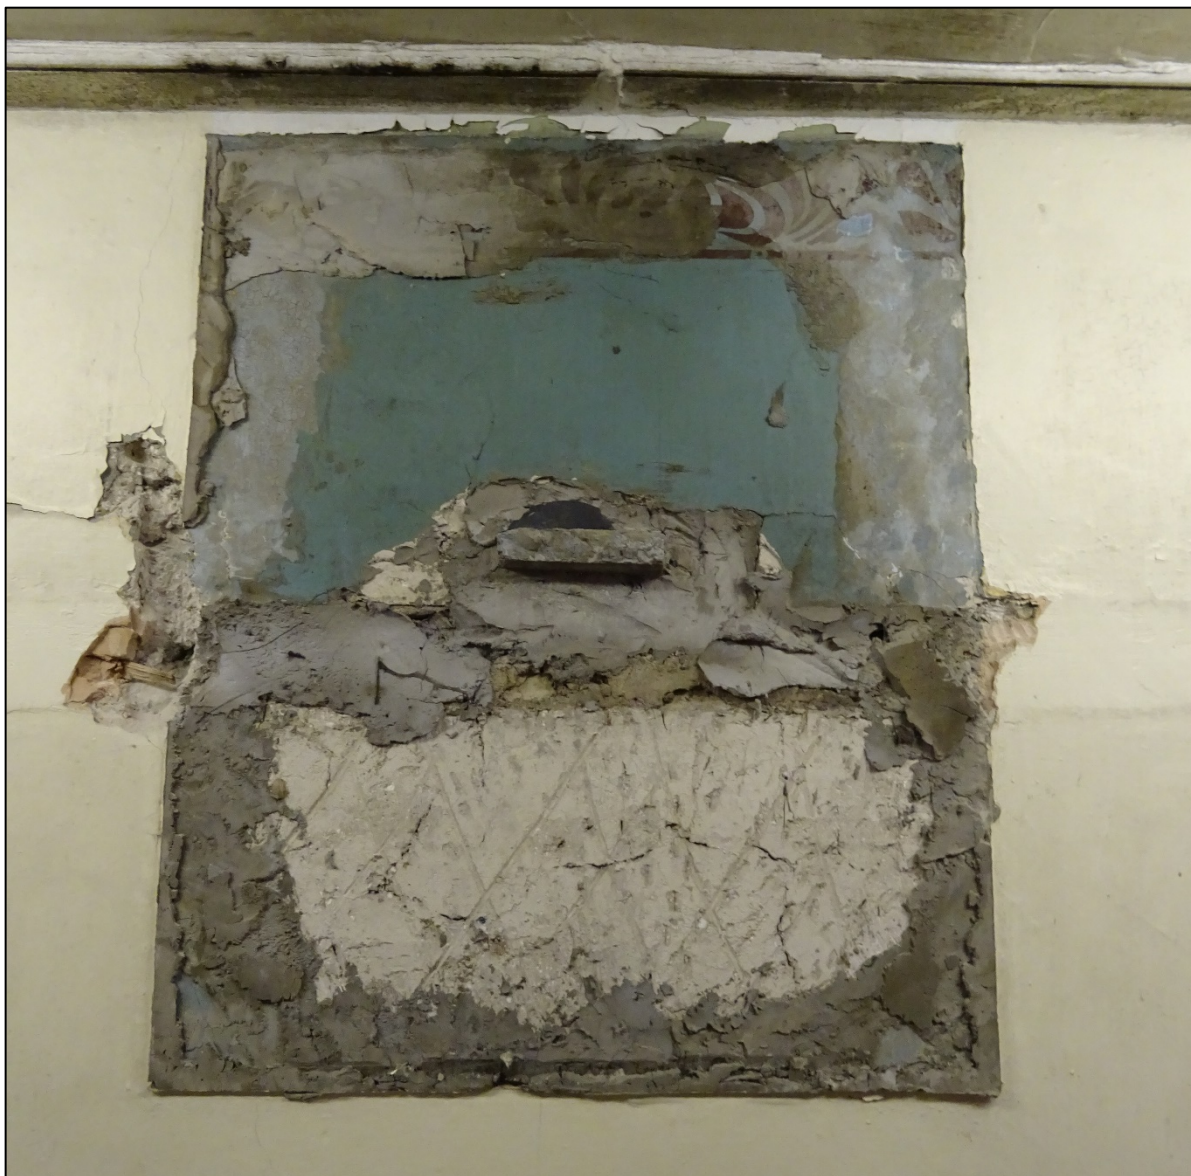
Plate 25: Former location of a war memorial plaque on west wall, with earlier red painted stencilled decoration visible, looking west.

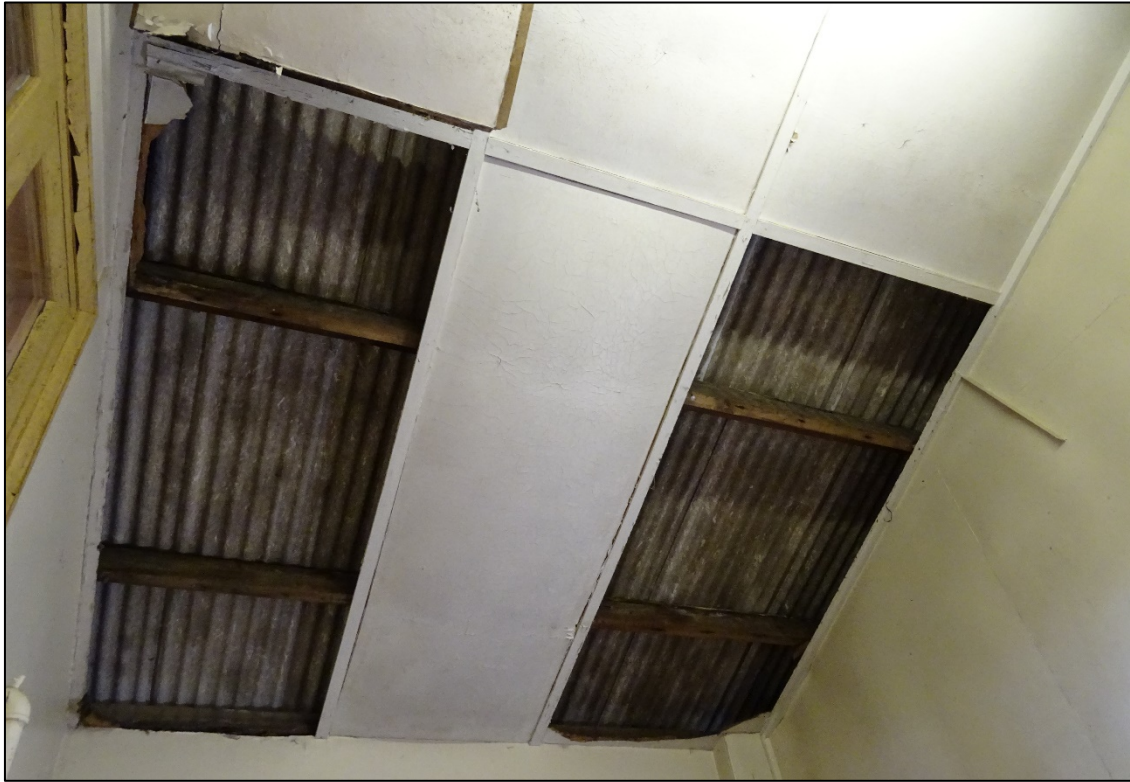
Plate 54: Ceiling of Vestry with missing plasterboard panels, looking west.

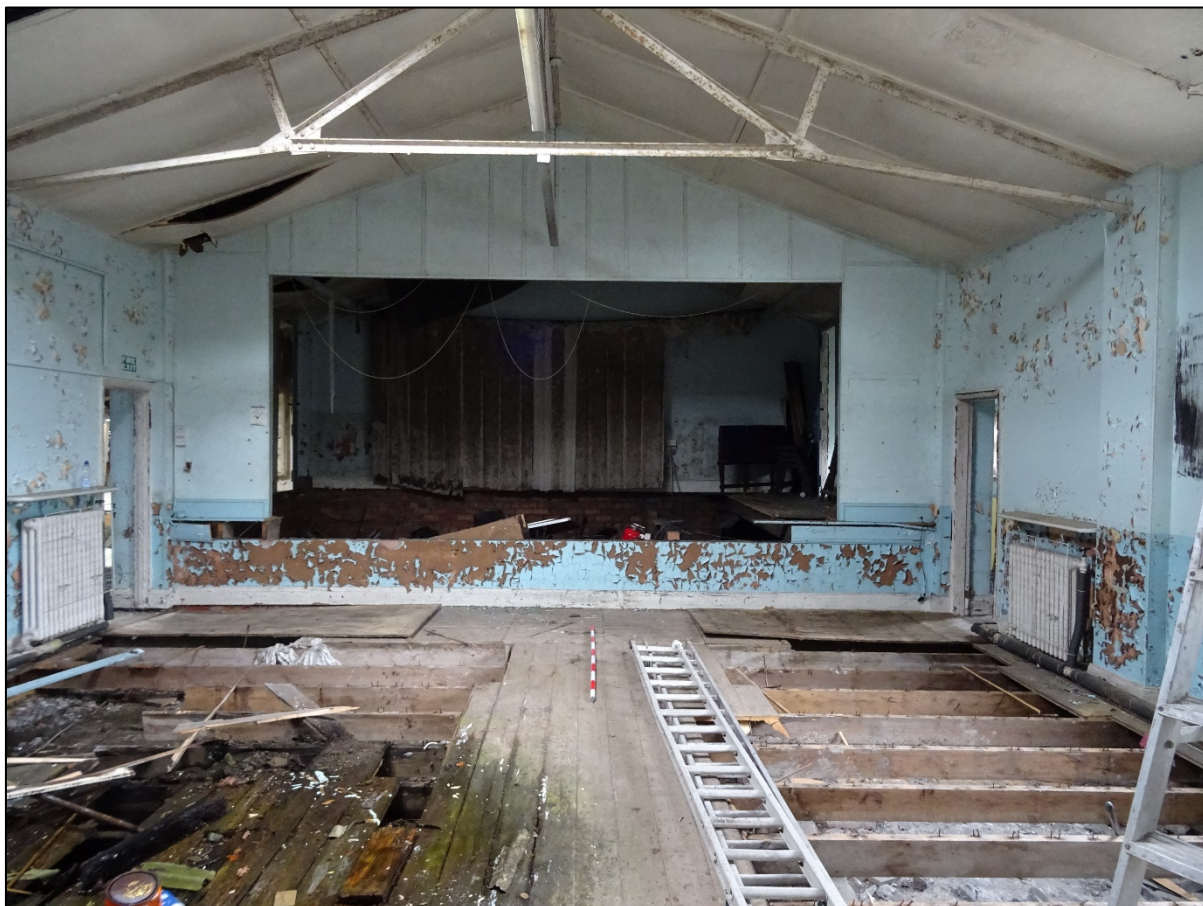
Plate 59: Community Hall, looking north. 2m scale.

- 3.3.17 The main hall room has wooden floorboards, some of which have been taken up and some have rotten (Plate 59). The walls are light blue painted plaster, except the south wall which is painted plasterboard (Plate 60). The ceiling has painted plasterboard with wooden frames and exposed iron rafters. It is in poor condition, with a hole in the ceiling to the west side and numerous collapsed boards.

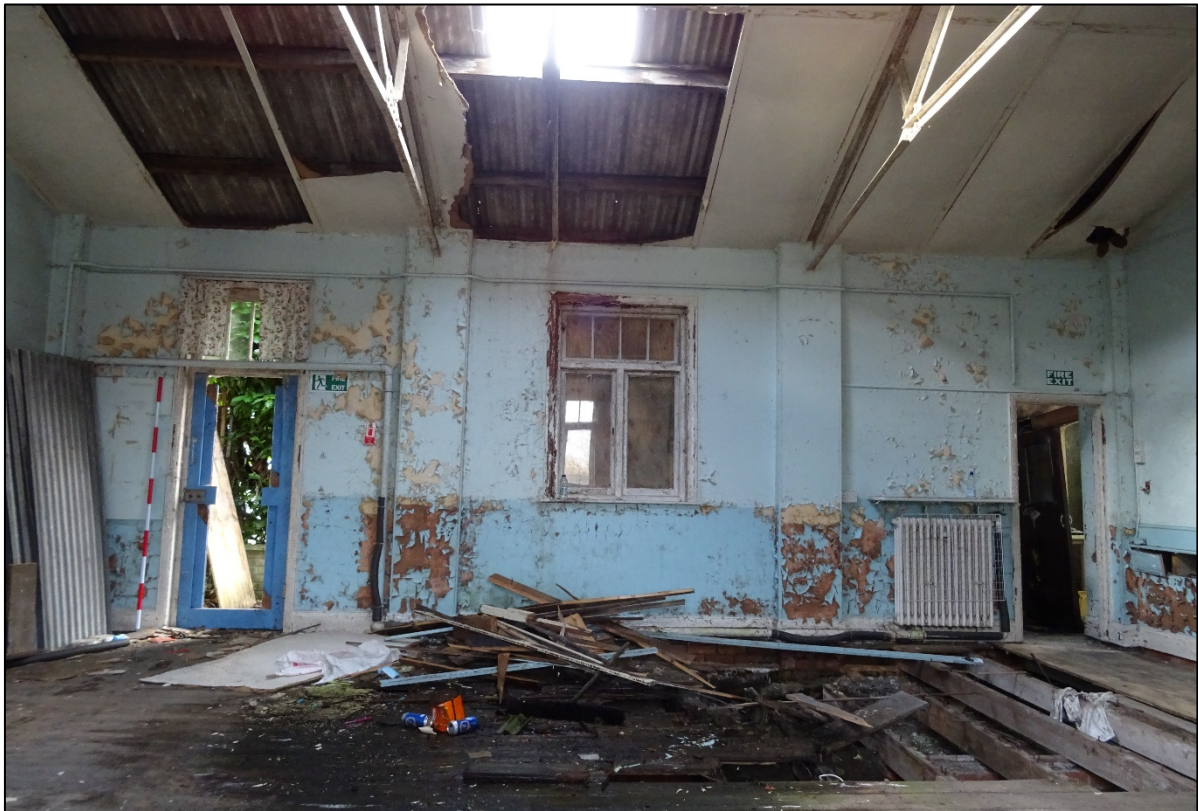
Plate 64: West wall of Community Hall, looking west. 2m scale.

- 3.3.19 The west wall has an exterior door at its southern end, a window to the centre, and a door to the toilets and kitchen at the northern end (Plate 64). There is a column radiator to the north end. The exterior door is broken, but it was a wooden batten, ledged and braced door painted blue in a white painted frame (Plate 65). It has a four-light transom window above. The window is the same as those on the east wall (Plate 66) and the door to the kitchen is the same as to the stage access (Plate 67).
