# Gorsaf Heddlu Caergybi, Caergybi, Ynys Môn Holyhead Police Station, Holyhead, Anglesey

Archaeological Mitigation (Strip/Map/Record)

## Report on Archaeological Mitigation (Strip/Map/Record)

Project Code: G2825 / HD24-020

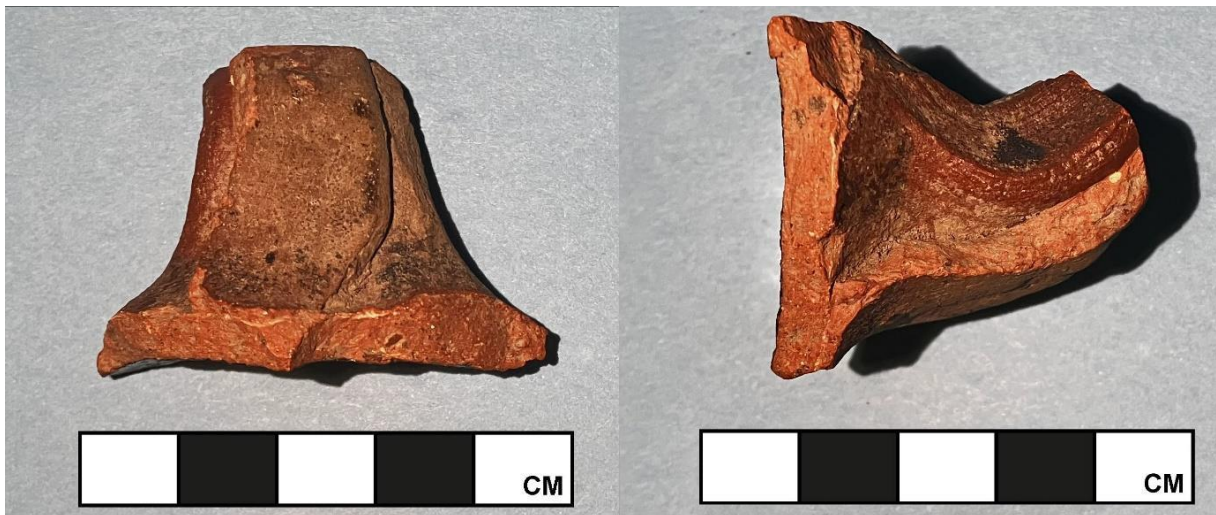
*Coarse earthenware sherd from (078) with clay strip luted to underside of handle.*

The assemblage largely comprises coarse wares typical of the late 17<sup>th</sup> to early 18<sup>th</sup>- centuries (c.1680-1720), with examples of slip-decorated earthenware, mottled ware, blackware, slip-coated ware, stoneware and coarse earthenware. The latter sherd, which was recovered from (078), is notable for a strip of clay applied to the underside of the handle to strengthen the join with the vessel body.

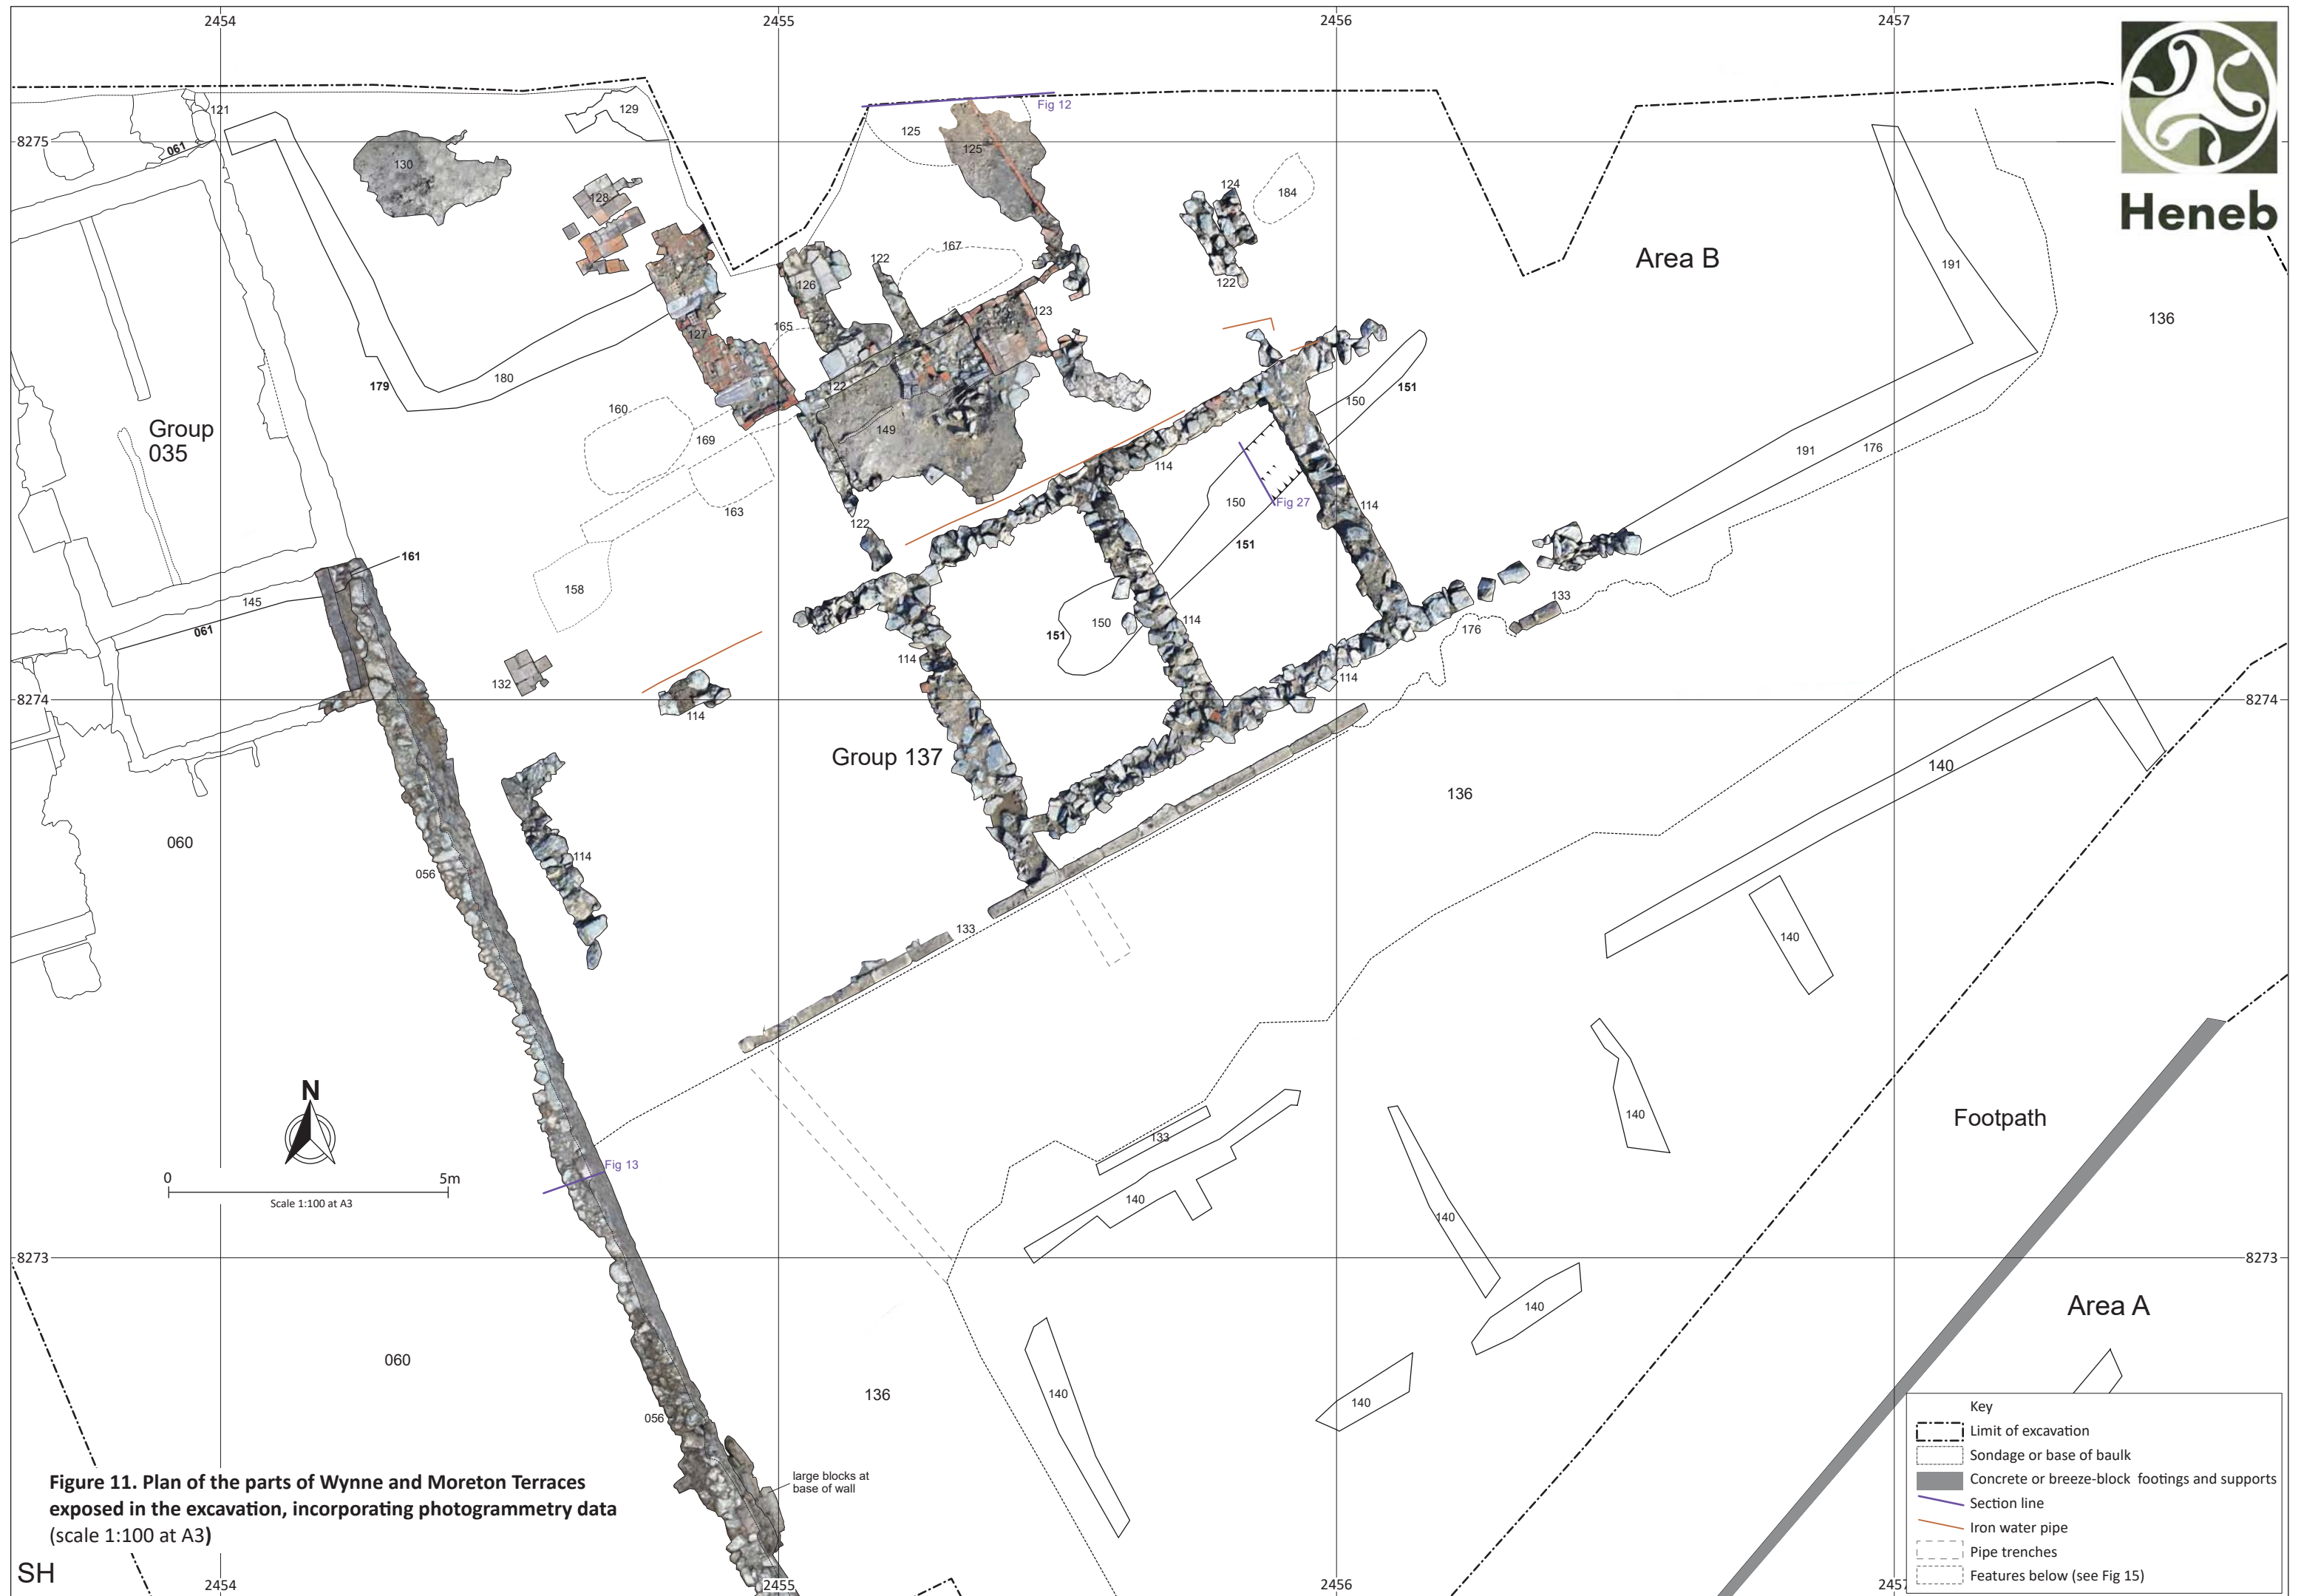
**Figure 11. Plan of the parts of Wynne and Moreton Terraces exposed in the excavation, incorporating photogrammetry data (scale 1:100 at A3)**

Wynne Terrace lay to the north-west and south-east of the middle section of the road. To the south-east of the road the fragmentary remains of foundations (140) show the location of four terrace houses and one larger building (Plate 22). The foundations are of local schist bonded with mortar and sit in foundation trenches. Each terrace house measured internally about 3.2m by 4.4m.

To the north-west of the road more survived, including the remains of five small terrace houses and one larger building. This whole area was recorded as Group 137 (Plate 23). The foundations (114/191), about 0.68m wide, were of mortared schist in foundation trenches and where best preserved defined small rectangular houses measuring about 3.3m by 4.6m internally (Plate 24). Behind the fairly solidly built houses were slighter walls, defining the back yards, with the concrete floor and other details of one yard surviving. The yard wall foundations (122) were 0.3m wide, built of stone with lime mortar and generally very fragmentary (Plate 25). Inside the best-preserved yard was a concrete floor (149) with the north-western part defined by a line of stones set on edge. There were also the foundations of a square brick structure (123), measuring 1.20m by 1.12m externally (Plate 26). This was a shed for an outside toilet, and it had a small area of tiled floor and broken remains of a ceramic pipe. To the west of this stone and brick had been laid to create a rough floor. This was probably to seal the top of an infilled cesspit (see discussion below). A small patch of tiles (132), further south-

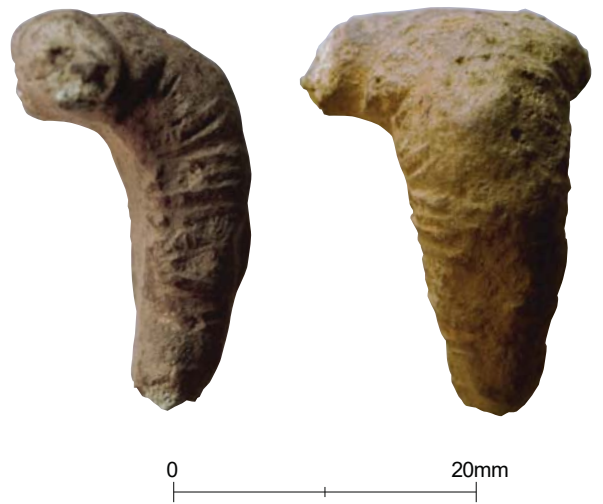
SF2: copper alloy brooch fragment (scale 2:1)

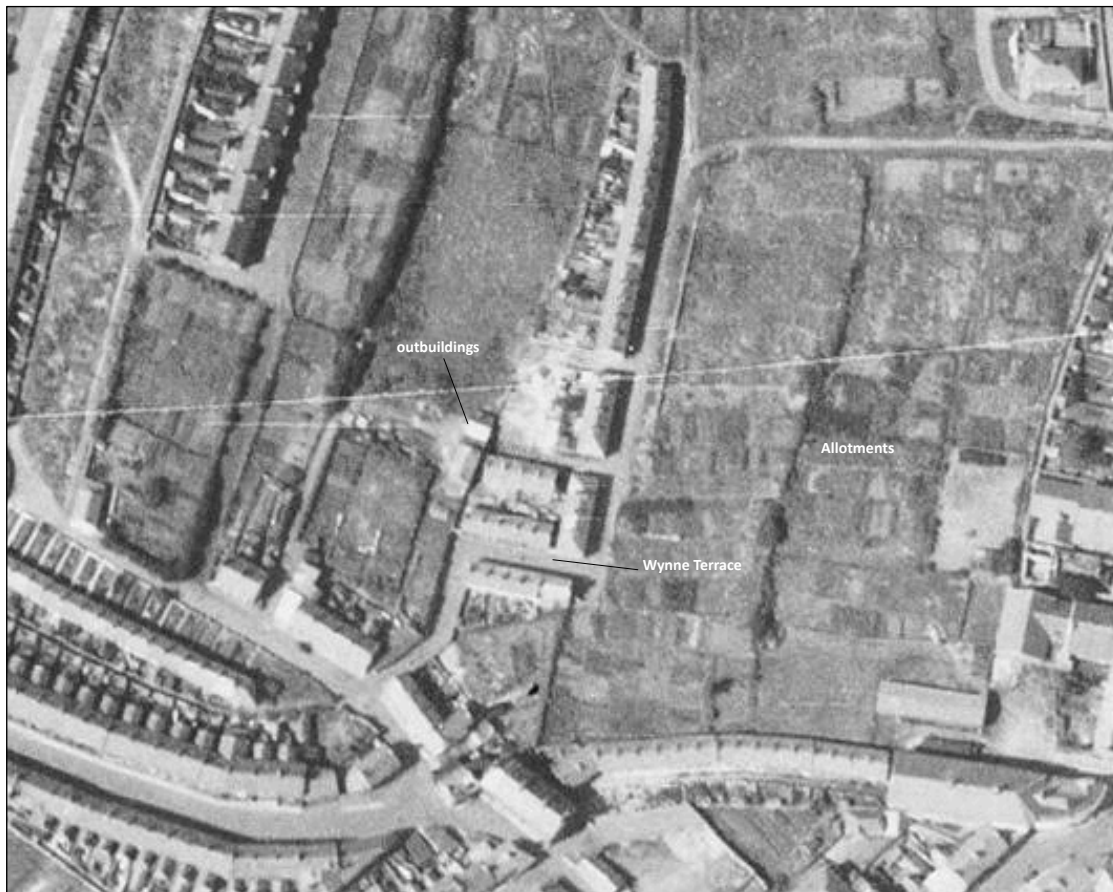
Plate 01. Harp Street and Wynne Terrace on an aerial photograph dating to 13th August 1945 (4534\_106GUK\_655, frame 3351)

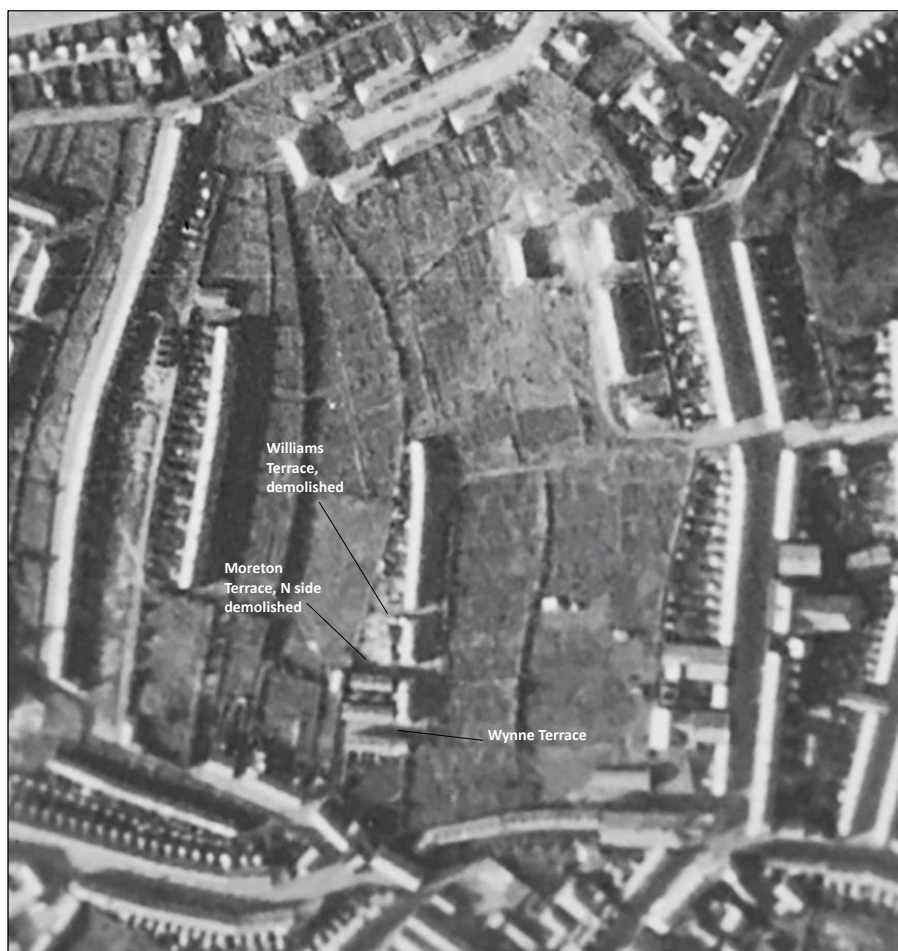
Plate 02. Harp Street and Wynne Terrace on an aerial photograph dating to 10th October 1941 (4103 RAF Medmenham 2204, frame 49)

Plate 02. Harp Street and Wynne Terrace on an aerial photograph dating to 10th October 1941 (4103 RAF Medmenham 2204, frame 49)

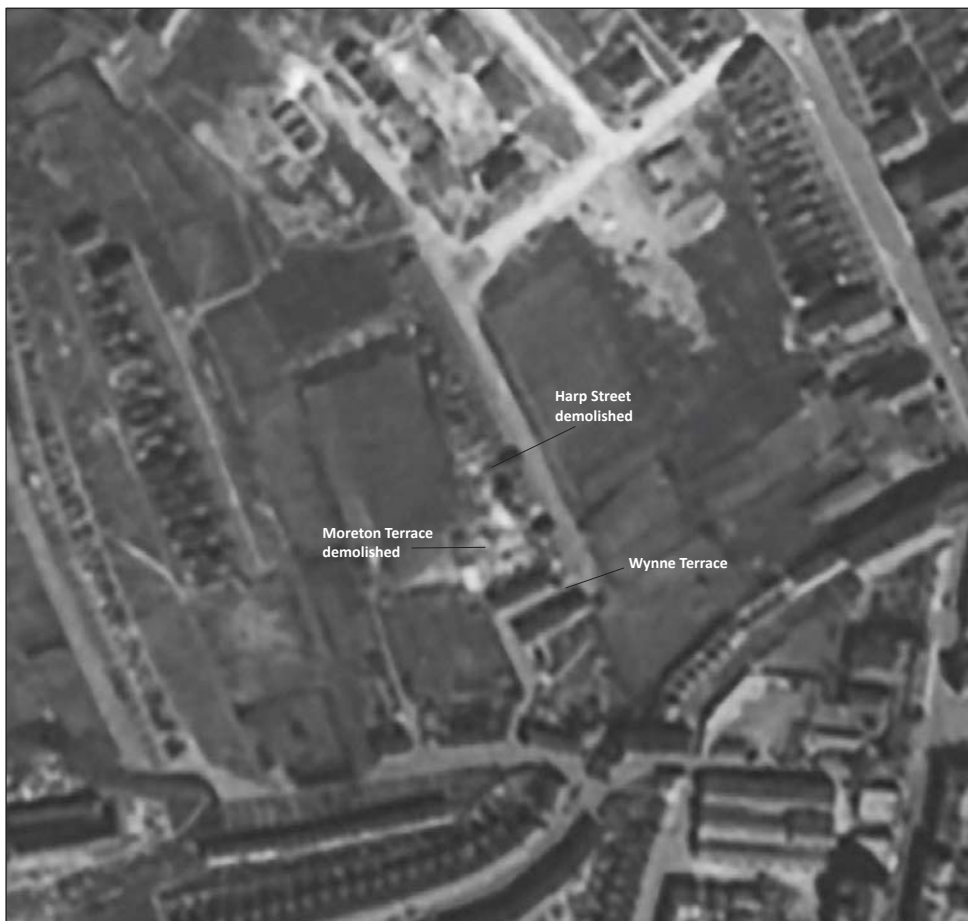
Plate 03. Harp Street and Wynne Terrace on 19th May 1948 with all of Moretons Terrace and Harp Street demolished (4841 RAF 540\_39, frame 5123)

Plate 03. Harp Street and Wynne Terrace on 19th May 1948 with all of Moretons Terrace and Harp Street demolished (4841 RAF 540\_39, frame 5123)

October 1940 (Daily Post website; History Points website), but the Harp Street area was not hit during the War, so the loss of these houses was not war damage. By 1948 the houses on the south-eastern side of Moretons Terrace had also been demolished, along with the whole of the Harp Street terraces, but the buildings in the field were still standing (Plate 03).

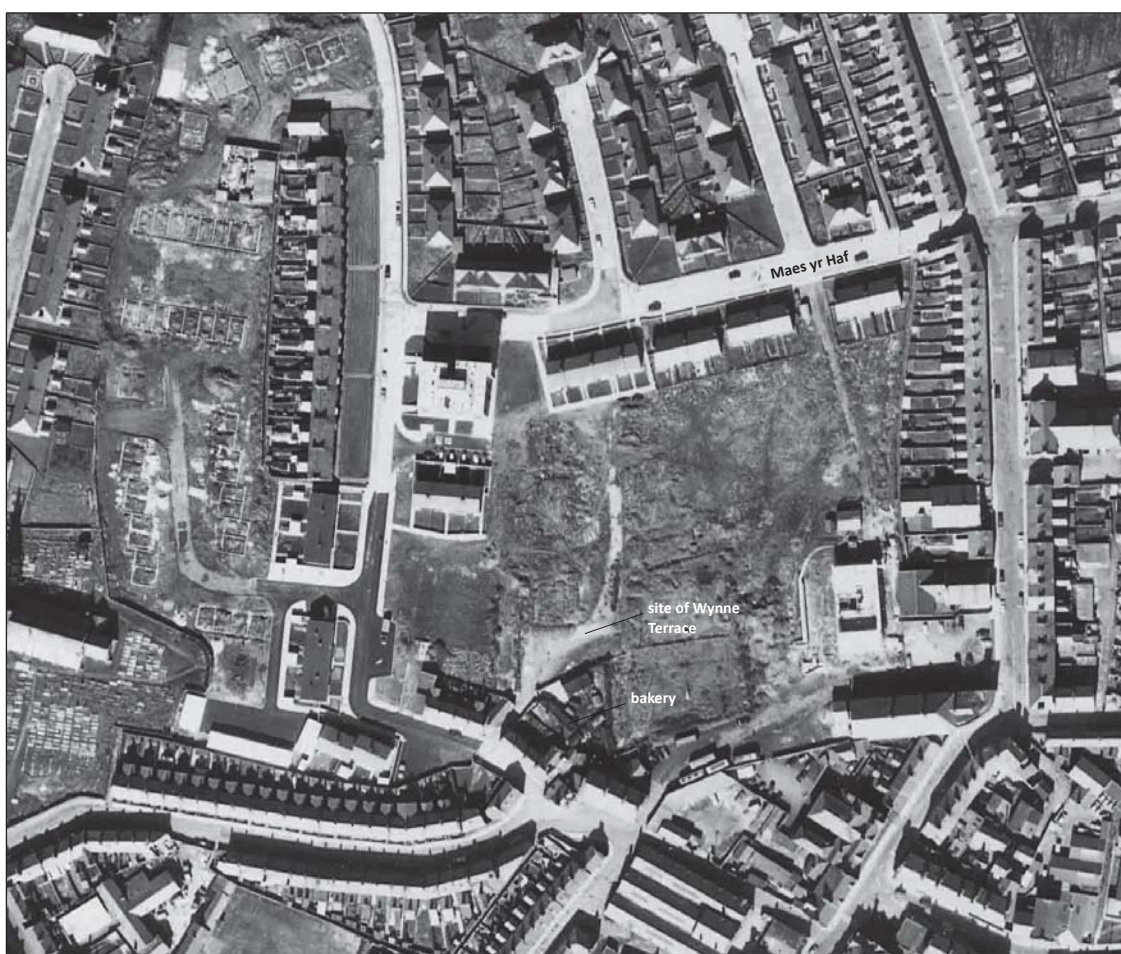
Plate 04. Wynne Terrace demolished by 3rd April 1966 (6614 OS66\_016, frame 070)

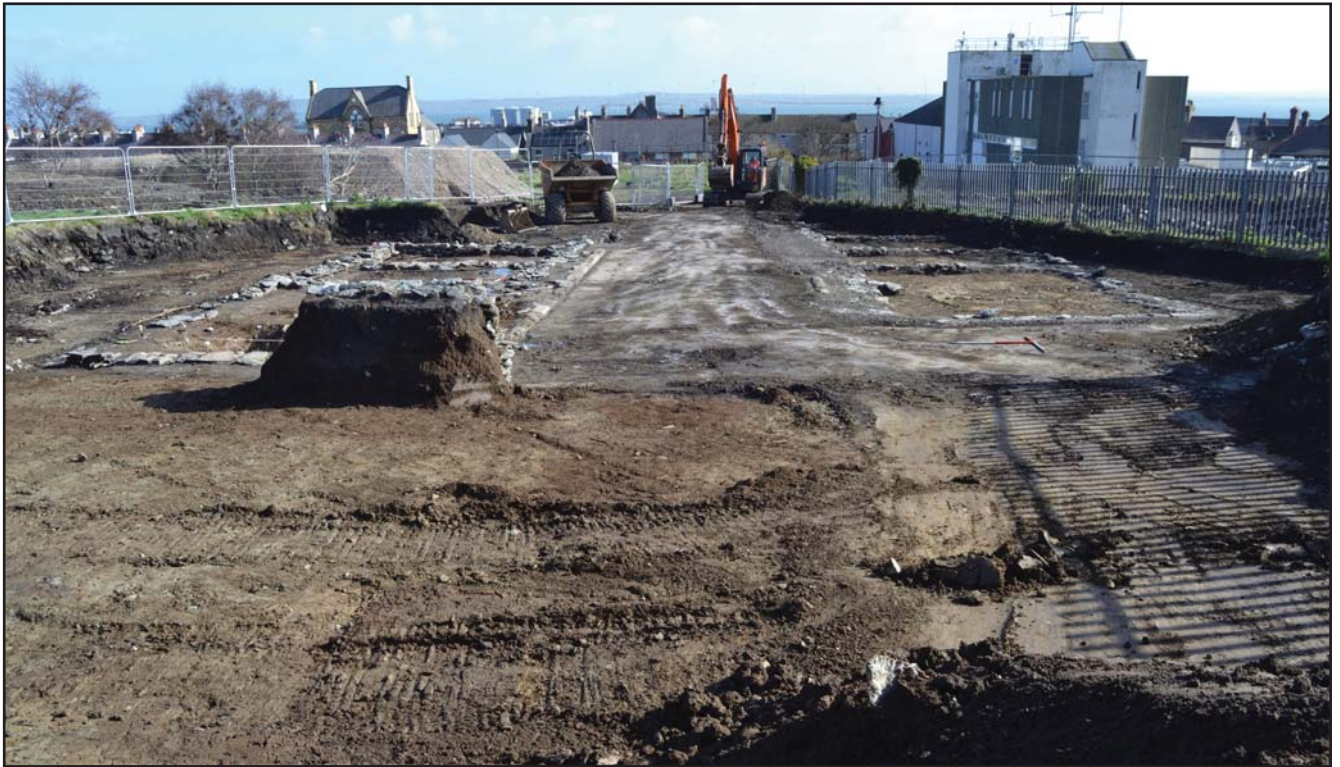
Plate 05. View of Area B with western end fully stripped, showing road and remains of Wynne Terrace. View from west-south-west (archive reference: G2825\_406)

North of the footpath in Area B the very base of the foundations of Wynne Terrace were found, buried under up to 0.9m of rubble from the demolition (Plate 05). The boundary wall to Wynne Terrace (wall 056) ran north-north-west to south-south-east across the western side of Area B and to the west of this a much greater depth of deposits survived with the foundations of outbuildings constructed within these. At the base of these deposits were several ditches, which relate to the cultivation of this area as fields and may have originated in the medieval period or earlier.

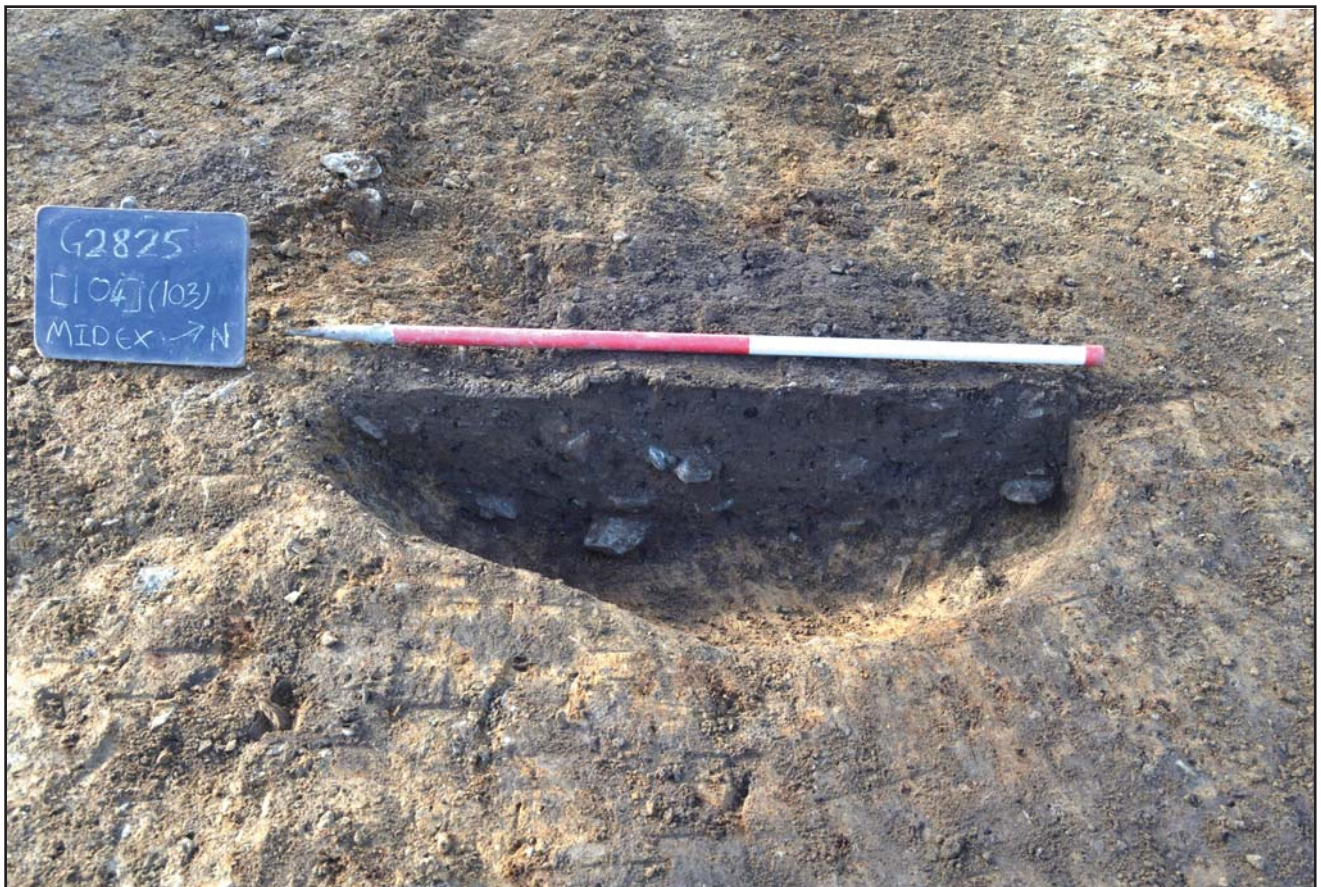
Plate 06. Pit [104] half sectioned. View from north-east (archive reference: G2825\_254)

Plate 06. Pit [104] half sectioned. View from north-east (archive reference: G2825\_254)

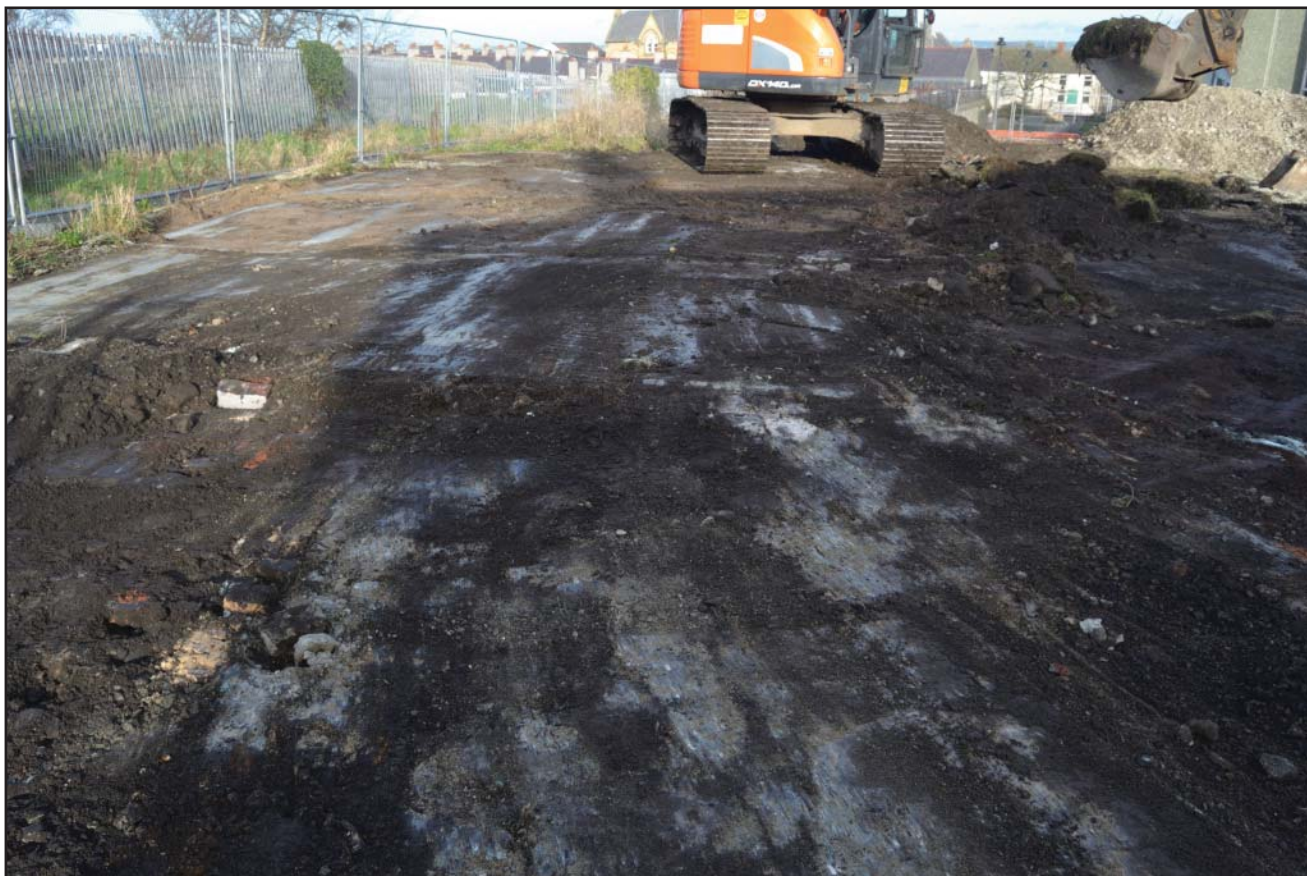
Plate 07. Bases of garages being exposed and removed in stripping. View from south-east (archive reference: G2825\_009)

Plate 07. Bases of garages being exposed and removed in stripping. View from south-east (archive reference: G2825\_009)

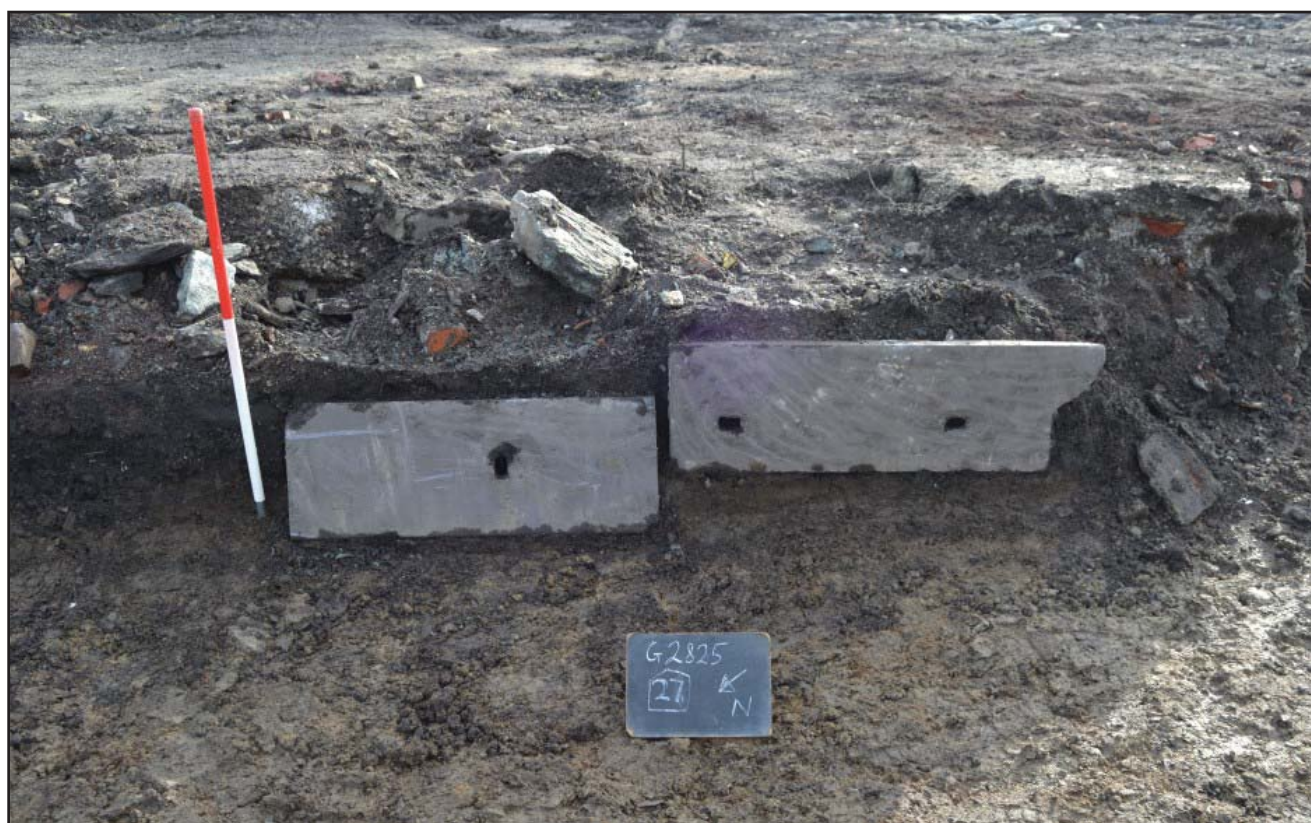
Plate 08. Slate slabs (027) against cut for garage construction. View from north-west (archive reference: G2825\_044)

Plate 08. Slate slabs (027) against cut for garage construction. View from north-west (archive reference: G2825\_044)

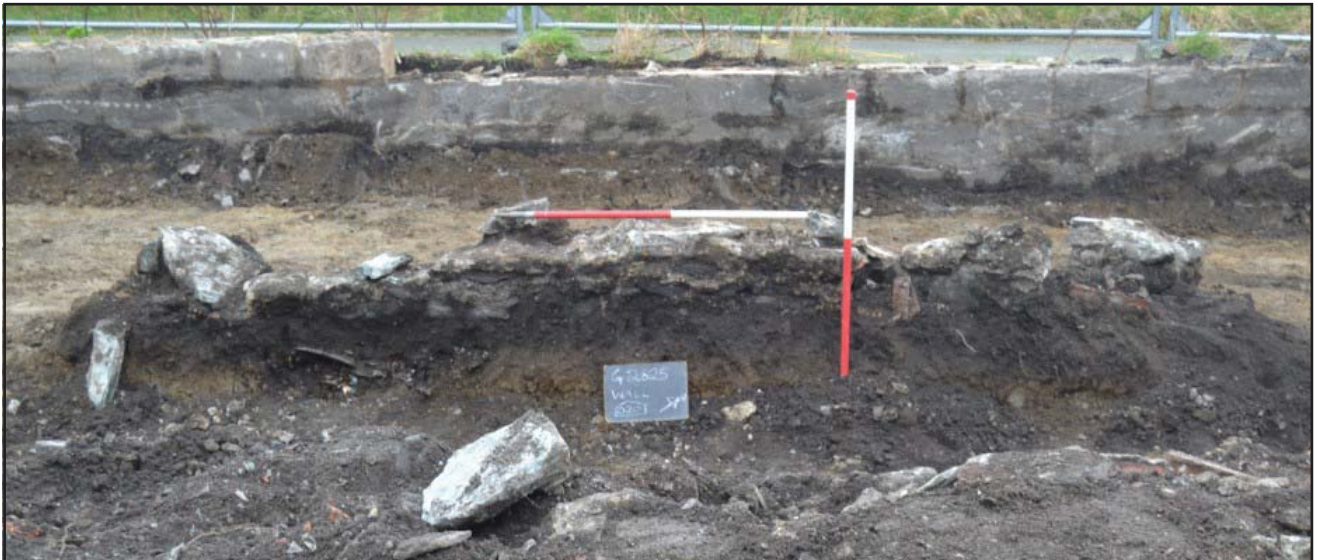
Plate 09. Wall (120) resting on garden soil. View from south-east (archive reference: G2825\_030)

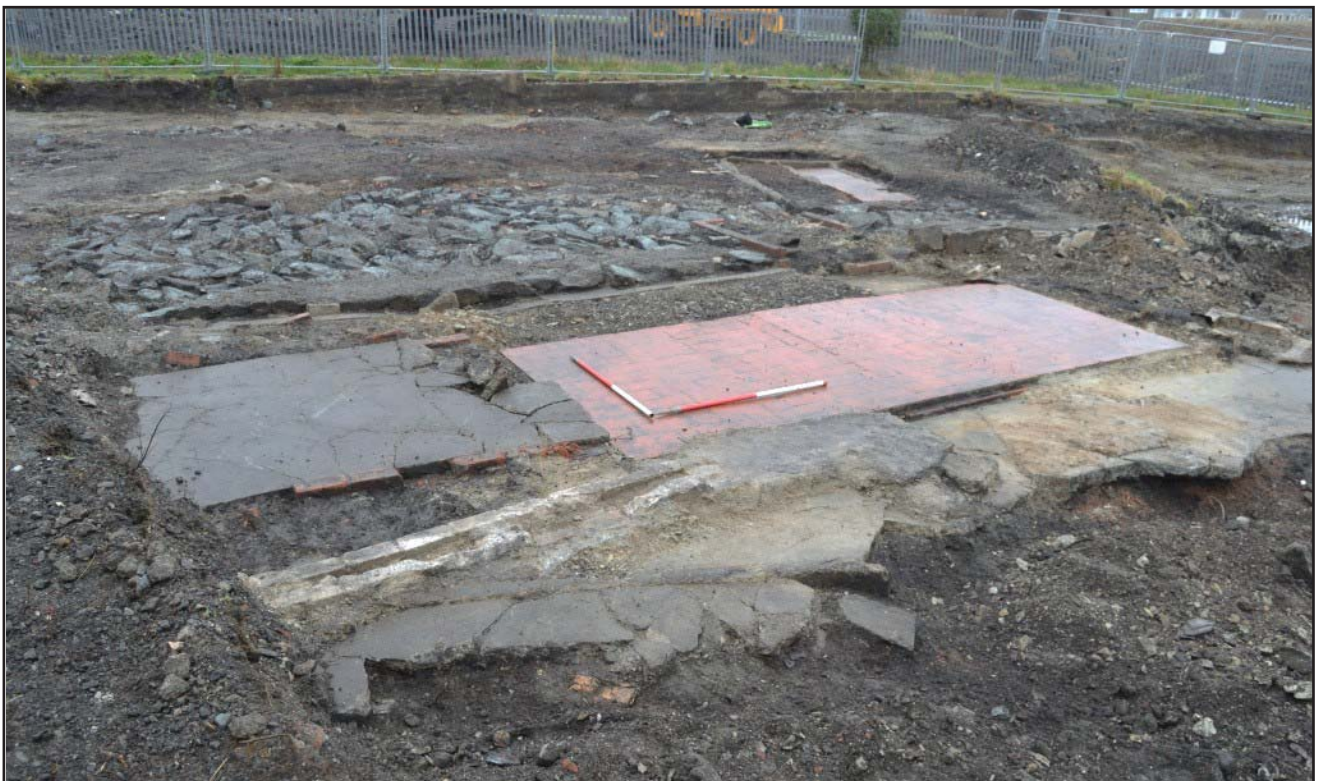
Plate 10. Remains of bakery (Group 028) with floors (004) and (019), and levelling deposit (017) in background. View from south-west (archive reference: G2825\_074)

In the south-western corner of the site were the foundations and floor layers of a building that local residents identified as a former bakery, recorded as Group 028 (Plate 10). No foundations of main structural walls were found but various floor surfaces and slight structures survived.

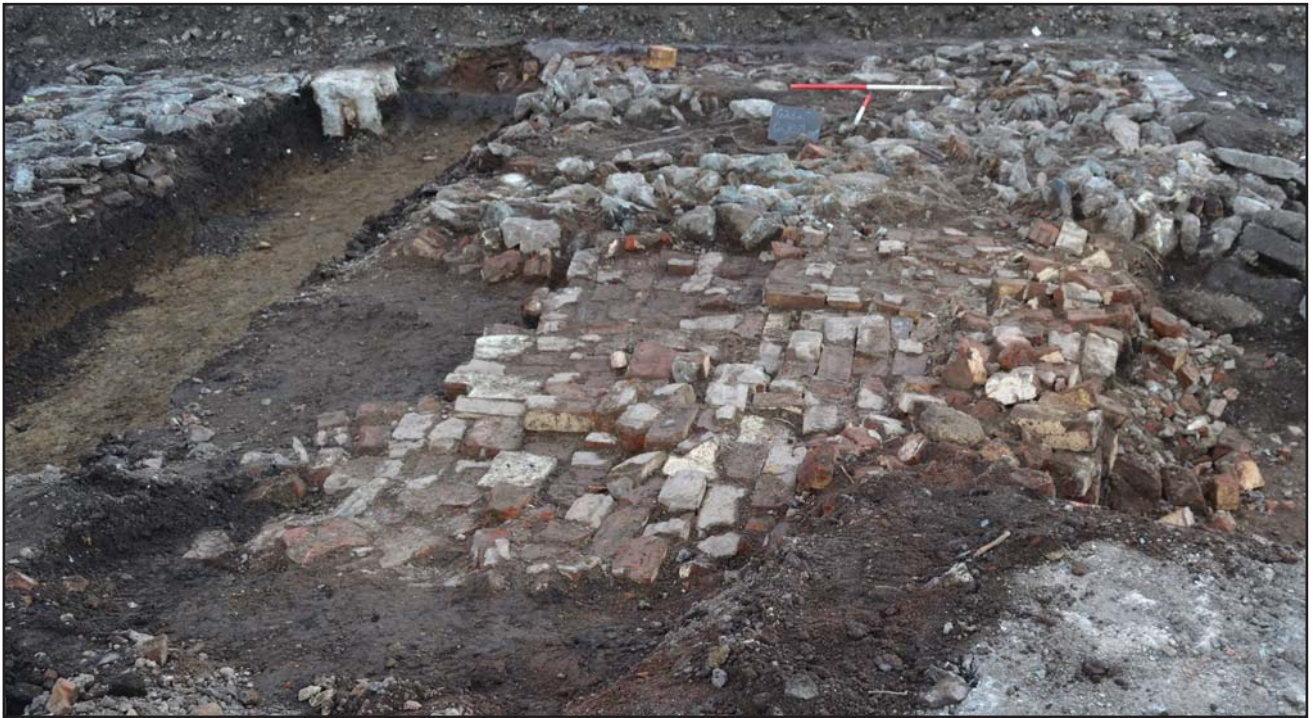
Plate 11. Bricks (026) and stone (009/057) forming levelling for bakery. View from north-east; scales 1m (archive reference: G2825\_178)

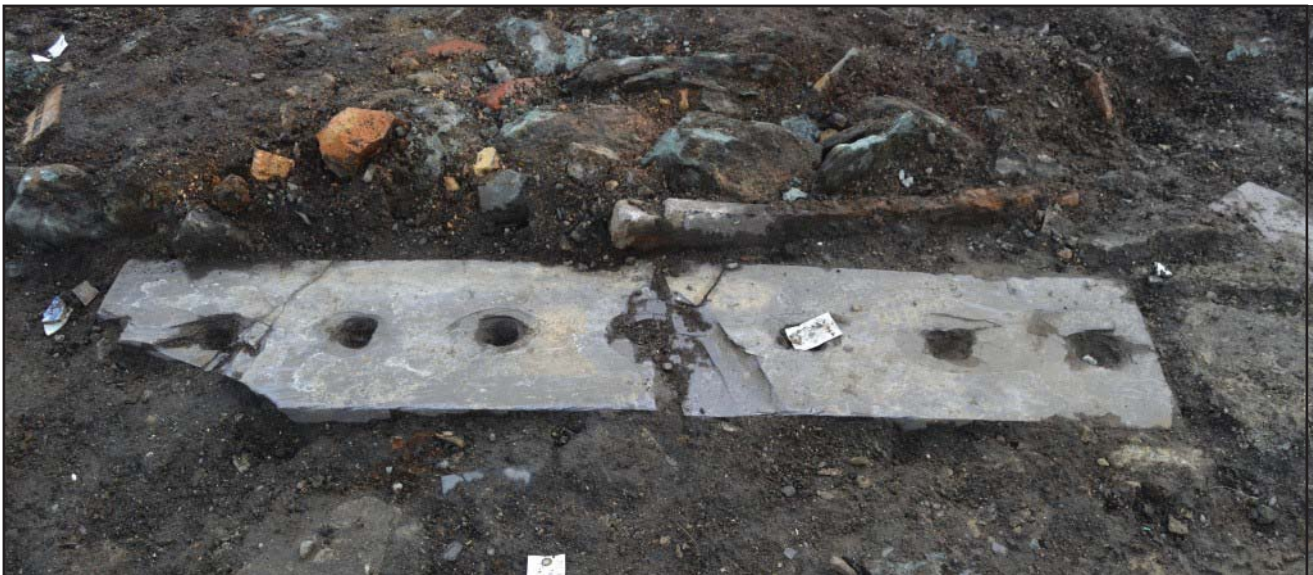
Plate 12. Slate slab (010). View from north-west (archive reference: G2825\_046)

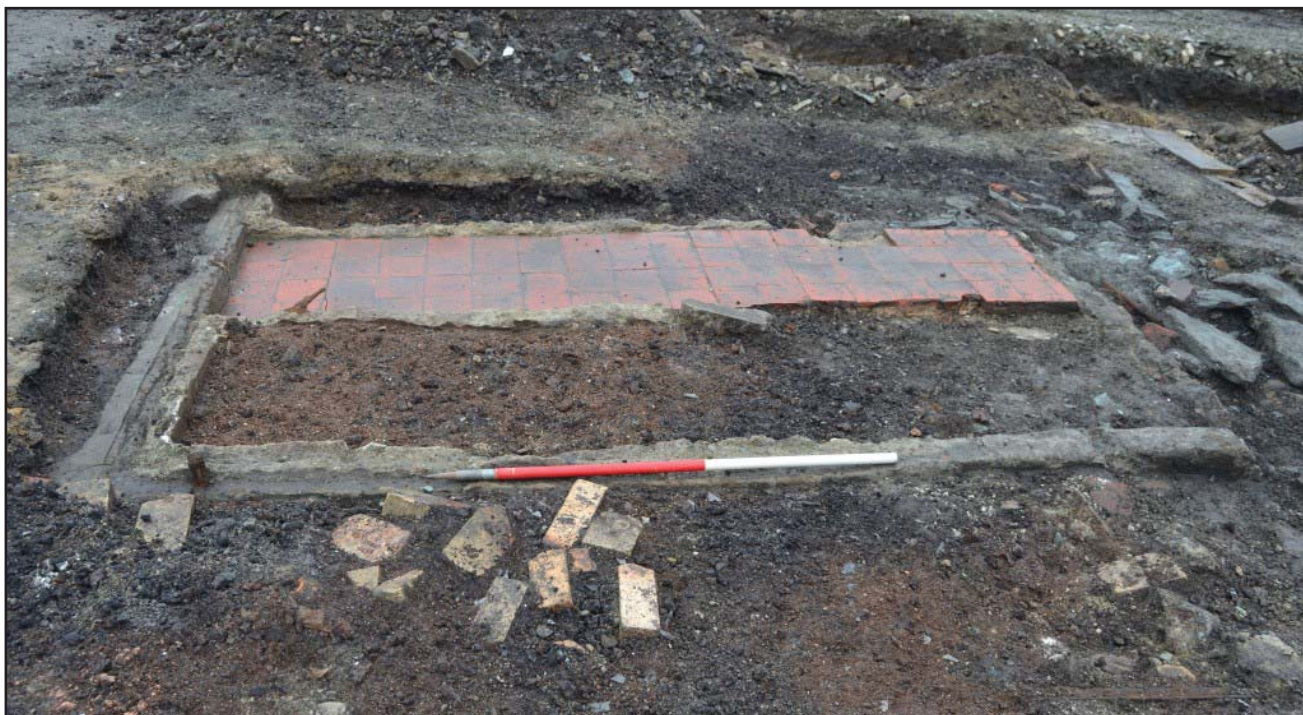
Plate 13. Structure (031) with tiled floor (032). View from north-east; scale 1m (archive reference: G2825\_069)

- Plate 13. Structure (031) with tiled floor (032). View from north-east; scale 1m (archive reference: G2825\_069)
- Plate 14. Section in southern corner of Area A through garden soil (002) and ploughsoil (021) with layer (014) in the base. View from north-east, scale 1m (archive reference: G2825\_161)

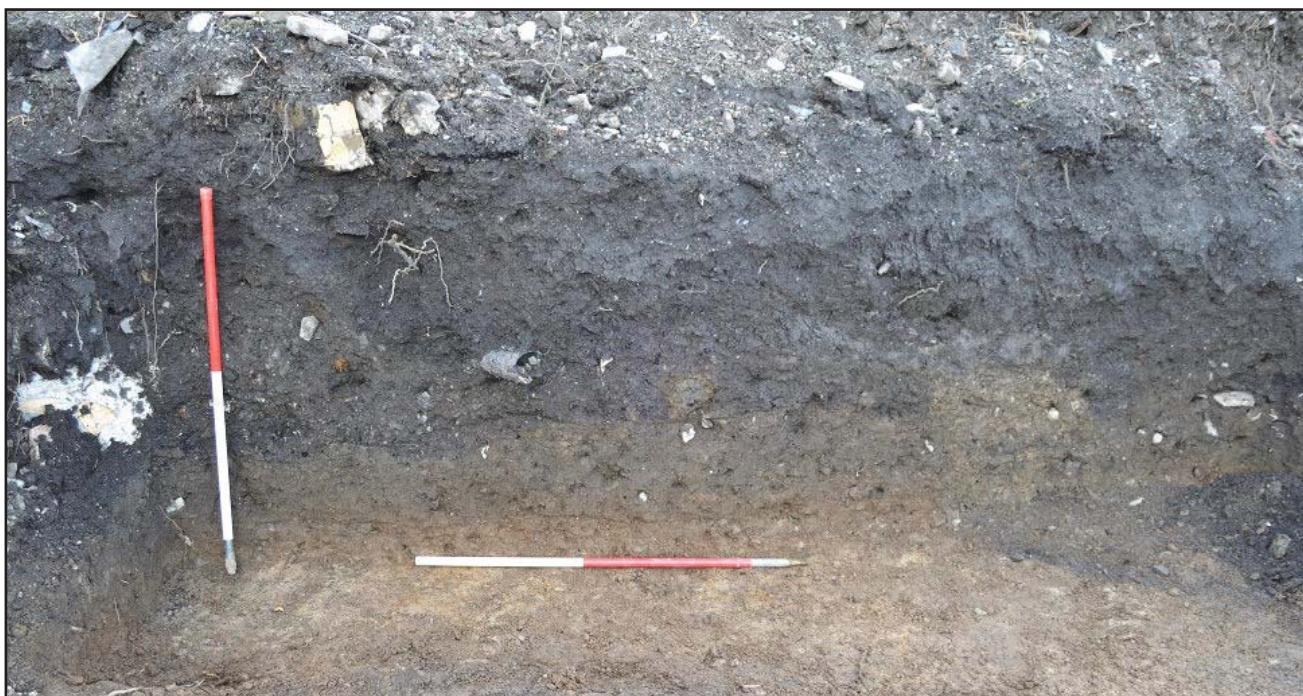
Plate 14. Section in southern corner of Area A through garden soil (002) and ploughsoil (021) with layer (014) in the base. View from north-east, scale 1m (archive reference: G2825\_161)

Beneath this, along much of the southern side of Area A, was a layer of loose, dark orange-brown silty loam with occasional small stones (Plate 14). This layer (021) was up to 0.5m deep and appeared to be a relict ploughsoil surviving under the level of disturbance by the gardening and building activity. Under the ploughsoil, close to the south-eastern limit of the excavations was a mid-grey clayey silt (014) up to 0.2m thick. This layer contained occasional small stones and some dark flecks, initially thought to be charcoal. Deposit 014 was seen along a 9m length on the limits of the site with a width of 3.0m exposed within the site. It was interpreted on site as being the fill of a shallow ditch [015], but the north-western side of this supposed feature sloped down very gradually, and it is more likely to have been the natural slope of the ground beyond the area levelled for building the Community Centre (Figure 09). Deposit 014 is therefore interpreted as the lower part of the relict ploughsoil.

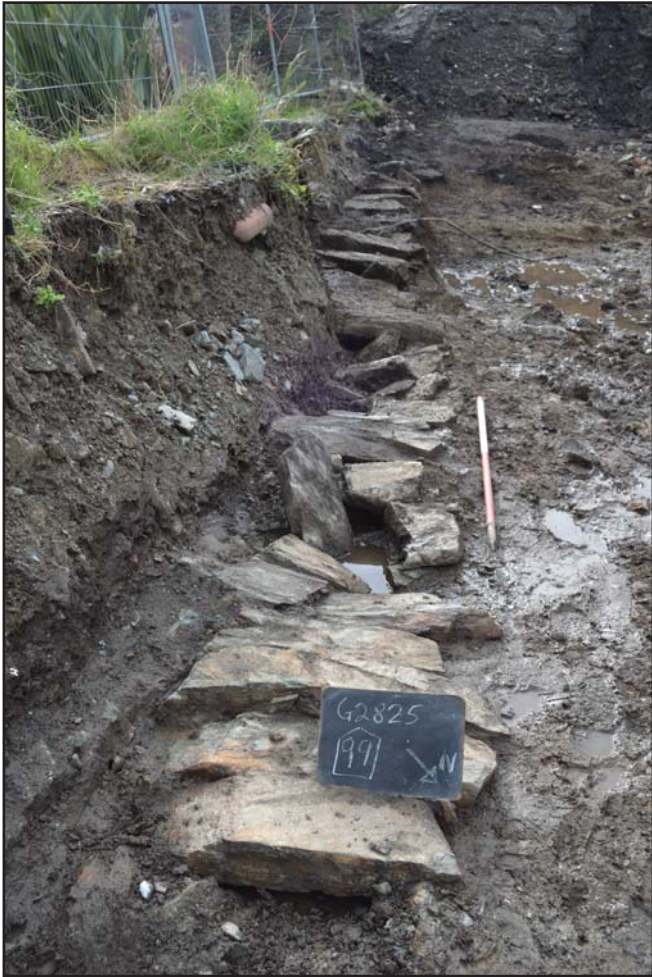
Plate 15. Capping of culvert (099), cut [098]. View from north-east; scale 1m (archive reference: G2825\_237)

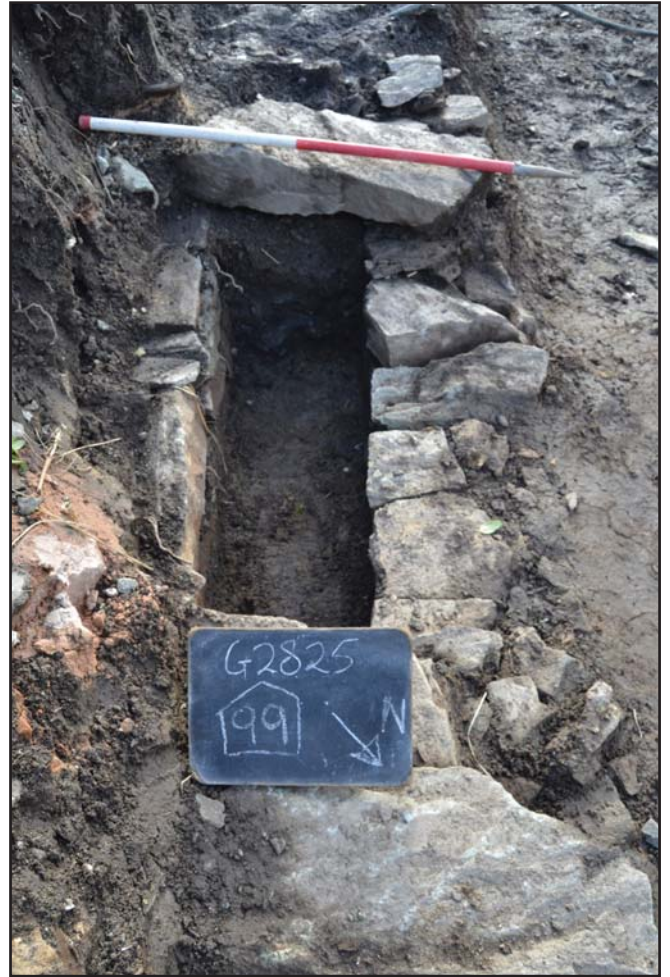
Plate 16. Culvert (099), cut [098], with interior exposed. View from north-east; scale 1m (archive reference: G2825\_256)

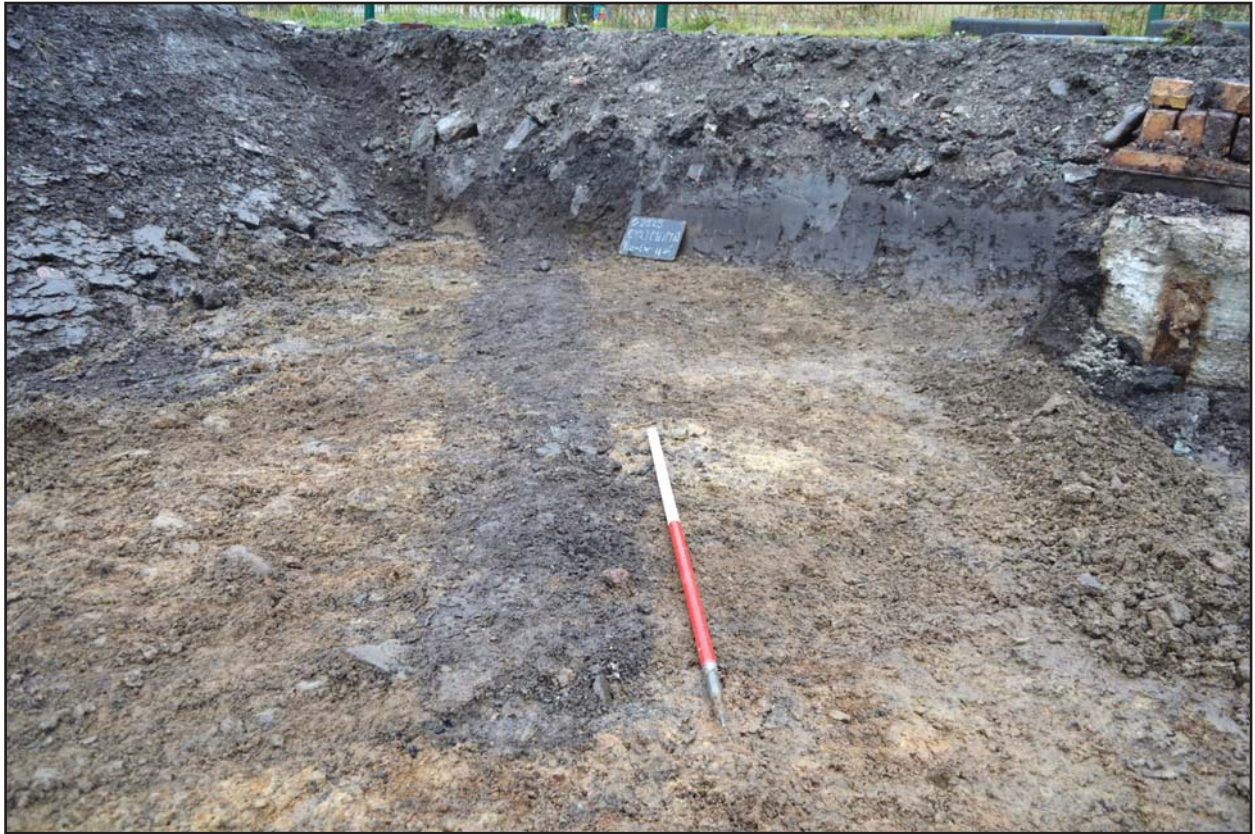
Plate 18. Possible foundation trench [092]. View from north-north-west; scale 1m (archive reference: G2825\_219)

- Plate 17. Ditch [088] with service trench [086] in background. View from south, scale 1m (archive reference: G2825\_216)
- Plate 18. Possible foundation trench [092]. View from north-north-west; scale 1m (archive reference: G2825\_219)
