# Gorsaf Heddlu Caergybi, Caergybi, Ynys Môn Holyhead Police Station, Holyhead, Anglesey

Archaeological Mitigation (Strip/Map/Record)

## Report on Archaeological Mitigation (Strip/Map/Record)

Project Code: G2825 / HD24-020

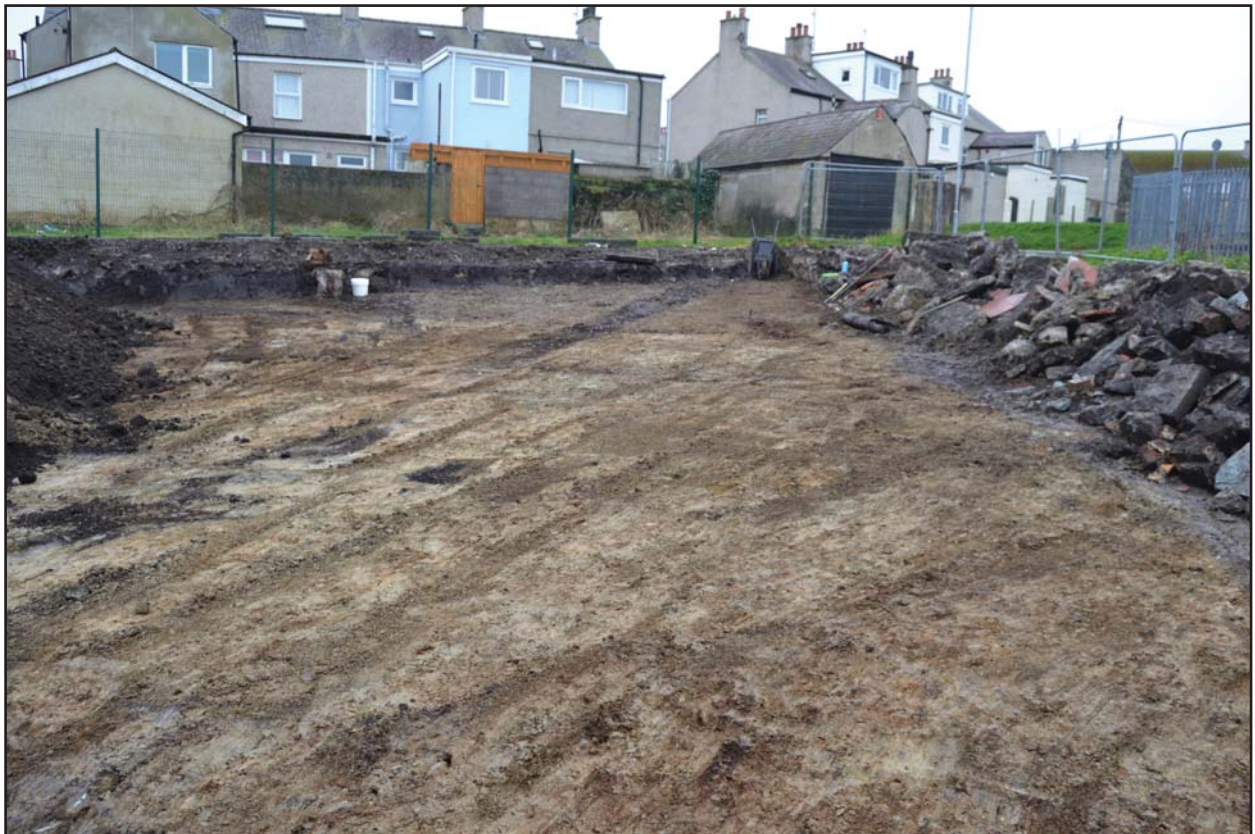
Plate 19. Area A stripped down to natural boulder clay. View from south (archive reference: G2825\_213)

- Plate 19. Area A stripped down to natural boulder clay. View from south (archive reference: G2825\_213)
- Plate 20. The road of Wynne Terrace (136). View from east-south-east (archive reference: G2825\_408)

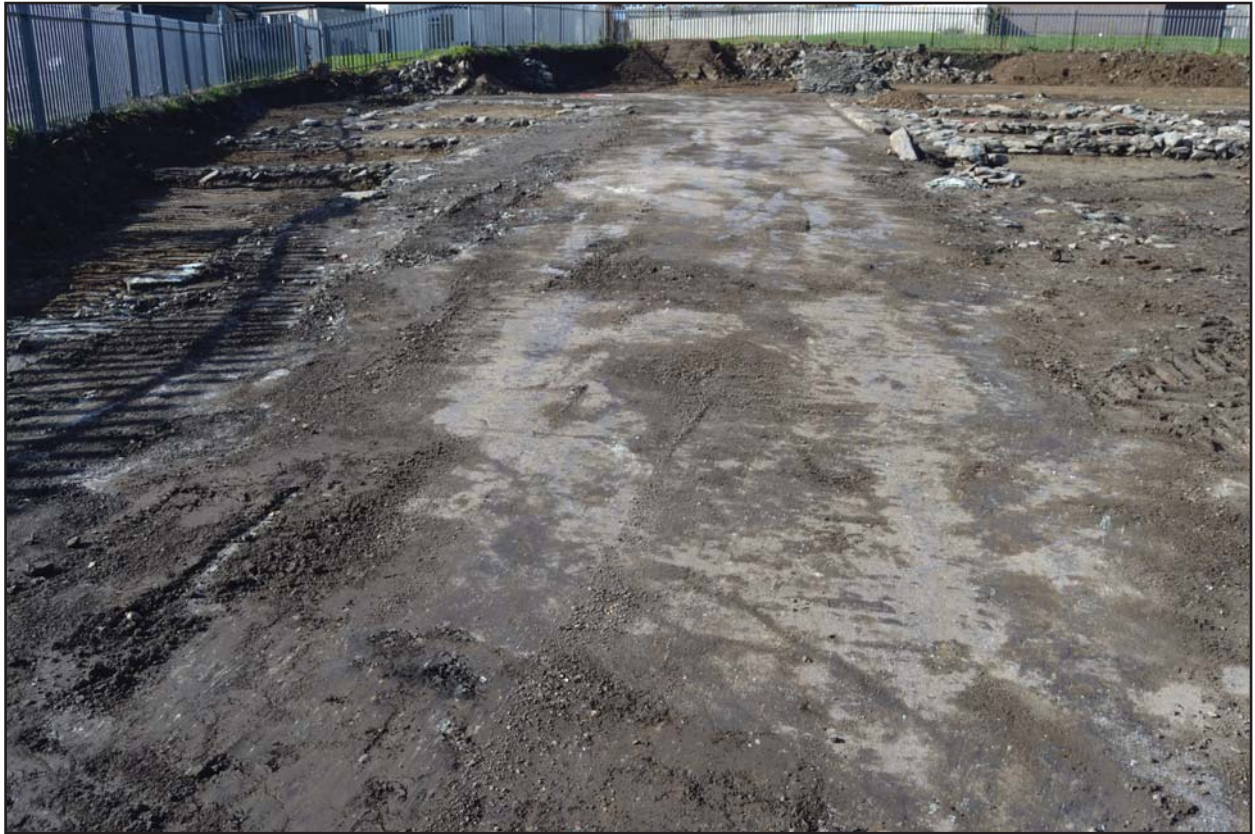
Plate 20. The road of Wynne Terrace (136). View from east-south-east (archive reference: G2825\_408)

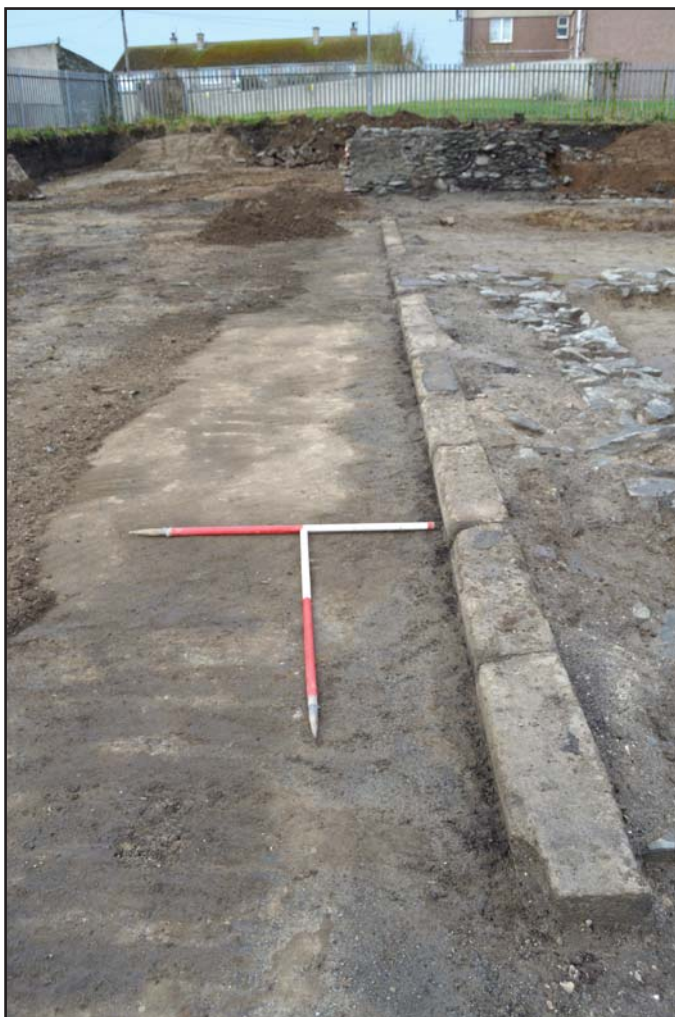
Plate 21. Road (136) and kerb (133). View from east, scales 1m (archive reference: G2825\_370)

- Plate 21. Road (136) and kerb (133). View from east, scales 1m (archive reference: G2825\_370)
- Plate 22. Foundations (141) of Wynne Terrace houses south-east of the road. View from south-west (archive reference: G2825\_403)

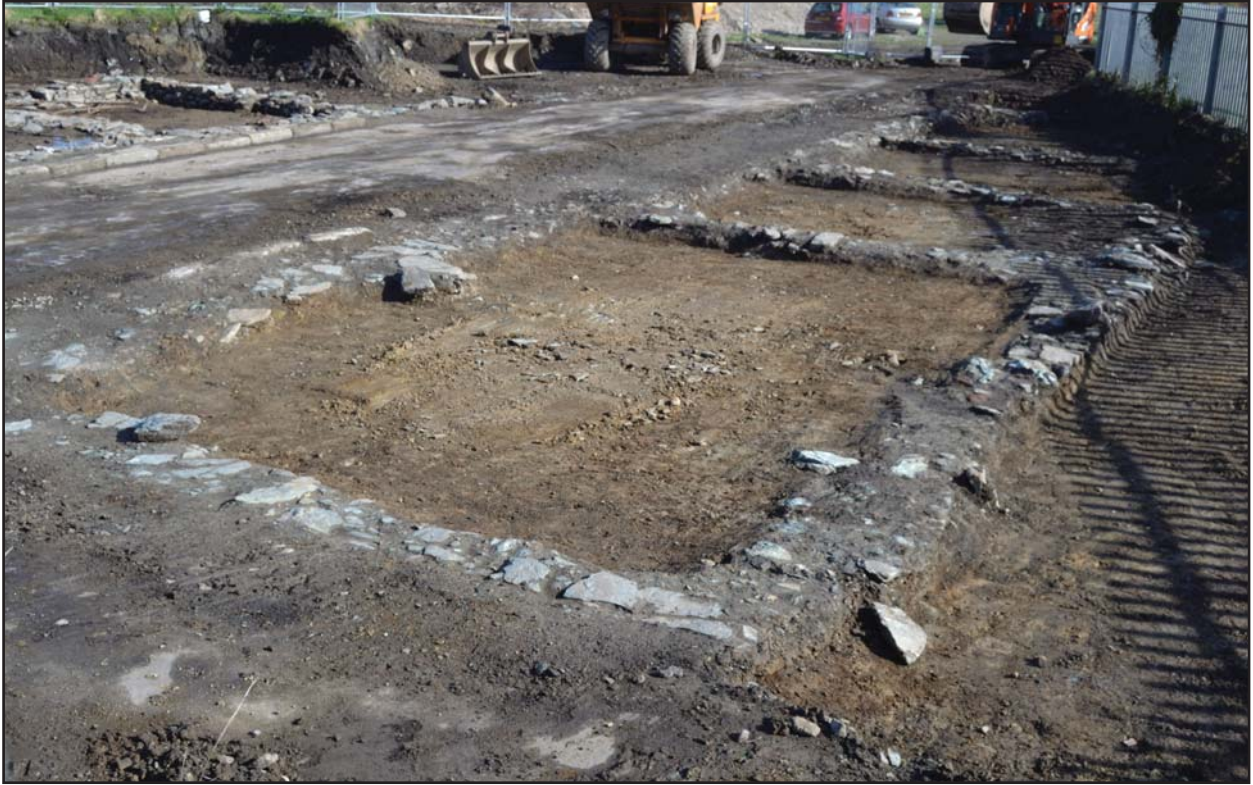
Plate 22. Foundations (141) of Wynne Terrace houses south-east of the road. View from south-west (archive reference: G2825\_403)

Wynne Terrace lay to the north-west and south-east of the middle section of the road. To the south-east of the road the fragmentary remains of foundations (140) show the location of four terrace houses and one larger building (Plate 22). The foundations are of local schist bonded with mortar and sit in foundation trenches. Each terrace house measured internally about 3.2m by 4.4m.

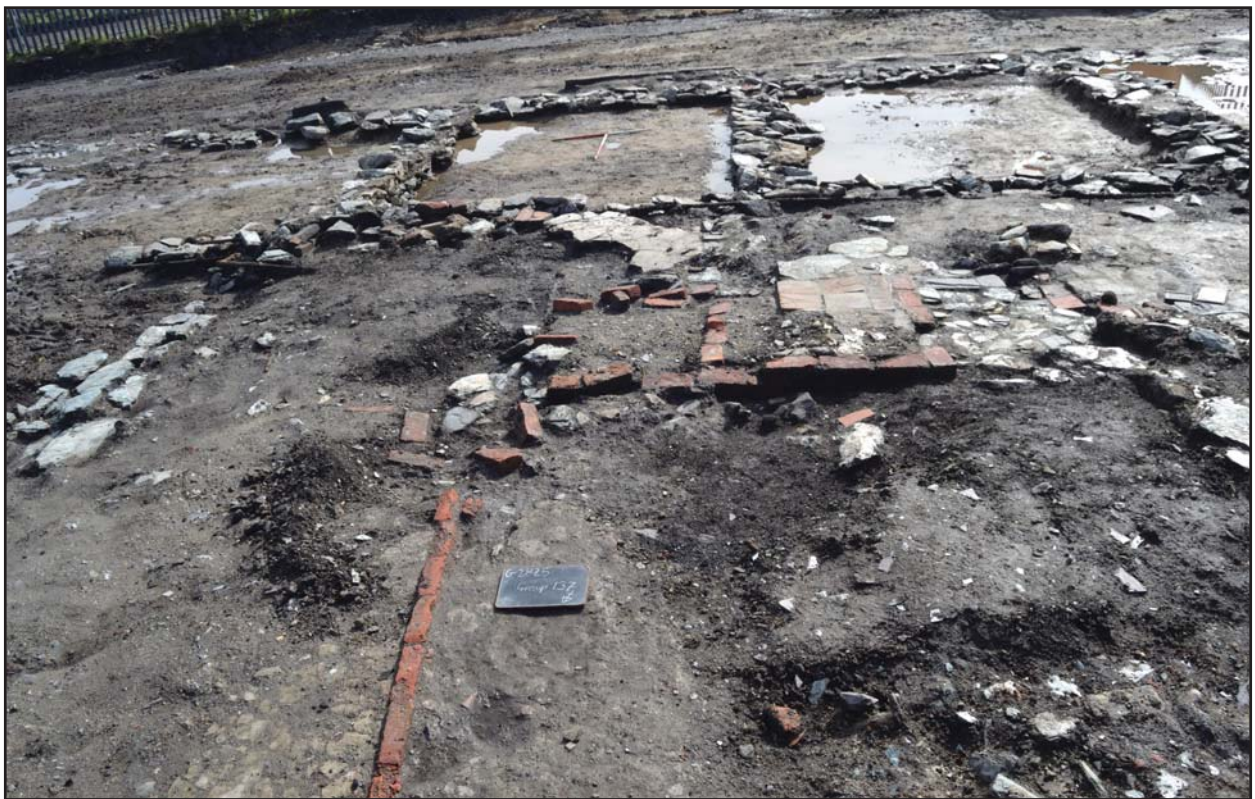
Plate 23. Building foundations and floors forming Group 137. View from north-north-west, scales 1m (archive reference: G2825\_324)

To the north-west of the road more survived, including the remains of five small terrace houses and one larger building. This whole area was recorded as Group 137 (Plate 23). The foundations (114/191), about 0.68m wide, were of mortared schist in foundation trenches and where best preserved defined small rectangular houses measuring about 3.3m by 4.6m internally (Plate 24). Behind the fairly solidly built houses were slighter walls, defining the back yards, with the concrete floor and other details of one yard surviving. The yard wall foundations (122) were 0.3m wide, built of stone with lime mortar and generally very fragmentary (Plate 25). Inside the best-preserved yard was a concrete floor (149) with the north-western part defined by a line of stones set on edge. There were also the foundations of a square brick structure (123), measuring 1.20m by 1.12m externally (Plate 26). This was a shed for an outside toilet, and it had a small area of tiled floor and broken remains of a ceramic pipe. To the west of this stone and brick had been laid to create a rough floor. This was probably to seal the top of an infilled cesspit (see discussion below). A small patch of tiles (132), further south-

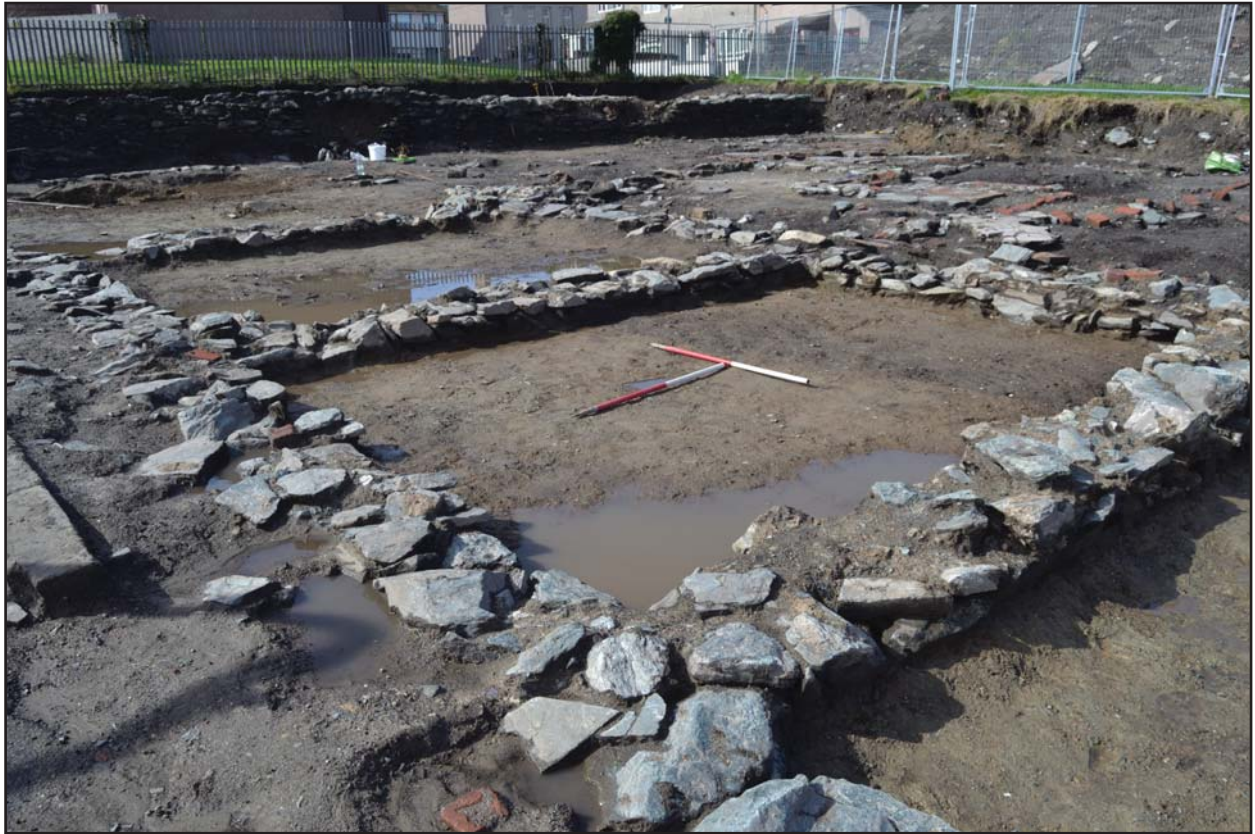
Plate 24. Foundations (114) of Wynne Terrace houses north-west of the road. View from north-east, scales 1m (archive reference: G2825\_330)

- Plate 23. Building foundations and floors forming Group 137. View from north-north-west, scales 1m (archive reference: G2825\_324)
- Plate 24. Foundations (114) of Wynne Terrace houses north-west of the road. View from north-east, scales 1m (archive reference: G2825\_330)

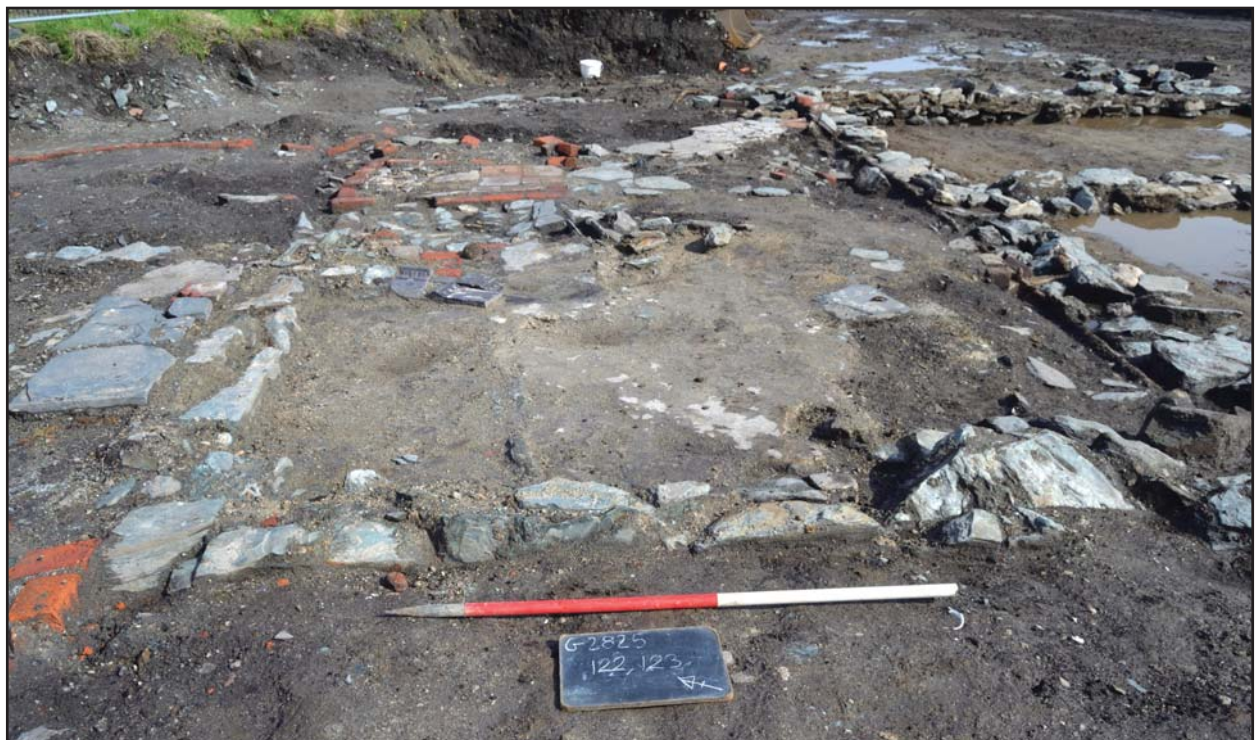
Plate 25. Backyards to Wynne Terrace with walls (122) and concrete floor (149). View from south-west, scale 1m (archive reference: G2825\_332)

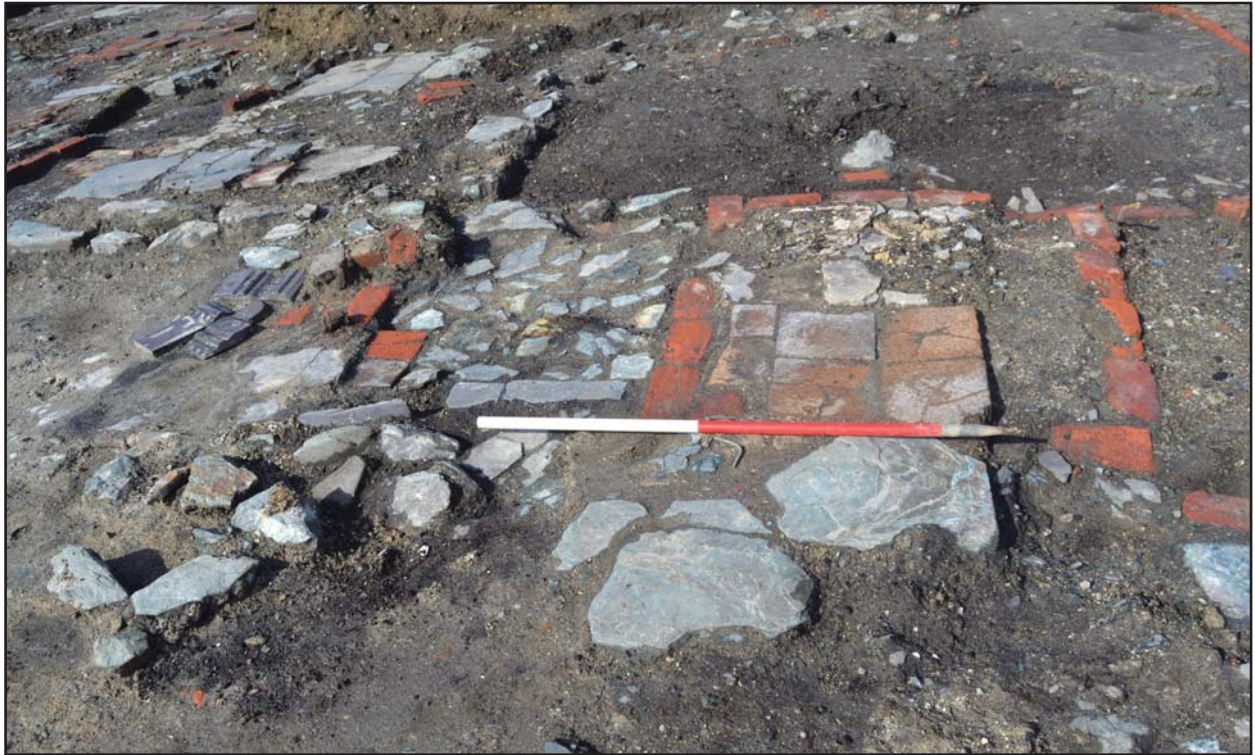
Plate 26. Base of outside toilets (123) behind Wynne Terrace. View from south-south-east, scale 1m (archive reference: G2825\_335)

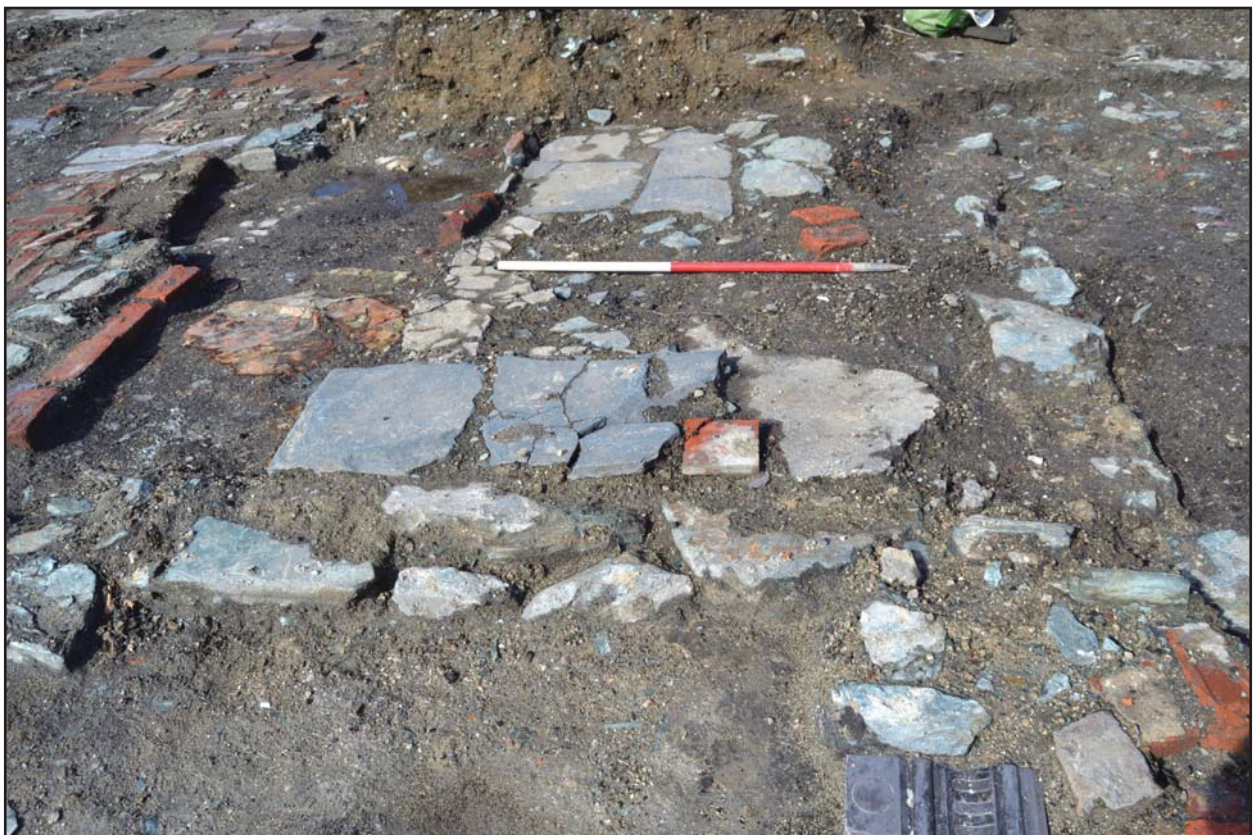
Plate 27. Floor (126) in backyard of Moretons Terrace. View from south-south-east, scale 1m (archive reference: G2825\_346)

- Plate 27. Floor (126) in backyard of Moretons Terrace. View from south-south-east, scale 1m (archive reference: G2825\_346)
- Plate 28. Flooring (127) including base for outside toilet in yard behind Moretons Terrace. View from south-south-east, scale 1m (archive reference: G2825\_348)

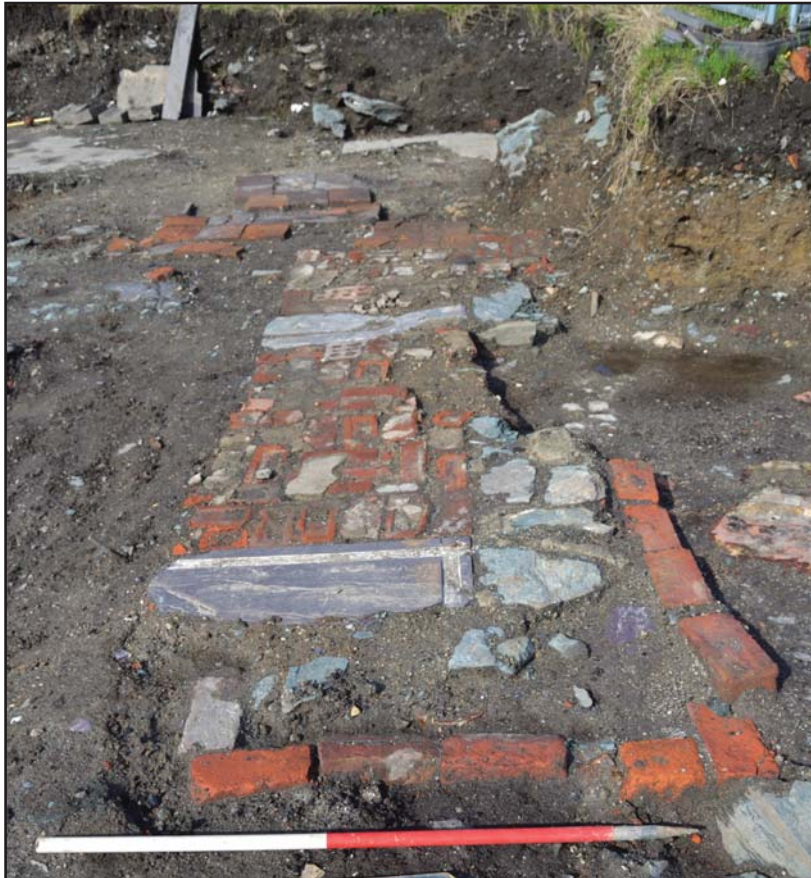
Plate 28. Flooring (127) including base for outside toilet in yard behind Moretons Terrace. View from south-south-east, scale 1m (archive reference: G2825\_348)

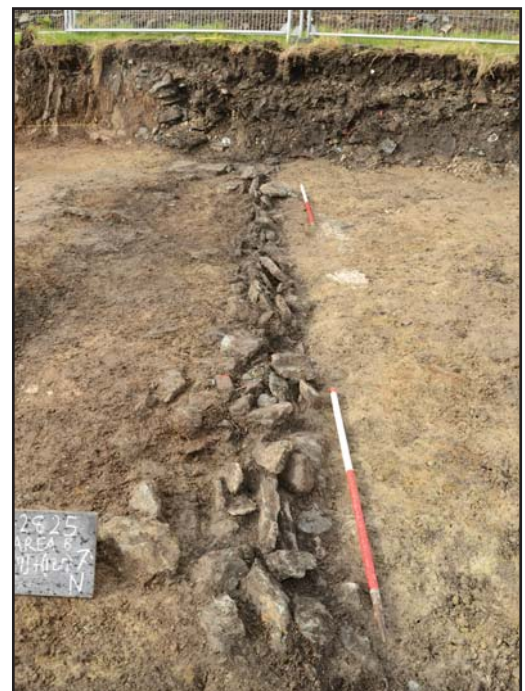
Plate 30. Part of wall foundation (080) in cut [179] for one of the Moretons Terrace houses. View from south-east, scale 1m (archive reference: G2825\_473)

The wall of the western house on Moretons Terrace was defined by stone (180) packed into a foundation trench [179] (Plates 29 and 30). Some of the stones were slabs laid flat, but others were set on edge and most at various angles, so it did not resemble the other foundations, and was initially thought to be some kind of drain. The tooth of a pig (SF13) was recovered from this feature.

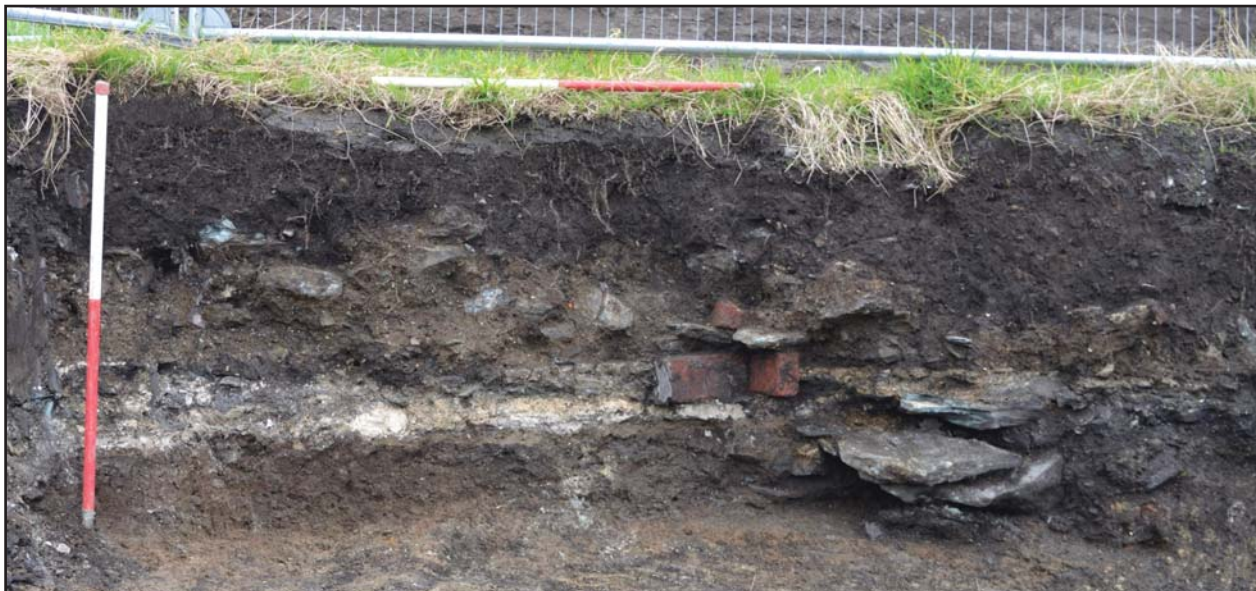
Plate 31. South facing section of northern baulk showing wall 198 (see Figure 12). View from south-west, scale 1m (archive reference: G2825\_440)

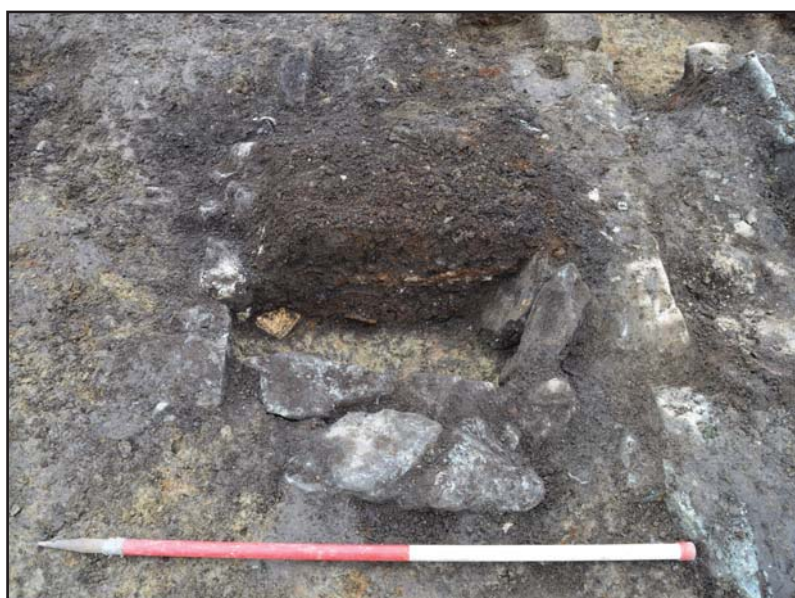
Plate 32. Cesspit [160] half sectioned. View from south-west, scale 1m (archive reference: G2825\_445)

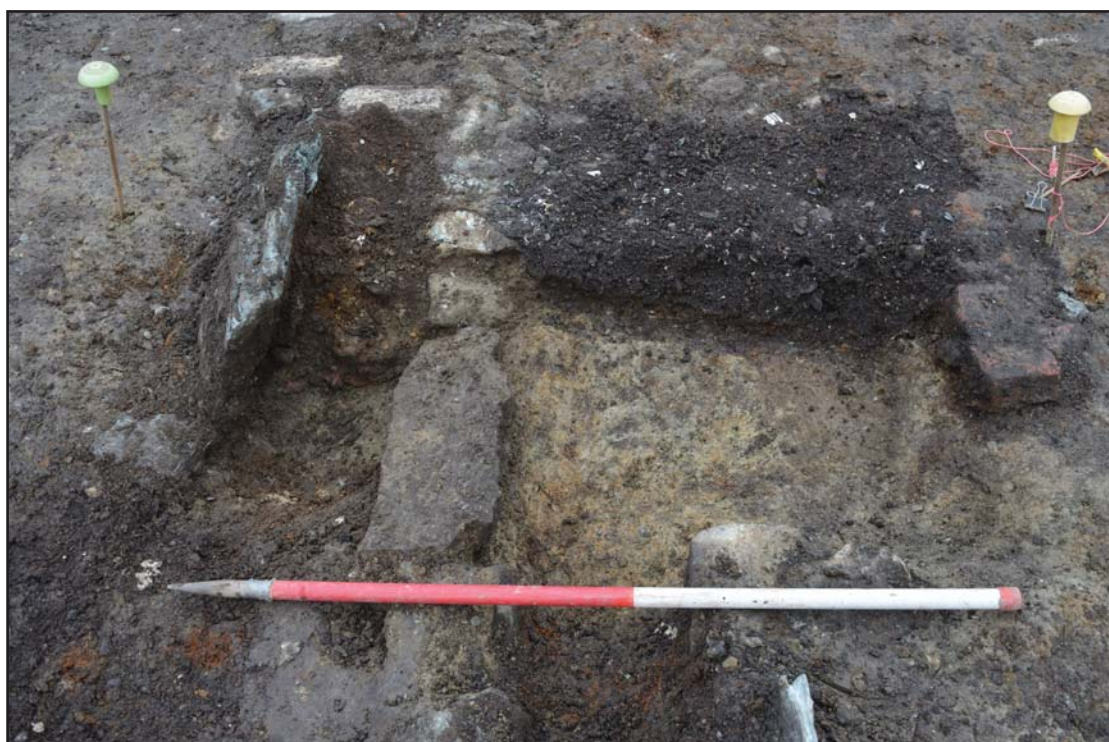
Plate 33. Cesspit [163] half sectioned with drain (169) running next to it and into it. View from south-west, scale 1m (archive reference: G2825\_442)

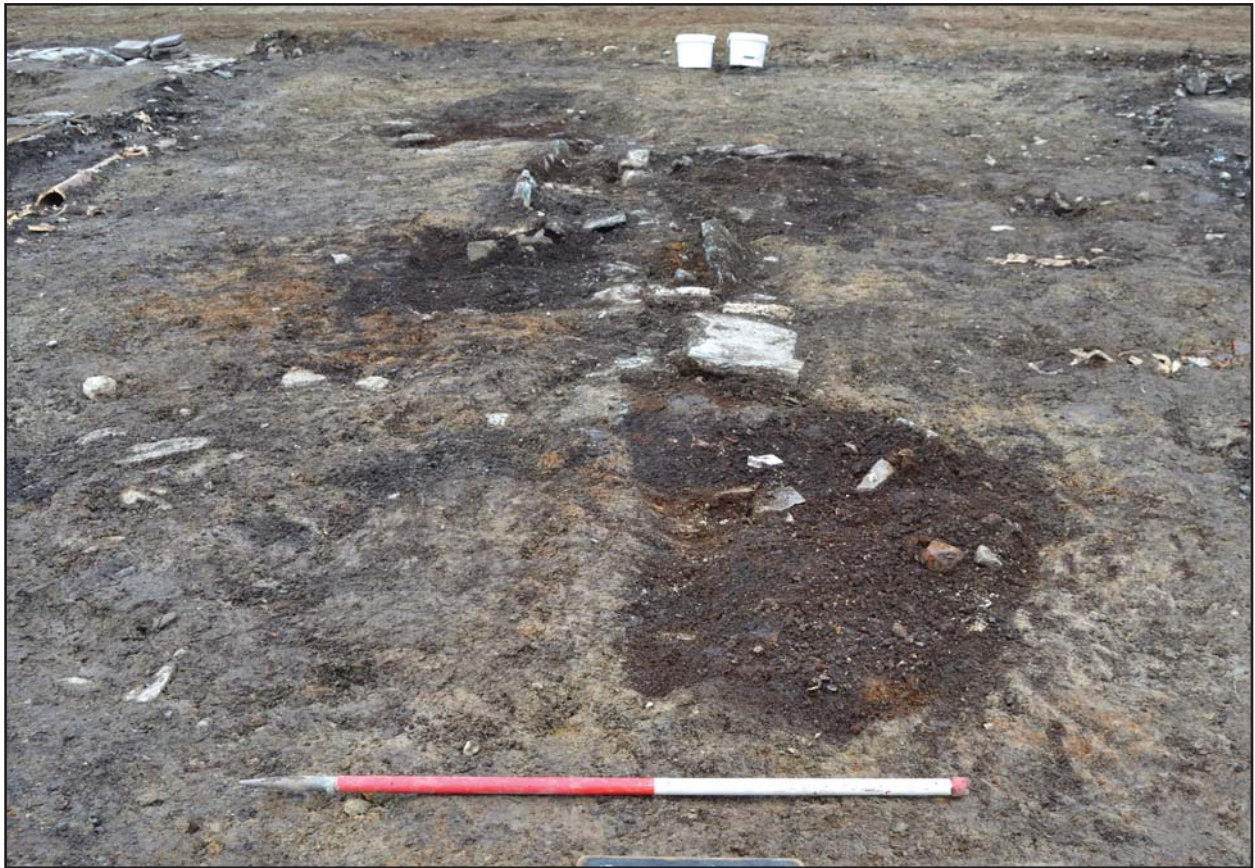
Plate 34. Cesspits and drain (169) with possible cesspit [167] in foreground. View from north-east, scale 1m (archive reference: G2825\_438)

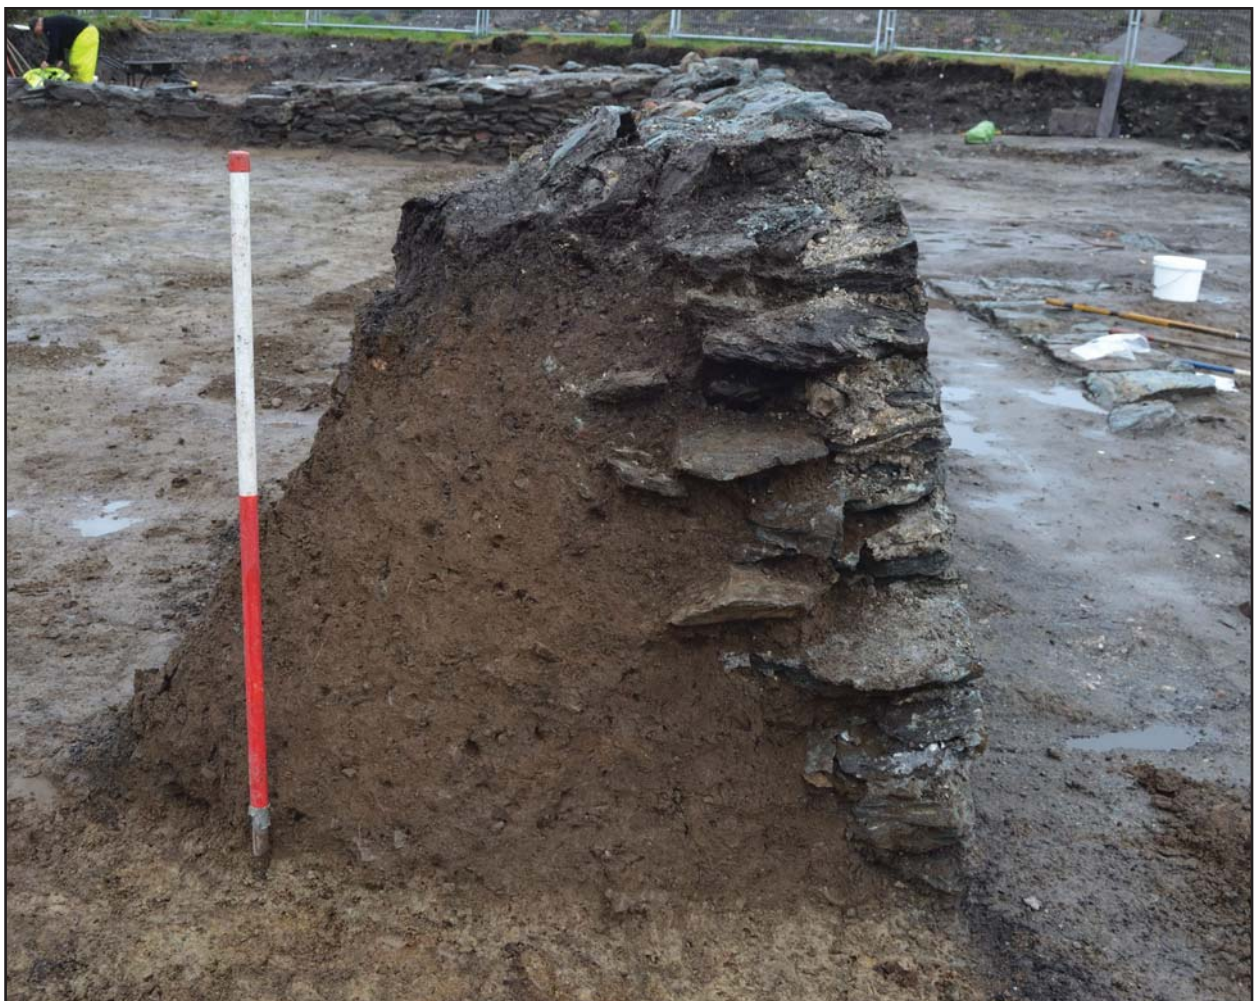
Plate 35. Section through revetment wall (056) showing where cut [144] has cut through the ploughsoil (075). View from south-south-east, scale 1m (archive reference: G2825\_320)

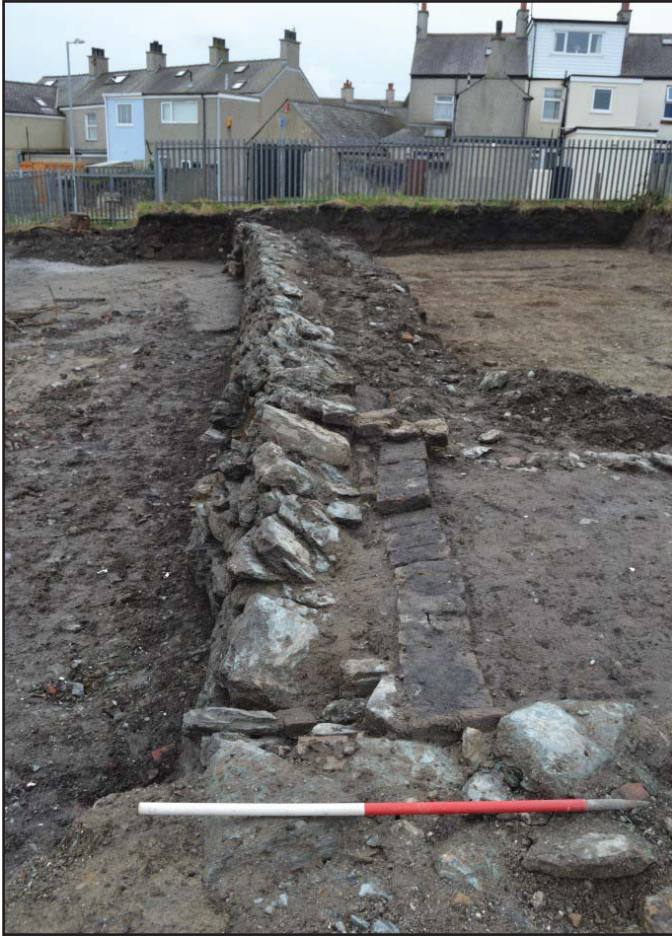
Plate 36. Northern end of revetment wall (056) in plan. View from north-north-west, scale 1m (archive reference: G2825\_147)

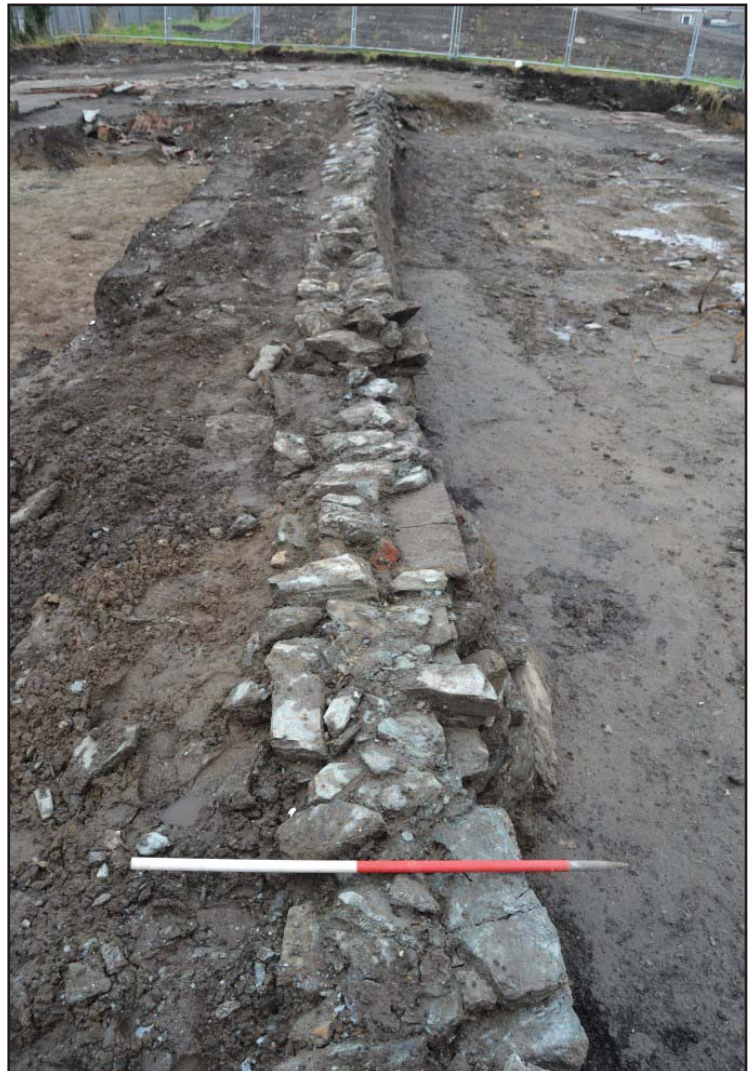
Plate 37. Southern end of revetment wall (056) in plan. View from south-south-east, scale 1m (archive reference: G2825\_148)

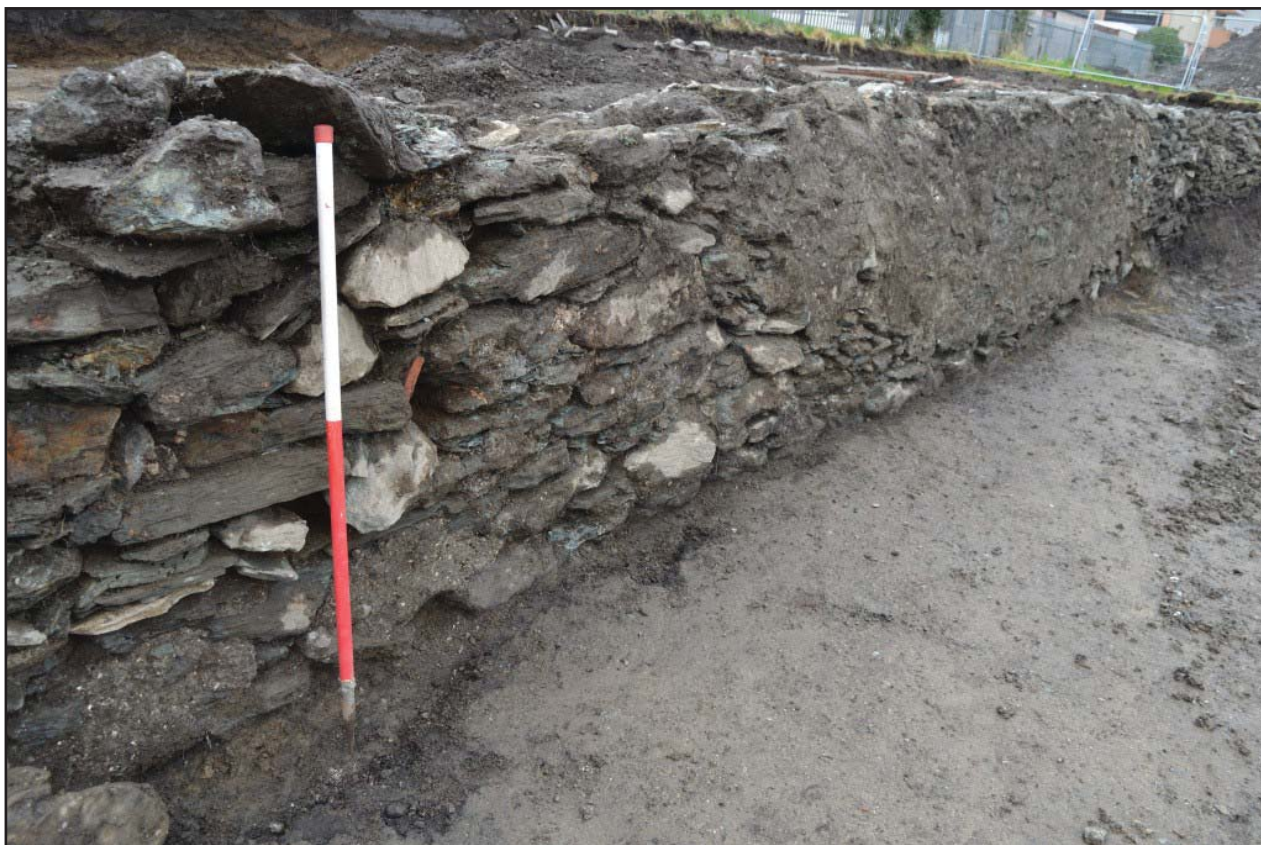
Plate 38. Face of revetment wall (056) at southern end next to road. View from south-east, scale 1m (archive reference: G2825\_156)

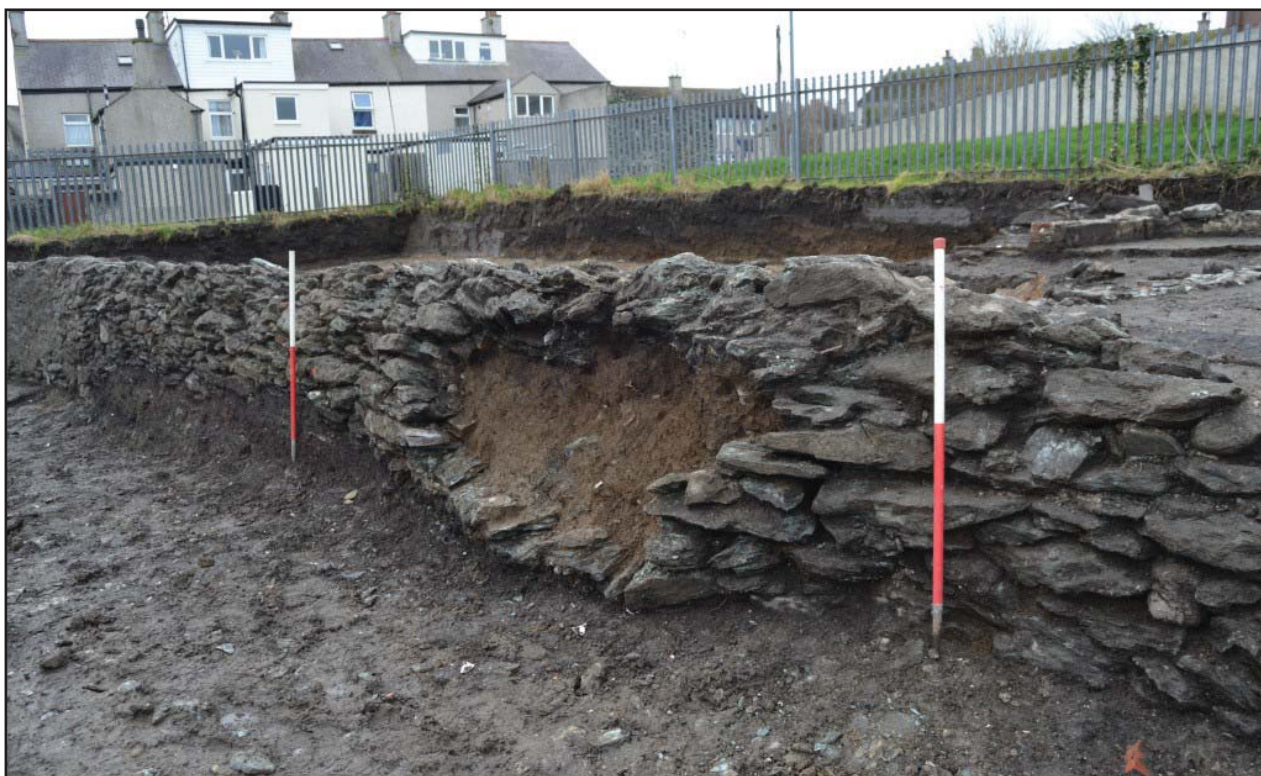
Plate 39. Face of revetment wall (056) at northern end with collapsed section. View from north-east, scale 1m (archive reference: G2825\_151)

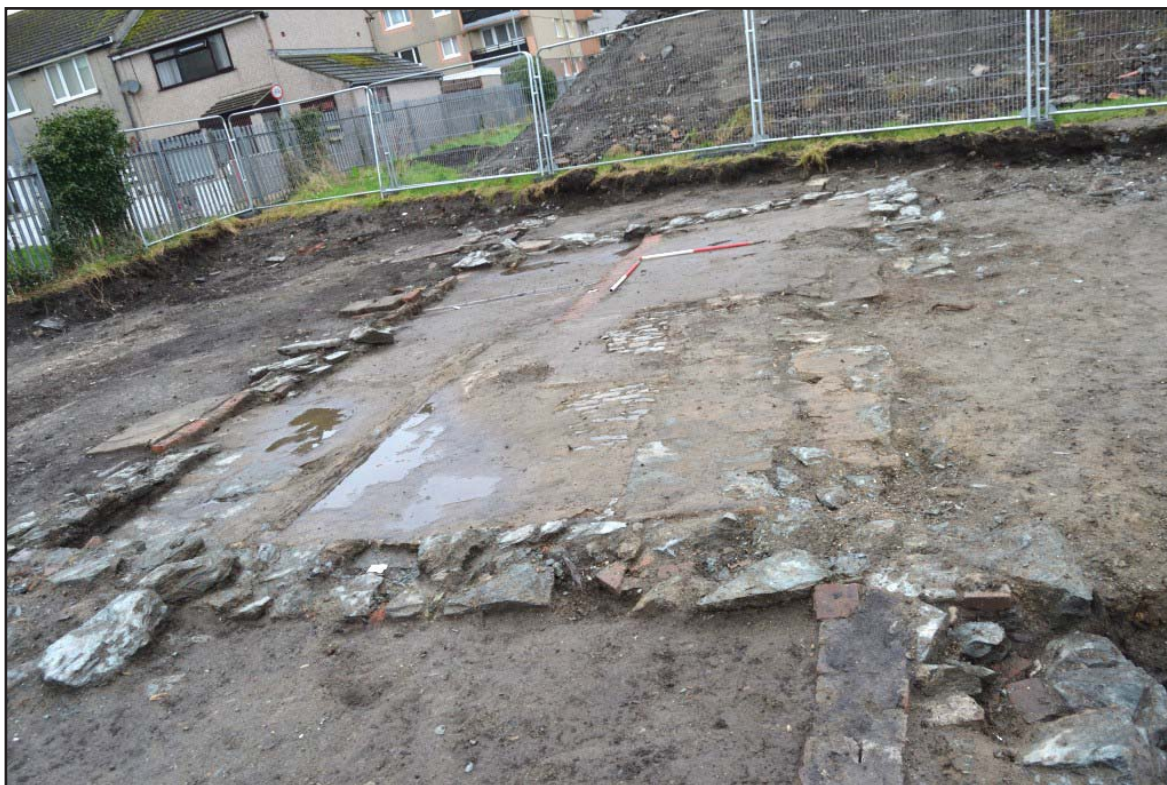
Plate 40. Building with walls (041) and floor (046). View from south-east, scale 1m (archive reference: G2825\_114)

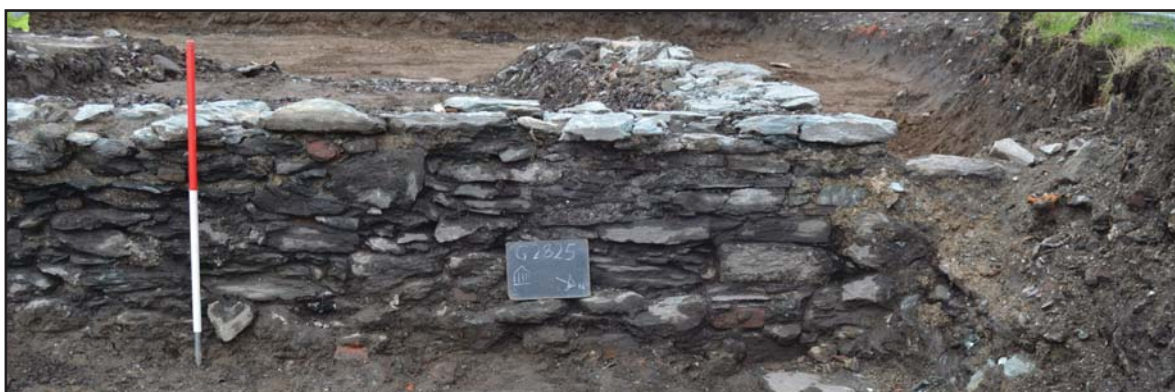
Plate 41. East-north-east face of wall (041). View from east-north-east, scale 1m (archive reference: G2825\_284)

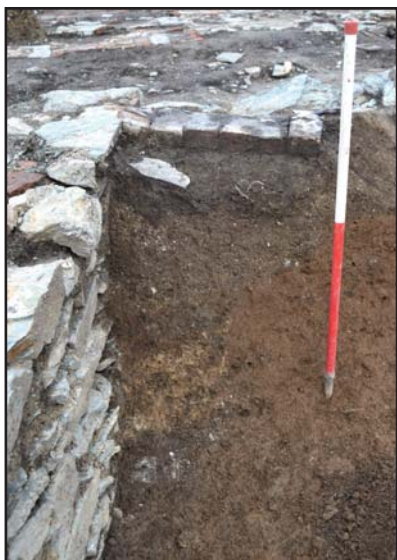
Plate 42. Foundation cut [061]. View from west, scale 1m (archive reference: G2825\_304)

- Plate 42. Foundation cut [061]. View from west, scale 1m (archive reference: G2825\_304)
- Plate 43. Junction of walls (056) (left) and (041) (right). View from east-north-east, scale 1m (archive reference: G2825\_314)

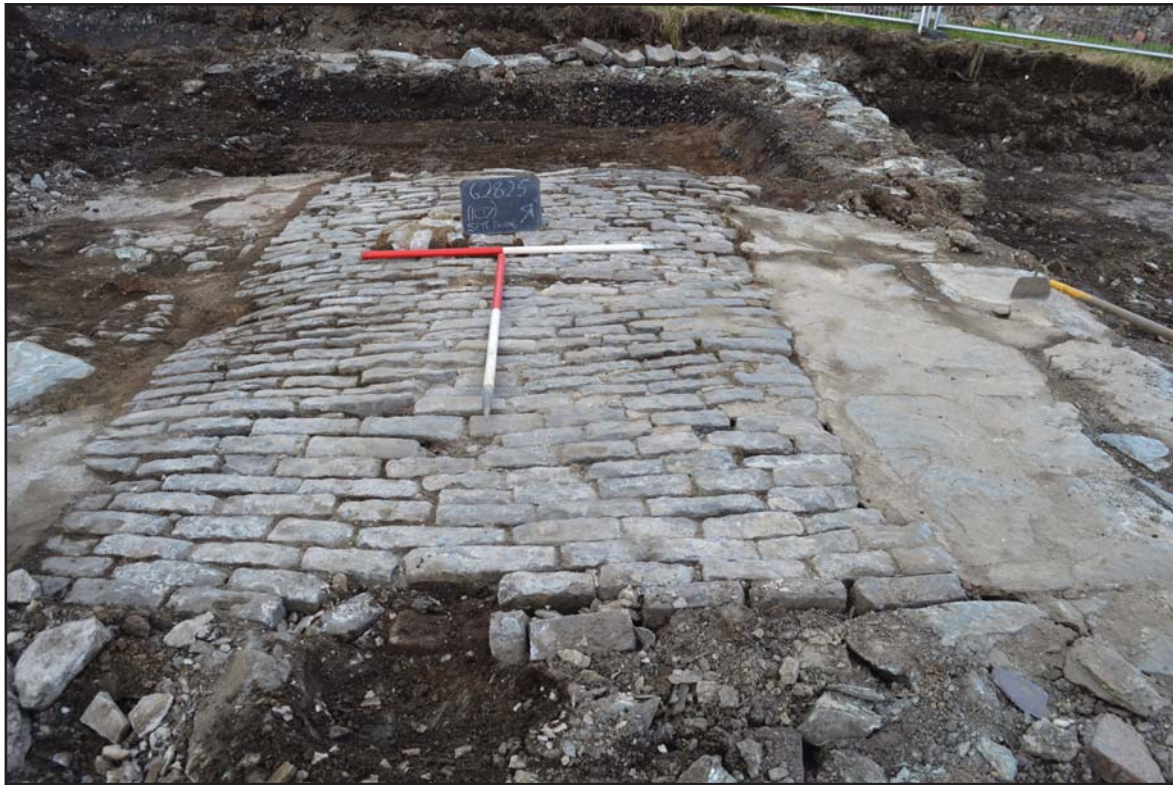
Plate 44. Floor with setts (107) and slabs (110) after concrete has been removed. View from south-east, scales 1m (archive reference: G2825\_270)

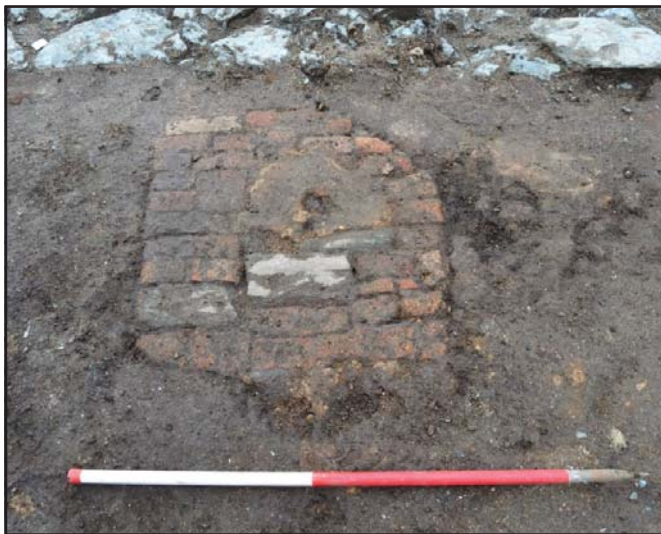
Plate 45. Brick base (052), possibly for a stove. View from north-north-west, scale 1m (archive reference: G2825\_143)

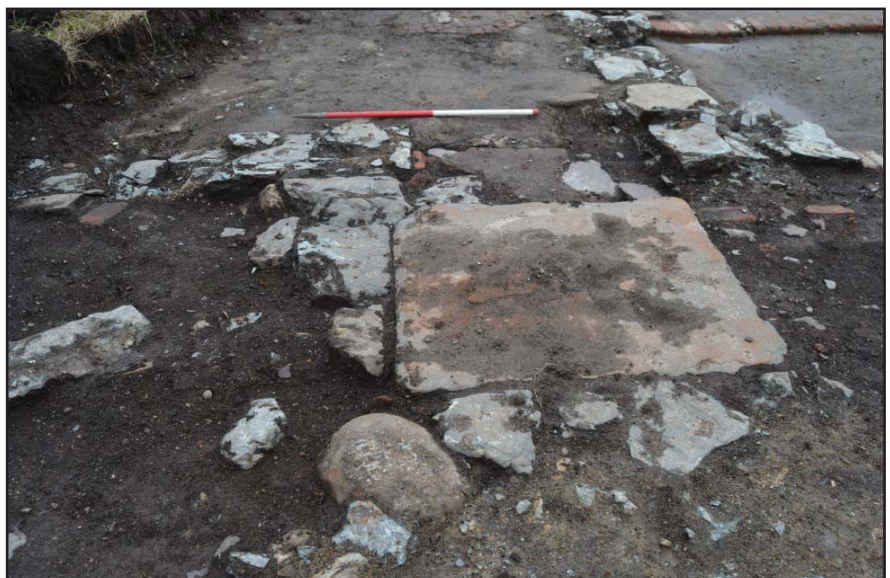
Plate 46. Hearth stone and chimney base (054). View from west-south-west, scale 1m (archive reference: G2825\_145)
