# Gorsaf Heddlu Caergybi, Caergybi, Ynys Môn Holyhead Police Station, Holyhead, Anglesey

Archaeological Mitigation (Strip/Map/Record)

## Report on Archaeological Mitigation (Strip/Map/Record)

Project Code: G2825 / HD24-020

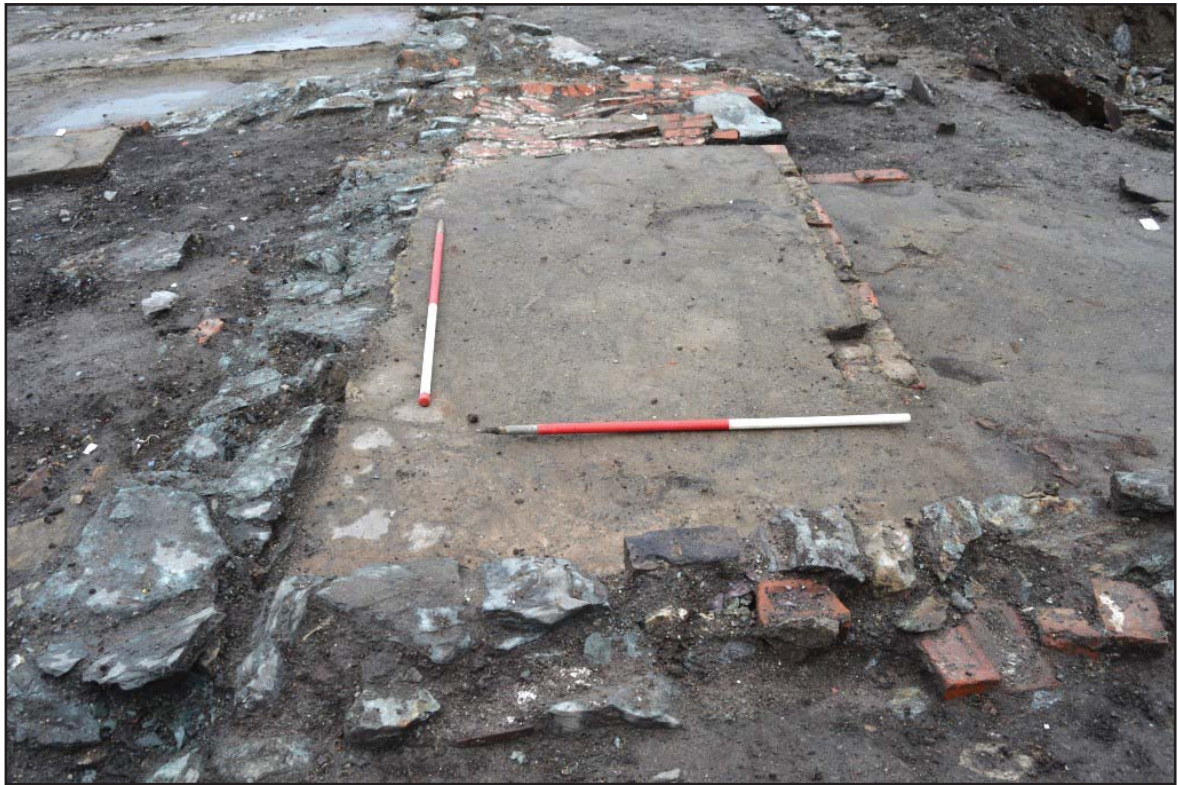
Plate 47. Wall (049) (left) running along the northern side of the pigsty. View from west-south-west, scales 1m (archive reference: G2825\_119)

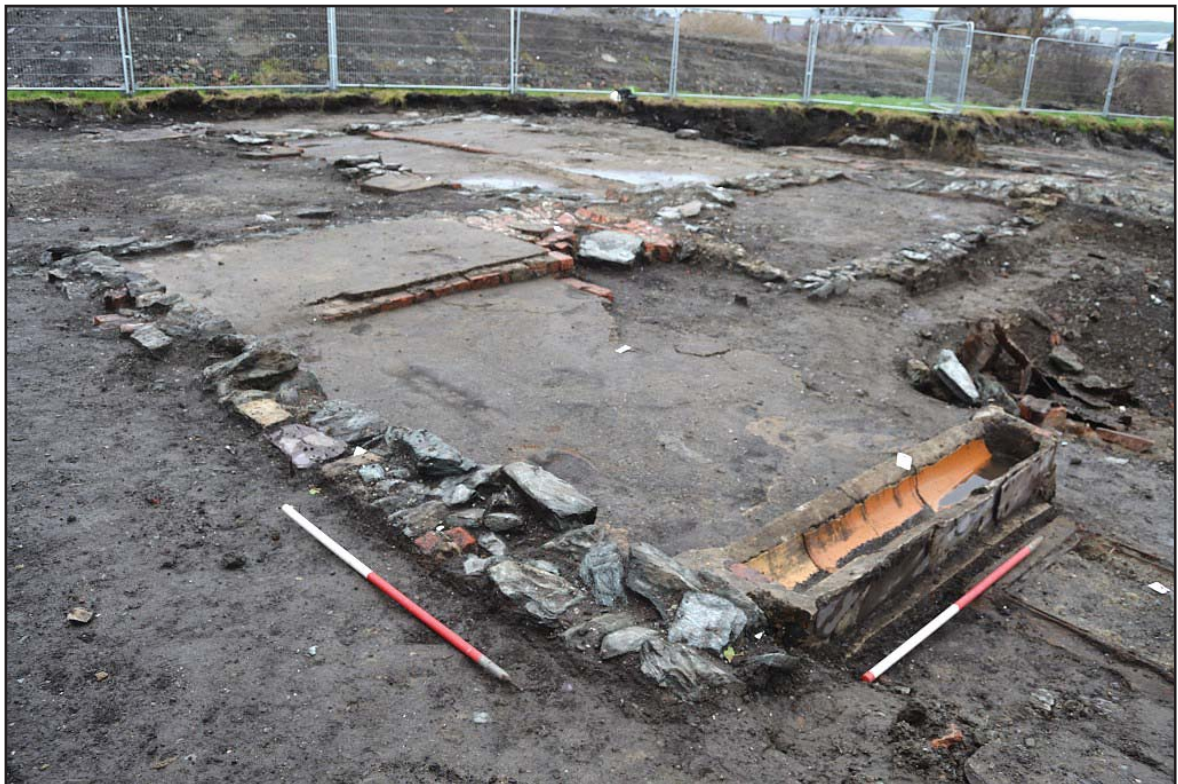
Plate 48. Pigsty with wall (036), floor (037) and trough (038). View from south-south-west, scales 1m (archive reference: G2825\_115)

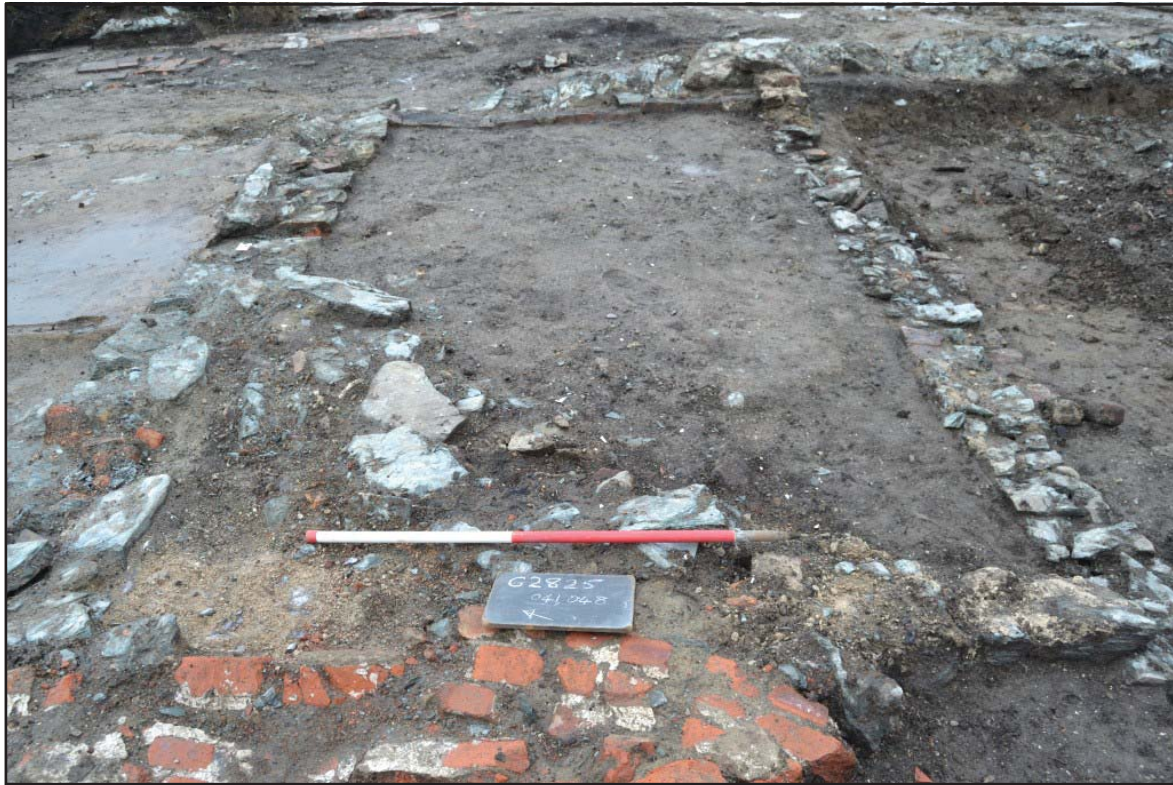
Plate 49. Wall (048) defining a small structure shown on the 1924 map as a glass house. View from west-south-west, scale 1m (archive reference: G2825\_122)

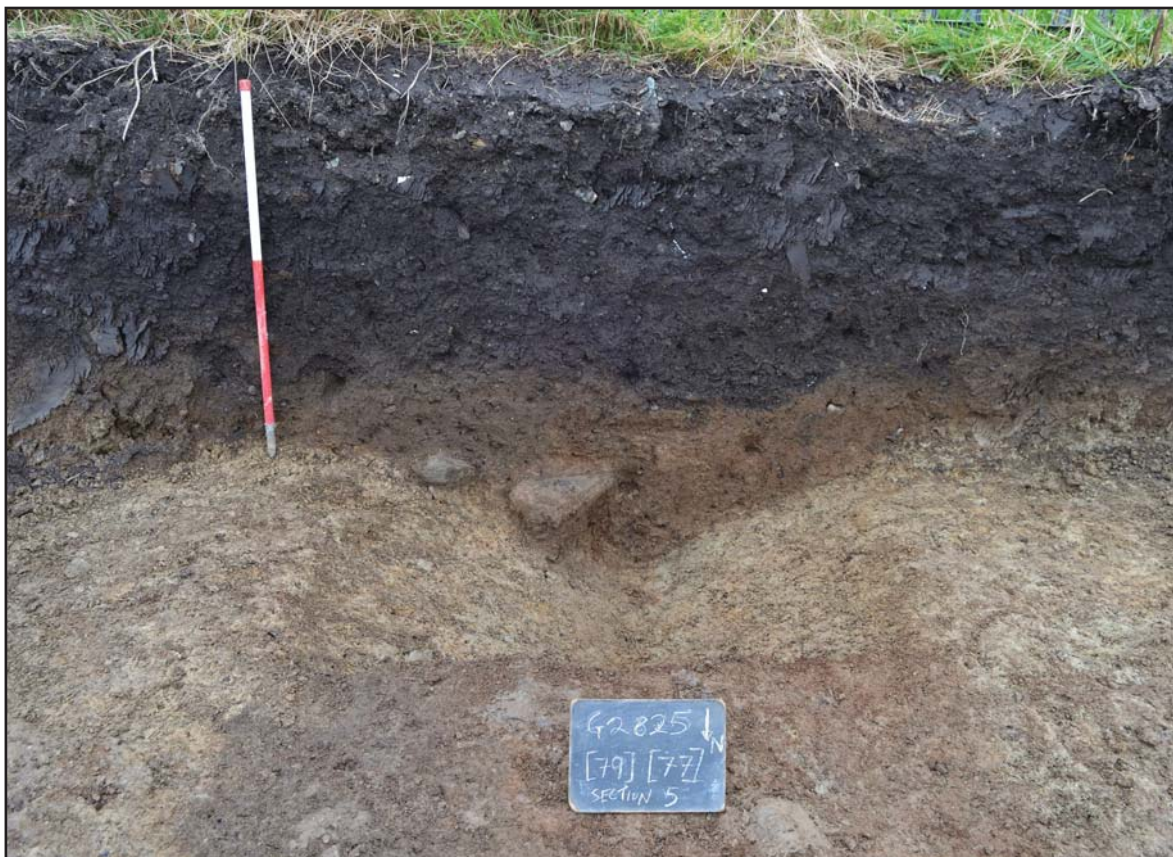
Plate 50. East-north-east facing section of the baulk showing ditches [077] and [079] and overlying garden soil (060) (see Figure 17). View from east-north-east, scale 1m (archive reference: G2825\_200)

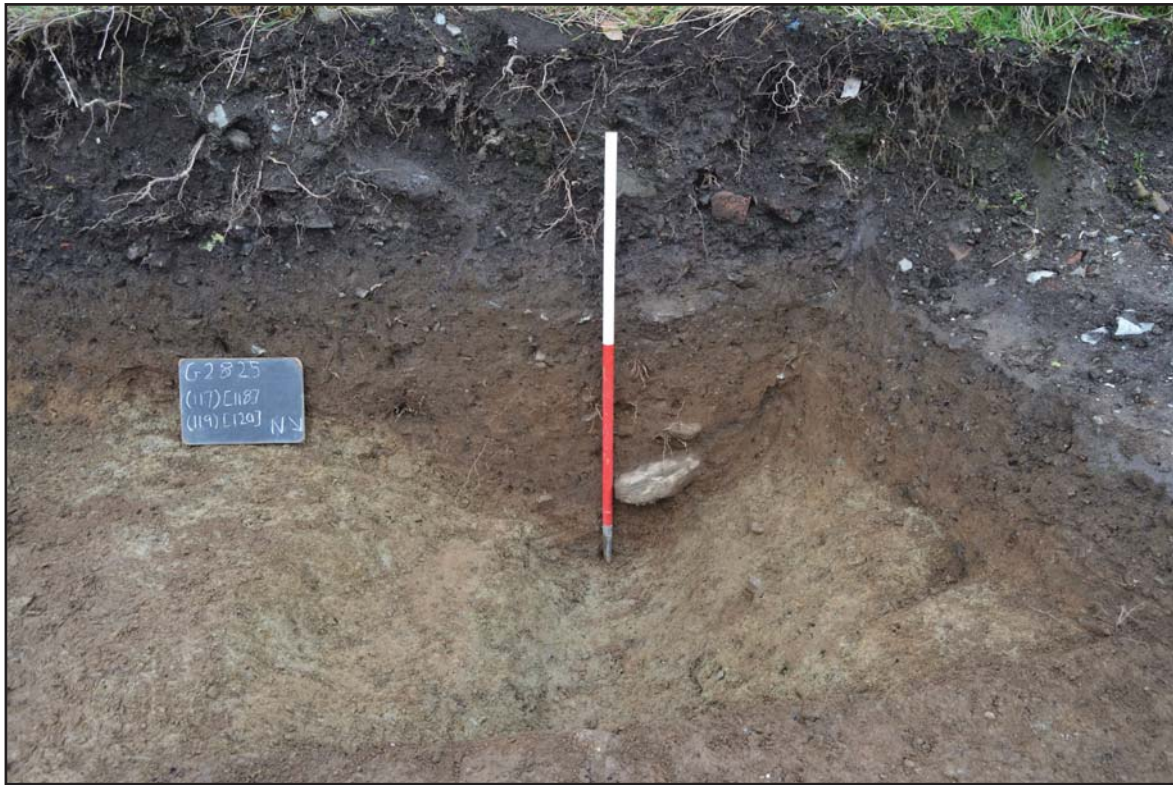
Plate 51. East-north-east facing section of baulk showing ditches [118] and [120] with ploughsoil (075) and garden soil (060). View from east-north-east, scale 1m (archive reference: G2825\_386)

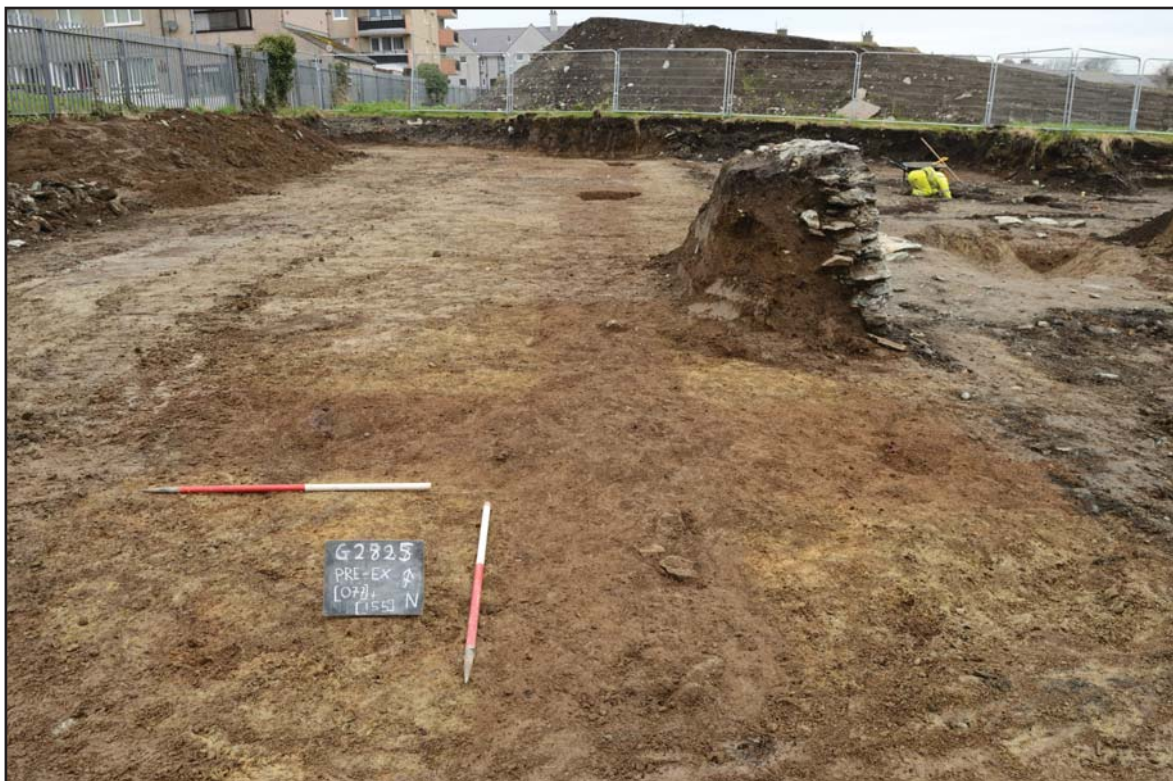
Plate 52. Junction of ditches [077] and [155]. View from south, scales 1m (archive reference: G2825\_444)

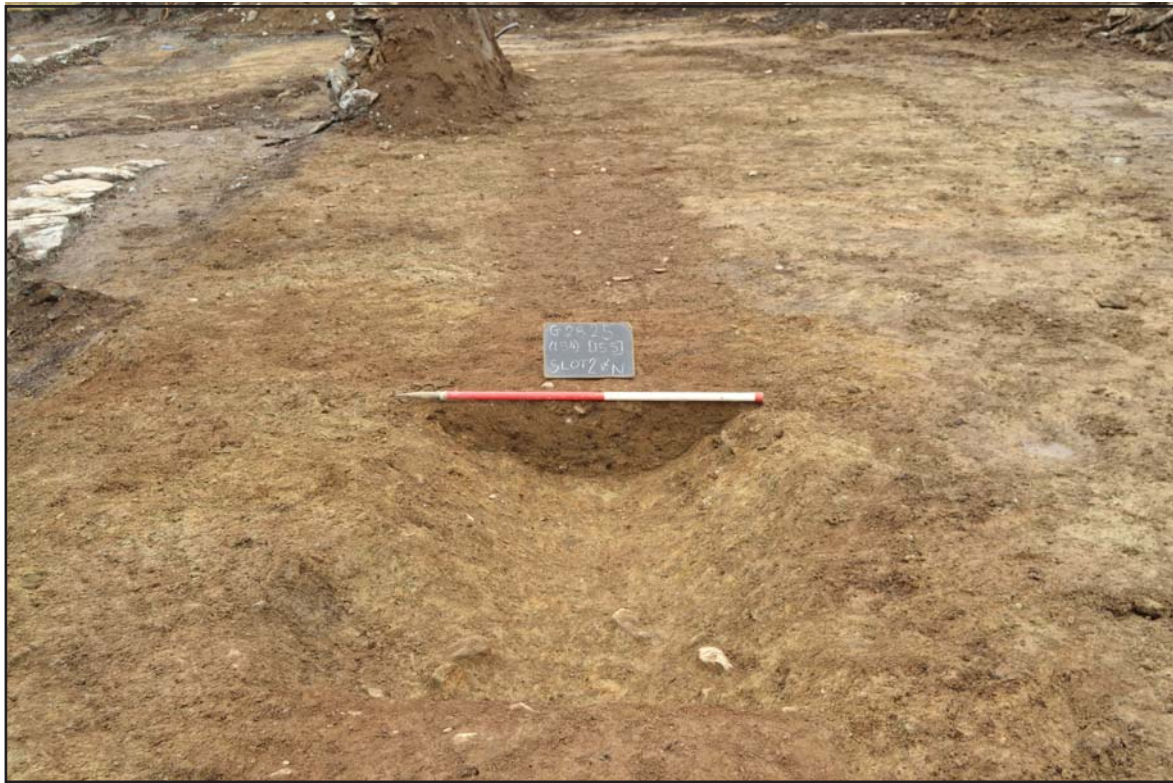
Plate 53. Ditch [155] showing section. View from north-north-west, scale 1m (archive reference: G2825\_428)

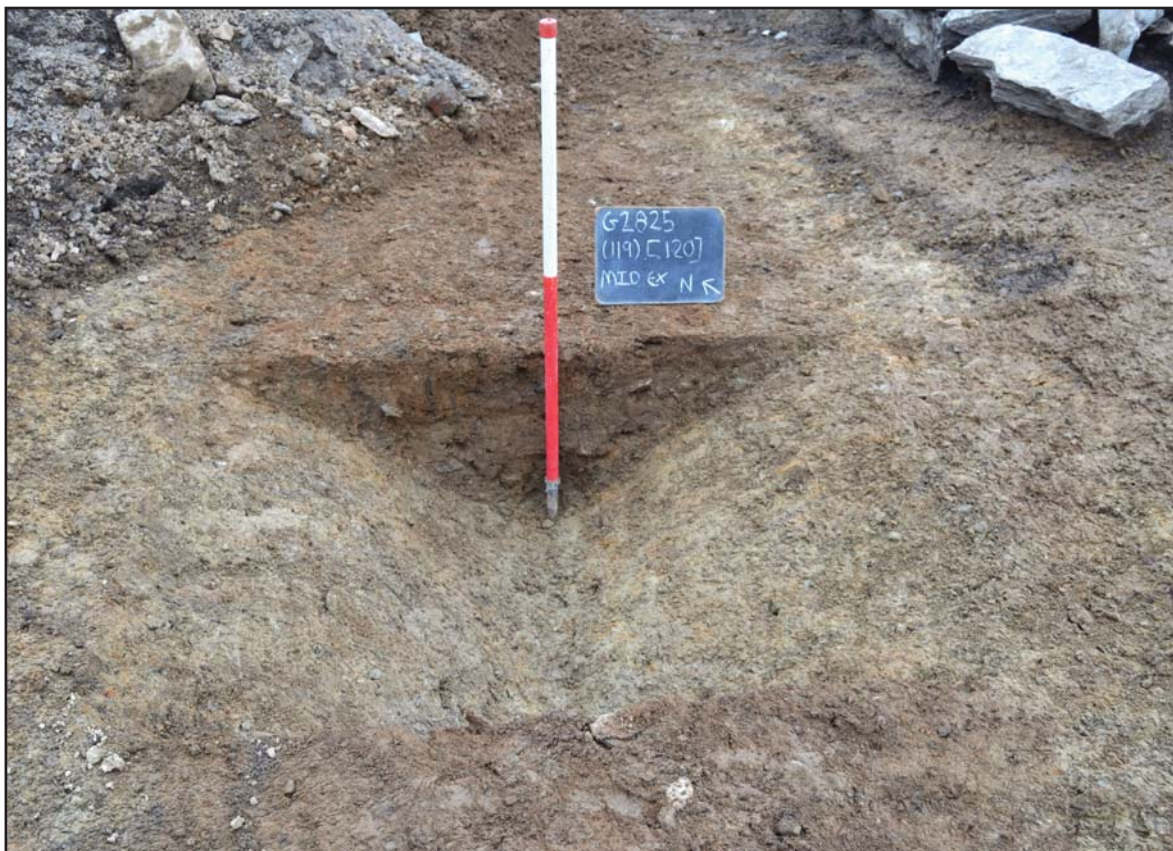
Plate 54. Section across ditch [120]. View from west-south-west, scale 1m (archive reference: G2825\_306)

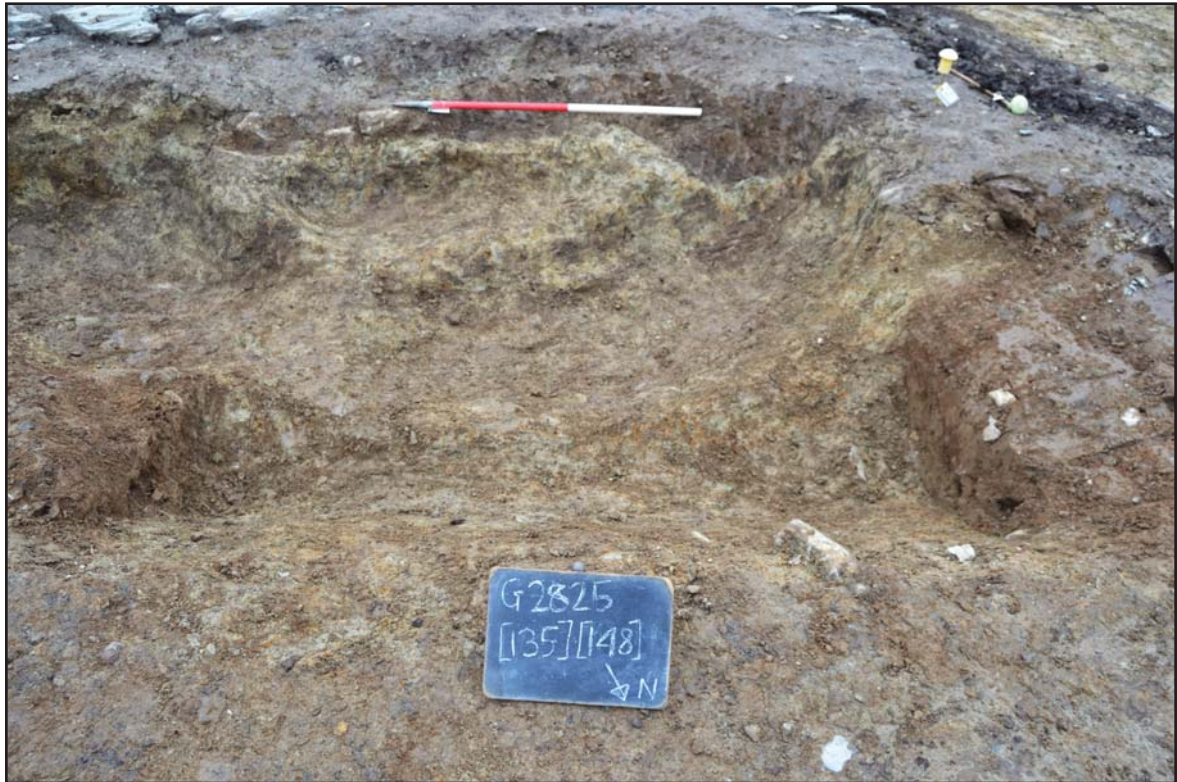
Plate 55. Pits [135], [142] and [148] fully excavated with ditch [153] in the foreground. View from north-east, scale 1m (archive reference: G2825\_378)

deposit cannot, therefore, be determined. Beneath the western end of Wynne Terrace were three intercutting pits ([135], [142] and [148]) (Plate 55). The fills, which were a grey-brown silty clay containing small stones, pot sherds and ash, were too similar for it to be possible to determine the sequence in which the pits were cut. Pit [142] contained a small 18<sup>th</sup> century pot sherd (SF34). The material in the pits showed that domestic waste had been dumped into them. What appeared during the excavation to be charcoal in the fill was in fact coal fragments and cinders showing that the waste was of a late date. The largest pit [135] measured about 1.8m by 1.2m and was 0.65m deep. Pit [142] was 0.35m deep and pit [148] was only 0.18m deep, clipping the western side of pit [135] (Plate 56). Both [135] and [148] had fairly gradual sides curving into rounded bases, while pit [142] had steep sides and a fairly flat base (Figures 23 and 24). Pits [135] and [148] were both sealed under a layer of orange-brown silty clay (146), possibly a levelling layer. There was nothing to indicate the function of the pits.

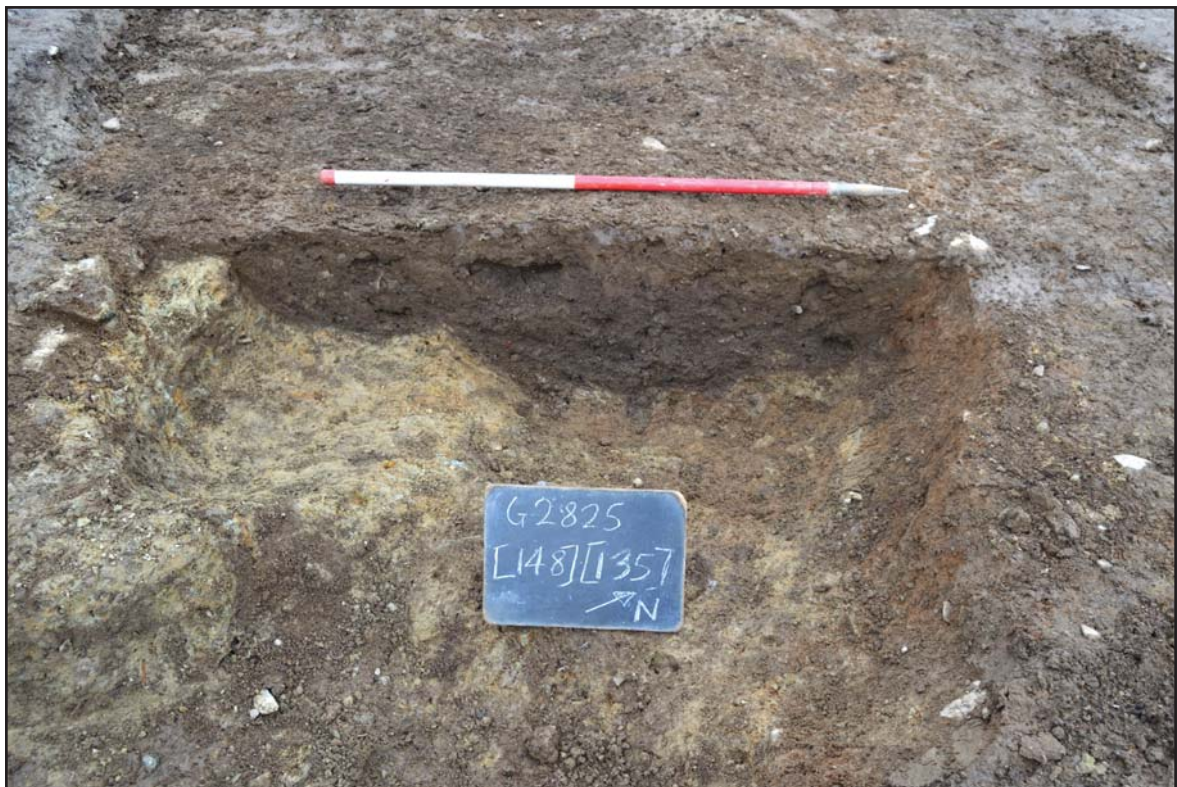
Plate 56. Section across pits [135] and [148]. View from south-east, scale 1m (archive reference: G2825\_364)

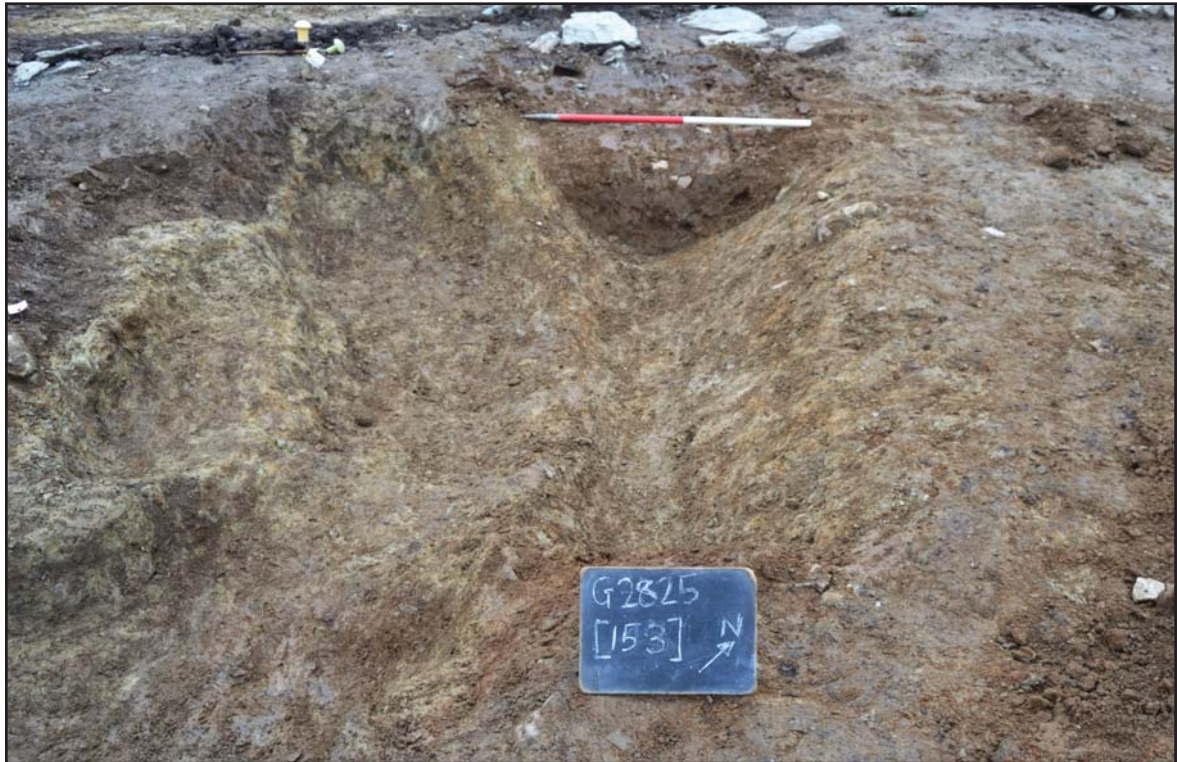
Plate 57. Sondage dug through ditch [153] showing section, with pits [135] and [148] to the left. View from south-east, scale 1m (archive reference: G2825\_376)

Running immediately east of pit [135], and probably cut by that pit, was a ditch [153]. This was 1.04m wide and 0.34m deep with a broad V-shaped profile (Figure 25, Plate 57) and though it curved slightly was generally running north-north-west to south-south-east. The fill (152) of the ditch was a brown clayey silt with frequent small stones. The line of this ditch was not followed but it is probable that it was the continuation of a ditch [195] further north. Ditch [195] ran north-north-west to south-south-east on the northern edge of the site. It was 0.66m deep, with a V-shaped profile and was filled with a stony brown silty clay (196) (Figure 26, Plate 58).

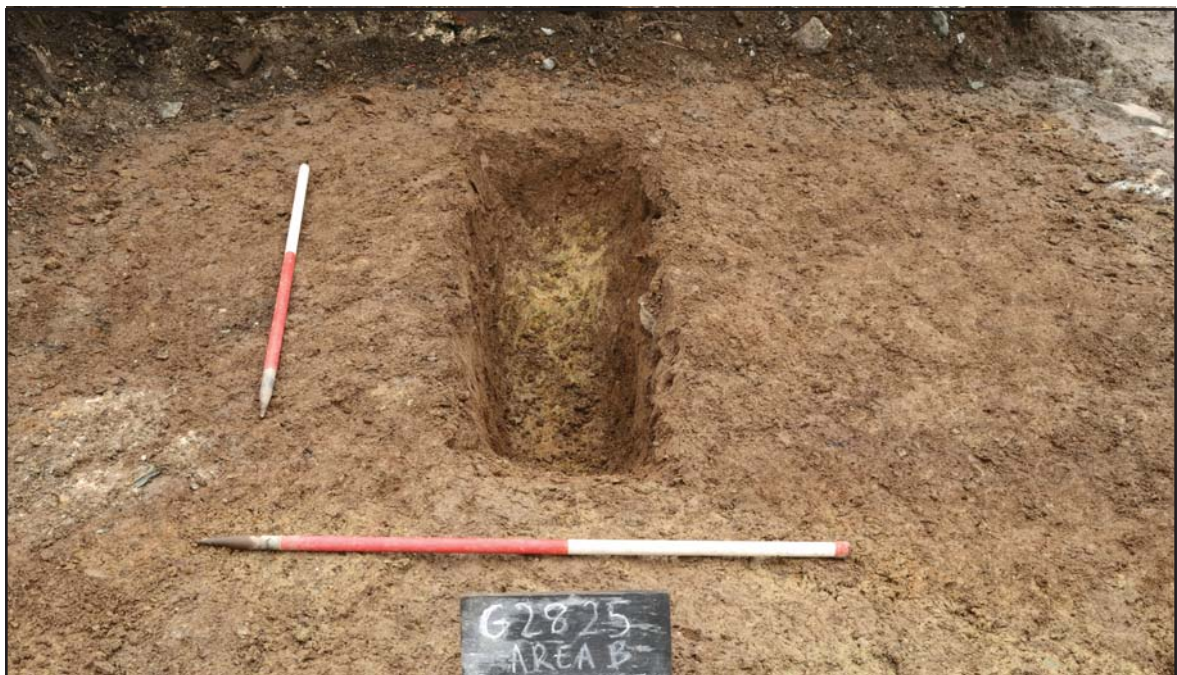
Plate 58. Sondage dug through ditch [195]. View from west, scales 1m (archive reference: G2825\_485)

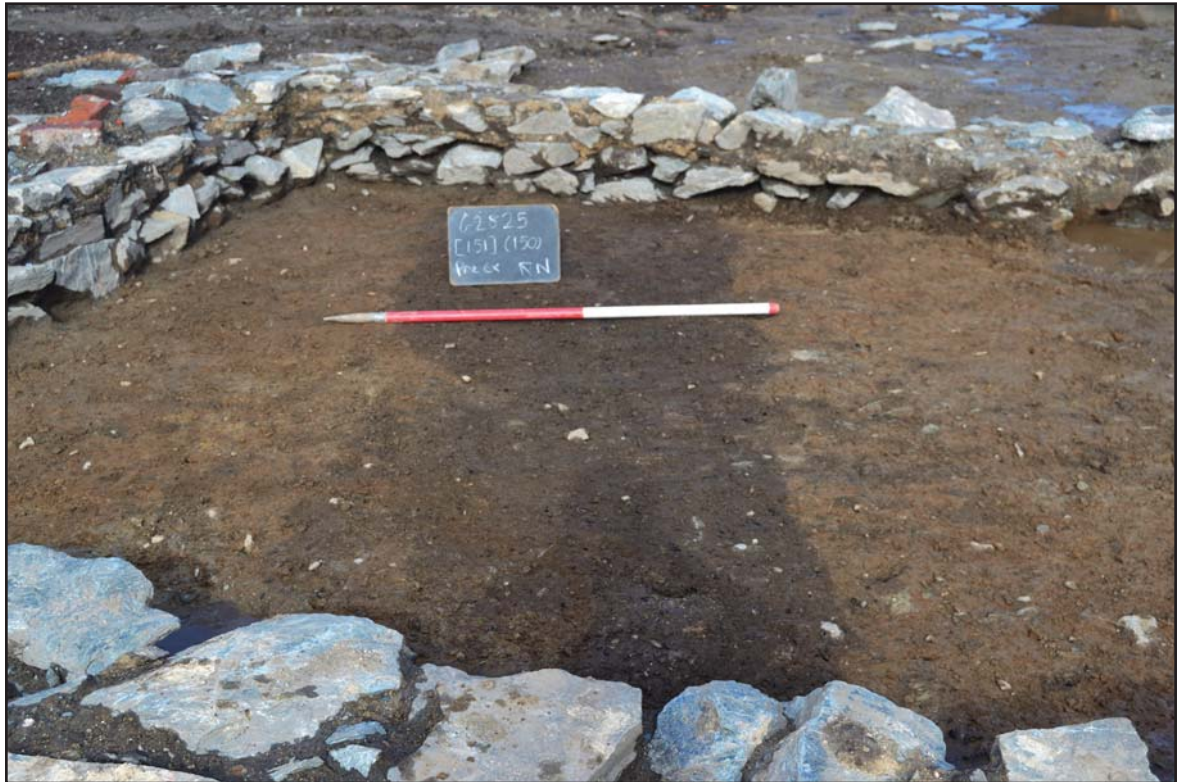
Plate 59. Linear feature [151] underneath Wynne Terrace. View from south-west, scale 1m (archive reference: G2825\_366)
