**Former Monmouth Hospital  
Hereford Road  
Monmouth  
Monmouthshire**  
*Archaeological Watching Brief*

CA Project: 4995  
CA Report: 16090

Archaeological Watching Brief

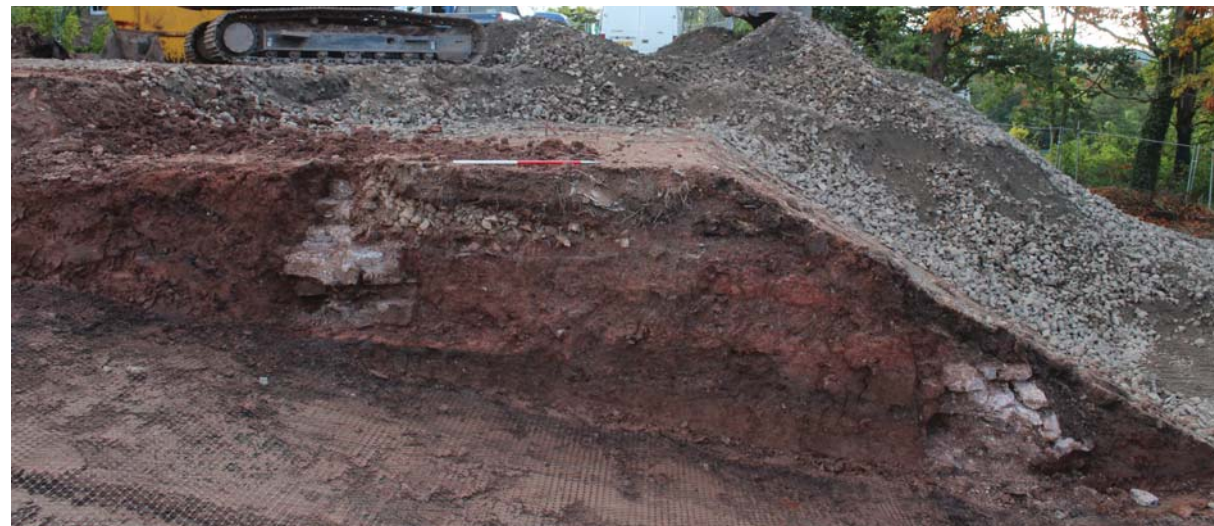
| CHECKED BY | LM/DJB | DATE | 18/02/2016 | 4 |

Archaeological plan of the Gaol site. The plan shows various features and their elevations. Key features include:

- 1052: Modern disturbance
- 1053: Modern disturbance
- 1034: Wall foundation
- 1033: Make up
- 1037: Demolition deposit
- 1035: Demolition deposit
- 1061: Dump
- 1036: Gravel path
- 1035: Make up
- 1031: Wall foundation
- 1049: Flower bed
- 1048: Surface
- 1043: Relict topsoil
- 1042: Dump
- 1041: Make up
- 1040: Outer gaol foundation wall
- 1038: Natural
- 1030: Construction cut
- 1032: Construction trench
- 1047: Possible floor
- 1046: Possible relict topsoil
- 1039: Relict topsoil
- 1045: Construction cut
- 1060: Outer gaol foundation wall
- 1040: Outer gaol foundation wall
- 1038: Natural
- 1030: Construction cut

- 5.1 Two areas of groundworks, recorded as Trenches 10 and 11, were archaeologically monitored during the current works. Natural geological substrate 1038/1107, consisting of red-brown silty clay, was revealed in Trench 10 at c.31.14m AOD (Fig. 4, Section AA) and in the base of modern foundations within Trench 11.

light grey brown lime mortar. The absence of dressed facing stones, coupled with its steeped construction, suggests only the foundation courses survive (Fig. 4, section AA and Fig. 5). The north-western corner of this wall was intentionally constructed with a curved corner.

- 5.7 Wall foundation 1031 was founded within a slight depression in the surface of gravel surface 1048. It is not clear whether this depression is a foundation trench or whether the wall was founded directly onto surface 1048; its weight subsequently compressed the underlying layer. There was certainly no construction cut above surface 1048 and makeup layers 1051 and 1044 overlay the offsets in the foundation implying they post-date the wall's construction (see Fig. 4; Section AA).

- 5.13 Overlying path 1036 and flower bed 1049 was a thin (0.05m) band of crushed lime mortar, 1035, (Fig. 4, section AA, and Fig. 5). This layer also overlay the upper step in the western face of wall 1031 and has been interpreted as a demolition layer resulting from the dismantling of wall 1031. Above this were a further number of dumps of demolition rubble (1037, 1061 and 1062) which included occasional bricks, orange pan tiles and window latch suggesting it was derived from the demolition of a building predating the hospital.

- 7.3 A relict soil 1039, observed overlying the natural substrate in Trench 10, contained pottery dating to 17th to 18th centuries. It was cut by the construction trench for the western outer gaol wall and sealed dumps 1041 and 1042, suggesting that this deposit probably pre-dates the construction of Monmouth Gaol in 1790 (Fig 4, section AA).

- 7.5 It seems probable, from the recovery of the 17th to 18th centuries pottery, that relict topsoil 1043 may be contemporary with the use of the gaol (Fig 4, section AA). The function of this soil, as well as possible clay floor 1047 and gravel surface 1048, is currently unknown. It remains undetermined whether they are floors of a prison structure or dumps contemporary with layers 1041 and 1042 that levelled the interior of the gaol. It is also unclear how these layers might relate to the central block of the gaol, located in Trenches 1, 2 and 3 during the 2007 evaluation (CA 2007). This is in part due to the paucity of the detailed cartographic evidence for within the gaol precinct, following the standard convention of the time that government buildings such as dockyards and prisons were not publicly mapped.

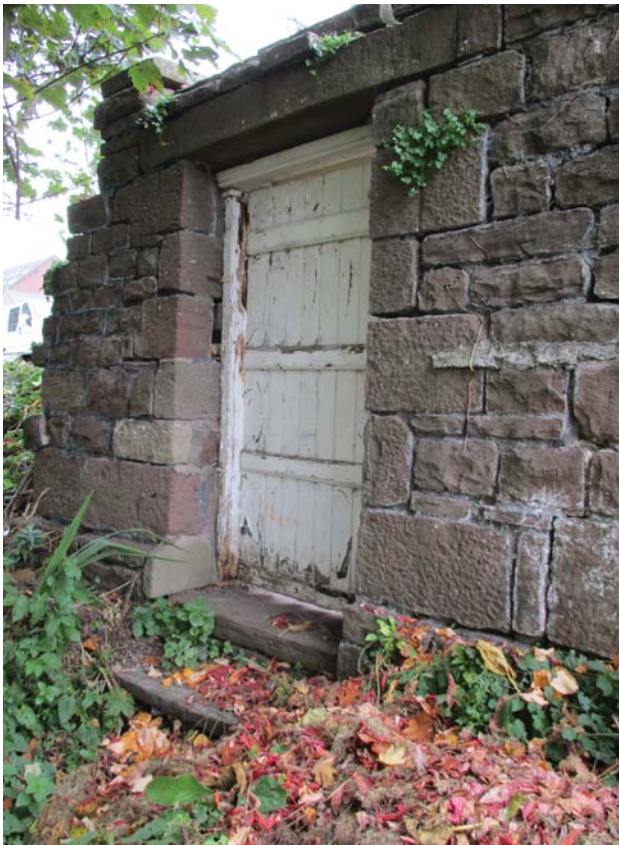
1881-1901 garden gate inserted into western outer wall of goal

- 7.4 It is clear from the topography off the site, with ground level falling away gently to the south and more steeply to the west, that construction of the gaol would have necessitated that the site be levelled to accommodate its buildings. It is therefore probable that dumps 1041 and 1042, interpreted as mass fills of re-deposited natural clays, were deliberately utilised to level the site. As these dump deposits were cut by north/south orientated construction trench for the gaol's western curtain wall (1030), it suggests that this initial levelling occurred prior to the construction of the gaol. It is also clear from the watching brief that only the foundations of the perimeter wall survives within the site, in contrast to the intact portion of the western gaol wall that survives just to the south, as the garden wall to No. 11-13 Hereford Road (Fig. 5).

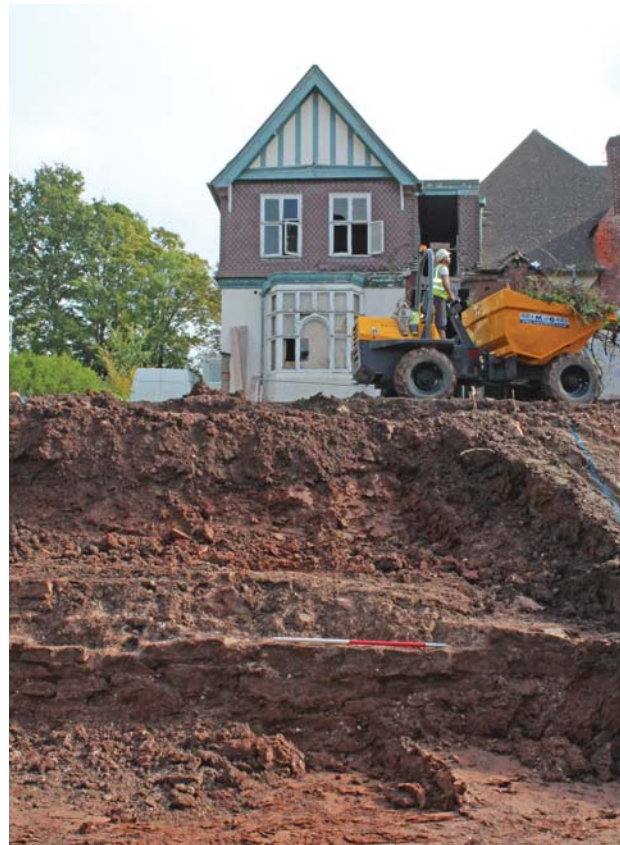
Western outer goal wall 1029 during excavation, looking east (1m scale)

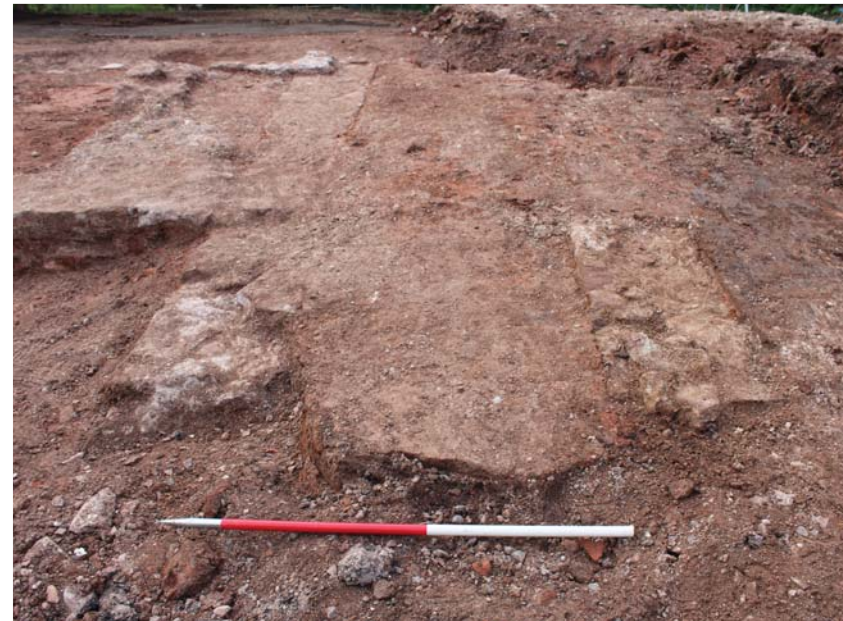
View of mortar floor 1056 and surface 1057, looking west (1m scale)

- 5.10 Within the 1m gap between wall foundations 1031 and 1055 two surfaces, 1056 and 1057, were observed. Mortar floor 1056 was a 0.07m thick and comprised lime mortar that had been truncated to the east by modern disturbance 1053. Surface 1057 was an area of compacted orange-brown clay to the west of surface 1056.

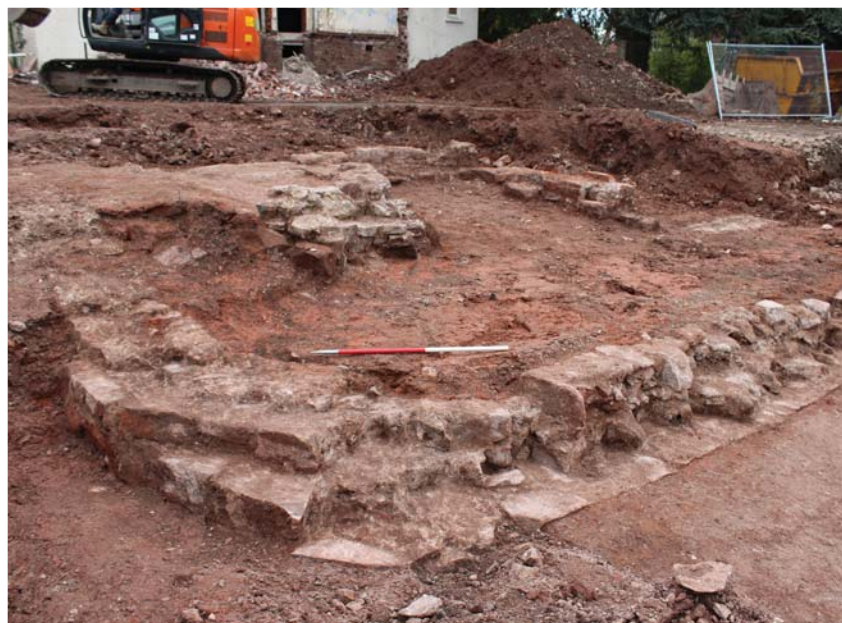
View of walls 1010 and 1031, looking south-east (1m scale)

- 5.11 East/west orientated wall foundations 1010 and 1011 may also belong to this phase of activity as they butted the western face of wall 1034 (Fig. 3). Both walls had been heavily disturbed by later activity. Wall foundation 1010 was 2.7m long and had a

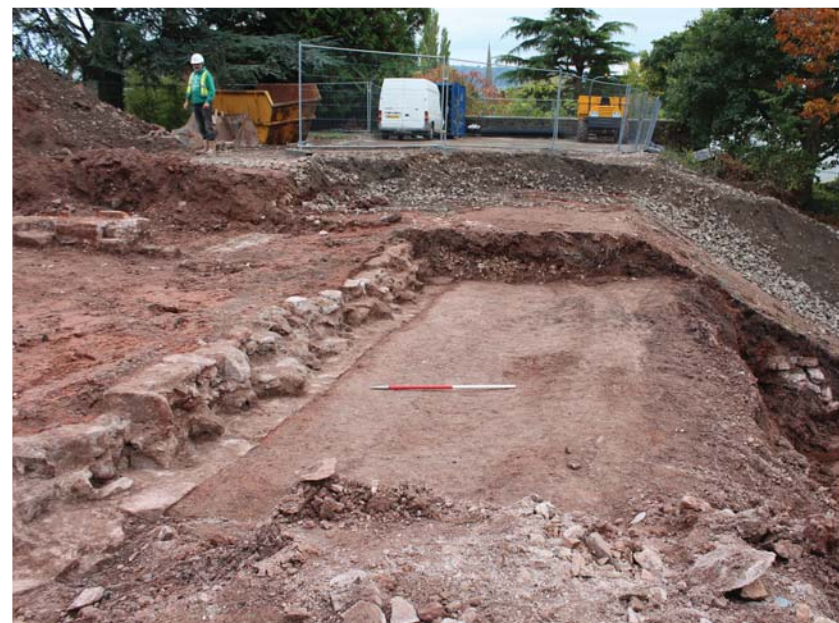
Garden walk way and demolition deposit 1035, looking south (1m scale)
