Maesdu Golf Course Llandudno Wales

Archaeological Watching Brief

> CA Project: 6374 CA Report: 6374_1

In November 2017 and November 2018, Cotswold Archaeology carried out an archaeological watching brief during groundworks associated with the creation of a drainage water holding reservoir at Maesdu Golf Course, Llandudno, Wales.

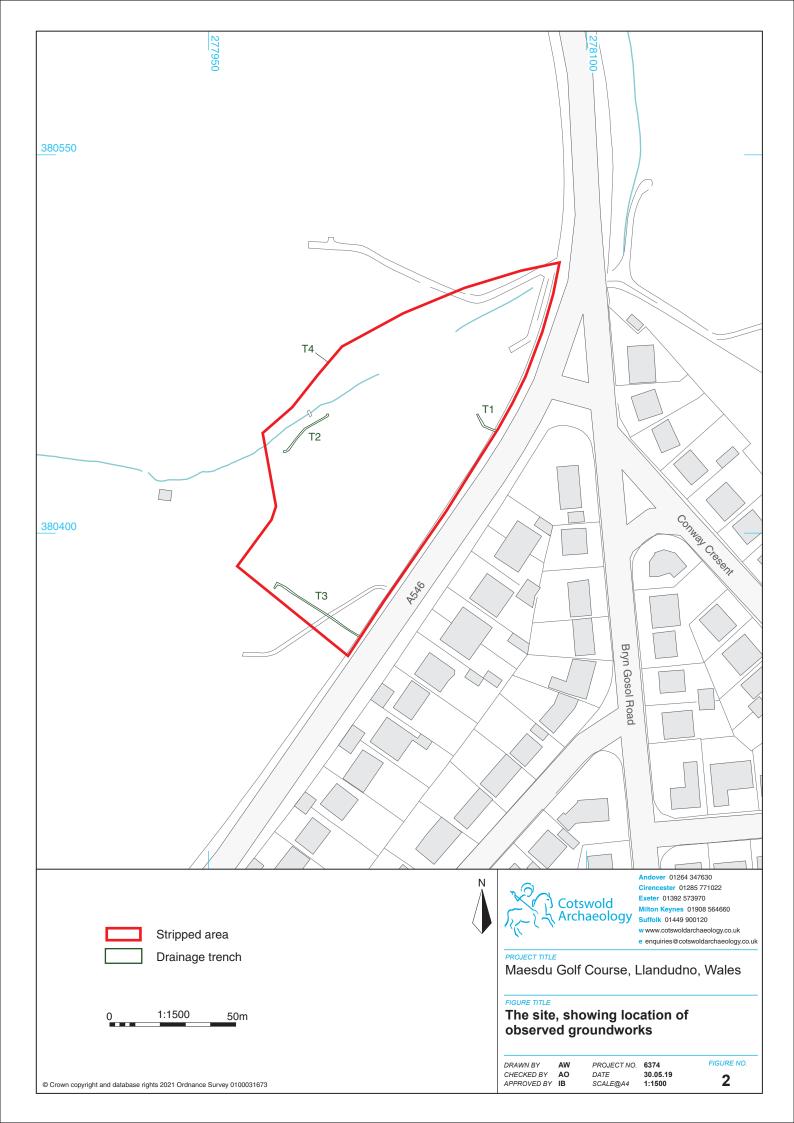
- 4.1. The monitored groundworks are shown on Figure 2. They comprised three trenches associated with new drainage features (T1–T3; November 2017) and subsequent stripping of topsoil from the entire application area (T4). T1–T3 were *c*. 10m–*c*. 40m long, 0.25m wide and 0.2m deep. T4 was *c*. 175m long and a maximum of *c*. 80m wide.
- 4.2. As the T4 topsoil strip exposed the natural substrate throughout the monitored area, no further monitoring of subsequent deeper excavations into the natural substrate took place.
- 4.3. Records were maintained in accordance with *CA Technical Manual 1: Fieldwork Recording Manual*.

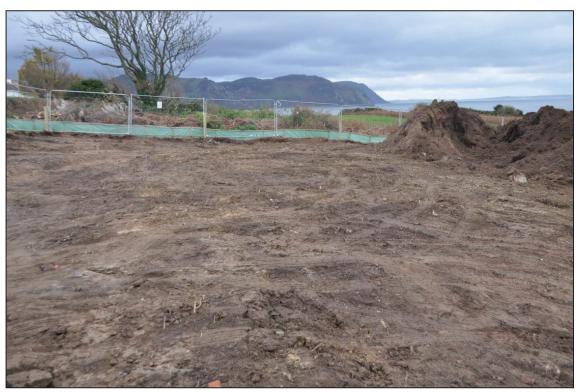
Topsoil removal from south-west corner of site
