Desk-based Assessment:

Tower Colliery, Hirwaun, Rhondda Cynon Taf

November 2019
(Updated September 2022)

Report No. 1848

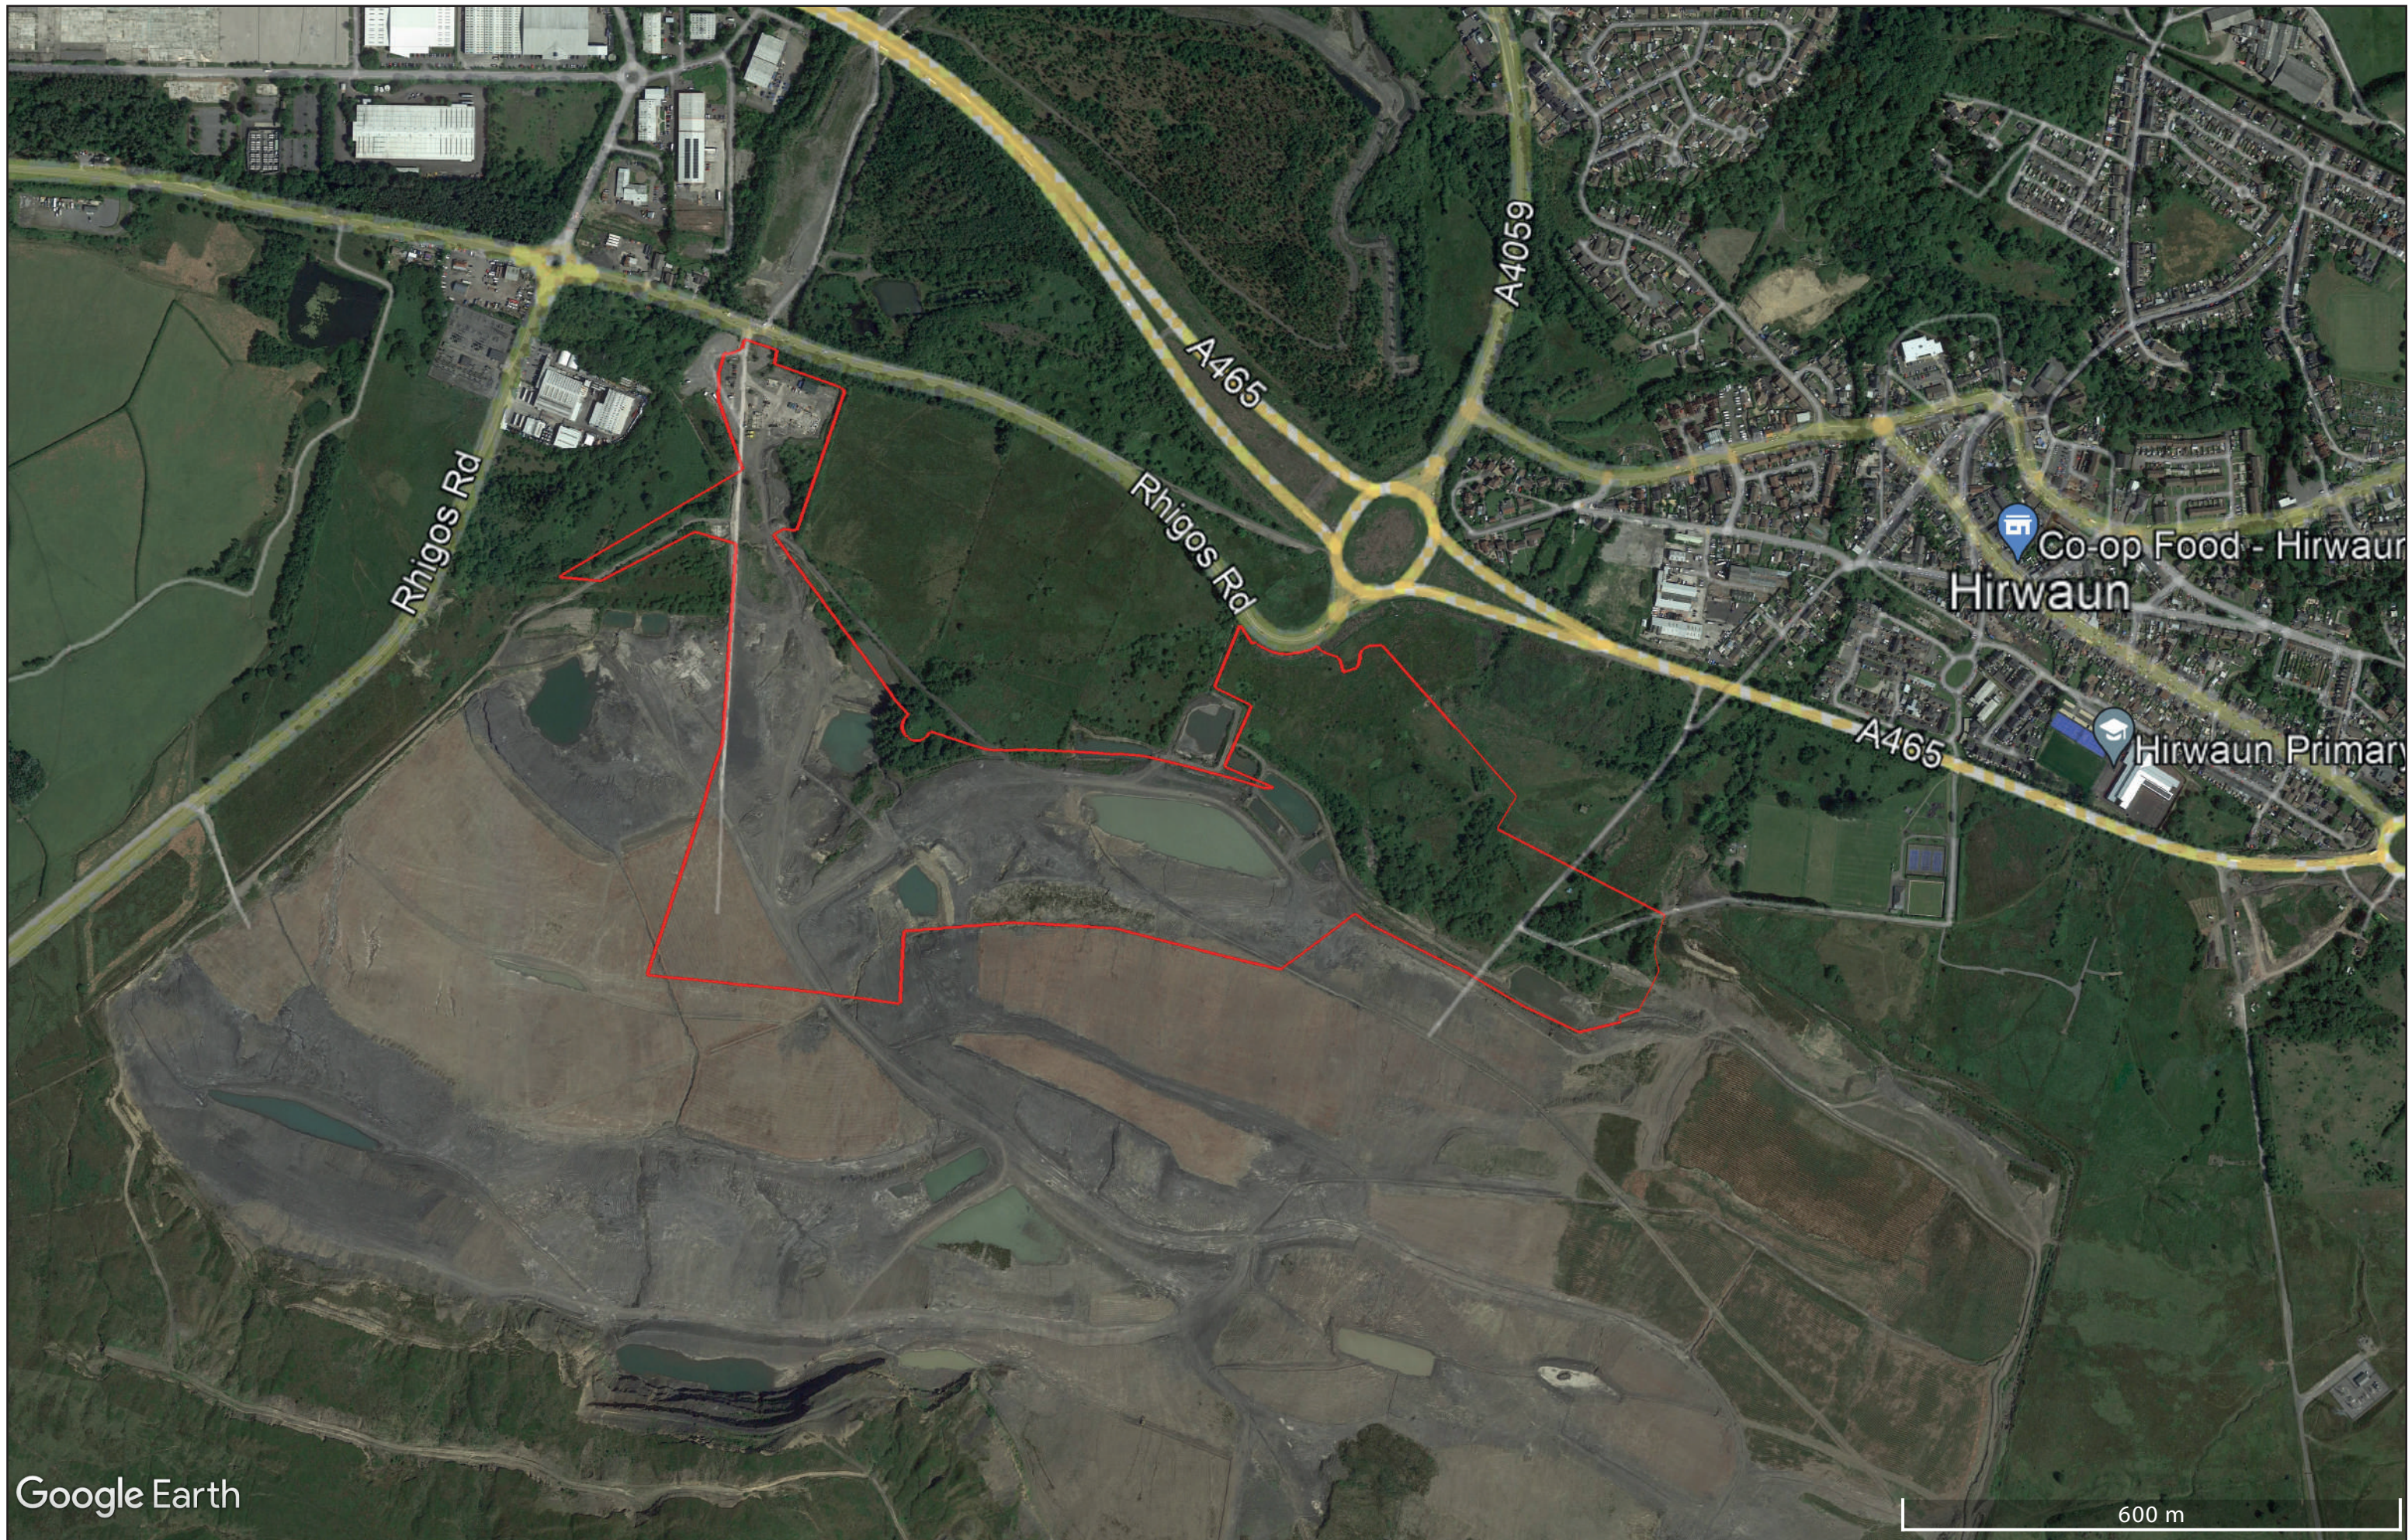
Figure 8. Aerial view of the proposed development area showing recent works (2021)

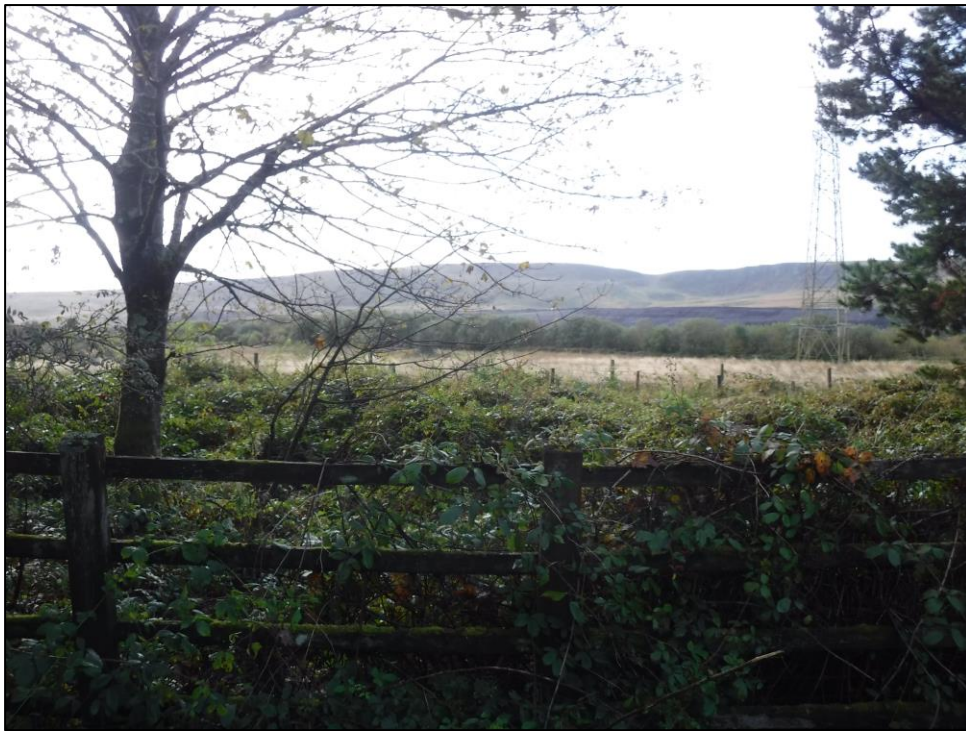
Plate 5. Location of Hirwuan Common Rifle Range (GGAT01275m), looking south-east

- 4.6.12 The site of the rifle range is approximately 220m south of the roundabout linking the A465 with the A4061 and A4059. The rifle range is first shown on the 1885 Ordnance Survey map (see section 5.3 below). Shooting competitions on Hirwaun Common were reported in the local press as early as 1861. The range had gone out of use by 1904 but it is believed that it came back into use briefly during the First World War. The field the range was located on has been truncated by the A465 to the north and opencast mining/reclamation to the south. The site was visited in 2013 and failed to detect any traces of the mapped range features. It was concluded that the field has had coal waste graded over it at some point since the range went out of use, part of the field being reclaimed and now used for pasture.

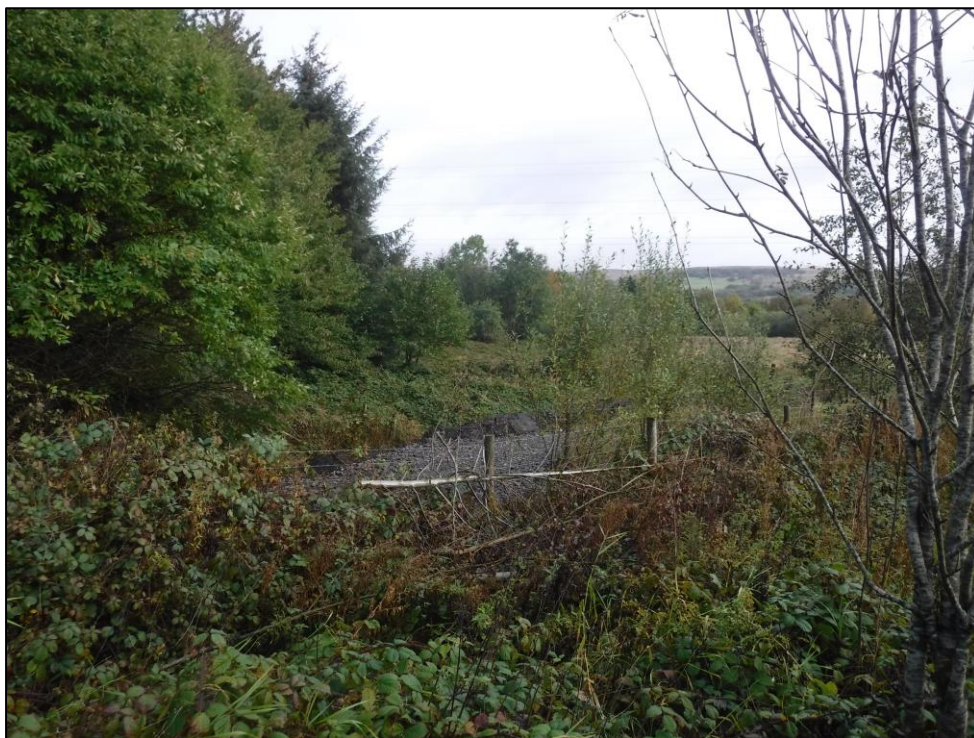
Plate 6. Location of Bute Colliery and Hirwaun Tramway (GGAT02498.0m), looking north-west

SUMMARY Course of the dismantled Bute Colliery to Hirwaun Tramway intersects with the preferred route south of A465 and has now been replaced by the Tower Road. To the south at SO 9506 0501 the Bute colliery tramway and the Aberdare to Rhondda Railway appear to

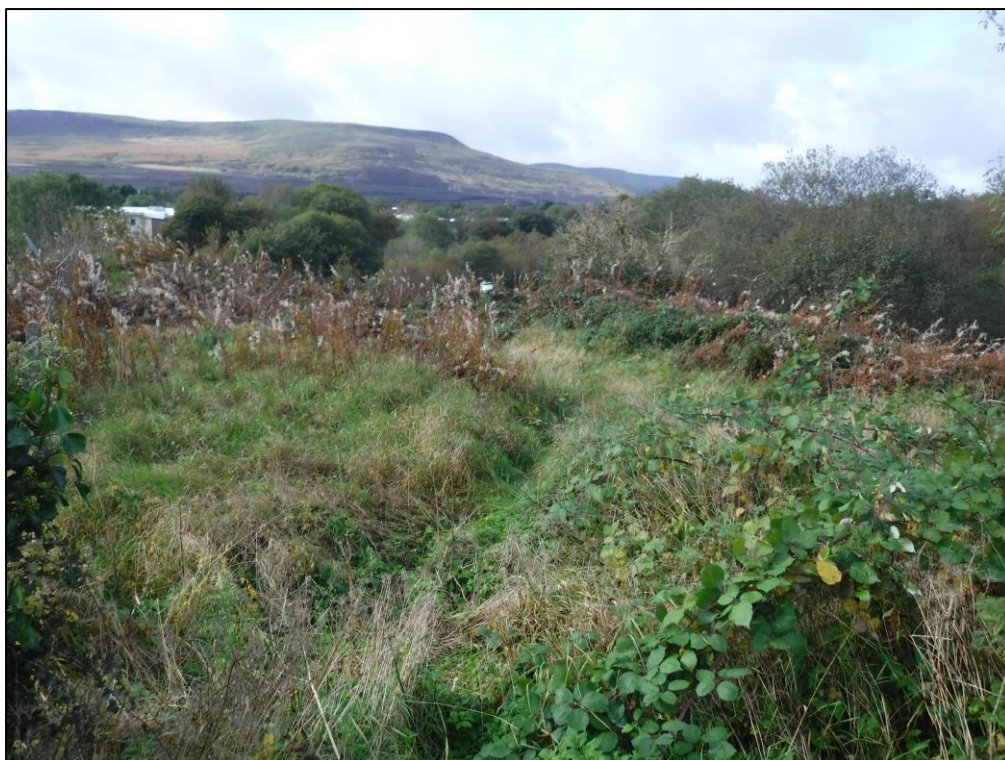
Plate 11. Site of Hirwaun Ironworks (BR157) with limited views of development site, facing south

- 4.4.4 The site currently comprises of four ruinous blast furnaces which survive as overgrown earthen mounds showing variable amounts of outer brickwork, both in situ and fallen. Aligned WNW-ESE they are separated from the charge bank by a blast passage. In addition to the ruins of the blast furnaces, the site retains a massive tramroad causeway and bridge (Cadw SM Report).

- 4.6.14 The site of Hirwaun Ironworks is located approximately 900m to the north of the development area. In 1757 John Mayberry founded the Hirwaun Ironworks (BR157; PRN 01109m) with the building of a furnace. This was to be the first coke-fired furnace in Wales. The ironworks were built along the River Cynon, which supplied the water to help power the ironworks. The Hirwaun Ironworks currently comprise of the ruins of the former ironworks. This includes four blast furnaces aligned WNW-ESE survive as overgrown earthen mounds showing variable amounts of outer brickwork, both in situ and fallen. They are separated from the charge bank by a blast passage which runs the full length to their rear. The Hirwaun Ironworks was the last of its type to close in the area and remained a forge and foundry until the 1900s.
