Name: Park Cottage

Parish: Trevethin Location: Pontypool

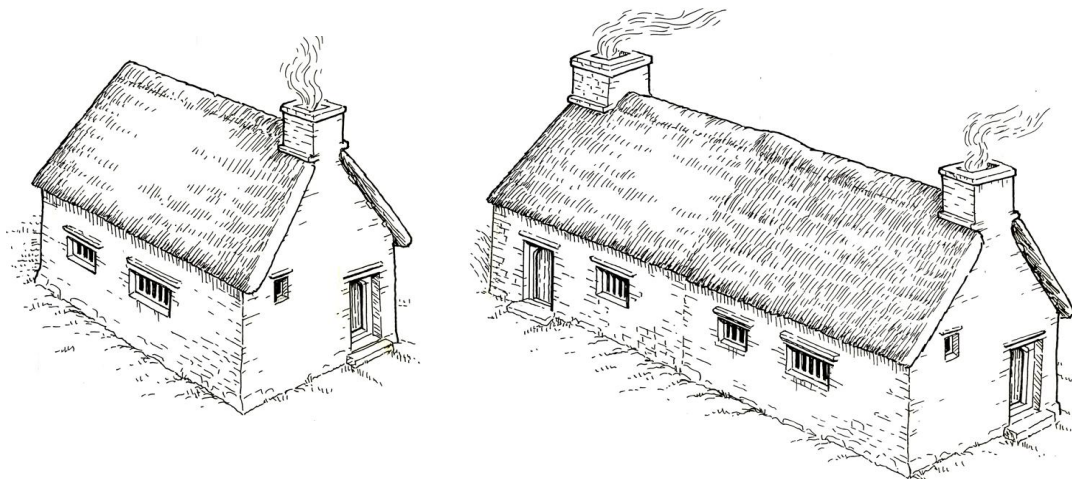
Development: The house originated as a modest dwelling of hearth-passage plan (below left), probably of early- or mid-seventeenth century date; to which a Second House, of lobby-entry plan, was added at the upper end (below right) later in the same century. The lobby-entrance was afterwards blocked when a large oven was inserted into the upper fireplace, and the hall inglenook was rebuilt on a smaller scale. These changes are all distinguished by the use of squarish stones, and may be eighteenth century in date. Subsequently, doorways were cut through into the Second House, so that the two dwellings effectively became one. The Second House appears to have been re-roofed at this time. Further alterations after 1841 included the two cross-wings added to the upper end of the range, but of these only the rebuilt kitchen survives.
