PE011 CARN INGLI CAMP:
RECONSOLIDATION COMPLETION REPORT

Prepared on behalf of the Pembrokeshire Coast National Authority by Tomos Jones, Community Archaeologist.

09 May 2025

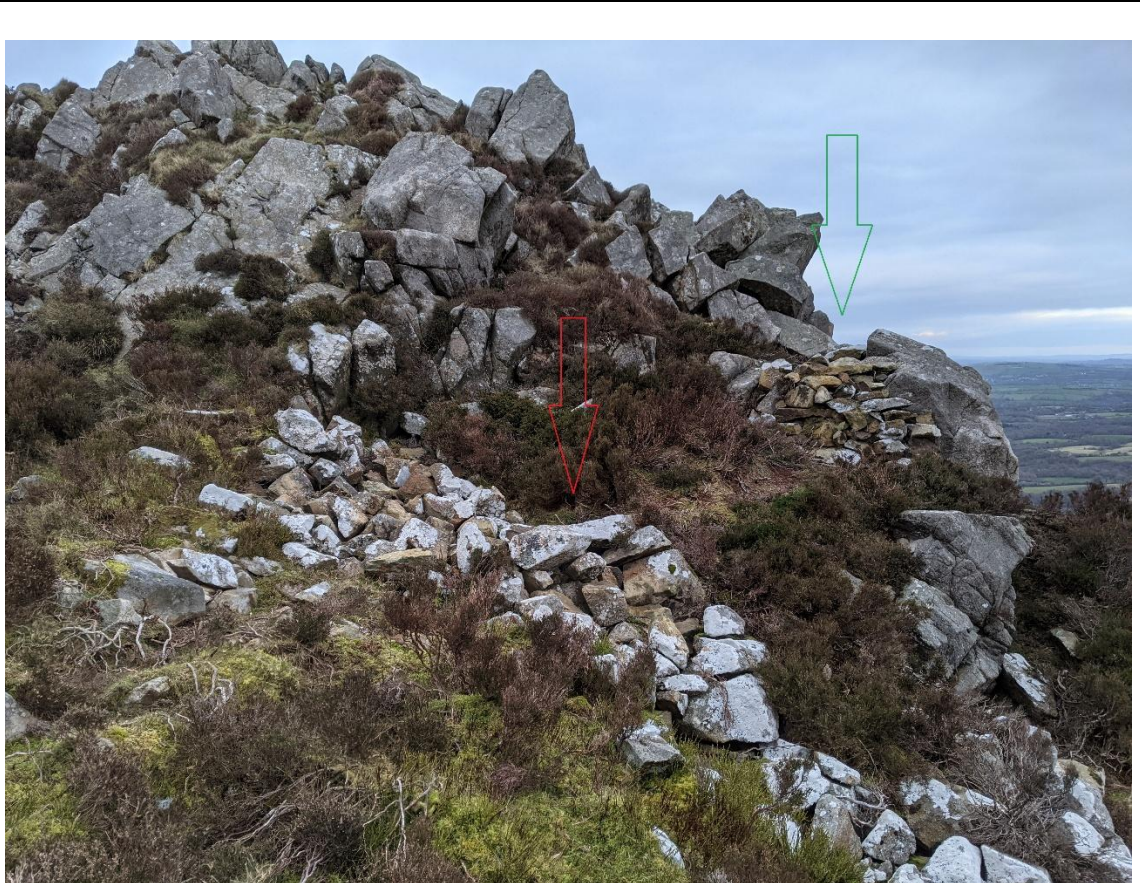
In 2023, the National Park Authority were made aware of disturbance to part of a rampart at the scheduled monument known as PE011 Carn Ingli Camp. Stones were removed from the rampart and used to construct a shelter nearby (see figure 2). The issue was identified by the area ranger who is familiar with the site. As such, the Authority were confident that the disturbance was recent. The issue was reported to Dyfed-Powys Police in September 2023 and discussions took place with Cadw to allow consent to dismantle the shelter and place the stones back in the disturbed rampart.

Figure 2. Image showing the disturbed rampart (red arrow) and shelter created using the rampart stones (green arrow).

Reconsolidation work was carried out and completed on 08 April 2025 by the Community Archaeologist and volunteers from the Friends of the Pembrokeshire Coast. Work was carried out in accordance with the methodology submitted to Cadw and adhered to the conditions of the scheduled monument consent. In summary:

- The Community Archaeologist explained to the Friends that the work was being carried out within a scheduled area and needed to follow the agreed methodology.
- Photographs were taken prior to carrying out the work and also upon completion to show the difference (see figures 3-8).
- Stones from the shelter were carefully removed and placed in the nearby rampart with the weathered side placed facing upwards.
- As a result of the work, lichen located on the stones now face towards the sun and the rampart looks less disturbed.
- The shelter incorporated stones from the rampart and an impressive boulder that naturally leans against the rock face at the summit of Carn Ingli. Dismantling the shelter enhances the boulder which may have held significance for the people who utilised the site during prehistory.

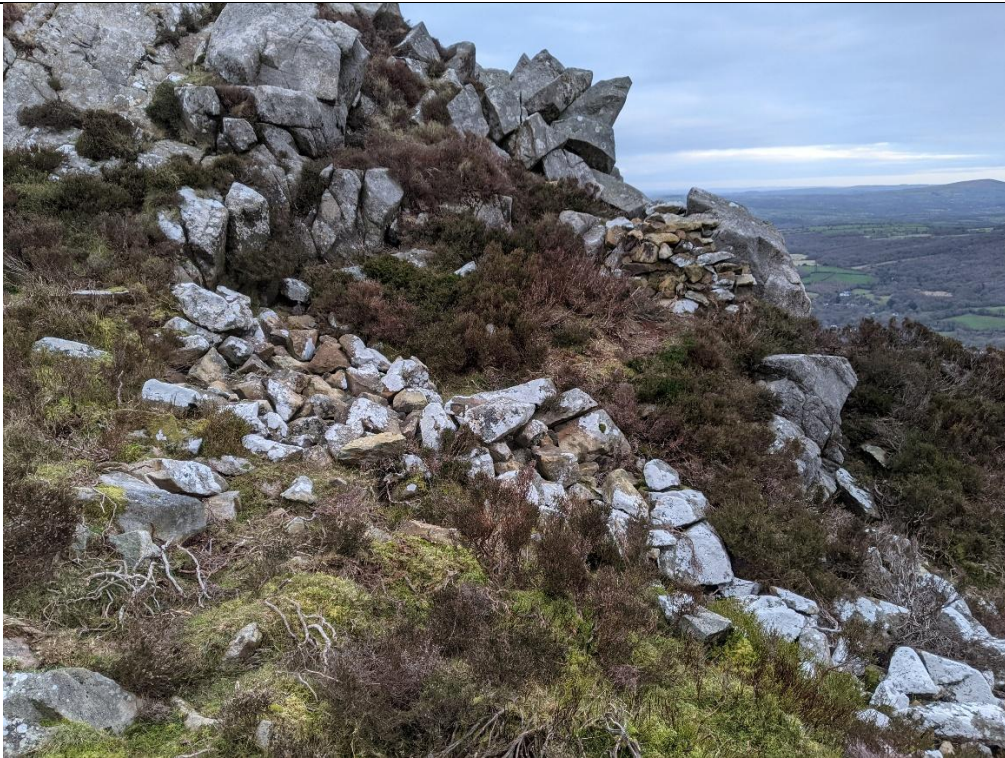
Figure 3. Image looking northeast, showing disturbed rampart and shelter.

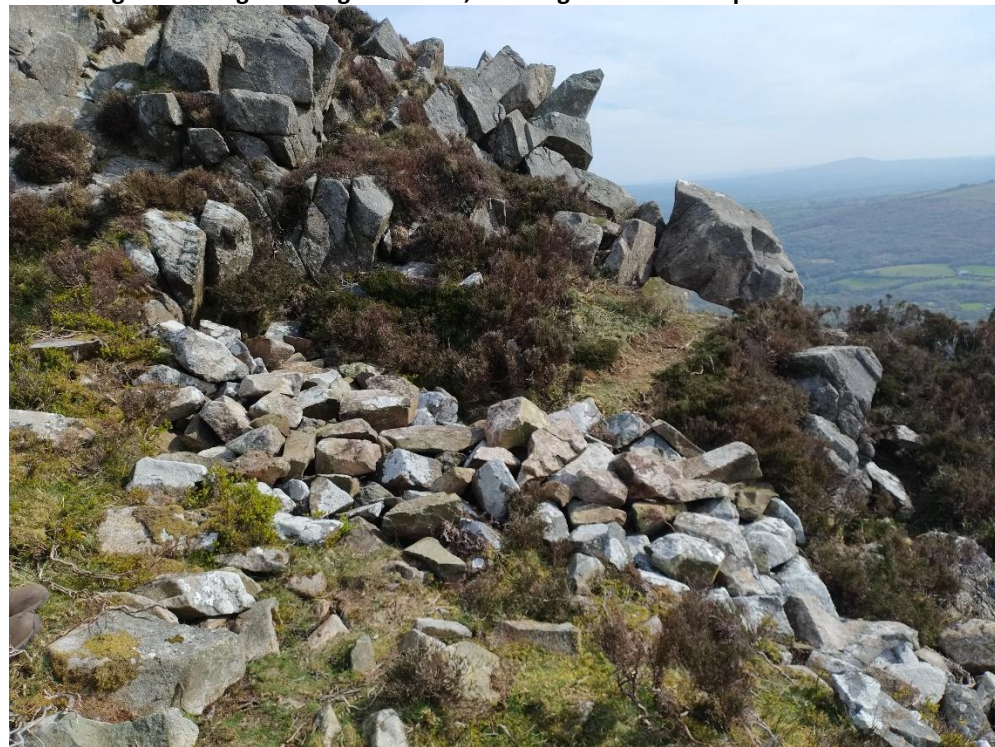
Figure 4. Image looking northeast after reconsolidation work.

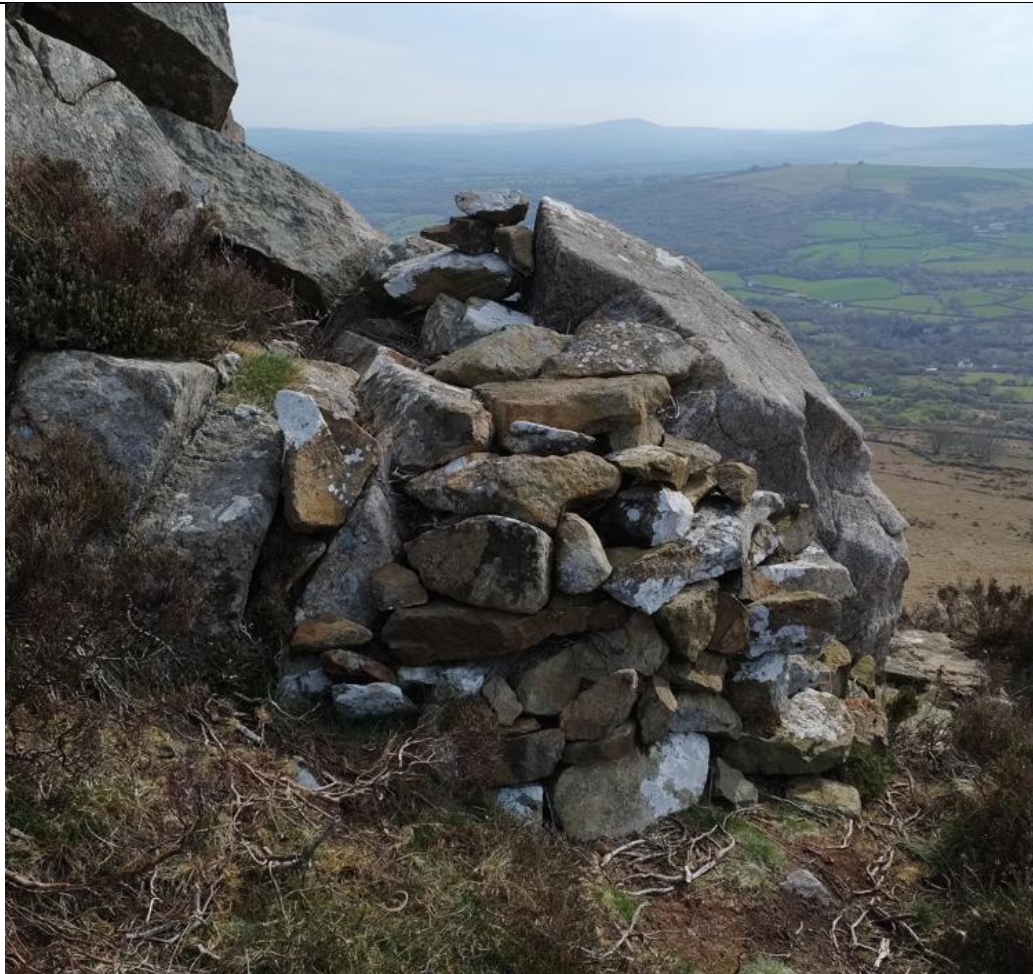
Figure 5. Image looking northeast showing shelter.

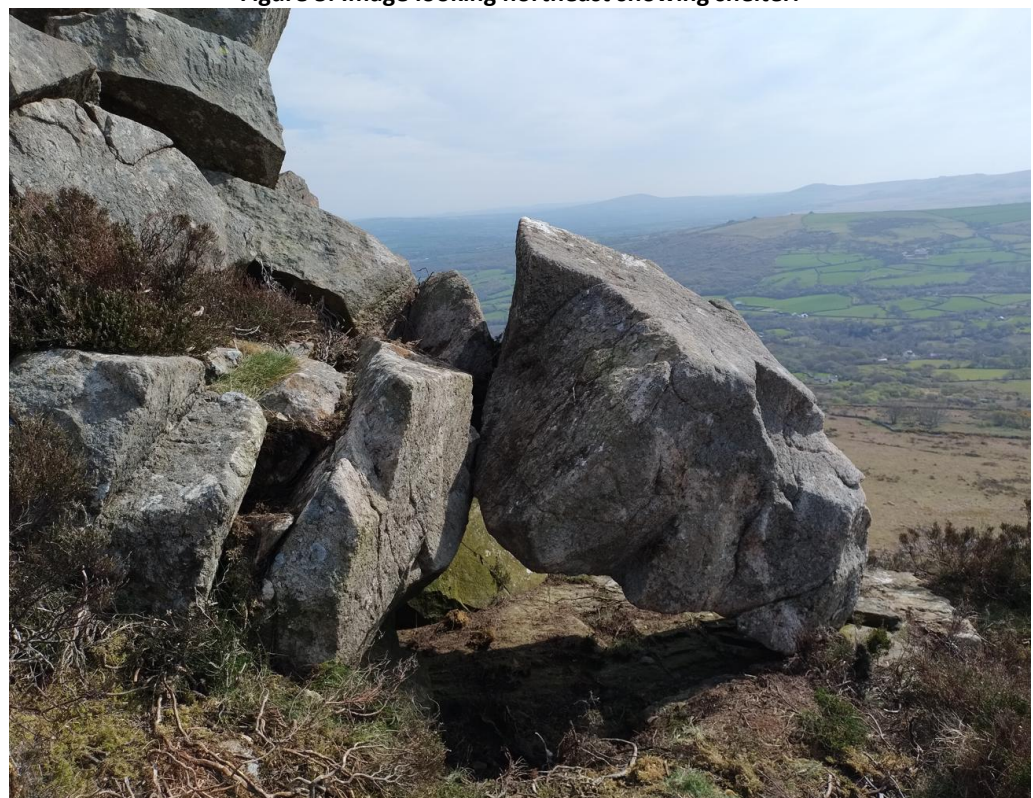
Figure 6. Image looking northeast after dismantling shelter and showing impressive leaning boulder.

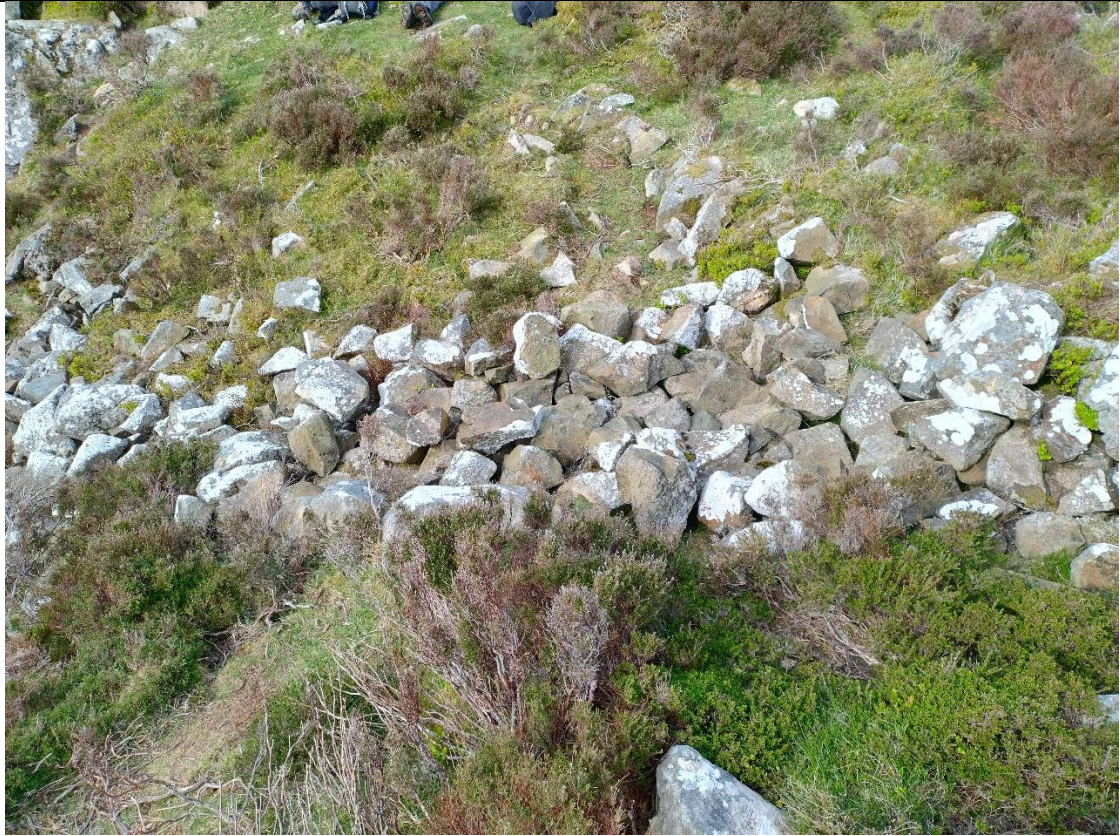
Figure 7. Image overlooking disturbed area of the rampart.

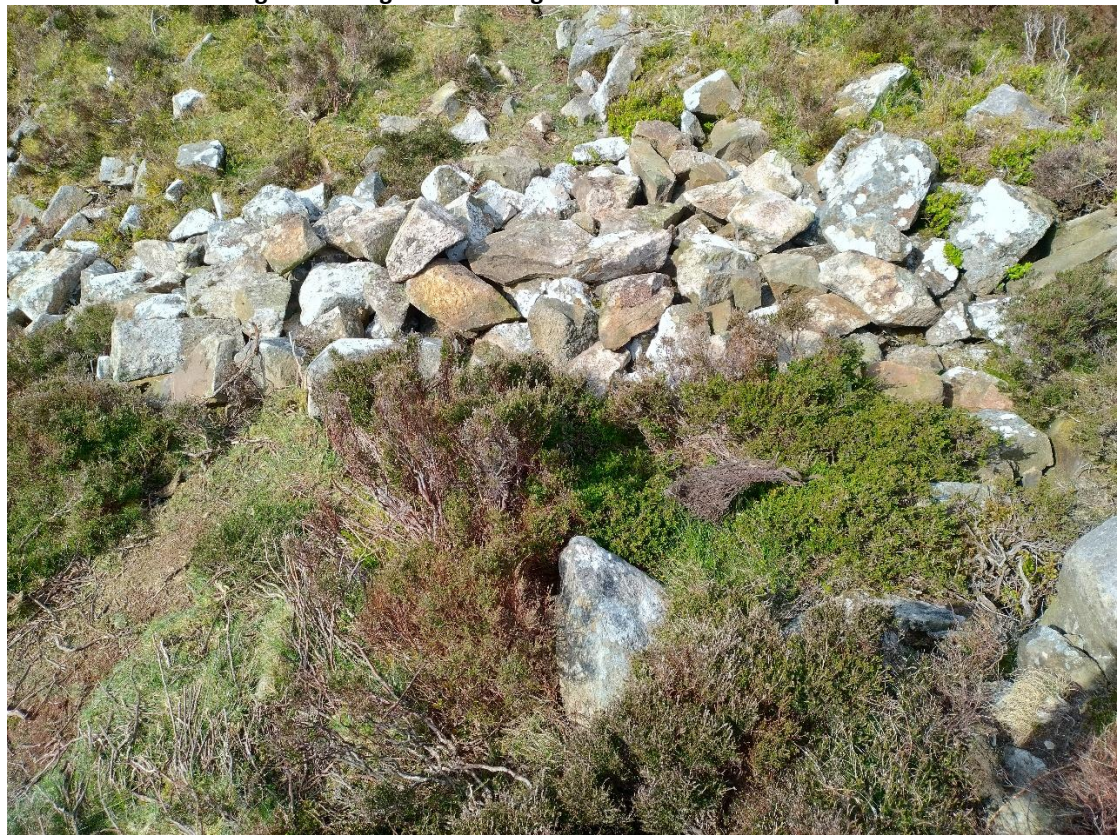
Figure 8. Image overlooking the rampart after the reconsolidation work.
