**MEADOW VIEW, LLANGOEDMOR,
CEREDIGION
(SN 2011 4580)
ARCHAEOLOGICAL WATCHING BRIEF**

RHIF YR ADRODDIAD / REPORT NO. 2010/15
RHIF Y PROSIECT / PROJECT RECORD NO. 98690

MEADOW VIEW, LLANGOEDMOR, CERDIGION, ARCHAEOLOGICAL WATCHING BRIEF

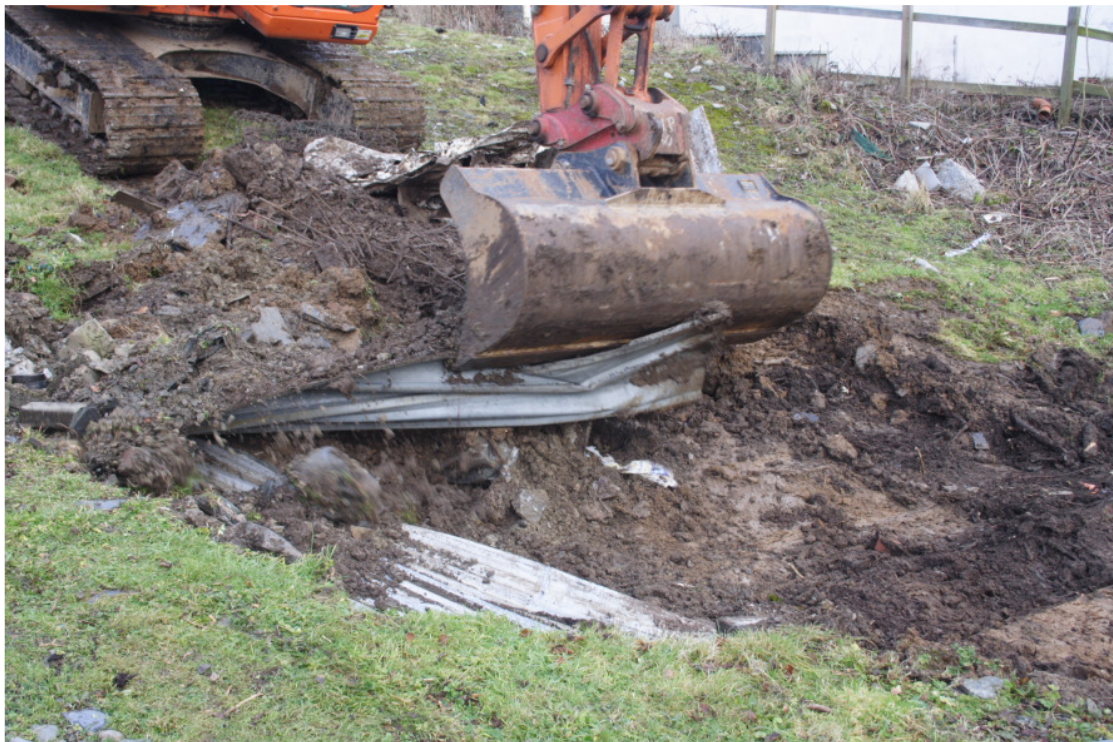
3.2.1 The building plot was located on a south-facing slope, which had been used to dispose of modern building debris, presumably originating from development of the adjacent buildings. This building debris layer proved to be up to 1 metre deep in places and covered the natural topography of the land.

Photo 2: Photo showing removal of modern debris.

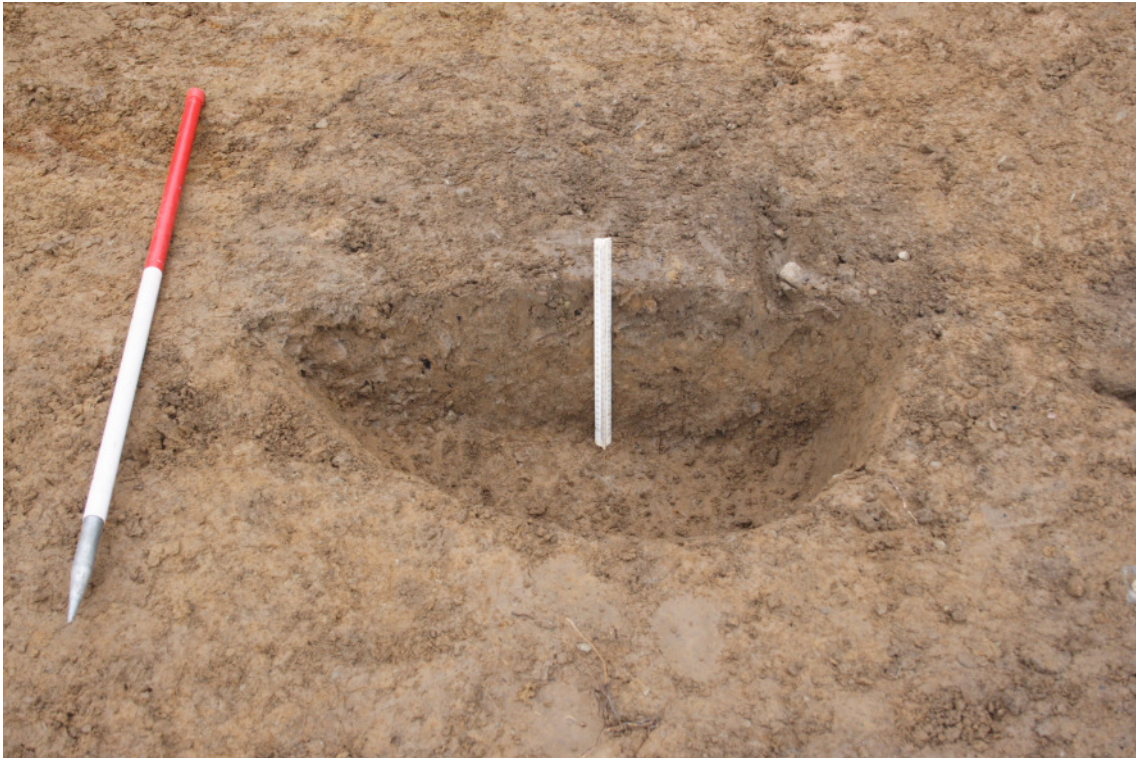
3.2.5 Three archaeologically significant features were revealed within the building plot, lying beneath the subsoil and cutting through the natural substrata. A circular pit [104], measuring c.1.20m in diameter and c.0.27m in depth. The pit contained a light yellowish brown, silty clay with occasional small pieces of charcoal, quartz and burnt fragments of bone. The bone showed signs of being heated under high temperatures. An animal tooth was recovered from the fill which suggests that the pit had most likely been backfilled with debris from a fire or a hearth, as opposed to being a pit associated with a cremation burial. The pit fill contained no dateable artefacts and it is considered that it pre dates the post medieval period.

Photo 3: Photo looking north at half sectioned pit [104].

4.3 Pit [104] contained bone that had been burnt at a high temperature, which could indicate a cremation, although as an animal tooth was also found in the pit, this is considered unlikely. It is probable that the bone originated from within a domestic hearth or fire, and the pit filled with the resulting debris when cleaned out. The edges of the pit showed no signs of heat and it was therefore most likely a pit dug out to dispose of rubbish. The fill of the pit also shows signs that it was backfilled in one episode, again pointing to it being a rubbish pit. It is unknown if all of the features are roughly contemporary, although it is considered quite likely.

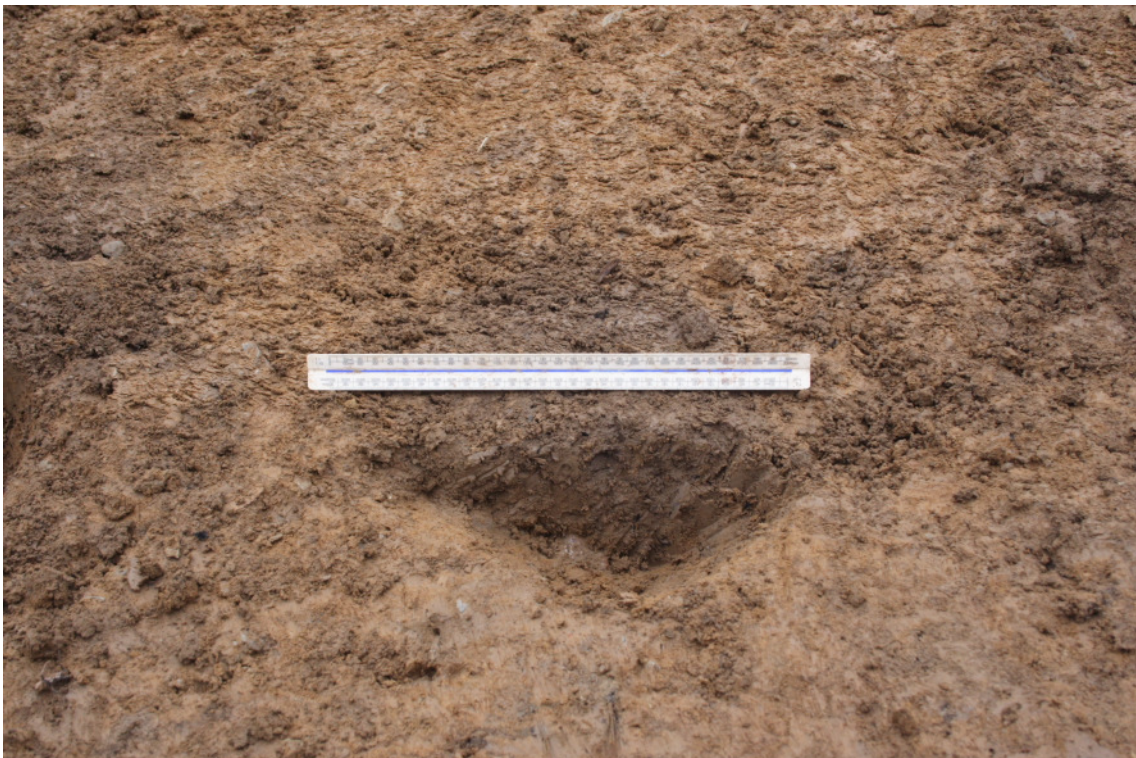
3.2.6 A stake hole [106] was recorded 0.18m to the south east of pit [104]. The feature was very shallow, filled with a mid greyish brown soil with charcoal. The feature measured 0.30 metres in diameter and 0.09 metres in depth.

Photo 4: Photo looking northwest showing stake hole [106].

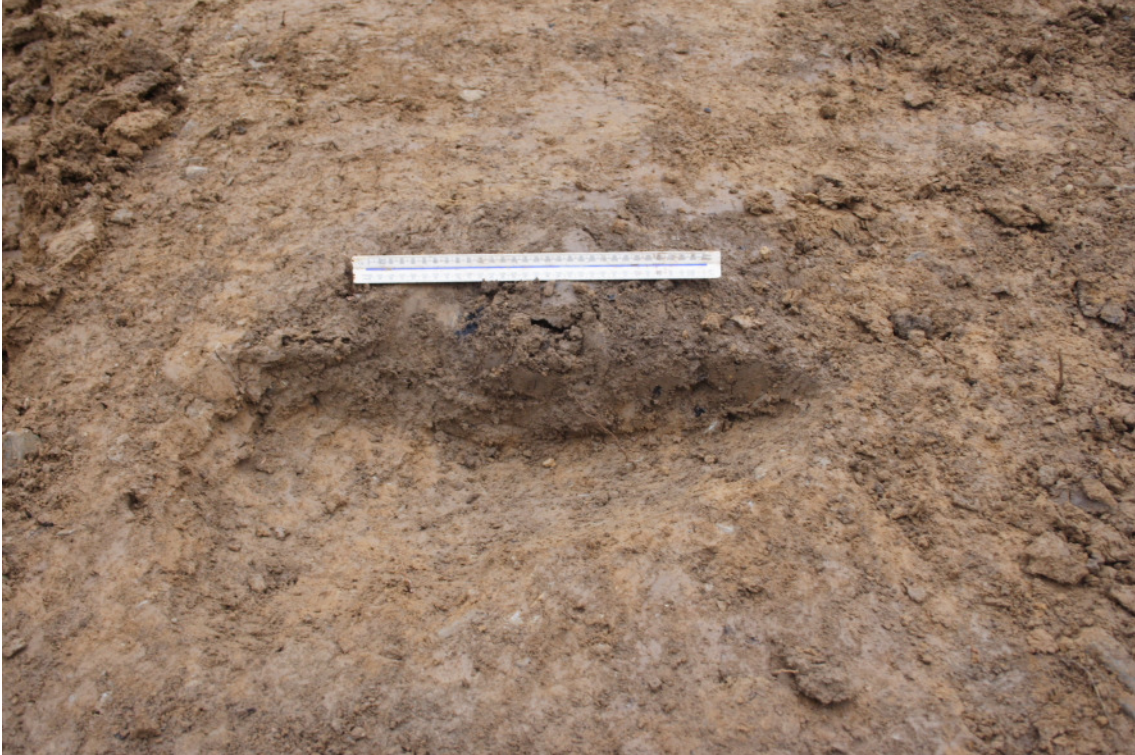
3.2.7 Situated 1.8m to the west of pit [104], another smaller pit was present. This pit had an almost identical fill to the stake hole [106] and could be considered contemporary.

Photo 5: Photo looking north showing shallow pit [108].
