Oxford Dendrochronology Laboratory

Trefadog, Llanfaethlu, Isle of Anglesey

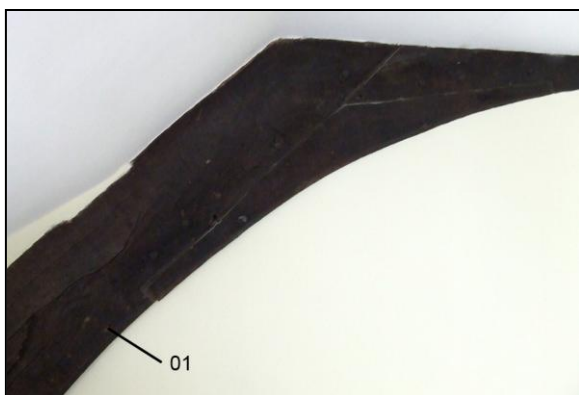
Figure 1: West cruck of central truss

It was decided that there were too few rings for dendrochronological dating, but two samples were taken in case it might be possible to carry out radiocarbon dating at a later stage. Sample 01 was taken from the west cruck of the central truss (Fig 1), next to the stairs, and had complete sapwood. Sample 02 was taken from a timber above the door on the east side of the truss (Fig 2).
