North West Wales Dendrochronology Project Plas y Dduallt, Maentwrog, Gwynedd

**EAS Client Report 2011/16
September 2011**

**North West Wales Dendrochronology Project
Plas y Dduallt, Maentwrog,
Gwynedd**

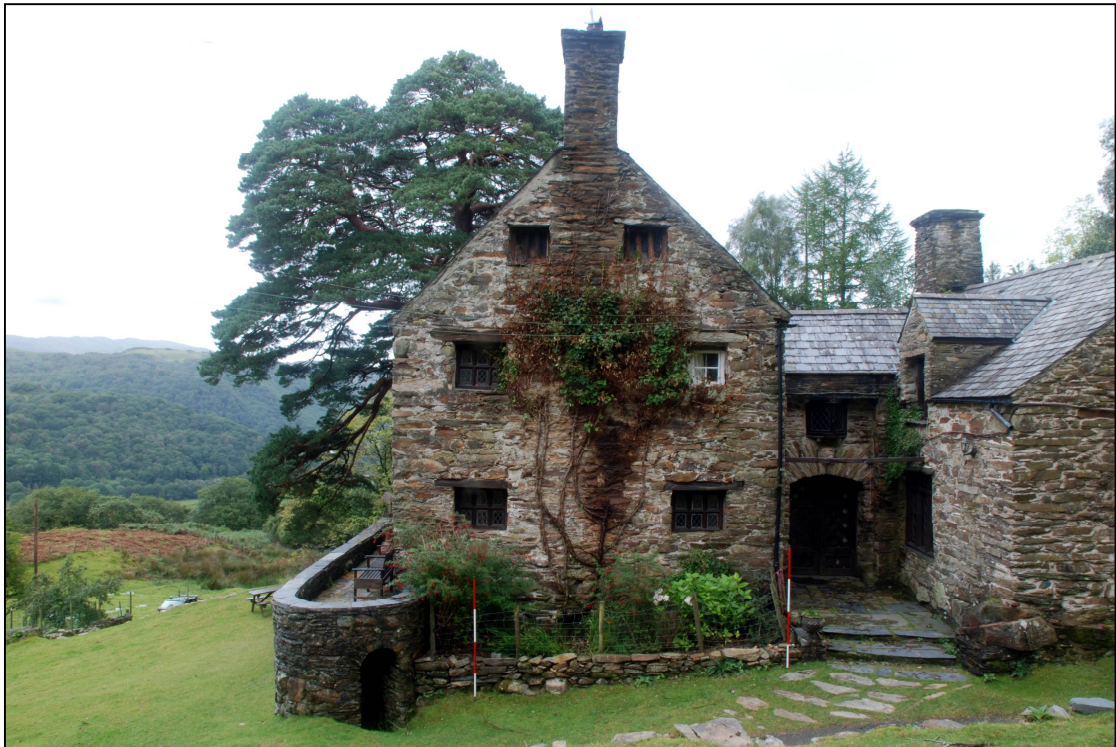
Plate 2: The north eastern elevation of the southern range

The core of the house has two parallel wings linked with a storey and a half lobby (Plate 1). To this is attached an agricultural wing to the north, a kitchen to the west and a cellar extension to the south. The southern wing is a two and a half storey building aligned approximately north-east to south-west. Constructed of poorly coursed stone, it has two, stone built, gable end chimneys and a slate roof with ceramic ridge tiles. The north eastern elevation has two windows on each storey (Plate 2). Three of the windows on the first two floors match with heavy wooden mullions and transoms, whilst the fourth is a modern replacement. Those windows in the attic space have plain, diamond, wooden mullions. The south eastern elevation sits over the later cellar extension (Plate 3). It has two centrally placed windows which have three lights separated by wooden mullions. The lower window has a stone hood mould. There is also a doorway with an arched head and small stone

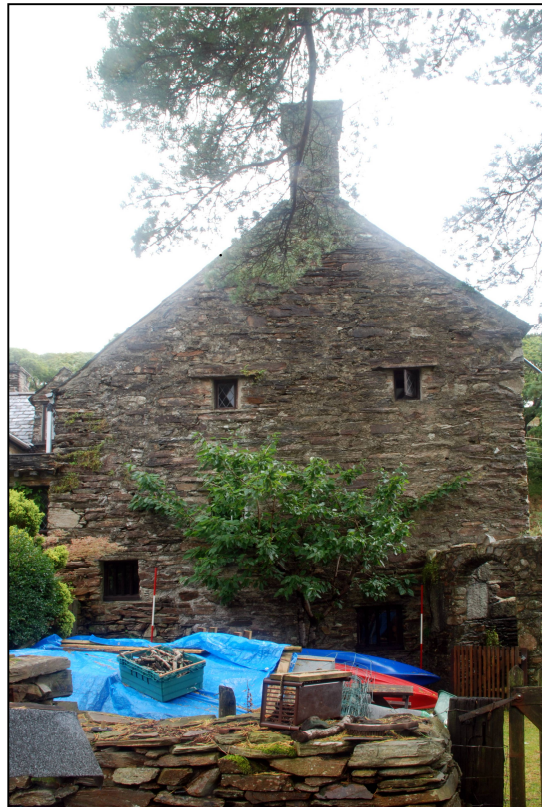
Plate 4: The south western elevation of the southern range

voussoirs, but no keystone. Below the main house is an extension to the cellar of poorly coursed slabby construction with mock arrow slot windows. The south western elevation (Plate 4) has a single window lighting the cellar, another for the ground floor and two lighting the first floor. All of the windows are relatively small in size, particularly those giving light to the first and ground floors. The ground floor window has a series of wooden mullions as does the cellar window, whilst the first floor windows are single pane casement windows with leaded lights

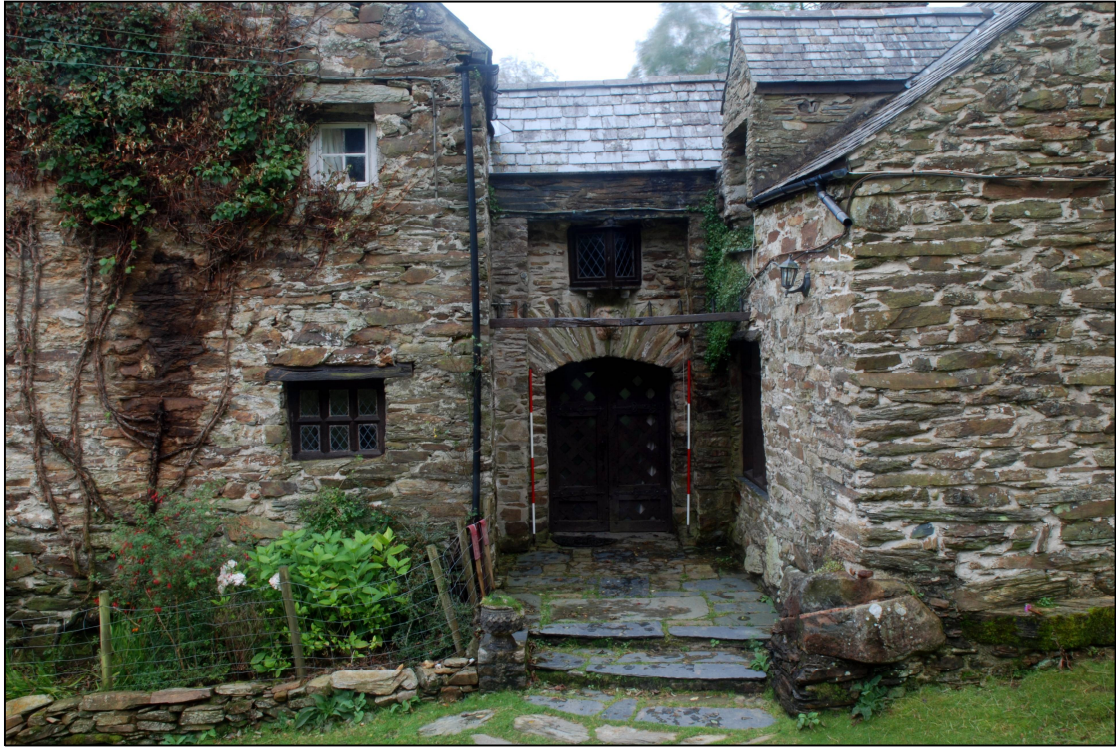
Plate 5: The front elevation of the lobby

The lobby has double door under a depressed arched with stone voussoirs (Plate 5). Above this is a triangular planned, oriel window with leaded lights. The rear elevation has a single six pane window with leaded lights on the ground floor and dormer with a two pane leaded window (Plate 6).

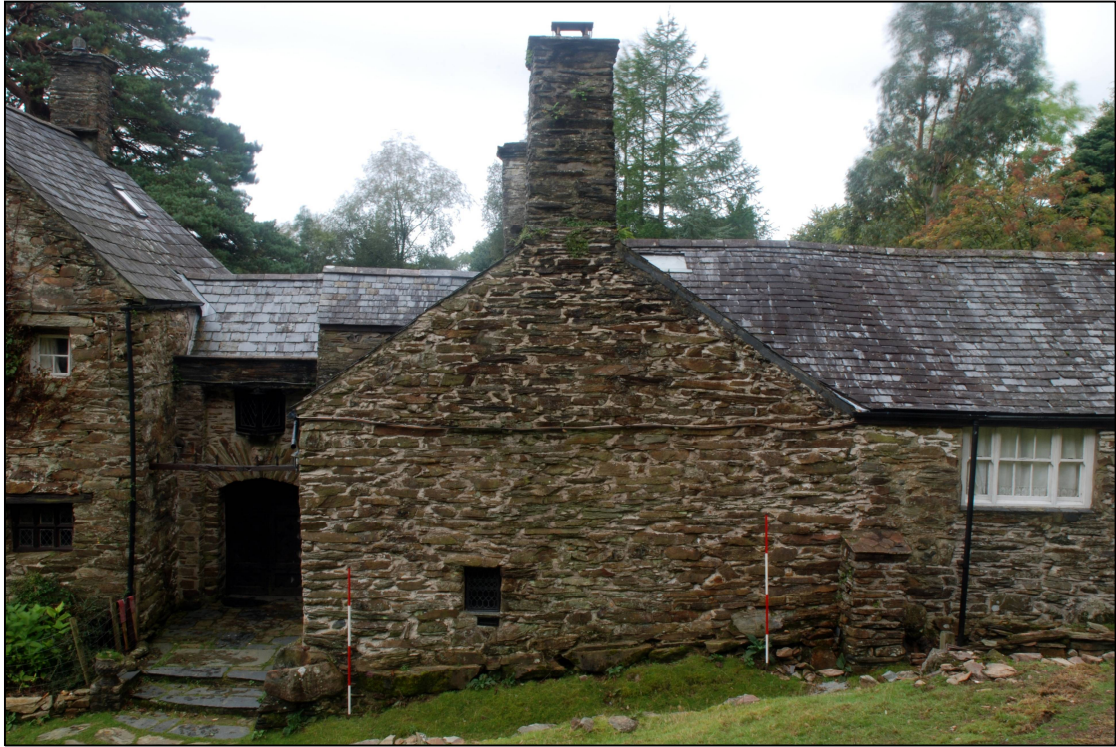
Plate 7: The front elevation of the northern range.

The northern wing is a storey and a half block with gable end chimneys and a slate roof with ceramic ridge tiles. It is constructed of slabby stone blocks, roughly coursed, with no emphasis at the quoins. The front elevation (Plate 7) has a single small window set low on the ground floor below which is a letter-box. There is a straight joint to the agricultural range to the north west and a later, small buttress, which obscures the base of this joint. The south eastern elevation (Plate 8) has a large window with six, leaded panes on the ground floor, adjacent to the front door. Above is a smaller, three pane window within a dormer. Both of the windows have wooden mullions and the lower window also has a wooden transom. At the north eastern foot of the wall there is a large rounded boulder with a series of small slabby stones which is distinct from the construction style of the main wall. Whilst it is possible that this is part of the foundations of the house it appears to be distinct and therefore may hint at an earlier structure.

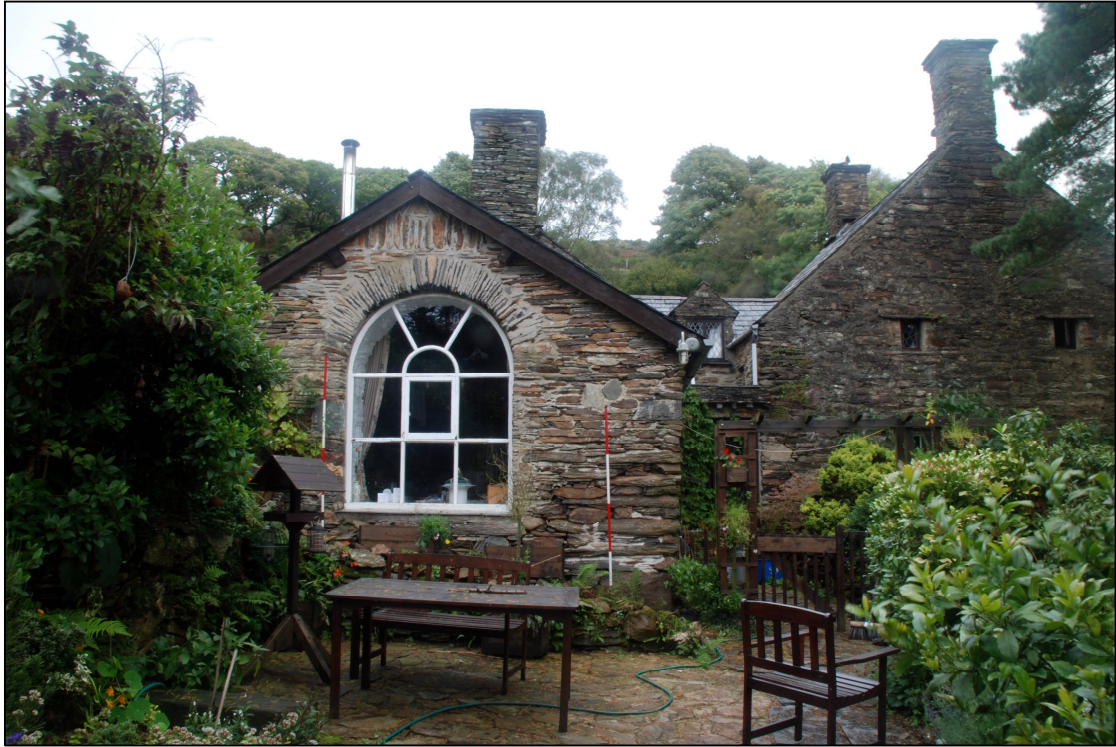
Plate 9: The kitchen extension

To the rear of the northern range, there is a later, kitchen range (Plate 9). This is constructed of roughly coursed stonework. There is a change in the stonework on the rear wall which is associated with the large, arched window. The later stonework is of smaller stones and its position, and relationship to the earlier stonework, suggests that much of the gable end has been replaced.

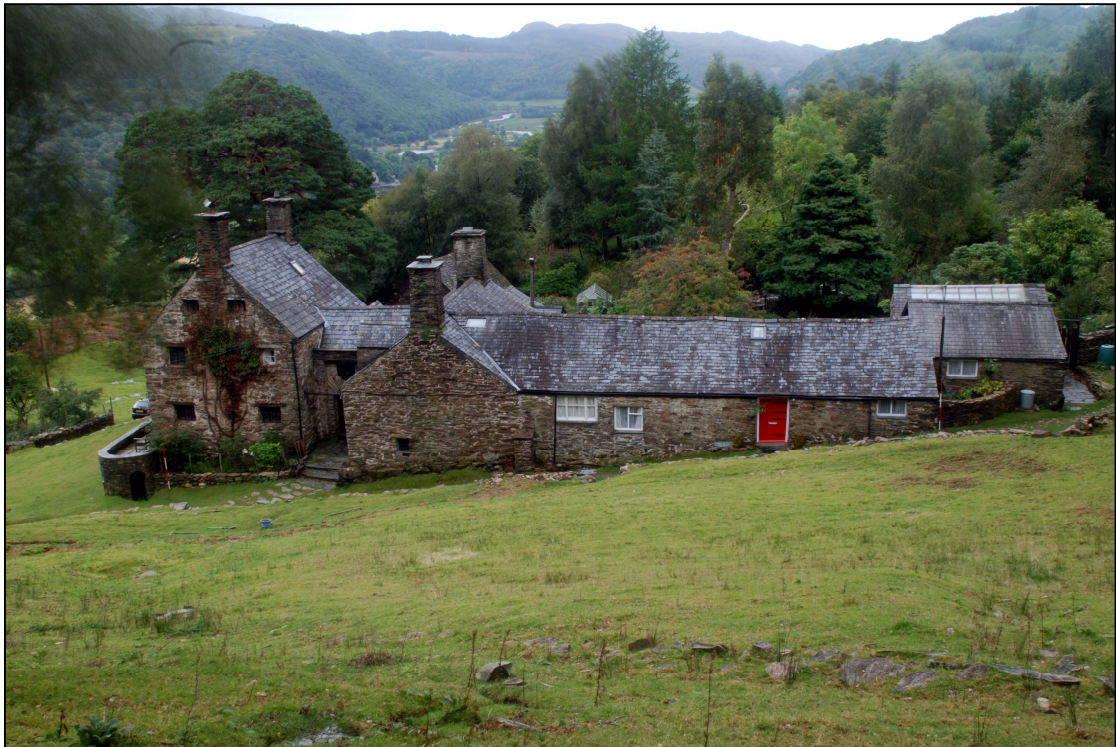
Plate 10: The agricultural range

The agricultural range (Plate 10) has been largely converted into holiday accommodation, although access to the first floor rooms of the northern range is via the south eastern end of the agricultural range. The converted section of the agricultural range is not part of this study.

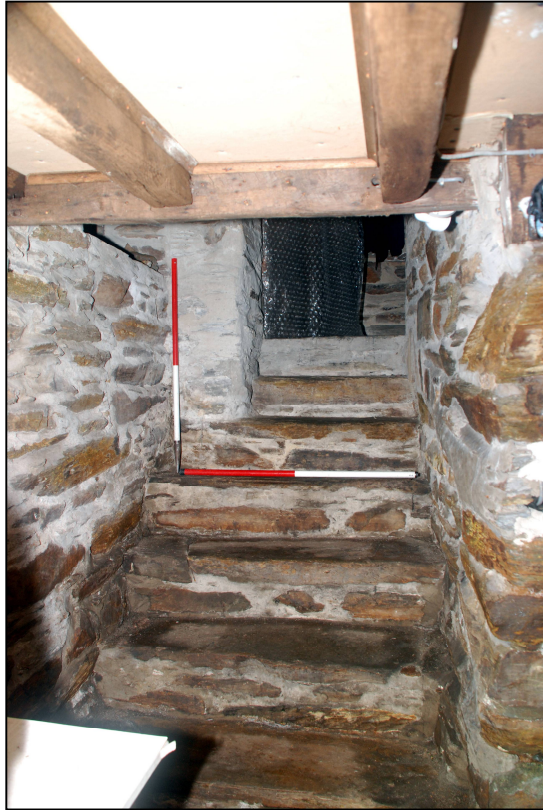
Plate 11: The cellar steps

Inside; the southern range has a cellar (Figure 3), ground floor parlour, first floor and attic bedrooms. The cellar is accessed from the lobby via a straight flight of stone steps (Plate 11) and had two windows in the south eastern wall. One gives light to the cellar head at ground floor level, whilst the other lights the main body of the cellar. There are two elements to the cellar, the main body and a passageway along the north eastern side. The main body of the cellar appears to be original and has the timberwork for the floor of the parlour above exposed (Plate 12). The main beam whilst embedded in the wall at its north western end is supported by a stone corbel at the south eastern end (Plate 13). The passageway is clearly later in date. It is accessed from the

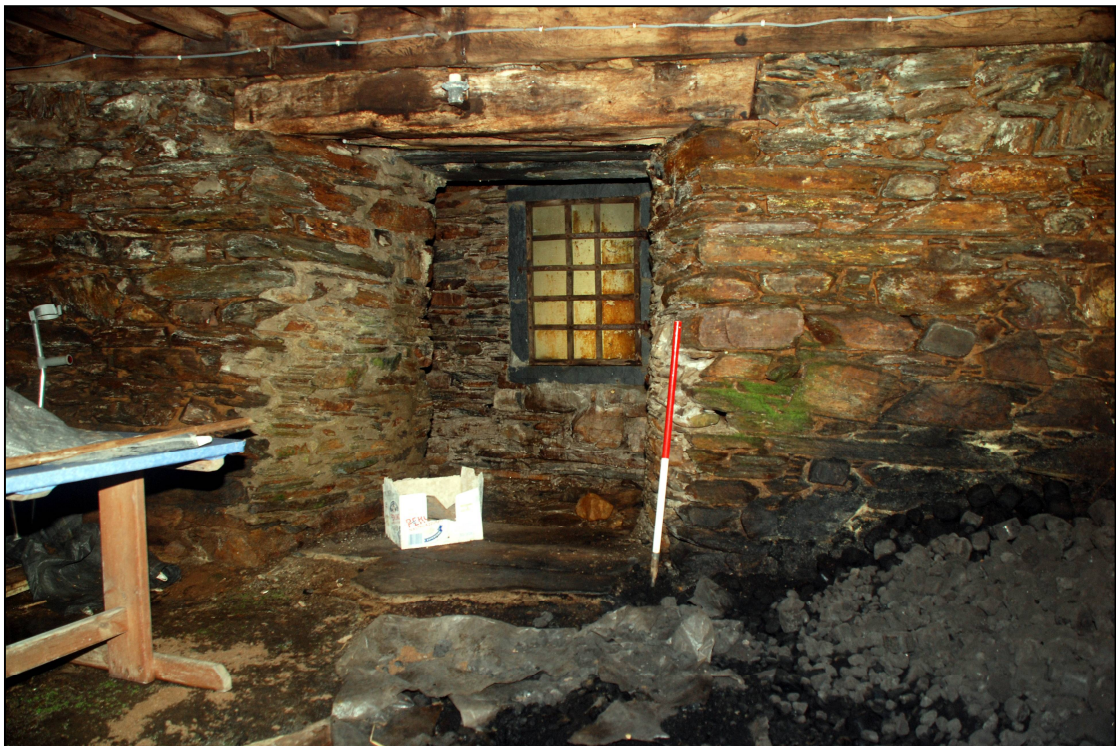
Plate 14: The “doorway” between the two cellars

main cellar via a splayed doorway (Plate 14) cut through the main cellar wall. The passage (Plate 15) leads to an external doorway and has a series of splayed, narrow slot type windows.

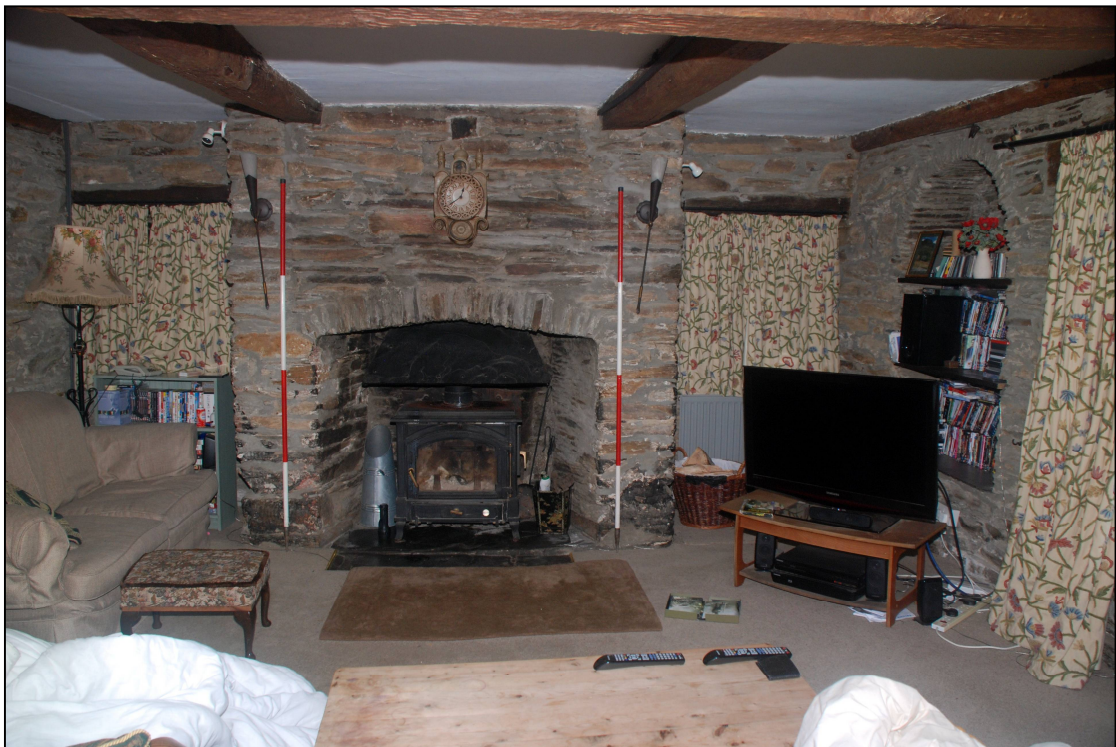
Plate 16: The chimney breast in the parlour

The parlour (Figure 4) has a stone built chimney breast at the north western end of the room (Plate 16). The ceiling has a main lateral beam and two longitudinal beams, but no joists. All of the beams are chamfered and stopped with straight cut stops (Plates 17 and 18). There is evidence, however that there were joists in the south eastern end of the room (Plate 19), but these have since been removed. There is also evidence that there was a partition below the western end of the northern longitudinal beam with a series of mortice holes on the underside of this beam (Plate 20). The western end of the longitudinal beam is supported by a corbelled support (Plate 21) consisting of a large stone beam supported by three corbelled blocks. On the north western wall there are two doorways, with arched doorheads formed with stone voussoirs with no keystone, whilst one of which gives access to the lobby, the other gives access to a stone stair case (Plate 22). The south eastern window frame has a series of graffiti on both the cill and mullion. On the mullion there are a series of initials above a daisy wheel (Plate 23). The initials are "I LL", below which is the letter "W" with a horizontal line. Below this is "RH II" and then an "I". At the bottom of the mullion is a daisy wheel design (Plate 24). On the cill are a scratched shield and the initials "RH II" (Plate 25).

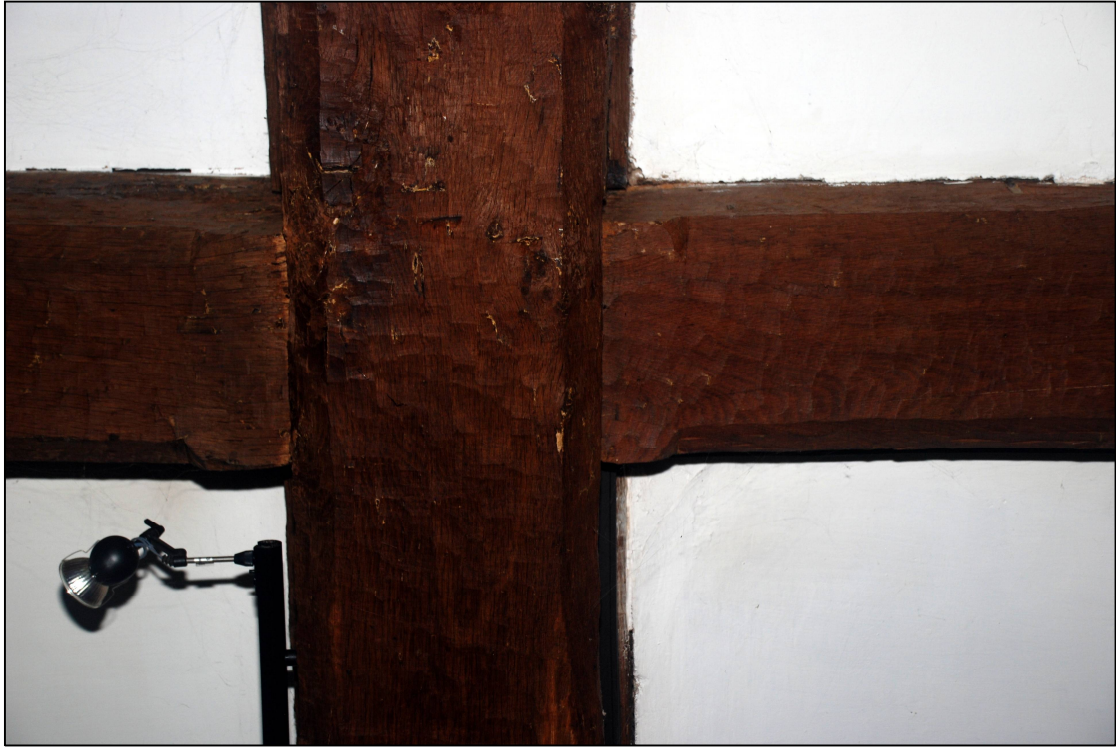
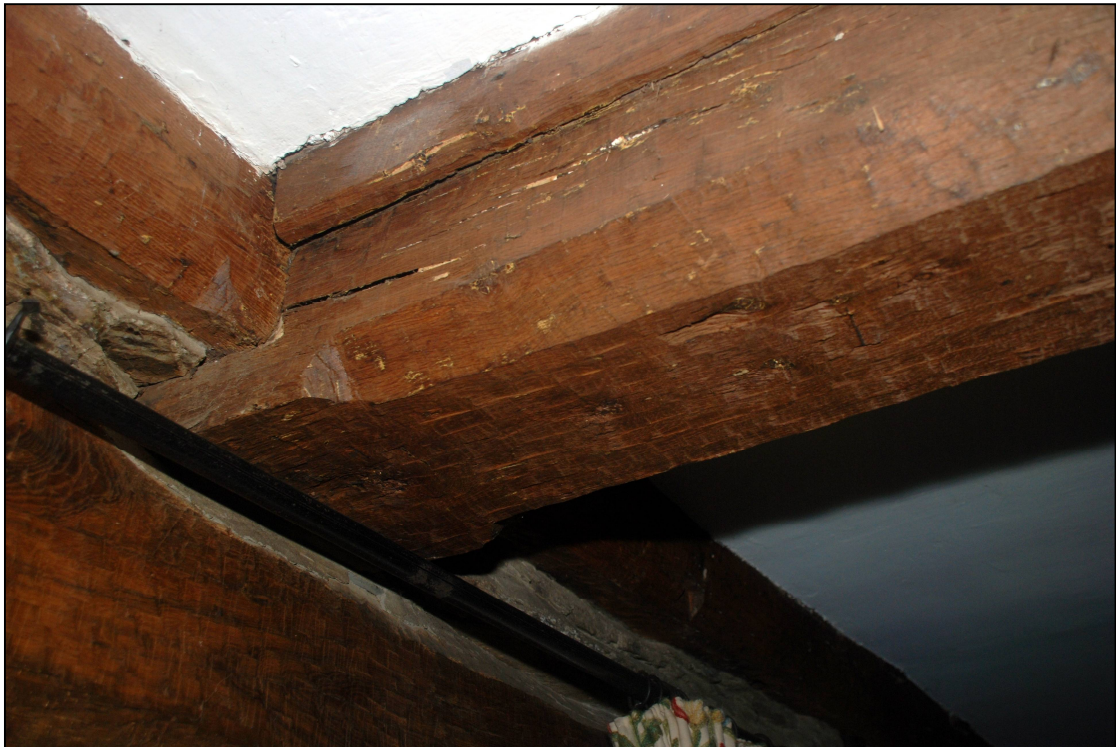
Plate 17: Chamfer and stops on ceiling beams of the parlour

Plate 18: The chamfer and stop on the transverse beam in the parlour

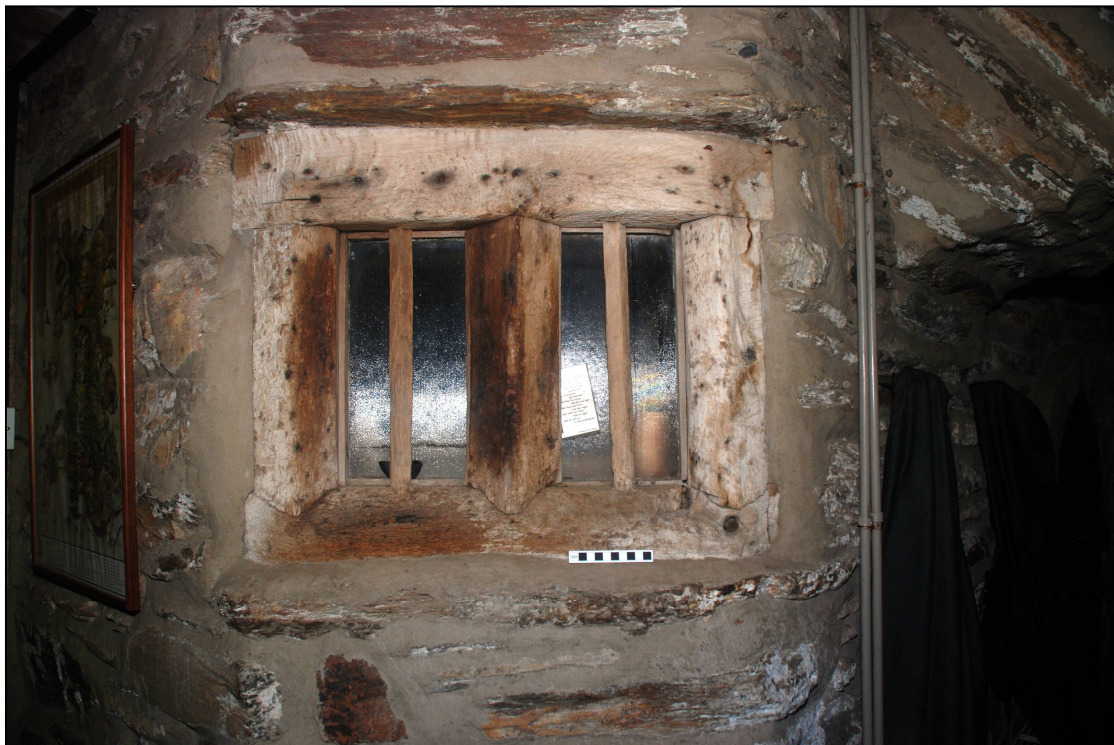
Plate 26: The window between the staircase and the lobby

The staircase has stone steps forming a winder staircase to the first floor. There are two windows lighting the staircase, the lower of which gives light from the lobby. This window has a diamond mullion, glazing stanchions and a heavy frame (Plate 26). The relationship between the parlour block and the lobby is not entirely clear. The lower window of the staircase may suggest that the lobby is a later feature linking the two ranges. If so, the staircase is contained by an external stair tower, however this would mean that the access to the cellar would have been via an external door.

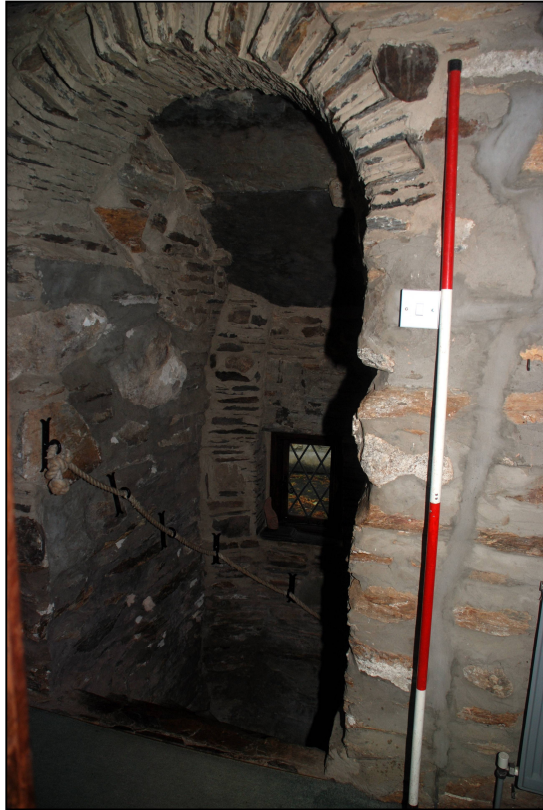
Plate 27: First floor access to the staircase

The staircase reaches the first floor (Figure 5) of the parlour range through an arched opening with stone voussoirs and no keystone (Plate 27). There is a corridor which links to the first floor of the lobby (Plate 28). Off this corridor is a bedroom, the access to attic, a cupboard and a bathroom. The bedroom has a timbered ceiling with two transverse beams supporting a series of joists (Plate 29). Both the joists (Plate 30) and the beams (Plate 31) are chamfered and stopped with straight cut stops. At the south western end of the bedroom, there is a partly blocked fireplace with a carved wooden lintel (Plate 32). This lintel is part of the restoration of the property carried out in the 1960's by Colonel Campbell
