CYNFAL-FAWR, MAENTWROG, GWYNEDD

Architectural Record

FINAL REPORT

Project Number: 2011-013(f)
Project Name: Cynfal-fawr, Maentwrog, Gwynedd

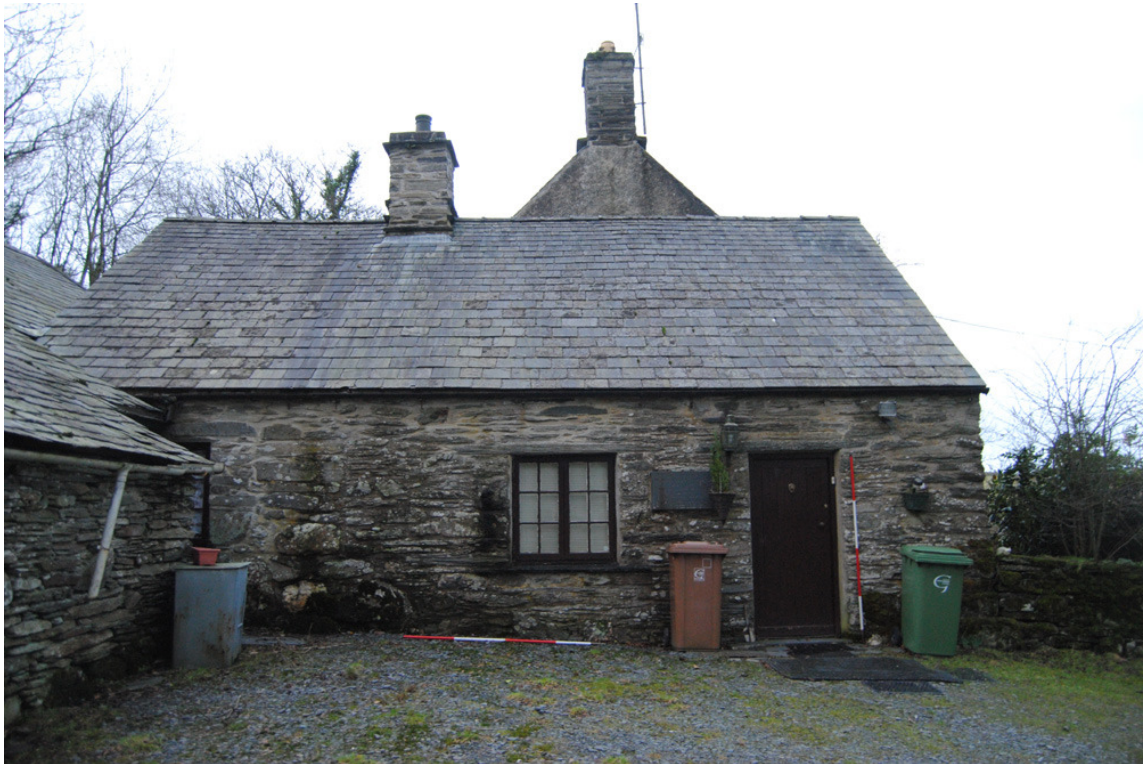
Plate 3: East Range, east elevation.

- 4.2.2 The **east elevation** (Plate 3) is stone-built of a single-storey, rising above a partly surviving offset stone footing, beneath a pitched, slate-clad roof, gabled to the north and extending over the northern roofslope of the adjacent, east-west aligned agricultural range to the south. A single ridge stack is offset towards the southern end of the range. The principal doorway is located to the north end of the range with two windows to the south, arranged to either side of the stack; the northern window opening houses a two-light timber casement while that to the south houses a 9-pane fixed-light, the latter opening having been reduced in width to the north (Plate 4). An indistinct ragged joint within the masonry of the elevation may indicate that the walls were built in more than one campaign. A plaque adjacent to the main doorway, introduced in 1949, commemorates Morgan Llwyd (1619-1659), who is recorded as having been born at the house (Plate 5).

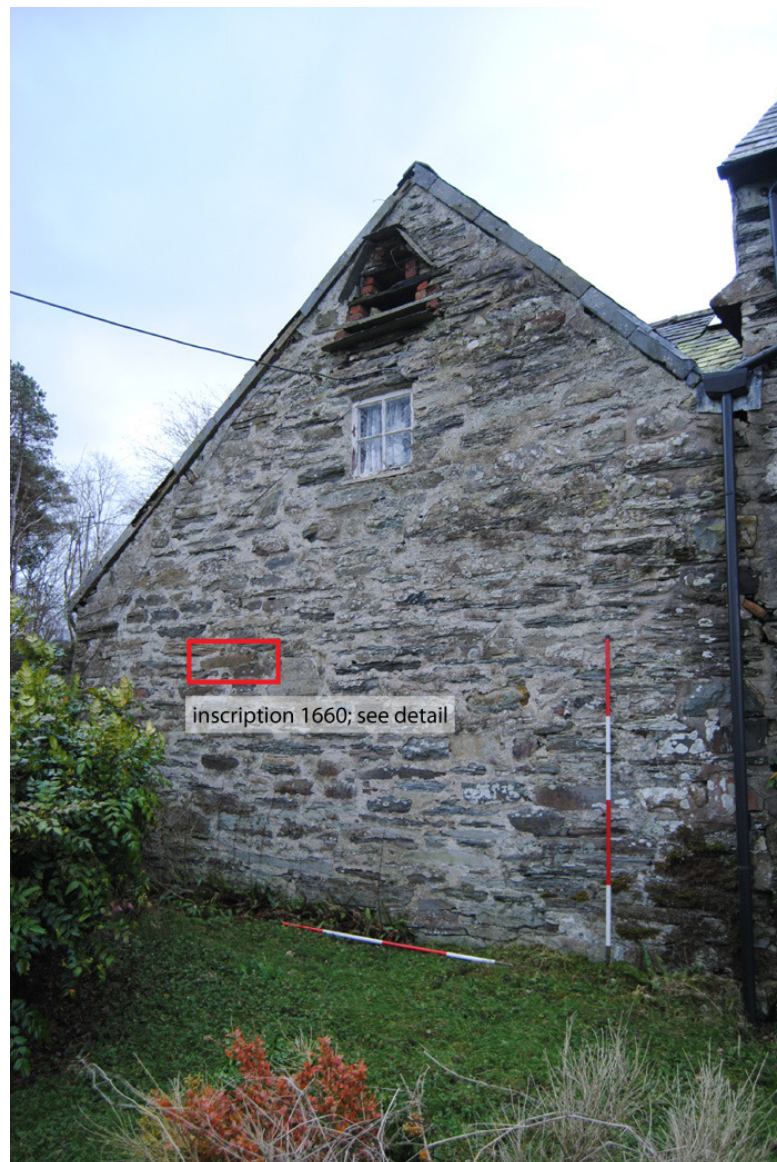
Plate 6: East range, north elevation.

- 4.2.3 The **north elevation** (Plate 6) presents an asymmetrical gable of stone rubble construction with a small 4-pane fixed-light window to the apex lighting the interior first floor beneath a series of inserted pigeon-holes, lined in red-brick with projecting slate ledges and canopy (Plate 8). A westward return of the offset footing is obscured by the raised level of the garden to the north of the house, but its presence implies that the north and east walls are contemporary. A stone within the eastern part of the wall at ground floor level includes the graffiti 'CALEB LLOYD 1660' (Plate 7). To the west, the gable end meets the refaced north elevation of the west range in an uneven straight joint, while a clear raising of the eastern wall and related alteration to the eastern roofslope is evidenced by a sloping scar (Plate 6).

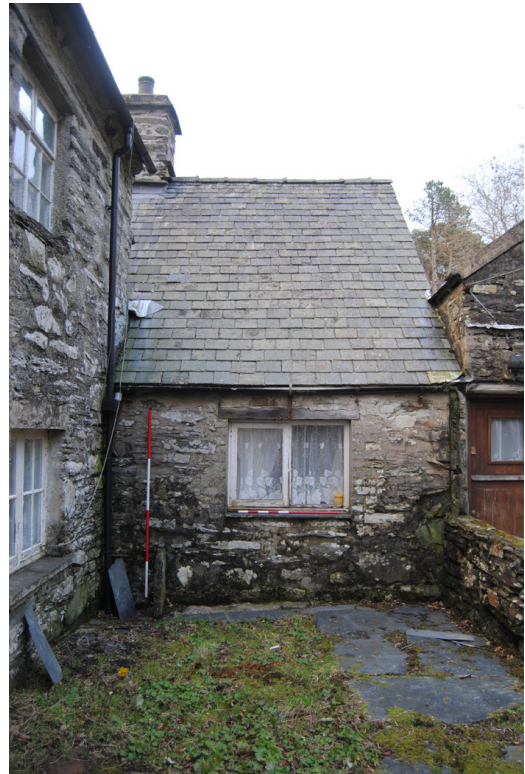
Plate 9: South-west elevation.

- 4.2.4 The southern section only of the **west elevation** is exposed (Plate 9), of stone rubble construction with an inserted two-light timber casement lighting the kitchen [GF03] internally, the northern section being abutted by the western range (see Plate 30). The **south elevation** is obscured by the adjoining agricultural range.

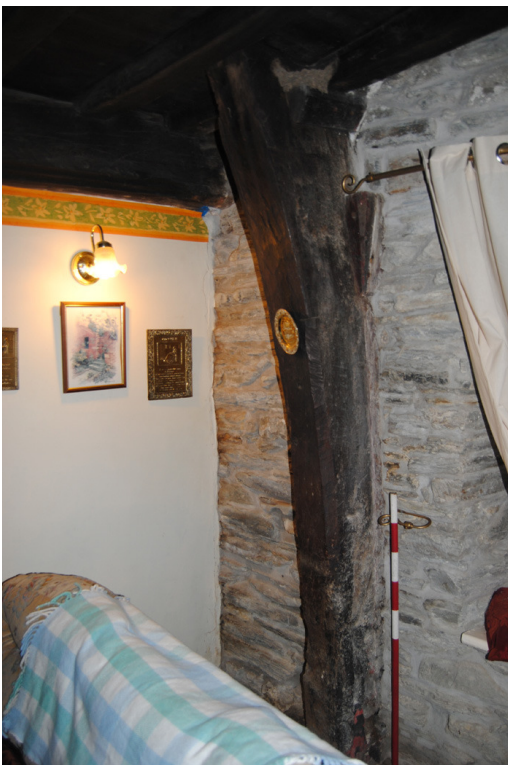
Plate 12: Eastern cruck blade visible in [GF02].

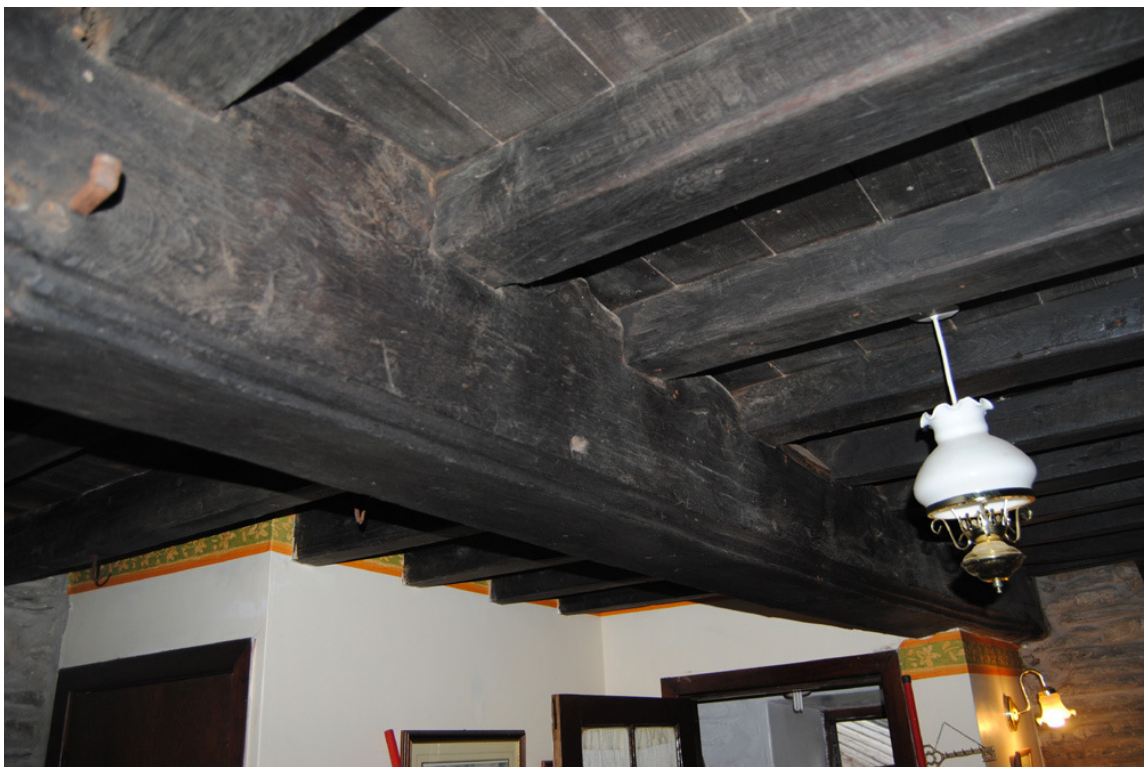
Plate 16: [GF02], inserted floor structure over former open hall.

- 4.2.6 The (inserted) ceiling of [GF02] is carried on a substantial central transverse beam (10 ½ x 14in. deep; Plate 16) moulded with run-out stops (Figure 4 inset profile A; Plate 17) and by a transverse beam, moulded to the north only (13 x 5in.; Figure 4 inset profile B), aligned immediately north of the inserted stack. The upper floor is carried by a total of 14 north-south aligned common joists, 4 x 5in. scantling at 16in. centres, unchamfered but with the arrises shaved off; the common joists to the north-east quadrant of the ceiling have been renewed with 6 x 3in. timbers, presumably related to alterations to the main stair.

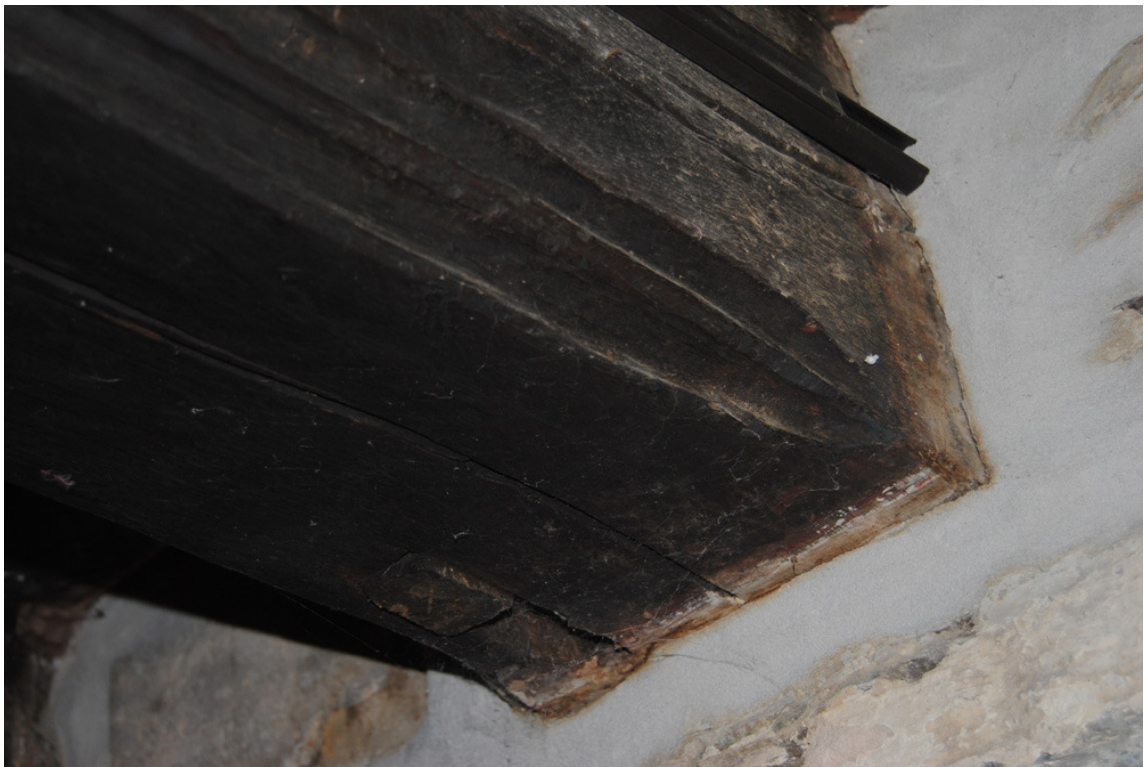
Plate 17: Decorated chamfer run-out to west end of main transverse beam of inserted floor.

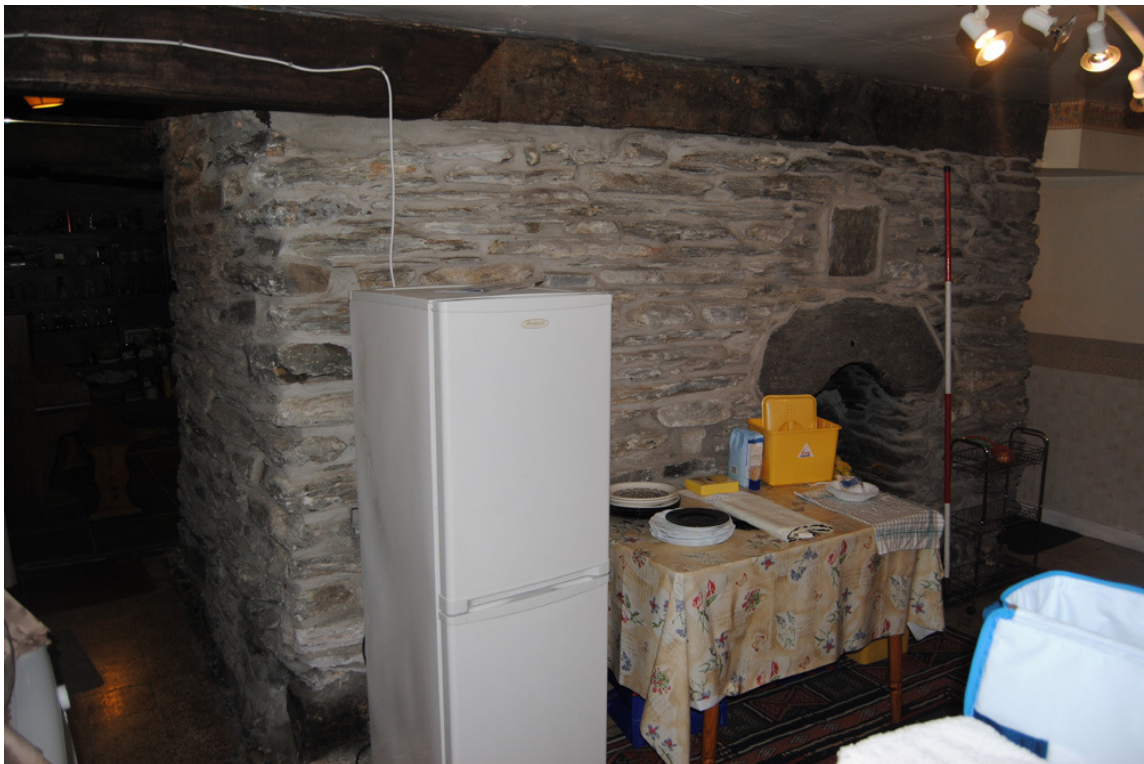
Plate 18: Rear (south) face of inserted stack; note FP (see Plate 19) and spliced head beam (Room [GF03]).

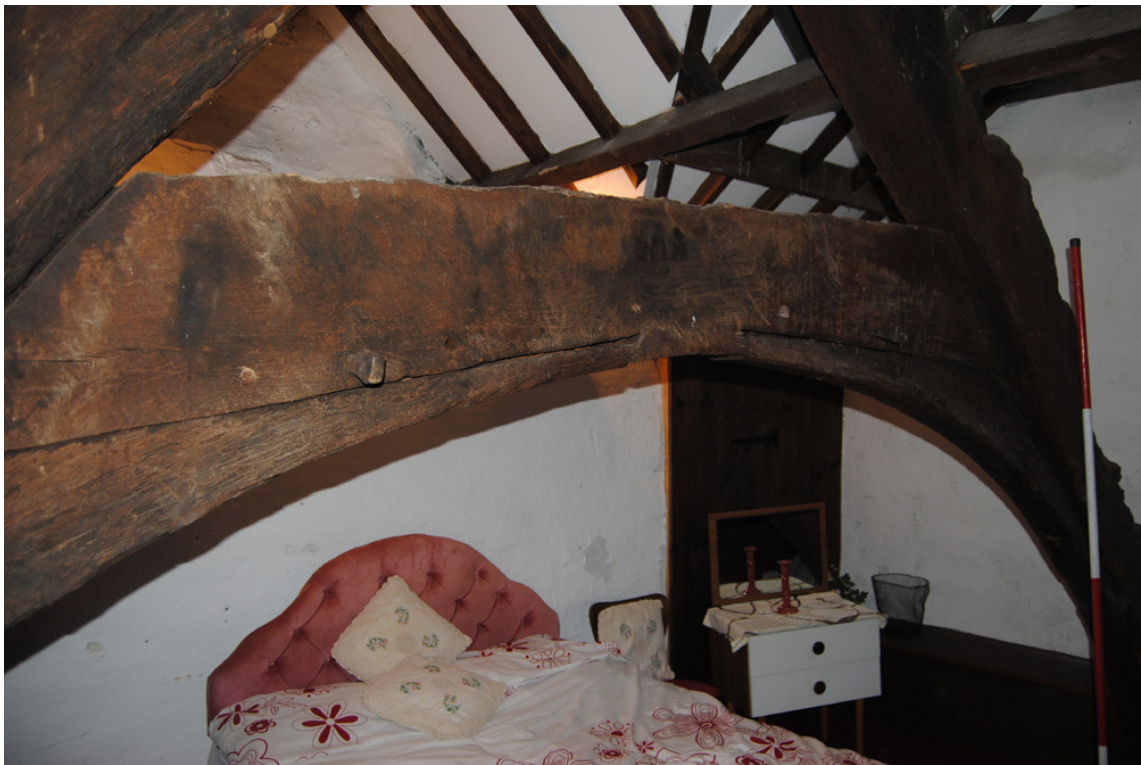
Plate 23: Cranked collar of open cruck truss.

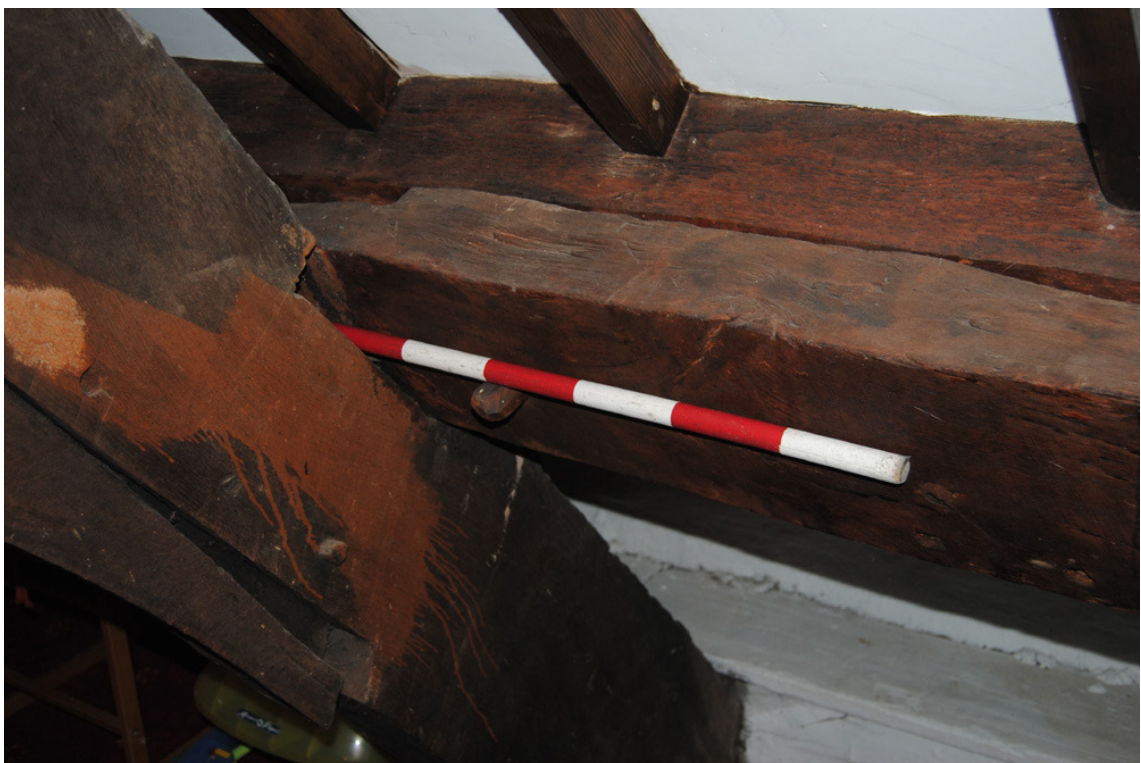
Plate 24: Surviving section of primary lower purlin to SE quadrant of roof structure.

4.2.10 The **roof** was originally carried on two tiers of through purlins though these have for the most part been renewed when the roof pitch was amended; a short section of primary, lower purlin survives to the south-east (Plate 24), this is of 10 x 4½ in. scantling and retains a redundant mortice, double-pegged, for primary longitudinal wind bracing. The purlin was scarfed at the bay division with a stop-splayed joint, single-pegged to the back face of the blade (Figure 6 inset detail **A**; Plate 26). The common rafters of the roof have been replaced throughout though peg-holes within the surviving section of primary purlin suggest original rafters at 16 in. centres.

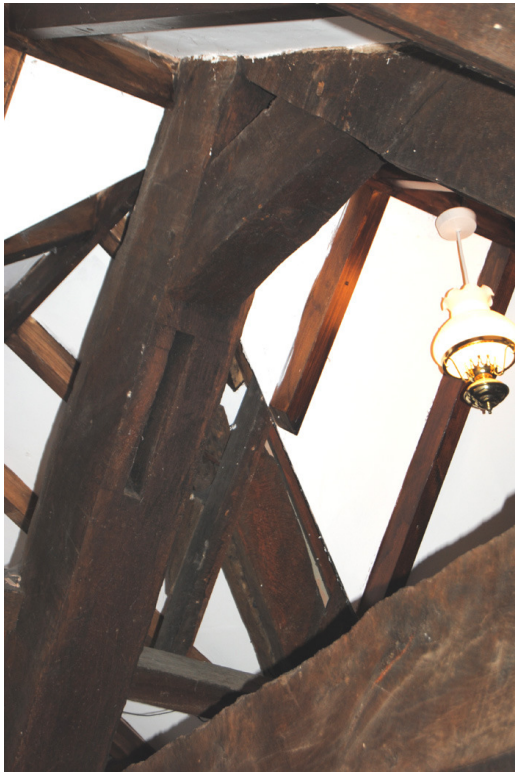
Plate 25: Redundant mortices (unpegged) for v-strutting above collar; note upper yoke.

- 4.2.9 First floor is accessed via the straight-flight stair rising against the north gable end which opens onto a single room [1F01], occupying that section of the range to the north of the inserted stone stack¹² and dominated by the upper section of the open cruck C1 (Figure 6; Plates 21/2). The cruck blades (6in. deep), smoothly curved to the lower section, straighten above the level of the inserted floor, rising as straight members to a vertical joint at the apex (Alcock's 'Type B'; Alcock 1981 95, fig. 49), joined by a slightly cambered, arch-braced collar (Plate 23), triple-pegged to the blades, and a high 'yoke' (Plate 25), the latter single-pegged.

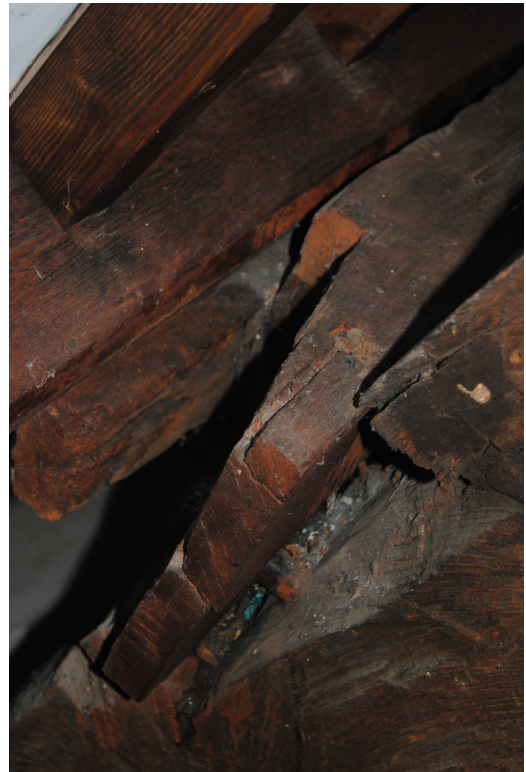
Plate 26: Detail of purlin scarf; splayed with squared abutments, single pegged.

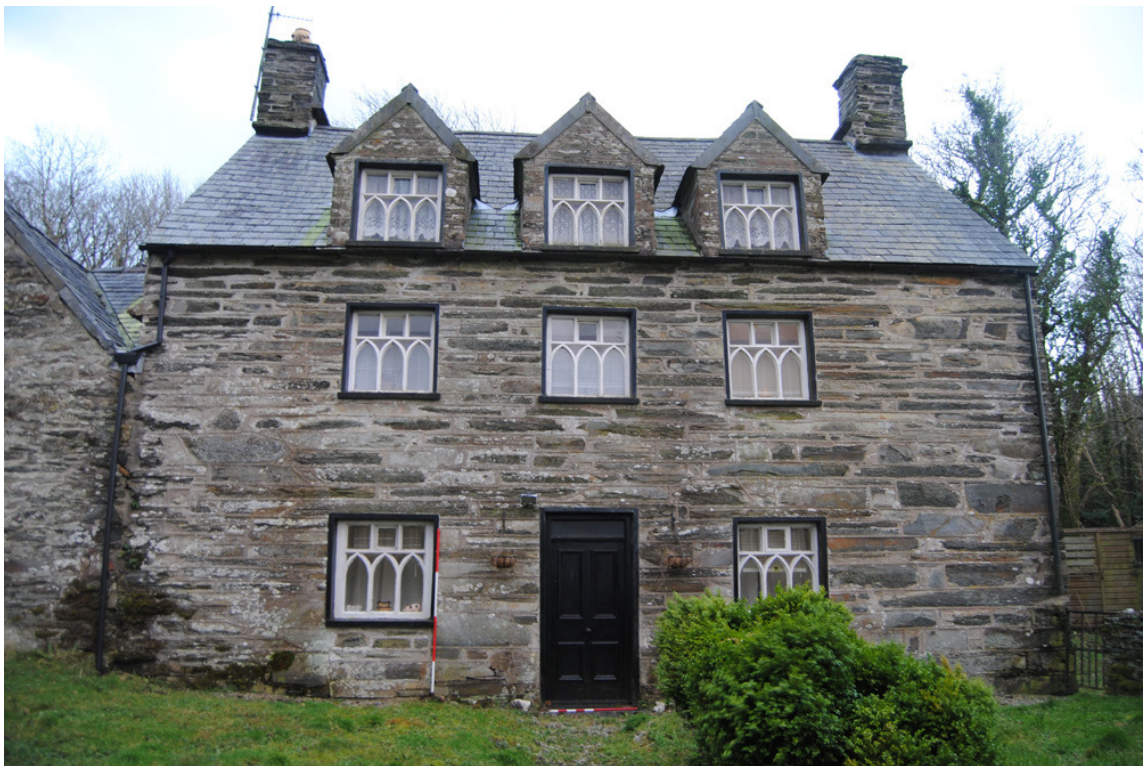
Plate 27: West Range; north elevation.

4.3.2 The **north elevation** (Plate 27) is stone-built of narrow, roughly coursed rubble, strap-pointed, with some longer stones incorporated as quoins and lintels, of two full storeys with attic beneath a pitched, slate-clad roof, gabled to east and west with ridge stacks rising above each gable end. To the east, the elevation is continuous with the north gable of the east range, the junction of the two ranges being marked by an irregular straight joint. The fenestration is of three regular, closely spaced window bays grouped together and slightly off-centre to the east. At ground level, a central 6-panel door is flanked by square window openings housing distinctive three-light casements with transoms and 'gothic' two-centred lower lights beneath three small, square panes. Similar windows light the first floor and attic storeys, the latter within closely set gabled dormers. Straight joints extend beneath the jambs of the eastern ground floor window indicating a former door (Plate 28).

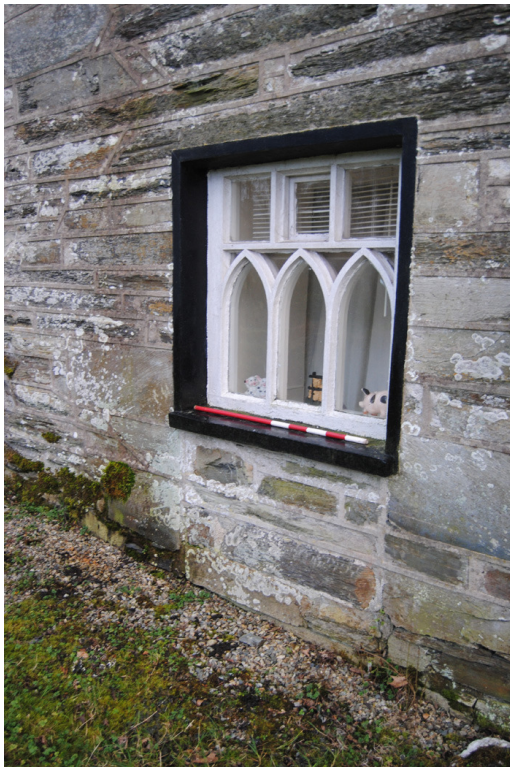
Plate 28: Eastern window with SJs beneath cill.

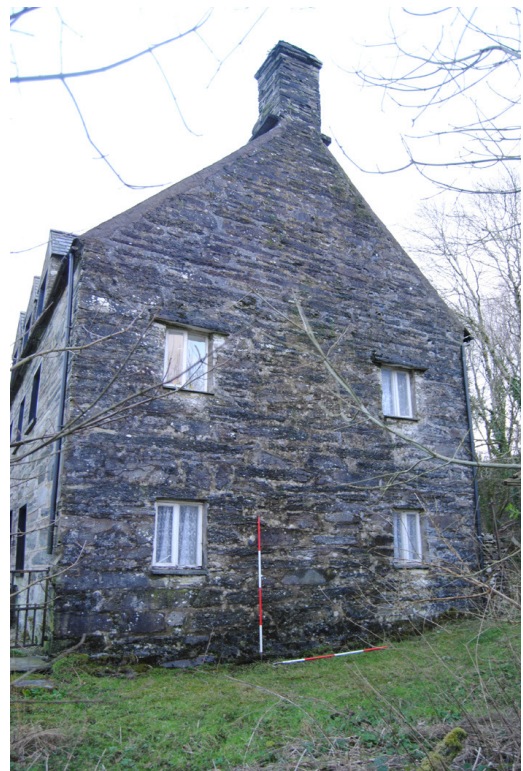
Plate 29: West Range; west elevation

4.3.4 The **west elevation** (Plate 29) presents a tall, wide gable of stone rubble construction, capped by a ridge stack and with simple square window openings housing two-light timber casements, two each to ground and first floor level to either side of the central stack. The **east elevation** is effectively obscured by the eastern range.

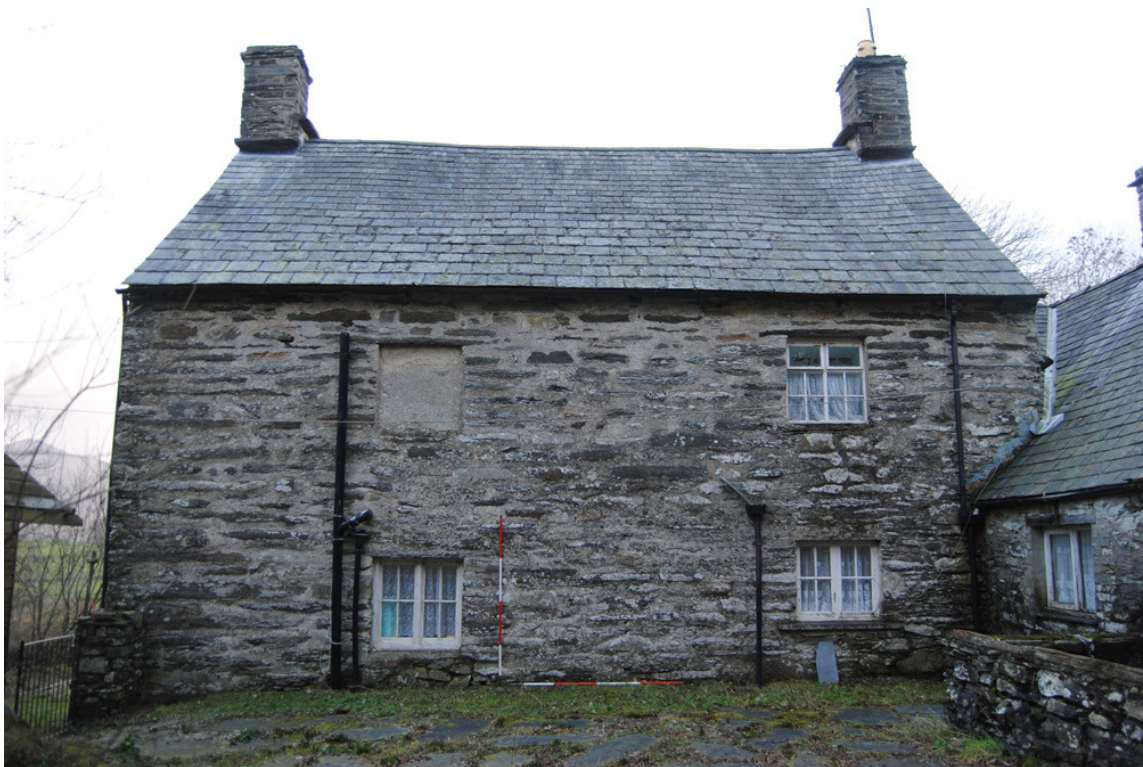
Plate 30: West Range; south elevation.

4.3.3 The **south elevation** (Plate 30) is of stone rubble construction rising to two full storeys beneath a pitched, slate-clad roof with ridge stacks to east and west. Two, widely spaced window openings housing two-light casements light the ground floor, repeated at first floor level, though here the western (left hand) opening is blocked. To the east, the range abuts the earlier east range.

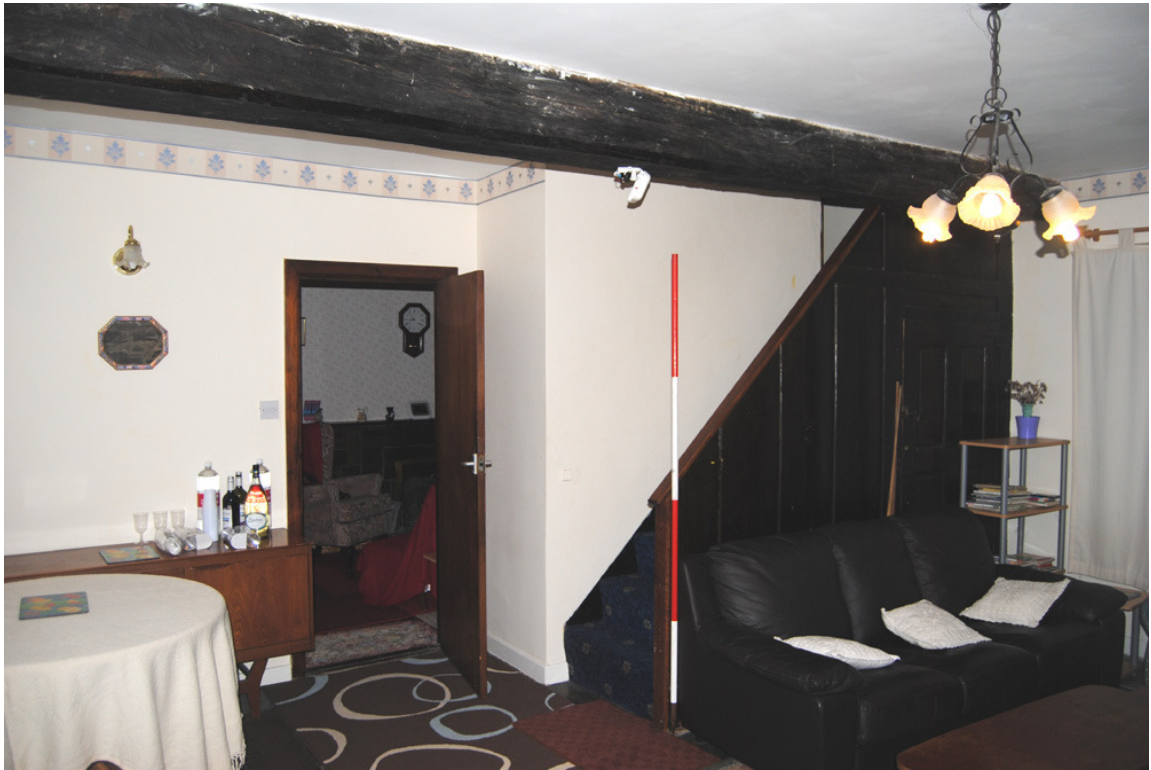
Plate 33: West Range; Room [GF07] looking south-east.

- 4.3.6 A dog-leg stair rises from north to south against the eastern side of central bay (Plate 33); the carcass of the stair appears modern, though the lower flanking wall facing onto room [GF07] is framed and includes a five-panel door with raised and fielded panels (Plate 35), serving an understair cupboard and hung on L-hinges (Plate 36) of a form popular from the early 18th century (Hall 2005, 53; fig. 2.74a).

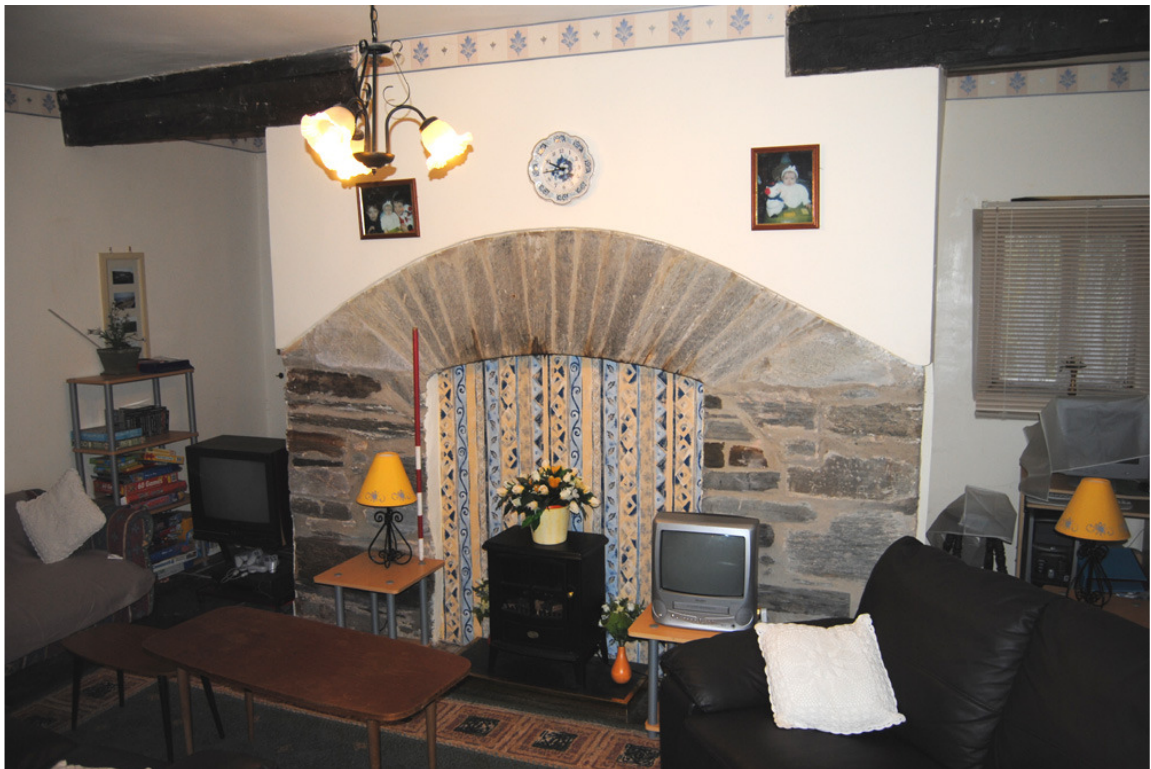
Plate 34: West Range; Room [GF07] looking west.

- 4.3.5 The **west range** is accessed via the principal doorway set slightly off centre to the west of the north elevation and, internally, via a doorway opening off the west side of the eastern range. The interior has been much altered and the primary layout is difficult to ascertain. **Ground floor** level (Figure 7) is subdivided by modern stud walls to form two principal spaces ([GF06] and [GF07] to east and west respectively), though a three-bay plan is indicated by two substantial (10 x 10in.) primary transverse ceiling beams, 1½ in. plain chamfered, unstopped; both ceiling beams display signs of fire damage, particularly the western beam visible within [GF07]. All windows are set within splayed reveals with integral window seats (Plate 32), except the north-east opening within [GF06] where perpendicular jambs extend to ground level; external straight joints beneath cill level indicate that this opening was formerly a door (Plate 31). Gable fireplaces heat the ground floor rooms, that to the west being furnished with a flat arched, stone voussoired head (Plate 34).
