North West Wales Dendrochronology Project Ty'n Llwyn, Llangar, Denbighshire

**EAS Client Report 2009/17
December 2009**

A report commissioned by The North West Wales Dendrochronology Project in partnership with The Royal Commission on the Ancient and Historical Monuments in Wales (RCAHMW).

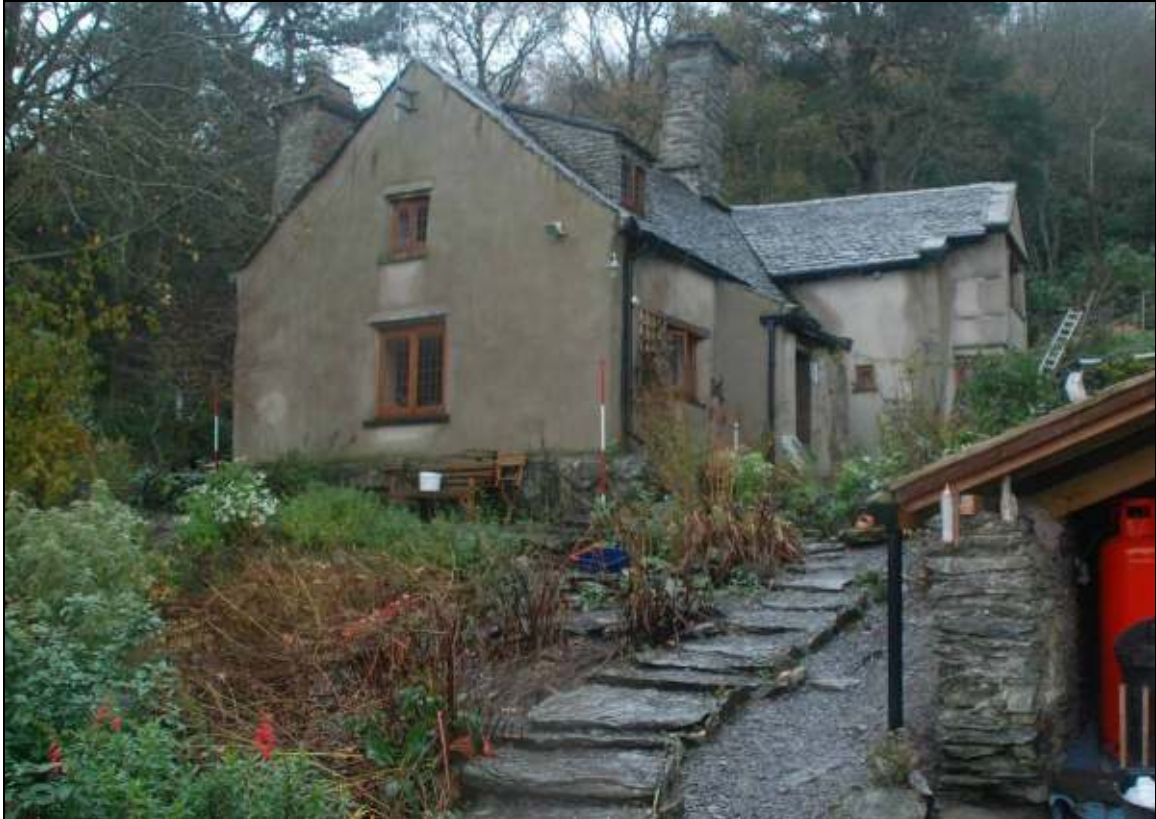
Plate 2: Ty'n Llwyn looking NE

Externally the house appears to be a storey and a half range running at right angles to the hillside with a short wing on the northern side (Figure 2, Plate 2). The walls are rendered, although small areas of exposed walling on the southern side of the property would suggest that they are constructed of randomly built stonework. The roof is covered by small slates and there is a tall central chimney projecting from the ridge. This chimney has a noticeable lean to the west (Plate 3). A secondary chimney protrudes from the southeast corner of the property. There are also a series of gabled and external dormer windows in the upper storey on both sides of the house which are assume to be later additions.

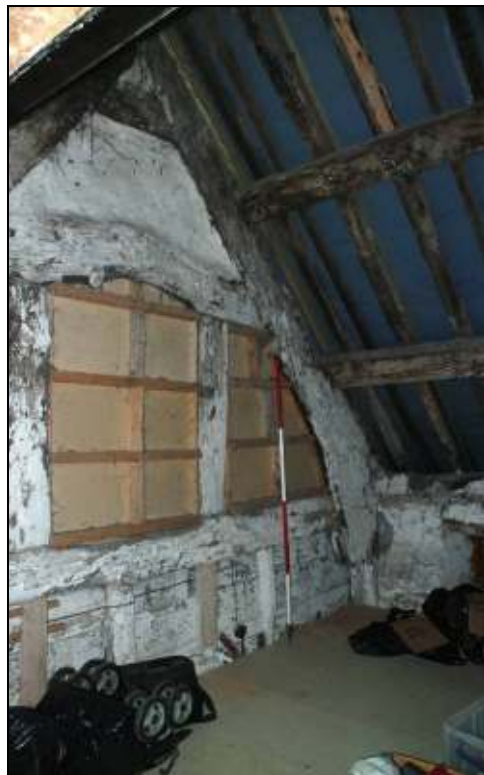
Plate 4: Truss 1 looking NW

Three, probably original, trusses were located within the main range of the building (Figure 2). Truss 1 was exposed, both in a first floor storage room at the west end of the property and in the master bedroom adjacent. The clearest exposure; however, was in the storage room. It consists of a cruck frame with a tie-beam, slightly curved collar and queen struts (Figure 3, Plates 4 and 5). A mortice in the foot of the current extent of the northern principal rafter (Figure 4, Plate 6) may suggest that this sat on a post and therefore could have been a raised cruck. Between the curved collar and a high straight collar, near to the peak of the truss was a panel of white washed lime plaster, assume to be a surviving wattle and daub partition (Plate 7). Two pairs of butt purlins and a ridge purlin were also noted. A series of peg holes along the lower side of the tie-beam mark the positions of a series of studs, presumably from an original partition, now lost. A cut out on the northern principal rafter is assumed to mark the position of a later modification, possibly a partition, now lost (Plate 8).

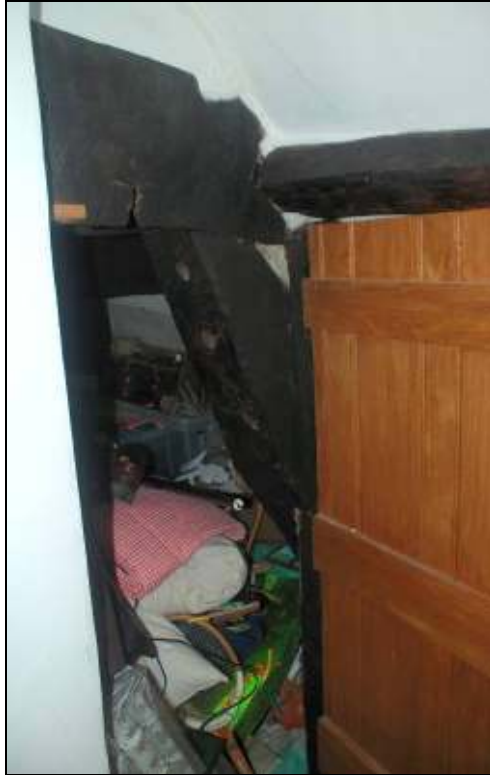
Plate 9: Truss 2, looking NW

There is only limited exposure of Truss 2, in a cupboard off the north side of master bedroom (Plate 9). It extends over the front of the main chimney breast. It is assumed that the chimney was inserted against this pre-existing feature.

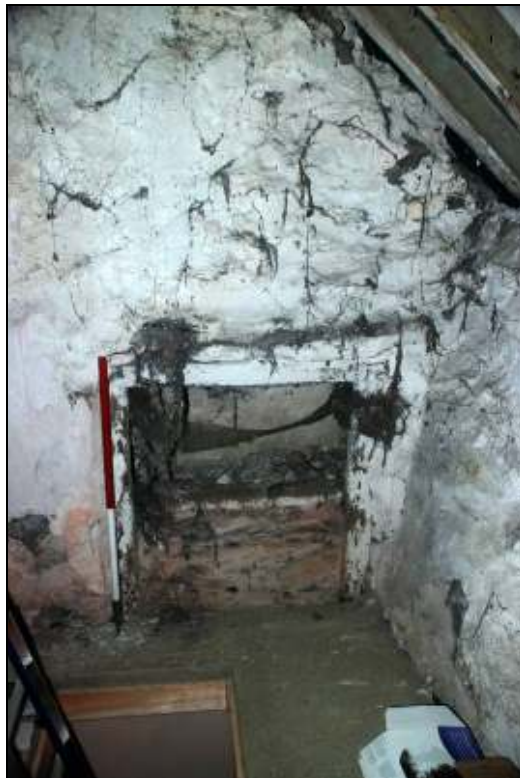
Plate 10: Blocked opening in western gable end, looking east.

Truss 1 sits above two posts which appear to be replacements. On both sides are iron pintels, presumably recording double doors below this truss at some point. Probably related to these pintels are two blocked openings in the gable wall (Plate 10) which appear to be agricultural in nature. Below the tie-beam of the truss are a series of three wide planks supported by modern wooden studs and jointed by an iron fishplate.

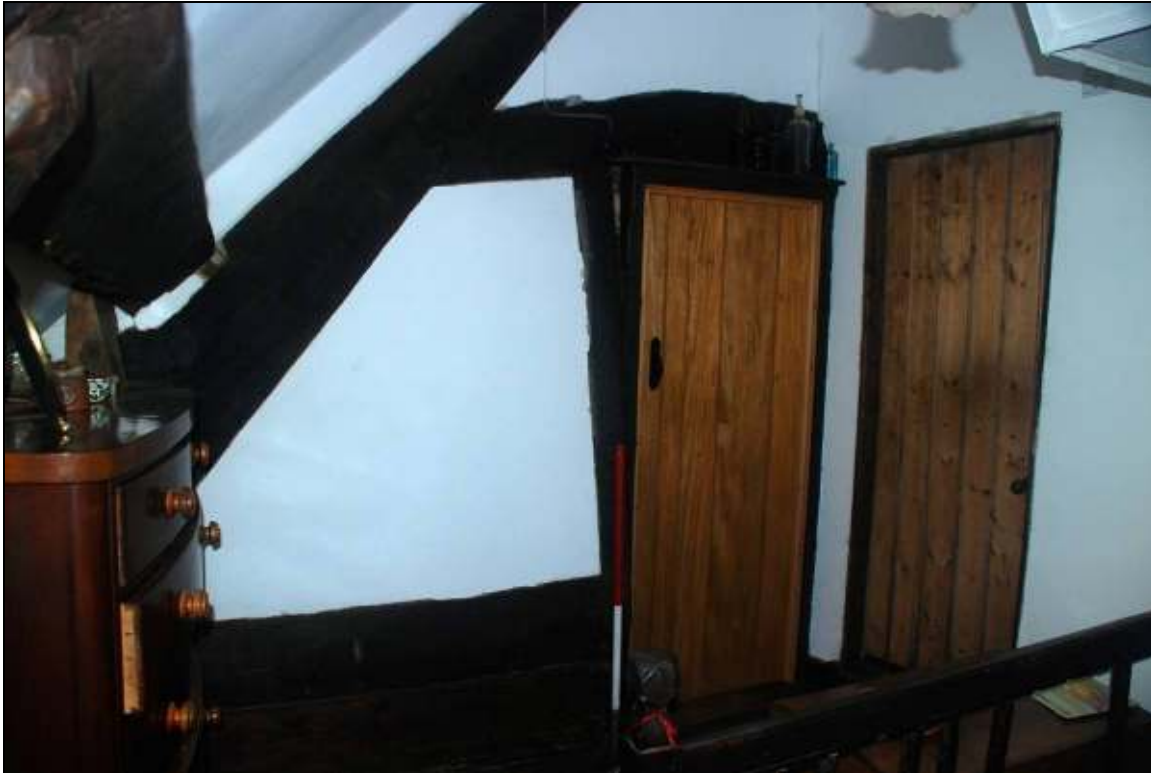
Plate 11: Truss 3 looking west.

Truss 3 appears to mark the western side of the cross passage, separating the hallway from the kitchen (Figure 3). The principal rafters have a slight curve at their base suggesting they may have been cruck frames (Plate 11). Once again there is a tie-beam and a slightly curved collar. The queen struts have been damaged by the insertion of a door, below the collar and between the queen struts. The relationship between the tie-beam the southern queen strut and the underlying post has been revealed by the insertion of the door (Figure 4). There is some indication that there have been windbraces linking this truss to the lower purlin in the form of an open socket on the upper surface of the purlin (Plate 12). On the ground floor there is a stud and rail partition on the southern side of the house (Plate 13). The post forming the southern side of the partition has its lower end removed at a height of 0.6 m above the current floor level which has been supported by two short studs supporting a short rail. Peg holes on the post suggest that the main middle rail of the partition may have continued.

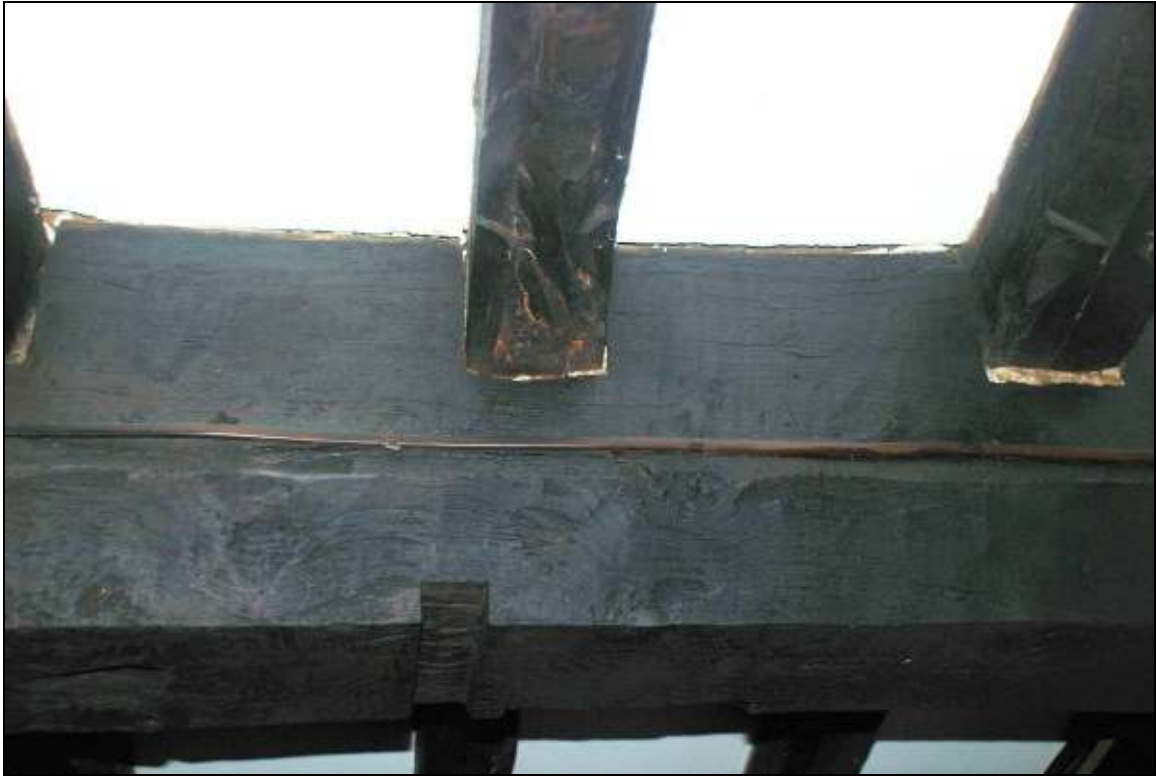
Plate 17: Slot cut in base of ceiling beam, looking west

The chimney and upper floor are inserted into an earlier structure. The fireplace was inserted against the central truss, preserving the probable extent of the original passageway. Graffiti on the side of the fireplace of 1656 presumably gives a *terminus post quem* for the insertion of the fireplace and the upper floor. The floor in the main room consists of a main beam and a series of housed joists (Plate 14). Both the joists and the beam are moderately chamfered (Figure 4) and are stopped at both ends. The beam has flat stops (Plate 15) whilst the joists have stepped stops (Plate 16). A slot cut into the main beam (Plate 17) suggests the position of a temporary division of the room.

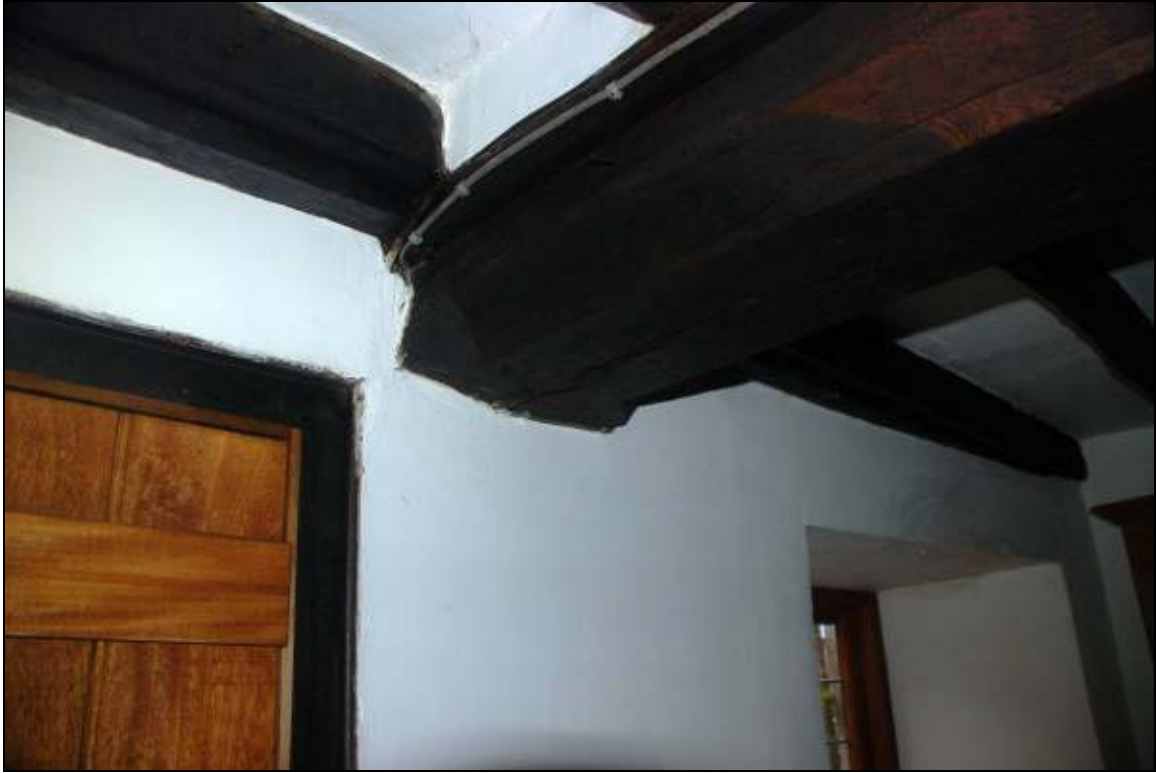
Plate 18: Form of the ceiling beam in the kitchen, looking south

The room currently used as the kitchen also has an inserted ceiling consisting of a central chamfered beam with squared cheek pieces on either side of the beam (Figure 4). Both the beam and the joists have angled run-out stops (Plates 18 and 19). The beam also has a daisy-wheel (Plate 20) inscribed on its eastern side near to the current external door to this room. It is likely that this floor was added in the eighteenth century and may relate to a cupboard door carved with a date of 1735.
